SUPPLEMENT TO STANDARD
OPERATION AND MAINTENANCE
MANUAL

SACRAMENTO RIVER
FLOOD CONTROL PROJECT

UNIT NO. 135

EAST LEVEE OF SUTTER BY-PASS
FROM
THE SUTTER BUTTES SOUTHERLY TO
ITS JUNCTION WITH THE FEATHER RIVER
AND
THE EAST AND WEST LEVEES OF WADSWORTH CANAL
AND
LEVEES OF INTERCEPTING CANALS

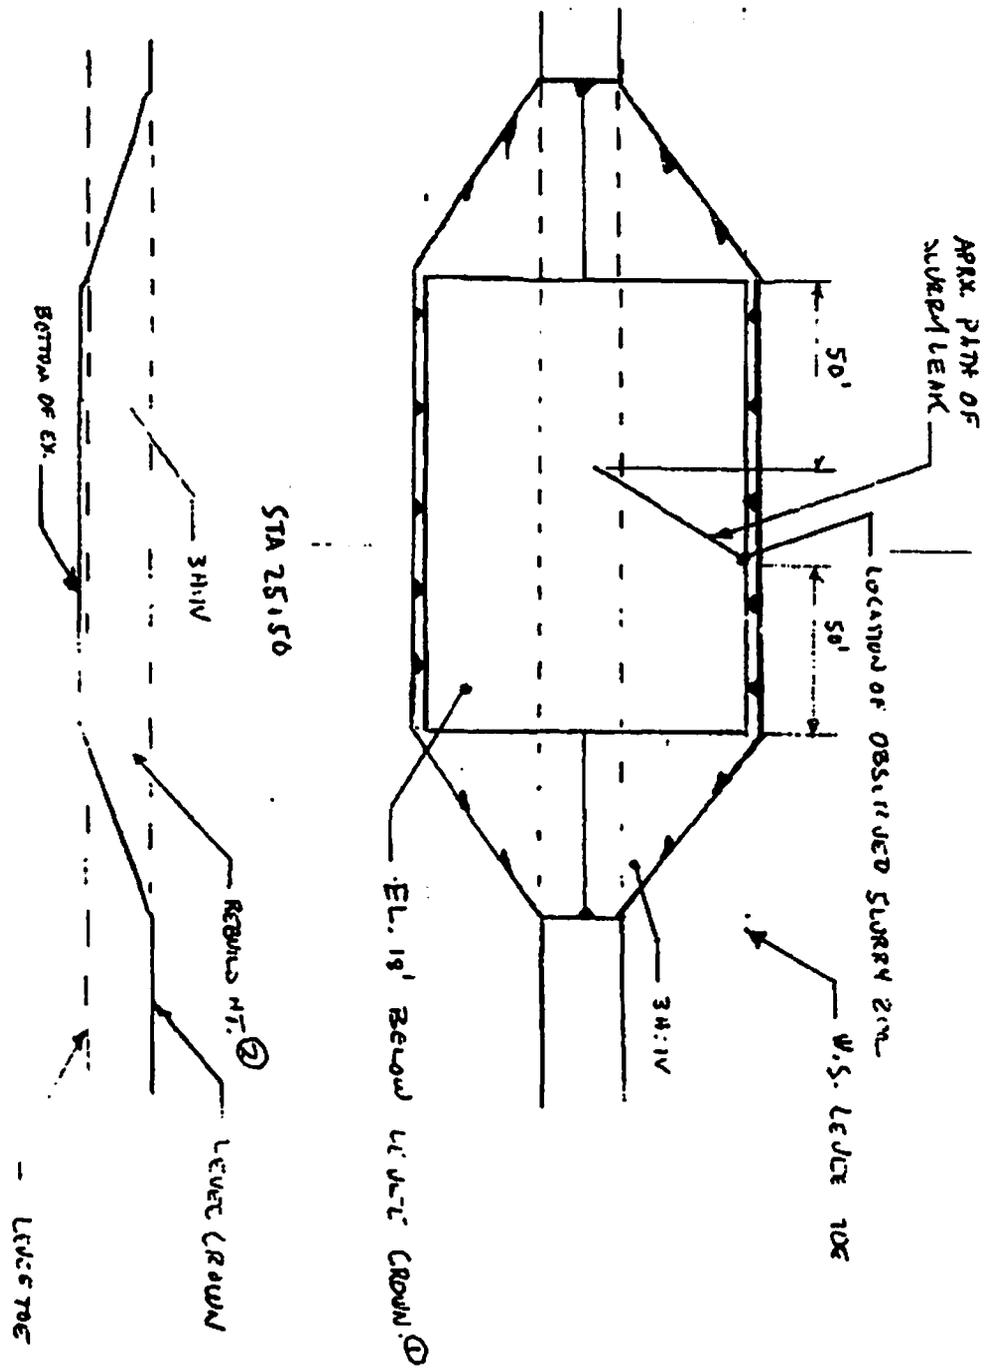
- 1.) FINAL DESIGN TO BE ADDED AND LATER TO BE SUBMITTED BY SOIL DESIGN PERSONNEL.
- 2.) RE-BUILD LEVEE TO 5' ORIGINAL TOP AND INSTALL SLURRY WALL.
- 3.) INSTALL SLURRY WALL (W.P. WALL) AS SHOWN ON PLAN SHEET C-308

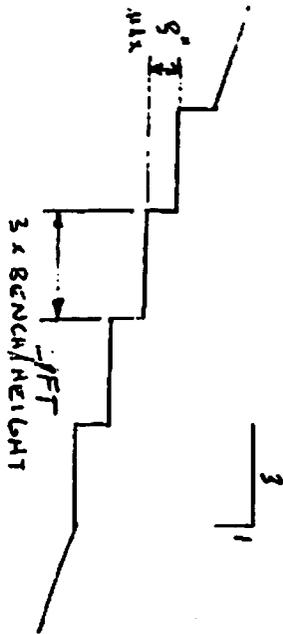
BENCH DETAIL

- CONTRACTOR MAY REMOVE LEVEE MATERIAL PROVIDED THAT ALL CEMENTED SOIL BLOCKS ARE REMOVED AND DISCARDED.
- MAXIMUM PARTICLE SIZE IS 3\" DIAMETER, MAX. DIMENSION.
- COMPACT ALL FILL IN CONFORMANCE WITH ASTM D698 >95% max dens.
- 4% 2/10s OF OPTIMUM MOISTURE CONTENT.
- MAX LIFT DEPTH IS 6 INCHES AS SHOWN ABOVE.
