MARIPOSA DAM  
AND  
RESERVOIR

MAINTENANCE MANUAL  
MARIPOSA PROJECT  
MERCED COUNTY STREAMS, CALIFORNIA

Prepared in the Sacramento District  
Corps of Engineers, U. S. Army  
Sacramento, California, dated 1 April 1952

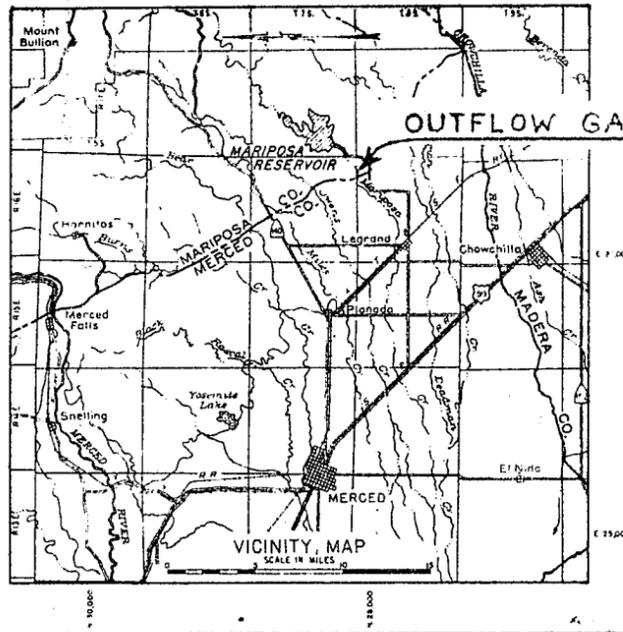
EXHIBIT B-1

OUTFLOW GAGING STATION

GROSS POOL  
ELEV. 439.5

<u>No.</u>	<u>Subject</u>	<u>No. of Sheets</u>
B-1	Key Map of Mariposa Project	1
B-2	Check List (3) - Mariposa Project	5
B-3	Sample Permit Forms and Federal Regulations	3
B-4	Index of Drawings	1
B-5	"As Constructed" Drawings (Unattached)	
B-6	Outlet and Spillway Rating Curves and Area Capacity Curves

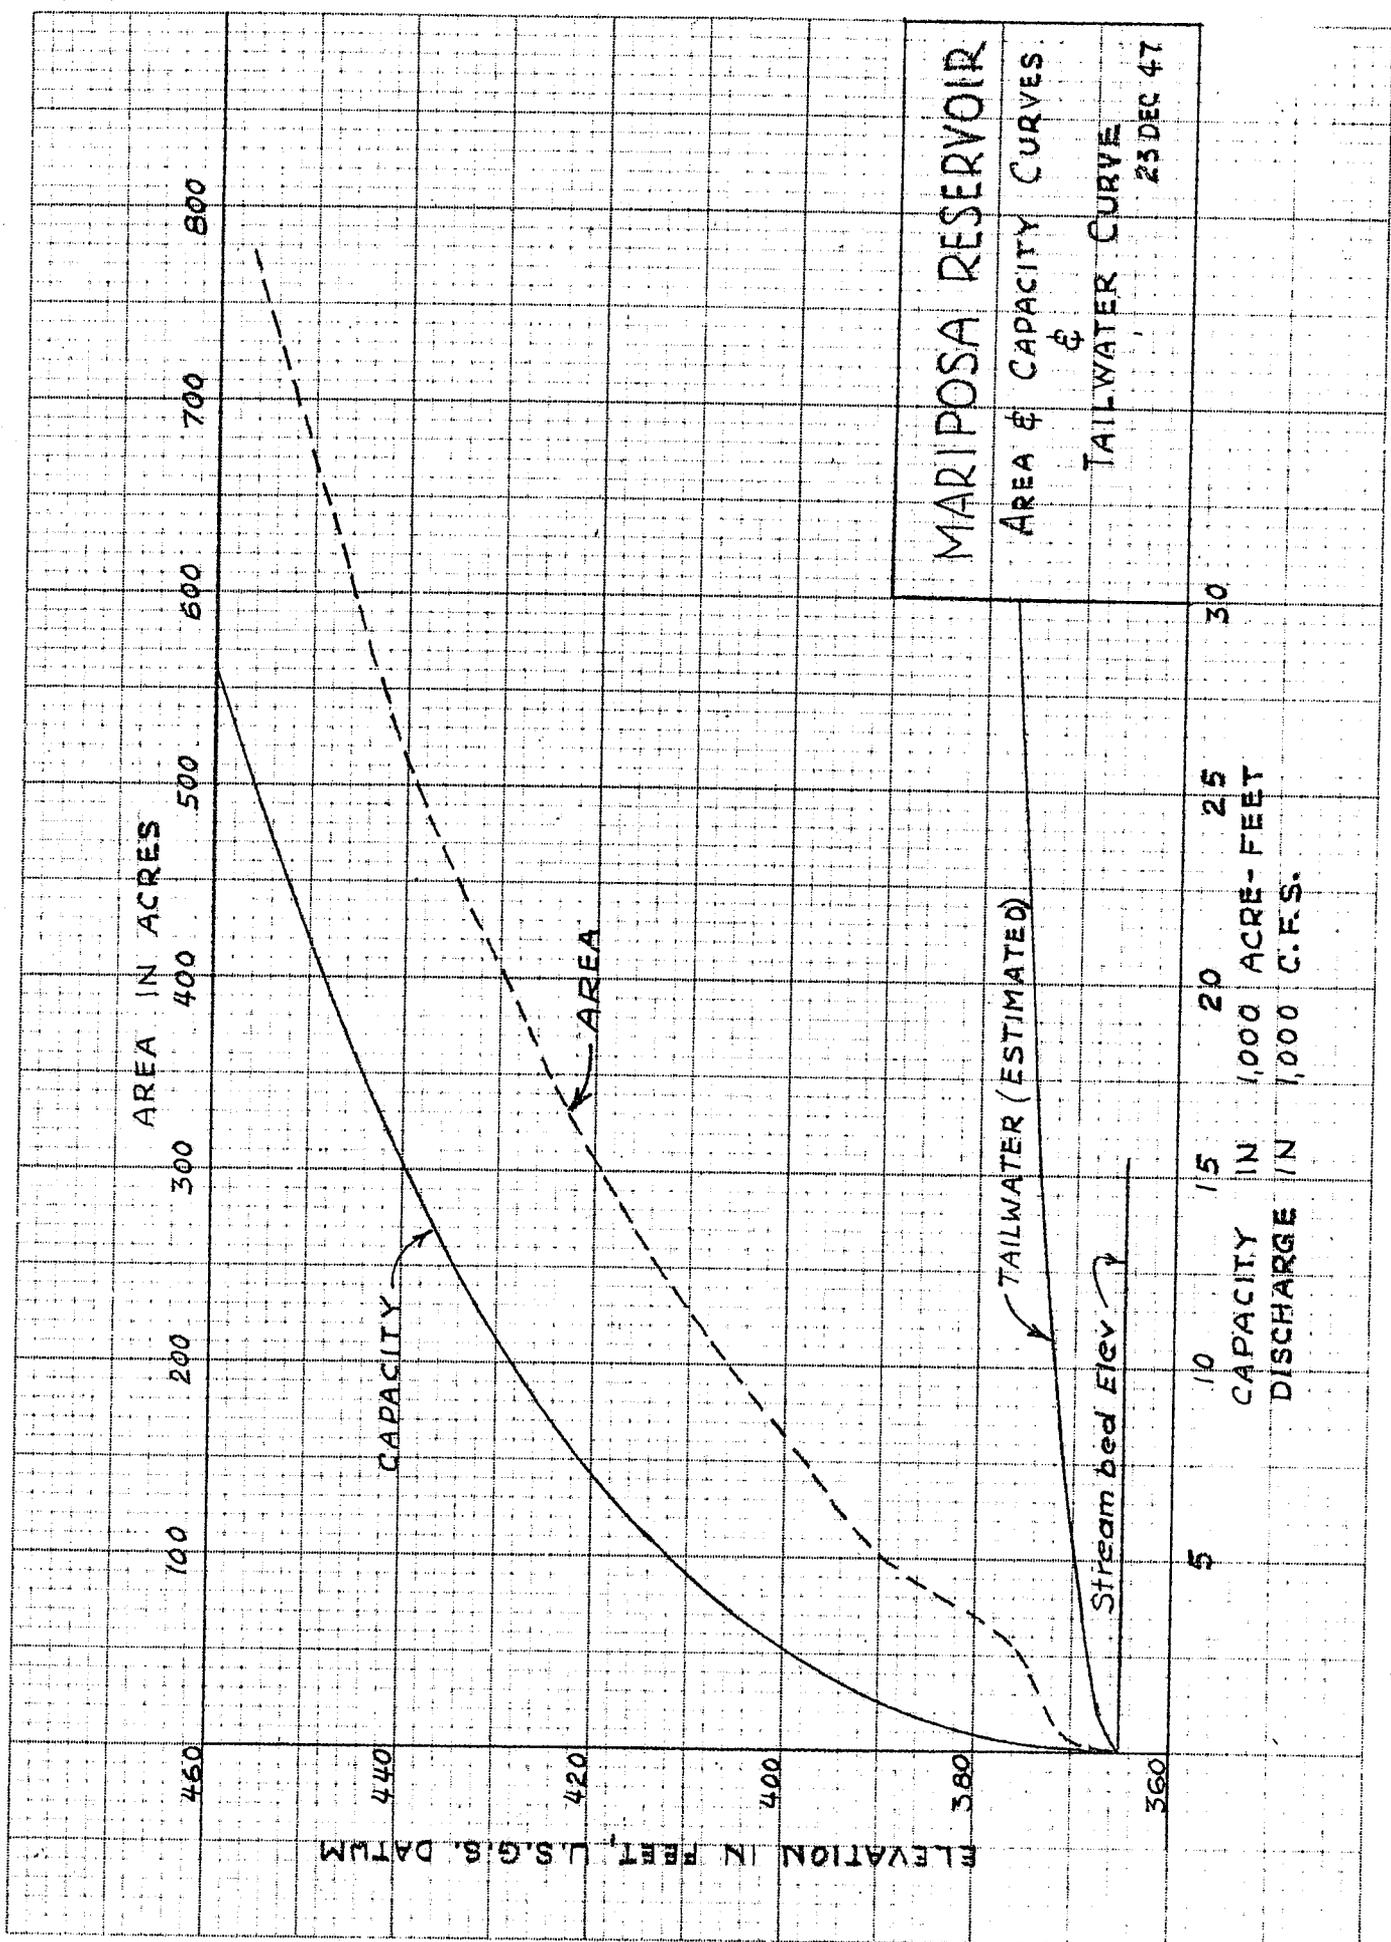
EXHIBIT B-6-1

POOL ELEVATION, N. FEET (U.S. G.S. DATUM)
