OWENS DAM
AND
RESERVOIR

MAINTENANCE MANUAL
OWENS CREEK PROJECT
MERCED COUNTY STREAMS, CALIFORNIA

Prepared in the Sacramento District
Corps of Engineers, U. S. Army
Sacramento, California, dated 1 April 1952

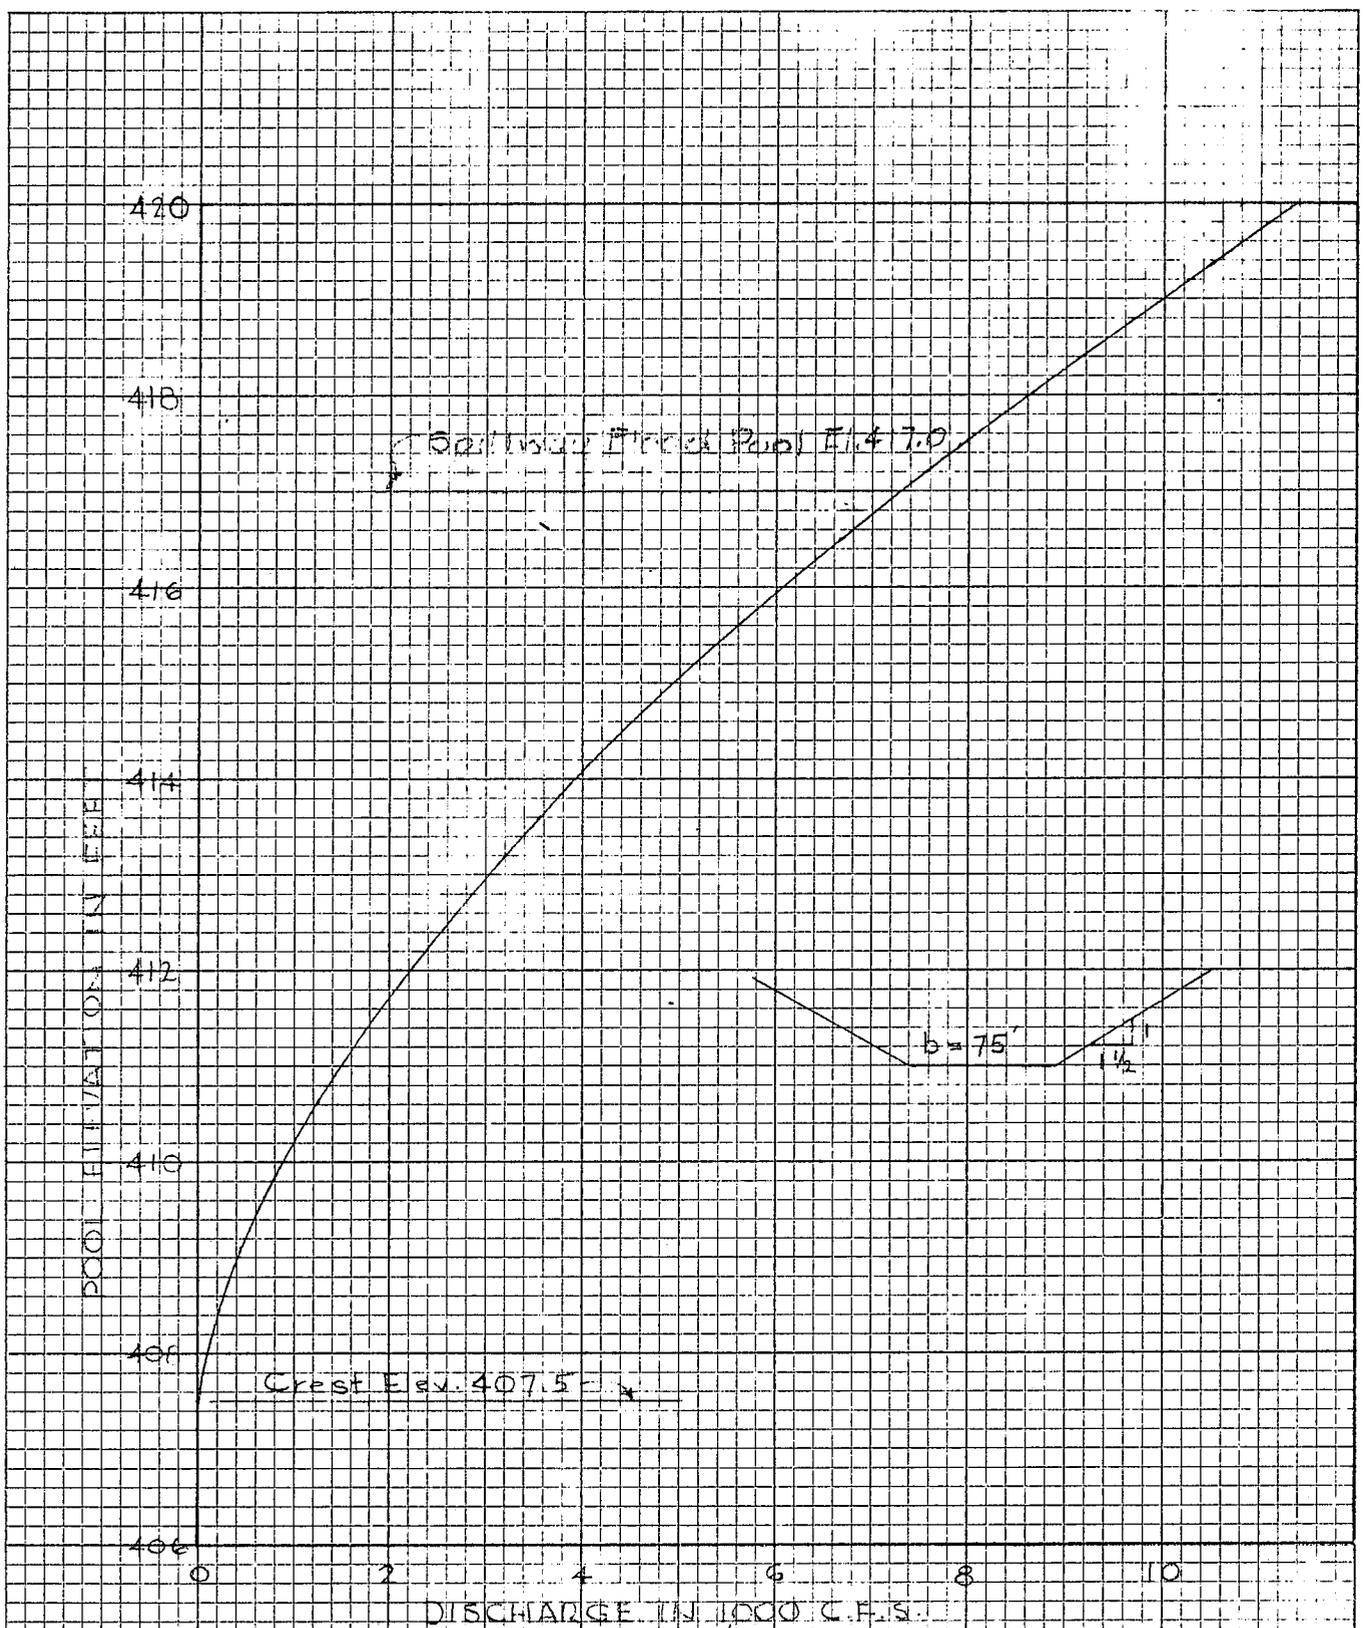
EXHIBIT B-5-2

OWENS PROJECT
BLOOD A.F.

SPILLWAY RATING CURVE

NRH
14 May 1948

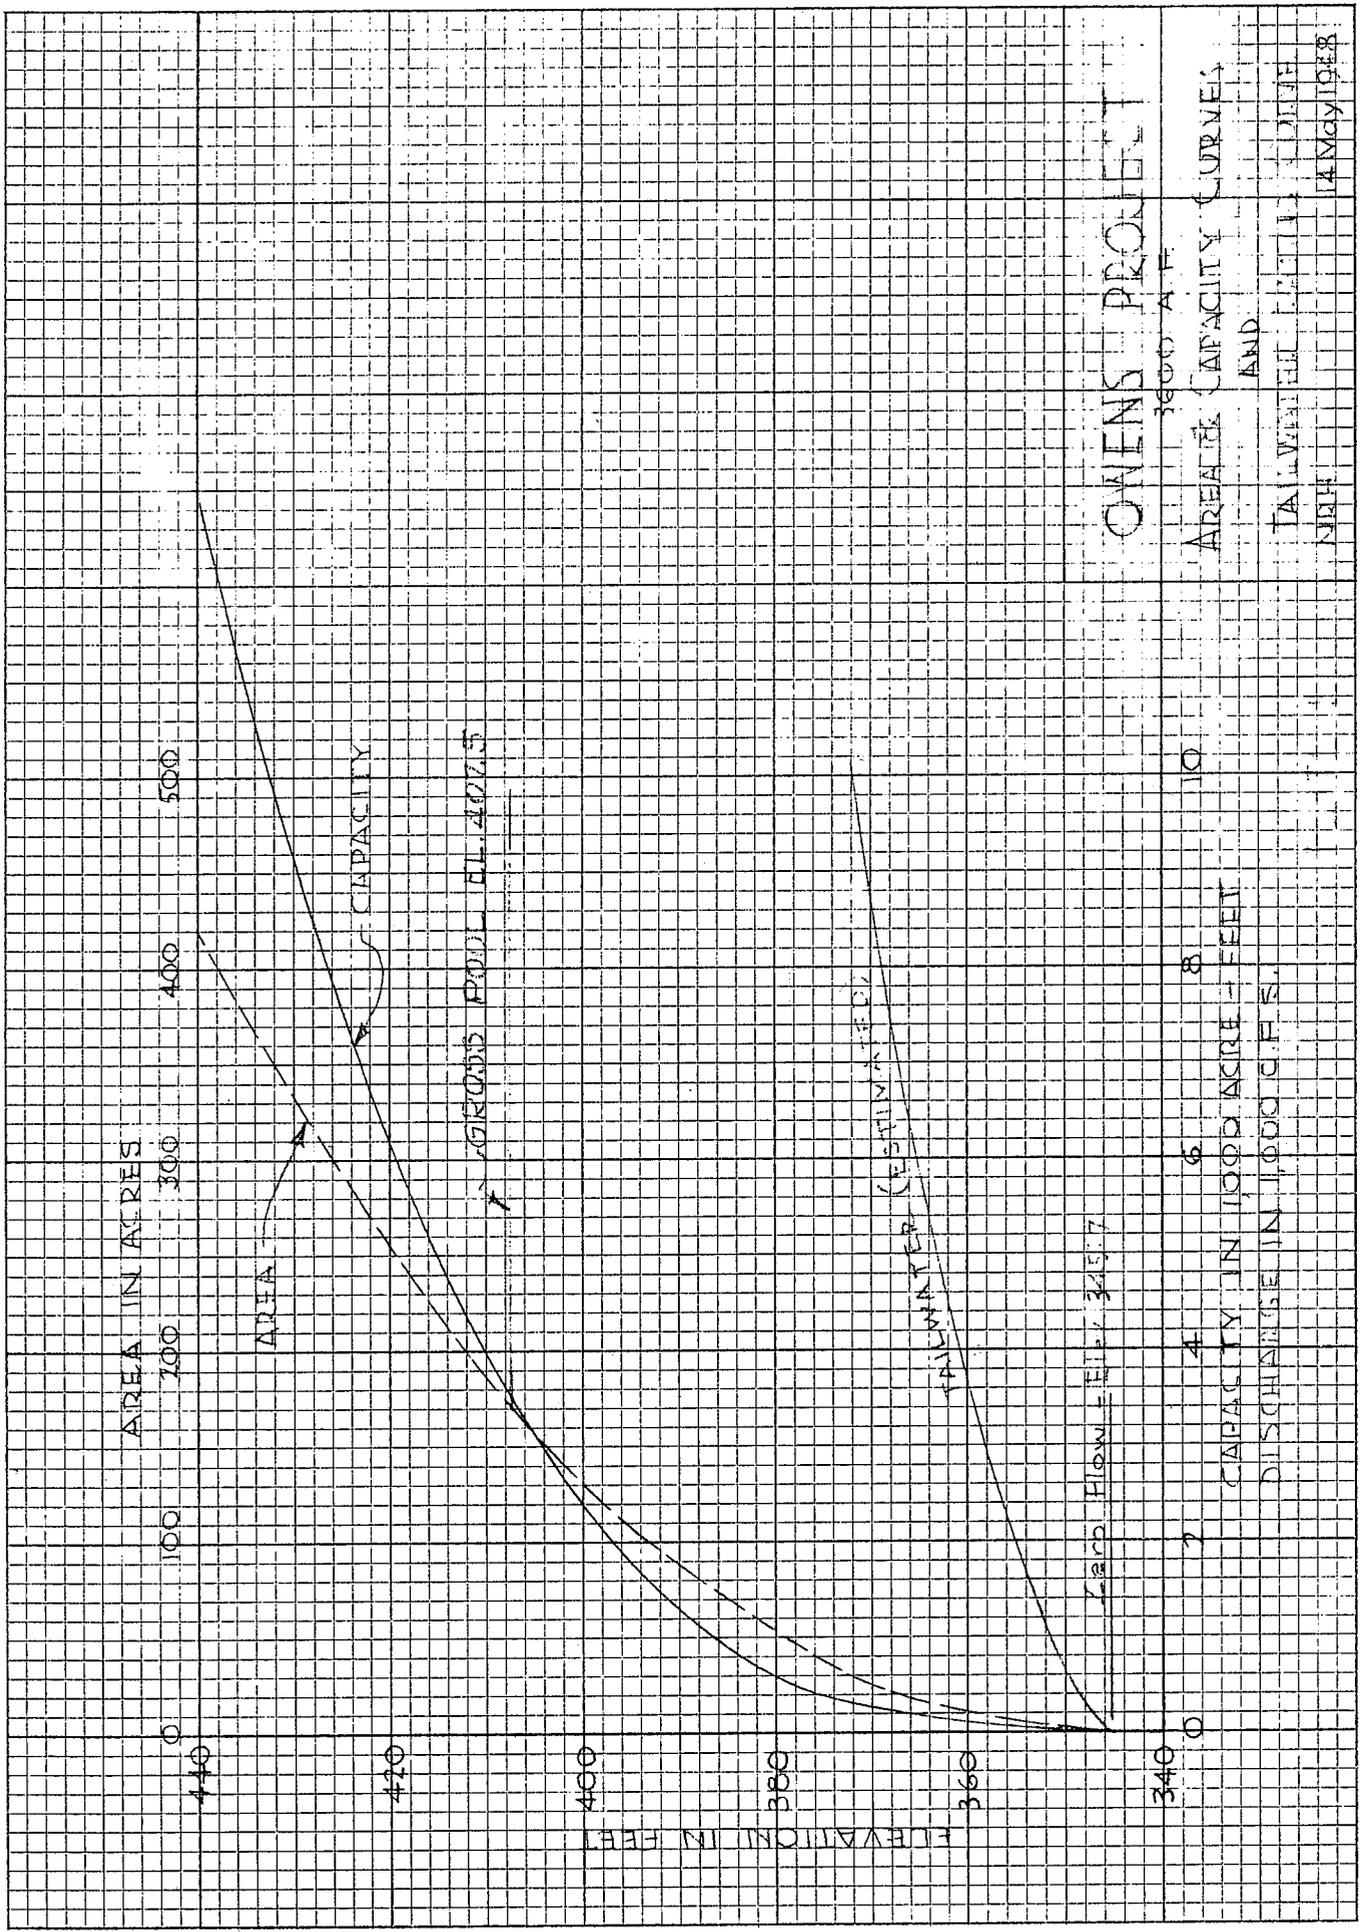
OWENS PROJECT
 3600 A.F.
 AREA & CAPACITY CURVES
 AND
 ESTIMATED RAINWATER
 CAPACITY
