Appendix **A**

Sacramento River Individual Agency Summary Reports

A total of 61 LMAs and 82 local reporting areas for Project Levees/Structures/Channels are included in the Sacramento River Flood Control Project. Appendix A includes an index to Sacramento River System LMAs, a map to show the locations of each reporting area, and individual LMA summary profiles. Appendix A includes:

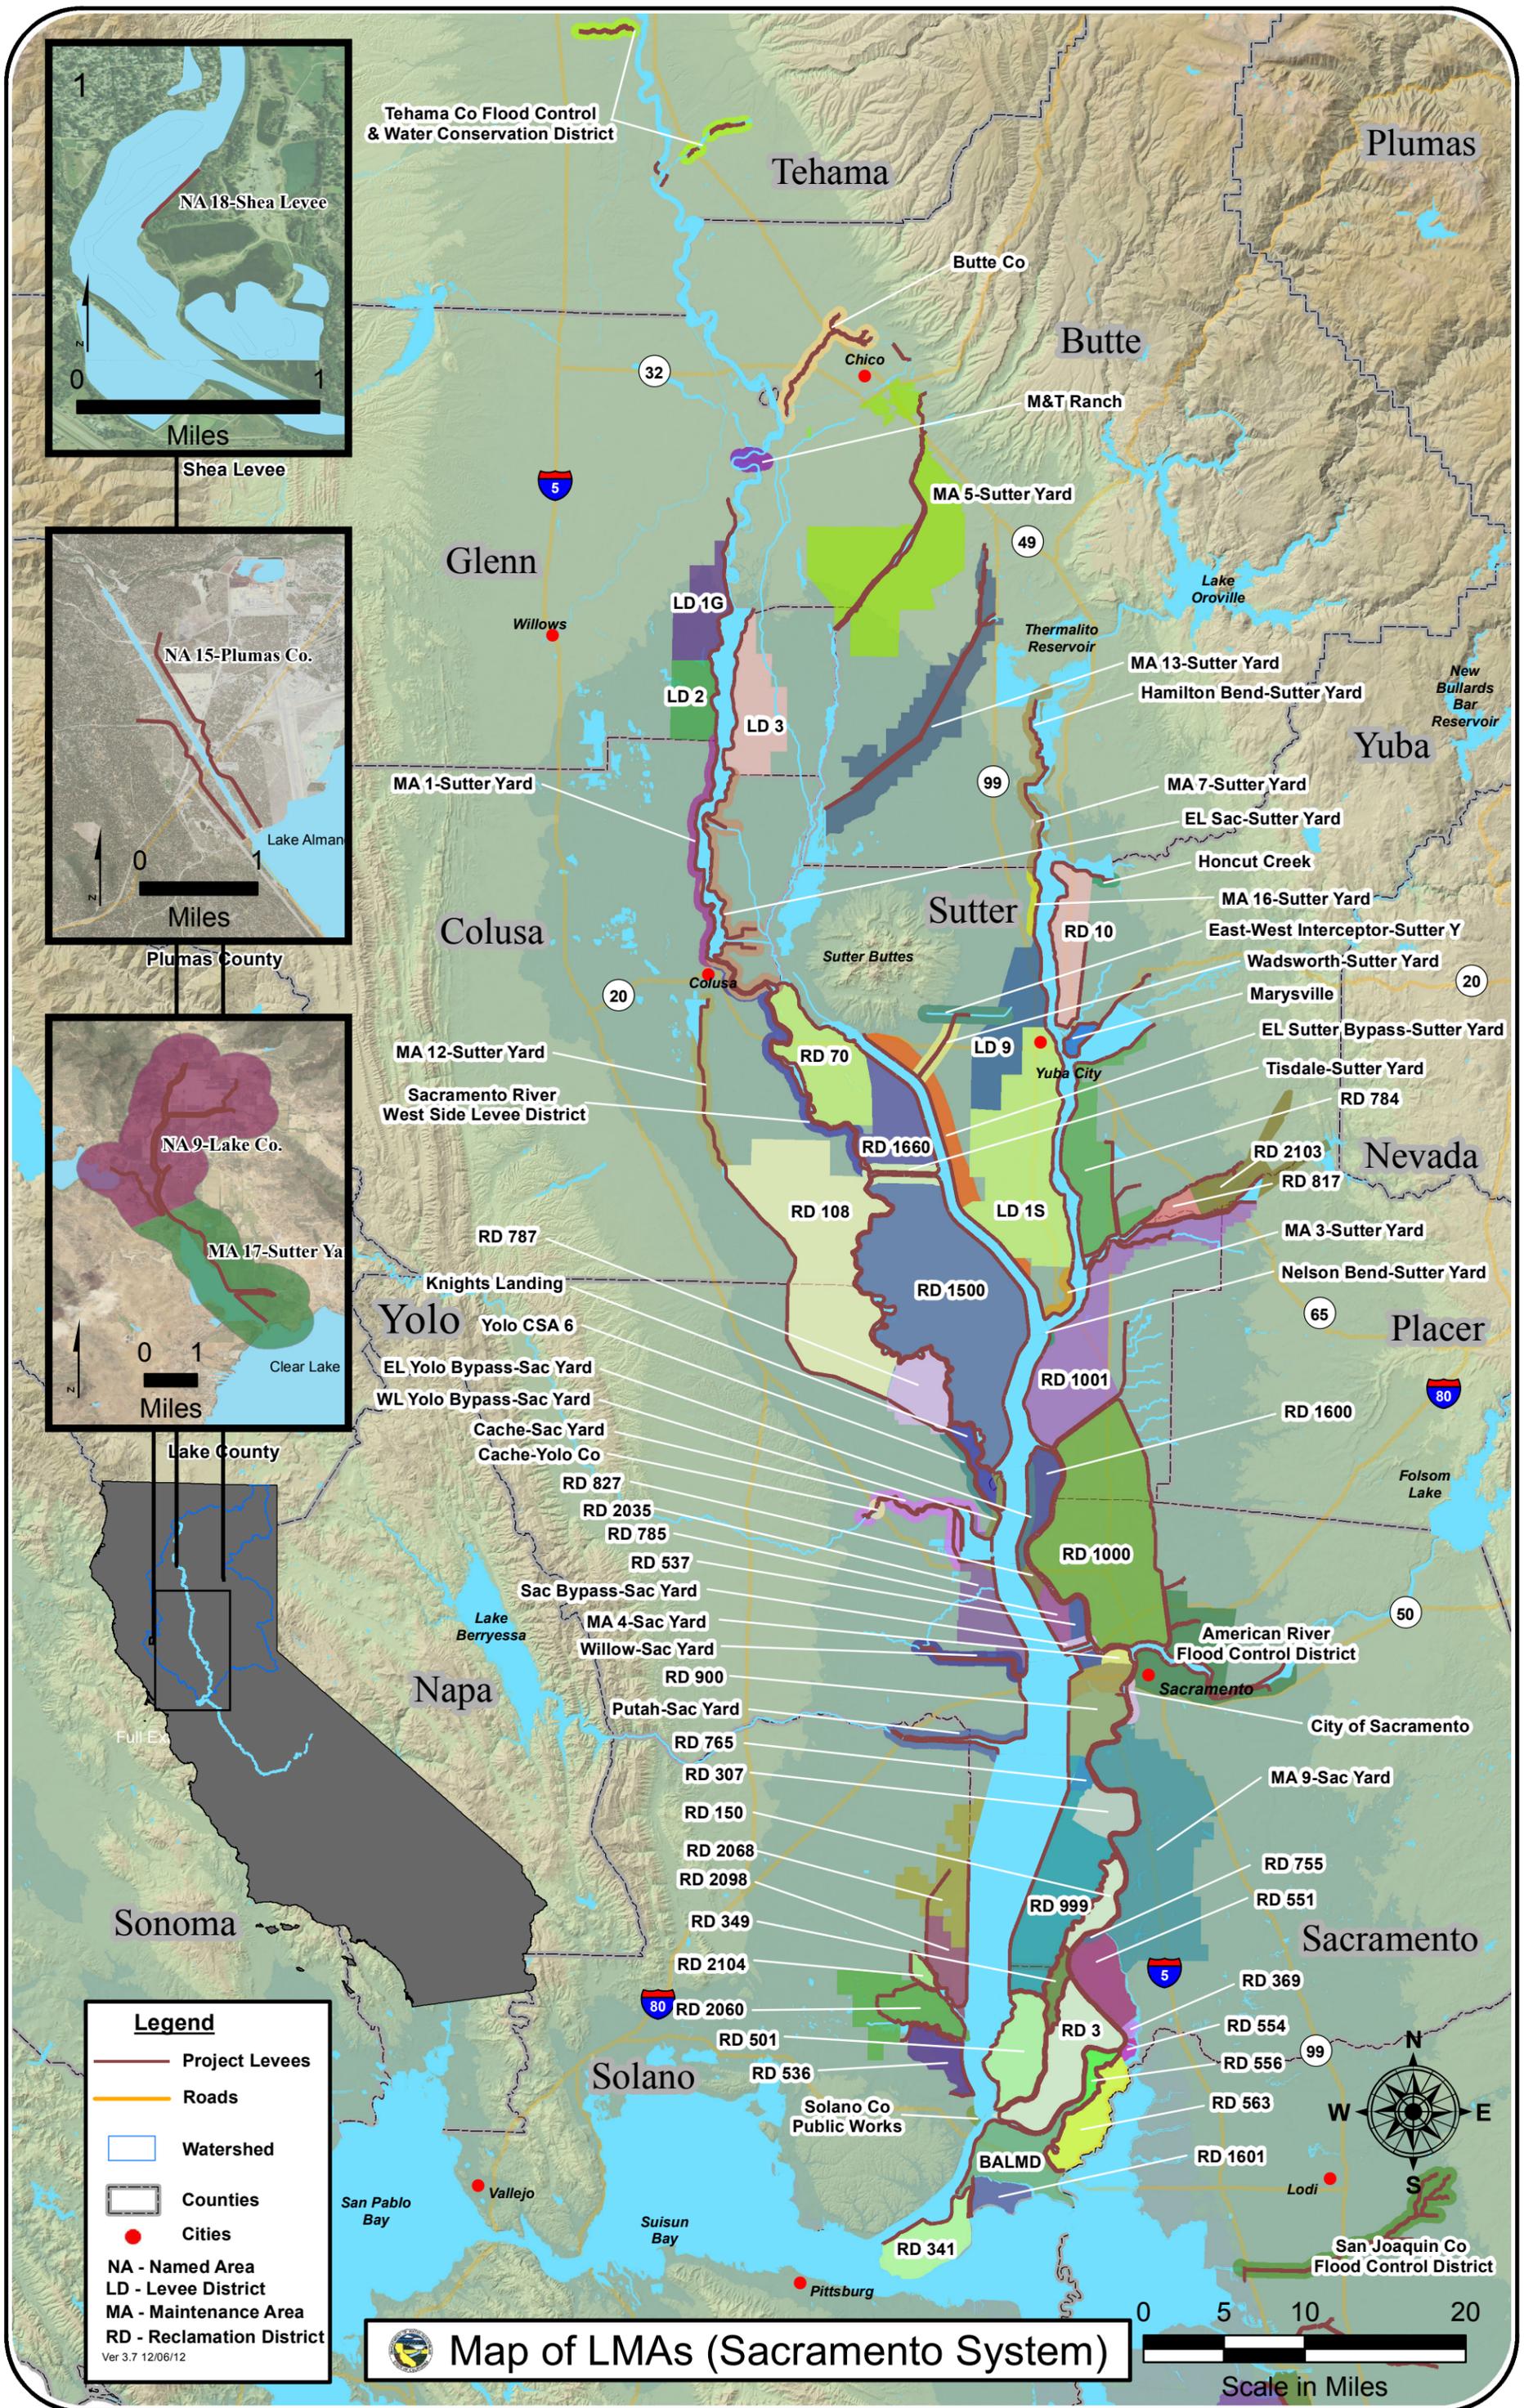
Map of LMAs (Sacramento System)

- Project Levees
- Roads
- Watershed
- Counties
- Cities
- NA - Named Area
- LD - Levee District
- MA - Maintenance Area
- RD - Reclamation District
