**State of California**  
The Natural Resources Agency  
Department of Water Resources  
Division of Flood Management

**2008**  
**INSPECTION REPORT**  
**OF THE**  
**CENTRAL VALLEY STATE-FEDERAL**  
**FLOOD PROTECTION SYSTEM**

**PUBLISHED IN APRIL 2009**

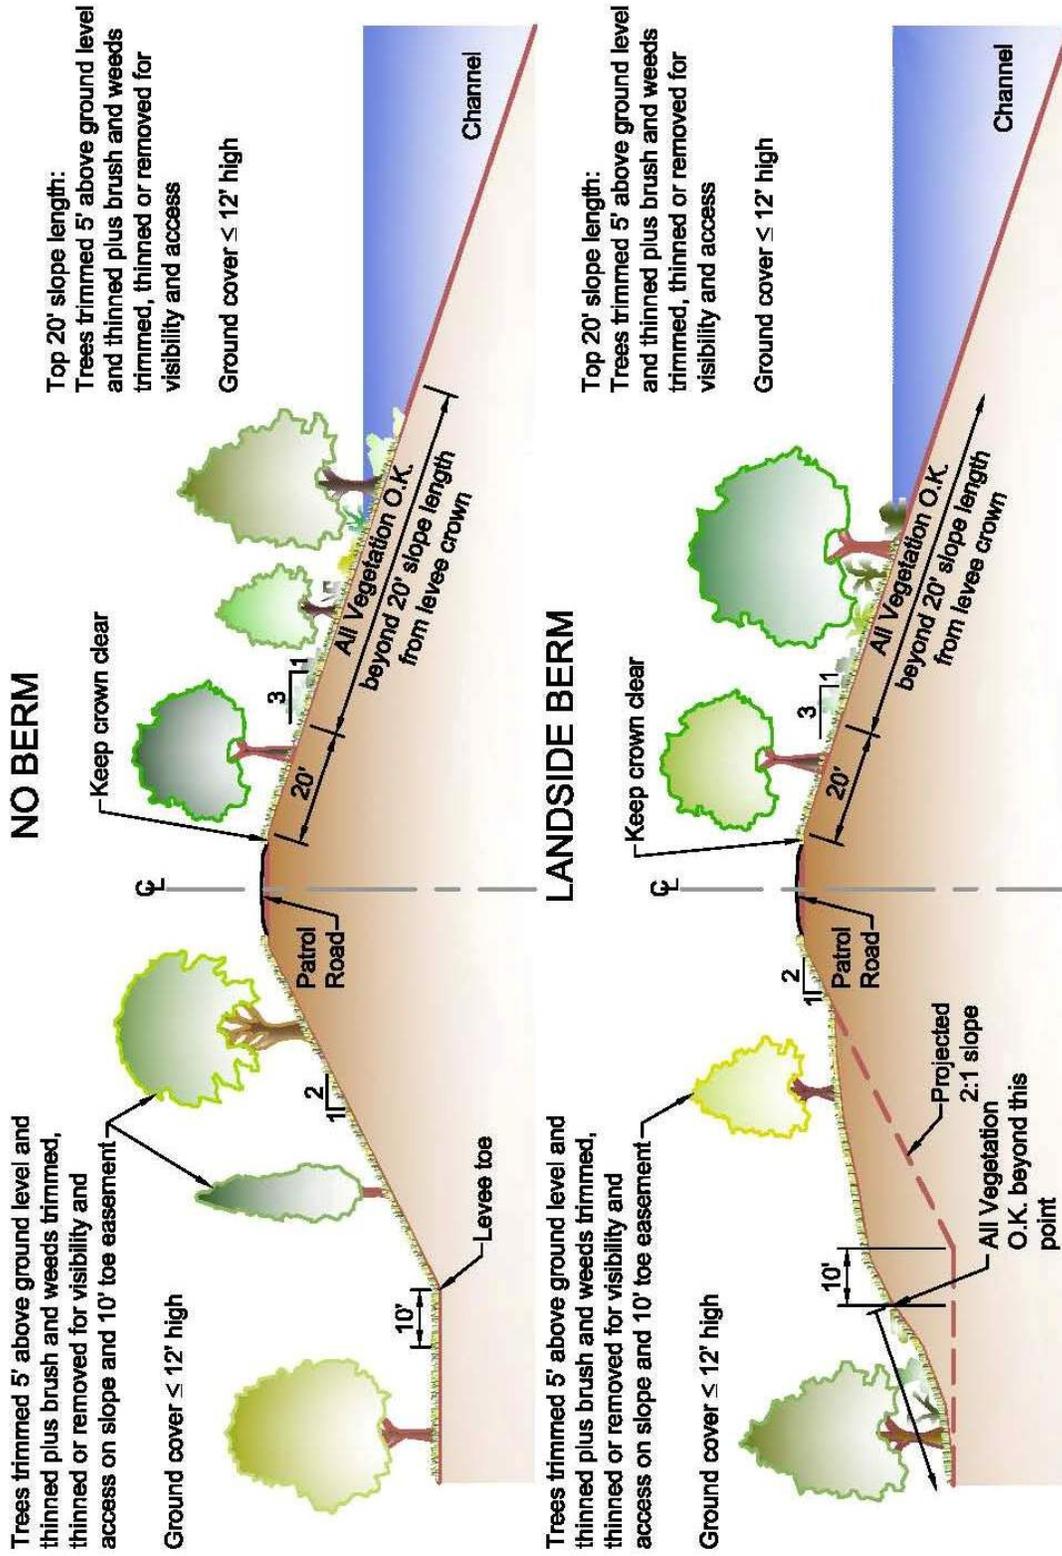
Figure 2-1

# DWR Interim Vegetation Inspection Criteria for Standard Levees, October 2007

These criteria are shown in Figures 2-1 and 2-2. The criteria protect levee operability and integrity by requiring open visibility and access to those portions of the levee most susceptible to high water damage while retaining vegetation that possess both habitat and environmental value and may have a positive effect on levee integrity. These criteria may change as the Central Valley Flood Protection Plan is developed.

obstructions. An un-maintained band of vegetation is allowed anywhere beyond 20 feet (slope length) from the waterside hinge (intersection of levee slope and crown – see Figures 2-1 and 2-2).

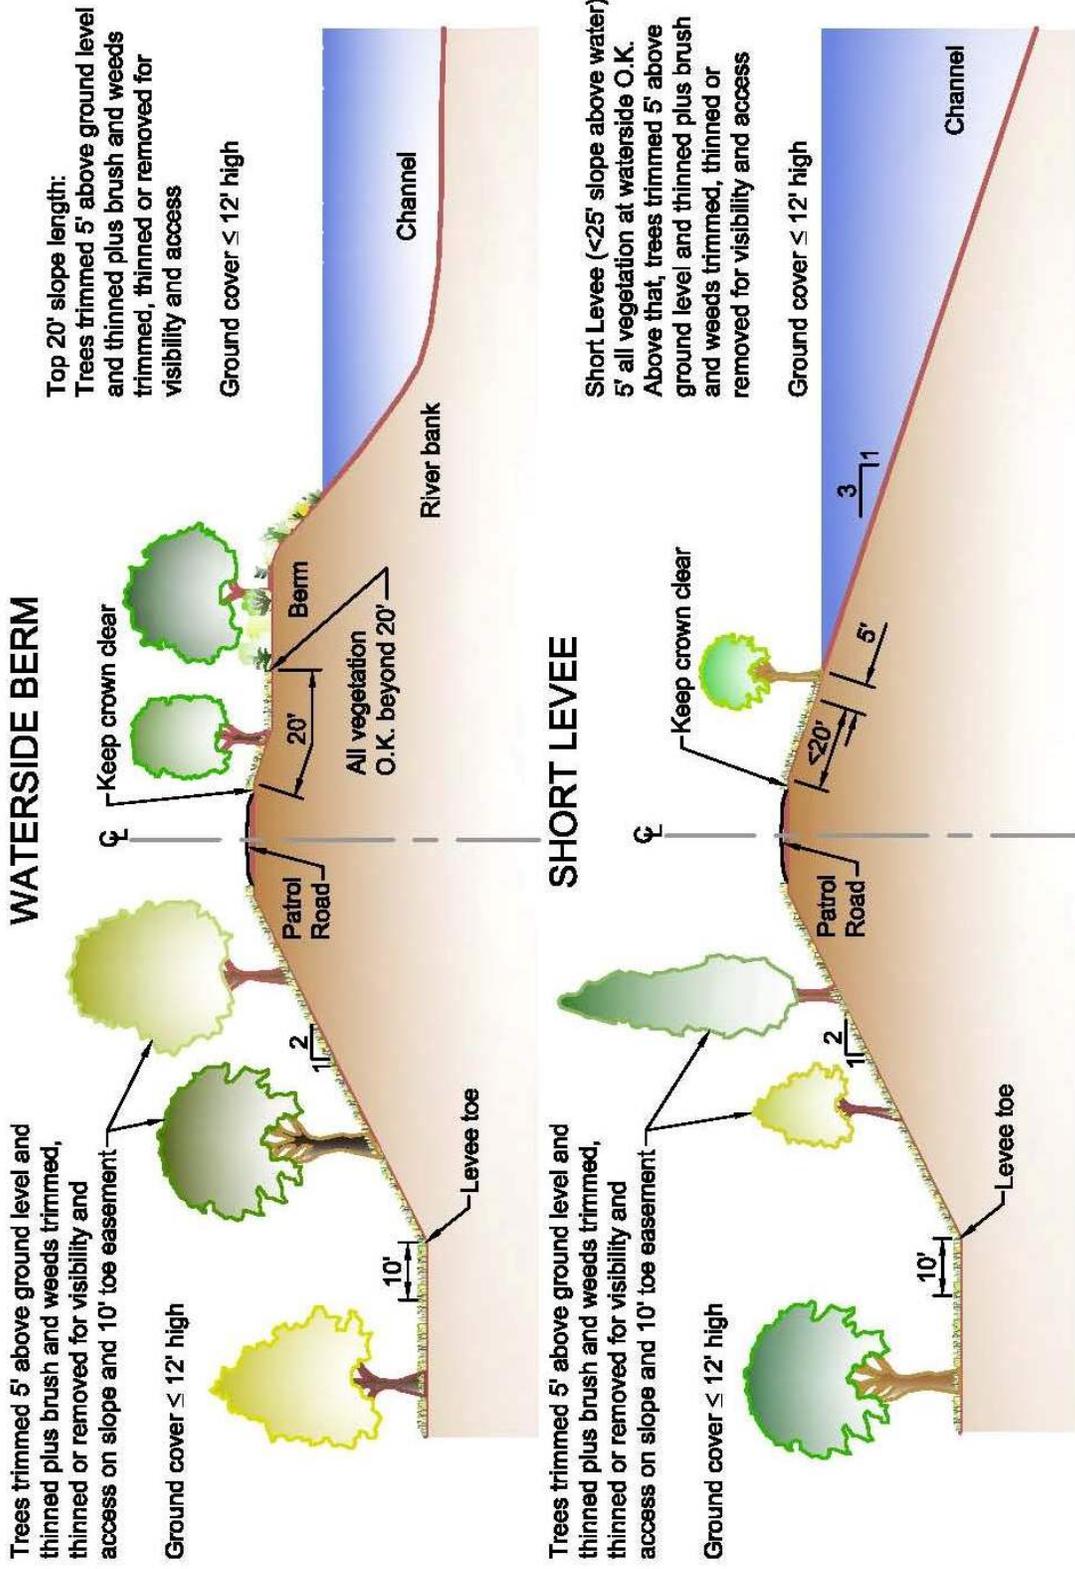
Figure 2-2

# DWR Interim Vegetation Inspection Criteria for Standard Levees, October 2007

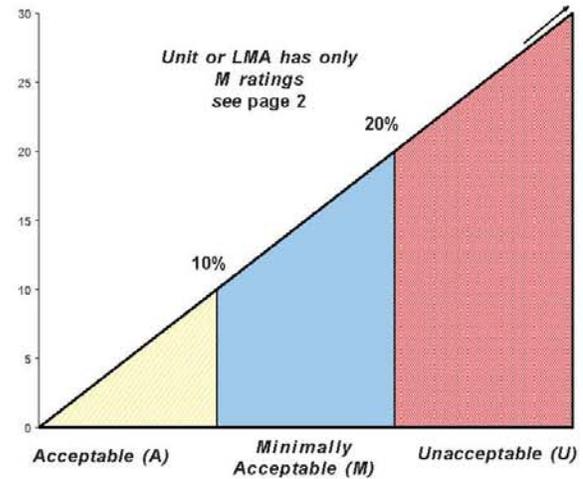
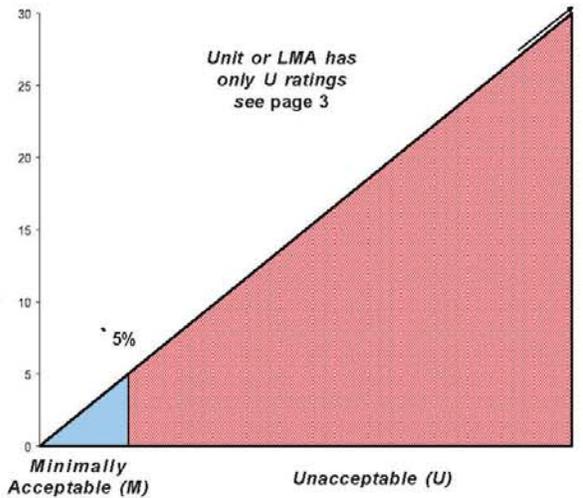
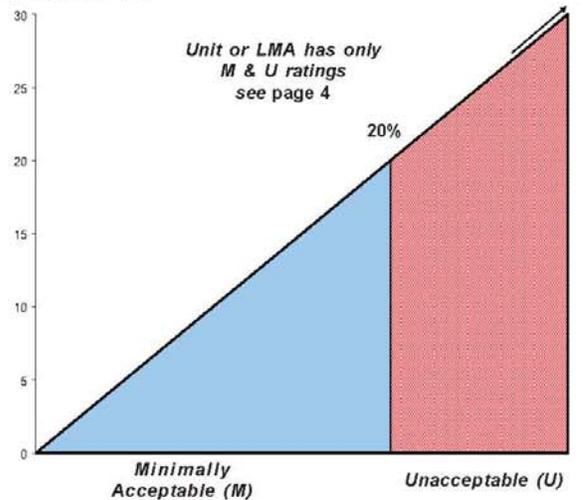
**Figure 2-3**

- Vegetation
- Trim / Thin Trees
- Enchroachments
- Animal Control
- Slope Stability
- Erosion / Bank Caving
- Cracking
- Crown Surface/Depressions/Rutting
- Rip Rap Revetments
- Seepage / Sandboils
- Underseepage Relief Wells
- Repair Gates

**Step 2:  
Overall  
Levee  
Rating**

Overall Maintenance Rating  
Flow Chart  
Page 1

Table 2-1 and Figures 2-3 through 2-6 explain the rating method.

In the field, each inspector documents the location, length, and type of maintenance category (see the guidelines listed above) giving a rating to each category found to be deficient in accordance with the established ratings *criteria* of section 2.3.1 and 2.3.2. In any field inspection process, there will be some inherent subjectivity. However, DWR believes that training, the use of the new database driven inspection software, new hardware, and the inclusion of the ratings *criteria* on the inspectors' field computers have led to more accurate and consistent ratings - which are provided by the inspectors themselves. Further, the new *methodology* of determining *overall unit and LMA ratings*, which is accomplished by the methods described in section 2.3.1 and Table 2-1 and Figures 2-3 through 2-6 has resulted in much more consistent and objective overall ratings.

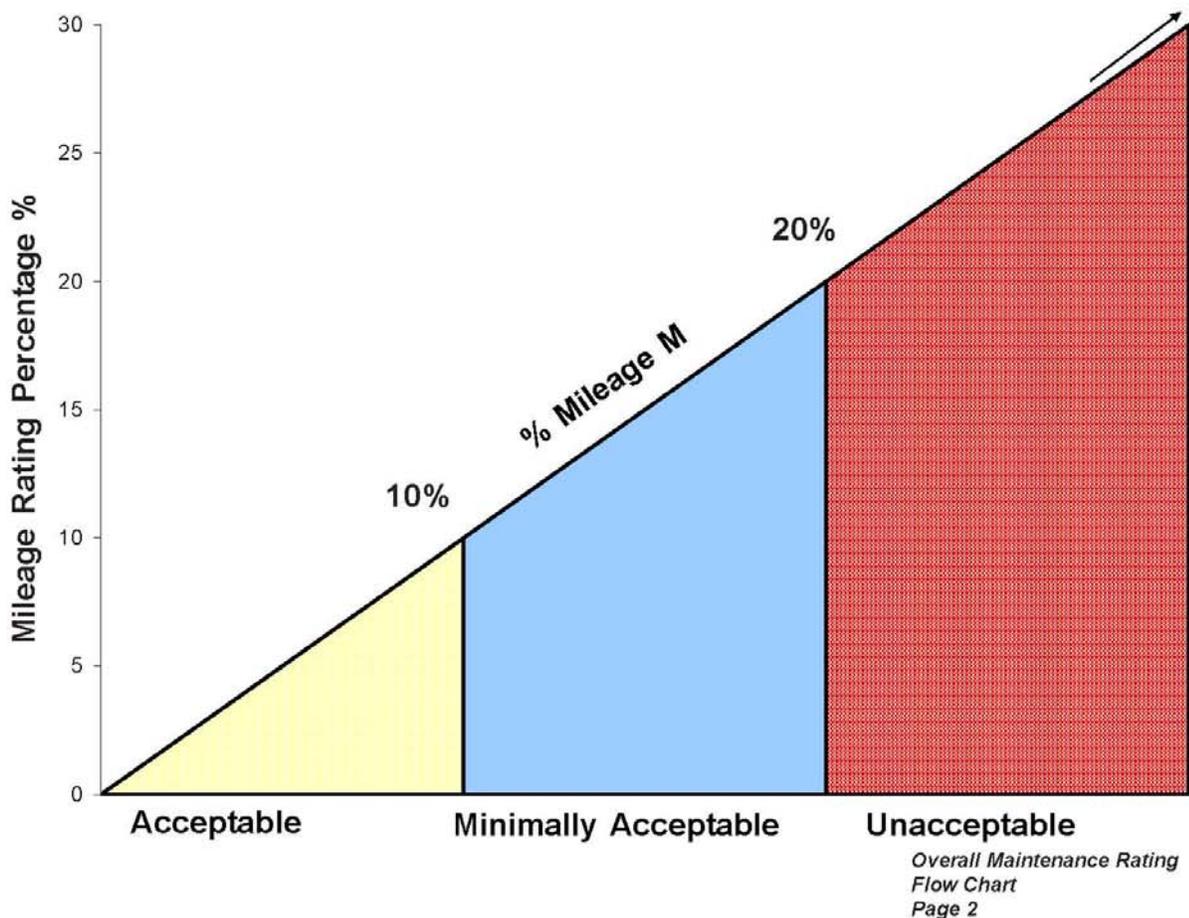
Figure 2-4

From 10.00% to 19.99% rating of M results in rating of M.

≥ 20.00% rating of M results in rating of U.

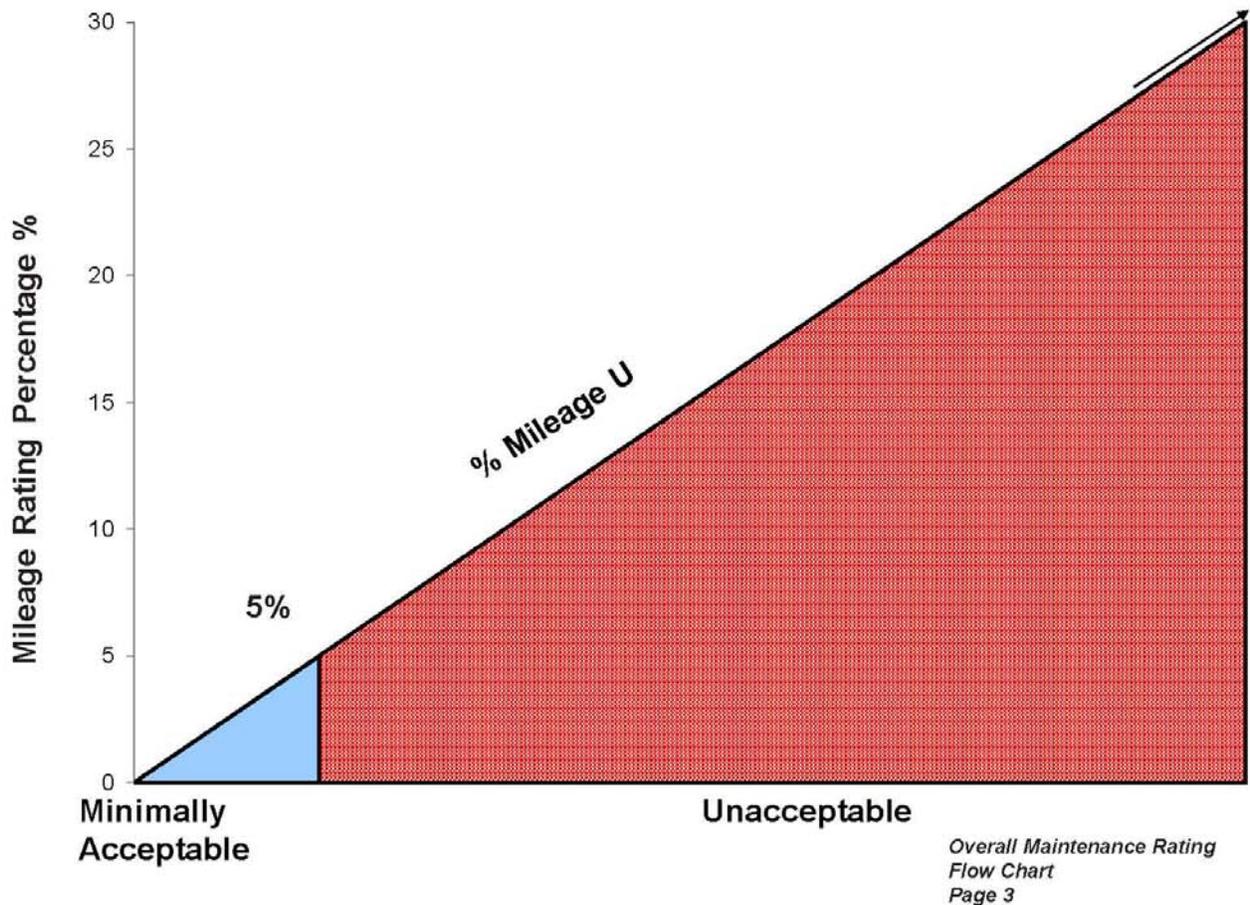
Figure 2-5

## OVERALL MAINTENANCE RATING FLOW CHART

From 0.01% to 4.99% U rating results in rating of M.

$\geq 5.00\%$  rating of U results in rating of U.

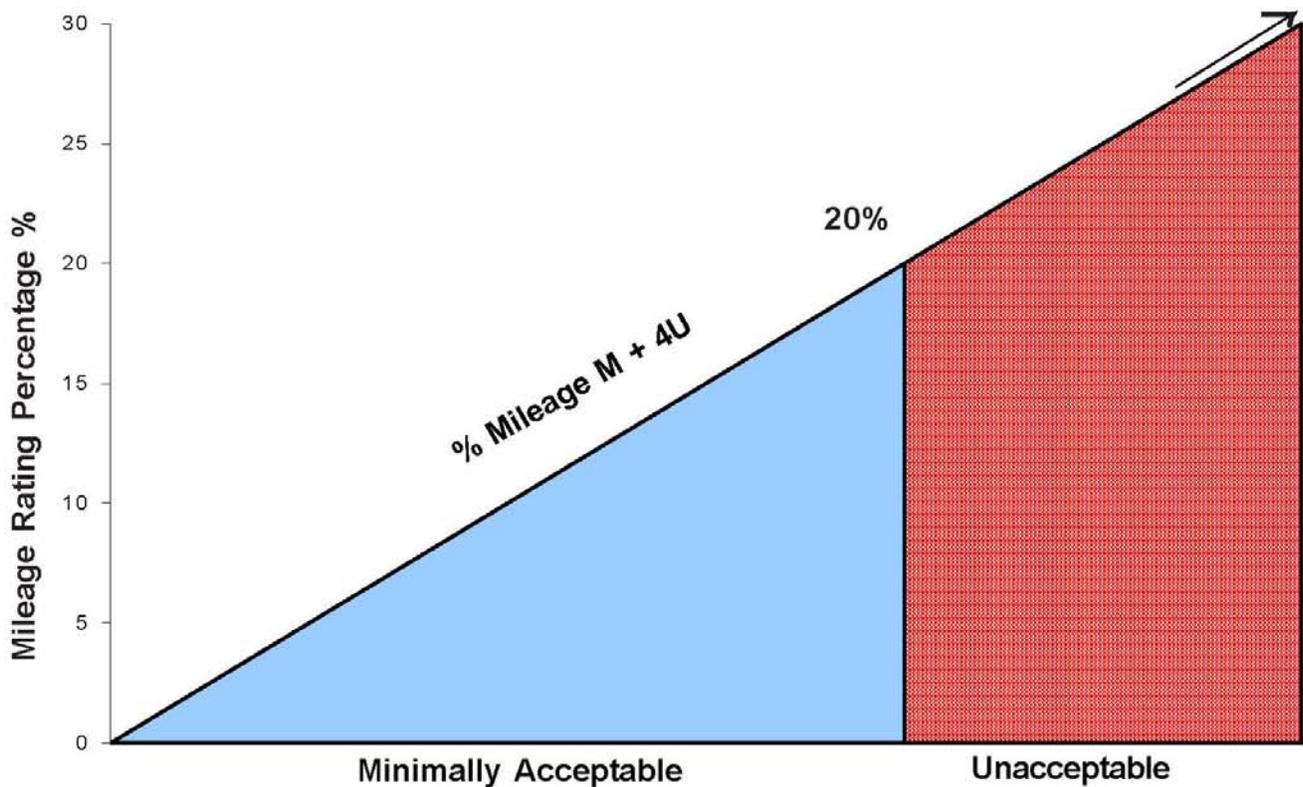
Figure 2-6

0.01% to 19.99% total of (M + 4U) results in rating of M.

≥ 20.00% rating of (M + 4U) results in rating of U.

Overall Maintenance  
Rating Flow Chart  
Page 4

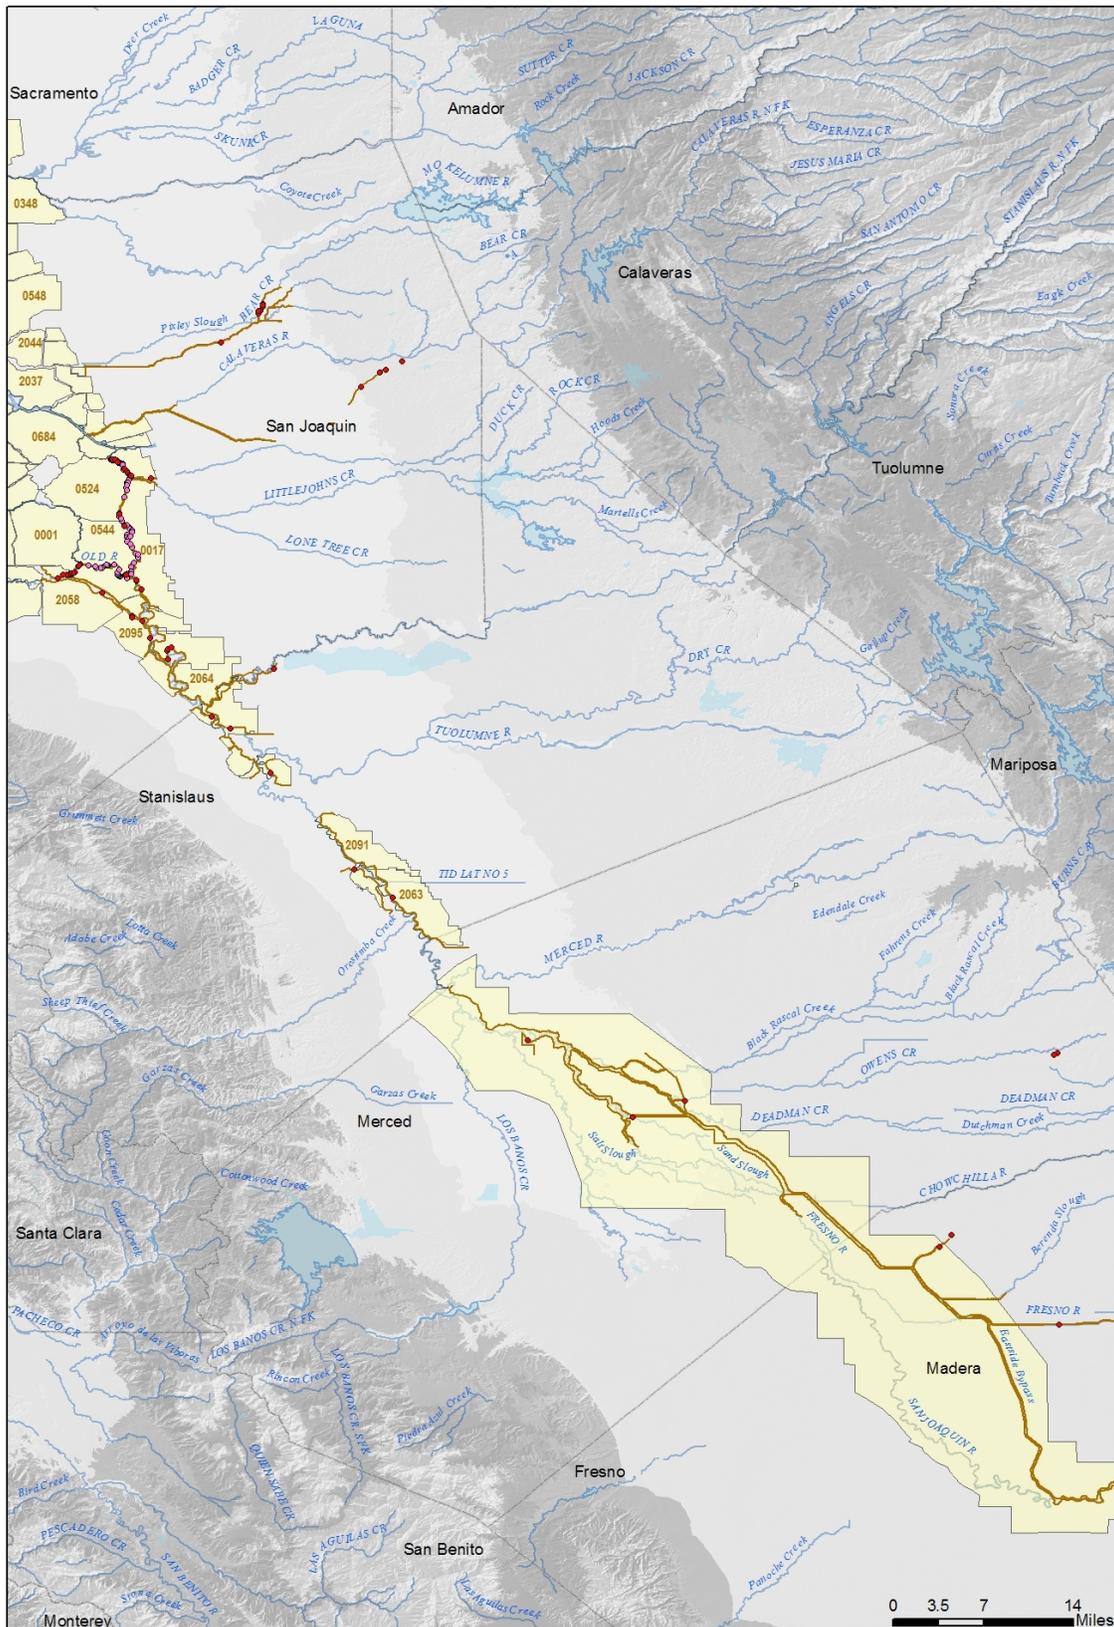
Figure 3-1 shows the current erosion sites in the San Joaquin River basin as red dots.

# Map of Jan Joaquin River Erosion Sites

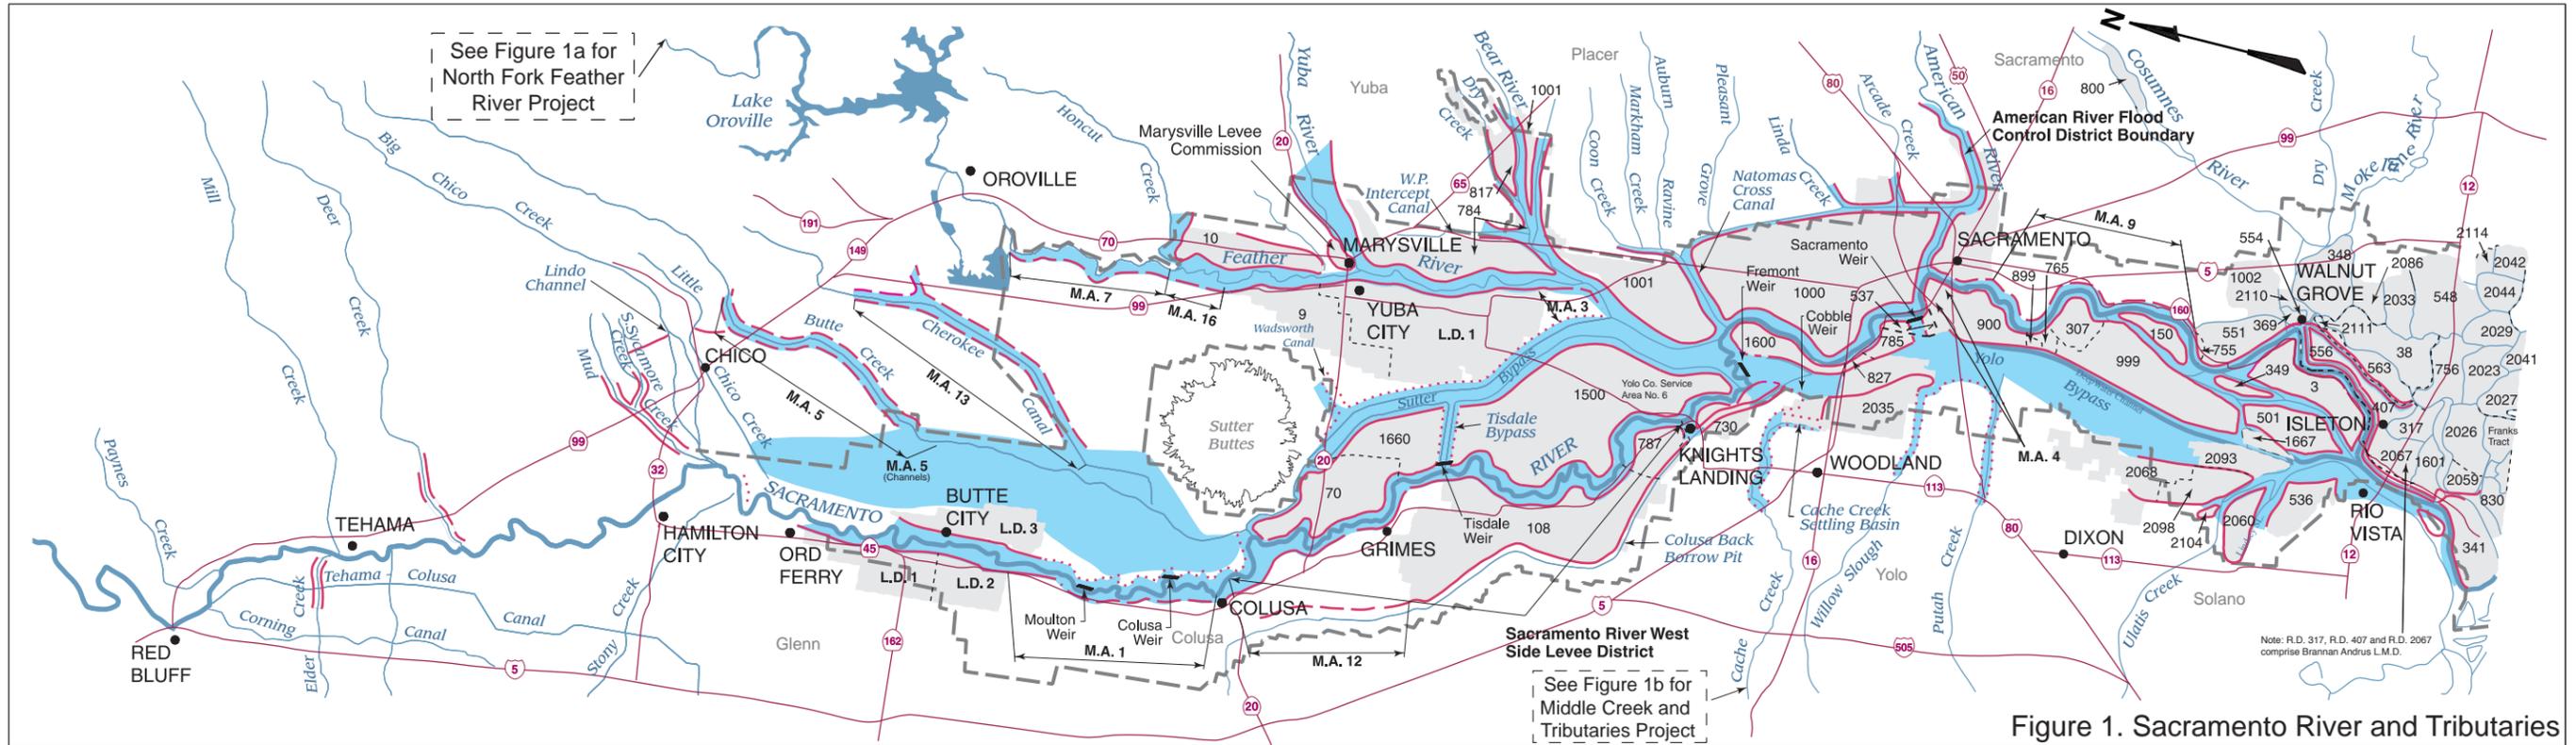
Figure 1. Sacramento River and Tributaries

# Flood Control Projects and Agencies

- R.D. 20 Reclamation and Levee Districts
- Project Levees Maintained by Department of Water Resources, Sec. 12878 to Sec. 1278.45 of the Water Code
- Project Levees Maintained by Department of Water Resources, Sec. 8361 of the Water Code
- Project Levees Maintained by Reclamation, Levee, and Drainage Districts and Municipalities
- Boundary of Sacramento-San Joaquin Drainage District

rivers draining into the San Joaquin Valley and the Tulare Lake Basin. The two major river flood protection systems (Plates 1 and 1A) have combined totals of approximately 1,569 miles of federal project levees (shown on Plate 2), 1,200 miles (148,000 acres) of designated floodways (shown on Plate 2), several thousand acres of project channels (shown on Plate 2), and 56 other major flood protection works (e.g. overflow weirs, flood relief structures, outfall gates, and the Sutter Bypass pumping plants). Designated Floodways, adopted by the Board, are a significant part of the flood protection system and include many major rivers and streams that are not Flood Control Project Channels.

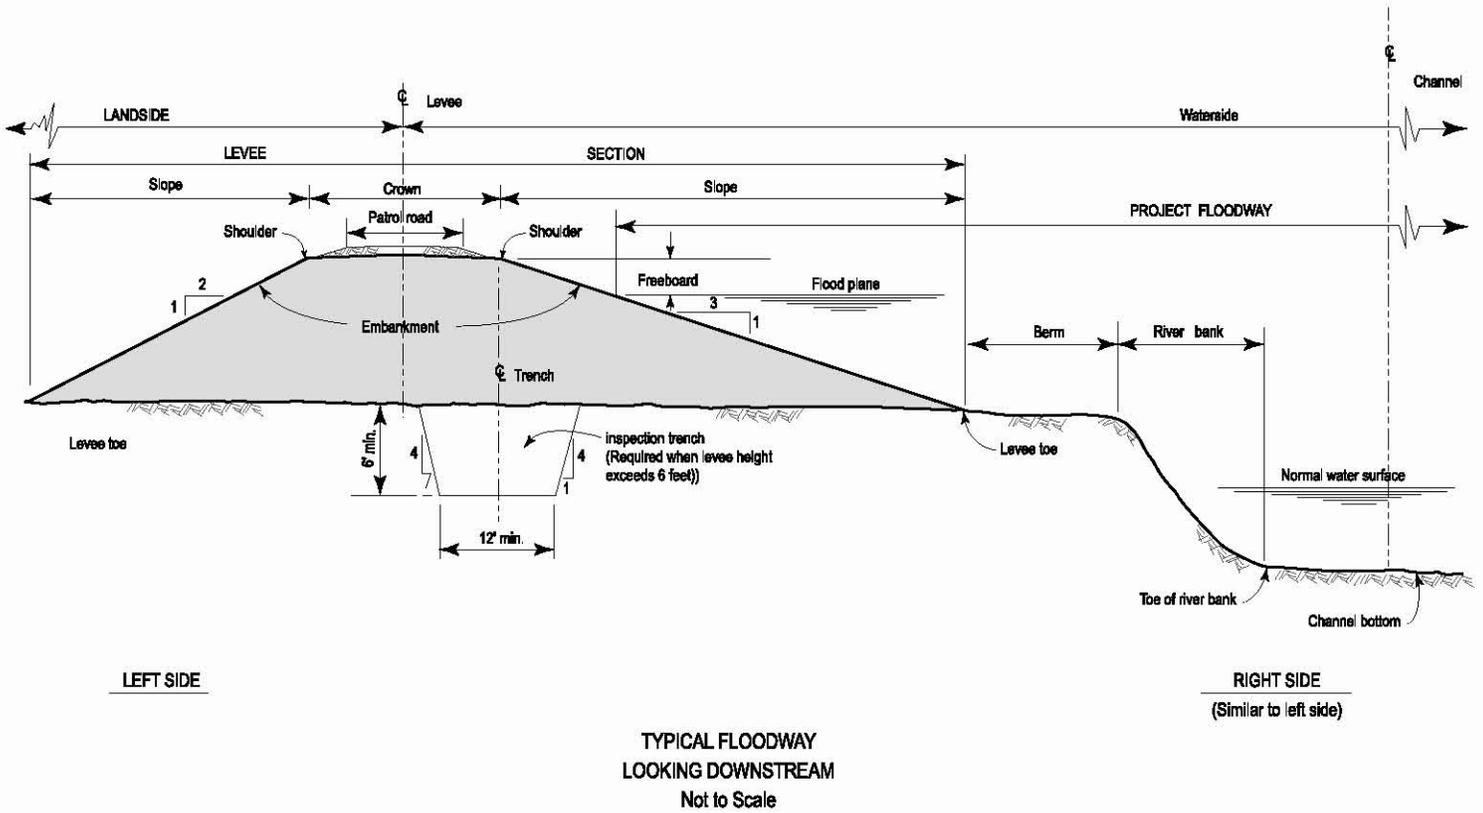
# Project Levee Standards and Terminology

ITEM	MINIMUM DIMENSIONS OF STANDARD LEVEE SECTIONS			
	MAIN RIVER CHANNELS	MAJOR TRIBUTARIES	MINOR TRIBUTARIES	BY PASSES
CROWN WIDTH	20'	20'	12'	20'
LAND SLOPE	1 on 2	1 on 2	1 on 2	1 on 2
WATER SLOPE	1 on 3	1 on 3	1 on 3	1 on 3
FREEBOARD	3' (1)	3'	3'	4' to 6'
PATROL ROAD WIDTH	12	12'	10'	12'

NOTE (1) 5 FEET ON MAIN CHANNEL BELOW CACHE SLOUGH (SACRAMENTO RIVER)
