2013

INSPECTION AND LOCAL MAINTAINING AGENCY REPORT OF THE CENTRAL VALLEY STATE-FEDERAL FLOOD PROTECTION SYSTEM

Department of Water Resources

Flood Project Integrity and Inspection Branch | Hydrology and Flood Operations Office | Division of Flood Management

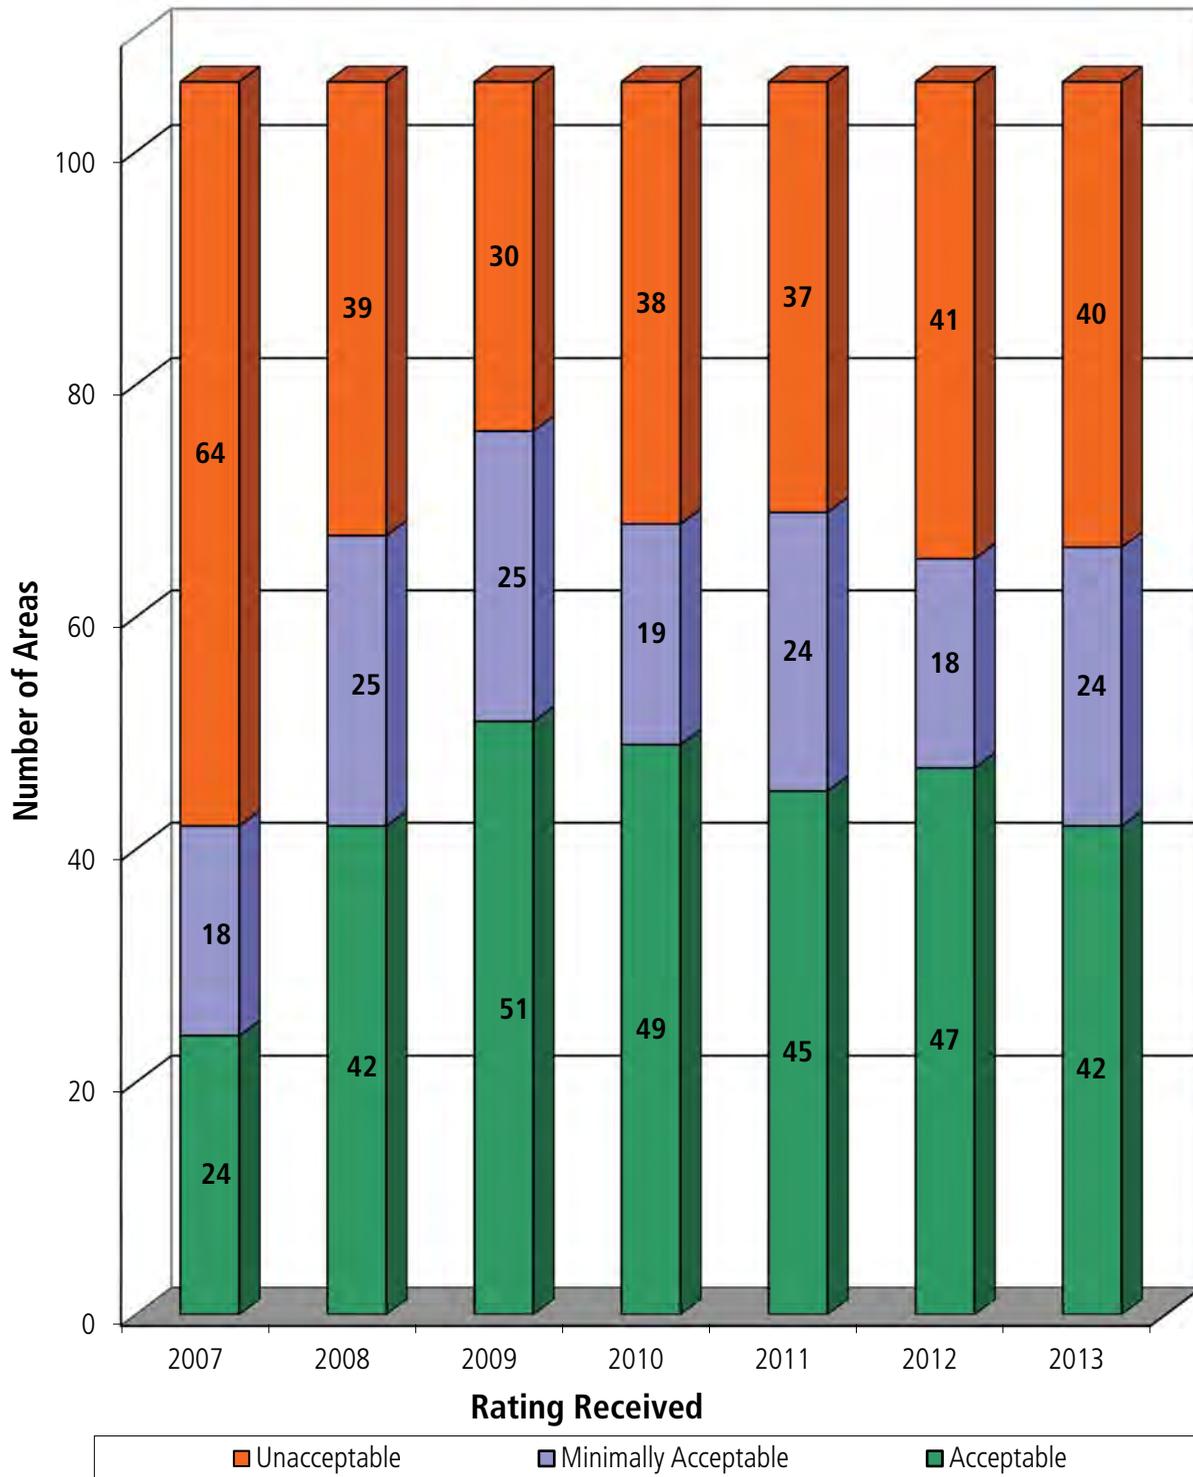
Figure 2-1: Summary of Area Maintenance Ratings for 2007 to 2013

Table 2-1 and Figure 2-1 show the numbers of Areas receiving each rating for 2007 through 2013. The length of vegetation deficiencies increased overall slightly compared to 2012. There was an increase of these issues in the Sacramento River system while it decreased in the San Joaquin River system. There was an increase in animal control issues while crown surface issues decreased. Other categories did not change significantly. Many of the LMAs have expressed limitations due to financial and environmental issues. Some LMAs are severely limited in what money they have been able to collect from residents to perform maintenance. Some LMAs also reported challenges in burning the vegetation this year.

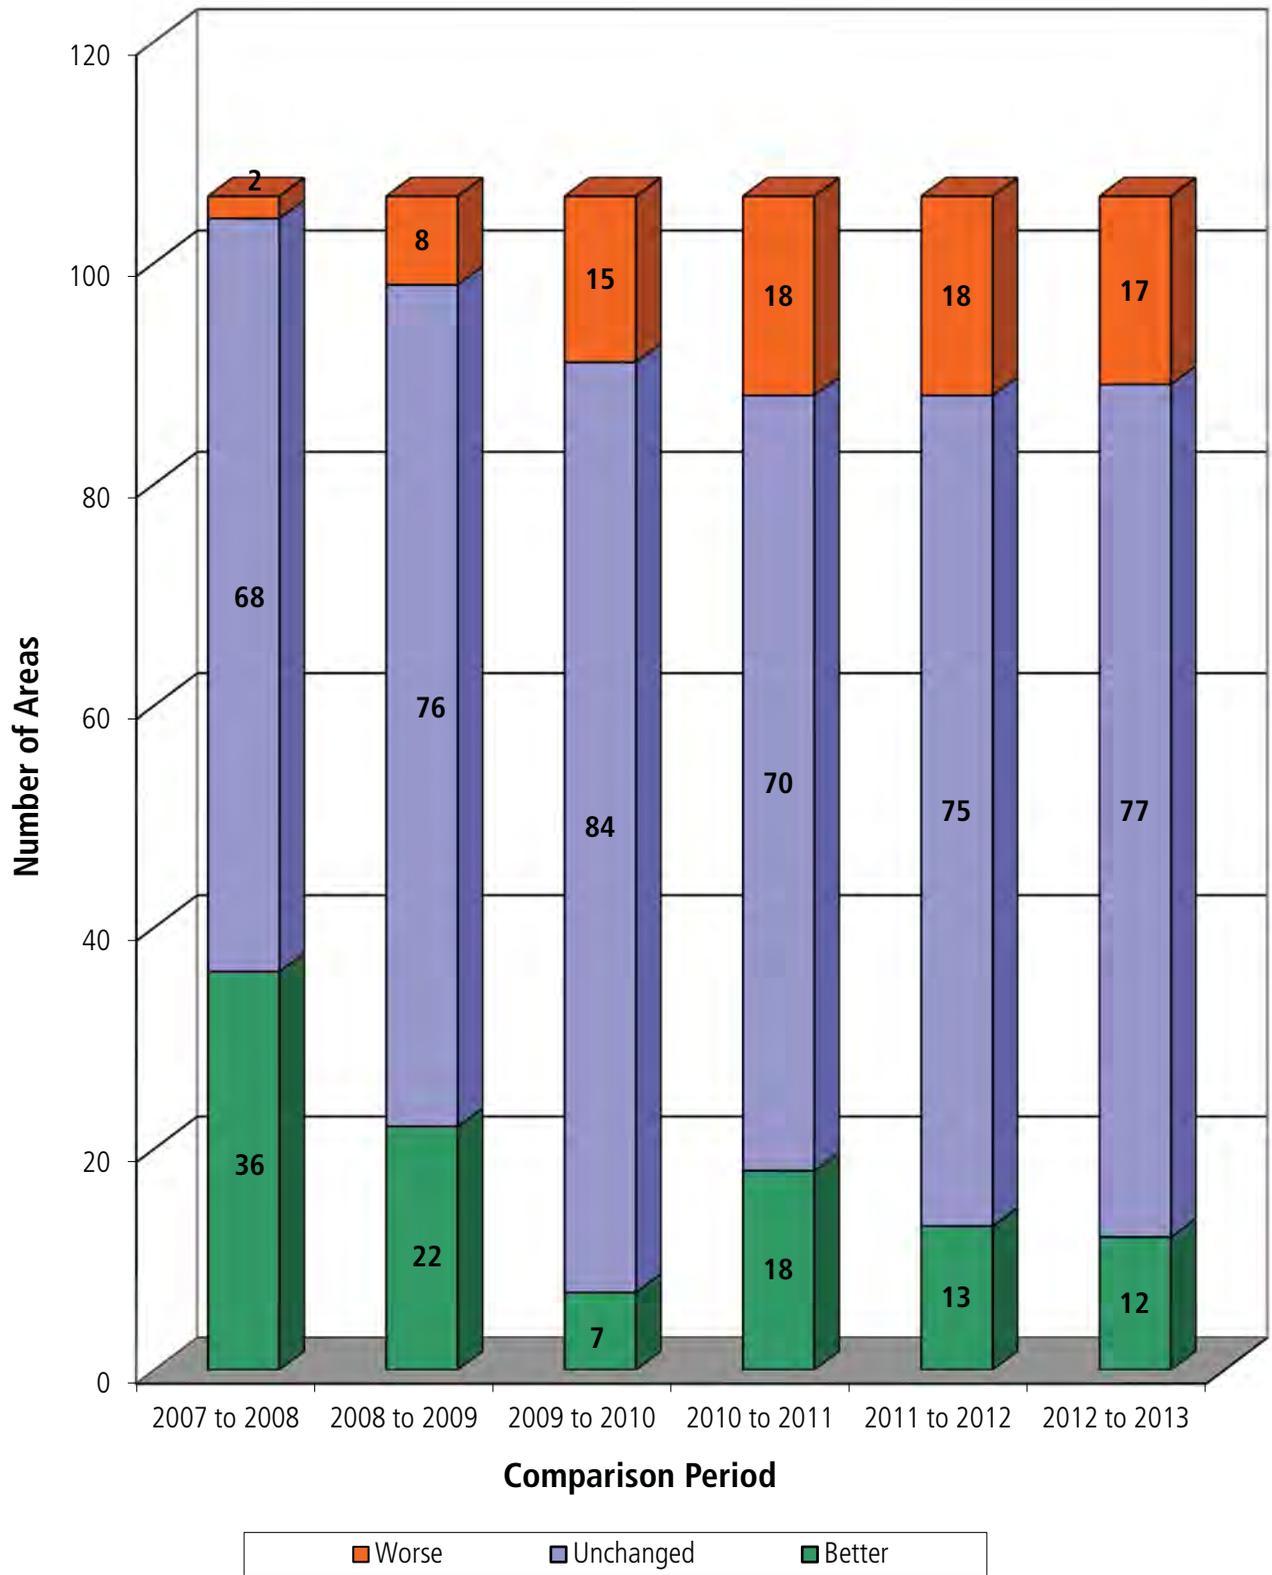
Figure 2-2: Area Maintenance Rating Changes for 2007 to 2013

Figure 2-2 shows the number of agencies that received better, unchanged, or worse ratings in 2013 compared with 2012, 2011, 2010, 2009, 2008, and 2007. Areas continue to generally receive better ratings than in 2007. LMRs contain more detailed information about each LMA. Appendix F provides more explanation of threshold percentages and the determination of overall ratings.

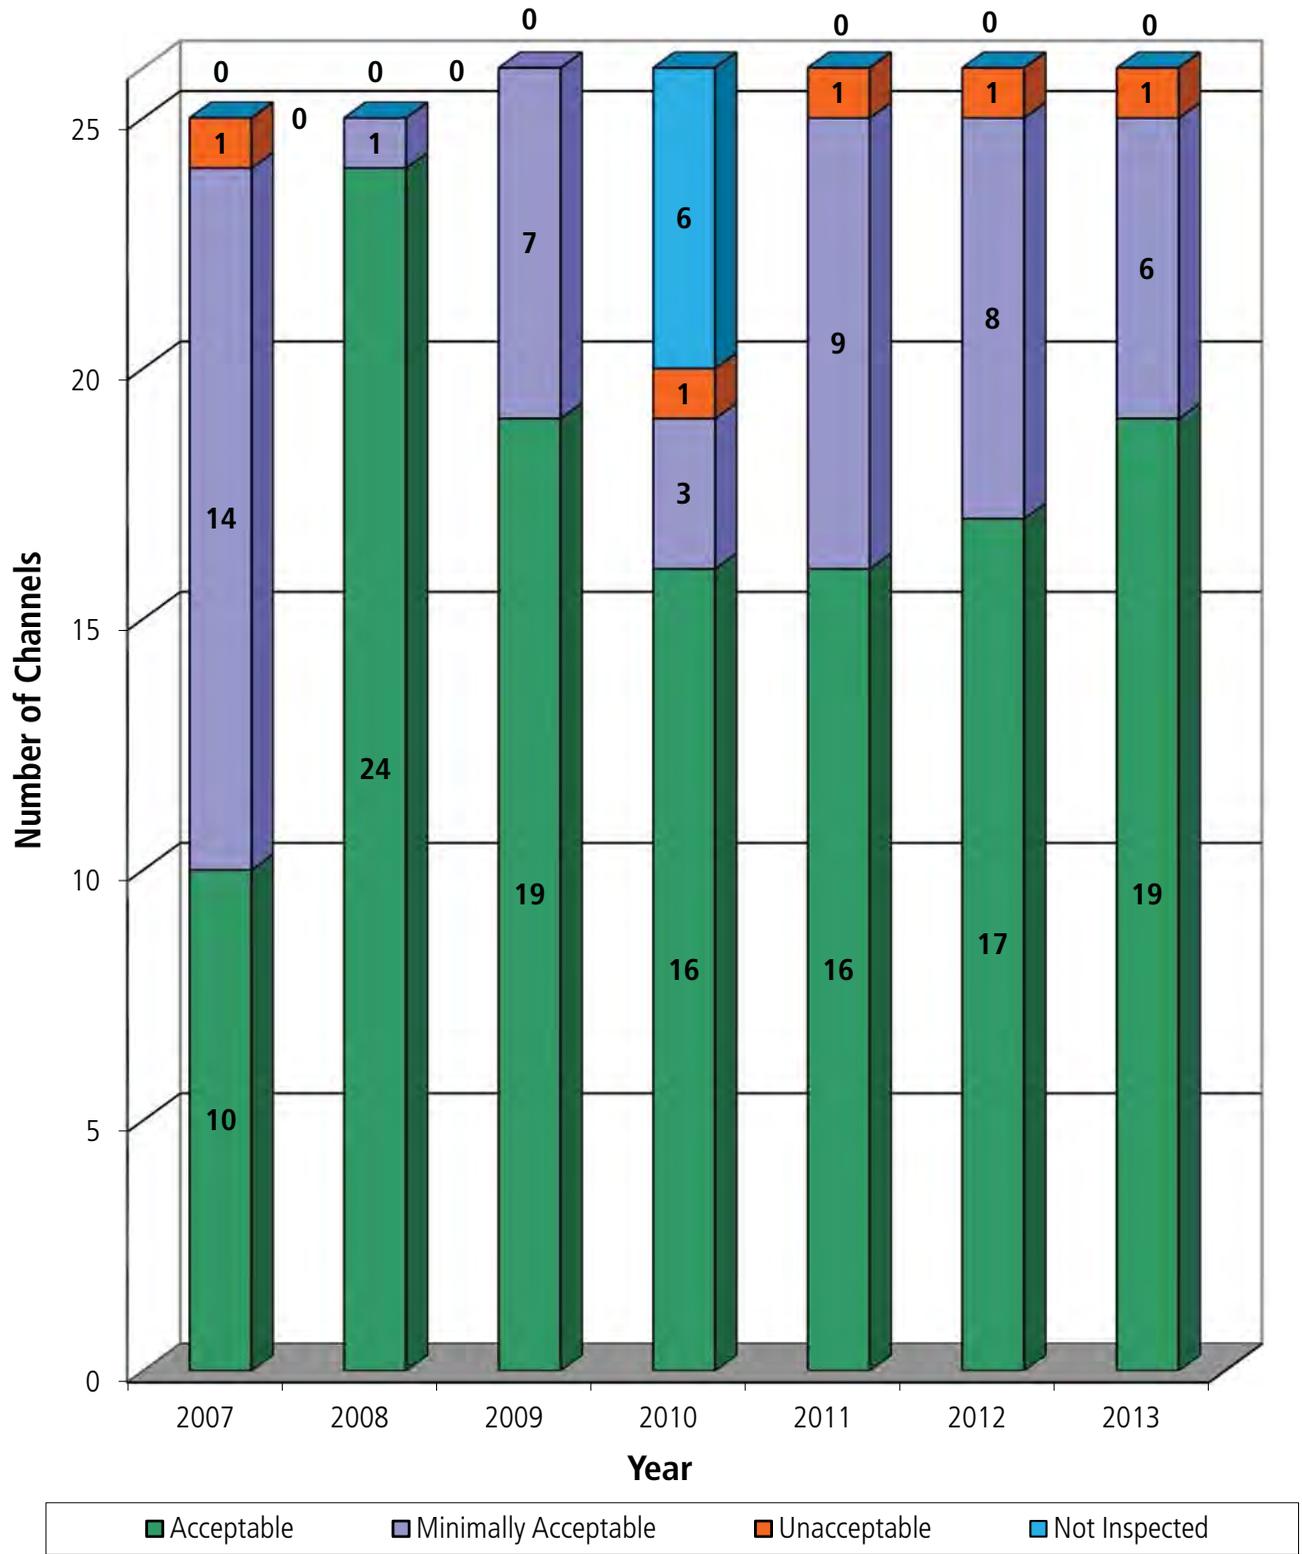
Figure 3-1: Comparison of Overall Channel Ratings for 2007 to 2013

One channel was rated as Unacceptable in 2013, while the number of Minimally Acceptable channels was six and nineteen channels were rated as acceptable, which is slightly better than 2012. This shows the similarity of maintenance found during inspection in 2013 as prior years. Figure 3-1 shows the progression of maintenance ratings from 2007 through 2013.

Appendix F details the method for determining overall ratings. Table 3-1 and Figure 3-1 show the numbers of each rating for the years 2007 through 2013.

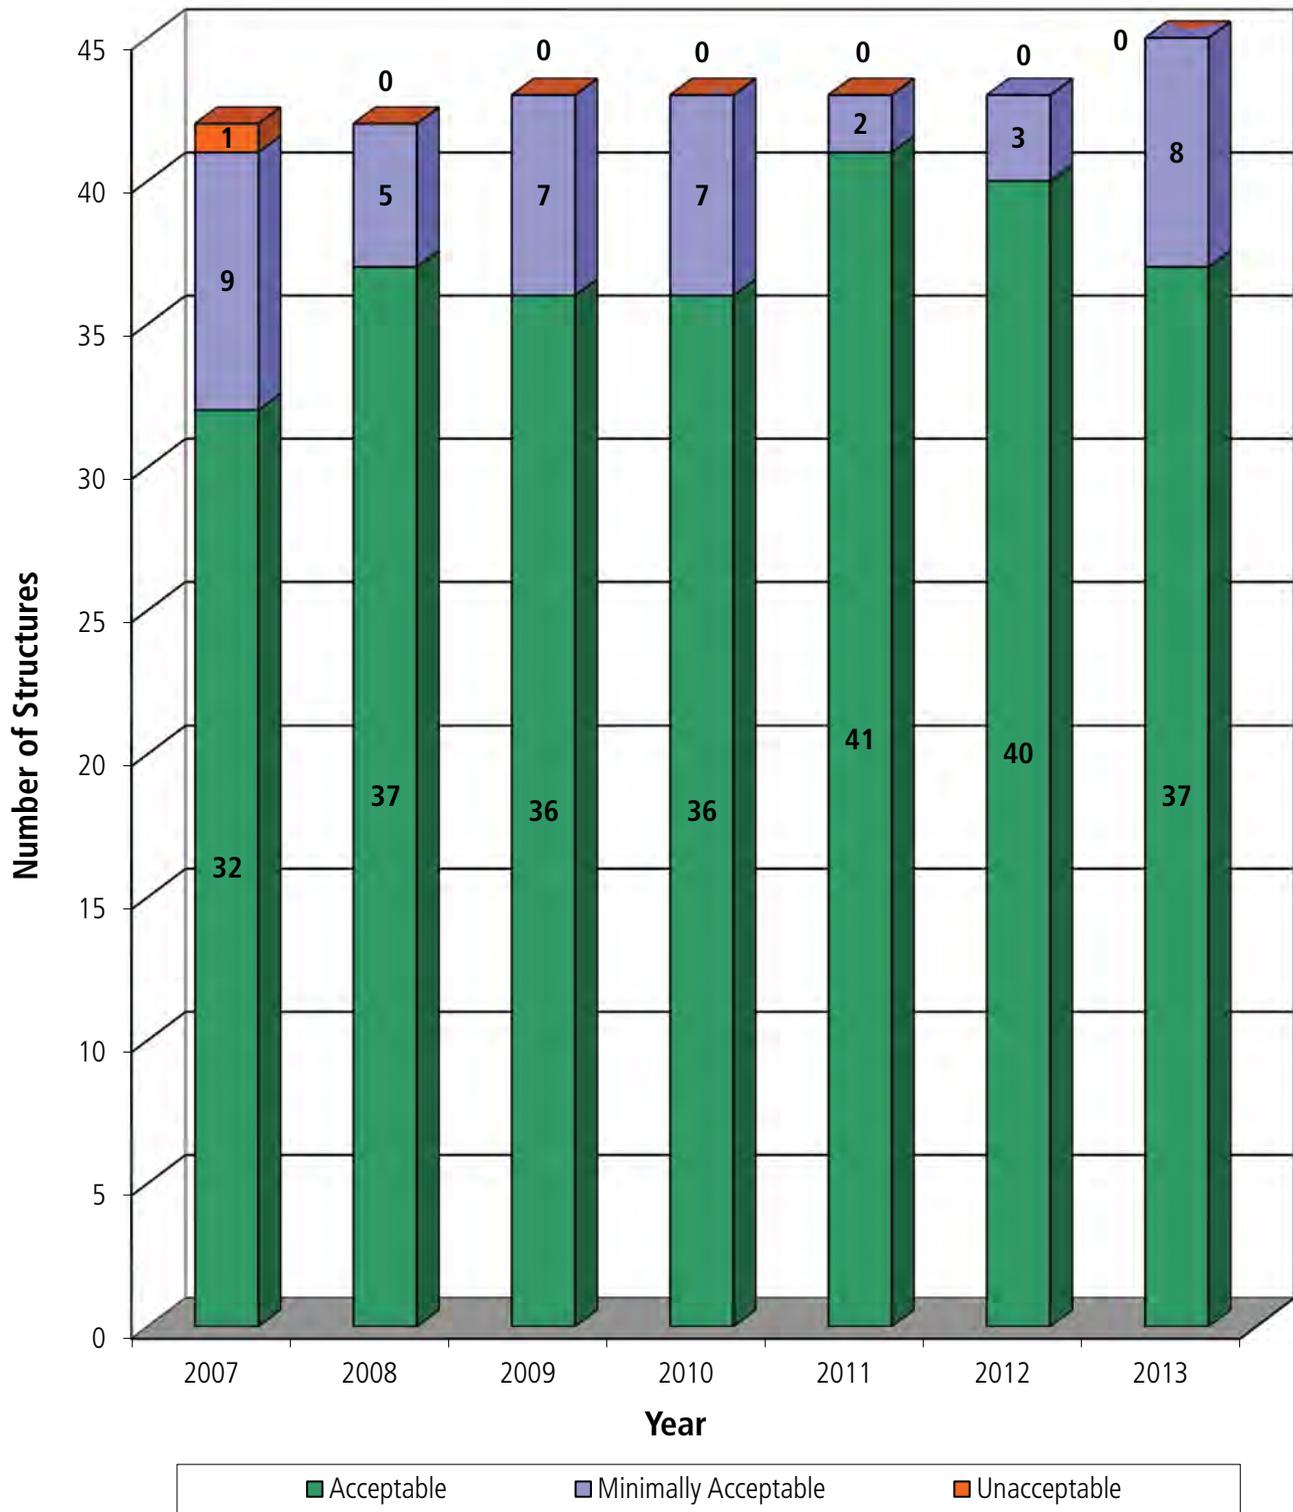
Figure 4-1: Comparison of Overall Structure Ratings for 2007 to 2013

The method for determining overall ratings is similar to the one used for channel inspections and is described in Appendix F. Table 4-1 shows the numbers of each rating for 2007-2013 for all structures. Figure 4-1 and Table 4-2 show ratings for each structure, while Figure 4-2 and Table 4-3 show ratings for each pumping plant. The LMAs have generally improved structure maintenance since 2007. FPIS staff have worked with DWR, the USACE, and the CVFPB staff to better understand responsibilities regarding structures. The El Camino Avenue Bridge over Steelhead Creek in Sacramento was added to structure inspections in 2009. M&T Ranch Overflow and Goose Lake Overflow structures were added to structure inspections in 2013. No maintaining agency has been identified for Paradise Dam. FPIS staff continue to research authorizations for the structures and will continue to refine what structures are inspected during these inspections.

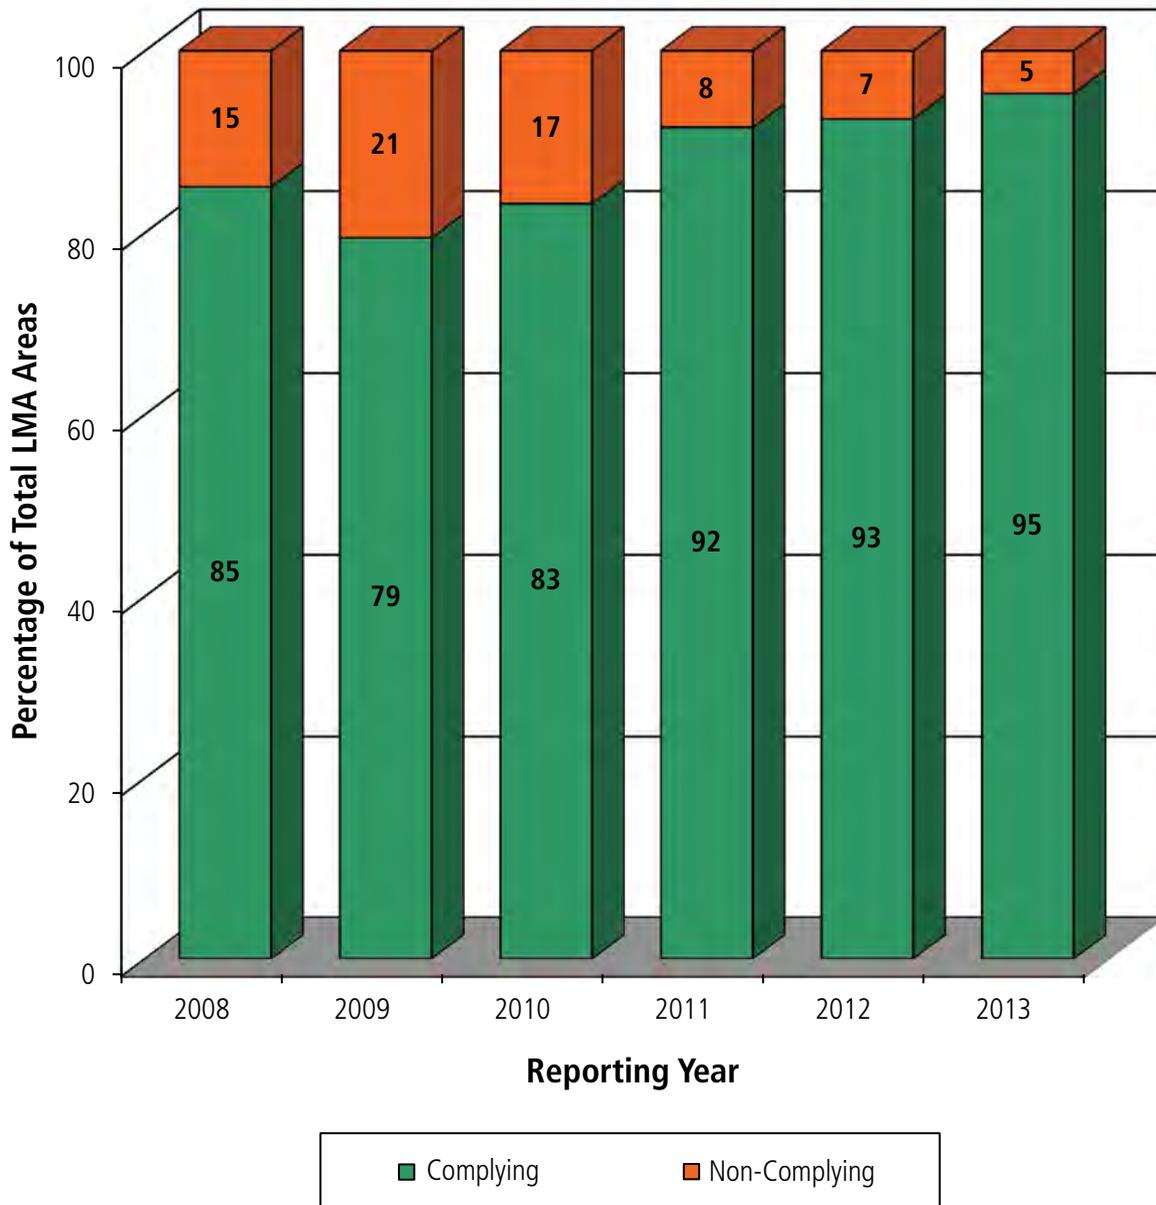
Figure 6-1: Reporting Compliance for 2008-2013

There is an increasing trend (Figure 6-1) of reporting compliance by LMAs since the program started in 2008. A system wide comparison of reporting compliance (Figure 6-2) shows at least 94% Areas belonging to the Sacramento system and 96% belonging to the San Joaquin system have reported in last two years. Overall, about 95% of Areas submitted their report this year. An increasing trend of electronic reporting is apparent in Figure 6-3. This year about 75% Areas submitted reports through DWR’s web-based LMA Reporting tool. This represents a 7% increase over last year’s electronic reporting. This could be attributed to continuous outreach activities and enhancement of reporting infrastructure since the inception of the tool.

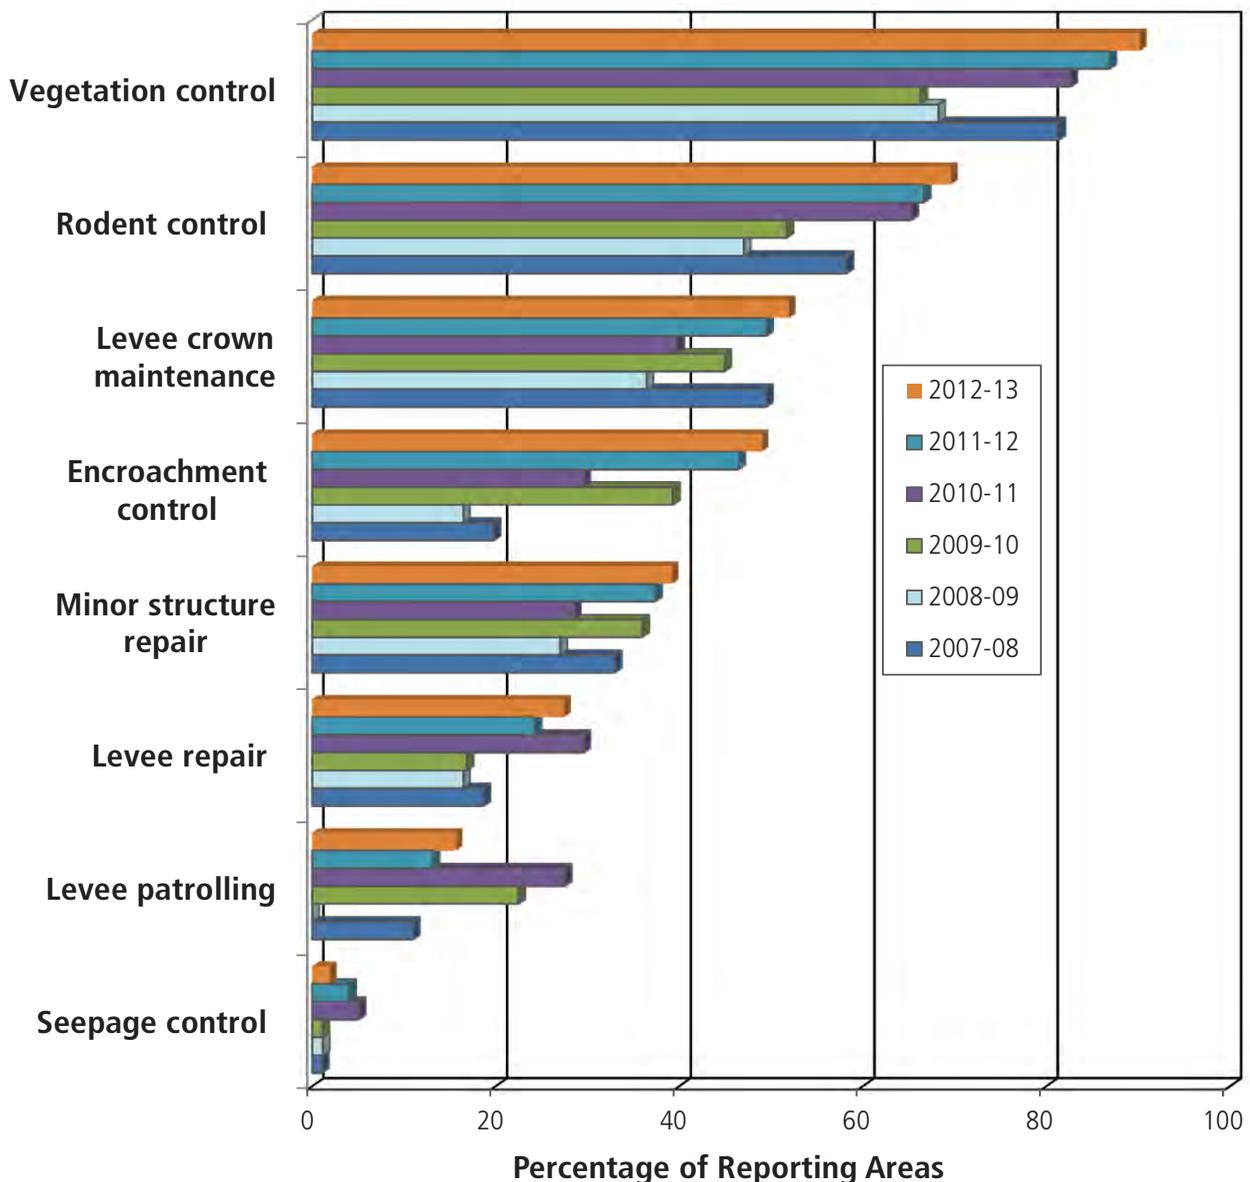
Figure 6-4: Key Performed Activities Reported for 2008-2013

About 96% of reporting Areas provided information on the summary of maintenance activities. As in the previous years, routine vegetation maintenance activities (burning, slope dragging, cutting, trimming, spraying), rodent control, levee crown grading, roadway maintenance and encroachment dominated LMA maintenance activities for fiscal year 2012-13. Figure 6-4 shows the activities Areas reported as having performed as a percentage of the total number of Areas who reported information during that year. Other reported key activities include minor structural repairs (mile markers, gates, barricades, and miscellaneous signs maintenance and repair), and minor levee repairs (erosion repair, hole grouting, revetment, rip-rap and slope repair). Some LMAs also reported levee patrolling and other planning activities such as preparation of five year maintenance plans.

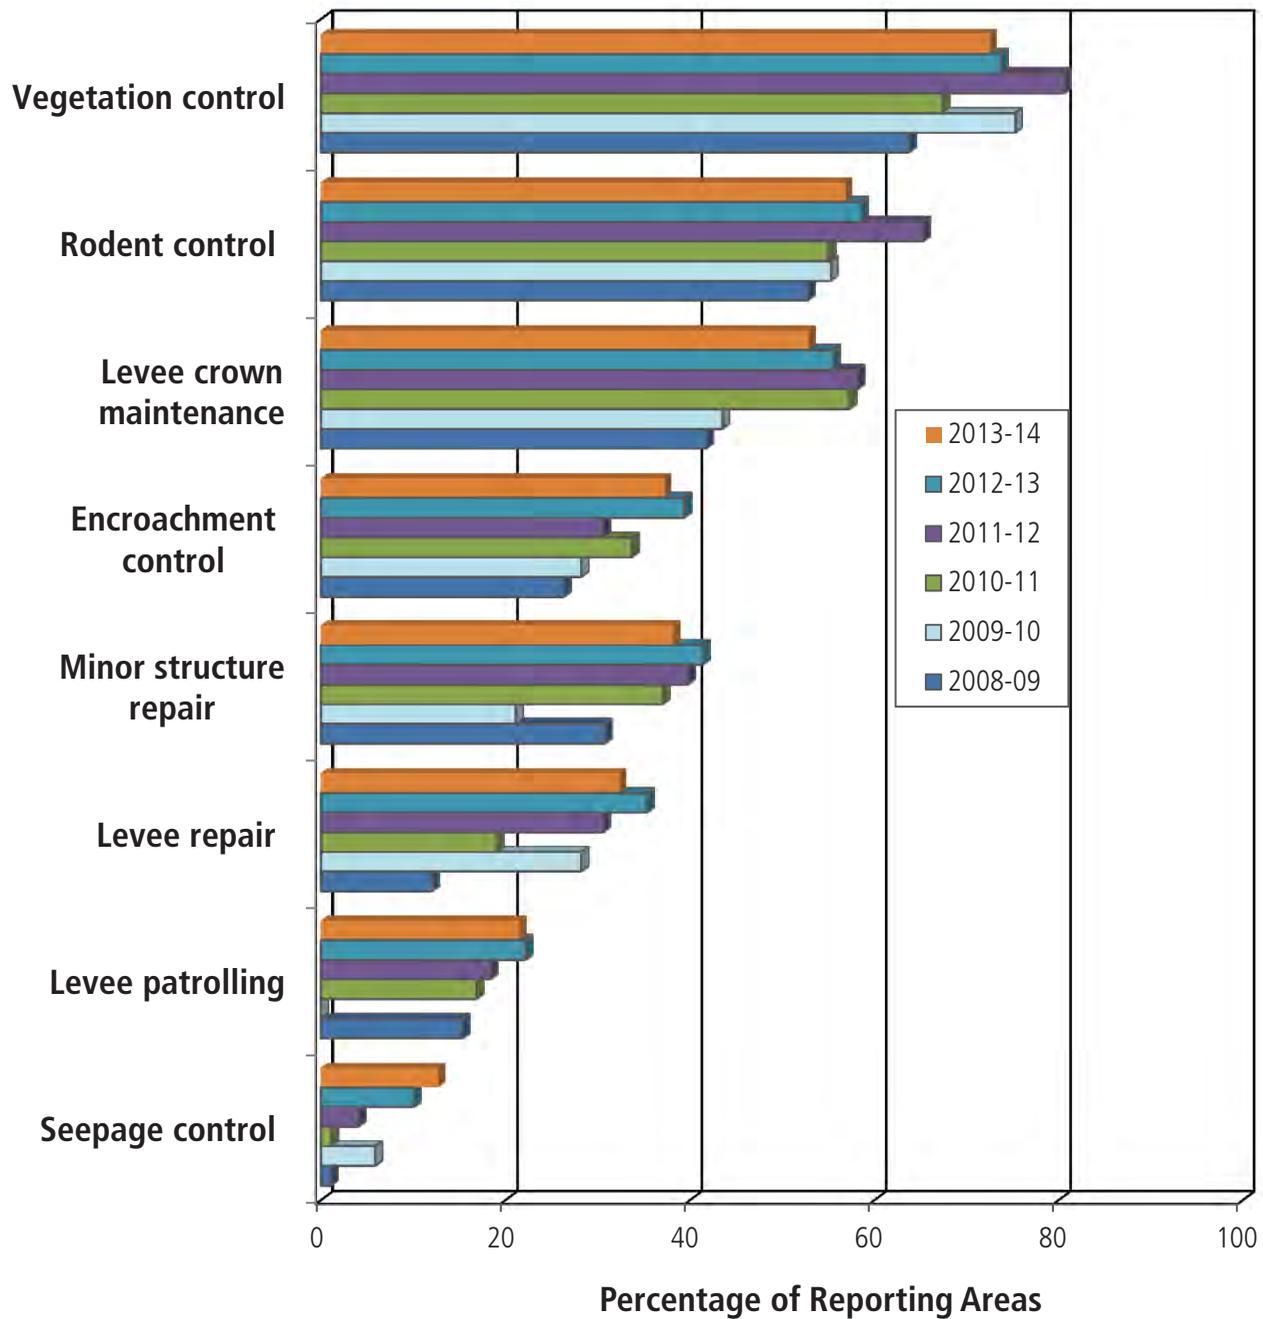
Figure 6-5: Key Planned Activities Reported for 2009-2014

A similar percentage of reporting Areas also provided information on the planned maintenance activities for the current fiscal year 2013-14. The planned activities reflect similar maintenance priorities as performed maintenance activities in fiscal year 2012-13. Figure 6-5 shows planned activities that were reported by LMAs.

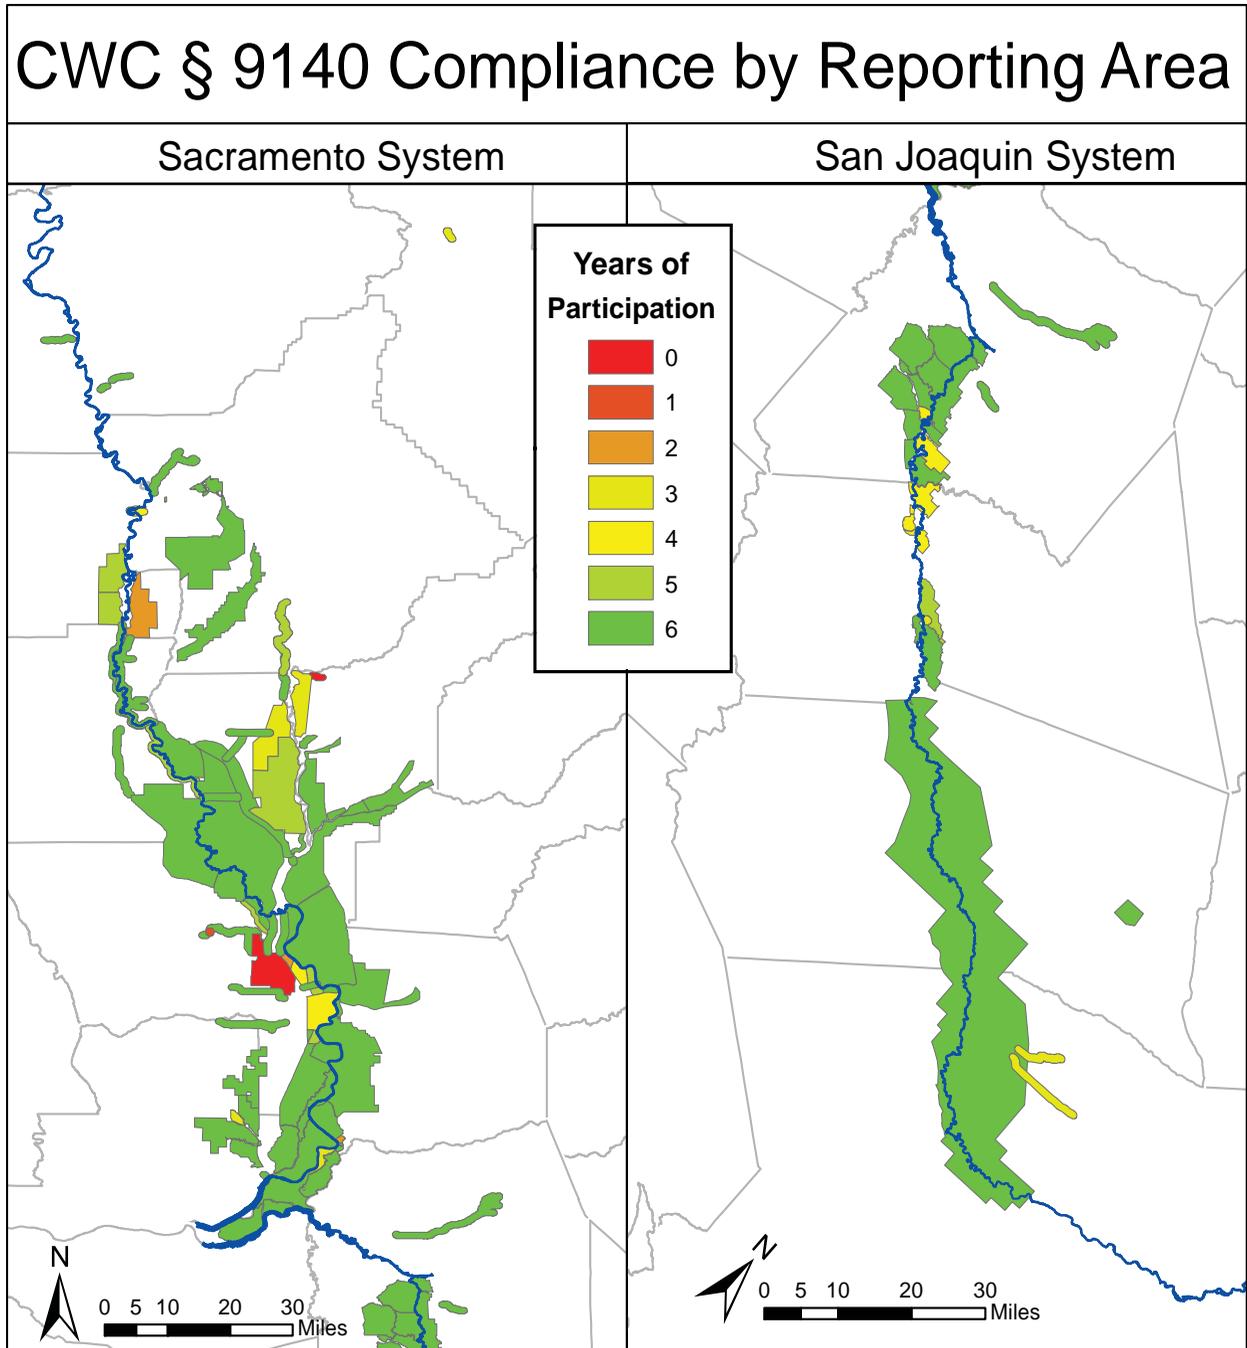
Figure 6-6: Compliance by Reporting Area for 2008-2013

Figure 6-6 shows a graphical representation of LMA’s compliance with the program for both the Sacramento and San Joaquin systems from 2008 through 2013. For the most part, both Sacramento and San Joaquin system LMAs complied with

the program for majority of the years since 2008. The figure also shows that there are a handful number of LMAs in the Sacramento system that never reported to the program. On the contrary, there are no single LMAs in the San Joaquin system that never reported to the program.

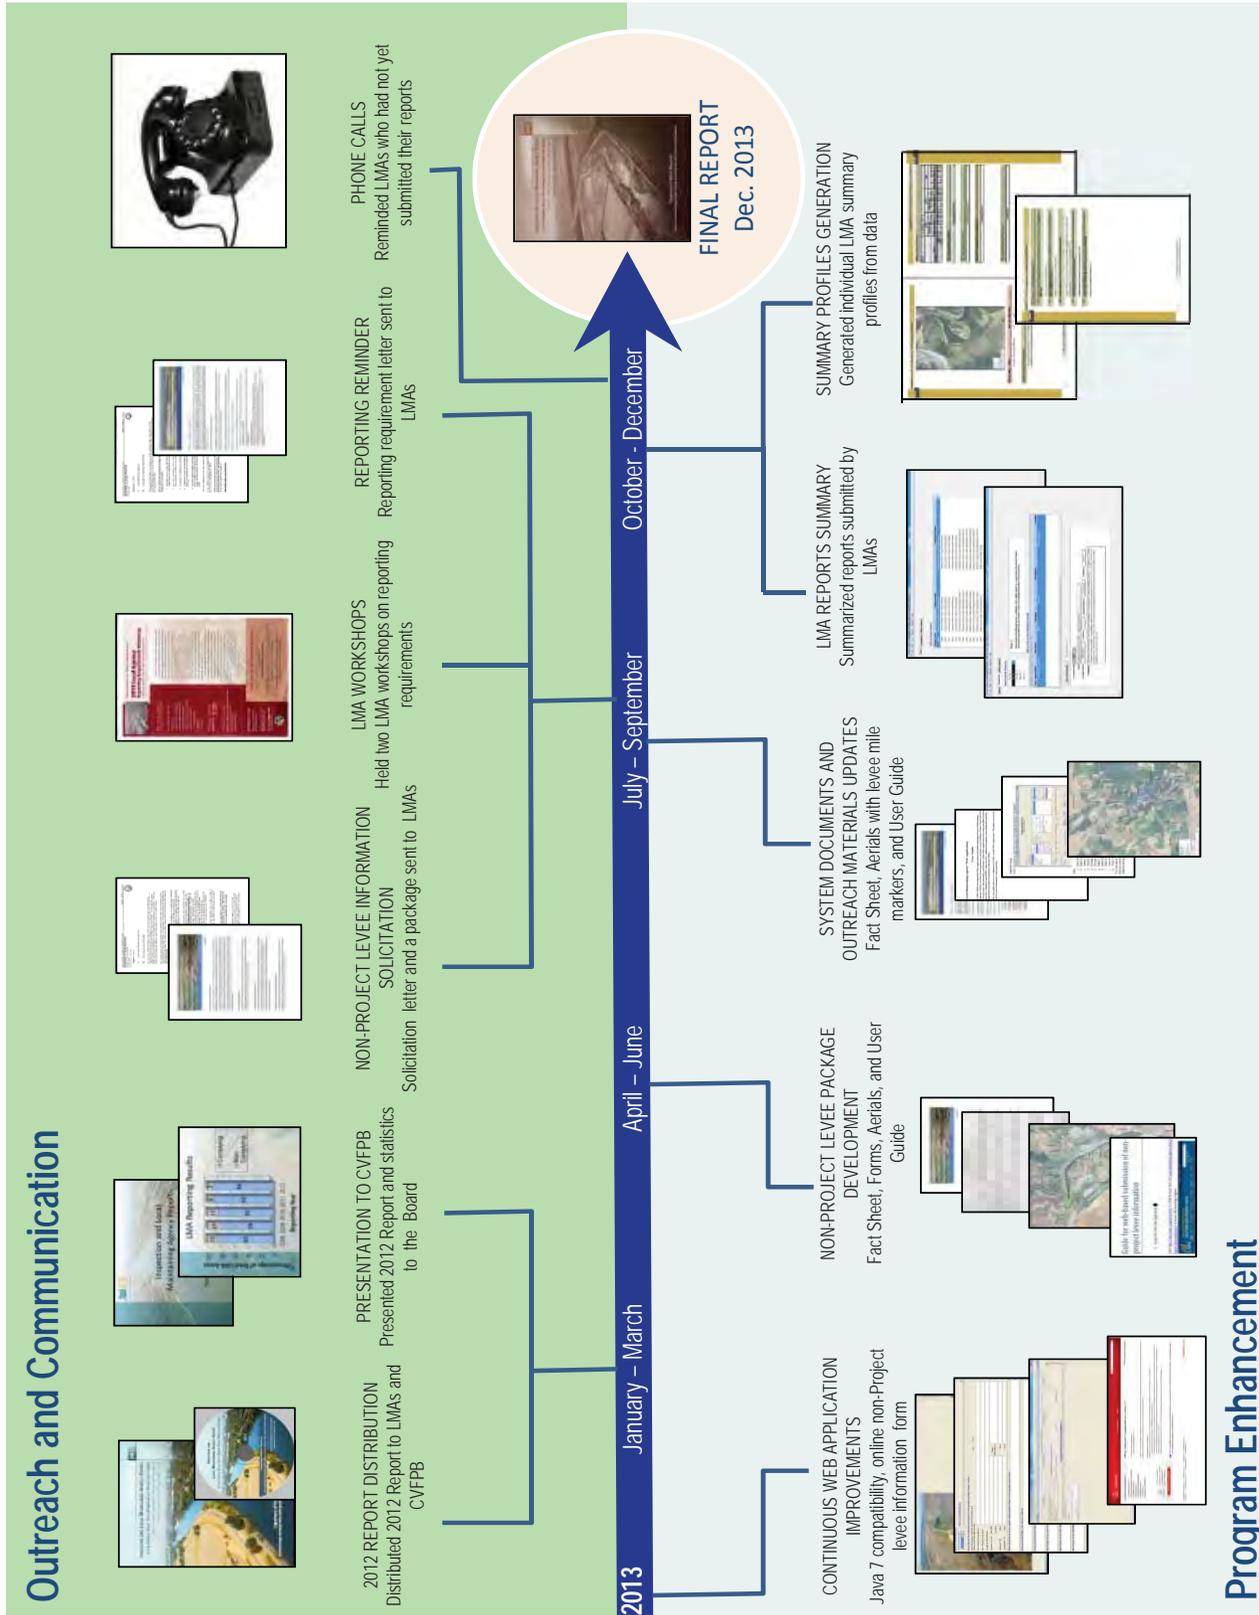
Figure 6-7: LMA Reporting Program Activities

DWR recognizes that the requirements of CWC Section 9140 placed a new reporting burden on LMAs. To help make reporting easier, DWR developed an outreach program and a web-based reporting tool to assist LMAs. DWR notified LMAs of the new reporting requirements, developed electronic and hard copy reporting options, and held a series of presentations and workshops. The process continues today, with DWR soliciting feedback from LMAs to improve the program. The following subsections and Figure 6-7 describe the chronology of the outreach process for 2013.

- Since 2008, DWR has been facilitating electronic submission and strongly encouraging LMAs to use the LMA Reporting Website. In 2013 about 75 percent of reporting LMAs reported electronically, which is a 7 percent increase over 2012. Details of DWR outreach activities for electronic submission and others are provided in Figure 6-7.
