Appendix **A**

Sacramento River Individual Agency Summary Reports

Sacramento River Basin include 85 local maintaining Areas that maintain Project Levees, Structures, and Channels. Out of 85 Areas, there are 37 RDs, 19 NAs, 14 STs, 10 MA and 5 LDs. Appendix A includes an index to the Sacramento River Basin Areas, a system map to show the locations of each reporting Area, and individual Area summary profiles.

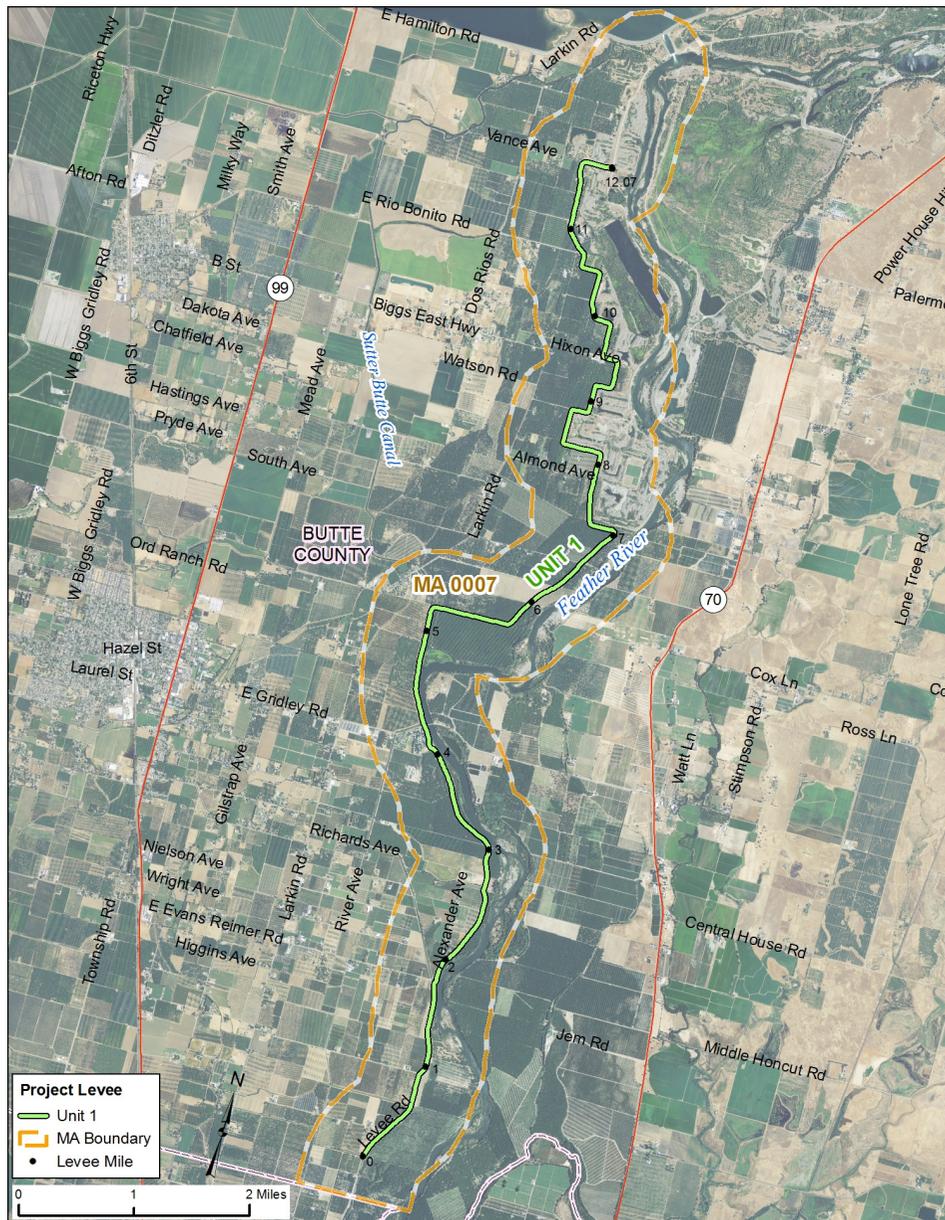
LMA Short Name : MA0007	Bank	Unit Length (Miles)
Unit No. 01 Feather River	RB	11.90

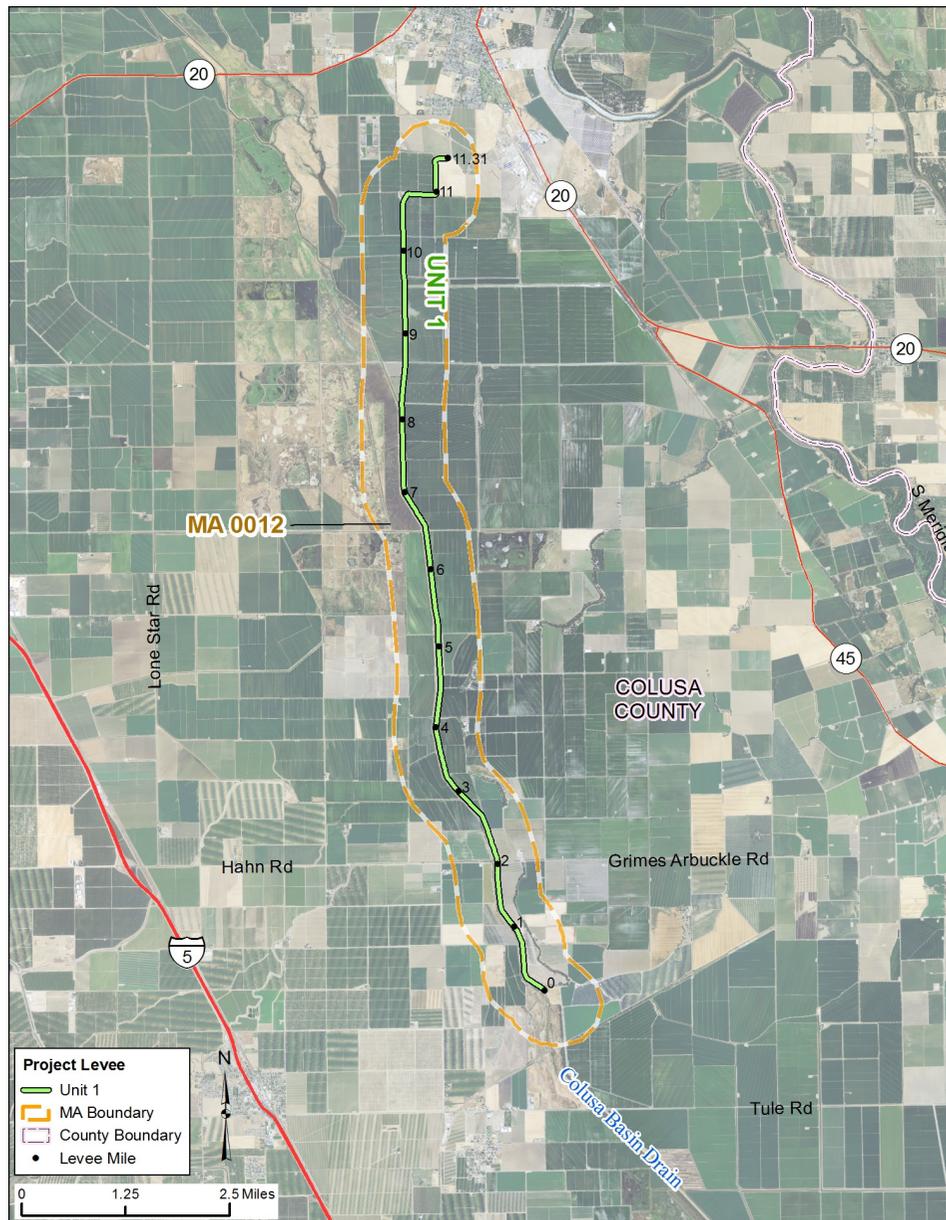
MA 12

LMA Short Name : MA0012		Bank	Unit Length (Miles)
Unit No. 01	Colusa Drain	LB	11.06

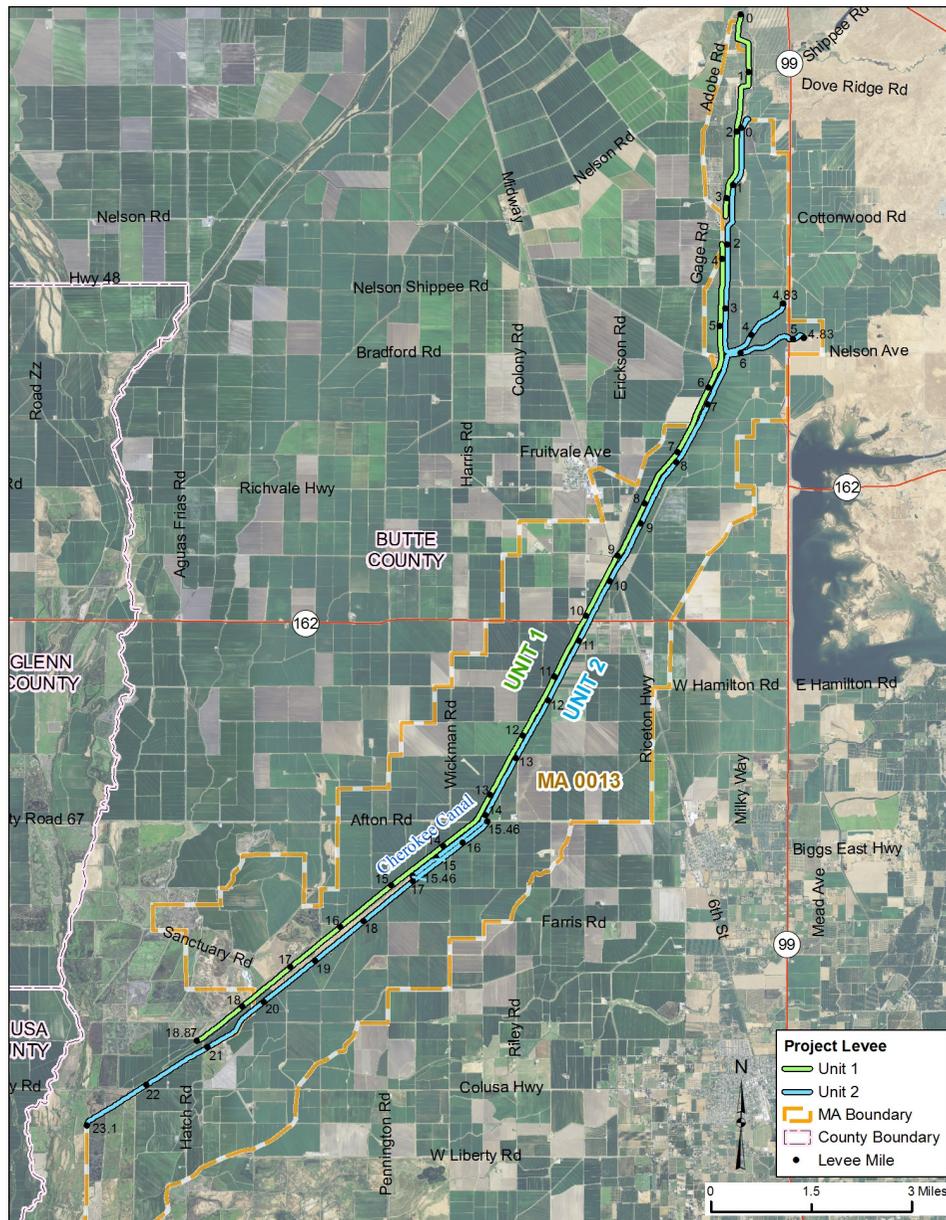
MA 13

LMA Short Name : MA0013		Bank	Unit Length (Miles)
Unit No. 01	Cherokee Canal	RB	18.19
Unit No. 02	Cherokee Canal	LB	22.84

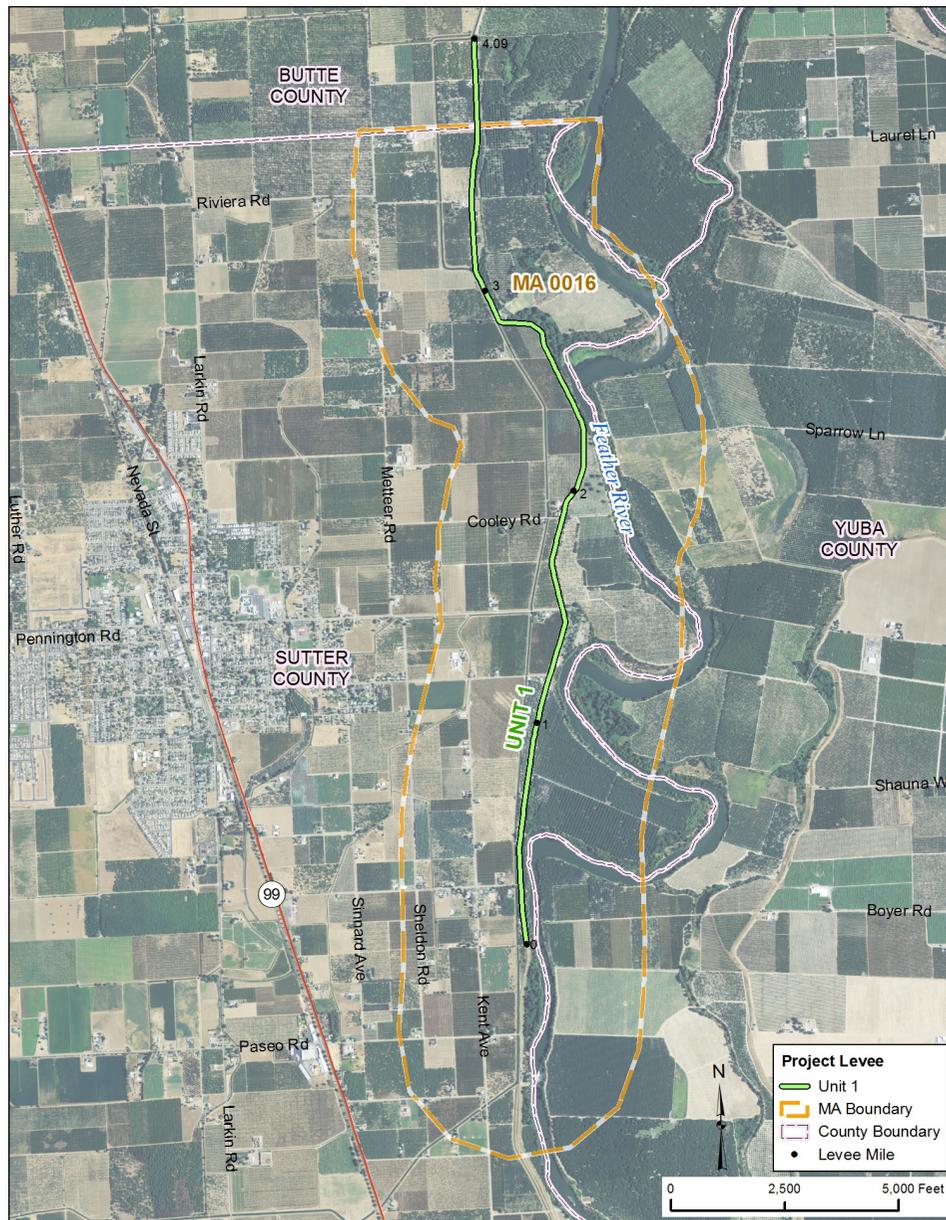
LMA Short Name : MA0016		Bank	Unit Length (Miles)
Unit No. 01	Feather River	RB	4.06

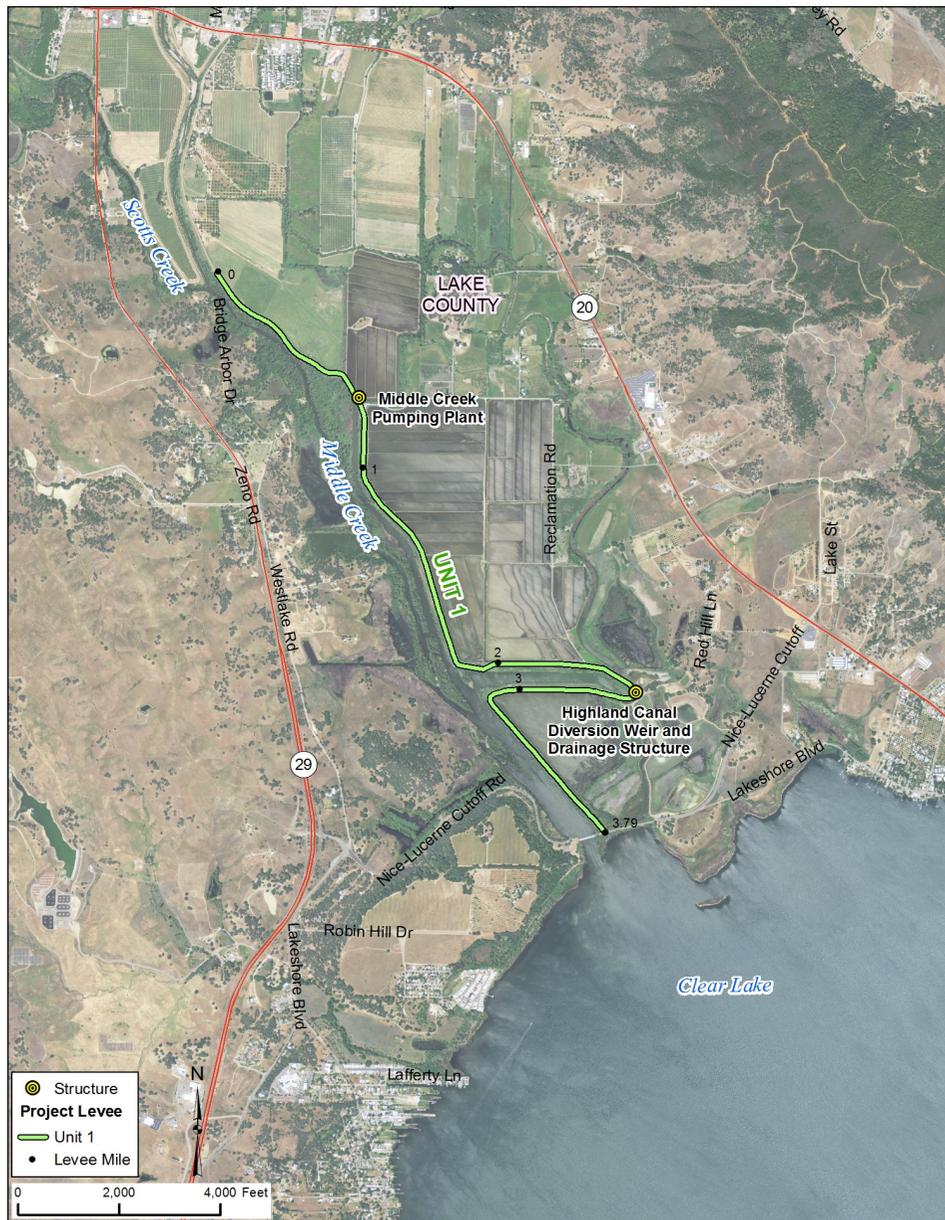
LMA Short Name :	MA0017	Bank	Unit Length (Miles)
Unit No. 01	Lake County Sutter Maintenance Yard - Middle Creek	LB	3.87

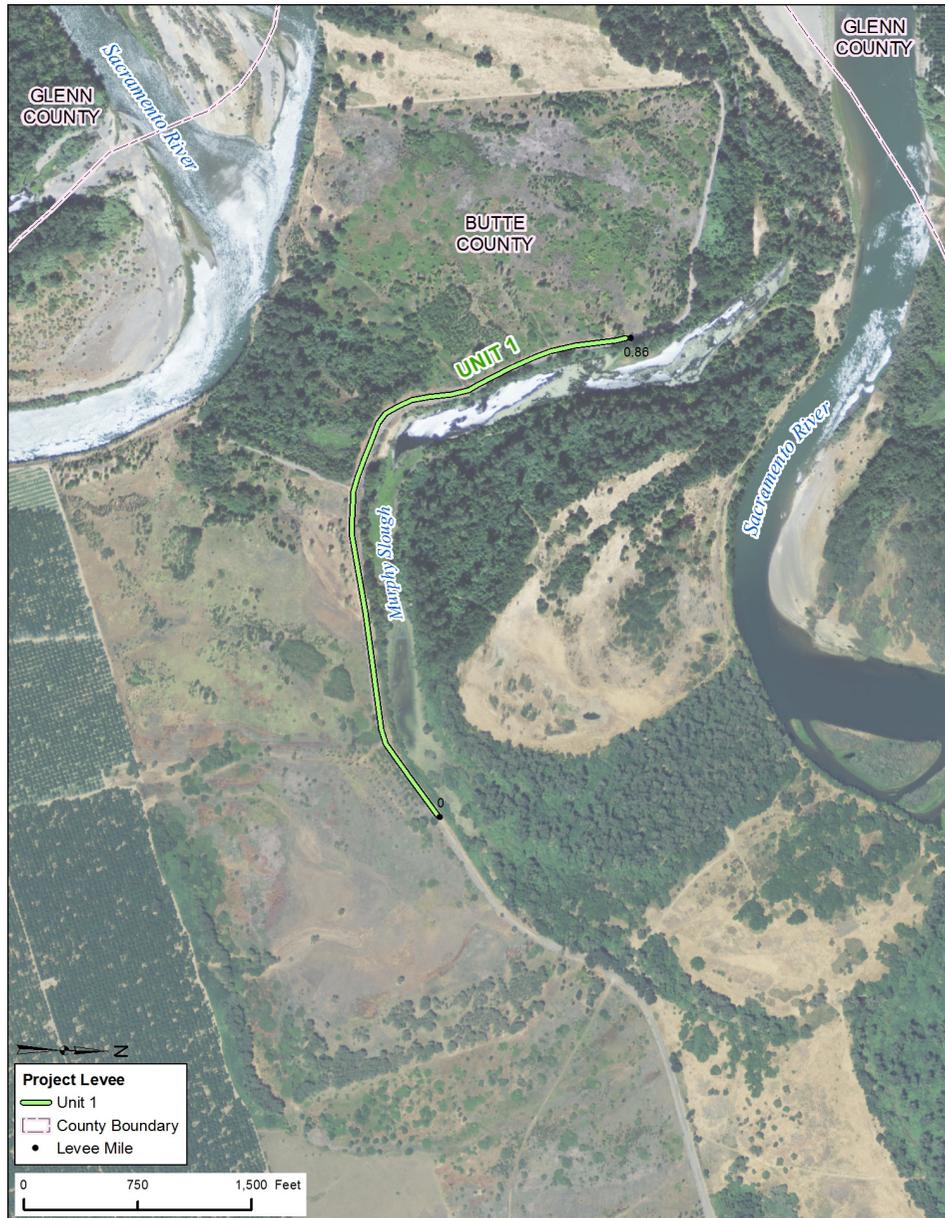
LMA Short Name : ST0014	Bank	Unit Length (Miles)
Unit No. 01 Murphy Slough at M&T Ranch	LB	0.83

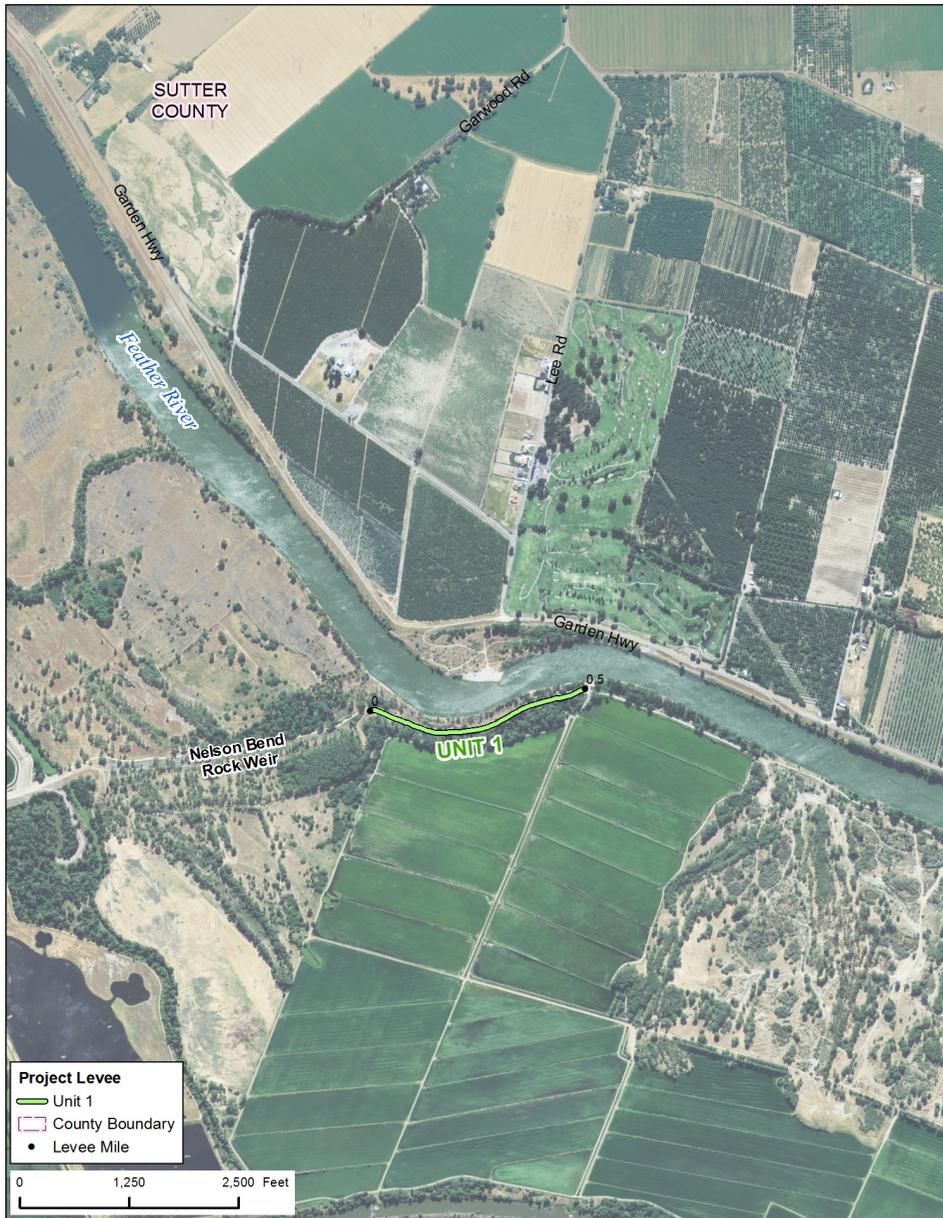
Nelson Bend

LMA Short Name : ST0006	Bank	Unit Length (Miles)
Unit No. 01 Feather River West Levee-Nelson Bend		0.50

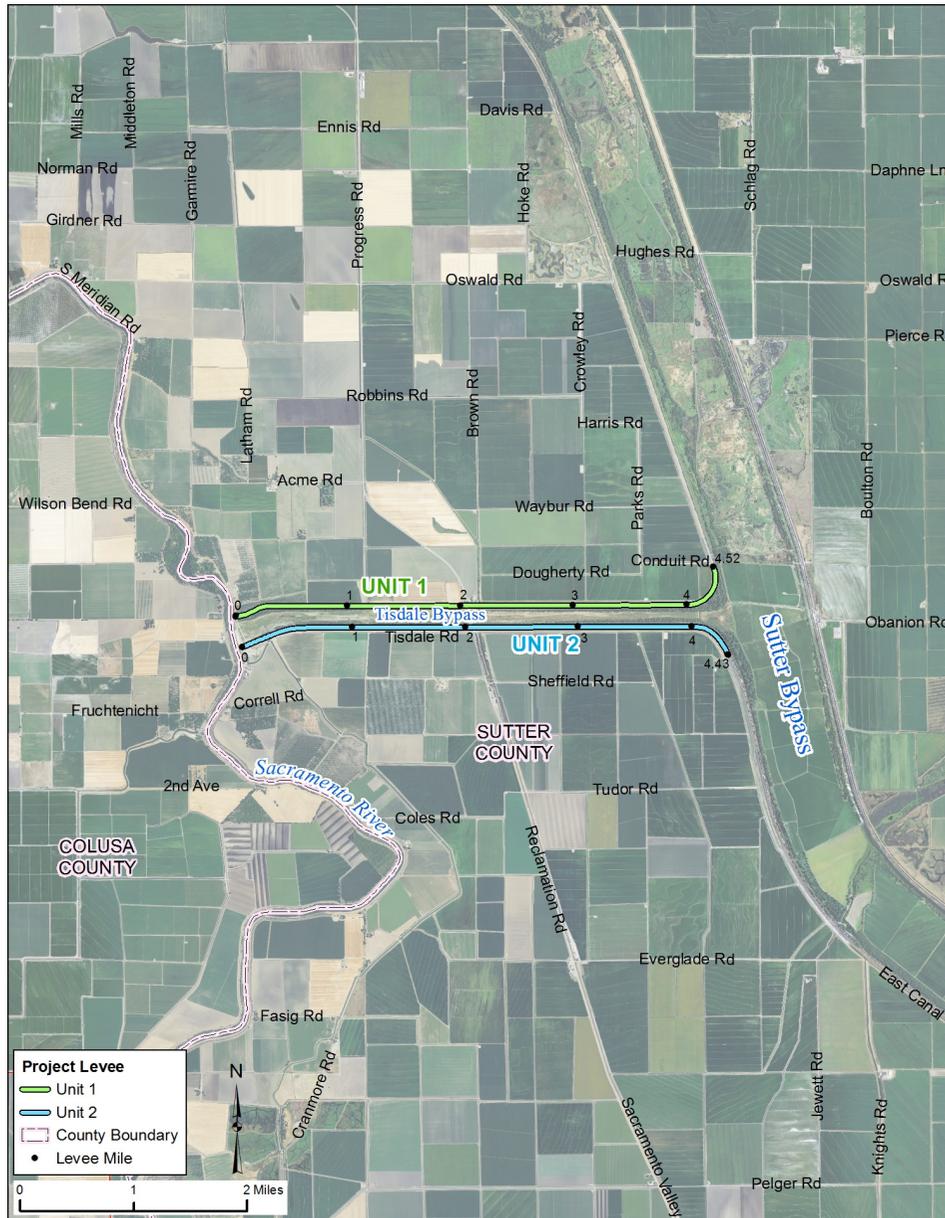
LMA Short Name : ST0009	Bank	Unit Length (Miles)
Unit No. 01 Tisdale Bypass	LB	4.51
Unit No. 02 Tisdale Bypass	RB	4.43

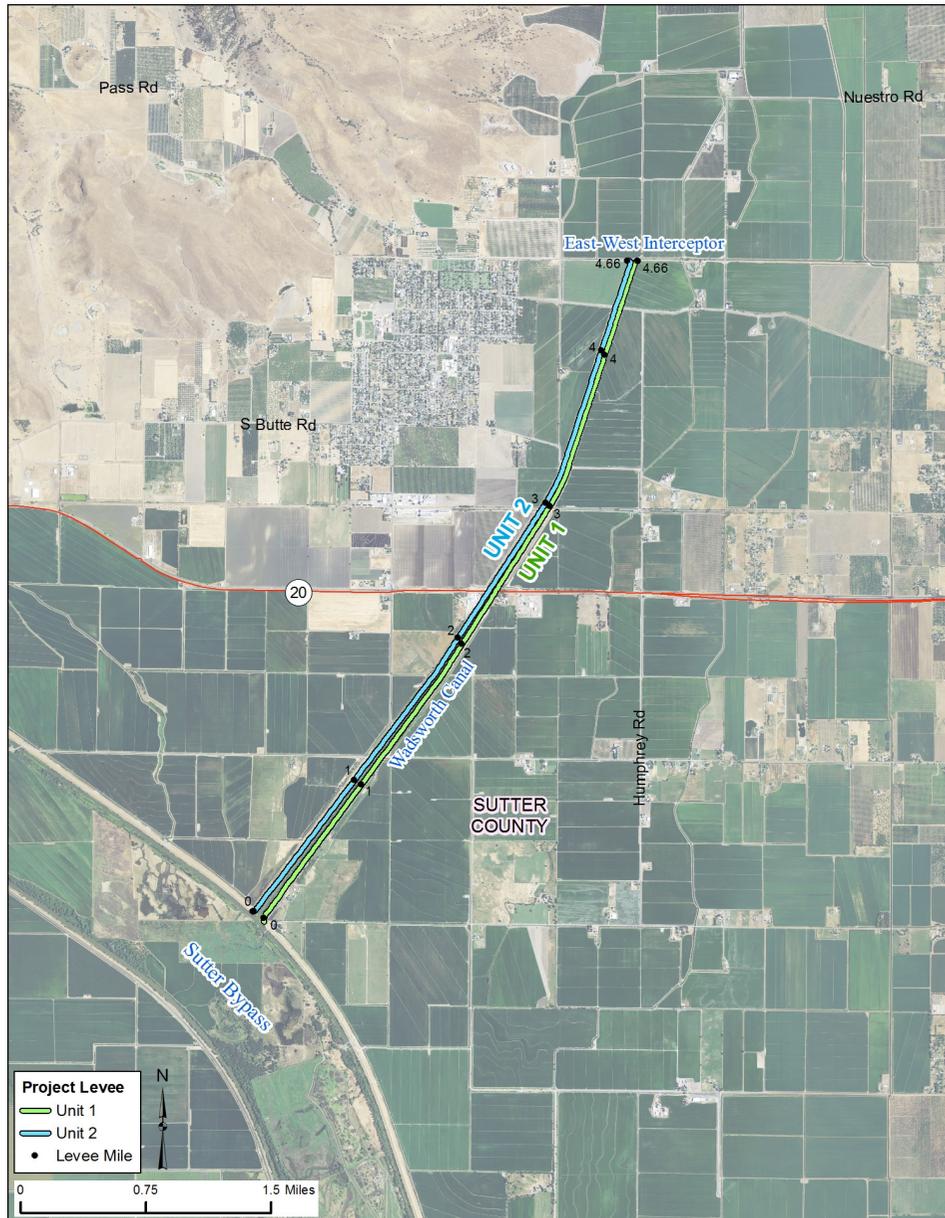
LMA Short Name : ST0010		Bank	Unit Length (Miles)
Unit No. 01	Wadsworth Canal	LB	4.63
Unit No. 02	Wadsworth Canal	RB	4.60
