**Flood Control Project Maintenance
Levee Inspections
LMA District Cover Sheet
Spring 2012 Levee Inspection Results**

Reclamation District No. 2103 Wheatland Vicinity

Levee Inspection Report By Mile - Spring 2012

Waterway	Bank	Unit Miles	Inspection Start/End	Inspector
Unit No. 01 South Dry Creek	Left	4.77	05/30/2012 05/30/2012	Rick Burnett

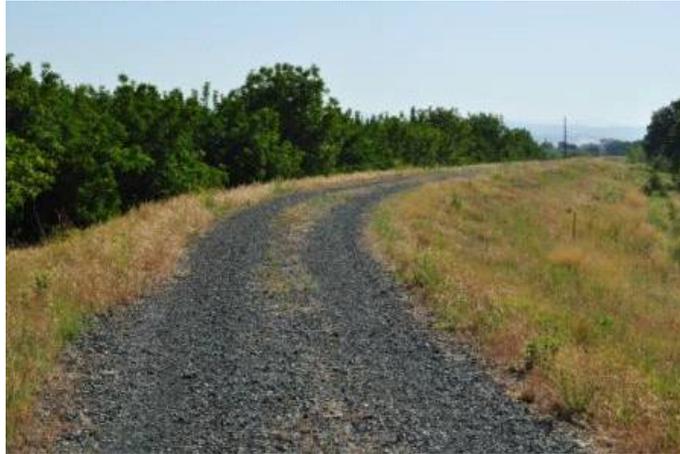
dpesaven_s_20120601_351.JPG

Levee Mile Report Line	1
Start Levee Mile	0.00
End Levee Mile	0.00
Location	Land Side
Category	Earthen Levee
Item	Vegetation

RD 2103 Unit 2 - Vegetation

LMIR No.	Levee Mile		Category	Item	* Location	** Rating	Action/Comment	GPS Latitude/Longitude		Issue No. Photo
	Start	End						Start	End	
1	0.00	0.00	Earthen Levee	Vegetation	LS	A	V1 : Control annual grass and weeds on the levee slopes and easements.	°	°	2
								°	°	Y
DWR ID: DWR_RD2103_02_s_2012_2										
2	0.30	0.30	Earthen Levee	Rip Rap Revetments	WSA/W	Ma	Inspector Comments: The District has a concern dead trees placed in the rip rap may not stay in place during a high water event.	38.994660 °	38.994660 °	4
								-121.432170 °	-121.432170 °	Y
DWR ID: DWR_RD2103_02_s_2012_4										
3	0.33	0.50	Earthen Levee	Vegetation	WSA/W	Ob	V8 : Environmental Requirements.	38.994787 °	38.995502 °	1
								-121.431728 °	-121.428730 °	Y
DWR ID: DWR_RD2103_02_s_2012_1										
4	0.68	0.68	Earthen Levee	Animal Control	LS	C	A1 : Exterminate rodents and backfill and compact or grout burrows.	38.996177 °	38.996177 °	6

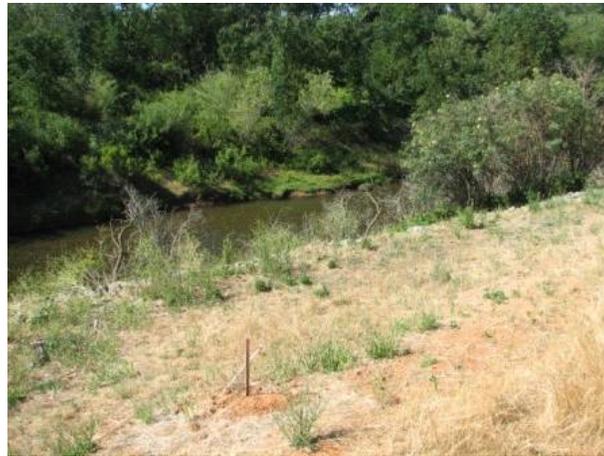
rburnett_s_20120508_350.jpg

Levee Mile Report Line	2
Start Levee Mile	0.30
End Levee Mile	0.30
Location	Water Side
Category	Earthen Levee
Item	Rip Rap Revetments

Trees at waters edge in the rip rap levee mile 0.30.

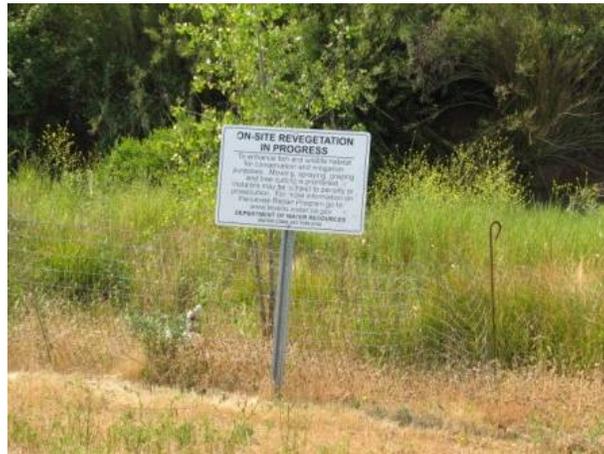
rburnett_s_20120508_349.jpg

Levee Mile Report Line	3
Start Levee Mile	0.33
End Levee Mile	0.50
Location	Water Side
Category	Earthen Levee
Item	Vegetation

Levee mile 0.33, this photo is looking at the landscaping, vegetation on the waterside slope
