**Flood Control Project Maintenance  
Levee Inspections**

**Fall 2010 Levee Maintenance Deficiency Summary Report**

**Sutter Maintenance Yard East Levee Sutter Bypass**

**Levee Inspection Report By Mile - Fall 2010**

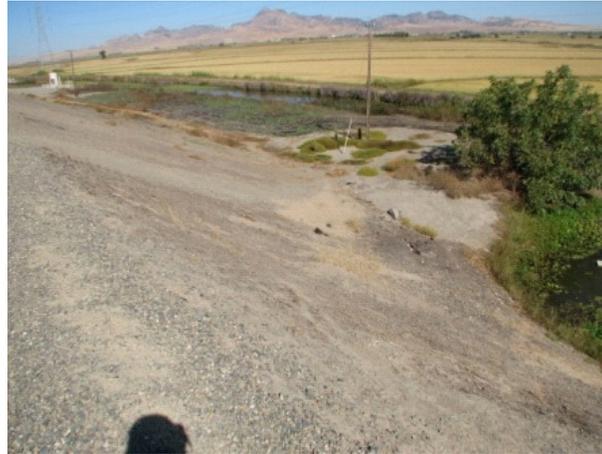
rduffey\_f\_20101101\_234.jpg

Levee Mile Report Line	2
Start Levee Mile	3.60
End Levee Mile	3.60
Location	Land Side
Category	Earthen Levee
Item	Animal Control

View of squirrel hole along slope.

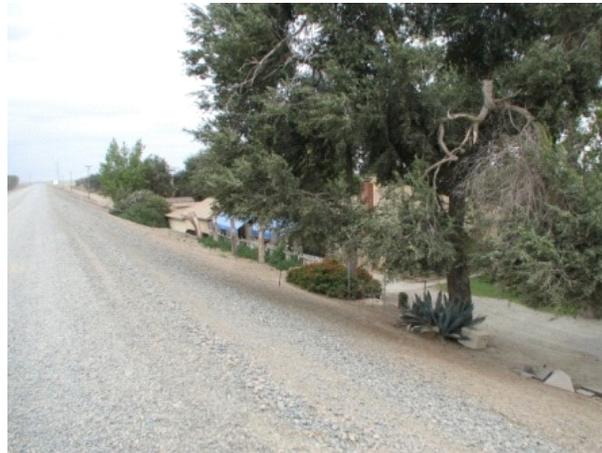
rduffey\_f\_20101101\_235.jpg

Levee Mile Report Line	5
Start Levee Mile	20.64
End Levee Mile	20.64
Location	Land Side
Category	Earthen Levee
Item	Encroachments

View of the building next to the landside toe of the levee.
