LMA: **NA0010 U23 Lower San Joaquin** Waterway: **RB San Joaquin River**  
 Site ID: **NA0010U23RM224.27** Status: **Repaired Site**

Latitude: **36.802116** Longitude: **-120.173847** River\_Mile: **224.27** Levee\_Mile: **9.15** Overall Rating:

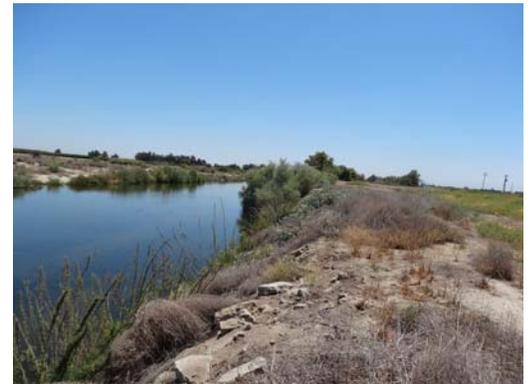
View downstream standing at the middle of the repaired site.

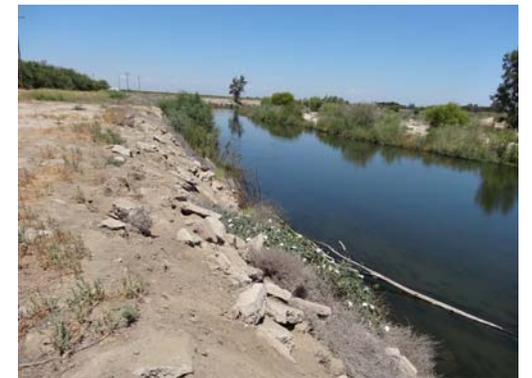
Close view of the repaired site.

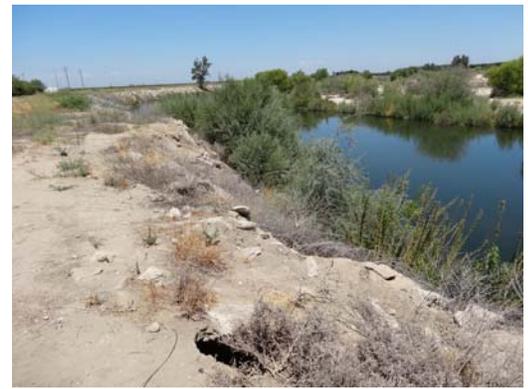
07/22/2014: No significant change observed.  
 07/11/2013: No significant change observed. Cracking on the repaired site is still visible. Wooden debris is present in the river near the site.  
 07/24/2012: The site has been repaired with clay material, riprap rocks, and broken concrete blocks, but the loose material and large cracking at the repaired site are visible. Need monitoring for the performance during the coming high flow events.  
 08/16/2011: The erosion is cutting into the levee. The site is located at the outside of a river bend, and the erosions were caused by river flows during the last flooding season. The ground was covered by dense grasses. Animal burrow holes are visible.

Upstream view of the repaired site.

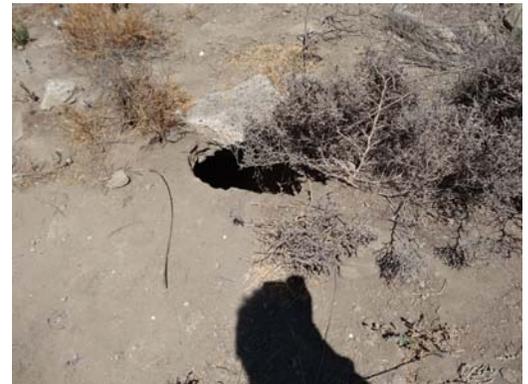
View of the repaired site. Note the animal holes on the ground.

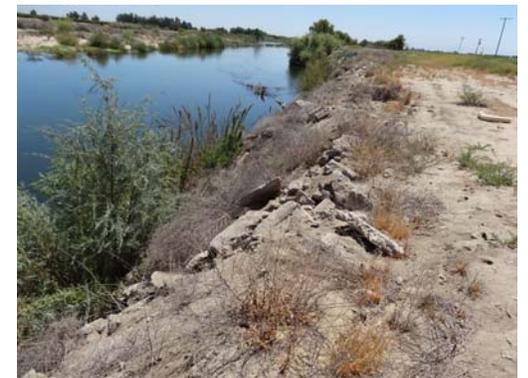
Looking down at the cracking at the repaired site.

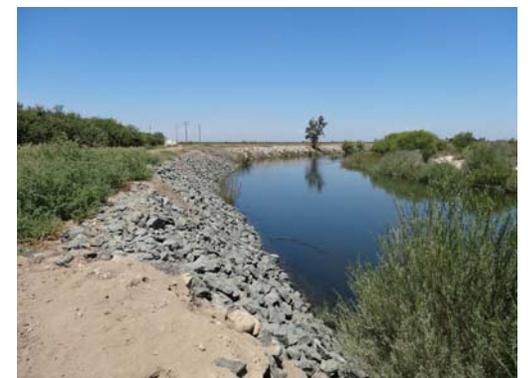
Upstream view of the repaired site.

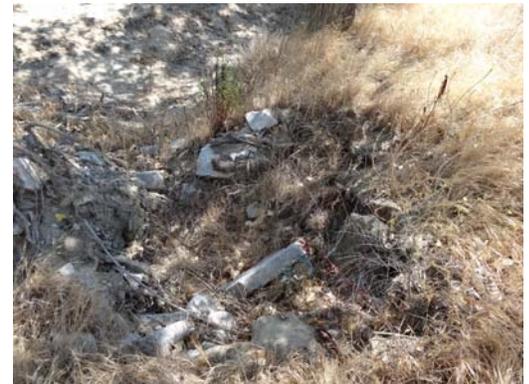
Close view of the site.

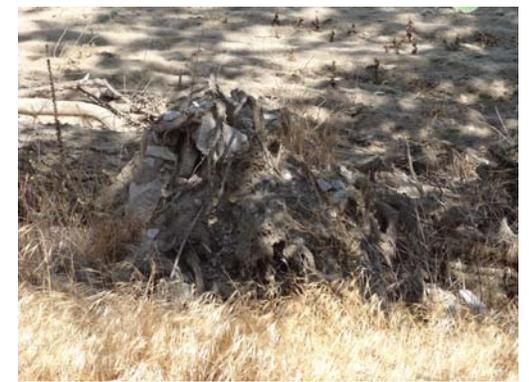
Tree roots exposed.

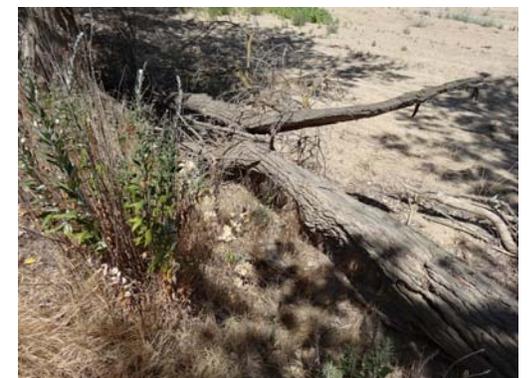
Close view of the site with the dead tree.

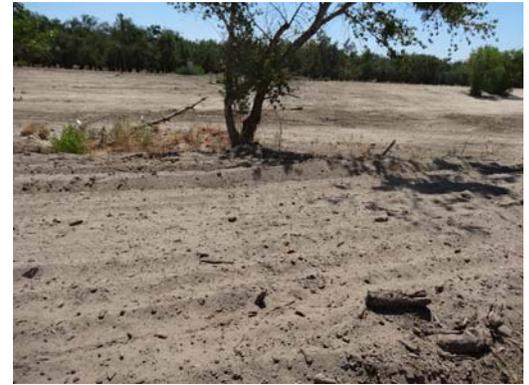
Close view of the site.

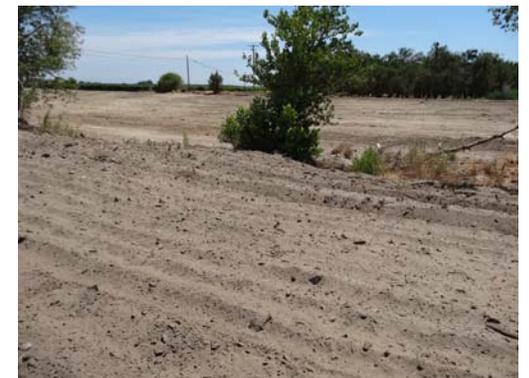
Close view of the site. Note the trees and vegetation at site.

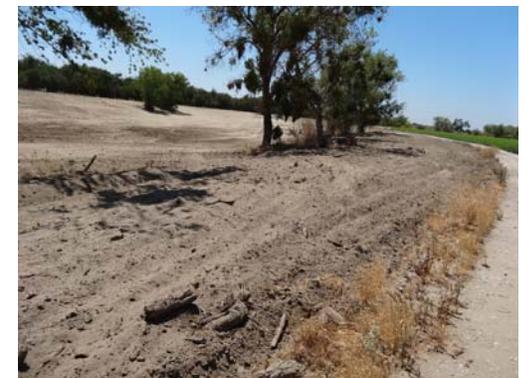
Close view of the site.

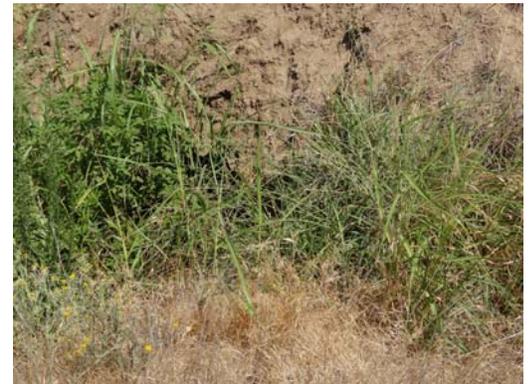
The erosion site is covered with dense vegetation.

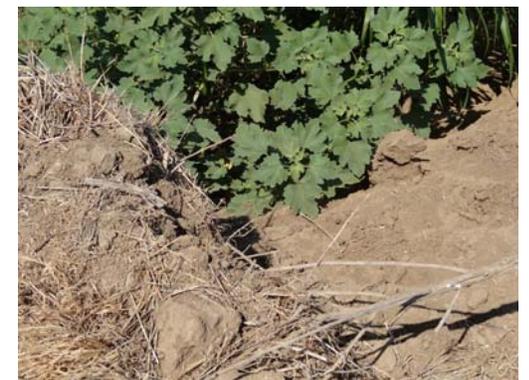
Downstream view of the levee. Soil has been added to the bank near the site.

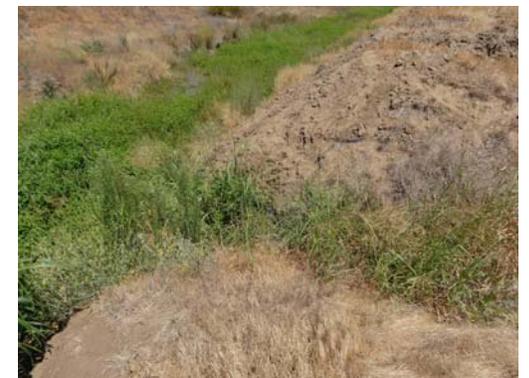
Looking down at the site.

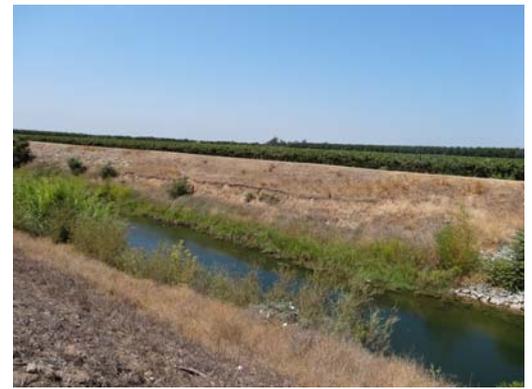
8/20/2014: Both ends of the erosion site are protected by riprap.

View of the site from the left river bank.

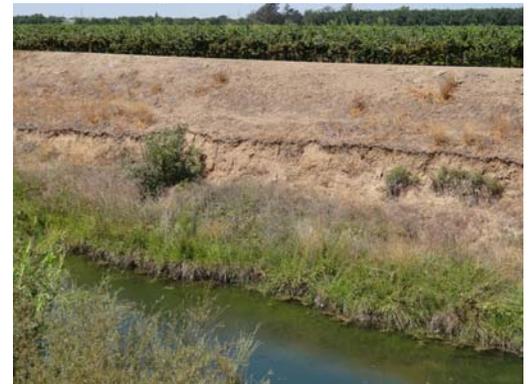
Close view of the erosion.

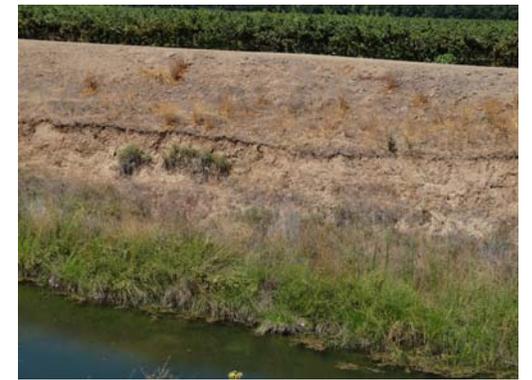
Close view of the erosion.

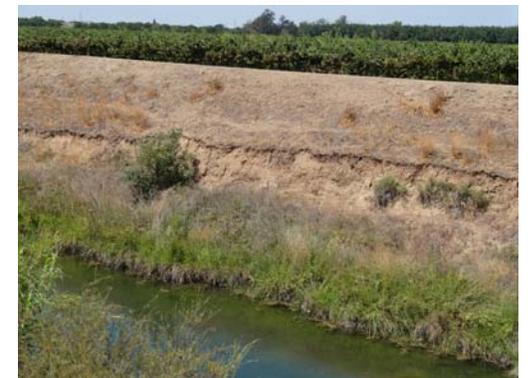
Close view of the erosion.

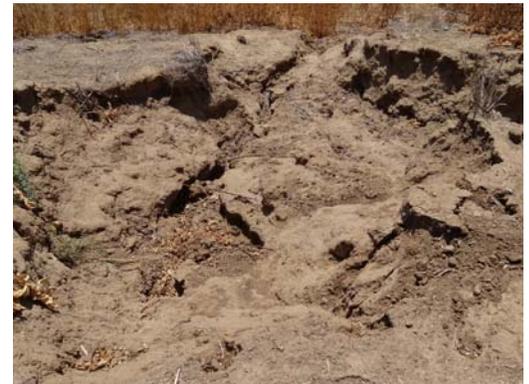
Close view of the erosion.

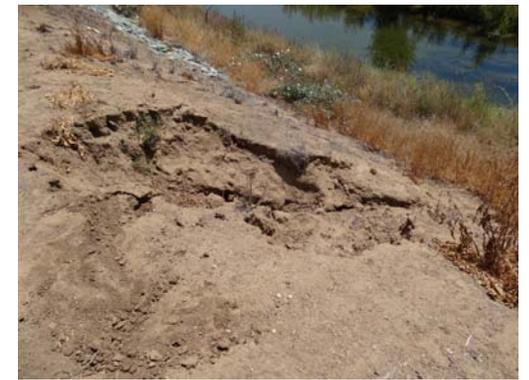
Close view of the erosion.

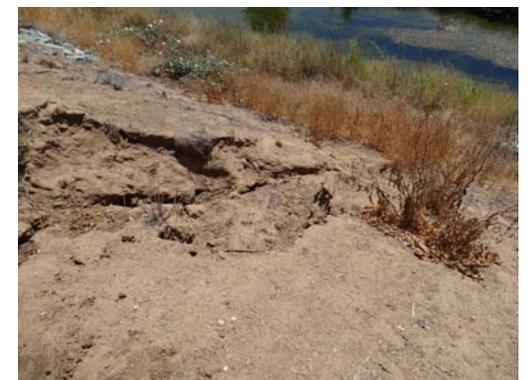
Close view of the erosion.

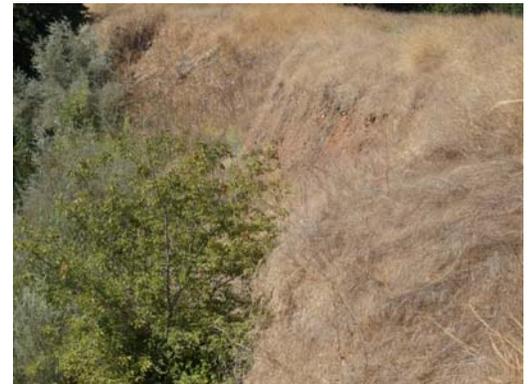
Close view of the erosion. Note the dense vegetation and tree on site.

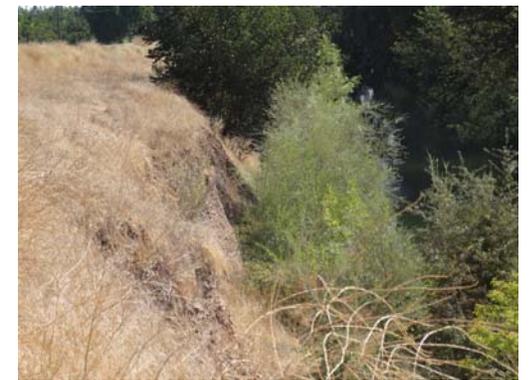
Close view of the erosion site. Small trees grow at the lower slope of the bank.

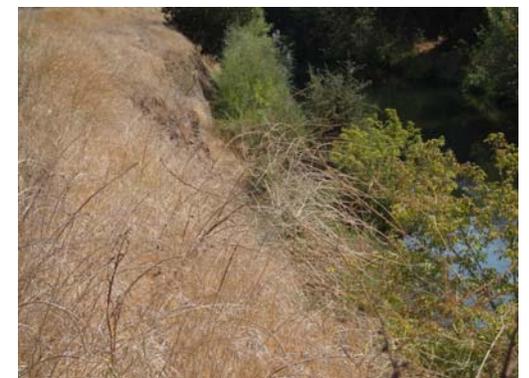
Looking down at the site.

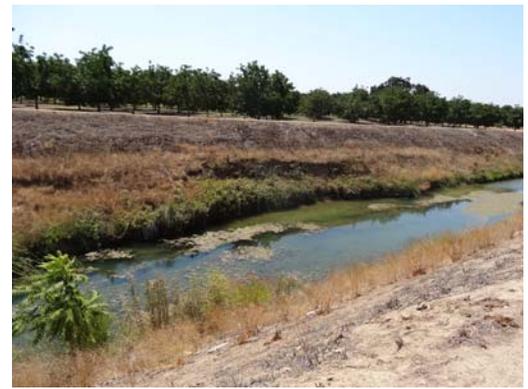
8/20/2014: No significant change observed.  
 9/12/2013: No significant change observed.  
 08/22/2012: Dense vegetation on site. There is no levee structure on site. The levee crest width and levee height were not measured or estimated in the field.

Downstream view of the site from the right river bank.

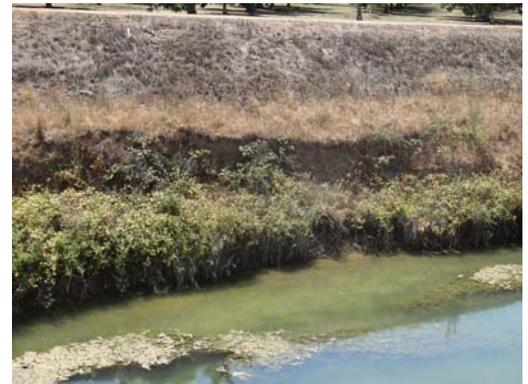
Close view of the erosion.

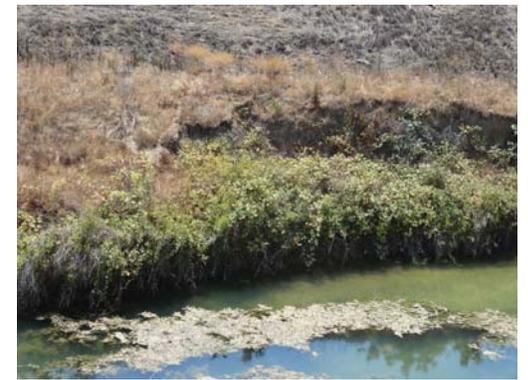
Closer view of the erosion.

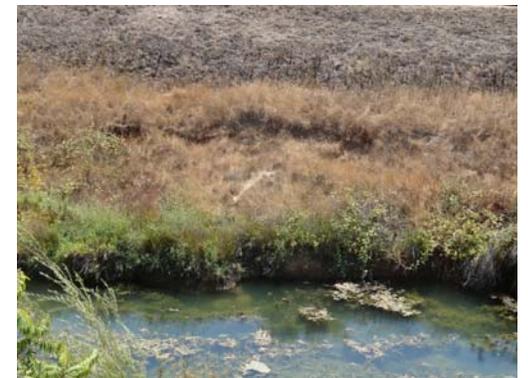
Front view of the erosion.

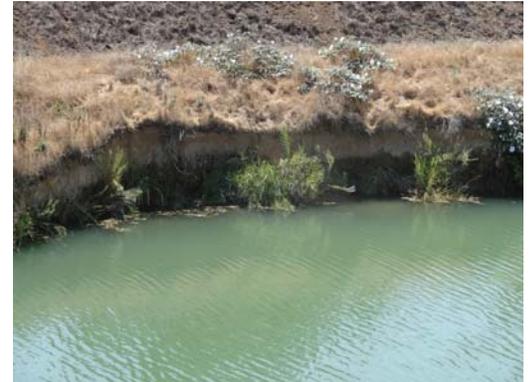
Close view of the erosion.

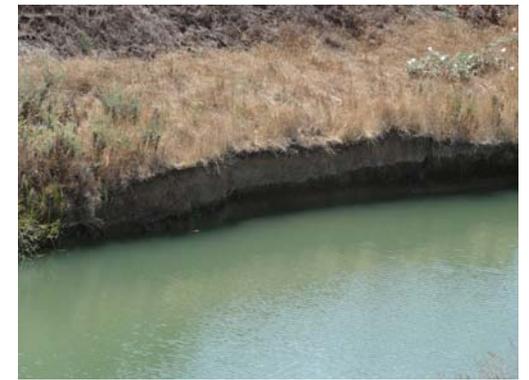
Close view of the erosion.

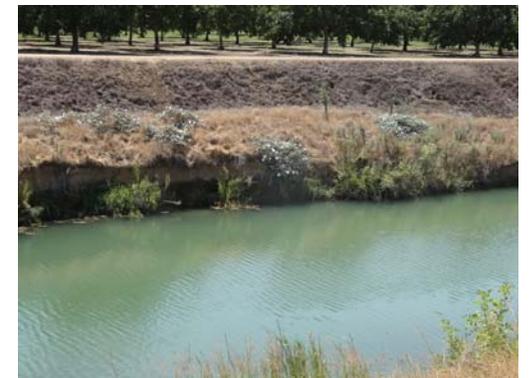
Close view of the erosion.

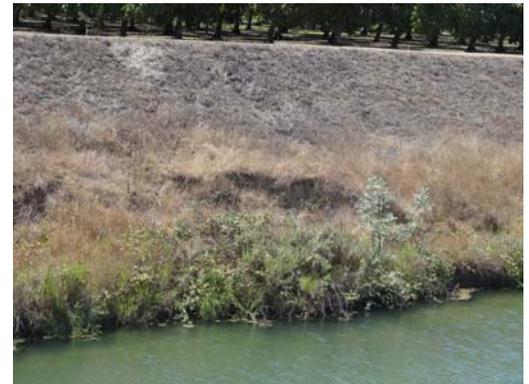
Close view of the erosion.

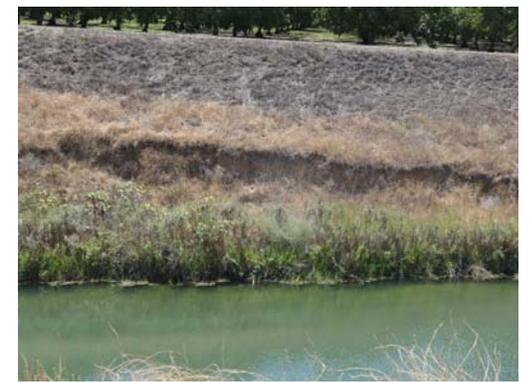
Close view of the erosion.

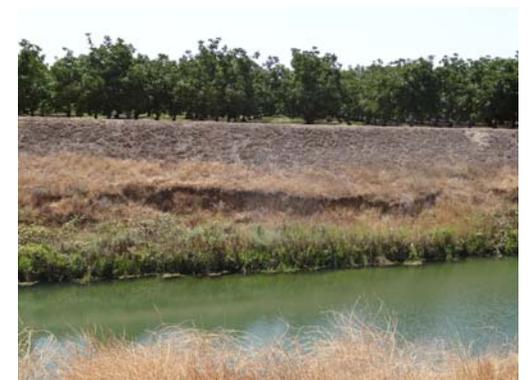
Front view of the erosion.

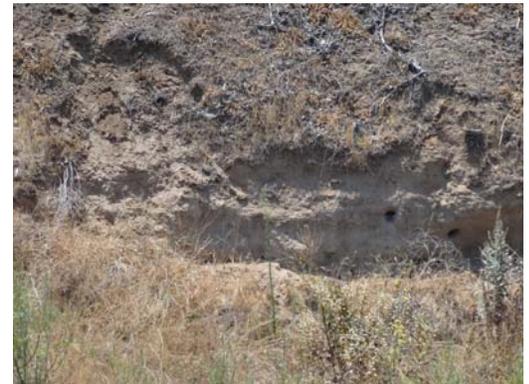
Close view of the erosion.

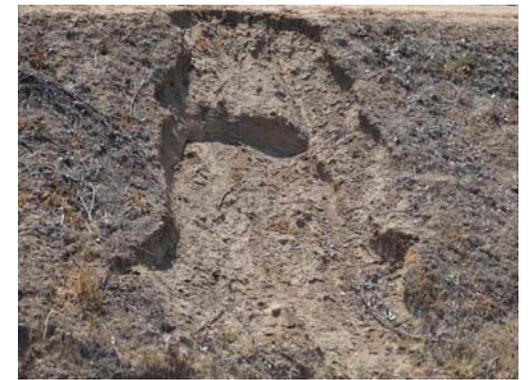
Close view of the erosion.

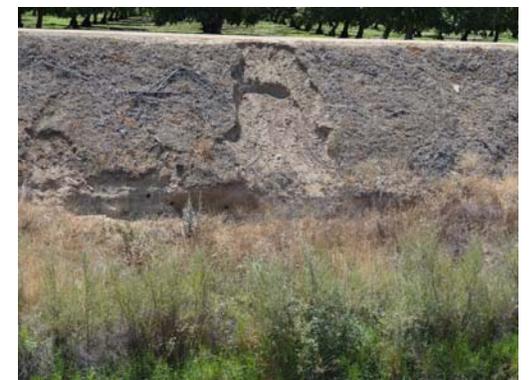
Close view of the erosion.

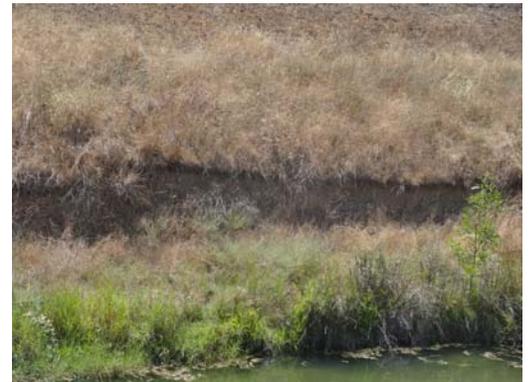
Close view of the erosion.

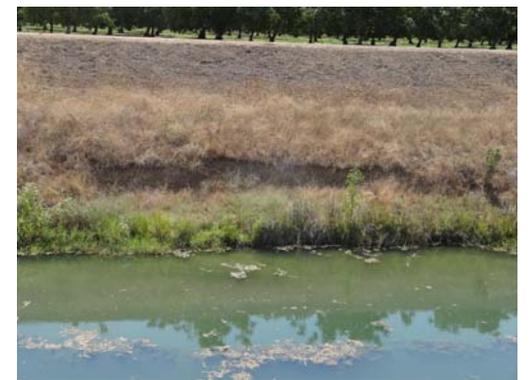
Closer view of the erosion.

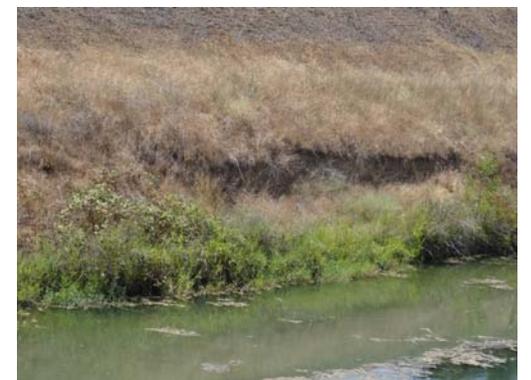
Closer view of the erosion.

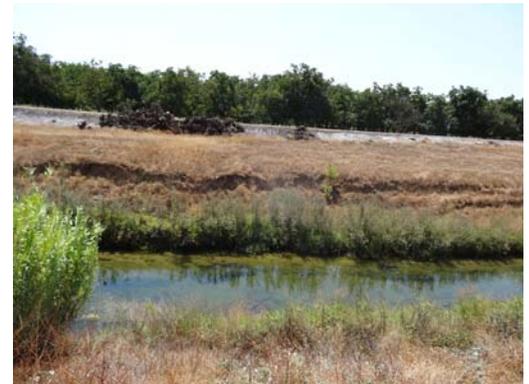
8/20/2014: No significant change observed.  
 9/12/2013: No significant change observed.  
 08/22/2012: The erosion occurred on a berm of approximately 25 ft. wide. Site is covered with dense vegetation. There is no levee structure on site. The levee crest width and levee height were not measured or estimated in the field.

Front view of the erosion.

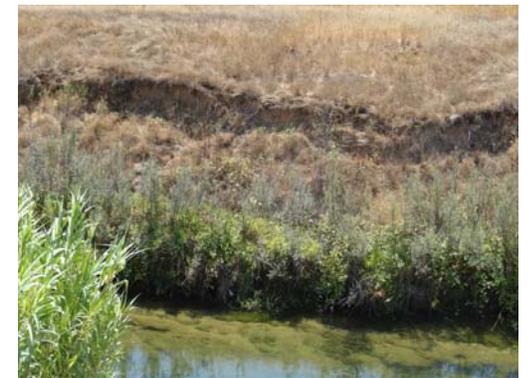
Close view of the erosion.

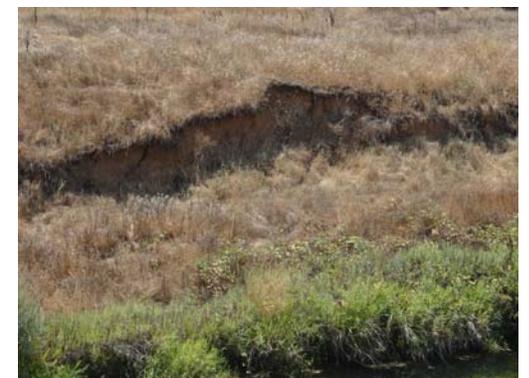
Closer view of the erosion.

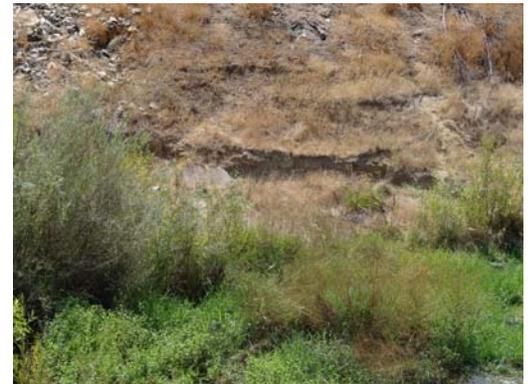
8/20/2014: No significant change observed. Note the site ID changed from NA0017U16RM10.82 to NA0017U16RM15.57 to reflect the correct river mile.  
 09/12/2013: The site is located at immediately downstream of a levee segment protected by broken concrete. There is no levee structure on site. The levee crest width and levee height were not measured or estimated in the field.

Close view of the erosion.

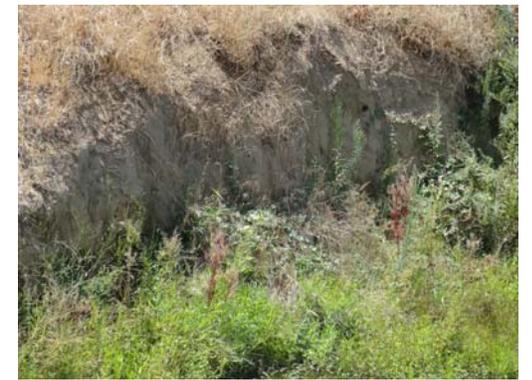
Close view of the erosion.

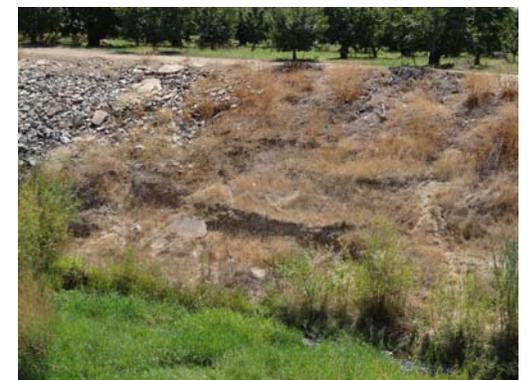
Close view of the erosion. Note the protected levee slope upstream of the site.

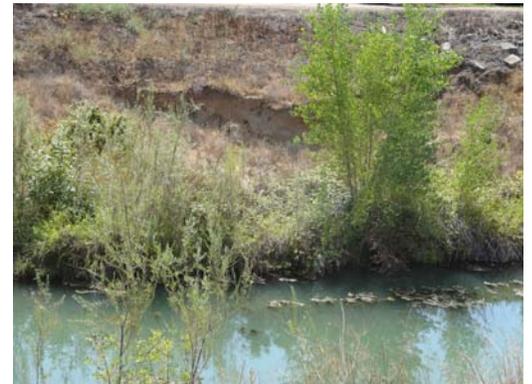
8/20/2014: No significant change observed.  
 9/12/2013: Site has been surveyed and the erosion has worsened since last year.  
 08/22/2012: Discontinuous scarp or pocket erosions occurred along a long stretch of the river, with an erosion height greater than 25 ft. at certain points. There is no levee structure on site. The levee crest width and levee height were not measured or estimated in the field.

Closer view of the erosion.

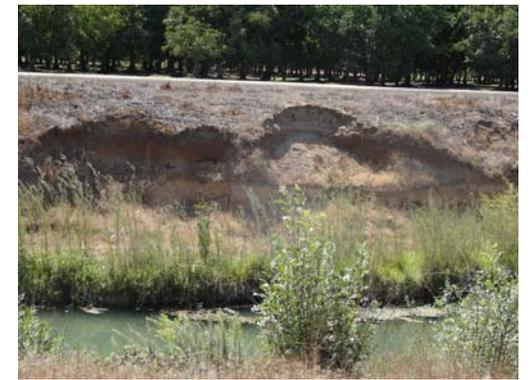
Front view of the erosion.

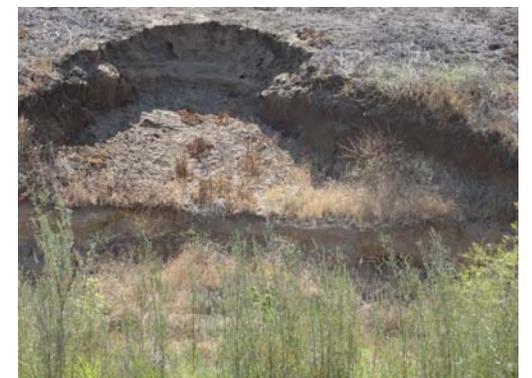
Close view of the erosion.

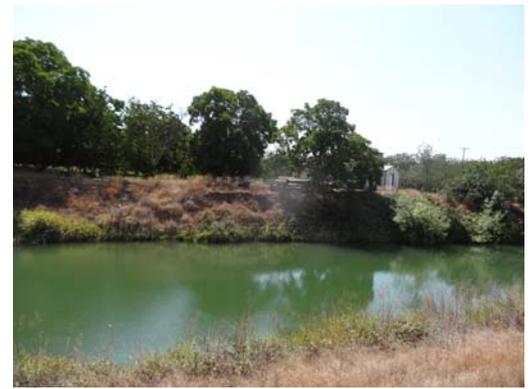
8/20/2014: The erosion is near a tree and probably has been made worse by the unstable bank slope.

View of the site from the right river bank.

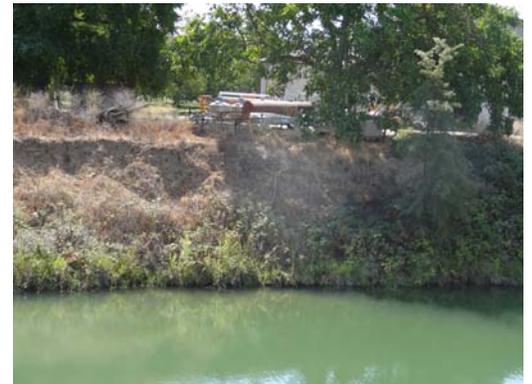
Close view of the erosion.

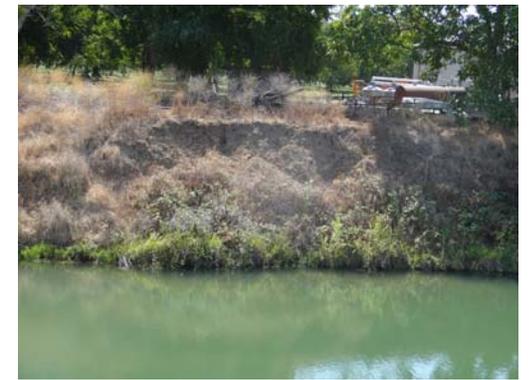
Close view of the erosion.

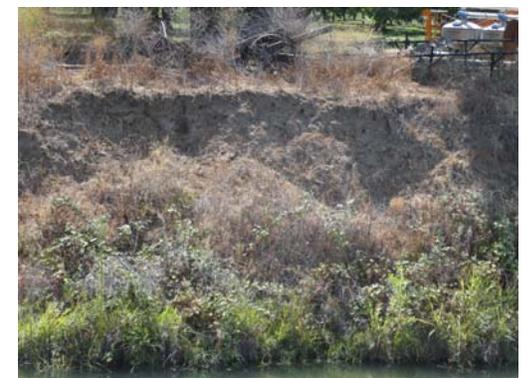
Close view of the erosion.

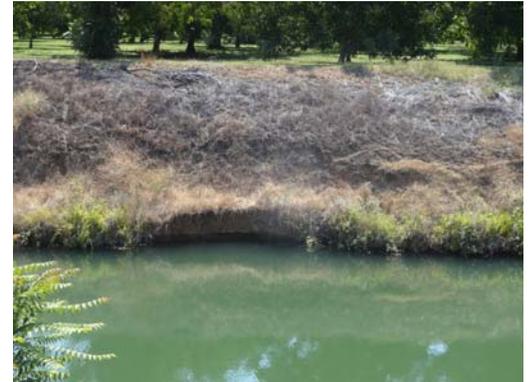
View from the right river bank.

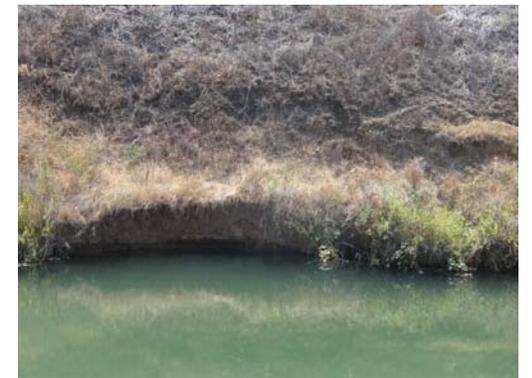
Close view of the erosion.

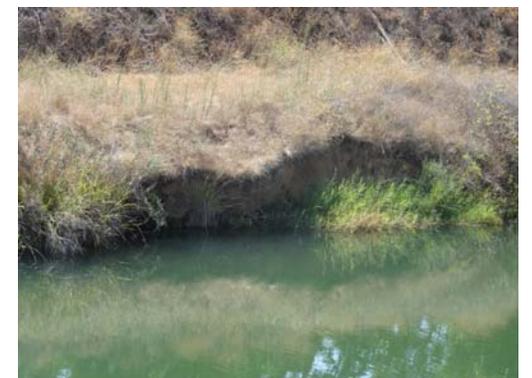
Close view of the erosion.

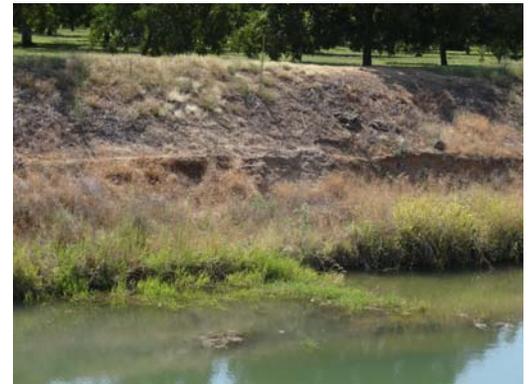
Front view of the site.

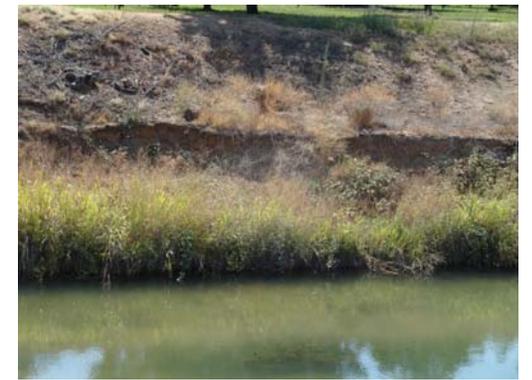
Closer view of the erosion.

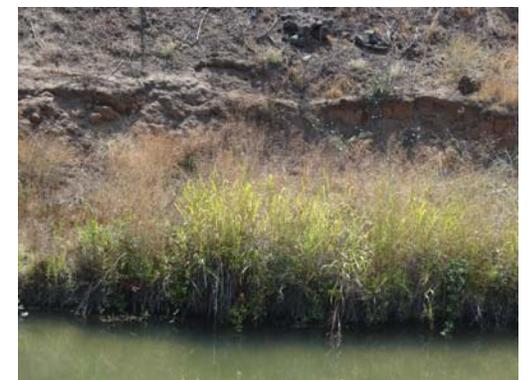
Close view of the erosion.

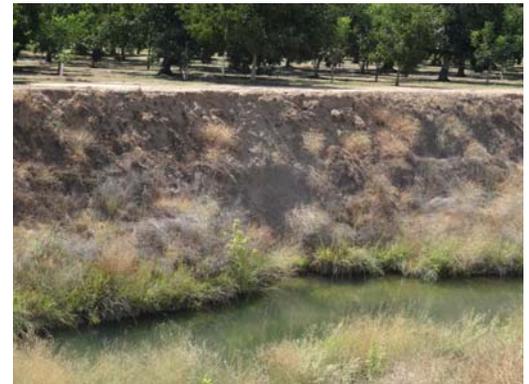
Close view of the erosion.

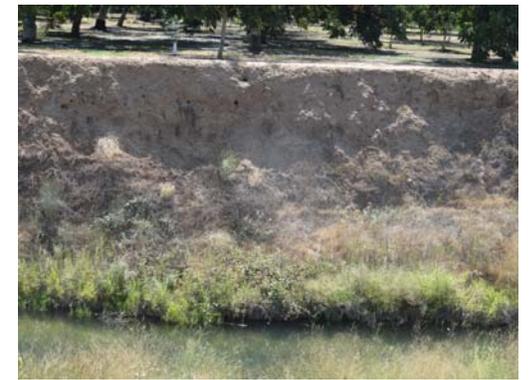
A close view of the erosion.

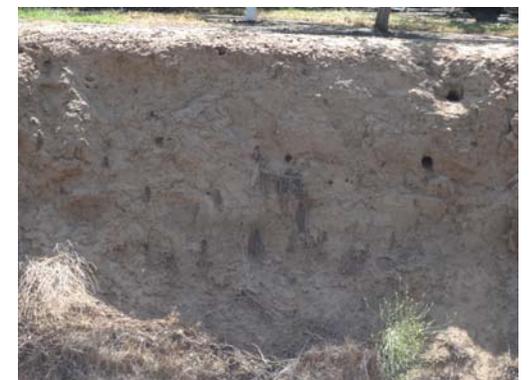
Close view of the erosion.

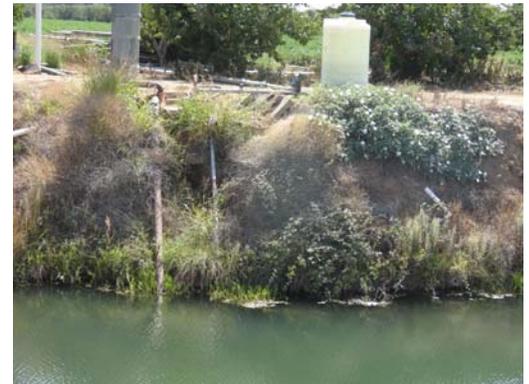
Front view of the erosion.

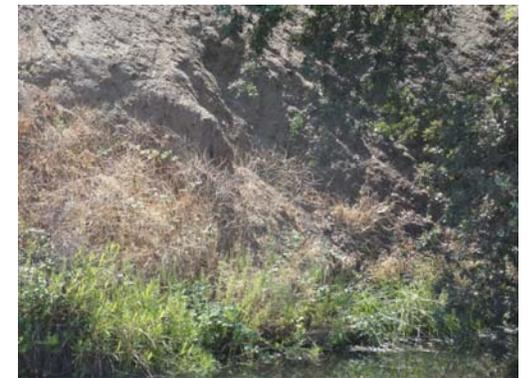
Closer view of the erosion.

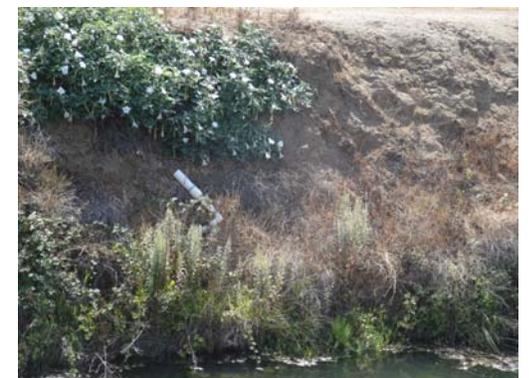
Closer view of the erosion.

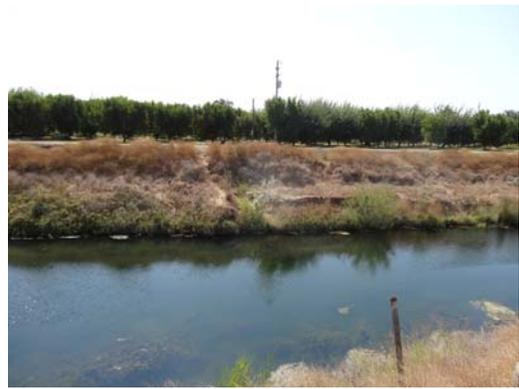
View of the site from right river bank.

8/20/2014: No significant change observed.  
 9/12/2013: No significant change observed.  
 08/22/2012: River-induced erosion occurred on the berm, while the runoff-induced erosion occurred on the levee slope. Site is covered with vegetation. There is no levee structure on site. The levee crest width and levee height were not measured or estimated in the field.

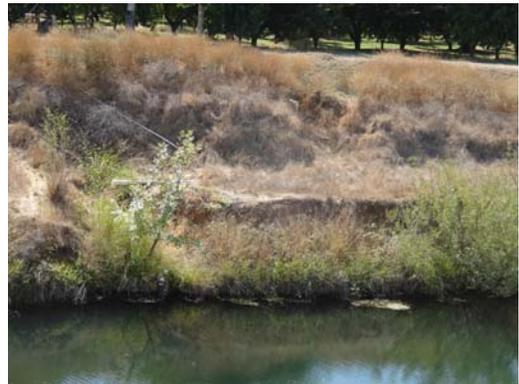
Closer view of the erosion.

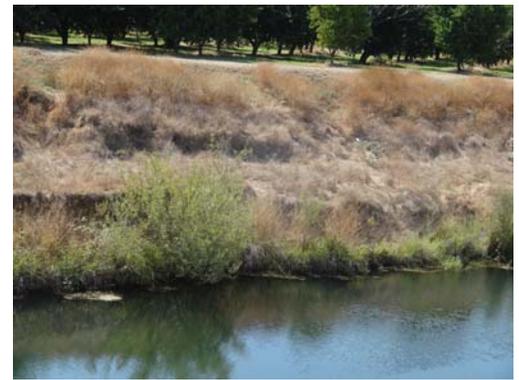
Front view of the erosion at the berm.

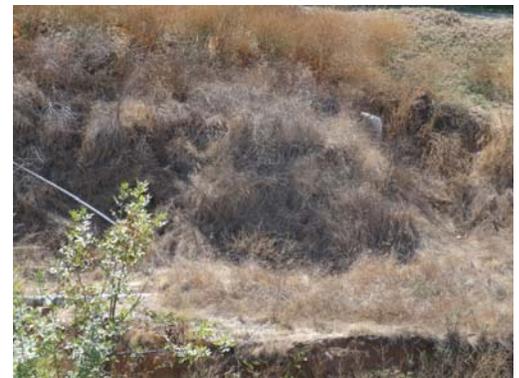
Another closer view of the erosion.

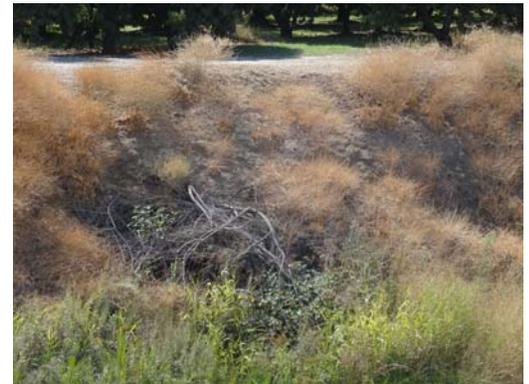
Front view of repaired site.

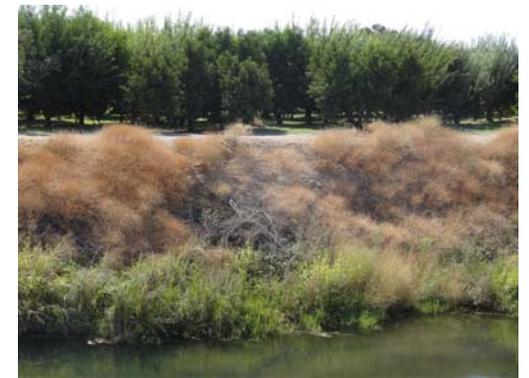
A closer view of the repaired site.

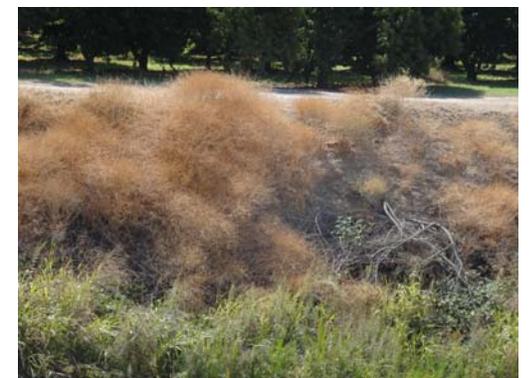
Close view of the repaired site.

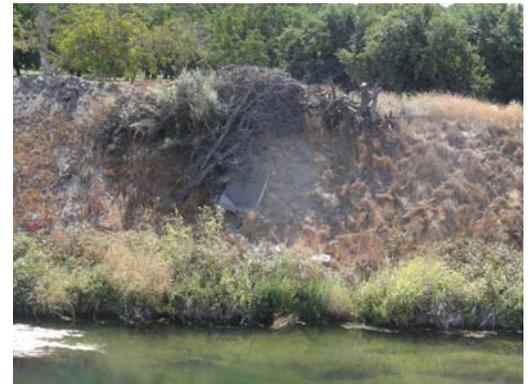
View of the repaired site.

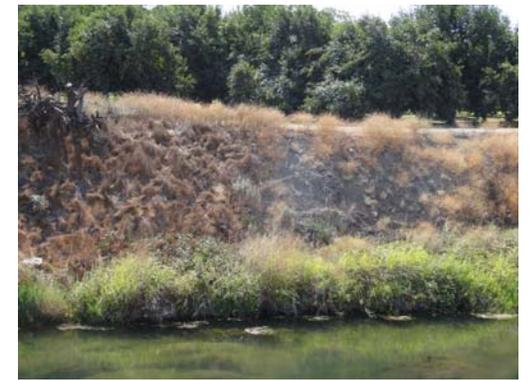
Front view of the repaired erosion.

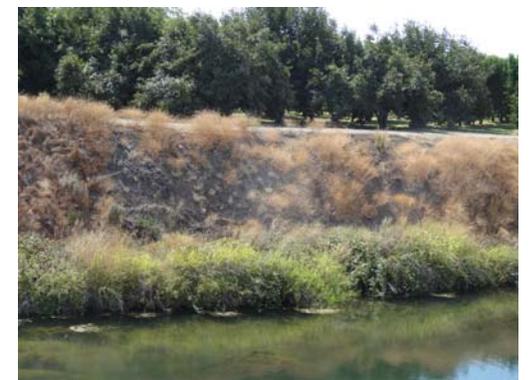
A closer view of the site. Note the pocket erosion immediately next to the repaired site.

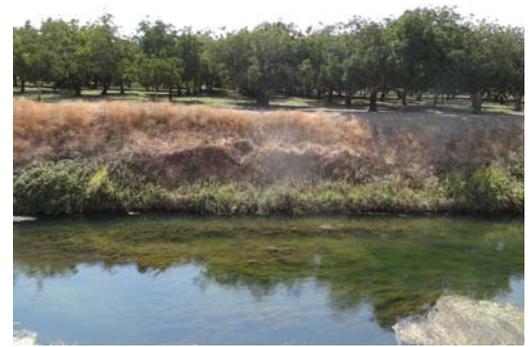
8/20/2014: A pocket erosion was found near the water's edge.

View of the site from the right river bank.

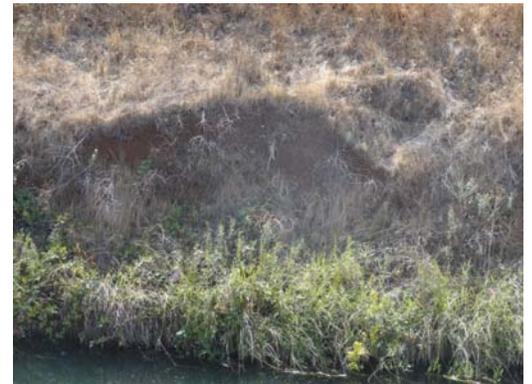
Close view of the erosion.

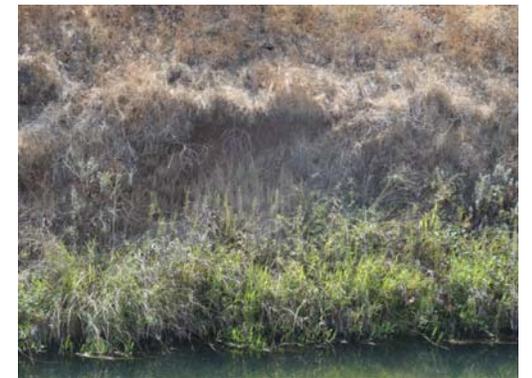
Close view of the erosion. Note the dense vegetation.

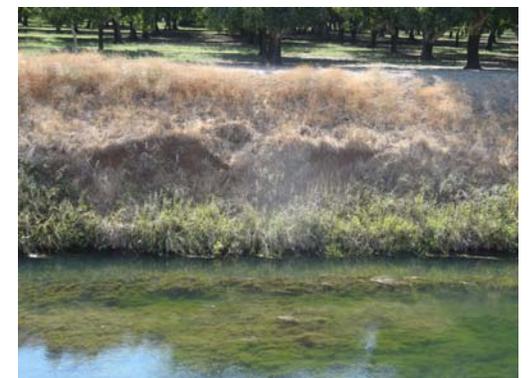
View of the site.

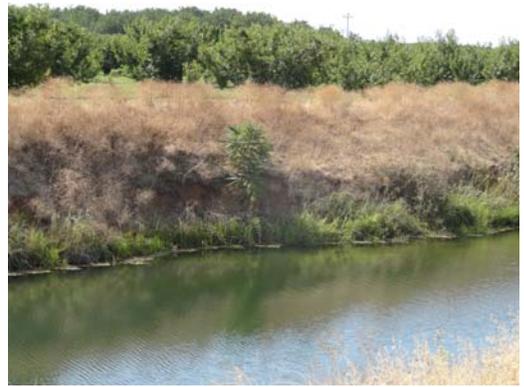
Front view of the erosion.

8/20/2014: No significant change observed.  
 9/12/2013: No significant change observed.  
 08/22/2012: Site Comprised of series of pocket and scarp erosions. Some of erosions are covered by grass or shrubs. There is no levee structure on site. The levee crest width and levee height were not measured or estimated in the field.

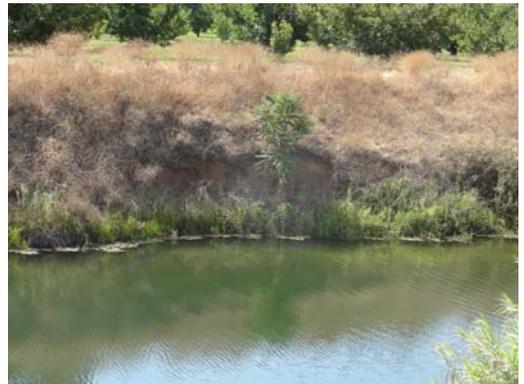
Front view of the erosion.

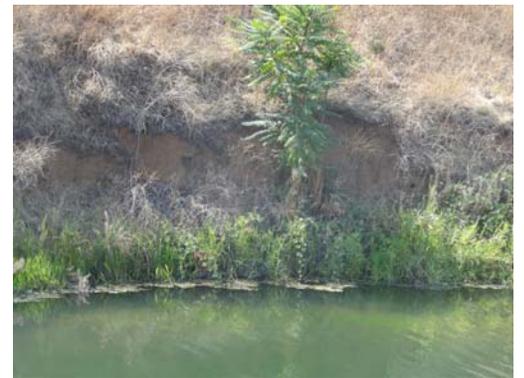
Close view of the erosion.

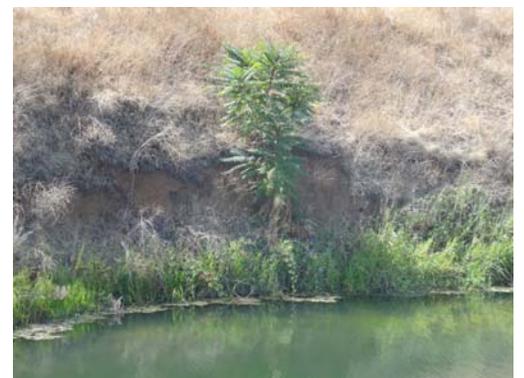
Close view of the scarp erosion.

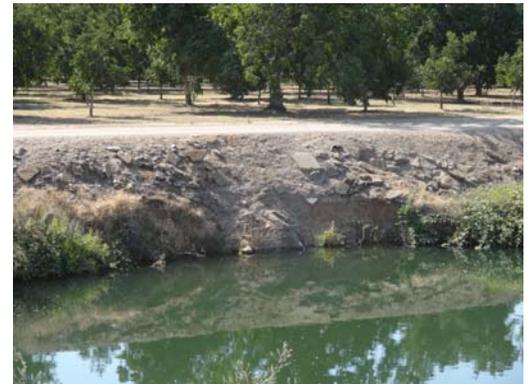
8/20/2014: No significant change has been observed.  
 9/12/2013: No significant change observed.  
 08/22/2012: The erosion was first reported in the 2012 spring levee inspection report. There is no levee structure on site. The levee crest width and levee height were not measured or estimated in the field.

Close view of the erosion. Note the vegetation at the site.

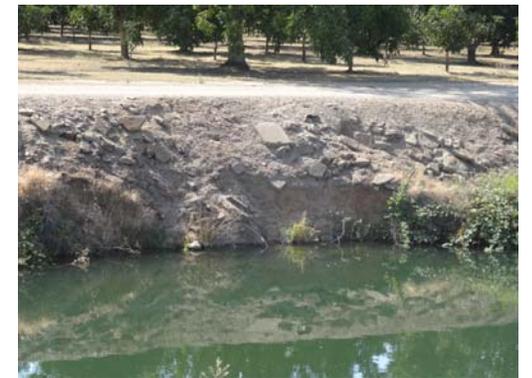
Close view of the erosion.

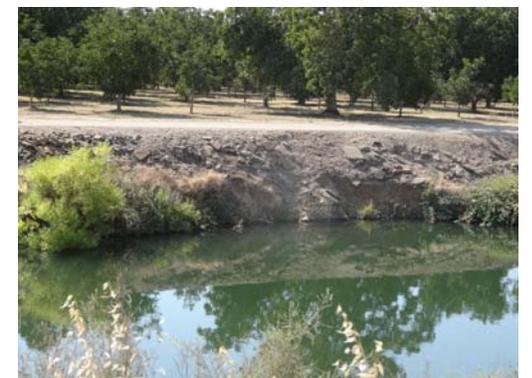
Close view of the site.

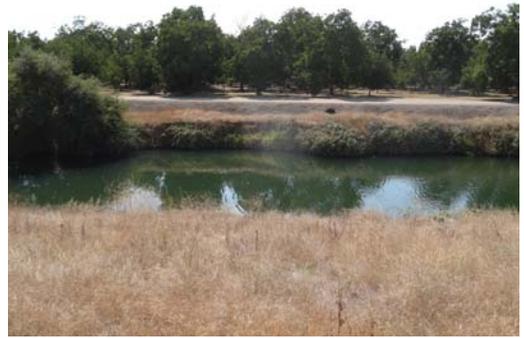
8/20/2014: No significant change observed.  
 9/12/2013: No significant change observed.  
 08/22/2012: Site is covered with dense vegetation. There is no levee structure on site. The levee crest width and levee height were not measured or estimated in the field.

Front view of the site.

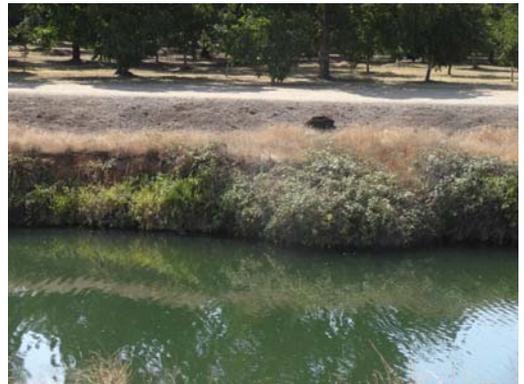
Front view of the erosion. Site is covered with vegetation and trees.

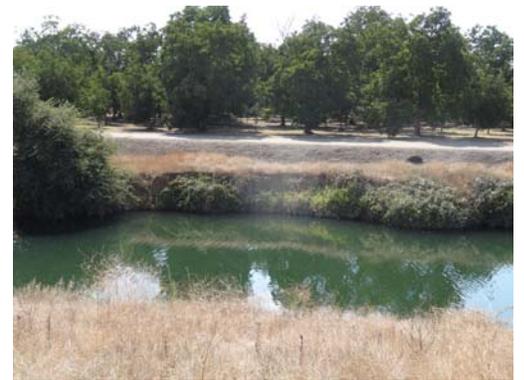
Closer view of the erosion.

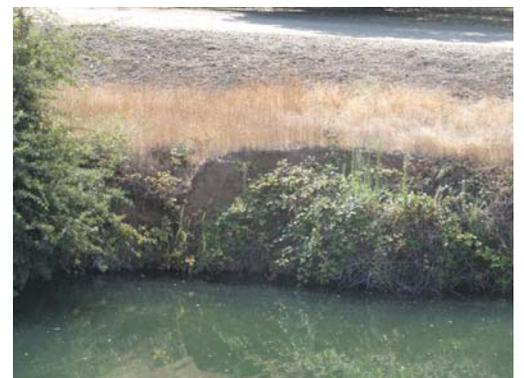
Close view of the erosion.

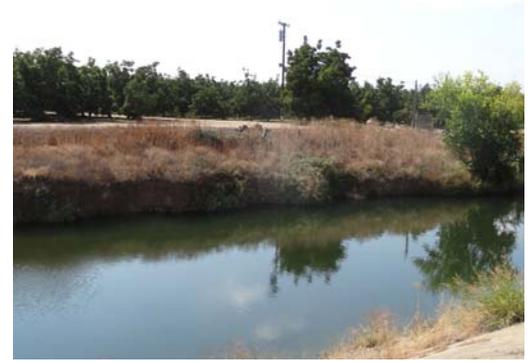
8/20/2014: No significant change observed.  
 9/12/2013: No significant change observed.  
 08/22/2012: Berm width is estimated as 5 ft. There is no levee structure on site. The levee crest width and levee height were not measured or estimated in the field.

Front view of the erosion

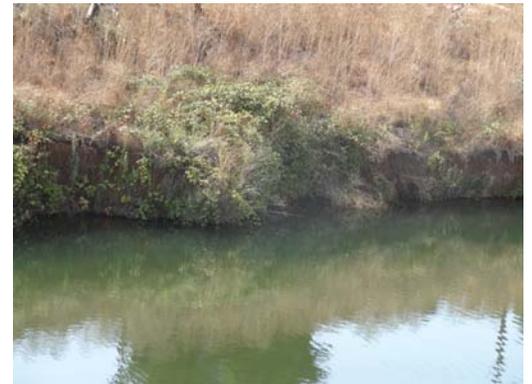
Close view of the erosion.

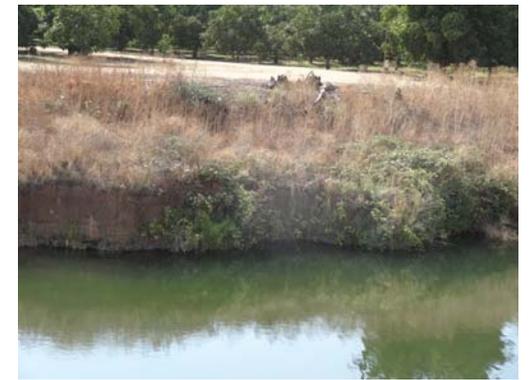
Front view of the erosion.

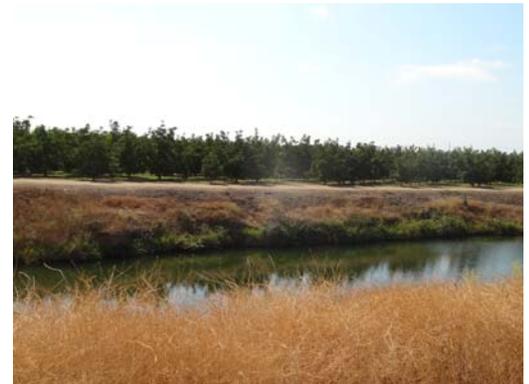
8/20/2014: No significant change observed  
 9/12/2013: No significant change observed.  
 08/22/2012: Site is covered by dense vegetation. Berm width is estimated as 5 ft. There is no levee structure on site. The levee crest width and levee height were not measured or estimated in the field.

Front view of the erosion.

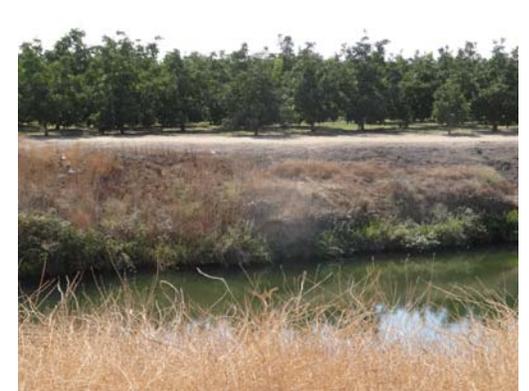
Front view of the erosion.

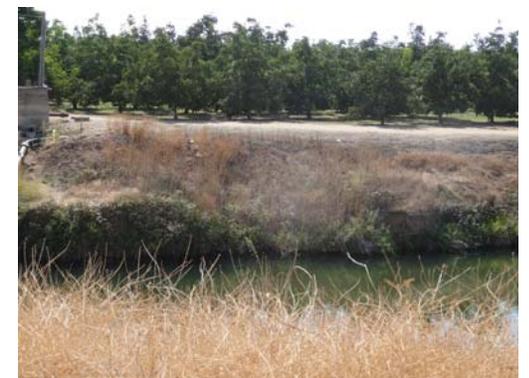
Close view of the erosion. Note the dense vegetation.

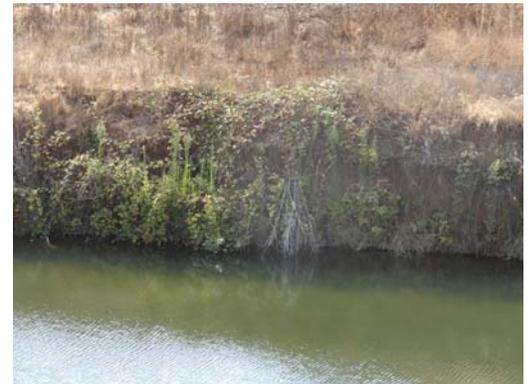
Close view of the erosion.

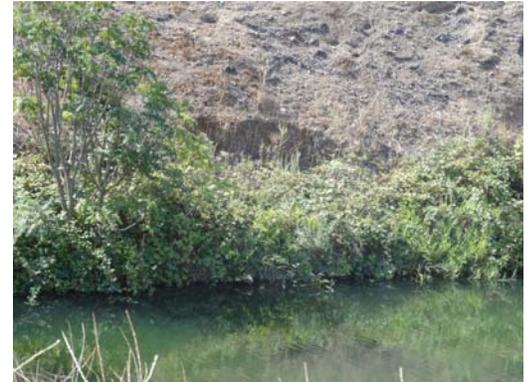
Front view of the pocket erosion.

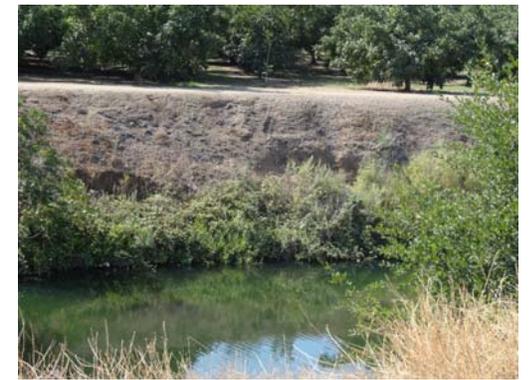
Close view of the pocket erosion.

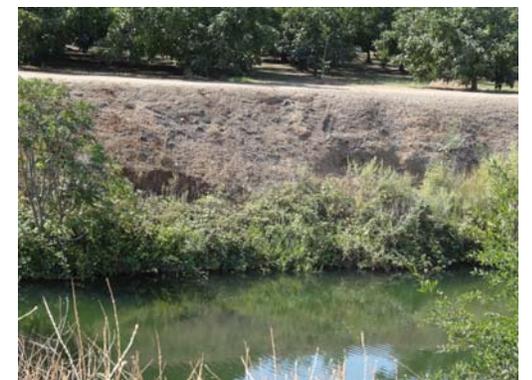
Close view of the erosion.

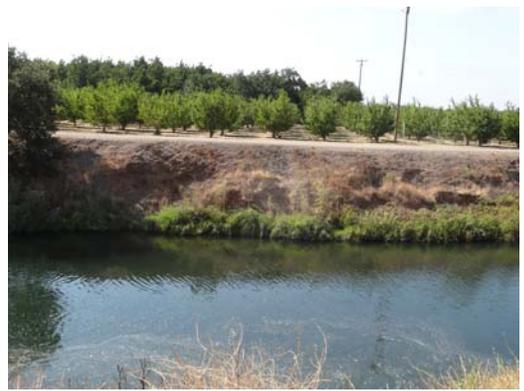
8/20/2014: No significant change observed.  
 9/12/2013: No significant change observed.  
 08/22/2012: The berm is estimated at 10 ft. Dense vegetation on site. There is no levee structure on site. The levee crest width and levee height were not measured or estimated in the field.

Front view of the erosion.

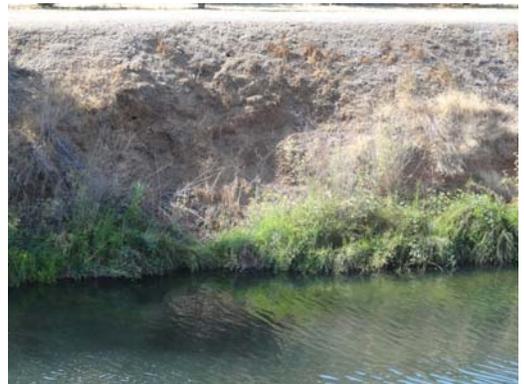
Close view of the erosion.
