LMA: **NA0010 U23 Lower San Joaquin** Waterway: **RB San Joaquin River**  
 Site ID: **NA0010U23RM224.27** Status: **Repaired Site**

Latitude: **36.802116** Longitude: **-120.173847** River\_Mile: **224.27** Levee\_Mile: **9.15** Overall Rating:

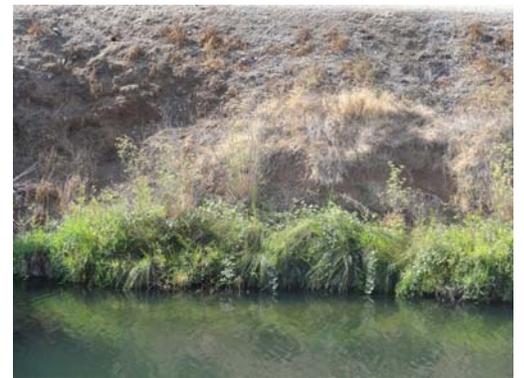
Front view of the erosion.

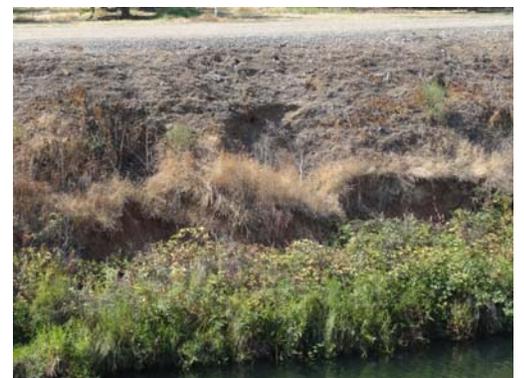
Close view of the erosion.

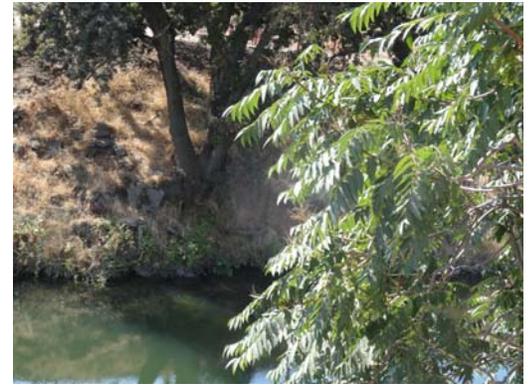
Front view of the erosion.

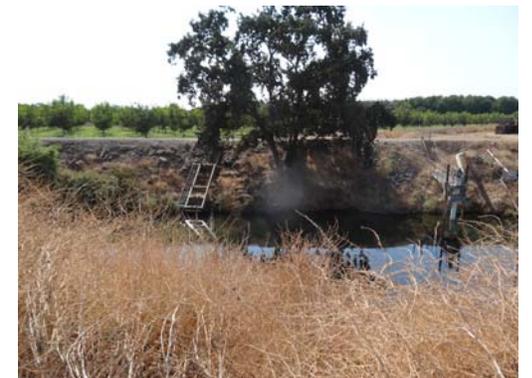
Front view of the erosion and broken concrete protection on the levee slope.

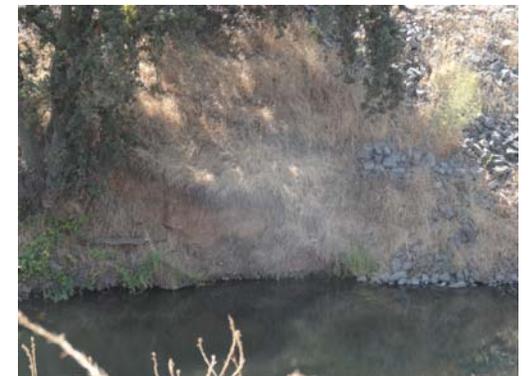
Closer view of the erosion.

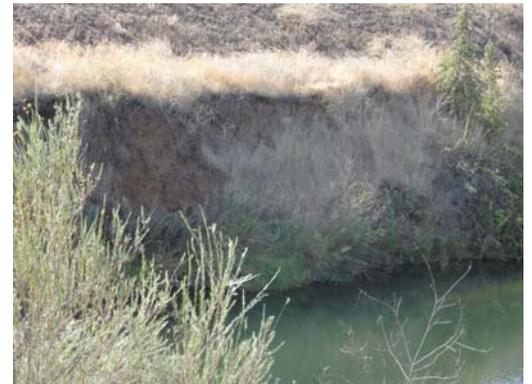
Front view of the erosion.

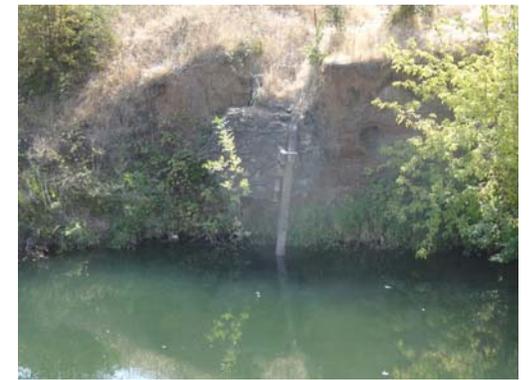
Close view of the erosion. Note the drainage pipe at the site.

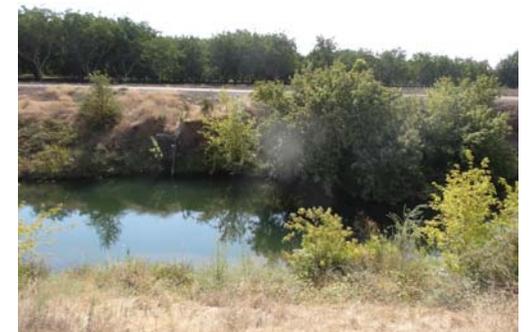
Front view of the site.

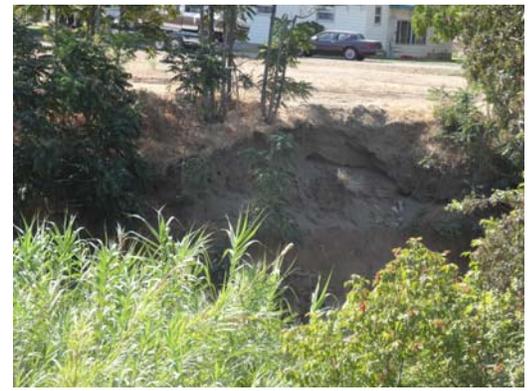
8/20/2014: The erosion at the site has worsened. The erosion increased both in both length and in height.  
 09/12/2013: Site has been visited and signs of new erosion are visible.  
 08/22/2012: The erosion was surveyed and documented for monitoring purpose. There is no levee structure on the site, only high ground protecting the land behind. The levee crest width and levee height were not measured or estimated in the field.

Front view of the erosion. Looking from the right side of the river.

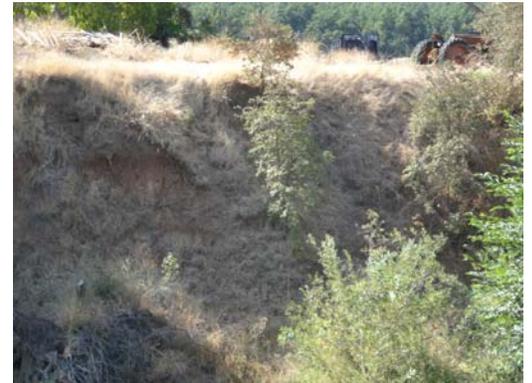
Close view of the erosion. Signs of new erosion along the site.

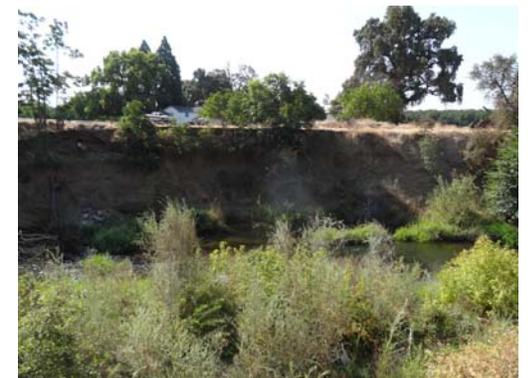
Close view of the erosion.

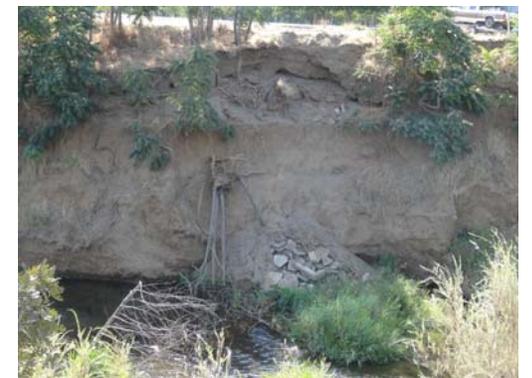
Close view of the erosion.

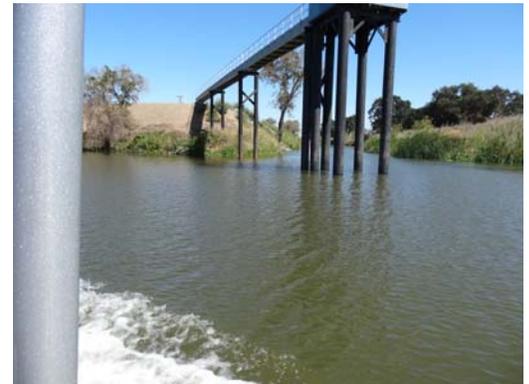
Close view of the erosion.

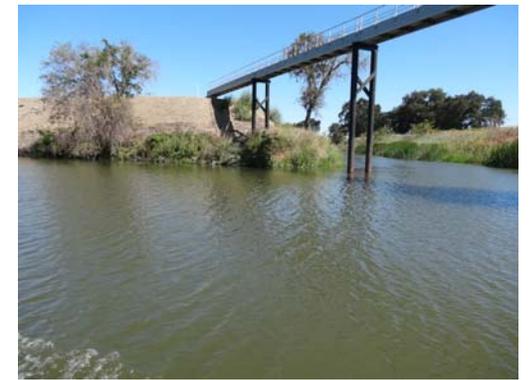
Close view of the erosion.

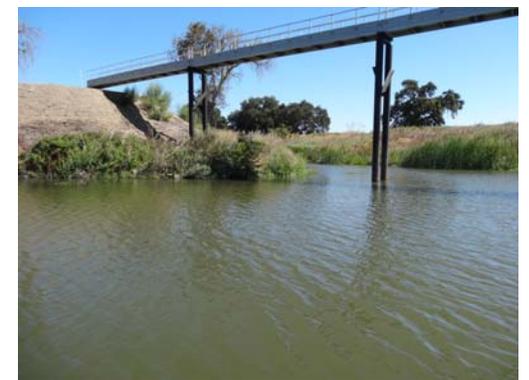
Front view of the site. Note the large tree on site.

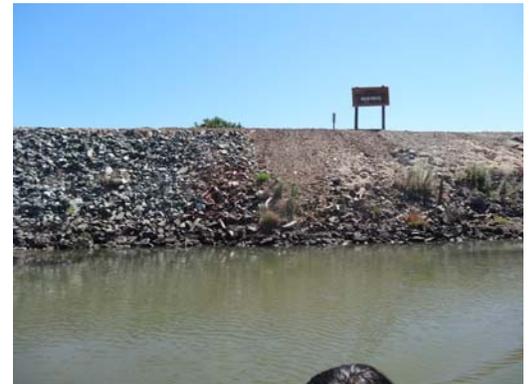
Close view of the repaired site.

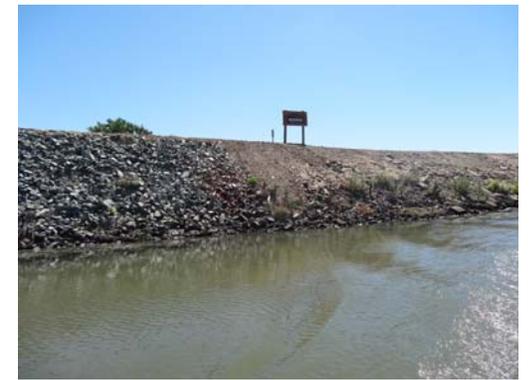
Close view of the repaired site.

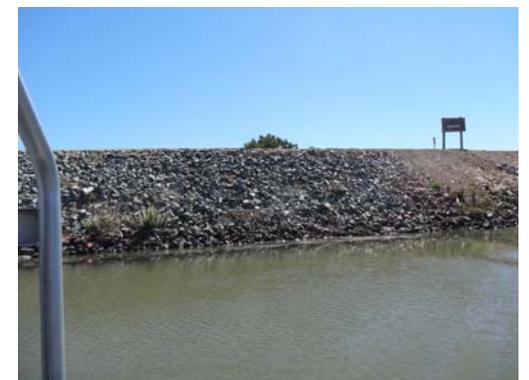
Close view of the repaired site.

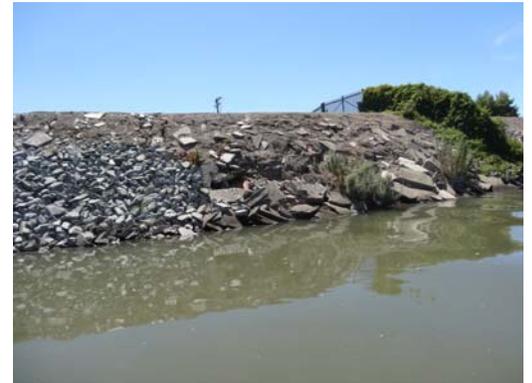
6/19/2014: No significant change observed.  
 08/13/2013: No significant change at this site.  
 08/07/2012: The erosion is nearly vertical, and has developed upward to halfway of the levee slope. The protecting concrete blocks have been washed away. Animal activities are visible.

Close view of the erosion.

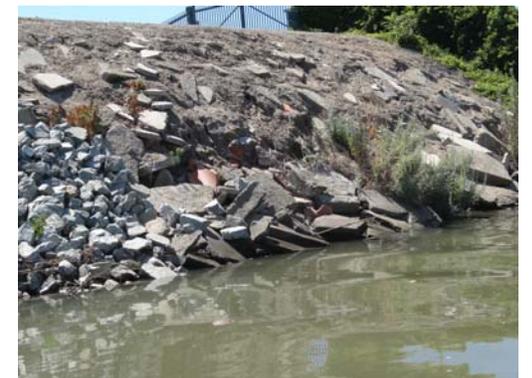
Close view of the erosion.

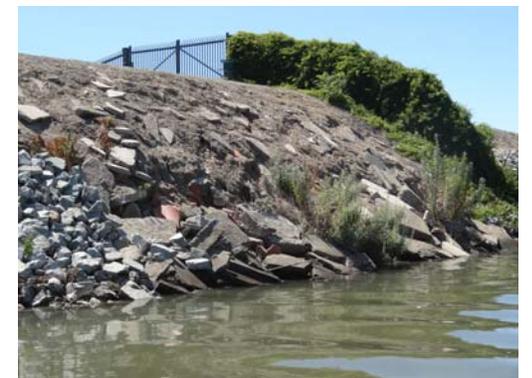
Close view of the erosion.

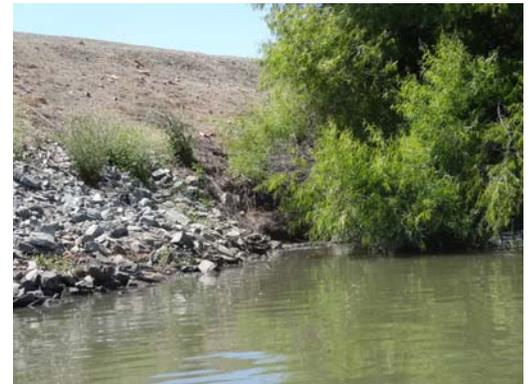
06/19/2014: The erosion has been repaired. A minor erosion is still visible near the tree.  
 08/13/2013: A mid-size tree is present immediately upstream of the erosion, which could block the view of the site. Some debris is visible.

Close view of the erosion.

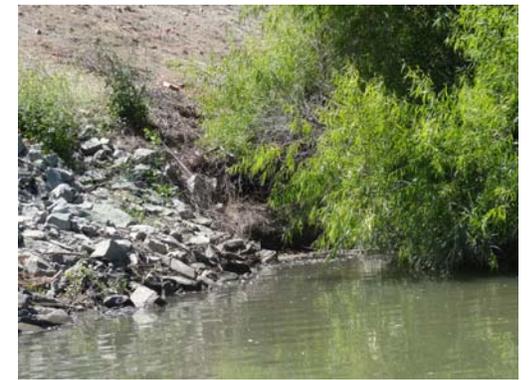
Close view of the erosion. Note the tree near the site.

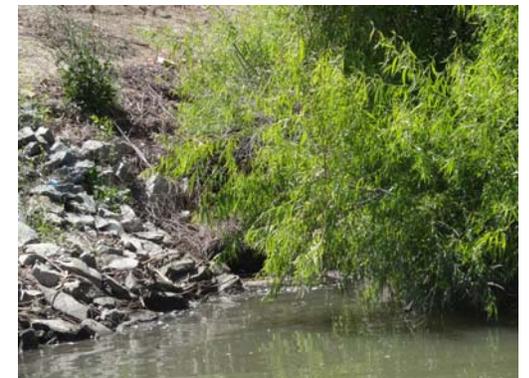
Close view of the erosion.

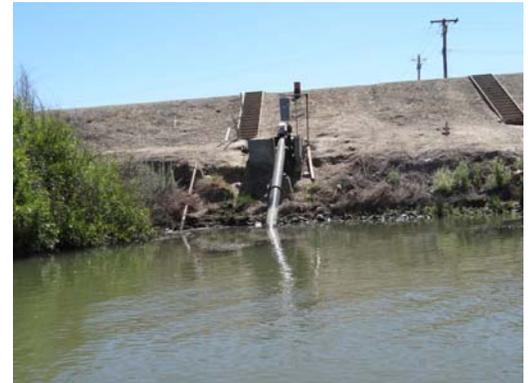
6/19/2014: The erosion was probably caused by the irrigation pipe found at the site.

Close view of the erosion site.

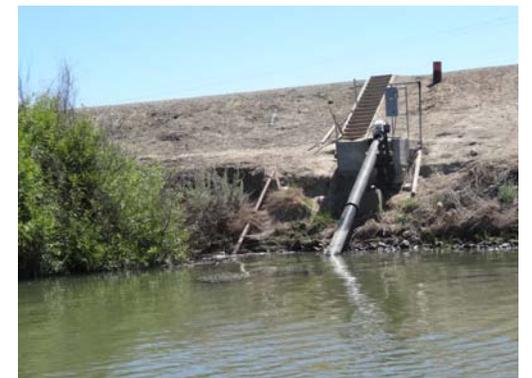
Close view of the site.

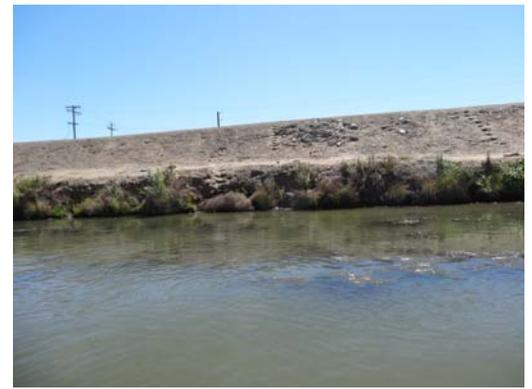
6/19/2014: The erosion is in the river bank which has an estimated 10-ft wide berm.

Front view of the erosion along the water edge. Note the vegetation at the erosion site.

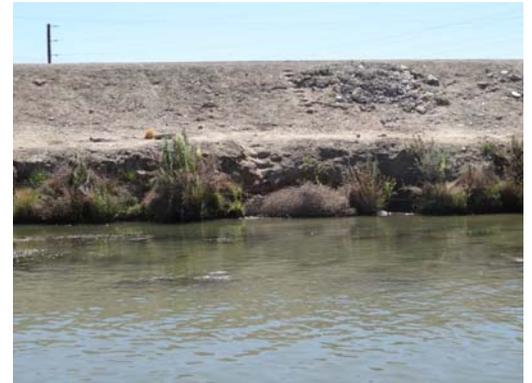
Close view of the erosion.

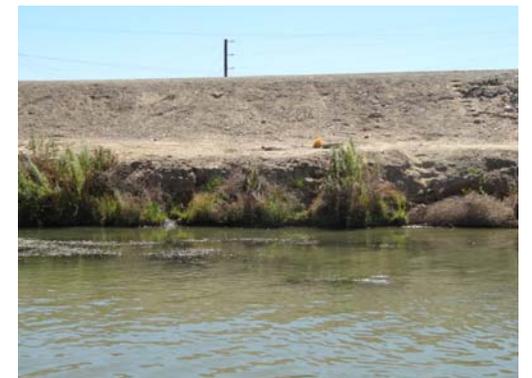
Close view of the erosion.

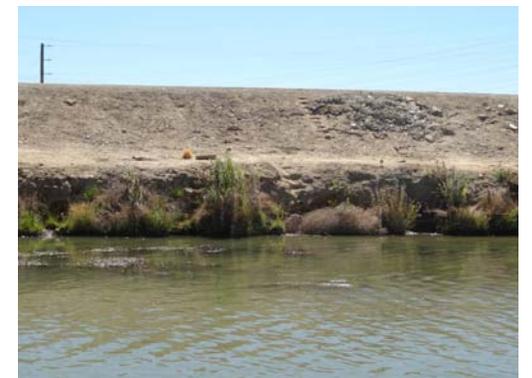
Close view of the erosion.

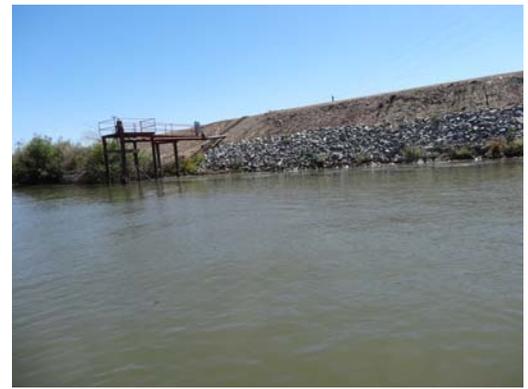
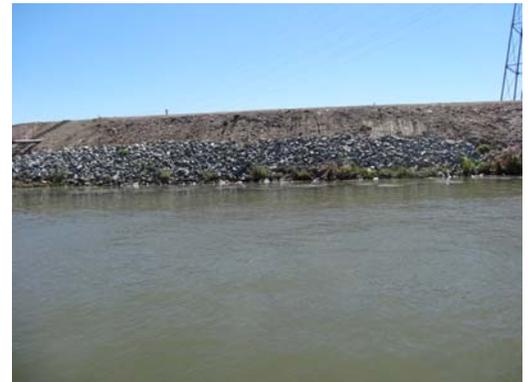
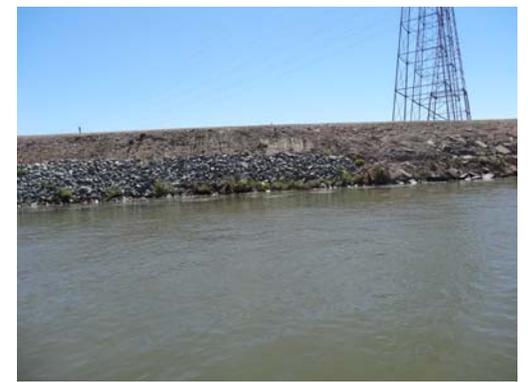
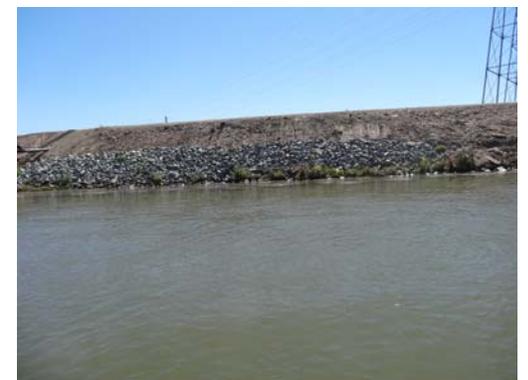
06/19/2014: The erosion has been repaired.  
 08/13/2013: Found during boat survey. There is vegetation at the site.

View from upstream of the repaired site.

Close view of the repaired site.

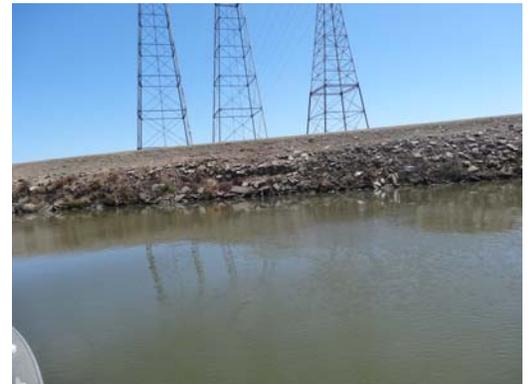
Front view of the erosion.

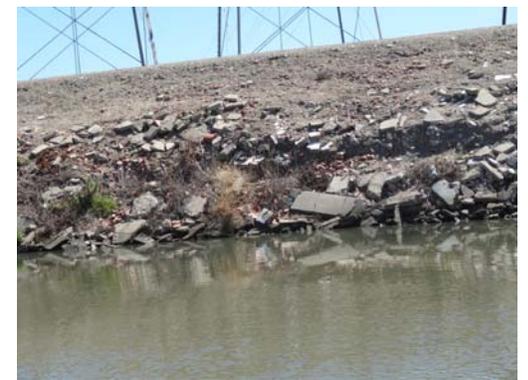
Close view of the erosion. The slope protection is poor.

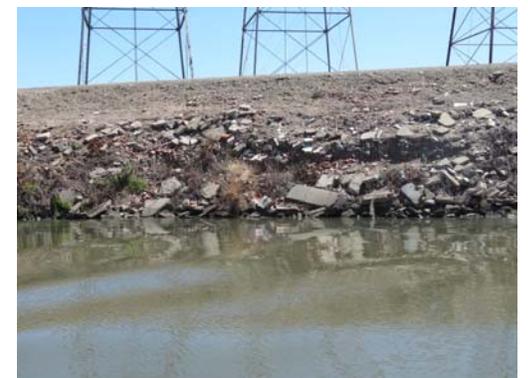
Close view of the erosion.

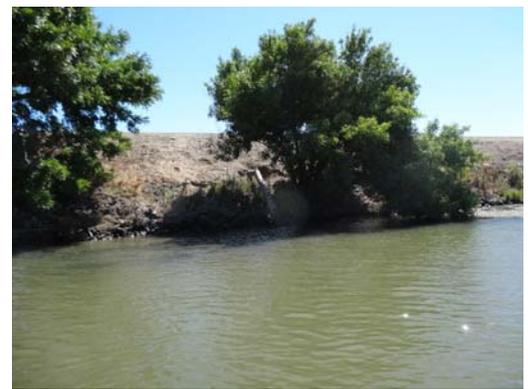
06/19/2014: The erosion is near a large tree and probably has been caused by the irrigation pipe on the site.

Front view of the erosion. Note the tree and the irrigation pipe.

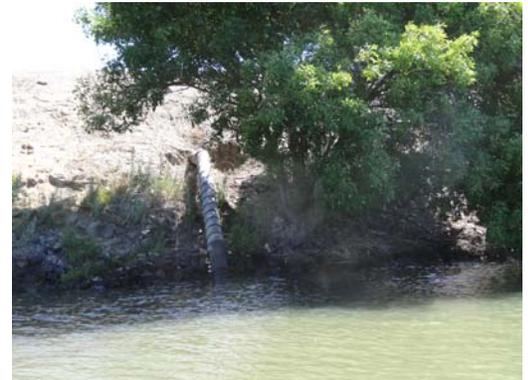
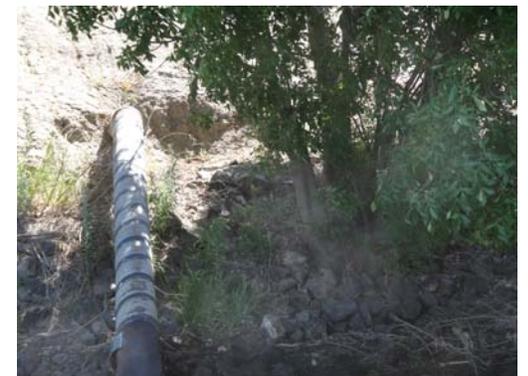
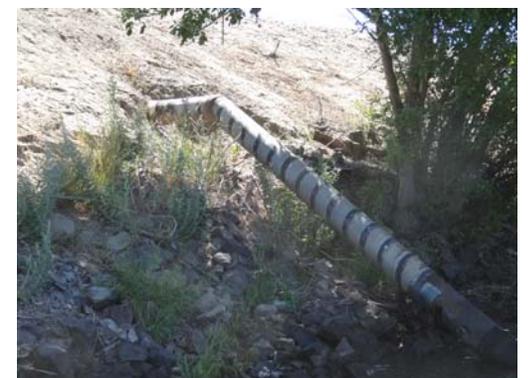
Close view of the erosion.

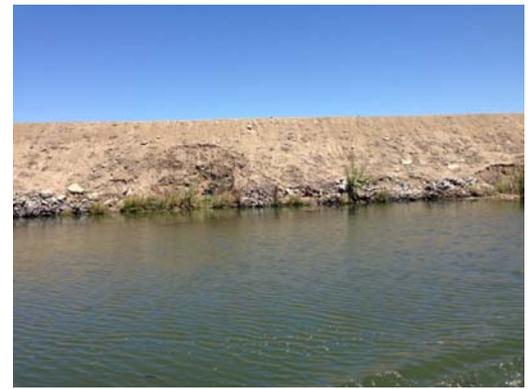
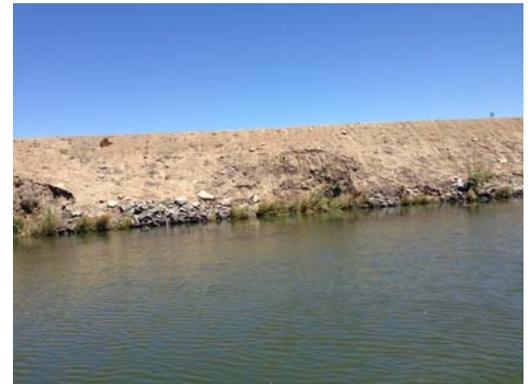
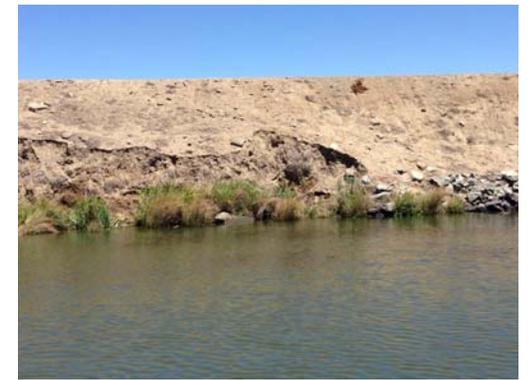
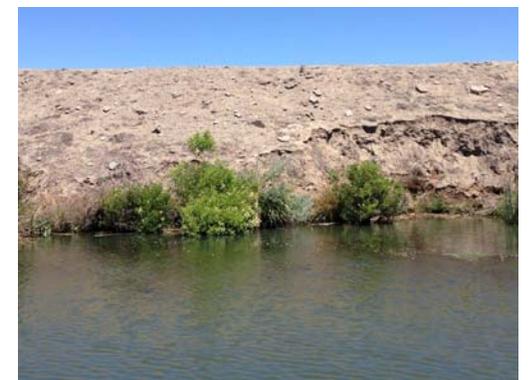
6/19/2014: No significant change observed.  
 08/13/2013: The boat survey found the erosion has progressed significantly in size and in number of pocket erosions.  
 08/07/2012: The site has been visited by boat survey. The erosion has developed in size, and more pocket erosions were found.  
 8/23/2011: Pockets erosions observed by last survey seem to have progressed during the last flood season. Continuous monitoring of this site suggested  
 9/07/2010: No significant change observed on site. There is emergent vegetation at the water line. Several pocket erosions lined along the lower slope that stretches from RM 40.86 to RM 41.14.  
 9/30/2009: No major change observed; the site was combined with other existing sites are RM's 40.93, 40.98, and 41.14 as one site; several pocket erosion just above non-uniform toe rip rap; previously rated "U"; bare spots along the upper slope.  
 2008: Possibly caused by wave wash erosion; several pocket erosion along the lower slope; site is inside of a bend.

Front view of the site.

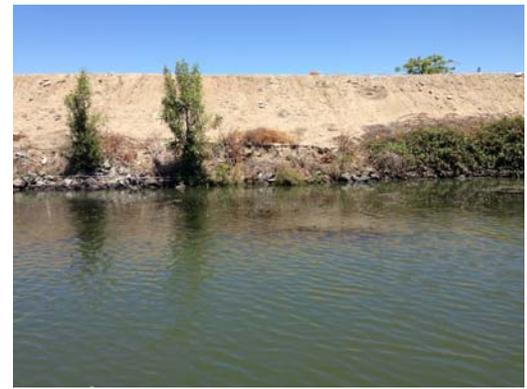
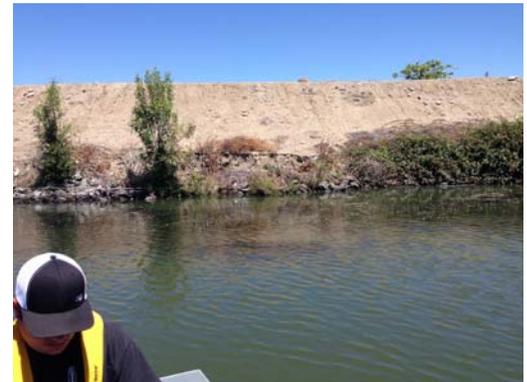
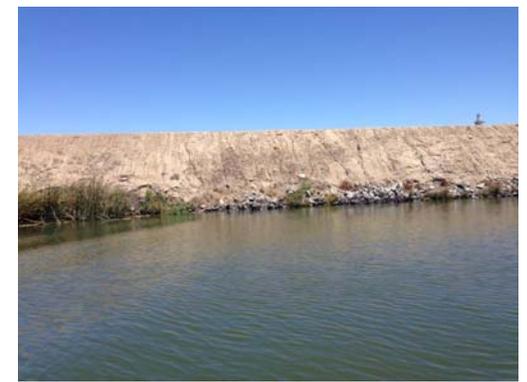
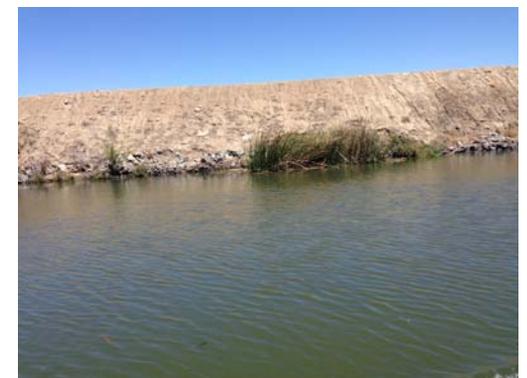
06/19/2014: No significant change observed.  
 08/13/2013: The pocket erosion is located at immediately upstream of a small oak tree.

Front view of the erosion.

Front view of the site.

Close view of the erosion.

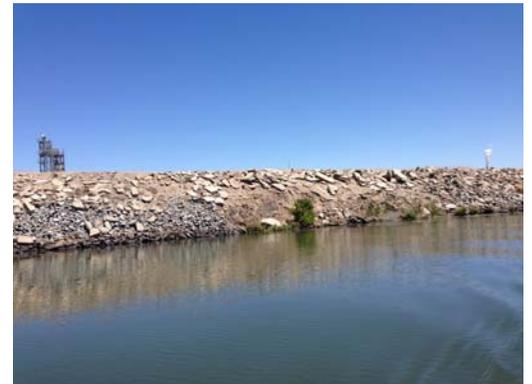
A closer view of the site. Note the protected bank downstream and upstream of the erosion.

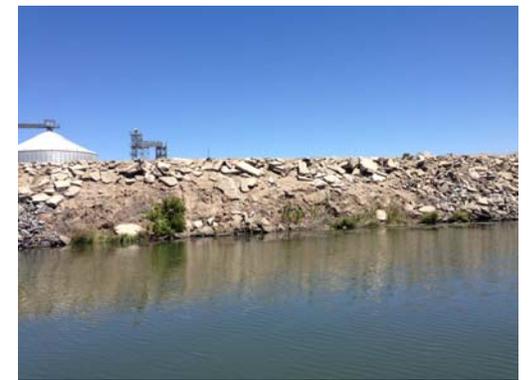
Front view of the site.

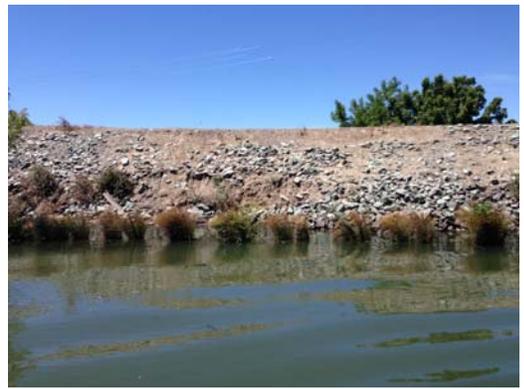
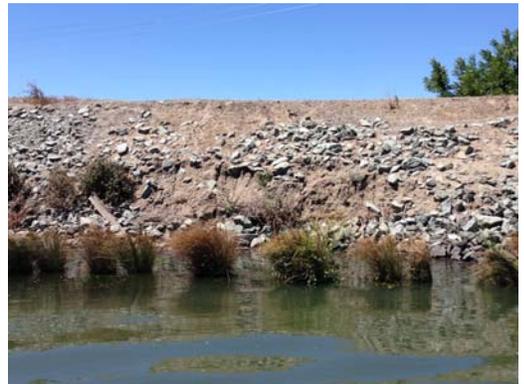
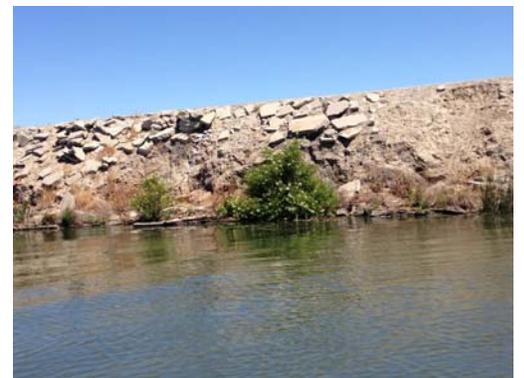
6/19/2014: No significant change observed.  
 08/13/2013: No significant change at this site.  
 08/07/2012: The site was first discovered by levee inspector in the spring inspection. Levee slope was protected with broken concrete blocks, but those blocks have been washed away during high flows.

Front view of the erosion.

Close view of the erosion.

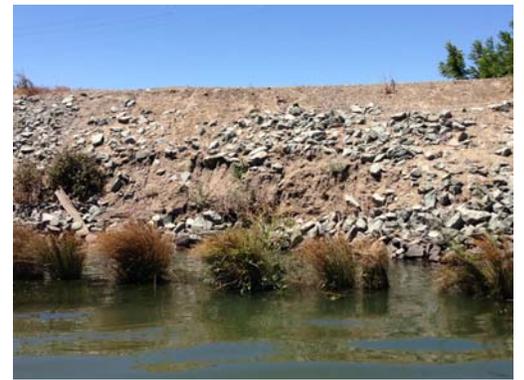
Front view of the erosion. Note the broken concrete blocks on the slope.

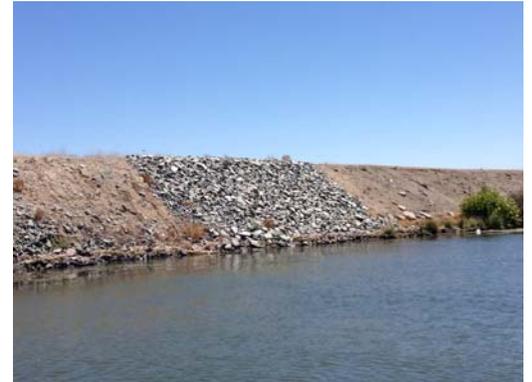
Close view of the site.

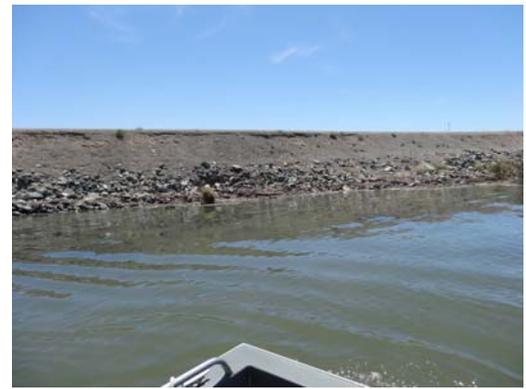
06/19/2014: A series of scarp erosions have been found on the lower levee slope and at the levee toe.

Front view of the erosion.

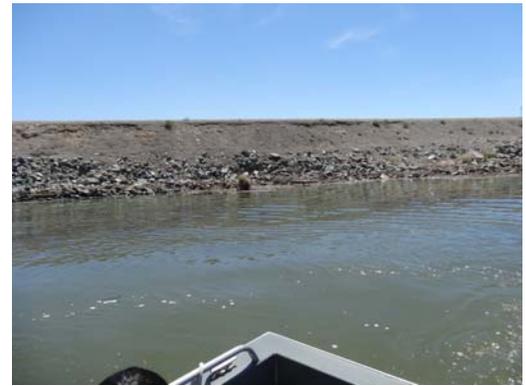
Close view of the erosion. Note the protection on the lower levee slope.

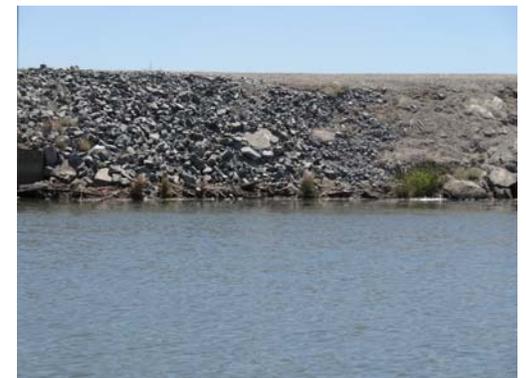
Close view of the erosion. The upstream end of the site is protected by riprap revetment.

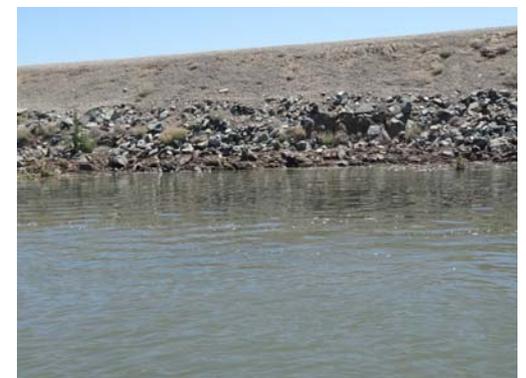
Close view of the erosion.

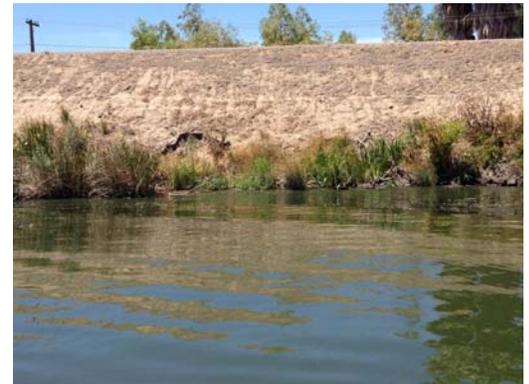
6/19/2014: No significant change observed.  
 08/13/2013: The erosion was discovered during 2013 spring levee inspection. Inspector comment: Erosion is located along the lower level of water-ward slope.

Front view of the erosion.

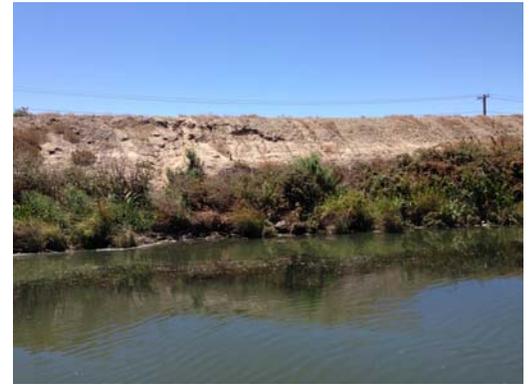
6/19/2014: No significant change observed.  
 08/13/2013: No significant change at this site.  
 8/7/2012: The erosion is at the upper levee slope, and likely caused by slope slip. The lower levee slope is covered with dense vegetation.

Front view of the site.

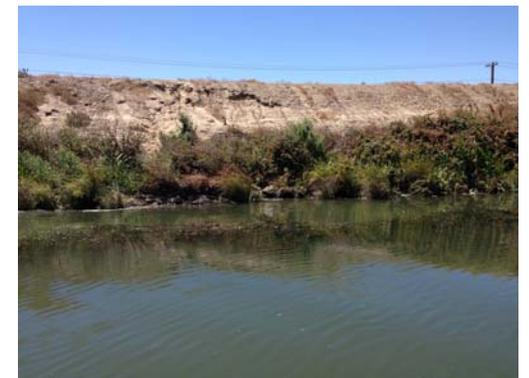
Close view of the erosion.

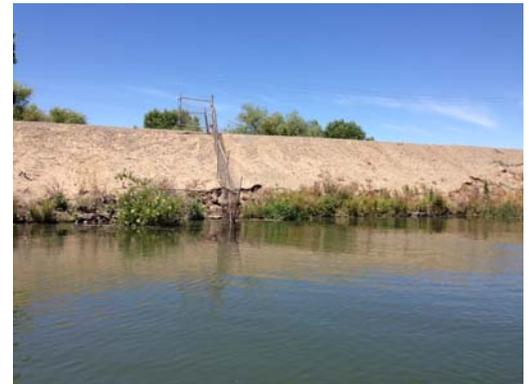
06/19/2014: No significant change observed.  
 08/13/2013: No significant change at this site.  
 08/07/2012: The site has been visited by boat survey. No significant change observed.  
 08/23/2011: The site is located immediately upstream of a Railroad bridge. Dense vegetation at the water line blocks the view of erosion.

Front view of the erosion site. Vegetation is visible.

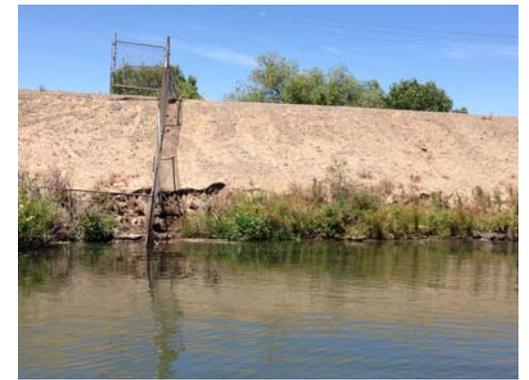
Front view of the erosion.

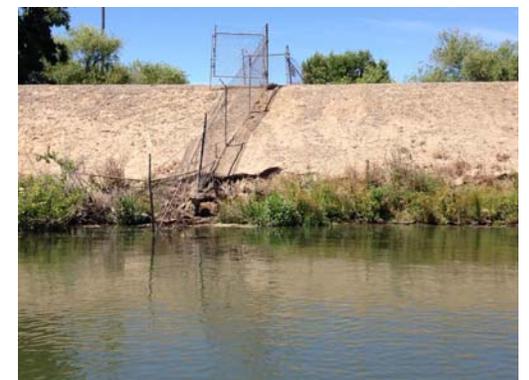
Front view of the erosion.

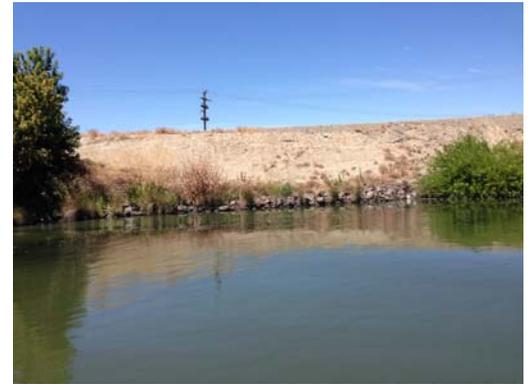
06/19/2014: No significant change observed.  
 08/13/2013: Site was discovered during boat survey. The dense vegetation blocks a clear view of the erosion. Size of erosion site was very roughly estimated.

A closer view of the erosion behind the vegetation.

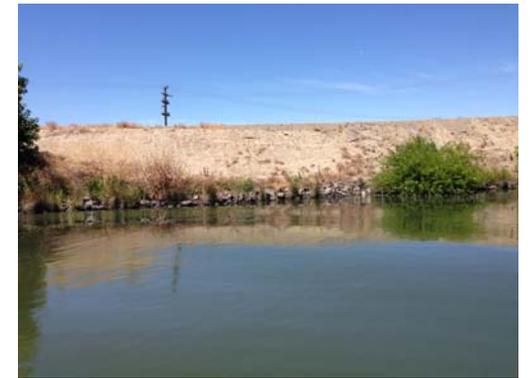
Close view of the site. Dense vegetation covers the erosion.

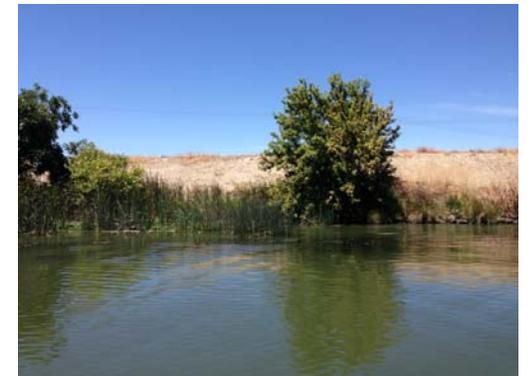
The erosion is invisible because of the dense vegetation.

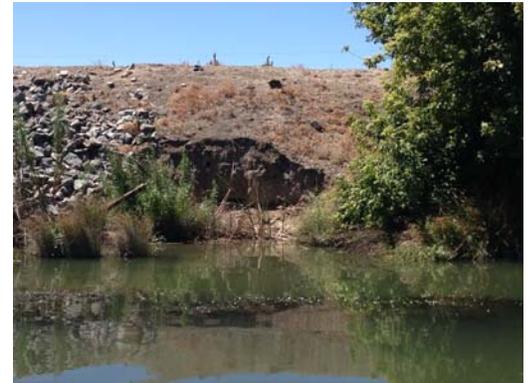
A close view of the erosion.

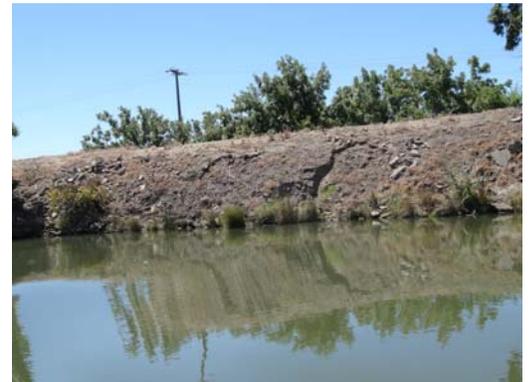
Close view of the erosion.

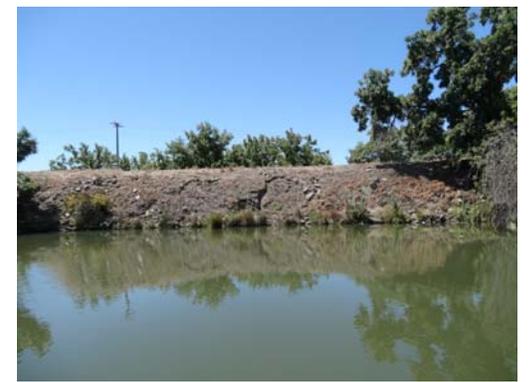
Close view of the erosion.

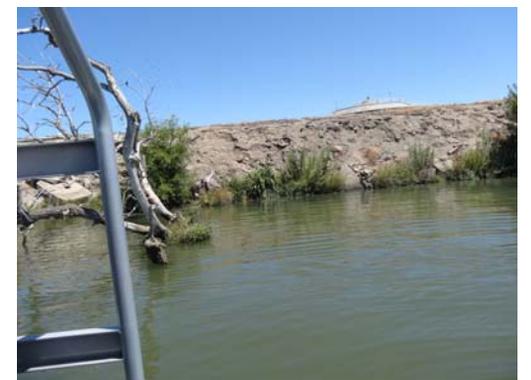
Close view of the erosion.

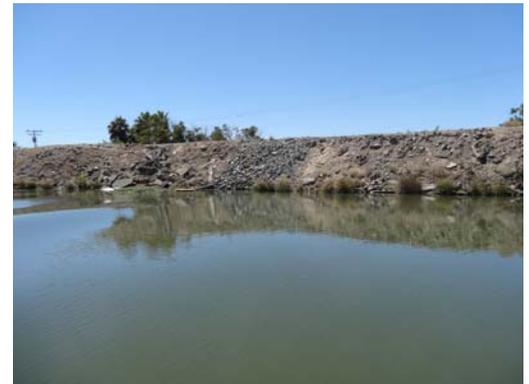
Close view of the erosion.

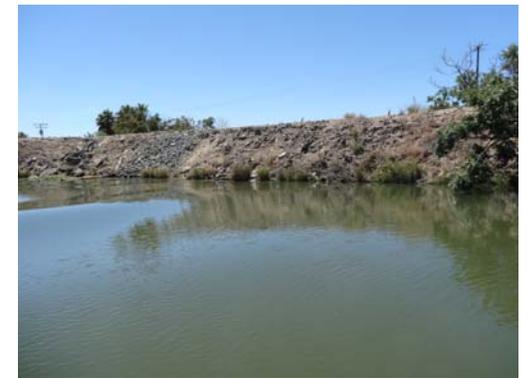
Front view of the site.

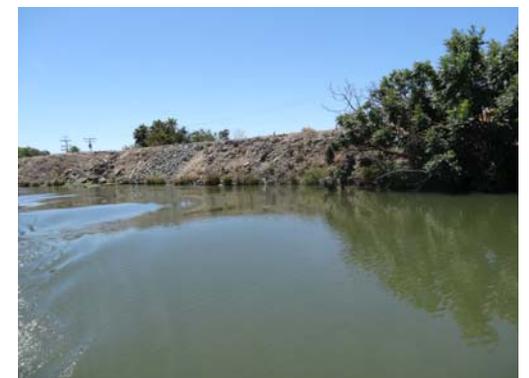
Front view of the erosion.

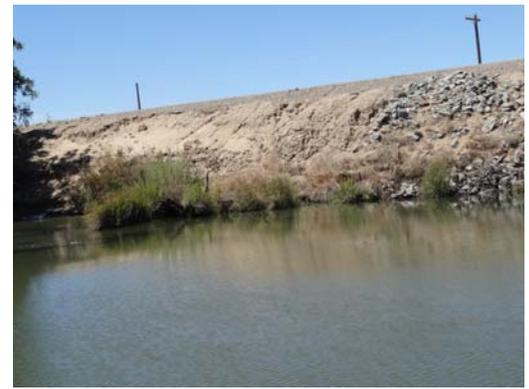
6/19/2014: No significant change observed.  
 08/13/2013: No significant change at this site.  
 08/07/2012: The site has been visited by boat survey. No significant change observed  
 08/23/2011: No significant change observed on site.  
 9/07/2010: No significant change observed on site. Vegetation is visible at the water line. There is an exposed pipe discharge partially hanging at the mid-slope, possibly still used for discharging irrigation/runoff water. There is minimal rip rap protection along the bank, and what's left of it is no longer adequately protecting the bank.  
 9/29/2009: Site consists of a 400-foot long eroding bank with minimal vegetation and protection; the existing rip rap has sloughed, rendering it useless; note that there is an exposed section of a pipe.  
 10/18/2006: There is extensive loss of rip rap on some sections; sewage disposal pond is on the landside of the levee; there is an exposed pipe outlet "hanging" from the upper slope.

Direct view of the site.

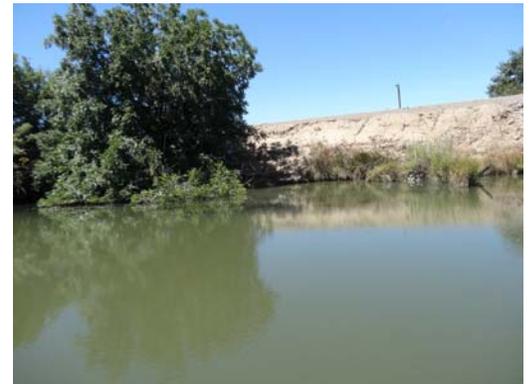
Direct view of the site.

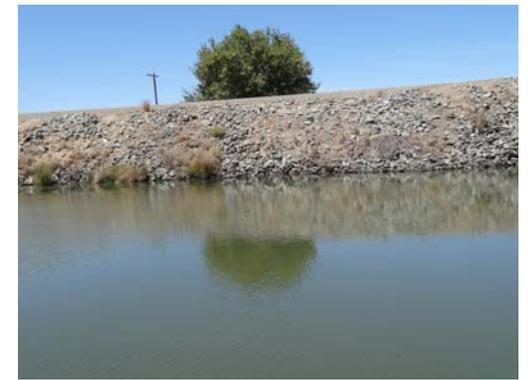
Close view of the upstream side of the erosion.

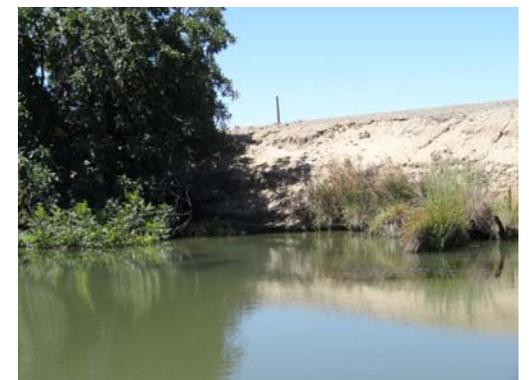
Close view of the site. Note the tree near the erosion site.

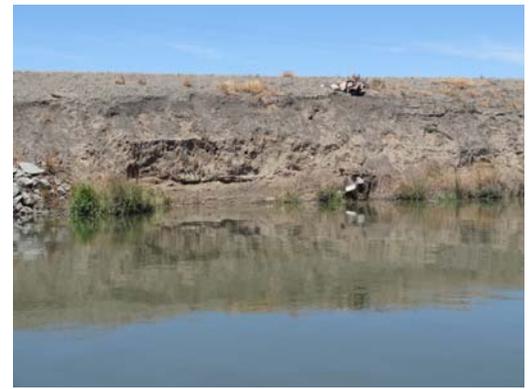
6/19/2014: No significant change observed.  
 08/13/2013: New signs of animal activity were found.  
 08/07/2012: The site was first reported in 2012 spring levee inspection report.

Front view of the erosion.

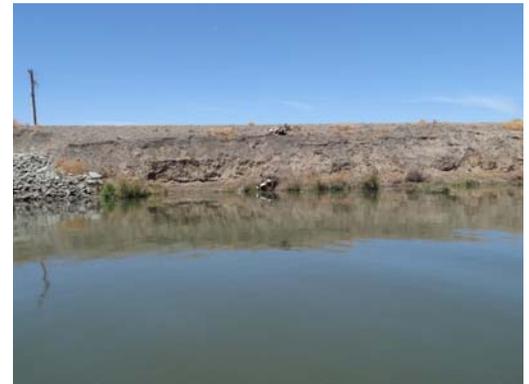
Front view of the erosion.

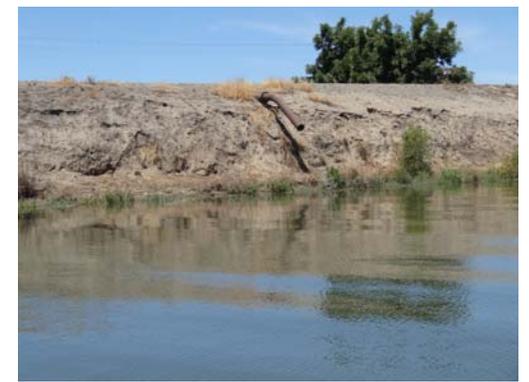
Front view of the erosion.

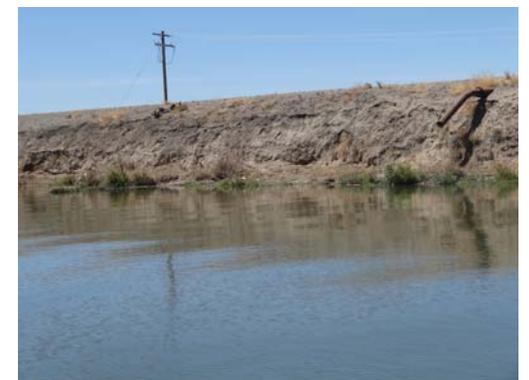
Front view of the erosion. Note the drainage pipe on the site.

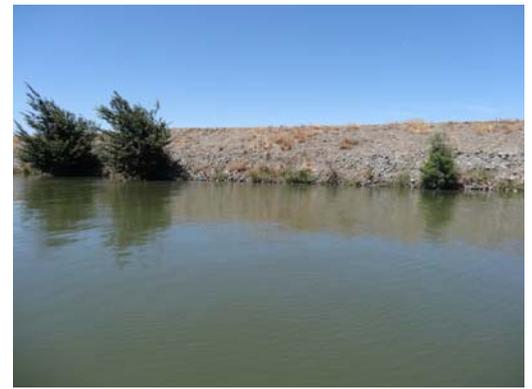
6/19/2014: No significant change observed.  
 08/13/2013: No significant change observed.  
 08/07/2012: The site was first reported in 2012 spring levee inspection report. The site is located about 750 ft downstream of SR 4 Bridge.

Front view of the erosion.

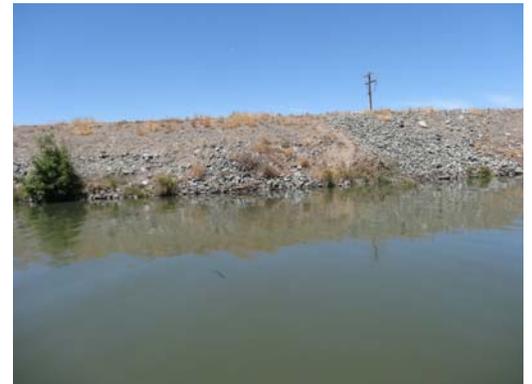
Front view of the erosion.

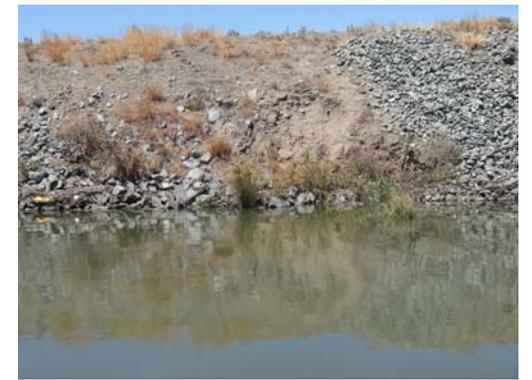
Close view of the erosion.

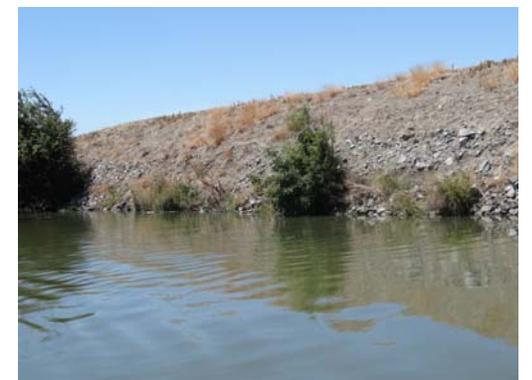
Downstream view of the erosion.

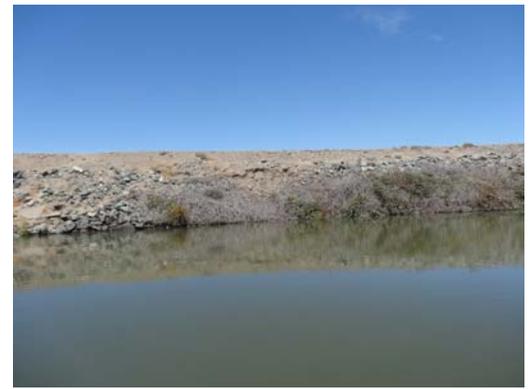
6/19/2014: No significant change observed.  
 08/13/2013: The site is located approximately 400 ft. downstream SR 4 Bridge. Dense vegetation is visible at the toe.

Front view of the erosion site.

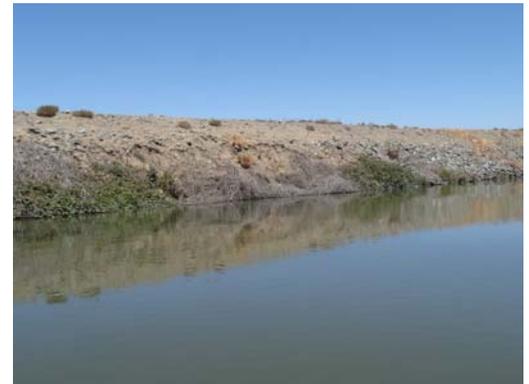
Close view of the erosion.

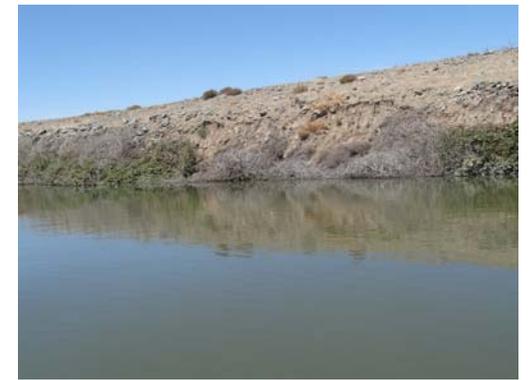
Close view of the erosion. Note the vegetation at the site.

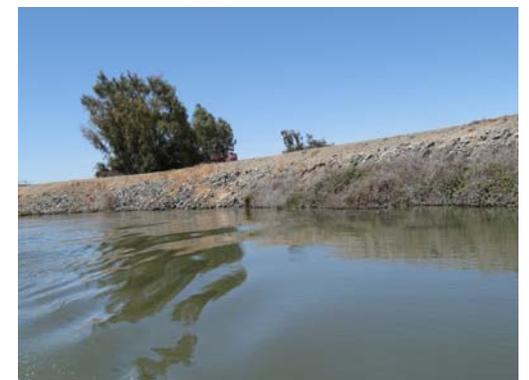
View of the erosion from downstream.

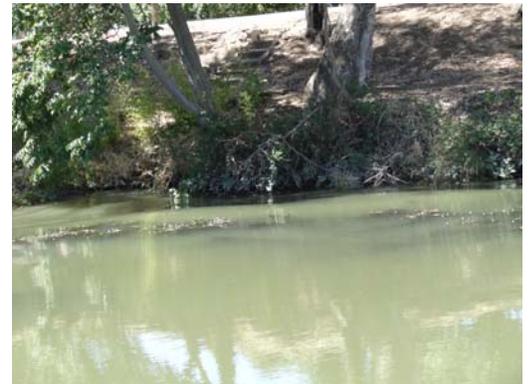
Close view of the erosion.

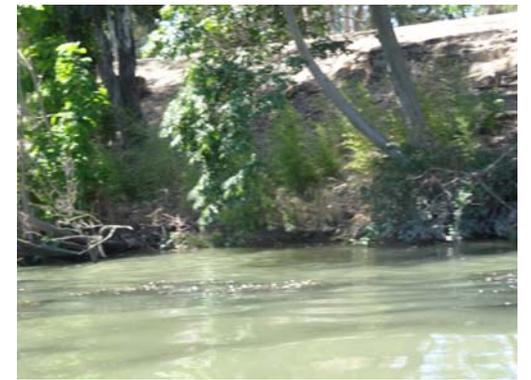
Front view of the erosion. Dense vegetation is visible.

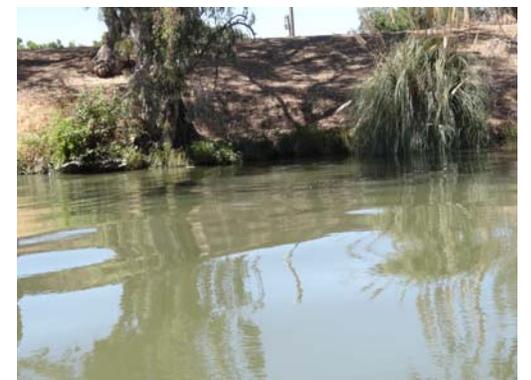
Close view of the erosion at the levee toe.

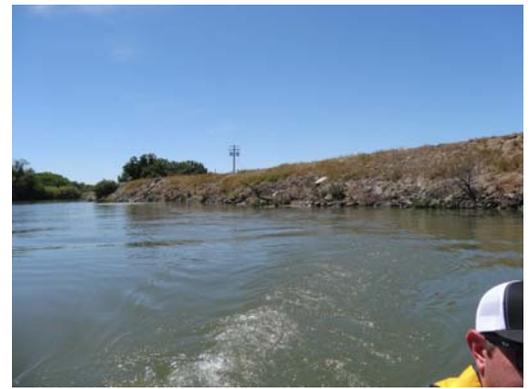
7/22/2014: The erosion has increased in size.  
 08/13/2013: No significant change observed. Slightly more vegetation was visible.  
 08/07/2012: The site was first reported in 2012 spring levee inspection report.

View from downstream.

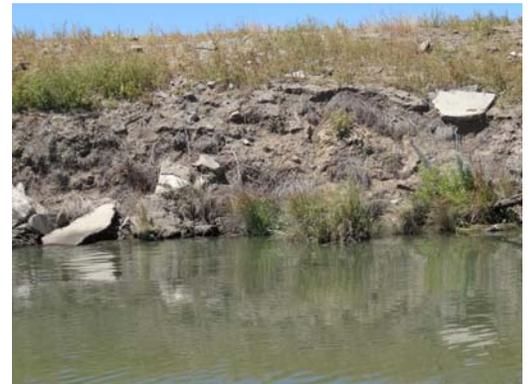
Close view of the pocket erosion.

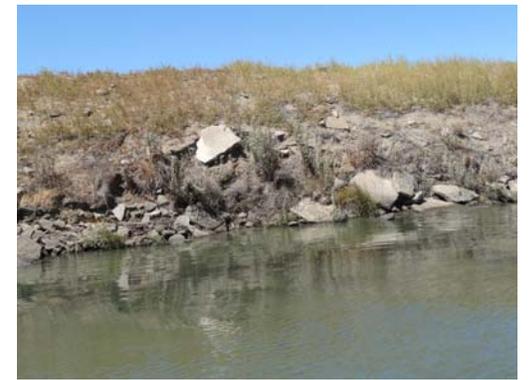
Close view of the pocket erosion. Note the vegetation at the site.

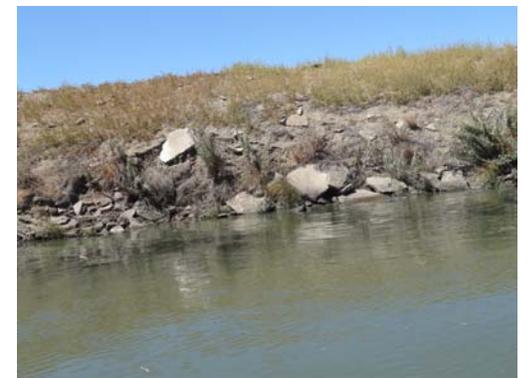
Front view of the erosion.

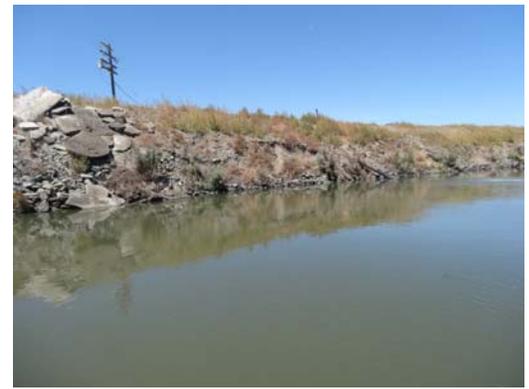
6/19/2014: No significant change observed.  
 08/13/2013: An irrigation pipe is on site.

View from upstream.

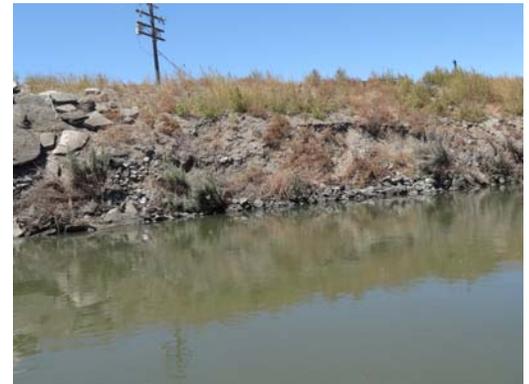
Front view of the erosion.
