LMA: **NA0010 U23 Lower San Joaquin** Waterway: **RB San Joaquin River**  
 Site ID: **NA0010U23RM224.27** Status: **Repaired Site**

Latitude: **36.802116** Longitude: **-120.173847** River\_Mile: **224.27** Levee\_Mile: **9.15** Overall Rating:

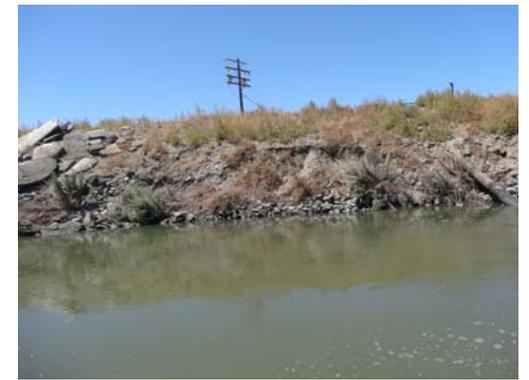
Close view of the erosion.

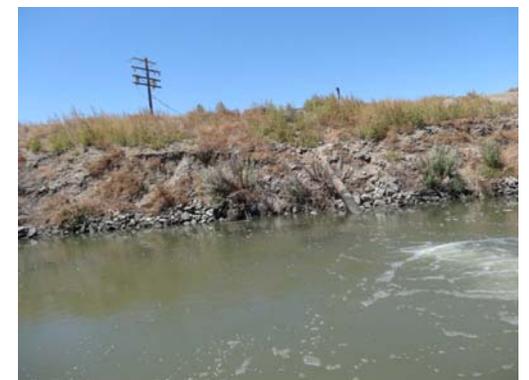
Close view of the erosion. Note the irrigation pipe.

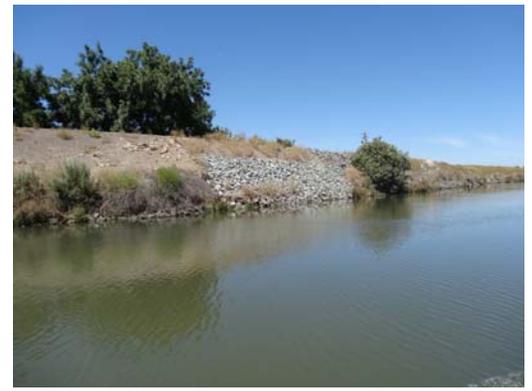
6/19/2014: The erosion was repaired.  
 08/13/2013: The length of erosion has progressed downstream, and the site length has increased from 12 ft in length last year to 100 feet in length this year.  
 08/07/2012: The site was first reported in the 2012 spring levee inspection report. The site is located at the inside corner of a river bend.

View from upstream.

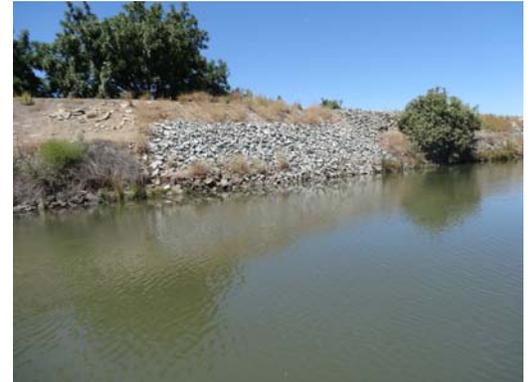
Front view of the repaired site.

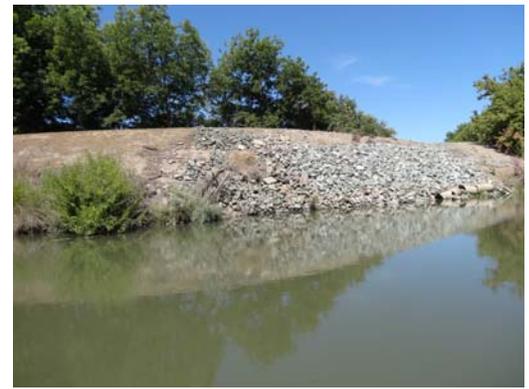
6/19/2014: The erosion was repaired.  
 08/13/2013: No significant change observed.  
 08/07/2012: The site was first reported in 2012 spring levee inspection report.

Upstream view of the repaired site.

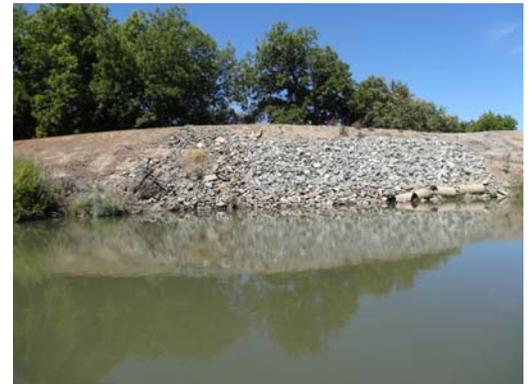
Close view of the repaired site.

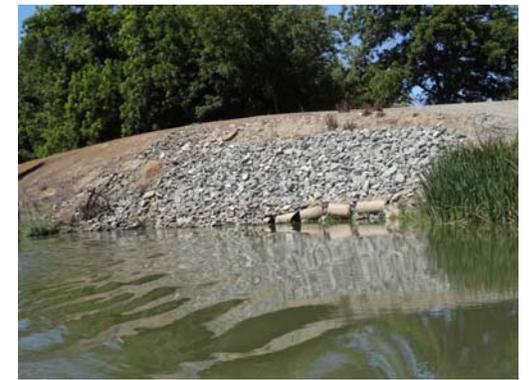
Closer view of the repaired site.

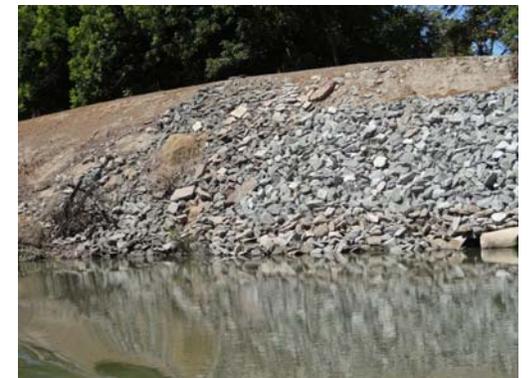
Close view of the repaired site. Note the vegetation at the site.

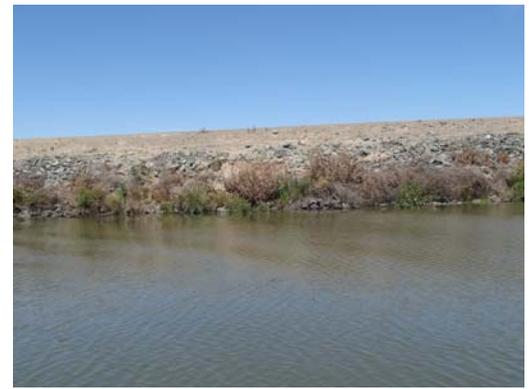
6/19/2014: No significant change observed.  
 08/13/2013: No significant change observed.  
 08/07/2012: The site was first reported in 2012 spring levee inspection report.

Front view of the erosion.

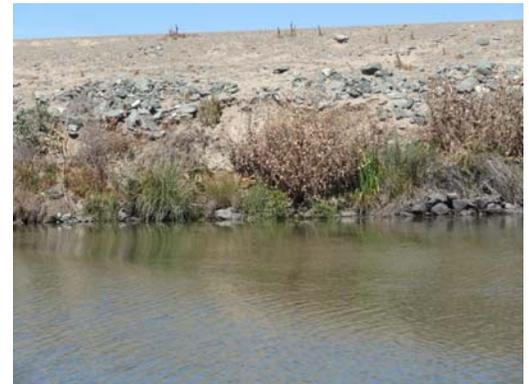
Close view of the erosion.

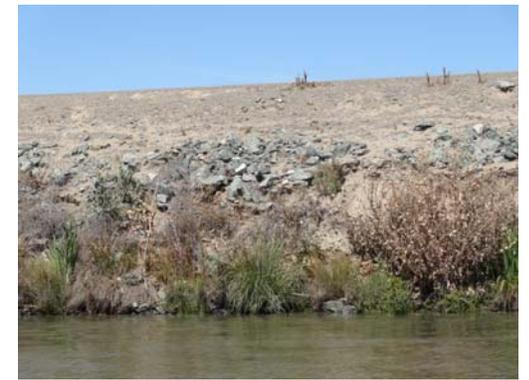
Close view of the erosion.

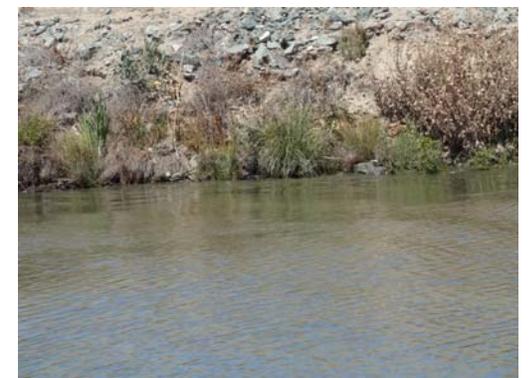
Close view of the erosion. Note the vegetation at the site.

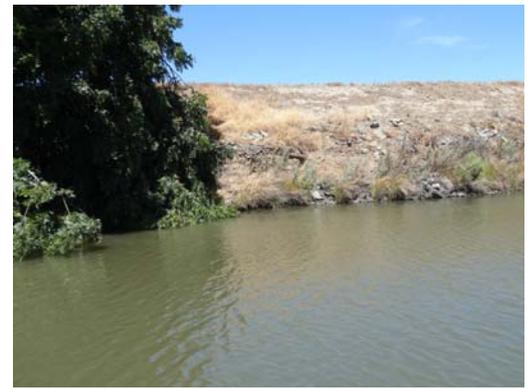
6/19/2014: No significant change observed.  
 08/13/2013: New erosion was found at the levee toe. Trees are present.  
 08/07/2012: The site has been repaired. Protecting riprap revetment has been placed at the levee shoulder and slope, but minor erosions are visible at the levee toe.  
 08/23/2011: Sloughing rip rap is visible on the site

Direct view of the site.

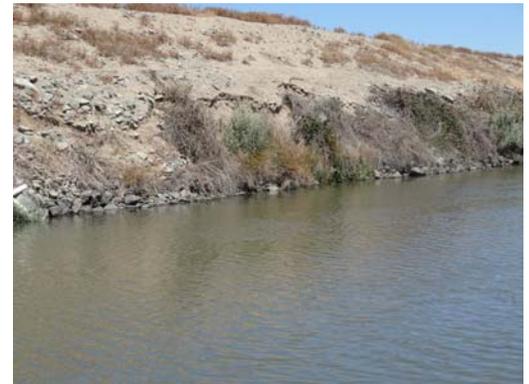
View from downstream.

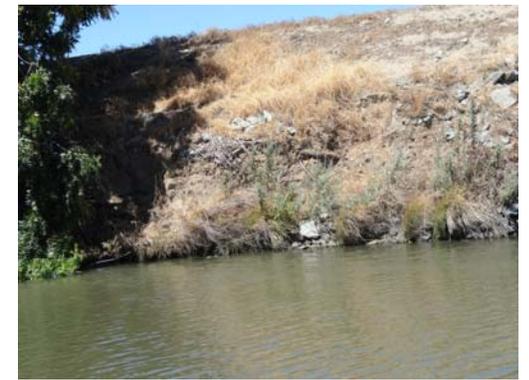
Closer view of the erosion.

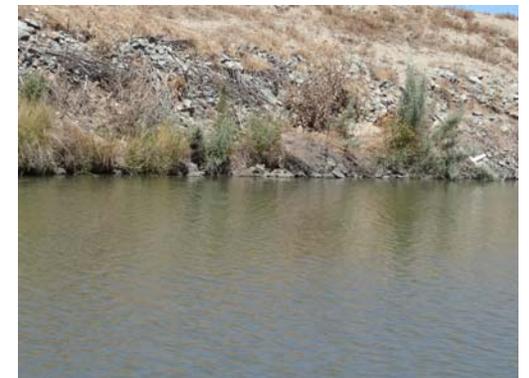
Close view of the erosion. Note vegetation at site.

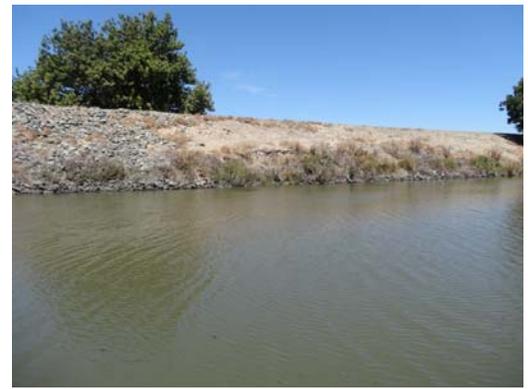
6/19/2014: No significant change observed.  
 08/13/2013: The levee toe seems to have been protected by river rocks and vegetation on site.

View from upstream of the erosion.

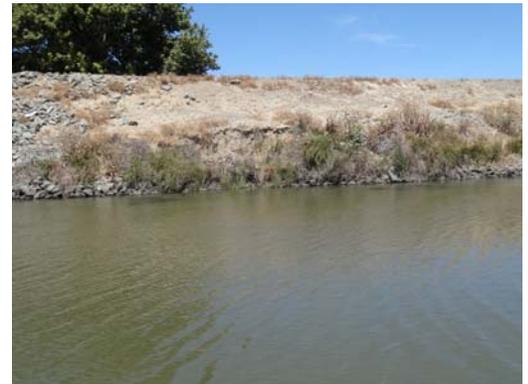
Front view of the erosion.

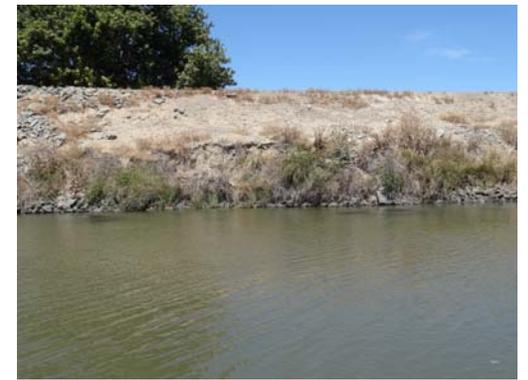
Close view of the erosion. Note river rocks and vegetation at the levee toe.

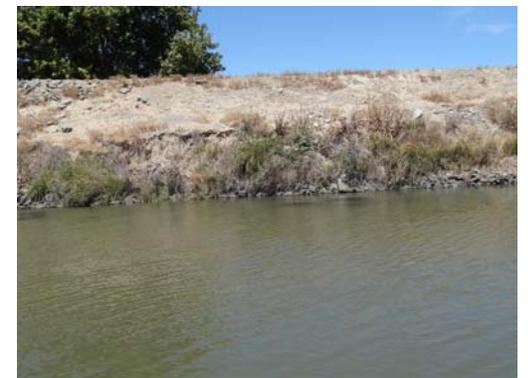
Front view of the erosion.

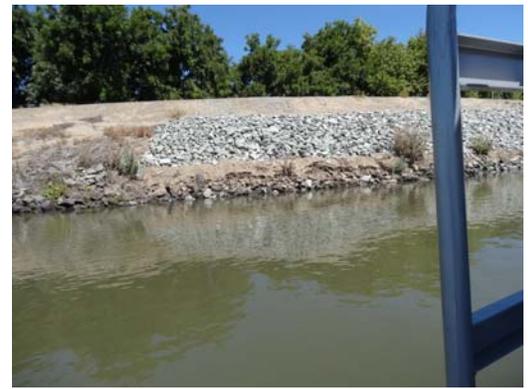
6/19/2014: The previous erosion was repaired. New erosion was found below the repaired levee slope.  
 08/13/2013: No significant change observed.  
 08/07/2012: The levee toe has been cut off along a 150 ft. long river stretch. The erosion is located just upstream of a river bend.

View of the repaired site. Note the new erosion at the levee toe.

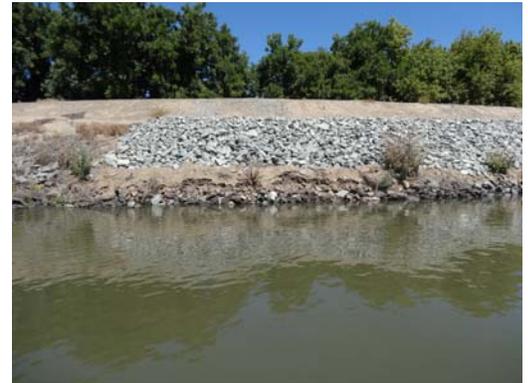
View of the repaired site.

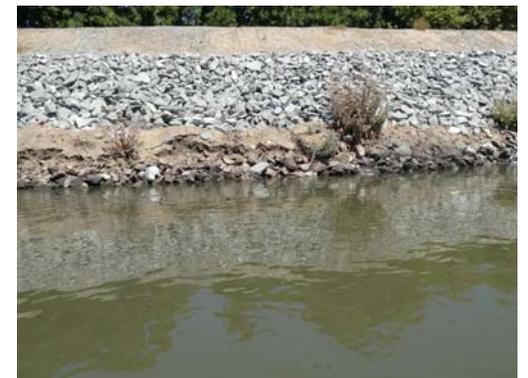
View of the repaired site.

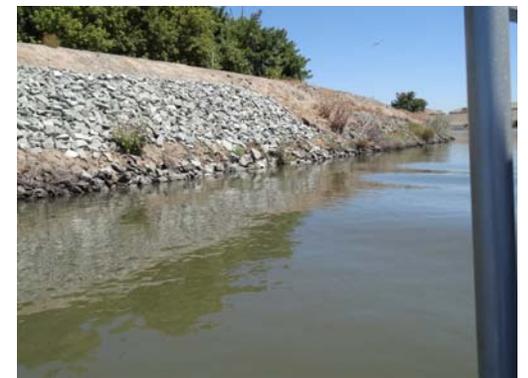
View of the repaired site.

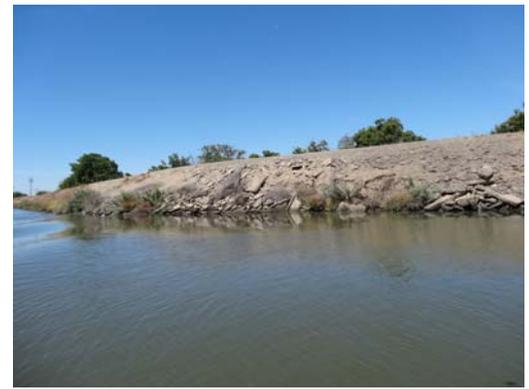
6/19/2014: No significant change observed.  
 08/13/2013: No significant change observed.  
 08/07/2012: The erosion is located at the inside of a river bend. Site is covered with broken concrete blocks and other debris.

Downstream view of the erosion site.

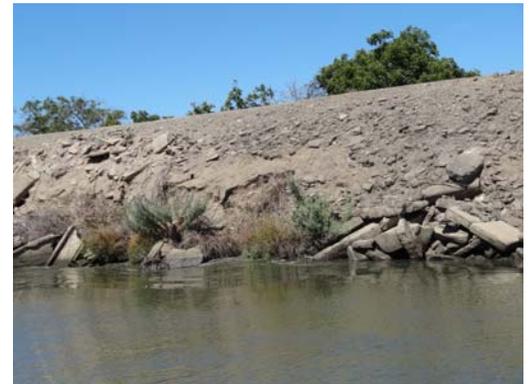
Front view of the site.

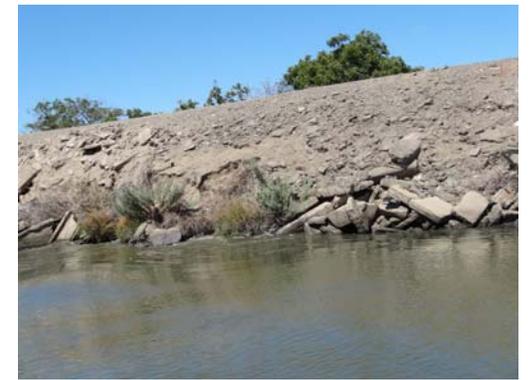
Front view of the site. Note the loosely placed concrete blocks.

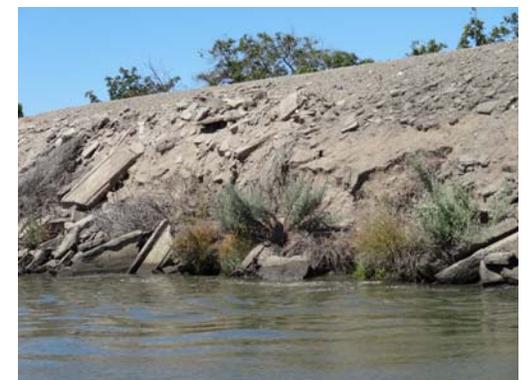
Close view of the erosion.

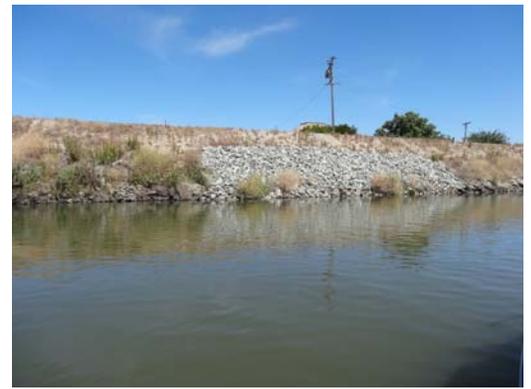
6/19/2014: The erosion was repaired.  
 08/13/2013: No significant change observed.  
 08/07/2012: The site has been visited by boat survey. No significant change observed  
 08/23/2011: Cracking erosion along the levee bank. Erosion appears to be caused by river flows.

Front view of the repaired site.

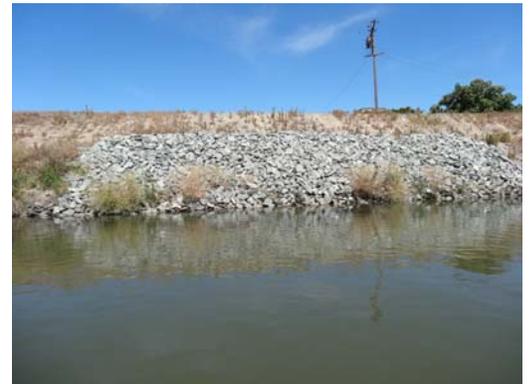
Front view of the repaired site.

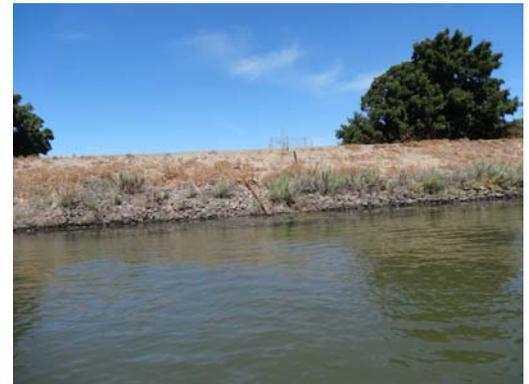
Front view of the site.

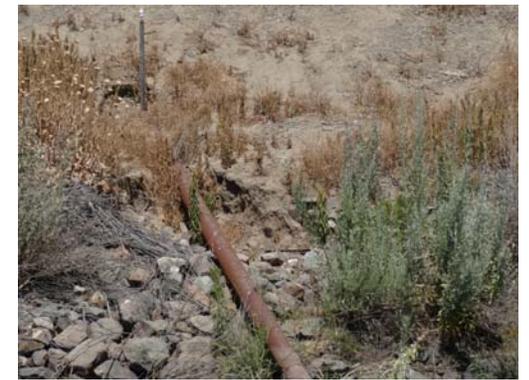
Front view of the site.

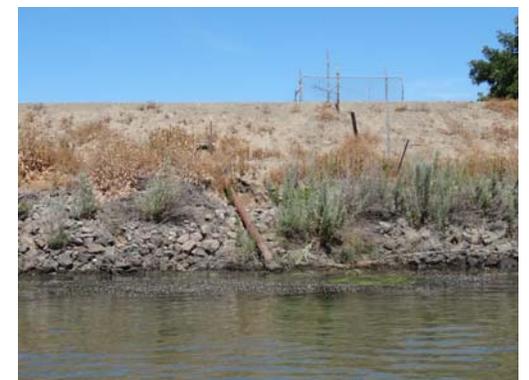
Front view of the site.

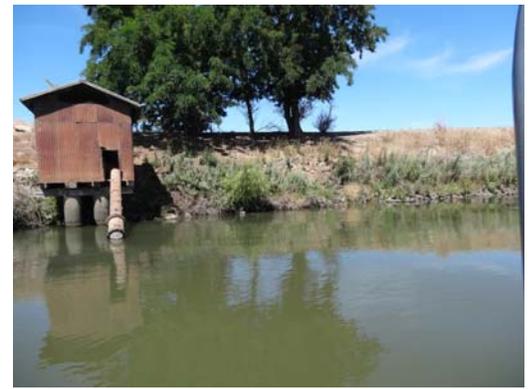
6/19/2014: No significant change observed.  
 08/13/2013: Larger trees are at the levee shoulder, and an irrigation pump station is next to the erosion site.

Front view of the erosion.

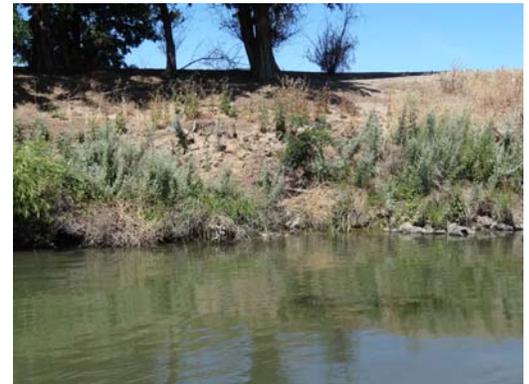
Close view of the site.

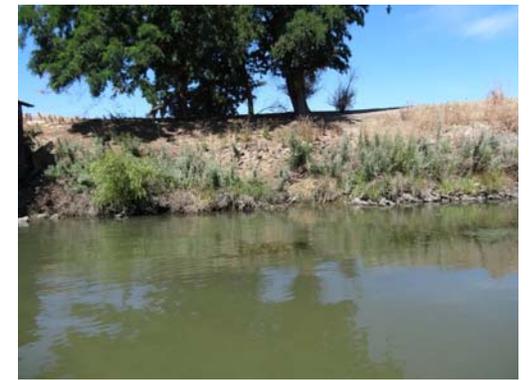
Close view of the site. Note large trees at the levee shoulder.

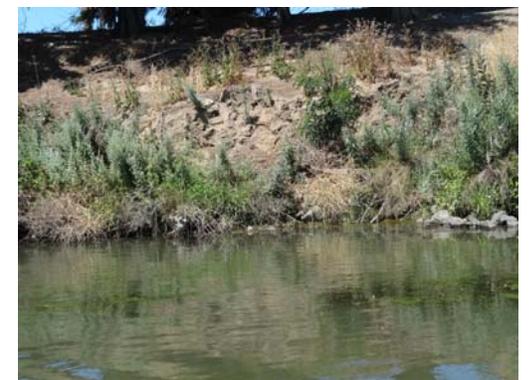
Close view of the erosion.

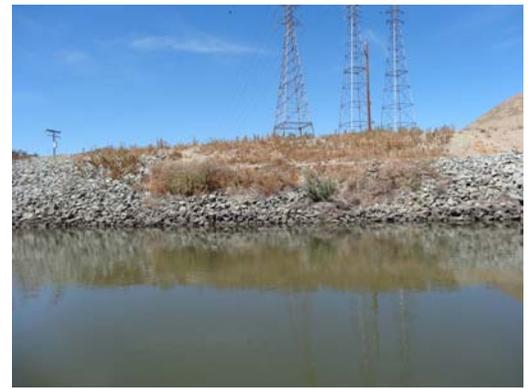
6/19/2014: The erosion was repaired.  
 08/13/2013: The boat survey found no significant change at this site, except slight animal activity was visible at the site.  
 08/07/2012: : The site has been visited by boat survey. No significant change observed  
 08/23/2011: No significant change observed on site.  
 09/07/2010: No significant change observed on site. Erosion site is located beneath Howard Road Bridge. Majority of the existing rip rap has slipped, dragging away levee materials and exposing the underlying soft soil.  
 08/06/2010: Recommend for annual assessment and monitoring during flood events, per CLRO.  
 09/30/2009: No major change observed since the last visit; upper portion of existing revetment has slipped, exposing the degrading bank; note that site # is the same as RM46.30, LM5.69 found in the CLRO CES Evaluation 2008 Report; site was previously rated "M".  
 11/04/2008: Previously repaired using rock revetment; upper portion of the revetment is sliding, causing deformation on the levee slope; site is upstream of Howards Road Bridge.

Sloughing rip rap just below the Howard Bridge abutment.

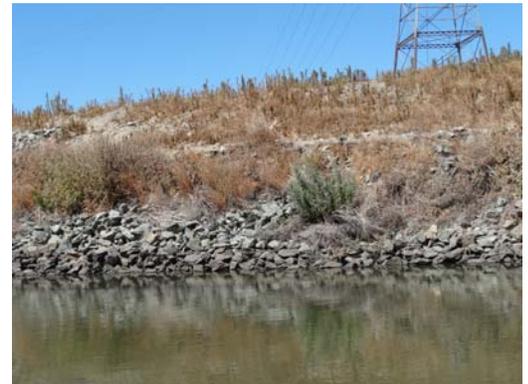
Sloughing rip rap adjacent to Howard Bridge.

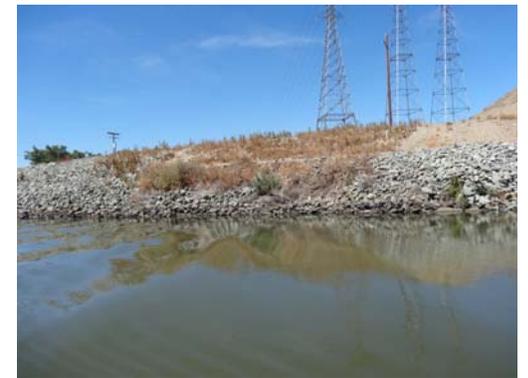
Front view of sloughing rip rap.

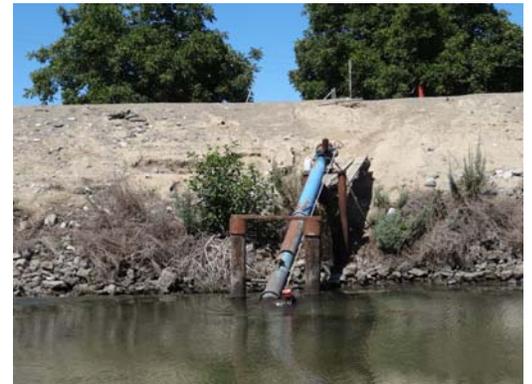
06/19/2014: No significant change observed.  
 08/13/2013: No significant change observed.  
 08/07/2012: The erosion is near a water-intake structure. Pipe leakage likely caused the erosion.

Close view of the erosion and the pipe.

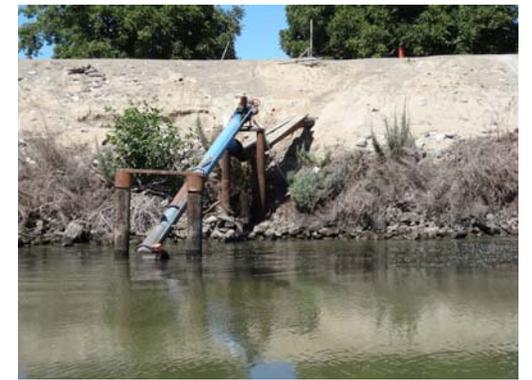
Closer view of the erosion.

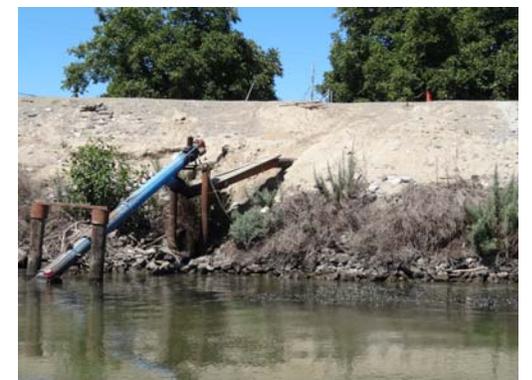
Closer view of the erosion and vegetation.

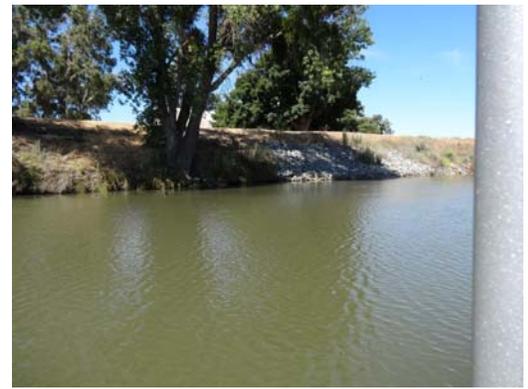
6/19/2014: Repaired site. No significant change observed.  
 08/13/2013: Repaired site. No new erosion found at the site.  
 08/07/2012: The site has been visited by boat survey. The site has been repaired with riprap protection. Rotten tree roots and minor erosion are visible immediately upstream of the site  
 08/23/2011: No significant change observed on site.  
 09/07/2010: No significant change observed on site. There are minor pockets of erosion lining the lower slope and undermining of the toe. There are annual grasses and emergent vegetation at the lower slope. Burrow holes were observed along the slope and persist throughout the 200-foot long site.  
 08/05/2010: Recommended for annual assessment and monitoring during flood events, per CLRO.  
 09/30/2009: No major change observed since last visit; despite dense vegetation, the bank continues to erode and slough; the levee toe is being undermined; note the tree on site; the site was previously rated "U".

Upstream view of the repaired site.

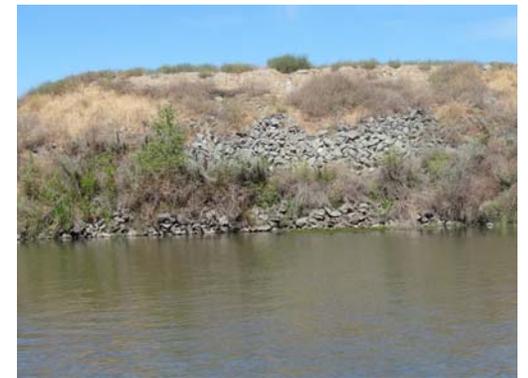
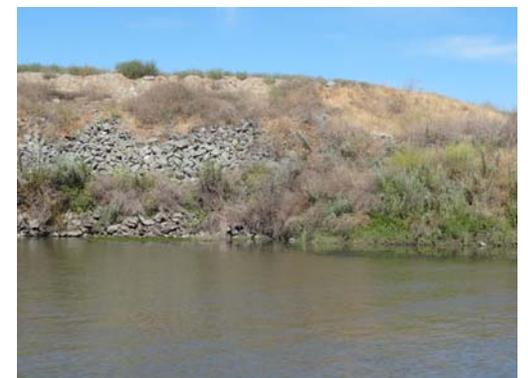
6/19/2014: The erosion was repaired.  
 08/13/2013: No significant change observed.  
 08/07/2012: The erosion is right at the inside of a river bend. Dense vegetation is visible at the site.

Front view of the erosion.

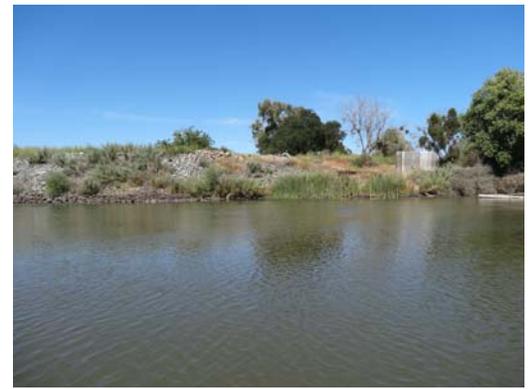
6/19/2014: No significant change observed.  
 08/13/2013: Pump has been removed. A larger pocket erosion has been found at the erosion site.  
 08/07/2012: The erosion is immediately upstream of a river bend. Dense vegetation is visible at the erosion site.

Front view of the erosion.

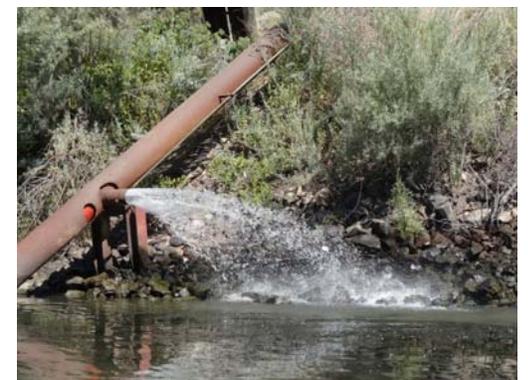
06/19/2014: No significant change observed.  
 08/13/2013: The erosion has been caused by irrigation pipe.

Close view of the site. The irrigation pump is running.

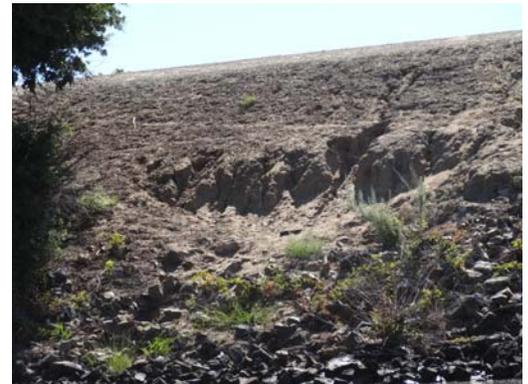
6/19/2014: No significant change observed.  
 08/13/2013: This erosion has been caused by instability of the levee . Larger trees exist downstream of the erosion site.

Front view of the erosion.

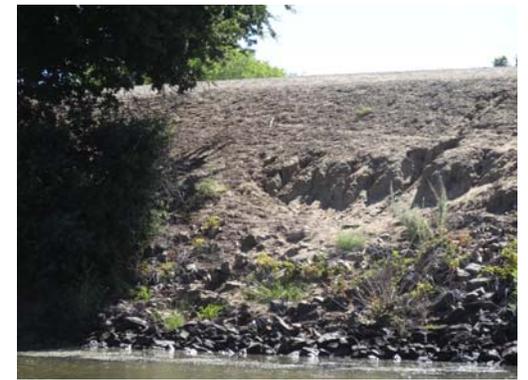
Close view of the erosion.

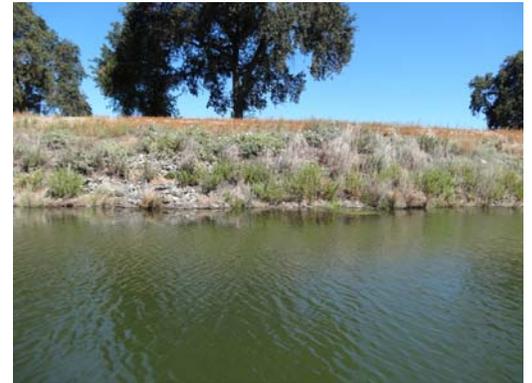
Close view of pocket erosion.

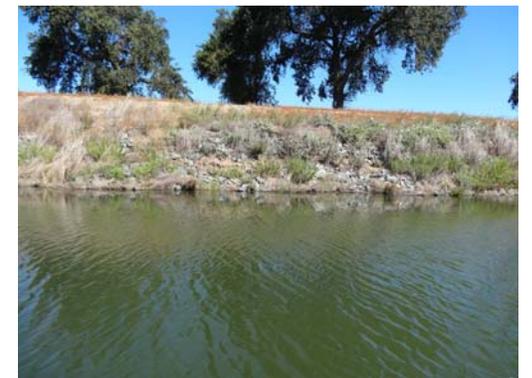
Close view of the erosion.

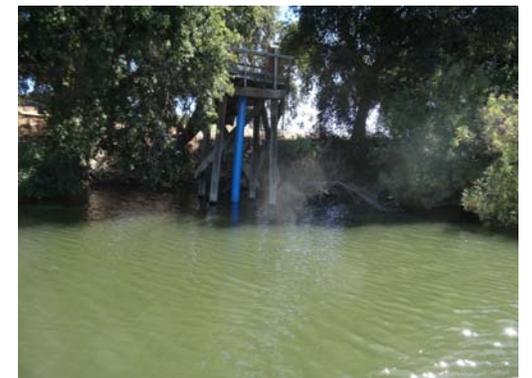
Close view of a fallen tree near the site.

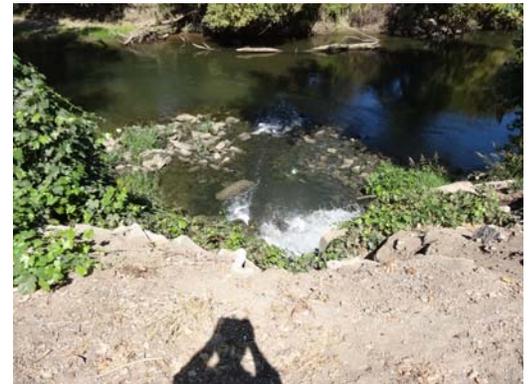
07/31/2014: No significant change observed.  
 09/10/2013: No significant change observed.  
 07/18/2012: No significant change observed.  
 08/18/2011: No significant change observed on site. Debris that blocks the irrigation outlet is visible.  
 10/19/2010: No significant change observed on site. Sloughing of the bank is occurring adjacent to an irrigation outlet structure. There is moderate to heavy vegetation along the bank that is well established. Broken chunks and slabs of concrete are used as rip rap and line the outside of the irrigation outlet structure. However, much of the rip rap along the slope is sloughing and could possibly lead to future slope instability.  
 08/05/2010: Recommended as a local maintenance issue, per CLRO.  
 08/20/2009: No major change observed since last visit; 1 inch fissure cracks developing on the slope; rip rap is showing signs of sloughing; recommend as local maintenance issue; site was previously rated "U".

Looking down at the site. The irrigation outlet is operating. Debris is visible at the outlet.

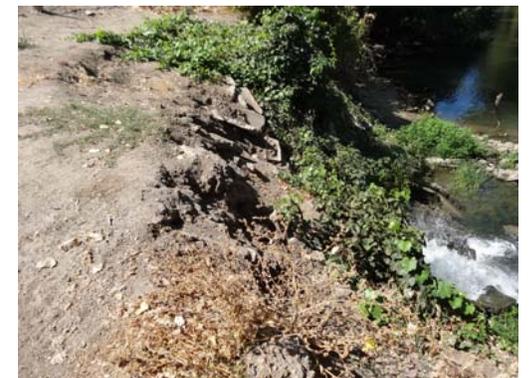
View of the current condition of the bank slope just above the irrigation outlet.

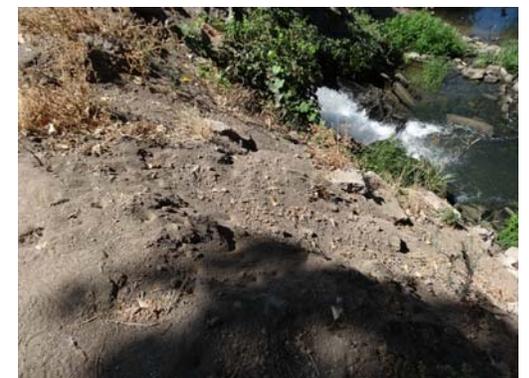
View of the loose material at the bank top.

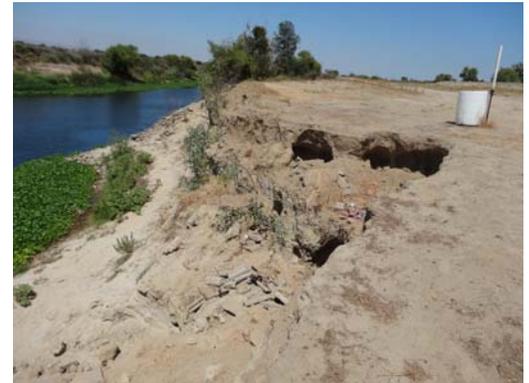
Looking upstream. Note the pocket erosion.

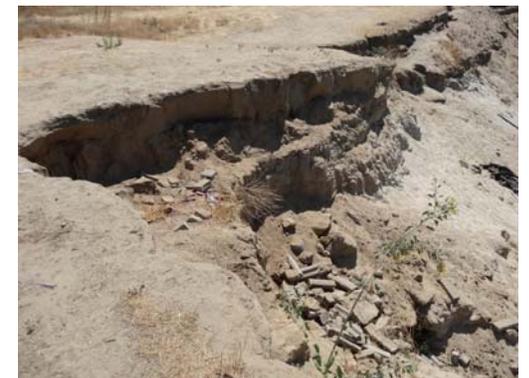
Close view of the pocket erosion.

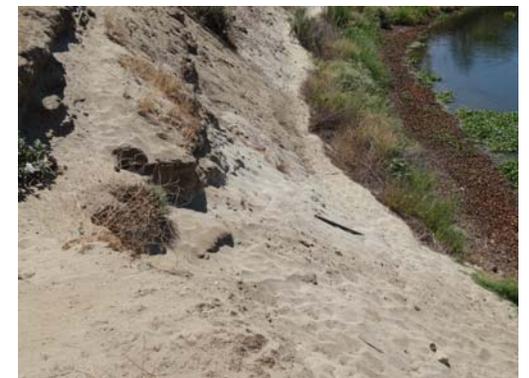
Close view of the erosion.

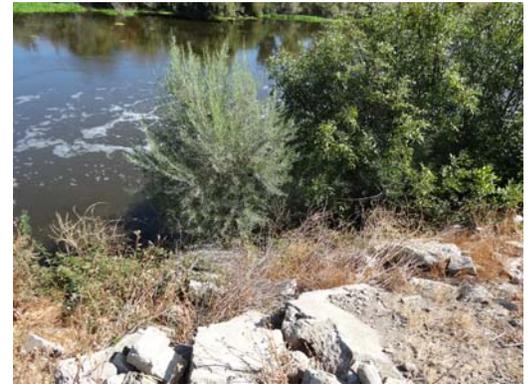
08/26/2014: No significant change observed.  
 08/28/2013: No significant change observed.  
 07/31/2012: Site was visited on 07/26/2012. No significant change observed. A new vertical pipe was installed and concrete blocks left on the site. Dense vegetation is visible at the site. No signs of new leaks or spill from the siphon breaker.  
 09/02/2011: Site was not visited due to the time limit.  
 09/22/2010: No significant change observed. Vegetation downstream, upstream and on the lower slope of the site have been recently sprayed. These areas were also fenced off during the site visit, making it difficult for us to examine the condition of the lower slope. Possible leak or spill from the siphon breaker is creating notches along the slope and developing into a headward erosion. If the problem continues, it will erode the slope and fully expose the pipe to outside elements.  
 07/23/2009: A possible leak or spill from a siphon breaker is eroding the slope and developing into a headward erosion; a portion of the buried pipe is exposed; the lower slope seems to be lined with chunks of concrete debris or other rock material.

Direct view of the site.

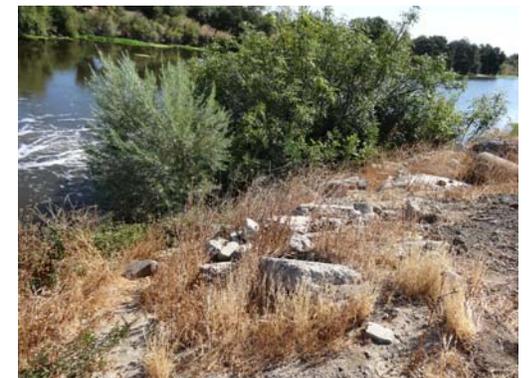
Direct view of the site.

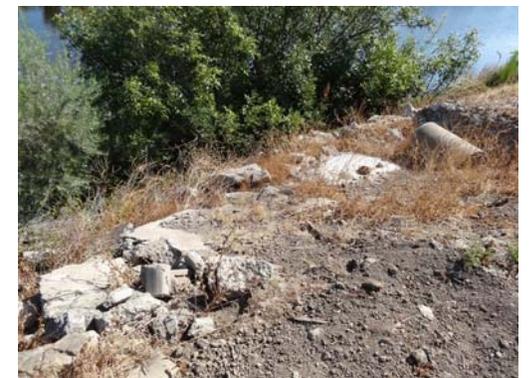
A close view of the site. Note the concrete debris.

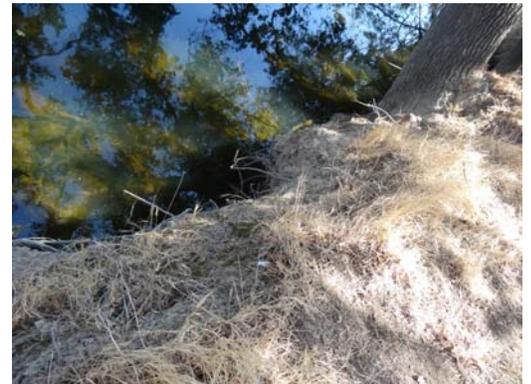
08/26/2014: No significant change observed.  
 08/28/2013: No significant change observed.  
 07/26/2012: The site has been visited, and no significant change has been observed.  
 09/02/2011: This site was not visited due to the time limit.  
 09/22/2010: No significant change observed. Minor pocket erosions are lined at the lower bank. Two large Oak and Willow trees are on mid-slope and bench. The remaining bench was re-measured and found to be approximately 10 feet. There was no indication of active erosion on site during the site visit.  
 08/05/2010: Recommended for annual assessment and monitoring of the site during flood events, per CLRO.  
 07/23/2009: No major change observed since last visit; site is a 200-ft. long near-vertical berm erosion; recommend annual assessment and monitoring of the erosion site, per CLRO CES Evaluation 2008 Report; Site # is the same site previously reported as RM4.0,LM4.51; previously rated "U".

Direct view of the erosion near a tree.

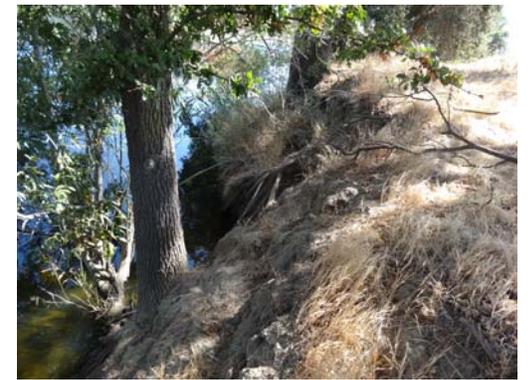
Direct view of the erosion near a tree.

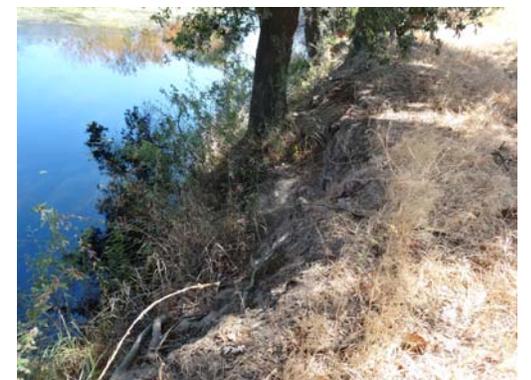
Direct view of the erosion near a tree.

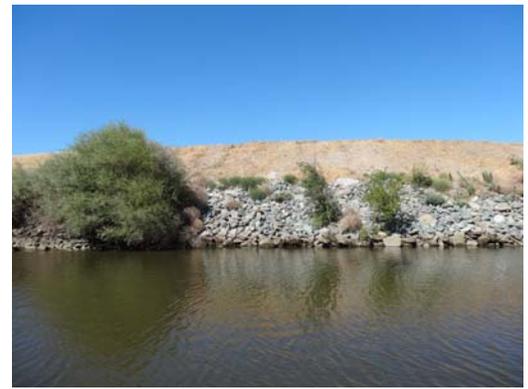
6/19/2014: No significant change observed.  
 08/13/2013. This was repaired prior to the boat survey. No new erosion found at the site  
 08/07/2012: The site has been visited by boat survey. No significant change observed  
 08/23/2011: No significant change observed at the site. There is vegetation on the slope. There is a bridge construction site just upstream of the erosion. The impact of the construction may need to be monitored.  
 09/07/2010: No significant change observed on site. Sloughing of the existing rip rap revetment on the lower slope has developed into an erosion pocket. There is moderate annual grass growth on the slope.  
 08/06/2010: Recommended as local maintenance issue, per CLRO.  
 03/09/2010: Per Michael Moncrief of MBK, site is scheduled for repair this year.  
 2009: Landside ground surface has been raised to the height of the levee crown; sloughing of the existing rip rap revetment on the lower slope that has created a pocket, exposing underlying soil; Site # is the same RM54.34,LM1.08; previously rated "M".

Front view of the repaired site.

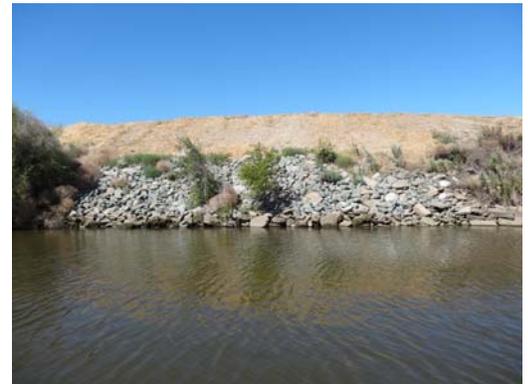
Front view of the rip rap.

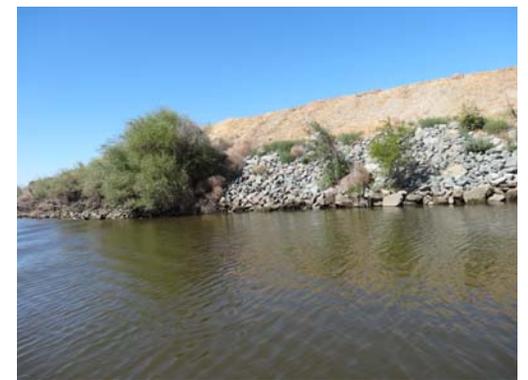
Downstream view of the erosion site and riprap revetment.

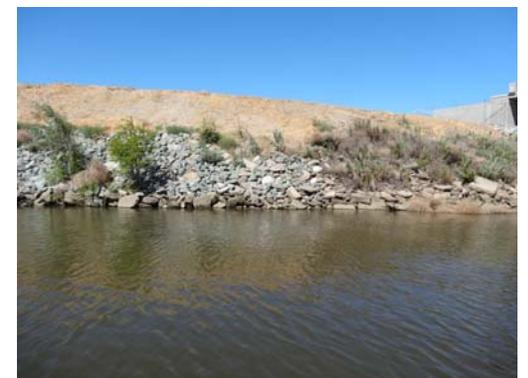
Front view of the site.

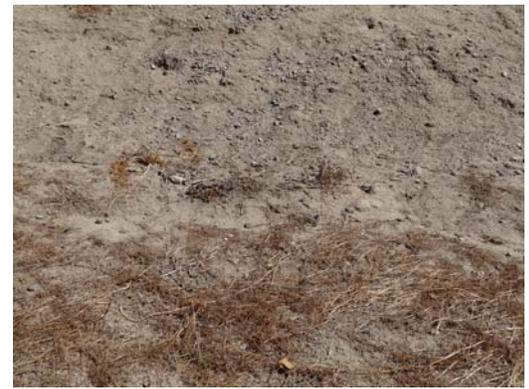
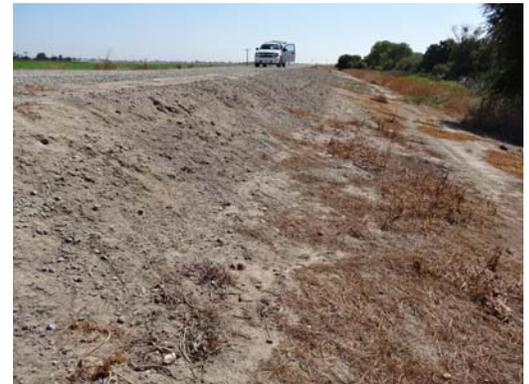
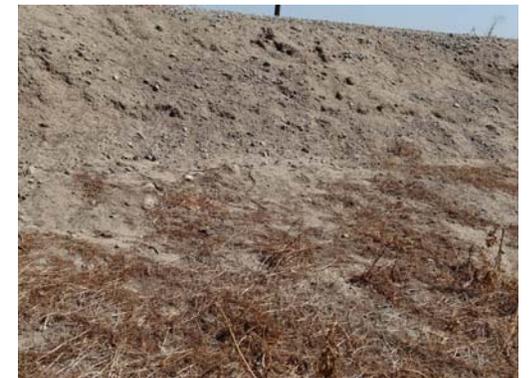
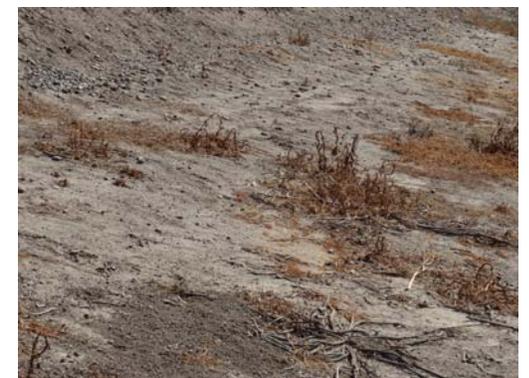
08/26/2014: The erosion was repaired.  
 08/28/2013: No significant change observed.  
 07/31/2012: Site was visited on 07/26/2012. No significant change observed.  
 09/02/2011: No significant change observed.  
 09/22/2010: No significant change observed. The foot-high near-vertical scarp still exists on levee toe. There is little to no vegetation on the slope.  
 03/09/2010: As discussed with Michael Moncrief of MBK, site will be addressed this year.  
 07/27/2009: 1 to 2 feet of near-vertical scarp on levee toe; damage was most likely caused by farming equipment during clearing or tilling operation; this is a maintenance-related issue.

Front view of the repaired site.

Downstream view of the repaired site.

Direct view of the repaired site.

A close view of the repaired site.

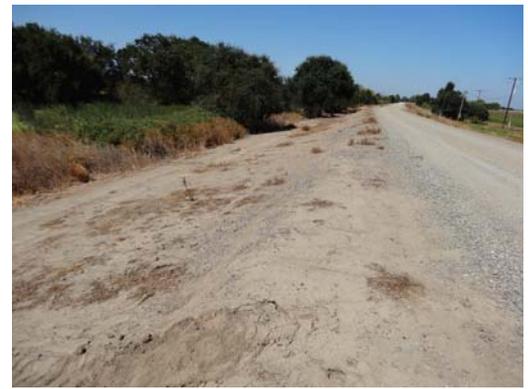
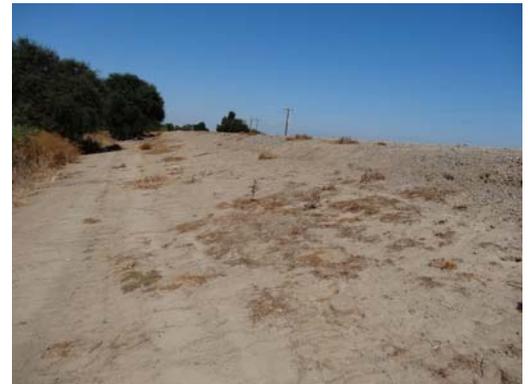
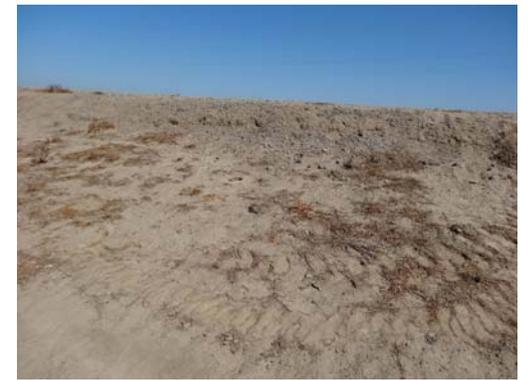
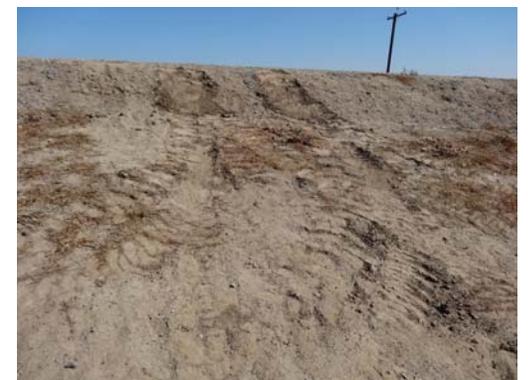
08/26/2014: The erosion was repaired.  
 08/28/2013: No significant change observed.  
 07/26/2012: Site was visited on 07/26/2012. No significant change observed.  
 09/02/2011: No significant change observed on site from last visit.  
 09/22/2010: No significant change observed on site. The fencing located on the berm was removed. Levee slope and berm area 10 feet from the levee toe are bare of any vegetation. The 1- to 2 feet of near-vertical scarp on the levee toe is unchanged.  
 03/09/2010: As discussed with Michael Moncrief of MBK Engineer, the district will address the site this year.  
 7/27/2009: 1 to 2 feet of near-vertical scarp on the levee toe; damage was most likely caused by agricultural equipment during clearing or tilling operation; this is a maintenance-related issue.

Downstream view of the repaired site.

Close view of the repaired site.

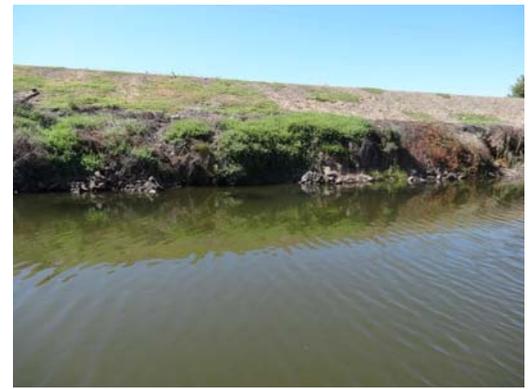
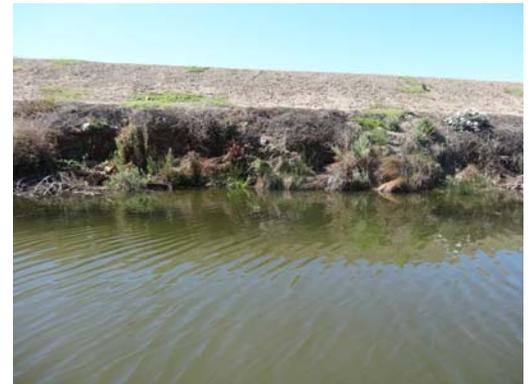
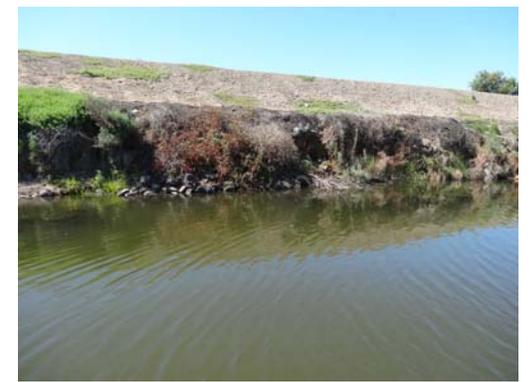
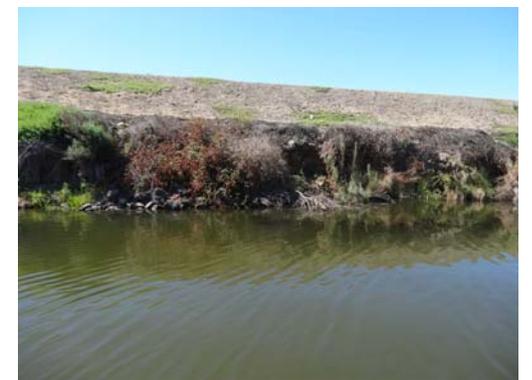
07/02/2014: No significant change observed.  
 08/13/2013: No significant change observed.  
 08/07/2012: The site has been visited by boat survey. No significant change observed  
 08/23/2011: Site is at the upstream of a drainage ditch.

Front view of the erosion.

Close view of the erosion.

Front view of the erosion. Note the dense vegetation.

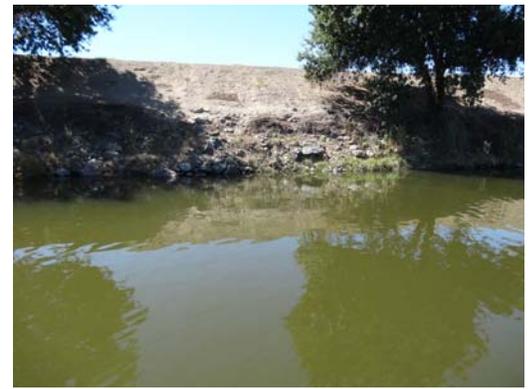
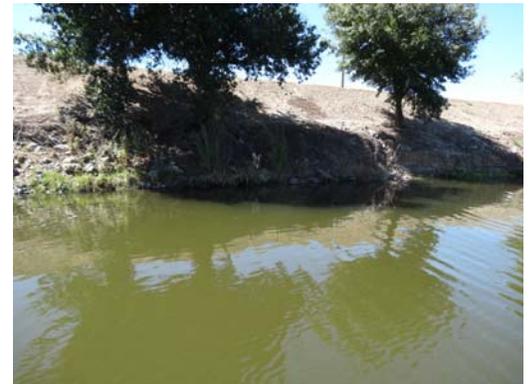
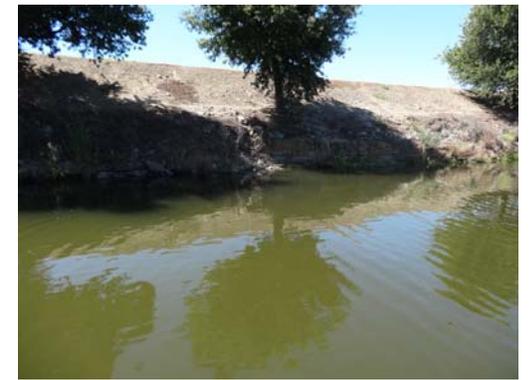
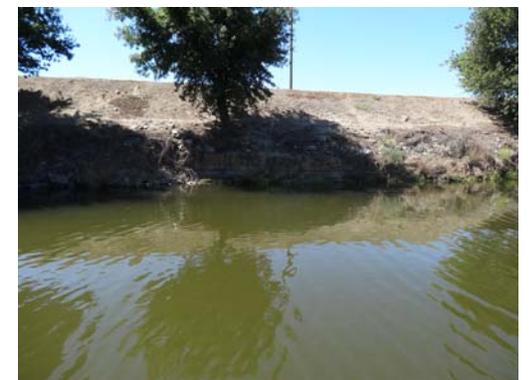
07/02/2014: No significant change observed.  
 08/13/2013: No significant change observed.  
 08/07/2012: The site has been visited by boat survey. No significant change observed  
 08/23/2011: Hard to view the erosion because of the dense vegetation and trees on site.  
 The site is under the bush, close to the tree.

Front view of the site.

Close view of the site.

Close view of the site. Note the vegetation.

View of the site from downstream.

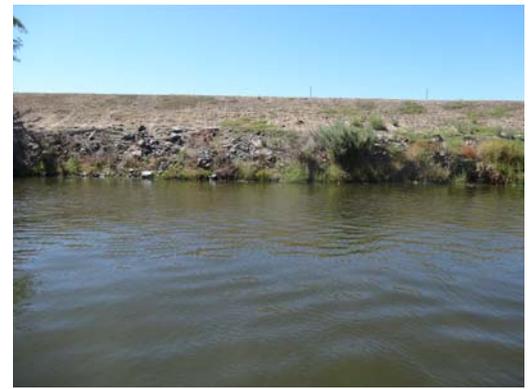
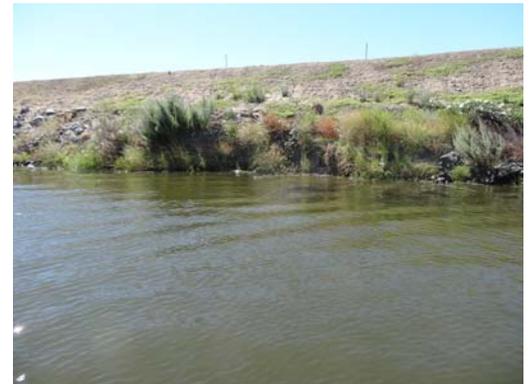
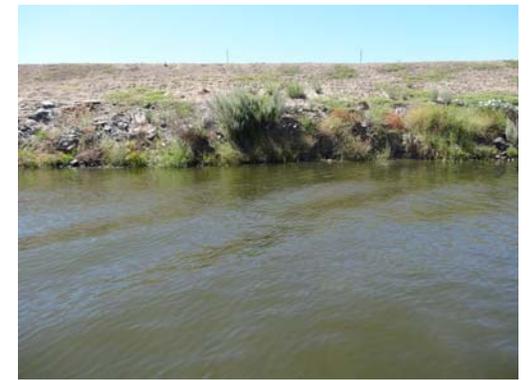
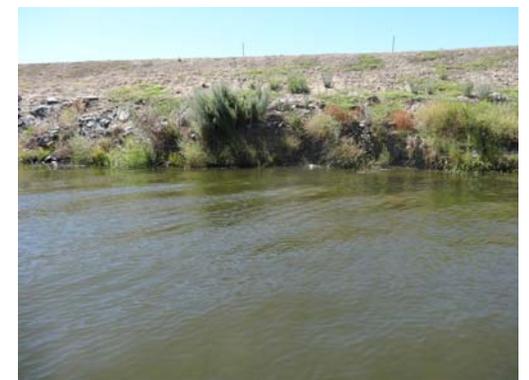
07/02/2014: No significant change observed.  
 08/13/2013: No significant change observed.  
 08/07/2012: The site has been visited by boat survey. No significant change observed  
 08/23/2011: The protection at the levee toe has been washed away.

Direct view of the site.

Front view of the erosion.

Close view of the erosion.

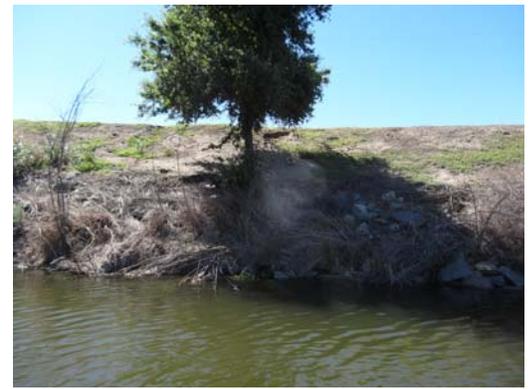
07/02/2014: No significant change observed.  
 08/13/2013: A new pocket erosion at the upper levee slope has been found directly above a large tree. The erosion might have been caused by internal pipe leakage or surface runoff.  
 08/07/2012: The site has been visited by boat survey. No significant change observed  
 08/23/2011: No significant change observed on site. Dense vegetation is visible along the water line.  
 09/07/2010: No significant change observed on site. Much of the upper slope was recently cleared of vegetation by spraying. 4- to 6-foot vertical scarp and pocket erosions are lined along a span of 475 feet. In some sections, the vertical scarp encroaches into the levee prism. There is a lack of berm along this reach, exposing the levee slope to high flow velocities during normal and flood events.  
 08/06/2010: Recommended as local maintenance issue, per CLRO.  
 03/09/2010: As discussed with Michael Moncrief of MBK Engineers, the site will be 'addressed' later this year.

09/29/2009: No major change observed since last visit; pocket erosion and a vertical scarp forming; this site was combined with Site RM30.13 and 30.02 with a combined total erosion length of 475 feet; recommended as annual assessment and monitoring of the site, per CLRO CES Evaluation 2008 Report; previously rated "M".  
 11/05/2008: Top of vertical scarp has rip rap that appears to be sliding; rodent holes; existing top rip rap

View of the pocket erosion and the tree.
