LMA: **NA0010 U23 Lower San Joaquin** Waterway: **RB San Joaquin River**  
 Site ID: **NA0010U23RM224.27** Status: **Repaired Site**

Latitude: **36.802116** Longitude: **-120.173847** River\_Mile: **224.27** Levee\_Mile: **9.15** Overall Rating:

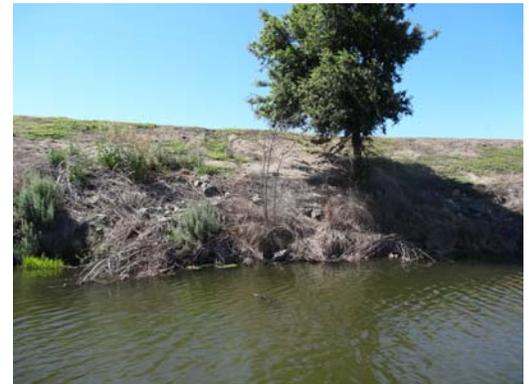
Close view of the pocket erosion.

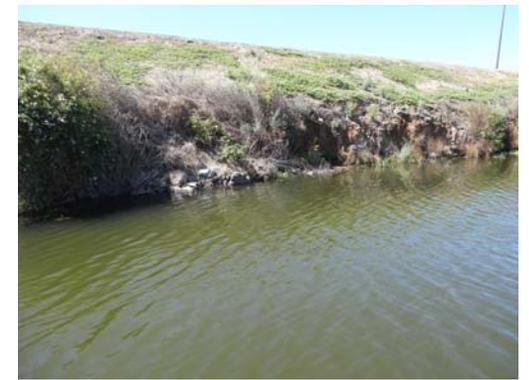
Front view of the site with dense vegetation.

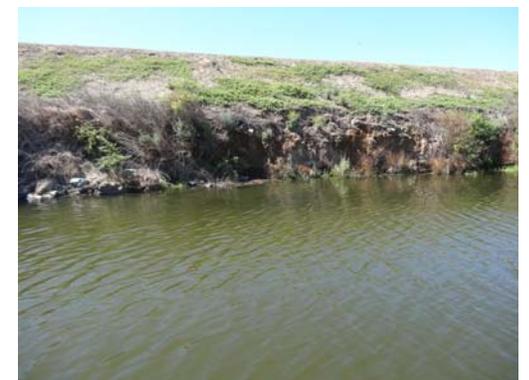
Front view of the existing erosion at the toe.

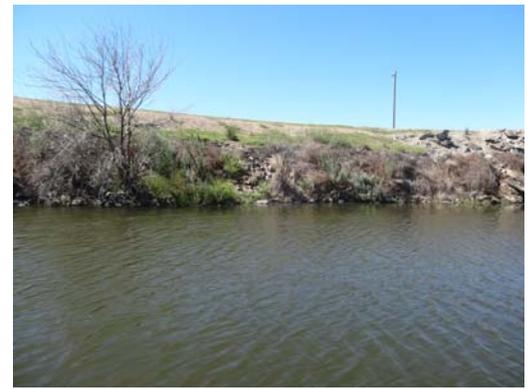
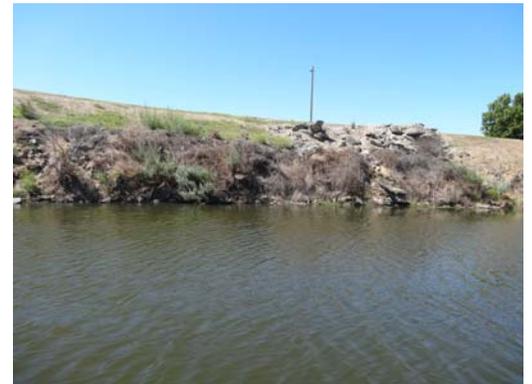
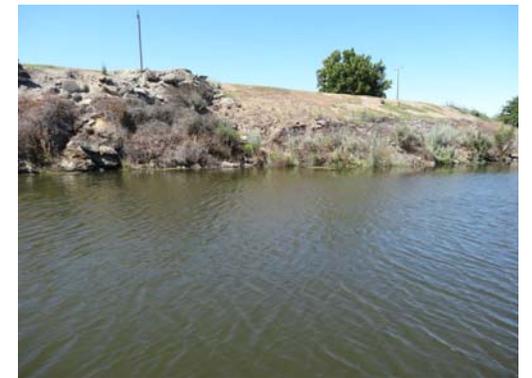
07/02/2014: No significant change observed.  
 08/13/2013: No significant change observed.  
 08/07/2012: The site has been visited by boat survey. No significant change observed  
 08/23/2011: The site is right at the downstream of a river bend.

Front view of the erosion.

Close view of the site.

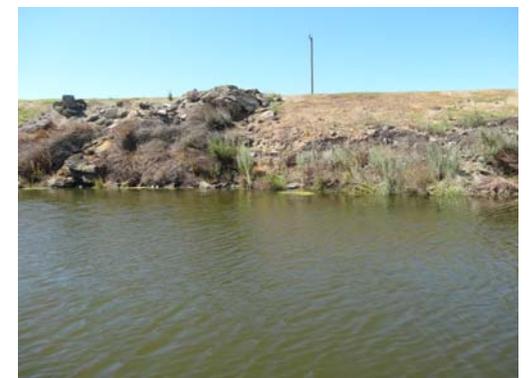
Close view of the site. Note the piled concrete debris.

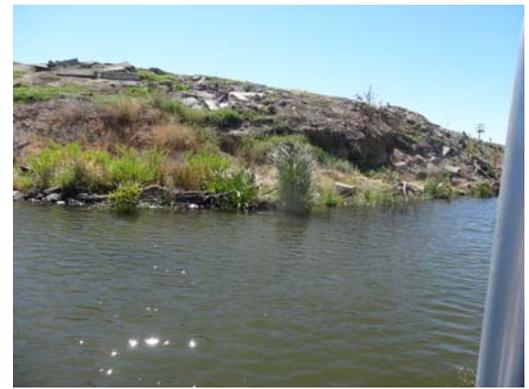
07/02/2014: No significant change observed.  
 08/13/2013: No significant change observed.  
 08/07/2012: The site has been visited by boat survey. No significant change observed.  
 08/23/2011: No significant change observed on site.  
 09/07/2010: No significant change observed on site. Much of the placed rip rap revetment has slid. It is no longer adequately protecting the slope.  
 08/06/2010: Recommended as local maintenance issue, per CLRO Report.  
 03/09/2010: As discussed with Michael Moncrief of MBK, site will be 'addressed' this year.  
 09/29/2009: No major change observed since last visit; a section of the rip rap has slipped, exposing a levee section that has eroded; recommended as local maintenance issue, per CLRO CES Evaluation 2008 Report; Site # is the same as RM30.43,LM0.63; previously rated "U".  
 11/05/2008: Site is located inside of a bend; scarp looks to be into the levee prism; piles of concrete chunks placed on the slope, with some of them already starting to slide.

Close view of the site.

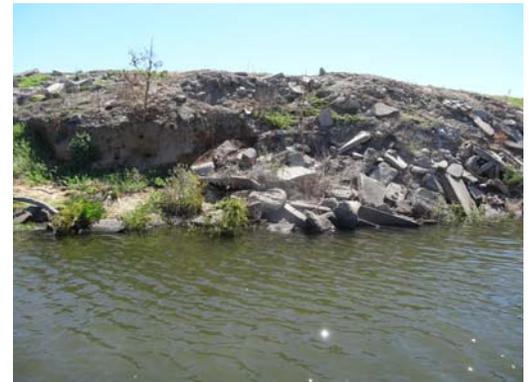
Front view of the site. Previously placed rip rap slipped, exposing the underlying soils and creating a pocket.

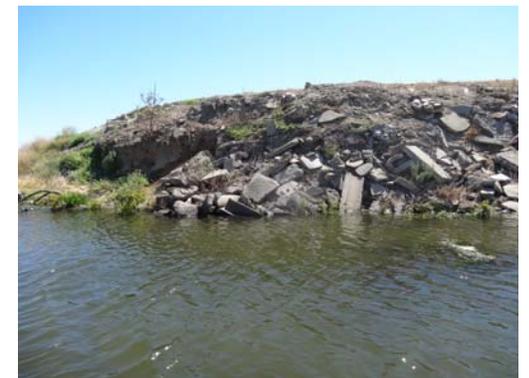
Front view of the site. Rip rap no longer adequately protecting levee slope.

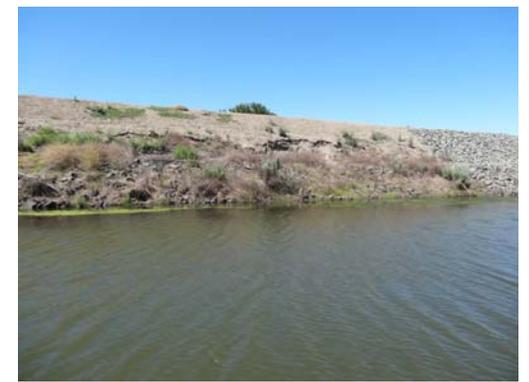
Front view of the site. Note the crack along the middle of the slope.

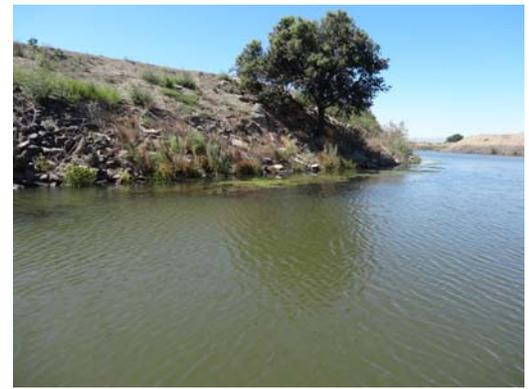
11/05/2008: Portion of rip rap collapsing.  
 09/14/2006: Portion of rip rap along the slope has collapsed; exposed levee section is starting to erode, exposing roots from the nearby tree.

Upstream view of the erosion site.

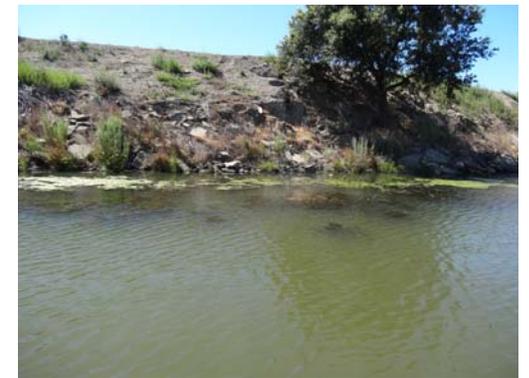
Front view of the site. Note existing broken concrete on the upper slope as well as on the lower slope and at the toe.

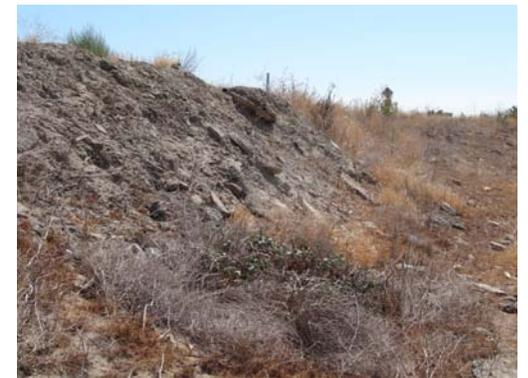
Looking downstream of the erosion site.

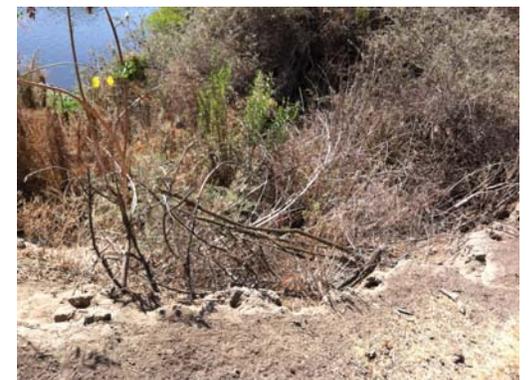
09/20/2013: No significant change in erosion observed. More vegetation at the site.  
 12/04/2012: The erosion has progressed remarkably toward levee, extended to the up- and downstream of the original pocket erosion. Trees and dense bush are present at the site. Animal burrow holes are visible, and possibly can cause seepage.  
 09/22/2010: No significant change observed. There is little visibility due to seasonal grass on the berm and slope.  
 08/18/2009: Site is located on berm; pocket erosion has developed; the site is covered in dense vegetation; there are several relief wells on the landside of the levee; site is Not Rated because berm width is greater than 30 feet; site should be monitored to keep track of erosion progress.

Direct view of the erosion. Note dense vegetation at the site.

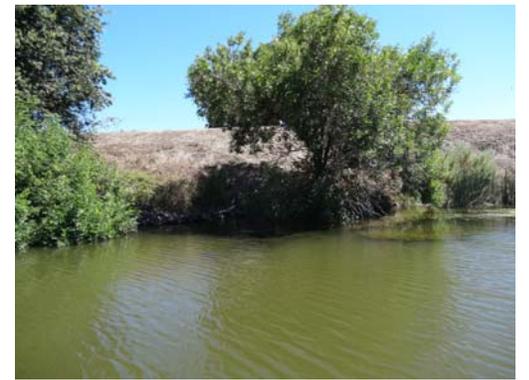
07/02/2014: No significant change observed.  
 08/13/2013: The erosion is around a tree at the levee toe. Dense vegetation is visible.

Close view of the site. Note the tree and the vegetation.

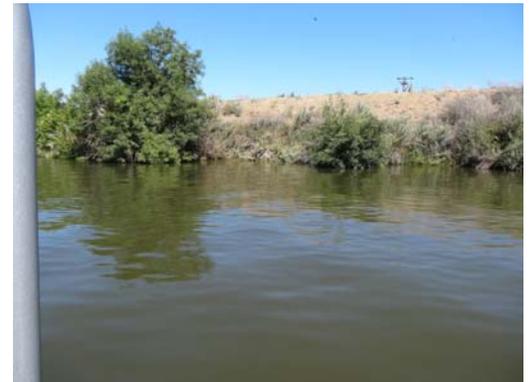
Front view of the site. Note the very dense white willow thickets on site.

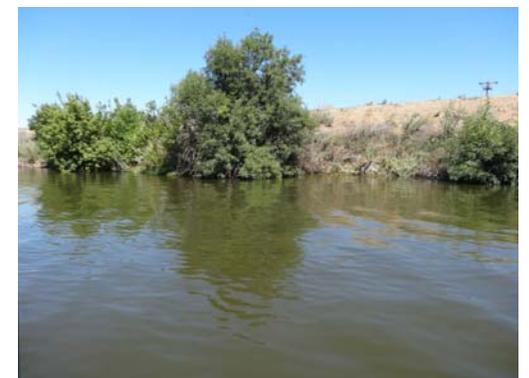
Front view of the site. Note the erosion is invisible because of the dense vegetation.

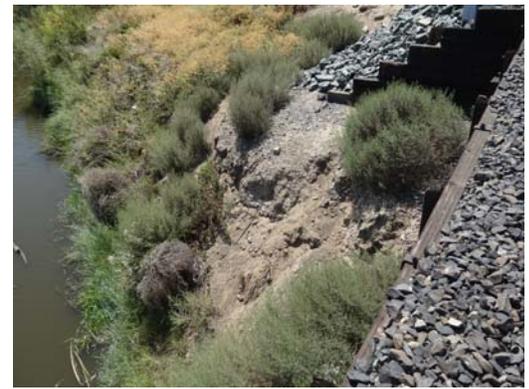
Direct view of the erosion upstream of Railroad bridge.

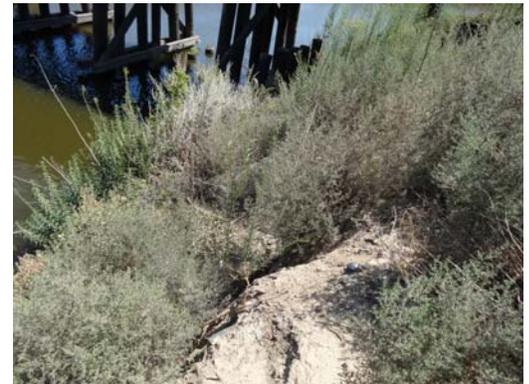
08/26/2014: No significant change observed.  
 08/28/2013: No significant change observed.  
 07/18/2012: No significant change observed.  
 09/02/2011: No significant change observed.  
 09/22/2010: No significant change observed. There is now considerable vegetation at the water line and along the lower berm slope. However, the erosion on the lower berm slope is still present and has not been corrected.  
 08/06/2010: Recommended for local maintenance issue, per CLRO.  
 07/29/2009: No major change since last visit; noticeable vegetation growth; erosion is on berm, but if left untreated, it will eventually erode into levee prism; site is recommended for annual assessment and monitoring of the site, per CLRO CES 2008 Report; Site # is the same as RM6.80,LM0.73; previously rated "U".  
 07/22/2008: Downstream of WPRR near siphon pipe & pump; sandy levee; visited by Jeff Van Gilder and LRO in 2008 for repair assessment; scouring downstream of RR crossing, possibly caused by eddy effects.

Looking down at the erosion downstream of the Railroad bridge.

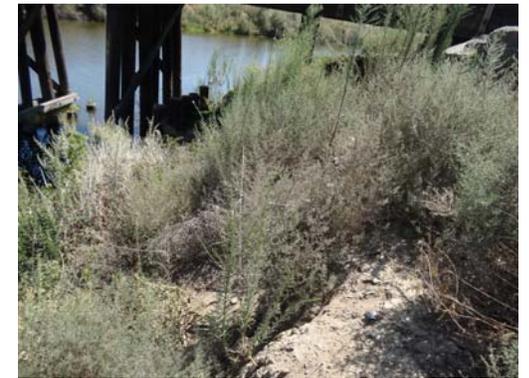
Close view of the erosion downstream of the RR bridge.

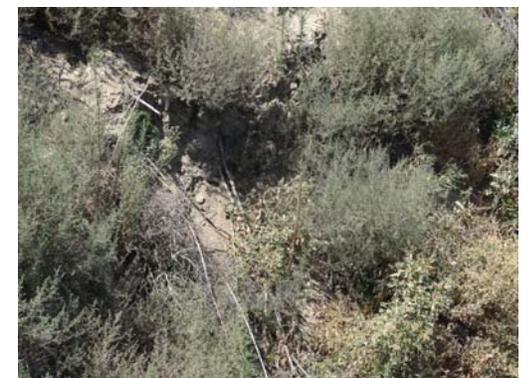
Close view of the erosion.

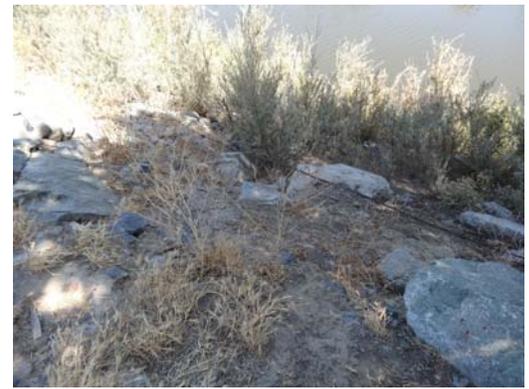
08/26/2014: The erosion was repaired.  
 08/28/2013: No significant change observed.  
 07/18/2012: No significant change observed.  
 09/02/2011: No significant change observed.  
 09/22/2010: No significant change observed. Sloughing of the existing rip rap possibly due to a combination of steep slope and undesirable flood conditions.  
 08/06/2010: Recommended as local maintenance issue, per CLRO.  
 07/29/2009: No major change observed since last visit; near-vertical slope that has rip rap sloughing; site is recommended as a local maintenance issue, per CLRO CES Evaluation 2008 Report; Site # is the same as RM6.90,LM0.86; previously rated "U".  
 07/22/2008: Previous erosion site that is partially protected with concrete rubble; erosion scarp is adjacent to the sloughing rip rap.  
 03/13/2007: Site visited on 03/13/2007.

Direct view of the repaired site.

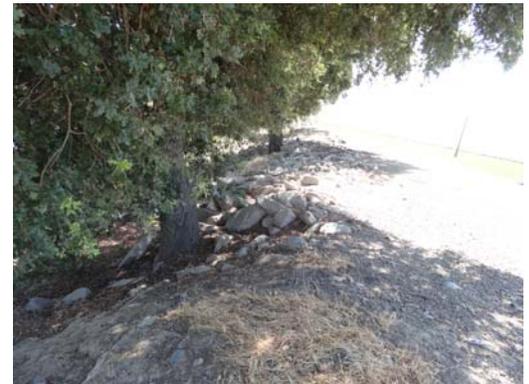
Direct view of the repaired site. Note the piled concrete debris at the shoulder and slope.

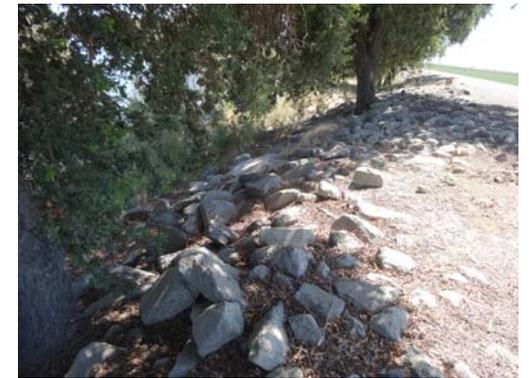
Direct view of the repaired site.

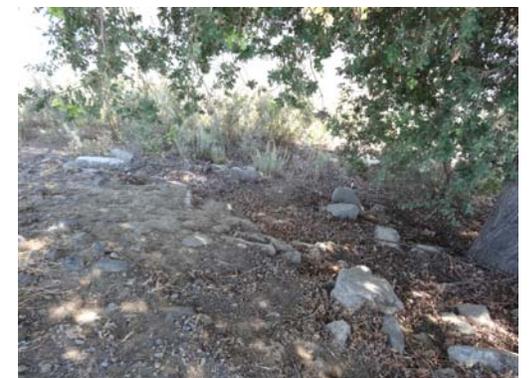
Close view of the repaired site. Note the vegetation at the toe.

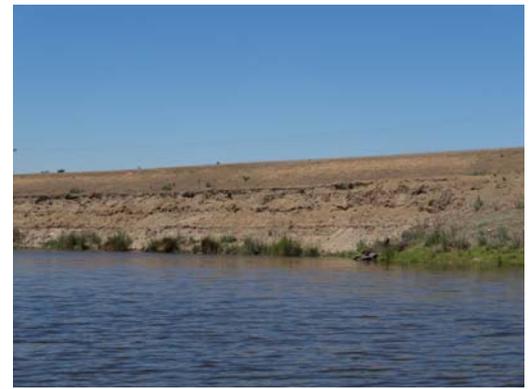
7/02/2014: No significant change observed.  
 08/28/2013: No significant change observed.  
 09/13/2012: The site has been visited by land survey. The vegetation on the site shows the erosion has not developed significantly from the last survey.  
 The site was not visited by boat survey due to the limitation of navigable waterway.  
 08/23/2011: No significant change observed.  
 9/22/2010: No significant change observed. There is moderate vegetation growth on the berm. Despite the erosion occurring on the berm, corrective action should be taken before the issue becomes severe.  
 9/29/2009: Site is immediately downstream of a section of existing rip rap; there is a 20-foot berm remaining; berm will continue to erode unless erosion is mitigated; Site# is the same as RM62.6, LM1.87; recommended for annual assessment, per CES Evaluation 2008 Report  
 2006: Visited 10/20/06

Close view of the site.

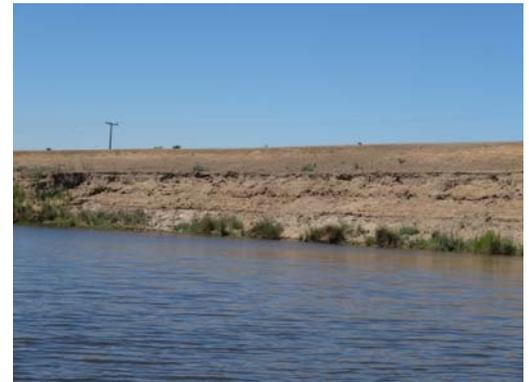
View of the erosion.

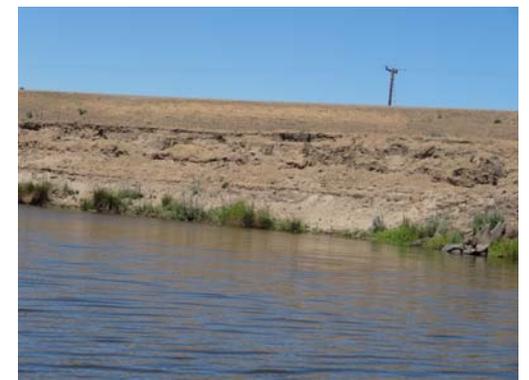
Close view of the site.

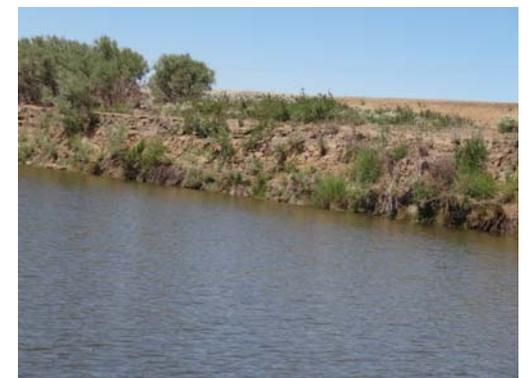
Close view of the site.

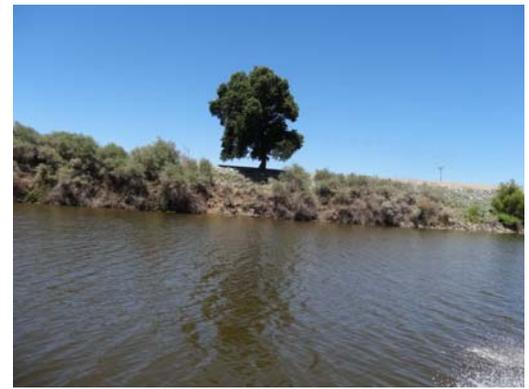
View of the erosion from the survey boat. The dense vegetation on the site blocks the view of the erosion.

7/02/2014: No significant change observed.  
 08/28/2013: No significant change observed. Dense vegetation blocks the visual inspection at the site.  
 09/13/2012: The site has been visited by land survey. The erosion is not visible from the levee slope because of dense vegetation at the site. Levee slope is protected by placed rocks. The site was not visited by boat survey due to the limitation of navigable waterway.  
 08/23/2011: Dense vegetation makes it difficult to view the possible erosion. No new development was observed on site.  
 09/23/2010: At the time of the inspection, the erosion site was difficult to view from the levee. The erosion is located on the bank toe, below the existing rip rap. There were no signs of repair on site, nor has the site been reported to be repaired by the district. Images taken from last year indicate that existing rip rap at the bank toe has sloughed exposing the underlying soils. Weakening of the toe could lead to future bank instability.

08/05/2010: Recommended for annual assessment and monitoring during flood events, per CLRO.  
 09/29/2009: No major change observed since last visit; sloughing of the rip rap above toe; erosion begins immediately downstream of existing rip rap revetment; roughly 15-foot berm remains; however, it will continue to erode and eventually intrude into the levee profile if left untreated.  
 10/20/2006: Just upstream of where berm starts to widen

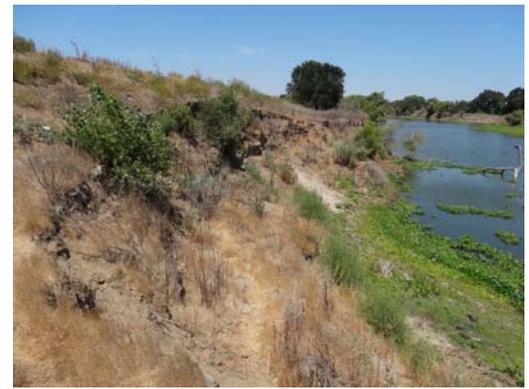
07/17/2014: No significant change observed.  
 09/20/2013: Site has been visited. There are signs of further erosion development along the levee slope and toe.  
 07/18/2012: The erosion has further developed toward levee crown. Vegetation has been removed.  
 08/18/2011: The erosion progressed significantly during the past flood season. The levee toe along the erosion site was washed away, and the erosion has cut the levee structure up to the point about 1/3 of the levee slope. The scarp height is approximately 17 feet. Very dense vegetation and trees are visible.  
 10/19/2010: No significant change observed on site. Remaining levee berm topsoil is of silty sand mixture. The erosion is near the downstream transition. An eddy has formed, and has scoured away a 100-foot section of the bank, possibly encroaching into the levee prism. Vegetation on site includes willows, oak, and cotton wood located from the bench to the toe. On the landside are rows of corn crop.

08/05/2010: Recommended for Repair, per CLRO.  
 2009: Site recommended as annual assessment and monitoring if critical erosion site, per CLRO CES Evaluation 2008 Report; an eddy has formed, eroding bank and intruding into the levee prism; Site # is the same as RM76.3, LM1.89; previously rated "U".  
 08/30/2007: Recommended for short list of immediate repair sites; silty sand levee material.

Upstream view of the erosion.

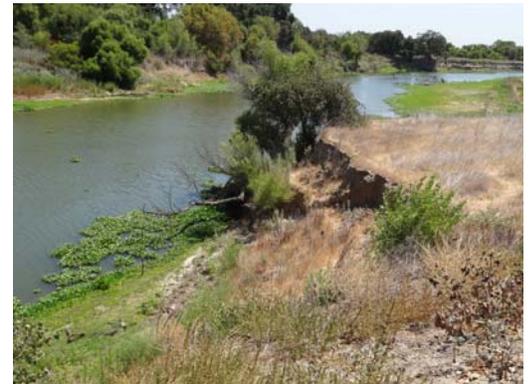
Downstream view of the erosion.

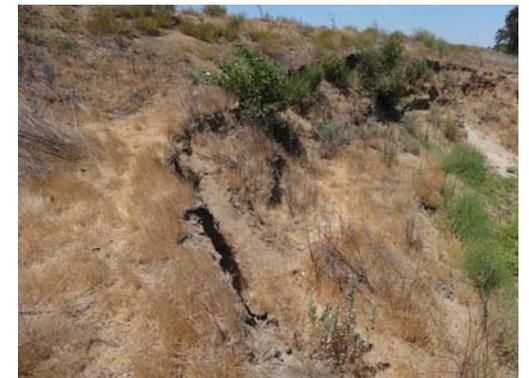
Close view of the erosion.

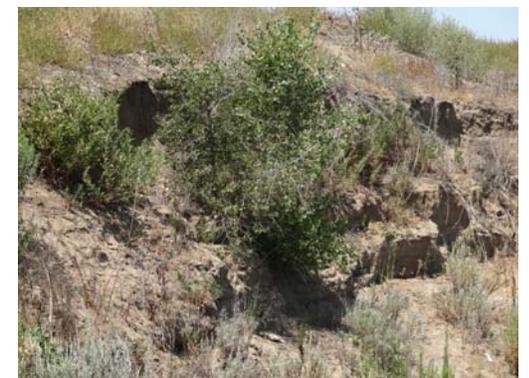
Close view of the erosion. Levee crest is approximately 8 feet above the erosion.
