LMA: **NA0011 U02 Madera County FC** Waterway: **RB Ash Slough**  
 Site ID: **NA0011U02RM2.57** Status: **Existing Site**

Latitude: **37.055596** Longitude: **-120.412647** River\_Mile: **2.57** Levee\_Mile: **1.15** Overall Rating: **U**

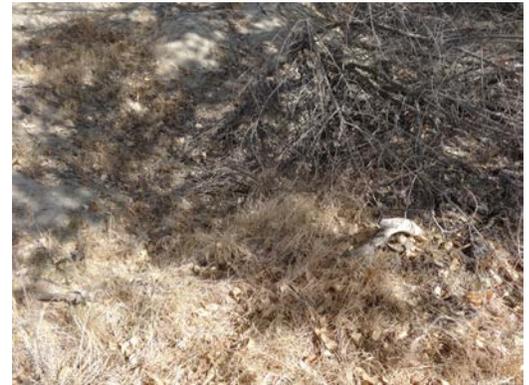
Close view of the site.

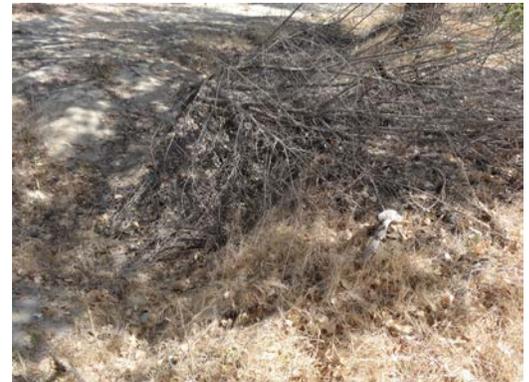
Debris at the site.

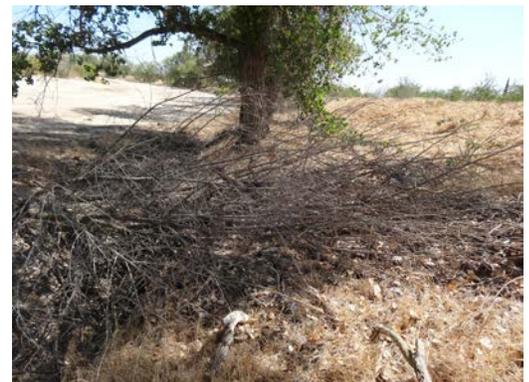
Close view of the site with the dead tree.

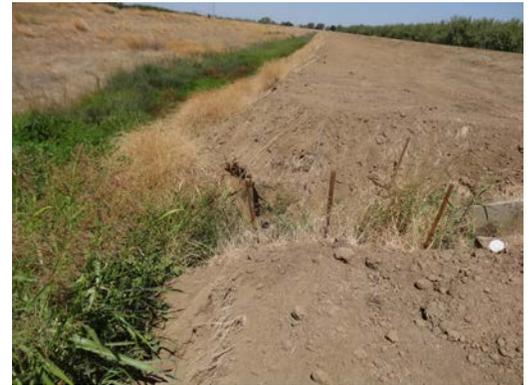
The erosion site has been repaired and vegetation has been removed.

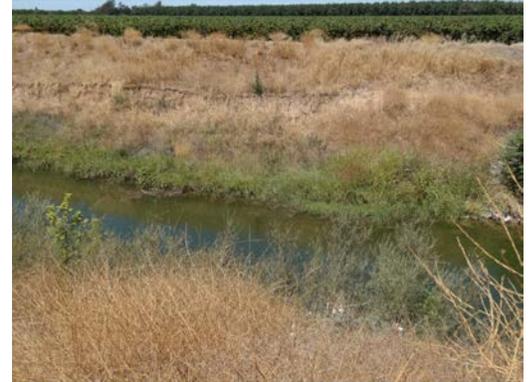
Close view of the erosion.

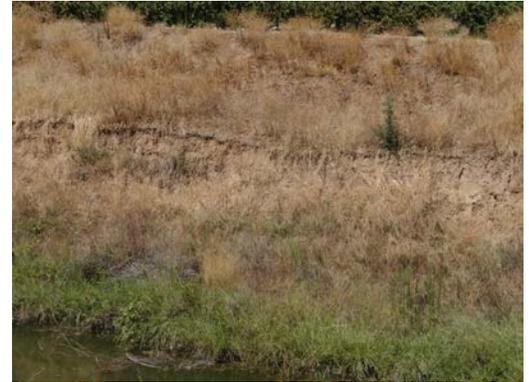
Close view of the erosion.

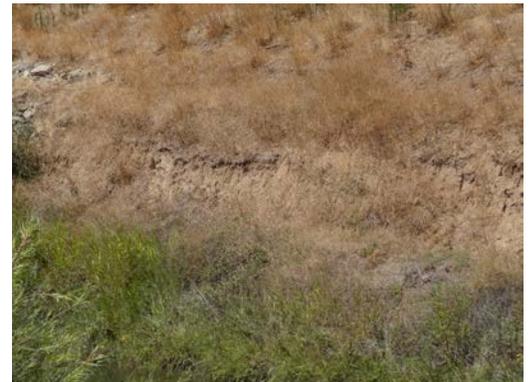
Close view of the erosion.

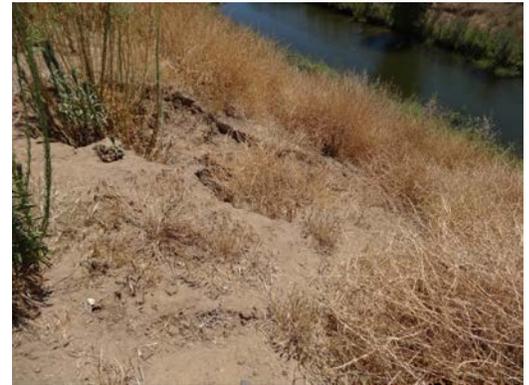
Close view of the erosion.

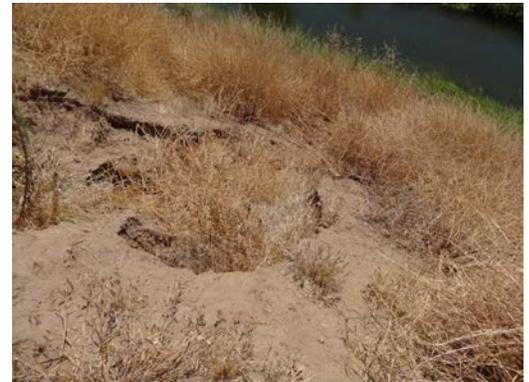
Close view of the erosion.

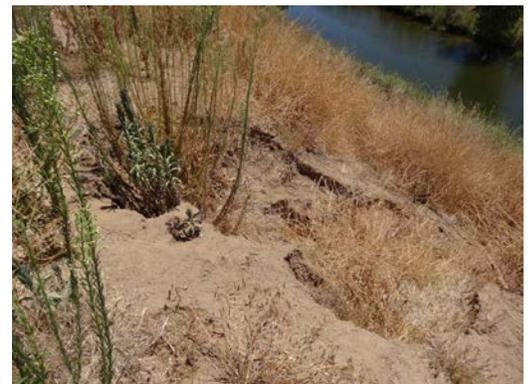
Close view of the erosion.

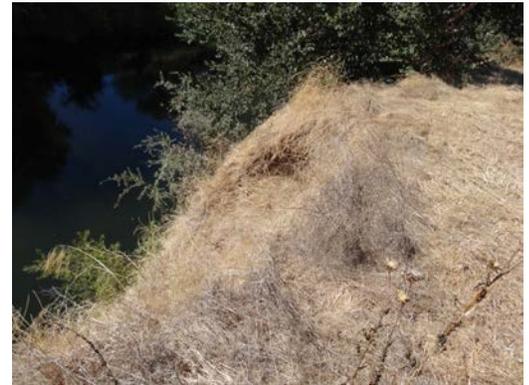
Close view of the erosion. Note the dense vegetation and tree on site.

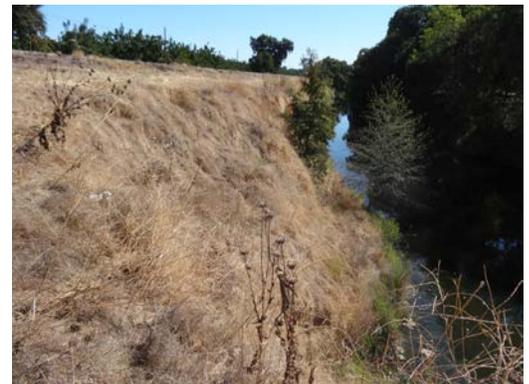
Close view of the erosion site. Small trees grow at the lower slope of the bank.

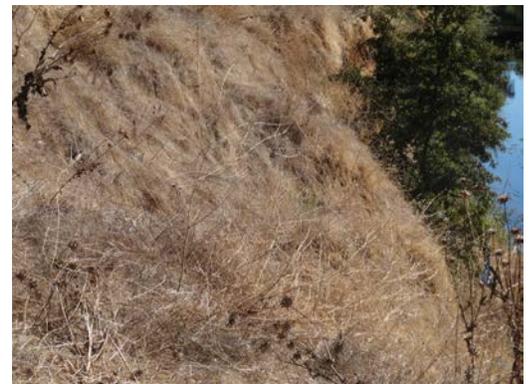
Looking down at the site.

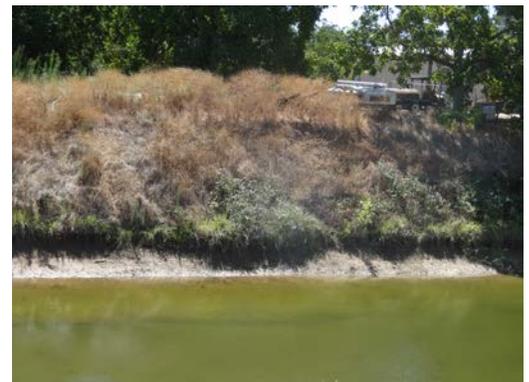
Close view of the erosion.

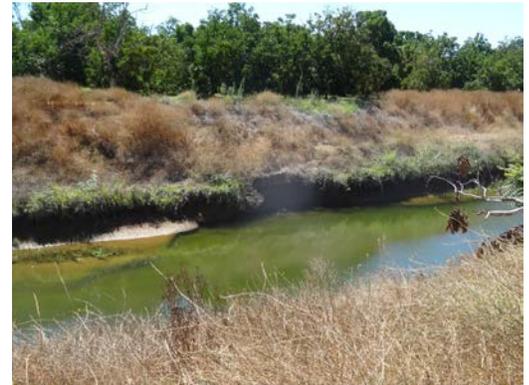
8/12/2015: No significant change observed.  
 8/20/2014: No significant change observed.  
 9/12/2013: The erosion seems to be caused by high river flow. Dense vegetation is present at the site. Signs of animal activities are visible. There is no levee structure on site. The levee crest width and levee height were not measured or estimated in the field.

View from the right river bank.

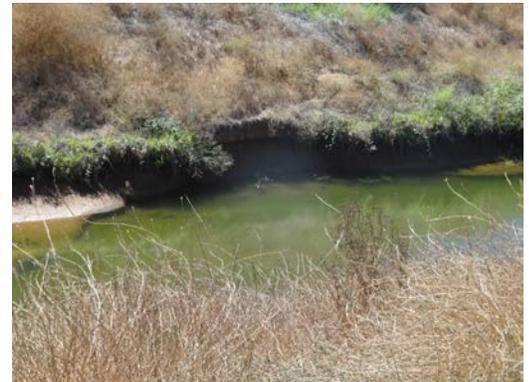
Close view of the erosion.

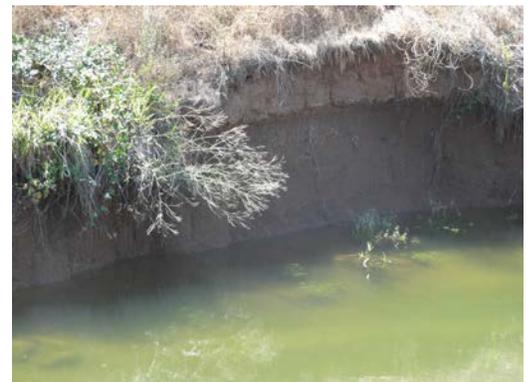
Close view of the erosion.

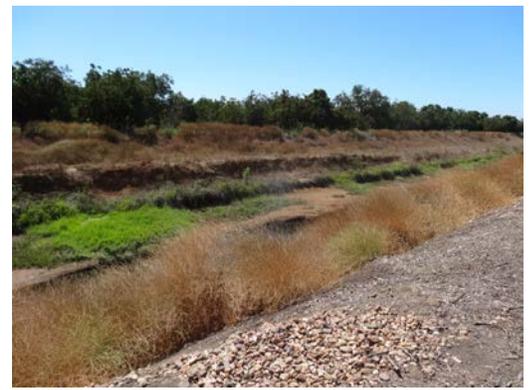
8/12/2015: No significant change observed.  
 8/20/2014: No significant change observed.  
 9/12/2013: No significant change observed.  
 08/22/2012: The site is located at the opposite river bank of E. Tobacco Road. There is no levee structure on site. The levee crest width and levee height were not measured or estimated in the field.

Upstream view of the site.

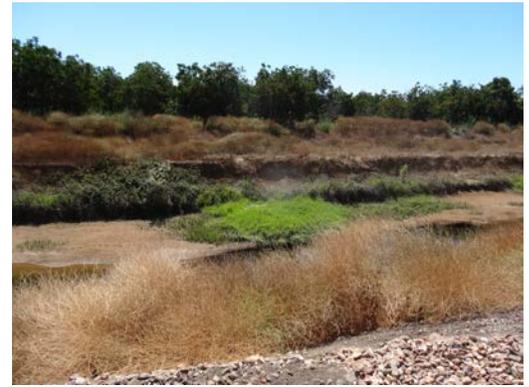
Front view of the site.

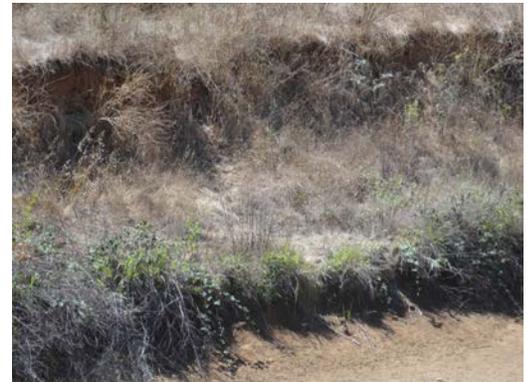
Closer view of the erosion.

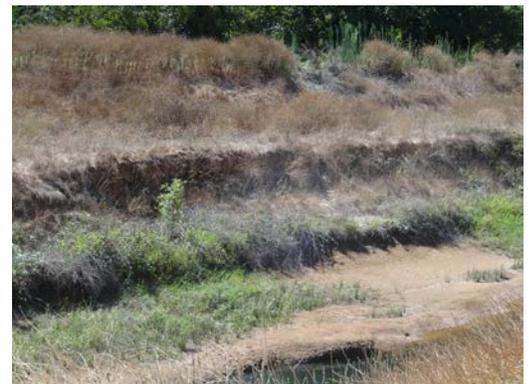
Close view of the erosion.

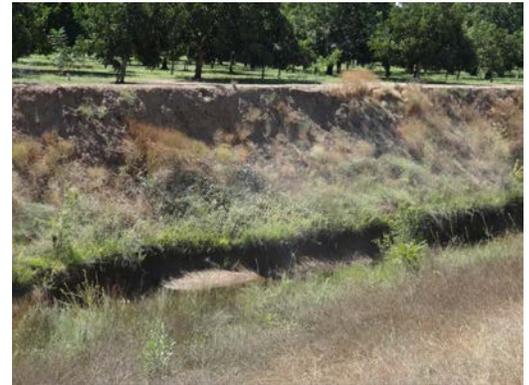
8/12/2015: No significant change observed.  
 8/20/2014: No significant change observed.  
 9/12/2013: Site has been surveyed and the pocket erosion has developed toward levee crest.  
 08/22/2012: A pocket erosion at the levee toe and on lower slope. The levee surface at the upper slope also shows signs of erosion due to poor maintenance. There is no levee structure on site. The levee crest width and levee height were not measured or estimated in the field.

Close view of the erosion.

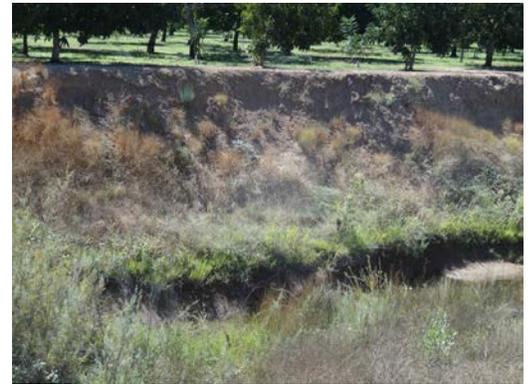
A close view of the erosion.

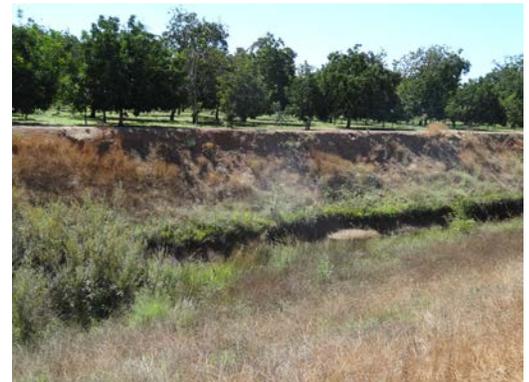
Close view of the erosion.

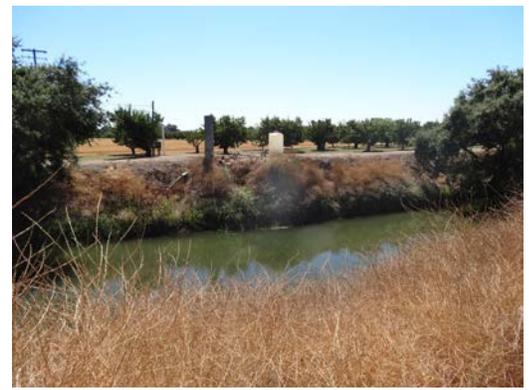
8/12/2015: No significant change observed.  
 8/20/2014: No significant change observed.  
 9/12/2013: No significant change observed.  
 08/22/2012: An irrigation pipe is present at the site, but probably did not cause the erosion. There is no levee structure on site. The levee crest width and levee height were not measured or estimated in the field.

View of the erosion site.

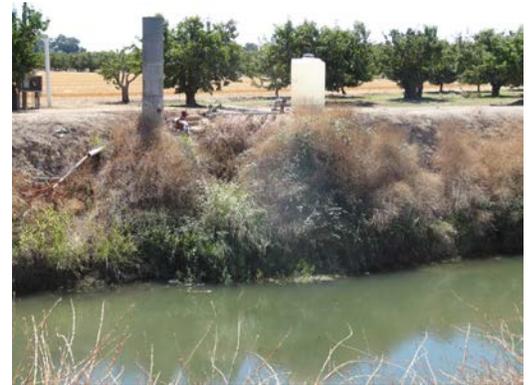
Front view of the erosion.

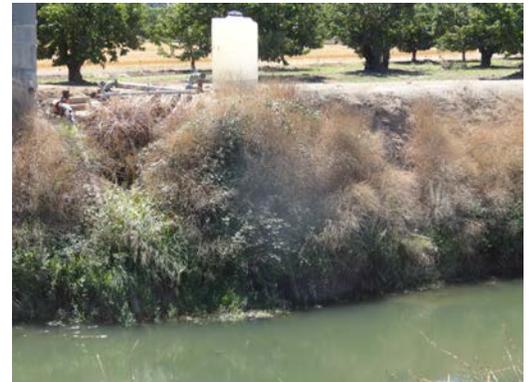
Closer view of the erosion.

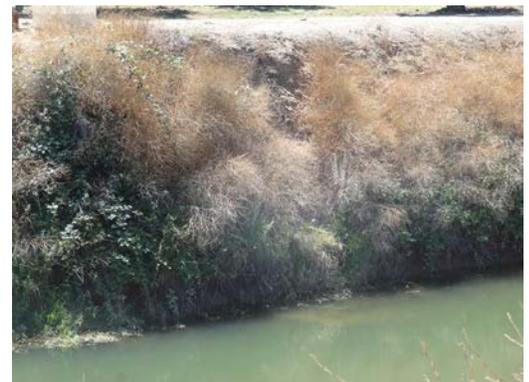
Closer view of the erosion.

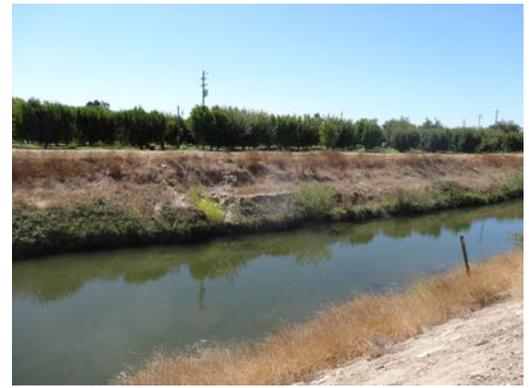
8/12/2015: No significant change observed.  
 8/20/2014: No significant change observed.  
 9/12/2013: No significant change observed.  
 08/22/2012: River-induced erosion occurred on the berm, while the runoff-induced erosion occurred on the levee slope. Site is covered with vegetation. There is no levee structure on site. The levee crest width and levee height were not measured or estimated in the field.

View of the site from right river bank.

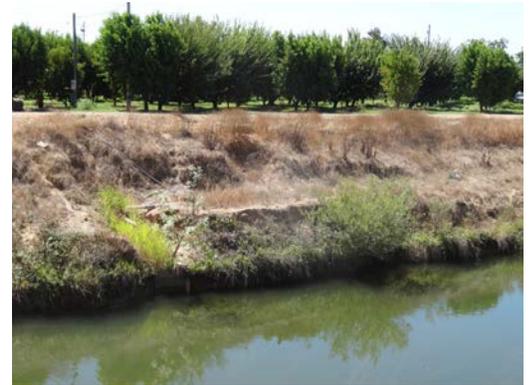
Closer view of the erosion.

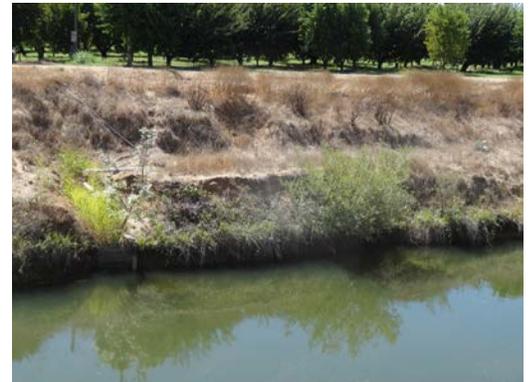
Front view of the erosion at the berm.

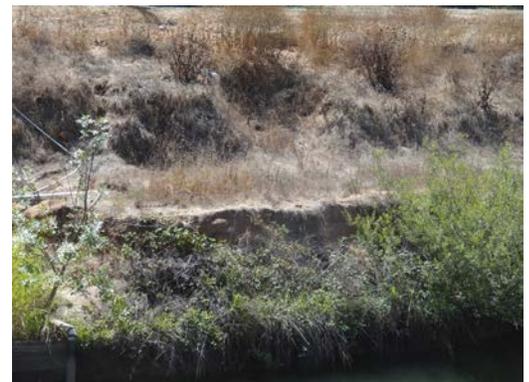
Closer view of the erosion.

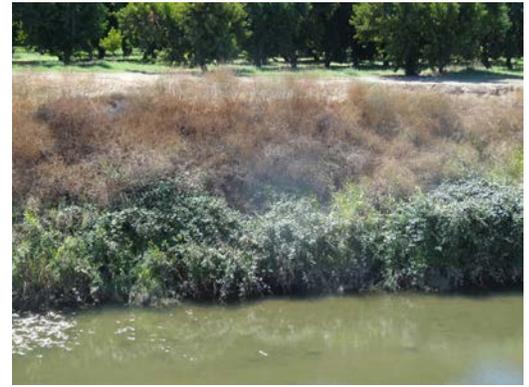
Front view of repaired site.

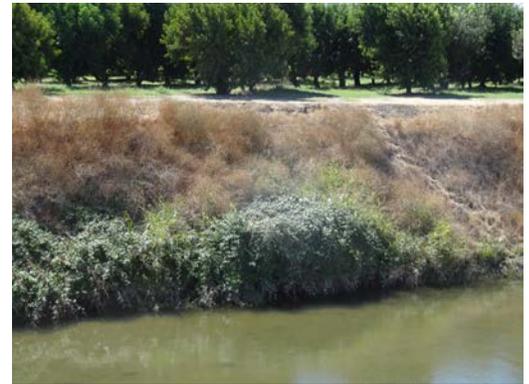
A closer view of the repaired site.

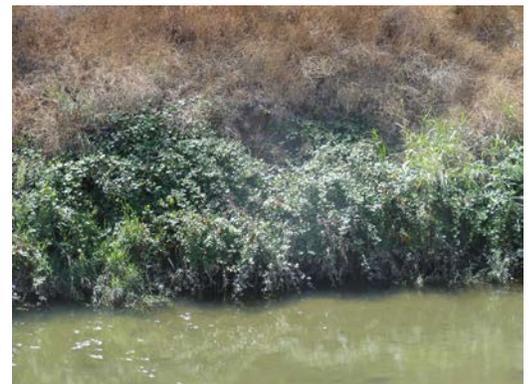
Close view of the repaired site.

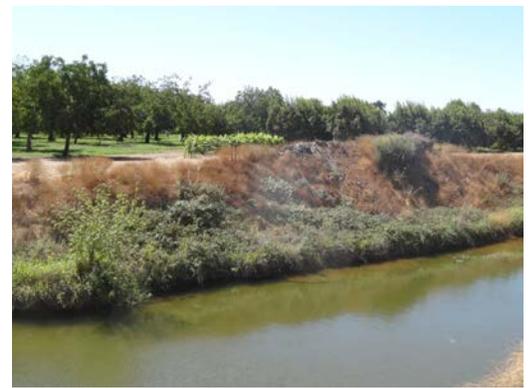
8/12/2015: No significant change observed. Slightly more vegetation is observed at the site.  
 8/20/2014: No significant change observed.  
 9/12/2013: This site has been repaired prior to this survey, but new erosion has developed immediately downstream of the site.  
 08/22/2012: Tow large-size pocket erosions. Site is covered with dense vegetation. There is no levee structure on site. The levee crest width and levee height were not measured or estimated in the field.

View of the repaired site.

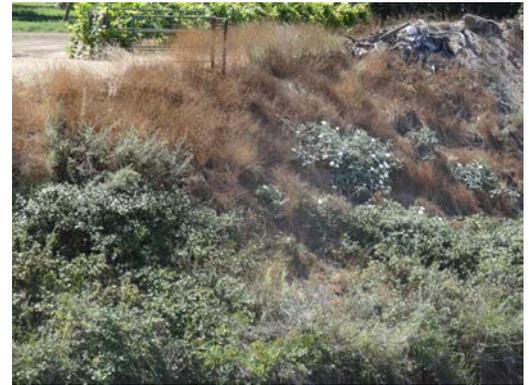
View of the repaired site.

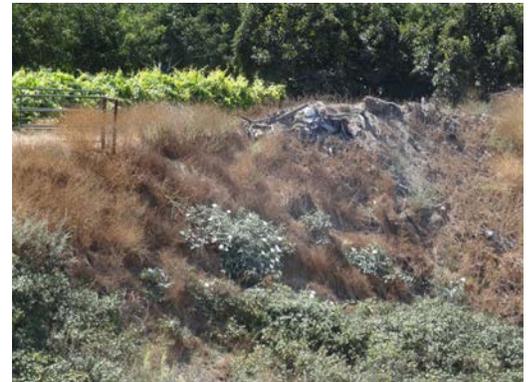
Front view of the repaired erosion.

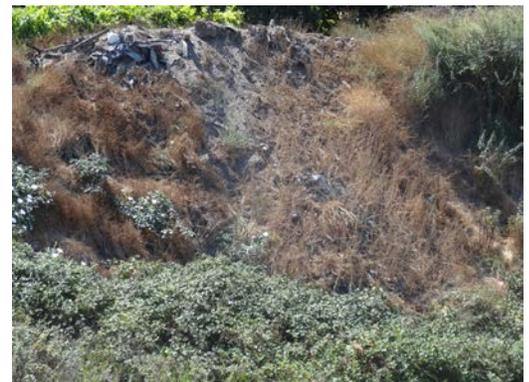
A closer view of the site. Note the pocket erosion immediately next to the repaired site.

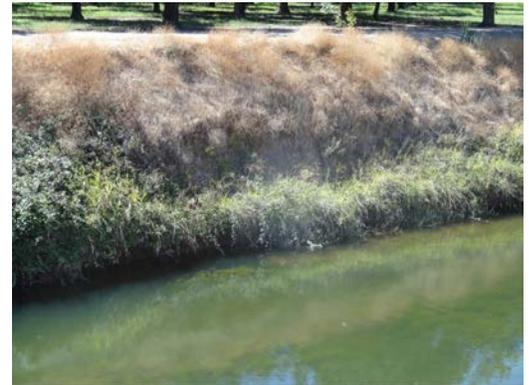
Close view of the erosion.

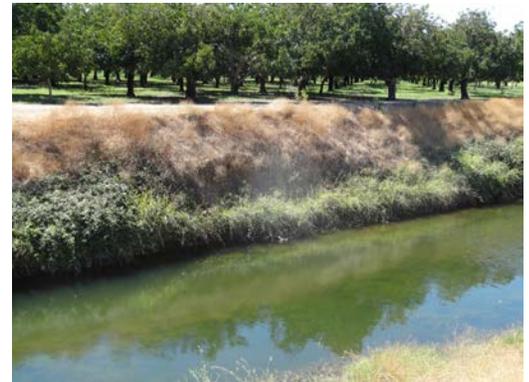
Close view of the erosion. Note the dense vegetation.

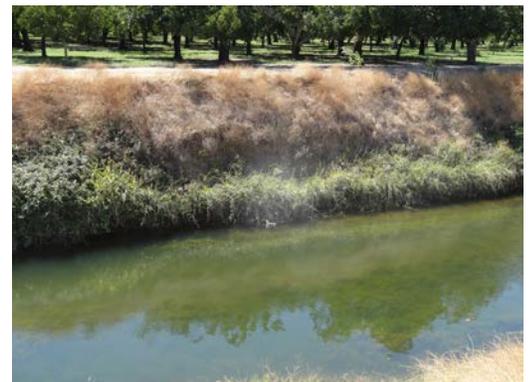
View of the site.

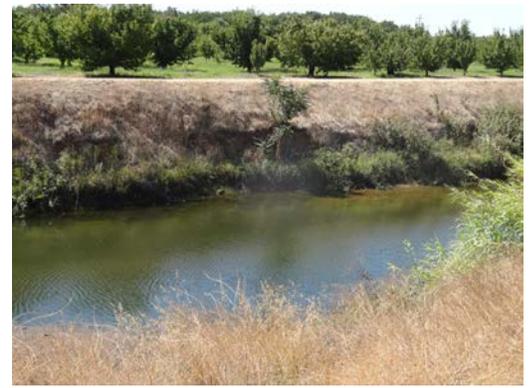
8/12/2015: No significant change observed.  
 8/20/2014: No significant change observed.  
 9/12/2013: No significant change observed.  
 08/22/2012: Site Comprised of series of pocket and scarp erosions. Some of erosions are covered by grass or shrubs. There is no levee structure on site. The levee crest width and levee height were not measured or estimated in the field.

Front view of the erosion.

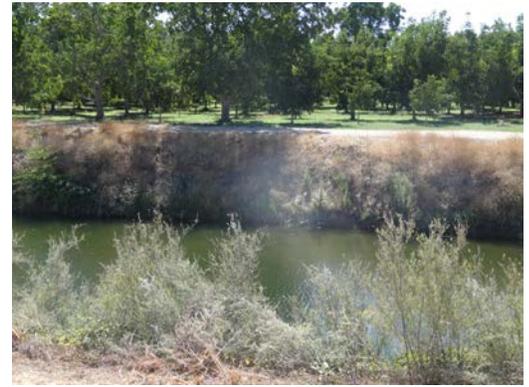
Front view of the erosion.

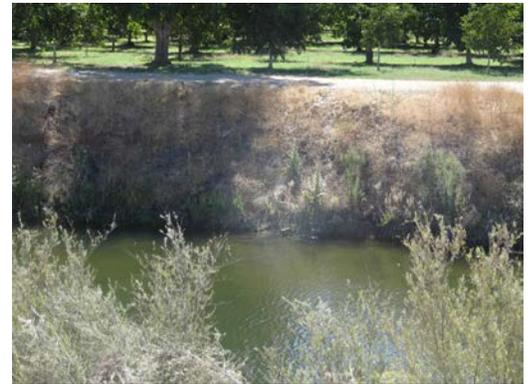
Close view of the erosion.

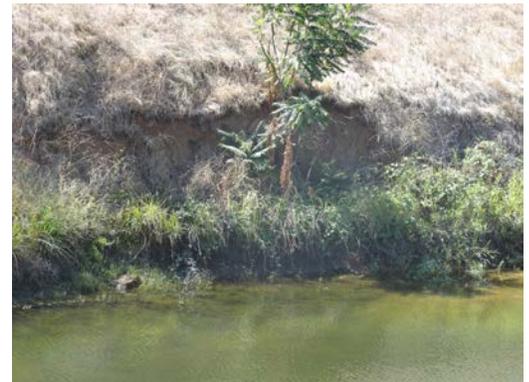
Close view of the scarp erosion. Note the small tree at the erosion site.

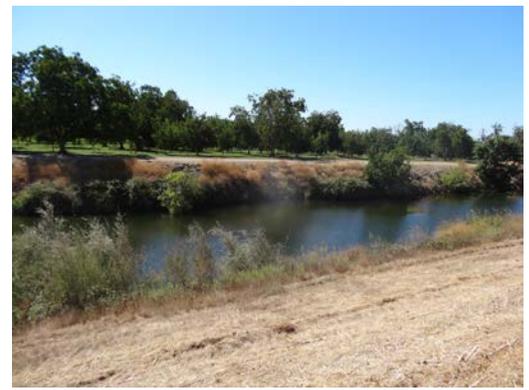
8/12/2015: No significant change observed.  
 8/20/2014: No significant change has been observed.  
 9/12/2013: No significant change observed.  
 08/22/2012: The erosion was first reported in the 2012 spring levee inspection report. There is no levee structure on site. The levee crest width and levee height were not measured or estimated in the field.

Front view of the site.

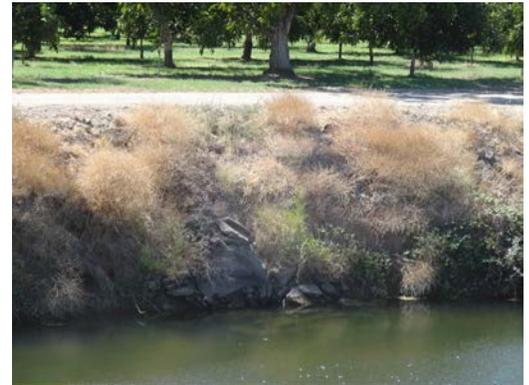
Close view of the erosion. Note the vegetation at the site.

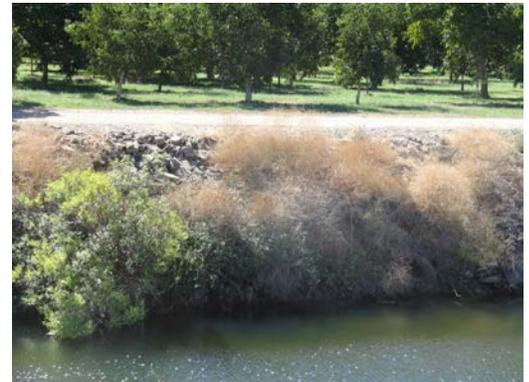
Close view of the erosion.

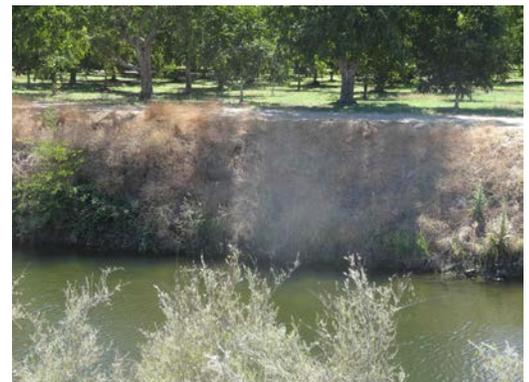
Close view of the site.

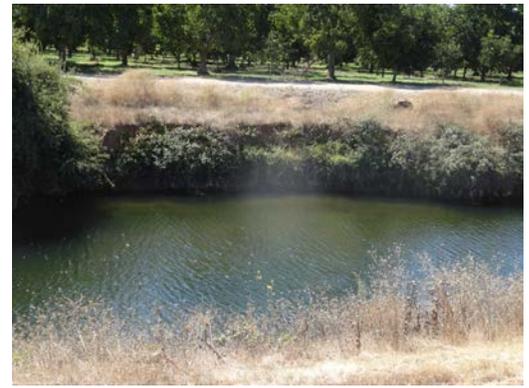
8/12/2015: No significant change observed.  
 8/20/2014: No significant change observed.  
 9/12/2013: No significant change observed.  
 08/22/2012: Site is covered with dense vegetation. There is no levee structure on site.  
 The levee crest width and levee height were not measured or estimated in the field.

Front view of the site.

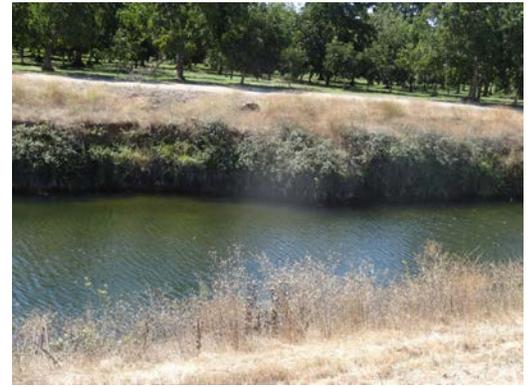
Front view of the erosion. Site is covered with vegetation and trees.

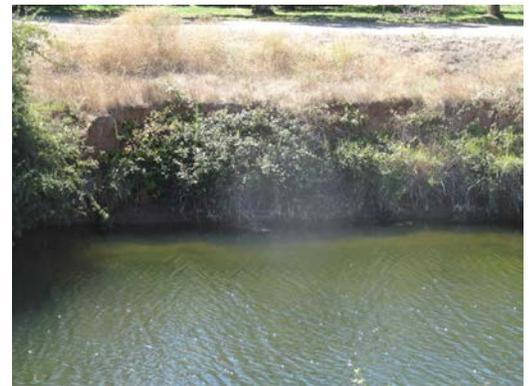
Closer view of the erosion.

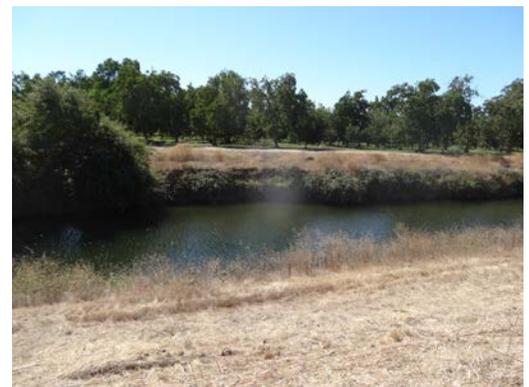
Front view of the site.

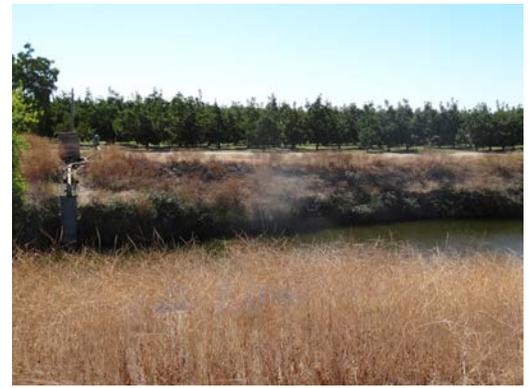
8/12/2015: No significant change observed.  
 8/20/2014: No significant change observed.  
 9/12/2013: No significant change observed.  
 08/22/2012: Berm width is estimated as 5 ft. There is no levee structure on site. The levee crest width and levee height were not measured or estimated in the field.

Front view of the erosion

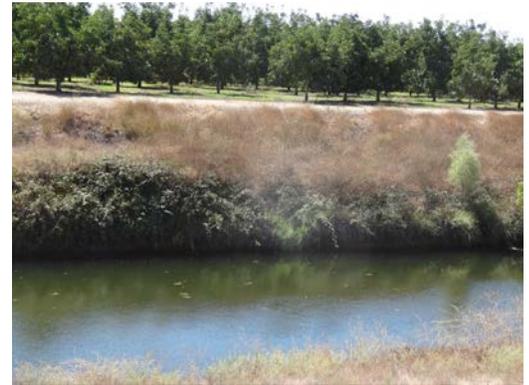
Close view of the erosion.

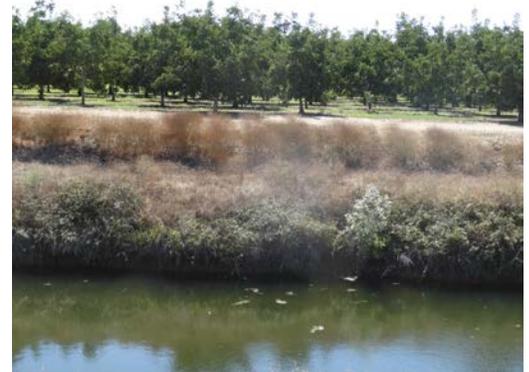
Front view of the erosion.

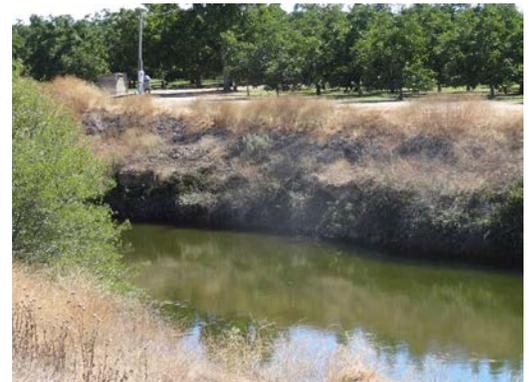
Close view of the erosion.

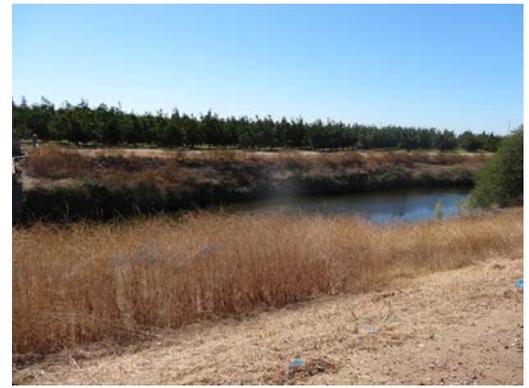
8/12/2015: No significant change observed.  
 8/20/2014: No significant change observed  
 9/12/2013: No significant change observed.  
 08/22/2012: Site is covered by dense vegetation. Berm width is estimated as 5 ft. There is no levee structure on site. The levee crest width and levee height were not measured or estimated in the field.

Looking at the erosion from right river bank.

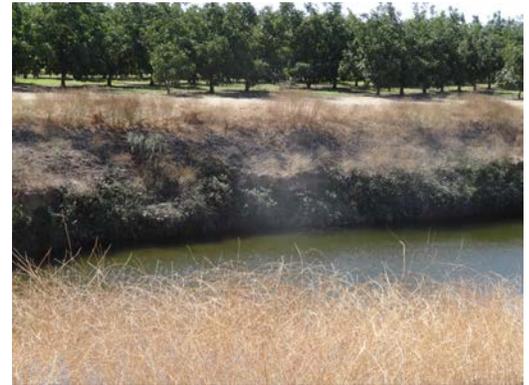
Front view of the erosion.

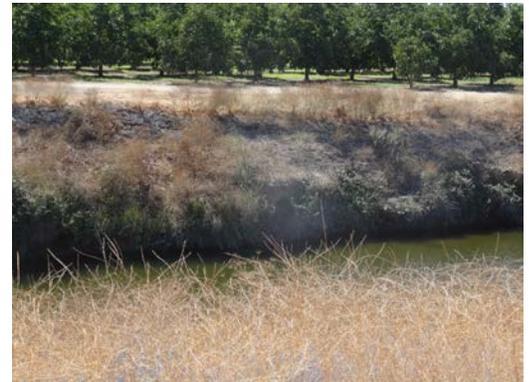
Front view of the erosion.

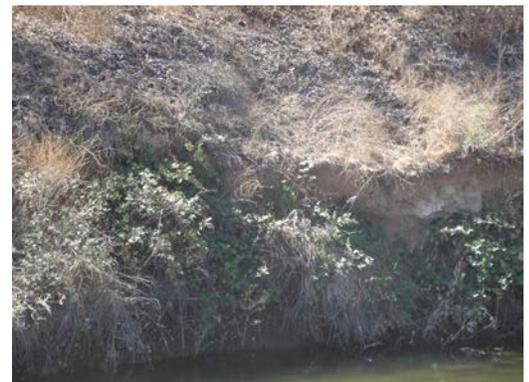
Close view of the erosion. Note the dense vegetation.

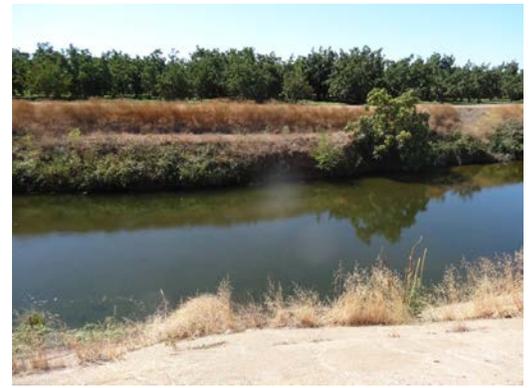
8/12/2015: No significant change observed.  
 8/20/2014: No significant change observed.  
 9/12/2013: No significant change observed.  
 08/22/2012: The erosion is covered by dense vegetation. There is no levee structure on site. The levee crest width and levee height were not measured or estimated in the field.

Front view of the erosion site.

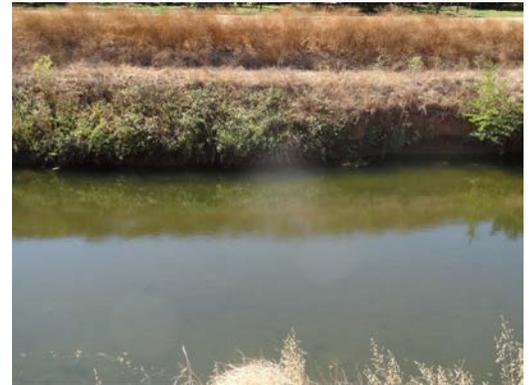
Close view of the erosion.

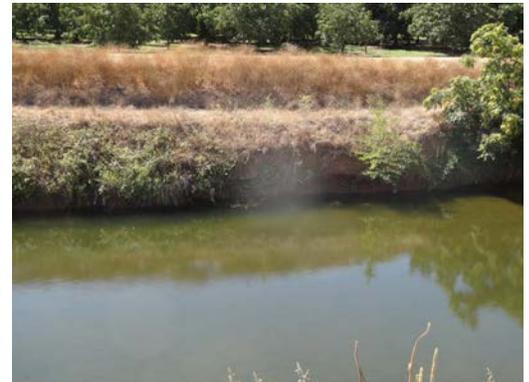
Close view of the erosion.

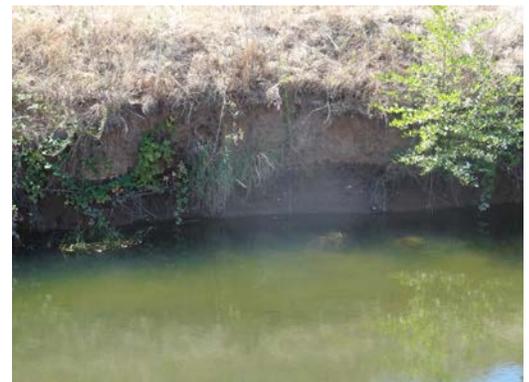
Close view of the erosion.

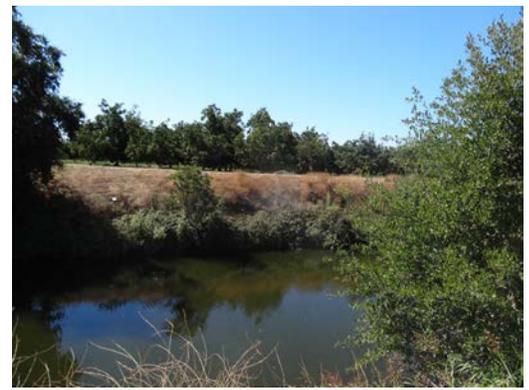
8/12/2015: No significant change observed.  
 8/20/2014: No significant change observed.  
 9/12/2013: No significant change observed.  
 08/22/2012: Site is covered with dense vegetation. A scarp erosion is adjacent to a pocket erosion at the downstream. There is no levee structure on site. The levee crest width and levee height were not measured or estimated in the field.

Front view of the erosion site from the left river bank.

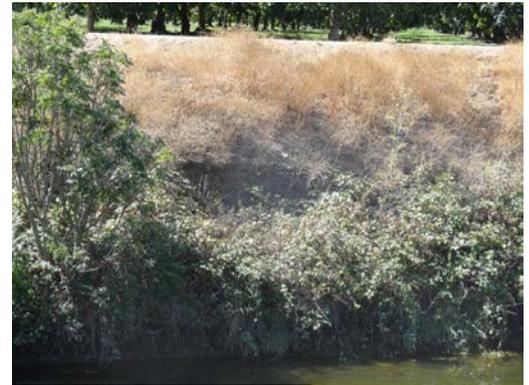
Front view of the pocket erosion.

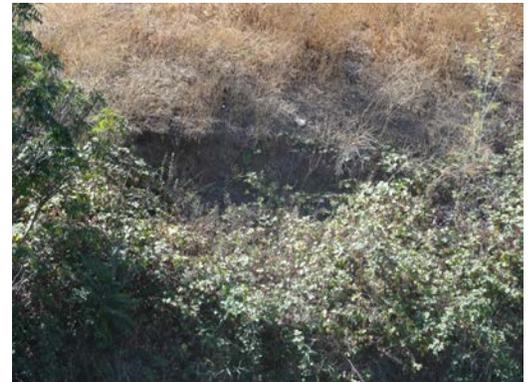
Close view of the pocket erosion.

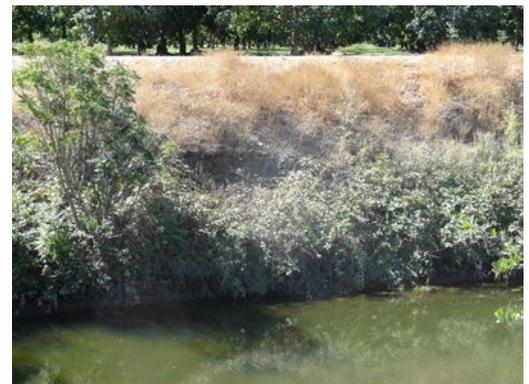
Close view of the erosion.

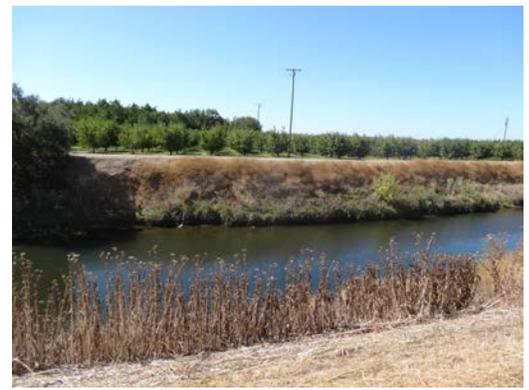
8/12/2015: No significant change observed.  
 8/20/2014: No significant change observed.  
 9/12/2013: No significant change observed.  
 08/22/2012: The berm is estimated at 10 ft. Dense vegetation on site. There is no levee structure on site. The levee crest width and levee height were not measured or estimated in the field.

Front view of the erosion.

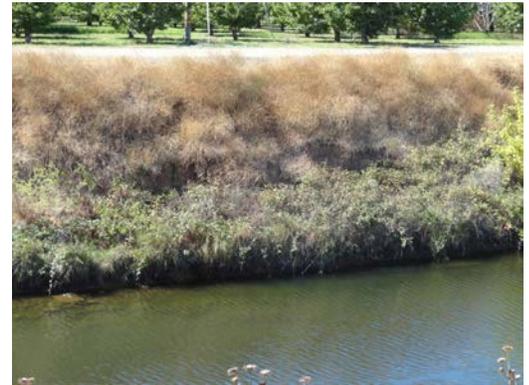
Close view of the erosion.

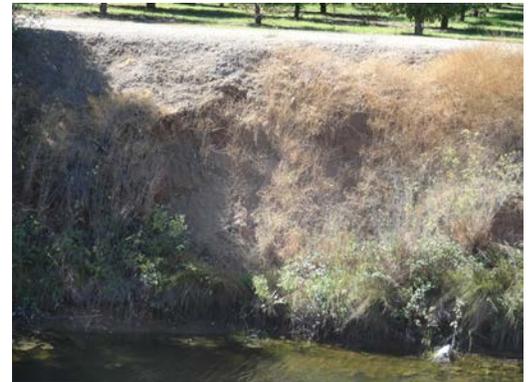
Close view of the erosion.

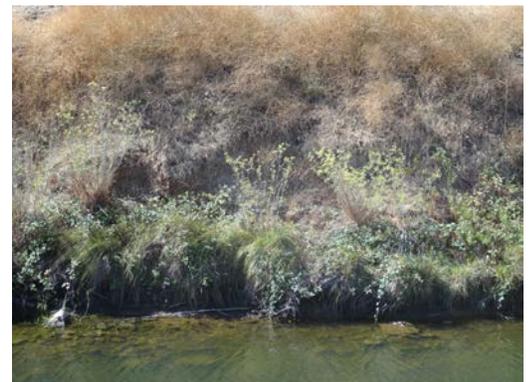
Close view of the erosion.

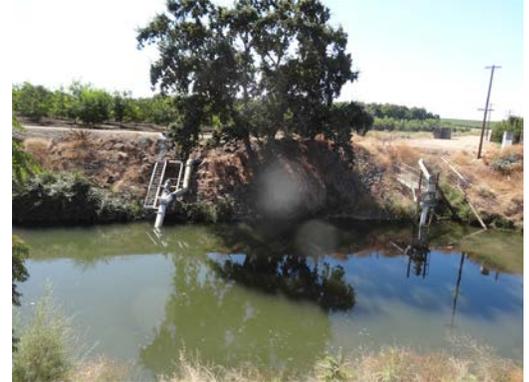
Front view of the erosion.

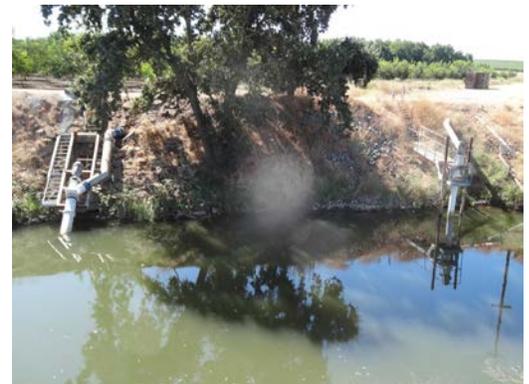
Front view of the erosion and broken concrete protection on the levee slope.

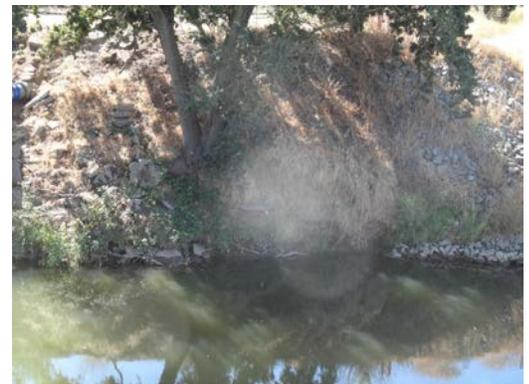
Closer view of the erosion.

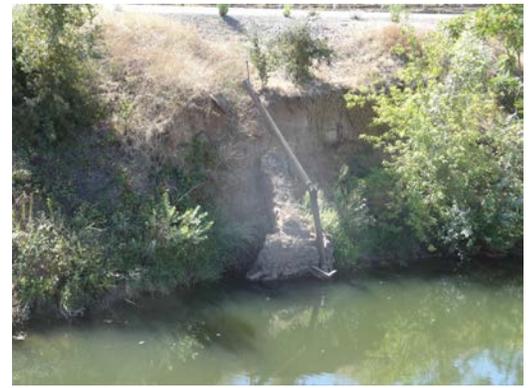
8/12/2015: No significant change observed.  
 8/20/2014: No significant change observed.  
 09/12/2013: No significant change observed.  
 08/22/2012: The erosion was surveyed and documented for monitoring purpose. There is no levee structure on the site, only high ground protecting the land behind. The levee crest width and levee height were not measured or estimated in the field.  
 There is a drainage pipe at the site, which might have caused the problem at one pocket erosion.

View of the site from right river bank.

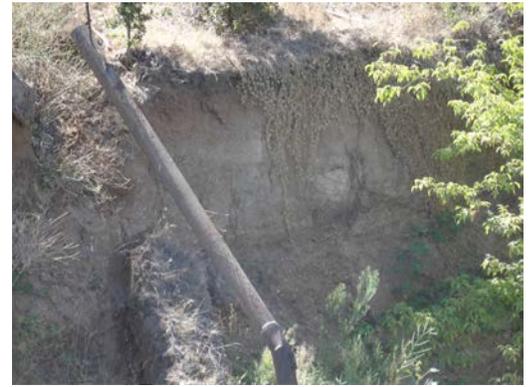
Close view of the erosion.

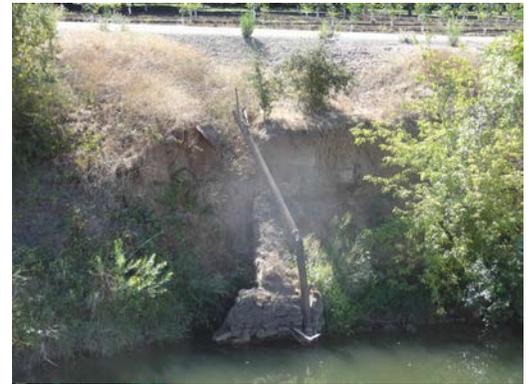
Close view of the erosion. Note the drainage pipe at the site.

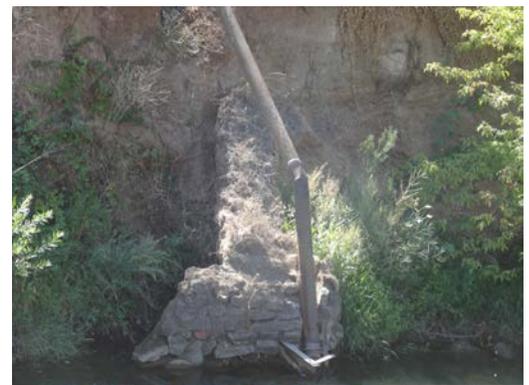
Close view of the site.

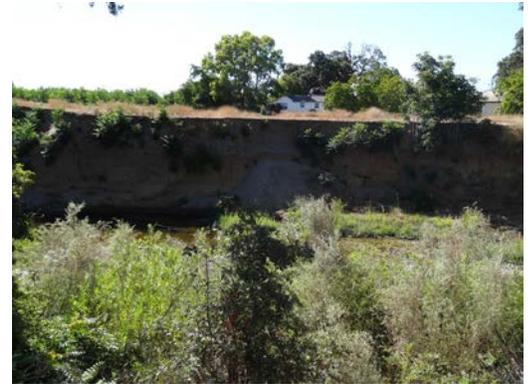
Close view of the erosion. Signs of new erosion along the site.

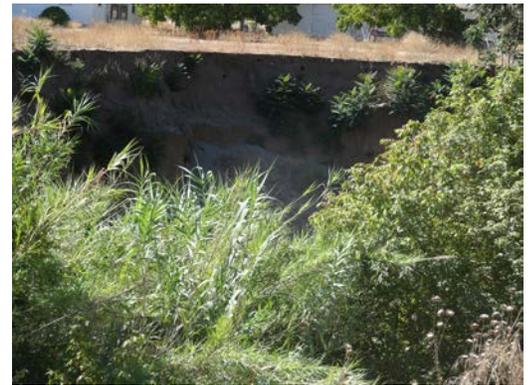
Close view of the erosion.

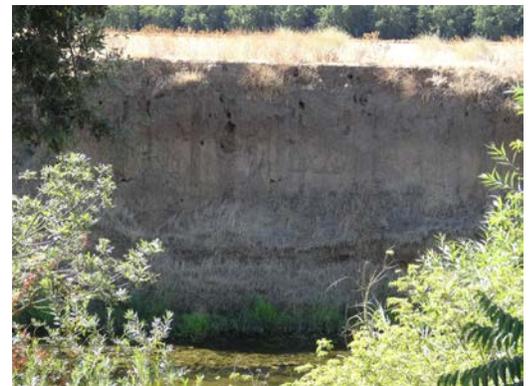
Close view of the erosion.

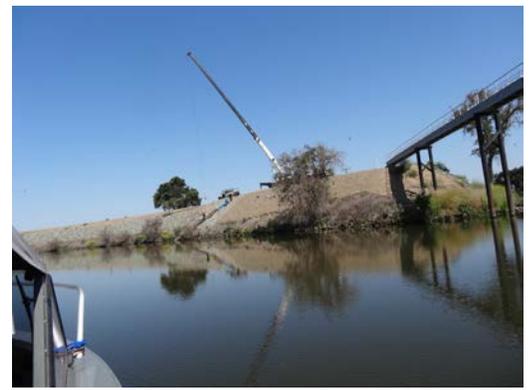
06/25/2015: No significant change observed.  
 07/02/2014: No significant change observed.  
 08/20/2013: No significant change at this site.  
 08/07/2012: The erosion is at the confluence of Old River and one of its tributary.

Front view of the erosion.

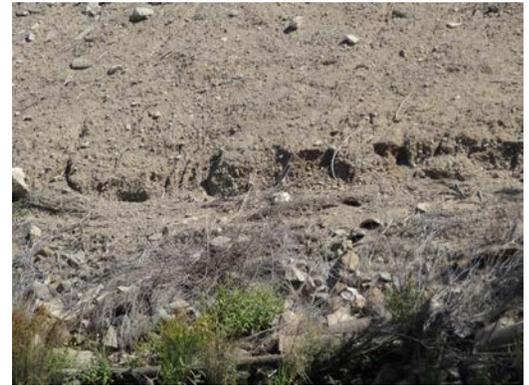
Close view of the erosion.

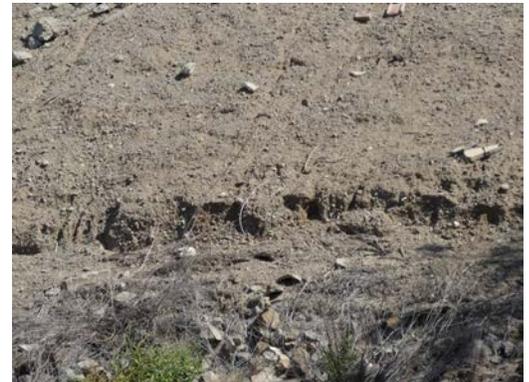
Close view of the erosion.

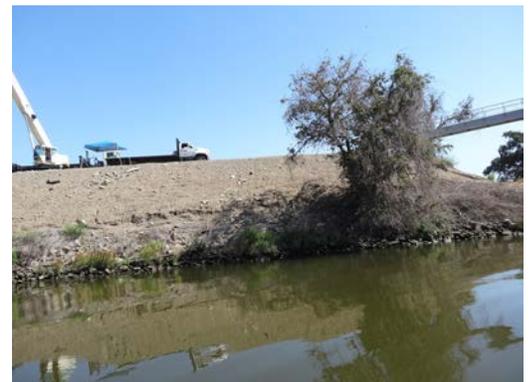
Front view of the site. Note the large tree on site.

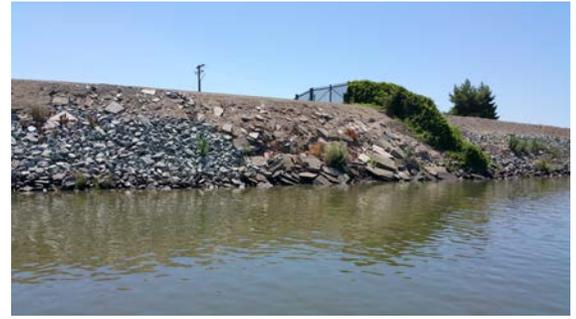
06/24/2015: No significant change observed.  
 6/19/2014: No significant change observed.  
 08/13/2013: No significant change at this site.  
 08/07/2012: The erosion is nearly vertical, and has developed upward to halfway of the levee slope. The protecting concrete blocks have been washed away. Animal activities are visible.

Front view of the erosion site. Note the concrete blocks and vegetation.

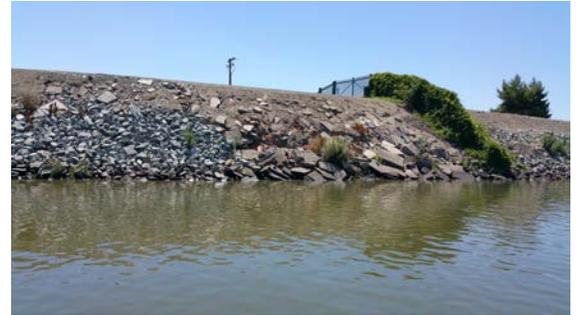
Close view of the erosion.

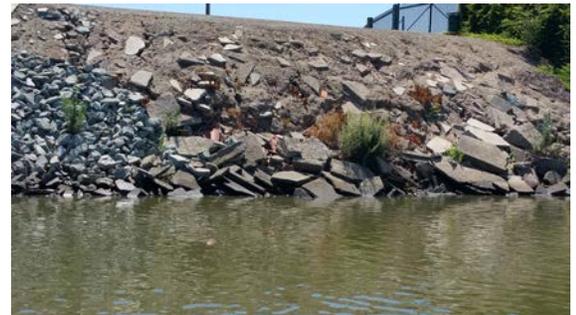
Close view of the erosion.

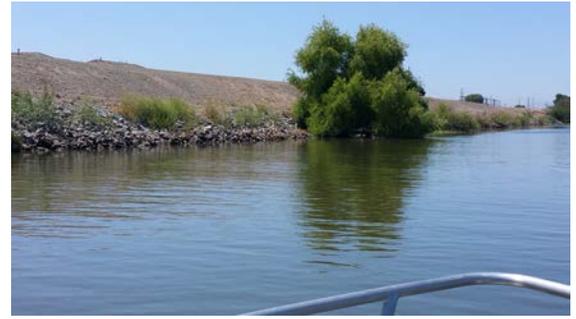
06/24/2015: No significant change observed.  
 06/19/2014: The erosion has been repaired. A minor erosion is still visible near the tree.  
 08/13/2013: A mid-size tree is present immediately upstream of the erosion, which could block the view of the site. Some debris is visible.

View from downstream.

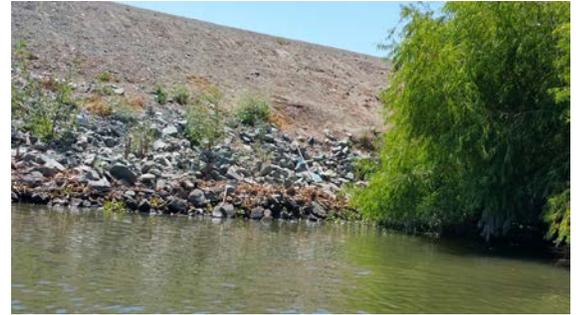
Close view of the repaired erosion site.

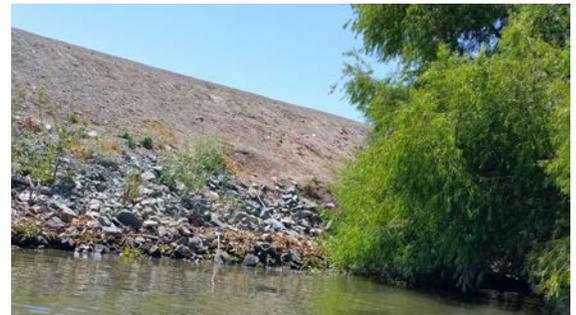
Close view of the repaired erosion site. Note the tree near the site.

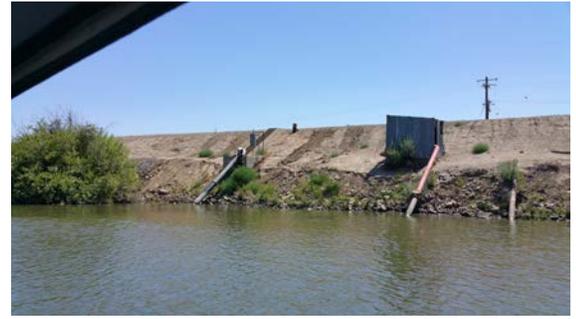
06/24/2015: Erosion has been repaired.  
 6/19/2014: The erosion was probably caused by the irrigation pipe found at the site.

View of the repaired erosion site from the survey boat.

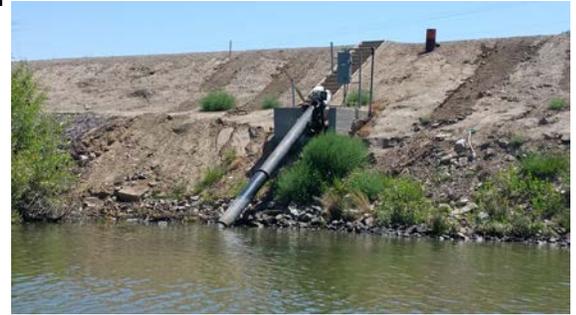
Close view of the repaired erosion site.

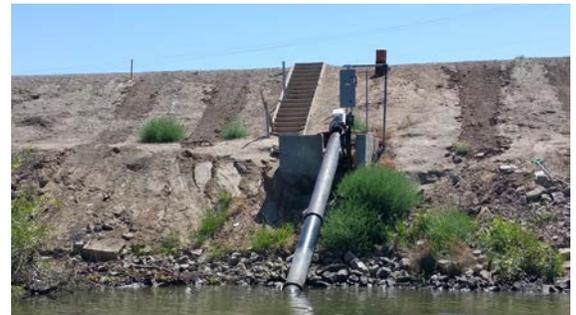
Close view of the site.

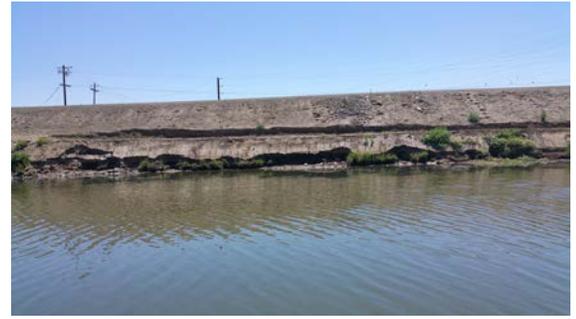
06/24/2015: Levee has been cut at the mid slope and a temporary step has been made for unknow purpose. More erosion has been found at the site.  
 6/19/2014: The erosion is in the river bank which has an estimated 10-ft wide berm.

Front view of the erosion site. Note the new cut at the middle levee slope.

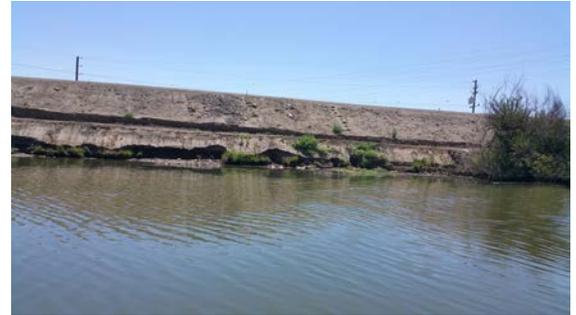
Front view of the erosion.

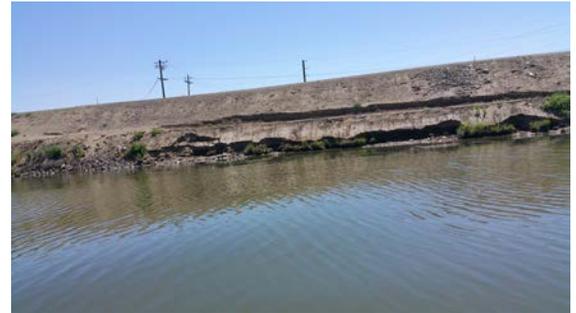
Front view of the erosion.
