LMA: **NA0011 U02 Madera County FC** Waterway: **RB Ash Slough**  
 Site ID: **NA0011U02RM2.57** Status: **Existing Site**

Latitude: **37.055596** Longitude: **-120.412647** River\_Mile: **2.57** Levee\_Mile: **1.15** Overall Rating: **U**

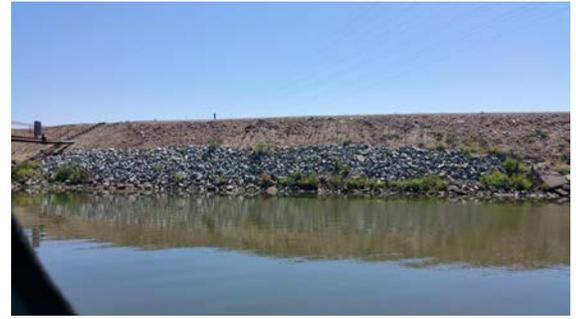
06/24/2015: No significant change observed.  
 06/19/2014: The erosion has been repaired.  
 08/13/2013: Found during boat survey. There is vegetation at the site.

Front view of the repaired site.

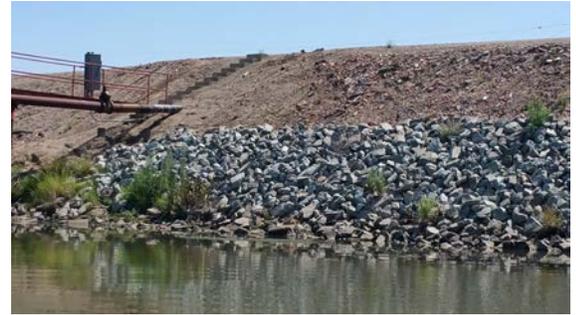
Close view of the repaired site.

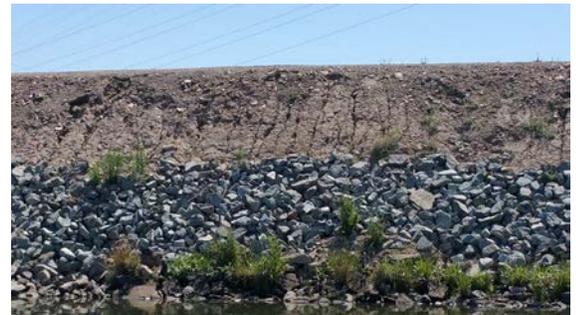
Close view of the repaired site.

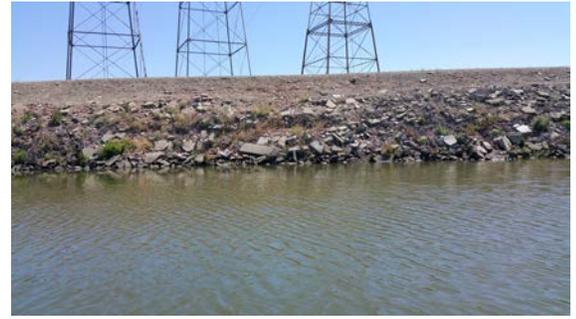
06/24/2015: No significant change observed.  
 06/19/2014: A pocket erosion was found during the boat survey.

Front view of the erosion.

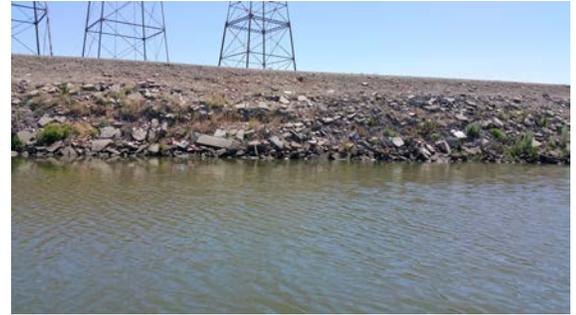
Front view of the erosion.

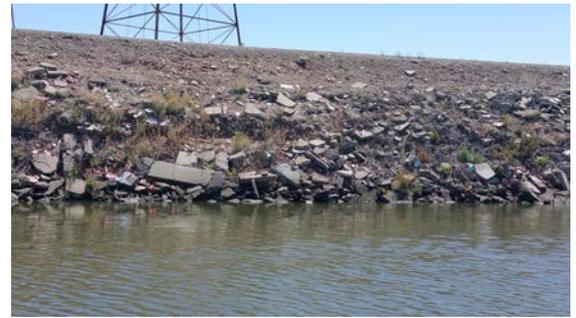
Close view of the erosion. The slope protection is poor.

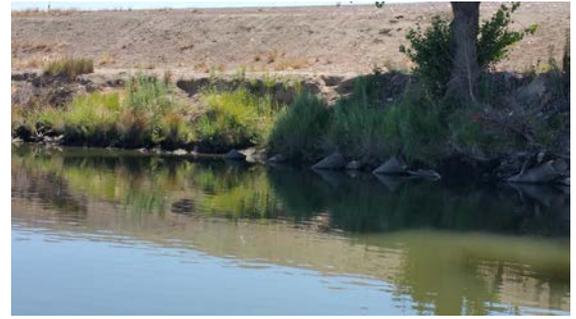
06/24/2015: No significant change observed.  
 06/19/2014: The erosion is near a large tree and probably has been caused by the irrigation pipe on the site.

Front view of the erosion. Note the tree and the irrigation pipe.

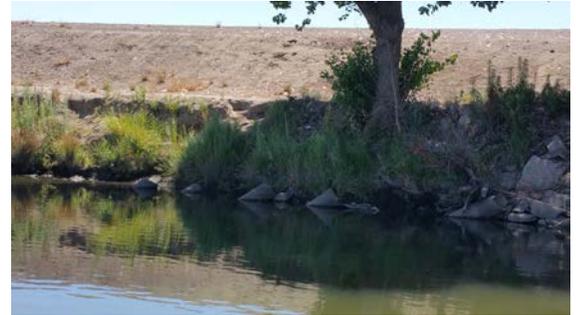
Close view of the erosion.

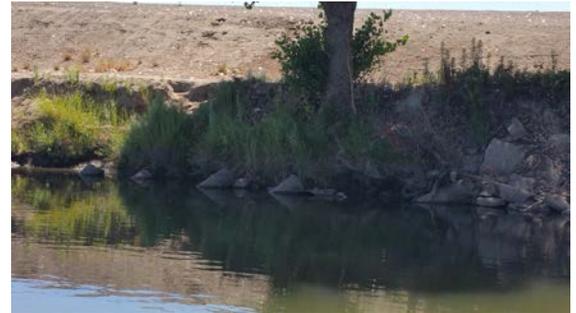
Close view of the erosion.

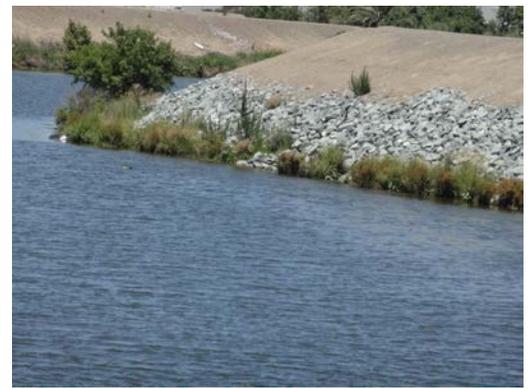
06/24/2015: The erosion has been repaired.  
 6/19/2014: No significant change observed.  
 08/13/2013: The boat survey found the erosion has progressed significantly in size and in number of pocket erosions.  
 08/07/2012: The site has been visited by boat survey. The erosion has developed in size, and more pocket erosions were found.  
 8/23/2011: Pockets erosions observed by last survey seem to have progressed during the last flood season. Continuous monitoring of this site suggested  
 9/07/2010: No significant change observed on site. There is emergent vegetation at the water line. Several pocket erosions lined along the lower slope that stretches from RM 40.86 to RM 41.14.  
 9/30/2009: No major change observed; the site was combined with other existing sites are RM's 40.93, 40.98, and 41.14 as one site; several pocket erosion just above non-uniform toe rip rap; previously rated "U"; bare spots along the upper slope.

Front view of the repaired site.

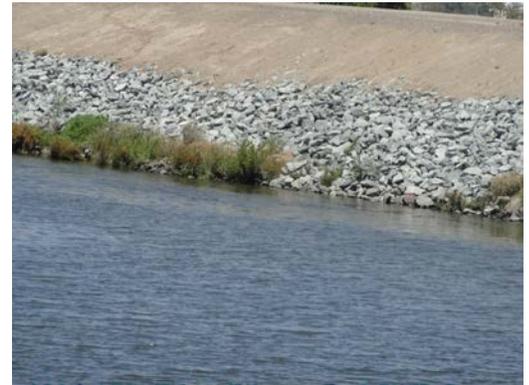
Front view of the repaired site.

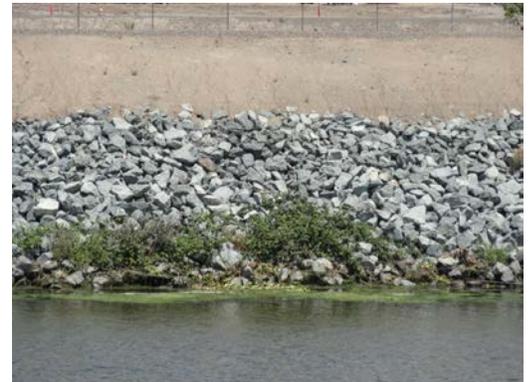
Close view of the repaired site.

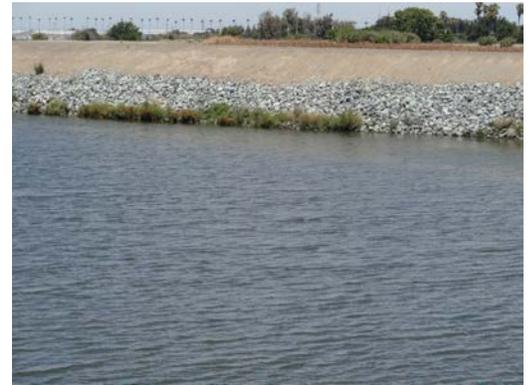
Front view of the of the repaired erosion site.

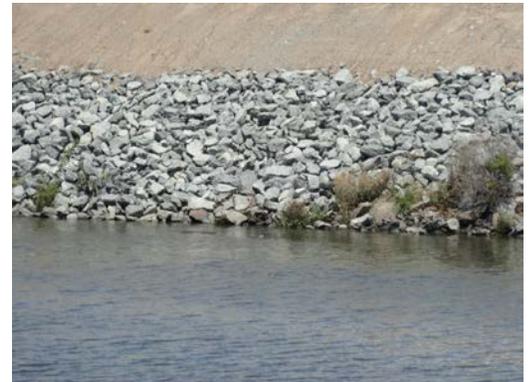
Front view of the repaired erosion site.

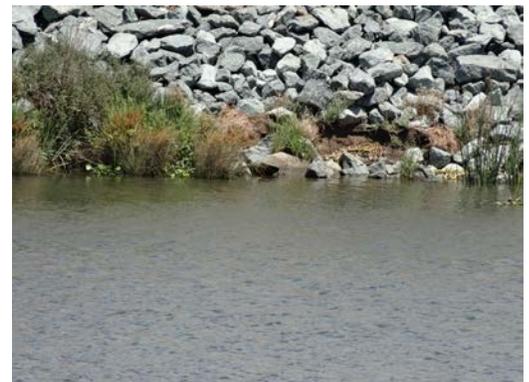
Close view of the repaired erosion site. Note the minor erosion at the water edge.

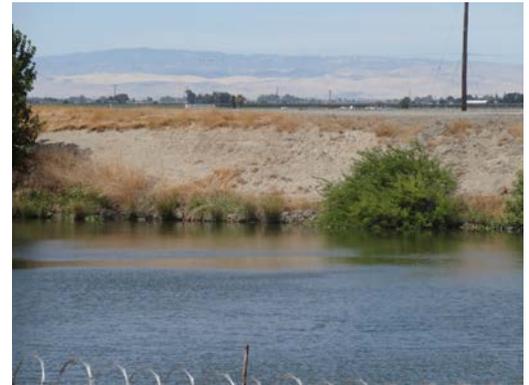
A closer view of the site.

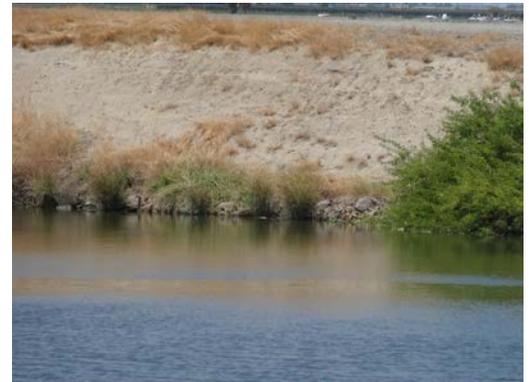
Front view of the site.

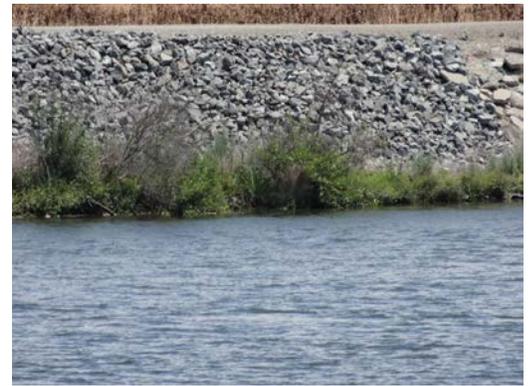
Front view of the repaired erosion site.

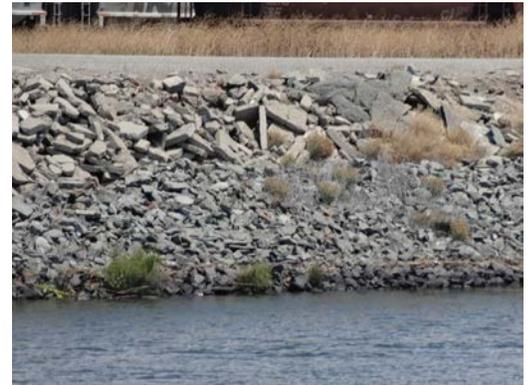
Close view of the repaired erosion site.

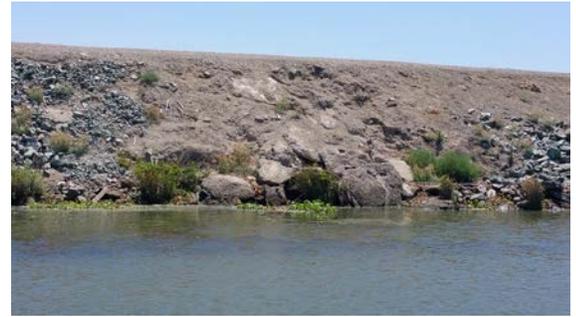
Front view of the erosion.

06/24/2015: No significant change observed.  
 06/19/2014: A series of scarp erosions have been found on the lower levee slope and at the levee toe.

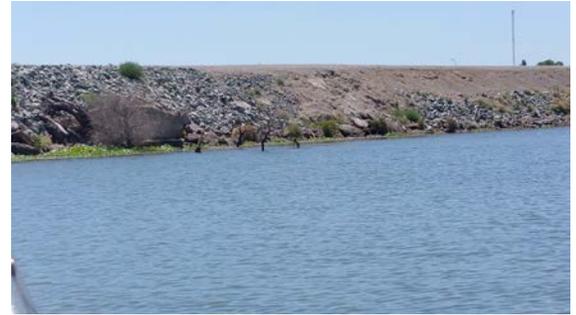
Close view of the erosion. Note the protection on the lower levee slope.

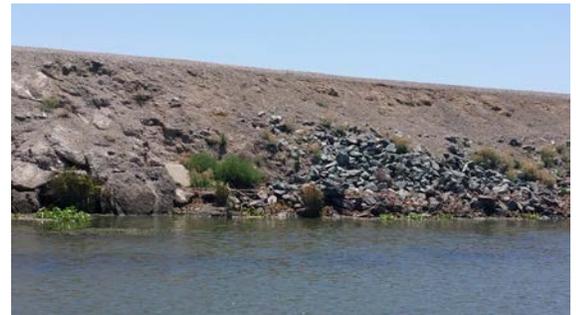
Close view of the erosion. The upstream end of the site is protected by riprap revetment.

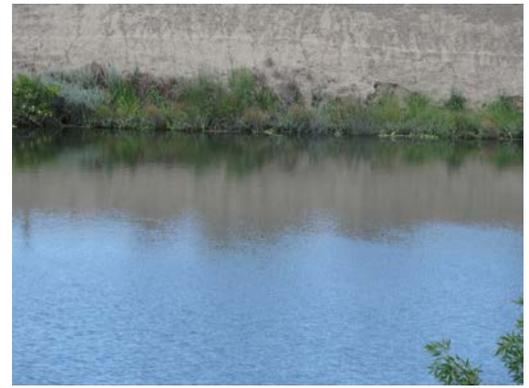
06/24/2015: No significant change observed.  
 6/19/2014: No significant change observed.  
 08/13/2013: The erosion was discovered during 2013 spring levee inspection. Inspector comment: Erosion is located along the lower level of water-ward slope.

Close view of the erosion.

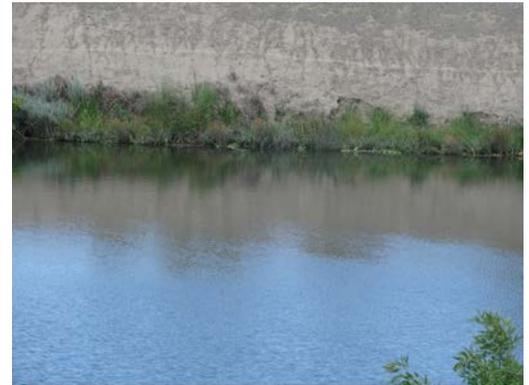
Front view of the erosion.

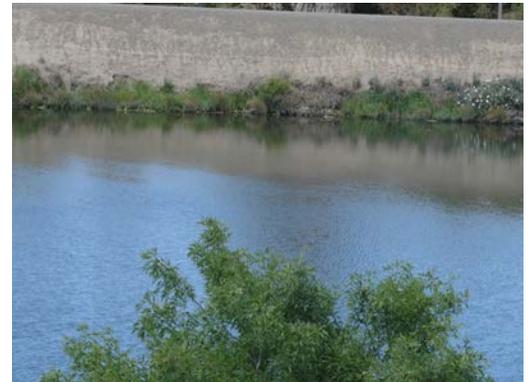
Close view of the erosion.

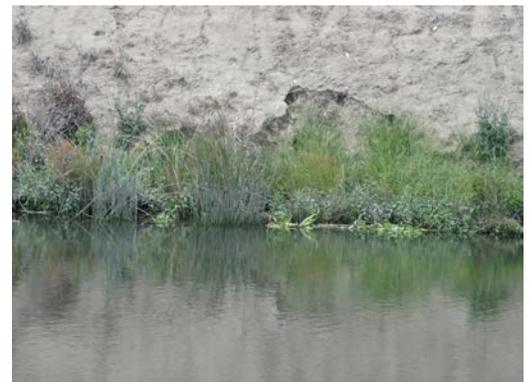
Close view of the erosion.

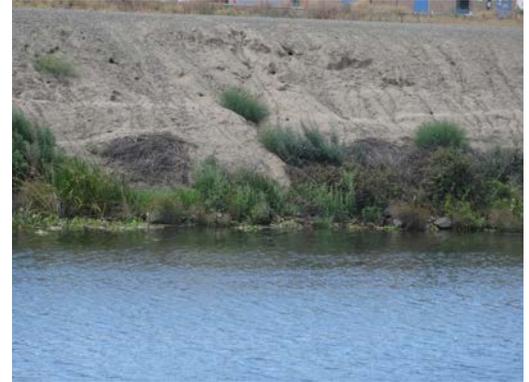
Front view of the site.

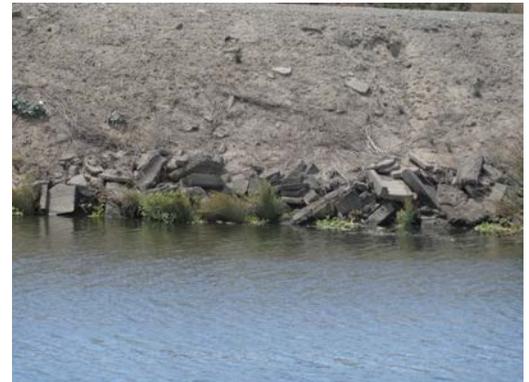
Close view of the erosion.

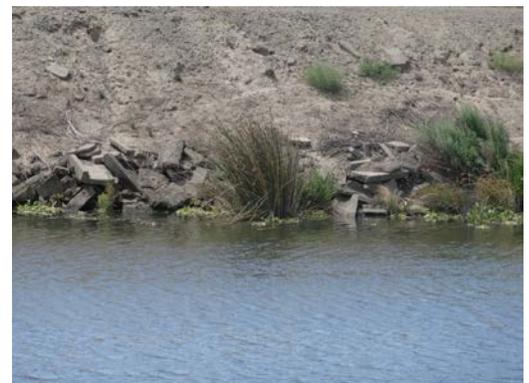
Close view of the erosion.

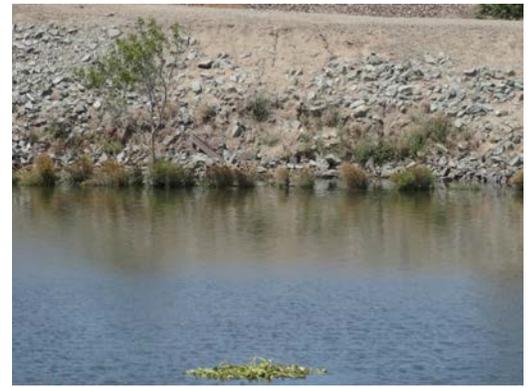
06/24/2015: The erosion site is immediately downstream of the RR bridge.

Front view of the erosion.

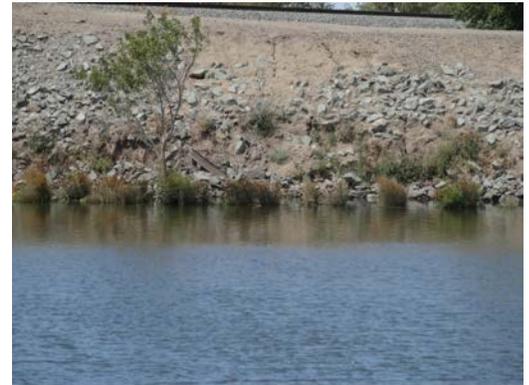
Close view of the erosion.

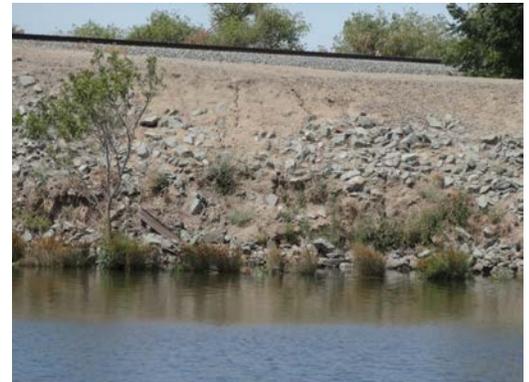
Close view of the erosion.

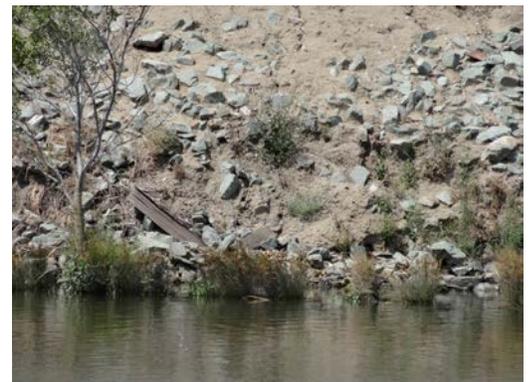
Close view of the erosion.

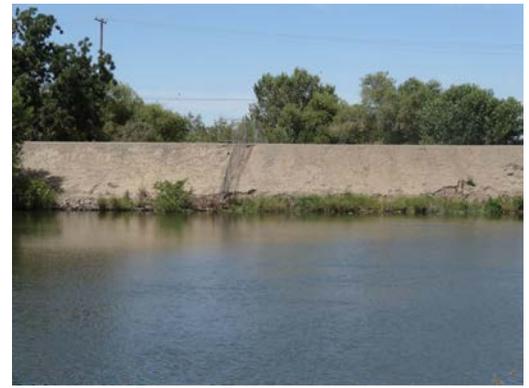
06/24/2015: No significant change observed.  
 06/19/2014: No significant change observed.  
 08/13/2013: No significant change at this site.  
 08/07/2012: The site has been visited by boat survey. No significant change observed.  
 08/23/2011: The site is located immediately upstream of a Railroad bridge. Dense vegetation at the water line blocks the view of erosion.

Front view of the erosion site.

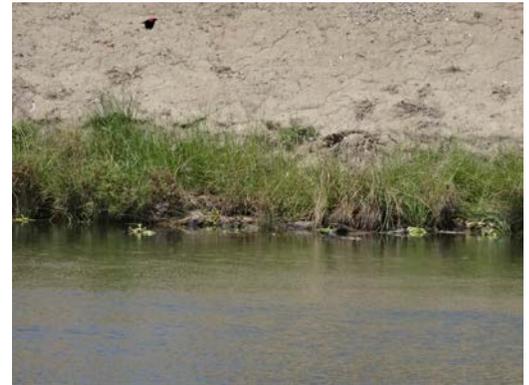
Front view of the erosion site. Vegetation is visible.

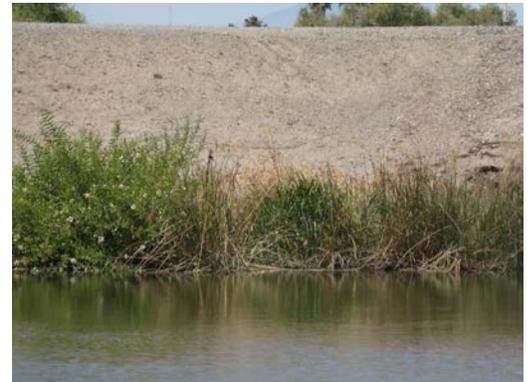
Front view of the erosion.

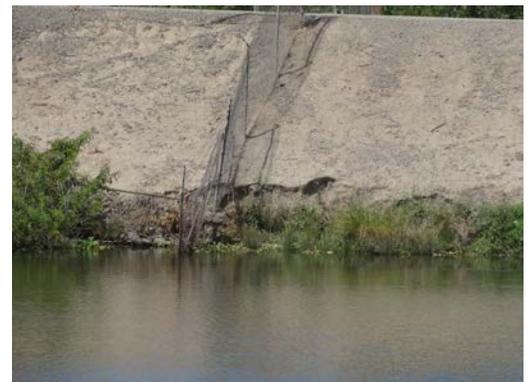
Front view of the erosion.

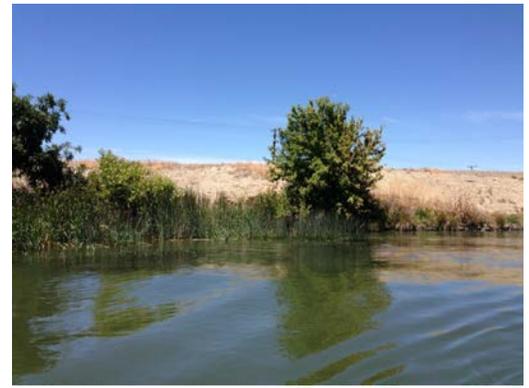
06/24/2015: No significant change observed.  
 06/19/2014: No significant change observed.  
 08/13/2013: Site was discovered during boat survey. The dense vegetation blocks a clear view of the erosion. Size of erosion site was very roughly estimated.

Front view of the erosion. The tree and vegetation block the view of the site.

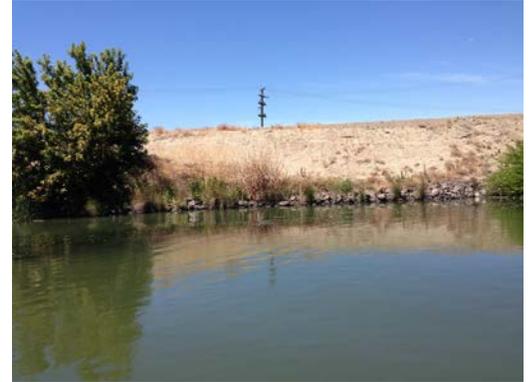
The erosion is invisible because of the dense vegetation.

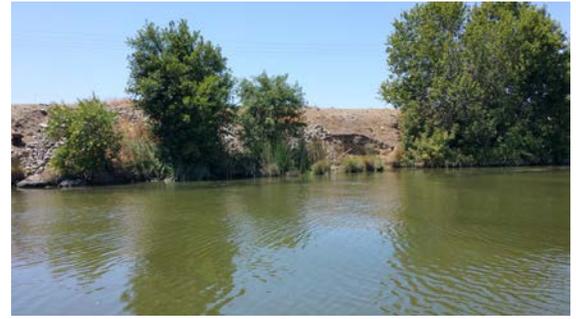
06/24/2015: No significant change observed.  
 6/19/2014: No significant change observed.  
 08/13/2013: No significant change at this site.  
 08/07/2012: The site has been visited by boat survey. No significant change observed  
 08/23/2011: The erosion site is immediately downstream of the riprap protection.

Front view of the erosion. Note the riprap protection near the site.

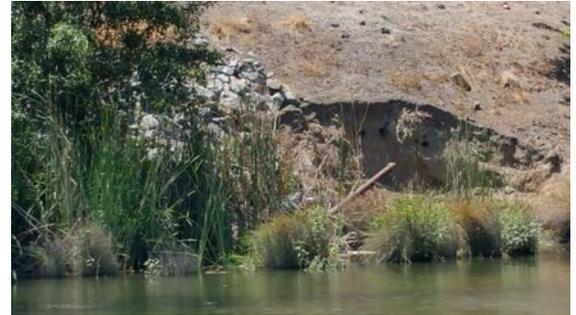
A close view of the erosion.

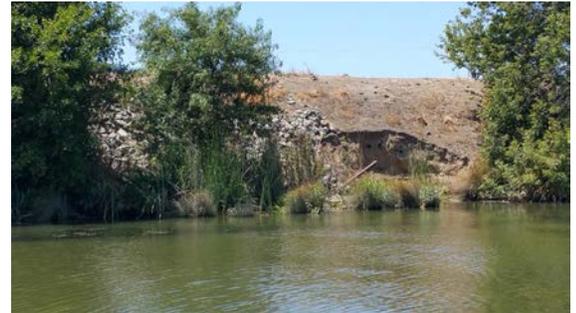
A close view of the erosion.

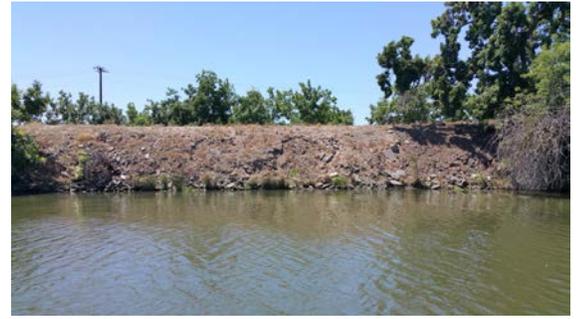
06/24/2015: No significant change observed.  
 6/19/2014: No significant change observed.  
 08/13/2013: No significant change at this site.  
 08/07/2012: The erosion was discovered during the boat survey.

Front view of the erosion.

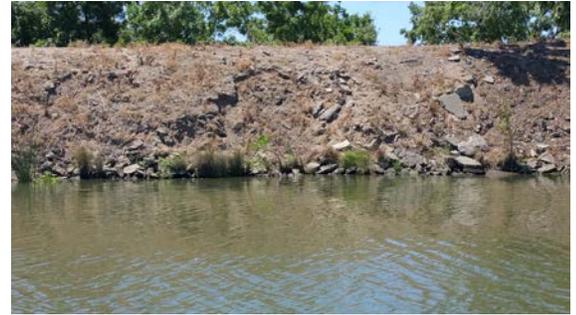
Close view of the erosion.

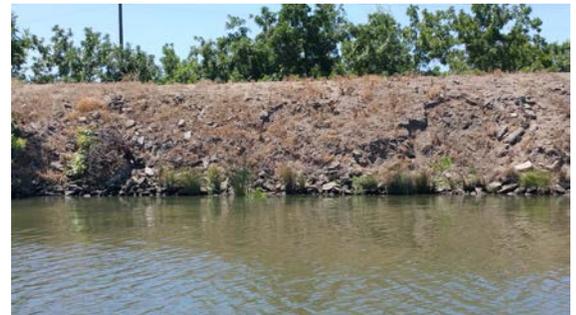
Close view of the erosion.

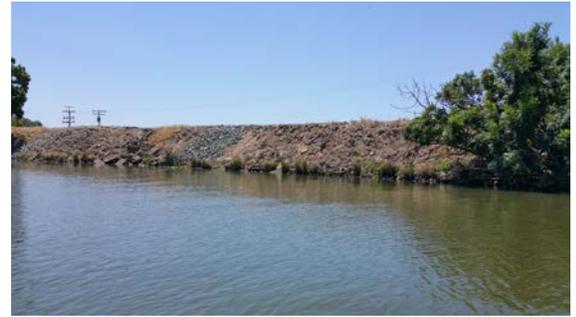
06/24/2015: No significant change observed.  
 6/19/2014: No significant change observed.  
 08/13/2013: No significant change at this site.  
 08/07/2012: The site has been visited by boat survey. Site has been repaired, but new erosion occurred at the levee slope and immediately upstream of the repaired site.  
 08/23/2011: The site is about 500 ft downstream of bridge. The levee toe seems to be protected, but the protection is being washed away.

Downstream view of the site.

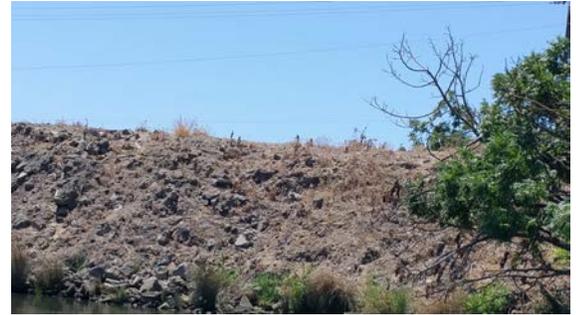
Close view of the erosion.

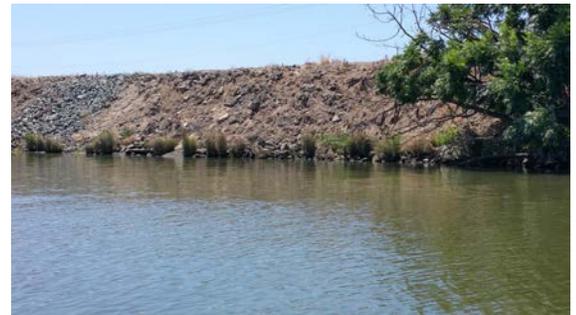
Front view of the site.

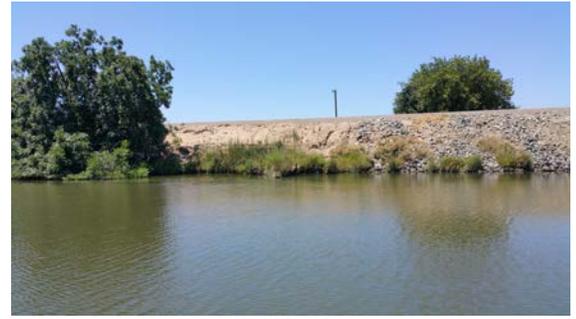
06/24/2015: No significant change observed.  
 6/19/2014: No significant change observed.  
 08/13/2013: No significant change at this site.  
 08/07/2012: The site has been visited by boat survey. No significant change observed  
 08/23/2011: No significant change observed on site.  
 9/07/2010: No significant change observed on site. Vegetation is visible at the water line. There is an exposed pipe discharge partially hanging at the mid-slope, possibly still used for discharging irrigation/runoff water. There is minimal rip rap protection along the bank, and what's left of it is no longer adequately protecting the bank.  
 9/29/2009: Site consists of a 400-foot long eroding bank with minimal vegetation and protection; the existing rip rap has sloughed, rendering it useless; note that there is an exposed section of a pipe.  
 10/18/2006: There is extensive loss of rip rap on some sections; sewage disposal pond is on the landside of the levee; there is an exposed pipe outlet "hanging" from the upper slope.

Direct view of the site.

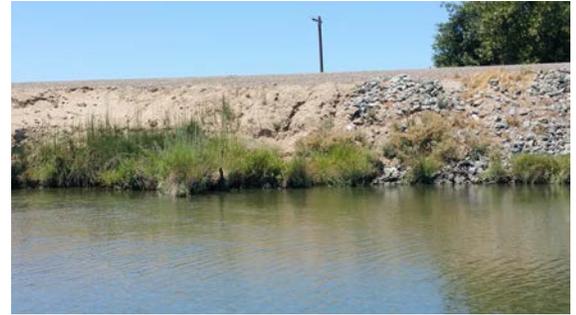
Direct view of the site.

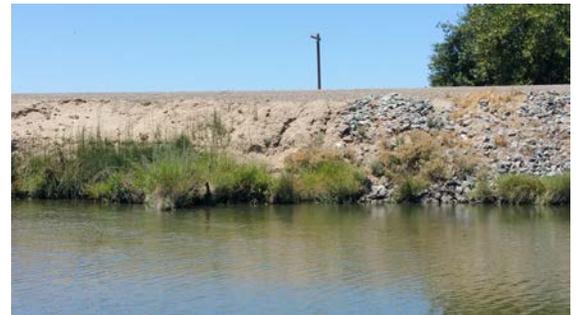
Close view of the upstream side of the erosion.

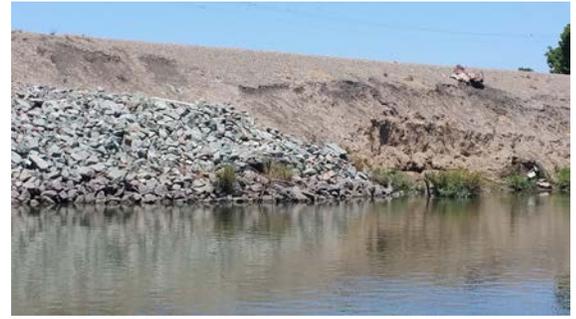
06/24/2015: No significant change observed.  
 6/19/2014: No significant change observed.  
 08/13/2013: New signs of animal activity were found.  
 08/07/2012: The site was first reported in 2012 spring levee inspection report.

Front view of the erosion.

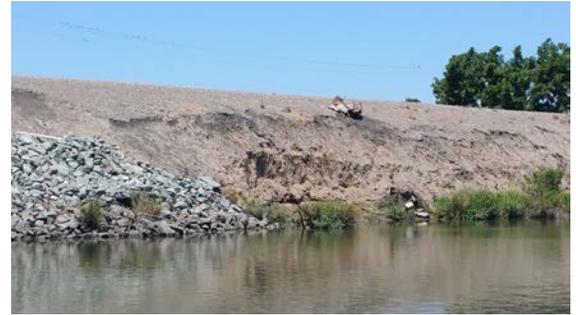
Front view of the erosion.

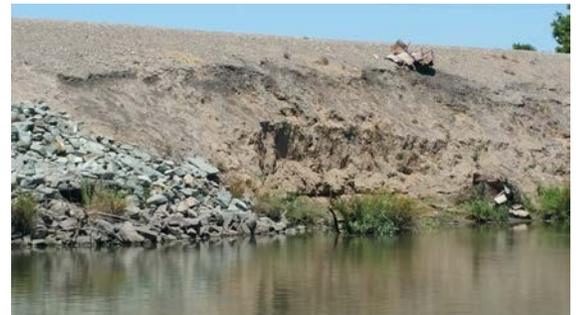
Front view of the erosion.

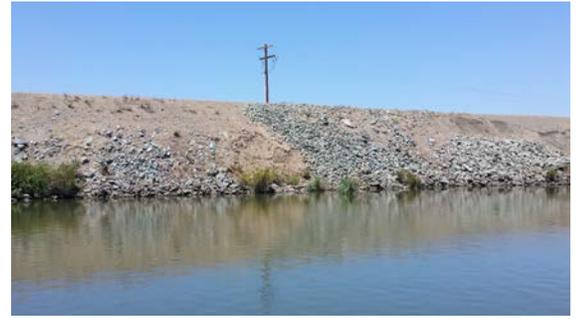
06/24/2015: No significant change observed.  
 6/19/2014: No significant change observed.  
 08/13/2013: No significant change observed.  
 08/07/2012: The site was first reported in 2012 spring levee inspection report. The site is located about 750 ft downstream of SR 4 Bridge.

Front view of the erosion.

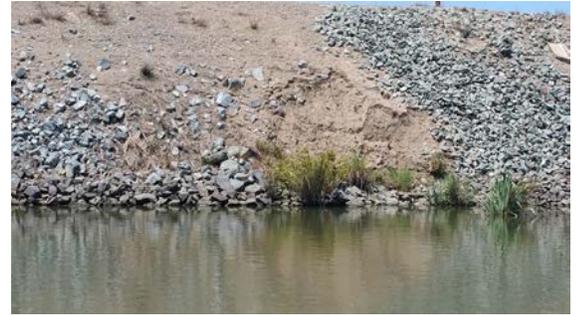
Front view of the erosion.

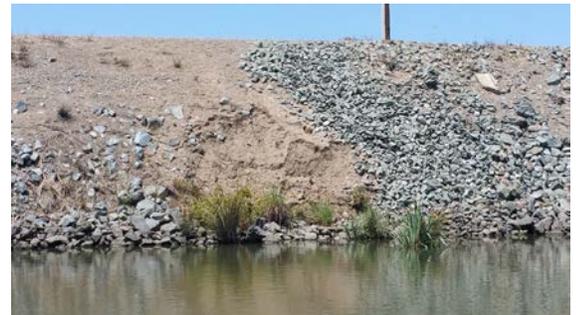
Close view of the erosion.

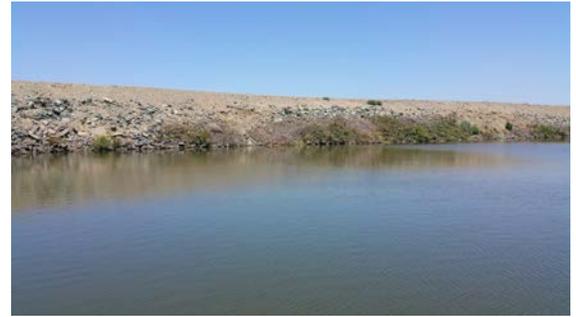
06/24/2015: No significant change observed.  
 6/19/2014: No significant change observed.  
 08/13/2013: The site is located approximately 400 ft. downstream SR 4 Bridge. Dense vegetation is visible at the toe.

Front view of the erosion site.

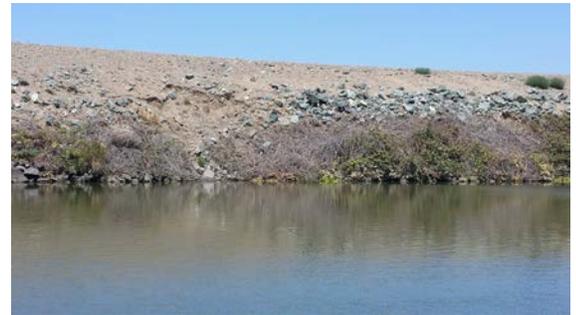
Close view of the erosion.

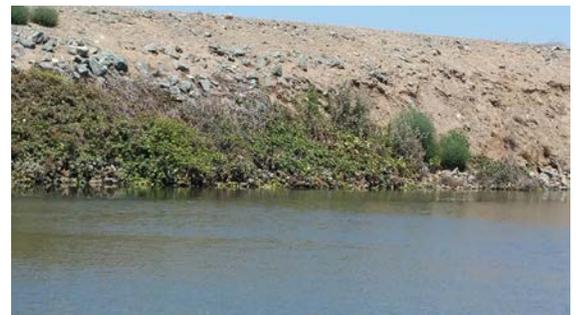
Close view of the erosion. Note the vegetation at the site.

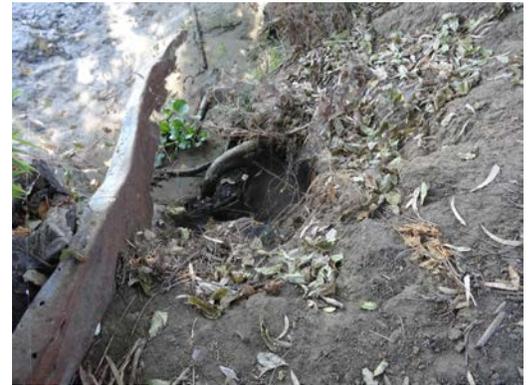
Close view of the erosion.

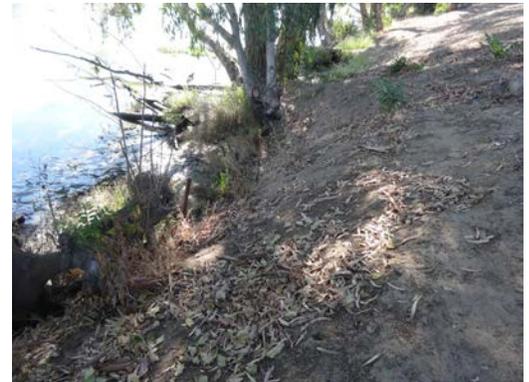
Front view of the erosion. Dense vegetation is visible.

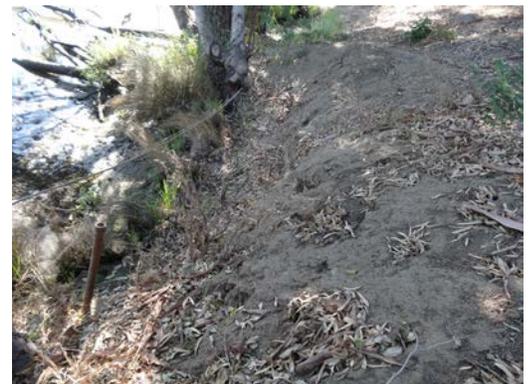
Close view of the erosion at the levee toe.

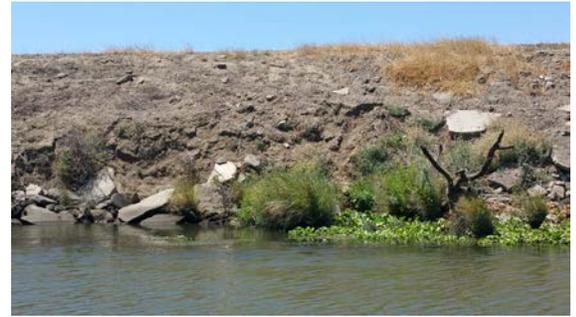
06/24/2015: No significant change observed.  
 7/22/2014: The erosion has increased in size.  
 08/13/2013: No significant change observed. Slightly more vegetation was visible.  
 08/07/2012: The site was first reported in 2012 spring levee inspection report.

View from downstream.

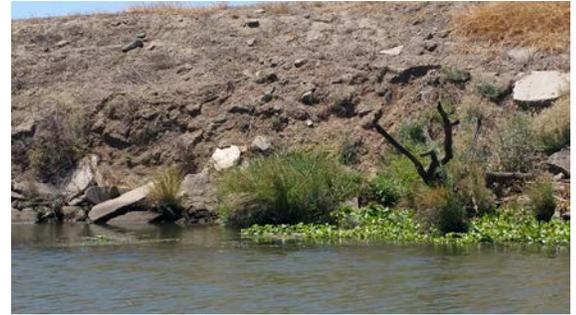
Close view of the pocket erosion.

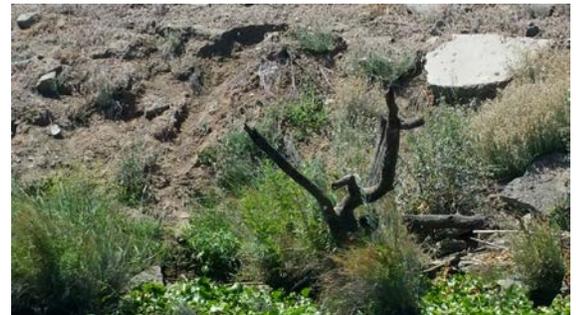
Close view of the pocket erosion. Note the vegetation at the site.

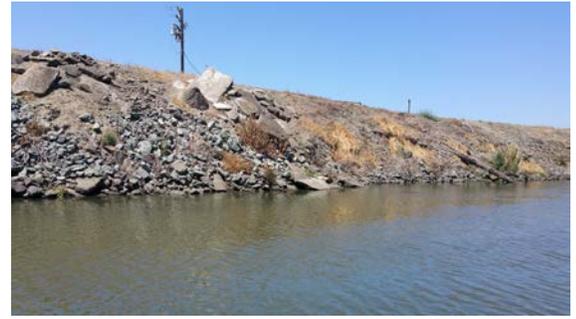
View from upstream.

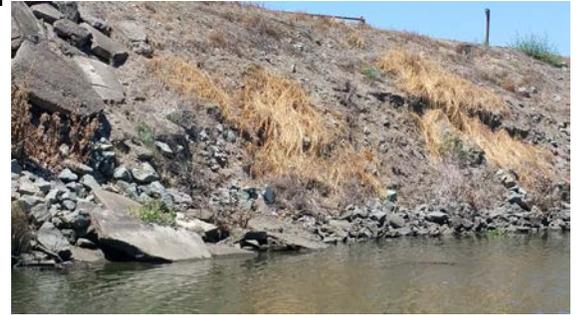
Close view of the erosion.

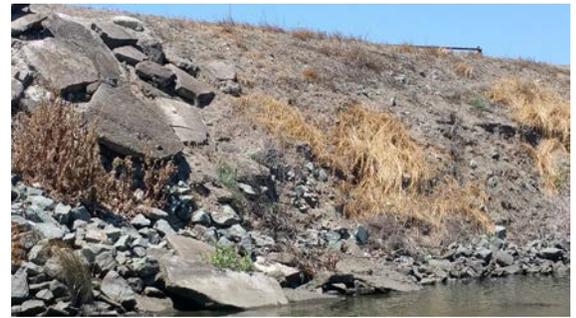
06/24/2015: No significant change observed.  
 6/19/2014: No significant change observed.  
 08/13/2013: An irrigation pipe is on site.

Close view of the erosion.

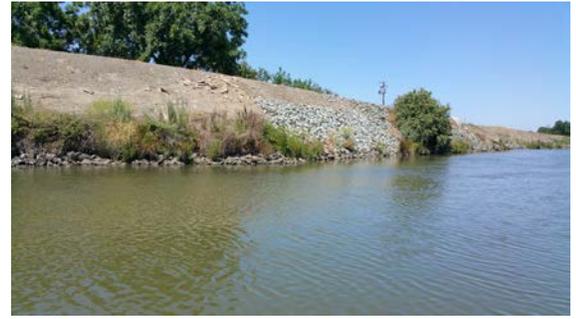
06/24/2015: No significant change observed.  
 6/19/2014: The erosion was repaired.  
 08/13/2013: The length of erosion has progressed downstream, and the site length has increased from 12 ft in length last year to 100 feet in length this year.  
 08/07/2012: The site was first reported in the 2012 spring levee inspection report. The site is located at the inside corner of a river bend.

View from upstream.

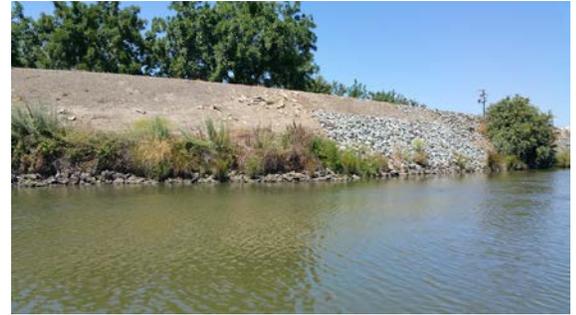
Front view of the repaired site.

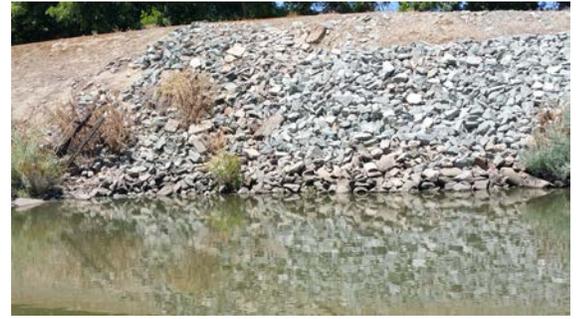
06/24/2015: No significant change observed.  
 6/19/2014: The erosion was repaired.  
 08/13/2013: No significant change observed.  
 08/07/2012: The site was first reported in 2012 spring levee inspection report.

Upstream view of the repaired site.

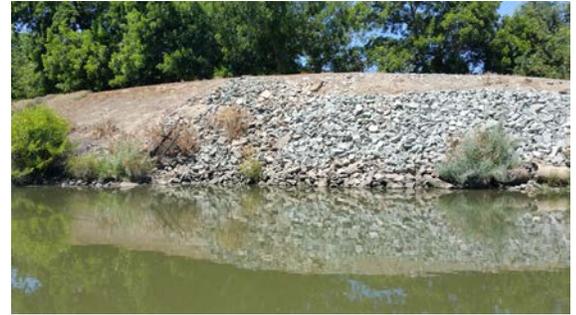
Close view of the repaired site.

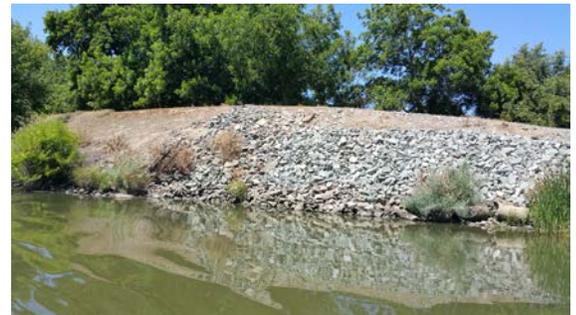
Closer view of the repaired site.

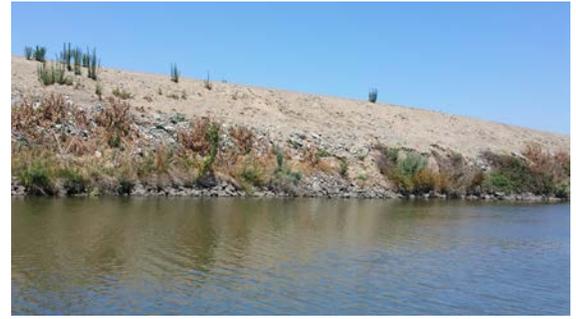
06/24/2015: No significant change observed.  
 6/19/2014: No significant change observed.  
 08/13/2013: No significant change observed.  
 08/07/2012: The site was first reported in 2012 spring levee inspection report.

Front view of the erosion.

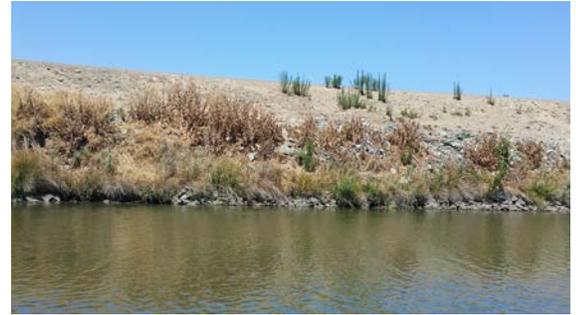
Close view of the erosion.

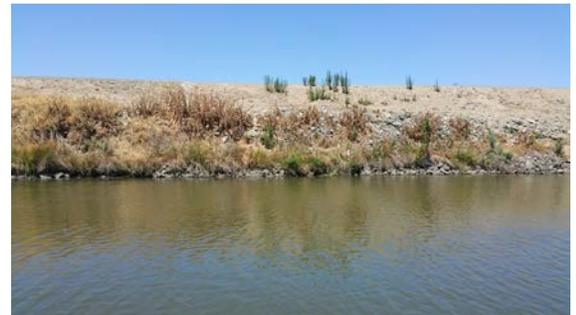
Close view of the erosion.

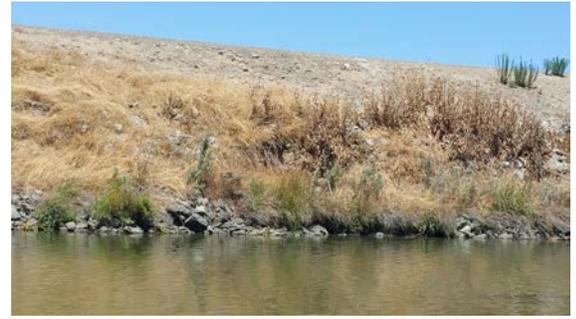
06/24/2015: No significant change observed.  
 6/19/2014: No significant change observed.  
 08/13/2013: New erosion was found at the levee toe. Trees are present.  
 08/07/2012: The site has been repaired. Protecting riprap revetment has been placed at the levee shoulder and slope, but minor erosions are visible at the levee toe.  
 08/23/2011: Sloughing rip rap is visible on the site

Direct view of the site.

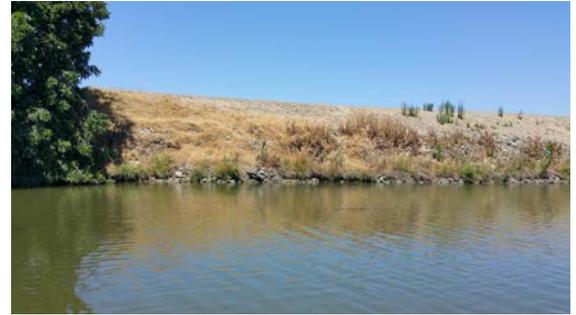
Front view of the site.

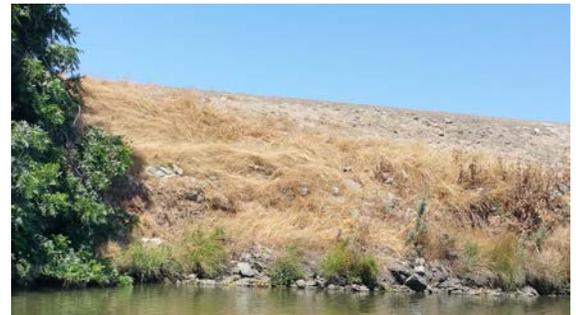
Closer view of the erosion.

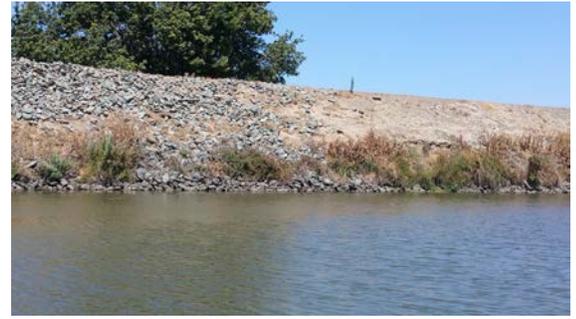
06/24/2015: No significant change observed.  
 6/19/2014: No significant change observed.  
 08/13/2013: The levee toe seems to have been protected by river rocks and vegetation on site.

View from upstream of the erosion.

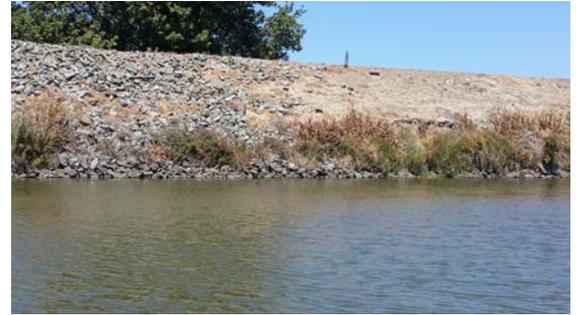
Front view of the erosion.

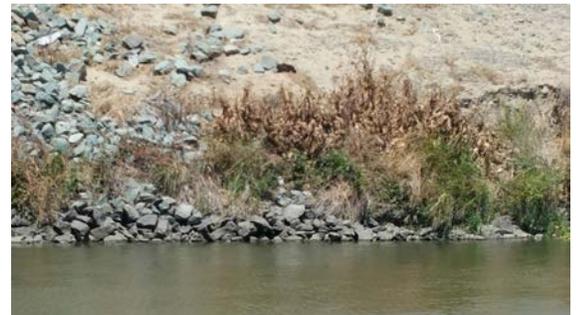
Close view of the erosion. Note river rocks and vegetation at the levee toe.

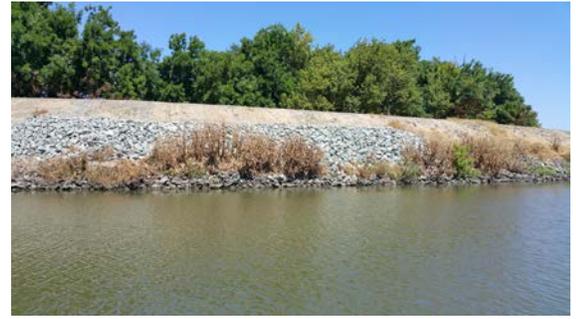
06/24/2015: No significant change observed.  
 6/19/2014: The previous erosion was repaired. New erosion was found below the repaired levee slope.  
 08/13/2013: No significant change observed.  
 08/07/2012: The levee toe has been cut off along a 150 ft. long river stretch. The erosion is located just upstream of a river bend.

View of the repaired site. Note the new erosion at the levee toe.

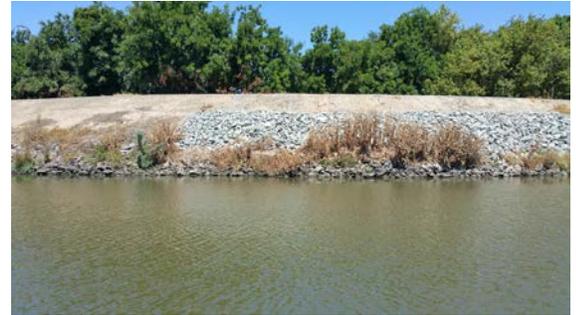
View of the repaired site.

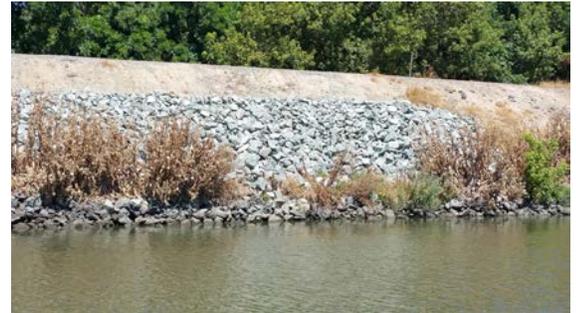
View of the repaired site.

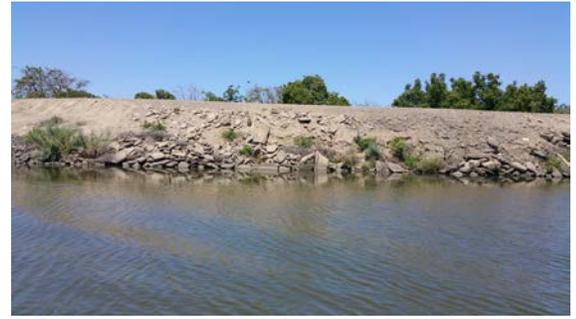
06/24/2015: No significant change observed.  
 6/19/2014: No significant change observed.  
 08/13/2013: No significant change observed.  
 08/07/2012: The erosion is located at the inside of a river bend. Site is covered with broken concrete blocks and other debris.

Front view of the erosion site.

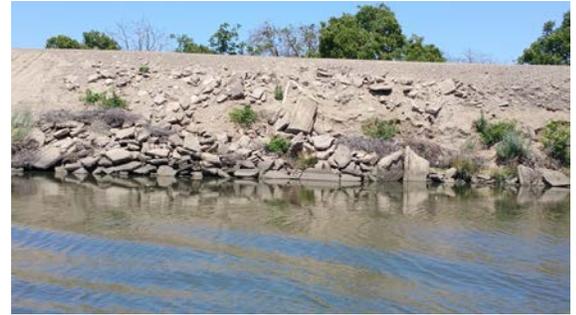
Close view of the site.

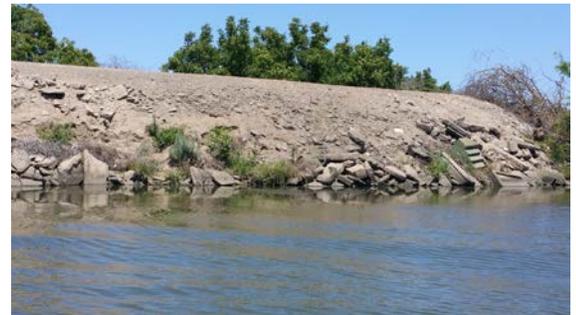
Front view of the site. Note the loosely placed concrete blocks.

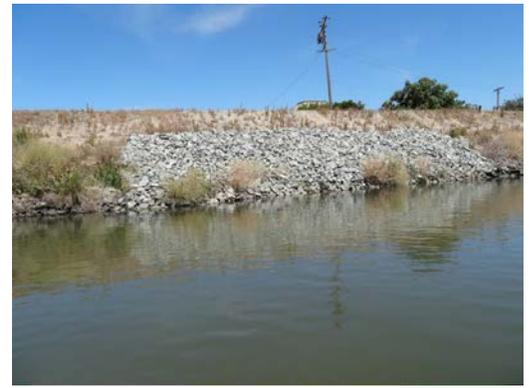
06/24/2015: No significant change observed.  
 6/19/2014: The erosion was repaired.  
 08/13/2013: No significant change observed.  
 08/07/2012: The site has been visited by boat survey. No significant change observed  
 08/23/2011: Cracking erosion along the levee bank. Erosion appears to be caused by river flows.

Front view of the repaired site.

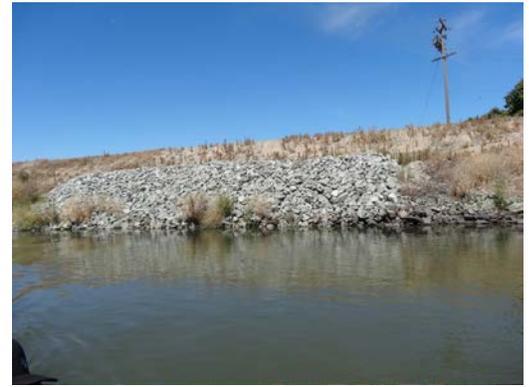
Front view of the repaired site.

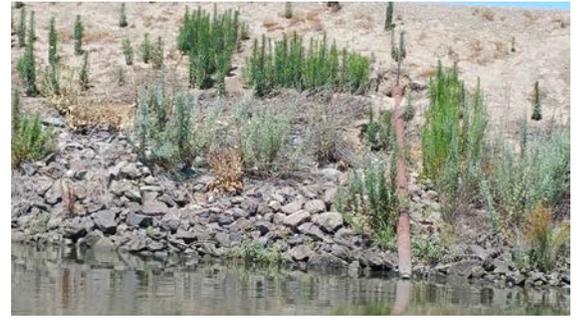
06/24/2015: No significant change observed.  
 6/19/2014: No significant change observed.  
 08/13/2013: The erosion seems to be getting worse. More material sloughing visible.  
 08/07/2012: The erosion is underneath an irrigation pipe. The likely cause of the erosion is the pipe leakage.

Close view of the erosion and the pipe.

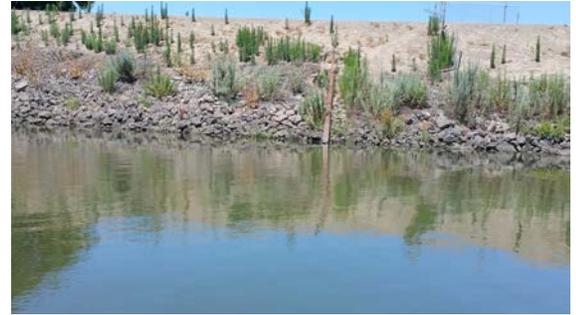
Front view of the site.

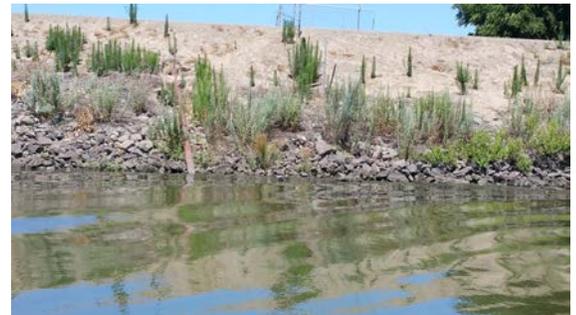
Front view of the site.

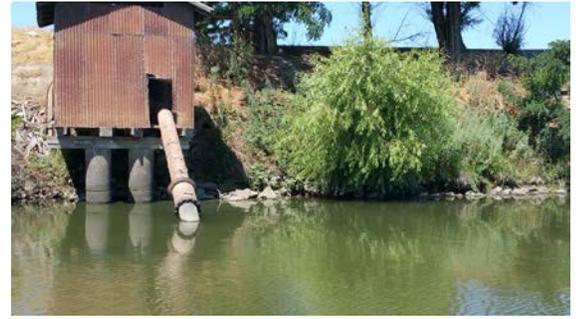
06/24/2015: No significant change observed.  
 6/19/2014: No significant change observed.  
 08/13/2013: Larger trees are at the levee shoulder, and an irrigation pump station is next to the erosion site.

Front view of the erosion.

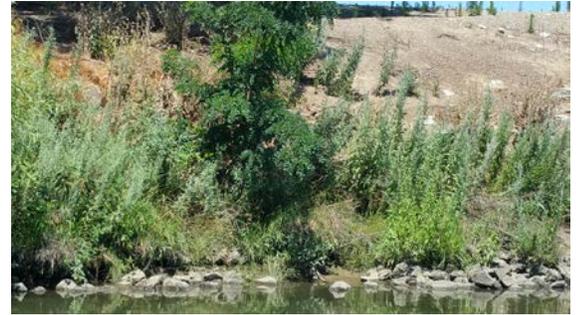
Close view of the site.

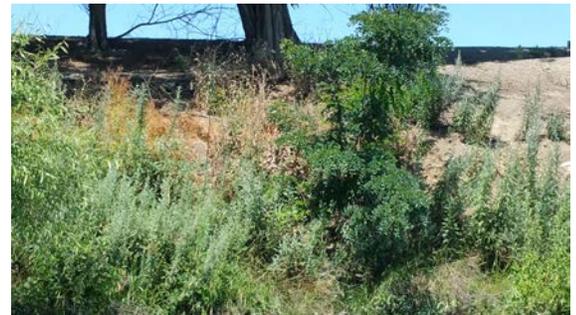
Close view of the site. Note large trees at the levee shoulder.

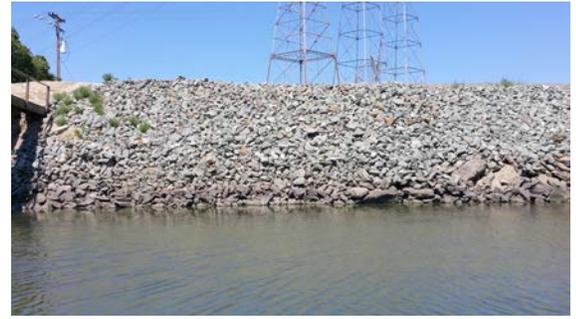
06/24/2015: No significant change observed.  
 6/19/2014: The erosion was repaired.  
 08/13/2013: The boat survey found no significant change at this site, except slight animal activity was visible at the site.  
 08/07/2012: : The site has been visited by boat survey. No significant change observed  
 08/23/2011: No significant change observed on site.  
 09/07/2010: No significant change observed on site. Erosion site is located beneath Howard Road Bridge. Majority of the existing rip rap has slipped, dragging away levee materials and exposing the underlying soft soil.  
 08/06/2010: Recommend for annual assessment and monitoring during flood events, per CLRO.  
 09/30/2009: No major change observed since the last visit; upper portion of existing revetment has slipped, exposing the degrading bank; note that site # is the same as RM46.30, LM5.69 found in the CLRO CES Evaluation 2008 Report; site was previously rated "M".

11/04/2008: Previously repaired using rock revetment; upper portion of the revetment is sliding, causing deformation on the levee slope; site is upstream of Howards Road Bridge.

Front view of the repaired site.

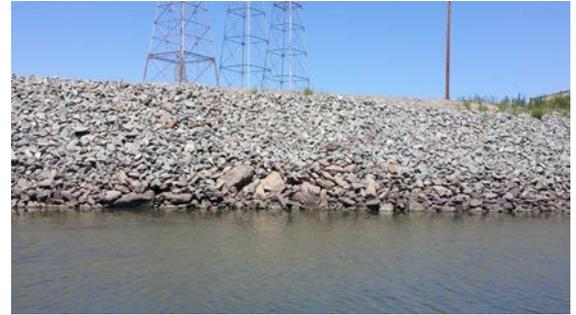
Front view of the repaired site.

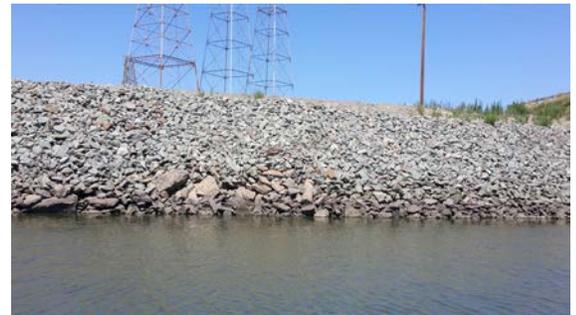
Front view of the repaired site.

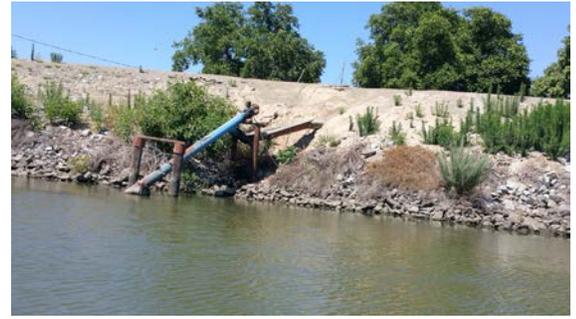
06/24/2015: No significant change observed.  
 06/19/2014: No significant change observed.  
 08/13/2013: No significant change observed.  
 08/07/2012: The erosion is near a water-intake structure. Pipe leakage likely caused the erosion.

Front view of the site.
