LMA: **NA0011 U02 Madera County FC** Waterway: **RB Ash Slough**  
 Site ID: **NA0011U02RM2.57** Status: **Existing Site**

Latitude: **37.055596** Longitude: **-120.412647** River\_Mile: **2.57** Levee\_Mile: **1.15** Overall Rating: **U**

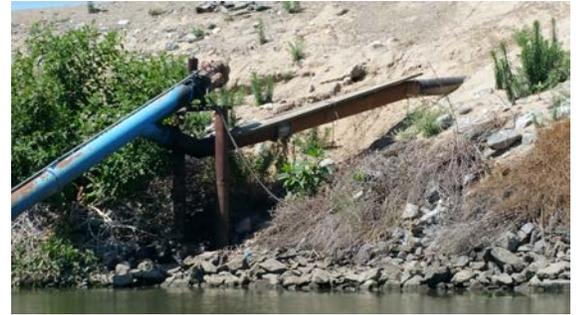
Close view of the erosion and the pipe.

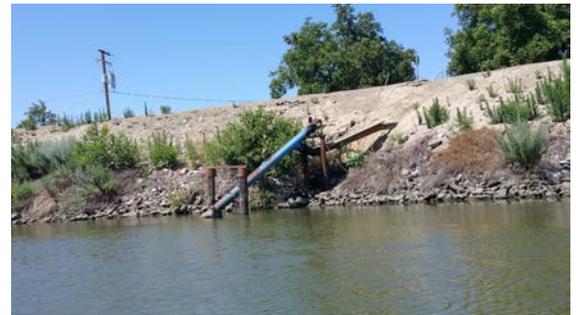
Closer view of the erosion.

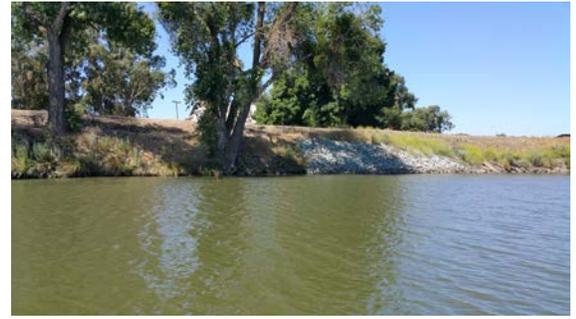
06/24/2015: No significant change observed.  
 6/19/2014: Repaired site. No significant change observed.  
 08/13/2013: Repaired site. No new erosion found at the site.  
 08/07/2012: The site has been visited by boat survey. The site has been repaired with riprap protection. Rotten tree roots and minor erosion are visible immediately upstream of the site  
 08/23/2011: No significant change observed on site.  
 09/07/2010: No significant change observed on site. There are minor pockets of erosion lining the lower slope and undermining of the toe. There are annual grasses and emergent vegetation at the lower slope. Burrow holes were observed along the slope and persist throughout the 200-foot long site.  
 08/05/2010: Recommended for annual assessment and monitoring during flood events, per CLRO.  
 09/30/2009: No major change observed since last visit; despite dense vegetation, the bank continues to erode and slough; the levee toe is being undermined; note the tree on site; the site was previously rated "U".

10/21/2008: Undermining of the levee toe; rodent holes in several location; trees with roots partially exposed; sloughing on slope.

Upstream view of the repaired site.

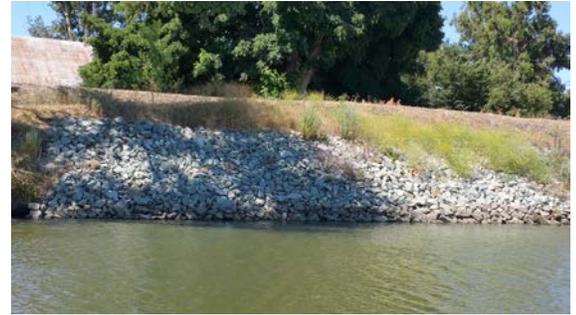
Front view of the repaired site.

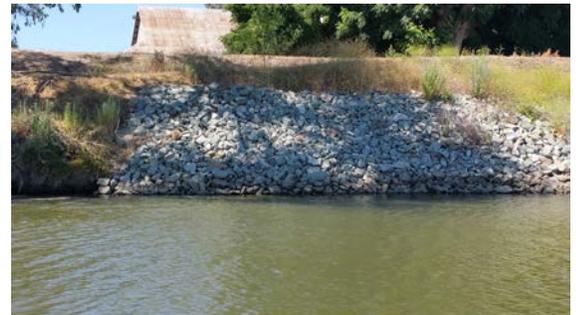
Front view of the site.

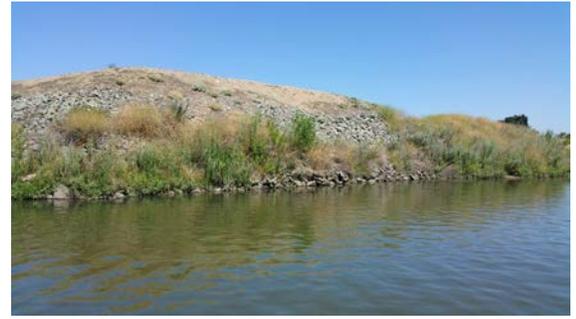
06/24/2015: No significant change observed.  
 6/19/2014: The erosion was repaired.  
 08/13/2013: No significant change observed.  
 08/07/2012: The erosion is right at the inside of a river bend. Dense vegetation is visible at the site.

Front view of the site.

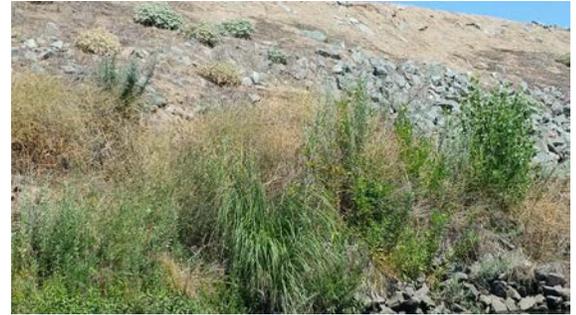
Close view of the site.

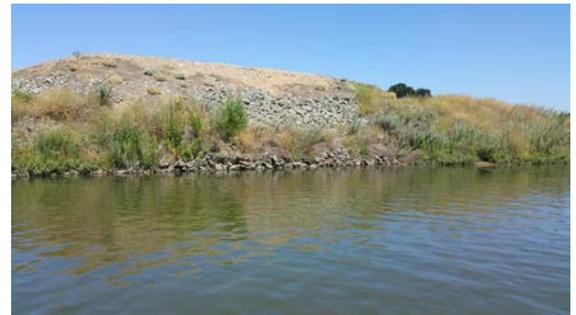
Front view of the erosion.

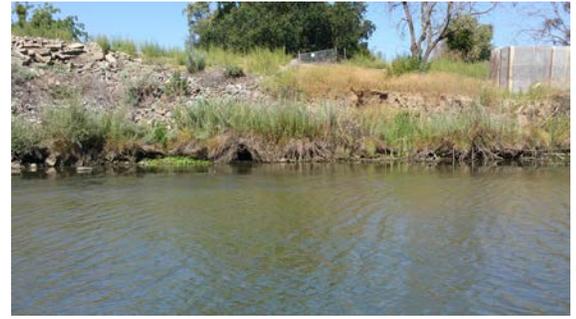
06/24/2015: No significant change observed.  
 6/19/2014: No significant change observed.  
 08/13/2013: Pump has been removed. A larger pocket erosion has been found at the erosion site.  
 08/07/2012: The erosion is immediately upstream of a river bend. Dense vegetation is visible at the erosion site.

Front view of the erosion.

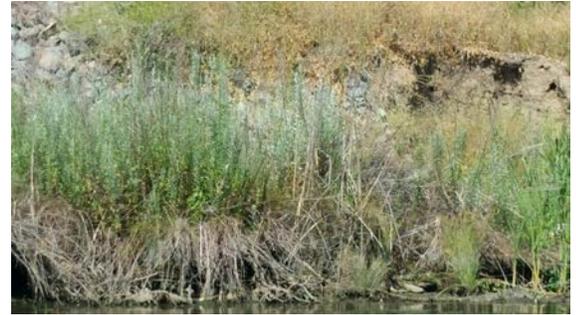
Close view of the site.

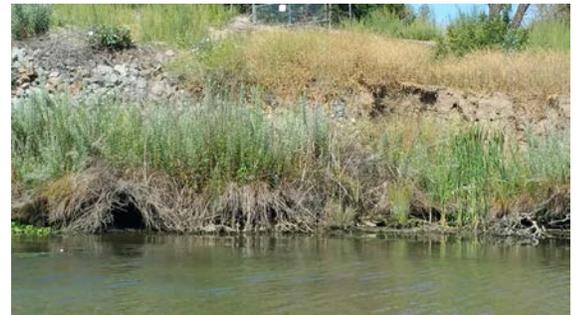
Close view of the site.

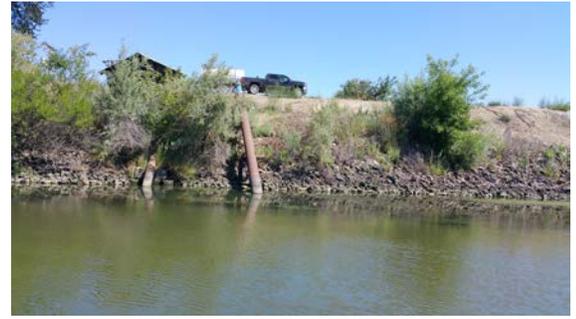
06/24/2015: No significant change observed.  
 06/19/2014: No significant change observed.  
 08/13/2013: The erosion has been caused by irrigation pipe.

Front view of the site.

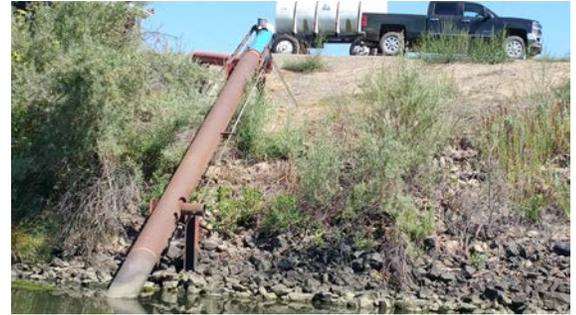
Close view of the site.

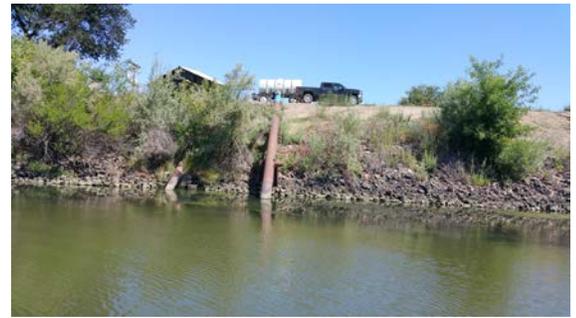
Close view of the site.

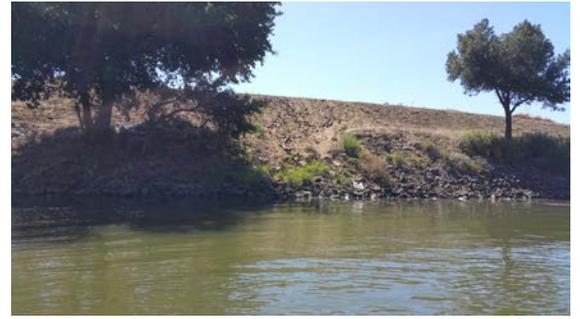
06/24/2015: The erosion has been repaired.  
 6/19/2014: No significant change observed.  
 08/13/2013: This erosion has been caused by instability of the levee . Larger trees exist downstream of the erosion site.

Front view of the repaired site.

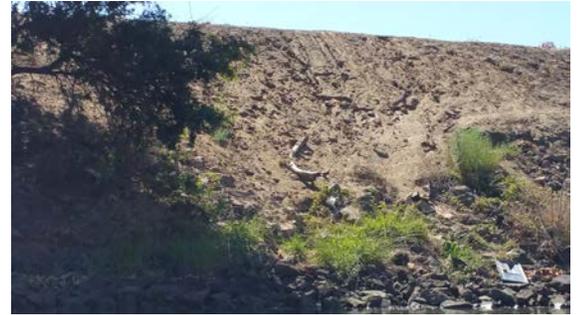
Front view of the repaired erosion site.

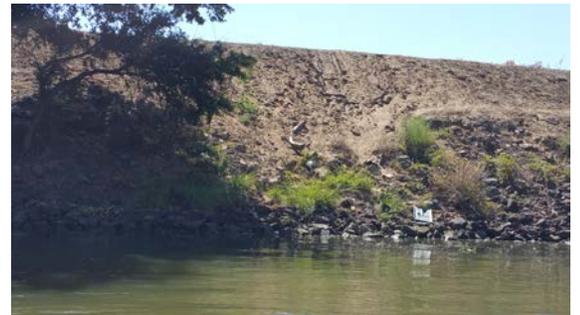
Close view of the repaired erosion site.

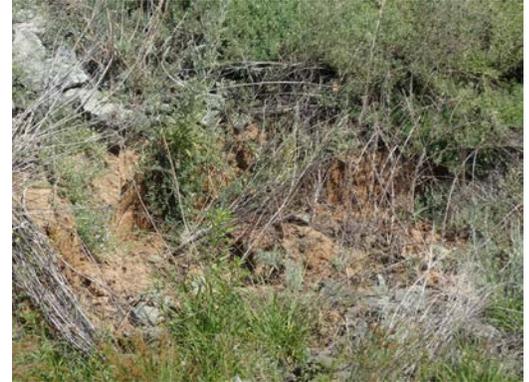
06/25/2015: No significant change observed.  
 07/02/2014: No significant change observed.  
 10/11/2013: No significant change observed.  
 08/07/2012: Series of pocket erosion were discovered at the levee toe during the boat survey. The area is covered with vegetation and riprap, but the rip rap has been washed away.

Close view of pocket erosion.

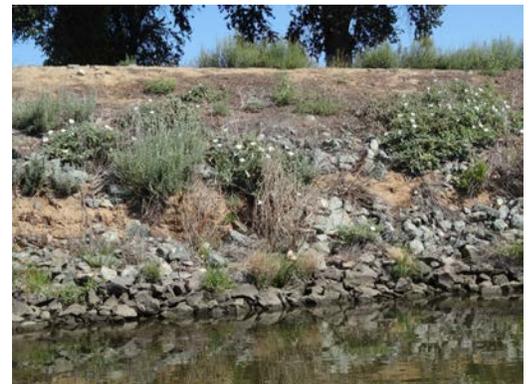
Close view of the erosion.

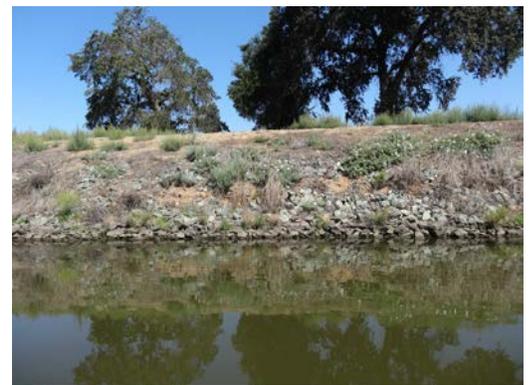
Close view of the site.

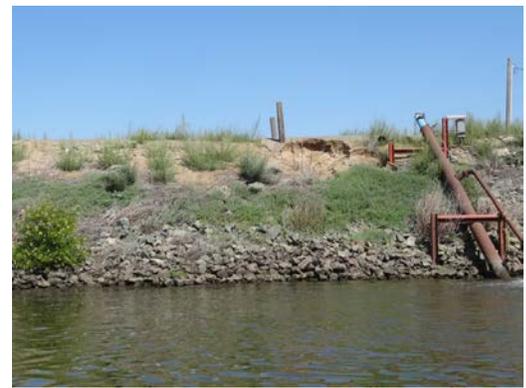
06/25/2015: The site was discovered during the boat survey. Irrigation pipe leakage caused the soil to sink at the upper levee shoulder. The lower part of the levee is protected by riprap rocks. The irrigation pump was operating at the site.

Front view of the erosion site.

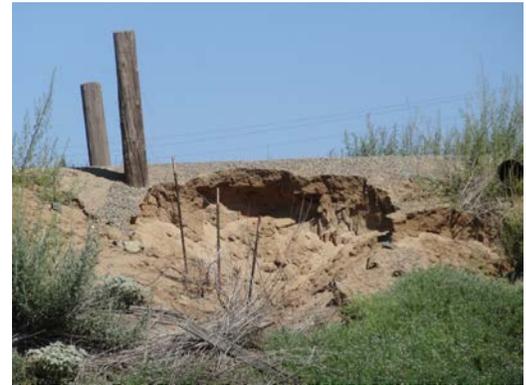
Close view of the erosion.

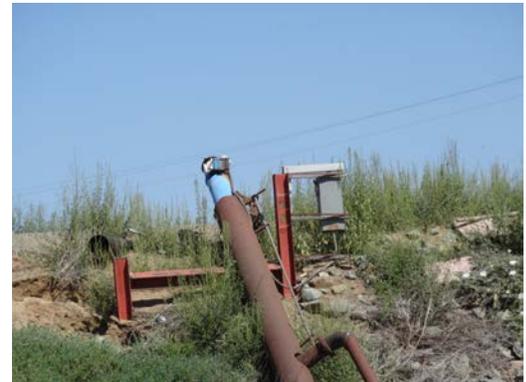
Close view of the erosion. Vegetation around the site is visible.

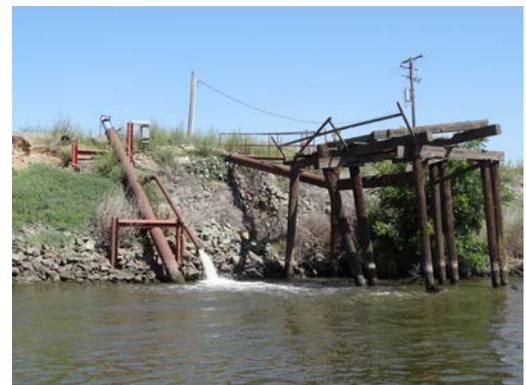
Front view of the site. Note the operating irrigation pump.

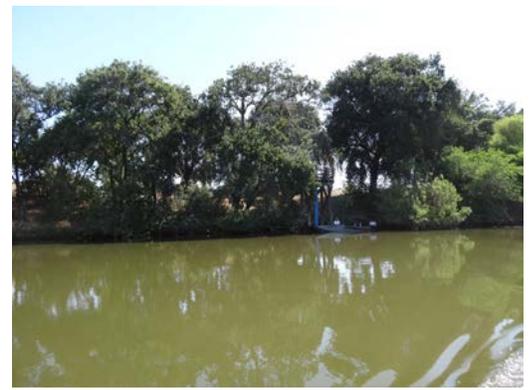
06/25/2015: No significant change observed.  
 07/02/2014: No significant change observed.  
 08/20/2013: No significant change observed.  
 08/07/2012: The site was first reported in 2012 spring levee inspection report. The data were estimated as the site is underneath a irrigation pump station and inaccessible by boat or land survey. It's possible the pump station played a role in the erosion.

Front view of the erosion site. View is partially blocked by the pump structure and vegetation.

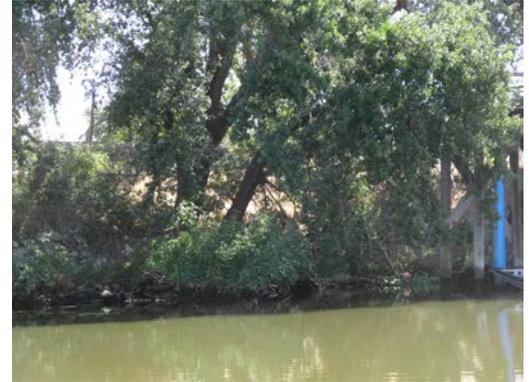
Front view of the site.

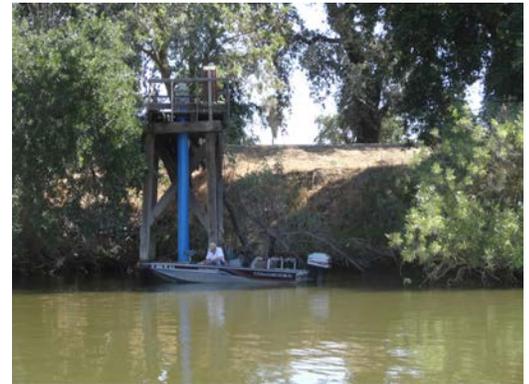
Close view of the site.

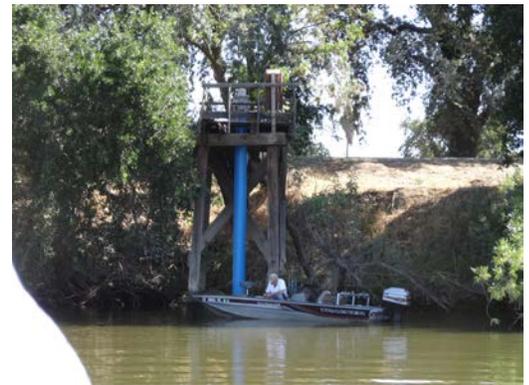
Front view of the site.

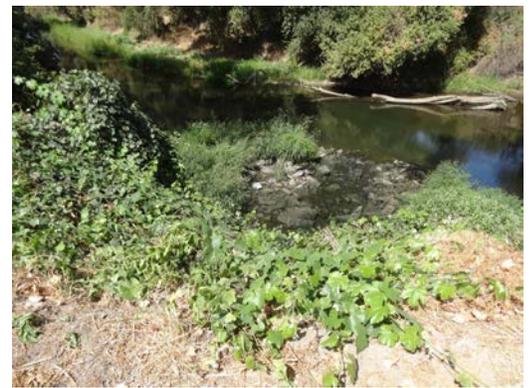
08/28/2015: No significant change observed.  
 07/31/2014: No significant change observed.  
 09/10/2013: No significant change observed.  
 07/18/2012: No significant change observed.  
 08/18/2011: No significant change observed on site. Debris that blocks the irrigation outlet is visible.  
 10/19/2010: No significant change observed on site. Sloughing of the bank is occurring adjacent to an irrigation outlet structure. There is moderate to heavy vegetation along the bank that is well established. Broken chunks and slabs of concrete are used as rip rap and line the outside of the irrigation outlet structure. However, much of the rip rap along the slope is sloughing and could possibly lead to future slope instability.  
 08/05/2010: Recommended as a local maintenance issue, per CLRO.  
 08/20/2009: No major change observed since last visit; 1 inch fissure cracks developing on the slope; rip rap is showing signs of sloughing; recommend as local maintenance issue; site was previously rated "U".

Direct view of the site.

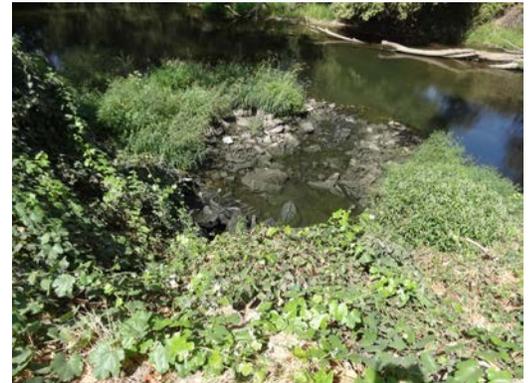
Looking down at the site.

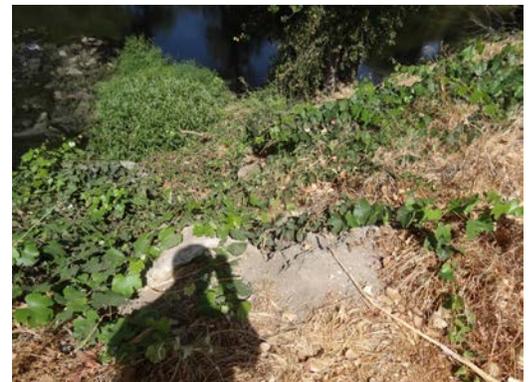
View of the current condition of the bank slope just above the irrigation outlet.

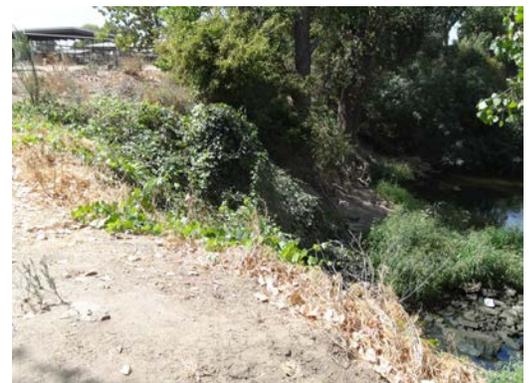
View of the loose material at the bank top.

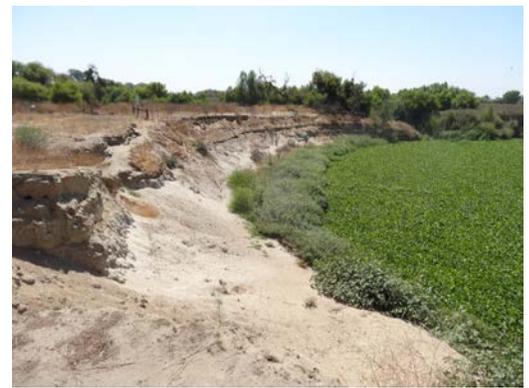
08/19/2015: No significant change observed.  
 7/17/2014: The erosion has slightly expanded toward levee toe at two pocket locations.  
 09/10/2013: The site has been visited. The erosion has expanded toward levee crest at two pocket locations.  
 07/18/2012: No significant change observed on the site.  
 08/18/2011: No significant change observed on the site. Dead trees and animal activities are visible. The closest point of the erosion site to the levee toe is about 100 ft.  
 10/19/2010: There is active scouring occurring on the bank due to the nature of the flow and the lack of armor protection. There is also a fallen log immediately downstream of where the erosion has occurred and is protruding outward, possibly creating an eddy and scouring the bank. With the remaining 100-foot wide berm, the levee prism is not yet affected. However, the bank will continue to degrade, and eventually intrude into the levee prism if no protection is put in place. Erosion site is recommended for annual assessment and monitoring during flood events.

Looking downstream.

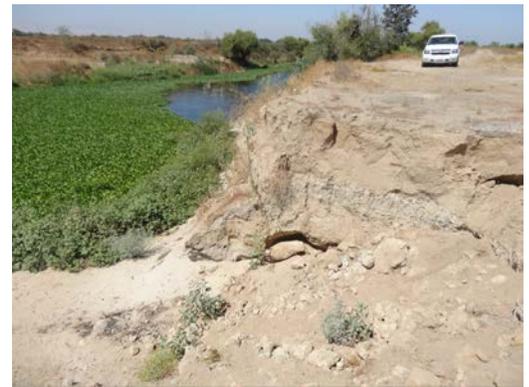
Looking upstream. Note the pocket erosion.

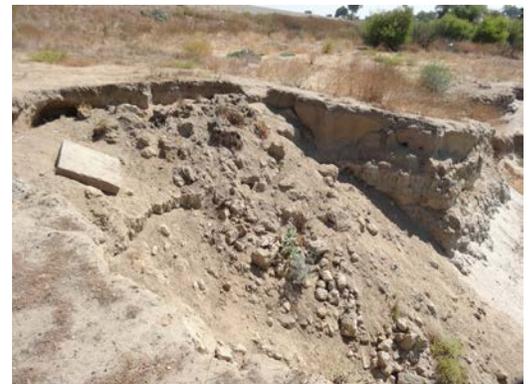
Close view of the pocket erosion.

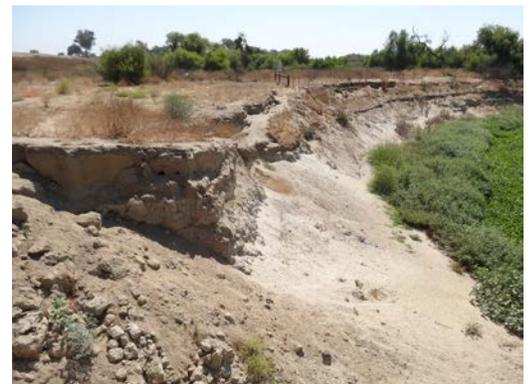
Close view of the erosion.

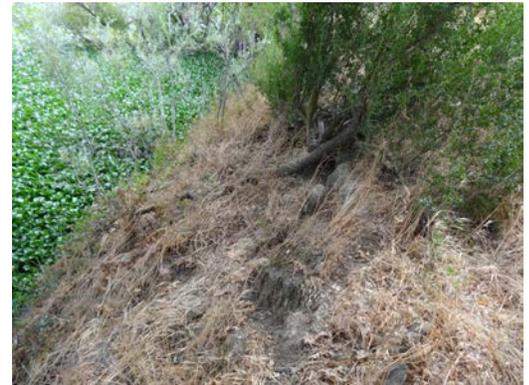
Direct view of the erosion near a tree.

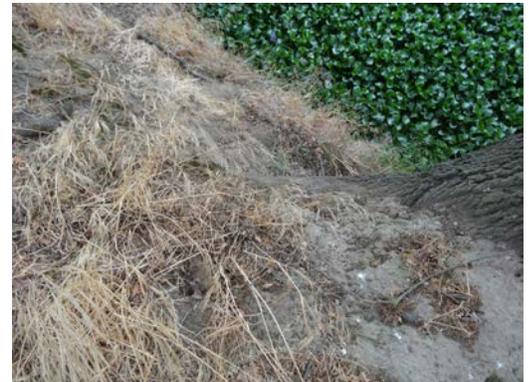
Direct view of the erosion near a tree.

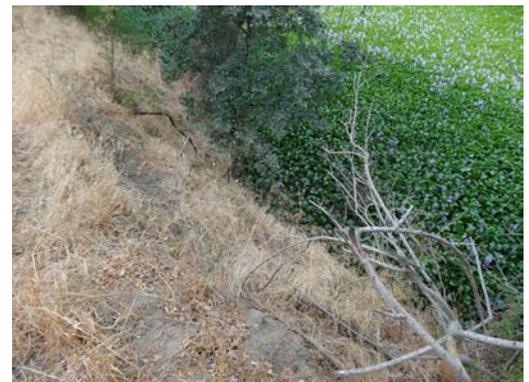
Direct view of the erosion near a tree.

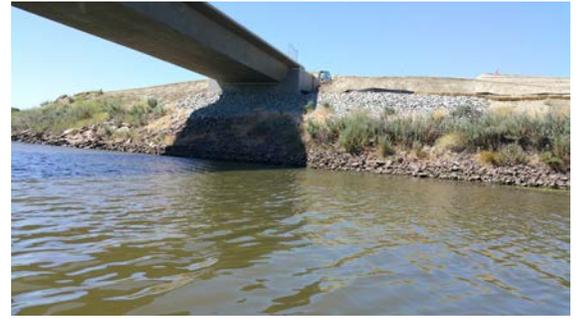
06/24/2015: No significant change observed.  
 6/19/2014: No significant change observed.  
 08/13/2013. This was repaired prior to the boat survey. No new erosion found at the site  
 08/07/2012: The site has been visited by boat survey. No significant change observed  
 08/23/2011: No significant change observed at the site. There is vegetation on the slope. There is a bridge construction site just upstream of the erosion. The impact of the construction may need to be monitored.  
 09/07/2010: No significant change observed on site. Sloughing of the existing rip rap revetment on the lower slope has developed into an erosion pocket. There is moderate annual grass growth on the slope.  
 08/06/2010: Recommended as local maintenance issue, per CLRO.  
 03/09/2010: Per Michael Moncrief of MBK, site is scheduled for repair this year.  
 2009: Landside ground surface has been raised to the height of the levee crown; sloughing of the existing rip rap revetment on the lower slope that has created a pocket, exposing underlying soil; Site # is the same RM54.34,LM1.08; previously rated "M".

Front view of the repaired site.

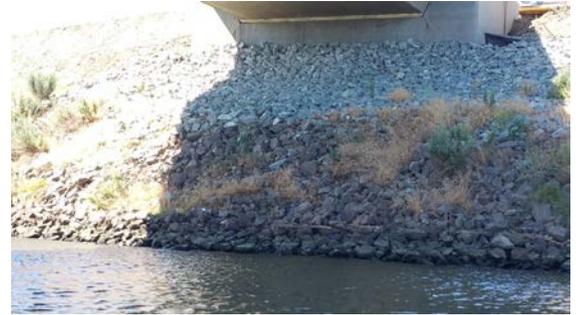
Front view of the rip rap.

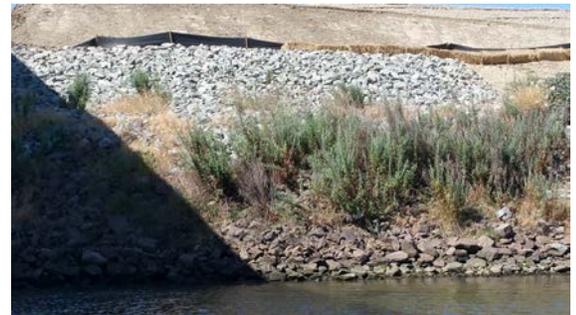
Front view of the site.

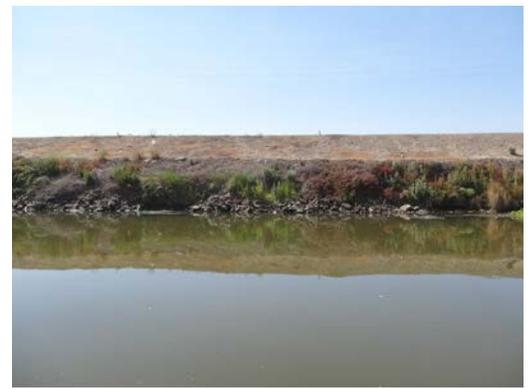
06/25/2015: No significant change observed.  
 07/02/2014: No significant change observed.  
 08/13/2013: No significant change observed.  
 08/07/2012: The site has been visited by boat survey. No significant change observed  
 08/23/2011: Site is at the upstream of a drainage ditch.

Front view of the erosion.

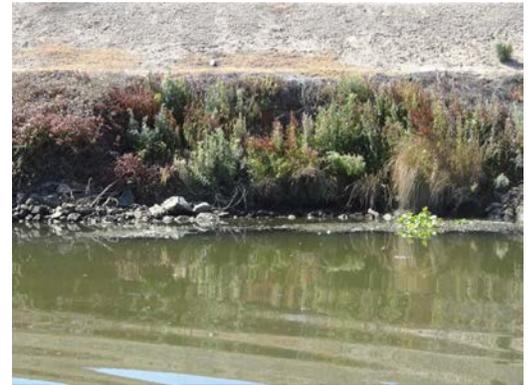
Front view of the erosion.

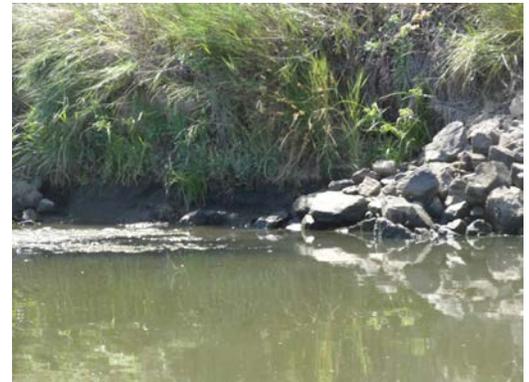
Close view of the erosion.

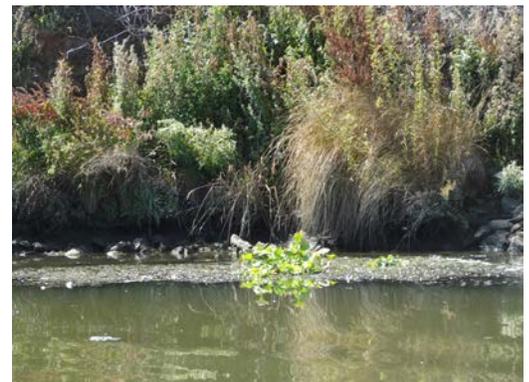
Front view of the erosion. Note the dense vegetation.

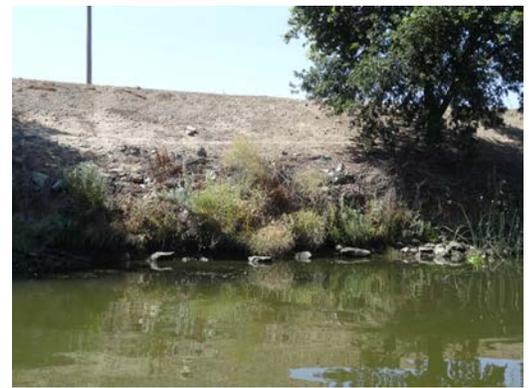
06/25/2015: No significant change observed.  
 07/02/2014: No significant change observed.  
 08/13/2013: No significant change observed.  
 08/07/2012: The site has been visited by boat survey. No significant change observed  
 08/23/2011: Hard to view the erosion because of the dense vegetation and trees on site.  
 The site is under the bush, close to the tree.

Front view of the site.

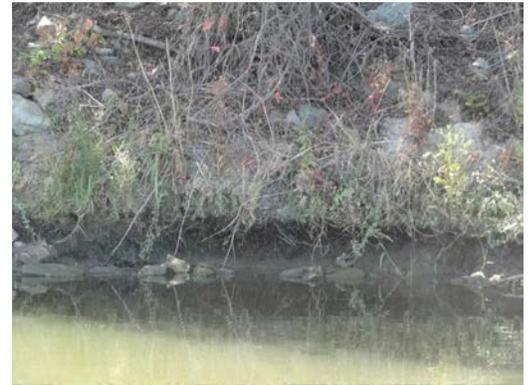
Close view of the site.

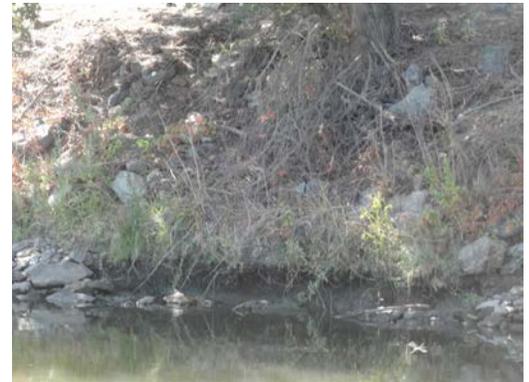
Close view of the site. Note the vegetation.

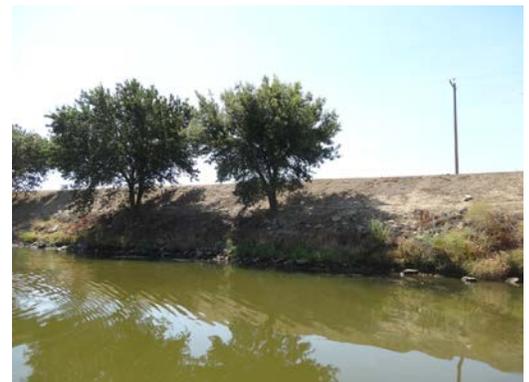
View of the site from downstream.

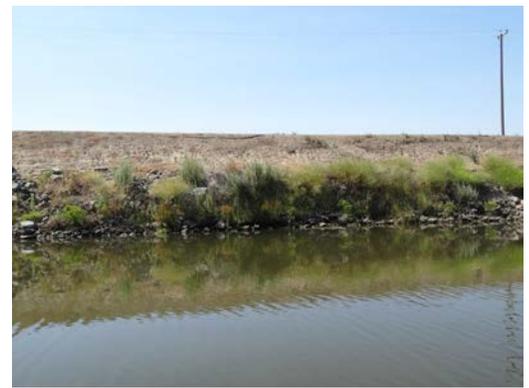
06/25/2015: No significant change observed.  
 07/02/2014: No significant change observed.  
 08/13/2013: No significant change observed.  
 08/07/2012: The site has been visited by boat survey. No significant change observed  
 08/23/2011: The protection at the levee toe has been washed away.

Direct view of the site.

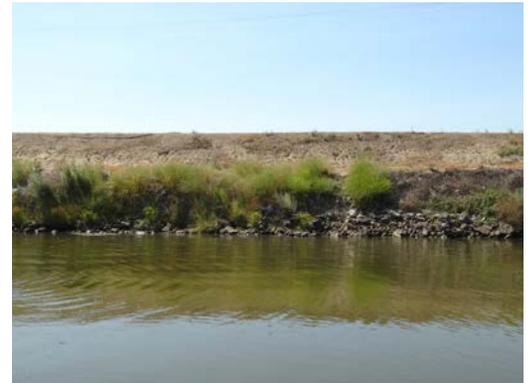
Front view of the erosion.

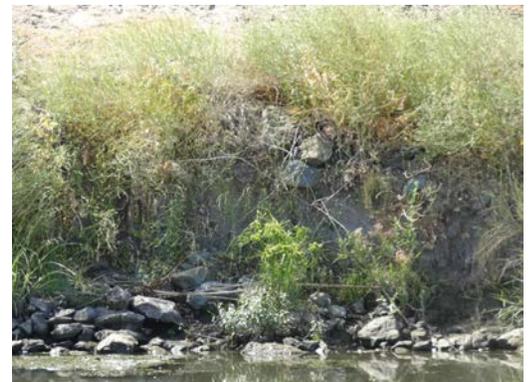
Close view of the erosion.

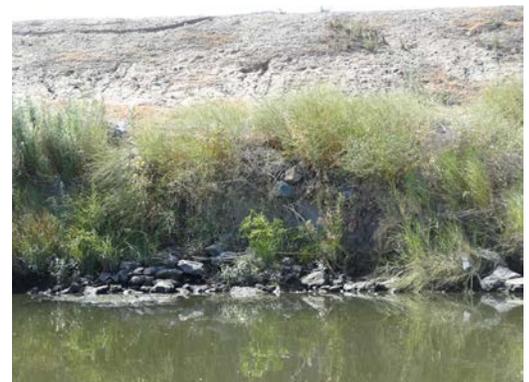
Close view of the erosion.

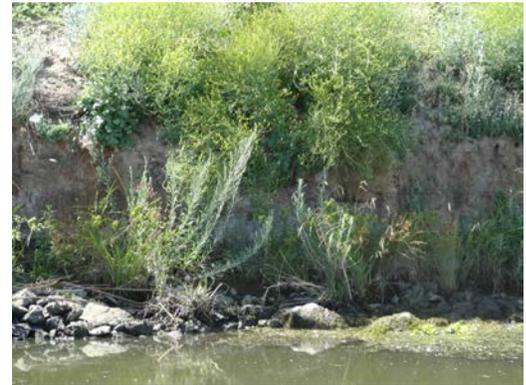
06/25/2015: No significant change observed.  
 07/02/2014: No significant change observed.  
 08/13/2013: A new pocket erosion at the upper levee slope has been found directly above a large tree. The erosion might have been caused by internal pipe leakage or surface runoff.  
 08/07/2012: The site has been visited by boat survey. No significant change observed  
 08/23/2011: No significant change observed on site. Dense vegetation is visible along the water line.  
 09/07/2010: No significant change observed on site. Much of the upper slope was recently cleared of vegetation by spraying. 4- to 6-foot vertical scarp and pocket erosions are lined along a span of 475 feet. In some sections, the vertical scarp encroaches into the levee prism. There is a lack of berm along this reach, exposing the levee slope to high flow velocities during normal and flood events.  
 08/06/2010: Recommended as local maintenance issue, per CLRO.

Close view of the pocket erosion.

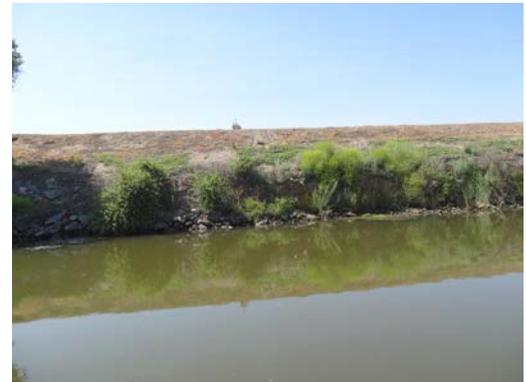
Front view of the site with dense vegetation.

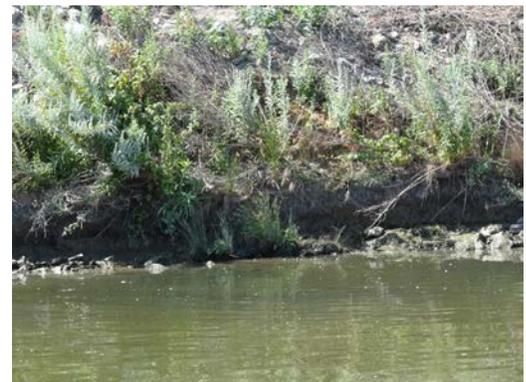
Front view of the existing erosion at the toe.

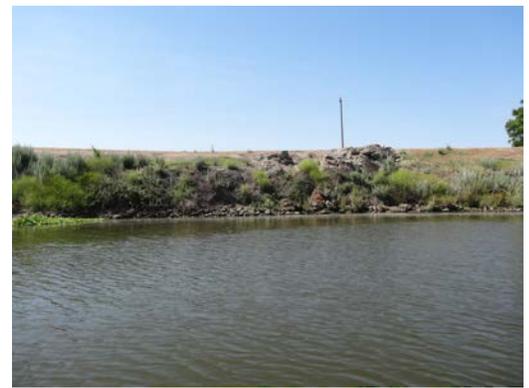
Front view of the erosion.

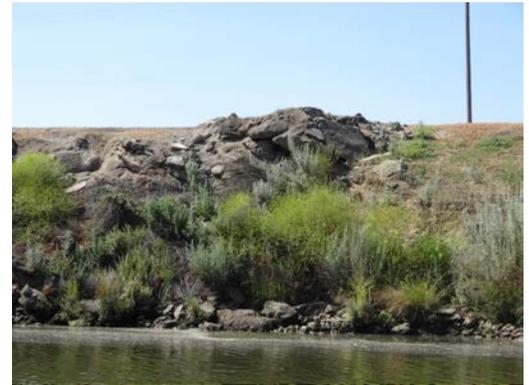
Close view of the site.

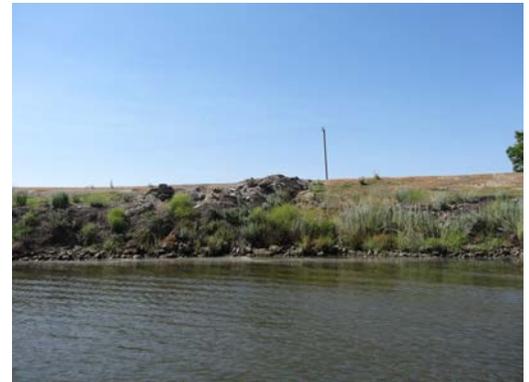
Front view of the erosion.

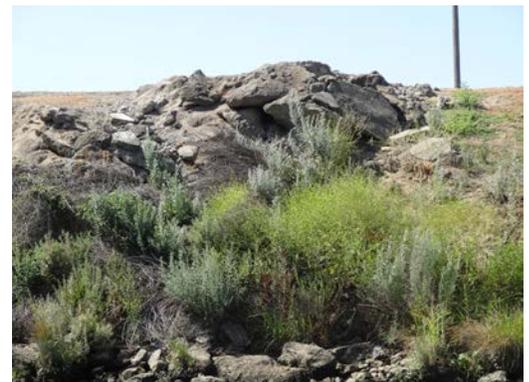
Close view of the site. Note the piled concrete debris.

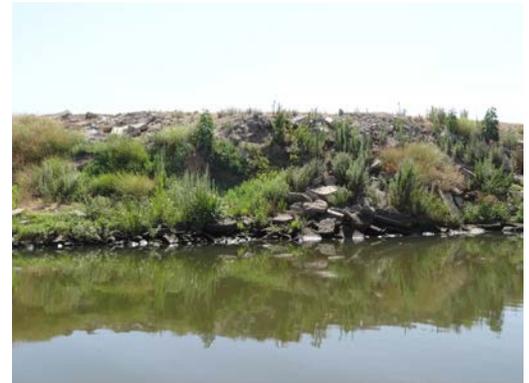
Front view of the site. Previously placed rip rap slipped, exposing the underlying soils and creating a pocket.

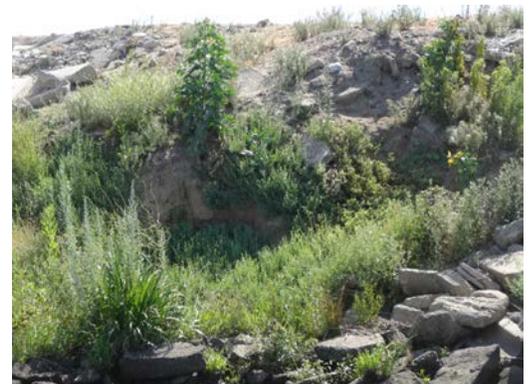
Front view of the site. Rip rap no longer adequately protecting levee slope.

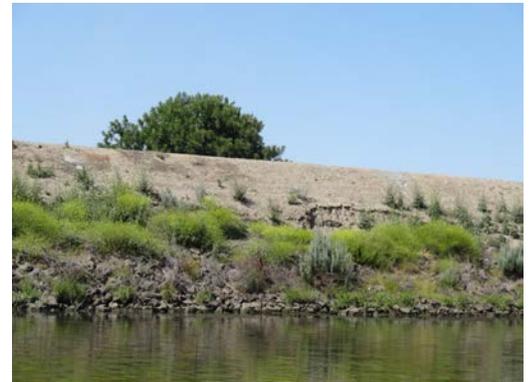
Front view of the site. Note the crack along the middle of the slope.

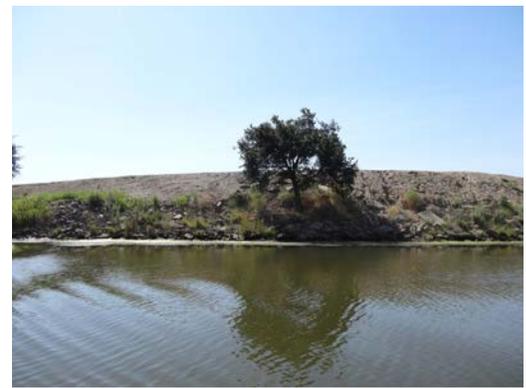
Front view of the erosion site.

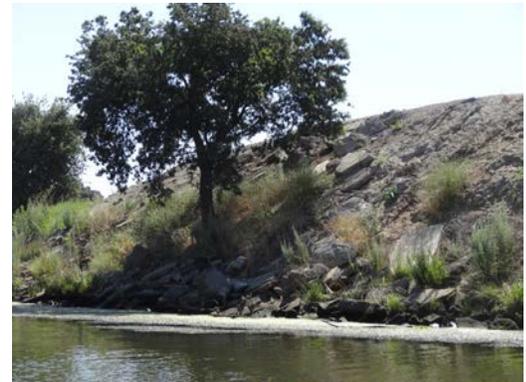
11/05/2008: Portion of rip rap collapsing.  
 09/14/2006: Portion of rip rap along the slope has collapsed; exposed levee section is starting to erode, exposing roots from the nearby tree.

Front view of the site. Note existing broken concrete on the upper slope as well as on the lower slope and at the toe.

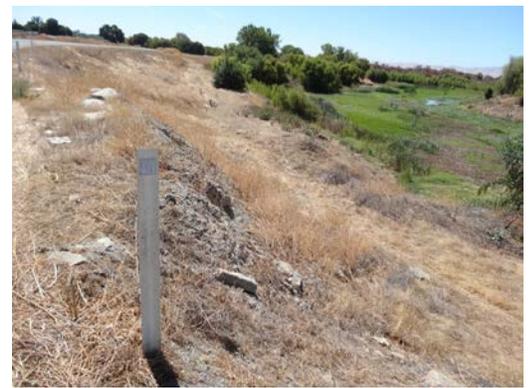
Looking upstream at the site.

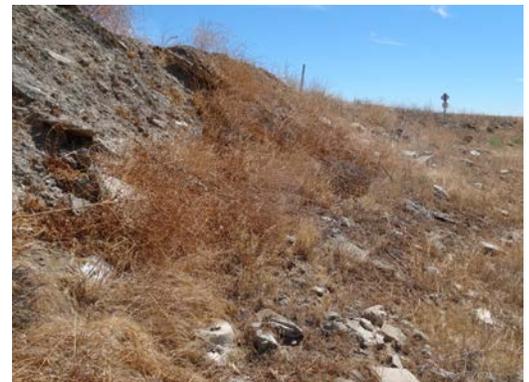
Looking downstream at the erosion site.

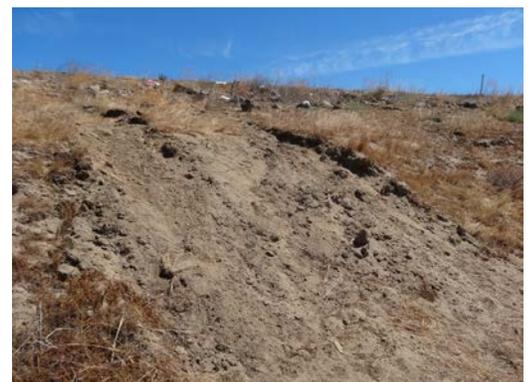
08/28/2015: No significant change observed. Loose material is visible at the upper levee slope. The loose soil may have been caused by runoff.  
 08/18/2014: No significant change observed.  
 09/10/2013: No significant change observed.  
 09/13/2012: No significant change observed.  
 08/18/2011: No significant change observed. Some new material added to the water side levee slope, but the added material is loose and seems not helping the levee protection.  
 10/05/2010: No significant change observed. Levee slope has minimal vegetation and lacks rip rap protection. Sandy material found on the lower and middle slope is an undesirable material to have on a levee.  
 08/05/2010: Recommended for annual assessment and monitoring during flood events, per CLRO.  
 08/20/2009: No major change since last visit; site is located in an oxbow; slope surface consists of very sandy material; there is a tree on site leaning and with exposed tree roots; site is recommended as a local maintenance issue, per CLRO CES Evaluation 2008 Report; Eddy Cordoza from the district is aware of the site and is looking for recommendation; site is previously rated "U".

Direct view of the levee slope. Note the loose soil possibly caused by runoff.

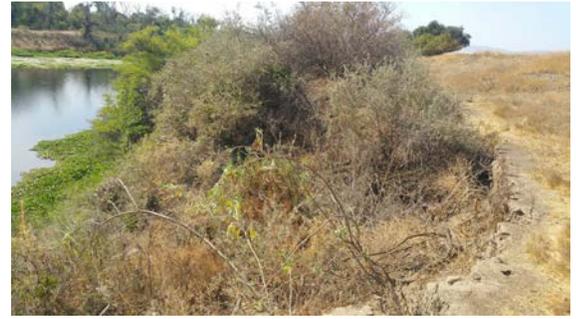
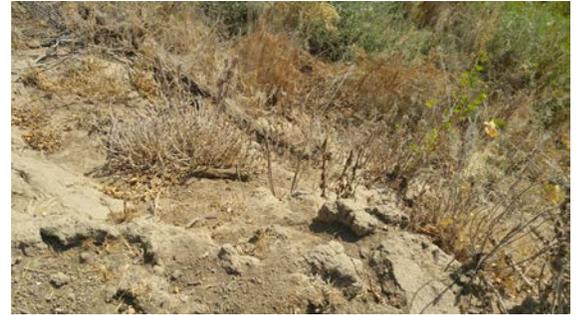
Close view of the erosion.

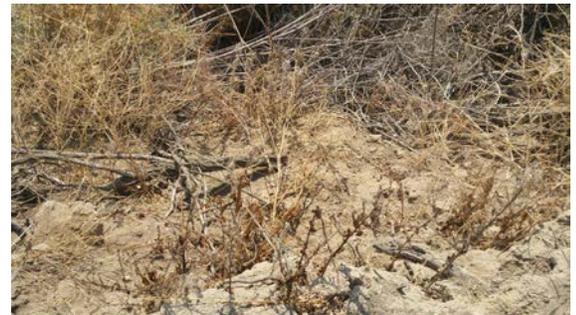
Direct view of the erosion. Note dense vegetation at the site.

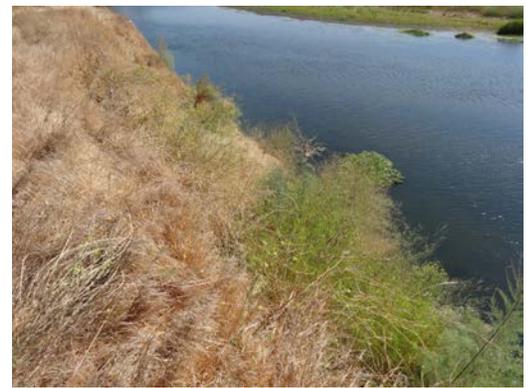
View of the downstream end of the erosion.

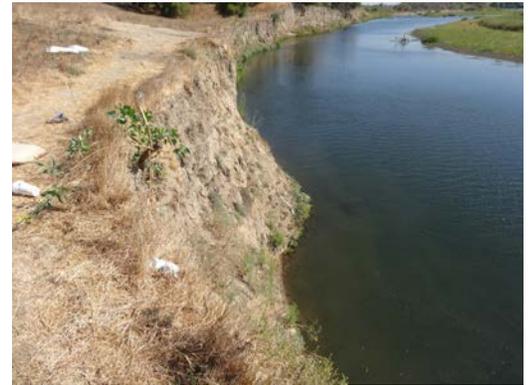
Close view of the erosion.

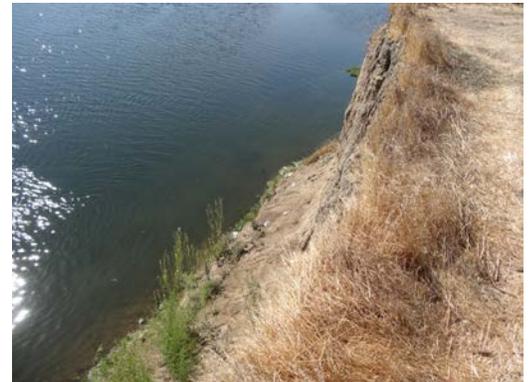
Direct view of the erosion.

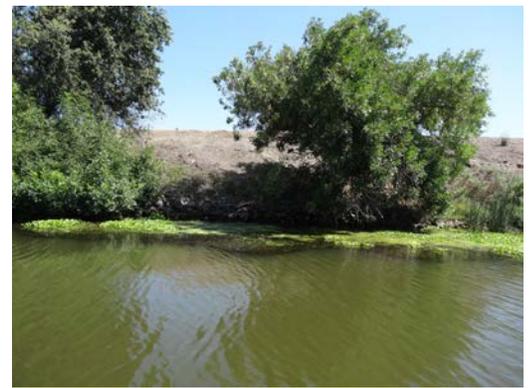
View of the erosion from the survey boat.

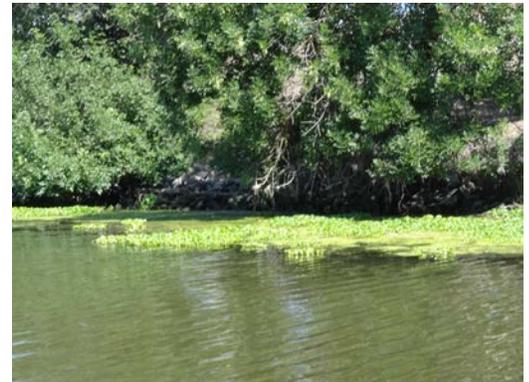
06/25/2015: No significant change observed.  
 07/02/2014: No significant change observed.  
 08/13/2013: The erosion is around a tree at the levee toe. Dense vegetation is visible.

Close view of the site. Note the tree and the vegetation.

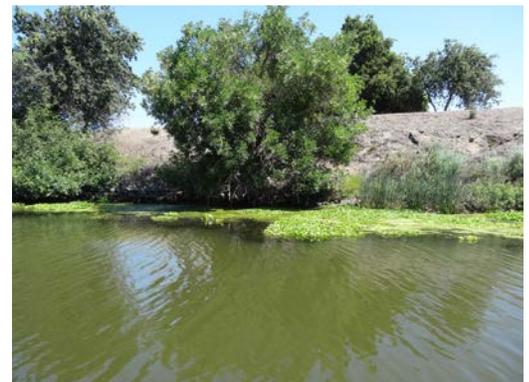
Front view of the erosion.

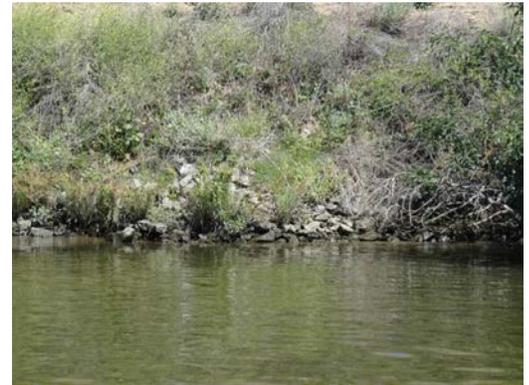
Front view of the site. Note the very dense white willow thickets on site.

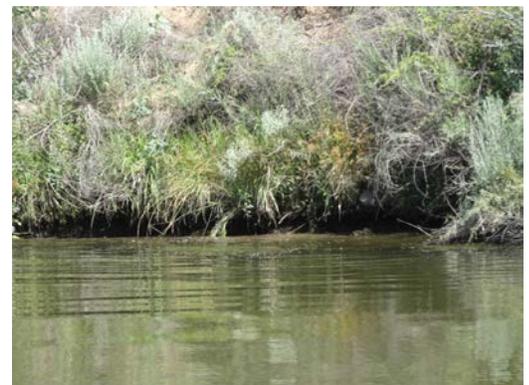
Front view of the site. Note the erosion is invisible because of the dense vegetation.

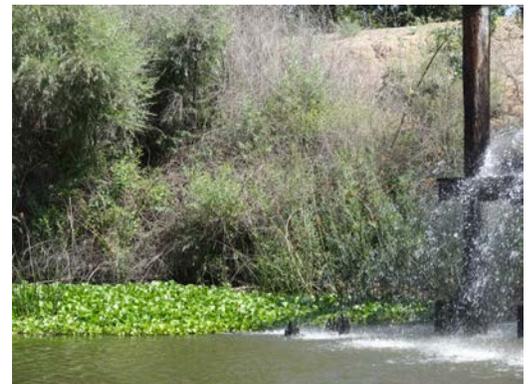
Close view of the site.

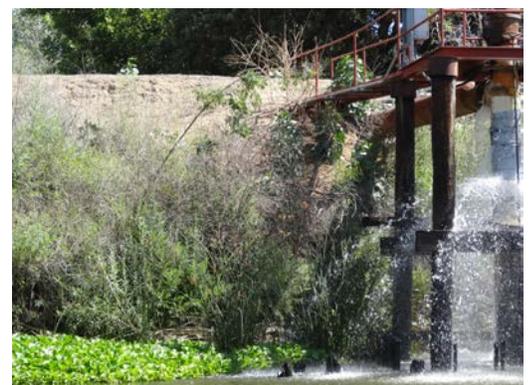
Close view of the site.

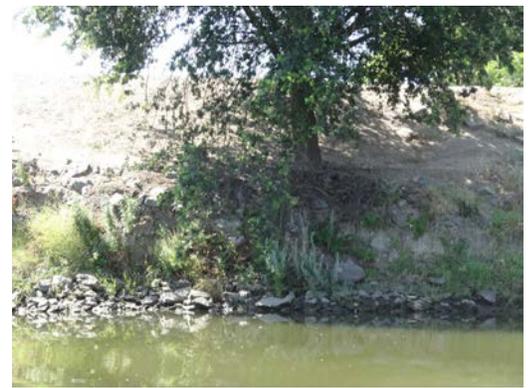
06/25/2015: The erosion is below a large oak tree. Vegetation is visible around the eroiosn site.

Front view of the erosion site. Note the large tree above the erosion.

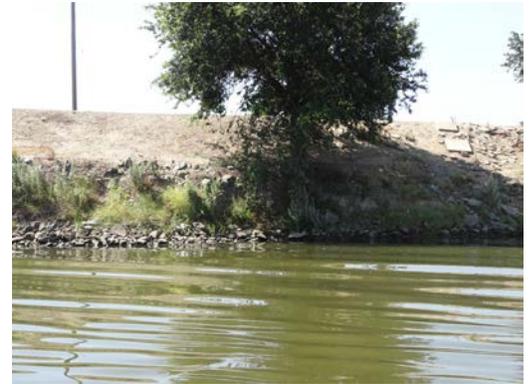
Close view of the erosion.

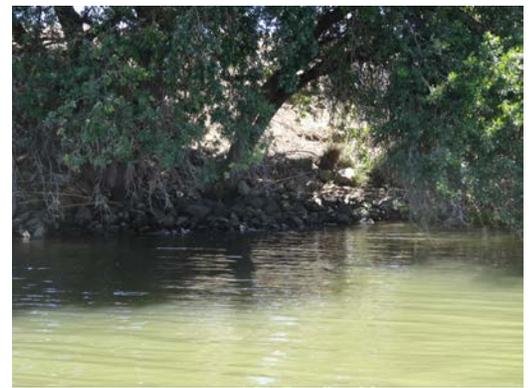
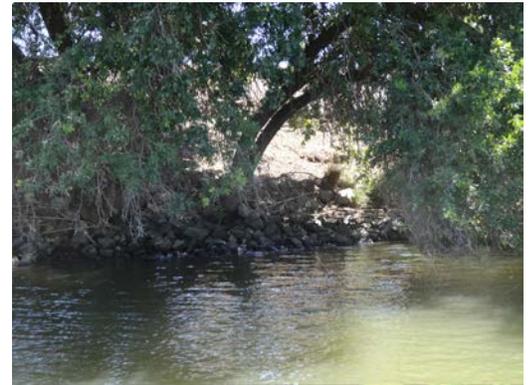
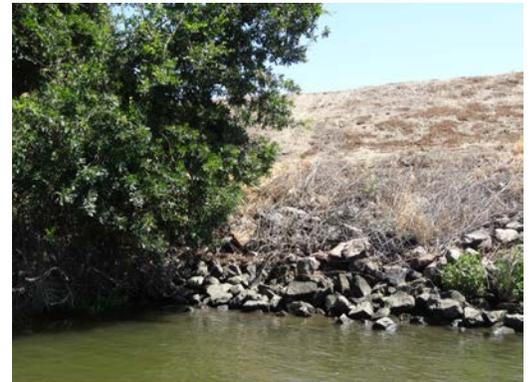
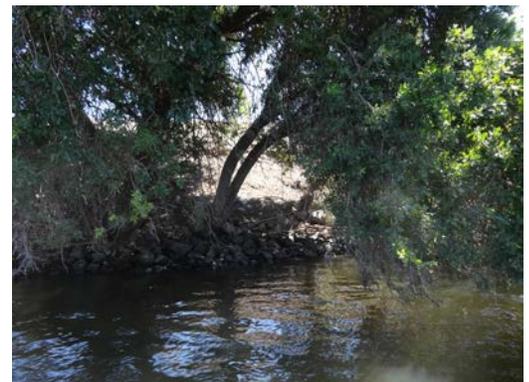
11/05/2008: Cut into levee profile; riprap slide; rodent holes; pictures do not match GPS and current condition.

View of the site from the survey boat.

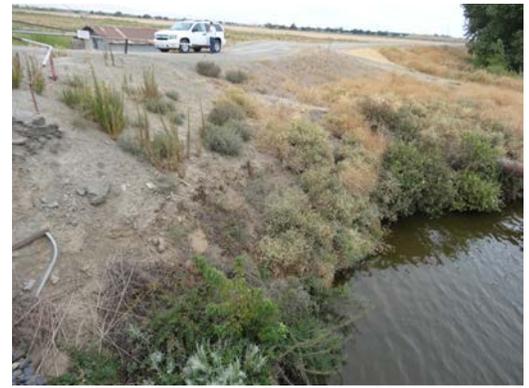
Direct view of the erosion upstream of Railroad bridge.

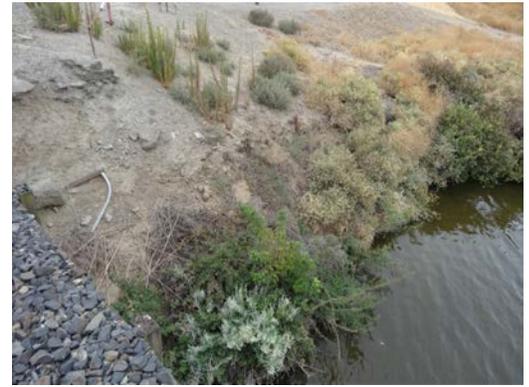
Looking down at the erosion downstream of the Railroad bridge.

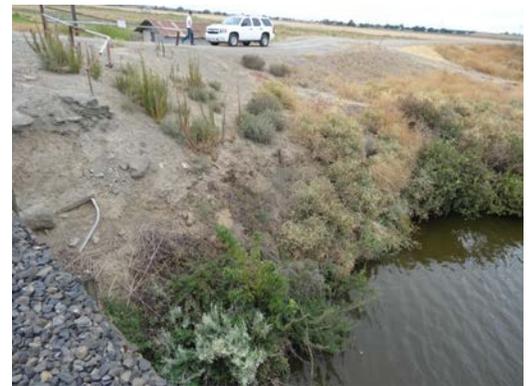
Close view of the erosion downstream of the RR bridge.

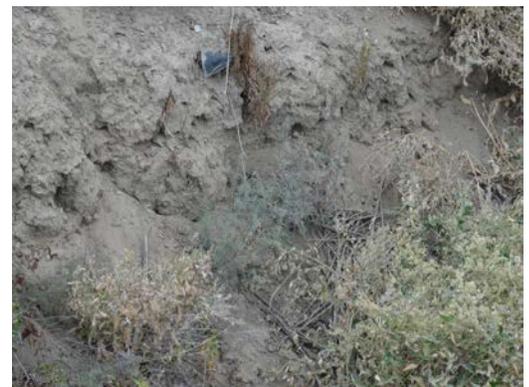
Close view of the erosion.

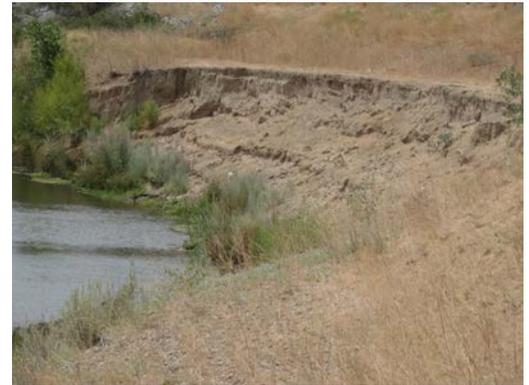
View of the erosion.

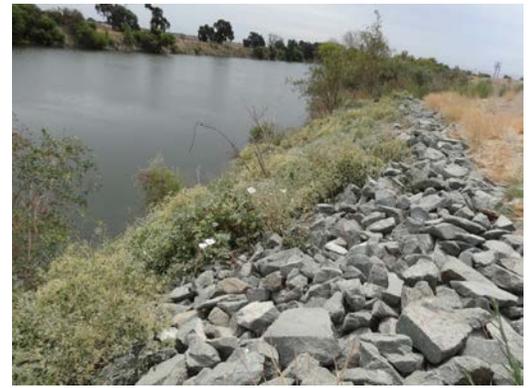
View of the erosion from the survey boat. The dense vegetation on the site blocks the view of the erosion.

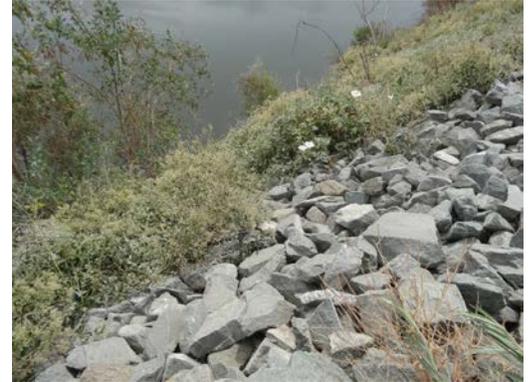
The erosion is not visible from the levee top. The levee slope is protected by riprap rocks.
