LMA: **NA0011 U02 Madera County FC** Waterway: **RB Ash Slough**  
 Site ID: **NA0011U02RM2.57** Status: **Existing Site**

Latitude: **37.055596** Longitude: **-120.412647** River\_Mile: **2.57** Levee\_Mile: **1.15** Overall Rating: **U**

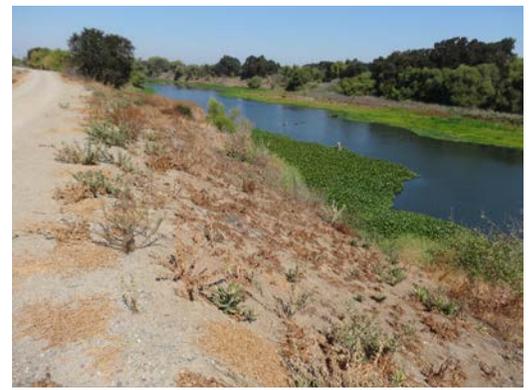
08/19/2015: No significant change observed.  
 07/17/2014: No significant change observed.  
 09/20/2013: Site has been visited. There are signs of further erosion development along the levee slope and toe.  
 07/18/2012: The erosion has further developed toward levee crown. Vegetation has been removed.  
 08/18/2011: The erosion progressed significantly during the past flood season. The levee toe along the erosion site was washed away, and the erosion has cut the levee structure up to the point about 1/3 of the levee slope. The scarp height is approximately 17 feet. Very dense vegetation and trees are visible.  
 10/19/2010: No significant change observed on site. Remaining levee berm topsoil is of silty sand mixture. The erosion is near the downstream transition. An eddy has formed, and has scoured away a 100-foot section of the bank, possibly encroaching into the levee prism. Vegetation on site includes willows, oak, and cotton wood located from the bench to the toe. On the landside are rows of corn crop.

Upstream view of the erosion.

08/05/2010: Recommended for Repair, per CLRO.  
 2009: Site recommended as annual assessment and monitoring if critical erosion site, per CLRO CES Evaluation 2008 Report; an eddy has formed, eroding bank and intruding into the levee prism; Site # is the same as RM76.3, LM1.89; previously rated "U".  
 08/30/2007: Recommended for short list of immediate repair sites; silty sand levee

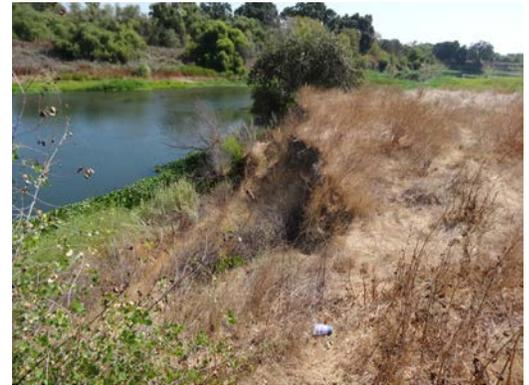
Downstream view of the erosion.

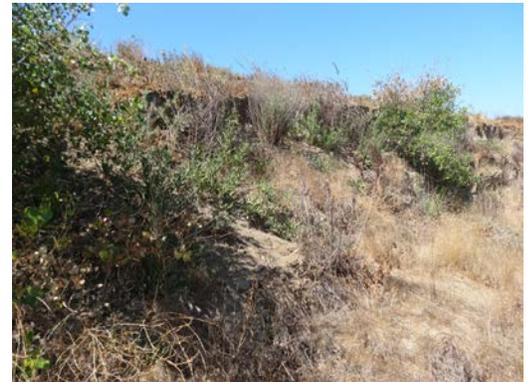
Close view of the erosion.

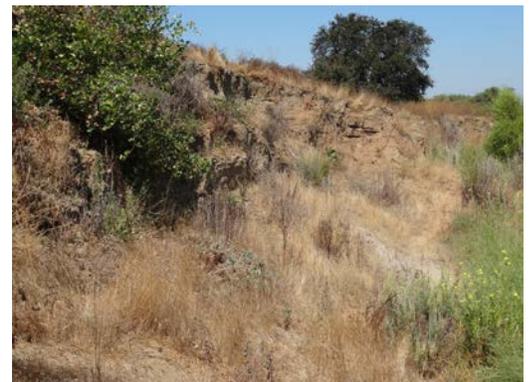
Close view of the erosion. Levee crest is approximately 8 feet above the erosion.
