LMA: **NA0010 U23 Lower San Joaquin Levee District**

Waterway: **RB San Joaquin River**

Site ID: **NA0010U23RM224.27**

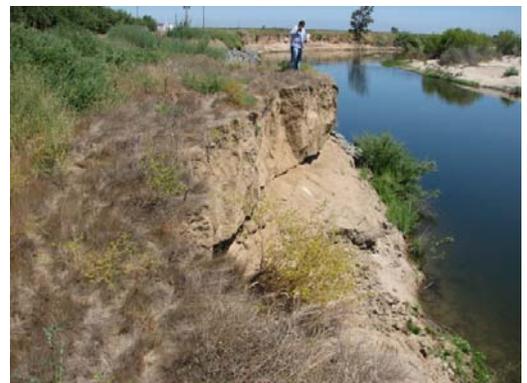
Looking upstream. This image shows the ending point of the riparian protection.

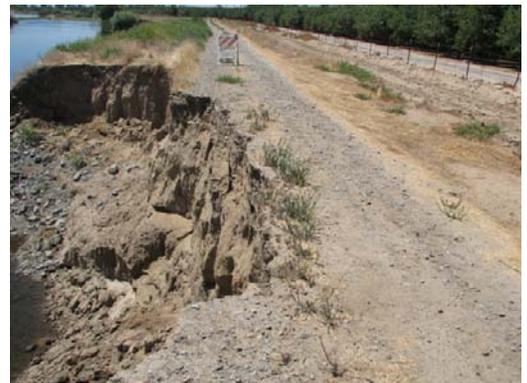
08/16/2011: The erosion is cutting into the levee. The site is located at the outside of a river bend, and the erosions were caused by river flows during the last flooding season. The ground was covered by dense grasses. Animal burrow holes are visible.

Looking downstream. The image shows the point where the erosion is cutting into the levee.

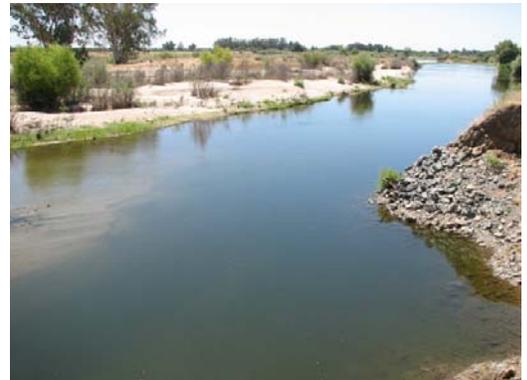
Looking downstream. The image shows the starting point of the riparian protection.

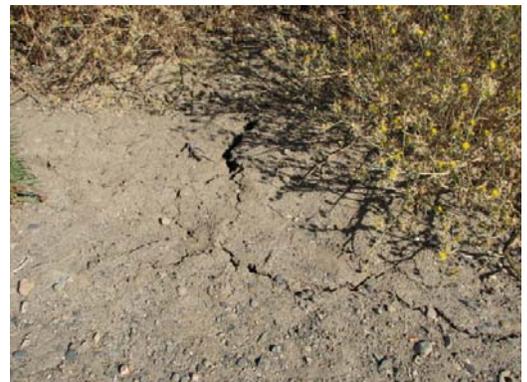
08/16/2011: No significant change was visible. Minor cracking on the waterside levee slope was spotted. 100 percent vegetation coverage with star thistles.  
 11/30/2010: Site was not inspected this year due to time constraints. There have been no reports from the district that the site has been corrected.  
 2009: Site recommended as local maintenance issue, per CLRO CES Evaluation 2008 Report; previously rated "U".  
 9/10/2007: GPS extended from opposite bank using Google Earth; signs of vehicular damage on levee.

Minor cracking visible on the site

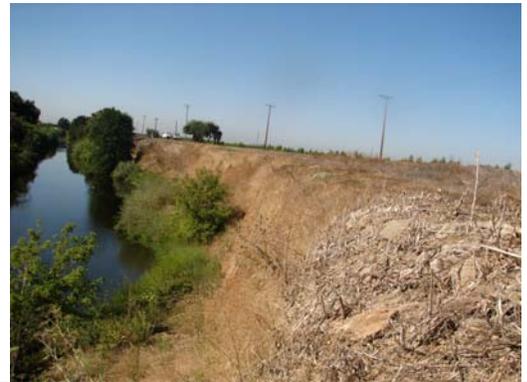
Looking downstream

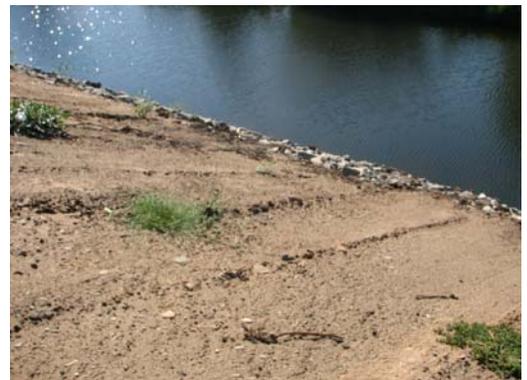
Close view of the repaired site. Note the riprap at the toe

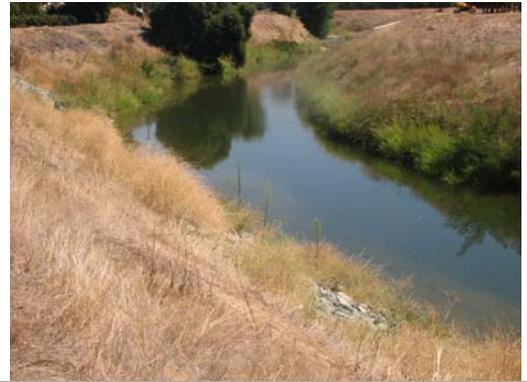
Downstream view of repaired site. Note the pocket erosion downstream of the riparian protection.

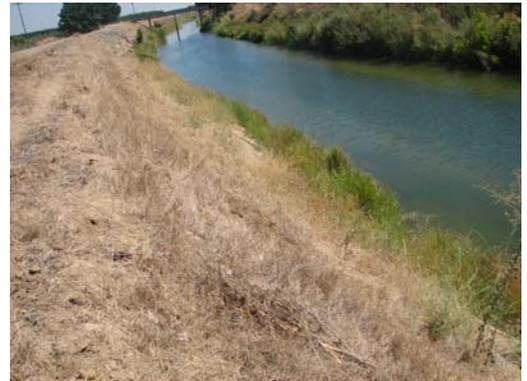
Looking at the upstream of the repaired site. Note the pocket erosion at the toe.

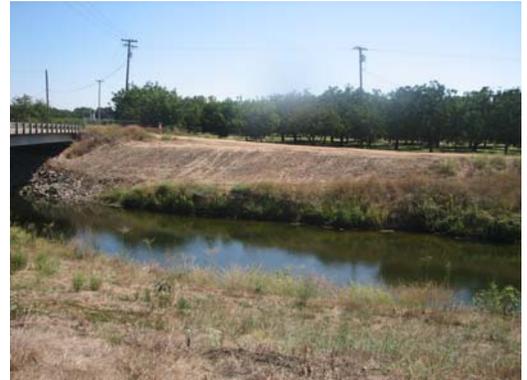
Looking at the site from right bank, downstream of the bridge

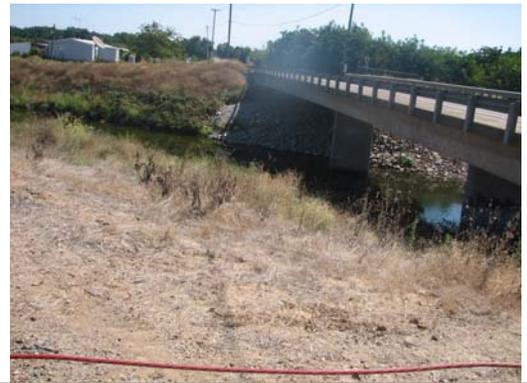
Upstream view of the site below east end abutment of Milton Bridge.

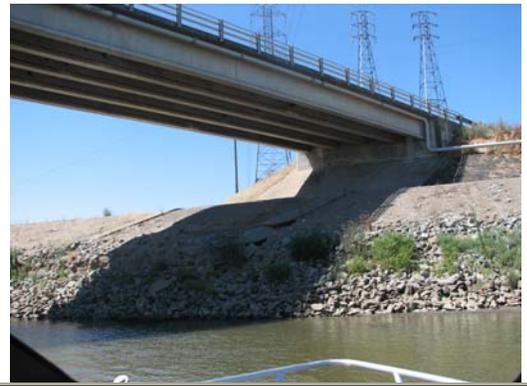
Comments:  
 08/23/2011: The repaired site shows no sign of new erosion activity. Vegetation visible on the site.  
 9/07/2010: Site has been repaired. Shot rock was placed on site. Site was previously rated "M".  
 9/29/2009: Pocket erosion just below and across the abutment of Howard Road Bridge; existing toe rip rap and concrete slabs in place; erosion may develop into a larger pocket erosion if no corrective action is taken.

Direct view of the repaired site. Vegetation visible on site.

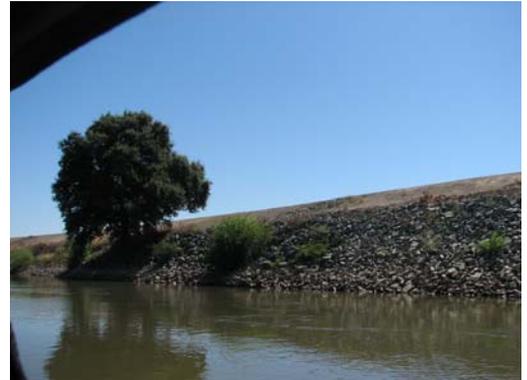
Tree and vegetation visible on the site

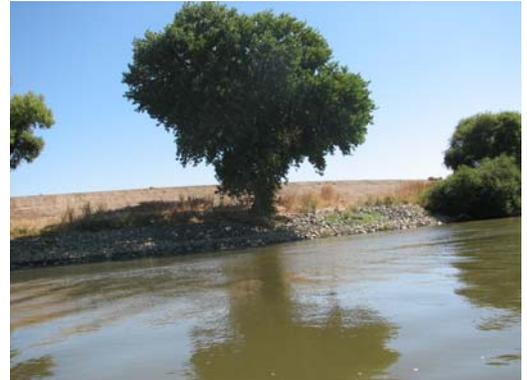
Direct view of the repaired site.

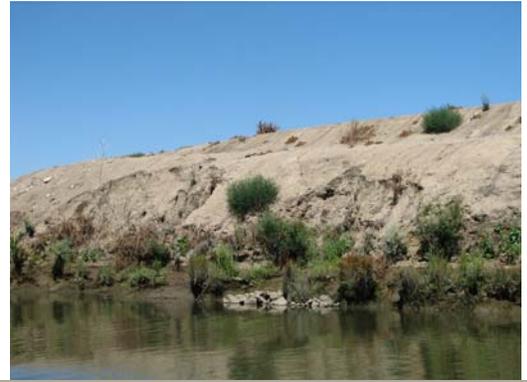
Front view of the site

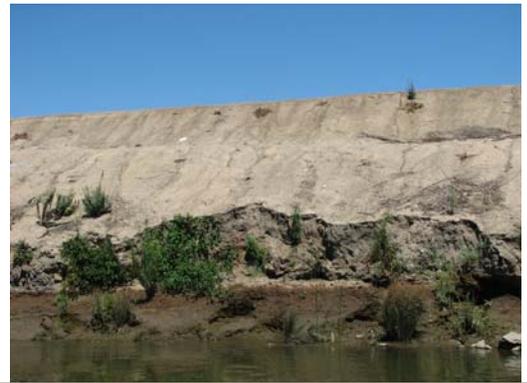
Front view of the site

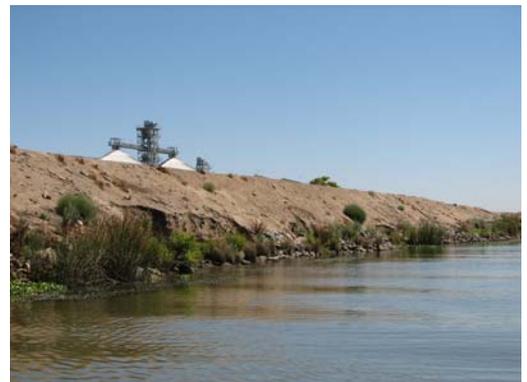
Upstream view of the site

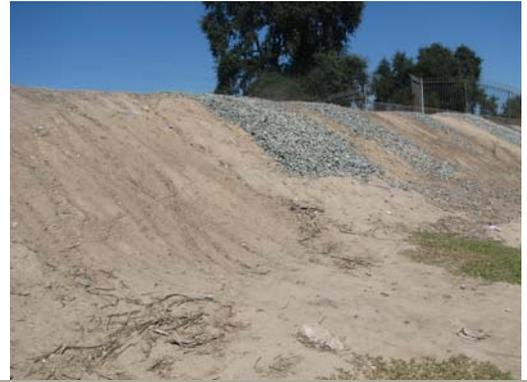
Looking from the levee toe at the site.

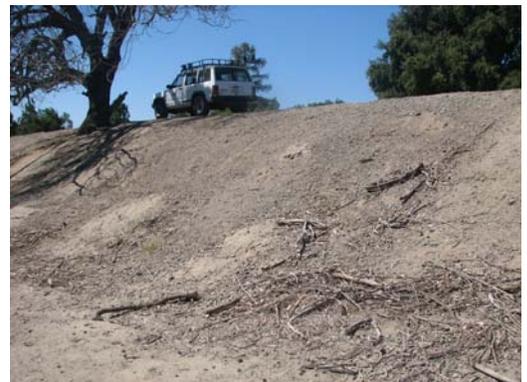
Looking downstream from levee toe

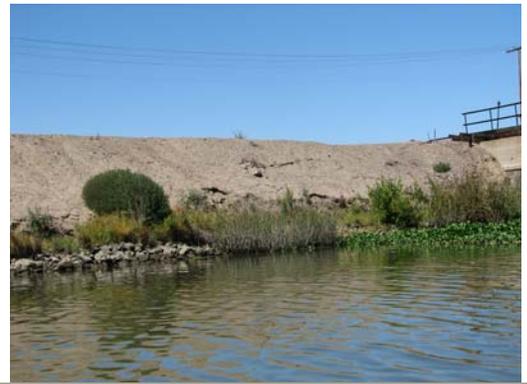
08/23/2011: The site is located immediately upstream of a Railroad bridge. Dense vegetation at the water line interferes the view of erosion.

Upstream view of the erosion site. Note the railroad bridge.

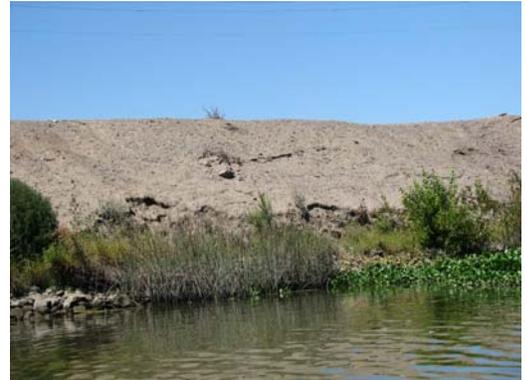
Front view of the erosion site. Vegetation visible

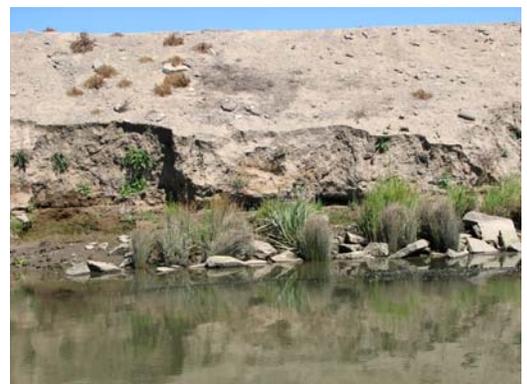
Front view of the erosion

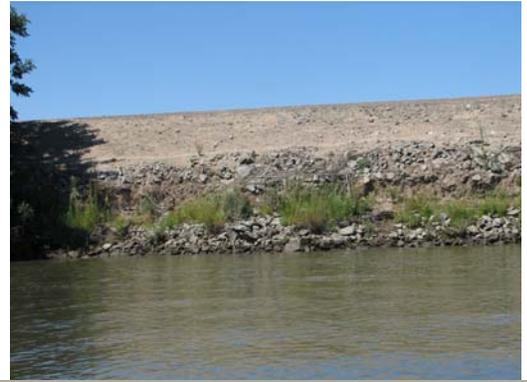
A closer view of the erosion

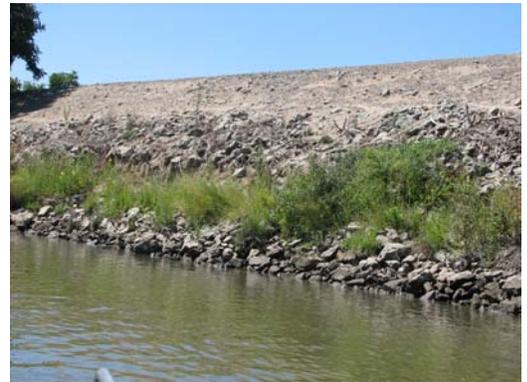
Front view of the erosion

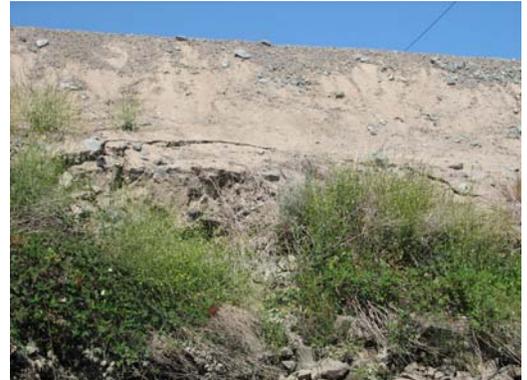
Front view of the erosion. Note the notches caused by the cracking

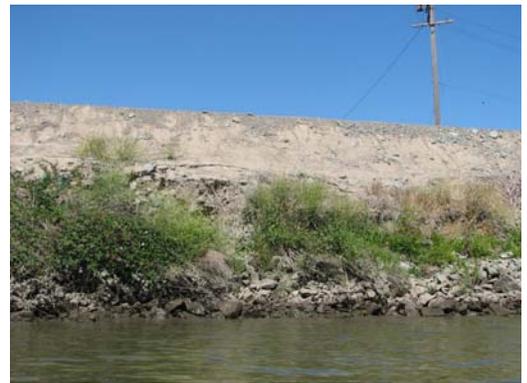
Front view of the site.

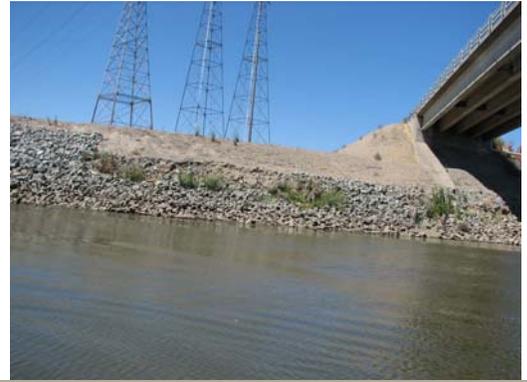
Sloughing rip rap adjacent to Howard Bridge.

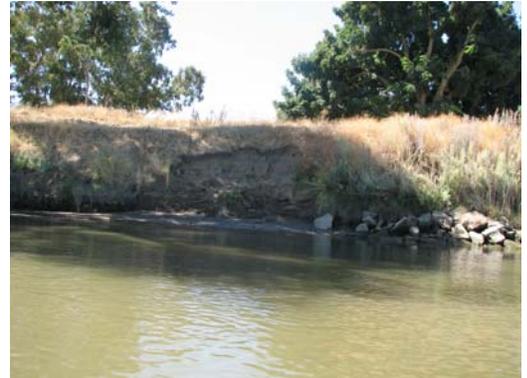
Upstream view of the site where undermining of the slope has occurred.

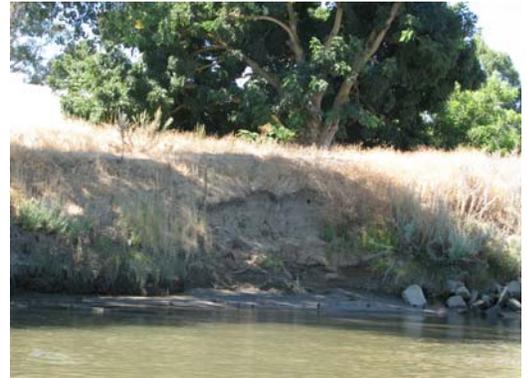
Front view of the site.

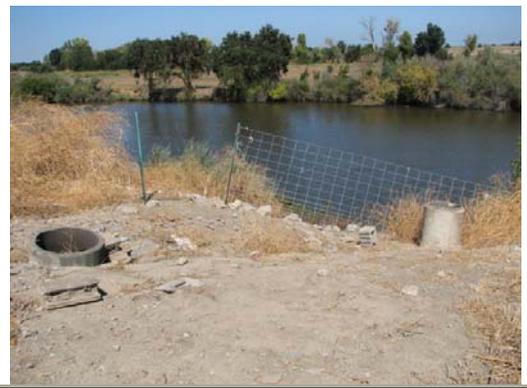
Downstream view of site. Note the fenced area

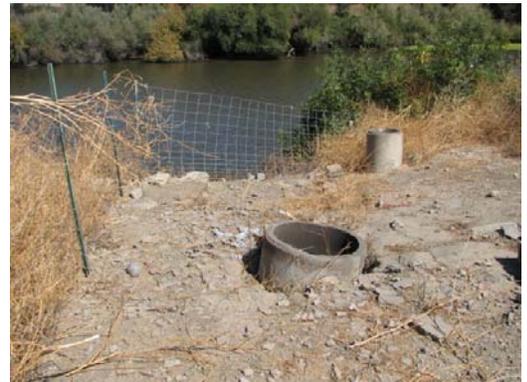
Direct view of siphon breaker.

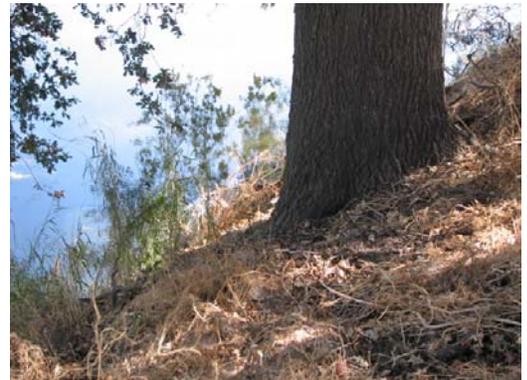
Upstream view of the base of 1 of 2 large Oake trees on site. No signs of scouring on the base.

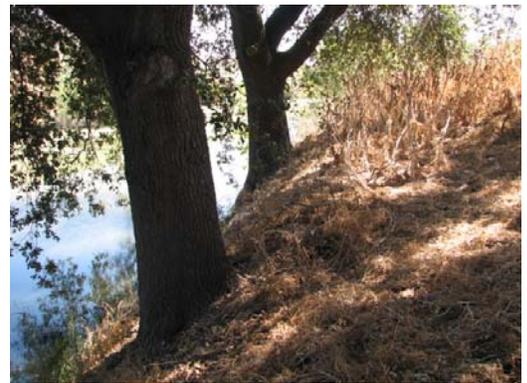
Upstream view of both Oak trees located on the bench.

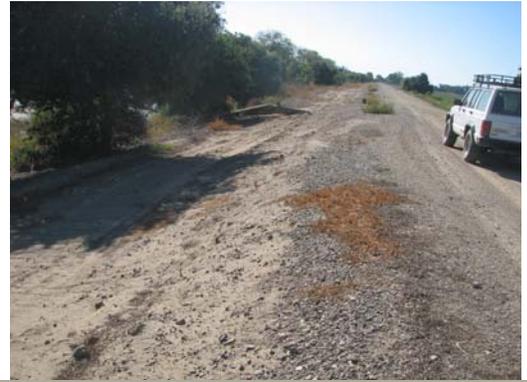
Upstream view of scarp.

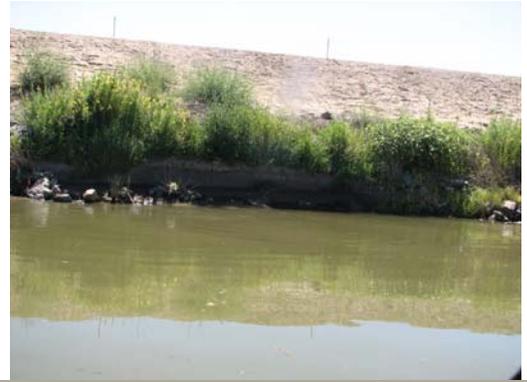
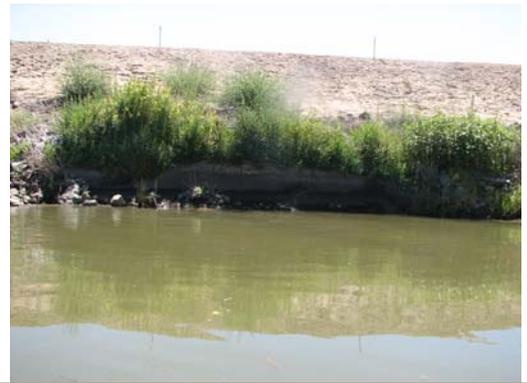
Front view of the erosion

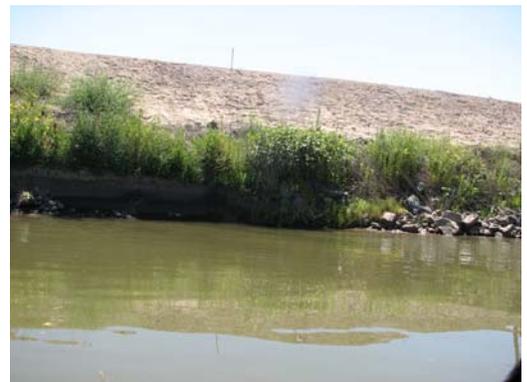
Front view of the site. Note the protection downstream of the erosion

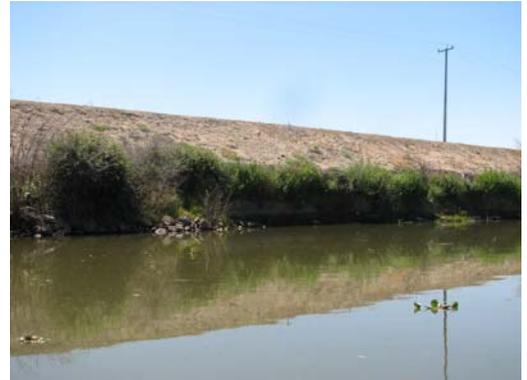
Another view of the same 5-ft scarp.

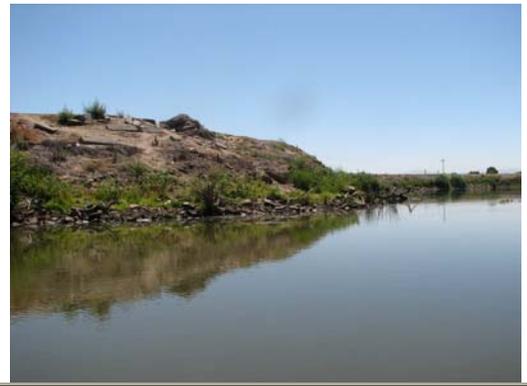
08/23/2011: No significant changes observed on site.  
 09/07/2010: No significant changes observed on site. Much of the placed rip rap revetment has slid. It is no longer adequately protecting the slope.  
 08/06/2010: Recommended as local maintenance issue, per CLRO Report.  
 03/09/2010: As discussed with Michael Moncrief of MBK, site will be 'addressed' this year.  
 09/29/2009: No major change observed since last visit; a section of the rip rap has slipped, exposing a levee section that has eroded; recommended as local maintenance issue, per CLRO CES Evaluation 2008 Report; Site # is the same as RM30.43,LM0.63; previously rated "U".  
 11/05/2008: Site is located inside of a bend; scarp looks to be into the levee prism; piles of concrete chunks placed on the slope, with some of them already starting to slide.

Upstream view of the site.

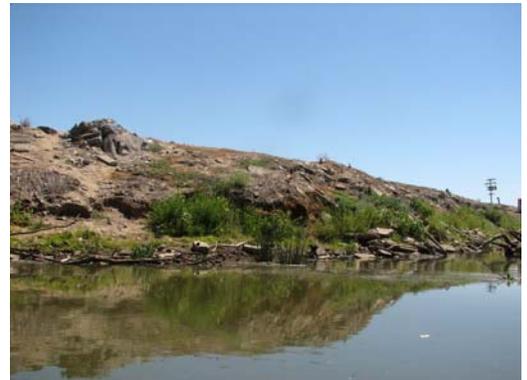
Downstream view of the site.

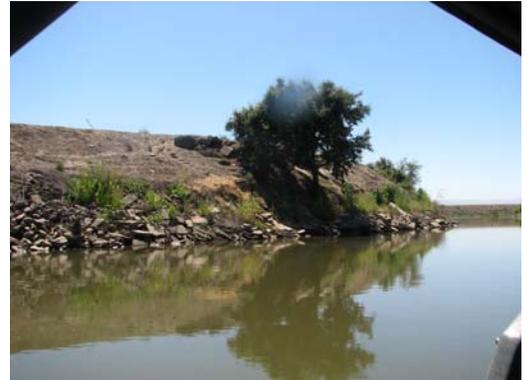
A closer look of the site

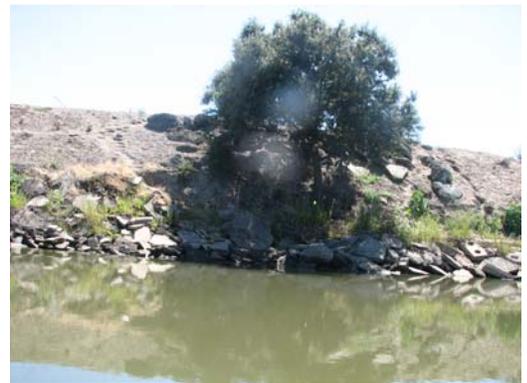
Front view of the site. Note existing broken concrete on the upper slope as well as on the lower slope and at the toe.

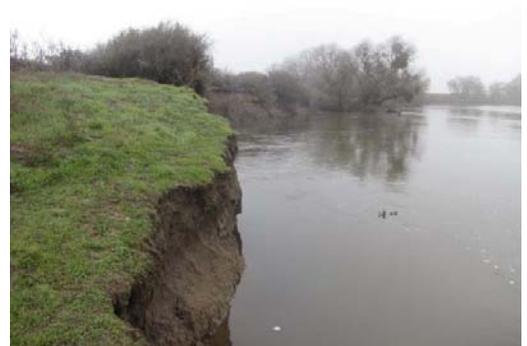
Looking south from station 0+00. Image taken by Herman Phillips

10/14/2011. This site was reported on Jan. 18. 2011. The first 100' of erosion appears to be a pervious cut with fresh activity. At station 2+00 the district president indicated that 60 - 80' of material eroded. The remainder berm width is at least 32 ft from the levee toe. As the levee is not at risk at this time, the site is not rated, but needs to be closely monitored for possible erosion failure during the upcoming flooding season.

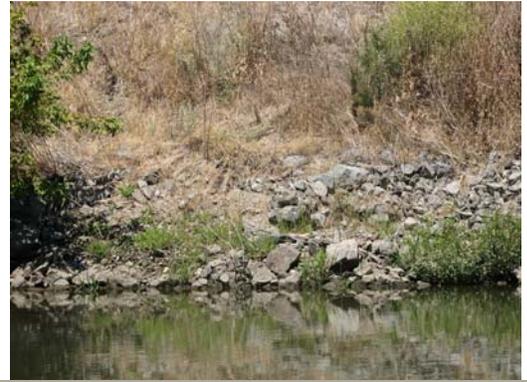
08/23/2011: Minor erosion activities are observed at the toe of the rip rap. Dense vegetation can block view for potential erosion.

Front view of the site.

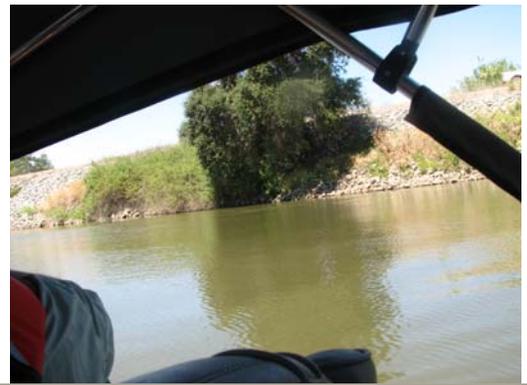
Front view of the site.

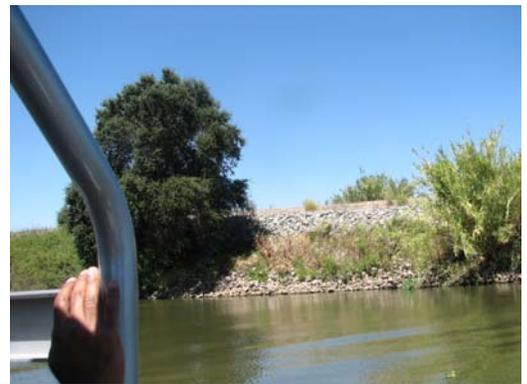
Downstream view of the site.

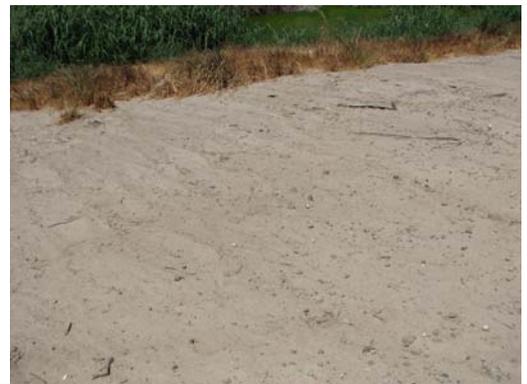
Close-in view of the repaired site.

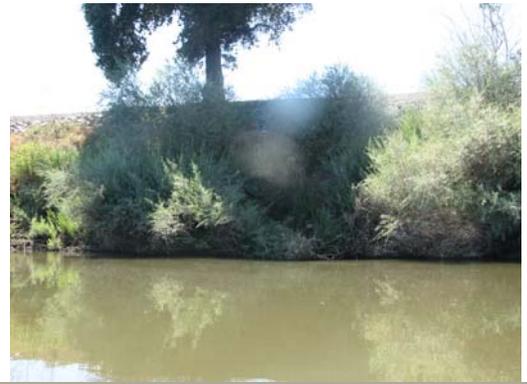
09/23/2010: At the time of the inspection, the erosion site was difficult to view from the levee. Erosion is located on the bank toe, below the existing rip rap. There were no signs of repair on site, nor has the site been reported to be repaired by the district. Images taken from last year indicate that existing rip rap at the bank toe has sloughed exposing the underlying soils. Weakening of the toe could lead to future bank instability.

09/29/2009: No major change observed since last visit; sloughing of the rip rap above toe; erosion begins immediately downstream of existing rip rap revetment; roughly 15-foot berm remains; however, it will continue to erode and eventually intrude into the levee profile if left untreated.

Front view of the erosion.

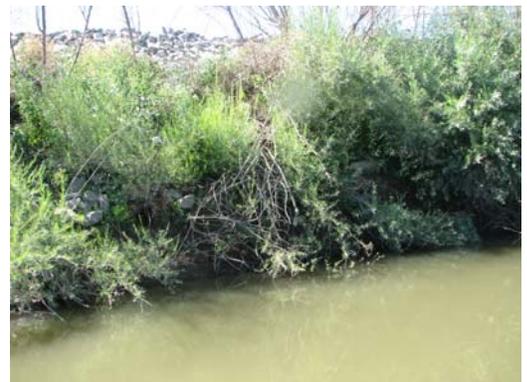
Direct view of the erosion.

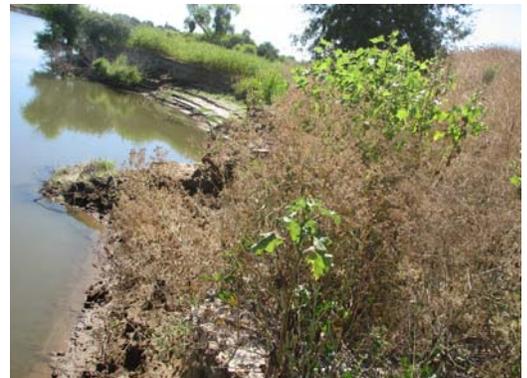
Looking upstream at the scour site. The dense vegetation visible.
