LMA: **NA0010 U23 Lower San Joaquin Levee District**

Waterway: **RB San Joaquin River**

Site ID: **NA0010U23RM224.27**

Status: **Repaired Site**

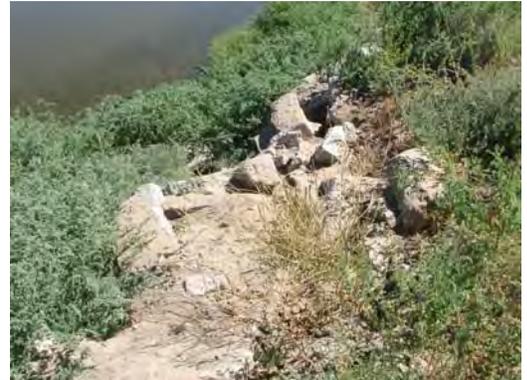
07/24/2012: Site has been repaired with riprap rocks and broken concrete blocks, but loose material and cracking are visible at the top of the repaired site. The site needs close monitoring for performance evaluation.

Looking downstream standing at the middle of the erosion site. Note the cracking and loosen material

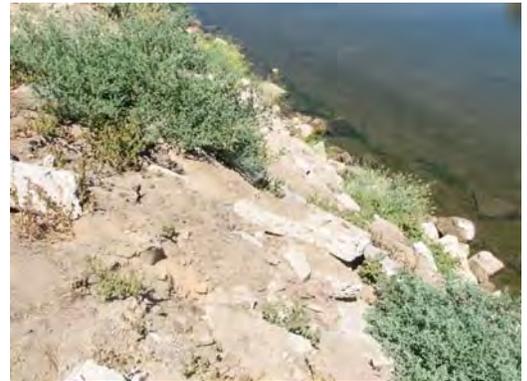
Close look at the repaired site.

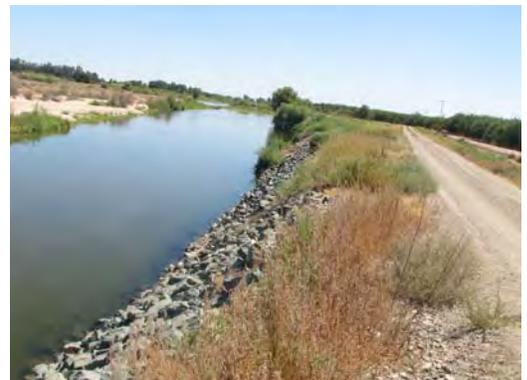
Looking downstream.

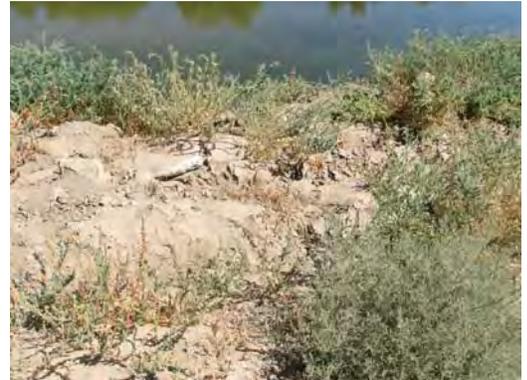
07/24/2012: The site has been repaired with clay material, riprap rocks, and broken concrete blocks, but the loose material and large crackings at the repaired site are visible. Need monitoring for the performance during the coming high flow events.

A close view at the repaired site at the corner of the river bend. Note the losen material and cracking

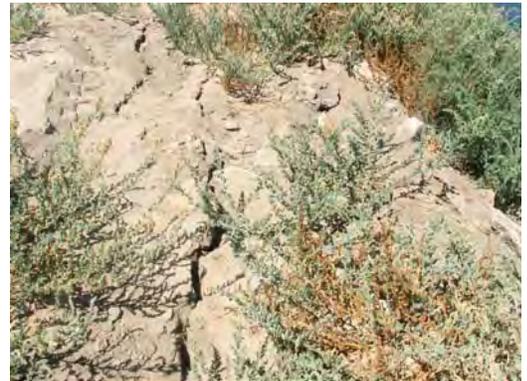
Looking downat the cracking at the repaired site

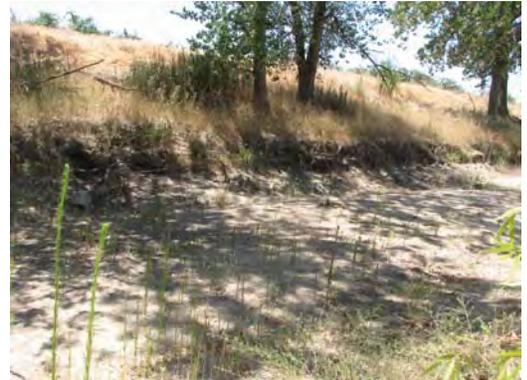
View from the riverbed

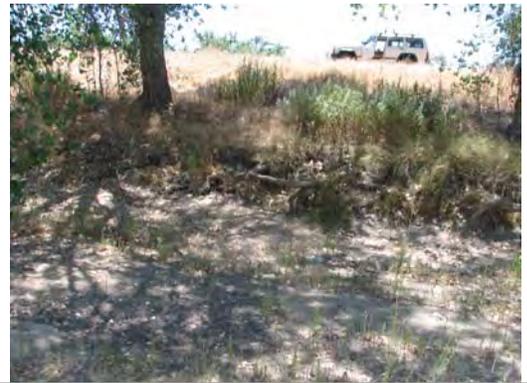
Tree roots exposed

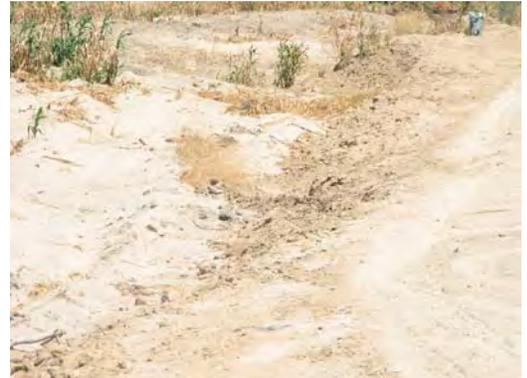
New dirt added to the levee

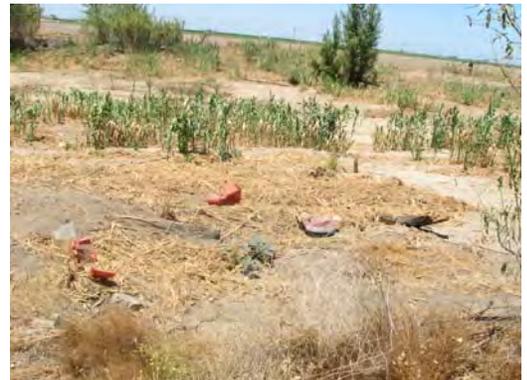
Notice the trash on the site

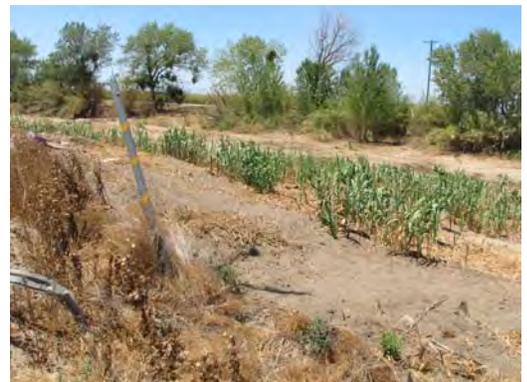
Vegetation on the levee

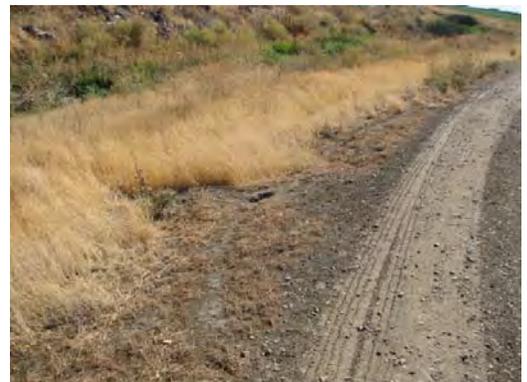
Minor cracking observed last year at the levee shoulder not visible because of the dried grass

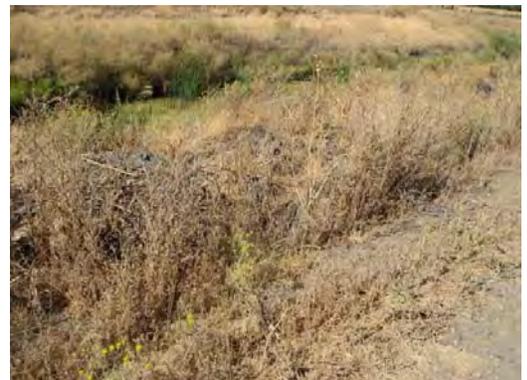
Minor cracking visible on the site

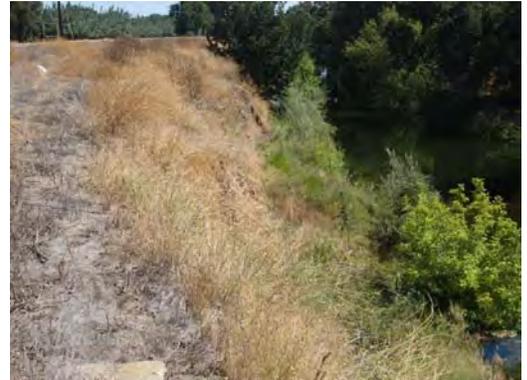
Close view of the erosion. Note the dense vegetation and tree on site.

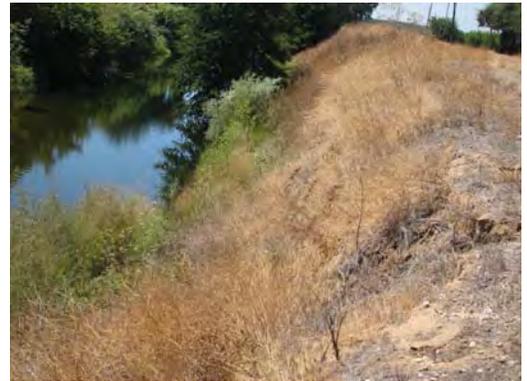
Close view of erosion site. Note the sloughing soil at the shoulder.

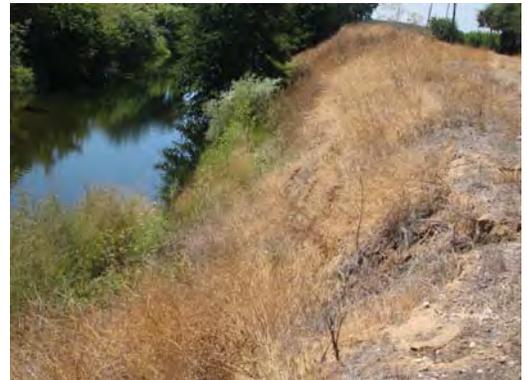
Closer look at the site. Sliding soil at upper slope.

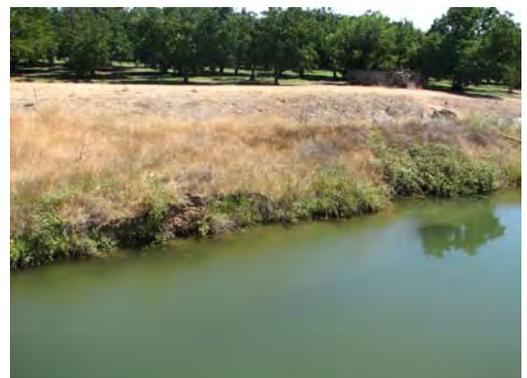
08/22/2012: Site is visited and no new erosion activity found at the repaired site, but new pocket erosion has developed at the toe downstream of the bridge.
 09/02/2011: The site has been repaired by the district. The site was previously rated "M".
 11/02/2010: No significant changes observed on site. Bridge scour has created a pocket erosion, exposing a portion of the underlying concrete padding.
 8/11/2009: Site is adjacent to abutment on Milton Road Bridge; pocket erosion has developed and will continue to expose the bridge foundation; this erosion appears to be critical as it may affect the bridge foundation.

The new developed erosion immediately downstream of the bridge. Viewed from the right bank.

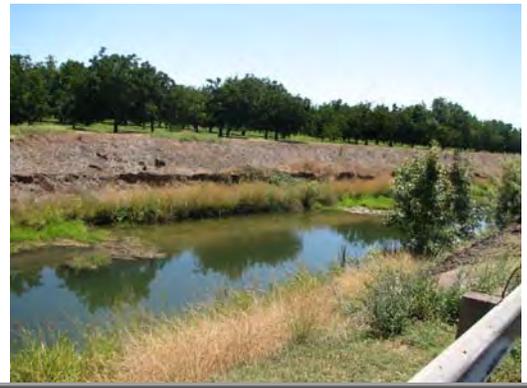
08/22/2012: The site is located at the oppsite river bank of E. Tobacco Road.

Looking downstream at the site

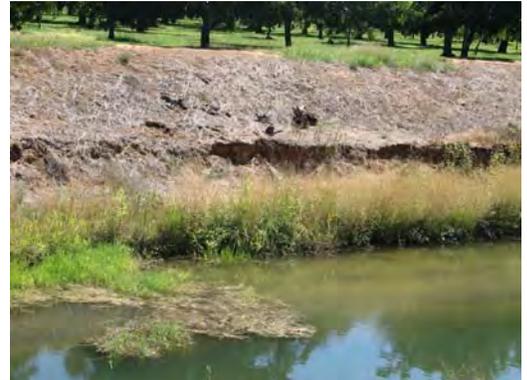
Closer view of the site

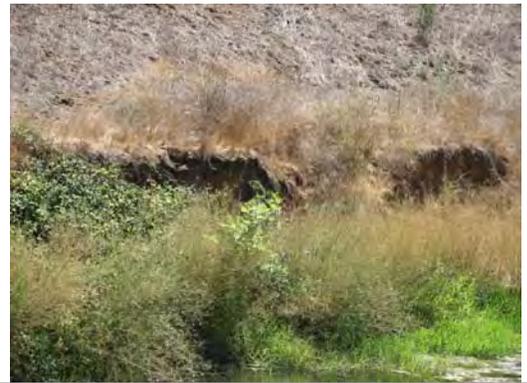
Closer view of erosion

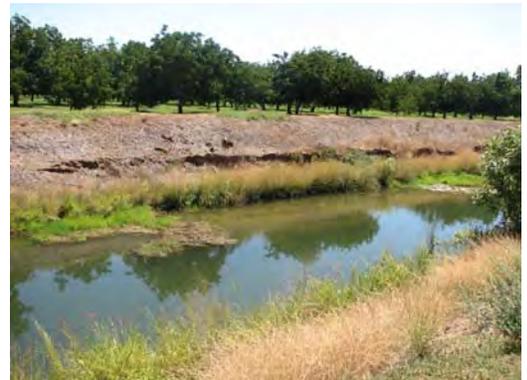
Front view of erosion

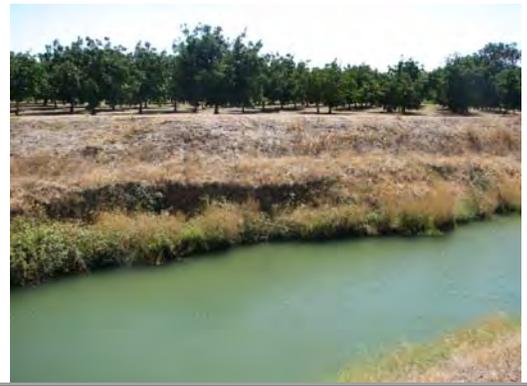
08/22/2012: Dense vegetation on site

Front view of erosion

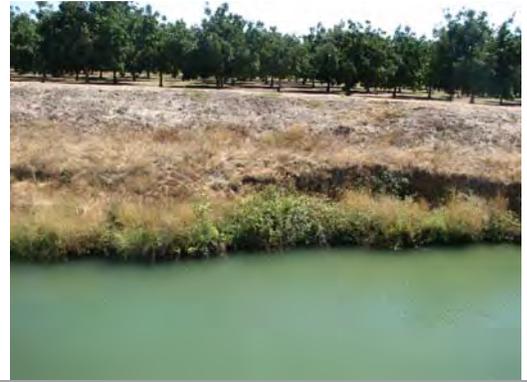
Front view of erosion

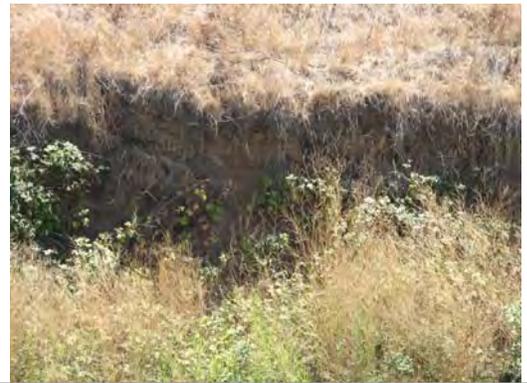
Closer view of erosion

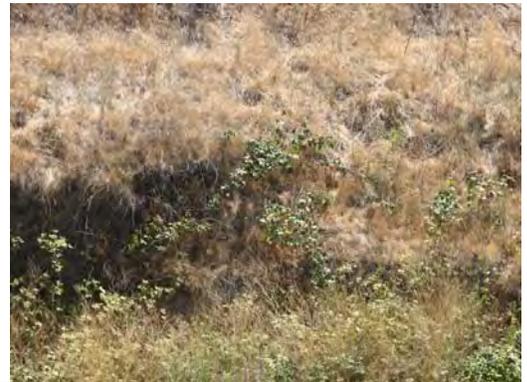
Close look at the erosion

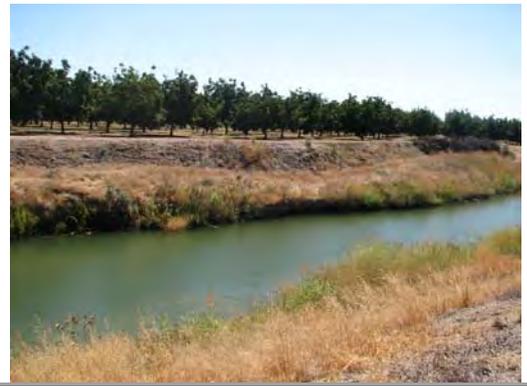
08/22/2012: Erosion is on berm. The berm width is estimated.

Looking downstream at the erosion

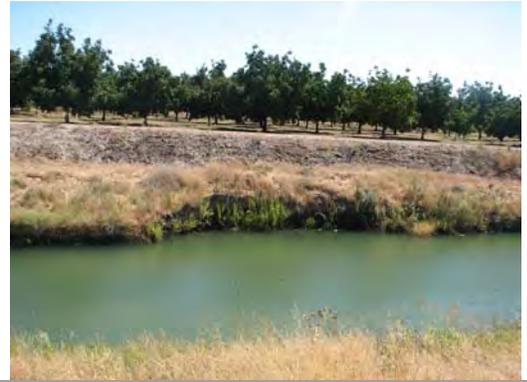
front view of erosion

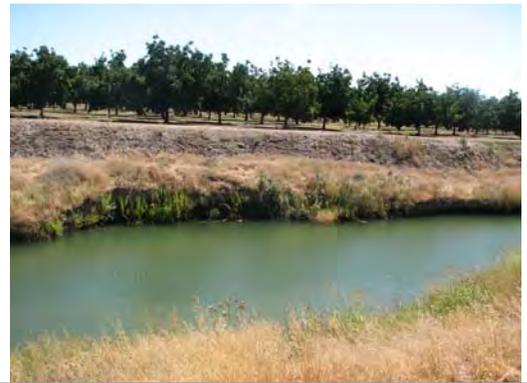
Front view of erosion

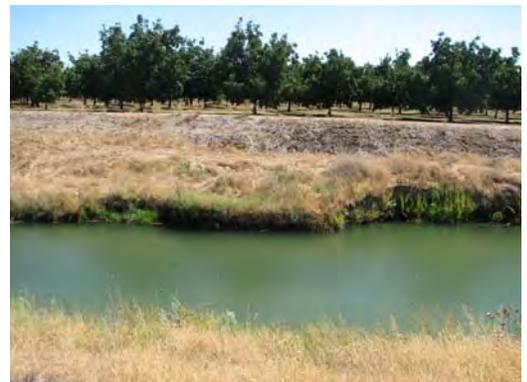
Front of view of erosion

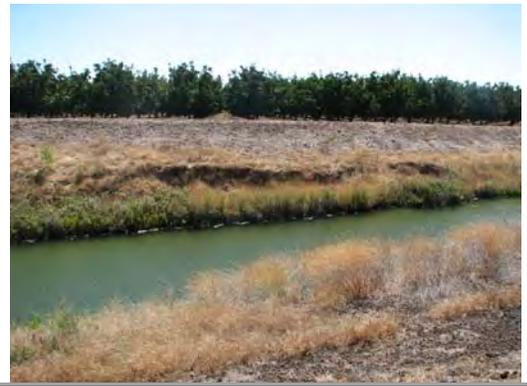
08/22/2012: Erosion is covered with dense vegetation.

Looking downstream at the erosion

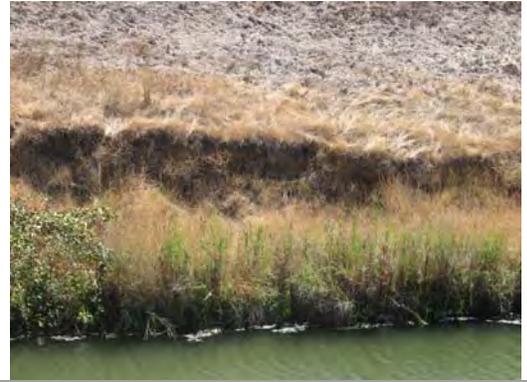
Close view of erosion

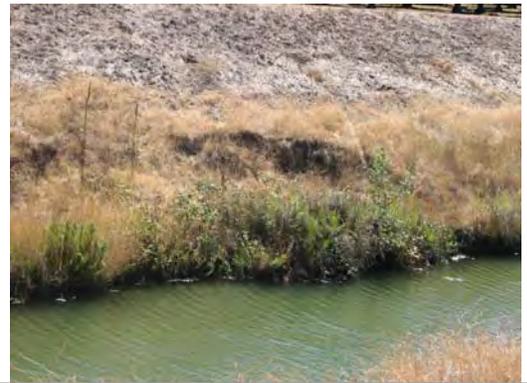
Another close view of erosion

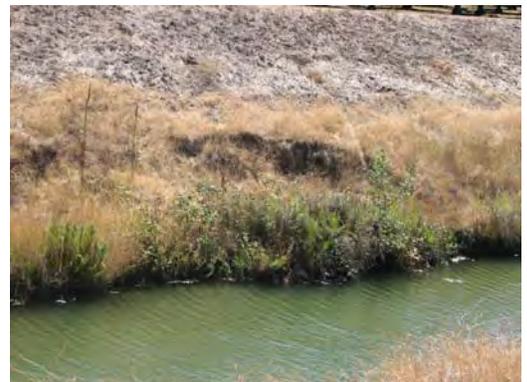
Front view of erosion

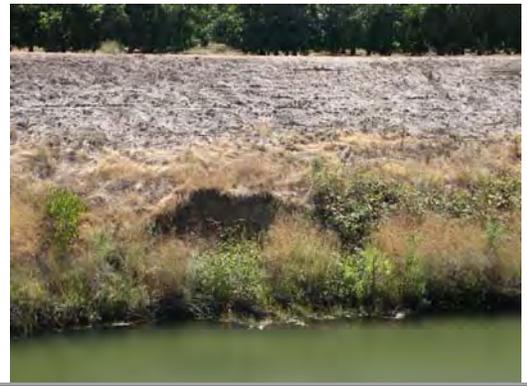
08/22/2012: Pocket erosion at the levee toe and slope. The erosion is covered with dense vegetation.

Front view of erosion

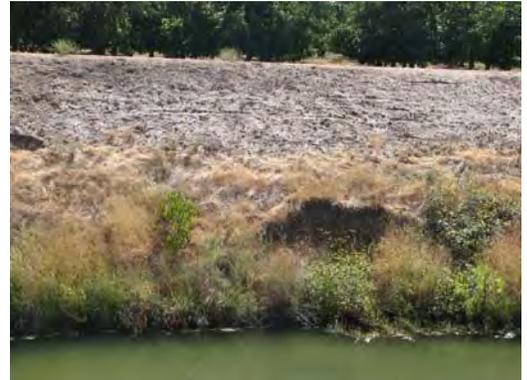
Front view of erosion

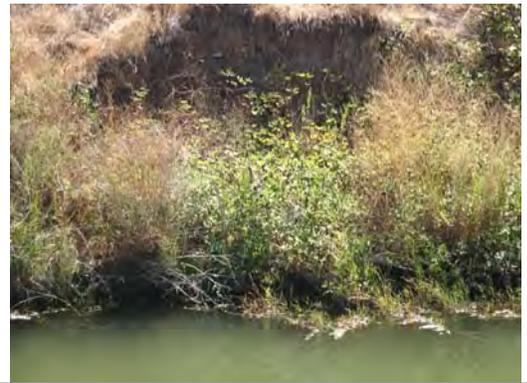
Closer view of erosion

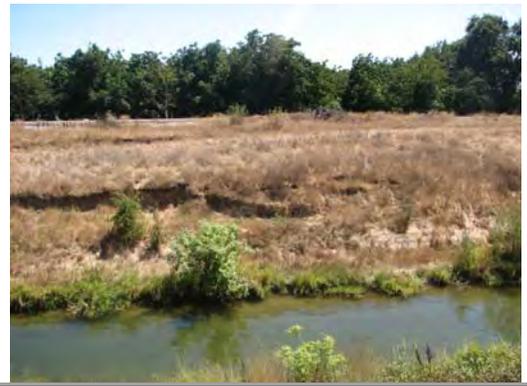
08/22/2012: Erosion occurred on a berm of approximately 25 ft wide. Site is covered with dense vegetation.

Front view of erosion

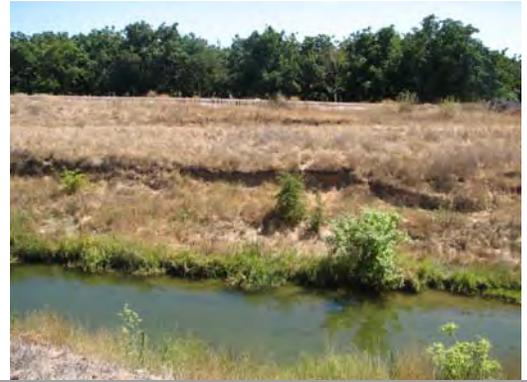
Front view of erosion

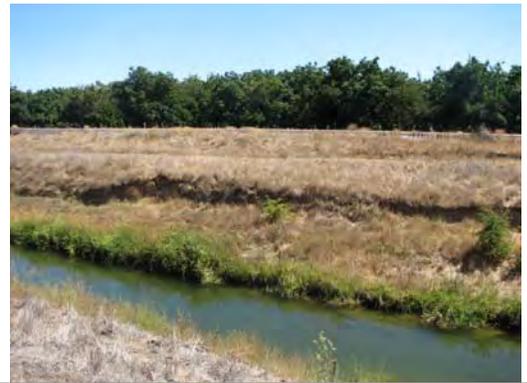
Front view of erosion

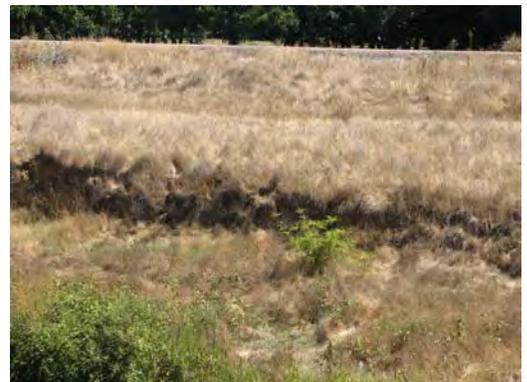
Closer view of erosion

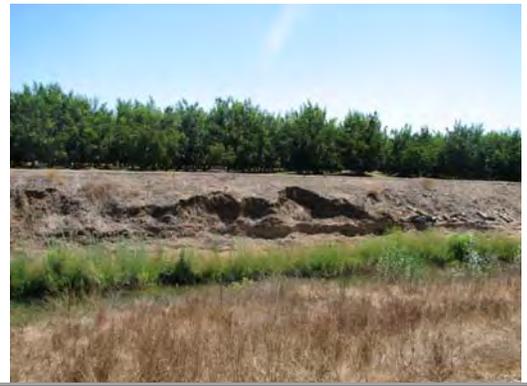
08/22/2012: Discontinuous scarp or pocket erosions occurred along a long stretch of the river, with a highest height larger than 25 ft at certain points.

Looking at the most downstream erosion at the site.

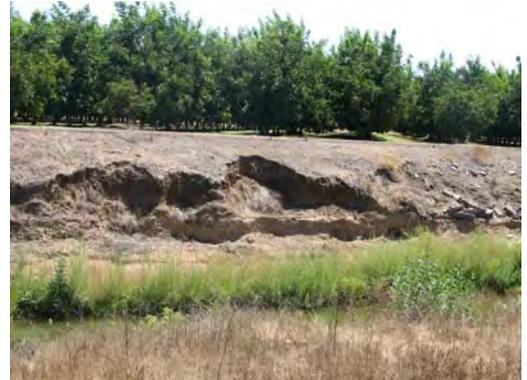
Closer view of the erosion

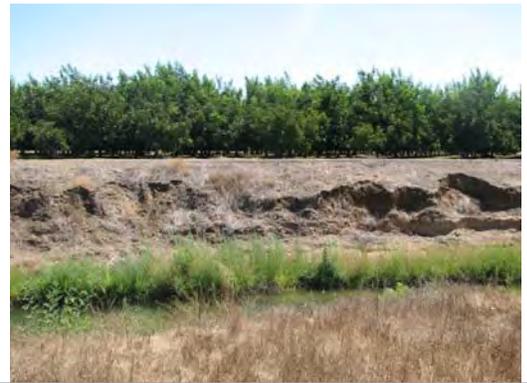
Front view of the erosion

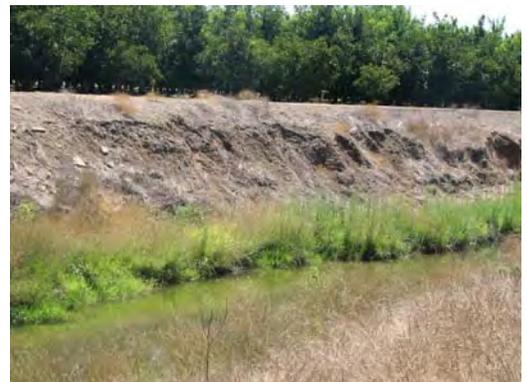
Front view of erosion

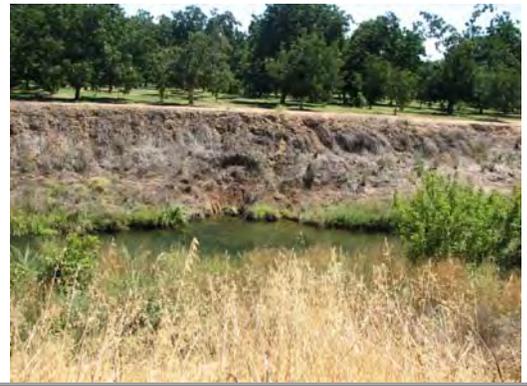
08/22/2012: A pocket erosion at the levee toe and on lower slope. The levee surface at the upper slope also shows signs of erosion due to poor maintenance.

Front view of erosion

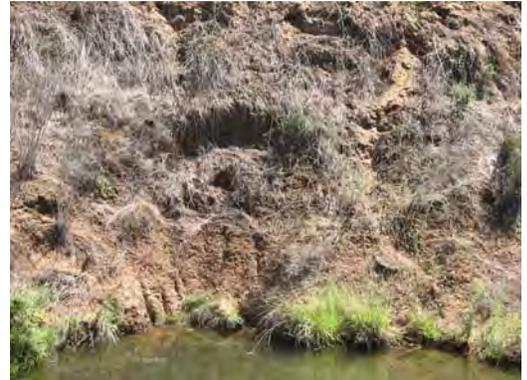
Close look at the erosion

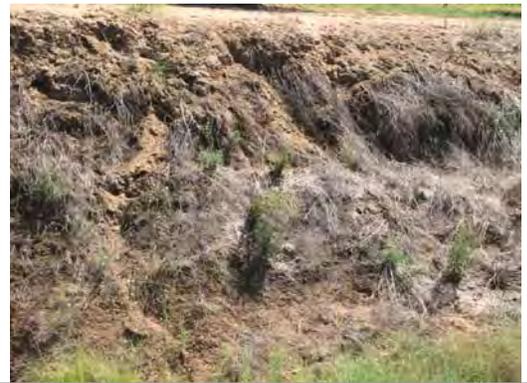
A close look at the upper levee slope above the pocket erosion

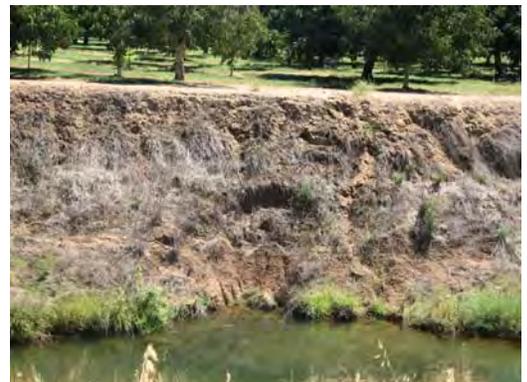
Front view of erosion

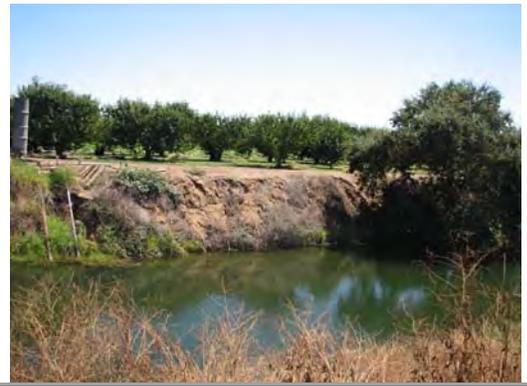
08/22/2012: A irrigation pipe presents at the site, but not likely has caused the erosion.

Front view of erosion. Note the irrigation pipe and the tree

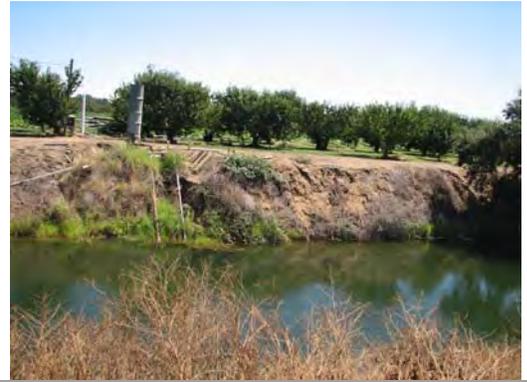
Front view of erosion.

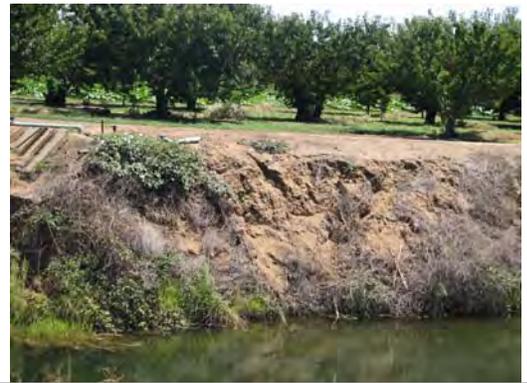
Closer look at erosion

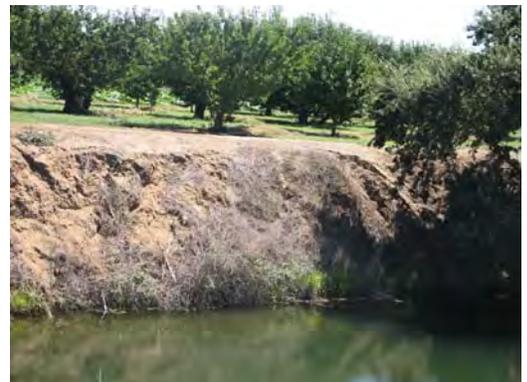
Closer look at erosion

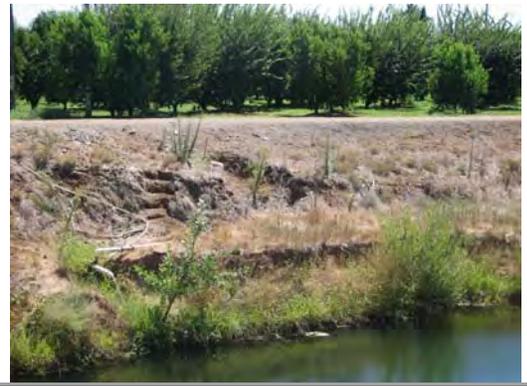
08/22/2012: River-induced erosion occurred on the berm, while the runoff-induced erosion on the levee slope. Site is covered with vegetation

Close look at the erosion. Note the erosion at the levee slope as well as berm.

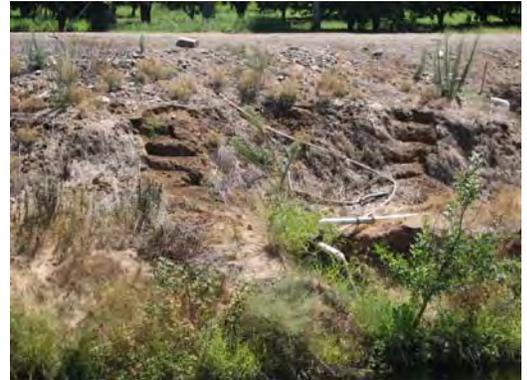
A closer look at the erosion

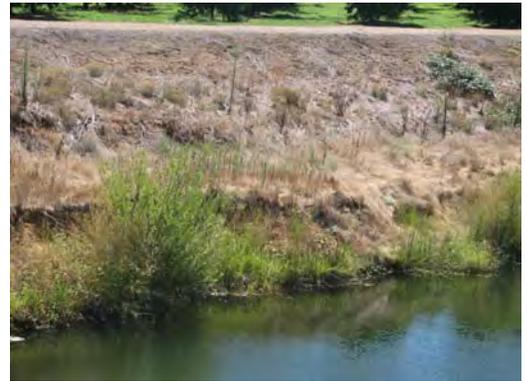
Front view of erosion at berm

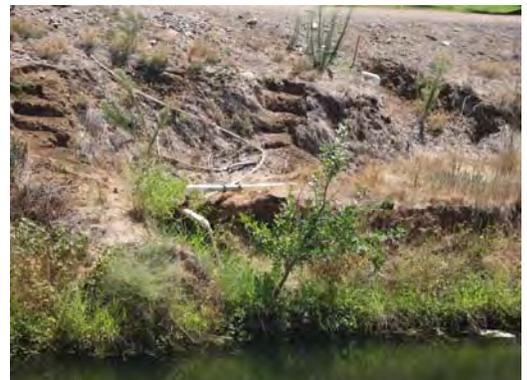
Another closer look at the erosion

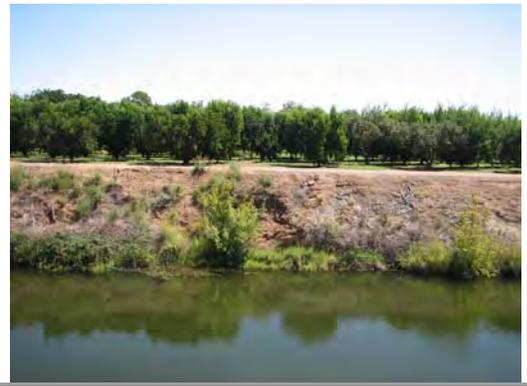
08/22/2012: Erosion is covered with grass and shrubs.

Front view of erosion

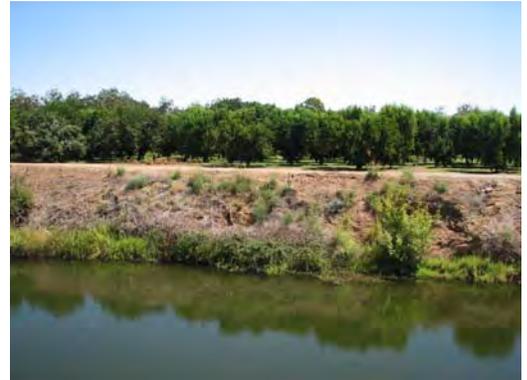
Front view of erosion

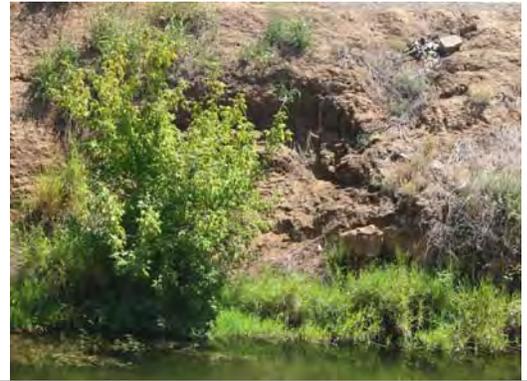
A closer look at the erosion

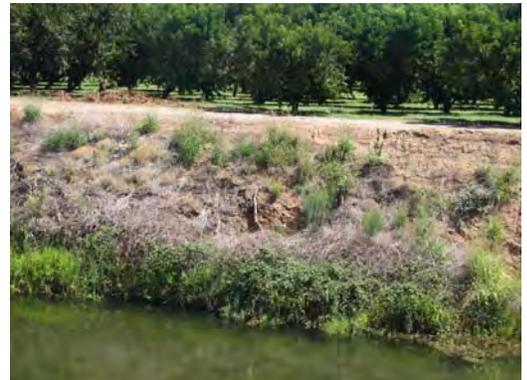
Front view of erosion

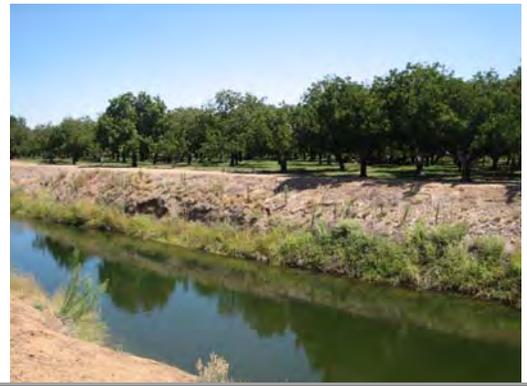
08/22/2012: Tow large-size pocket erosions. Site is covered with dense vegetation.

Looking upstream

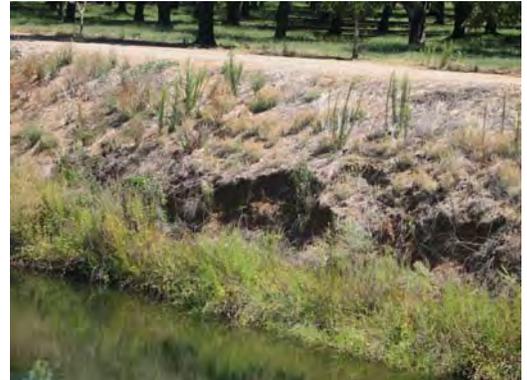
Front view of erosion

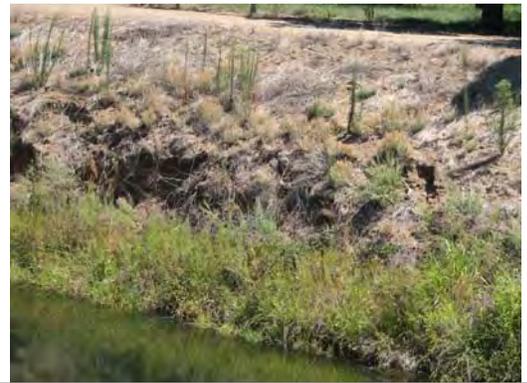
front view of erosion

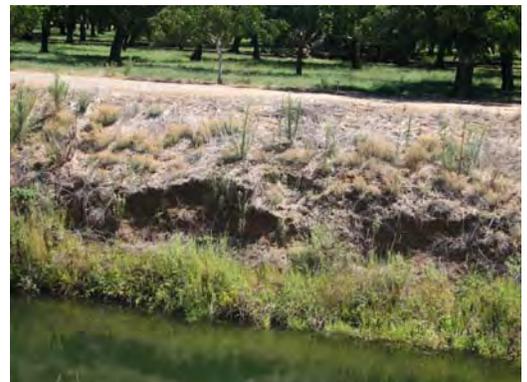
A closer look at the erosion

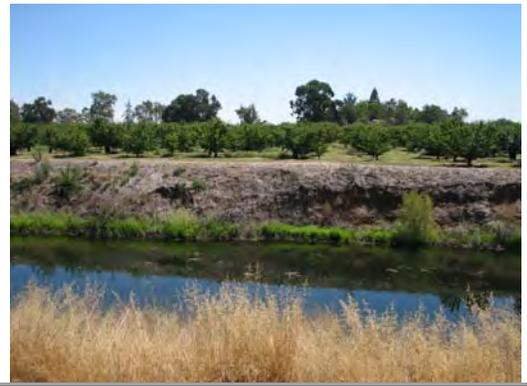
08/22/2012: Site Comprised of series of pocket and scarp erosions. Some of erosions are covered by grass or shrubs.

Front view of the erosion.

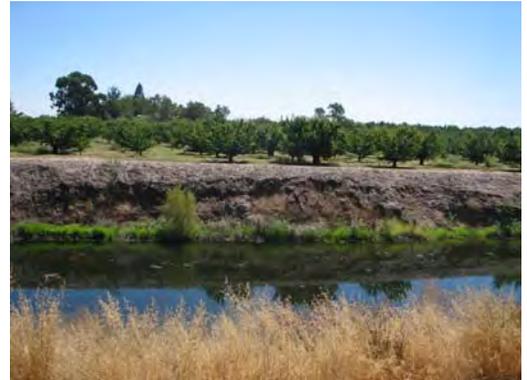
Front view of erosion

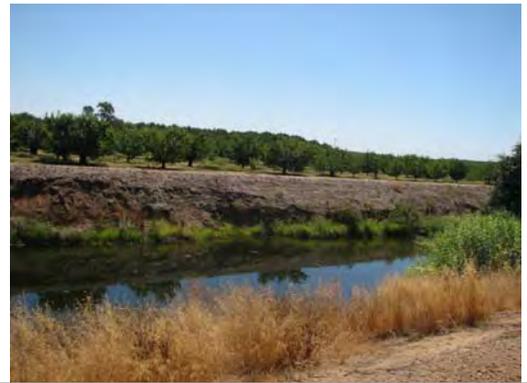
Looking downstream

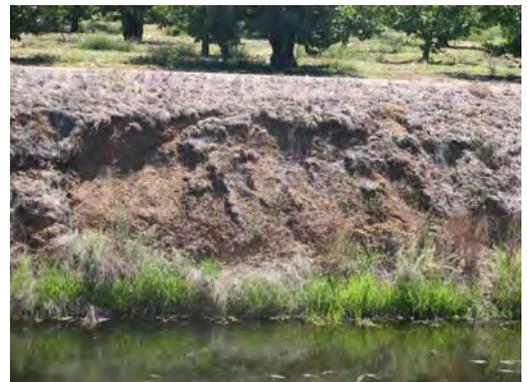
Close view of the scarp erosion

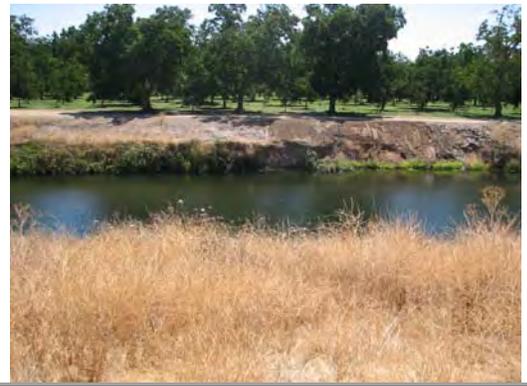
08/22/2012: The erosion was firstly reported in 2012 spring levee inspection report. Fresh soil exposed at the site as a result of possible effort for levee slope enhancement.

Front view of the site.

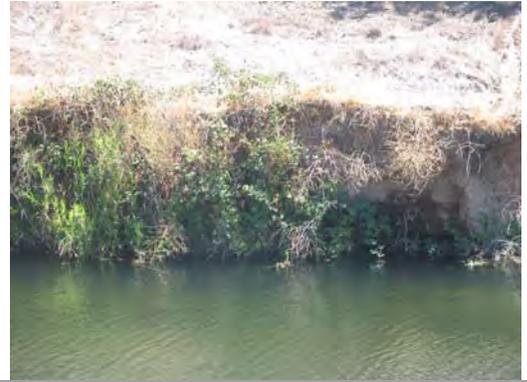
Close view of erosion. Note the vegetation at the site

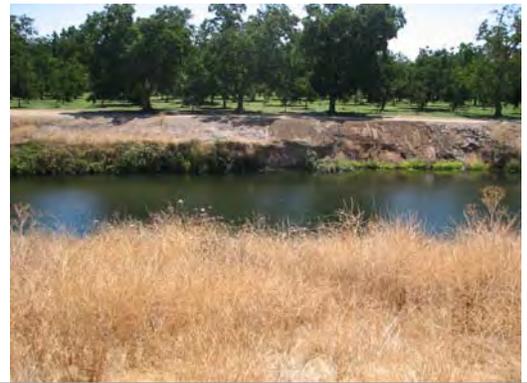
Front view of erosion

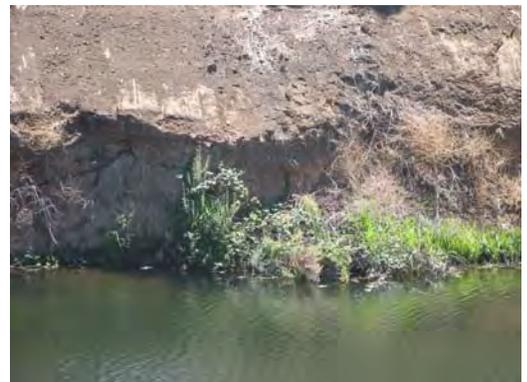
Close look at the site.

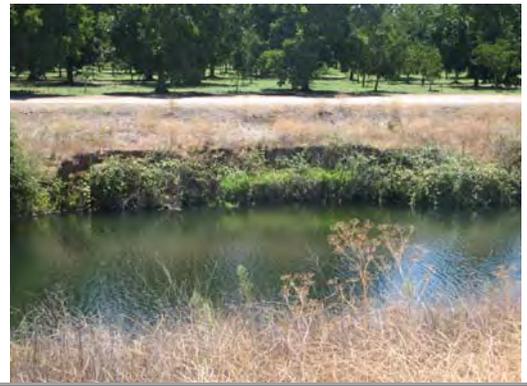
08/22/2012: Site is covered with dense vegetation.

Front view of the erosion.

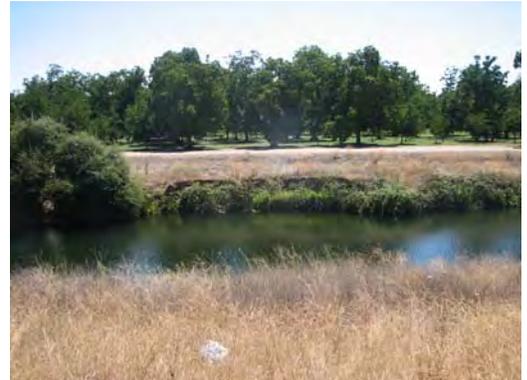
Front view of the erosion. Site is covered with vegetation and trees.

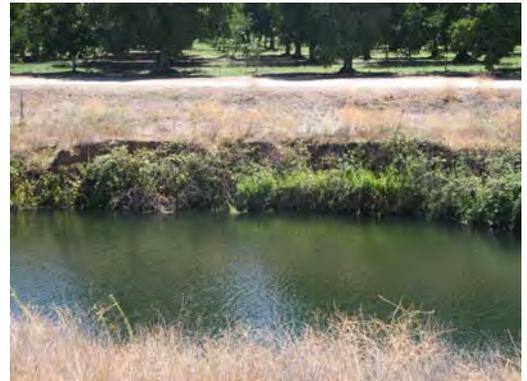
Closer view of the erosion

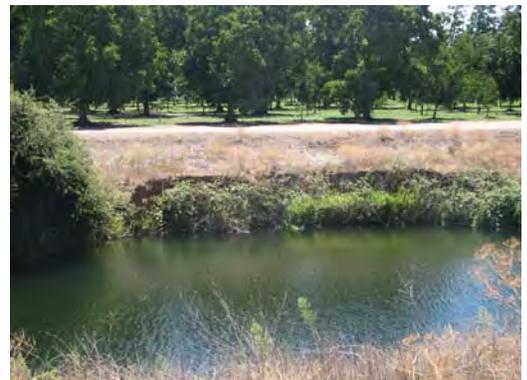
front of the erosion

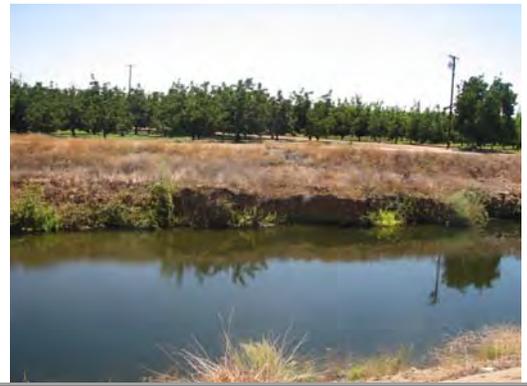
08/22/2012: Berm width is estimated as 5 ft.

Looking downstream at the erosion site

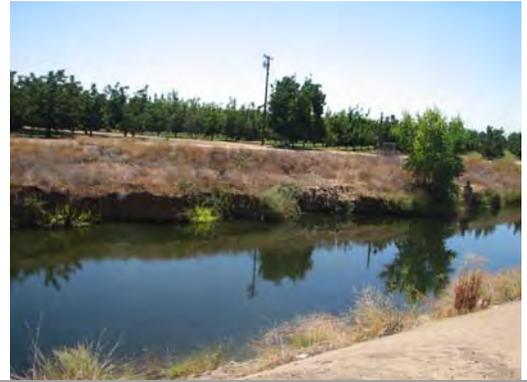
Looking downstream at the erosion

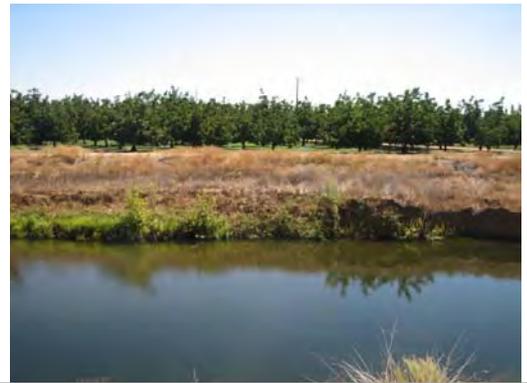
Front view of the erosion

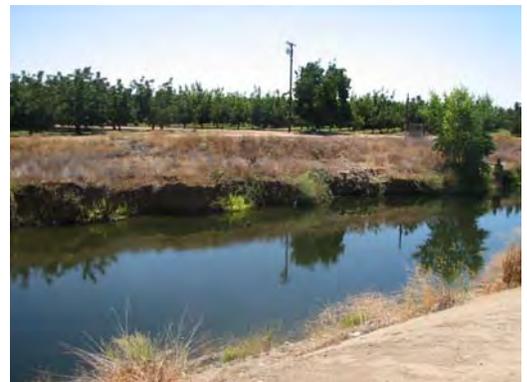
Front view of the erosion

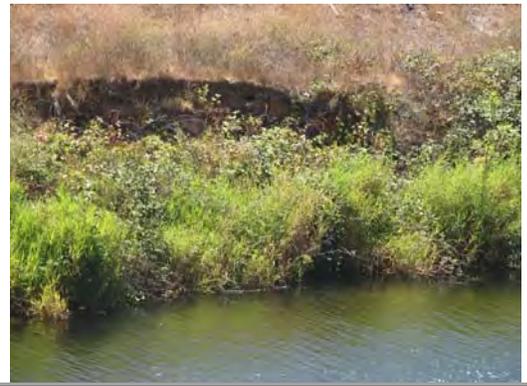
08/22/2012: Site is covered by dense vegetation. Berm width is estimated as 5 ft.

Close view of the erosion

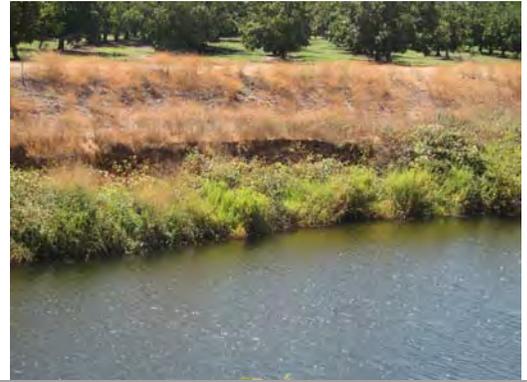
Looking downstream at the erosion

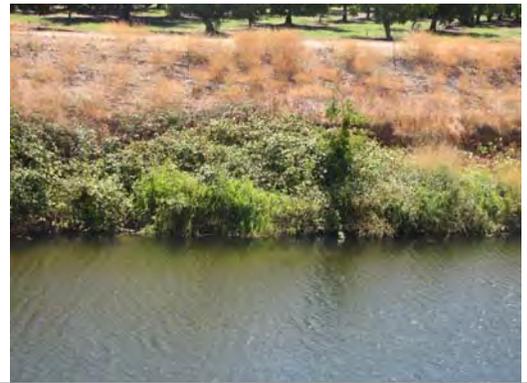
Front view of the erosion

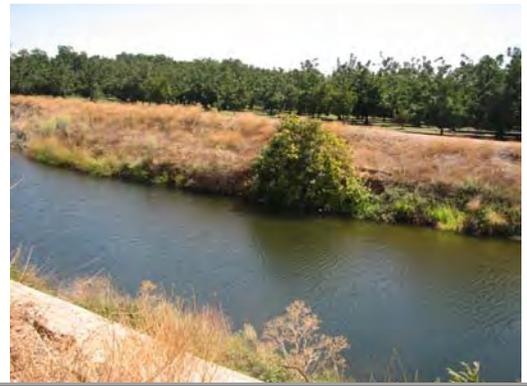
08/22/2012: Erosion is covered by dense vegetation.

Front view of erosion site

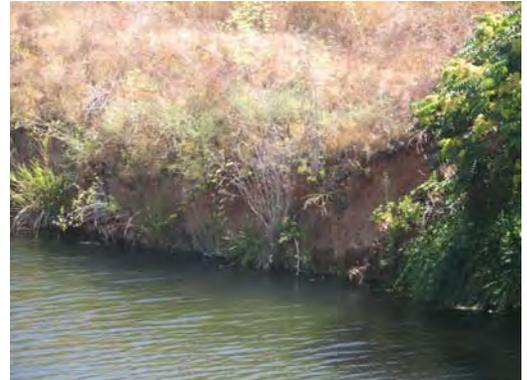
Close view of erosion

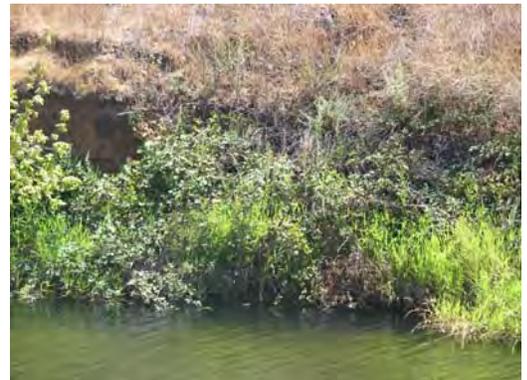
close view of erosion. Note the dense vegetation at the site

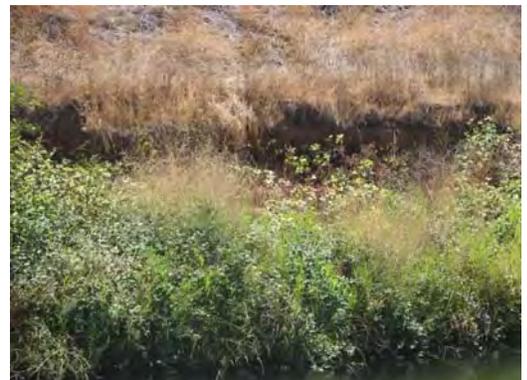
Front view of erosion

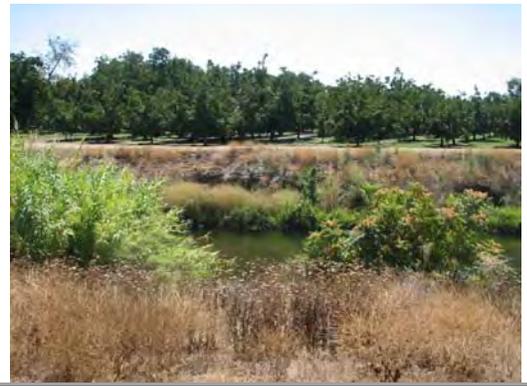
08/22/2012: Site is covered with dense vegetation. A scarp erosion is adjacent to a pocket erosion at the downstream.

Front view of erosion site. A pocket erosion is at the downstream

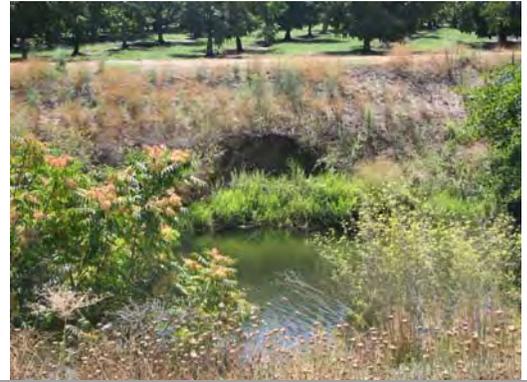
Front view of the pocket erosion

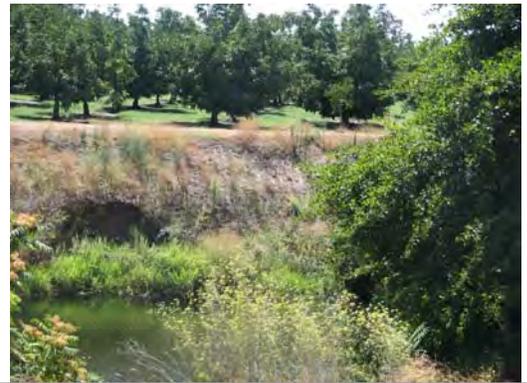
Front of pocket erosion

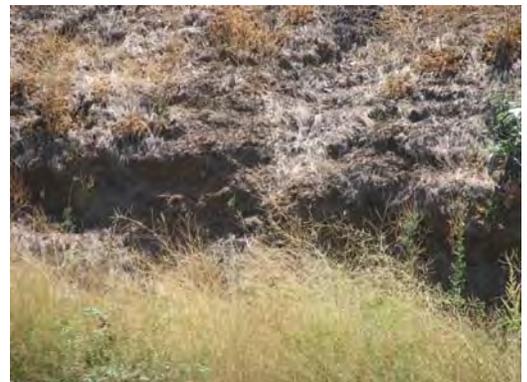
Close view of the scarp erosion

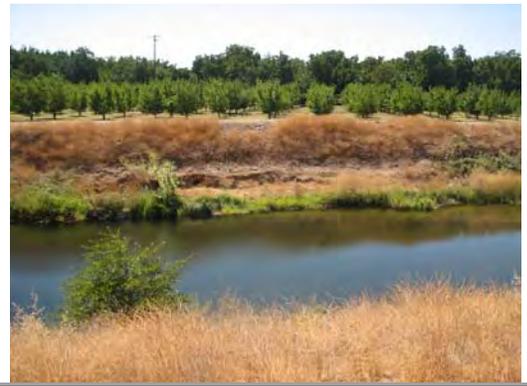
08/22/2012: The berm is estimated at 10 ft. Dense vegetation on site

Front view of erosion.

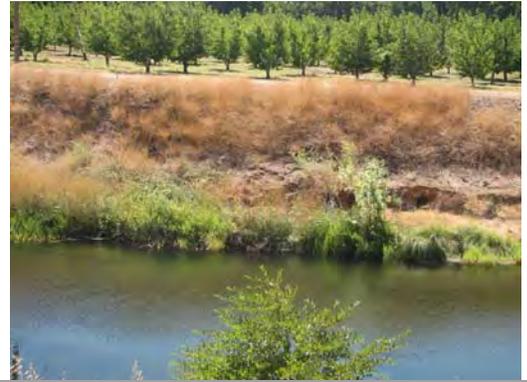
Close look at the erosion

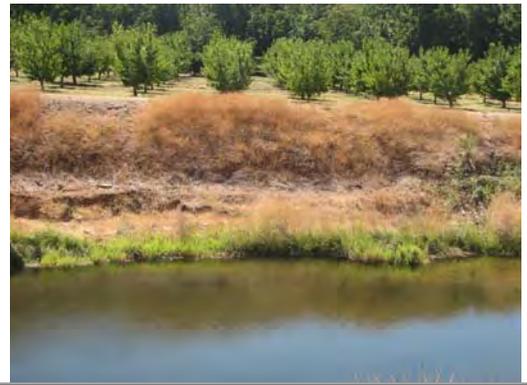
Front view of erosion

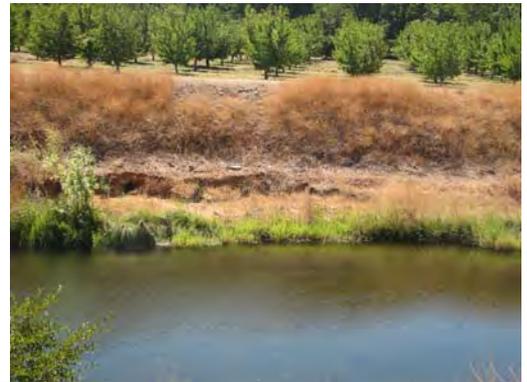
Front view of erosion

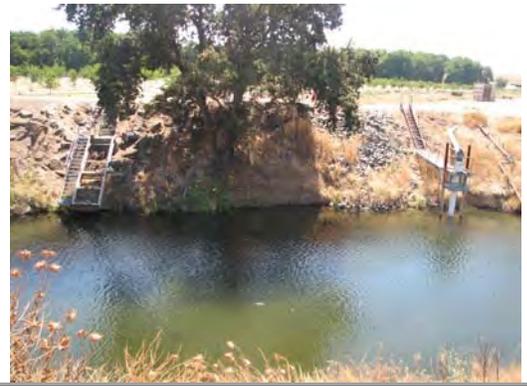
08/22/2012: Erosion is at the outside corner of a river bend, and next to a tree at the levee toe. Irrigation structure presents at the site.

Front view of erosion. Erosion is next to a tree at the levee toe.

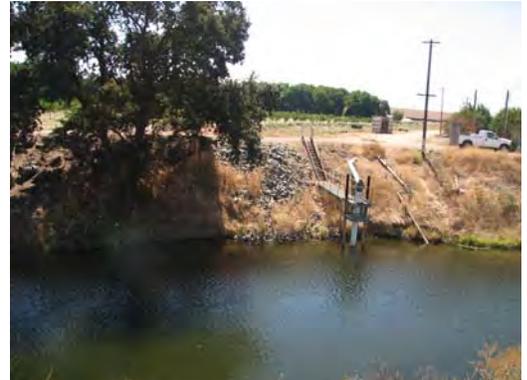
Front view of eroision. Note the irrigation pipe at the erosion site

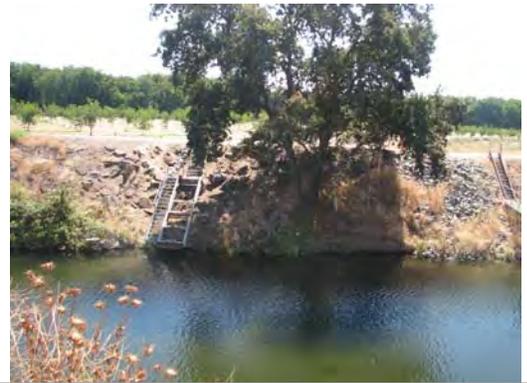
Front view of erosion and broken concrete protection at levee slope

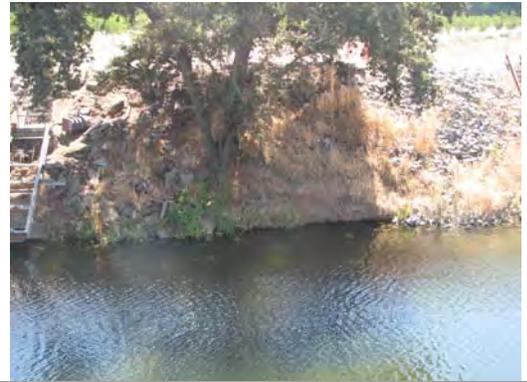
Closer view of erosion

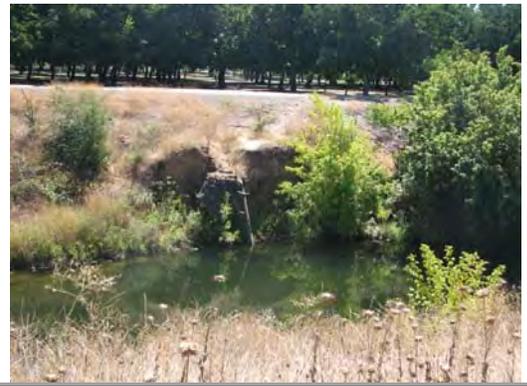
08/22/2012: The erosion was surveyed and documented for monitoring purpose. There is no levee structure on the site, only high ground protecting the land behind.. There is a drainage pipe at the site, which might have caused the problem at one pocket erosion.

Front view of erosion. Note the drainage pipe at the site.

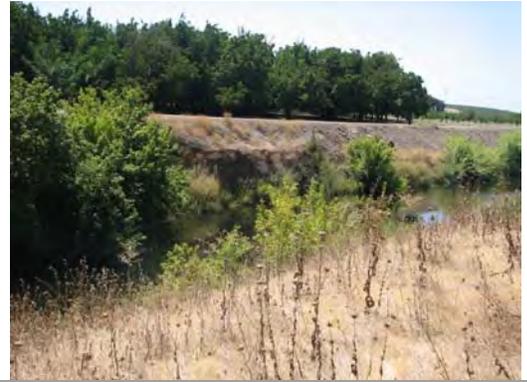
Looking downstream

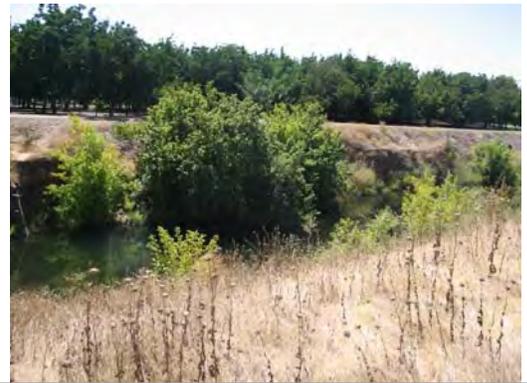
Looking downstream

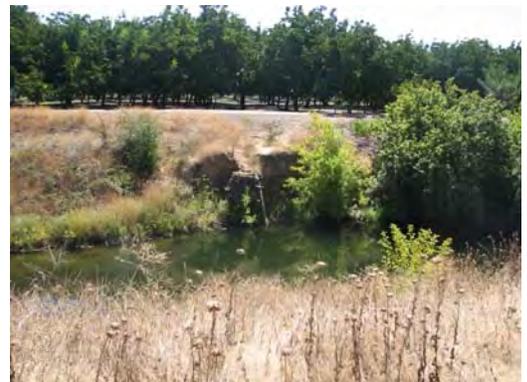
Front view of the site

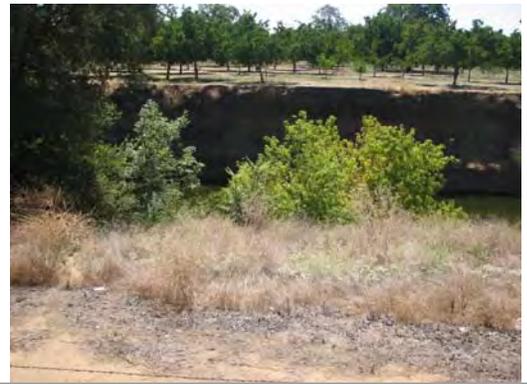
08/22/2012: The erosion was surveyed and documented for monitoring purpose. There is no levee structure on the site, only high ground protecting the land behind.

Front view of erosion. Looking from the right side of the river.

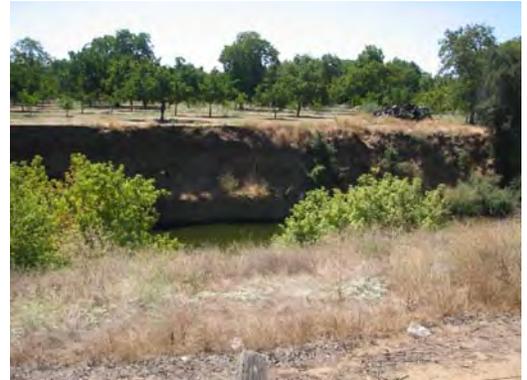
Looking downstream standing on the right side river bank.

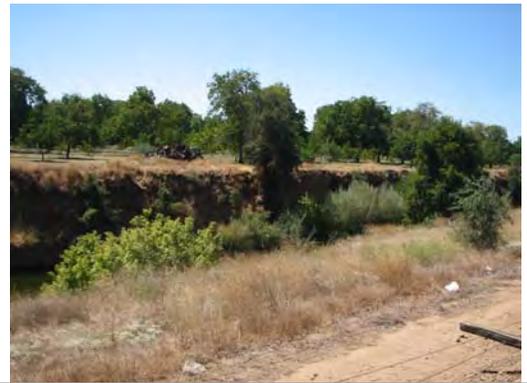
Looking downstream from right side of the river
