LMA: **NA0010 U23 Lower San Joaquin Levee District**

Waterway: **RB San Joaquin River**

Site ID: **NA0010U23RM224.27**

Status: **Repaired Site**

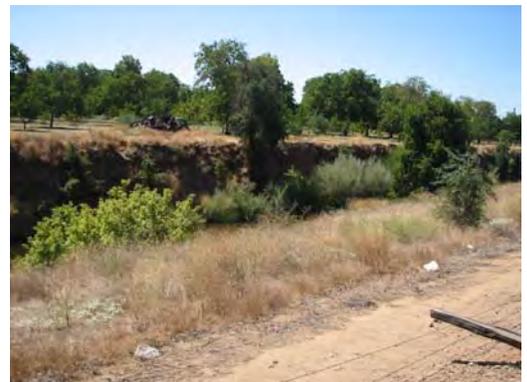
close view of the erosion

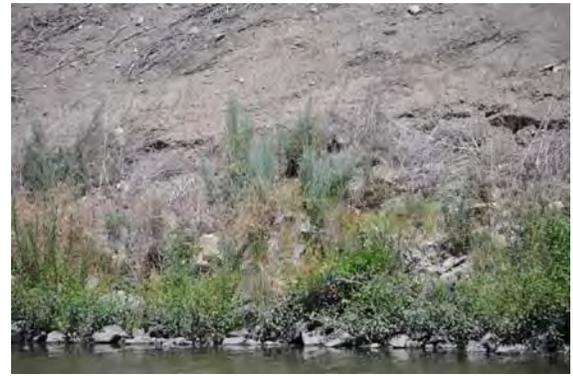
Close view of erosion

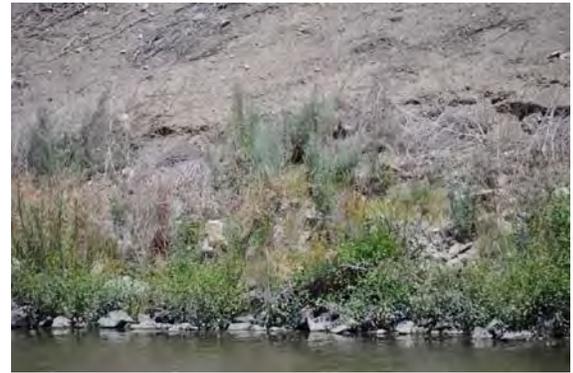
Close view of erosion

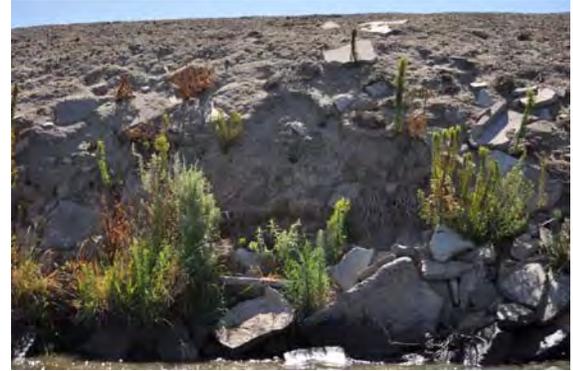
Close view of erosion. Animal holes are visible

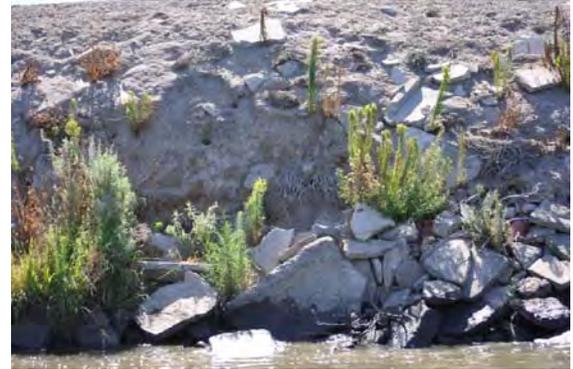
Close view of erosion

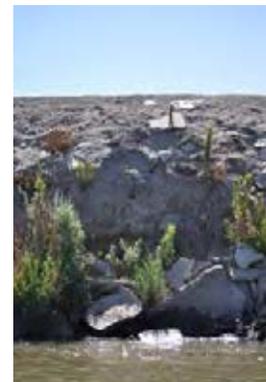
Close view of erosion

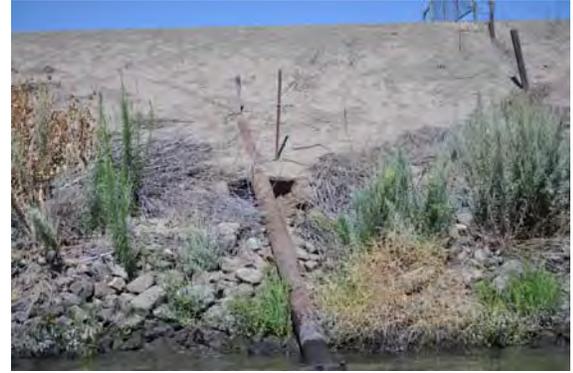
08/07/2012: Erosion is underneath an irrigation pipe. The likely cause of the erosion is the pipe leakage.

Front view of the site

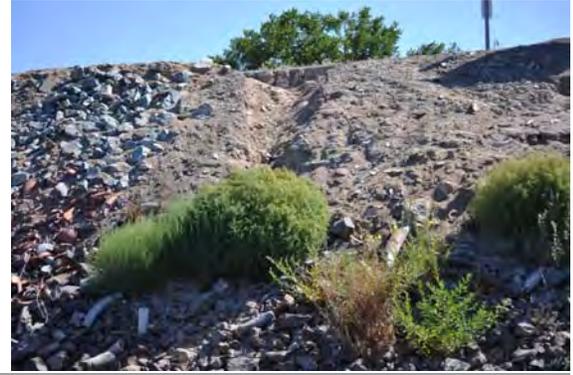
08/07/2012: The erosion is immediately upstream of riprap protection section. The possible cause of the erosion is the rainfall runoff washout.

Close view of the site

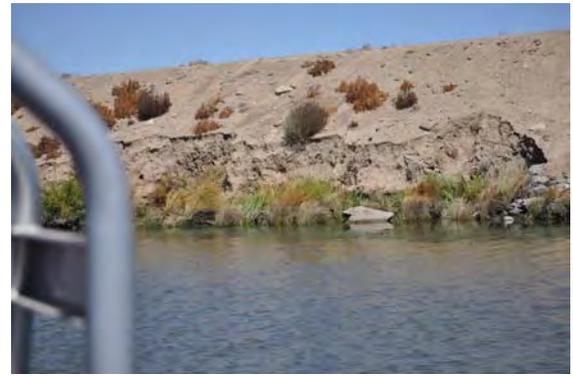
08/07/2012: The site has been visited by boat survey. The erosion has developed in size, and more pocket erosions found.
 8/23/2011: Pockets erosions observed by last survey seem have progressed during the last food season. Continuous monitoring of this site suggested
 9/07/2010: No significant change observed on site. There is emergent vegetation at the water line. Several pocket erosions lined along the lower slope that stretches from RM 40.86 to RM 41.14.
 9/30/2009: No major change observed; the site was combined with other existing sites are RM's 40.93, 40.98, and 41.14 as one site; several pocket erosion just above non-uniform toe rip rap; previously rated "U"; bare spots along the upper slope.
 2008: Possibly caused by wave wash erosion; several pocket erosion along the lower slope; site is inside of a bend.
 2006: Visited site 09/12/06.

Front view of the site

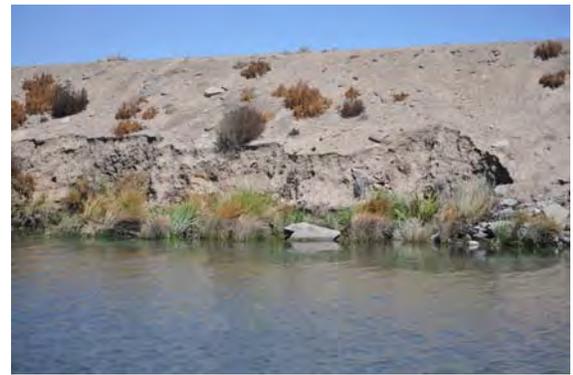
Front view of the site

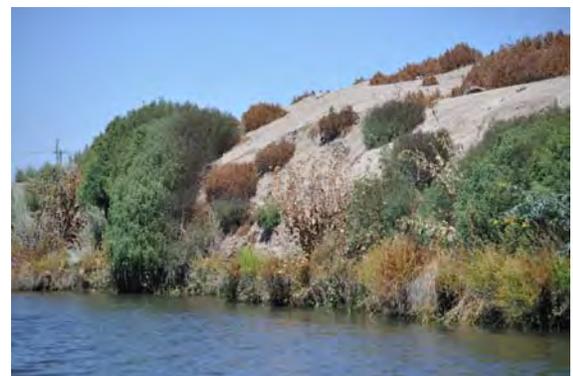
Downstream view of the site

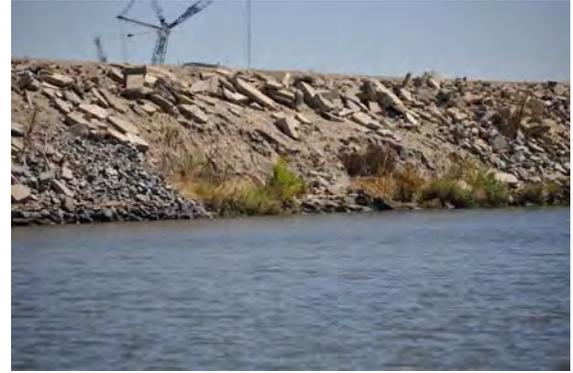
8/7/2012: The erosion is next to a repaired site and approximately 400 feet downstream of a river bend. There are broken concretes at the upper levee slope, but not visible at the levee toe or lower slope. Likely the protection concrete blocks have been washed away

A closer look at the site. Note the protected bank downstream and upstream of the erosion

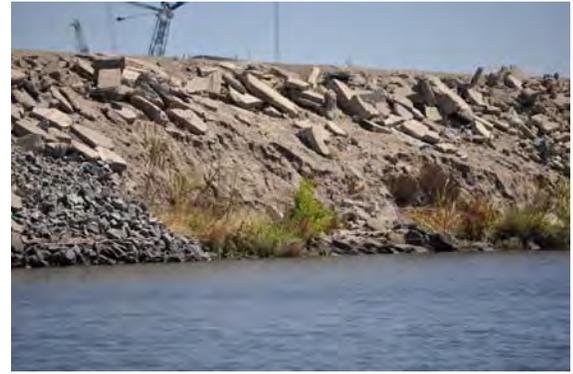
Front view of the site

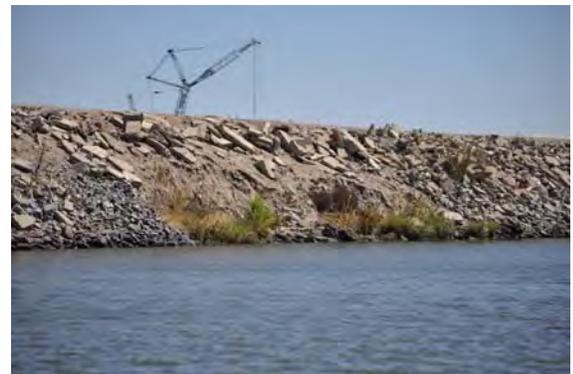
Front view of the site

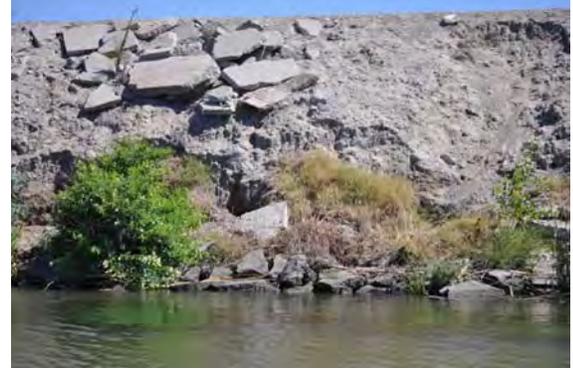
08/07/2012: The site was first discovered by levee inspector in the spring inspection. Levee slope was protected with broken concrete blocks, but those blocks have been washed away during high flows.

Close view of erosion

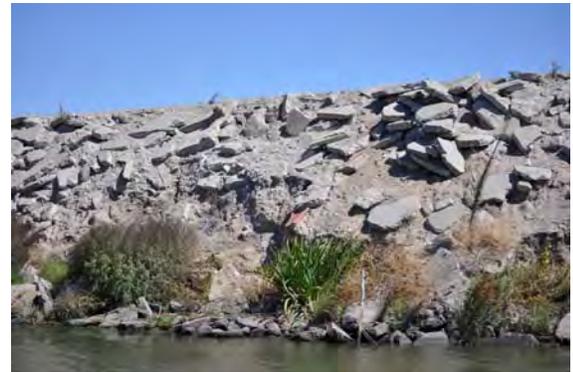
Front view of the erosion.

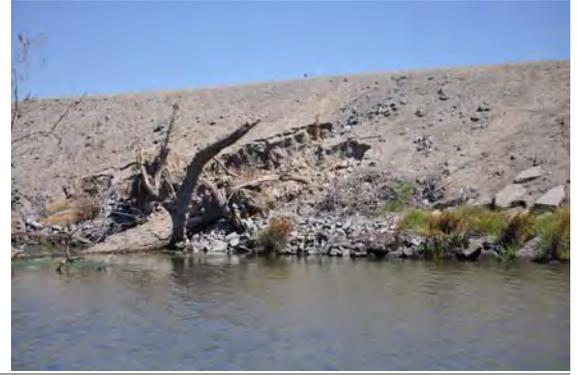
08/07/2012: The rootball of a fallen tree removed material from the levee. Immediately action needed to remove the fallen tree trunk and repair the damage.

close view of the site

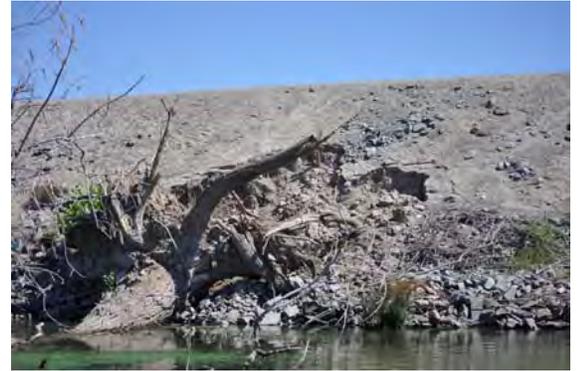
Closer view of the site

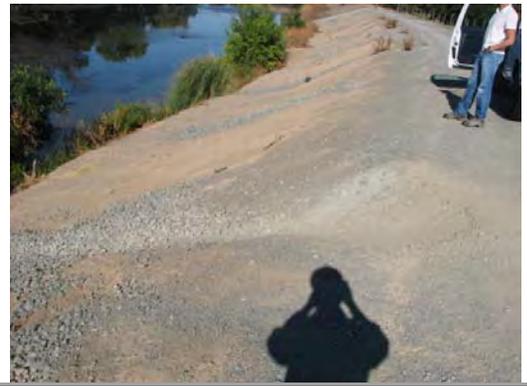
07/26/2012: No new erosion has been observed.
 09/02/2011: Site has been repaired with added soil and crashed rock. No new erosion activities found on site.
 11/30/2010: Site was not inspected this year due to time constraints. There has been no reports from the district that the site was corrected. Continue to monitor during flood events.
 08/05/2010: Recommended for annual assessment and monitoring during flood events, per CLRO.
 2009: Erosion appears to be maintenance-related, and not caused by riverflow; recommend annual assessment and monitoring of erosion site, per Critical Erosion Sites Evaluation 2008 Report; previously rated "U".
 9/12/2006: Headward erosion along the levee bank; erosion has created "notches" estimated to be about 12 feet in height; erosion appears to be maintenance related; DWR Inspector for the area says the erosion has been present for years.

Looking downstream of the repaired site.

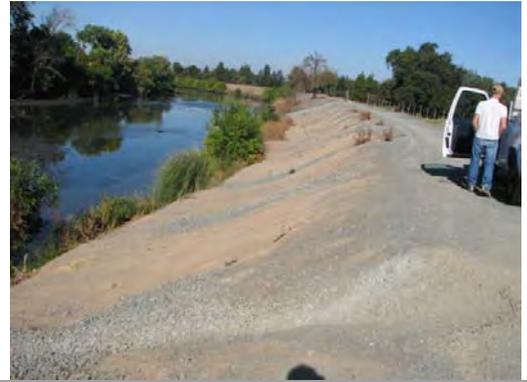
Looking downstream

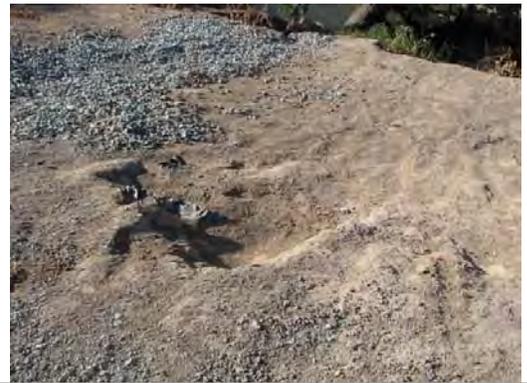
Close look at the repaired site.

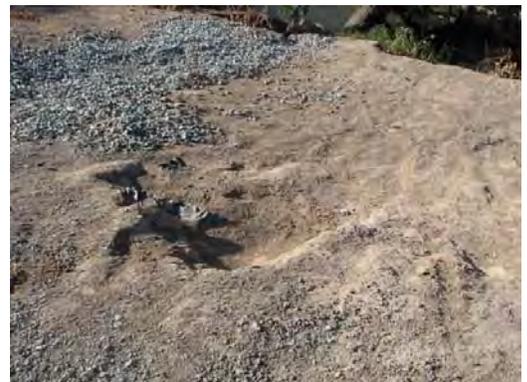
Looking upstream from levee top

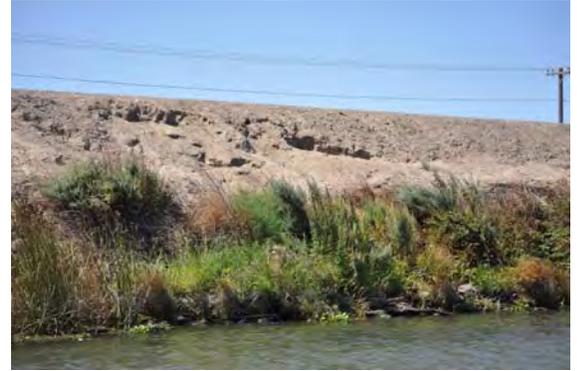
8/7/2012: Erosion is at the upper levee slope, and likely caused by slope slip. The lower levee slope is covered with dense vegetation.

Front view of the site

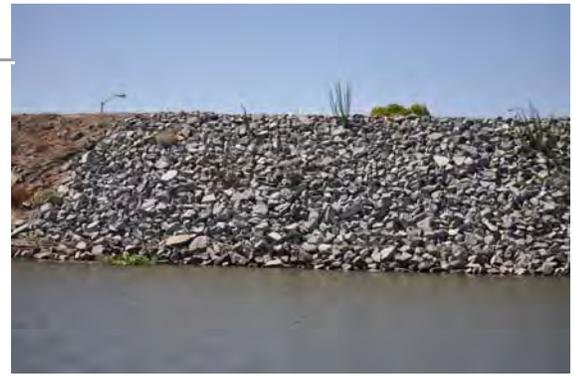
08/07/2012: The site has been visited by boat survey. The site seems to have been repaired.
 08/23/2011: No significant changes observed on site.
 09/07/2010: No significant changes observed on site. Some emergent vegetation at the lower and middle slope. Existing revetment is no longer adequately protecting the oversteepened slope. Some of the broken concrete used as revetment has slid, dragging levee materials away from the slope and creating notches.
 09/29/2009: Erosion site extends from RM 41.11 to 41.18; existing revetment is no longer adequately protecting the oversteepened slope.
 2008: Existing concrete slabs were placed as temporary fix; some of the slabs have started to slide, dragging levee materials away from the slope and creating notches; note that a sewage treatment plant is located on the landside of the levee.

Direct view of the site.

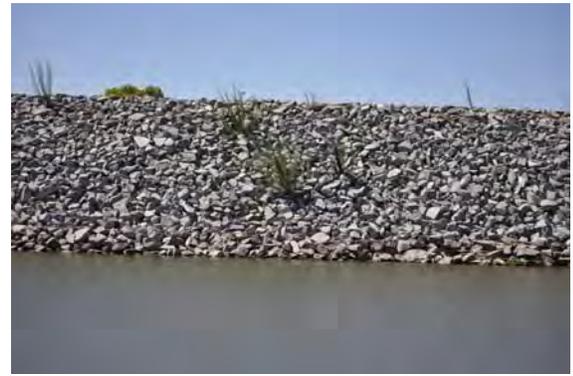
Direct view of the site.

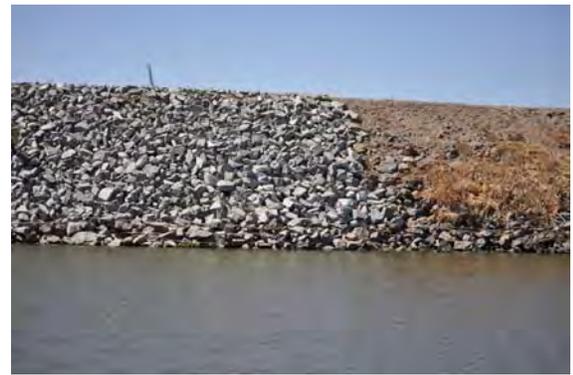
Direct view of the site.

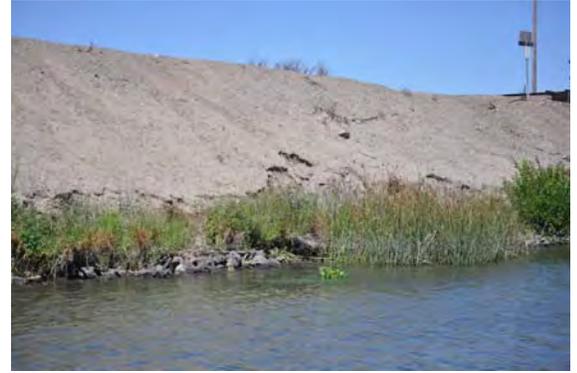
08/07/2012: The site has been visited by boat survey. No significant change observed
 08/23/2011: The site is located immediately upstream of a Railroad bridge. Dense vegetation at the water line interferes the view of erosion.

Front view of the erosion site. Vegetation visible

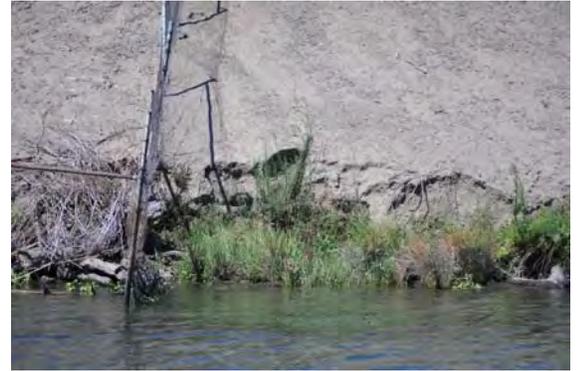
Front view of erosion

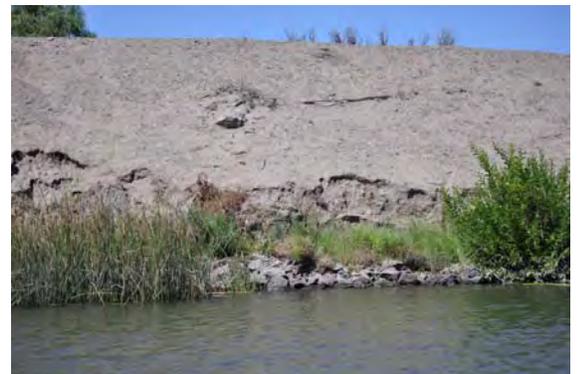
Front view of erosion

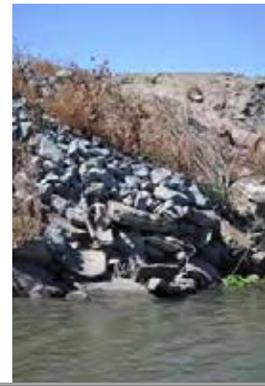
Comments:
 08/07/2012: The site has been visited by boat survey. No significant change observed
 08/23/2011: The erosion site is immediately donstream of the riprap protection.

Front view of the erosion. Note the riprap protection near the site

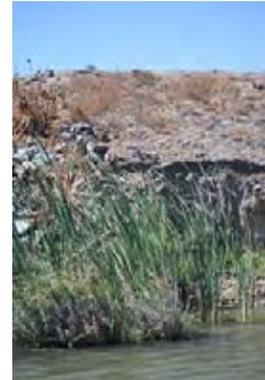
A close view of the erosion

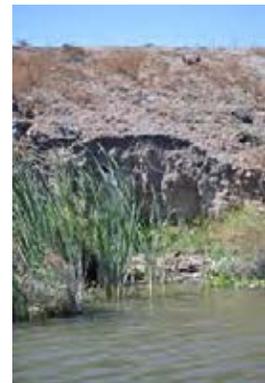
Front view of the site

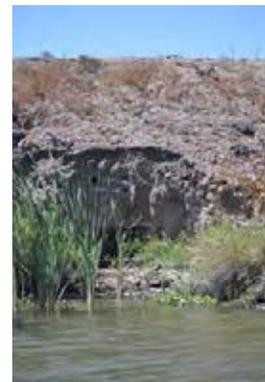
Front view of the site

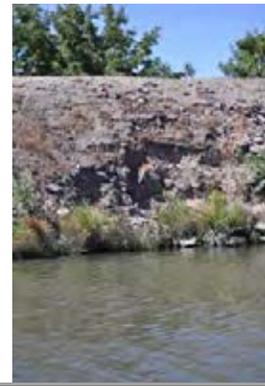
08/07/2012: The erosion was discovered during the boat survey.

Front view of erosion

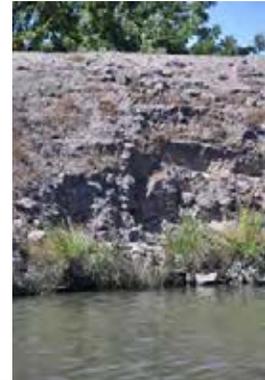
Front view of erosion

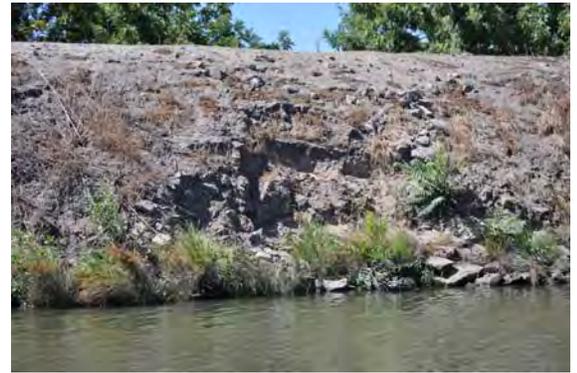
Front view of erosion

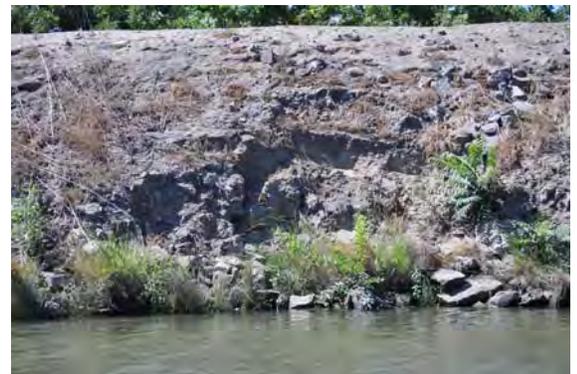
Front view of erosion

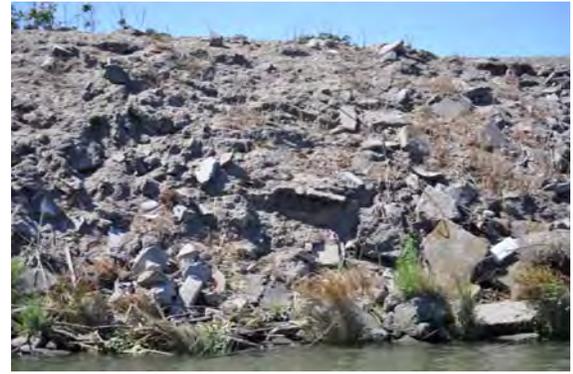
08/07/2012: The site has been visited by boat survey. Site has been repaired, but new erosion occurred at the levee slope and immediately upstream of the repaired site.
 08/23/2011: The site is about 500 ft downstream of bridge. The levee toe seems to be protected, but the protection is being washed away.

Front view of the site

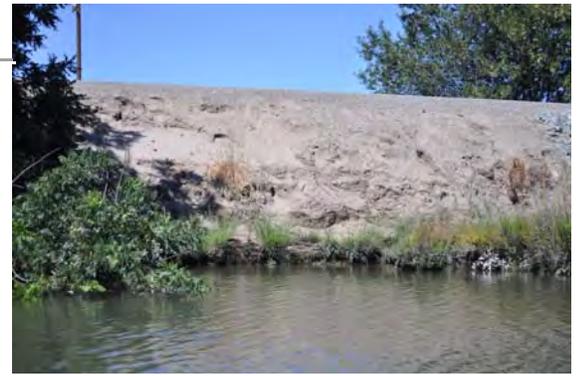
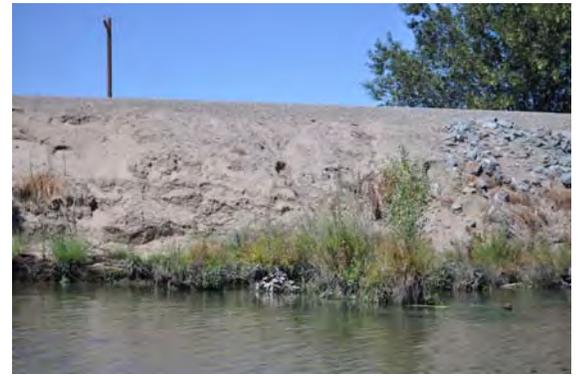
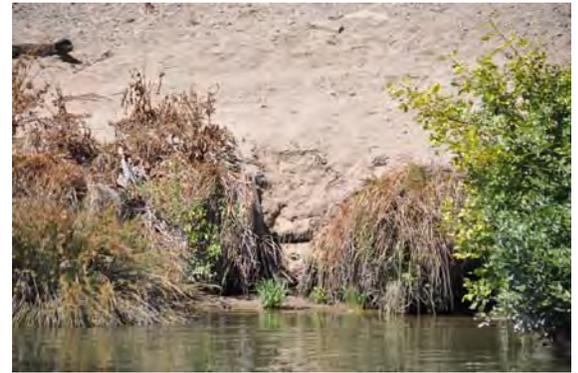
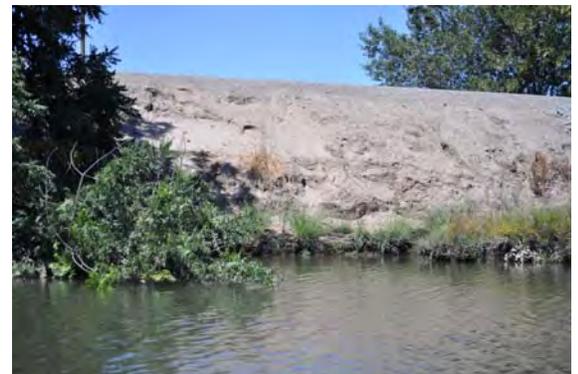
08/07/2012: The site has been visited by boat survey. No significant changes observed
 08/23/2011: No significant changes observed on site.
 9/07/2010: No significant changes observed on site. Some emergent vegetation at the water line. There is an exposed pipe discharge partially hanging at the mid-slope, possibly still used for discharging irrigation/runoff water. There is minimal rip rap protection along the bank, and what's left of it is no longer adequately protecting the bank.
 9/29/2009: Site consists of a 400-foot long eroding bank with minimal vegetation and protection; the existing rip rap has sloughed, rendering it useless; note that there is an exposed section of a pipe.
 10/18/2006: There is extensive loss of rip rap on some sections; sewage disposal pond is on the landside of the levee; there is an exposed pipe outlet "hanging" from the upper slope.

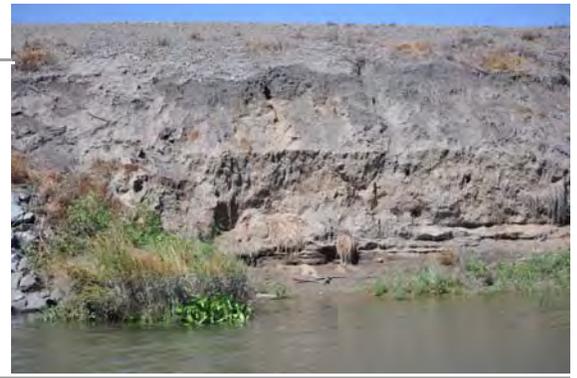
08/07/2012: The site was first reported in 2012 spring levee inspection report.

close view of the erosion

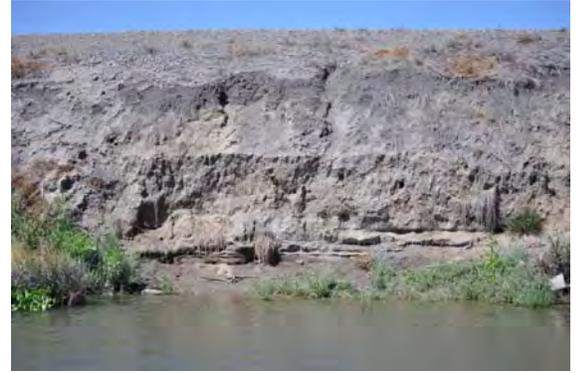
Front view of the erosion

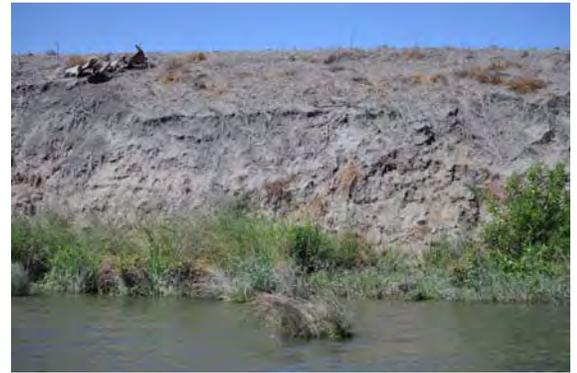
Front view of the erosion

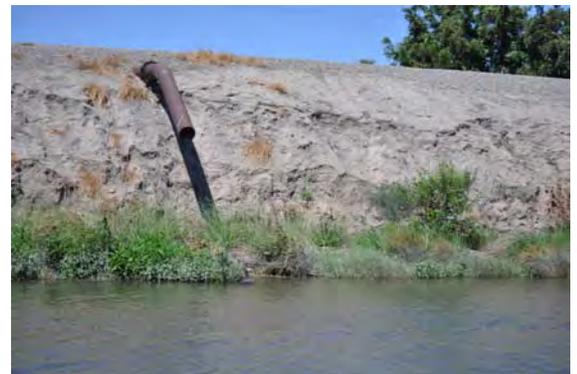
Front view of the erosion. Note the drainage pipe on the site. .

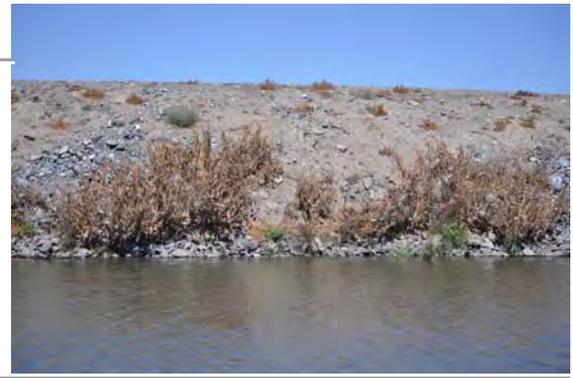
08/07/2012: The site was first reported in 2012 spring levee inspection report. The site is located about 750 ft downstream of SR 4 Bridge.

Upstream view of the erosion

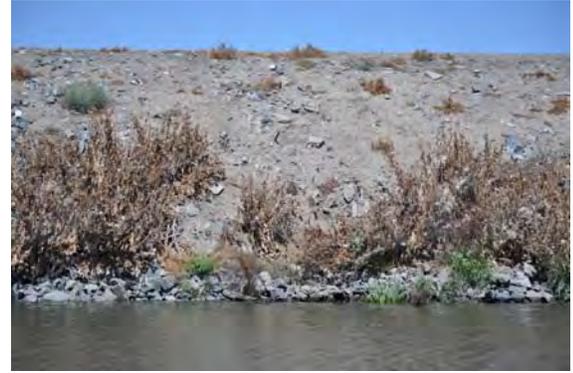
Close view of the erosion

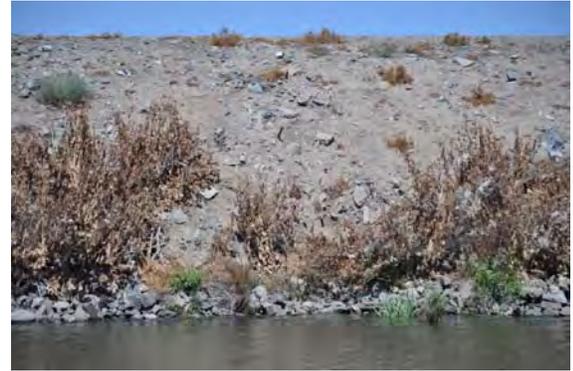
Close view of the erosion

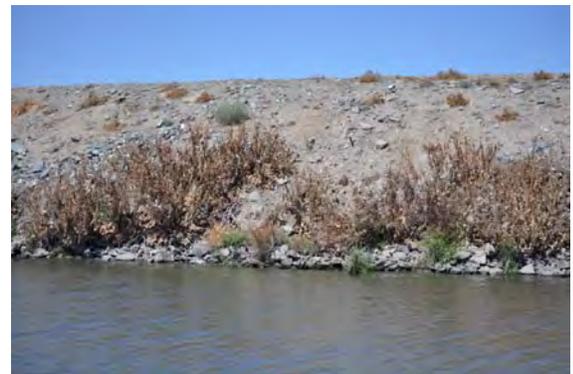
Downstream view of the erosion

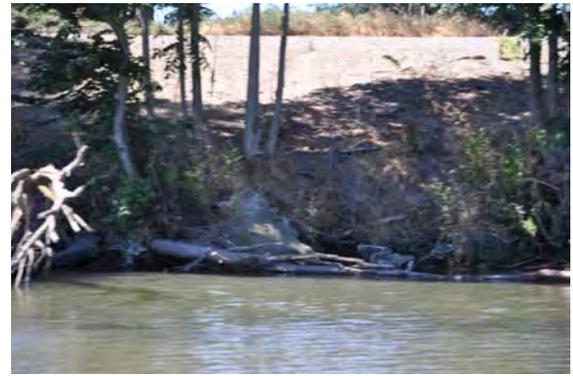
08/07/2012: : The site has been visited by boat survey. No significant change observed
 08/23/2011: No significant changes observed on site. Trees concerned still in place.
 09/07/2010: No significant changes observed on site. The concern here is the undermining of the levee toe where most of trees are. There are erosion pockets lined along the lower slope and at the base of the trees, exposing tree roots. There is minimal slope protection.
 09/29/2009: The lower slope is lined with minor erosion pockets; some tree roots are exposed; there is visible undermining of the levee toe; site is immediately upstream of the Highway 4 Bridge; the bridge is possibly causing a scour to occur, eroding the bank.

Large trees along the levee toe. There is minimal slope protection. The erosion near tree visible.

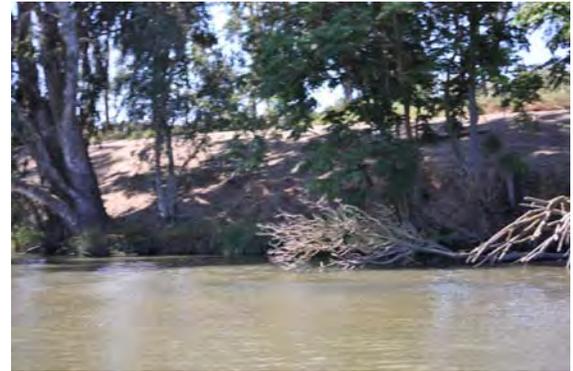
Front view of erosion

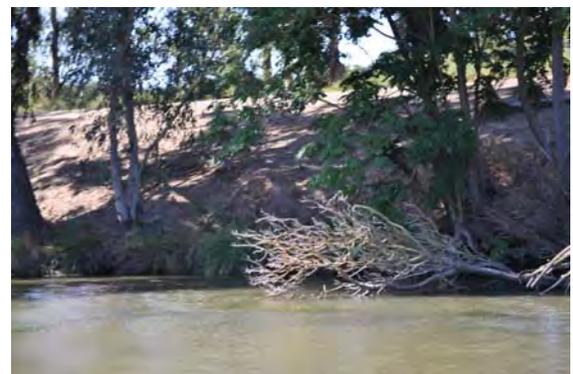
Fallen tree near the site

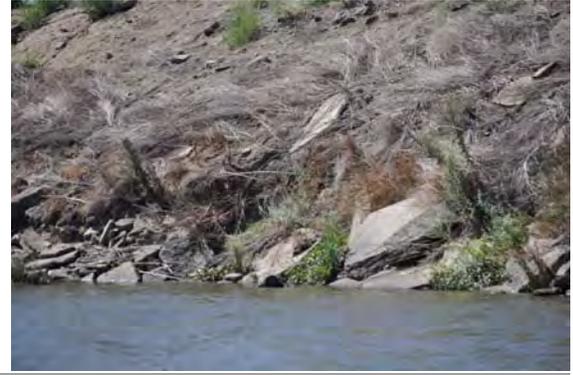
Close view of the pocket erosion

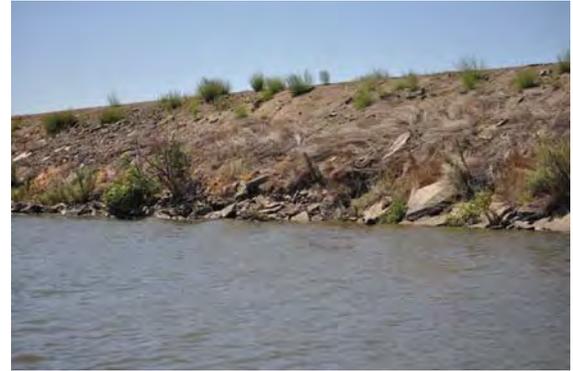
Downstream view of erosion.

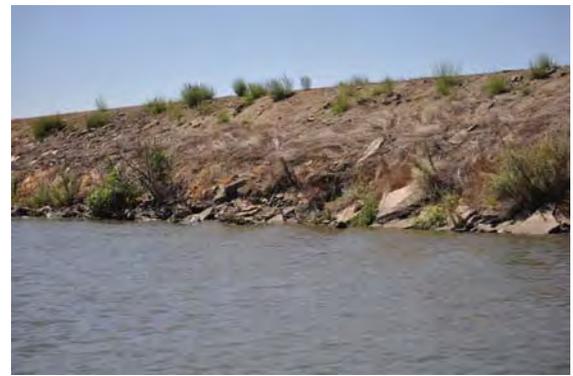
front view of erosion

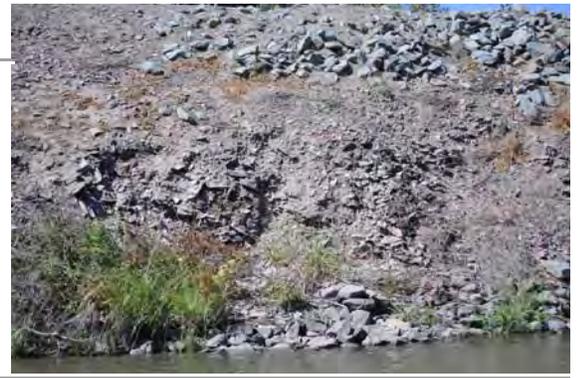
08/07/2012: The site was first reported in 2012 spring levee inspection report. The site is located at the inside corner of a river bend.

Close look of the site.

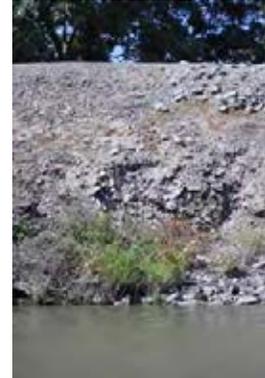
Front view of the site

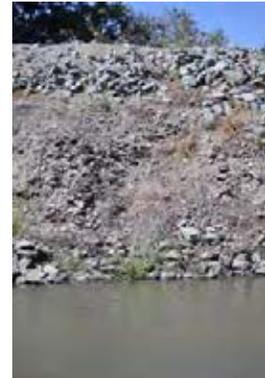
Front view fo the site. Note the soil type

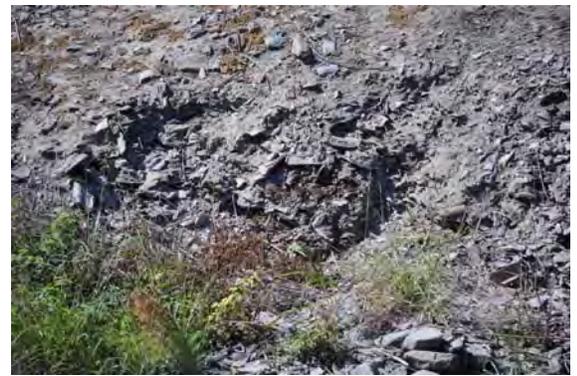
closer view of the erosion

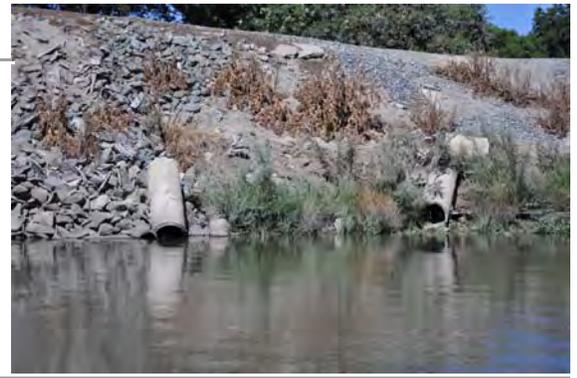
08/07/2012: The site was first reported in 2012 spring levee inspection report.

Upstream view of erosion

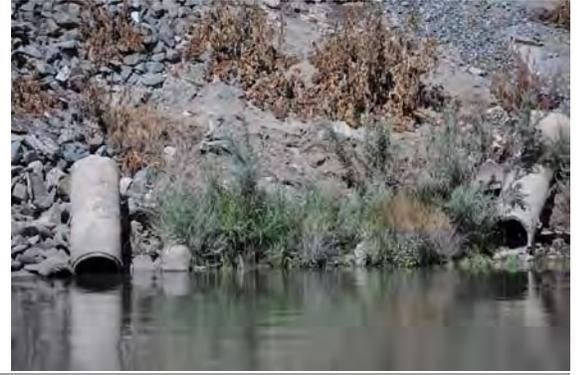
Close view of erosion

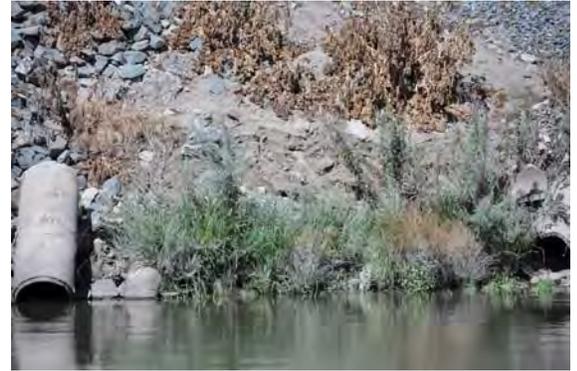
closer view of erosion

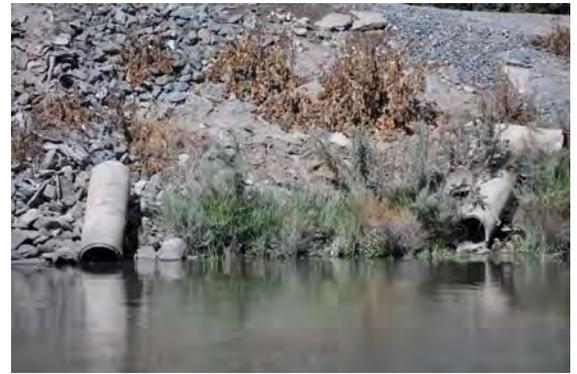
Front view of erosion

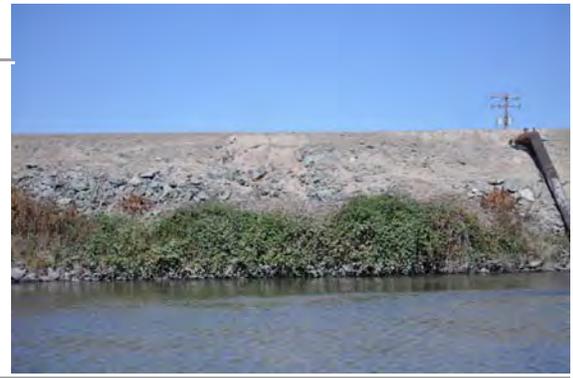
08/07/2012: The site was first reported in 2012 spring levee inspection report.

Front view of erosion

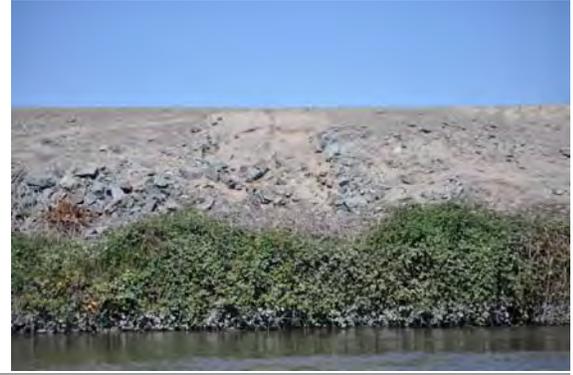
Close view of erosion

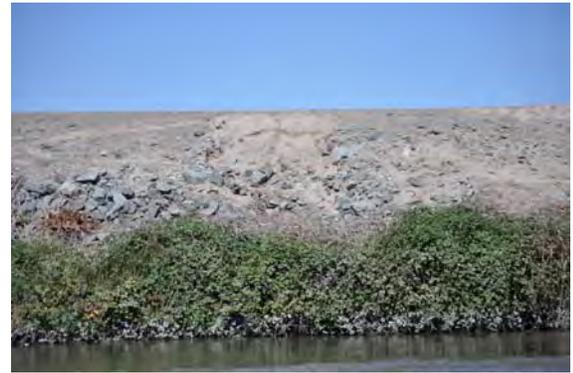
Close view of erosion

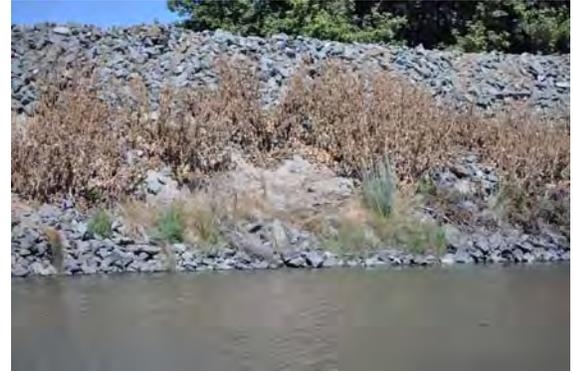
08/07/2012: The site has been repaired. Protecting riprap revetment has been placed at the levee shoulder and slope, but minor erosions are visible at the levee toe.
 08/23/2011: Sloughing rip rap is visible on the site

A closer view of the erosion

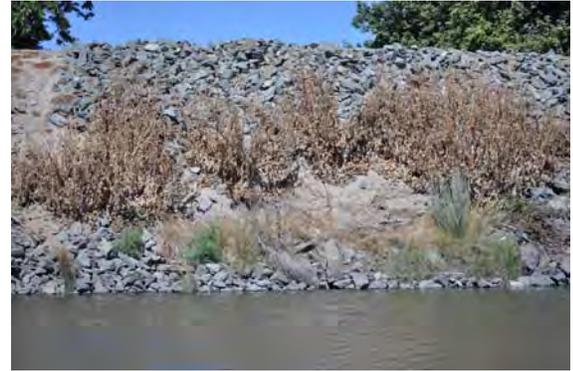
Closer view of the erosion

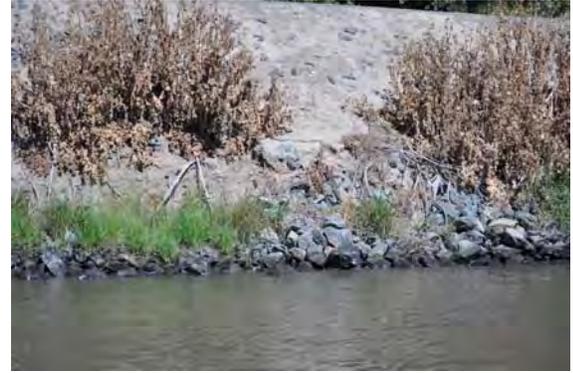
Front view of erosion

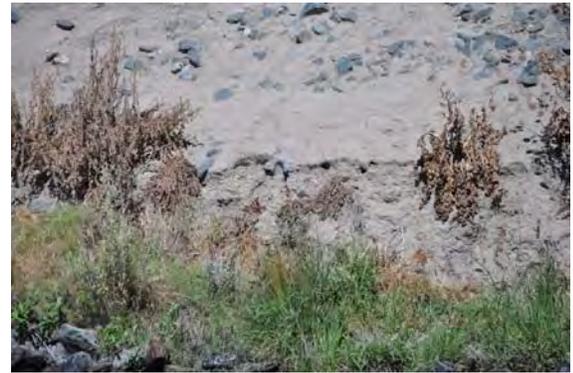
Front view of erosion

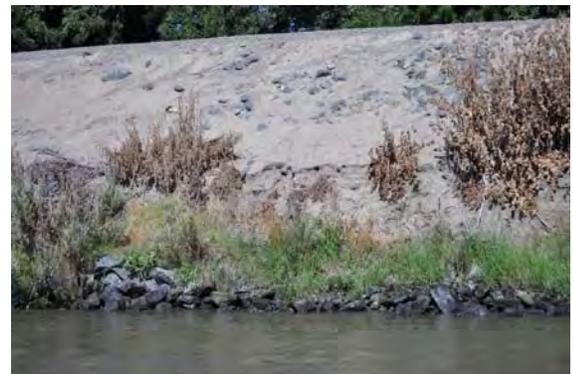
Front view of erosion

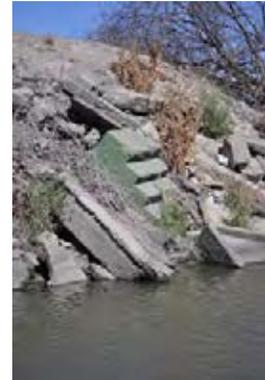
08/07/2012: Erosion is located at the inside of a river bend. Site is covered with broken concrete blocks and other debris.

Front view of the site.

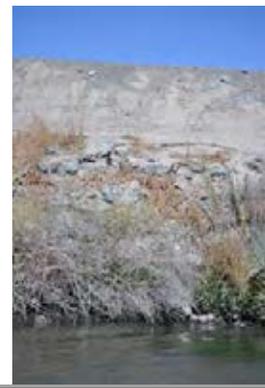
08/07/2012: The site has been visited by boat survey. No significant change observed
 08/23/2011: Cracking erosion along the levee bank. Erosion appears to be caused by river flows.

Front view of the erosion site

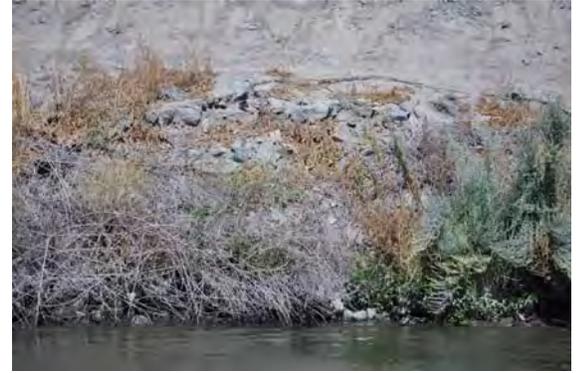
Front view of the erosion.

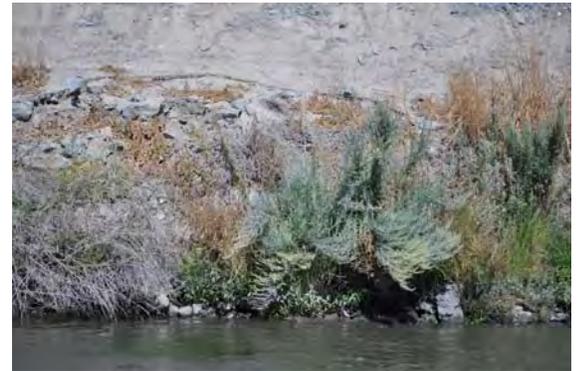
Front view of the site.

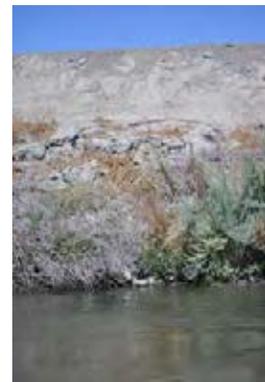
Close view of the site. Note the vegetation at the site

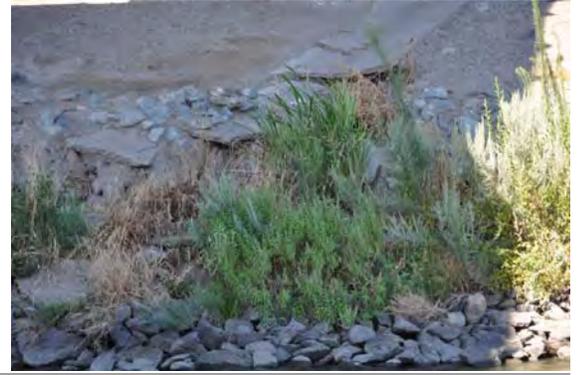
08/07/2012: : The site has been visited by boat survey. No significant change observed
 08/23/2011: No significant changes observed on site.
 09/07/2010: No significant changes observed on site. Erosion site is located beneath Howard Road Bridge. Majority of the existing rip rap has slipped, dragging away levee materials and exposing the underlying soft soil.
 08/06/2010: Recommend for annual assessment and monitoring during flood events, per CLRO.
 09/30/2009: No major changes observed since the last visit; upper portion of existing revetment has slipped, exposing the degrading bank; note that site # is the same as RM46.30, LM5.69 found in the CLRO CES Evaluation 2008 Report; site was previously rated "M".
 11/04/2008: Previously repaired using rock revetment; upper portion of th revetment is sliding, causing deformation on the levee slope; site is upstream of Howards Road Bridge.

Sloughing rip rap adjacent to Howard Bridge.

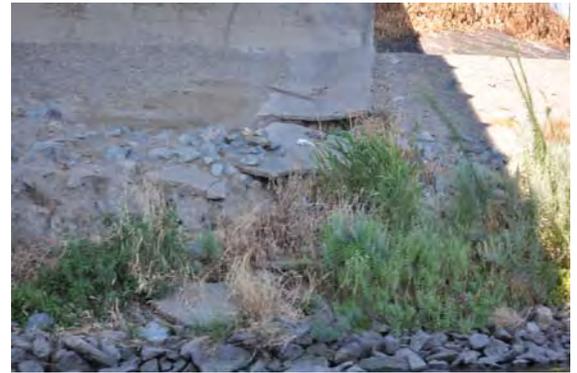
Front view of sloughing rip rap.

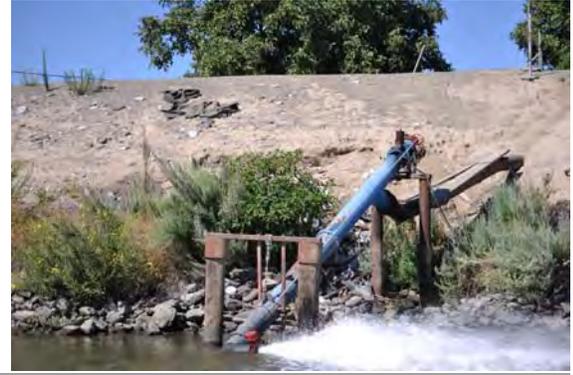
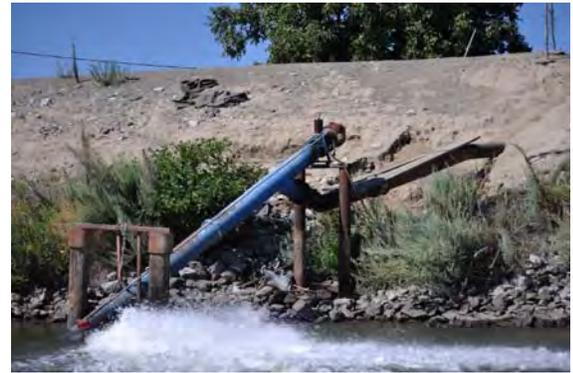
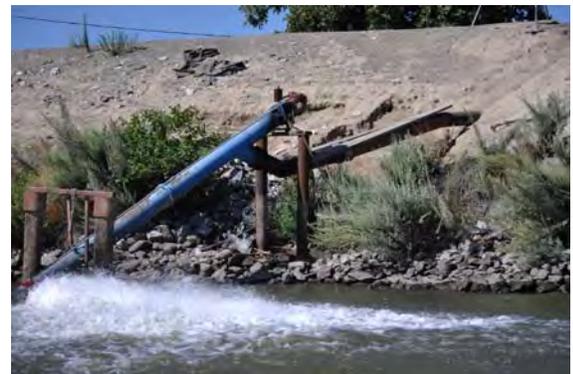
08/07/2012: The erosion is near a water-intake structure. Pipe leakage likely caused the erosion.

Closer look of the erosion and the pipe

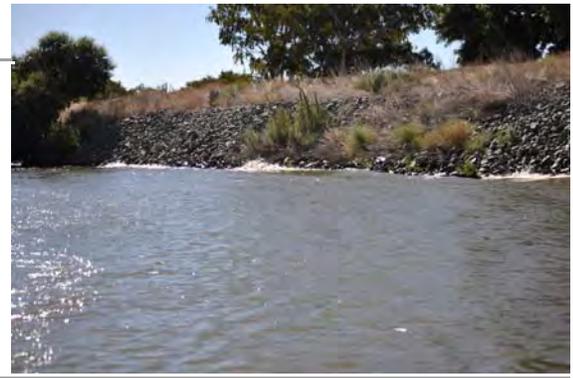
08/07/2012: :The site has been visited by boat survey. The site has been repaired with riprap protection. Rotten tree roots and minor erosion visible immediately upstream of the site
 08/23/2011: No significant changes observed on site.
 09/07/2010: No significant changes observed on site. There are minor pockets of erosion lining the lower slope and undermining of the toe. There are annual grasses and emergent vegetation at the lower slope. Burrow holes were observed along the slope and persist throughout the 200-foot long site.
 08/05/2010: Recommended for annual assessment and monitoring during flood events, per CLRO.
 09/30/2009: No major change observed since last visit; despite dense vegetation, the bank continues to erode and slough; the levee toe is being undermined; note the tree on site; the site was previously rated "U".
 10/21/2008: Undermining of the levee toe; rodent holes in several location; trees with roots partially exposed; sloughing on slope.

Upstream view of the repaired site

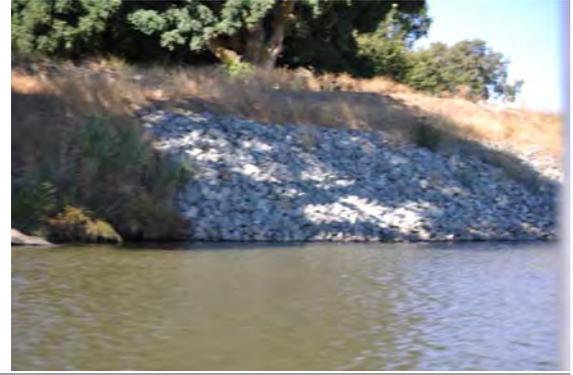
Front view of the repaired site

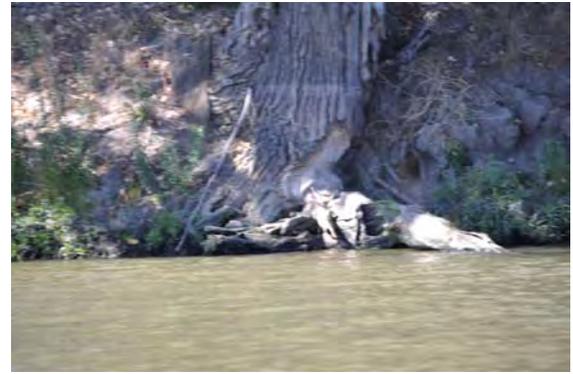
View of the tree root

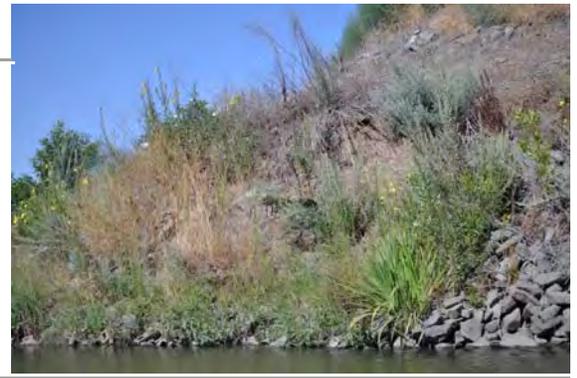
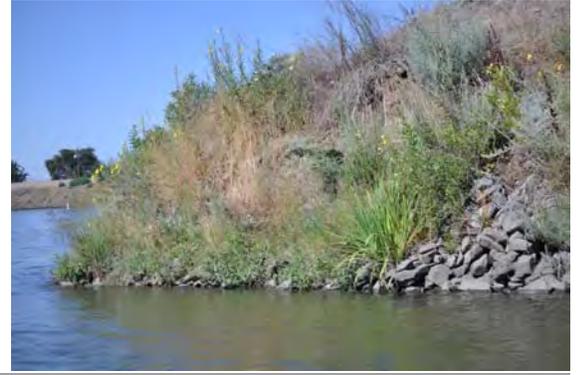
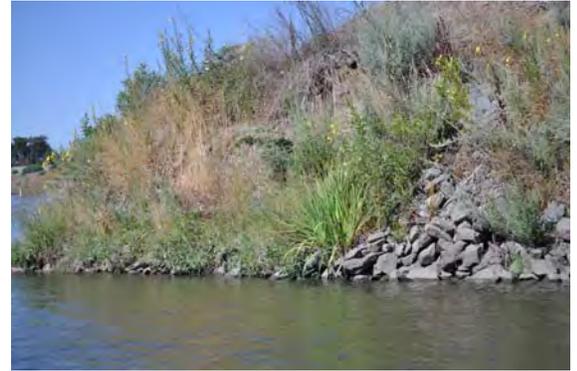
08/07/2012: Erosion is right at the inside of a river bend. Dense vegetation visible at the site.

Front view of erosion

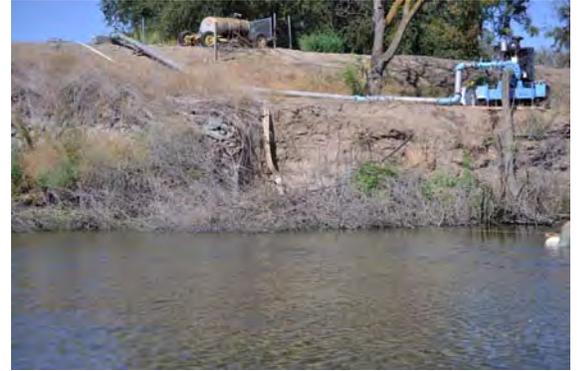
Front view of the site. Note the dense vegetation and rocks immediately upstream of the erosion

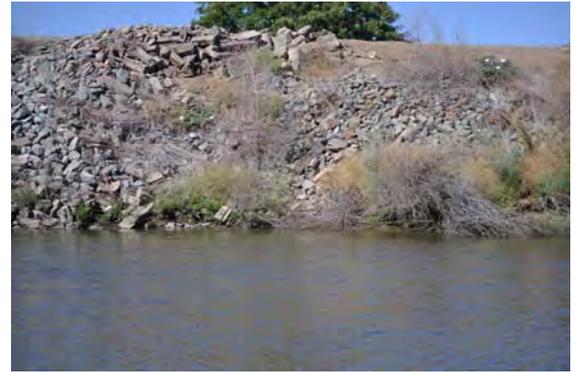
Upstream of the site is protected by rocks and broken concrete

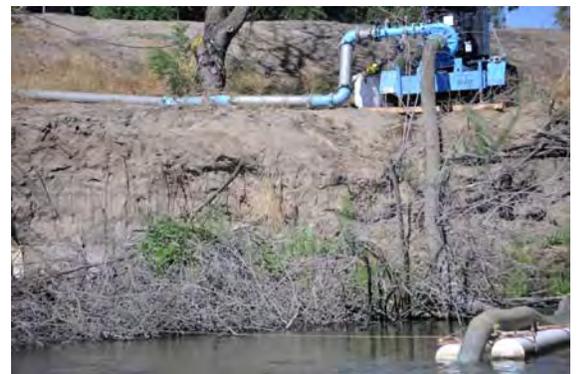
Close view of the site

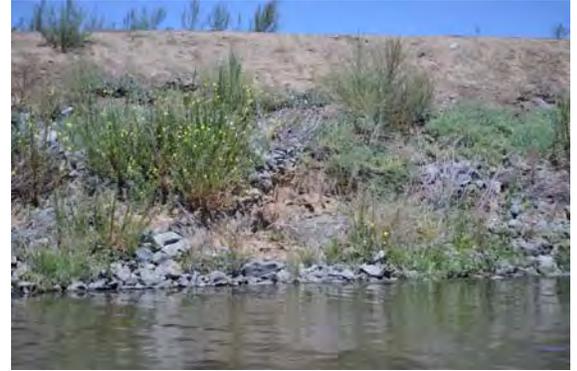
Front view of pocket erosion

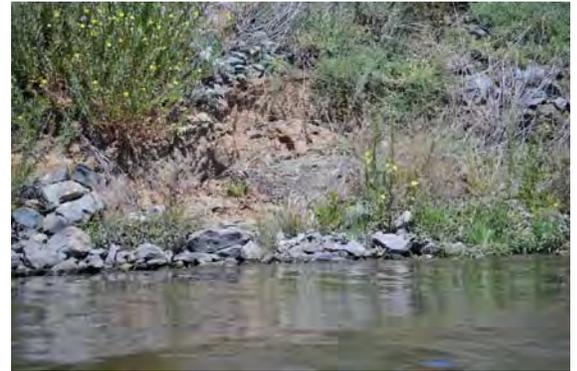
close look at the erosion

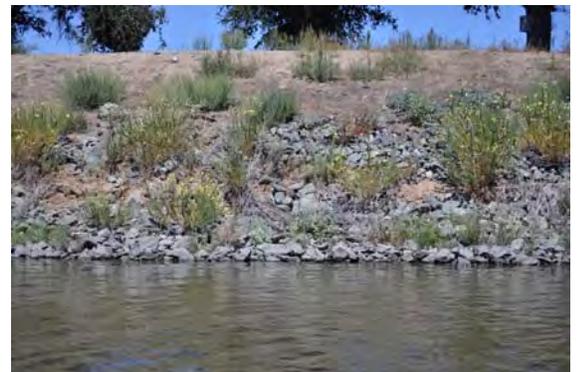
Front view of pocket erosions

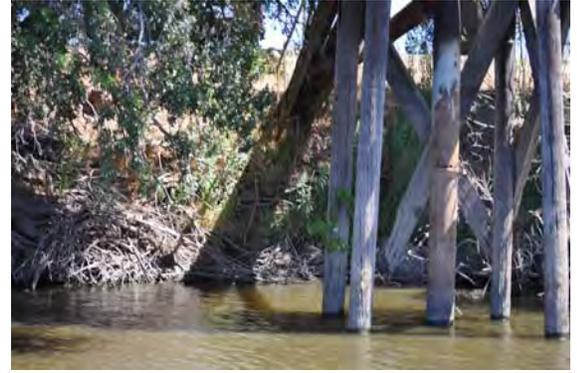
Front view of the site

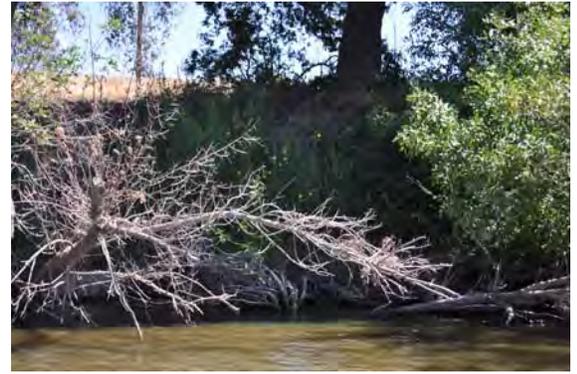
Close view of a fallen tree near the site

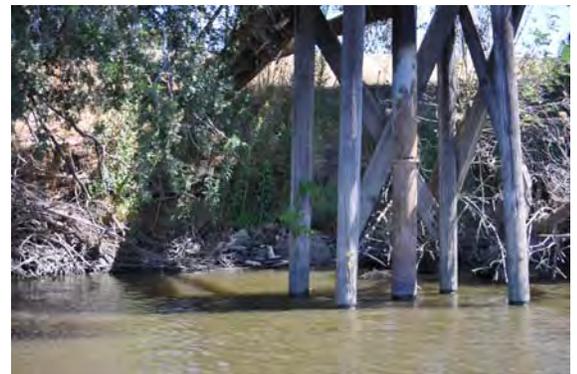
Front view of site
