LMA: **NA0010 U23 Lower San Joaquin Levee District**

Waterway: **RB San Joaquin River**

Site ID: **NA0010U23RM224.27**

Status: **Repaired Site**

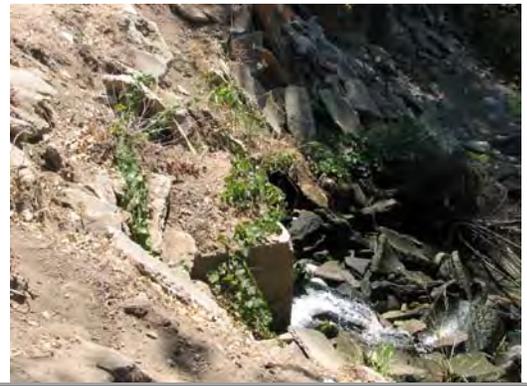
07/18/2012: No significant changes observed.
 08/18/2011: No significant changes observed on site. Debris that blocks the irrigation outlet visible.
 10/19/2010: No significant changes observed on site. Sloughing of the bank is occurring adjacent to an irrigation outlet structure. There is moderate to heavy vegetation along the bank that is well established. Broken chunks and slabs of concrete are used as rip rap and line the outside of the irrigation outlet structure. However, much of the rip rap along the slope is sloughing and could possibly lead to future slope instability.
 08/05/2010: Recommended as a local maintenance issue, per CLRO.
 08/20/2009: No major change observed since last visit; 1 inch fissure cracks developing on the slope; rip rap is showing signs of sloughing; recommend as local maintenance issue; site was previously rated "U".
 2008: No change from previous year; irrigation outlet located on site; rip rap placed on river bank.

Direct view of the site.

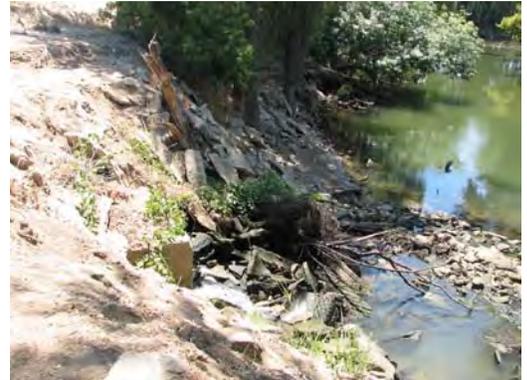
Looking downstream of the site. The irrigation outlet operating. Debris at the outlet visible

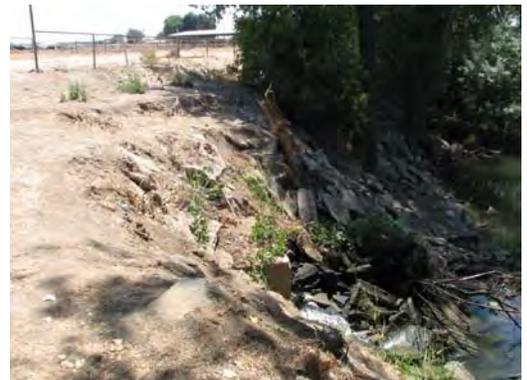
View of the current condition of the levee slope just above the irrigation outlet.

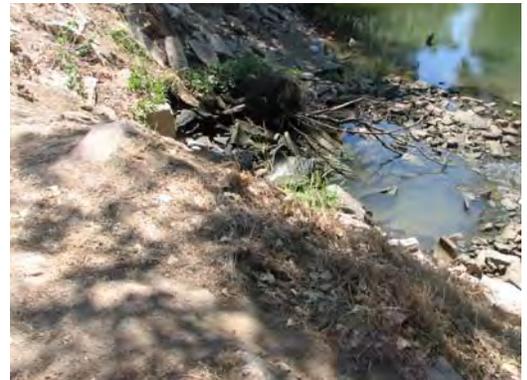
Downstream view of the site.

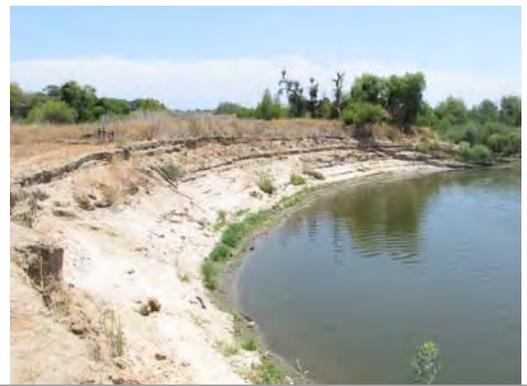
07/18/2012: No significant change observed on the site.
 08/18/2011: No significant changes observed on the site. Dead trees and animal activities visible. The closest point of the erosion site to the levee toe is about 100 ft.
 10/19/2010: There is active scouring occurring on the bank due to the nature of the flow and the lack of armor protection. There is also a fallen log immediately downstream of where the erosion has occurred and is protruding outward, possibly creating an eddy and scouring the bank. With the remaining 100-foot wide berm, the levee prism is not yet affected. However, the bank will continue to degrade, and eventually intrude into the levee prism if no protection is put in place. Erosion site is recommended for annual assessment and monitoring during flood events.

From the berm looking downstream.

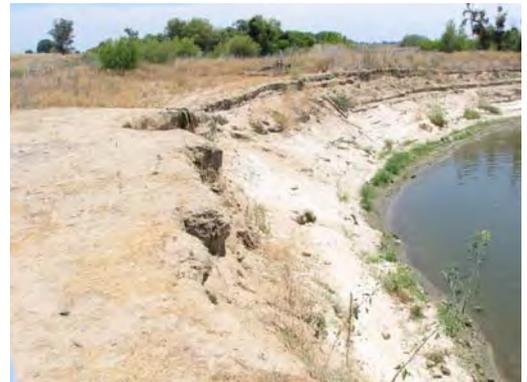
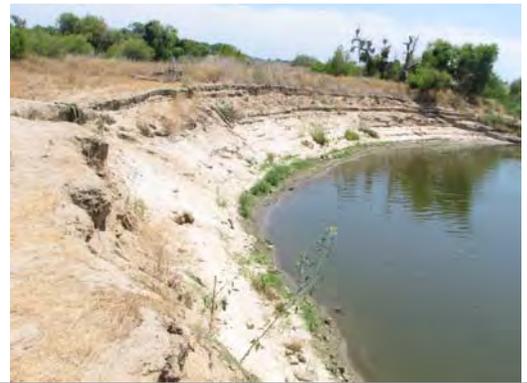
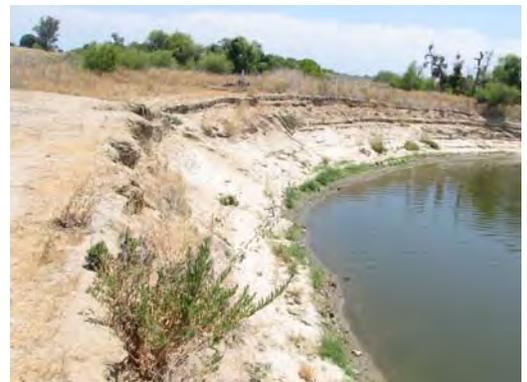
Close look at the erosion

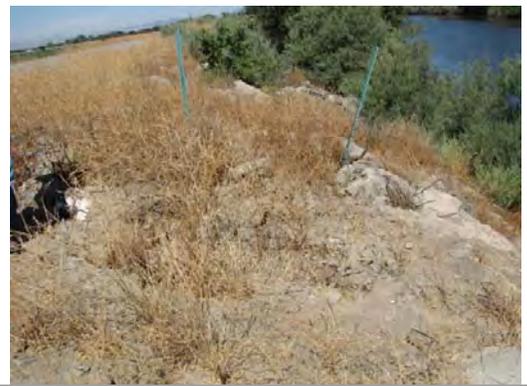
07/31/2012: Site was visited on 07/26/2012. No significant change observed. A new vertical pipe was installed and concrete blocks left on the site. Dense vegetation around the site. No signs of new leaks or spill from the siphon breaker.
 09/02/2011: Site was not visited due to the time limit.
 09/22/2010: No significant changes observed. Vegetation downstream, upstream and on the lower slope of the site have been recently sprayed. These areas were also fenced off during the site visit, making it difficult for us to examine the condition of the lower slope. Possible leak or spill from the siphon breaker is creating notches along the slope and developing into a headward erosion. If the problem continues, it will erode the slope and fully expose the pipe to outside elements.
 07/23/2009: A possible leak or spill from a siphon breaker is eroding the slope and developing into a headward erosion; a portion of the buried pipe is exposed; the lower slope seems to be lined with chunks of concrete debris or other rock material.

Close look at the site. Note the concrete blocks and vegetation.

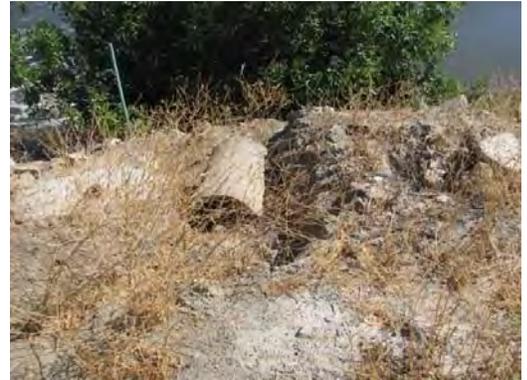
Direct view of siphon breaker.

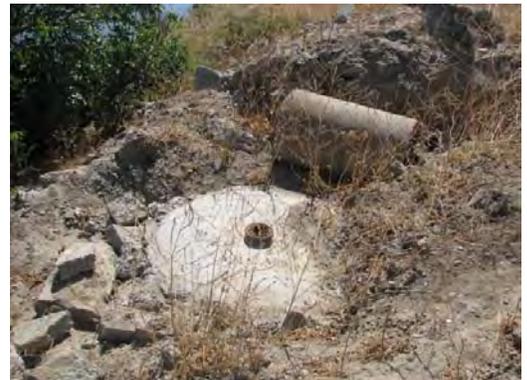
Direct view of siphon breaker. Recently placed vertical pipe

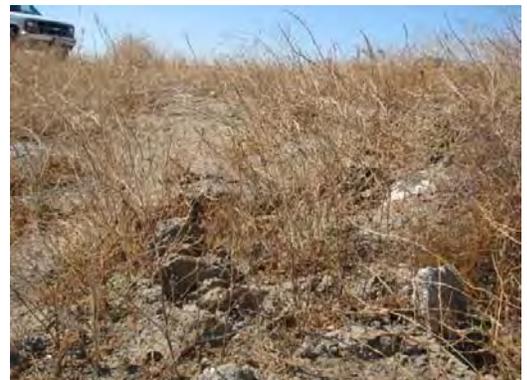
A close look at the site. Note the concrete debris.

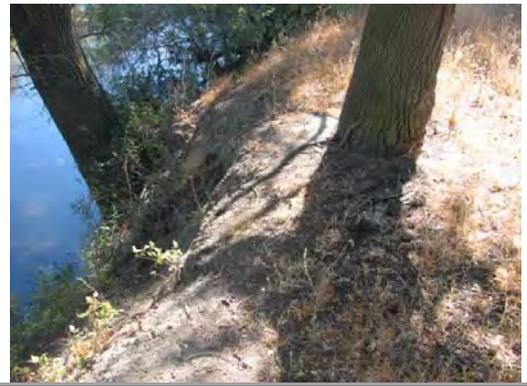
07/26/2012: The site has been visited, and no significant change has been observed.
 09/02/2011: This site was not visited due to the time limit.
 09/22/2010: No significant changes observed. Minor pocket erosions are lined at the lower bank. Two large Oak and Willow trees are on midslope and bench. The remaining bench was re-measured and found to be approximately 10 feet. There was no indication of active erosion on site during the site visit.
 08/05/2010: Recommended for annual assessment and monitoring of site during flood events, per CLRO.
 07/23/2009: No major change observed since last visit; site is a 200-ft. long near-vertical berm erosion; recommend annual assessment and monitoring of erosion site, per CLRO CES Evaluation 2008 Report; Site # is the same site previously reported as RM4.0,LM4.51; previously rated "U".
 09/10/2008: Two large trees (2-3' DBH) with partial roots exposed.
 2007: Visited site 03/13/2007.

Direct view at a pocket erosion site. Vegetation has developed and covered the erosion.

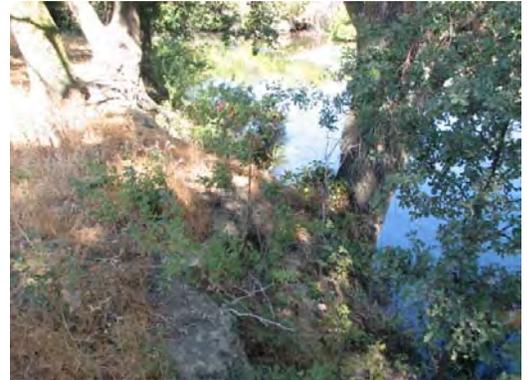
Direct view at the erosion near a tree

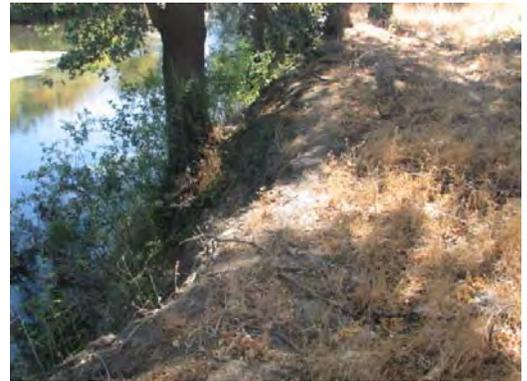
Direct view at the erosion near a tree

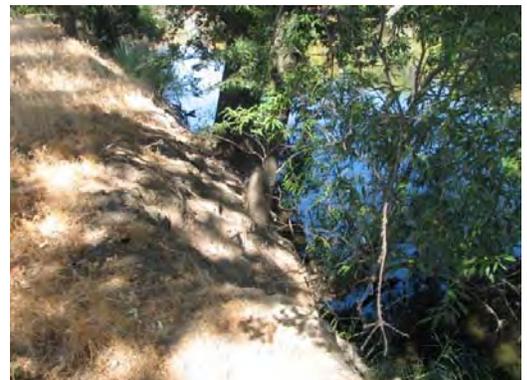
Direct view at the erosion near a tree

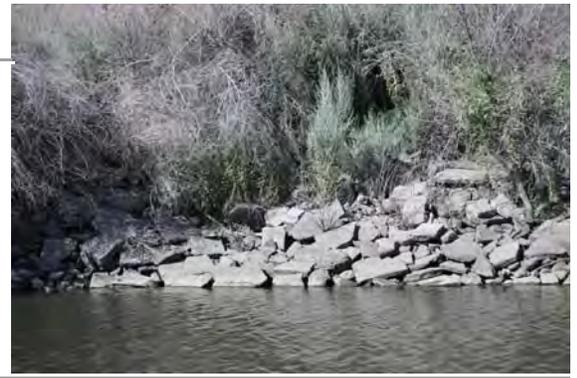
08/07/2012: The site has been visited by boat survey. No significant change observed
 08/23/2011: No significant changes observed on site. Vegetation on the slope. There is a bridge construction site just upstream of the erosion. The impact of the construction may need to be monitored.
 09/07/2010: No significant changes observed on site. Sloughing of the existing rip rap revetment on the lower slope has developed into an erosion pocket. There is moderate annual grass growth on the slope.
 08/06/2010: Recommended as local maintenance issue, per CLRO.
 03/09/2010: Per Michael Moncrief of MBK, site is scheduled for repair this year.
 2009: Landside ground surface has been raised to the height of the levee crown; sloughing of the existing rip rap revetment on the lower slope that has created a pocket, exposing underlying soil; Site # is the same RM54.34,LM1.08; previously rated "M".
 2006: Previously marked with stake.

Front view of the erosion site

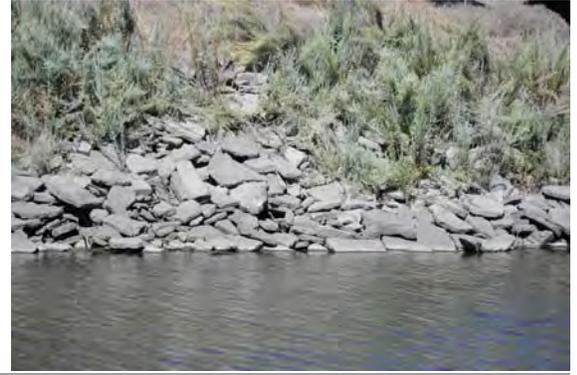
Front view of the rip rap

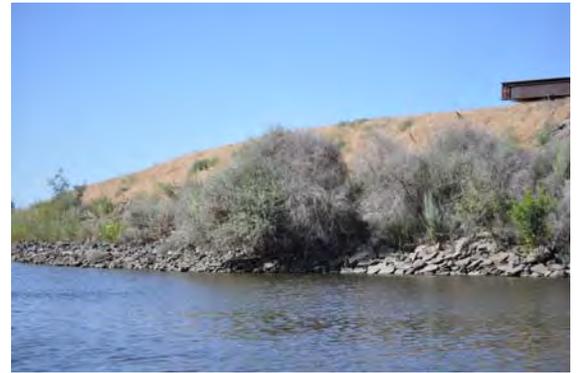
Downstream view of the erosion site and riprap revetment

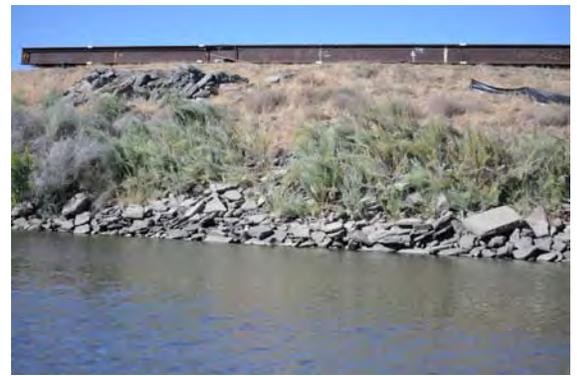
Front view of the site

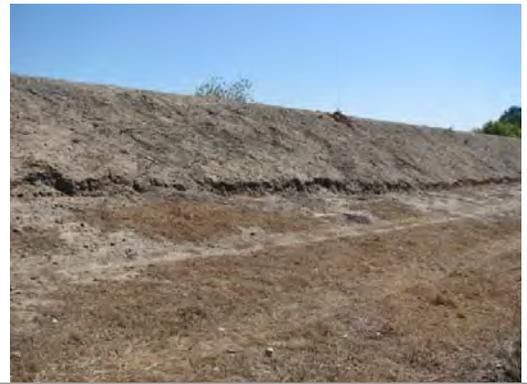
07/31/2012: Site was visited on 07/26/2012. No significant change observed.
 09/02/2011: No significant changes observed on site from the previous visit.
 09/22/2010: No significant changes observed on site. The foot-high near-vertical scarp still exists on levee toe. There is little to no vegetation on the slope.
 03/09/2010: As discussed with Michael Moncrief of MBK, site will be addressed this year.
 07/27/2009: 1 to 2 feet of near-vertical scarp on levee toe; damage was most likely caused by farming equipment during clearing or tilling operation; this is a maintenance-related issue.

Upstream view of site. Note the vertical scarp at the toe.

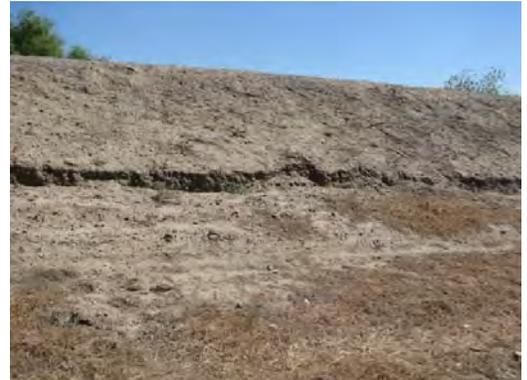
Direct view of site.

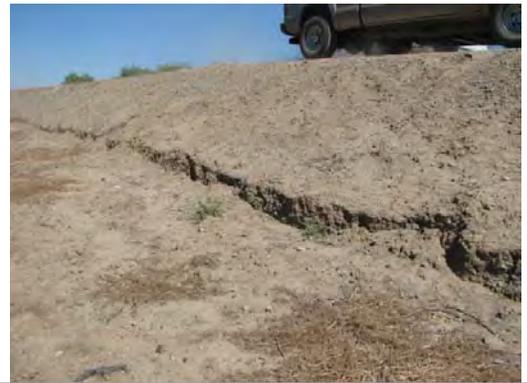
Downstream view of site.

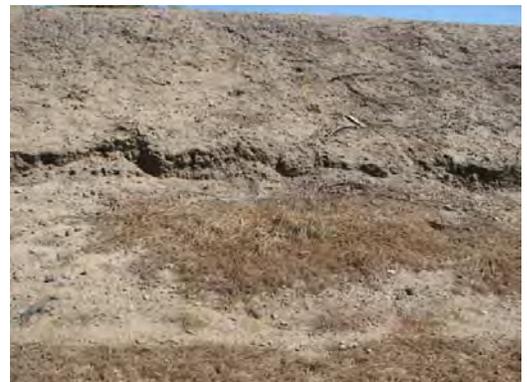
A close view of site.

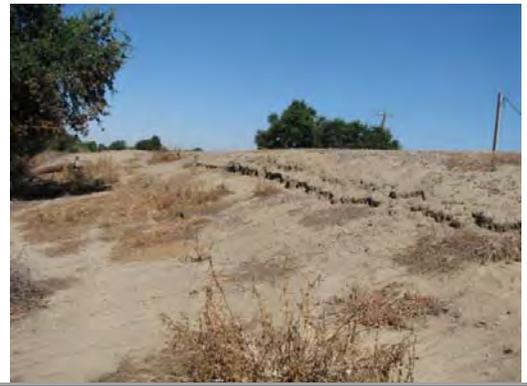
07/26/2012: Site was visited on 07/26/2012. No significant changes observed.
 09/02/2011: : No significant changes observed on site from last visit.
 09/22/2010: No significant changes observed on site. The fencing located on the berm was removed. Levee slope and berm area 10 feet from the levee toe are bare of any vegetation. The 1- to 2 feet of near-vertical scarp on the levee toe is unchanged.
 03/09/2010: As discussed with Michael Moncrief of MBK Engineer, the district will address the site this year.
 7/27/2009: 1 to 2 feet of near-vertical scarp on the levee toe; damage was most likely caused by agricultural equipment during clearing or tilling operation; this is a maintenance-related issue.

Downstream view of scarp caused by a maintenance equipment.

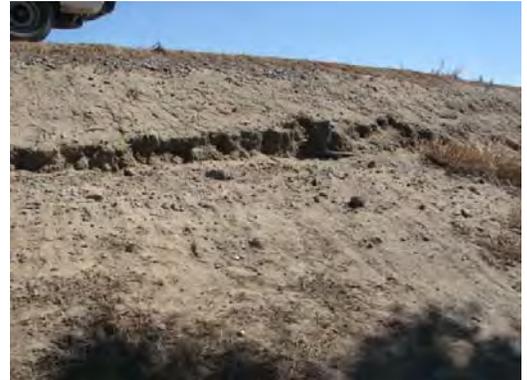
Close view of scarp.

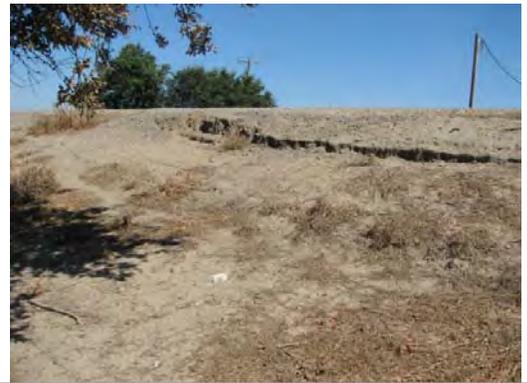
downstream view of site.

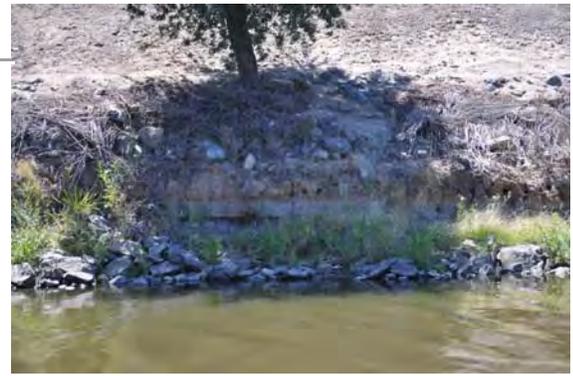
08/07/2012: The site has been visited by boat survey. No significant change observed
 08/23/2011: Site is at the upstream of a drainage ditch.

Front view of erosion

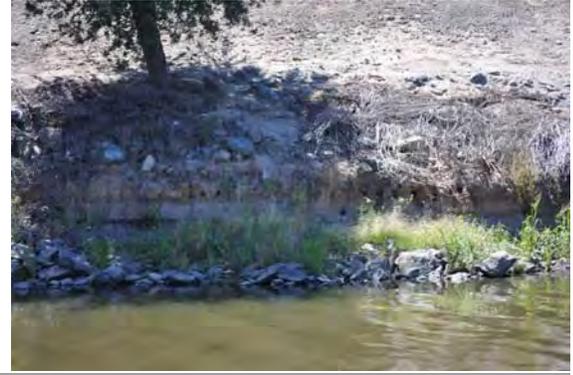
Front view of the erosion

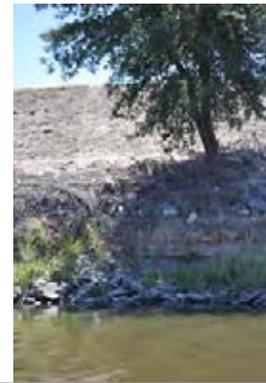
Upstream view of the erosion

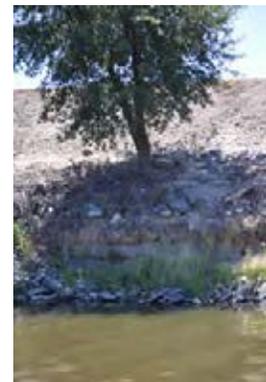
Front view of the erosion. Note the dense vegetation.

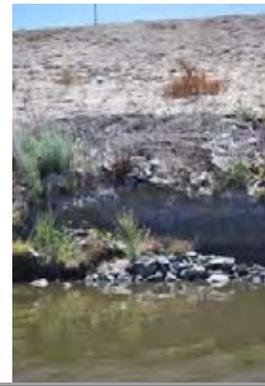
08/07/2012: The site has been visited by boat survey. No significant change observed
 08/23/2011: Hard to view the erosion because of the dense vegetation and trees on site.
 The site is under the bush, close to the tree.

close view of the site

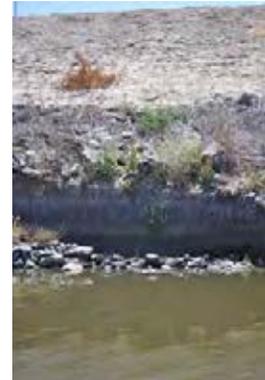
Close view of the site

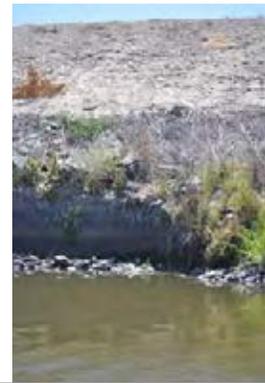
Front view of the site. Note the vegetation

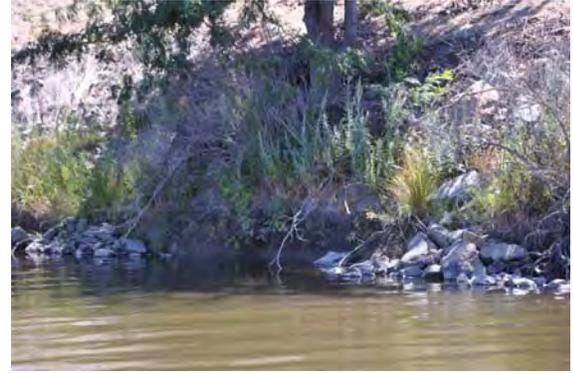
08/07/2012: The site has been visited by boat survey. No significant change observed
 08/23/2011: The protection at the levee toe has been washed away.

Front view of the erosion

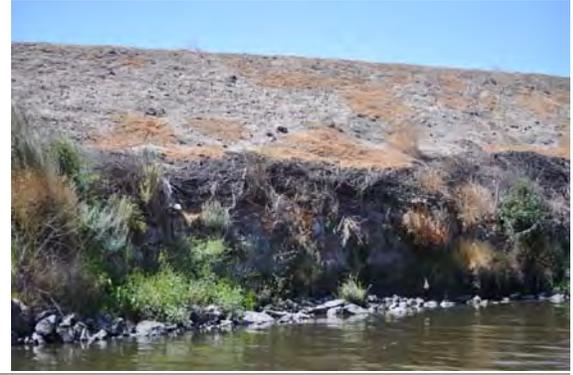
08/07/2012: The site has been visited by boat survey. No significant change observed
 08/23/2011: No significant changes observed on site. Dense vegetation visible along the water line.
 09/07/2010: No significant changes observed on site. Much of the upper slope was recently cleared of vegetation by spraying. 4- to 6-foot vertical scarp and pocket erosions are lined along a span of 475 feet. In some sections, the vertical scarp encroaches into the levee prism. There is a lack of berm along this reach, exposing the levee slope to high flow velocities during normal and flood events.
 08/06/2010: Recommended as local maintenance issue, per CLRO.
 03/09/2010: As discussed with Michael Moncrief of MBK Engineers, the site will be 'addressed' later this year.
 09/29/2009: No major change observed since last visit; pocket erosion and a vertical scarp forming; this site was combined with Site RM30.13 and 30.02 with a combined total erosion length of 475 feet; recommended as annual assessment and monitoring of site, per CLRO CES Evaluation 2008 Report; previously rated "M".

Another view of the same 5-ft scarp.

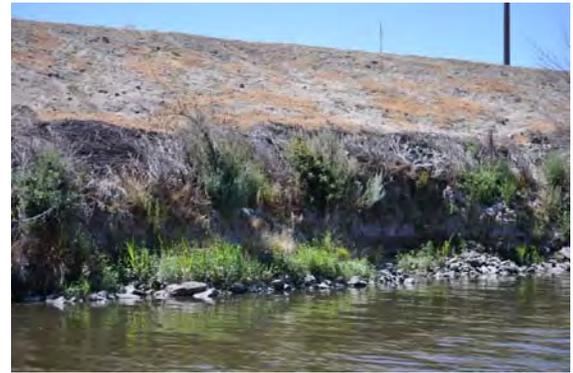
Front view of the site with dense vegetation.

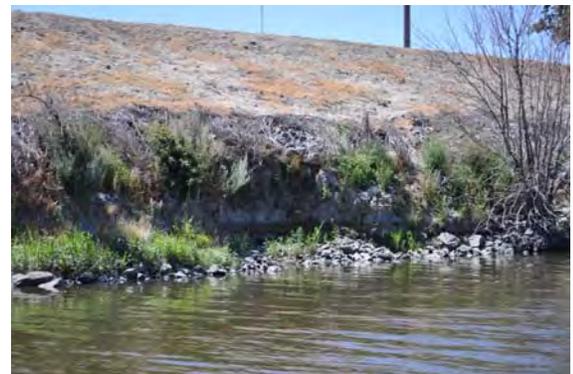
Front view of the site with dense vegetation

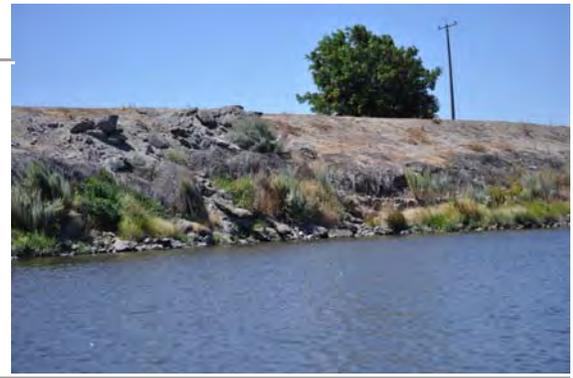
08/07/2012: The site has been visited by boat survey. No significant change observed
 08/23/2011: The site is right at the downstream of a river bend.

Upstream view of the erosion.

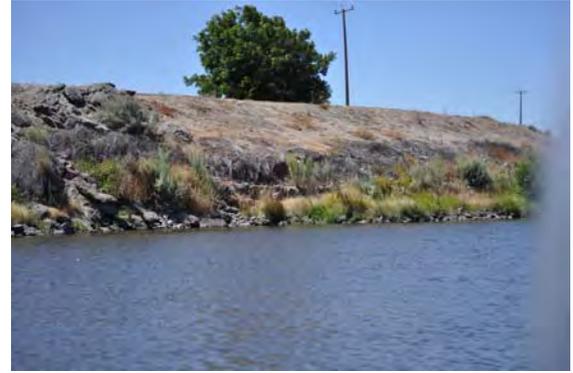
Close view of the site

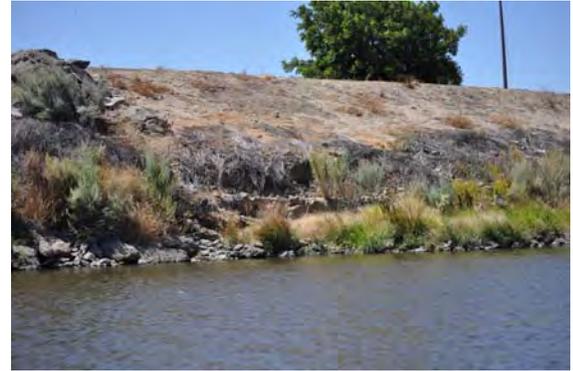
Front view of the erosion.

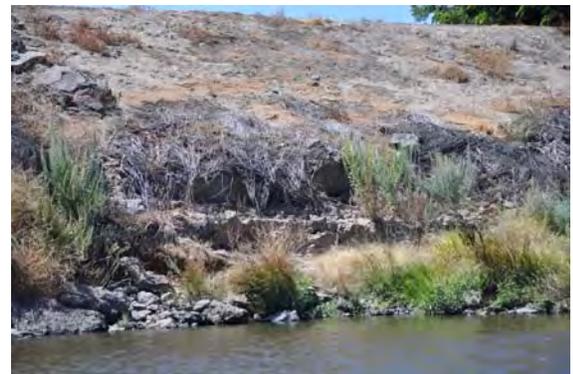
Front view of the site

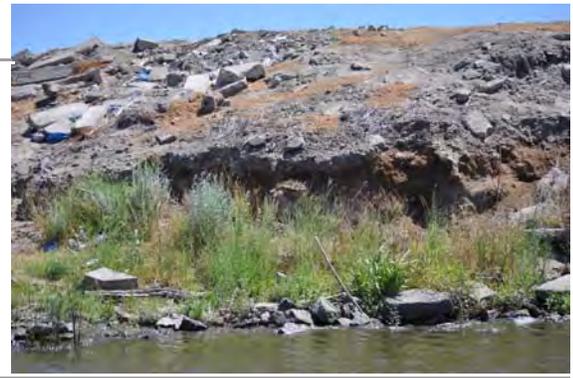
08/07/2012: The site has been visited by boat survey. No significant change observed
 08/23/2011: No significant changes observed on site.
 09/07/2010: No significant changes observed on site. Much of the placed rip rap revetment has slid. It is no longer adequately protecting the slope.
 08/06/2010: Recommended as local maintenance issue, per CLRO Report.
 03/09/2010: As discussed with Michael Moncrief of MBK, site will be 'addressed' this year.
 09/29/2009: No major change observed since last visit; a section of the rip rap has slipped, exposing a levee section that has eroded; recommended as local maintenance issue, per CLRO CES Evaluation 2008 Report; Site # is the same as RM30.43,LMO.63; previously rated "U".
 11/05/2008: Site is located inside of a bend; scarp looks to be into the levee prism; piles of concrete chunks placed on the slope, with some of them already starting to slide.

Close view of the site.

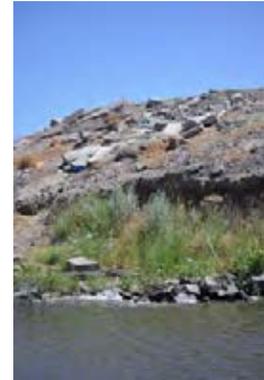
Front view of the site. Previously placed rip rap slipped, exposing the underlying soils and creating a pocket.

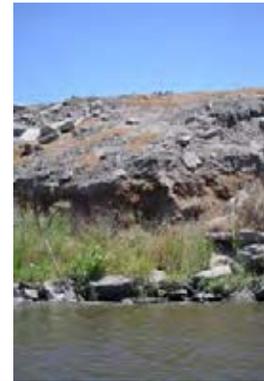
Front view of the site. Rip rap no longer adequately protecting levee slope.

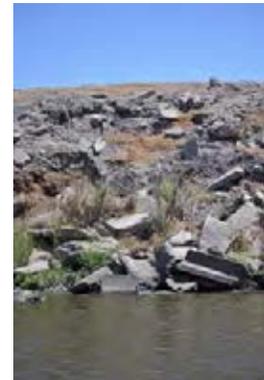
Front view of the site.

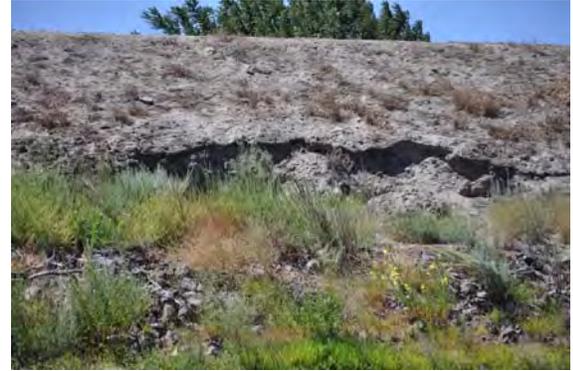
08/07/2012: The site has been visited by boat survey. No significant change observed
 08/23/2011: No significant changes observed on site.
 09/07/2010: No significant changes observed on site. Much of the seasonal grass along the slope was cleared. Site consists of an existing scalloped erosion approximately 30 feet long by 5 feet wide at its widest opening. The lateral crack is extended outwards along the middle slope. There is a 1 to 2 feet of differential settlement that could further develop into a shallow slide.
 08/06/2010: Recommended as local maintenance issue, per CLRO.
 03/09/2010: As discussed with Michael Moncrief of MBK Engineer, site will be 'addressed' this year.
 09/28/2009: No major change observed; section of rip rap has slipped, creating a terraced effect; dense vegetation growth; recommended as a local maintenance issue, per CLRO CES Evaluation 2008 Report; Site # is the same as RM31.12,LM1.25; previously rated "U".

close view of the site

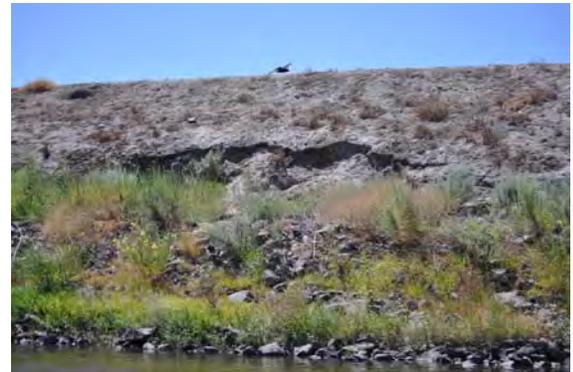
Front view of the site just above existing rip rap.

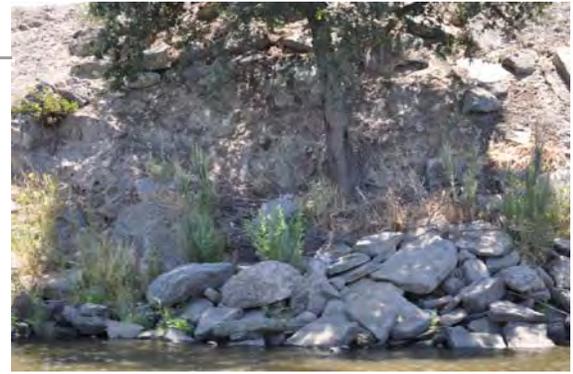
08/07/2012: The site has been visited by boat survey. No significant change observed
 08/23/2011: No significant changes observed on site.
 09/07/2010: No significant changes observed on site. There is a small- to medium sized Oak tree on the mid-slope just above rip rap. Some of the rip rap has collapsed, creating a pocket erosion just above the existing toe rip rap and upstream of the Oak tree.
 08/06/2010: Recommended as local maintenance issue, per CLRO.
 03/09/2010: As discussed with Michael Moncrief of MBK Engineer, site will be 'addressed' in 2010.
 09/29/2009: No major change since last visit; sliding of the rip rap at the base of the lone tree; there is noticeable man-made trail and foot traffic extending from the crown to the toe; much of the broken concrete used as temporary rip rap has slid, exposing portion of the bare levee slope; recommended as local maintenance issue, per CLRO CES Evaluation 2008 Report; Site # is the same as RM31.3,LM1.45; previously rated "M".

11/05/2008: Portion of rip rap collapsing.
 09/14/2006: Portion of rip rap along the slope has collapsed; exposed levee section is starting to erode, exposing roots from the nearby tree.

Close view of the site where a small to medium sized Oak tree is located.

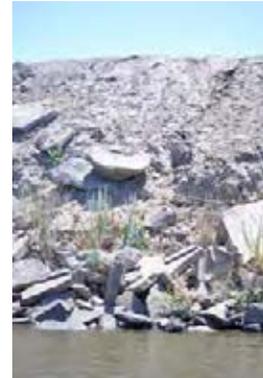
A closer look of the site near the oak tree

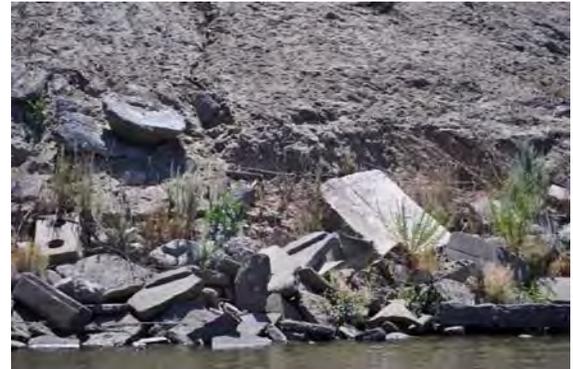
Front view of the site. Note existing broken concrete on the upper slope as well as on the lower slope and at the toe.

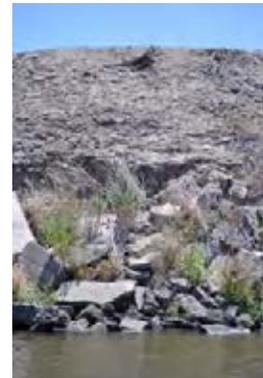
Front view of the site.

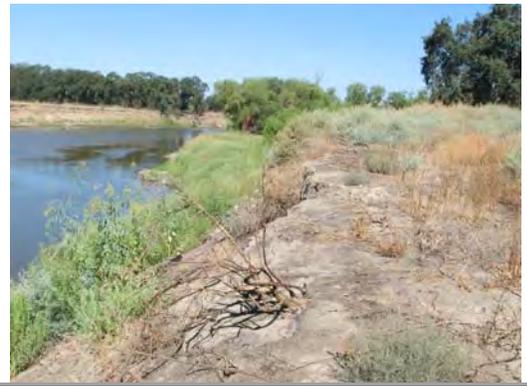
07/24/2012: Learned from the district that the upstream erosion has been repaired by placing broken concrete blocks. Visual inspection at the repaired site found no new erosion development. No significant change observed on the site at the downstream section of the repaired erosion site.

10/14/2011. This site was reported on Jan. 18, 2011. The first 100' of erosion appears to be a previous cut with fresh activity. At station 2+00 the district president indicated that 60 - 80' of material eroded. The remainder berm width is at least 32 ft from the levee toe. As the levee is not at risk at this time, the site is not rated, but needs to be closely monitored for possible erosion failure during the upcoming flooding season.

Looking downstream at the erosion

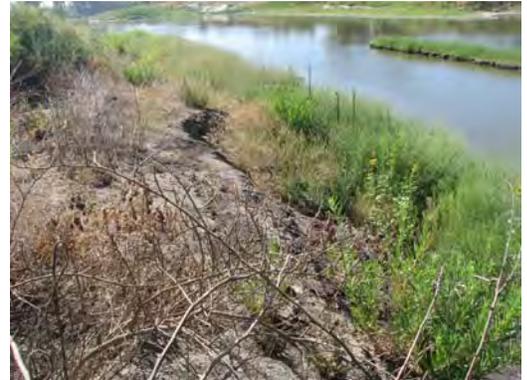
Direct view of the erosion

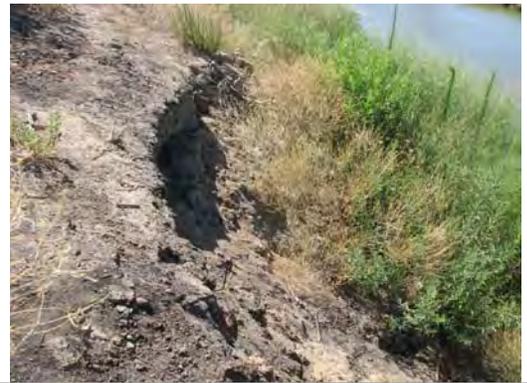
Closer view of the erosion

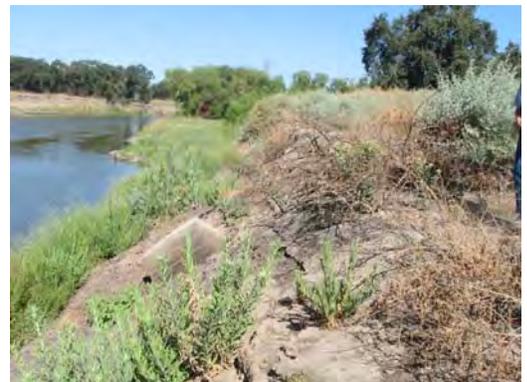
Looking downstream at the erosion

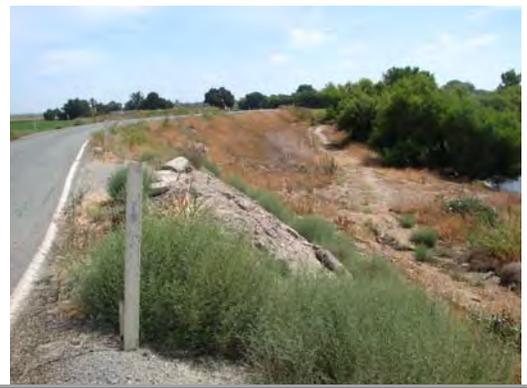
09/13/2012: No significant changes observed on site.
 08/18/2011: No significant changes observed on site. Some new material added to the water side levee slope, but the added material is loose and seems not helping the levee protection.
 10/05/2010: No significant changes observed on site. Levee slope has minimal vegetation and lacks rip rap protection. Sandy material found on the lower and middle slope is an undesirable material to have on a levee.
 08/05/2010: Recommended for annual assessment and monitoring during flood events, per CLRO.
 08/20/2009: No major change since last visit; site is located in an oxbow; slope surface consists of very sandy material; there is a tree on site leaning and with exposed tree roots; site is recommended as a local maintenance issue, per CLRO CES Evaluation 2008 Report; Eddy Cordoza from the district is aware of the site and is looking for recommendation; site is previously rated "U".

Looking upstream of the site .

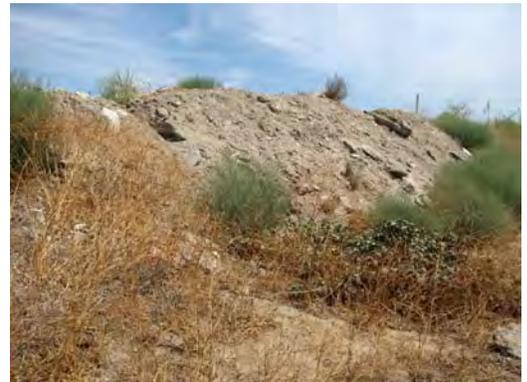
Looking up to the levee crown at the added material.

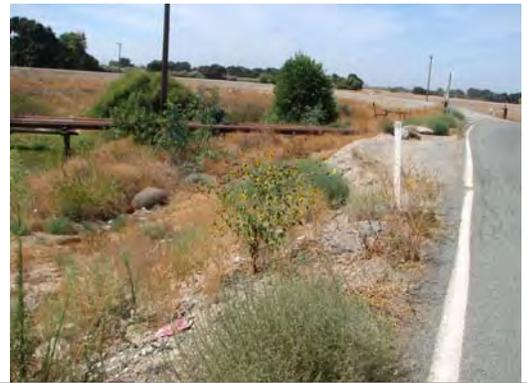
Looking upstream of the erosion site

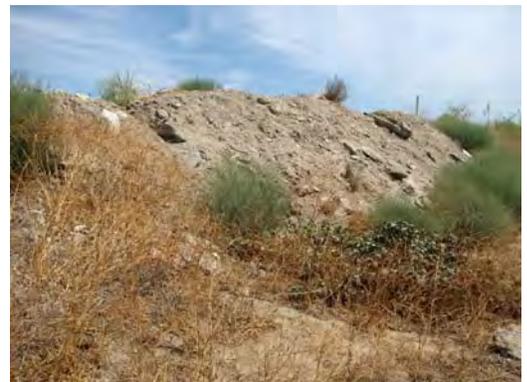
Direct look at the levee slope.

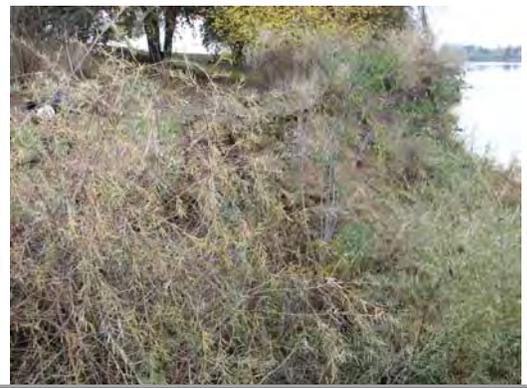
12/04/2012: The erosion has progressed remarkably toward levee, extended to the up- and downstream of the original pocket erosion. Trees and dense bush present at the site. Animal burrow holes are visible, and possibly can cause seepage.
 09/22/2010: No significant changes observed. There is little visibility due to seasonal grass on the berm and slope.
 08/18/2009: Site is located on berm; pocket erosion has developed; the site is covered in dense vegetation; there are several relief wells on the landside of the levee; site is Not Rated because berm width is greater than 30 feet; site should be monitored to keep track of erosion progress.

Looking downstream

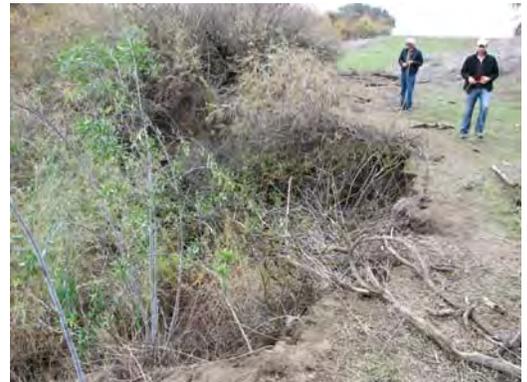
Looking upstream

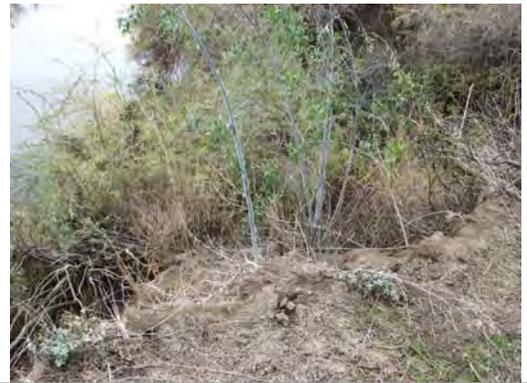
Direct view at the erosion

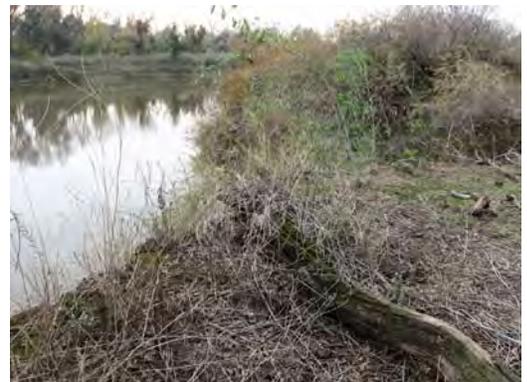
View from levee top

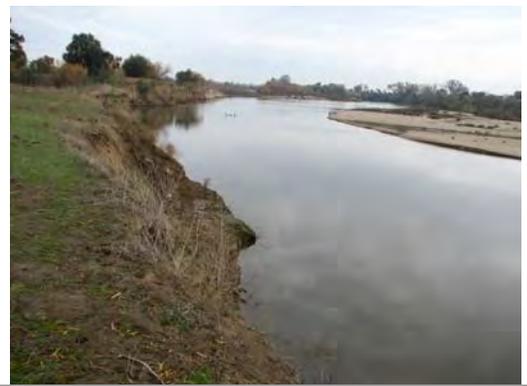
12/04/2012: This site has been documented before, and a cost estimate to repair has been prepared dated 05/09/2010. The fresh cut shows the erosion is developing. The berm width is at least 42 feet. Sticks were placed at three locations along the river bank, with 3 sticks 5 feet apart at each location.

Looking downstream. At the downstream end the erosion occurring at a spur levee.

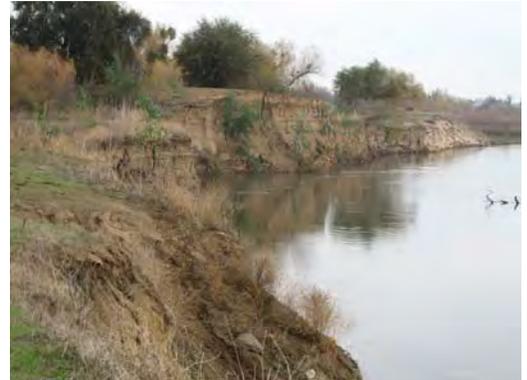
Looking downstream at the erosion at the spur levee

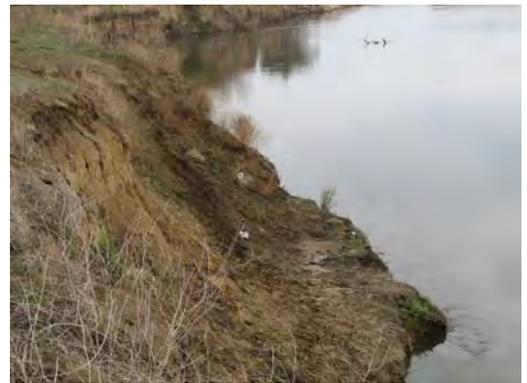
Direct view of the erosion

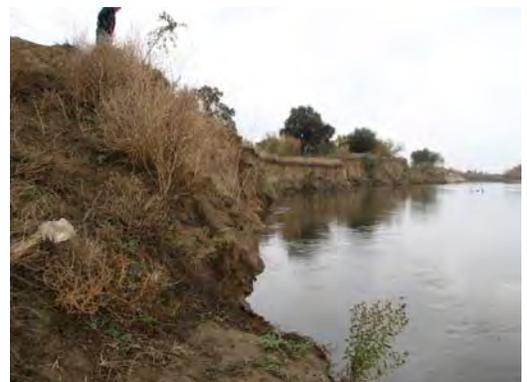
Looking downstream standing at the water edge

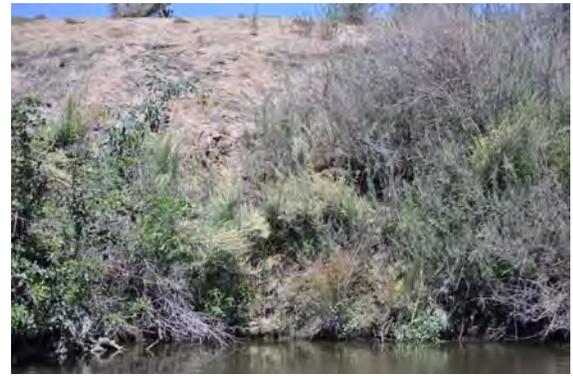
08/07/2012: The site has been visited by boat survey. No significant change observed
 08/23/2011: The 5-foot vertical scarp shows no significant change from the last year inspection. No new erosion activities observed. Dense white willow trees on site.
 09/07/2010: It was difficult to view the erosion due to the thick Willow thickets and other vegetation at the water line. At the time of the inspection, there were no signs of repair on site. As noted during the last survey, there is a 5-foot vertical scarp along the lower slope that may be subjected to high flow velocities.
 08/05/2010: Recommended for repair, per CLRO; "Erosion of this site may be subjective to rapid rates of erosion."
 09/28/2009: No major change observed; 5-foot vertical scarp is immediately downstream of where berm has tapered; site is recommended as local maintenance issue, per CLRO CES Evaluation 2008 Report; Site # is the same as RM29.6,LM0.60; previously rated "U".

Front view of the site. Note the very dense white willow thickets on site.

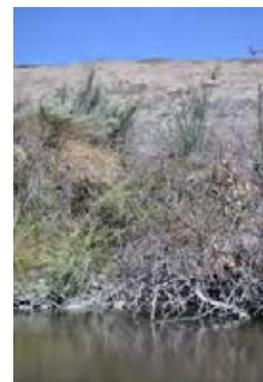
Front view of the site. Note the erosion invisible because of the dense vegetation

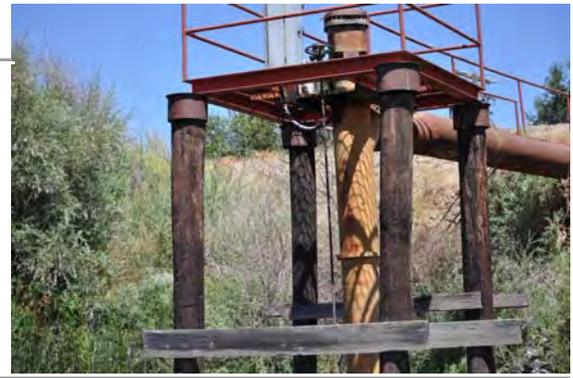
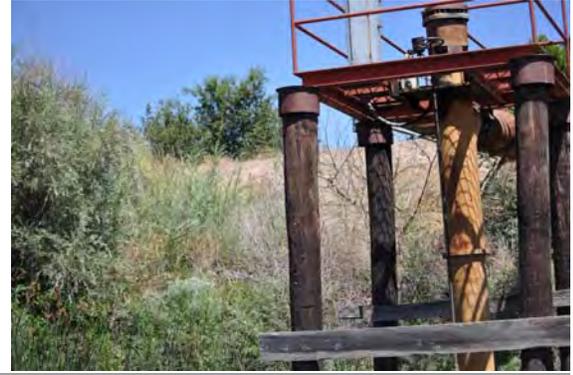
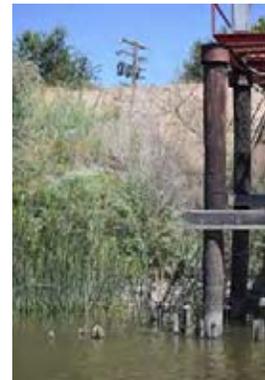
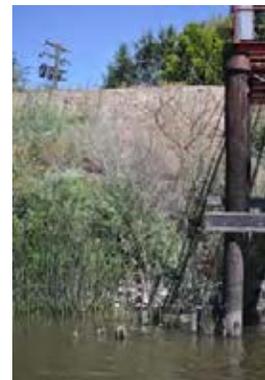
08/07/2012: The site has been visited by boat survey. No significant change observed
 08/23/2011: The site shows loose material around the pipe crossing. The operation of the pipe might have caused certain impact on the levee.

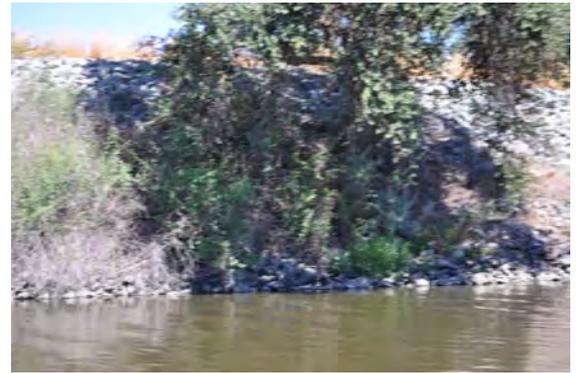
08/07/2012: The site has been visited by boat survey. No significant change observed
 08/23/2011: No significant changes observed on site.
 09/07/2010: Site appears to have been repaired by placing shot rock along the entire slope as revetment. Seasonal grasses growing over the placed revetment. Emergent vegetation at the lower slope that could possibly be covering the vertical scarp that was previously observed. It is recommended that another inspection be conducted to verify status of site. It was previously rated "U".
 08/06/2010: Recommended as local maintenance issue, per CLRO.
 09/28/2009: Rock revetment placed on the upper slope; however, vertical scarp still exists; site is recommended for annual assessment and monitoring of erosion site, per CLRO CES Evaluation 2008 Report; Site # is the same as RM29.95, LM0.22; previously rated "M".
 11/05/2008: Pocket erosion with vertical scarp; loss of rip rap; mild vegetation growth since previous survey.

Front view of the site. Note the vegetation at the site

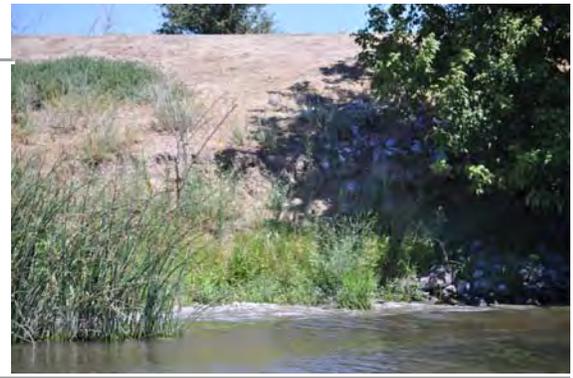
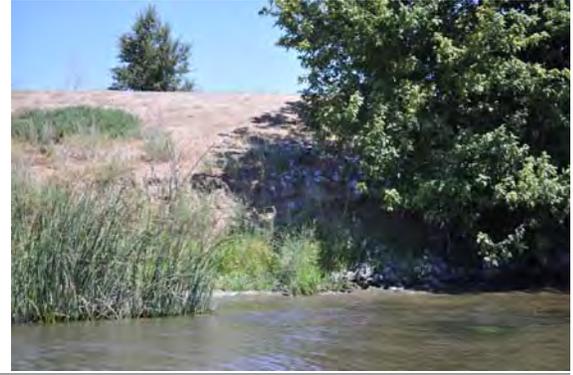
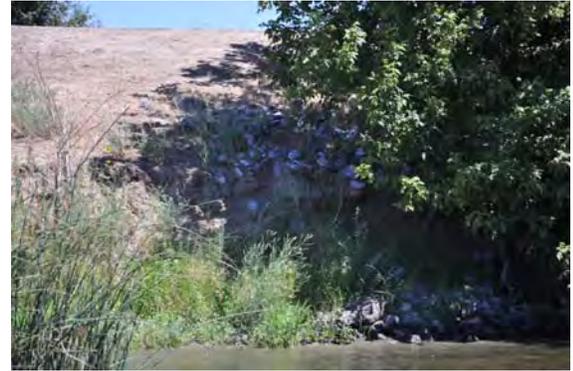
08/07/2012: The site has been visited by boat survey. No significant change observed
 08/23/2011: No significant changes observed on site.
 09/07/2010: Site consists of a jutting rip rap that has created an eddy, scouring the levee slope. Most sections of the toe and lower slope are lined with rip rap. However, the rip rap is sloughing on the mid slope and at the toe, exposing the underlying soils and tree roots. The remaining revetment is no longer adequately protecting the slope. There are 3 Sycamore trees at the toe with exposed tree roots.
 08/05/2010: Recommended for repair, per CLRO.
 09/28/2009: Pocket erosion on lower slope just above the toe rip rap; protruding rip rap upstream is creating an eddy, scouring the levee slope; Site # is the same as RM28.40,LM0.30; previously rated "U"; pictures will be made available during the next survey.
 11/05/2008: Cut into levee profile; riprap slide; rodent holes; pictures do not match GPS and current condition.

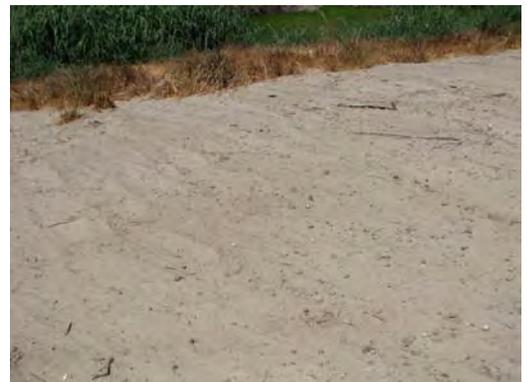
09/26/2012: Site was not surveyed this year due to time constraints. There have been no reports from the levee inspectors or district that this site has new erosion.
 08/18/2011: This site was repaired. No new erosion visible.
 11/30/2010: Site was not surveyed this year due to time constraints. There have been no reports from the district that this site was corrected.
 08/05/2010: Recommended for annual assessment and monitoring during flood events, per CLRO.
 08/25/2009: No major change since last visit; sloughing of the lower slope that's created a terraced effect; damage could be caused by wave action during an extended flooding; site is recommended as local maintenance issue, per CLRO CES Evaluation 2008 Report; previously rated "M".
 08/09/2007: Not as serious - use lower rating.

Close-in view of the repaired site.

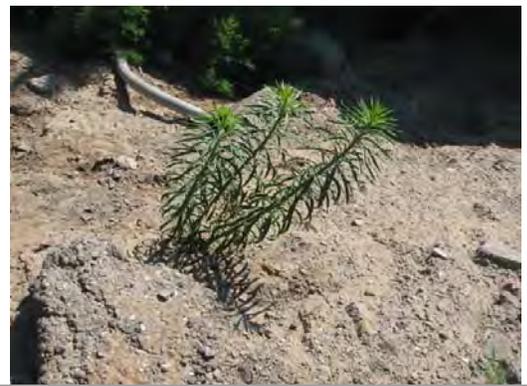
07/18/2012: No significant changes observed on site.
 09/02/2011: No significant changes observed on site.
 09/22/2010: No significant changes observed on site. There is now considerable vegetation at the water line and along the lower berm slope. However, the erosion on the lower berm slope is still present and has not been corrected.
 08/06/2010: Recommended for local maintenance issue, per CLRO.
 07/29/2009: No major change since last visit; noticeable vegetation growth; erosion is on berm, but if left untreated, it will eventually erode into levee prism; site is recommended for annual assessment and monitoring of site, per CLRO CES 2008 Report; Site # is the same as RM6.80,LM0.73; previously rated "U".
 07/22/2008: Downstream of WPRR near siphon pipe & pump; sandy levee; visited by Jeff Van Gilder and LRO in 2008 for repair assessment; scouring downstream of RxR crossing, possibly caused by eddy effects.

Direct view of the erosion at the downstream of RR bridge.

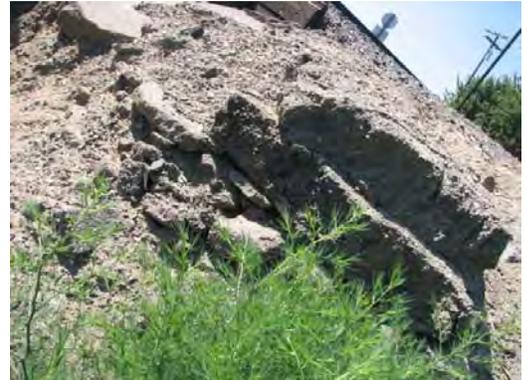
looking up at the erosion from the lower levee slope

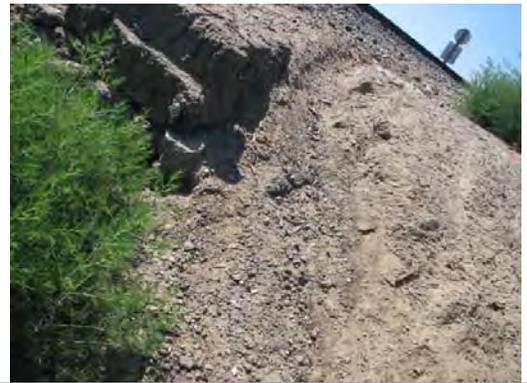
Closer view of the erosion

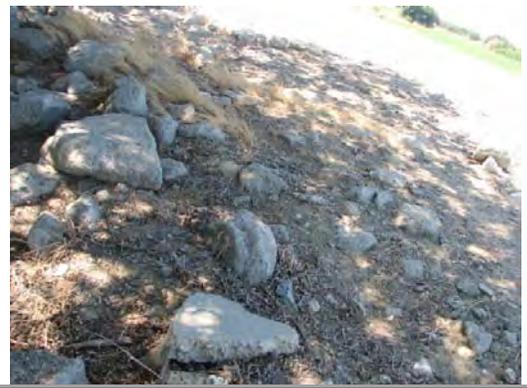
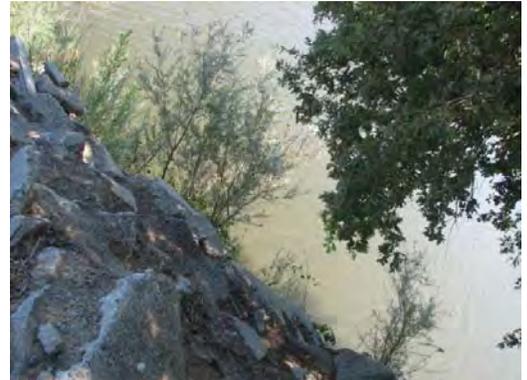
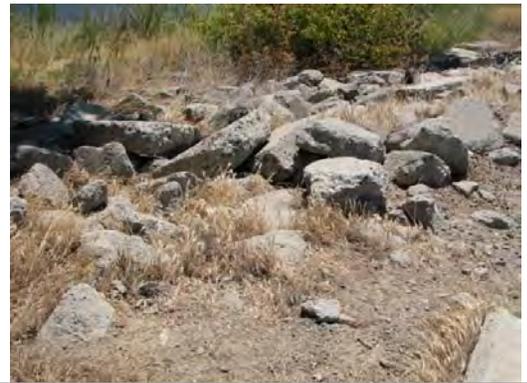
07/18/2012: No significant changes observed.
 09/02/2011: No significant changes observed.
 09/22/2010: No significant changes observed. Sloughing of the existing rip rap possibly due to a combination of steep slope and undesirable flood conditions.
 08/06/2010: Recommended as local maintenance issue, per CLRO.
 07/29/2009: No major change observed since last visit; near-vertical slope that has rip rap sloughing; site is recommended as a local maintenance issue, per CLRO CES Evaluation 2008 Report; Site # is the same as RM6.90,LM0.86; previously rated "U".
 07/22/2008: Previous erosion site that is partially protected with concrete rubble; erosion scarp is adjacent to the sloughing rip rap.
 03/13/2007: Site visited on 03/13/2007.
