LMA: **NA0010 U23 Lower San Joaquin Levee District**

Waterway: **RB San Joaquin River**

Site ID: **NA0010U23RM224.27**

Status: **Repaired Site**

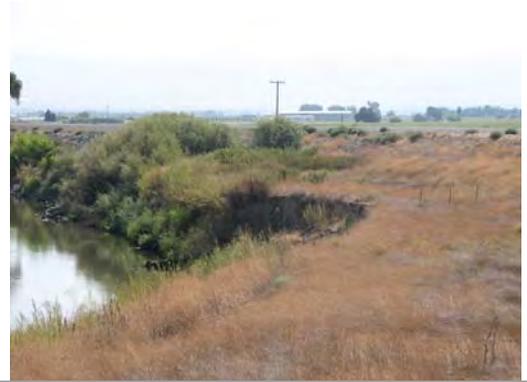
09/13/2012: The site has been visited by land survey. The vegetation on the site shows the erosion has not developed significantly from the last survey. The site was not visited by boat survey due to the limitation of navigatable waterway.
 08/23/2011: No significant changes observed on the site.
 9/22/2010: No significant changes observed on site. There is moderate vegetation growth on the berm. Despite the erosion occurring on the berm, corrective action should be taken before the issue becomes severe.
 9/29/2009: Site is immediately downstream of a section of existing rip rap; there is a 20-foot berm remaining; berm will continue to erode unless erosion is mitigated; Site# is the same as RM62.6, LM1.87; recommended for annual assessment, per CES Evaluation 2008 Report
 2006: Visited 10/20/06

Looking upstream of the site. Note dense vegetation on the berm.

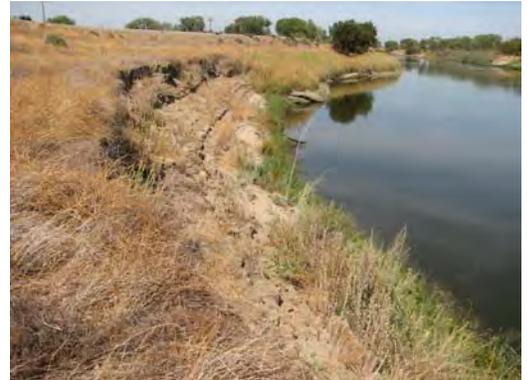
Looking downstream of the site.

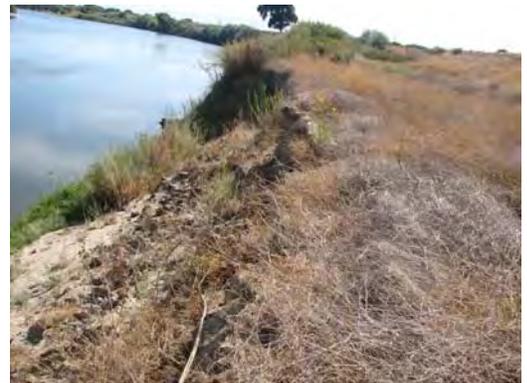
Close view of the site.

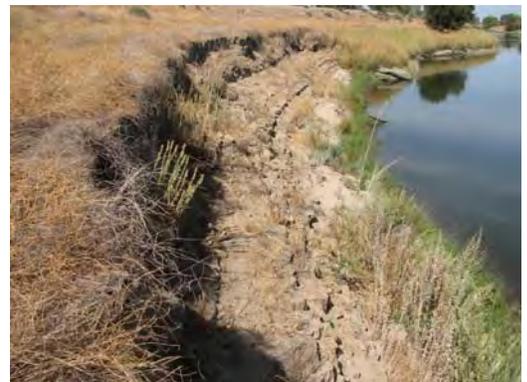
Close view of the site.

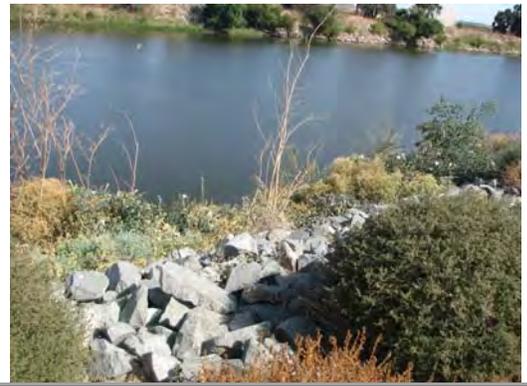
08/23/2011: Dense vegetation makes it difficult to view the possible erosion. No new development was observed on site.

View from levee slope. The dense vegetation on the site block the view of the erosion

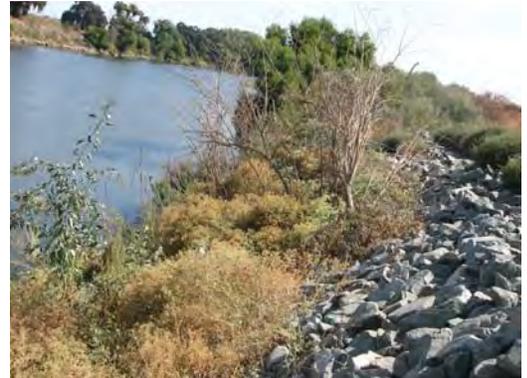
09/23/2010: At the time of the inspection, the erosion site was difficult to view from the levee. Erosion is located on the bank toe, below the existing rip rap. There were no signs of repair on site, nor has the site been reported to be repaired by the district. Images taken from last year indicate that existing rip rap at the bank toe has sloughed exposing the underlying soils. Weakening of the toe could lead to future bank instability.

09/29/2009: No major change observed since last visit; sloughing of the rip rap above toe; erosion begins immediately downstream of existing rip rap revetment; roughly 15-foot berm remains; however, it will continue to erode and eventually intrude into the levee profile if left untreated.

Front view of the erosion.

08/05/2010: Recommended for annual assessment and monitoring during flood events, per CLRO.

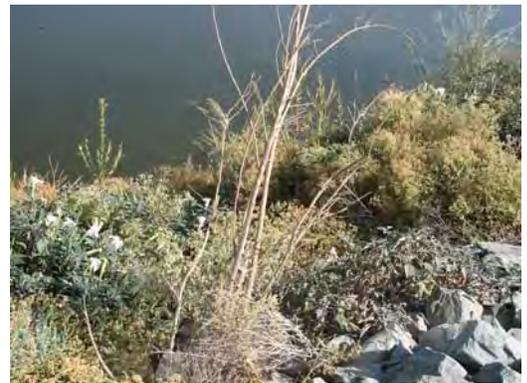
Direct view of the erosion.

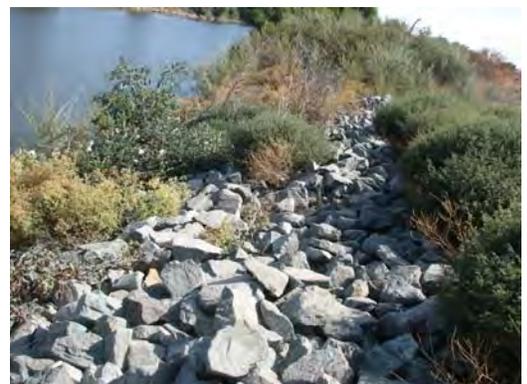
A closer look at the site

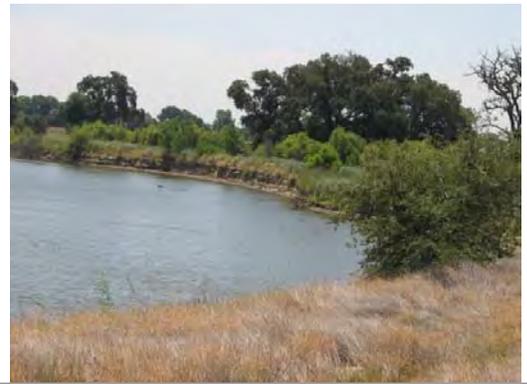
07/18/2012: Erosion has further developed toward levee crown. Vegetation has been removed.
 08/18/2011: Erosion progressed significantly during the past flood season. The levee toe along the erosion site was washed away, and the erosion has cut the levee structure up to the point about 1/3 of the levee slope. The scarp height is approximately 17 feet. Very dense vegetation on the site. Trees visible.
 10/19/2010: No significant changes observed on site. Remaining levee berm topsoil is of silty sand mixture. Erosion is near the downstream transition. An eddy has formed, and has scoured away a 100-foot section of the bank, possibly encroaching into the levee prism. Vegetation on site includes willows, oak, and cotton wood located from the bench to the toe. On the landside are rows of corn crop.
 08/05/2010: Recommended for Repair, per CLRO.
 2009: Site recommended as annual assessment and monitoring if critical erosion site, per CLRO CES Evaluation 2008 Report; an eddy has formed, eroding bank and intruding into the levee prism; Site # is the same as RM76.3,LM1.89; previously rated "U".

Looking downstream from levee top. The tree at the water edge is the visible starting point of the erosion.

08/30/2007: Recommended for short list of immediate repair sites; silty sand levee material.

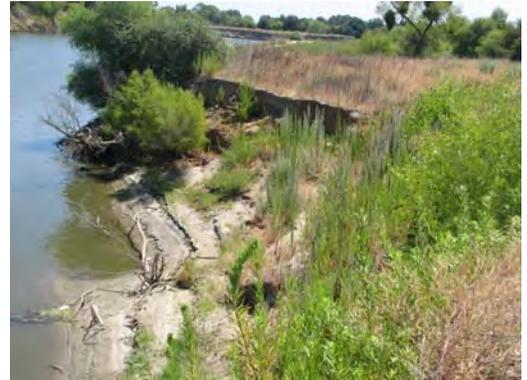
A close look at the erosion.

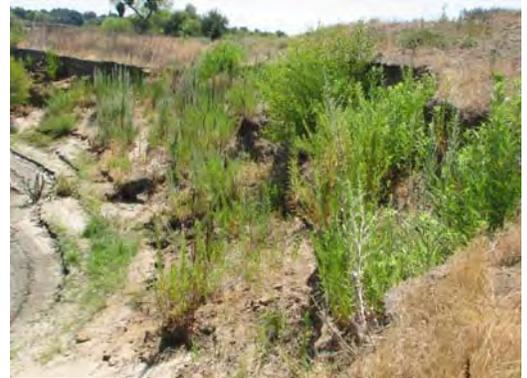
Looking downstream at the scour site. It seems the erosion has further developed upward to the levee top since the last survey

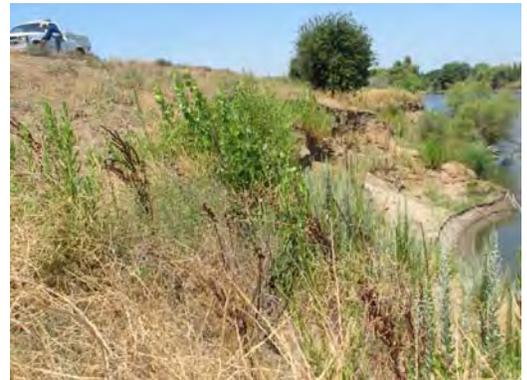
Looking downstream at the scour site. The fresh scoring is visible.
