Flood Control Project Maintenance Levee Inspections

Fall 2020 Levee Maintenance Deficiency Summary Report

Sacramento River Basin

Levee District No. 0003 (Glenn County)

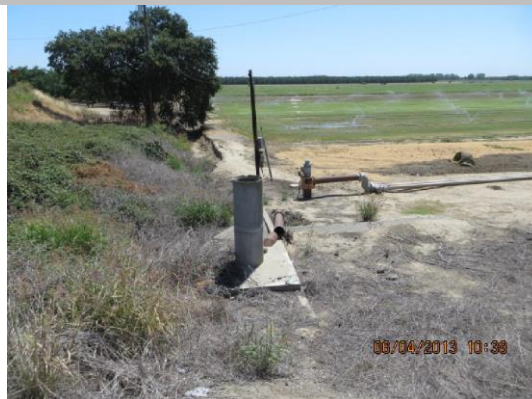
Photo 1 of 3 : UCIP_FA_2020_14643_24142.jpg

Concrete standpipe on LS toe.

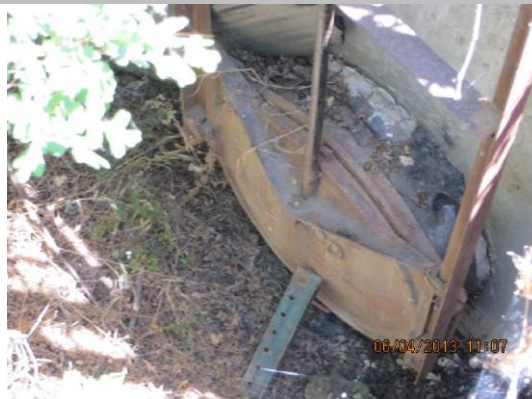
Photo 3 of 3 : UCIP_FA_2020_14664_24160.jpg

Slidegate inside concrete box on WS slope.

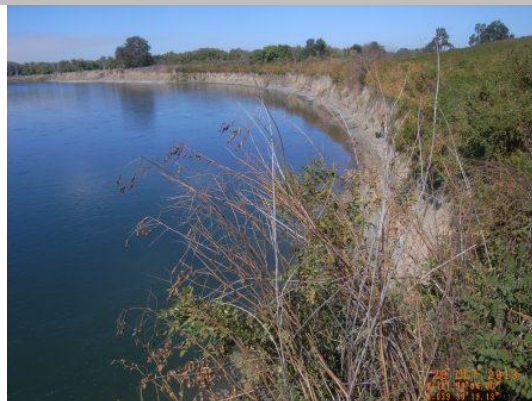
Photo 1 of 1 : FA_2020_LD0003_27_106_20200915_00044.jpg

Comment Code					
Inspector Comment					
2017 Site ID: SAC 172.0 L Status: Critical 2017 Field Notes: Significant erosion in last year. Erosion is entering levee prism, at current erosion rate, one more large storm and the levee will be comprised. Upgraded to critical. Site History: 2007 - Getting close to the levee. Bank is clayey silt with clayey/silty toe. 2008 - Looks a little worse at the upstream end. 2009 - Some new erosion and slumping. 2010 - Some new erosion upstream of site, actively eroding at low flow. New bank swallow colony noted. 2011 - Significant erosion since last year, with an estimated 10 to 15 feet of berm lost. Large sections of the bank have slumped off. 2012 - Part of the site appears to be stabilizing, but still minor slumping in other locations. 2013 - Minor new erosion at toe.

USACE 2013 Photo #1
