Flood Control Project Maintenance
Levee Inspections
LMA District Cover Sheet

Sutter Maintenance Yard Maintenance Area 0005

**Flood Control Project Maintenance
Levee Inspections
Unit Cover Sheet**

Waterway			Bank	Unit Miles
Unit No. 01 Butte Creek			Left	15.08
	Spring (March - May)	Summer (June - August)	(September - November) Fall	Winter (December - February)
Unit Maintenance Rating (Fall Only)				
Date of Inspection	4/17/2024 - 4/17/2024			
DWR Inspector	Makar Sokol			
Accompanied By	Shawn Freitag DWR Sutter

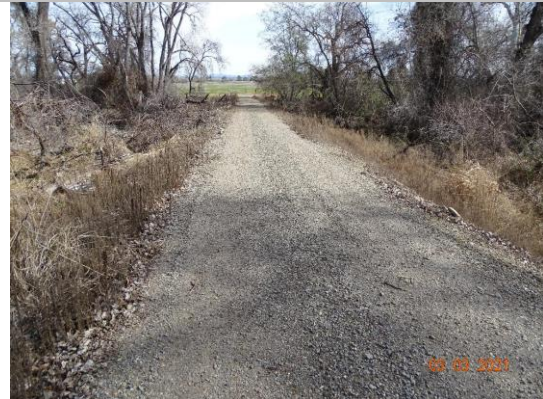
Photo 1 of 3 : UCIP_SP_2024_64542_96648.jpg

Comment Code						
Inspector Comment						
DS_ID:1609 FS_ID:64542 EP_NO: N/A Repair Type: Non-Urgent EVAL Issue: 4b, Safety Issue Crossing Status: Found UCIP Comments: 03/03/2021 Crossing changed from No Action Needed to Non-Urgent. Missing cover on 48-inch riser on waterside slope. No permit found authorizing this crossing. Legacy irrigation pipe. (O.Yakimov - UCIP DWR)05/15/2017 Crossing appears to be in good condition. Pipe has been selected for to be internally cleanded and inspected as part of the DMP project. (A. Freitag - DWR Sutter Yard)11/15/2016 Crossing appears to be in good condition. (A. Freitag - DWR Sutter Yard)05/09/2016 Crossing appeears to be in good condition. (A. Freitag - DWR Sutter Yard)08/05/2015 Crossing appears in good condition. No noticeable issues to report. (A. Freitag - DWR Sutter Yard)12/08/2014 Same as last inspection. (A. Freitag - DWR Sutter Yard)06/11/2014 Same as last inspection. (A. Freitag - DWR Sutter Yard)11/20/2013 Same as last inspection. (A. Freitag - DWR Sutter Yard)05/29/2013 Same as last inspection. (A. Freitag - DWR Sutter Yard) FIELD_STRUCT_DESC: 36-inch corrugated metal irrigation pipe through the levee, 8 feet below the crown. Slide gate in a 48-inch corrugated metal riser on the waterside (WS) slope. Concrete "U" shaped headwalls at the toe of each slope. [Additional Reference(s): DWR Levee Log, 1990 (HLM 0.07). USACE Sacramento O&M Manual, Unit 516, April 1960, Revised 3 February 2011, (Station 5+92), listed as 36-inch pipe. FS Date: 3/3/2021 9:12:51 AM

Top of Levee: View of crown at the crossing.

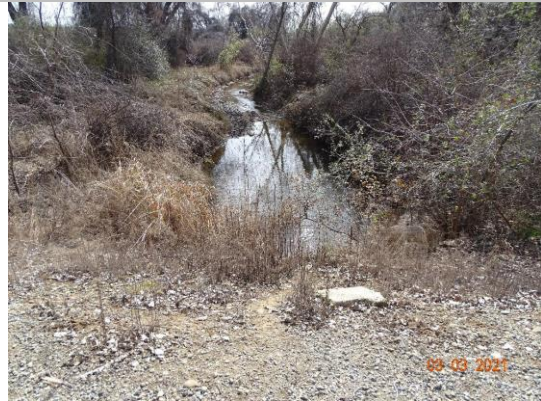
Photo 2 of 3 : UCIP_SP_2024_64542_96649.jpg

Land-Side: View landside from crown

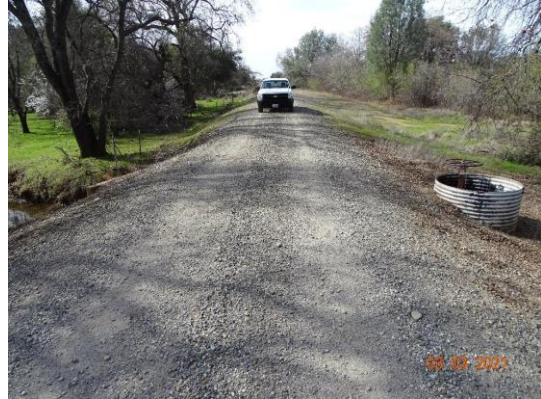
Photo 1 of 3 : UCIP_SP_2024_64543_96659.jpg

Comment Code					
Inspector Comment					
DS_ID:1610 FS_ID:64543 EP_NO: N/A Repair Type: Non-Urgent EVAL Issue: 4b, Safety Issue Crossing Status: Found UCIP Comments: 03/03/2021 Record updated from No Action Needed to Non-Urgent. Missing cover on 36-inch CMP riser on waterside slope. No permit has been identified authorizing pipe. DMP internal video inspection has not found pipe integrity issues. LOF of crossing is less or equal to 4.0. Recommend next video inspection in 5 years. (O.Yakimov - DWR UCIP) 05/15/2017 Crossing appears to be in good condition. Pipe has been selected to be internally cleaned and inspected as part of the DMP project. (A. Freitag - DWR Sutter Yard)11/15/2016 Crossing appears to be in good condition. (A. Freitag - DWR Sutter Yard)05/09/2016 Crossing appears to be in good condition. (A. Freitag - DWR Sutter Yard)08/05/2015 Crossing appears in good condition. No noticeable issues to report. (A. Freitag - DWR Sutter Yard)12/08/2014 Same as last inspection. (A. Freitag - DWR Sutter Yard)06/11/2014 Same as last inspection. (A. Freitag - DWR Sutter Yard)11/20/2013 Same as last inspection. (A. Freitag - DWR Sutter Yard)05/29/2013 Same as last inspection. (A. Freitag - DWR Sutter Yard) FIELD_STRUCT_DESC: 42-inch corrugated metal irrigation pipe through the levee, 8 feet below the crown. Slide gate in a 36-inch corrugated metal riser on the waterside (WS) slope. Concrete "U" shaped headwalls at the WS and the landside (LS) toes. Wooden weir slats within the LS toe headwall. [Additional Reference(s): DWR Levee Log, 1990 (HLM 0.14). USACE Sacramento O&M Manual, Unit 516, April 1960, Revised 3 February 2011, (Station 2+68), listed as 42-inch pipe]. FS Date: 3/3/2021 9:41:53 AM

Top of Levee: View of levee crown looking downstream

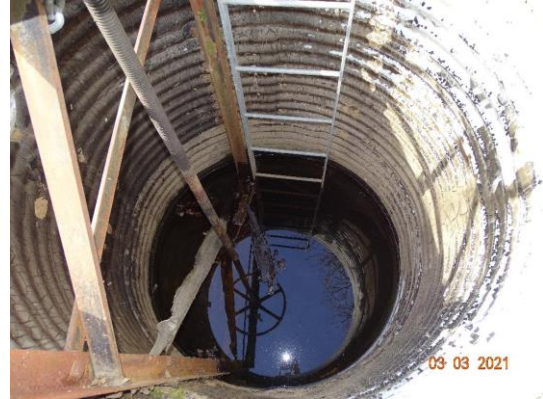
Photo 2 of 3 : UCIP_SP_2024_64543_96656.jpg

Water-Side: View of slide gate in CMP riser

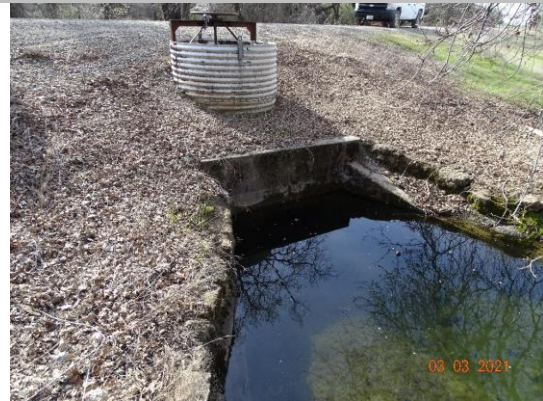
Photo 3 of 3 : UCIP_SP_2024_64543_96657.jpg

Water-Side: Headwall and pipe end on waterside

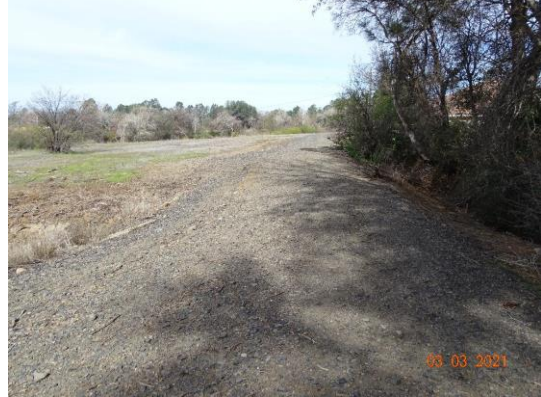
Photo 1 of 3 : UCIP_SP_2024_81034_96679.jpg

Comment Code					
Inspector Comment					
DS_ID:1611 FS_ID:81034 EP_NO: N/A Repair Type: No Action Needed EVAL Issue: Crossing Status: Found UCIP Comments: 09/20/2023 DMP internal video inspection has found none or minor pipe defects. Recommend next video inspection in 5 years. (J. Taylor - DWR UCIP)03/03/2021 Record updated from No Action Needed to Non-Urgent. No permit has been identified authorizing pipe. Pipe has been CIPP lined. (O.Yakimov - DWR UCIP) 05/15/2017 Crossing appears to be in good condition. Pipe has been selected to be internally cleaned and inspected as part of the DMP project. (A. Freitag - DWR Sutter Yard)11/15/2016 Crossing appears to be in good condition. (A. Freitag - DWR Sutter Yard)05/09/2016 Crossing appears to be in good condition. (A. Freitag - DWR Sutter Yard)08/05/2015 Crossing appears in good condition. No noticeable issues to report. (A. Freitag - DWR Sutter Yard)12/08/2014 Same as last inspection. (A. Freitag - DWR Sutter Yard)06/11/2014 Same as last inspection. (A. Freitag - DWR Sutter Yard)11/20/2013 Same as last inspection. (A. Freitag - DWR Sutter Yard)05/29/2013 Same as last inspection. (A. Freitag - DWR Sutter Yard) FIELD_STRUCT_DESC: 24-inch CIPP-lined corrugated metal drainage pipe through the levee, 6 feet below the crown. Flap gate on the waterside (WS). Concrete "U" shaped headwalls at the toe of the landside (LS) and the waterside (WS) slopes. [Additional Reference(s): DWR Levee Log, 1990 (HLM 0.60).USACE Sacramento O&M Manual, Unit 516, April 1960, Revised 3 February 2011, (Station 205+60), listed as 24-inch pipe]. FS Date: 3/3/2021 10:15:11 AM

Top of Levee: View of levee crown looking downstream

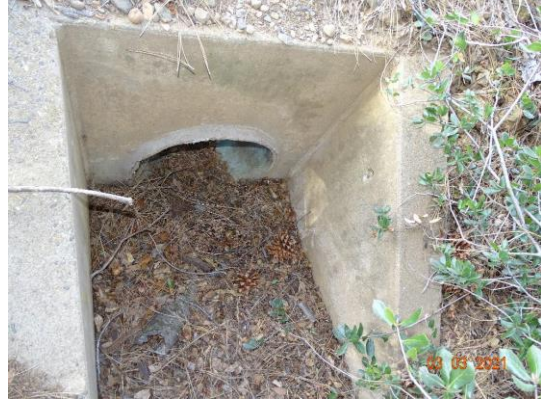
Photo 2 of 3 : UCIP_SP_2024_81034_96682.jpg

Land-Side: Pipe inlet and headwall at levee toe

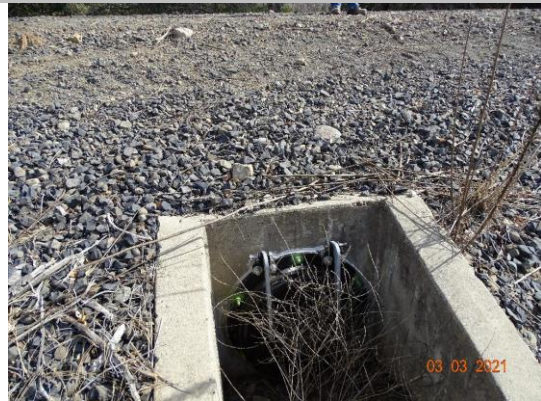
Photo 3 of 3 : UCIP_SP_2024_81034_96683.jpg

Water-Side: Headwall and flap gate on levee slope

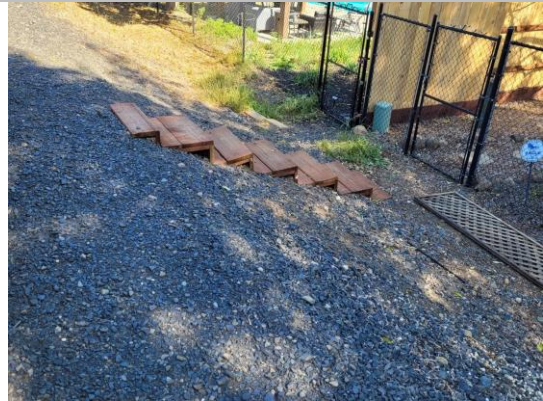
Photo 1 of 1 : SP_2024_MA0005_196_87_20240212_00016.jpg

LM Start	1.02	Rating **	M	Issue No.	87
LM End	1.02	Issue Type +	En	Location *	LS
Category	Earthen Levee			GPS Latitude/Longitude	
				Start	End
Item	Encroachments			39.684334°	39.684334°
				-121.776814°	-121.776814°
DWR ID	DWR_MA0005_01_s_2022_87				
Comment Code					
ST : Stairway					
Inspector Comment

View of the stairway on the landside slope. Spring 2023.

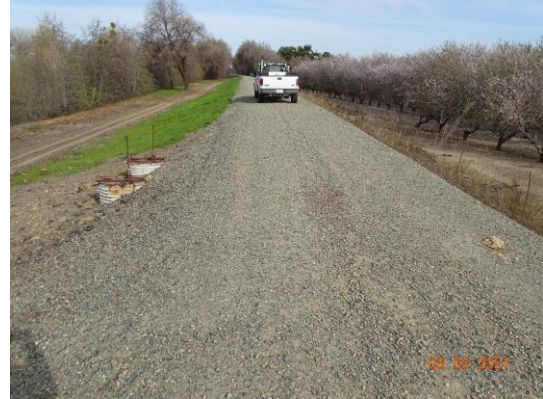
Photo 1 of 3 : UCIP_SP_2024_65178_97384.jpg

Comment Code					
Inspector Comment					
DS_ID:1616 FS_ID:65178 EP_NO: N/A Repair Type: Non-Urgent EVAL Issue: 5, Pipe Damage Crossing Status: Found UCIP Comments: 03/03/2021 Record remains Non-Urgent. Excavation on landside near concrete distribution box has been backfilled. No permit has been identified authorizing pipe. (O.Yakimov - DWR UCIP) 06/05/2019 No issues recorded during inspection. (O.Yakimov - DWR UCIP) 05/15/2017 Crossing appears to be in good condition. LS inlet is located in the Distribution box on the LS toe. This is an overflow pipe used to regulate water levels in side the box. Pipe has been selected to be internally cleaned and inspected as part fo the DMP project. (A. Freitag - DWR Sutter Yard)11/15/2016 Crossing appears to be in good condition. (A. Freitag - DWR Sutter Yard)05/09/2016 Crossing appears to be in good condition. (A. Freitag - DWR Sutter Yard)08/05/2015 WS pipe end is being overgrown by trees and other vegetation. Needs to be cleared back. (A. Freitag - DWR Sutter Yard)12/08/2014 Same as last inspection. (A. Freitag - DWR Sutter Yard)06/11/2014 Same as last inspection. (A. Freitag - DWR Sutter Yard)11/20/2013 Same as last inspection. (A. Freitag - DWR Sutter Yard)05/29/2013 Same as last inspection. (A. Freitag - DWR Sutter Yard) FIELD_STRUCT_DESC: 24-inch corrugated metal drainage pipe through the levee, 12.0 feet below the crown. Slide gate in a corrugated metal riser on the waterside (WS) slope. Flap gate on the WS toe. Inlet on the landside (LS) toe. [Additional Reference(s): DWR Levee Log, 1990 (HLM 3.95). USACE Sacramento O&M Manual, Unit 516, April 1960, Revised 3 February 2011, (381+36), listed as 24-inch pipe]. FS Date: 3/3/2021 3:22:22 PM

Top of Levee: View of levee crown looking upstream

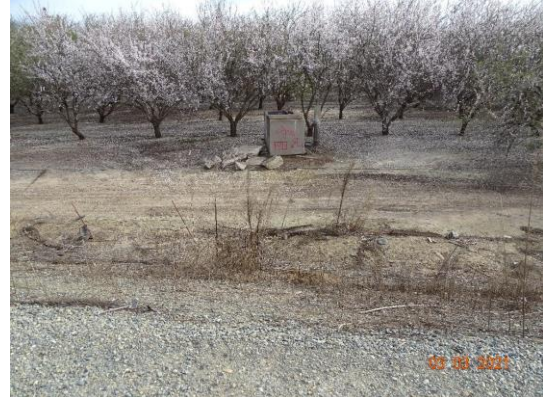
Photo 2 of 3 : UCIP_SP_2024_65178_97385.jpg

Land-Side: View of levee slope looking from crown

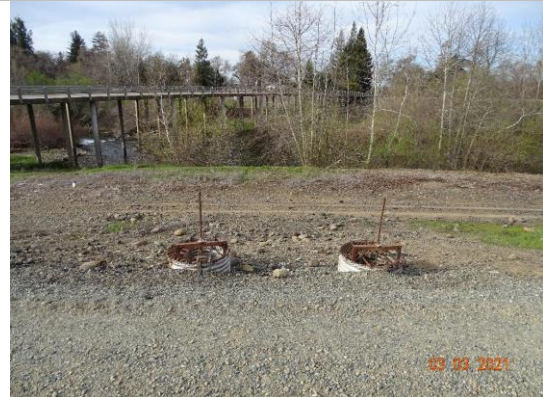
Photo 3 of 3 : UCIP_SP_2024_65178_97386.jpg

Water-Side: View of levee slope looking from crown

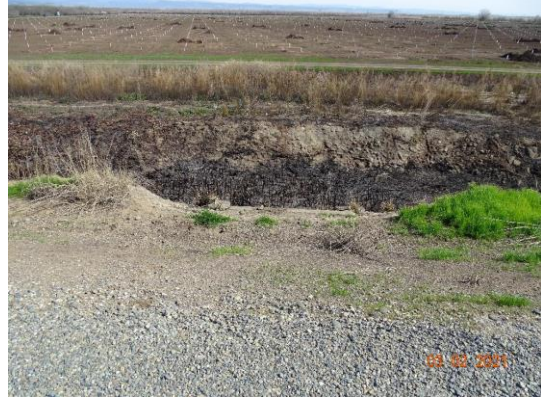
Photo 1 of 3 : UCIP_SP_2024_65267_97442.jpg

Comment Code					
Inspector Comment					
DS_ID:1620 FS_ID:65267 EP_NO: N/A Repair Type: Non-Urgent EVAL Issue: 4b, Safety Issue Crossing Status: Found UCIP Comments: 03/02/2021 Record remains Non-Urgent. Missing CMP cover on waterside slope - possible fall hazard. No permit has been identified authorizing pipe. Slide gate in CMP riser closed, crossing doesn't look abandoned. DMP internal video inspection has found pipe integrity issues. LOF of crossing is between 4.1 and 5. Crossing will be monitored until funding becomes available for rehabilitation. (O.Yakimov - DWR UCIP) 05/23/2019 (O. Magana - DWR UCIP)05/15/2017 Abandoned and needs to be done properly. A sink hole formed in the WS toe road and revealed the location of the WS pipe end. Sink hole will need to be repaired before the next high water season but the pipe has been selected to be internally cleaned and camera inspected as part of the DMP project so it will have needed to be excavated along the WS end anyways. (A. Freitag - DWR Sutter Yard)11/15/2016 Abandoned. Needs cover for the standpipe. (A. Freitag - DWR Sutter Yard)05/09/2016 Abandoned pipe. Needs a cover for the standpipe. (A. Freitag - DWR Sutter Yard)08/05/2015 Abandoned crossing. Covers need to be made for tops of standpipes to prevent falls. (A. Freitag - DWR Sutter Yard)12/08/2014 Same as last inspection. (A. Freitag - DWR Sutter Yard)06/11/2014 Same as last inspection. (A. Freitag - DWR Sutter Yard)11/19/2013 Same as last inspection. (A. Freitag - DWR Sutter Yard)05/29/2013 Same as last inspection. Land owner said pipes are abandoned and no longer used. Covers should be made for top of standpipe to prevent falls. Pipes should be properly abandoned. (A. Freitag - DWR Sutter Yard)10/30/2012 Pipe 1/2 filled with soil at slide gate end. (W. Wylie - DWR UCIP) FIELD_STRUCT_DESC: 1 of 2: 36-inch drainage pipe through the levee, 11 feet below the crown. Slide gate in a 54-inch corrugated metal riser on the waterside (WS) slope. Concrete "U" headwall on the landside (LS). [Additional Reference(s): DWR Levee Log, 1990 (HLM 5.66). USACE Sacramento O&M Manual, Unit 516, April 1960, Revised 3 February 2011, (Station 470+00), listed as 36-inch pipe]. USACE As-Built Drawing No. 50-04-3367, Sheet 8, STA 470+00, July 22 1957]. FS Date: 3/2/2021 8:23:38 AM

Land-Side: View of levee slope looking from crown

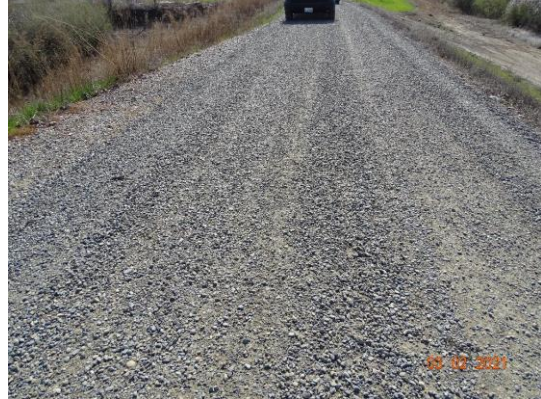
Photo 1 of 3 : UCIP_SP_2024_65315_97469.jpg

Comment Code					
Inspector Comment					
DS_ID:1622 FS_ID:65315 EP_NO: N/A Repair Type: Non-Urgent EVAL Issue: Crossing Status: Not Found UCIP Comments: 03/02/2021 Record remains Non-Urgent. Crossing not found. Geophysical results did not confirm presence of pipe through levee. Record will remain in UCIP's inspection records until future Levee Improvement Project can confirm no crossing was found through the levee. No permit has been identified authorizing pipe. (O.Yakimov - DWR UCIP) 05/15/2017 Unable to locate. (A. Freitag - DWR Sutter Yard) 11/15/2016 Unable to locate. The concrete fill in the LS toe channel appears to just be erosion protection. (A. Freitag - DWR Sutter Yard) 08/05/2015 Unable to locate. (A. Freitag - DWR Sutter Yard) 12/08/2014 Same as last inspection. (A. Freitag - DWR Sutter Yard) 06/11/2014 Same as last inspection. (A. Freitag - DWR Sutter Yard) 11/19/2013 Same as last inspection. (A. Freitag - DWR Sutter Yard) 05/29/2013 Same as last inspection. (A. Freitag - DWR Sutter Yard) FIELD_STRUCT_DESC: 18-inch corrugated metal drainage pipe through the levee, 15 feet below the crown, indicator found. Concrete headwall and flap gate on the waterside (WS). Concrete fill in channel on the landside (LS) toe is a good indicator of the pipe location. [Additional Reference(s): DWR Levee Log, 1990 (HLM 5.85). USACE As-Built Drawing No. 50-04-3367, Sheet 8, just upstream of Station 480+50, July 22, 1957, listed as 18-inch pipe]. FS Date: 3/2/2021 9:39:12 AM

Top of Levee: View of levee crown looking downstream

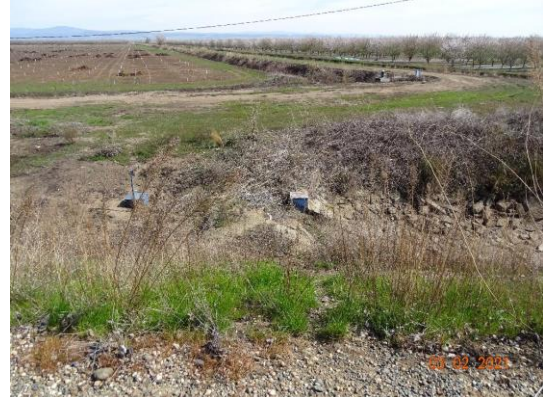
Photo 2 of 3 : UCIP_SP_2024_65315_97467.jpg

Land-Side: View of levee slope looking from crown

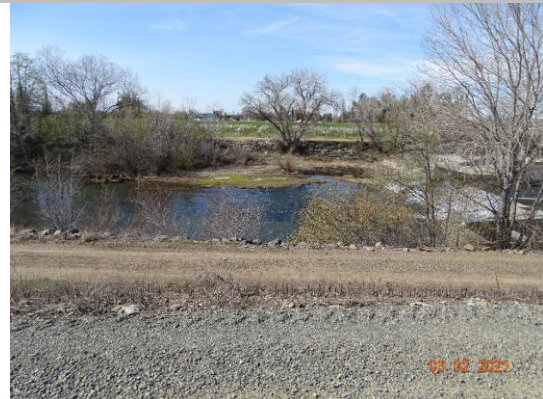
Photo 3 of 3 : UCIP_SP_2024_65315_97468.jpg

Water-Side: View of levee slope looking from crown

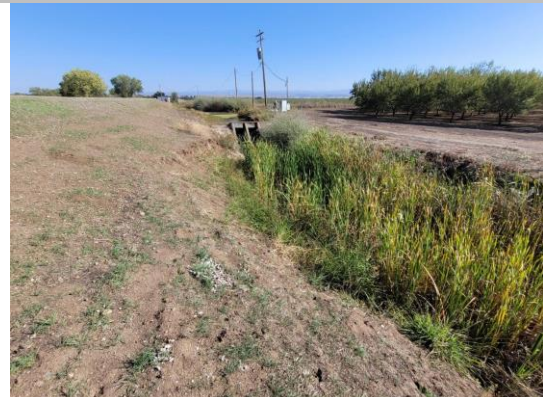
Photo 1 of 1 : SP_2024_MA0005_196_56_20240212_00015.jpg

LM Start	5.81	Rating **	U	Issue No.	56
LM End	5.81	Issue Type +	Ma	Location *	LS
Category	Earthen Levee			GPS Latitude/Longitude	
				Start	End
Item	Erosion / Bank Caving			39.621261°	39.621261°
				-121.773973°	-121.773973°
DWR ID	DWR_MA0005_01_f_2016_56				
Comment Code					
E2 : Schedule repair of erosion site prior to the next inspection.					
Inspector Comment

View of the erosion at the landside toe. Fall 2022.

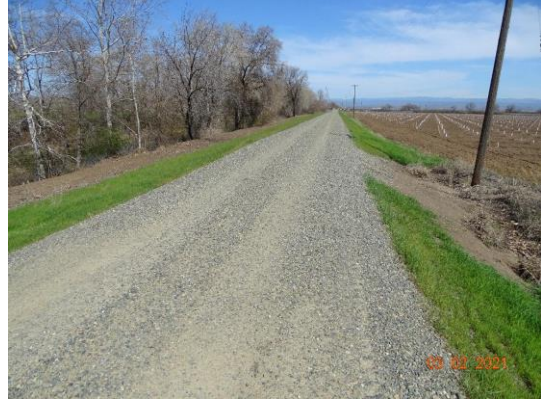
Photo 1 of 3 : UCIP_SP_2024_65433_97531.jpg

DS_ID:1628
FS_ID:65433
EP_NO: N/A
Repair Type: Non-Urgent
EVAL Issue:
Crossing Status: Found
UCIP Comments: 03/02/2021 Record remains Non-Urgent. No permit has been identified authorizing pipe. Crossing appears abandoned. Headwall on landside and pipe inlet have been cleared from dirt. Pipe end is still burried in soil on waterside and not found. DMP internal video inspection has not found pipe integrity issues. LOF of crossing is less or equal to 4.0. Recommend next video inspection in 5 years.
(O.Yakimov - DWR UCIP)
05/16/2017 LS inlet is almost completely buried. Nothing visible on the WS. Pipe has been selected to be internally cleaned and inspected as part of the DMP poject. (A. Freitag - DWR Sutter Yard)11/15/2016 Appears abandoned and should be done so properly. (A. Freitag - DWR Sutter Yard)05/11/2016 Possibly an abandoned crossing. LS inlet was over 50% buried and nothing was found on the WS. (A. Freitag - DWR Sutter Yard)08/04/2015 LS pipe end filled about 50% with soil and WS pipe end is buried. (A. Freitag - DWR Sutter Yard)12/08/2014 Same as last inspection. (A. Freitag - DWR Sutter Yard)06/11/2014 Same as last inspection. (A. Freitag - DWR Sutter Yard)11/19/2013 Same as last inspection. (A. Freitag - DWR Sutter Yard)05/29/2013 Same as last inspection. (A. Freitag - DWR Sutter Yard)10/30/2012 Pipe filled with soil and outlet/appurtances are burried. (W. Wylie - DWR UCIP)

Top of Levee: View of levee crown looking upstream

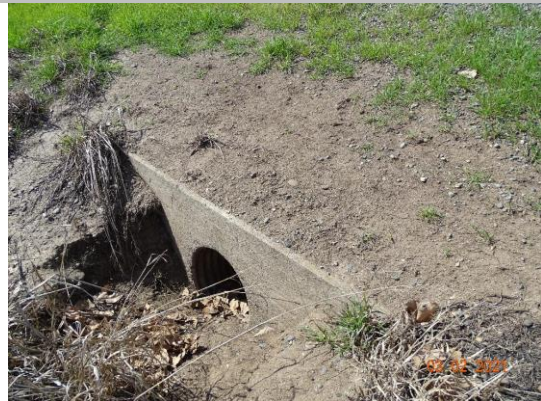
Photo 3 of 3 : UCIP_SP_2024_65433_97534.jpg

Land-Side: Exposed headwall and pipe inlet at landside toe

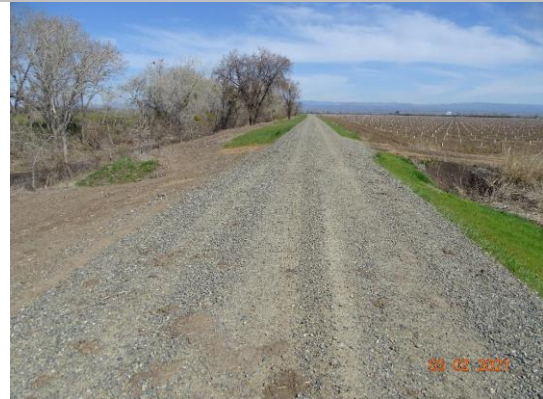
Photo 1 of 3 : UCIP_SP_2024_81039_97555.jpg

Comment Code						
Inspector Comment						
DS_ID:1629 FS_ID:81039 EP_NO: N/A Repair Type: No Action Needed EVAL Issue: Crossing Status: Found UCIP Comments: 09/20/2023 DMP internal video inspection has found none or minor pipe defects. Recommend next video inspection in 5 years. (J. Taylor - DWR UCIP)03/02/2021 Record remains Non-Urgent. No permit has been identified authorizing pipe. Crossing has been CIPP-lined, new flap gate installed on waterside. (O.Yakimov - DWR UCIP) 05/16/2017 LS inlet is half blocked off by flash boards and sediment. WS flap gate is blocked closed by sediment. Pipe has been selected to be internally cleaned and inspected as part of the DMP project. (A. Freitag - DWR Sutter Yard)11/15/2016 LS inlet was unburied and entire pipe is about 25% full of soil. WS flapgate was shut and partially buried. (A. Freitag - DWR Sutter Yard)05/11/2016 WS flap gate was about 50% buried and LS was 100% buried. Appears to be an abandoned crossing. (A. Freitag - DWR Sutter Yard)08/04/2015 WS flap gate is partially buried by soil and being overgrown with vegetation. LS pipe end was underwater and suspected to still be completely buried with soil. (A. Freitag - DWR Sutter Yard)12/08/2014 Same as last inspection. (A. Freitag - DWR Sutter Yard)06/11/2014 Same as last inspection. (A. Freitag - DWR Sutter Yard)11/19/2013 Same as last inspection. (A. Freitag - DWR Sutter Yard)05/29/2013 Same as last inspection. (A. Freitag - DWR Sutter Yard)10/30/2012 Pipe filled with soil. (W. Wylie - DWR UCIP) FIELD_STRUCT_DESC: 24-inch CIPP-lined corrugated metal drainage pipe through the levee, 9.3 feet below the crown. Flap gate on the waterside (WS). Concrete headwalls at the landside (LS) and the WS toes. [Additional Reference(s): DWR Levee Log, 1990 (HLM 8.35). USACE Sacramento O&M Manual, Unit 515, April 1955, Revised 28 December 2010, (Station 609+79), listed as 24-inch pipe. USACE As-Built Drawing No. 50-04-2637, Sheet 3, Station 609+78.5, 7 January 1953]. FS Date: 3/2/2021 3:05:29 PM

Top of Levee: View of levee crown looking upstream

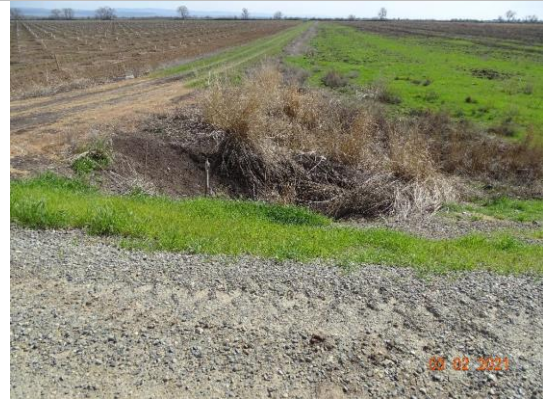
Photo 3 of 3 : UCIP_SP_2024_81039_97556.jpg

Land-Side: View of levee slope looking from crown

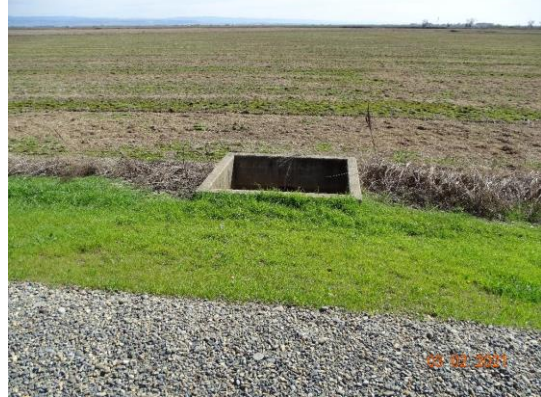
Photo 1 of 3 : UCIP_SP_2024_65744_98029.jpg

Comment Code					
Inspector Comment					
DS_ID:1631 FS_ID:65744 EP_NO: N/A Repair Type: Urgent EVAL Issue: 1, Pipe Integrity Crossing Status: Found UCIP Comments: 03/02/2021 Record updated from Non-Urgent to Urgent. Crossing appears abandoned. DMP internal video inspection has found pipe integrity issues. LOF of crossing is between 5 and 6. Crossing will be monitored until funding becomes available to address the issues. Pipe and pipe appurtenances are not found on waterside. Missing slide gate in concrete distribution box at landside toe. The box is open at ground level, recommend installing a cover for trip and fall protection. No permit has been identified authorizing pipe. (O.Yakimov - DWR UCIP) 05/16/2017 Abandoned and needs to be done so properly. (A. Freitag - DWR Sutter Yard)11/15/2016 Abandoned. (A. Freitag - DWR Sutter Yard)05/11/2016 Abandoned pipe. (A. Freitag - DWR Sutter Yard) 08/04/2015 Abandoned pipe. Casey Wilder has started the steps to have the pipe properly abandoned and removed from the levee. (A. Freitag - DWR Sutter Yard)12/08/2014 Same as last inspection. (A. Freitag - DWR Sutter Yard)06/11/2014 Same as last inspection. (A. Freitag - DWR Sutter Yard)11/19/2013 Same as last inspection. (A. Freitag - DWR Sutter Yard)05/29/2013 Same as last inspection. (A. Freitag - DWR Sutter Yard)10/30/2012 Need to confirm proper abandonment of pipe. Pipe should be plugged on LS. (W. Wylie - DWR UCIP) FIELD_STRUCT_DESC: 16-inch steel irrigation pipe through the levee, 11.5 feet below the crown. Pump located on the waterside (WS). Distribution box at the landside (LS) toe. [Additional Reference(s): DWR Levee Log, 1990 (HLM 9.21). USACE Sacramento O&M Manual, Unit 515, April 1955, Revised 28 December 2010, (Station 655+68), listed as 16-inch pipe. USACE As-Built Drawing No. 50-04-2637, Sheet 3, Station 655+68.2, 7 January 1953]. FS Date: 3/2/2021 6:58:11 AM

Land-Side: View of levee slope looking from crown. Distribution box at levee toe needs a cover

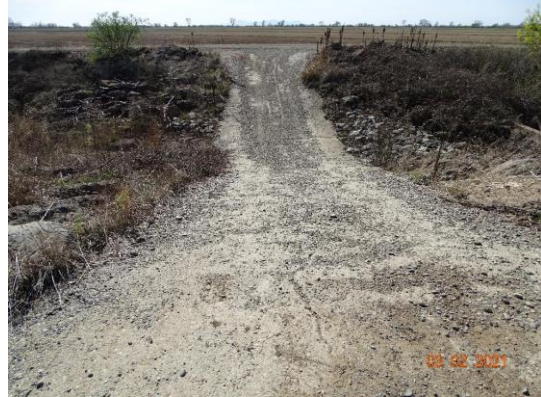
Photo 1 of 3 : UCIP_SP_2024_65745_98033.jpg

Comment Code					
Inspector Comment					
DS_ID:1775 FS_ID:65745 EP_NO: N/A Repair Type: Non-Urgent EVAL Issue: Crossing Status: Found UCIP Comments: 03/02/2021 Record updated from No Action Needed to Non-Urgent. No permit has been identified authorizing pipe. This pipe penetrates channel crossing constructed at elevation lower than levee. (O.Yakimov - DWR UCIP) 05/16/2017 Crossing appears to be in good condition. (A. Freitag - DWR Sutter Yard)11/15/2016 Crossing appears to be in good condition. (A. Freitag - DWR Sutter Yard)05/11/2016 Crossing appears to be in good condition. (A. Freitag - DWR Sutter Yard)08/04/2015 Crossing is in good condition. No noticeable issues to report. (A. Freitag - DWR Sutter Yard)12/08/2014 Same as last inspection. (A. Freitag - DWR Sutter Yard)06/11/2014 Same as last inspection. (A. Freitag - DWR Sutter Yard)11/19/2013 Same as last inspection. (A. Freitag - DWR Sutter Yard)05/29/2013 Flap gates were removed by DWR Sutter Maintenance Yard to allow water to flow freely through crossing and not back up in ditch. (A. Freitag - DWR Sutter Yard)10/30/2012 Seems there should be flap gates on this structure. (W. Wylie - DWR UCIP) FIELD_STRUCT_DESC: [Robert's Creek Outlet Structure] 1 of 4: 66-inch corrugated metal drainage pipe through the levee, 17.9 feet below the crown. Concrete headwalls on the landside (LS) and the waterside (WS). Flap gate located on the WS. [Additional Reference(s): DWR Levee Log, 1990 (HLM 9.66). USACE Sacramento O&M Manual, Unit 515, April 1955, Revised 28 December 2010, (Station 678+00), listed as 66-inch pipe. USACE As-Built Drawing No. 50-04-2637, Sheet 3, Station 678+00, 7 January 1953]. FS Date: 3/2/2021 8:28:51 AM

View of channel crossing looking perpendicular to Butte Creek

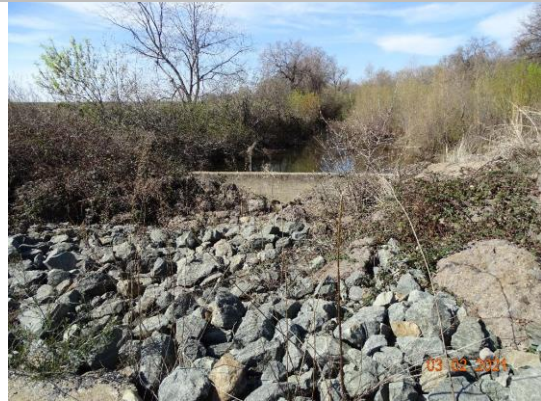
Photo 2 of 3 : UCIP_SP_2024_65747_98046.jpg

Comment Code						
Inspector Comment						
DS_ID:1632 FS_ID:65747 EP_NO: N/A Repair Type: Non-Urgent EVAL Issue: Crossing Status: Found UCIP Comments: 03/02/2021 Record updated from No Action Needed to Non-Urgent. No permit has been identified authorizing pipe. This pipe penetrates channel crossing constructed at elevation lower than levee. (O.Yakimov - DWR UCIP) 5/16/2017 Crossing appears to be in good condition. (DWR Sutter Yard- AFreitag)11/15/2016 Crossing appears to be in good condition. (DWR Sutter Yard- AFreitag)5/11/2016 Crossing appears to be in good condition.8/4/2015 Crossing appears in good condition. No noticeable issues to report.12/8/2014 Same as last inspection.6/11/2014 Same as last inspection.11/19/2013 Same as last inspection.5/29/2013 Flap gates were removed by DWR Sutter Maintenance Yard to allow water to flow freely through crossing and not back up in ditch.10/30/2012 Seems there should be flap gates on this structure. FIELD_STRUCT_DESC: [Robert's Creek Outlet Structure] 3 of 4: 66-inch corrugated metal drainage pipe through the levee, 17.9 feet below the crown. Concrete headwalls on the landside (LS) and the waterside (WS). Flap gate located on the WS. [Additional Reference(s): DWR Levee Log, 1990 (HLM 9.66). USACE Sacramento O&M Manual, Unit 515, April 1955, Revised 28 December 2010, (Station 678+00), listed as 66-inch pipe. USACE As-Built Drawing No. 50-04-2637, Sheet 3, Station 678+00, 7 January 1953]. FS Date: 3/2/2021 8:51:11 AM

View of Butte Creek looking downstream

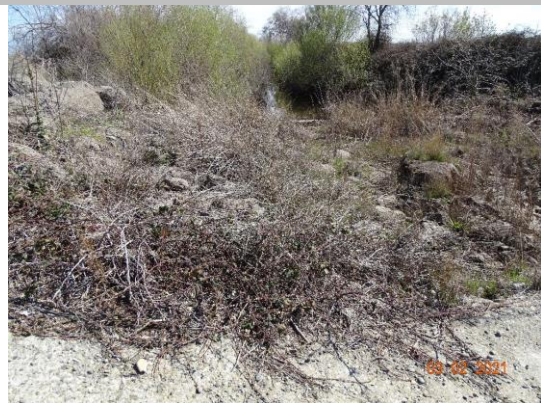
Photo 3 of 3 : UCIP_SP_2024_65747_98047.jpg

View of Butte Creek looking upstream

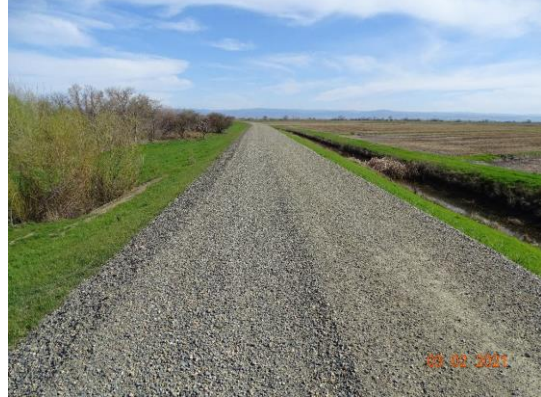
Photo 1 of 3 : UCIP_SP_2024_65750_98061.jpg

Comment Code					
Inspector Comment					
DS_ID:1634 FS_ID:65750 EP_NO: N/A Repair Type: Non-Urgent EVAL Issue: 5, Pipe Damage Crossing Status: Found UCIP Comments: 03/02/2021 Record remains Non-Urgent. DMP internal video inspection has found pipe integrity issues. LOF of crossing is between 4.1 and 5. Crossing will be monitored until funding becomes available for rehabilitation. Crossing appears abandoned. Headwall and slide gate on waterside buried in soil. Vegetation and debris clearing needed at landside pipe end. No permit has been identified authorizing pipe. (O.Yakimov - DWR UCIP) 5/16/2017 Abandoned- needs to be done so properly. Pipe has been selected to be internally cleaned and inspected as part of the DMP project. (DWR Sutter Yard- AFreitag)11/15/2016 Abandoned. (DWR Sutter Yard- AFreitag)5/11/2016 Abandoned crossing.8/4/2015 Abandoned pipe. Casey Wilder has started the steps to have the pipe properly abandoned and removed from the levee.12/8/2014 Same as last inspection.6/11/2014 Same as last inspection.11/19/2013 Same as last inspection.5/29/2013 Same as last inspection. FIELD_STRUCT_DESC: 24-inch corrugated metal irrigation pipe through the levee, 14.5 feet below the crown. Slide gate on the waterside (WS) on concrete headwall. Flap gate on the landside (LS). [Additional Reference(s): DWR Levee Log, 1990 (HLM 10.41). USACE Sacramento O&M Manual, Unit 515, April 1955, Revised 28 December 2010, (Station 717+50), listed as 24-inch pipe. USACE As-Built Drawing No. 50-04-2637, Sheet 4, Station 717+50, 7 January 1953]. FS Date: 3/2/2021 9:47:39 AM

Top of Levee: View of levee crown looking upstream

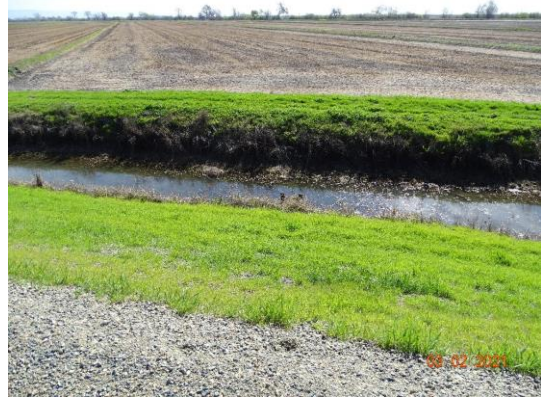
Photo 2 of 3 : UCIP_SP_2024_65750_98062.jpg

Land-Side: View of levee slope looking from crown

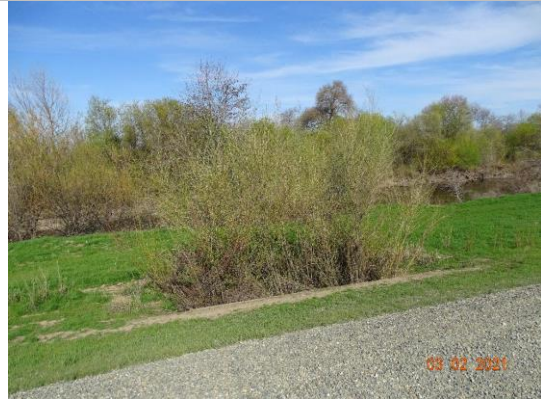
Photo 3 of 3 : UCIP_SP_2024_65750_98063.jpg

Water-Side: View of levee slope looking from crown

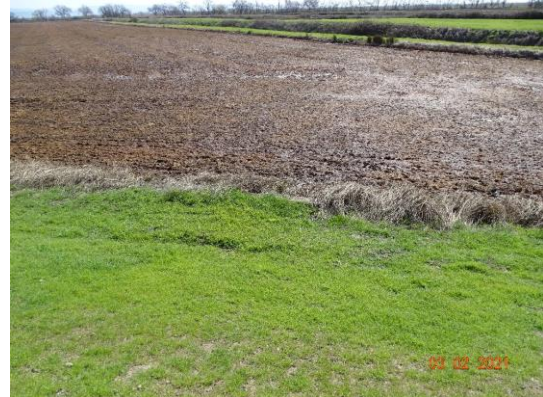
Photo 1 of 3 : UCIP_SP_2024_65751_98068.jpg

Comment Code					
Inspector Comment					
DS_ID:1635 FS_ID:65751 EP_NO: N/A Repair Type: Non-Urgent EVAL Issue: Crossing Status: Found UCIP Comments: 03/02/2021 Record remains Non-Urgent. Crossing appears abandoned. Pipe not found on waterside. Concrete headwall and pipe inlet are buried in soil at landside levee toe. Geophysical study indicates possible presence of pipe through levee. Owner needs to coordinate with the CVFPB to remove or abandon crossing according to Title 23 requirements. No permit has been identified authorizing pipe. (O.Yakimov - DWR UCIP) 5/16/2017 Abandoned- needs to be done so properly. (DWR Sutter Yard- AFreitag)11/15/2016 Abandoned. (DWR Sutter Yard- AFreitag)5/11/2016 Abandoned crossing.8/4/2015 Abandoned pipe. Casey Wilder has started the steps to have the pipe properly abandoned and removed from the levee.12/8/2014 Same as last inspection.6/11/2014 Same as last inspection.11/19/2013 Same as last inspection.5/29/2013 Same as last inspection.10/30/2012 Pipe buried on both sides of levee. FIELD_STRUCT_DESC: 30-inch corrugated metal drainage pipe through the levee, 12.2 feet below the crown. Flap gate on the waterside (WS) end. [Additional Reference(s): DWR Levee Log, 1990 (HLM 10.99). USACE Sacramento O&M Manual, Unit 515, April 1955, Revised 28 December 2010, (Station 748+53), listed as 30-inch pipe. USACE As-Built Drawing No. 50-04-2637, Sheet 4, 748+53, 7 January 1953]. FS Date: 3/2/2021 9:59:40 AM

Land-Side: View of levee slope looking from crown

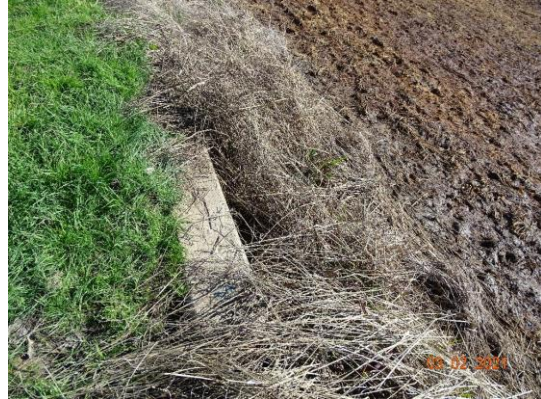
Photo 2 of 3 : UCIP_SP_2024_65751_98070.jpg

Land-Side: Headwall and pipe inlet at levee toe buried in soil

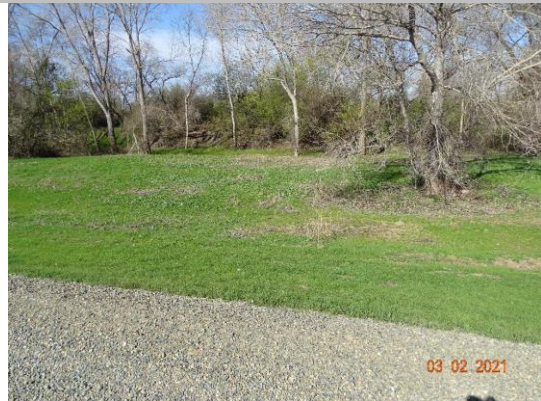
Photo 3 of 3 : UCIP_SP_2024_65751_98069.jpg

Water-Side: View of levee slope looking from crown

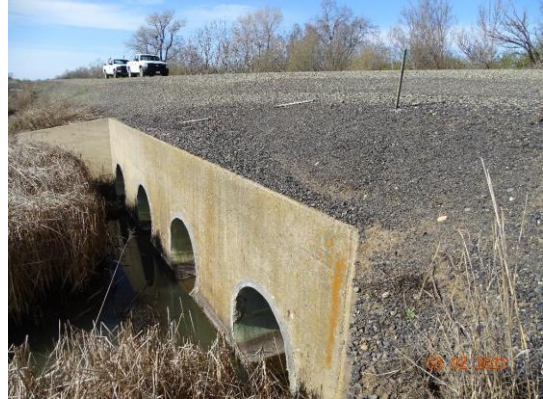
Photo 2 of 3 : UCIP_SP_2024_81038_98105.jpg

Land-Side: Concrete headwall and CIPP-lined pipe

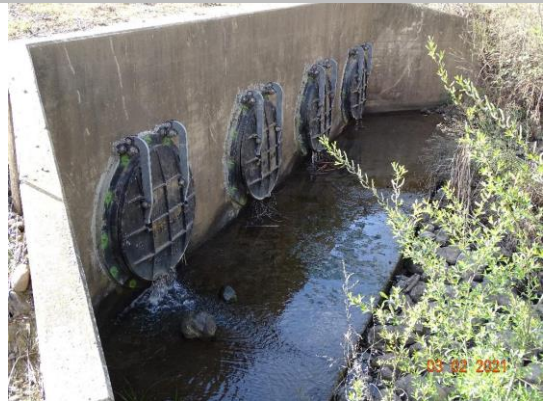
Photo 3 of 3 : UCIP_SP_2024_81038_98104.jpg

Water-Side: Concrete headwall and flap gate on pipe end

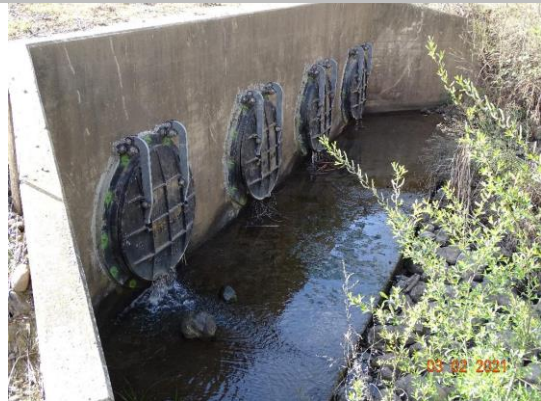
Photo 3 of 3 : UCIP_SP_2024_81042_98109.jpg

Water-Side: Concrete headwall and flap gate on pipe end

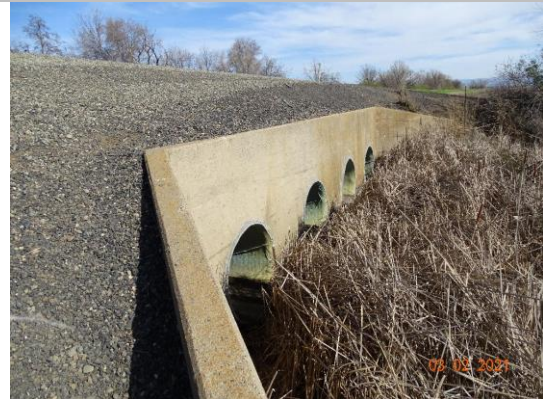
Photo 2 of 3 : UCIP_SP_2024_81037_98115.jpg

Land-Side: Concrete headwall and CIPP-lined pipe

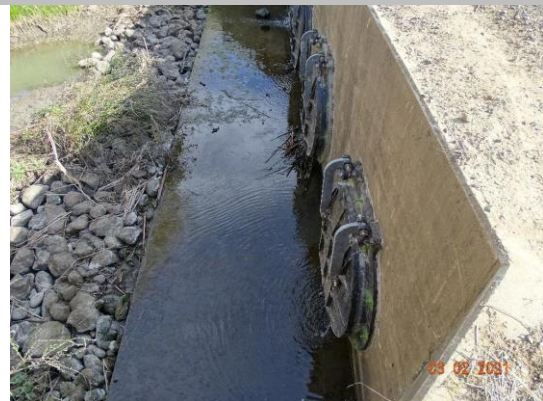
Photo 3 of 3 : UCIP_SP_2024_81037_98114.jpg

Water-Side: Concrete headwall and flap gate on pipe end

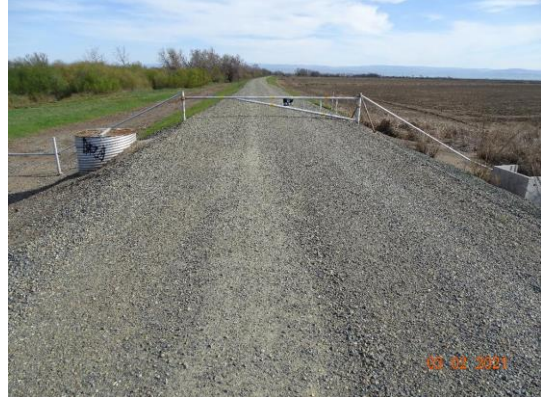
Photo 1 of 3 : UCIP_SP_2024_65838_98164.jpg

Comment Code						
Inspector Comment						
DS_ID:25461 FS_ID:65838 EP_NO: N/A Repair Type: No Action Needed EVAL Issue: Crossing Status: Found UCIP Comments: 03/02/2021 Record remains No Action Needed. No issues observed during inspection. DMP internal video inspection has not found pipe integrity issues. LOF of crossing is less or equal to 4.0. Recommend next video inspection in 5 years. c 05/16/2017 Crossing appears to be in good condition. Pipe has been selected to be internally cleaned and inspected as part of the DMP project. (A. Freitag - DWR Sutter Yard)11/15/2016 Crossing appears to be in good condition. (A. Freitag - DWR Sutter Yard)06/22/2016 Inspector's notes and photos related to new pipe from DS_ID 1637 have been transferred. Pipe record, DS_ID 1637, has been retired since pipe was removed from the levee and a new pipe was installed. Need Permit No. to update UCIP records. (O. Magana - DWR UCIP)05/11/2016 Crossing appears to be in good condition. (A. Freitag - DWR Sutter Yard)08/04/2015 Crossing appears in good condition. No noticeable issues to report. (A. Freitag - DWR Sutter Yard)06/11/2014 Same as last inspection. (A. Freitag - DWR Sutter Yard)11/19/2013 Same as last inspection. (A. Freitag - DWR Sutter Yard)07/30/2013 Pipe installed. (O. Magana - DWR UCIP) FIELD_STRUCT_DESC: 30-inch double walled high-density polyethylene (HDPE) drainage pipe through the levee, 15 feet below the crown. Pipe encased in controlled low-strength material (CLSM) through the levee. 60-inch corrugated metal pipe (CMP) riser with positive shutoff device inside is located on the landside (LS). Concrete headwall and flap gate located on the waterside (WS) end. Pipe installed in 2013 by DWR Sutter Yard. This crossing replaces 30-inch pipe (see DSID 1637). (30-inch HDPE pipe approved under Project Authorization No. A2013038, 2013 - Department of Water Resources). FS Date: 3/2/2021 2:30:57 PM

Top of Levee: View of levee crown looking upstream

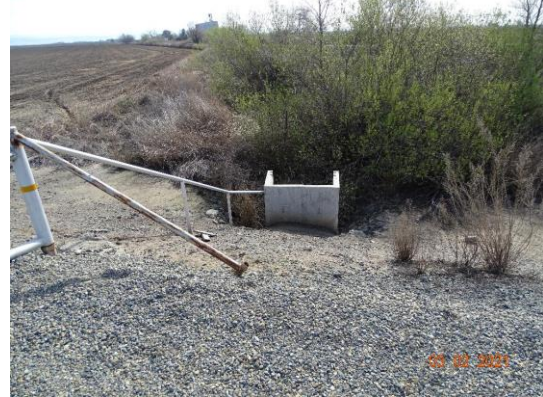
Photo 2 of 3 : UCIP_SP_2024_65838_98165.jpg

Land-Side: View of levee slope looking from crown

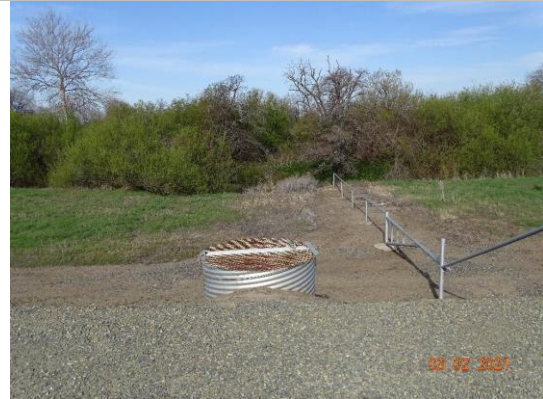
Photo 3 of 3 : UCIP_SP_2024_65838_98166.jpg

Water-Side: View of levee slope looking from crown

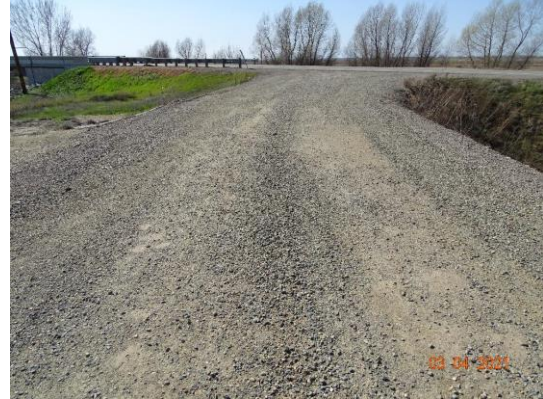
Photo 1 of 3 : UCIP_SP_2024_65899_98212.jpg

Comment Code					
Inspector Comment					
DS_ID:1788 FS_ID:65899 EP_NO: N/A Repair Type: No Action Needed EVAL Issue: Crossing Status: Not Found UCIP Comments: 03/04/2021 Record remains No Action Needed. Pipe was abandoned under Permit No. 17212. (O.Yakimov - DWR UCIP) 05/18/2017 Unable to locate. (A. Freitag - DWR Sutter Yard) 11/14/2016 Abandoned. (A. Freitag - DWR Sutter Yard) 05/23/2016 Abandoned. (A. Freitag - DWR Sutter Yard) 07/28/2015 Unable to locate. (A. Freitag - DWR Sutter Yard) 11/25/2014 Unable to locate. (A. Freitag - DWR Sutter Yard) 06/04/2014 Same as last inspection. (A. Freitag - DWR Sutter Yard) 11/12/2013 Unable to locate. (A. Freitag - DWR Sutter Yard) 06/06/2013 Same as last inspection. Unable to locate. (A. Freitag - DWR Sutter Yard) FIELD_STRUCT_DESC: 1 of 3: 24-inch corrugated metal drainage pipe through the levee, 16.6 feet below the crown. Slide gate on the waterside (WS) toe with an access platform and a walkway over the gates. Concrete headwall and trash rack on the landside (LS) toe. (24-inch pipe abandoned under Permit No. 17212, 17212-Rev, 2005 - Butte County Department of Public Works). [Additional Reference(s): DWR Levee Log, 1990 (HLM 1.67). USACE Sacramento O&M Manual, Unit 515, April 1955, Revised 28 December 2010, (Station 927+50), listed as 24-inch pipe. USACE As-Built Drawing No. 50-04-2637, Sheet 5, Station 927+50, 7 January 1953]. FS Date: 3/4/2021 11:52:54 AM

Top of Levee: View of levee crown looking downstream

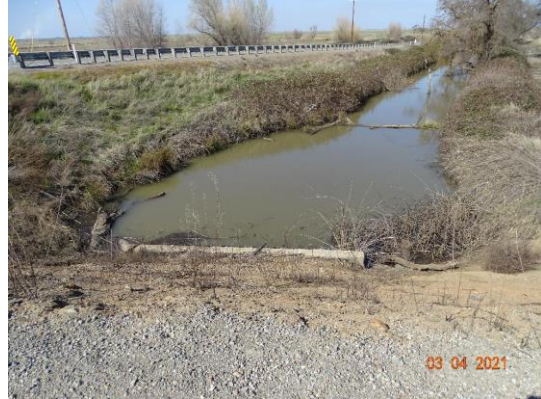
Photo 2 of 3 : UCIP_SP_2024_65899_98213.jpg

Land-Side: View of levee slope looking from crown

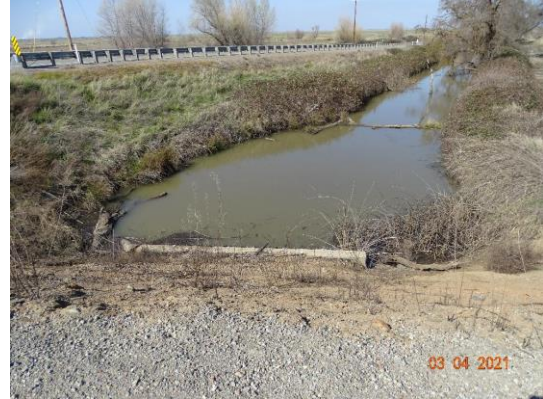
Photo 2 of 3 : UCIP_SP_2024_65900_98216.jpg

Land-Side: View of levee slope looking from crown

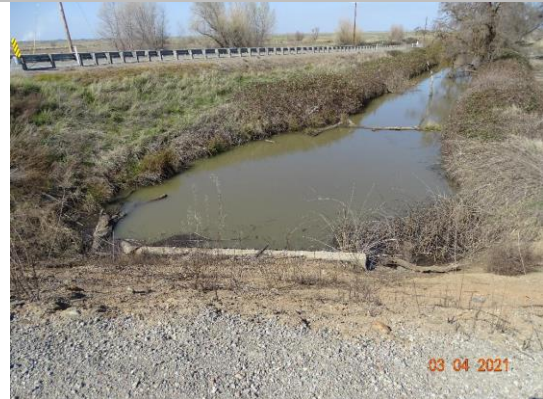
Photo 2 of 3 : UCIP_SP_2024_65901_98219.jpg

Land-Side: View of levee slope looking from crown

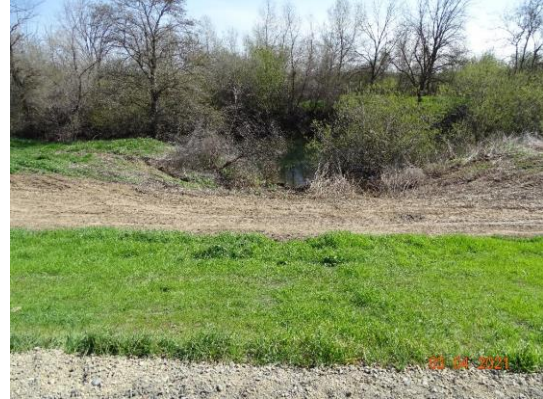
Photo 1 of 3 : UCIP_SP_2024_81083_98237.jpg

DS_ID:1645
FS_ID:81083
EP_NO: N/A
Repair Type: Urgent
EVAL Issue: 2b, Levee Integrity
Crossing Status: Found
UCIP Comments: 09/25/2023 DMP internal video inspection has found none or minor pipe defects. Recommend next video inspection in 5 years. (J. Taylor - DWR UCIP)03/04/2021 Record remains Urgent. Erosion around headwall on landside is present. Debris at the bottom of flap gate on waterside prevents flap gate from closing. No permit has been identified authorizing pipe. (O.Yakimov - DWR UCIP)

Water-Side: View of levee slope looking from crown

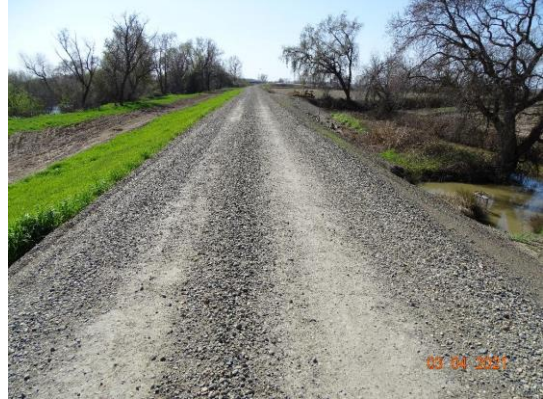
Photo 2 of 3 : UCIP_SP_2024_81083_98240.jpg

Top of Levee: View of levee crown looking downstream

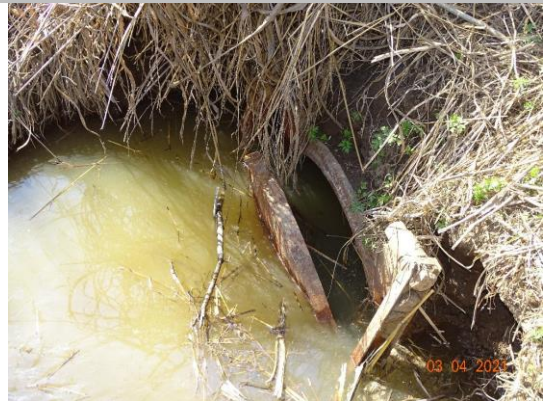
Photo 3 of 3 : UCIP_SP_2024_81083_98239.jpg

LM Start	1.91	Rating **	U	Issue No.	104 (cont)
LM End	1.91	Issue Type +	Ma	Location *	
Category	Supplemental		GPS Latitude/Longitude		
			Start	End	
Item	DWR UCIP LMA Responsibility		39.537455°	39.537455°	
			-121.853061°	-121.853061°	
DWR ID	1645

Water-Side: Closeup view of flap gate open due to sediment and debris buildup at the bottom

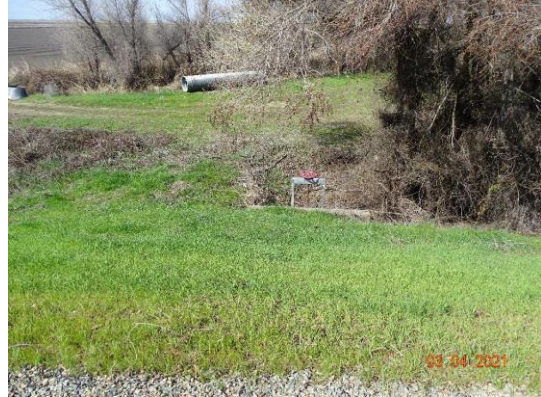
Photo 1 of 3 : UCIP_SP_2024_81084_98336.jpg

DS_ID:1647
 FS_ID:81084
 EP_NO: N/A
 Repair Type: No Action Needed
 EVAL Issue:
 Crossing Status: Found
 UCIP Comments: 09/25/2023 DMP internal video inspection has found none or minor pipe defects. Recommend next video inspection in 5 years. (J. Taylor - DWR UCIP)03/04/2021 Record remains Non-Urgent. No permit has been identified authorizing pipe. Pipe has been CIPP lined, new flap gate on waterside pipe end installed, slide gate at landside levee toe was replaced with a new one. (O.Yakimov - DWR UCIP) 05/18/2017 Crossing appears to be in good condition. Tree near the LS screw gate could use some trimming. Pipe has been selected to be internally cleaned and inspected as part of the DMP project. (A. Freitag - DWR Sutter Yard)11/14/2016 Crossing appears to be in good condition. (A. Freitag - DWR Sutter Yard)05/23/2016 Crossing appears to be in good condition. (A. Freitag - DWR Sutter Yard)07/28/2015 Pipe appears in good condition. No noticeable issues to report. (A. Freitag - DWR Sutter Yard)06/06/2013 Same as last inspection. (A. Freitag - DWR Sutter Yard)11/12/2013 Same as last inspection. (A. Freitag - DWR Sutter Yard)06/04/2014 Same as last inspection. (A. Freitag - DWR Sutter Yard)11/25/2014 Same as last inspection. (A. Freitag - DWR Sutter Yard)

Land-Side: View of levee slope looking from crown

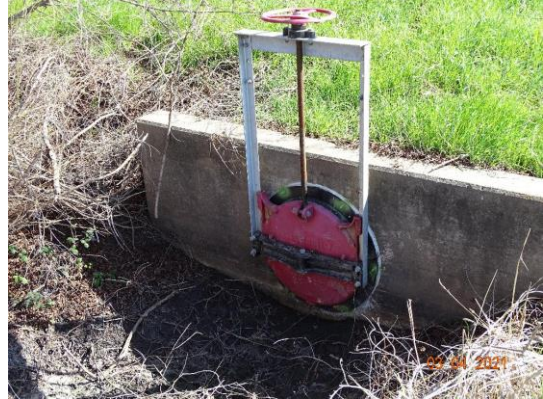
Photo 2 of 3 : UCIP_SP_2024_81084_98337.jpg

Land-Side: Headwall and new slide gate installed at levee toe

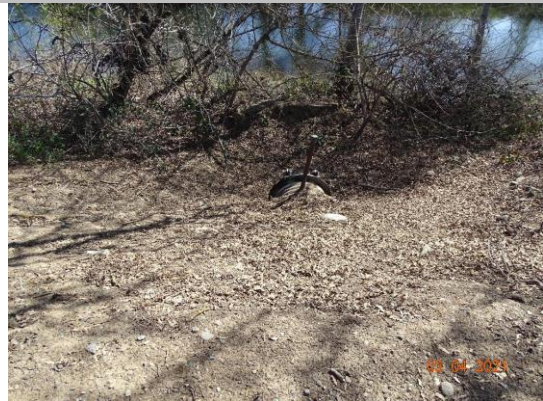
Photo 3 of 3 : UCIP_SP_2024_81084_98334.jpg

Water-Side: View of levee slope looking from crown

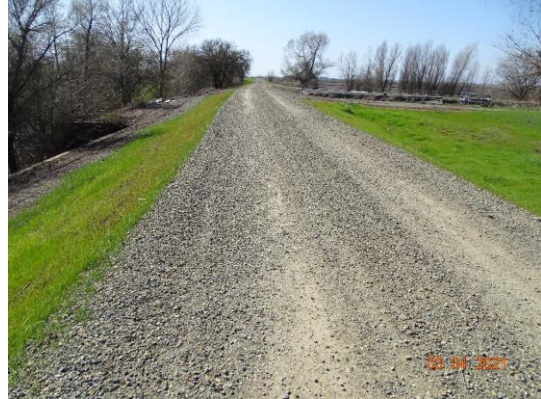
Photo 1 of 3 : UCIP_SP_2024_66081_98389.jpg

DS_ID:16300
FS_ID:66081
EP_NO: N/A
Repair Type: Urgent
EVAL Issue: 1, Pipe Integrity
Crossing Status: Found
UCIP Comments: 03/04/2021 Record updated from No Action Needed to Urgent. Missing flap gate on pipe end at headwall on waterside. One of the attached photos shows flap gate installed inside the pipe approximately at landside toe. Unable to confirm flap gate integrity. Portion of pipe under levee remains open to flood water that increases risk of levee failure. No permit has been identified authorizing pipe onstallation. DMP internal video inspection has found pipe integrity issues. LOF of crossing is between 5 and 6. Crossing will be monitored until funding becomes available to address the issues. (O.Yakimov - DWR UCIP)
05/18/2017 Crossing appears to be in good condition. Pipe has been selected to be internally cleaned and inspected as part of the DMP project. (A. Freitag - DWR Sutter Yard)05/23/2016 Crossing is not abandoned. Water was flowing through from the LS to WS. LS pipe inlet is about 100 yds from LS levee toe across the LS canal. (A. Freitag - DWR Sutter Yard)07/28/2015 Crossing is listed as abandoned but it is not filled with concrete like crossings 1-4 here. (A. Freitag - DWR Sutter Yard)11/25/2014 Same as last inspection. (A. Freitag - DWR Sutter Yard)06/04/2014 Same as last inspection. (A. Freitag - DWR Sutter Yard)11/13/2013 Same as last inspection. (A. Freitag - DWR Sutter Yard)06/06/2013 Sutter Maintenance Yard supervisor Jason Cooper said there is a flap gate on the LS end of the pipe in the western most ditch to prevent high water flooding. Not sure if this is adequate, will talk to levee inspector to find out. (A. Freitag - DWR Sutter Yard)11/01/2012 Pipe open on WS and is not filled with concrete. (W. Wylie - DWR UCIP)

Top of Levee: View of levee crown looking downstream

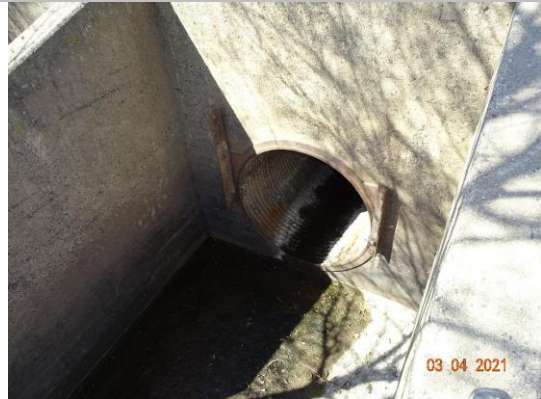
Photo 2 of 3 : UCIP_SP_2024_66081_98386.jpg

LM Start	4.09	Rating **	U	Issue No.	106 (cont)
LM End	4.09	Issue Type +	En	Location *	
Category	Supplemental			GPS Latitude/Longitude	
				Start	End
Item	DWR UCIP Field Study			39.562875°	39.562875°
				-121.828782°	-121.828782°
DWR ID	16300

Water-Side: Pipe missing flap gate at headwall

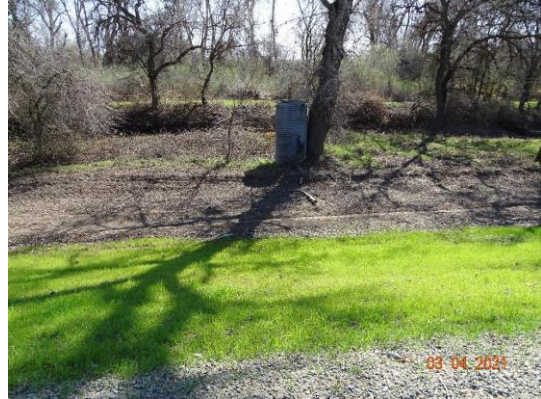
Photo 2 of 3 : UCIP_SP_2024_66386_98831.jpg

LM Start	5.35	Rating **	M	Issue No.	107 (cont)	
LM End	5.35	Issue Type +	Ma	Location *		
Category	Supplemental			GPS Latitude/Longitude		
				Start		End
Item	DWR UCIP LMA Responsibility			39.576008°		39.576008°
				-121.812599°		-121.812599°
DWR ID	1650

Water-Side: View of levee slope looking from crown. CMP riser with slide gate on levee berm

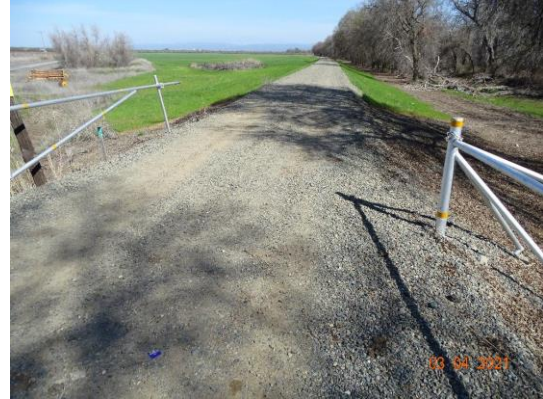
Photo 1 of 3 : UCIP_SP_2024_81085_98875.jpg

Comment Code					
Inspector Comment					
DS_ID:1654 FS_ID:81085 EP_NO: N/A Repair Type: No Action Needed EVAL Issue: Crossing Status: Found UCIP Comments: 09/25/2023 DMP internal video inspection has found none or minor pipe defects. Recommend next video inspection in 5 years. (J. Taylor - DWR UCIP)03/04/2021 Record updated from No Action Needed to Non-Urgent. No permit has been identified authorizing pipe. Pipe has been CIPP lined, new flap gate installed on waterside end. (O.Yakimov - DWR UCIP) 05/18/2017 Crossing appears to be in good condition. Pipe has been selected to be internally cleaned and inspected as part of the DMP project. (A. Freitag - DWR Sutter Yard)11/14/2016 Crossing appears to be in good condition. (A. Freitag - DWR Sutter Yard)05/23/2016 Crossing appears to be in good condition. (A. Freitag - DWR Sutter Yard)07/28/2015 Crossing appears in good condition. No noticeable issues to report. (A. Freitag - DWR Sutter Yard)11/24/2014 Same as last inspection. (A. Freitag - DWR Sutter Yard)06/04/2014 Same as last inspection. (A. Freitag - DWR Sutter Yard)11/12/2013 Same as last inspection. (A. Freitag - DWR Sutter Yard)06/06/2013 Same as last inspection. (A. Freitag - DWR Sutter Yard) FIELD_STRUCT_DESC: 24-inch CIPP-lined corrugated metal drainage pipe through the levee, 9.4 feet below the crown. Flap gate on the waterside (WS). Concrete headwalls at both the landside (LS) and the WS toes. [Additional Reference(s): DWR Levee Log, 1990 (HLM 6.56). USACE Sacramento O&M Manual, Unit 515, April 1955, Revised 28 December 2010, (Station 627+00), listed as 24-inch pipe. USACE As-Built Drawing No. 50-04-2637, Sheet 3, Station 627+00, 7 January 1953]. FS Date: 3/4/2021 1:12:00 PM

Top of Levee: View of levee crown looking upstream

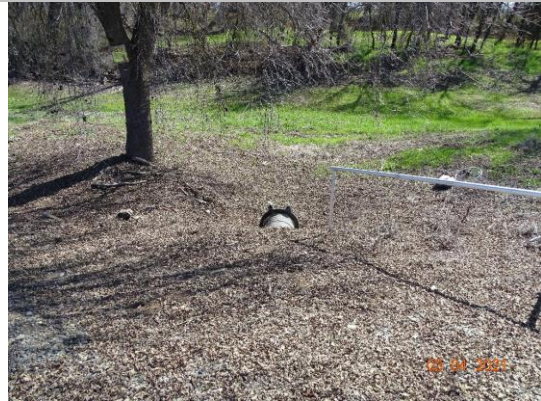
Photo 2 of 3 : UCIP_SP_2024_81085_98876.jpg

Water-Side: View of levee slope looking from crown
