Flood Control Project Maintenance
Levee Inspections
LMA District Cover Sheet

Sutter Maintenance Yard Maintenance Area 0005

**Flood Control Project Maintenance
Levee Inspections
Unit Cover Sheet**

Waterway			Bank	Unit Miles
Unit No. 01 Butte Creek			Left	15.08
	Spring (March - May)	Summer (June - August)	(September - November) Fall	Winter (December - February)
Unit Maintenance Rating (Fall Only)				
Date of Inspection	4/17/2024 - 4/17/2024			
DWR Inspector	Makar Sokol			
Accompanied By	Shawn Freitag DWR Sutter

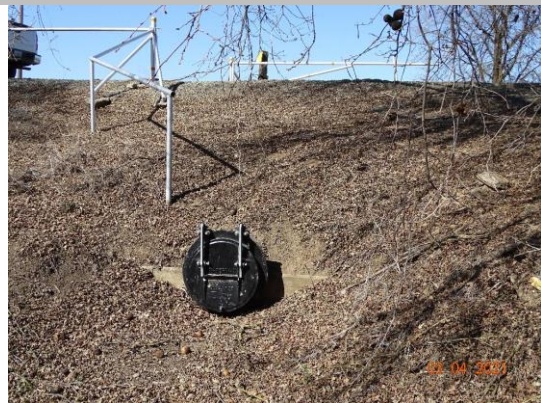
Photo 3 of 3 : UCIP_SP_2024_81085_98879.jpg

Water-Side: New flap gate installed on pipe end

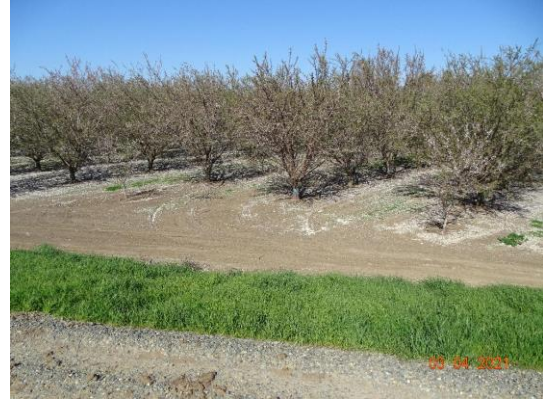
Photo 2 of 3 : UCIP_SP_2024_66495_98887.jpg

Land-Side: View of levee slope looking from crown

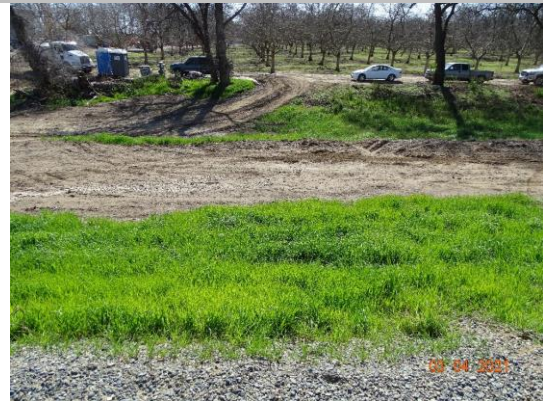
Photo 3 of 3 : UCIP_SP_2024_66495_98888.jpg

Water-Side: View of levee slope looking from crown

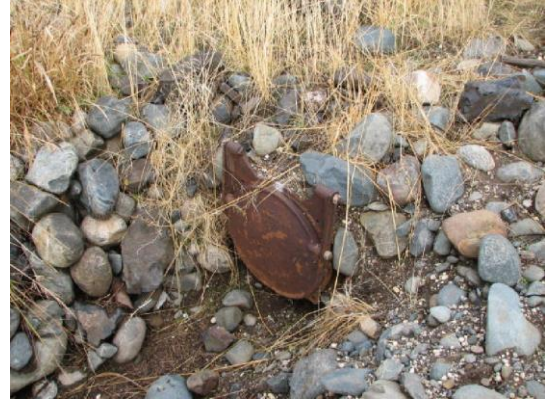
Photo 1 of 2 : UCIP_SP_2024_81087_68129.jpg

DS_ID:1656
FS_ID:81087
EP_NO: N/A
Repair Type: Non-Urgent
EVAL Issue:
Crossing Status: Found
UCIP Comments: 09/25/2023 DMP internal video inspection has found none or minor pipe defects. Recommend next video inspection in 5 years. (J. Taylor - DWR UCIP)03/04/2021 Record remains Non-Urgent. Unable to inspect crossing due to construction activity. No permit has been identified authorizing pipe. (O.Yakimov - DWR UCIP)

Flap gate at WS toe.

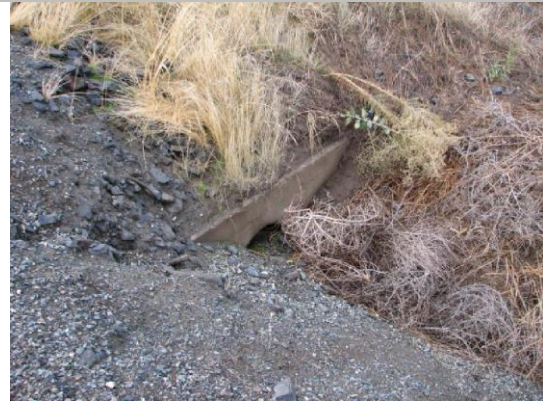
Photo 2 of 2 : UCIP_SP_2024_81087_68128.jpg

Concrete headwall on LS toe.

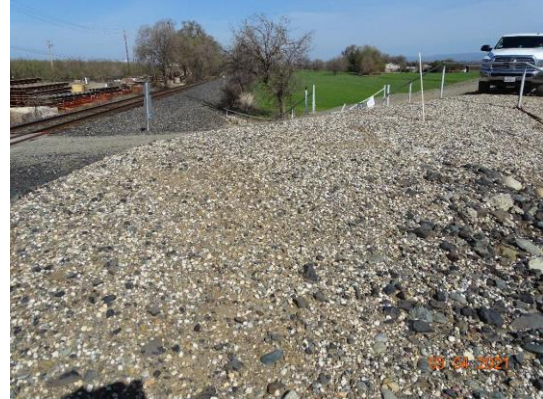
Photo 1 of 3 : UCIP_SP_2024_66520_98907.jpg

Comment Code					
Inspector Comment					
DS_ID:1660 FS_ID:66520 EP_NO: N/A Repair Type: Non-Urgent EVAL Issue: Crossing Status: Not Found UCIP Comments: 03/04/2021 Record updated from No Action Needed to Non-Urgent. Crossing not found. Geophysical results did not confirm presence of pipe through levee. Record will remain in UCIP's inspection records until future Levee Improvement Project can confirm no crossing was found through the levee. No permit has been identified authorizing pipe. (O.Yakimov - DWR UCIP) 06/13/2019 Levee mile and coordinates were updated based on the USACE's as-built drawing no. 50-4-2637 from CLM 8.009 (39.60789, -121.785435) to CLM 8.031 (39.608234, -121.785203). (O. Magana - DWR UCIP) 05/18/2017 Unable to locate. (A. Freitag - DWR Sutter Yard) 11/14/2016 Unable to locate. (A. Freitag - DWR Sutter Yard) 05/12/2016 Unable to locate. (A. Freitag - DWR Sutter Yard) 07/30/2015 Unable to locate. (A. Freitag - DWR Sutter Yard) 11/24/2014 Unable to locate. (A. Freitag - DWR Sutter Yard) 06/04/2014 Same as last inspection. (A. Freitag - DWR Sutter Yard) 11/12/2013 Unable to locate. (A. Freitag - DWR Sutter Yard) 06/06/2013 Same as last inspection. Unable to locate. (A. Freitag - DWR Sutter Yard) FIELD_STRUCT_DESC: 24-inch corrugated metal drainage pipe through the levee, 6.7 feet below the crown. Concrete headwalls at both the landside (LS) and the waterside (WS) toes. Flap gate on the WS. [Additional Reference(s): DWR Levee Log, 1990 (HLM 8.12). USACE Sacramento O&M Manual, Unit 515, April 1955, Revised 28 December 2010, (Station 541+00), listed as 24-inch pipe. USACE As-Built Drawing No. 50-04-2637, Sheet 2, just upstream of SP RR, 7 January 1953]. FS Date: 3/4/2021 3:31:15 PM

Top of Levee: View of levee crown looking across

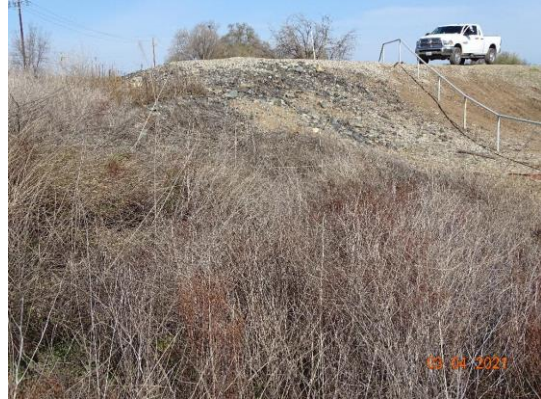
Photo 2 of 3 : UCIP_SP_2024_66520_98906.jpg

Water-Side: View of levee slope looking from toe

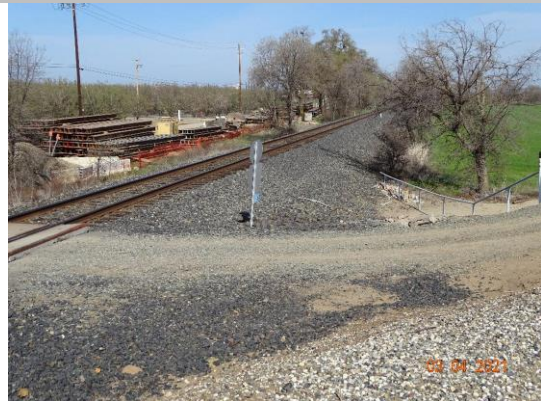
Photo 3 of 3 : UCIP_SP_2024_66520_98908.jpg

Land-Side: View of levee slope looking from crown

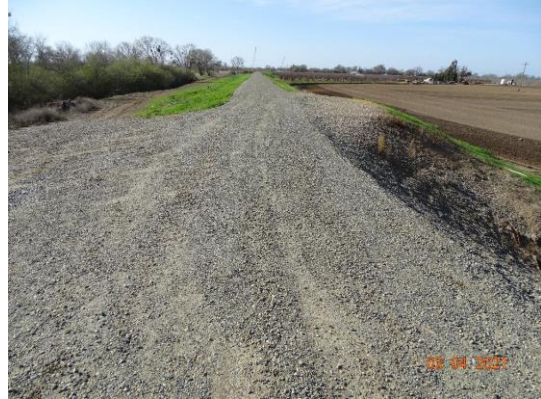
Photo 1 of 3 : UCIP_SP_2024_81089_98961.jpg

DS_ID:1663
FS_ID:81089
EP_NO: N/A
Repair Type: No Action Needed
EVAL Issue:
Crossing Status: Found
UCIP Comments: 09/25/2023 DMP internal video inspection has found none or minor pipe defects. Recommend next video inspection in 5 years. (J. Taylor - DWR UCIP)03/04/2021 Record updated from No Action Needed to Non-Urgent. No permit has been identified authorizing pipe. This pipe has been CIPP lined, according to Sutter Yard flap gate was replaced in 2019. (O.Yakimov - DWR UCIP) 05/18/2017 Crossing appears to be in good condition. Pipe has been selected to be internally cleaned and inspected as part of the DMP project. (A. Freitag - DWR Sutter Yard)11/14/2016 Crossing appears to be in good condition. (A. Freitag - DWR Sutter Yard)05/12/2016 Crossing appears to be in good condition. (A. Freitag - DWR Sutter Yard)07/30/2015 Crossing appears in good condition. No noticeable issues to report. (A. Freitag - DWR Sutter Yard)11/24/2014 Same as last inspection. (A. Freitag - DWR Sutter Yard)06/04/2014 Same as last inspection. (A. Freitag - DWR Sutter Yard)11/13/2013 Damaged pipe section was dug up and replaced. New WS flapgate with u-shaped wingwall installed on end of pipe. (A. Freitag - DWR Sutter Yard)06/06/2013 Same as last inspection. Plans have been made to repair during summer of 2013 before high water season. (A. Freitag - DWR Sutter Yard)11/01/2012 Pipe rusted through along bottom at WS outlet. Sink hole over pipe on WS berm. WS headwall eroded eternally around backside of headwall. (W. Wylie - DWR UCIP) FIELD_STRUCT_DESC: 24-inch CIPP-lined corrugated metal drainage pipe through the levee, 15 feet below the crown. Flap gate on the waterside (WS). Concrete headwalls on both the landside (LS) and the WS. [Additional Reference(s): DWR Levee Log, 1990 (HLM 8.89). USACE Sacramento O&M Manual, Unit 516 - Upper Butte Creek - Part No. 2, April 1960, pipe is only referenced in USACE As-Built Drawing No. 50-4-3367, Exhibit B, Sheet 11, (Station 340+04)].

Top of Levee: View of levee crown looking downstream

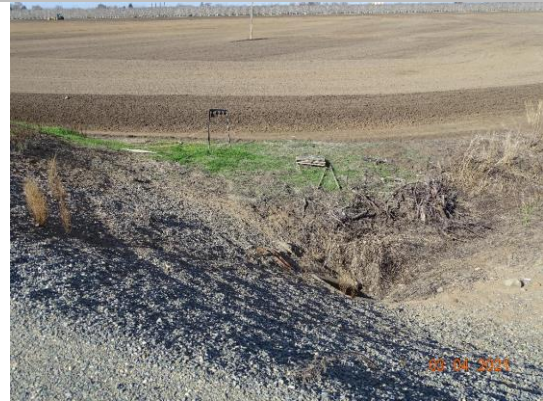
Photo 2 of 3 : UCIP_SP_2024_81089_98962.jpg

Land-Side: View of levee slope looking from crown

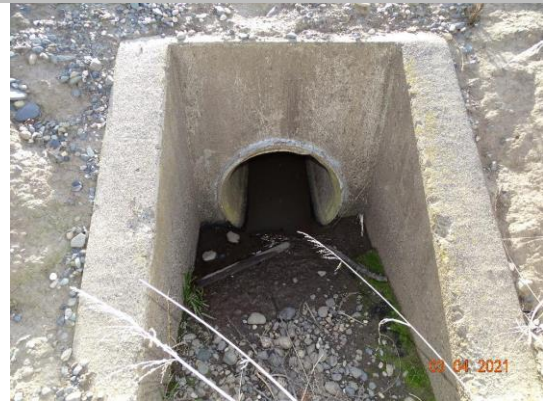
Photo 3 of 3 : UCIP_SP_2024_81089_98959.jpg

Land-Side: CIPP-lined pipe at headwall

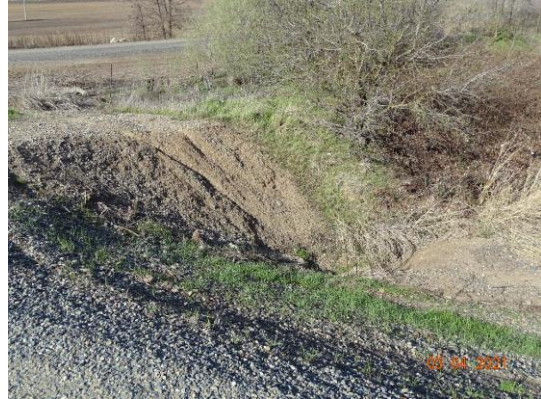
Photo 2 of 3 : UCIP_SP_2024_81090_98965.jpg

Water-Side: View of levee slope looking from crown

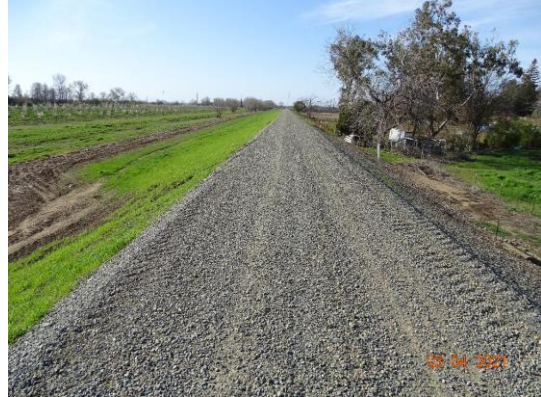
Photo 1 of 3 : UCIP_SP_2024_81091_98969.jpg

Comment Code						
Inspector Comment						
DS_ID:1665 FS_ID:81091 EP_NO: N/A Repair Type: No Action Needed EVAL Issue: Crossing Status: Found UCIP Comments: 09/25/2023 DMP internal video inspection has found none or minor pipe defects. Recommend next video inspection in 5 years. (J. Taylor - DWR UCIP)03/04/2021 Record remains Non-Urgent. No permit has been identified authorizing pipe. Crossing has been CIPP lined, new flap gate installed. (O.Yakimov - DWR UCIP) 05/18/2017 Crossing appears to be in good condition. Pipe has been selected to be internally cleaned and inspected as part of the DMP project. (A. Freitag - DWR Sutter Yard)11/14/2016 Crossing appears to be in good condition. (A. Freitag - DWR Sutter Yard)05/12/2016 Crossing appears to be in good condition. (A. Freitag - DWR Sutter Yard)07/30/2015 Crossing appears in good condition. No noticeable issues to report. (A. Freitag - DWR Sutter Yard)11/24/2014 Same as last inspection. (A. Freitag - DWR Sutter Yard)06/04/2014 Same as last inspection. (A. Freitag - DWR Sutter Yard)11/13/2013 Same as last inspection. (A. Freitag - DWR Sutter Yard)06/06/2013 Same as last inspection. (A. Freitag - DWR Sutter Yard) FIELD_STRUCT_DESC: 24-inch CIPP-lined corrugated metal drainage pipe through the levee, 11.3 feet below the crown. Flap gate on the waterside (WS). Concrete headwalls on both the landside (LS) and the WS. [Additional Reference(s): DWR Levee Log, 1990 (HLM 9.25). USACE Sacramento O&M Manual, Unit 516, April 1960, Revised 3 February 2011, (Station 321+20), listed as 24-inch pipe]. FS Date: 3/4/2021 2:56:21 PM

Top of Levee: View of levee crown looking downstream

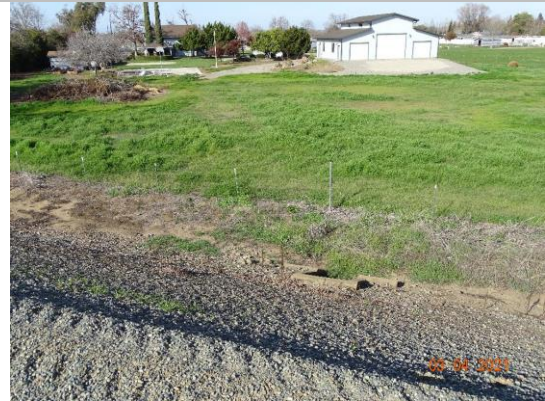
Photo 2 of 3 : UCIP_SP_2024_81091_98970.jpg

Land-Side: View of levee slope looking from crown

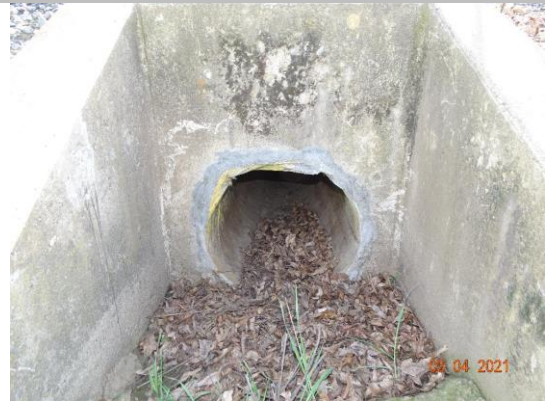
Photo 3 of 3 : UCIP_SP_2024_81091_98973.jpg

LM Start	9.12	Rating **	A	Issue No.	116 (cont)
LM End	9.12	Issue Type +	Ma	Location *

Land-Side: CIPP-lined pipe at headwall

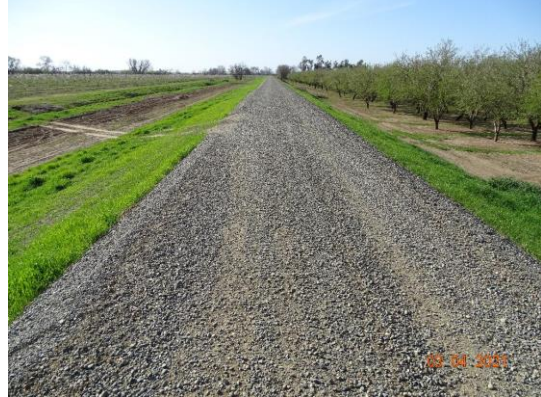
Photo 1 of 3 : UCIP_SP_2024_66675_98979.jpg

Comment Code					
Inspector Comment					
DS_ID:16851 FS_ID:66675 EP_NO: N/A Repair Type: Non-Urgent EVAL Issue: Crossing Status: Not Found UCIP Comments: 10/19/2021 During O&M Manual review this crossing has been identified at STA 309+11 (not STA 304+10). Updated references and coordinates of the crossing. If crossing still not found during next field visit recommend to conduct geophysical survey at new location. (O.Yakimov - DWR UCIP) 03/04/2021 Record updated from No Action Needed to Non-Urgent. Crossing not found. Geophysical results did not confirm presence of pipe through levee. Record will remain in UCIP's inspection records until future Levee Improvement Project can confirm no crossing was found through the levee. No permit has been identified authorizing pipe. (O.Yakimov - DWR UCIP) 05/18/2017 Unable to locate. (A. Freitag - DWR Sutter Yard) 11/14/2016 Unable to locate. (A. Freitag - DWR Sutter Yard) 05/12/2016 Unable to locate. (A. Freitag - DWR Sutter Yard) 07/30/2015 Unable to locate. (A. Freitag - DWR Sutter Yard) 11/24/2014 Unable to locate. (A. Freitag - DWR Sutter Yard) 06/04/2014 Unable to locate. (A. Freitag - DWR Sutter Yard) 11/13/2013 Unable to locate. (A. Freitag - DWR Sutter Yard) 06/06/2013 Same as last inspection. Unable to locate. (A. Freitag - DWR Sutter Yard) FIELD_STRUCT_DESC: 24-inch corrugated metal drainage pipe through the levee, 7.9 feet below the crown, not found. Concrete headwall indicated on the drawing. [Additional Reference(s): USACE Sacramento O&M Manual, Unit 516, April 1960, Revised 3 February 2011, (Station 309+11), listed as 14-inch pipe]. FS Date: 3/4/2021 3:03:26 PM

Top of Levee: View of levee crown looking downstream

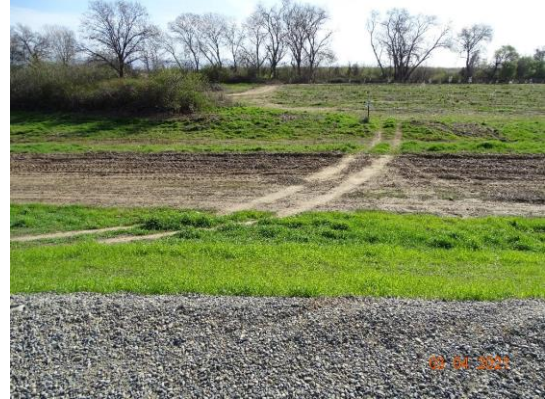
Photo 2 of 3 : UCIP_SP_2024_66675_98980.jpg

LM Start	9.35	Rating **	M	Issue No.	117 (cont)
LM End	9.35	Issue Type +	Ma	Location *	
Category	Supplemental			GPS Latitude/Longitude	
				Start	End
Item	DWR UCIP LMA Responsibility			39.625507°	39.625507°
				-121.775325°	-121.775325°
DWR ID	16851

Water-Side: View of levee slope looking from crown

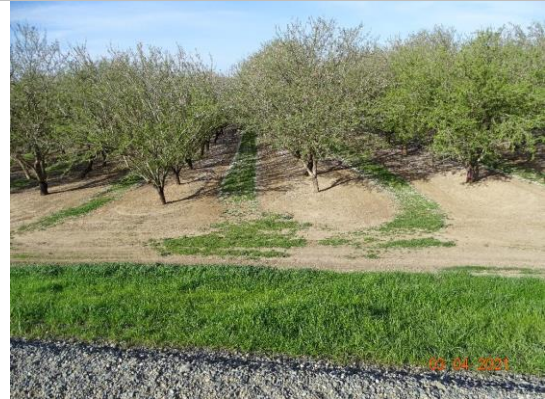
Photo 3 of 3 : UCIP_SP_2024_66675_98981.jpg

LM Start	9.35	Rating **	M	Issue No.	117 (cont)
LM End	9.35	Issue Type +	Ma	Location *

Land-Side: View of levee slope looking from crown

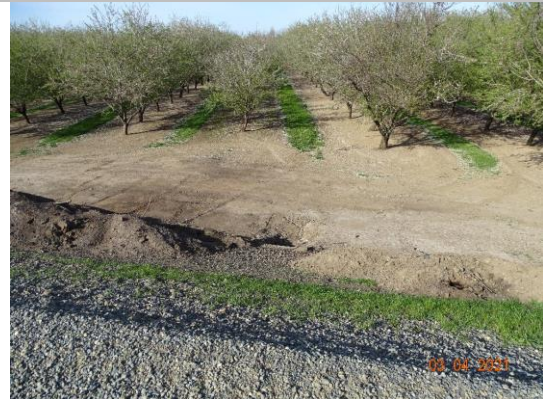
Photo 2 of 3 : UCIP_SP_2024_81092_98975.jpg

LM Start	9.44	Rating **	M	Issue No.	118 (cont)
LM End	9.44	Issue Type +	Ma	Location *	
Category	Supplemental			GPS Latitude/Longitude	
				Start	End
Item	DWR UCIP LMA Responsibility			39.626894°	39.626894°
				-121.775180°	-121.775180°
DWR ID	1666

Land-Side: View of levee slope looking from crown

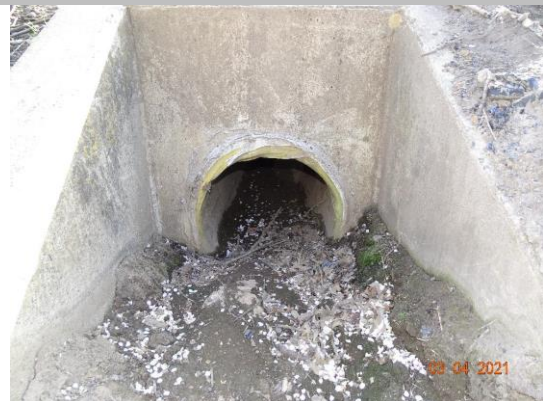
Photo 3 of 3 : UCIP_SP_2024_81092_98978.jpg

LM Start	9.44	Rating **	M	Issue No.	118 (cont)
LM End	9.44	Issue Type +	Ma	Location *

Land-Side: CIPP-lined pipe, headwall at levee toe

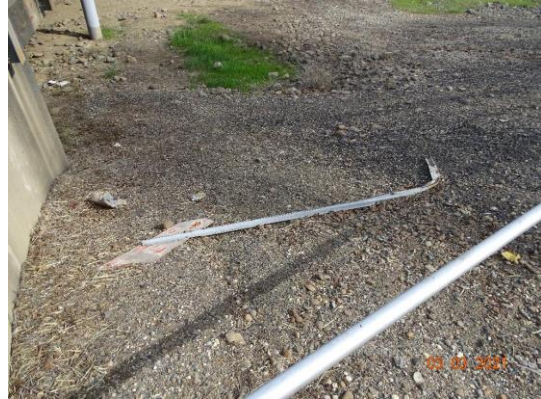
Photo 3 of 3 : UCIP_SP_2024_66677_98987.jpg

LM Start	10.93	Rating **	M	Issue No.	119 (cont)	
LM End	10.93	Issue Type +	En	Location *		
Category	Supplemental			GPS Latitude/Longitude		
				Start		End
Item	DWR UCIP Field Study			39.645796°	39.645796°	
				-121.786696°	-121.786696°	
DWR ID	1668

Water-Side: Fallen gas line sign on levee slope

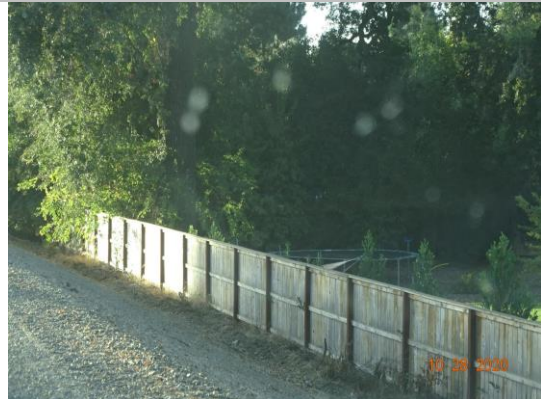
Photo 1 of 1 : SP_2024_MA0005_197_60_20240212_00009.jpg

LM Start	10.98	Rating **	U	Issue No.	60
LM End	11.04	Issue Type +	En	Location *	LS
Category	Earthen Levee			GPS Latitude/Longitude	
				Start	End
Item	Encroachments			39.646523 °	39.647238 °
				-121.787310 °	-121.787866 °
DWR ID	DWR_MA0005_02_f _ 2016_60				
Comment Code					
FE : Fence					
Inspector Comment

View of a wooden fence along the landside toe. Fall 2020.

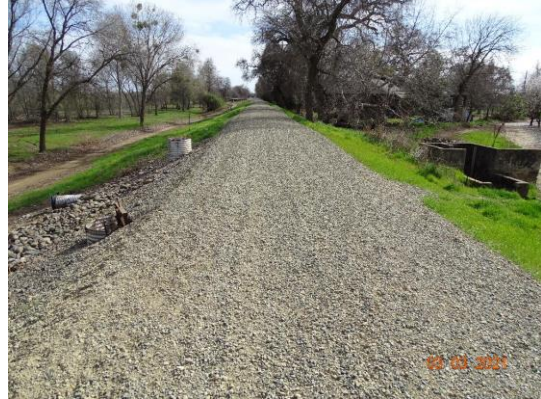
Photo 1 of 3 : UCIP_SP_2024_66857_99000.jpg

Comment Code					
Inspector Comment					
DS_ID:1671 FS_ID:66857 EP_NO: N/A Repair Type: Non-Urgent EVAL Issue: 11, Maintenance Compliance Issue Crossing Status: Found UCIP Comments: 03/03/2021 Record remains Non-Urgent. Crossing appears abandoned. Slide gate is in closed position, stem is bent. Soil and debris at the bottom of CMP riser on waterside shoulder cover slide gate. No permit has been identified authorizing pipe. DMP internal video inspection has not found pipe integrity issues. LOF of crossing is less or equal to 4.0. Recommend next video inspection in 5 years. (O.Yakimov - DWR UCIP) 05/18/2017 Abandoned- WS end still buried. (A. Freitag - DWR Sutter Yard)11/14/2016 Appears abandoned. (A. Freitag - DWR Sutter Yard)05/11/2016 Abandoned crossing. (A. Freitag - DWR Sutter Yard)07/30/2015 Abandoned crossing. Unable to locate the WS end of pipe. (A. Freitag - DWR Sutter Yard)11/24/2014 Same as last inspection. (A. Freitag - DWR Sutter Yard)06/04/2014 Same as last inspection. (A. Freitag - DWR Sutter Yard)11/13/2013 Same as last inspection. (A. Freitag - DWR Sutter Yard)06/06/2013 Same as last inspection. (A. Freitag - DWR Sutter Yard)11/01/2012 Pipe appears abandoned. It needs to be abandoned properly. (W. Wylie - DWR UCIP) FIELD_STRUCT_DESC: 30-inch corrugated metal irrigation pipe through the levee, 9.4 feet below the crown. Slide gate in a 42-inch corrugated metal riser on the waterside (WS) slope. Concrete distribution box on the landside (LS). [Additional Reference(s): DWR Levee Log, 1990 (HLM 11.27). USACE Sacramento O&M Manual, Unit 516, April 1960, Revised 3 February 2011, (Station 215+46), listed as 30-inch pipe]. FS Date: 3/3/2021 10:16:09 AM

Top of Levee: View of levee crown looking downstream

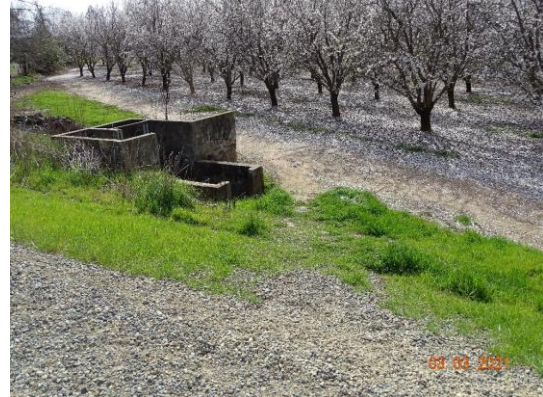
Photo 2 of 3 : UCIP_SP_2024_66857_99003.jpg

LM Start	11.12	Rating **	M	Issue No.	120 (cont)
LM End	11.12	Issue Type +	En	Location *	
Category	Supplemental		GPS Latitude/Longitude		
			Start	End	
Item	DWR UCIP Field Study		39.648185°	39.648185°	
			-121.788563°	-121.788563°	
DWR ID	1671

Land-Side: View of levee slope looking from crown. Concrete distribution box at levee toe

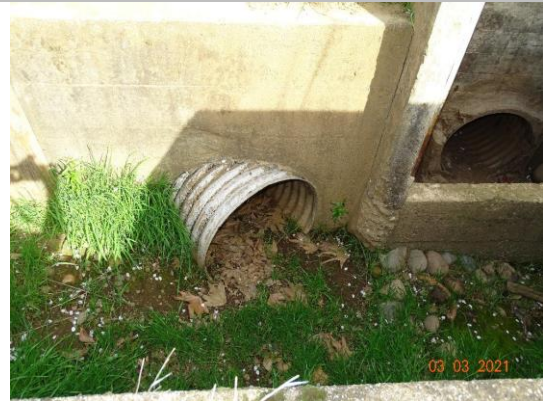
Photo 3 of 3 : UCIP_SP_2024_66857_99004.jpg

LM Start	11.12	Rating **	M	Issue No.	120 (cont)
LM End	11.12	Issue Type +	En	Location *

Land-Side: Pipe end in concrete box at levee toe

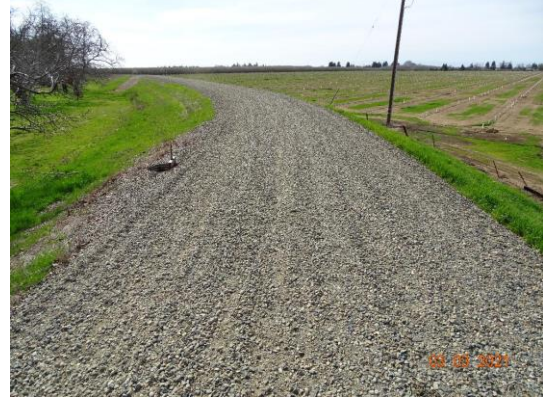
Photo 1 of 3 : UCIP_SP_2024_66886_99009.jpg

DS_ID:1673
FS_ID:66886
EP_NO: N/A
Repair Type: Non-Urgent
EVAL Issue: 4b, Safety Issue
Crossing Status: Found
UCIP Comments: 03/03/2021 Record remains Non-Urgent. CMP riser on waterside slope is open at ground level. Recommend installation of top cover. Crossing appears abandoned. Headwall is buried in soil at landside toe, soil at the bottom of CMP riser on waterside slope blocks slide gate from opening. Capped pipe in front of headwall on landside may not belong to this crossing. Geophysical study indicates possible presence of pipe through levee. Owner needs to coordinate with the CVFPB to remove or abandon crossing according to Title 23 requirements. No permit has been identified authorizing pipe. (O.Yakimov - DWR UCIP)
05/23/2019 (O. Magana - DWR UCIP)05/18/2017 Abandoned- needs to be done properly. Pipe has been selected to be internally cleaned and inspected as part of the DMP project. (A. Freitag - DWR Sutter Yard)11/14/2016 Abandoned- needs a cover for standpipe. (A. Freitag - DWR Sutter Yard)05/11/2016 Abandoned crossing. Needs a cover for the WS riser. (A. Freitag - DWR Sutter Yard)08/03/2015 Crossing appears abandoned. Only the slide gate inside riser on the WS shoulder could be found. Riser needs a cover made for it. (A. Freitag - DWR Sutter Yard)11/24/2014 Same as last inspection. (A. Freitag - DWR Sutter Yard)06/04/2014 Same as last inspection. (A. Freitag - DWR Sutter Yard)11/13/2013 Slide gate top and stem were repaired to make gate operational. (A. Freitag - DWR Sutter Yard)06/06/2013 New slidegate is planned to be installed during summer of 2013. (A. Freitag - DWR Sutter Yard)11/01/2012 Slide gate on WS shoulder bent and damaged (inoperable) Pipe appears abandoned. (W. Wylie - DWR UCIP)

FIELD_STRUCT_DESC: 24-inch corrugated metal drainage pipe through the levee, 14 feet below the crown. Slide gate in a corrugated metal riser on the waterside (WS) slope. [Additional Reference(s): DWR Levee Log, 1990 (HLM 12.98). USACE Sacramento O&M Manual, Unit 516, April 1960, Revised 3 February 2011, (Station 126+91), listed as 24-inch pipe].
FS Date: 3/3/2021 11:13:03 AM

Top of Levee: View of levee crown looking downstream

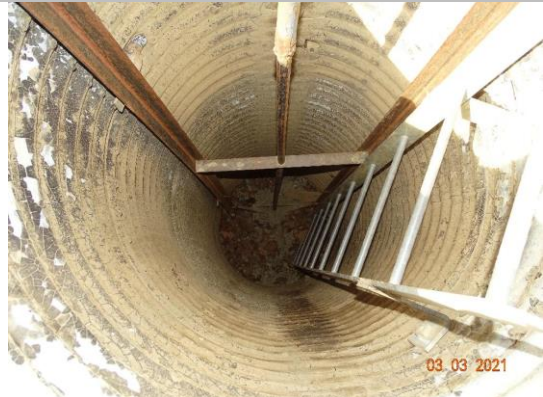
Photo 2 of 3 : UCIP_SP_2024_66886_99011.jpg

LM Start	12.80	Rating **	M	Issue No.	121 (cont)
LM End	12.80	Issue Type +	Ma	Location *	
Category	Supplemental			GPS Latitude/Longitude	
				Start	End
Item	DWR UCIP LMA Responsibility			39.670982°	39.670982°
				-121.783103°	-121.783103°
DWR ID	1673

Water-Side: View inside CMP riser. Soil buildup at bottom

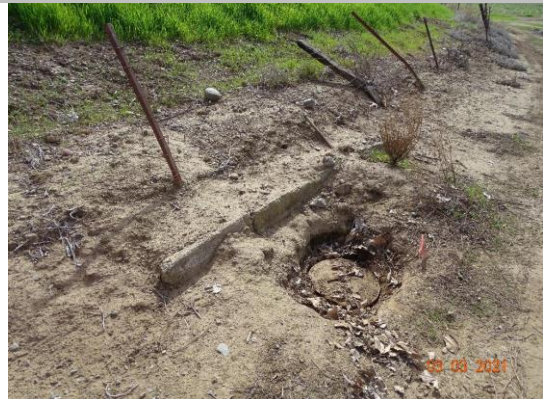
Photo 3 of 3 : UCIP_SP_2024_66886_99013.jpg

LM Start	12.80	Rating **	M	Issue No.	121 (cont)
LM End	12.80	Issue Type +	Ma	Location *

Land-Side: Buried in soil headwall at levee toe. Capped pipe in front of headwall

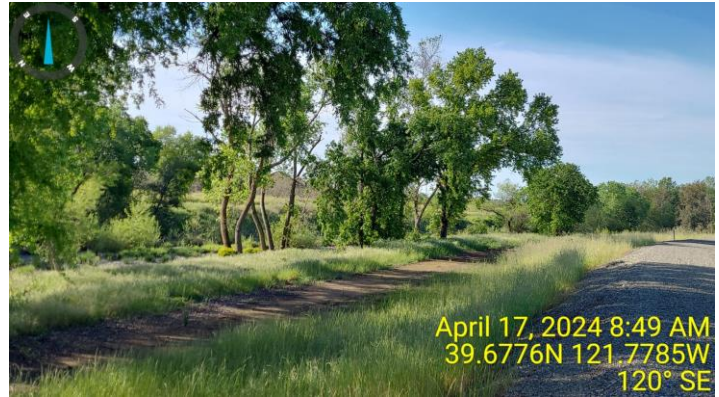
Photo 1 of 1 : SP_2024_MA0005_197_42_20240422_00094.jpg

LM Start	13.16	Rating **	M	Issue No.	42
LM End	13.37	Issue Type +	Ma	Location *	WS
Category	Earthen Levee			GPS Latitude/Longitude	
				Start	End
Item	Vegetation			39.675451°	39.678143°
				-121.780225°	-121.778342°
DWR ID	DWR_MA0005_02_s_2024_42				
Comment Code					
V1 : Control annual grass and weeds on the levee slopes and easements.					
Inspector Comment

View of the vegetation along the waterside slope. Spring 2024.

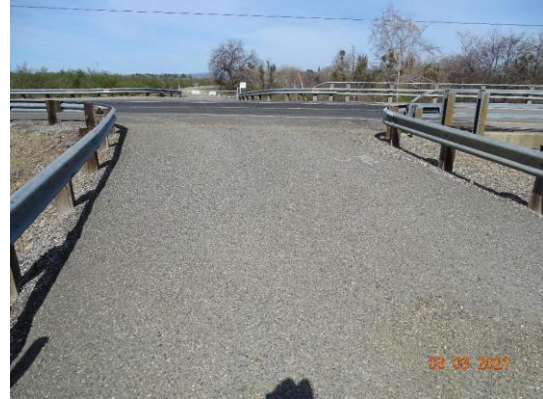
Photo 1 of 3 : UCIP_SP_2024_77839_99026.jpg

Comment Code					
Inspector Comment					
DS_ID:1740 FS_ID:77839 EP_NO: 17127 Repair Type: Urgent EVAL Issue: 1, Pipe Integrity Crossing Status: Found UCIP Comments: 12/13/2022 Record updated from Non-Urgent to Urgent. DMP internal video inspection has found pipe integrity issues. LOF of crossing is between 5 and 6. Crossing will be monitored until funding becomes available to address the issues. (O.Yakimov - DWR UCIP) 03/03/2021 Record updated from No Action Needed to Non-Urgent. Vegetation and debris around headwall and flap gate on waterside need to be cleared. (O.Yakimov - DWR UCIP) 5/18/2017 Crossing appears to be in good condition. Pipe has been selected to be internally cleaned and inspected as part of the DMP project. (A. Freitag - DWR Sutter Yard)11/14/2016 Crossing appears to be in good condition. (A. Freitag - DWR Sutter Yard)05/11/2016 Ws flap gate is being overgrown by vegetation. (A. Freitag - DWR Sutter Yard)08/03/2015 Crossing appears in good condition. No noticeable issues to report. (A. Freitag - DWR Sutter Yard)11/24/2014 Flap gate needs to be dug out and unblocked. (A. Freitag - DWR Sutter Yard)06/04/2014 Same as last inspection. (A. Freitag - DWR Sutter Yard)11/13/2013 Flap gate is completely blocked from being able to open. (A. Freitag - DWR Sutter Yard)06/06/2013 Same as last inspection. (A. Freitag - DWR Sutter Yard)11/01/2012 Debris, soil, and vegetation creating minor blockage at flap gate outlet. (W. Wylie - DWR UCIP) FIELD_STRUCT_DESC: 36-inch corrugated metal drainage pipe through the levee, 12 feet below the crown. 4-foot by 4-foot concrete box and slide gate on the landside (LS). Concrete headwall and flap gate at the waterside (WS) outlet. (36-inch pipe authorized under Permit No. 17127, 1999 - Butte County, Department of Public Works). FS Date: 3/3/2021 8:30:03 PM

Top of Levee: View of levee crown looking upstream

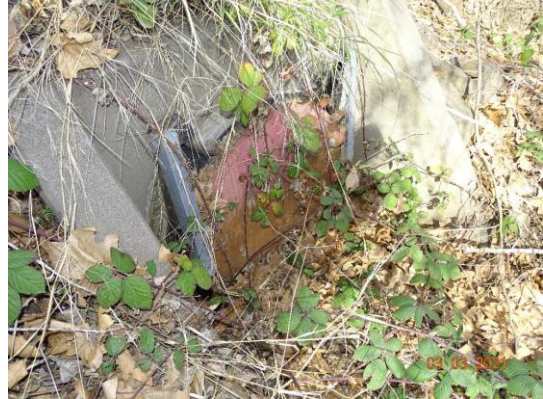
Photo 2 of 3 : UCIP_SP_2024_77839_99029.jpg

LM Start	13.38	Rating **	U	Issue No.	122 (cont)
LM End	13.38	Issue Type +	En	Location *	
Category	Supplemental		GPS Latitude/Longitude		
			Start	End	
Item	DWR UCIP Field Study		39.678267°	39.678267°	
			-121.778322°	-121.778322°	
DWR ID	1740

Water-Side: Flap gate at levee toe buried in vegetation and debris

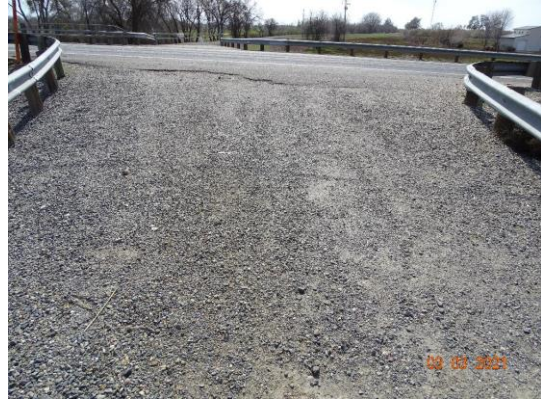
Photo 1 of 3 : UCIP_SP_2024_81093_99074.jpg

Comment Code					
Inspector Comment					
DS_ID:1679 FS_ID:81093 EP_NO: N/A Repair Type: No Action Needed EVAL Issue: Crossing Status: Found UCIP Comments: 09/25/2023 DMP internal video inspection has found none or minor pipe defects. Recommend next video inspection in 5 years. (J. Taylor - DWR UCIP)03/03/2021 Record updated from No Action Needed to Non-Urgent. No permit has been identified authorizing pipe. According to DMP records this crossing was CIPP-lined on 07/19/2019. (O.Yakimov - DWR UCIP) 05/18/2017 Crossing appears to be in good condition. Pipe has been selected to be internally cleaned and inspected as part of the DMP project. (A. Freitag - DWR Sutter Yard)11/14/2016 Crossing appears to be in good condition. (A. Freitag - DWR Sutter Yard)05/11/2016 Crossing appears to be in good condition. (A. Freitag - DWR Sutter Yard)08/03/2015 Crossing appears in good condition. No noticeable issues to report. (A. Freitag - DWR Sutter Yard)11/25/2014 Same as last inspection. (A. Freitag - DWR Sutter Yard)06/04/2014 Same as last inspection. (A. Freitag - DWR Sutter Yard)11/13/2013 Same as last inspection. (A. Freitag - DWR Sutter Yard)06/06/2013 Same as last inspection. (A. Freitag - DWR Sutter Yard) FIELD_STRUCT_DESC: 24-inch CIPP-lined corrugated metal drainage pipe through the levee, 14.5 feet below the crown. Concrete "U" shaped headwall on the waterside (WS). Flap gate on the WS. [Additional Reference(s): DWR Levee Log, 1990 (HLM 13.61). USACE Sacramento O&M Manual, Unit 516, April 1960, Revised 3 February 2011, (Station 93+78), listed as 24-inch pipe]. FS Date: 3/3/2021 2:46:16 PM

Top of Levee: View of levee crown looking downstream

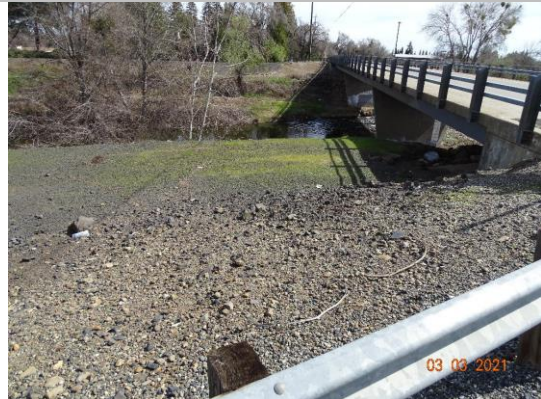
Photo 2 of 3 : UCIP_SP_2024_81093_99075.jpg

LM Start	13.40	Rating **	A	Issue No.	123 (cont)
LM End	13.40	Issue Type +	Ma	Location *	
Category	Supplemental			GPS Latitude/Longitude	
				Start	End
Item	DWR UCIP LMA Responsibility			39.678550°	39.678550°
				-121.778339°	-121.778339°
DWR ID	1679

Water-Side: View of levee slope looking from crown

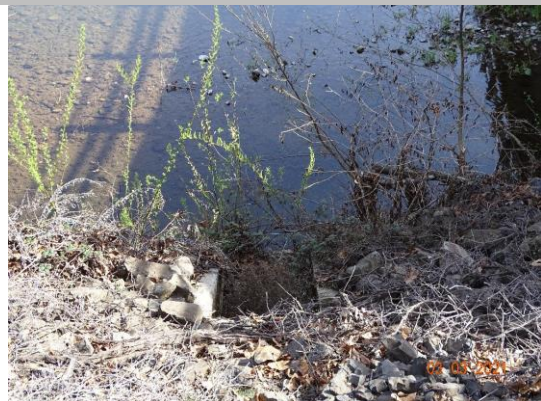
Photo 3 of 3 : UCIP_SP_2024_81093_99076.jpg

LM Start	14.33	Rating **	A	Issue No.	123 (cont)
LM End	14.33	Issue Type +	Ma	Location *

Water-Side: Pipe outlet at riverbank

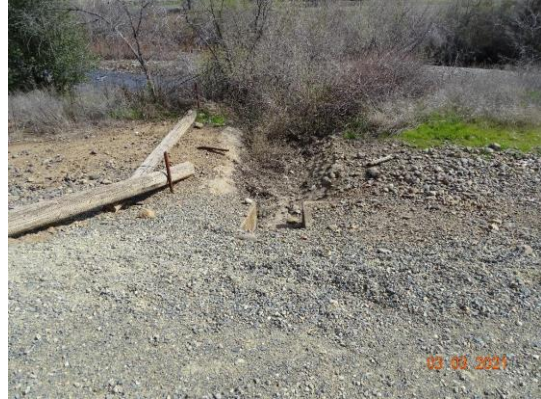
Photo 1 of 3 : UCIP_SP_2024_67139_99087.jpg

DS_ID:1682
FS_ID:67139
EP_NO: N/A
Repair Type: Urgent
EVAL Issue: 3a, Flood Risk
Crossing Status: Found
UCIP Comments: 03/03/2021 Record updated from No Action Needed to Urgent. Debris inside the pipe blocks flap gate from complete closing that is posing flood risk to landside. Debris needs to be cleared for proper operation. No permit has been identified authorizing pipe. DMP internal video inspection has not found pipe integrity issues. LOF of crossing is less or equal to 4.0. Recommend next video inspection in 5 years. (O.Yakimov - DWR UCIP)
05/23/2019 (O. Magana - DWR UCIP)05/18/2017 Crossing appears to be in good condition. Pipe has been selected to be internally cleaned and inspected as part of the DMP project. (A. Freitag - DWR Sutter Yard)11/14/2016 Crossing appears to be in good condition. (A. Freitag - DWR Sutter Yard)05/11/2016 Crossing appears to be in good condition. (A. Freitag - DWR Sutter Yard)08/03/2015 Crossing appears in good condition. No noticeable issues to report. (A. Freitag - DWR Sutter Yard)11/25/2014 Same as last inspection. (A. Freitag - DWR Sutter Yard)06/04/2014 Same as last inspection. (A. Freitag - DWR Sutter Yard)11/13/2013 Same as last inspection. (A. Freitag - DWR Sutter Yard)06/06/2013 Same as last inspection. (A. Freitag - DWR Sutter Yard)

FIELD_STRUCT_DESC: 24-inch corrugated metal drainage pipe through the levee, 7.2 feet below the crown. Concrete "U" shaped headwall and grouted spillway on the waterside (WS). Slide gate in a 48-inch concrete standpipe on the landside (LS). Flap gate on the WS.
[Additional Reference(s): DWR Levee Log, 1990 (HLM 14.68). USACE Sacramento O&M Manual, Unit 516, April 1960, Revised 3 February 2011, (Station 37+10), listed as 24-inch pipe]. USACE As-Built Drawing No. 50-04-3350, Sheet 20, STA 37+10, 12 August 1959].
FS Date: 3/3/2021

Water-Side: View of levee slope looking from crown

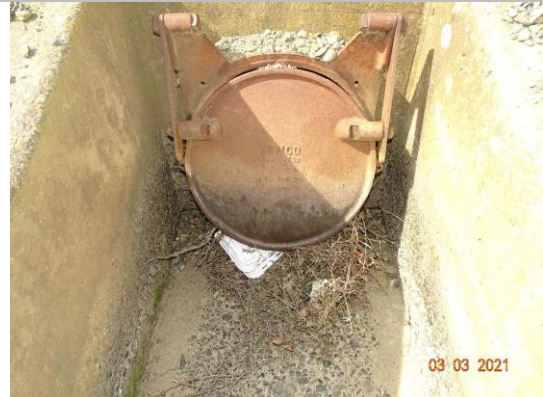
Photo 2 of 3 : UCIP_SP_2024_67139_99088.jpg

Water-Side: U-shaped headwall, flap gate on pipe end. Clearing of debris in pipe is required

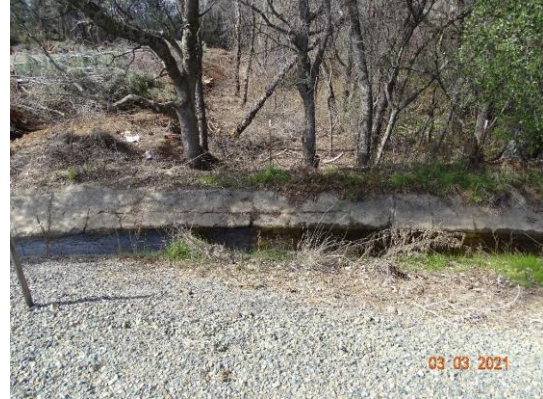
Photo 1 of 3 : UCIP_SP_2024_81094_99090.jpg

Land-Side: View of levee slope looking from crown

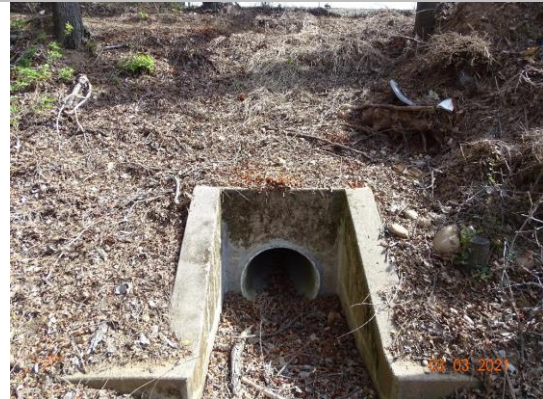
Photo 2 of 3 : UCIP_SP_2024_81094_99091.jpg

Land-Side: U-shaped headwall and pipe inlet at levee toe

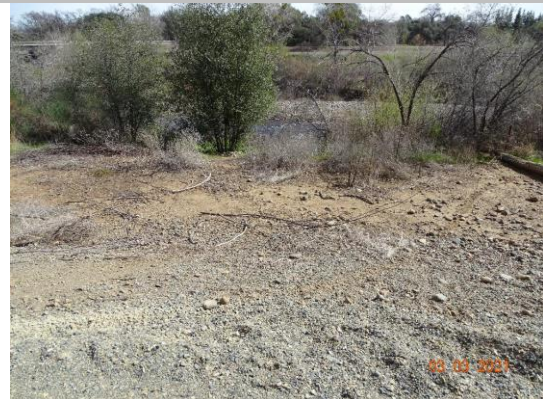
Photo 3 of 3 : UCIP_SP_2024_81094_99089.jpg

Water-Side: View of levee slope looking from crown

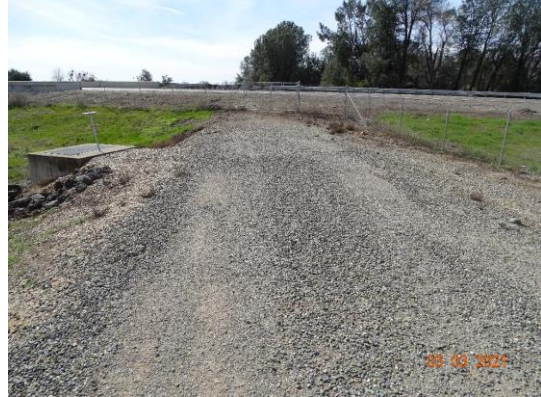
Photo 1 of 3 : UCIP_SP_2024_67141_99093.jpg

Top of Levee: View of levee crown looking downstream

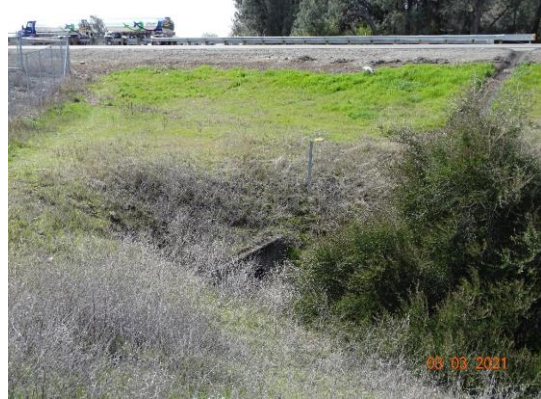
Photo 2 of 3 : UCIP_SP_2024_67141_99094.jpg

Land-Side: Headwall and pipe inlet at drainage ditch

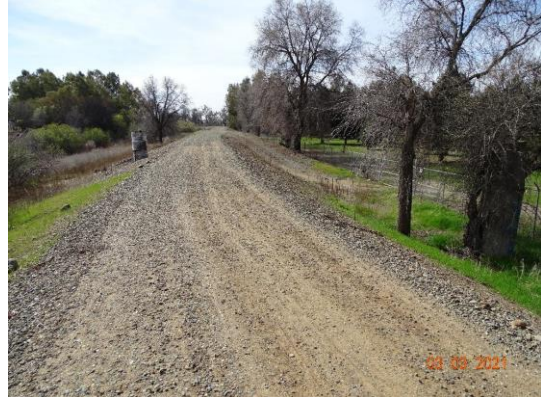
Photo 1 of 3 : UCIP_SP_2024_67143_99103.jpg

Top of Levee: View of levee crown looking downstream

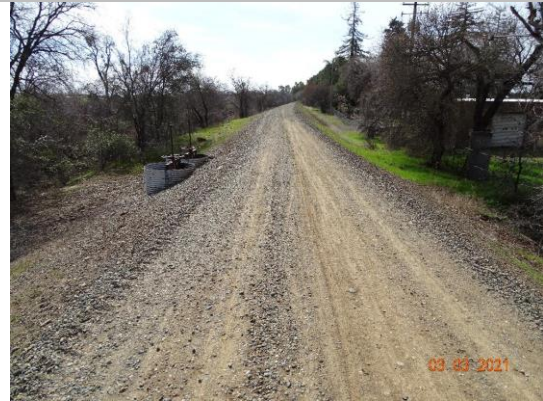
Photo 1 of 3 : UCIP_SP_2024_67144_99108.jpg

Top of Levee: View of levee crown looking downstream

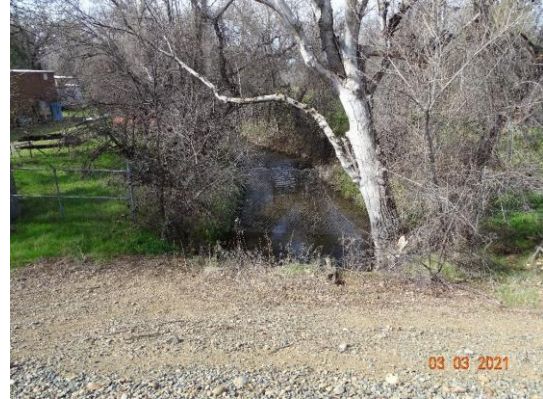
Photo 2 of 3 : UCIP_SP_2024_67144_99110.jpg

Water-Side: View of levee slope looking from crown

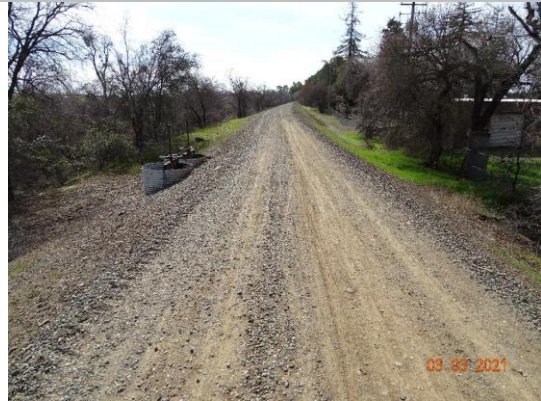
Photo 1 of 3 : UCIP_SP_2024_67145_99113.jpg

Top of Levee: View of levee crown looking downstream

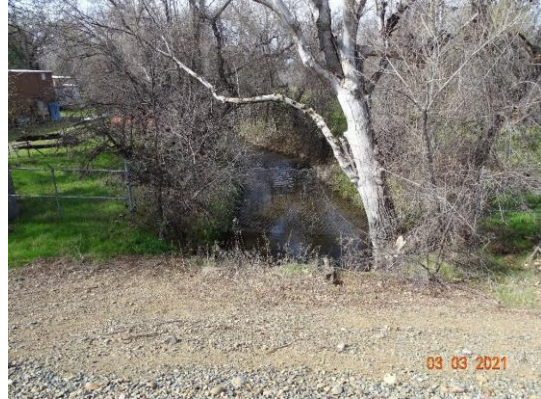
Photo 2 of 3 : UCIP_SP_2024_67145_99115.jpg

Water-Side: View of levee slope looking from crown

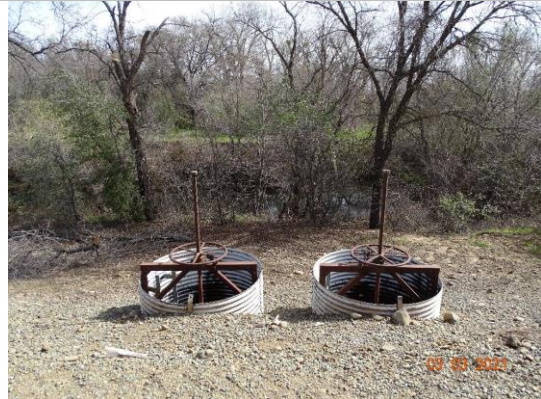
Photo 3 of 3 : UCIP_SP_2024_67145_99114.jpg

Comment Code					
Inspector Comment					
DS_ID:16316 FS_ID:67145 EP_NO: N/A Repair Type: Non-Urgent EVAL Issue: 4b, Safety Issue Crossing Status: Found UCIP Comments: 03/03/2021 Record remains Non-Urgent. CMP riser on waterside shoulder is open at ground level. Recommend installation of top cover. No permit has been identified authorizing pipe. (O.Yakimov - DWR UCIP) 05/18/2017 Crossing appears to be in good condition. WS riser needs a cover. (A. Freitag - DWR Sutter Yard)11/14/2016 Good condition- needs a cover for standpipe. (A. Freitag - DWR Sutter Yard)05/11/2016 Needs a lcover for riser. The rest of the crossing appears in good condition. (A. Freitag - DWR Sutter Yard)08/03/2015 Crossing appears in good condition but needs a cover made for the riser. (A. Freitag - DWR Sutter Yard)11/25/2014 Same as last inspection. (A. Freitag - DWR Sutter Yard)06/04/2014 Same as last inspection. (A. Freitag - DWR Sutter Yard)11/13/2013 Same as last inspection. (A. Freitag - DWR Sutter Yard)06/06/2013 Same as last inspection. Need to construct cover for top of standpipe. (A. Freitag - DWR Sutter Yard)11/01/2012 Good candidate for video inspection. (W. Wylie - DWR UCIP) FIELD_STRUCT_DESC: 2 of 2: 54-inch corrugated metal irrigation pipe (siphon) through the levee, 17.8 feet below the crown. Slide gate in a 66-inch corrugated metal riser on the waterside (WS). Concrete headwall and irrigation ditch at the landside (LS) toe. Edgar Slough riser units in the floodway. [Additional Reference(s): DWR Levee Log, 1990 (HLM 15.71). USACE Sacramento O&M Manual, Unit 516, April 1960, Revised 3 February 2011, (Station 132+00), listed as 54-inch pipe]. FS Date: 3/3/2021 3:51:42 PM

Water-Side: View of levee slope looking from crown. CMP riser needs a top cover
