**Flood Control Project Maintenance
Levee Inspections**
LMA District Cover Sheet
Spring 2017 Levee Inspection Results

Sutter Maintenance Yard Maintenance Area 0012

Spring 2017 Levee Inspection Results

Waterway			Bank	Unit Miles
Unit No. 01 Colusa Drain			Left	11.06
	Spring (March - May)	Summer (June - August)	(September - November) Fall	Winter (December - February)
Unit Maintenance Rating (Fall Only)				
Date of Inspection	3/16/2017 - 3/16/2017			
DWR Inspector	Bob Duffey			
Accompanied By	Bryan Reniff Sutter Maintenance Yard

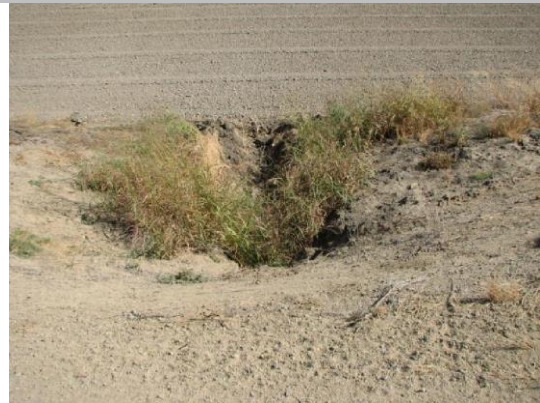
Photo 1 of 3 : UCIP_SP_2017_51780_68977.jpg

Intake on LS toe.

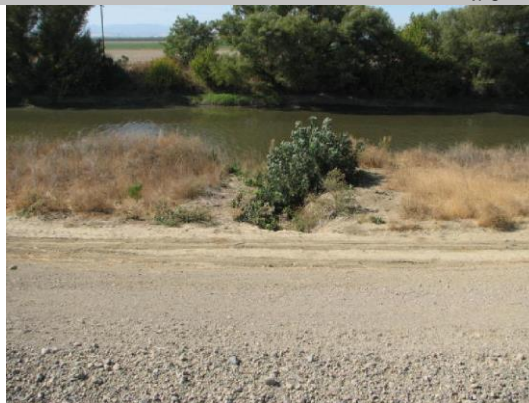
Photo 2 of 3 : UCIP_SP_2017_51780_68976.jpg

Outlet at WS toe.

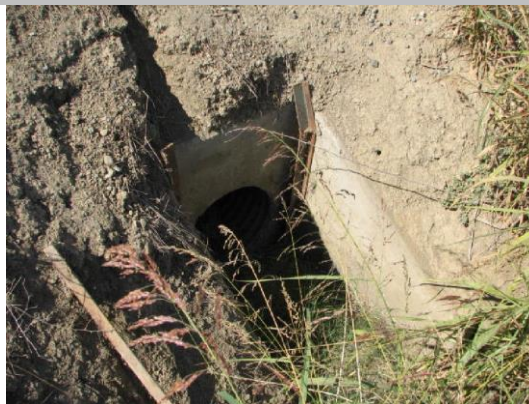
Photo 3 of 3 : UCIP_SP_2017_51780_68975.jpg

Concrete U shaped headwall on LS toe.

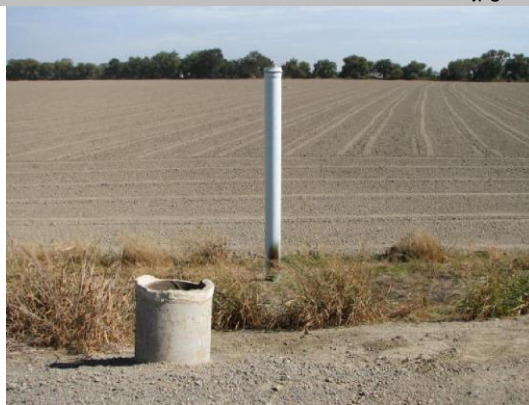
Photo 2 of 3 : UCIP_SP_2017_51781_68980.jpg

Concrete and PVC risers on LS.

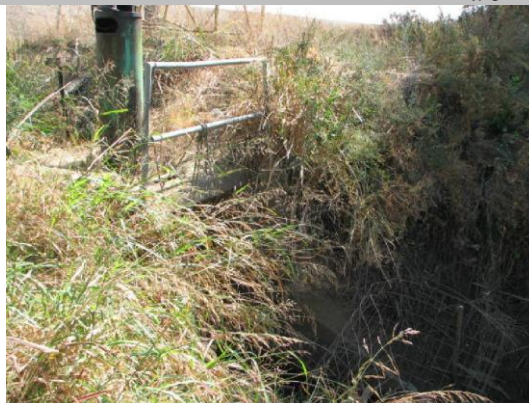
Photo 3 of 3 : UCIP_SP_2017_51781_68979.jpg

Comment Code						
Inspector Comment						
FS_ID:51781 DS_ID:17148 EP_NO: 9382 Repair Type: Non-Urgent Crossing Status: Found UCIP Comments: 5/2/2017 WS is being overgrown with vegetation. The rest of the crossing appears to be in good condition. (DWR Sutter Yard- A Freitag)10/17/2016 Vegetation is overgrowing the WS head wall near the pump. The rest of the crossing appears to be in good condition. (DWR Sutter Yard- A Freitag)5/31/2016 Crossing appears to be in good condition.5/4/2015 Crossing appears in good condition. No noticeable issues to report.6/17/2014 Same as last inspection.12/16/2013 Same as last inspection.7/16/2013 Same as last inspection. FIELD_STRUCT_DESC: 18-inch steel irrigation pipe through the levee, 3 feet below the crown. Pump, butterfly valve, and concrete headwall at the edge of bank. Bank cobble re-vetted 10 feet on both waterside (WS) and landside (LS) of installation. 18-inch polyvinyl chloride (PVC) standpipe on the LS berm. Siphon breaker in 18-inch concrete riser on the LS shoulder. Service pole at the edge of the bank. (Automatic Board Order (ABO) issued as Permit No. 9382, 1974 - Baber) [Additional Reference(s): DWR Levee Log, 2005. USACE Sacramento O&M Manual 132, October 1959 (HLM 1.53)] FS Date: 5/2/2017 1:47:19 PM

Pump and concrete headwall at WS toe.

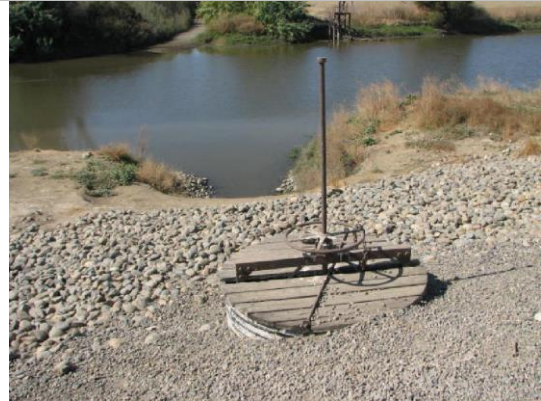
Photo 1 of 3 : UCIP_SP_2017_51785_68991.jpg

60-inch standpipe with slide gate on WS slope with outlet in background.

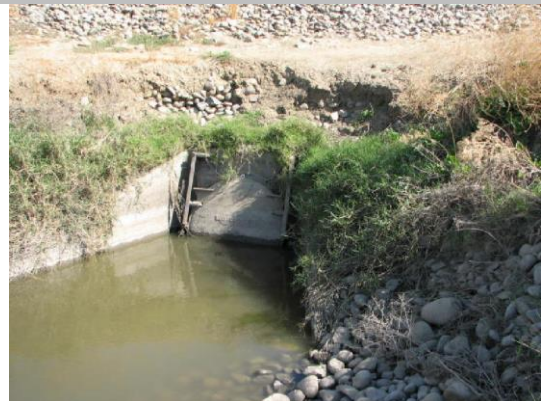
Photo 2 of 3 : UCIP_SP_2017_51785_68990.jpg

Flap gate and concrete headwall at WS toe.

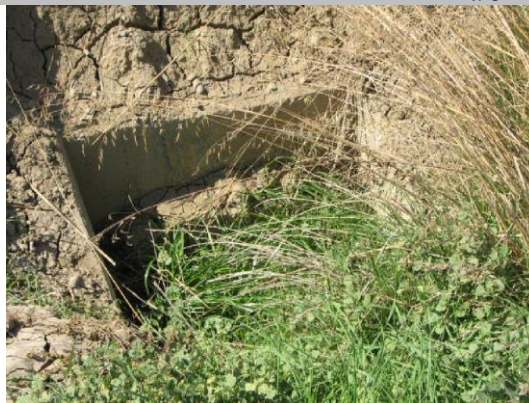
Photo 3 of 3 : UCIP_SP_2017_51786_68992.jpg

Comment Code						
Inspector Comment						
FS_ID:51786 DS_ID:17151 EP_NO: 9391 Repair Type: Non-Urgent Crossing Status: Found UCIP Comments: 5/2/2017 Both ends of pipe buried. (DWR Sutter Yard- AFreitag)10/17/2016 Appears abandoned. Both pipe ends are completely buried. (DWR Sutter Yard- AFreitag)9/29/2016 Crossing has been downgraded from Urgent to Non-Urgent both pipe ends are buried. Having both ends buried prevents water from flowing from WS to LS during flood season. Need to contact owner and have owner coordinate with CVFPB to comply with Title 23. (DWR UCIP - omagana)5/31/2016 Both pipe ends are buried. Pipe is non-operational. (DWR Sutter Yard - afreitag)5/4/2015 LS and WS ends are blocked with soil. Pipe is inoperable as it is. (DWR Sutter Yard - afreitag)6/17/2014 Same as last inspection. (DWR Sutter Yard - afreitag)12/16/2013 Same as last inspection. (DWR Sutter Yard - afreitag)7/16/2013 LS inlet is completely filled with soil. Needs to be cleaned out. (DWR Sutter Yard - afreitag)10/11/2012 Inlet is partially filled with soil. (DWR Sutter Yard - wwylie) FIELD_STRUCT_DESC: *ABANDONED* 24-inch corrugated metal drainage pipe through the levee, 13 feet below the crown. Flap gate, concrete headwall and grouted cobble spillway on the waterside (WS). Concrete headwall located on the landside (LS). (Automatic Board Order (ABO) issued as Permit No. 9391, Christenson). [Additional Reference(s): DWR Levee Log, 2005. USACE Sacramento O&M Manual 132, October 1959 (HLM 2.02)] FS Date: 5/2/2017 2:01:25 PM

Concrete U shaped headwall at LS toe.

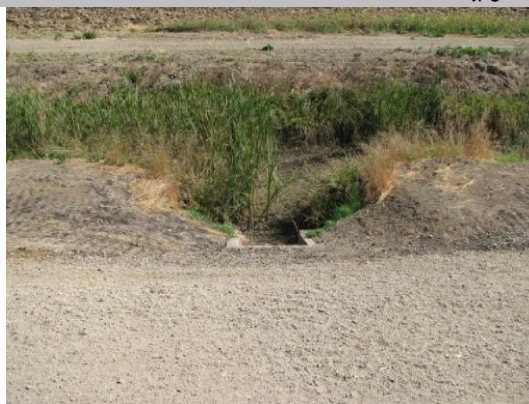
Photo 2 of 3 : UCIP_SP_2017_51791_69013.jpg

Concrete U shaped headwall on LS toe.

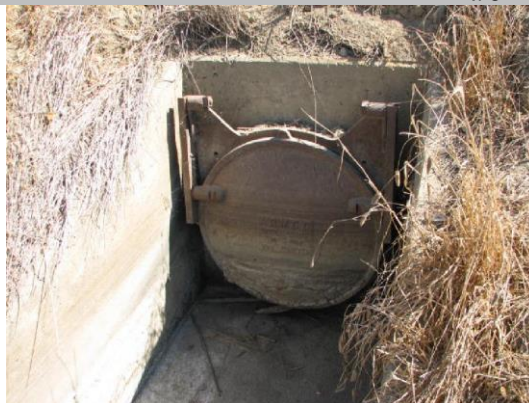
Photo 3 of 3 : UCIP_SP_2017_51791_69012.jpg

Concrete U shaped headwall and flap gate on WS toe.

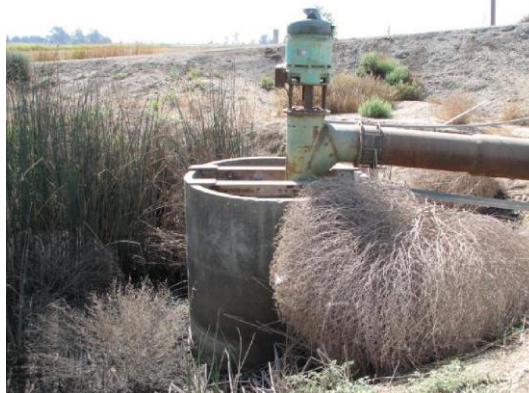
Photo 1 of 3 : UCIP_SP_2017_51792_69017.jpg

Pump on Concrete riser at LS toe.

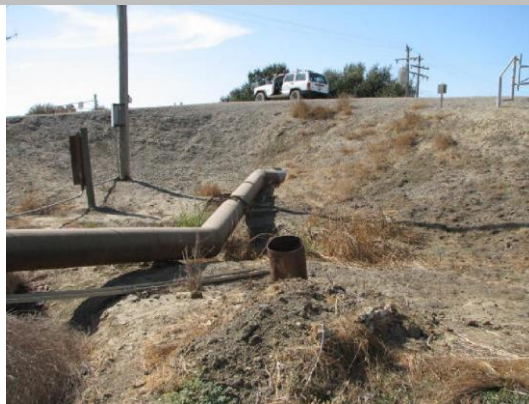
Photo 2 of 3 : UCIP_SP_2017_51792_69016.jpg

Pipe through levee at LS slope.

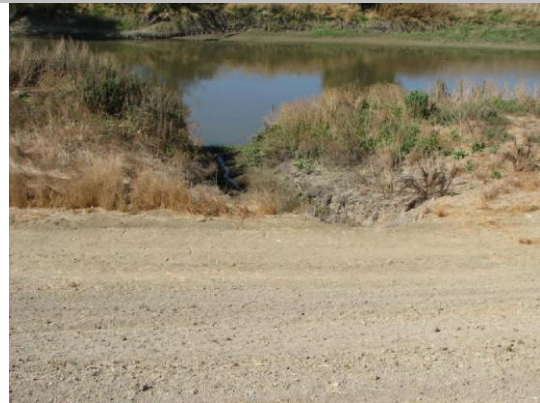
Photo 1 of 3 : UCIP_SP_2017_51795_69026.jpg

Outlet channel on WS toe.

UCIP Comments: 5/2/2017 Crossing appears to be in good condition.

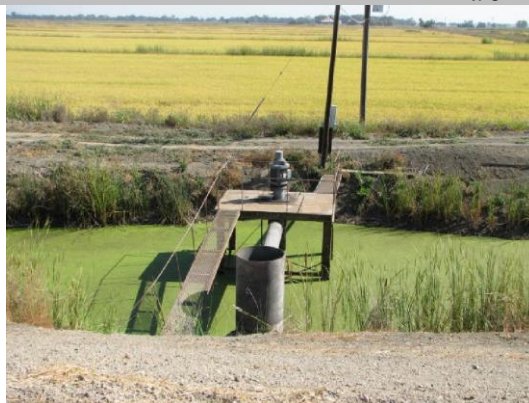
Photo 2 of 3 : UCIP_SP_2017_51795_69025.jpg

Pump, walkway, and standpipe on LS toe.

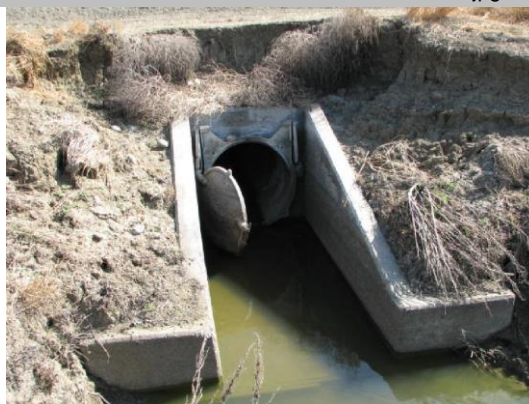
Photo 3 of 3 : UCIP_SP_2017_51795_69024.jpg

Flap gate in concrete U-shaped headwall on WS toe.

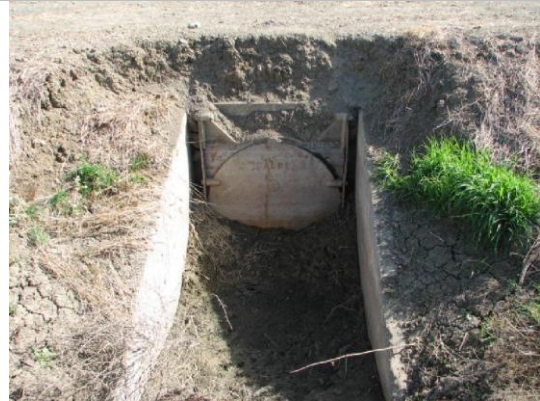
Photo 3 of 3 : UCIP_SP_2017_51796_69028.jpg

Comment Code						
Inspector Comment						
FS_ID:51796 DS_ID:17191 EP_NO: N/A Repair Type: Non-Urgent Crossing Status: Found UCIP Comments: 5/2/2017 WS headwall and flapgate almost completely buried with only a small portion of the head wall visible. LS end is buried and unable to be located. (DWR Sutter Yard-AFreitag)10/17/2016 WS flap gate is still silted over and LS inlet is heavily vegetated and unable to be inspected. (DWR Sutter Yard-AFreitag)9/29/2016 Crosssing has been downgraded from Urgent to Non-Urgent WS flap gate is closed shut due to sediment build up. For flood season flap gate is required to be closed. Need to coordinate with owner to remove sediment from WS to have WS flap gate be operable after flood season. (DWR UCIP - omagana)5/31/2016 WS pipe end was mostly underwater but it appears to still be silted over. (DWR Sutter Yard - afreitag)5/4/2015 WS flapgate is blocked by sediment and unable to open. LS inlet is hidden by sediment and heavy vegetation and unable to be located. Needs to be cleared. (DWR Sutter Yard - afreitag)6/17/2014 Same as last inspection. (DWR Sutter Yard - afreitag)12/16/2013 Same as last inspection. (DWR Sutter Yard - afreitag)7/16/2013 Same as last inspection. (DWR Sutter Yard - afreitag)10/11/2012 Pipe is clogged at both the inlet and outlet. Good candidate for video inspection. (DWR UCIP - wwylie) FIELD_STRUCT_DESC: 48-inch corrugated metal drainage pipe through the levee, approximately 15 feet below the crown. Concrete headwalls on both the waterside (WS) and (LS) ends with an automatic drainage gate on the WS. [Additional Reference(s): USACE Sacramento O&M Manual 132, October 1959 (HLM 5.12)] FS Date: 5/2/2017 2:31:39 PM

Concrete U shaped headwall and flap gate on WS toe.

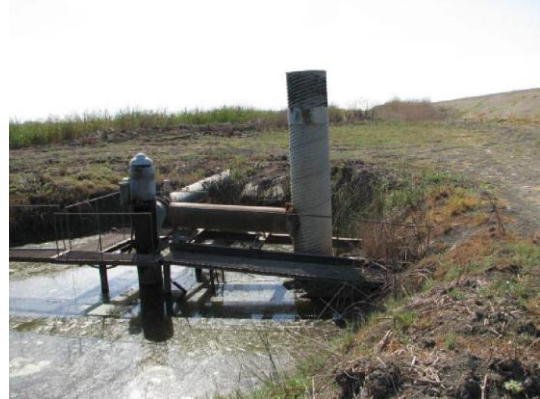
Photo 1 of 3 : UCIP_SP_2017_51797_69034.jpg

36-inch CM standpipe with steel pipe extension for weir on LS toe. pump not associated with storm drain crossing.

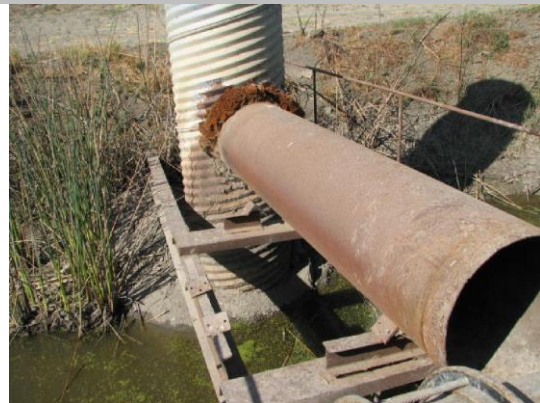
Photo 2 of 3 : UCIP_SP_2017_51797_69033.jpg

36-inch CM standpipe with steel pipe extension for weir on LS toe.

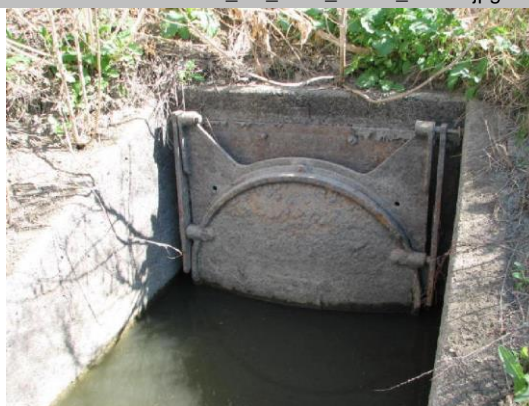
Photo 3 of 3 : UCIP_SP_2017_51797_69032.jpg

Flap gate in concrete U-shaped headwall at WS toe.

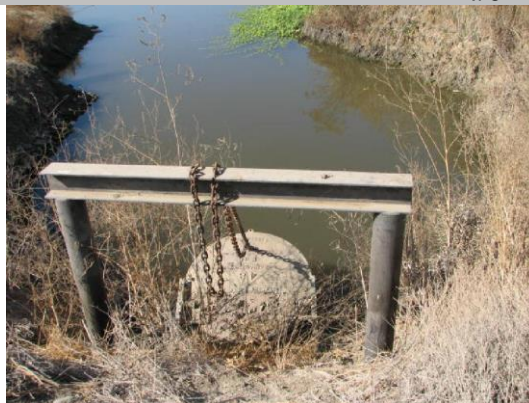
Photo 1 of 3 : UCIP_SP_2017_51798_69042.jpg

48-inch flap gate on WS toe.

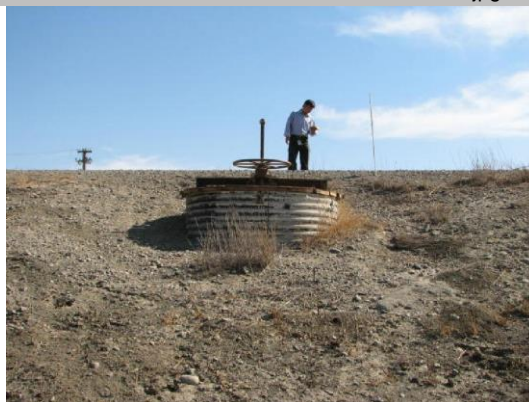
Photo 2 of 3 : UCIP_SP_2017_51798_69041.jpg

60-inch CMP riser with slide gate on WS slope.

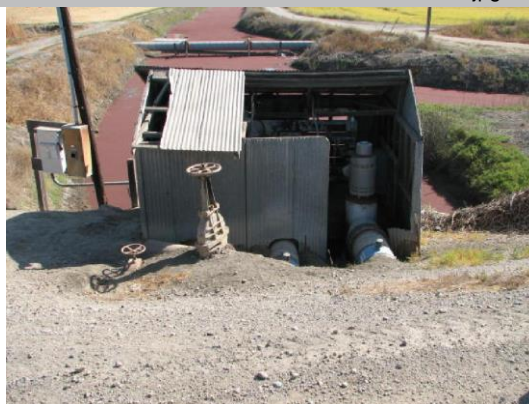
Photo 2 of 3 : UCIP_SP_2017_51799_69067.jpg

Pumphouse on LS slope.

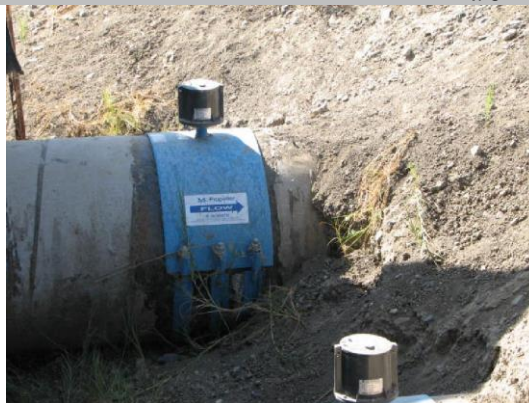
Photo 3 of 3 : UCIP_SP_2017_51799_69066.jpg

24-inch pipe on LS slope.

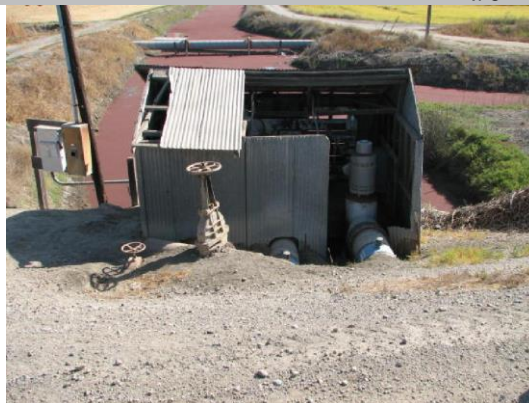
Photo 1 of 3 : UCIP_SP_2017_51802_69076.jpg

Pump house on LS slope

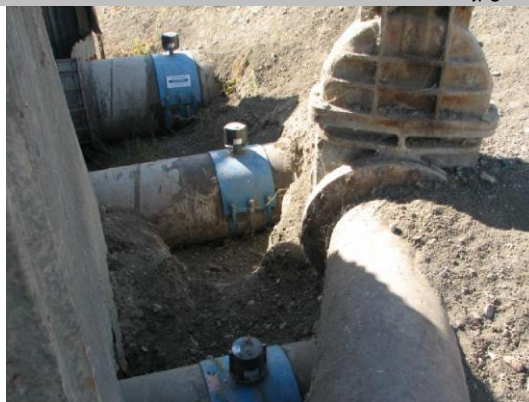
Photo 2 of 3 : UCIP_SP_2017_51802_69075.jpg

20-inch pipe at center of photo.

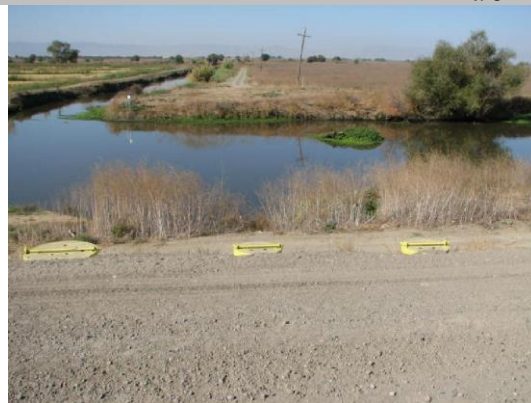
Photo 1 of 3 : UCIP_SP_2017_51801_69064.jpg

Siphon Breaker on WS shoulder.

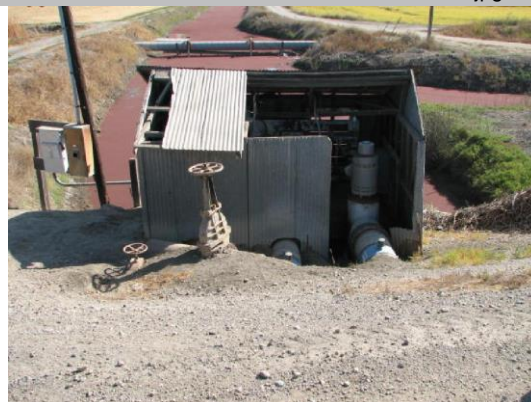
Photo 2 of 3 : UCIP_SP_2017_51801_69063.jpg

Comment Code					
Inspector Comment					
FS_ID:51801 DS_ID:20716 EP_NO: 13699 Repair Type: Non-Urgent Crossing Status: Found UCIP Comments: 5/2/2017 Pipe appears to be in good conition. Minor erosion above the LS pump house. (DWR Sutter Yard- A/Freitag)10/17/2016 Crossing appears to be in good condition. (DWR Sutter Yard- A/Freitag)5/31/2016 Crossing appears to be in good condition.5/4/2015 Corssing appears to be in good condition. No noticeable issues to report.6/17/2014 Same as last inspection.12/16/2013 Same as last inspection.7/16/2013 Same as last inspection.10/11/2012 Oil leaks at pump head. FIELD_STRUCT_DESC: 2 of 2: 20-inch soilproofed steel drainage pipe through the levee, 4.4 feet below the crown. Cobble revetted sump located on the waterside (WS). Siphon breaker in 24-inch metal pipe risers on the WS shoulder. Pump house at toe of landside (LS) slope. This crossing replaces the previous 18-inch pipe listed in the USACE Sacramento O&M manual (HLM 6.13), see DS_ID 17198. (Permit No. 13699, 1984 - Davis Ranches) FS Date: 5/2/2017 2:36:30 PM

Pumphouse on LS slope.

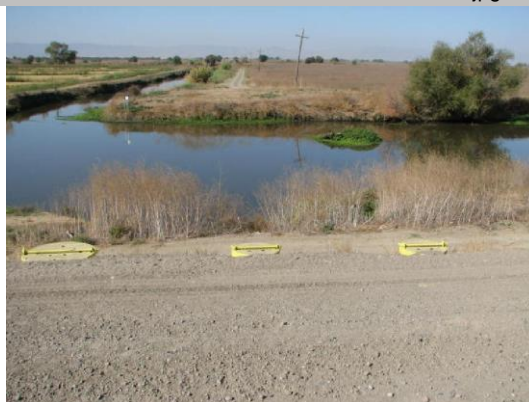
Photo 2 of 3 : UCIP_SP_2017_51803_69080.jpg

Siphon breaker on WS shoulder.

Comment Code						
Inspector Comment						
FS_ID:51803 DS_ID:17199 EP_NO: 9390 Repair Type: Non-Urgent Crossing Status: Found UCIP Comments: 5/2/2017 Pipe appears to be in good condition. Minor erosion above the LS pump house. (DWR Sutter Yard-AFreitag)10/17/2016 Crossing appears to be in good condition. (DWR Sutter Yard- AFreitag)5/31/2016 Crossing appears to be in good condition.5/4/2015 Corssing appears to be in good condition. No noticeable issues to report.6/17/2014 Same as last inspection.12/16/2013 Same as last inspection.7/16/2013 Same as last inspection.10/11/2012 Minor oil leak on pump. FIELD_STRUCT_DESC: 3 of 3: 18-inch steel drainage pipe through the levee, 4.4 feet below the crown. Cobble revetted sump located on the waterside (WS). Siphon breaker in 16-inch metal pipe risers on the WS shoulder. Pump house at toe of landside (LS) slope. (Automatic Board Order (ABO) issued as Permit No. 9390, 1974 - Profpe) [Additional Reference(s): DWR Levee Log, 2005. USACE Sacramento O&M Manual 132, October 1959 (HLM 6.13)] FS Date: 5/2/2017 2:37:23 PM

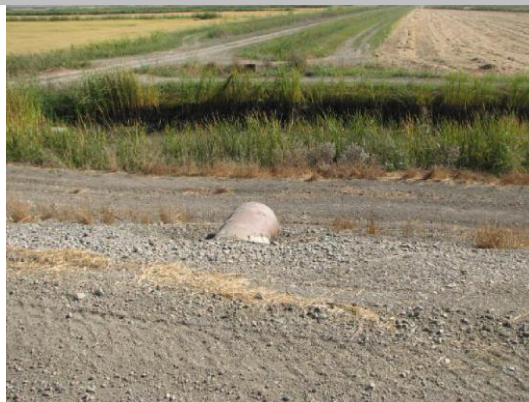
Photo 2 of 3 : UCIP_SP_2017_51804_69088.jpg

FS_ID:51804
DS_ID:17163
EP_NO: 9390
Repair Type: Non-Urgent
Crossing Status: Found
UCIP Comments: 5/2/2017 Appears abandoned- pipe capped on both ends. Should be removed. (DWR Sutter Yard- A Freitag)10/17/2016 Appears abandoned and should be removed. (DWR Sutter Yard- A Freitag)5/31/2016 Appears to be abandoned. Pipe is capped on both WS and LS ends.5/4/2015 Corssing appears to be in good condition. No noticeable issues to report.6/17/2014 Same as last inspection.12/16/2013 Same as last inspection.7/16/2013 Same as last inspection.10/11/2012 Rodent burrowing along sides of pipe on LS.
FIELD_STRUCT_DESC: 24-inch steel irrigation pipe through the levee, 3 feet below the crown. Both ends capped, terminating on levee slopes. (Automatic Board Order (ABO) issued as Permit No. 9390, 1974 - Profpe) [Additional Reference(s): DWR Levee Log, 2005. USACE Sacramento O&M Manual 132, October 1959 (HLM 7.76)]
FS Date: 5/2/2017 2:45:44 PM

Pipe on LS.

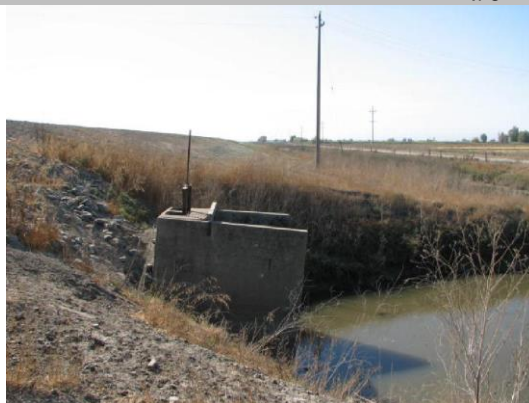
Photo 1 of 3 : UCIP_SP_2017_51806_69100.jpg

FS_ID:51806
DS_ID:17166
EP_NO: 9390
Repair Type: Urgent
Crossing Status: Found
UCIP Comments: 5/2/2017 Ws headwal still appears to be tilting away from the levee. No wheel to operate the WS slidegate. (DWR Sutter Yard- AFreitag)10/17/2016 WS concrete headwall is still tiltig away from the levee. (DWR Sutter Yard- AFreitag)5/31/216 Ws concrete headwall is still tilting away from the levee and towards the WS ditch. (DWR Sutter Yard - afreitag)5/4/2015 WS concrete headwall tilting away from the levee slope. (DWR Sutter Yard - afreitag)6/17/2014 Same as last inspection. (DWR Sutter Yard - afreitag)12/16/2013 Same as last inspection. (DWR Sutter Yard - afreitag)7/16/2013 Same as last inspection. (DWR Sutter Yard - afreitag)10/11/2012 Concrete Headwall tilting on WS slope. (DWR UCIP - wwylie)
FIELD_STRUCT_DESC: 36-inch corrugated metal drainage pipe through the levee, 15 feet below the crown. Concrete head wall, slide gate and grouted revetment on the waterside (WS). Slide gate and concrete headwall located on the landside (LS). (Automatic Board Order (ABO) issued as Permit No. 9390, 1974 - Profpe). [Additional Reference(s): DWR Levee Log, 2005. USACE Sacramento O&M Manual 132, October 1959 (HLM 9.24)]

Tilting headwall on WS toe.

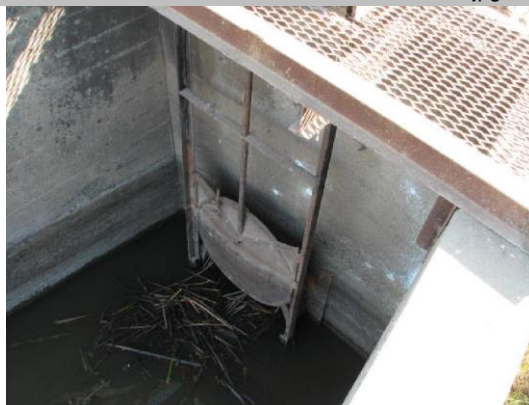
Photo 2 of 3 : UCIP_SP_2017_51806_69099.jpg

Slidegate on WS toe.

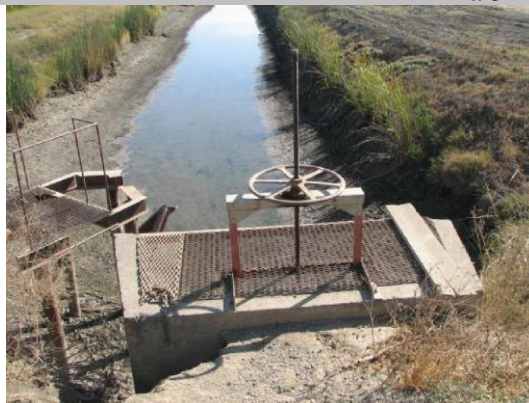
Photo 3 of 3 : UCIP_SP_2017_51806_69102.jpg

Comment Code						
Inspector Comment						
FS_ID:51806 DS_ID:17166 EP_NO: 9390 Repair Type: Urgent Crossing Status: Found UCIP Comments: 5/2/2017 Ws headwal still appears to be tilting away from the levee. No wheel to operate the WS slidegate. (DWR Sutter Yard- AFreitag)10/17/2016 WS concrete headwall is still tiltig away from the levee. (DWR Sutter Yard- AFreitag)5/31/216 Ws concrete headwall is still tilting away from the levee and towards the WS ditch. (DWR Sutter Yard - afreitag)5/4/2015 WS concrete headwall tilting away from the levee slope. (DWR Sutter Yard - afreitag)6/17/2014 Same as last inspection. (DWR Sutter Yard - afreitag)12/16/2013 Same as last inspection. (DWR Sutter Yard - afreitag)7/16/2013 Same as last inspection. (DWR Sutter Yard - afreitag)10/11/2012 Concrete Headwall tilting on WS slope. (DWR UCIP - wwylie) FIELD_STRUCT_DESC: 36-inch corrugated metal drainage pipe through the levee, 15 feet below the crown. Concrete head wall, slide gate and grouted revetment on the waterside (WS). Slide gate and concrete headwall located on the landside (LS). (Automatic Board Order (ABO) issued as Permit No. 9390, 1974 - Profpe). [Additional Reference(s): DWR Levee Log, 2005. USACE Sacramento O&M Manual 132, October 1959 (HLM 9.24)] FS Date: 5/2/2017 2:46:54 PM

slide gate and headwall on LS toe.

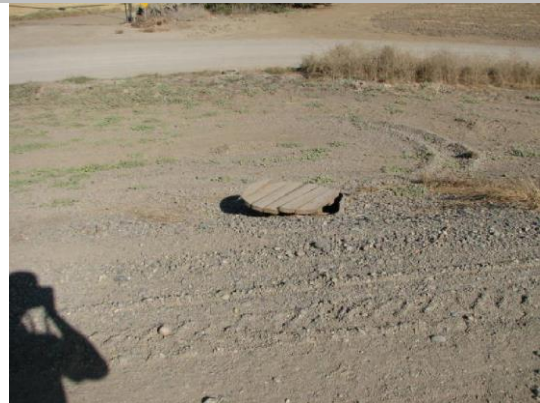
Photo 1 of 2 : UCIP_SP_2017_51810_69115.jpg

Comment Code					
Inspector Comment					
FS_ID:51810 DS_ID:17157 EP_NO: 9386 Repair Type: Non-Urgent Crossing Status: Found UCIP Comments: 5/2/2017 Abandoned- needs to be done properly. (DWR Sutter Yard- A Freitag)10/17/2016 Abandoned crossing. (DWR Sutter Yard- A Freitag)5/31/2016 Abandoned crossing. Both pipe ends and slide gate inside of riser are buried.5/4/2015 Both pipe ends and slide gate in riser are plugged with soil. Crossing is inoperable.6/17/2014 Same as last inspection.12/16/2013 Same as last inspection.7/16/2013 Same as last inspection.10/11/2012 Pipe plugged with soil on both ends as well as at slide gate on WS slope. Slide gate inoperable. FIELD_STRUCT_DESC: *ABANDONED* 24-inch corrugated metal drainage pipe through the levee, 8 feet below the crown. Slide gate in 36-inch pipe riser on the waterside (WS) shoulder. Levee turns eastward. (Automatic Board Order (ABO) issued as Permit No. 9386, 1974 - Wescott) [Additional Reference(s): DWR Levee Log, 2005. USACE Sacramento O&M Manual 132, October 1959 (HLM 11.17)] FS Date: 5/2/2017 2:51:53 PM

cover on 36-inch CMP standpipe on WS slope.
