**Flood Control Project Maintenance
Levee Inspections**
LMA District Cover Sheet
Spring 2020 Levee Inspection Results

Sutter Maintenance Yard Maintenance Area 0012

Spring 2020 Levee Inspection Results

Waterway			Bank	Unit Miles
Unit No. 01 Colusa Drain			Left	11.06
	Spring (March - May)	Summer (June - August)	(September - November) Fall	Winter (December - February)
Unit Maintenance Rating (Fall Only)				
Date of Inspection	4/1/2020 - 4/1/2020			
DWR Inspector	Zach Jojola			
Accompanied By

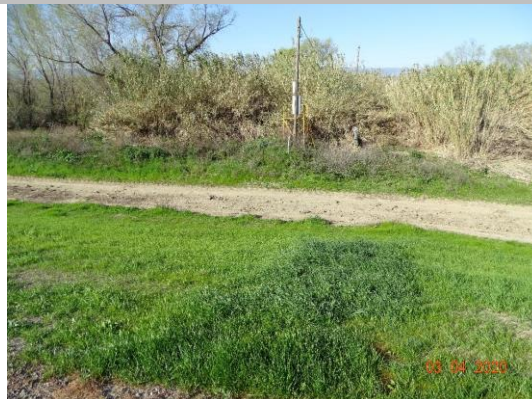
Photo 2 of 3 : UCIP_SP_2020_56167_83467.jpg

View of WS looking from crown

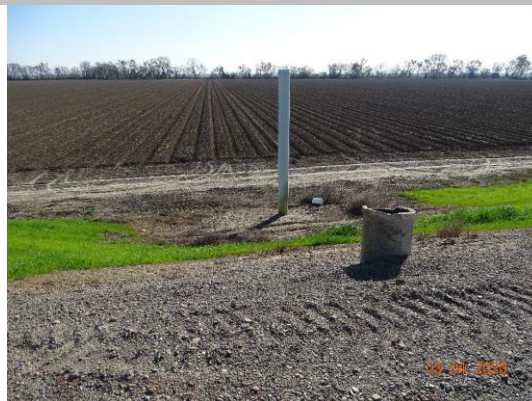
Photo 3 of 3 : UCIP_SP_2020_56167_83468.jpg

View of LS looking from crown

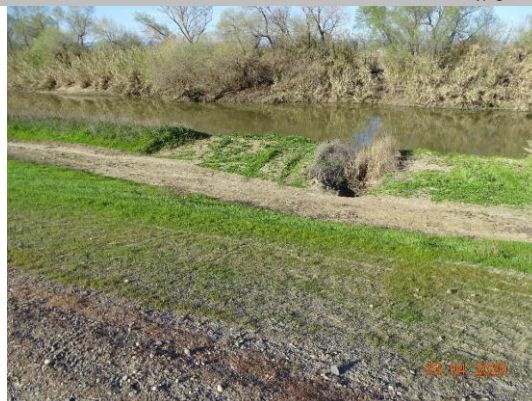
Photo 2 of 3 : UCIP_SP_2020_56168_83474.jpg

View of WS looking from levee crown

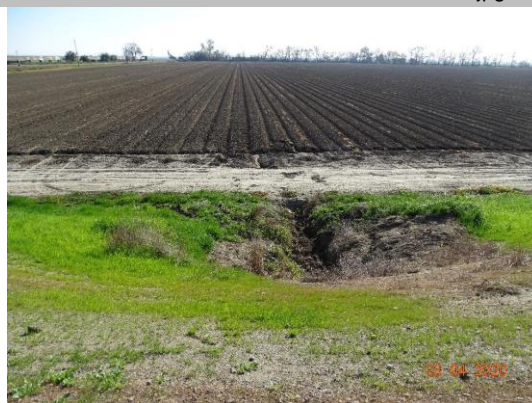
Photo 3 of 3 : UCIP_SP_2020_56168_83475.jpg

View of LS looking from levee crown

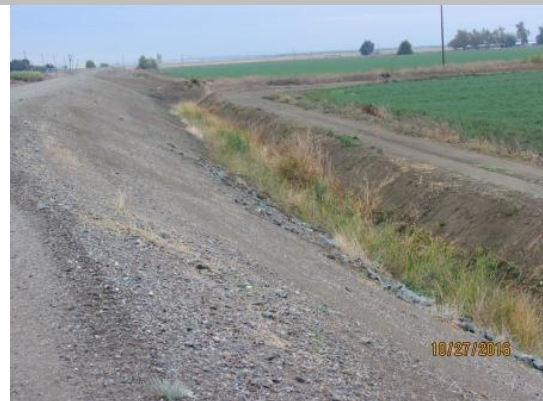
Photo 1 of 1 : SP_2020_MA0012_299_1_20200228_00001.jpg

LM Start	2.59	Rating **	U	Issue No.	1
LM End	3.68	Issue Type +	En	Location *	LS
Category	Earthen Levee			GPS Latitude/Longitude	
				Start	End
Item	Encroachments			39.067419 °	39.081684 °
				-122.009699 °	-122.016243 °
DWR ID	DWR_MA0012_01_s_2019_1				
Comment Code					
DT : Ditch					
Inspector Comment

View of a ditch along the landside toe. Fall 2016.

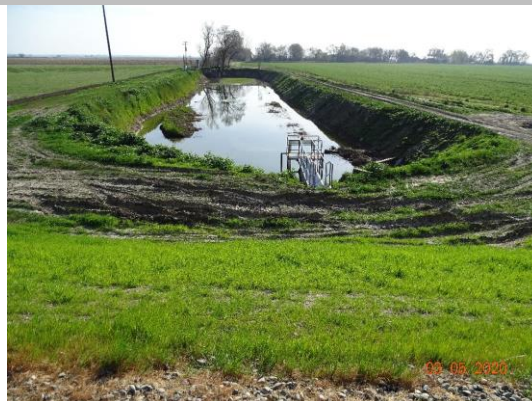
Photo 2 of 3 : UCIP_SP_2020_56176_83527.jpg

View of LS looking from levee crown

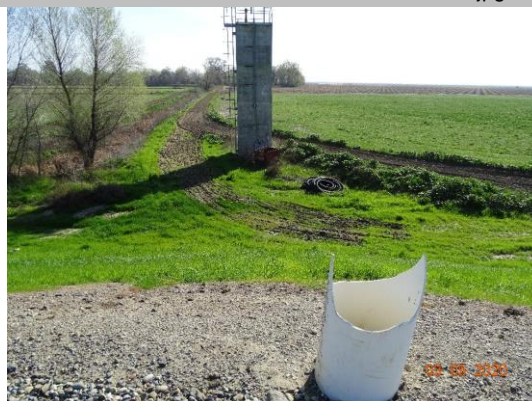
Photo 2 of 3 : UCIP_SP_2020_56159_83434.jpg

DS_ID:17186
FS_ID:56159
EP_NO: 16874
Repair Type: Urgent
Crossing Status: Found
UCIP Comments: 03/05/2020 Record updated from No Action Needed to Urgent. Pipe exposed due to unauthorized excavation on WS berm 25 feet from WS toe. Excavation measures 12' x 15' x 4.5' deep. Broken PVC riser on LS shoulder and leaking siphon breaker inside of PVC riser. (O.Yakimov - DWR UCIP) 5/2/2017 Crossing appears to be in good condition. (DWR Sutter Yard- A.Freitag)
10/17/2016 Crossing appears to be in good condition. (DWR Sutter Yard- A.Freitag)
05/31/2016 Crossing appears to be in good condition.
05/04/2015 Crossing appears to be in good condition. No noticeable issues to report.
06/17/2014 Same as last inspection.
12/16/2013 Same as last inspection.
07/16/2013 Same as last inspection.
FIELD_STRUCT_DESC: 36-inch asphalt coated steel irrigation pipe through the levee, 2.0 feet below the crown. Pump facility located on the waterside (WS). Siphon breaker in an 18-inch polyvinyl chloride (PVC) riser located on the landside (LS) shoulder. 40-foot tall, 8-foot by 8-foot concrete tower, 50 feet from the LS toe. (36-inch pipeline authorized under Permit No. 16874, 1998 - Wallace Brothers).

View of LS looking from levee crown

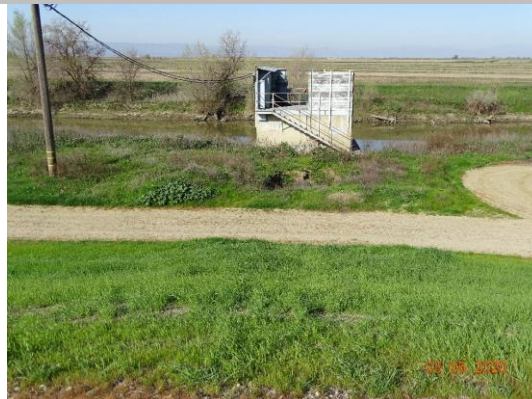
Photo 3 of 3 : UCIP_SP_2020_56159_83436.jpg

View of WS looking from levee crown

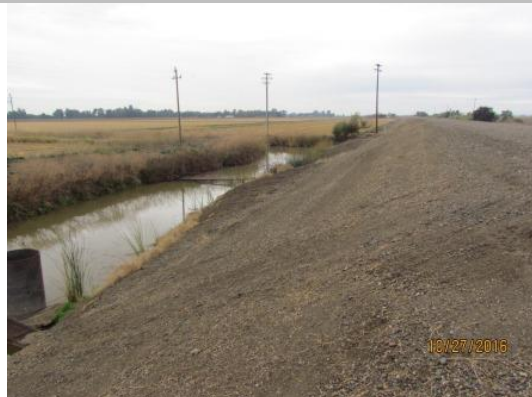
Photo 1 of 1 : SP_2020_MA0012_299_4_20200228_00002.jpg

LM Start	4.72	Rating **	M	Issue No.	4
LM End	4.77	Issue Type +	En	Location *	LS
Category	Earthen Levee			GPS Latitude/Longitude	
				Start	End
Item	Encroachments			39.096839 °	39.097455 °
				-122.015568 °	-122.015581 °
DWR ID	DWR_MA0012_01_s_2012_4				
Comment Code					
DT : Ditch					
Inspector Comment

View of a ditch along the landside toe.

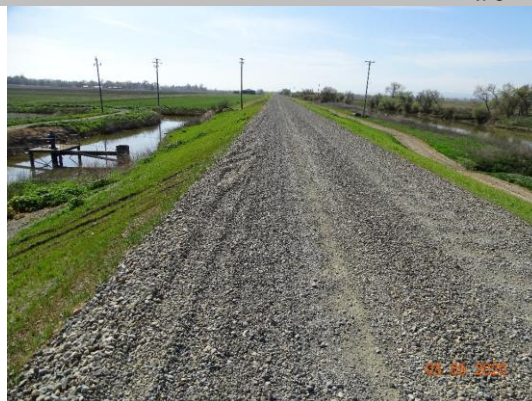
Photo 1 of 3 : UCIP_SP_2020_56180_83547.jpg

Comment Code						
Inspector Comment						
DS_ID:17158 FS_ID:56180 EP_NO: 9390 Repair Type: Non-Urgent Crossing Status: Found UCIP Comments: 03/05/2020 Record updated from No Action Needed to Non-Urgent. Pump in drainage ditch and standpipe are not designed per O&M As-Built drawing. Unable to locate a permit for modifications. Need to have CVFPB review ABO and determine current owner. (O.Yakimov - DWR UCIP) 05/02/2017 Crossing appears to be in good condition. There is minor sediment build up in front of the WS flap gate/ (DWR Sutter Yard-A.Freitag) 10/17/2016 Crossing appears to be in good condition. (DWR Sutter Yard- A.Freitag) 05/31/2016 Crossing appears to be in good condition. 05/04/2015 Crossing appears to be in good condition. No noticeable issues to report. 06/17/2014 Same as last inspection. 12/16/2013 Same as last inspection. 07/16/2013 New flapgate installed on WS pipe end. 10/11/2012 Flap gate broken on WS, Pipe shows significant rust at outlet. This is a good candidate for video inspection. (DWR UCIP – W.Wylie) FIELD_STRUCT_DESC: 36-inch corrugated metal drainage pipe though the levee, 20 feet below the crown. Pump on metal pier in landside (LS) channel. 40-inch steel standpipe at the LS toe. Flap gate and concrete headwall on the waterside (WS). Concrete headwall on the LS. (36-inch pipe [HLM 4.87] authorized under Automatic Board Order (ABO) issued as Permit No. 9390, 1974 - Annie D. Propfe). (24-inch pipe [HLM 4.87] authorized under Automatic Board Order (ABO) issued as Permit No. 8233, 1972 - Olive P. Davis Estate). [Additional Reference(s): DWR Levee Log, 2005 (HLM 4.87). USACE Sacramento O&M Manual, Unit 132, October 1959, Revised 14 January 2019, (HLM 4.87), listed as 36-inch pipe. USACE As-Built Drawing No. 50-4-3081, Sheet 6 and 16, Station 1581+10, 4 April 1957]. FS Date: 3/5/2020 7:55:59 AM

View of levee crown at the crossing looking downstream

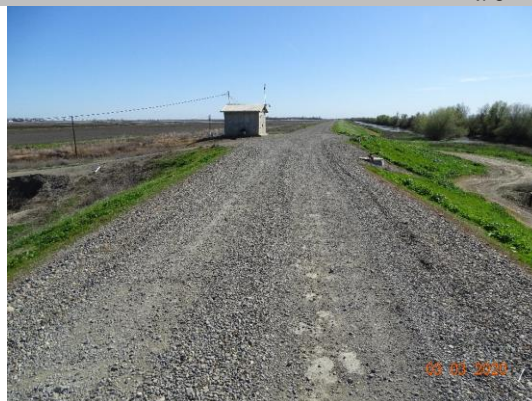
Photo 1 of 3 : UCIP_SP_2020_56183_83569.jpg

Comment Code						
Inspector Comment						
DS_ID:17161 FS_ID:56183 EP_NO: 9390 Repair Type: Non-Urgent Crossing Status: Found UCIP Comments: 03/03/2020 Record updated from No Action Needed to Non-Urgent. Need to have CVFPB review ABO and determine current owner. (O.Yakimov - DWR UCIP) 05/02/2017 Crossing appears to be in good condition. (DWR Sutter Yard- A.Freitag) 10/17/2016 Crossing appears to be in good condition. (DWR Sutter Yard- A.Freitag) 05/31/2016 Crossing appears to be in good condition. 05/04/2015 Crossing appears to be in good condition. No noticeable issues to report. 06/17/2014 Same as last inspection. 12/16/2013 Same as last inspection. 07/16/2013 Same as last inspection. FIELD_STRUCT_DESC: 48-inch corrugated metal drainage pipe through the levee, 20.3 feet below the crown. Concrete headwall and cobble revetted spillway on the waterside (WS). Slide gate in a 60-inch corrugated metal pipe (CMP) riser on the WS slope. Concrete headwall located on the landside (LS). (48-inch pipe [HLM 6.10] authorized under Automatic Board Order (ABO) issued as Permit No. 9390, 1974 - Annie D. Propfe). (58-inch pipe [HLM 6.1] authorized under Automatic Board Order (ABO) issued as Permit No. 8234, 1972 - Glenn Irrigation District). [Additional Reference(s): DWR Levee Log, 2005(HLM 6.10). USACE Sacramento O&M Manual, Unit 132, October 1959, Revised 14 January 2019, (HLM 6.10), listed as 48-inch pipe. USACE As-Built Drawing No. 50-4-3081, Sheet 7 and 16, Station 1648+88.2, 4 April 1957]. FS Date: 3/3/2020 1:07:35 PM

View of levee crown at the crossing looking downstream

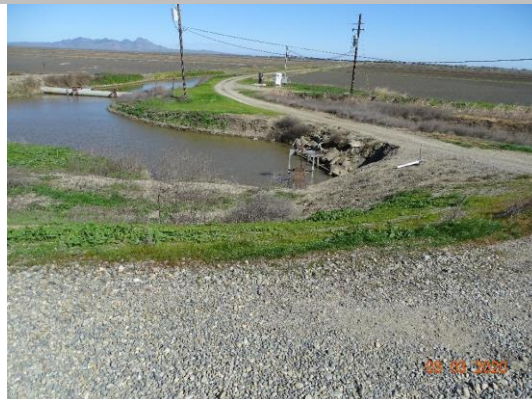
Photo 2 of 3 : UCIP_SP_2020_56183_83570.jpg

View of LS looking from levee crown

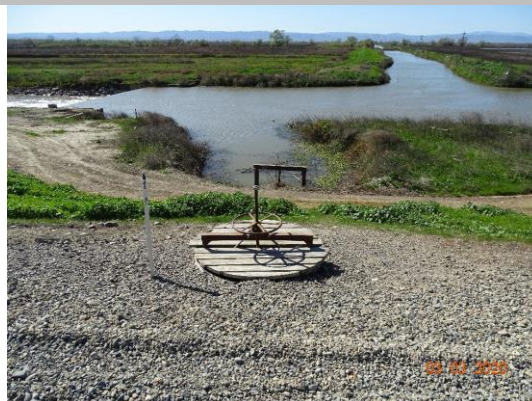
Photo 3 of 3 : UCIP_SP_2020_56183_83571.jpg

View of WS looking from levee crown

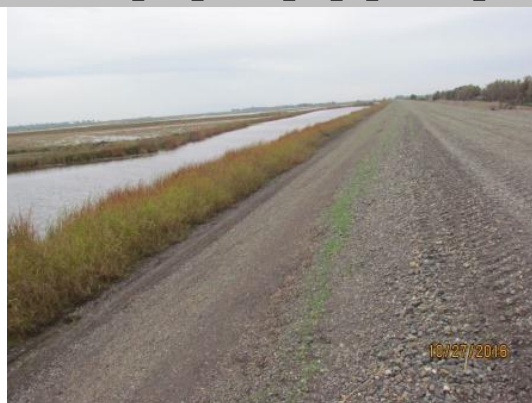
Photo 1 of 1 : SP_2020_MA0012_299_37_20200228_00007.jpg

LM Start	6.02	Rating **	U	Issue No.	37
LM End	7.20	Issue Type +	En	Location *	LS
Category	Earthen Levee			GPS Latitude/Longitude	
				Start	End
Item	Encroachments			39.115518 °	39.131618 °
				-122.017908 °	-122.022785 °
DWR ID	DWR_MA0012_01_f_2018_37				
Comment Code					
DT : Ditch					
Inspector Comment

View of a ditch along the landside toe.

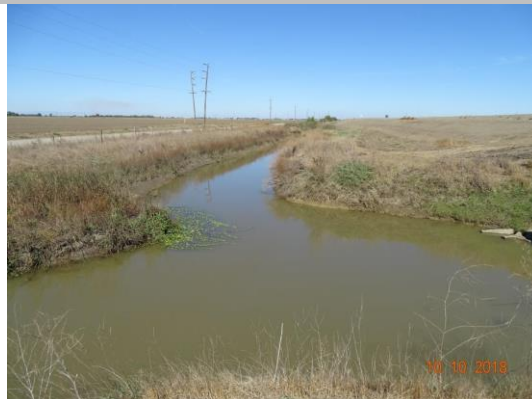
Photo 2 of 2 : SP_2020_MA0012_299_35_20200228_00006.jpg

LM Start	9.02	Rating **	A/W	Issue No.	35
LM End	9.04	Issue Type +	Ma	Location *	WS
Category	Supplemental			GPS Latitude/Longitude	
				Start	End
Item	2017 USACE Erosion Survey			39.157957 °	39.158226 °
				-122.021950 °	-122.021950 °
DWR ID	DWR_MA0012_01_f_2018_35				
Comment Code					
Inspector Comment					
2017 Site ID: SYC 9.3 L					
Status: Eroding					
2017 Field Notes: Access Issues - Could not observe					
Site History: 2011 - Erosion occurring upstream and downstream of an irrigation diversion structure.

Upstream view of Colusa Basin from the diversion structure. Fall 2018.

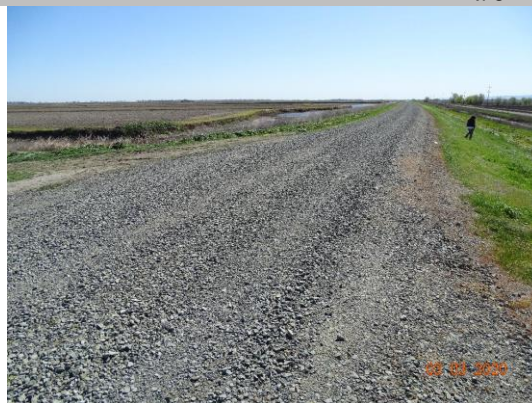
Photo 1 of 3 : UCIP_SP_2020_56188_83629.jpg

DS_ID:17164
 FS_ID:56188
 EP_NO: 9390
 Repair Type: Non-Urgent
 Crossing Status: Not Found
 UCIP Comments: 03/03/2020 Record updated from No Action Needed to Non-Urgent. Crossing not found. Unauthorized encroachment recorded in Levee Log prior to 2011. Recommend geophysical study. Suspect that this pipe is the same record as DSID 17189. (O.Yakimov - DWR UCIP)
 05/02/2017 Unable to locate. (DWR Sutter Yard- A.Freitag)
 10/17/2016 Unable to locate. (DWR Sutter Yard- A.Freitag)
 05/31/2016 Unable to locate.
 05/04/2015 Unable to locate.
 06/17/2014 Unable to locate.
 12/16/2013 Unable to locate.
 07/16/2013 Same as last inspection. Unable to locate.
 FIELD_STRUCT_DESC: 24-inch drainage pipe through the levee, 3 feet below the crown. Capped on both waterside (WS) and landside (LS) ends. (24-inch pipe [HLM 9.23] authorized under Automatic Board Order (ABO) issued as Permit No. 9390, 1974 - Annie D. Propfe).

View of levee crown at the crossing looking downstream

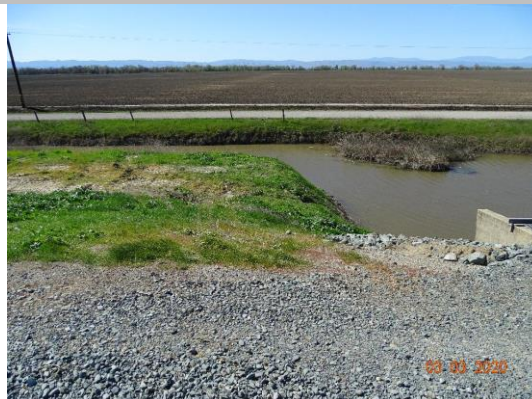
Photo 2 of 3 : UCIP_SP_2020_56188_83628.jpg

View of WS looking from levee crown

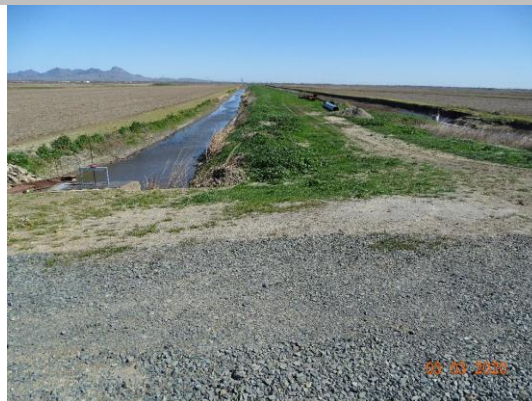
Photo 3 of 3 : UCIP_SP_2020_56188_83627.jpg

View of LS looking from levee crown

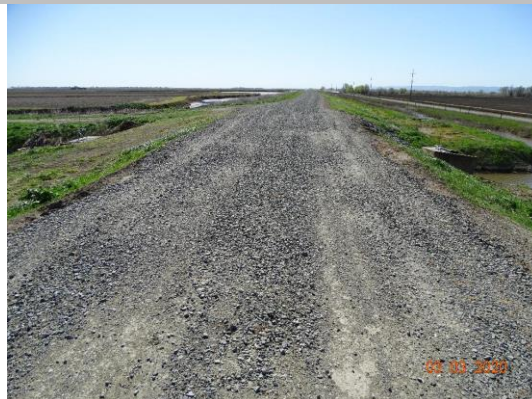
Photo 1 of 3 : UCIP_SP_2020_56190_83618.jpg

DS_ID:17165
FS_ID:56190
EP_NO: 9390
Repair Type: Non-Urgent
Crossing Status: Indicator Found
UCIP Comments: 03/03/2020 Record remains Non-Urgent. Crossing appears abandoned. Only pumping platform and steel walkway found on LS. Unable to confirm pipe removal. According to O&M as-built this pipe was running on the top of pipe DSID 17166 at the time of levee construction and was discharging into a concrete spill box on WS. Need to have CVFPB review ABO and determine current owner.
(O.Yakimov - DWR UCIP)
05/02/2017 Abandoned- only LS steel walkway is visible. (DWR Sutter Yard- A.Freitag)
10/17/2016 Abandoned. (DWR Sutter Yard- A.Freitag)
05/31/2016 Abandoned crossing.
05/04/2015 Abandoned crossing.
06/17/2014 Same as last inspection.
12/16/2013 Same as last inspection.
07/16/2013 Same as last inspection.
10/11/2012 Pipe abandoned. Steel pump platform remains on LS slope, but all appearances have been removed. (DWR UCIP - W.Wylie)

FIELD_STRUCT_DESC: 18-inch steel drainage pipe through the levee, 3 feet below the crown. Waterside (WS) end open into concrete spill box. Pump located on the landside (LS) on steel pier. (18-inch pipe [HLM 9.24] authorized under Automatic Board Order (ABO) issued as Permit No. 9390, 1974 - Annie D. Propfe). [Additional Reference(s): DWR Levee Log, 2005 (HLM 9.24). USACE Sacramento O&M Manual, Unit 132, October 1959, Revised 14 January 2019, (HLM 9.24), listed as 18-inch pipe. USACE As-Built Drawing No. 50-4-3081, Sheet 9 and 16, Station 1810+96.5, 4 April 1957].
FS Date: 3/3/2020 3:34:02 PM

View of levee crown at the crossing looking downstream

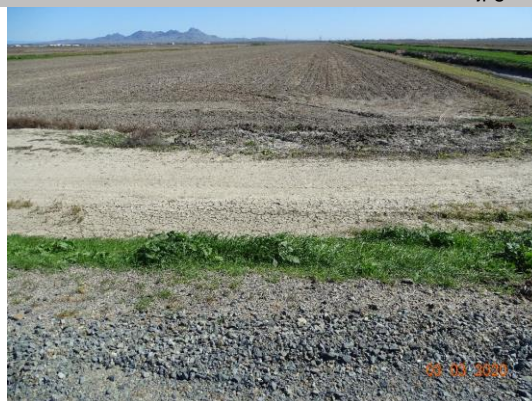
Photo 2 of 3 : UCIP_SP_2020_56191_83624.jpg

View of LS looking from levee crown

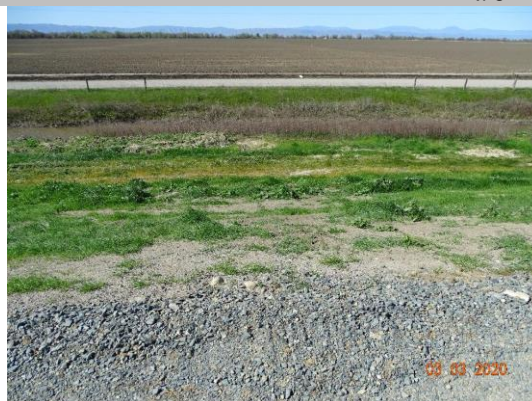
Photo 3 of 3 : UCIP_SP_2020_56191_83625.jpg

View of WS looking from levee crown

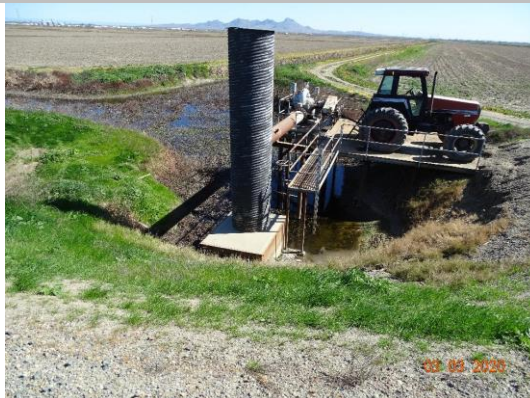
Photo 2 of 3 : UCIP_SP_2020_56192_83634.jpg

Stanspipe, pump in drainage ditch, and tractor used as a pump motor on LS

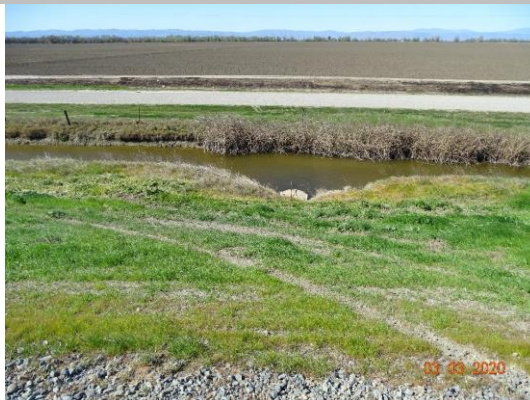
Photo 3 of 3 : UCIP_SP_2020_56192_83638.jpg

View of WS looking from levee crown

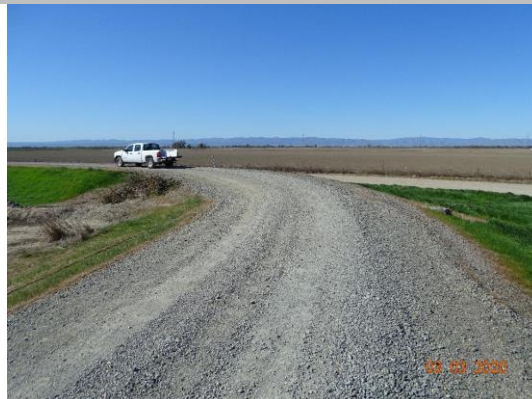
Photo 1 of 3 : UCIP_SP_2020_56155_83418.jpg

DS_ID:17157
FS_ID:56155
EP_NO: 9386
Repair Type: Non-Urgent
Crossing Status: Found
UCIP Comments: 03/03/2020 Record remains Non-Urgent. Crossing appears abandoned. Geophysical study indicates presence of pipe through levee, pipe crossing levee at angle. Pipe inlet on LS not found. Need to have CVFPB review ABO and determine current owner. (O.Yakimov - DWR UCIP)
05/02/2017 Abandoned - needs to be done properly. (DWR Sutter Yard- A.Freitag)
10/17/2016 Abandoned crossing. (DWR Sutter Yard- A.Freitag)
05/31/2016 Abandoned crossing. Both pipe ends and slide gate inside of riser are buried.
05/04/2015 Both pipe ends and slide gate in riser are plugged with soil. Crossing is inoperable.
006/17/2014 Same as last inspection.
12/16/2013 Same as last inspection.
07/16/2013 Same as last inspection.
10/11/2012 Pipe plugged with soil on both ends as well as at slide gate on WS slope. Slide gate inoperable. (W.Wylie - DWR UCIP)

FIELD_STRUCT_DESC: 24-inch corrugated metal drainage pipe through the levee, 8 feet below the crown. Slide gate in a 36-inch riser on the waterside (WS) shoulder. Levee turns eastward. (24-inch pipe [HLM 11.17] authorized under Automatic Board Order (ABO) issued as Permit No. 9386, 1974 - C. J. Wescott Jr.). [Additional Reference(s): DWR Levee Log, 2005 (HLM 11.17). USACE Sacramento O&M Manual, Unit 132, October 1959, Revised 14 January 2019, (HLM 11.17), listed as 24-inch pipe. USACE As-Built Drawing No. 50-4-3081, Sheet 10 and 16, Station 1912+40, 4 April 1957].
FS Date: 3/3/2020 11:49:40 AM

View of levee crown at crossing looking downstream

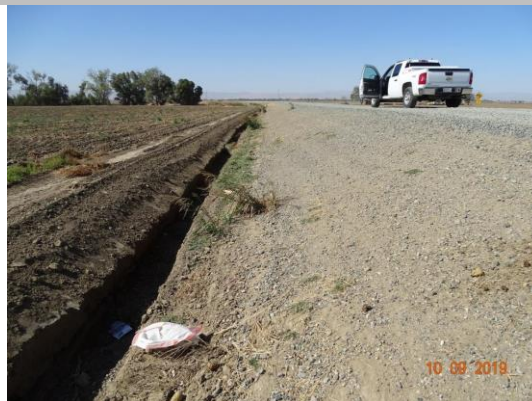
Photo 1 of 2 : SP_2020_MA0012_299_31_20200228_00003.jpg

LM Start	10.95	Rating **	U	Issue No.	31
LM End	11.05	Issue Type +	En	Location *	LS
Category	Earthen Levee			GPS Latitude/Longitude	
				Start	End
Item	Encroachments			39.180121 °	39.180198 °
				-122.013693 °	-122.011833 °
DWR ID	DWR_MA0012_01_f_2019_31				
Comment Code					
DT : Ditch					
Inspector Comment					
Landowner appears to have installed a landside toe irrigation ditch.

View of the ditch at the landside toe. Fall 2019.

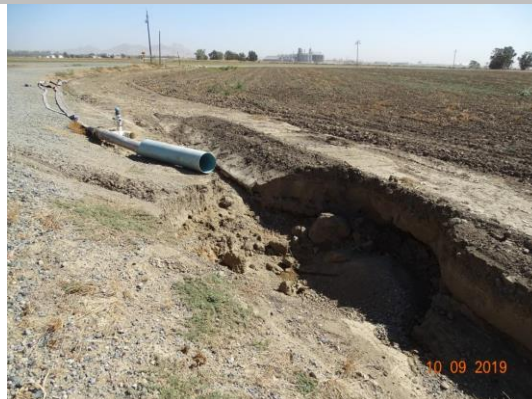
Photo 2 of 2 : SP_2020_MA0012_299_31_20200228_00004.jpg

View of the water source. Fall 2019.
