**Flood Control Project Maintenance  
Levee Inspections  
LMA District Cover Sheet**

**Sutter Maintenance Yard Maintenance Area 0012**

Waterway			Bank	Unit Miles
Unit No. 01 Colusa Drain			Left	11.06
	Spring (March - May)	Summer (June - August)	(September - November) Fall	Winter (December - February)
Unit Maintenance Rating (Fall Only)				
Date of Inspection	3/30/2022 - 3/30/2022			
DWR Inspector	Zach Jojola			
Accompanied By

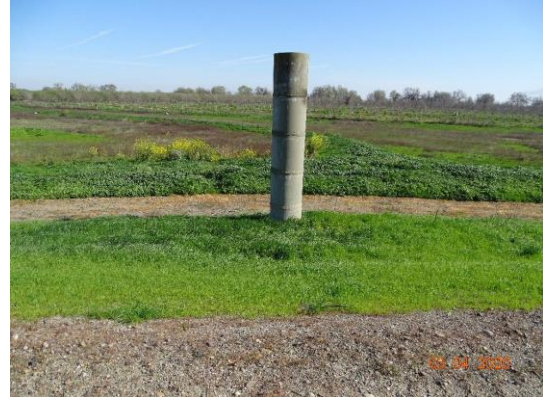
Photo 2 of 3 : UCIP\_SP\_2022\_57221\_83445.jpg

View of LS looking from levee crown

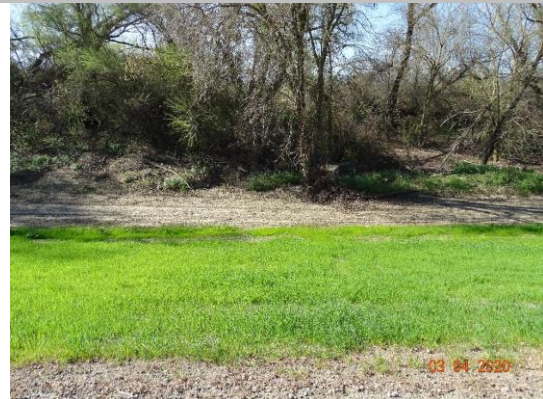
Photo 3 of 3 : UCIP\_SP\_2022\_57221\_83446.jpg

View of WS looking from levee crown

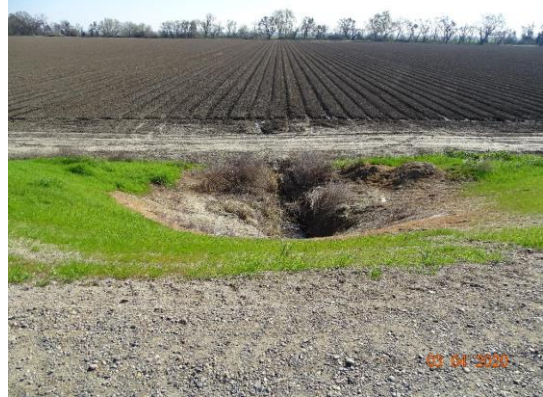
Photo 2 of 3 : UCIP\_SP\_2022\_57190\_83459.jpg

Comment Code						
Inspector Comment						
FS_ID:57190 DS_ID:17147 EP_NO: 9382 Repair Type: Non-Urgent Crossing Status: Found UCIP Comments: 03/04/2020 Record updated from No Action Needed to Non-Urgent. Pipe has been CIPP-lined under the DWR DMP Phase 2 Project. Need to have CVFPB review ABO and determine current owner. (O.Yakimov - DWR UCIP) 05/02/2017 Crossing appears to be in good condition. (A.Freitag - DWR Sutter Yard)10/17/2016 Crossing appears to be in good condition. This is a gravity for the LS. (A.Freitag - DWR Sutter Yard)05/31/2016 Crossing appears to be in good condition. (A.Freitag - DWR Sutter Yard)05/04/2015 Crossing is in good condition. No issues. (A.Freitag - DWR Sutter Yard)06/17/2014 Same as last inspection. (A.Freitag - DWR Sutter Yard)12/16/2013 Same as last inspection. (A.Freitag - DWR Sutter Yard)07/16/2013 Same as last inspection. (A.Freitag - DWR Sutter Yard) FIELD_STRUCT_DESC: 24-inch corrugated metal CIPP-lined drainage pipe through the levee, 13 feet below the crown. Flap gate, concrete headwall, and grouted cobble spillway on the waterside (WS). Concrete headwall on the landside (LS). (24-inch pipe [HLM 1.40] authorized under Automatic Board Order (ABO) issued as Permit No. 9382, 1974 - Olen C. Bober; 24-inch pipe [HLM 1.40] was also authorized under Automatic Board Order (ABO) issued as Permit No. 8228, 1972 - Olin C. Baber). [Additional Reference(s): DWR Levee Log, 2005 (HLM 1.40). USACE Sacramento O&M Manual, Unit 132, October 1959, Revised 14 January 2019, (HLM 1.40), listed as 24-inch pipe. USACE As-Built Drawing No. 50-4-3081, Sheet 4 and 15, Station 1402+63, 4 April 1957]. FS Date: 3/4/2020 9:53:00 AM

View of LS looking from levee crown

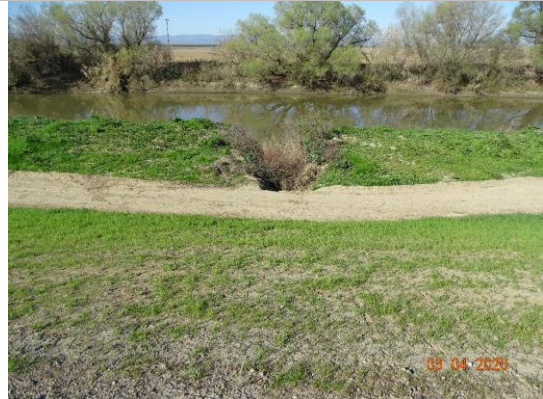
Photo 3 of 3 : UCIP\_SP\_2022\_57190\_83460.jpg

View of WS looking from levee crown

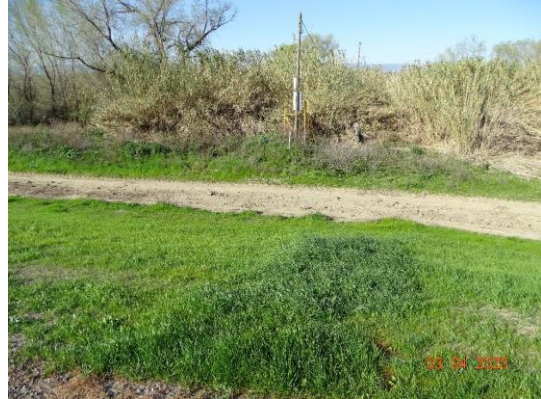
Photo 2 of 3 : UCIP\_SP\_2022\_57223\_83467.jpg

Comment Code						
Inspector Comment						
FS_ID:57223 DS_ID:17148 EP_NO: 9382 Repair Type: Non-Urgent Crossing Status: Found UCIP Comments: 03/04/2020 Record remains Non-Urgent. Need to have CVFPB review ABO and determine current owner. Taller grass observed along pipe alignment on WS slope. Pressure test or video inspection of crossing is recommended. (O.Yakimov - DWR UCIP)05/02/2017 WS is being overgrown with vegetation. The rest of the crossing appears to be in good condition. (A.Freitag - DWR Sutter Yard)10/17/2016 Vegetation is overgrowing the WS head wall near the pump. The rest of the crossing appears to be in good condition. (A.Freitag - DWR Sutter Yard)05/31/2016 Crossing appears to be in good condition. (A.Freitag - DWR Sutter Yard)05/04/2015 Crossing appears in good condition. No noticeable issues to report. (A.Freitag - DWR Sutter Yard)06/17/2014 Same as last inspection. (A.Freitag - DWR Sutter Yard)12/16/2013 Same as last inspection. (A.Freitag - DWR Sutter Yard)07/16/2013 Same as last inspection. (A.Freitag - DWR Sutter Yard) FIELD_STRUCT_DESC: 18-inch steel irrigation pipe through the levee, 3 feet below the crown. Pump, butterfly valve, and concrete headwall at the edge of the bank. Bank cobble revetted 10 feet on both the waterside (WS) and the landside (LS) of installation. 18-inch polyvinyl chloride (PVC) standpipe on the LS berm. Siphon breaker in 18-inch concrete riser on the LS shoulder. Service pole at the edge of the bank. (18-inch pipe [HLM 1.53] authorized under Automatic Board Order (ABO) issued as Permit No. 9382, 1974 - Olen C. Baber; 18-inch pipe [HLM 1.53] was also authorized under Automatic Board Order (ABO) issued as Permit No. 8228, 1972 - Olin C. Baber). [Additional Reference(s): DWR Levee Log, 2005 (HLM 1.53), listed as 18-inch pipe. USACE Sacramento O&M Manual, Unit 132, October 1959, Revised 14 January 2019, (HLM 1.53). USACE As-Built Drawing No. 50-4-3081, Sheet 4 and 15, Station 1409+25, 4 April 1957]. FS Date: 3/4/2020 10:15:00 AM

View of WS looking from crown

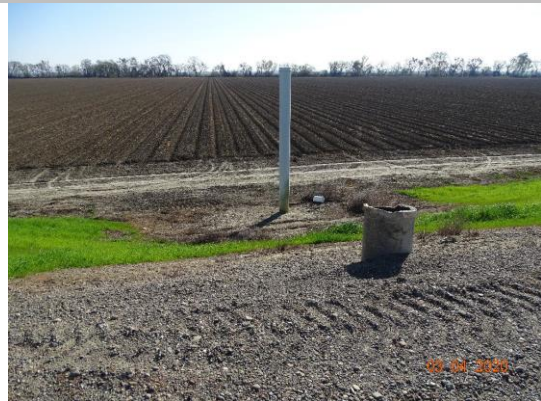
Photo 3 of 3 : UCIP\_SP\_2022\_57223\_83468.jpg

View of LS looking from crown

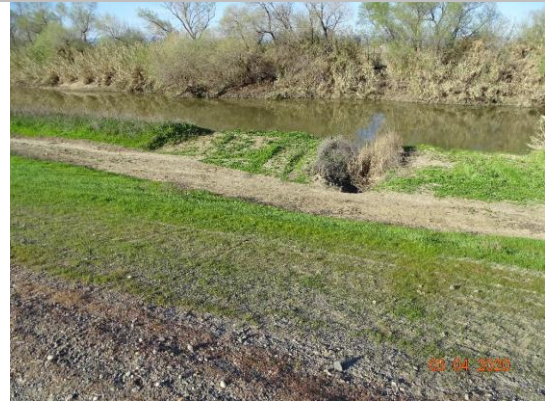
Photo 2 of 3 : UCIP\_SP\_2022\_57224\_83474.jpg

FS\_ID:57224  
DS\_ID:17149  
EP\_NO: 9382  
Repair Type: Non-Urgent  
Crossing Status: Found  
UCIP Comments: 03/04/2020 Record remains Non-Urgent. Pipe has been CIPP-lined and new flap gate installed under the DWR DMP Phase 2 Project. Vegetation around flap gate was cleared. Need to have CVFPB review ABO and determine current owner. (O.Yakimov - DWR UCIP) 05/02/2017 WS flapgate buried by sediment. Needs to be dug out. (A.Freitag - DWR Sutter Yard)10/17/2016 Crossing appears to be in good condition. This is a gravity drain for the LS. (A.Freitag - DWR Sutter Yard)05/31/2016 LS inlets was partially plugged. WS flapgate was clear of sediment and able to operate properly. (A.Freitag - DWR Sutter Yard)05/04/2015 WS flapgate is blocked by sediment and unable to open. LS inlet is plugged by silt and wood chippings. Needs to be cleaned. (A.Freitag - DWR Sutter Yard)06/17/2014 Flap gate was cleaned out and is fully closed. LS inlet still partially full of soil. (A.Freitag - DWR Sutter Yard)12/16/2013 Same as last inspection. WS flapgate still needs to be cleaned out and shut. (A.Freitag - DWR Sutter Yard)07/16/2013 Same as last inspection. Make sure flapgate is closed before highwater season. (A.Freitag - DWR Sutter Yard)10/11/2012 Inlet on LS filled partially with soil. Outlet blocked with soil and the flap gate won't close. (W.Wylie - DWR UCIP)

View of WS looking from levee crown

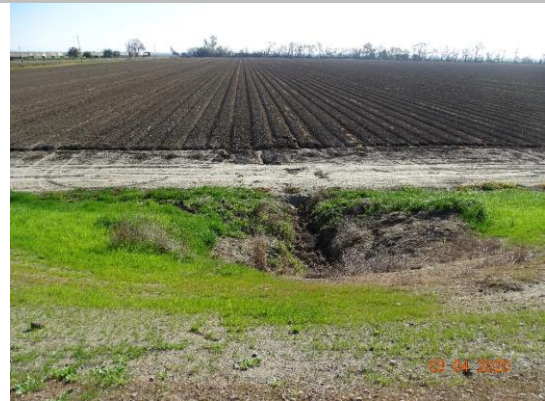
Photo 3 of 3 : UCIP\_SP\_2022\_57224\_83475.jpg

View of LS looking from levee crown

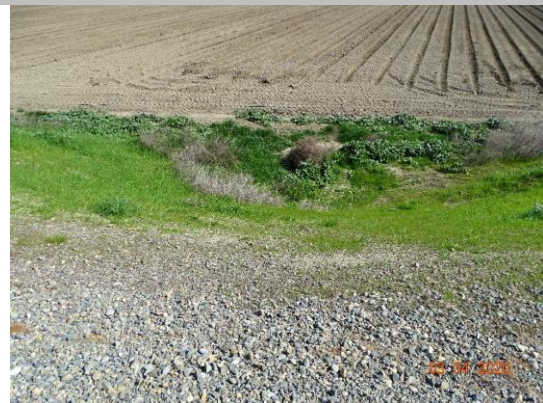
Photo 3 of 3 : UCIP\_SP\_2022\_57228\_83499.jpg

View of LS looking from levee crown

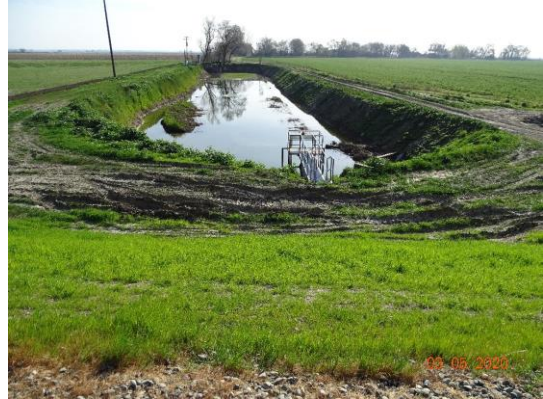
Photo 2 of 3 : UCIP\_SP\_2022\_57196\_83527.jpg

FS\_ID:57196  
DS\_ID:17154  
EP\_NO: 9388  
Repair Type: Urgent  
Crossing Status: Found  
UCIP Comments: 03/05/2020 Record remains Non-Urgent. New cover on CMP riser has been installed. Piping around slide gate at LS toe was modified, new 14-inch pipes installed. Unable to locate a permit for system modification. New steel walkway to slide gate on LS. Need to coordinate with LMA for find a permit authorizing modification. Need to have CVFPB review ABO and determine current owner. (O.Yakimov - DWR UCIP)  
10/05/2018 Fall hazard: missing cover on CMP riser. Closure devices are present on both ends of crossing and seem to be in operable condition. Downgraded to non-urgent. Recommend owner add cover to CMP riser. (O.Yakimov - DWR UCIP)  
05/02/2017 WS slide gate stem is still bent, wheel to operate gate is missing. Needs a cover made for the standpipe to prevent falls. (A.Freitag - DWR Sutter Yard)10/17/2016 Slide gate stem is still and the gate appears to be inoperable. (A.Freitag - DWR Sutter Yard)05/31/2016 Slide gate stem is still bent. WS flap gate is chained open. (A.Freitag - DWR Sutter Yard)

05/04/2015 Slide gate stem is still bent. Gate looks to be unable to close all the way. (A.Freitag - DWR Sutter Yard)06/17/2014 Same as last inspection. (A.Freitag - DWR Sutter Yard)12/16/2013 Slide gate stem is still bent. WS flapgate was closed. (A.Freitag - DWR Sutter Yard)  
07/16/2013 Water flowing through pipe so screw gate definitely not closed. Was told NOV's have been sent for owner to replace stem. Flap gate gets closed for flood season. (A.Freitag - DWR Sutter Yard)  
10/11/2012 Slide gate inoperable, but appears to be in closed position. Flap gate held in open position. Good candidate for video inspection when, if ever, dry. (W.Wylie - DWR UCIP)  
FIELD\_STRUCT\_DESC: 48-inch corrugated metal drainage pipe through the levee, 28 feet below the crown. Slide gate in a 66-inch riser on the waterside (WS) slope. Concrete headwall on the WS. Grouted cobble spillway from drainage ditch to large canal on the landside (LS). (48-inch pipe [HLM 3.78] authorized under Automatic Board Order (ABO) issued as Permit No. 9388, 1974 - Pauline A. Wallace; 48-inch pipe [HLM 3.78] was also authorized under Automatic Board Order (ABO) issued as Permit No. 8231, 1972 - Roy E. Kitts). [Additional Reference(s): DWR Levee Log, 2005 (HLM 3.78). USACE Sacramento O&M Manual, Unit 132, October 1959, Revised 14 January 2019, (HLM 3.78), listed as 48-inch pipe. USACE As-Built Drawing No. 50-4-3081, Sheet 5 and 15, Station 1524+75, 4 April 1957].

View of LS looking from levee crown

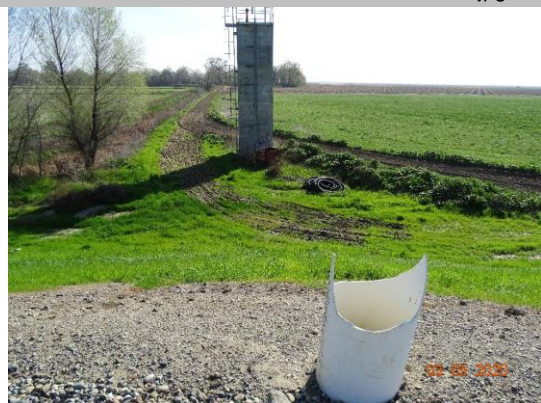
Photo 2 of 3 : UCIP\_SP\_2022\_57197\_83434.jpg

View of LS looking from levee crown

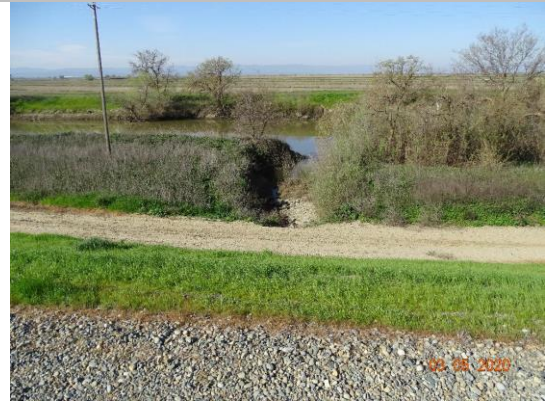
Photo 2 of 3 : UCIP\_SP\_2022\_57229\_83532.jpg

View of WS looking from levee crown

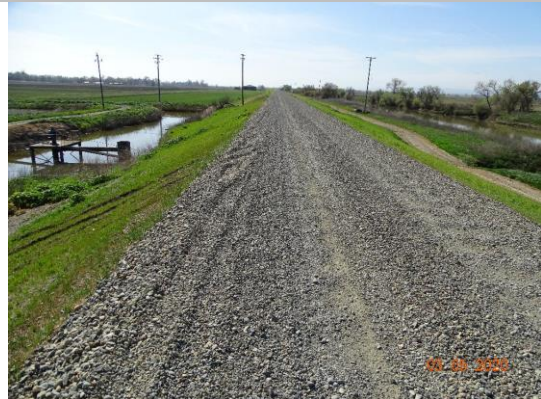
Photo 1 of 3 : UCIP\_SP\_2022\_57231\_83547.jpg

FIELD\_STRUCT\_DESC: 36-inch corrugated metal drainage pipe through the levee, 20 feet below the crown. Pump on metal pier in landside (LS) channel. 40-inch steel standpipe at the LS toe. Flap gate and concrete headwall on the waterside (WS). Concrete headwall on the LS. (36-inch pipe [HLM 4.87] authorized under Automatic Board Order (ABO) issued as Permit No. 9390, 1974 - Annie D. Propfe; 24-inch pipe [HLM 4.87] was also authorized under Automatic Board Order (ABO) issued as Permit No. 8233, 1972 - Olive P. Davis Estate). [Additional Reference(s): DWR Levee Log, 2005 (HLM 4.87). USACE Sacramento O&M Manual, Unit 132, October 1959, Revised 14 January 2019, (HLM 4.87), listed as 36-inch pipe. USACE As-Built Drawing No. 50-4-3081, Sheet 6 and 16, Station 1581+10, 4 April 1957].  
FS Date: 3/5/2020 7:55:00 AM

View of levee crown at the crossing looking downstream

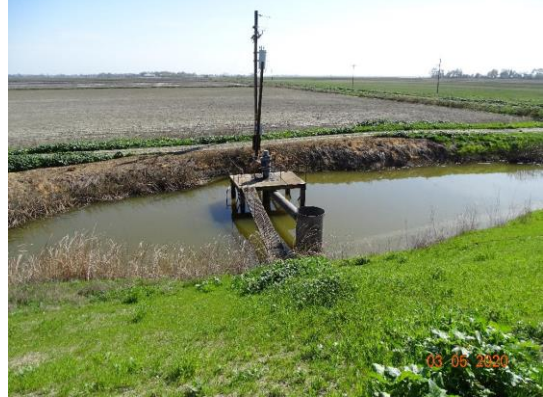
Photo 2 of 3 : UCIP\_SP\_2022\_57231\_83548.jpg

View of LS looking from levee crown

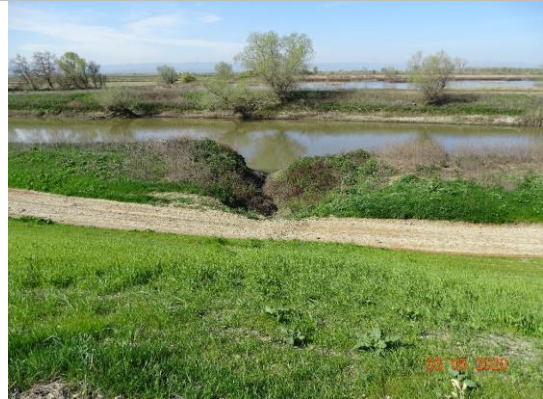
Photo 3 of 3 : UCIP\_SP\_2022\_57231\_83549.jpg

View of WS looking from levee crown

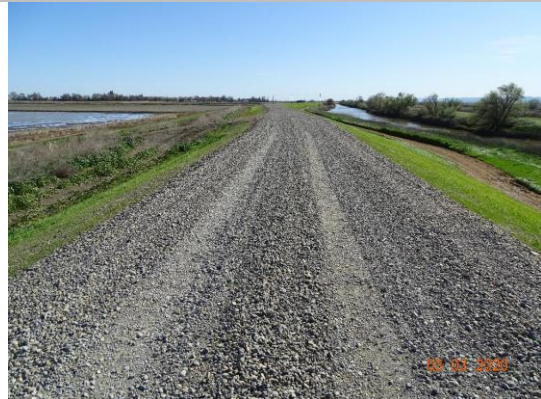
Photo 1 of 3 : UCIP\_SP\_2022\_57232\_83554.jpg

View of levee crown at the crossing looking downstream

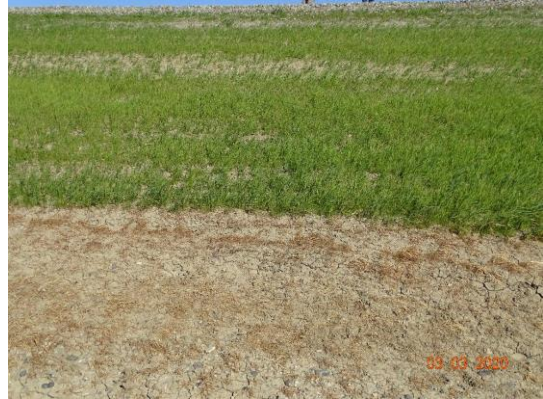
Photo 2 of 3 : UCIP\_SP\_2022\_57232\_83558.jpg

View of WS slope looking from levee toe

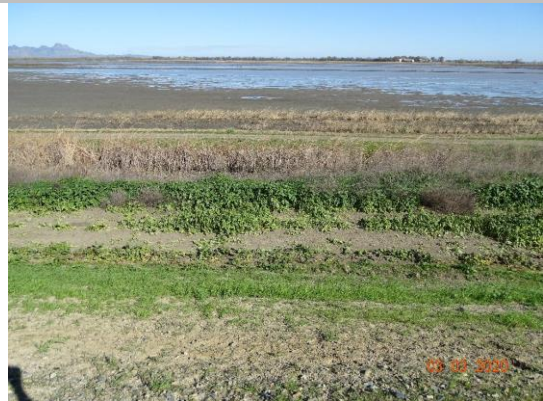
Photo 3 of 3 : UCIP\_SP\_2022\_57232\_83556.jpg

View of LS looking from levee crown

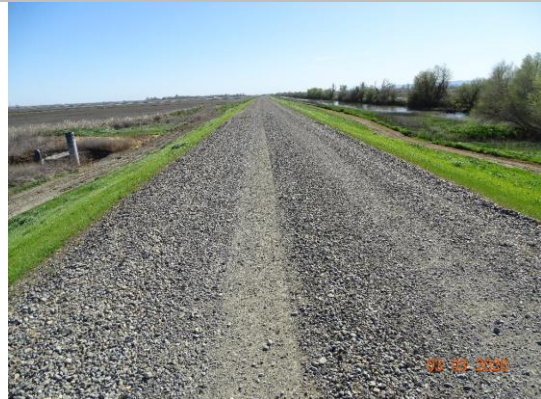
Photo 1 of 3 : UCIP\_SP\_2022\_57234\_83561.jpg

View of levee crown at the crossing looking downstreams

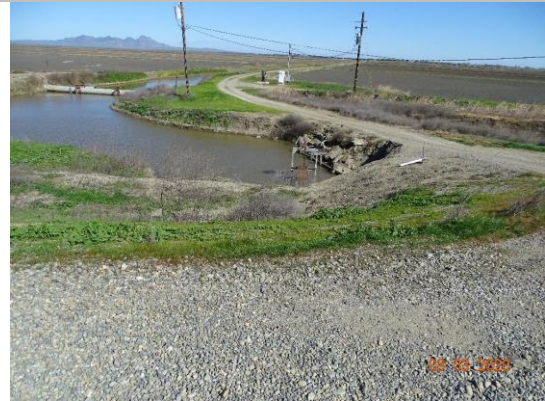
Photo 2 of 3 : UCIP\_SP\_2022\_57280\_83570.jpg

View of LS looking from levee crown

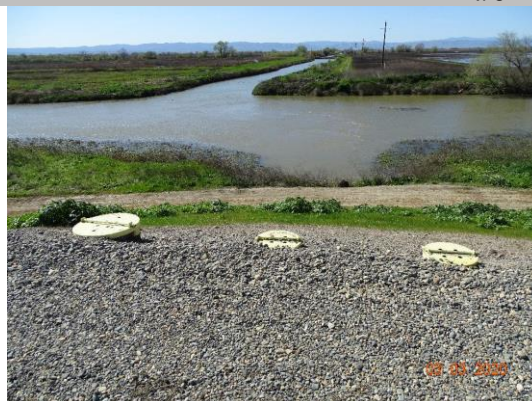
Photo 2 of 3 : UCIP\_SP\_2022\_57238\_83595.jpg

View of WS looking from levee crown

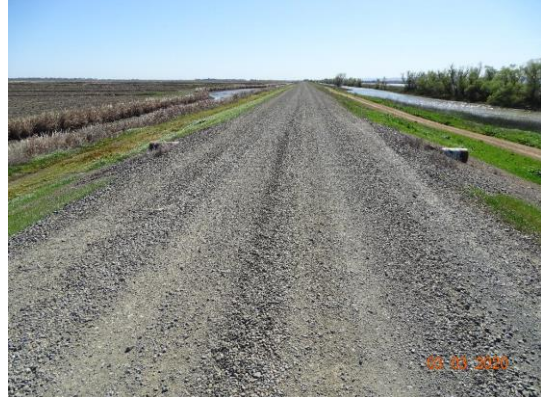
Photo 1 of 3 : UCIP\_SP\_2022\_57239\_83602.jpg

Comment Code					
Inspector Comment					
FS_ID:57239 DS_ID:17163 EP_NO: 9390 Repair Type: Non-Urgent Crossing Status: Found UCIP Comments: 03/03/2020 Record remains Non-Urgent. Pipe is plate welded over both ends. Rodent burrows under pipe on WS. Crossing appears abandoned. Need to have CVFPB review ABO and determine current owner. (O.Yakimov - DWR UCIP) 05/02/2017 Appears abandoned- pipe capped on both ends. Should be removed. (A.Freitag - DWR Sutter Yard) 10/17/2016 Appears abandoned and should be removed. (A.Freitag - DWR Sutter Yard) 05/31/2016 Appears to be abandoned. Pipe is capped on both WS and LS ends. (A.Freitag - DWR Sutter Yard) 05/04/2015 Crossing appears to be in good condition. No noticeable issues to report. (A.Freitag - DWR Sutter Yard)06/17/2014 Same as last inspection. (A.Freitag - DWR Sutter Yard)12/16/2013 Same as last inspection. (A.Freitag - DWR Sutter Yard) 07/16/2013 Same as last inspection. (A.Freitag - DWR Sutter Yard)10/11/2012 Rodent burrowing along sides of pipe on LS. (W.Wylie - DWR UCIP) FIELD_STRUCT_DESC: 24-inch steel irrigation pipe through the levee, 3 feet below the crown. Both ends capped, terminating on levee slopes. (24-inch pipe [HLM 7.76] authorized under Automatic Board Order (ABO) issued as Permit No. 9390, 1974 -Annie D. Propfe; 24-inch pipe [HLM 7.76] was also authorized under Automatic Board Order (ABO) issued as Permit No. 8233, 1972 - Olive P. Davis Estate). [Additional Reference(s): DWR Levee Log, 2005 (HLM 7.76). USACE Sacramento O&M Manual, Unit 132, October 1959, Revised 14 January 2019, (HLM 7.76), listed as 24-inch pipe. USACE As-Built Drawing No. 50-4-3081, Sheet 8 and 16, Station 1734+67.5, 1/4-inch cover plate continuously welded over each end, 4 April 1957]. FS Date: 3/3/2020

View of levee crown at crossing looking downstream

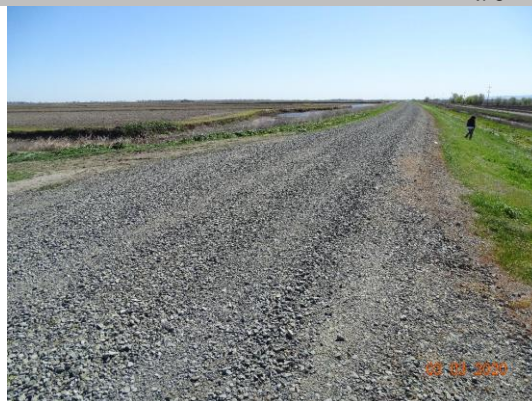
Photo 1 of 3 : UCIP\_SP\_2022\_57240\_83629.jpg

Comment Code						
Inspector Comment						
FS_ID:57240 DS_ID:17164 EP_NO: 9390 Repair Type: Non-Urgent Crossing Status: Not Found UCIP Comments: 03/03/2020 Record updated from No Action Needed to Non-Urgent. Crossing not found. Unauthorized encroachment recorded in Levee Log prior to 2011. Recommend geophysical study. Suspect that this pipe is the same record as DSID 17189. (O.Yakimov - DWR UCIP) 05/02/2017 Unable to locate. (A.Freitag - DWR Sutter Yard) 10/17/2016 Unable to locate. (A.Freitag - DWR Sutter Yard) 05/31/2016 Unable to locate. (A.Freitag - DWR Sutter Yard) 05/04/2015 Unable to locate. (A.Freitag - DWR Sutter Yard) 06/17/2014 Unable to locate. (A.Freitag - DWR Sutter Yard) 12/16/2013 Unable to locate. (A.Freitag - DWR Sutter Yard) 07/16/2013 Same as last inspection. Unable to locate. (A.Freitag - DWR Sutter Yard) FIELD_STRUCT_DESC: 24-inch drainage pipe through the levee, 3 feet below the crown. Capped on both waterside (WS) and landside (LS) ends. (24-inch pipe [HLM 9.23] authorized under Automatic Board Order (ABO) issued as Permit No. 9390, 1974 - Annie D. Propfe). [Additional Reference(s): DWR Levee Log, 2005 (HLM 9.23). FS Date: 3/3/2020 3:23:00 PM

View of levee crown at the crossing looking downstream

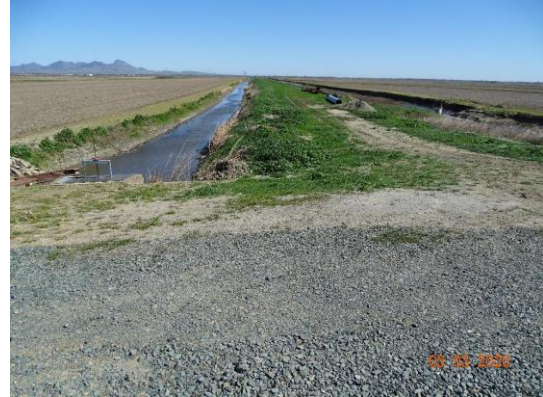
Photo 3 of 3 : UCIP\_SP\_2022\_57240\_83627.jpg

View of LS looking from levee crown

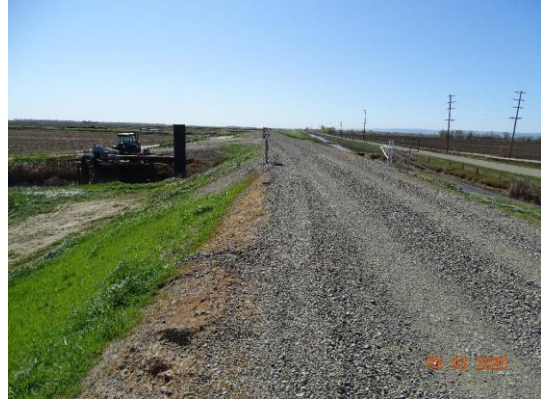
Photo 1 of 3 : UCIP\_SP\_2022\_57219\_83633.jpg

FS\_ID:57219  
DS\_ID:17167  
EP\_NO: 9389  
Repair Type: Urgent  
Crossing Status: Found  
UCIP Comments: 03/03/2020 Record remains Urgent. Pipe is excessively corroded inside at WS end. Recommend internal video inspection of crossing. Need to have CVFPB review ABO and determine current owner. (O.Yakimov - DWR UCIP)  
10/05/2018 Flap gate was installed at WS end of the pipe. Pipe is excessively corroded looking inside from WS end. Video inspection is recommended. Cracks more than 1-inch wide were observed on WS slope around pipe alignment that may be a sign of slope instability. (O.Yakimov - DWR UCIP)  
05/02/2017 No repairs have been made to this crossing yet. WS flap gate is still disconnected from end of pipe and pipe is showing heavy signs of rust and deterioration as far in as i can see from the WS end. Pipe should be internally camera inspected and repaired/replaced. (A.Freitag - DWR Sutter Yard)

View of levee crown at the crossing  
looking downstream

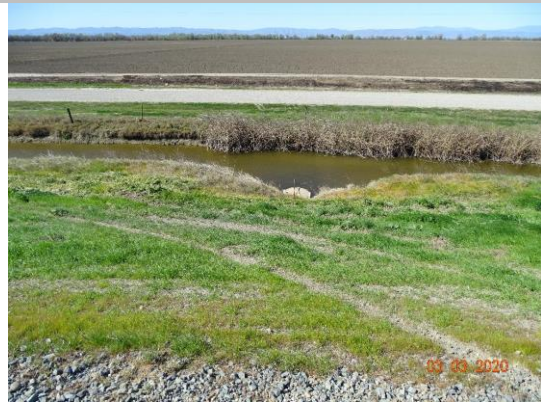
Photo 3 of 3 : UCIP\_SP\_2022\_57219\_83638.jpg

View of WS looking from levee crown

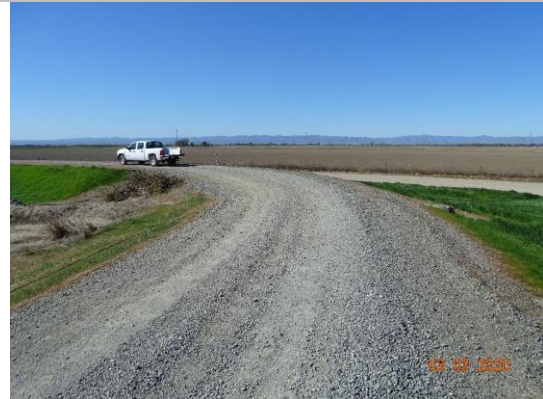
Photo 1 of 3 : UCIP\_SP\_2022\_57245\_83418.jpg

Comment Code						
Inspector Comment						
FS_ID:57245 DS_ID:17157 EP_NO: 9386 Repair Type: Non-Urgent Crossing Status: Found UCIP Comments: 03/03/2020 Record remains Non-Urgent. Crossing appears abandoned. Geophysical study indicates presence of pipe through levee, pipe crossing levee at angle. Pipe inlet on LS not found. Need to have CVFPB review ABO and determine current owner. (O.Yakimov - DWR UCIP) 05/02/2017 Abandoned - needs to be done properly. (A.Freitag - DWR Sutter Yard) 10/17/2016 Abandoned crossing. (A.Freitag - DWR Sutter Yard) 05/31/2016 Abandoned crossing. Both pipe ends and slide gate inside of riser are buried. (A.Freitag - DWR Sutter Yard) 05/04/2015 Both pipe ends and slide gate in riser are plugged with soil. Crossing is inoperable. (A.Freitag - DWR Sutter Yard) 06/17/2014 Same as last inspection. (A.Freitag - DWR Sutter Yard) 12/16/2013 Same as last inspection. (A.Freitag - DWR Sutter Yard) 07/16/2013 Same as last inspection. (A.Freitag - DWR Sutter Yard) 10/11/2012 Pipe plugged with soil on both ends as well as at slide gate on WS slope. Slide gate inoperable. (W.Wylie - DWR UCIP) FIELD_STRUCT_DESC: 24-inch corrugated metal drainage pipe through the levee, 8 feet below the crown. Slide gate in a 36-inch riser on the waterside (WS) shoulder. Levee turns eastward. (24-inch pipe [HLM 11.17] authorized under Automatic Board Order (ABO) issued as Permit No. 9386, 1974 - C. J. Wescott Jr.). [Additional Reference(s): DWR Levee Log, 2005 (HLM 11.17). USACE Sacramento O&M Manual, Unit 132, October 1959, Revised 14 January 2019, (HLM 11.17), listed as 24-inch pipe. USACE As-Built Drawing No. 50-4-3081, Sheet 10 and 16, Station 1912+40, 4 April 1957]. FS Date: 3/3/2020 11:49:00 AM

View of levee crown at crossing looking downstream

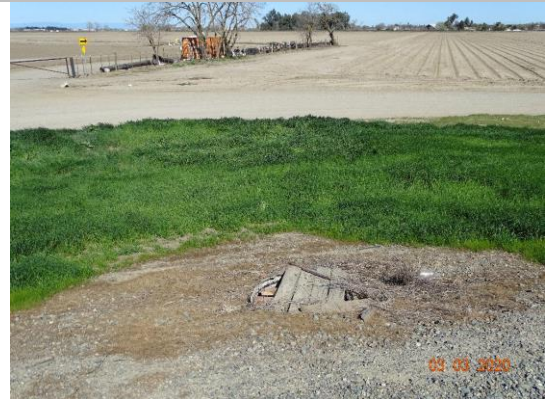
Photo 2 of 3 : UCIP\_SP\_2022\_57245\_83421.jpg

Water-Side looking from the crown
