**Flood Control Project Maintenance
Levee Inspections**
LMA District Cover Sheet
Spring 2020 Levee Inspection Results

Sutter Maintenance Yard Maintenance Area 0013

Spring 2020 Levee Inspection Results

Waterway			Bank	Unit Miles
Unit No. 01 Cherokee Canal			Right	18.19
	Spring (March - May)	Summer (June - August)	(September - November) Fall	Winter (December - February)
Unit Maintenance Rating (Fall Only)				
Date of Inspection	4/9/2020 - 4/9/2020			
DWR Inspector	Makar Sokol			
Accompanied By	Bob Duffey Sutter Maintenance Yard

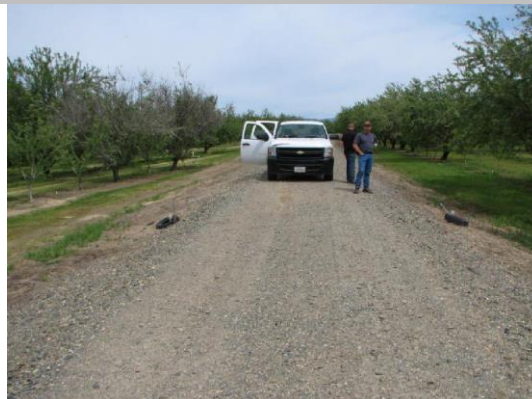
Photo 1 of 3 : UCIP_SP_2020_54936_66680.jpg

Comment Code					
Inspector Comment					
DS_ID:16327 FS_ID:54936 EP_NO: 6135 Repair Type: Urgent Crossing Status: Found UCIP Comments: 08/06/2019 Crossing remains Urgent because of the levee erosion on both the WS and LS. Need to contact owner to address the open section to levee and determine if the pipe is still leaking. (O. Magana - DWR UCIP, A. Freitag - DWR Sutter Yard)08/23/2018 Same as last inspection; crossing remains Urgent because levee erosion on both WS and LS still present (D. Sanoski - DWR UCIP).06/14/2017 LS slope still dug away from around the pipe. Appears no repairs have been made to the pipe yet. (DWR Sutter Yard- A.Freitag)11/16/2016 Appears no repairs have been made here yet as LS slope is still dug away. (DWR Sutter Yard- A.Freitag)04/28/2016 8-inch pipe was running water but was leaking at a weld joint on the LS slope. Pipe appears to have been dug out by the landowner but unsure if repairs are being made yet. (see photo 5)07/14/2015 Pipe end is still welded solid.05/21/2014 Same as last inspection.12/02/2013 Same as last inspection.07/10/2013 Same as last inspection. FIELD_STRUCT_DESC: 8-inch steel irrigation pipe through the levee 2.8 feet below the crown. Permit requirements are as follow: during the flood season the 5-inch irrigation pipe will be removed and a plate bolted over the waterside (WS) end of the 8-inch. Pipe section is completely buried. Current configuration does not allow for 5-inch irrigation pipe to slide pipe through. 8-inch pipe is welded solid. (8-inch pipe authorized under Permit No. 6135, 1968 - George Washington) [Additional Reference(s): DWR Levee Log, 1993 (HLM 0.29)] FS Date: 8/6/2019 8:33:00 AM

Overview of the crossing.

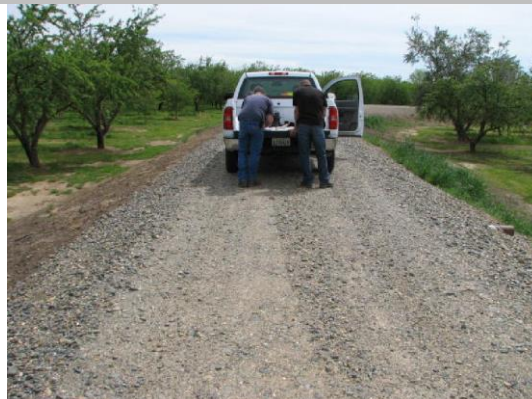
Photo 1 of 3 : UCIP_SP_2020_54937_66686.jpg

Comment Code					
Inspector Comment					
DS_ID:16342 FS_ID:54937 EP_NO: 12129 Repair Type: Non-Urgent Crossing Status: Found UCIP Comments: 08/06/2019 Need to contact owner to address proper abandonment per Title 23. Owner will need to coordinate with CVFPB. (O. Magana - DWR UCIP, A. Freitag - DWR Sutter Yard)06/14/2017 Abandoned- needs to be done properly. (DWR Sutter Yard- AFreitag)11/16/2016 Abandoned. WS end still has plate bolted on. (DWR Sutter Yard- AFreitag)04/28/2016 Crossing still has plate bolted on it at the WS end and LS end was mostly buried.07/14/2015 WS pipe end still had plate bolted on it.05/21/2014 Same as last inspection.12/02/2013 Same as last inspection.07/10/2013 Same as last inspection.04/12/2012 WS pipe daylight has bolted plate. FIELD_STRUCT_DESC: *ABANDONED* 6-inch steel irrigation pipe through the levee, 2.4 feet below the crown. Steel plate bolted on the waterside (WS) end. (5-inch water pipe authorized under Permit No. 12129, 12129A, 1977 - John & Jerie Malina) [Additional Reference(s): DWR Levee Log, 1993 (HLM 0.52)] FS Date: 8/6/2019 8:35:00 AM

View of levee crown at crossing looking downstream at right bank of Cherokee Canal.

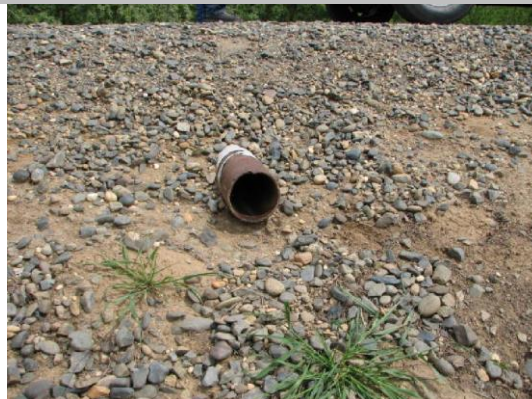
Photo 3 of 3 : UCIP_SP_2020_54937_66685.jpg

LS-Outlet

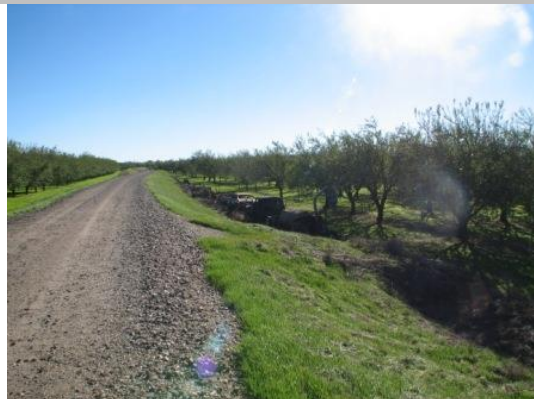
Photo 1 of 1 : SP_2020_MA0013_300_12_20200226_00005.jpg

LM Start	0.73	Rating **	M	Issue No.	12
LM End	0.76	Issue Type +	En	Location *	LS
Category	Earthen Levee			GPS Latitude/Longitude	
				Start	End
Item	Encroachments			39.587905 °	39.587505 °
				-121.700822 °	-121.700880 °
DWR ID	DWR_MA0013_01_s_2012_12				
Comment Code					
EQ : Equipment					
Inspector Comment					
Remove the equipment from the landside toe.

View of the equipment along the landside toe of the levee.

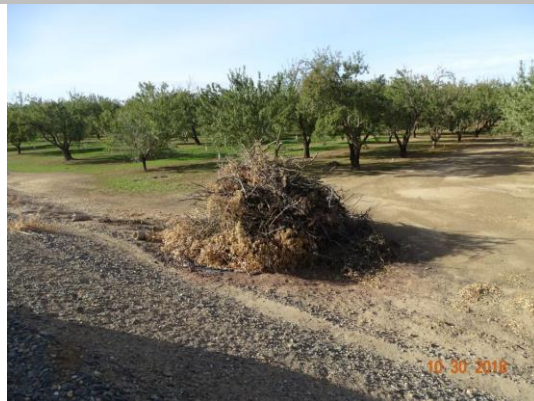
Photo 1 of 1 : SP_2020_MA0013_300_61_20200226_00010.jpg

LM Start	0.83	Rating **	M	Issue No.	61
LM End	0.83	Issue Type +	En	Location *	LS
Category	Earthen Levee			GPS Latitude/Longitude	
				Start	End
Item	Encroachments			39.586417 °	39.586417 °
				-121.700585 °	-121.700585 °
DWR ID	DWR_MA0013_01_f _ 2018_61				
Comment Code					
PR : Prunings					
Inspector Comment					
Remove the prunings from the landside slope.

View of the prunings along the landside slope.

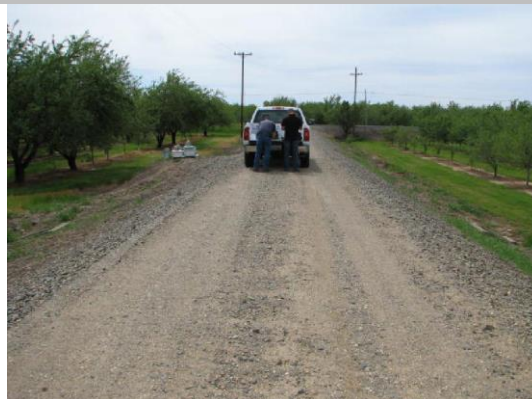
Photo 1 of 3 : UCIP_SP_2020_54938_66689.jpg

Comment Code						
Inspector Comment						
DS_ID:16343 FS_ID:54938 EP_NO: N/A Repair Type: Non-Urgent Crossing Status: Found UCIP Comments: 08/06/2019 Record has been updated from No Action Needed to Non-Urgent, due to unauthorized encroachment. Pipe has been lined. (O. Magana - DWR UCIP, A. Freitag - DWR Sutter Yard)06/14/2017 Crossing appears to be in good condition. Pipe has been selected to be internally cleaned and inspected as part of the DMP project. (DWR Sutter Yard- A.Freitag)11/16/2016 Crossing appears to be in good condition. (DWR Sutter Yard- A.Freitag)04/28/2016 Crossing appears to be in good condition.07/14/2015 Crossing appears in good condition. No noticeable issues to report.05/21/2014 Same as last inspection.12/02/2013 Same as last inspection.07/10/2013 Same as last inspection.04/17/2012 Drain is still in use. 4 inch pipe in channel near WS headwall (see photo). The pipe does not appear to impact the crossing. FIELD_STRUCT_DESC: 24-inch corrugated metal drainage pipe through the levee, 8.6 feet below the crown. Concrete "U" headwalls on both the waterside (WS) and landside (LS). Flap gate on the WS end. [Additional Reference(s): DWR Levee Log, 1993 (HLM 1.15). USACE Sacramento O&M Manual 519, June 1962 (HLM 1.15), As-built DWG No. 50-4-3608, Sheet No. 3608/19.1, STA 1072+20E, page 20 of 28 electronic file, listed as 24-inch CMP; As-built DWG No 50-4-3037 referenced not available] FS Date: 8/6/2019 8:46:00 AM

Overview of levee crown at crossing looking D/S .

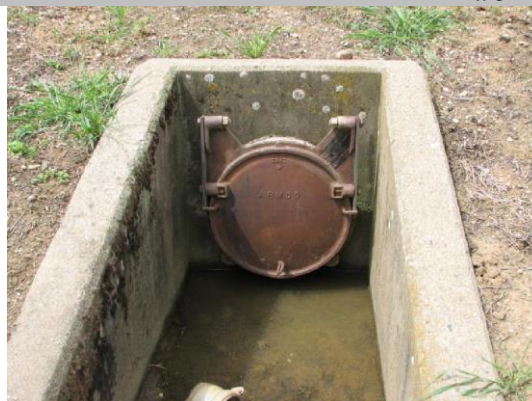
Photo 2 of 3 : UCIP_SP_2020_54938_66688.jpg

View of WS headwall and flap gate.

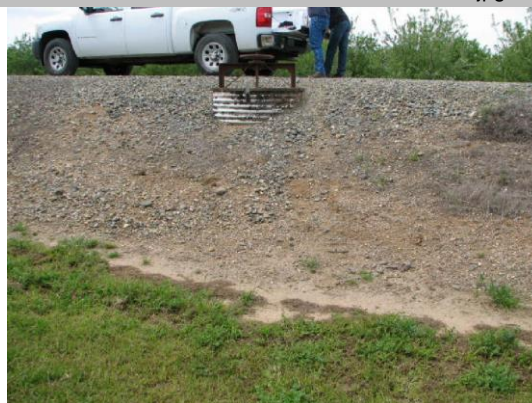
Photo 2 of 3 : UCIP_SP_2020_54939_66699.jpg

Corrugated metal riser with slide gate located on WS slope.

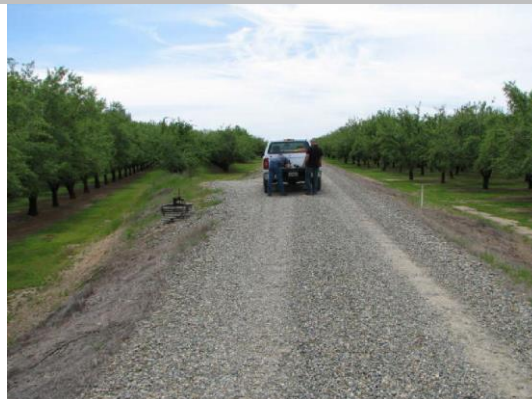
Photo 1 of 3 : UCIP_SP_2020_56082_66700.jpg

DS_ID:16345
FS_ID:56082
EP_NO: N/A
Repair Type: Non-Urgent
Crossing Status: Found
UCIP Comments: 08/06/2019 Record remains Non-Urgent, pipe has been abandoned. Crossing needs to be abandoned properly per Title 23. No owner has been identified for this crossing. Recommend adding cover to riser as a safety measure. (O. Magana - DWR UCIP, A. Freitag - DWR Sutter Yard)06/14/2017 PVC pipe still present blocking screw gate. LS inlet of the 24" cmp pipe is about 75% blocked by sediment. (DWR Sutter Yard- AFreitag)11/16/2016 PVC pipe still present blocking the screw gate. (DWR Sutter Yard- AFreitag)04/28/2016 Pvc pipe is still present through the crossing. Slide gate cannot shut fully.07/14/2015 4-inch pipe still present and blocking the screw gate.05/21/2014 Same as last inspection.12/02/2013 Same as last inspection.07/15/2013 Same as last inspection.04/17/2012 Crossing has 4-inch pipe inside blocking positive closure/notify landowner to remove prior to flood season. LS crossing is blocked about 50% by sediment build up. Burrow activity present on LS near crossing.

Overview of levee at crossing looking downstream.

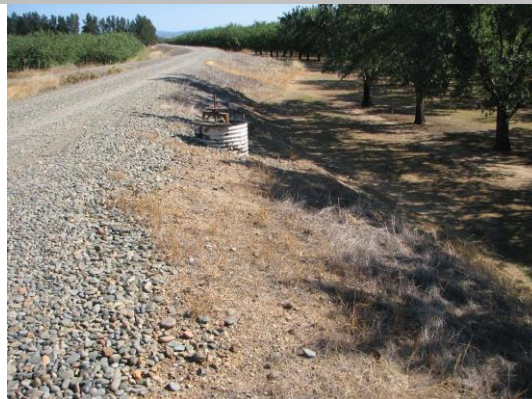
Photo 2 of 3 : UCIP_SP_2020_56082_66704.jpg

WS view looking upstream.

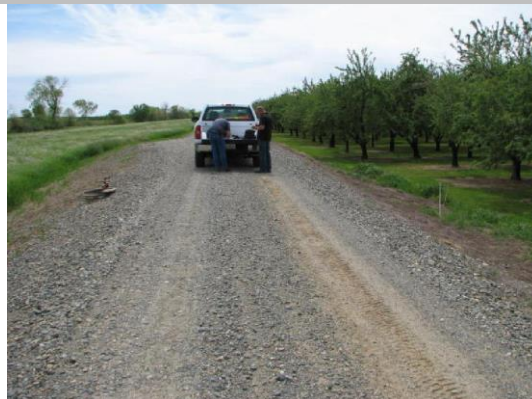
Photo 1 of 3 : UCIP_SP_2020_56083_66708.jpg

Comment Code					
Inspector Comment					
DS_ID:16346 FS_ID:56083 EP_NO: N/A Repair Type: Non-Urgent Crossing Status: Found UCIP Comments: 08/06/2019 Record remains Non-Urgent, pipe has been abandoned. Crossing needs to be abandoned properly per Title 23. No owner has been identified for this irrigation pipe. Recommend adding cover to riser as a safety measure. (O. Magana - DWR UCIP, A. Freitag - DWR Sutter Yard)06/14/2017 Still no LS inlet visible- trace with locator/GPR to try and locate. Wooden debris down inside of WS standpipe. Pipe has been selected to be internally cleaned and inspected as part of the DMP project. (DWR Sutter Yard- AFreitag)11/16/2016 Appears abandoned. Unable to find anything on LS. (DWR Sutter Yard- AFreitag)04/28/2016 Appears to be an abandoned crossing. LS headwall and pipe inlet are still completely buried.07/14/2015 Still cannot find an inlet or outlet.05/21/2014 Same as last inspection.12/02/2013 Same as last inspection.07/15/2013 Same as last inspection.04/17/2012 Non functional crossing due to LS headwall buried. This crossing was listed in the USACE Periodic Inspection report as Corp's inspect ID#USACE_CESPK_M13D_2011_p_0119 for no inlet or outlet visible. FIELD_STRUCT_DESC: *ABANDONED* 24-inch corrugated metal irrigation pipe through the levee 7.8 feet below the crown. Slide gate in corrugated metal pipe riser on the waterside (WS) slope. Pipe continues across channel. Concrete "U" headwall on the landside (LS). [Additional Reference(s): DWR Levee Log, 1993 (HLM 2.35). USACE Sacramento O&M Manual 519, June 1962 (HLM 2.35), listed as 24-inch pipe] FS Date: 8/6/2019 9:30:00 AM

Overview of crossing looking DS.

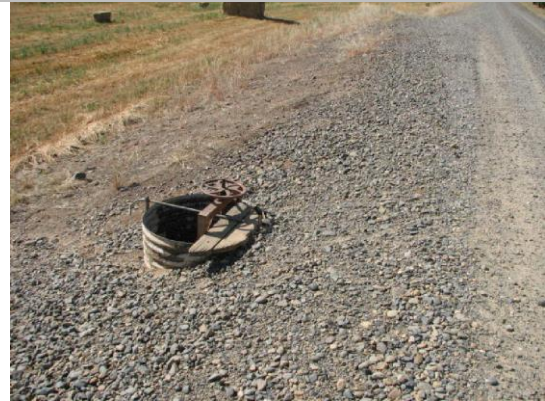
Photo 2 of 3 : UCIP_SP_2020_56083_66709.jpg

Corrugated riser located on WS slope.

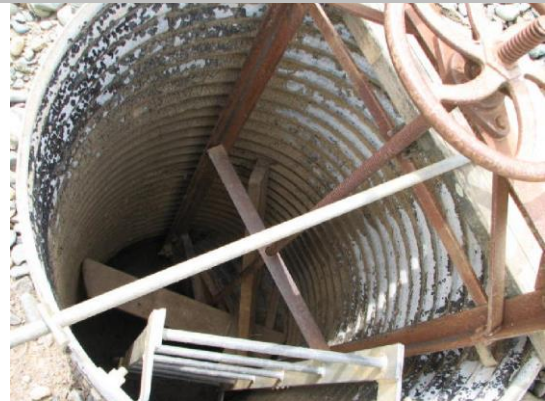
Photo 3 of 3 : UCIP_SP_2020_56083_66707.jpg

Corrugated metal riser on WS slope. Lid panel blocking gate.

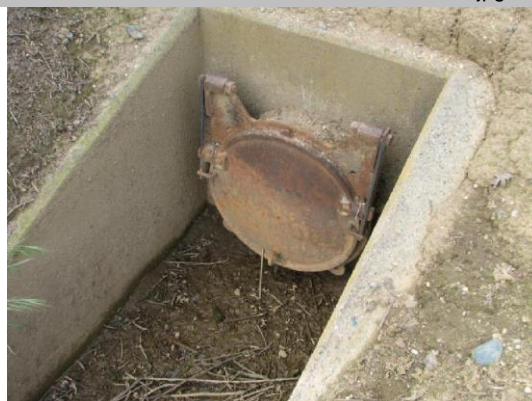
Photo 2 of 3 : UCIP_SP_2020_54942_66714.jpg

Flap gate at WS.

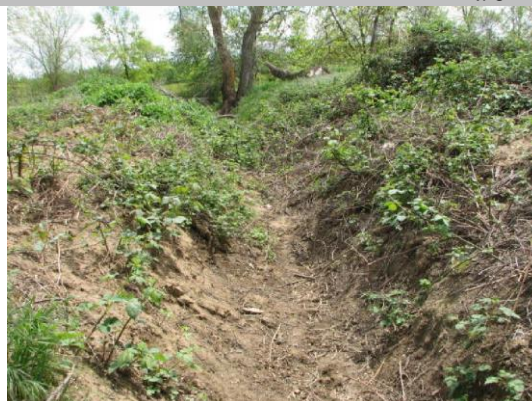
Photo 3 of 3 : UCIP_SP_2020_54942_66711.jpg

View of channel.

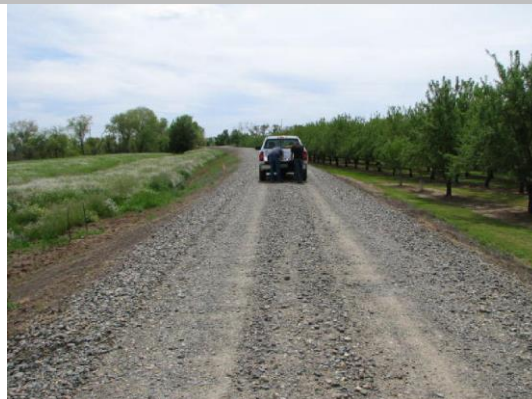
Photo 1 of 3 : UCIP_SP_2020_54943_66718.jpg

DS_ID:17372
FS_ID:54943
EP_NO: N/A
Repair Type: Non-Urgent
Crossing Status: Found
UCIP Comments: 08/06/2019 Record remains Non-Urgent, no permit identified authorizing pipe. Pipe has been internally cleaned and cleared of any obstructions on the WS and LS. DMP internal inspection pending. (O. Magana - DWR UCIP, A. Freitag - DWR Sutter Yard)06/14/2017 WS flap gate is completely buried by sediment-needs to be dug out. Pipe is about 50% full of sediment inside. Pipe has been selected to be internally cleaned and inspected as part of the DMP project. (DWR Sutter Yard- A.Freitag)11/16/2016 Pipe about 50% full of sediment. (DWR Sutter Yard- A.Freitag)04/28/2016 Pipe on LS is about 50% full of sediment. There is now a concrete pipe that discharges into the LS inlet of this crossing. Not sure where the concrete pipe comes from.07/14/2015 Crossing appears in good condition. No noticeable issues to report.05/21/2014 Same as last inspection.12/02/2013 Pipe section was dug up and repaired. Crossing is now in good condition.07/15/2013 Pipe appears to have a possible hole in top of pipe about 10ft. in from LS headwall.04/17/2012 LS headwall blocked by sediment (50 % of opening is covered). LS floor is higher than LS pipe invert. WS headwall has been recently cleared of vegetation and sediment. This crossing was listed in the USACE Periodic Inspection report as Corp's inspect ID#USACE_CESPK_M13D_2011_p_0157 for WS and LS inlet/outlet blocked by sediment.

Overview of levee crown looking downstream at crossing.

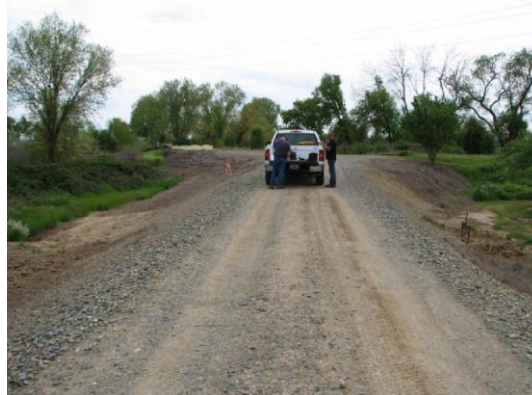
Photo 1 of 3 : UCIP_SP_2020_54944_66725.jpg

Comment Code					
Inspector Comment					
DS_ID:16349 FS_ID:54944 EP_NO: N/A Repair Type: Non-Urgent Crossing Status: Found UCIP Comments: 08/06/2019 Record remains Non-Urgent, no permit found authorizing pipe. Pipe has been lined. (O. Magana - DWR UCIP, A. Freitag - DWR Sutter Yard)06/14/2017 Both pipe ends and gates are mostly buried- need to be dug out. Pipe has been selected to be internally cleaned and inspected as part of the DMP project. (DWR Sutter Yard- AFreitag)11/16/2016 Both gates closed but partially buried and unable to open. (DWR Sutter Yard- AFreitag)04/28/2016 Sediment build up on both gates blocking them from operating properly.07/14/2015 Crossing appears in good condition. No noticeable issues to report.05/21/2014 Same as last inspection.12/02/2013 Same as last inspection.07/15/2013 Stem on LS screw gate has been replaced and is now full functional.04/17/2012 LS slide gate stem is bent and prevents gate from fully closing. Both WS and LS have been cleared of debris and sediment. This crossing was listed in the USACE Periodic Inspection report as Corp's inspect ID#USACE_CESPK_M13D_2011_p_0162 for inoperable gates on WS & LS due to sediment and grass blocking inlet and outlet. FIELD_STRUCT_DESC: 24-inch corrugated metal drainage pipe through the levee, 8.9 feet below the crown. Concrete "U" headwalls on both the waterside (WS) and landside (LS) ends. Flap gate visible on the waterside (WS) end. [Additional Reference(s): DWR Levee Log, 1993 (HLM 3.29). USACE Sacramento O&M Manual 519, June 1962 (HLM 3.29), listed as 24-inch pipe] FS Date: 8/6/2019 10:02:00 AM

Overview of levee crown looking DS at crossing.

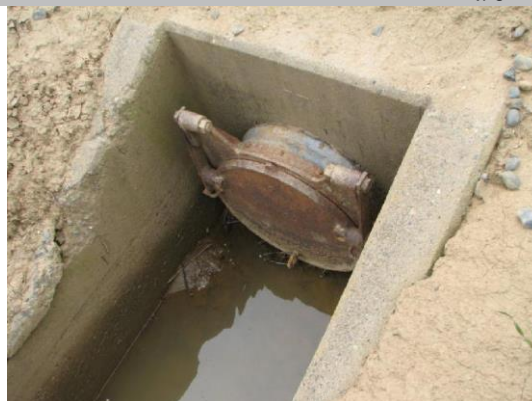
Photo 2 of 3 : UCIP_SP_2020_54944_66724.jpg

Flap gate on WS.

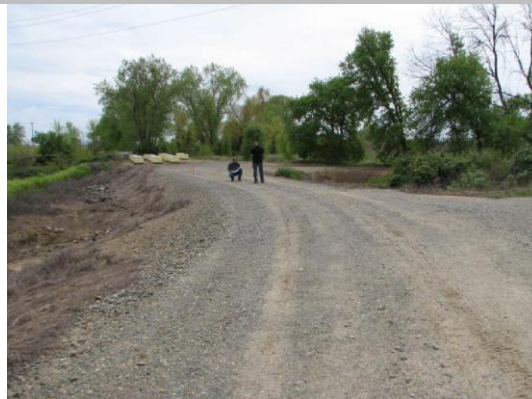
Photo 1 of 3 : UCIP_SP_2020_54945_66731.jpg

DS_ID:16350
FS_ID:54945
EP_NO: N/A
Repair Type: Non-Urgent
Crossing Status: Found
UCIP Comments: 08/06/2019 Record has been updated from No Action Needed to Non-Urgent, no permit has been found authorizing pipe. Pipe has been lined. (O. Magana - DWR UCIP, A. Freitag - DWR Sutter Yard)06/14/2017 WS flap gate is buried by sediment- needs to be dug out. Pipe has been selected to be internally cleaned and inspected as part of the DMP project. (DWR Sutter Yard- AFreitag)11/16/2016 Crossing appears to be in good condition. (DWR Sutter Yard- AFreitag)04/28/2016 Crossing appears to be in good condition.07/14/2015 Crossing appears in good condition. No noticeable issues to report.05/21/2014 Same as last inspection.12/02/2013 Same as last inspection.07/15/2013 Same as last inspection.04/17/2012 WS headwall has been cleared of debris and sedimentation.
FIELD_STRUCT_DESC: 24-inch corrugated metal drainage pipe through the levee, 8.4 feet below the crown. Concrete "U" headwalls on both the waterside (WS) and landside (LS) ends. Flap gate on the WS end. [Additional Reference(s): DWR Levee Log, 1993 (HLM 3.31). USACE Sacramento O&M Manual 519, June 1962 (HLM 3.31), listed as 24-inch pipe]

Overview of levee crown at crossing.

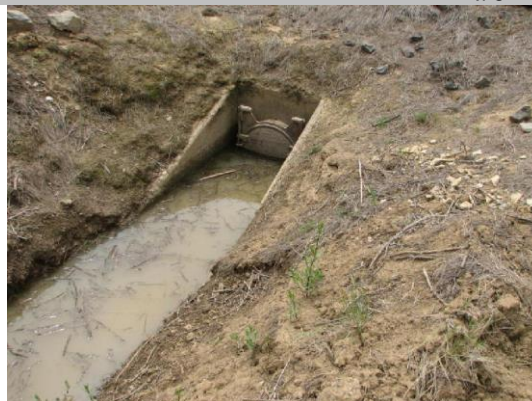
Photo 2 of 3 : UCIP_SP_2020_54945_66730.jpg

View of WS flap gate.

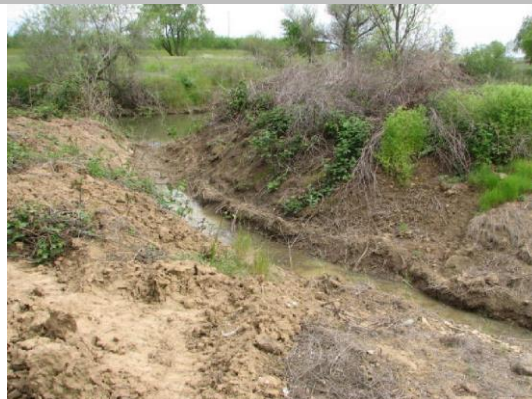
Photo 3 of 3 : UCIP_SP_2020_54945_66732.jpg

Sedimentation cleared on WS.

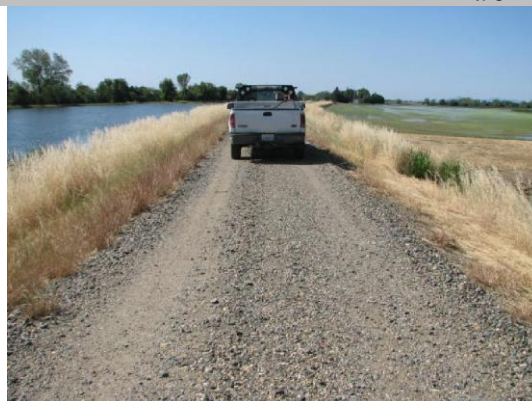
Photo 1 of 3 : UCIP_SP_2020_54946_66736.jpg

DS_ID:16351
FS_ID:54946
EP_NO: N/A
Repair Type: Non-Urgent
Crossing Status: Found
UCIP Comments: 08/26/2019 Record has been updated from No Action Needed to Non-Urgent, no permit has been identified for this crossing. Crossing is scheduled to be lined. (O. Magana - DWR UCIP, A. Freitag - DWR Sutter Yard)06/14/2017 Both pipe ends were underwater during site visit. Pipe has been selected to be internally cleaned and inspected as part of the DMP project. (DWR Sutter Yard-AFreitag)11/16/2016 Crossing appears to be in good condition. (DWR Sutter Yard- AFreitag)04/28/2016 Both sides of the crossing were underwater during time of inspection.07/14/2015 Crossing appears in good condition. No noticeable issues to report.05/21/2014 Same as last inspection.12/02/2013 Same as last inspection.07/15/2013 Slopes have been cleared of vegetation and are in good condition.04/18/2012 Limited inspection on WS and LS slope due to dense vegetation. Need photos of cleared slopes.

Overview of levee crown at crossing looking downstream.

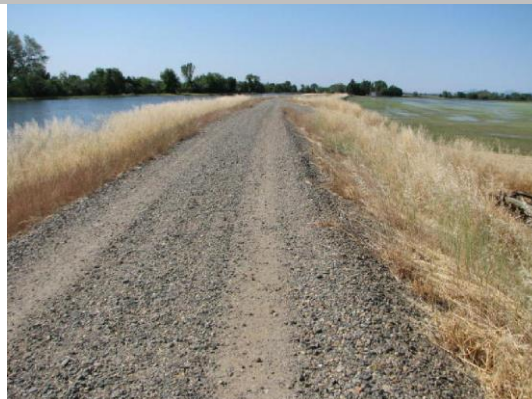
Photo 1 of 3 : UCIP_SP_2020_54947_66743.jpg

DS_ID:16365
FS_ID:54947
EP_NO: N/A
Repair Type: Non-Urgent
Crossing Status: Found
UCIP Comments: 08/26/2019 Record remains Non-Urgent, pipe has been abandoned. No permit has been identified for this crossing. DMP internal inspection has not been completed. (O. Magana - DWR UCIP, A. Freitag - DWR Sutter Yard)06/14/2017 Appears abandoned-needs to be done properly. WS gate was buried/submerged and the LS slide gate is still damaged and buried. Pipe has been selected to be internally cleaned and inspected as part of the DMP project. (DWR Sutter Yard- AFreitag)11/16/2016 Both LS and WS gates buried. (DWR Sutter Yard- AFreitag)04/28/2016 Abandoned crossing. Ls screw is still bent and mostly buried.07/14/2015 LS screw gate is still damaged and buried. Crossing is non-functional.05/21/2014 Same as last inspection.12/02/2013 Same as last inspection.07/15/2013 Slopes have been cleared of vegetation and are in good condition. LS screw gate is still bent and silted over.04/18/2012 LS slide gate covered with silt. Slide gate is bent. Crossing appears not be in use. Limited inspection on WS and LS slope due to dense vegetation. Need photos of cleared slopes.

Overview of levee crown at crossing looking downstream.

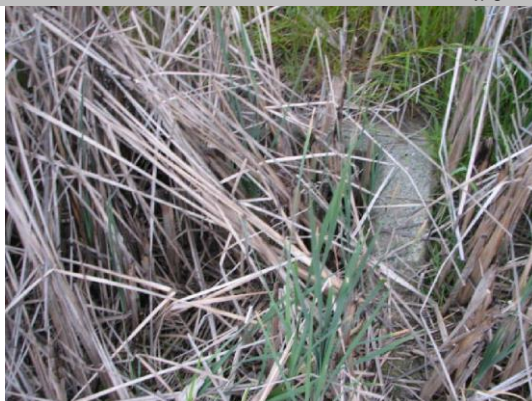
Photo 2 of 3 : UCIP_SP_2020_54947_66741.jpg

WS flap gate blocked by debris.

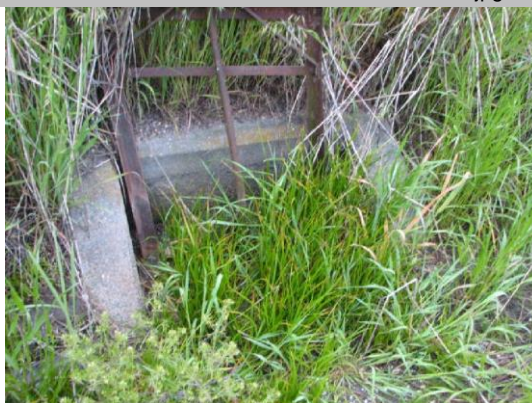
Photo 3 of 3 : UCIP_SP_2020_54947_66742.jpg

LS slide gate covered with silt. Slide gate is bent.

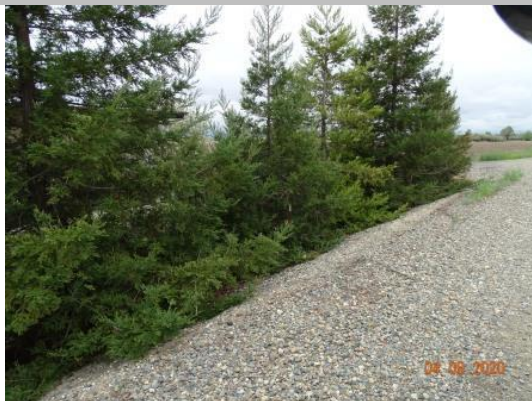
Photo 1 of 1 : SP_2020_MA0013_300_18_20200415_00180.jpg

LM Start	4.06	Rating **	M	Issue No.	18
LM End	4.13	Issue Type +	En	Location *	LS
Category	Earthen Levee			GPS Latitude/Longitude	
				Start	End
Item	Vegetation			39.541660 °	39.540651 °
				-121.707408 °	-121.707404 °
DWR ID	DWR_MA0013_01_s_2013_18				
Comment Code					
V6 : Landscaping					
Inspector Comment

View of the trees along the landside slope. Spring 2020.

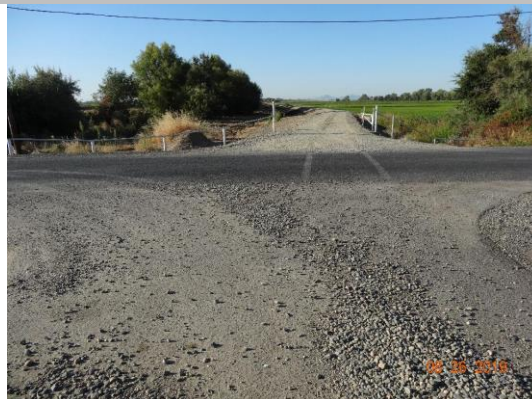
Photo 3 of 3 : UCIP_SP_2020_54948_80281.jpg

Overview of levee crown looking d/s towards crossing.

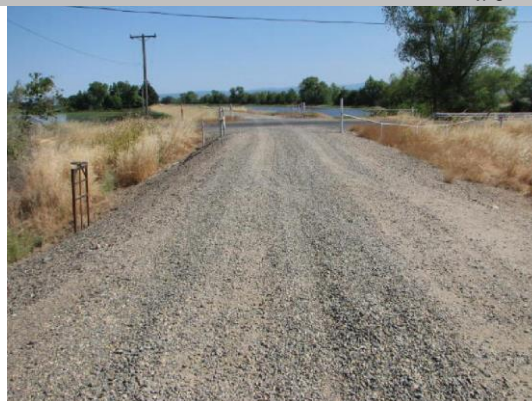
Photo 1 of 3 : UCIP_SP_2020_54949_66752.jpg

Comment Code					
Inspector Comment					
DS_ID:16341 FS_ID:54949 EP_NO: N/A Repair Type: Non-Urgent Crossing Status: Found UCIP Comments: 08/26/2019 Record has been updated from No Action Needed to Non-Urgent, no permit has been found authorizing pipe. Pipe is scheduled to be lined. (O. Magana - DWR UCIP, A. Freitag - DWR Sutter Yard)06/14/2017 WS flap gate is shut but blocked by sediment- needs to be dug out. LS slide gate has some minor sediment built up against it. Pipe has been selected to be internally cleaned and inspected as part of the DMP project. (DWR Sutter Yard- AFreitag)11/16/2016 Crossing appears to be in good condition. (DWR Sutter Yard- AFreitag)04/28/2016 Crossing appears to be in good condition.07/13/2015 Crossing appears in good condition. No noticeable issues to report.05/21/2014 Same as last inspection.12/02/2013 Same as last inspection.07/15/2013 Same as last inspection.04/18/2012 Minor debris on landside inlet. This crossing was listed in the USACE Periodic Inspection report as Corp's inspect ID#USACE_CESPK_M13D_2011_p_0189 for sediment and grass blocking WS and LS. FIELD_STRUCT_DESC: 36-inch corrugated metal drainage pipe through the levee, 9.1 feet below the crown. Flap gate on the waterside (WS) end. Slide gate located on the landside (LS) end. Concrete "U" headwalls on both ends. [Additional Reference(s): DWR Levee Log, 1993 (HLM 4.43). USACE Sacramento O&M Manual 519, June 1962 (HLM 4.43), As-built DWG No. 50-4-3608, Sheet No. 3608/19.1, STA 891+52E, page 20 of 28 electronic file, listed as 36-inch CMP; As-built DWG No 50-4-3037 referenced not available] FS Date: 8/26/2019 12:26:00 PM

Overview of levee crown at crossing looking upstream.

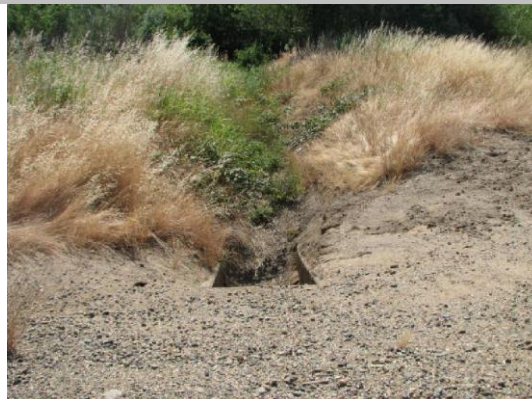
Photo 2 of 3 : UCIP_SP_2020_54949_66753.jpg

View of WS slope and toe.

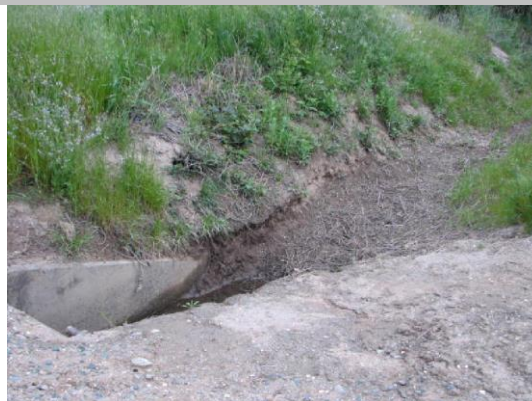
Photo 3 of 3 : UCIP_SP_2020_54949_66750.jpg

View of WS.

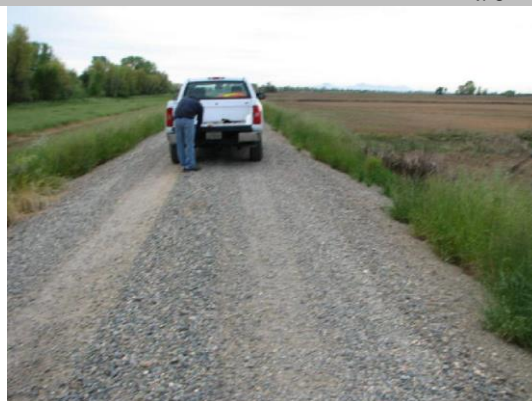
Photo 1 of 3 : UCIP_SP_2020_54950_66756.jpg

DS_ID:16355
FS_ID:54950
EP_NO: N/A
Repair Type: Non-Urgent
Crossing Status: Found
UCIP Comments: 08/26/2019 Record has been updated from No Action Needed to Non-Urgent, no permit has been identified for this pipe. Pipe is scheduled to be lined. (O. Magana - DWR UCIP, A. Freitag - DWR Sutter Yard)06/14/2017 WS flap gate is submerged and appears to be half buried by sediment. LS slide gate is fully submerged on the edge of the rice field. Pipe has been selected to be internally cleaned and inspected as part of the DMP project. (DWR Sutter Yard- A.Freitag)11/16/2016 Crossing appears to be in good condition. (DWR Sutter Yard- A.Freitag)04/28/2016 Crossing appears to be in good condition.07/13/2015 LS screw gate was completely submerged but crossing appears to be in good condition.05/21/2014 Same as last inspection.12/02/2013 Same as last inspection.07/15/2013 No signs of burrowing activity on this inspection.04/18/2012 Burrow activity near crossing, burrow holes present on WS slope.

Overview of levee crown at crossing looking downstream at right bank of Cherokee Canal.

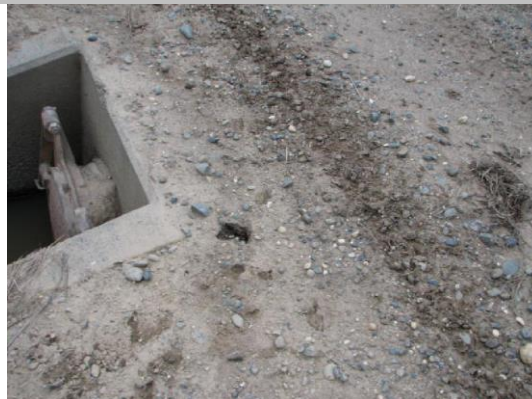
Photo 2 of 3 : UCIP_SP_2020_54950_66758.jpg

Burrow activity on WS slope.

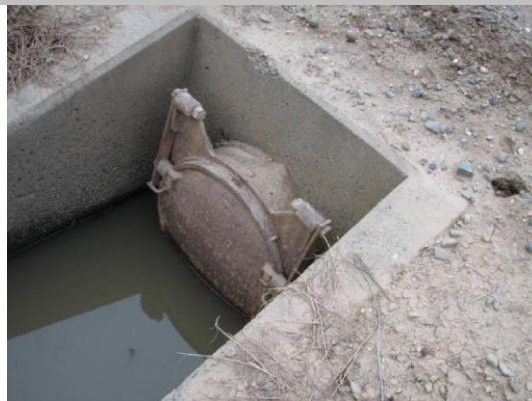
Photo 3 of 3 : UCIP_SP_2020_54950_66755.jpg

View of WS flap gate.

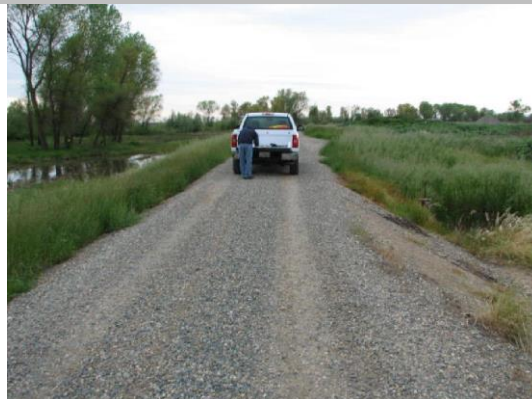
Photo 1 of 3 : UCIP_SP_2020_54951_66762.jpg

Item	DWR UCIP LMA Responsibility		39.523236 °	39.523236 °						
			-121.707650 °	-121.707650 °						
DWR ID	16356									
Comment Code										
Inspector Comment										
DS_ID:16356 FS_ID:54951 EP_NO: N/A Repair Type: Non-Urgent Crossing Status: Found UCIP Comments: 08/26/2019 Record has been updated from No Action Needed to Non-Urgent, no permit has been identified authorizing this pipe. Pipe is scheduled to be lined. Minor sloughing observed on LS just immediately d/s of concrete headwall (see photo). (O. Magana - DWR UCIP, A. Freitag - DWR Sutter Yard)06/14/2017 Crossing appears to be in good condition. Pipe has been selected to be internally cleaned and inspected as part of the DMP project. (DWR Sutter Yard- AFreitag)11/16/2016 Crossing appears to be in good condition. (DWR Sutter Yard- AFreitag)04/28/2016 Crossing appears to be in good condition.07/13/2015 LS screw gate was completely submerged and WS flap gate was propped open by a wood block but crossing appears to be in good condition.05/21/2014 Same as last inspection.12/02/2013 Same as last inspection.07/15/2013 Same as last inspection.04/18/2012 Minor vegetation on LS slope. This crossing was listed in the USACE Periodic Inspection report as Corp's inspect ID#USACE_CESPK_M13D_2011_p_0204 for restriction view of gates. FIELD_STRUCT_DESC: 24-inch corrugated metal drainage pipe through the levee, 8.4 feet below the crown. Flap gate on the waterside (WS) end. Slide gate on the landside (LS) end. Concrete "U" headwalls on both ends. [Additional Reference(s): DWR Levee Log, 1993 (HLM 5.43). USACE Sacramento O&M Manual 519, June 1962 (HLM 5.43), As-built DWG No. 50-4-3608, Sheet No. 3608/18, STA 839+50E, page 19 of 28 electronic file, listed as 24-inch CMP; As-built DWG No 50-4-3037 referenced not available] FS Date: 8/26/2019 12:29:00 PM

Overview of levee crown at crossing looking D/S on right bank of Cherokee Canal.

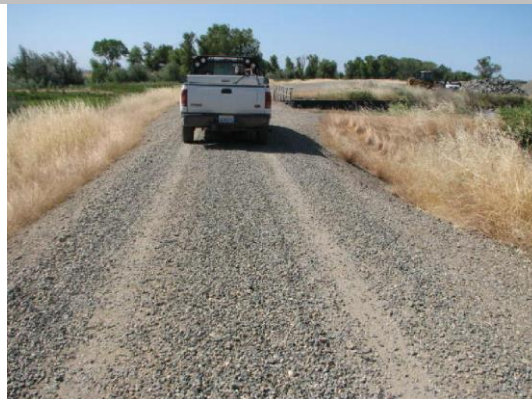
Photo 1 of 3 : UCIP_SP_2020_54952_66764.jpg

DS_ID:16357
FS_ID:54952
EP_NO: N/A
Repair Type: Non-Urgent
Crossing Status: Found
UCIP Comments: 08/26/2019 Record remains Non-Urgent, no permit has been identified authorizing this pipe. Pipe has been lined. (O. Magana - DWR UCIP, A. Freitag - DWR Sutter Yard)06/14/2017 WS flap gate is partially buried by sediment- needs to be dug out. LS appears to be in good condition. Pipe has been selected to be internally cleaned and inspected as part of the DMP project. (DWR Sutter Yard- A Freitag)11/16/2016 WS flap gate closed but blocked from opening by sediment. (DWR Sutter Yard- A Freitag)04/28/2016 WS flap gate blocked from opening by sediment.07/13/2015 WS flap gate is blocked from opening by sediment. Needs to be dug out.05/21/2014 Same as last inspection.12/02/2013 Same as last inspection.07/15/2013 Slopes have been cleared of vegetation and are in good condition.04/18/2012 Limited inspection on WS and LS slopes due to dense vegetation. Need photos of cleared slopes.

Overview of levee crown at crossing looking downstream.

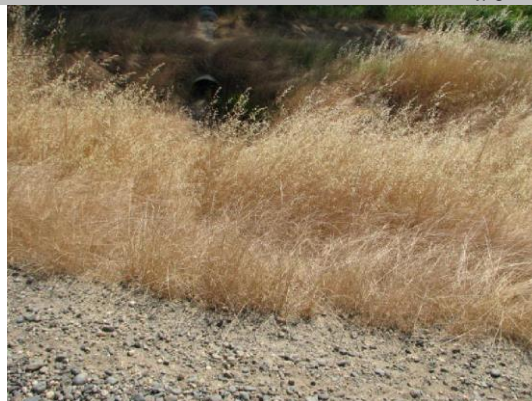
Photo 2 of 3 : UCIP_SP_2020_54952_66765.jpg

View of WS slope and channel.

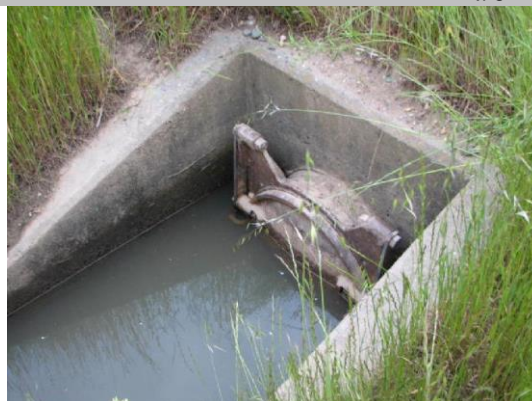
Photo 3 of 3 : UCIP_SP_2020_54952_66768.jpg

View of WS flap gate.

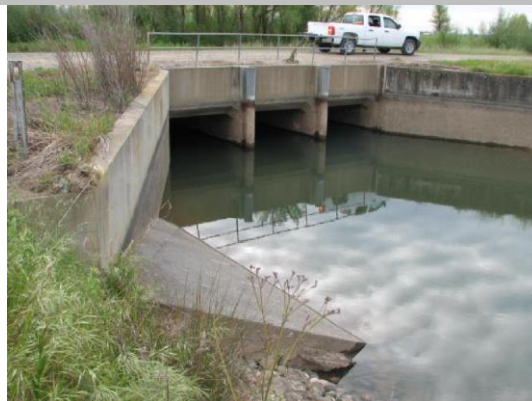
Photo 3 of 3 : UCIP_SP_2020_54956_66776.jpg

Siphon - LS. View of U/S wingwall.

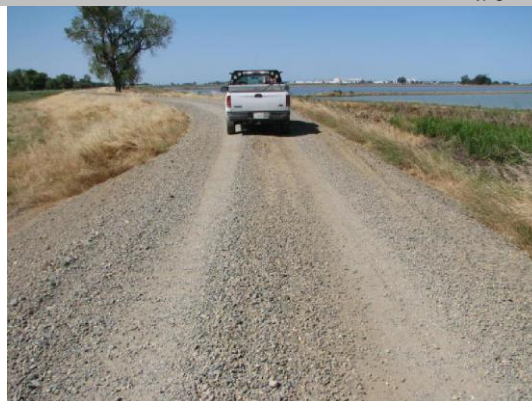
Photo 1 of 3 : UCIP_SP_2020_54957_66793.jpg

DS_ID:16359
FS_ID:54957
EP_NO: N/A
Repair Type: Non-Urgent
Crossing Status: Found
UCIP Comments: 08/26/2019 Record remains Non-Urgent, no permit has been identified authorizing pipe. Pipe is scheduled to be lined. (O. Magana - DWR UCIP, A. Freitag - DWR Sutter Yard)06/14/2017 WS Flap gate is completely buried- needs to be dug out. LS is blocked off by flashboards that are partially buried. Pipe has been selected to be internally cleaned and inspected as part of the DMP project. (DWR Sutter Yard- A.Freitag)11/16/2016 WS still completely buried. (DWR Sutter Yard- A.Freitag)04/28/2016 WS gate and headwall are buried. Only the top of the headwall was visible. LS appeared ok.07/13/2015 Both the LS screw gate and WS flap gate are completely buried.05/21/2014 Same as last inspection.12/02/2013 Same as last inspection.07/15/2013 Slopes have been cleared of vegetation and are in good condition. WS headwall and flap gate are fully covered in debris and not visible. Need to clear.04/18/2012 High sedimentation build up at WS and LS headwall. Limited inspection due to dense vegetation on WS and LS slope. Need photo of cleared WS and LS slopes. This crossing was listed in the USACE Periodic Inspection report as Corp's inspect ID# USACE_CESPK_M13D_2011_p_0210 for WS gate submerged. FIELD_STRUCT_DESC: 24-inch corrugated metal drainage pipe through the levee, 9.2 feet below the crown. Flap gate on the waterside (WS) end. Concrete "U" headwalls on both ends. [Additional Reference(s): DWR Levee Log, 1993 (HLM 5.73). USACE Sacramento O&M Manual 519, June 1962 (HLM 5.73), As-built DWG No. 50-4-3608, Sheet No. 3608/18, STA 820+50E, page 19 of 28 electronic file, listed as 24-inch CMP; As-built DWG No 50-4-3037 referenced not available]

Overview of levee crown at crossing looking downstream.

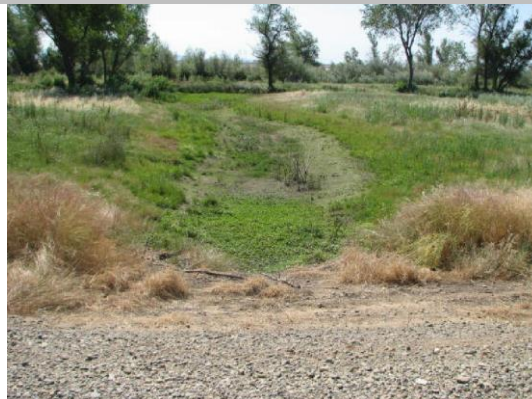
Photo 2 of 3 : UCIP_SP_2020_54957_66794.jpg

View of WS slope and toe.

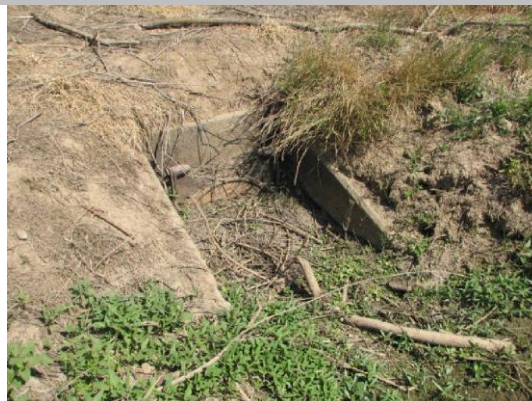
Photo 3 of 3 : UCIP_SP_2020_54957_66791.jpg

View of WS flap gate buried.

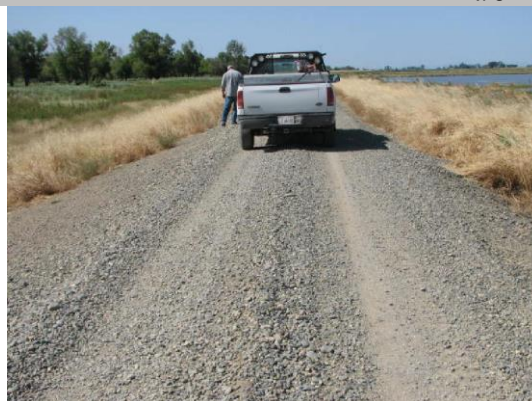
Photo 1 of 3 : UCIP_SP_2020_54958_66800.jpg

Comment Code						
Inspector Comment						
DS_ID:16360 FS_ID:54958 EP_NO: N/A Repair Type: Non-Urgent Crossing Status: Found UCIP Comments: 08/26/2019 Record has been updated from No Action Needed to Non-Urgent, no permit has been identified authorizing pipe. Pipe is scheduled to be lined. (O. Magana - DWR UCIP, A. Freitag - DWR Sutter Yard)06/14/2017 Crossing appears to be in good condition. LS is completely submerged in an irrigation ditch. Pipe has been selected to be internally cleaned and inspected as part of the DMP project. (DWR Sutter Yard- AFreitag)11/16/2016 Crossing appears to be in good condition. (DWR Sutter Yard- AFreitag)04/28/2016 Crossing appears to be in good condition.07/13/2015 LS screw gate was completely submerged but crossing appears to be in good condition.05/21/2014 Same as last inspection.12/02/2013 Same as last inspection.07/15/2013 Same as last inspection.04/18/2012 Burrow activity near crossing; burrow holes present on LS. FIELD_STRUCT_DESC: 24-inch corrugated metal drainage pipe through the levee, 6.2 feet below the crown. Flap gate on the waterside (WS) end. Slide gate on the landside (LS) end. Concrete "U" headwalls on both ends. [Additional Reference(s): DWR Levee Log, 1993 (HLM 5.97). USACE Sacramento O&M Manual 519, June 1962 (HLM 5.97), As-built DWG No. 50-4-3608, Sheet No. 3608/18, STA 808+00E, page 19 of 28 electronic file, listed as 24-inch CMP; As-built DWG No 50-4-3037 referenced not available] FS Date: 8/26/2019 12:40:00 PM

Overview of levee crown at crossing looking downstream.

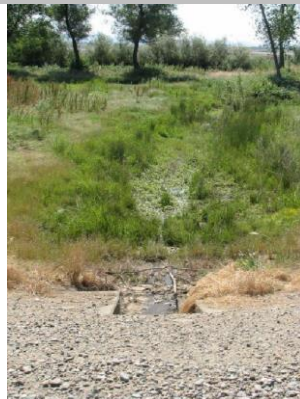
Photo 2 of 3 : UCIP_SP_2020_54958_66801.jpg

View of WS slope and toe.

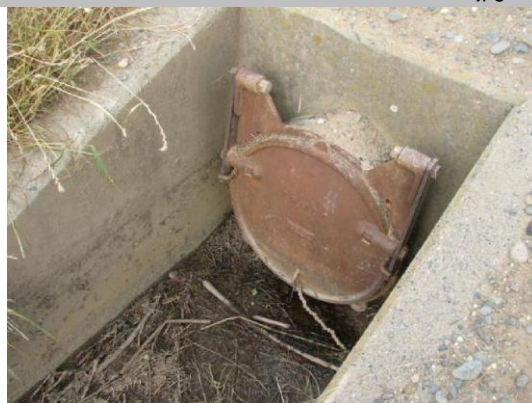
Photo 3 of 3 : UCIP_SP_2020_54958_66799.jpg

Flap gate WS

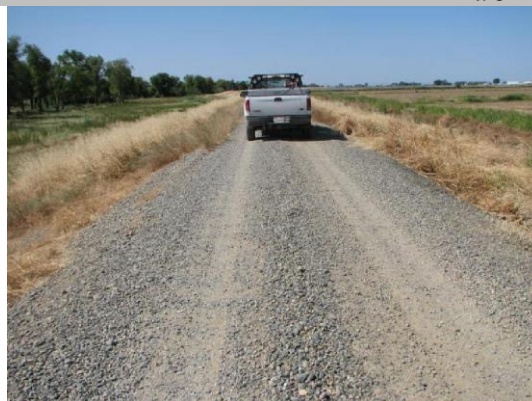
Photo 1 of 3 : UCIP_SP_2020_54959_66808.jpg

Comment Code						
Inspector Comment						
DS_ID:16361 FS_ID:54959 EP_NO: N/A Repair Type: Non-Urgent Crossing Status: Found UCIP Comments: 08/26/2019 Record remains Non-Urgent, no permit has been identified authorizing pipe. Pipe is scheduled to be lined. (O. Magana - DWR UCIP, A. Freitag - DWR Sutter Yard)06/14/2017 WS appears to be in good condition. LS slide gate is buried and submerged. Pipe has been selected to be internally cleaned and inspected as part of the DMP project. (DWR Sutter Yard- AFreitag)11/16/2016 LS screw gate is buried and non-operational. (DWR Sutter Yard- AFreitag)04/28/2016 LS screw gate is still completely buried. 07/13/2015 LS screw gate is completely buried.05/21/2014 Same as last inspection.07/15/2013 WS slope has been cleared of vegetation and is in good condition. LS screw gate is still buried.12/02/2013 Same as last inspection.04/18/2012 LS slide gate is buried. Pipe is not visible on LS toe. Limited inspection on WS slope due to dense vegetation. FIELD_STRUCT_DESC: 24-inch corrugated metal drainage pipe through the levee, 7.4 feet below the crown. Flap gate on the waterside (WS) end. Slide gate on the landside (LS) end. Concrete "U" headwalls on both ends. [Additional Reference(s): DWR Levee Log, 1993 (HLM 6.32). USACE Sacramento O&M Manual 519, June 1962 (HLM 6.34), As-built DWG No. 50-4-3608, Sheet No. 3608/18, STA 789+00E, page 19 of 28 electronic file, listed as 24-inch CMP; As-built DWG No 50-4-3037 referenced not available] FS Date: 8/26/2019 12:41:00 PM

Overview of levee crown at crossing looking downstream.

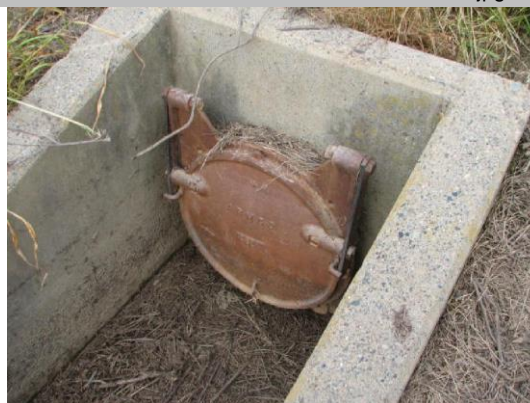
Photo 3 of 3 : UCIP_SP_2020_54959_66804.jpg

View of WS flap gate.

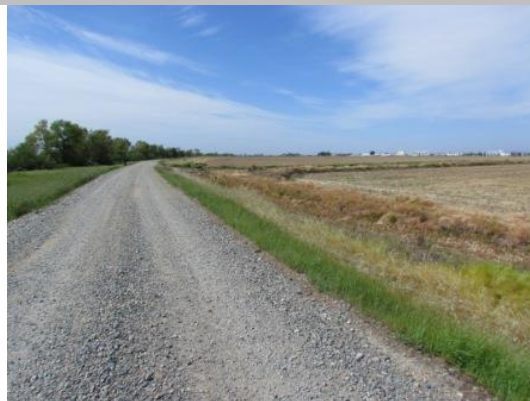
Photo 1 of 1 : SP_2020_MA0013_300_3_20200226_00001.jpg

LM Start	6.41	Rating **	M	Issue No.	3
LM End	6.99	Issue Type +	En	Location *	LS
Category	Earthen Levee			GPS Latitude/Longitude	
				Start	End
Item	Encroachments			39.508928 °	39.501438 °
				-121.714842 °	-121.719715 °
DWR ID	DWR_MA0013_01_s_2012_3				
Comment Code					
DT : Ditch					
Inspector Comment

View of the agricultural ditch along the toe.

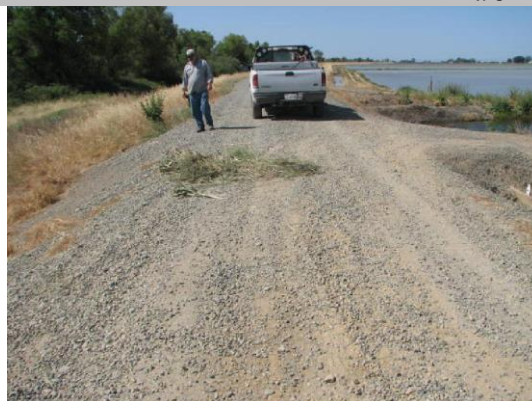
Photo 1 of 3 : UCIP_SP_2020_55967_66814.jpg

DS_ID:16362
FS_ID:55967
EP_NO: 5200B
Repair Type: Non-Urgent
Crossing Status: Found
UCIP Comments: 08/26/2019 Record has been updated from No Action Needed to Non-Urgent, potential levee integrity issues. This crossing is part of DMP's Phase 1 eligibility. No internal inspection has been completed for this crossing. Minor holes visible on LS that could be associated with burrow activity or signs of sink hole. Need internal inspection of pipe to determine condition of pipe through the levee. (O. Magana - DWR UCIP, A. Freitag - DWR Sutter Yard)06/14/2017 Hole/erosion behind the flashboards was repaired. New flash boards were installed and the erosion hole filled back in. Pipe has been selected to be internally cleaned and inspected as part of the DMP project. (DWR Sutter Yard- A.Freitag)11/16/2016 Hole/erosion still present behind the LS flashboards. (DWR Sutter Yard- A.Freitag)04/28/2016 Hole still present behind the LS flashboards. Rest of the crossing appeared in good condition. (DWR Sutter Yard - afreitag)07/13/2015 Hole still present behind the LS flashboards. (DWR Sutter Yard - afreitag)05/21/2014 Same as last inspection. (DWR Sutter Yard - afreitag)12/02/2013 Same as last inspection. (DWR Sutter Yard - afreitag)07/15/2013 WS slope has been cleared of vegetation and is in good condition. Hole is still present behind flash boards on LS. (DWR Sutter Yard - afreitag)04/18/2012 Hole behind flashboards against slide gate on LS slope (Health and Safety Issue). Limited inspection on WS slope due to dense vegetation. Need photo of cleared slope on WS. (DWR UCIP - omagana)

Overview of levee crown at crossing looking downstream.

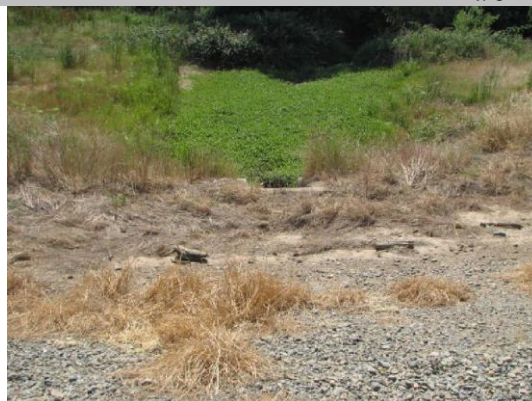
Photo 2 of 3 : UCIP_SP_2020_55967_66813.jpg

View of WS slope and toe.

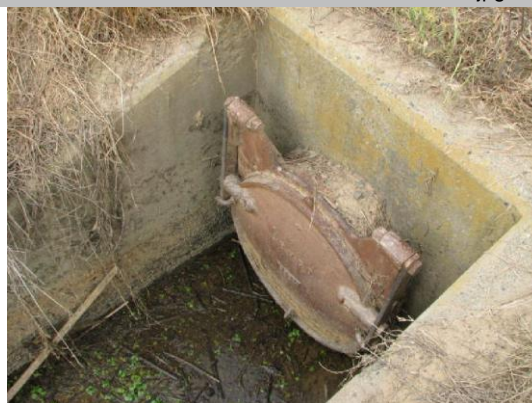
Photo 3 of 3 : UCIP_SP_2020_55967_66811.jpg

WS flap gate.

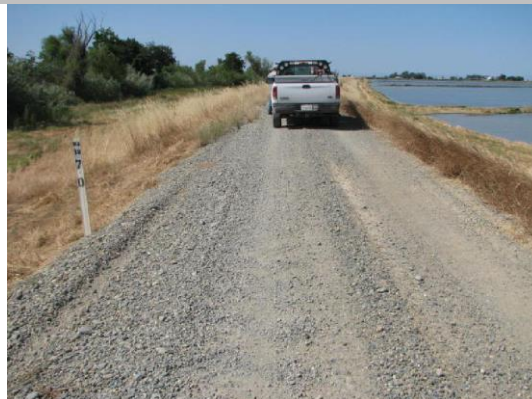
Photo 1 of 3 : UCIP_SP_2020_54967_66833.jpg

DS_ID:16329
FS_ID:54967
EP_NO: N/A
Repair Type: Non-Urgent
Crossing Status: Found
UCIP Comments: 08/26/2019 Record remains Non-Urgent, due to no permit found authorizing pipe and maintenance issue. Pipe is scheduled to be lined. Slide gate detached and sitting on the side of concrete wingwall. Slide gate will need to be re-attached. (O. Magana - DWR UCIP, A. Freitag - DWR Sutter Yard)06/14/2017 LS slide gate is still damaged and needing to be replaced. WS appeared to be in good condition. Pipe has been selected to be internally cleaned and inspected as part of the DMP project. (DWR Sutter Yard- A.Freitag)11/16/2016 Needs a new screw gate installed on the LS. (DWR Sutter Yard- A.Freitag)04/28/2016 LS slide gate is still bent. Everything else with the crossing appeared ok.07/13/2015 LS screw gate needs to be replaced. Everything else with crossing seems to be in good condition.05/21/2014 Same as last inspection.12/02/2013 Same as last inspection.07/15/2013 Slopes have been cleared of vegetation and are in good condition. There were no apparent signs of settling. LS screw gate is still damaged.04/18/2012 LMA's inspection sheet of 2011 indicates settlement and visible corrosion. Damage/severe corrosion on screw gate where it bolts to headwall. No visible signs of settlement due to high vegetation cover. Limited inspection on WS and LS slopes due to dense vegetation. Need photos of cleared slopes for this crossing.

Overview of levee crown at crossing looking D/S.

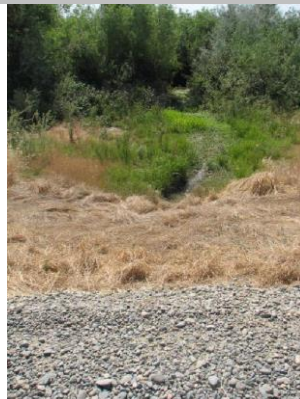
Photo 2 of 3 : UCIP_SP_2020_54967_66832.jpg

View of WS slope and toe.

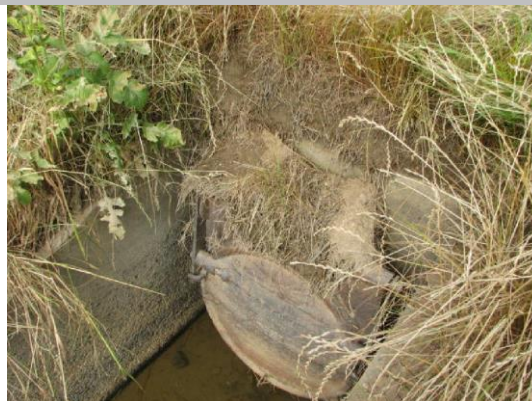
Photo 3 of 3 : UCIP_SP_2020_54967_66837.jpg

WS Flap Gate

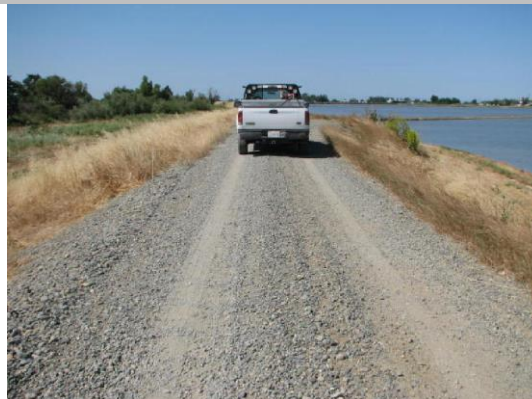
Photo 1 of 3 : UCIP_SP_2020_56089_66844.jpg

DS_ID:16354
FS_ID:56089
EP_NO: N/A
Repair Type: Non-Urgent
Crossing Status: Found
UCIP Comments: 08/26/2019 Record remains Non-Urgent, no permit has been identified authorizing pipe. Pipe is scheduled to be lined. (O. Magana - DWR UCIP, A. Freitag - DWR Sutter Yard)06/14/2017 LS slide gate stem still bent. WS appeared to be in good condition. Pipe has been selected to be internally cleaned and inspected as part of the DMP project. (DWR Sutter Yard- A.Freitag)11/16/2016 Screw gate stem bent but gate is still operational. (DWR Sutter Yard- A.Freitag)04/28/2106 Tested positive closure device the bent stem on the slide gate did not seem to affect its functions. Gate operable.07/13/2015 LS screw gate stem is still bent. Gate should still be able to close fully. The rest of the crossing seems to be in good condition.05/21/2014 Same as last inspection.12/02/2013 Same as last inspection.07/15/2013 Slopes have been cleared of vegetation and are in good condition. LS screw gate stem is still bent.04/18/2012 LS slide gate stem is bent and needs to be replaced. Limited inspection on WS and LS slope due to dense vegetation. Need photos of cleared slopes during next inspection. Confirmed flap gate on WS. This crossing was listed in the USACE Periodic Inspection report as Corp's inspect ID#USACE_CESPK_M13D_2011_p_0244 for submerged WS gate. FIELD_STRUCT_DESC: 24-inch corrugated metal drainage pipe through the levee, 11.2 feet below the crown. Flap gate on the waterside (WS) end. Slide gate on the landside (LS) end. Concrete "U" headwall on both ends. [Additional Reference(s): DWR Levee Log, 1993 (HLM 7.34). USACE Sacramento O&M Manual 519, June 1962 (HLM 7.34), As-built DWG No. 50-4-3608, Sheet No. 3608/18, STA 736+00E, page 19 of 28 electronic file, listed as 24-inch CMP; As-built DWG No 50-4-3037 referenced not available]

Overview of levee crown at crossing looking D/S.

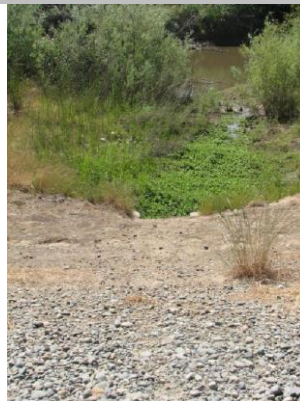
Photo 2 of 3 : UCIP_SP_2020_56089_66845.jpg

View of WS slope and toe.

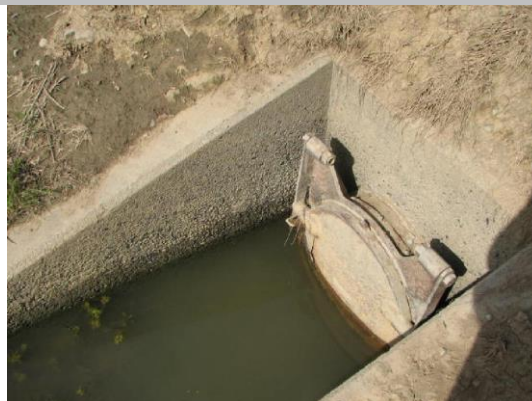
Photo 3 of 3 : UCIP_SP_2020_56089_66842.jpg

WS Flap Gate

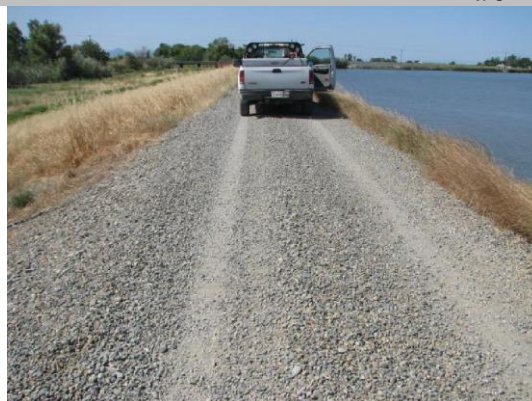
Photo 1 of 3 : UCIP_SP_2020_54969_66853.jpg

Comment Code						
Inspector Comment						
DS_ID:16352 FS_ID:54969 EP_NO: N/A Repair Type: Non-Urgent Crossing Status: Found UCIP Comments: 08/26/2019 Record has been updated from No Action Needed to Non-Urgent, no permit has been identified authorizing pipe. Pipe is scheduled to be lined. (O. Magana - DWR UCIP, A. Freitag - DWR Sutter Yard)06/14/2017 Crossing appears to be in good condition. Pipe has been selected to be internally cleaned and inspected as part of the DMP project. (DWR Sutter Yard-AFreitag)11/16/2016 Crossing appears to be in good condition. (DWR Sutter Yard- AFreitag)04/28/2016 Crossing appears to be in good condition.07/13/2015 WS ditch is getting to be heavily vegetated but it is not yet affecting flap gate operation. Vegetation needs to be cleared back some.05/21/2014 Same as last inspection.12/02/2013 Same as last inspection.07/15/2013 Slopes have been cleared of vegetation and are in good condition.04/18/2012 Limited inspection on WS and LS slopes due to dense vegetation. Need photos of cleared WS and LS slopes during next inspection. FIELD_STRUCT_DESC: 24-inch corrugated metal drainage pipe through the levee, 10.2 feet below the crown. Flap gate on the waterside (WS) end. Screw gate on the landside (LS) end. Concrete headwall on both ends. [Additional Reference(s): DWR Levee Log, 1993 (HLM 7.58). USACE Sacramento O&M Manual 519, June 1962 (HLM 7.58), As-built DWG No. 50-4-3608, Sheet No. 3608/18, STA 724+32E, page 19 of 28 electronic file, listed as 24-inch CMP; As-built DWG No 50-4-3037 referenced not available] FS Date: 8/26/2019 1:03:00 PM

View of levee crown at crossing looking D/S.

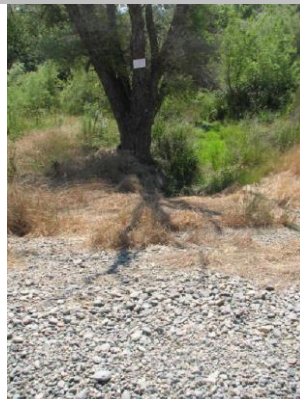
Photo 2 of 3 : UCIP_SP_2020_54969_66851.jpg

WS view of slope and channel.
