**Flood Control Project Maintenance
Levee Inspections**
LMA District Cover Sheet
Spring 2020 Levee Inspection Results

Sutter Maintenance Yard Maintenance Area 0013

Spring 2020 Levee Inspection Results

Waterway			Bank	Unit Miles
Unit No. 01 Cherokee Canal			Right	18.19
	Spring (March - May)	Summer (June - August)	(September - November) Fall	Winter (December - February)
Unit Maintenance Rating (Fall Only)				
Date of Inspection	4/9/2020 - 4/9/2020			
DWR Inspector	Makar Sokol			
Accompanied By	Bob Duffey Sutter Maintenance Yard

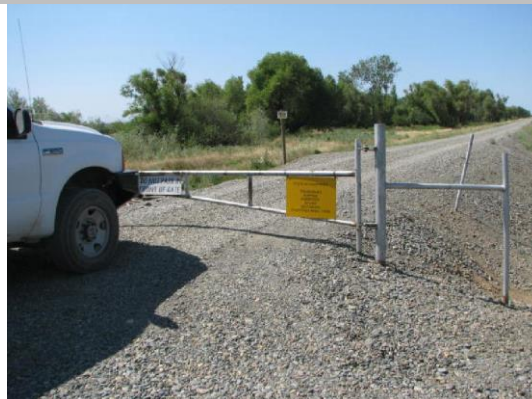
Photo 1 of 3 : UCIP_SP_2020_56090_66867.jpg

Comment Code						
Inspector Comment						
DS_ID:16320 FS_ID:56090 EP_NO: N/A Repair Type: Non-Urgent Crossing Status: Found UCIP Comments: 08/26/2019 Record has been updated from No Action Needed to Non-Urgent, no permit has been identified authorizing pipe. Pipe is scheduled to be lined. The following maintenance issues should be addressed: clear vegetation from LS inlet and repair CMP riser lid (safety measure). (O. Magana - DWR UCIP, A. Freitag - DWR Sutter Yard)06/14/2017 Debris down inside of WS riser. The rest of the crossing appears to be in good condition. Pipe has been selected to be internally cleaned and inspected as part of the DMP project. (DWR Sutter Yard- A.Freitag)11/16/2016 Crossing appears to be in good condition. (DWR Sutter Yard- A.Freitag)04/28/2016 Crossing appears to be in good condition.07/13/2015 The bottom of the entire pipe has about 8inch of sediment in it. Sediment is preventing the screw gate from fully closing. WS flap gate seems to be in good condition.05/21/2014 Same as last inspection.12/03/2013 Same as last inspection.07/15/2013 Same as last inspection. FIELD_STRUCT_DESC: 48-inch corrugated metal drainage pipe through the levee, 9.9 feet below the crown. Flap gate on the waterside (WS) end. Slide gate in corrugated metal pipe riser on the WS slope. Concrete "U" headwalls on both ends. Spillway grouted for 35 feet. [Additional Reference(s): DWR Levee Log, 1993 (HLM 7.76). USACE Sacramento O&M Manual 519, June 1962 (HLM 7.76), As-built DWG No. 50-4-3608, Sheet No. 3608/18, STA 714+28E, page 19 of 28 electronic file, listed as 48-inch CMP; As-built DWG No 50-4-3037 referenced not available] FS Date: 8/26/2019 1:06:00 PM

Overview of levee crown at crossing (past gate) looking D/S.

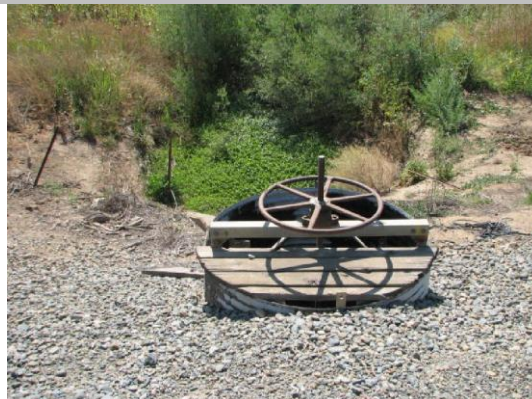
Photo 2 of 3 : UCIP_SP_2020_56090_66865.jpg

View of WS slope, corrugated metal riser with slide gate.

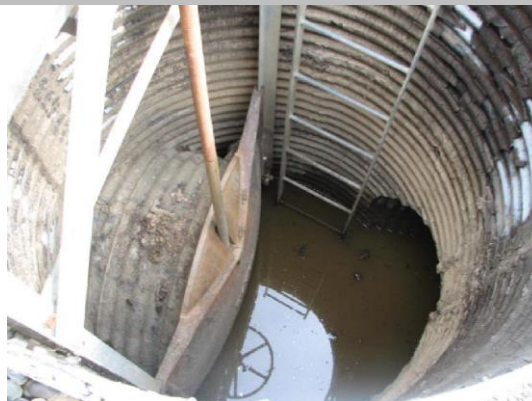
Photo 3 of 3 : UCIP_SP_2020_56090_66863.jpg

WS Slide gate

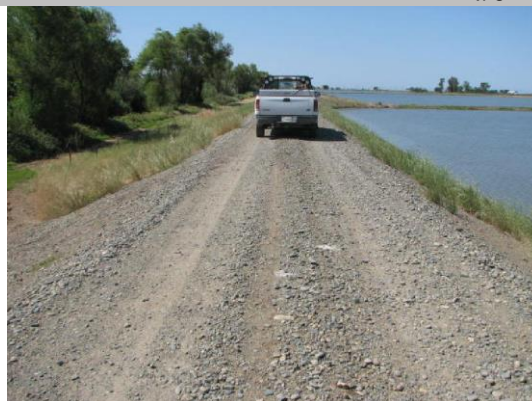
Photo 1 of 3 : UCIP_SP_2020_54973_66872.jpg

Comment Code						
Inspector Comment						
DS_ID:16321 FS_ID:54973 EP_NO: N/A Repair Type: Non-Urgent Crossing Status: Found UCIP Comments: 08/27/2019 Record has been updated from No Action Needed to Non-Urgent, no permit has been identified authorizing pipe. Pipe is scheduled to be lined. (O. Magana - DWR UCIP, A. Freitag - DWR Sutter Yard)06/14/2017 Crossing appears to be in good condition. Pipe has been selected to be internally cleaned and inspected as part of the DMP project. (DWR Sutter Yard- AFreitag)11/16/2016 Crossing appears to be in good condition. (DWR Sutter Yard- AFreitag)04/28/2016 Crossing appears to be in good condition.07/13/2015 Crossing appears to be in good condition. 05/21/2014 Same as last inspection.12/03/2013 Same as last inspection.07/15/2013 Same as last inspection.04/18/2012 Sediment build up against flashboards. Flashboards are in use on landside of levee. FIELD_STRUCT_DESC: 24-inch corrugated metal drainage pipe through the levee, 8.2 feet below the crown. Flap gate on the waterside (WS) end. Concrete "U" headwalls on both ends. Flashboards should be present on the landside (LS). [Additional Reference(s): DWR Levee Log, 1993 (HLM 8.11). USACE Sacramento O&M Manual 519, June 1962 (HLM 8.12), As-built DWG No. 50-4-3608, Sheet No. 3608/18, STA 696+00E, page 19 of 28 electronic file, listed as 24-inch CMP; As-built DWG No 50-4-3037 referenced not available] FS Date: 8/27/2019 2:07:00 PM

Overview of levee crown at crossing looking D/S.

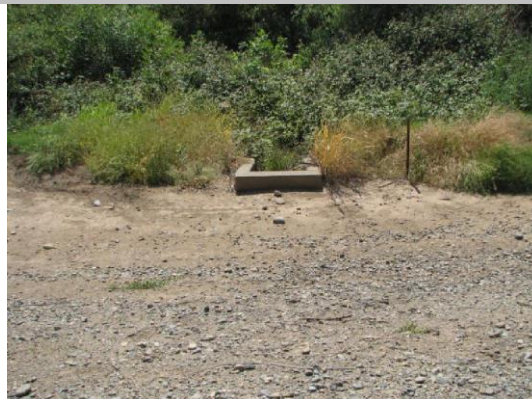
Photo 2 of 3 : UCIP_SP_2020_54973_66873.jpg

View of WS slope and toe.

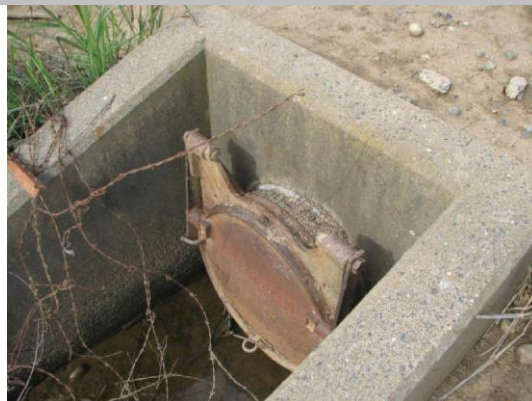
Photo 3 of 3 : UCIP_SP_2020_54973_66869.jpg

WS Flap gate

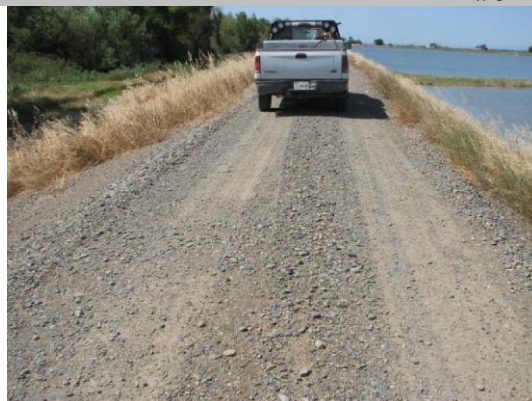
Photo 1 of 3 : UCIP_SP_2020_54974_66876.jpg

DS_ID:16322
FS_ID:54974
EP_NO: N/A
Repair Type: Non-Urgent
Crossing Status: Found
UCIP Comments: 08/27/2019 Record remains Non-Urgent, no permit has been identified authorizing pipe. Vegetation needs to be cleared from inlet/outlet. Pipe is scheduled to be lined. (O. Magana - DWR UCIP, A. Freitag - DWR Sutter Yard)06/14/2017 Both sides of the crossing were buried with sediment- needs to be cleared away. Pipe has been selected to be internally cleaned and inspected as part of the DMP project. (DWR Sutter Yard- AFreitag)11/16/2016 WS flap gate is closed but is blocked from opening by sediment. (DWR Sutter Yard- AFreitag)04/28/2016 Crossing appears to be in good condition.07/13/2015 Minor sediment build up blocking flap gate from opening on WS. Needs to be dug out.05/21/2014 Same as last inspection.12/03/2013 Same as last inspection.07/15/2013 Slopes are cleared of vegetation and are in good condition. WS flap gate is blocked from opening fully by sediment.04/18/2012 Sediment build up on LS. Debris (broken panels) scattered near LS headwall. Limited inspection on WS and LS slope due to dense vegetation. Need photos of cleared WS and LS slopes.

Overview of levee crown at crossing looking D/S.

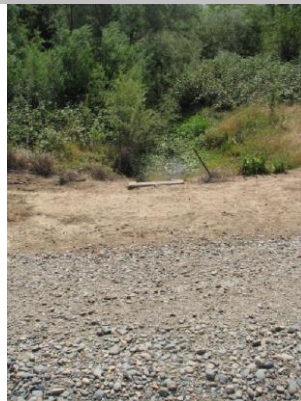
Photo 2 of 3 : UCIP_SP_2020_54974_66874.jpg

View of WS slope and toe.

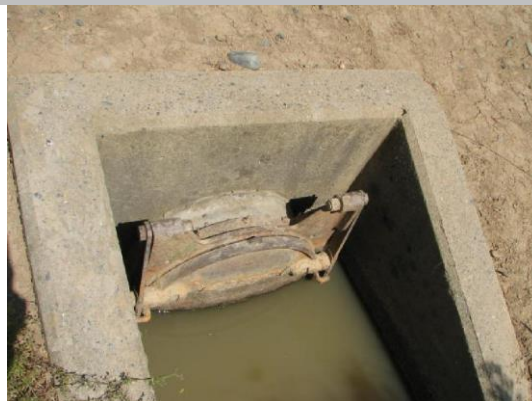
Photo 3 of 3 : UCIP_SP_2020_54974_66877.jpg

View of WS flap gate and headwall.

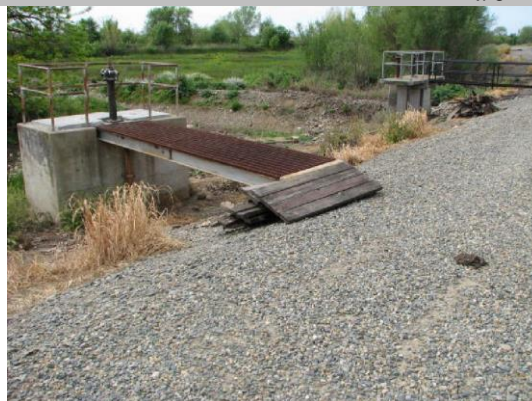
Photo 1 of 3 : UCIP_SP_2020_54975_66881.jpg

DS_ID:16323
FS_ID:54975
EP_NO: N/A
Repair Type: Urgent
Crossing Status: Found
UCIP Comments: 08/27/2019 Same as last inspection; crossing remains Urgent due to LS toe erosion. No permit has been identified authorizing irrigation structure. (O. Magana - DWR UCIP, A. Freitag - DWR Sutter Yard)08/23/2018 Same as last inspection; crossing remains Urgent because LS erosion is still present and poses a levee integrity risk (D. Sanoski - DWR UCIP).06/14/2017 LS underwater but levee erosion is still present- needs to be repaired. Pipe has been selected to be internally cleaned and inspected as part of the DMP project. (DWR Sutter Yard- A.Freitag)11/16/2016 LS erosion is still a major problem here. (DWR Sutter Yard- A.Freitag)04/28/2016 Erosion still present at the LS headwall. (DWR Sutter Yard - afreitag)07/13/2015 Erosion still present behind the LS headwall. It looks to be getting worse and is starting to affect the levee slope. (DWR Sutter Yard - afreitag)05/21/2014 Same as last inspection. (DWR Sutter Yard - afreitag)12/03/2013 Same as last inspection. (DWR Sutter Yard - afreitag)07/15/2013 Same as last inspection. (DWR Sutter Yard - afreitag)04/18/2012 Concrete headwall is cracked, erosion behind headwall is also present. LS headwall needs to be repaired/replaced. Remove wooden debris from levee shoulder. (DWR UCIP - omagana)

Catwalk and screw gate located on WS.

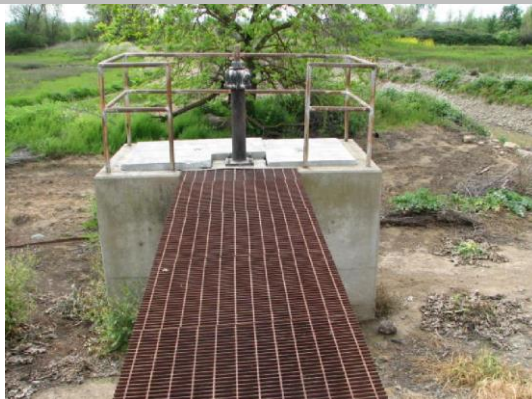
Photo 2 of 3 : UCIP_SP_2020_54975_66884.jpg

Catwalk & gate located on WS. No daylight point on WS.

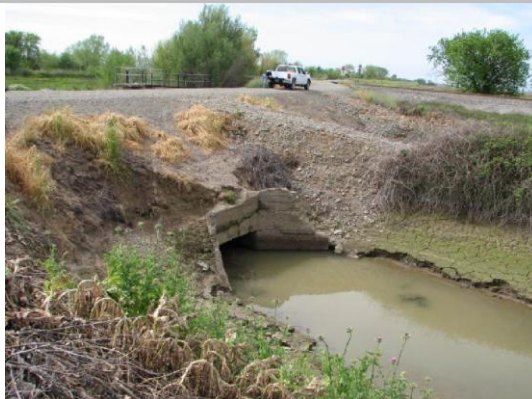
Photo 3 of 3 : UCIP_SP_2020_54975_66882.jpg

View of LS structure. Erosion present behind headwall.

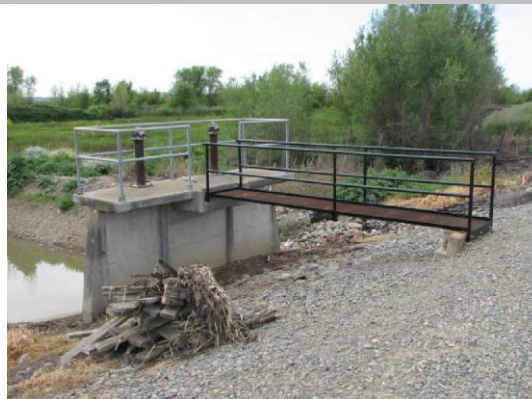
Photo 2 of 3 : UCIP_SP_2020_55011_66892.jpg

Catwalk, sluice gates, & headwall on WS.

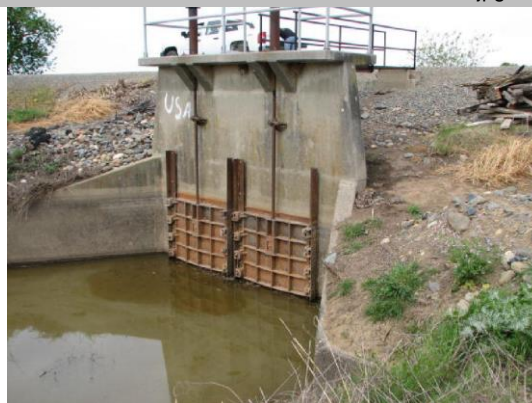
Photo 3 of 3 : UCIP_SP_2020_55011_66891.jpg

Headwall and sluice gates located on WS.

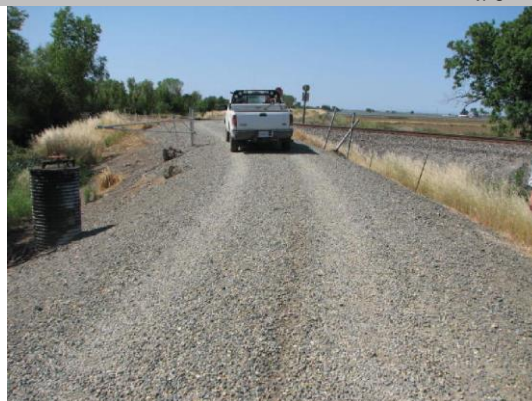
Photo 1 of 3 : UCIP_SP_2020_54978_66895.jpg

Comment Code					
Inspector Comment					
DS_ID:16325 FS_ID:54978 EP_NO: N/A Repair Type: Non-Urgent Crossing Status: Found UCIP Comments: 08/28/2019 Record remains Non-Urgent, no permit has been identified authorizing pipe. Spoke to Richvalle Irrigation District manager and he mentioned that this structure is not theirs. He recommended that LMA-Sutter Yard break lock to access crossing. Crossing appears to fit general configuration for drainage structure. (O. Magana - DWR UCIP, A. Freitag - DWR Sutter Yard)08/27/2019 No permit has been found authorizing this structure. Need to find owner. Originally assigned to LMA-Sutter Yard however, unknown locks on WS slide gates. This crossing is not maintained or operated by LMA-Sutter Yard. (O. Magana - DWR UCIP, A. Freitag - DWR Sutter Yard)06/14/2017 Debris drifts built up around the WS slide gates-needs to be cleared away. LS appears to be n good condition. Pipe has been selected to be internally cleaned and inspected as part of the DMP project. (DWR Sutter Yard- AFreitag)11/16/2016 Crossing appears to be in good condition. (DWR Sutter Yard- AFreitag)04/28/2016 Crossing appears to be in good condition.07/13/2015 Crossing appears in good condition. No noticeable issues to report.05/21/2014 Same as last inspection.12/03/2013 Same as last inspection.07/15/2013 LS slope has been sprayed and cleared of vegetation and is in good condition.04/18/2012 Limited inspection on LS slope due to dense vegetation. Need photo of cleared vegetation from slopes and WS headwall. Minor debris scattered on WS slope. FIELD_STRUCT_DESC: 24-inch corrugated metal drainage pipe angled through the levee, 12.6 feet below the crown. Slide gate in corrugated metal pipe riser on the waterside (WS) slope. Slide gate on the WS end. Concrete "U" headwall on both ends. [Additional Reference(s): DWR Levee Log, 1993 (HLM 8.98). USACE Sacramento O&M Manual 519, June 1962 (HLM 8.98), As-built DWG No. 50-4-3608, Sheet No. 3608/18, 20, STA 648+55.16E, page 19, 21 of 28 electronic file, listed as 24-inch CMP] FS Date: 8/27/2019 2:11:00 PM

Overview of levee crown at crossing looking D/S.

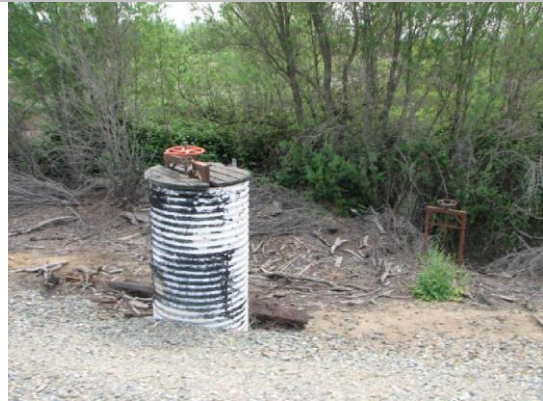
Photo 2 of 3 : UCIP_SP_2020_54978_66897.jpg

View of WS slope with 2 slide gates.

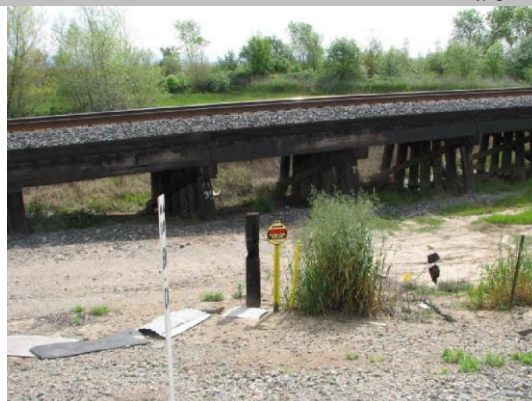
Photo 1 of 3 : UCIP_SP_2020_54979_66904.jpg

DS_ID:16326
FS_ID:54979
EP_NO: 3836
Repair Type: Non-Urgent
Crossing Status: Indicator Found
UCIP Comments: 08/27/2019 Record has been updated from No Action Needed to Non-Urgent, need to reach out to owner to obtain maintenance records. (O. Magana - DWR UCIP, A. Freitag - DWR Sutter Yard)06/14/2017 Crossing appears to be in good condition. (DWR Sutter Yard- A.Freitag)11/16/2016 Crossing appears to be in good condition. (DWR Sutter Yard- A.Freitag)04/28/2016 Crossing appears to be in good condition.07/13/2015 Crossing appears in good condition. No noticeable issues to report.05/21/2014 Same as last inspection.12/03/2013 Same as last inspection.07/15/2013 Same as last inspection.04/18/2012 Line is still in use. Visible markers on WS and LS.
FIELD_STRUCT_DESC: 8.625-inch high pressure steel fuel line through the levee, 3.2 feet below the crown. Marker located on the waterside (WS). Kinder Morgan is the owner of line--contact information is 213.624.9461 or Chico Local Area Manager, Frank Villalovos 530.342.6140 (o) or 530.624.4048 ? Or email villalovosf@kindermorgan.com. Additional contact is Ken Yeo, Sacramento Local Area Manager, at 916.416.7938 or by email yeok@kindermorgan.com. Frank Villalovos is the primary contact for this crossing. (Permit No. 3836, 1962 - Southern Pacific Pipelines Inc.) [Additional Reference(s): DWR Levee Log, 1993 (HLM 9.01)]

Underground petroleum pipeline marker visible on WS.

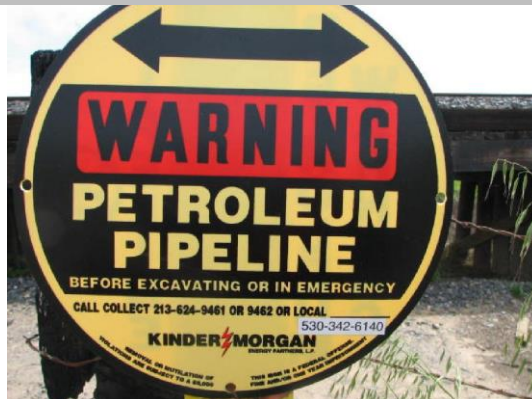
Photo 2 of 3 : UCIP_SP_2020_54979_66903.jpg

Petroleum information marker.

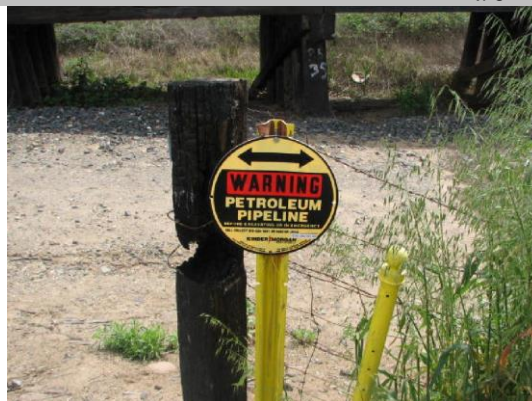
Photo 3 of 3 : UCIP_SP_2020_54979_66902.jpg

Sign visible on WS.

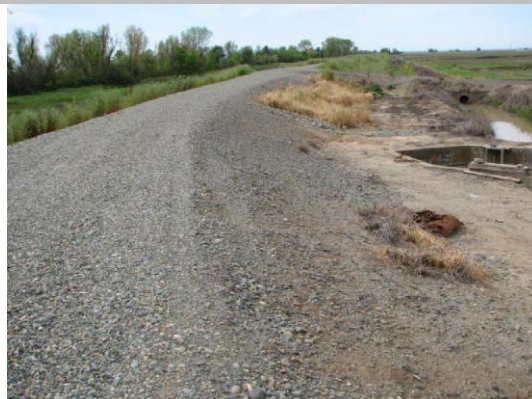
Photo 1 of 3 : UCIP_SP_2020_54980_66908.jpg

DS_ID:16828
FS_ID:54980
EP_NO: N/A
Repair Type: Non-Urgent
Crossing Status: Found
UCIP Comments: 08/27/2019 Record remains Non-Urgent due to potential threat to levee and no permit identified authorizing this pipe. Small leak found on LS by concrete distribution box about 10 feet from levee toe. (O. Magana - DWR UCIP, A. Freitag - DWR Sutter Yard)06/14/2017 Erosion still present on the side of the LS structure- still not affecting levee yet. (DWR Sutter Yard- AFreitag)11/16/2016 Some erosion still present near the LS structure. Does not affect the levee yet. (DWR Sutter Yard- AFreitag)04/28/2016 Erosion happening around the concrete structure on LS. Its not yet affecting the levee but will keep monitoring.07/13/2015 Crossing appears in good condition. No noticeable issues to report.05/21/2014 Same as last inspection.12/03/2013 Same as last inspection.07/15/2013 Same as last inspection.04/18/2012 Crossing is not visible on WS. FIELD_STRUCT_DESC: 72-inch irrigation pipe through the levee located 14.2 feet below the crown. Appurtenances include concrete pipe siphon, screw gate, and distribution box visible on the landside (LS). No appurtenances found on the waterside (WS). [Additional Reference(s): DWR Levee Log, 1993 (HLM 3.80), listed as 60-inch pipe. USACE Sacramento O&M Manual 519, June 1962 (HLM 9.02), listed as 72-inch pipe siphon, As-built DWG No. 50-4-3608, Sheet No. 3608/20, STA 646+33.31E, page 21 of 28 electronic file, listed as 6-foot diameter concrete pipe (siphon)]

Overview picture looking south

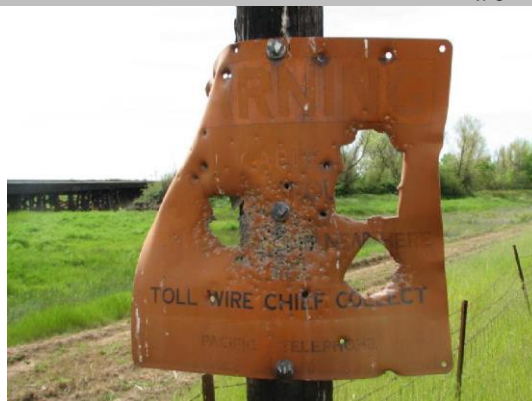
Photo 1 of 3 : UCIP_SP_2020_54981_66909.jpg

Comment Code						
Inspector Comment						
DS_ID:16328 FS_ID:54981 EP_NO: 1234A Repair Type: Non-Urgent Crossing Status: Indicator Found UCIP Comments: 08/27/2019 Record remains Non-Urgent, due to maintenance issue and/or potential abandonment of pipe through levee. Marker is still missing unable to determine if crossing has been abandoned. Need to contact owner to determine status of crossing. (O. Magana - DWR UCIP, A. Freitag - DWR Sutter Yard)06/14/2017 WS marker missing. (DWR Sutter Yard- A.Freitag)11/16/2016 WS marker is knocked over and laying on the ground. (DWR Sutter Yard- A.Freitag)04/28/2016 Marker missing on WS.07/13/2015 Crossing appears in good condition. No noticeable issues to report.Need to contact owner to replace marker.07/15/2013 Same as last inspection.12/03/2013 Same as last inspection.05/21/2014 Same as last inspection. FIELD_STRUCT_DESC: Underground telephone cable through the levee at an unknown depth below the crown. (Permit No. 1234, 1234A, 1947 - Pacific Telephone and Telegraph Company [PT&T]) [Additional Reference(s): DWR Levee Log, 1993 (HLM 9.03)] FS Date: 8/27/2019 2:13:00 PM

Underground telephone cable marker located on WS.

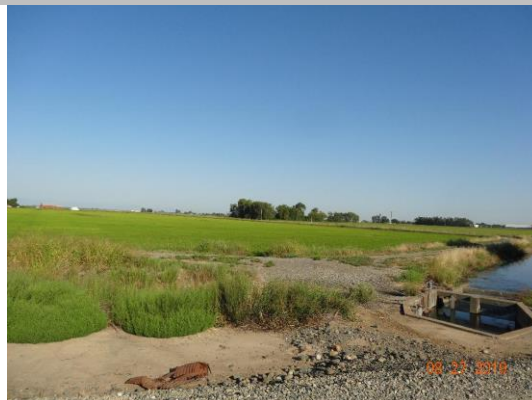
Photo 2 of 3 : UCIP_SP_2020_54981_80467.jpg

LS view: overview of LS, no marker found.

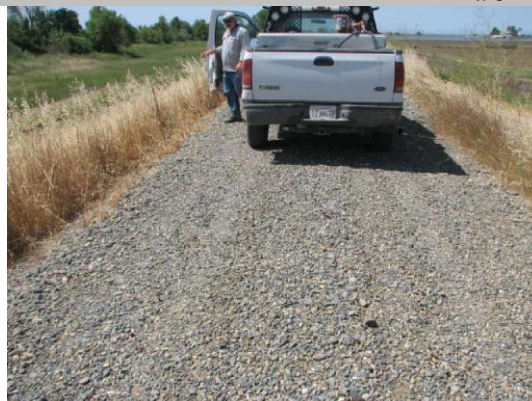
Photo 1 of 3 : UCIP_SP_2020_54982_66910.jpg

DS_ID:16317
FS_ID:54982
EP_NO: N/A
Repair Type: Non-Urgent
Crossing Status: Found
UCIP Comments: 08/27/2019 Record has been updated from No Action Needed to Non-Urgent, no permit has been identified authorizing pipe. Pipe is scheduled to be lined. (O. Magana - DWR UCIP, A. Freitag - DWR Sutter Yard)06/14/2017 Crossing appears to be in good condition. Pipe has been selected to be internally cleaned and inspected as part of the DMP project. (DWR Sutter Yard- AFreitag)11/16/2016 Crossing appears to be in good condition. (DWR Sutter Yard- AFreitag)04/28/2016 Crossing appears to be in good condition.07/13/2015 LS inlet has minor vegetation still. WS appears in good condition.05/21/2014 Same as last inspection.12/03/2013 Same as last inspection.07/15/2013 Slopes have been cleared of vegetation and are in good condition.04/18/2012 Limited inspection on WS and LS slopes due to dense vegetation. Need photos of cleared WS and LS slopes. This crossing was listed in the USACE Periodic Inspections as Corp's Inpect ID# USACE_CESPK_M13D_2011_p_0278 for WS outlet sedimentation and sediment/grass at LS inlet.

Overview of levee crown at crossing looking downstream.

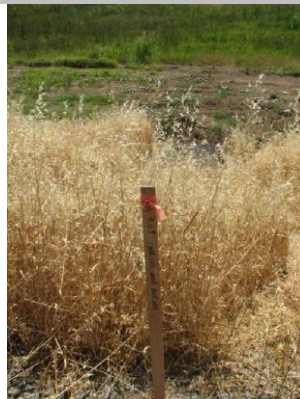
Photo 2 of 3 : UCIP_SP_2020_54982_66911.jpg

View of WS slope and toe.

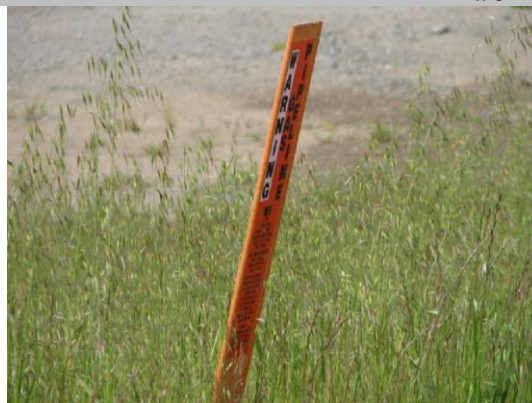
Photo 1 of 3 : UCIP_SP_2020_54986_66917.jpg

Comment Code					
Inspector Comment					
DS_ID:16331 FS_ID:54986 EP_NO: 1238 Repair Type: Non-Urgent Crossing Status: Indicator Found UCIP Comments: 08/27/2019 Record has been updated from No Action Needed to Non-Urgent, no maintenance records were made available to determine condition of line through levee. Need to contact owner to request maintenance records to confirm integrity of line. (O. Magana - DWR UCIP, A. Freitag - DWR Sutter Yard)06/14/2017 Crossing appears to be in good condition. (DWR Sutter Yard-AFreitag)11/16/2016 Crossing appears to be in good condition. (DWR Sutter Yard- AFreitag)04/28/2016 Crossing appears to be in good condition.07/13/2015 Crossing appears in good condition. No noticeable issues to report.05/21/2014 Same as last inspection.12/03/2013 Same as last inspection.07/15/2013 New structure with shutoff valve installed about 5ft. from LS toe. FIELD_STRUCT_DESC: 8-inch high pressure gas line through the levee, 13.3 feet below the crown. Substation with wire enclosure at the landside (LS) toe. (Permit No. 1238, 1947 - Pacific Gas and Electric Company [PG&E]) [Additional Reference(s): DWR Levee Log, 1993 (HLM 10.03). USACE Sacramento O&M Manual 519, June 1962 (HLM 10.03), listed as 8-inch gas line] FS Date: 8/27/2019 2:15:00 PM

Underground gas line marker on LS.

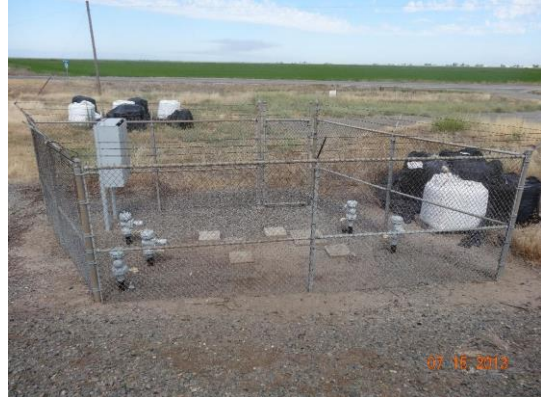
Photo 2 of 3 : UCIP_SP_2020_54986_66919.jpg

Substation near LS toe

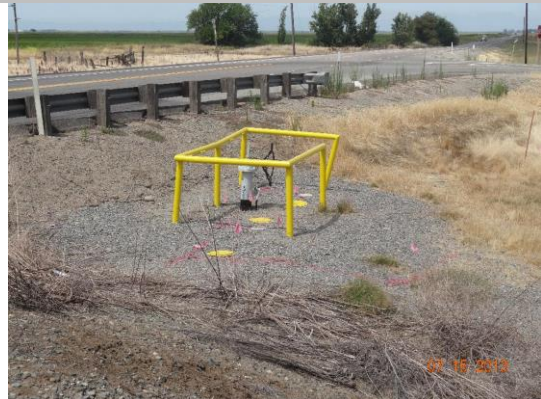
Photo 3 of 3 : UCIP_SP_2020_54986_66918.jpg

New shutoff valve structure near LS toe

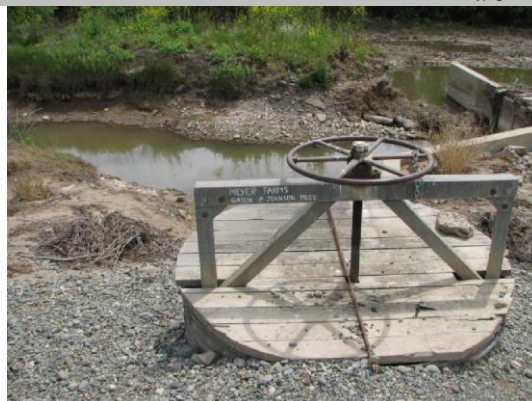
Photo 2 of 3 : UCIP_SP_2020_54990_66925.jpg

Corrugated metal riser with owner information.

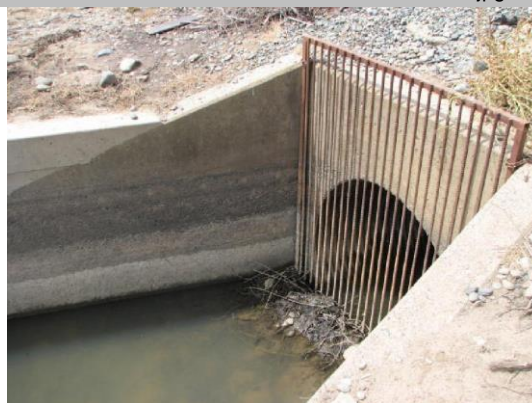
Photo 3 of 3 : UCIP_SP_2020_54990_66928.jpg

Trash rack on WS headwall.

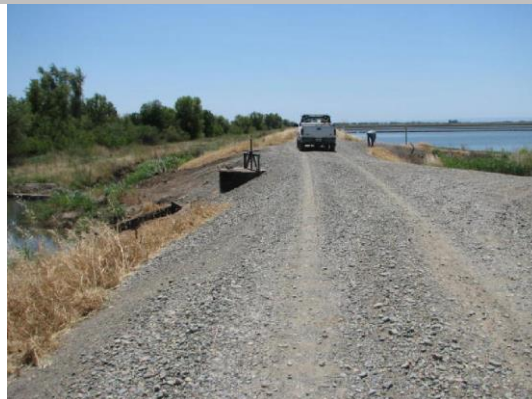
Photo 1 of 3 : UCIP_SP_2020_54989_66934.jpg

DS_ID:16333
FS_ID:54989
EP_NO: N/A
Repair Type: Non-Urgent
Crossing Status: Found
UCIP Comments: 08/27/2019 Record has been updated from No Action Needed to Non-Urgent, no permit has been identified authorizing the dual purpose of this crossing. Crossing is used as an irrigation turnout. Flow from Cherokee canal is diverted upstream by weir and feed into an irrigation canal that runs parallel along WS levee toe for about 2.5 miles. The irrigation turnout is used to divert water from WS irrigation canal to LS. Need to update crossing type from Drainage to Other. This crossing is not maintained or operated by LMA-Sutter Yard. (O. Magana - DWR UCIP, A. Freitag - DWR Sutter Yard)06/15/2017 Crossing appears to be in good condition. Pipe has been selected to be internally cleaned and inspected as part of the DMP project. (DWR Sutter Yard- A.Freitag)11/17/2016 Crossing appears to be in good condition. (DWR Sutter Yard- A.Freitag)04/28/2016 Crossing appears to be in good condition.07/13/2015 Crossing appears in good condition. No noticeable issues to report.05/21/2014 Same as last inspection.12/03/2013 Same as last inspection.07/15/2013 Same as last inspection.

Overview of levee crown at crossing looking downstream.

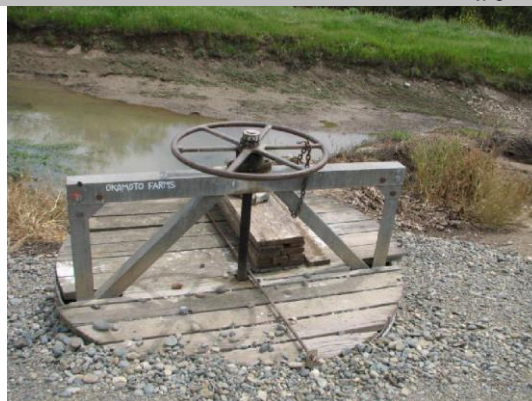
Photo 2 of 3 : UCIP_SP_2020_54989_66932.jpg

WS slide gate with owner information.

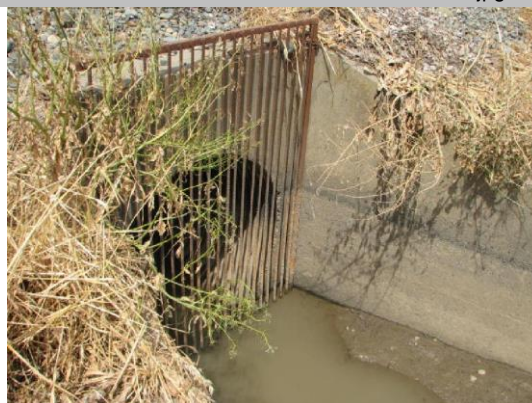
Photo 3 of 3 : UCIP_SP_2020_54989_66930.jpg

Trash rack on WS headwall.

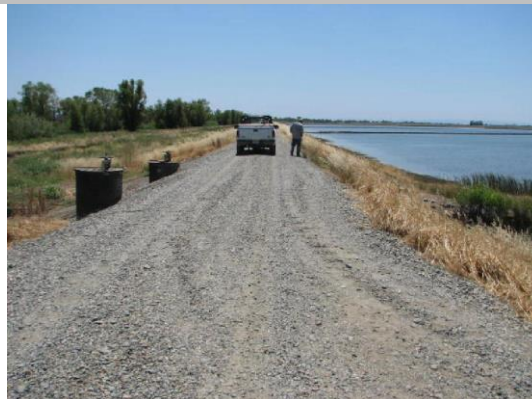
Photo 1 of 3 : UCIP_SP_2020_56091_66940.jpg

DS_ID:16334
FS_ID:56091
EP_NO: N/A
Repair Type: Non-Urgent
Crossing Status: Found
UCIP Comments: 08/27/2019 Record has been updated from No Action Needed to Non-Urgent, no permit has been identified authorizing this crossing. Irrigation siphon crosses under Cherokee Canal and Unit 2 levee at DSID 16385. (O. Magana - DWR UCIP, A. Freitag - DWR Sutter Yard)06/15/2017 WS pipe end still unknown- try to locate using GPR/ utility locator. Pipe has been selected to be internally cleaned and inspected as part of the DMP project. (DWR Sutter Yard- A.Freitag)11/17/2016 Cannot locate the WS pipe end. (DWR Sutter Yard- A.Freitag)04/28/2016 Crossing appears to be in good condition but could not locate the WS pipe end.07/13/2015 New screw gate installed inside the WS standpipe. 05/21/2014 Same as last inspection.12/03/2013 Same as last inspection.07/15/2013 Slopes have been cleared of vegetation and are in good condition. Still no sign of WS end of pipe.04/18/2012 Limited inspection on WS and LS slope due to dense vegetation. WS outlet of pipe not found. Need photos of cleared WS and LS slopes. Determine if WS outlet daylights after WS slope is cleared.

Overview of levee crown at crossing looking downstream.

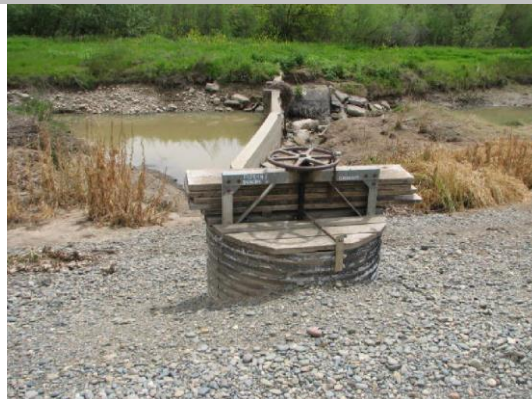
Photo 2 of 3 : UCIP_SP_2020_54993_66947.jpg

View from levee crown of WS slope and channel.

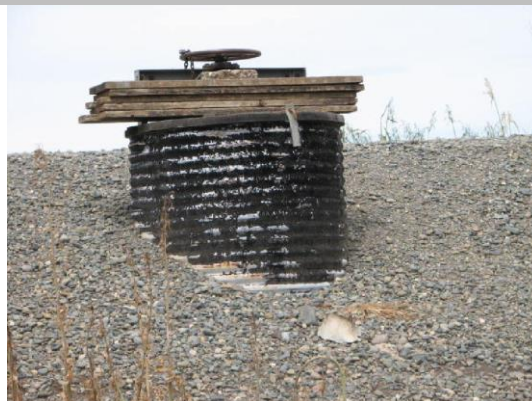
Photo 3 of 3 : UCIP_SP_2020_54993_66948.jpg

Water side screw gate located near crown hinge

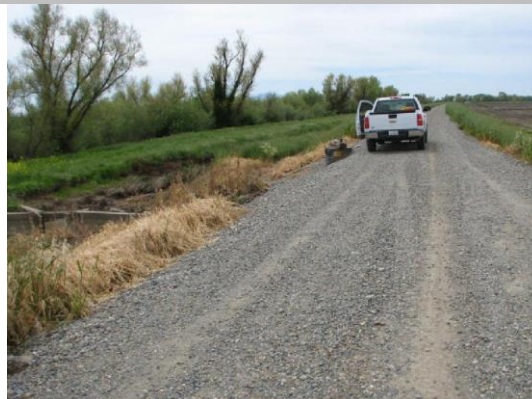
Photo 1 of 3 : UCIP_SP_2020_54994_66952.jpg

DS_ID:16336
FS_ID:54994
EP_NO: N/A
Repair Type: Non-Urgent
Crossing Status: Found
UCIP Comments: 08/27/2019 Record remains Non-Urgent, no permit has been identified authorizing the dual purpose of this crossing and slide gate is still missing from the WS CMP riser. Crossing is used as an irrigation turnout. Flow from Cherokee Canal is diverted upstream by weir and feed into an irrigation canal that runs parallel along WS levee toe for about 2.5 miles. The irrigation turnout is used to divert water from WS irrigation canal to LS. Need to update crossing type from Drainage to Other. This crossing is not maintained or operated by LMA-Sutter Yard. (O. Magana - DWR UCIP, A. Freitag - DWR Sutter Yard)06/15/2017 Slide gate still missing from inside of WS standpipe. Pipe has been selected to be internally cleaned and inspected as part of the DMP project. (DWR Sutter Yard- A.Freitag)11/17/2016 Slide gate still missing from inside the WS standpipe. (DWR Sutter Yard-A.Freitag)04/28/2016 Slide gate was removed from inside the WS standpipe.07/13/2015 New screw gate installed on the WS pipe end in the irrigation ditch.05/21/2014 Same as last inspection.12/03/2013 Same as last inspection.07/15/2013 Same as last inspection.04/18/2012 Irrigation turnout. Not in use during April 2012 Inspection. During the follow up May 2012 Inspection structure was being used as irrigation turnout, reason for barcode tags. FIELD_STRUCT_DESC: 30-inch corrugated metal drainage pipe through the levee, 10.7 feet below the crown. Slide gate in corrugated metal pipe (CMP) riser on the waterside (WS) slope. Concrete "U" headwalls on both ends. This crossing is used as an irrigation turnout bar code plate located on the WS slide gate (identified as 141 and 142). [Additional Reference(s): DWR Levee Log, 1993 (HLM 12.94). USACE Sacramento O&M Manual 519, June 1962 (HLM 12.94), As-built DWG No. 50-4-3511, Sheet No. 3511/8.3, STA 444+29E, page 8 of 31 electronic file, listed as 30-inch CMP; As-built DWG No 50-4-3037 referenced not available]

Overview picture looking south on right bank of Cherokee Canal.

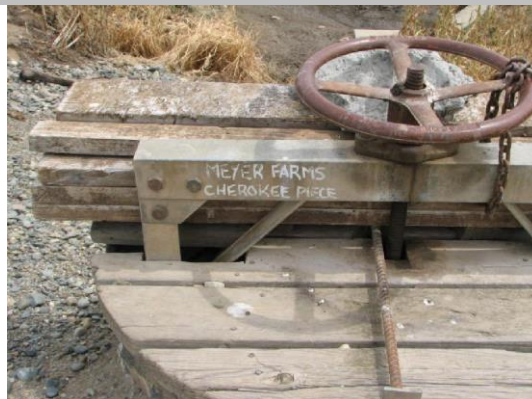
Photo 3 of 3 : UCIP_SP_2020_54994_66951.jpg

Slide gate located on WS slope. Owner information marked on gate.

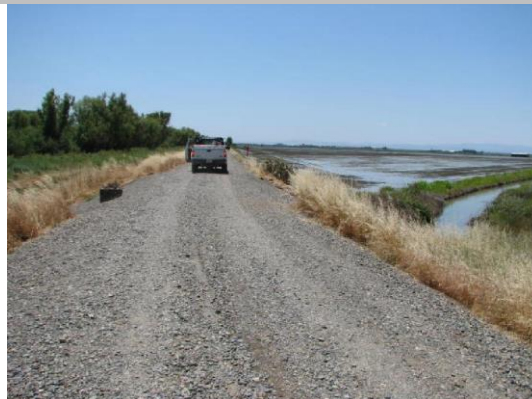
Photo 1 of 3 : UCIP_SP_2020_54996_66966.jpg

DS_ID:16337
FS_ID:54996
EP_NO: N/A
Repair Type: Non-Urgent
Crossing Status: Found
UCIP Comments: 08/27/2019 Record has been updated from No Action Needed to Non-Urgent, no permit has been identified authorizing the dual purpose of this crossing. Crossing is used as an irrigation turnout. Flow from Cherokee Canal is diverted upstream by weir and feed into an irrigation canal that runs parallel along WS levee toe for about 2.5 miles. The irrigation turnout is used to divert water from WS irrigation canal to LS. Need to update crossing type from Drainage to Other. This crossing is not maintained or operated by LMA-Sutter Yard. (O. Magana - DWR UCIP, A. Freitag - DWR Sutter Yard)06/15/2017 Crossing appears to be in good condition. Pipe has been selected to be internally cleaned and inspected as part of the DMP project. (DWR Sutter Yard- A.Freitag)11/17/2016 Ws pipe end was submerged but crossing appears to be in good condition. (DWR Sutter Yard- A.Freitag)05/03/2016 Crossing appears to be in good condition.07/13/2015 New screw gate installed inside of WS standpipe.05/21/2014 Same as last inspection.12/03/2013 Same as last inspection.07/15/2013 Same as last inspection.

Overview of levee crown at crossing looking downstream.

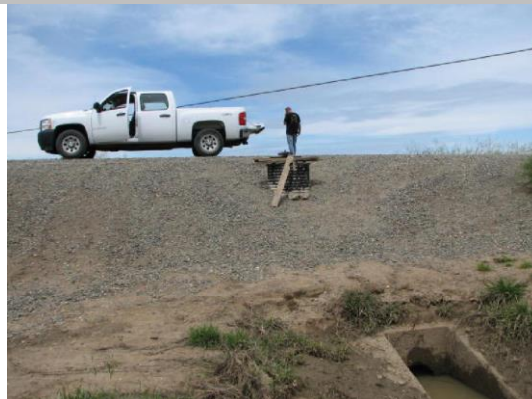
Photo 2 of 3 : UCIP_SP_2020_54996_66963.jpg

View of WS slope.

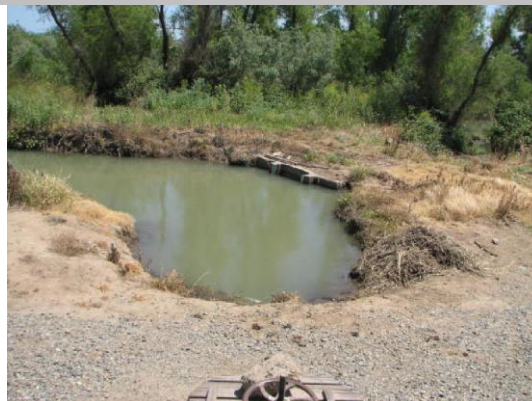
Photo 3 of 3 : UCIP_SP_2020_54996_66967.jpg

View of WS slope and channel.

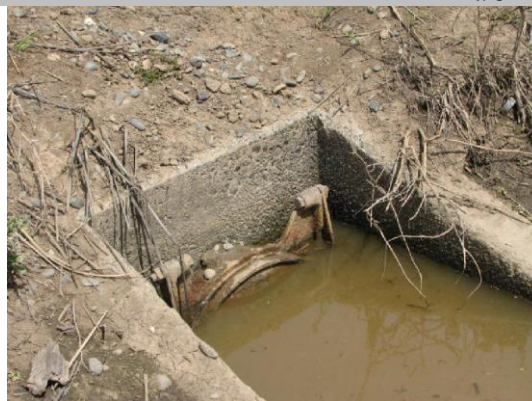
Photo 1 of 3 : UCIP_SP_2020_54997_66970.jpg

DS_ID:16338
FS_ID:54997
EP_NO: N/A
Repair Type: Non-Urgent
Crossing Status: Found
UCIP Comments: 08/27/2019 Record remains Non-Urgent, no permit has been identified authorizing pipe. Pipe is scheduled to be lined. (O. Magana - DWR UCIP, A. Freitag - DWR Sutter Yard)08/23/2018 WS flap gate has been replaced. LS outlet still has a lot of vegetation, but overall levee integrity looks good at time of this inspection.
Downgrading to Non-Urgent from Urgent due to fixed flap gate and current levee condition (D. Sanoski - DWR UCIP).06/15/2017 Not abandoned- WS flap gate was dug out and opened draining water from the LS ditch. WS flap gate is heavily corroded and has a broken hinge-needs to be replaced. LS is still very overgrown and needs to be cleared. Pipe has been selected to be internally cleaned and inspected as part of the DMP project. (DWR Sutter Yard- A.Freitag)11/17/2016 Appears abandoned. WS flap gate completely silted over and LS screw gate is completely overgrown by a tree and is not accessible for inspection. (DWR Sutter Yard- A.Freitag)05/03/2016 Crossing appears to be abandoned. WS flap gate was completely silted over and LS slide gate is very overgrown by a tree.07/13/2015 WS flap gate is blocked from opening by sediment and vegetation. Needs to be cleared away. LS opening is being over grown by a tree and needs to be cutback.05/22/2014 Same as last inspection.12/03/2013 Same as last inspection.07/15/2013 Same as last inspection.04/18/2012 Tree has fallen at LS inlet and damaged slide gate. The tree needs to be removed and screw gate repaired. Limited inspection on LS due to fallen tree.

WS headwall and flap gate.

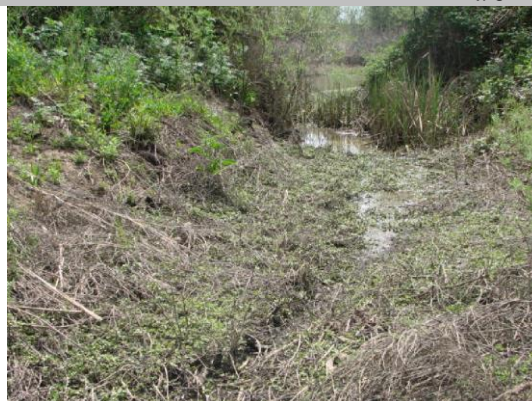
Photo 2 of 3 : UCIP_SP_2020_54997_66971.jpg

View of channel at crossing.

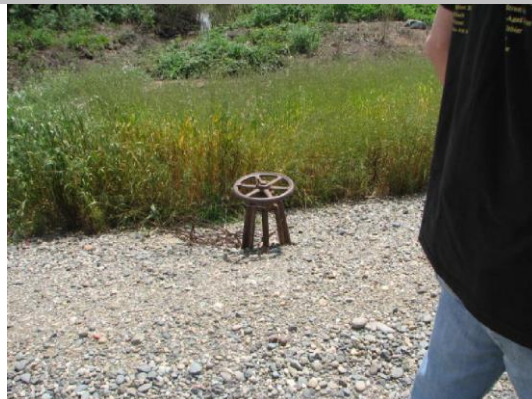
Photo 1 of 3 : UCIP_SP_2020_54998_66972.jpg

DS_ID:16339
FS_ID:54998
EP_NO: N/A
Repair Type: Non-Urgent
Crossing Status: Found
UCIP Comments: 08/27/2019 Record remains Non-Urgent, crossing has been abandoned. Need to update crossing type from Drainage to Irrigation. Crossing was used as a irrigation line and not drainage. This crossing is not maintained or operated by LMA-Sutter Yard. (O. Magana - DWR UCIP, A. Freitag - DWR Sutter Yard)06/15/2017 Abandoned- still only the structure on the WS shoulder found. (DWR Sutter Yard- A.Freitag)11/17/2016 Abandoned. (DWR Sutter Yard- A.Freitag)05/03/2016 ABANDONED CROSSING07/13/2015 Abandoned crossing. Slide gate is buried on the WS.05/22/2014 Same as last inspection.12/03/2013 Same as last inspection.07/15/2013 Same as last inspection.04/18/2012 Non-functional crossing-buried slide gate on WS. Limited inspection on WS and LS slope/toe due to dense vegetation. Need photo of cleared WS & LS slopes or toe. This crossing is listed in the USACE periodic inspection report as Corp's Inspection ID# USACE_CESPK_M13D_2011_p_0352 for abandoned gate on WS slope.

Buried slide gate on the WS slope.

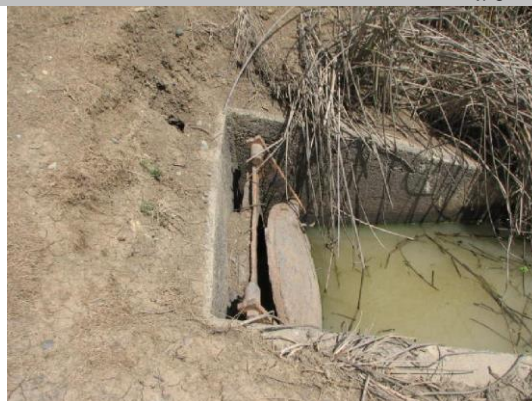
Photo 1 of 3 : UCIP_SP_2020_54999_66976.jpg

DS_ID:16368
FS_ID:54999
EP_NO: N/A
Repair Type: Urgent
Crossing Status: Found
UCIP Comments: 08/27/2019 Record remains Urgent due to pipe integrity and levee integrity issues. Previously noted holes on the pipe collar located at WS have been sealed using splash zone epoxy. Two holes (possible sink holes) were observed behind WS concrete headwall. Recommend internal inspection of pipe through levee to determine if sink holes are attributed to holes in pipe. (O. Magana - DWR UCIP, A. Freitag - DWR Sutter Yard)08/23/2018 WS pipe unable to be inspected due to heavy vegetation at inlet, so assume same as last inspection. Noticed a long crack a couple feet above WS headwall that could be of concern; possible future slough if soil gets saturated during next high water event and could be a sign of internal pipe degradation. LS outlet and slope looked good. Urgent due to long crack, obstructed inspection view of WS inlet, and 2016 photos of holes in pipe (D. Sanoski - DWR UCIP).06/15/2017 WS pipe end still showing heavy signs of corrosion and deterioration with visible holes between the concrete headwall and flap gate flange. Pipe was almost 100% full of water so could not visually inspect inside of the pipe to see if theres any damage inside of the levee segment. Pipe has been selected to be internally cleaned and inspected as part of the DMP project. (DWR Sutter Yard- A Freitag)11/17/2016 Top of pipe on WS still showing heavy signs of corrosion with visible holes between the flap gate flange and the concrete headwall. The pipe was mostly underwater so could not internally inspect it for more damage or corrosion. (DWR Sutter Yard- A Freitag)05/03/2016 Top of the pipe on the WS has holes in it between the flap gate flange and headwall. Crossing is showing signs of rust and deterioration but it was mostly underwater so could not inspect the inside of the pipe. (DWR Sutter Yard - a Freitag)07/13/2015 Both sides of crossing were underwater at the time of inspection. (DWR Sutter Yard - a Freitag)05/22/2014 Same as last inspection. (DWR Sutter Yard - a Freitag)12/03/2013 Same as last inspection. (DWR Sutter Yard - a Freitag)07/15/2013 Slopes have been cleared of vegetation and are in good condition. WS flap gate is still lodged open. (DWR Sutter Yard - a Freitag)04/18/2012 Limited inspection on LS slope due to dense vegetation. Need photos of cleared WS & LS slopes. The flap gate is lodged open. (DWR UCIP - omagana)

Headwall and flapgate located on water side of levee

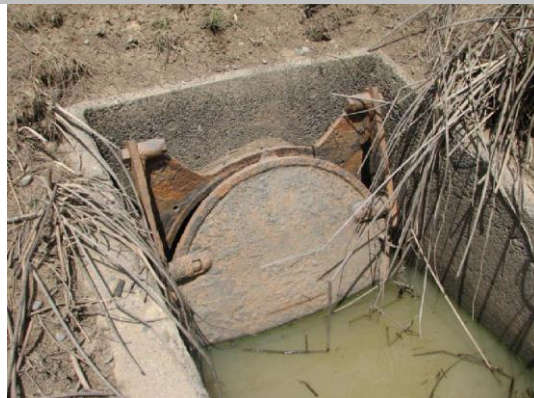
Photo 2 of 3 : UCIP_SP_2020_54999_66974.jpg

Headwall and flapgate located on water side of levee

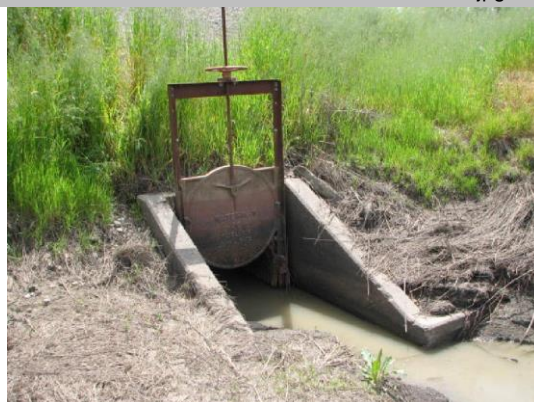
Photo 3 of 3 : UCIP_SP_2020_54999_66975.jpg

Head wall and screw gate located on land side of levee

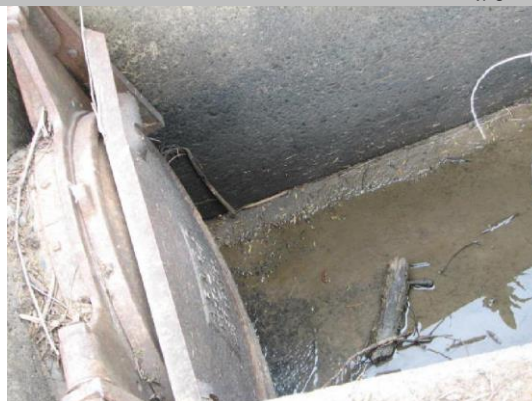
Photo 1 of 3 : UCIP_SP_2020_55000_66981.jpg

DS_ID:16367
FS_ID:55000
EP_NO: N/A
Repair Type: Non-Urgent
Crossing Status: Found
UCIP Comments: 08/27/2019 Record has been updated from No Action Needed to Non-Urgent, no permit has been identified authorizing pipe. Pipe is scheduled to be lined. (O. Magana - DWR UCIP, A. Freitag - DWR Sutter Yard)06/15/2017 Crossing appears to be in good condition. Pipe has been selected to be internally cleaned and inspected as part of the DMP project. (DWR Sutter Yard- AFreitag)11/17/2016 Crossing appears to be in good condition. (DWR Sutter Yard- AFreitag)05/03/2016 Crossing appears to be in good condition.07/13/2015 Crossing appears in good condition. No noticeable issues to report.05/22/2014 Same as last inspection.12/03/2013 Same as last inspection.07/15/2013 Slopes have been cleared of vegetation and are in good condition.04/18/2012 Limited inspection on WS and LS slope due to dense vegetation. Need overall photo of crossing and photos of cleared WS & LS slopes.

WS headwall and flapgate

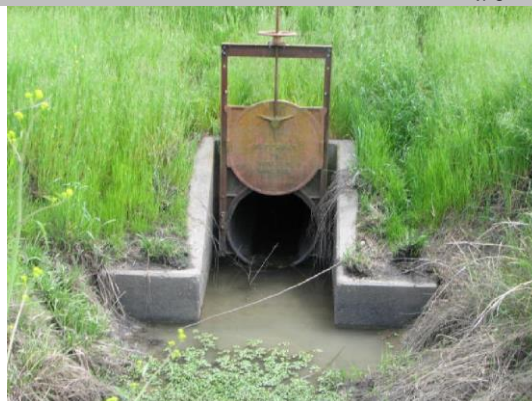
Photo 2 of 3 : UCIP_SP_2020_55000_66980.jpg

Slide gate located on LS toe. Dense vegetation present on LS slope.

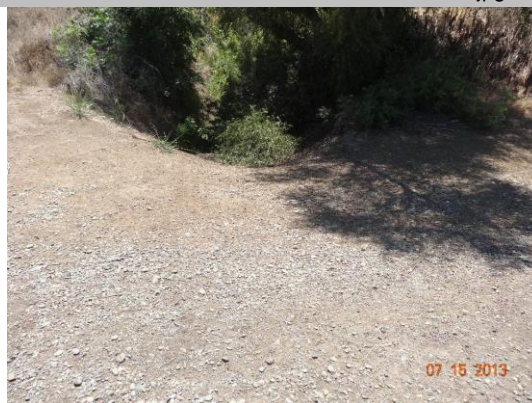
Photo 3 of 3 : UCIP_SP_2020_55000_66982.jpg

WS slope cleared of vegetation

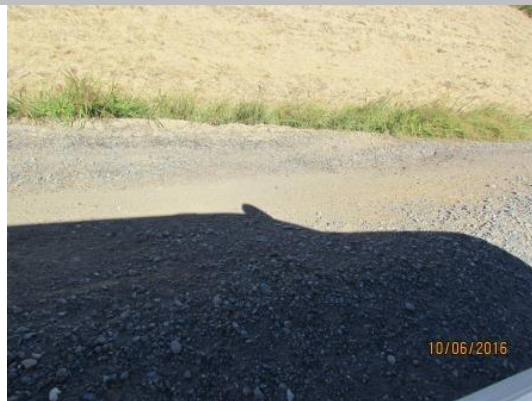
Photo 1 of 1 : SP_2020_MA0013_300_57_20200226_00008.jpg

LM Start	15.58	Rating **	M	Issue No.	57
LM End	15.58	Issue Type +	Ma	Location *	LS
Category	Earthen Levee			GPS Latitude/Longitude	
				Start	End
Item	Slope Stability			39.400380 °	39.400380 °
				-121.808432 °	-121.808432 °
DWR ID	DWR_MA0013_01_f _ 2016_57				
Comment Code					
S1 : Repair slope instability.					
Inspector Comment

View of slope instability along the landside slope.

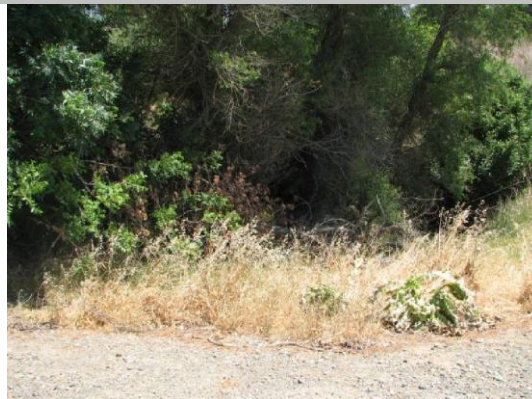
Photo 2 of 3 : UCIP_SP_2020_56092_66987.jpg

View of WS.

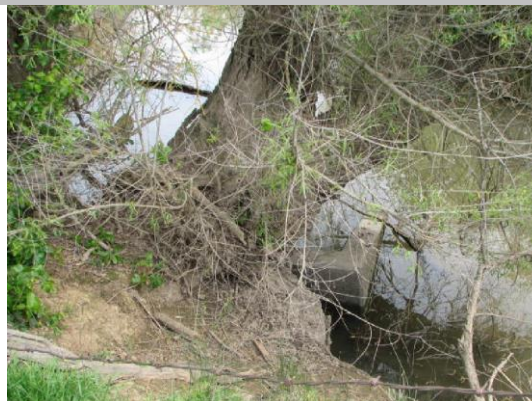
Photo 3 of 3 : UCIP_SP_2020_56092_66986.jpg

View of headwall within channel.

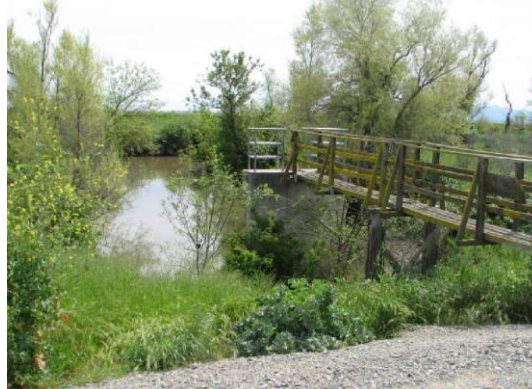
Photo 1 of 3 : UCIP_SP_2020_56093_66993.jpg

DS_ID:16373
FS_ID:56093
EP_NO: 11805B
Repair Type: Non-Urgent
Crossing Status: Found
UCIP Comments: 08/27/2019 Record remains Non-Urgent, sloughing/erosion observed on the LS toe during inspection. Recommend monitoring to determine progression of sloughing/erosion. (O. Magana - DWR UCIP, A. Freitag - DWR Sutter Yard)06/15/2017 Both pipe ends submerged during site visit. LS ditch near pipe end is heavily vegetated and covering the pipe end. There is some erosion happening at the LS levee toe but this is more of a ditch problem and not a problem with the pipe. (DWR Sutter Yard- A.Freitag)11/17/2016 Both pipe ends underwater at time of inspection. (DWR Sutter Yard- A.Freitag)05/03/2016 Crossing was underwater on both sides of levee during this inspection. Looks as if the wooden walkway was the same and no repairs have been made.07/13/2015 LS inlet still underwater. WS screw gate appears in good condition. Wooden walkway to the screw gate needs repairs.05/22/2014 Same as last inspection.12/03/2013 Same as last inspection.07/15/2013 Same as last inspection.04/18/2012 LS inlet is not visible-underwater. Limited inspection on WS and LS slope/toe due to dense vegetation. Need photos of cleared WS & LS slopes.

WS view of appurtenances (catwalk, slide gate, and headwall)

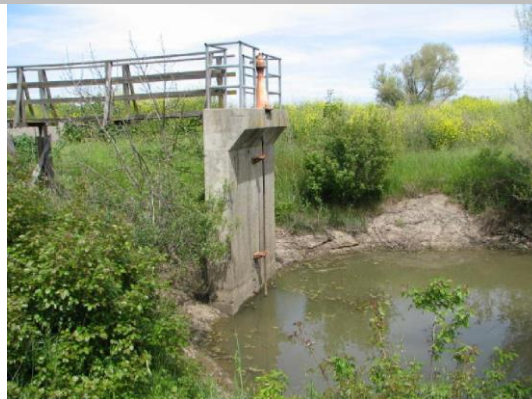
Photo 2 of 3 : UCIP_SP_2020_56093_66995.jpg

WS view of catwalk, slide/screw gate, and headwall

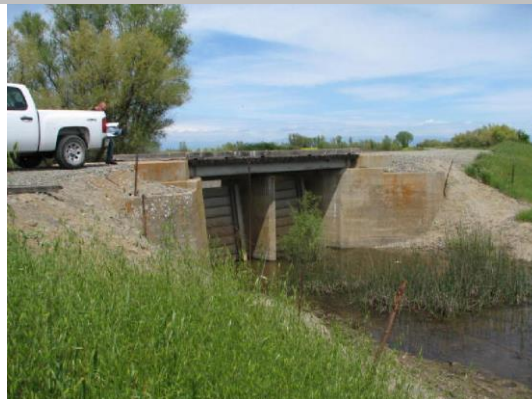
Photo 1 of 3 : UCIP_SP_2020_56094_74500.jpg

DS_ID:16372
FS_ID:56094
EP_NO: N/A
Repair Type: Non-Urgent
Crossing Status: Found
UCIP Comments: 08/27/2019 Structure is referenced in Permit Number 11805. Need to pull permit to review details. Need to update structure description to reference correct permit. (O. Magana - DWR UCIP, A. Freitag - DWR Sutter Yard)06/15/2017 Crossing appears to be in good condition. Pipe has been selected to be internally cleaned and inspected as part of the DMP project. (DWR Sutter Yard- AFreitag)11/17/2016 Crossing appears to be in good condition. (DWR Sutter Yard- AFreitag)05/03/2016 Crossing appears to be in good condition.07/13/2015 Crossing appears in good condition. No noticeable issues to report.05/22/2014 Same as last inspection.12/03/2013 Same as last inspection.07/15/2013 Same as last inspection.04/18/2012 The structures are closed with metal stop logs (weir type structure). The stop logs appear to be removable, however; there is a wooden bridge over the structure that would have to be removed in order to raise the stop logs. There is 1-foot of clearance between the bottom of the bridge and the top of the stop logs.

WS view of structure.

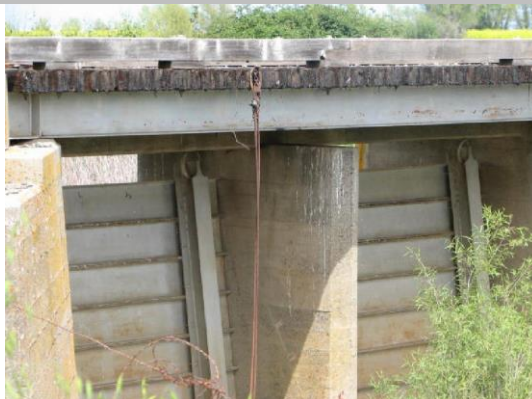
Photo 2 of 3 : UCIP_SP_2020_56094_74503.jpg

View of crossing and panels attached to concrete walls.

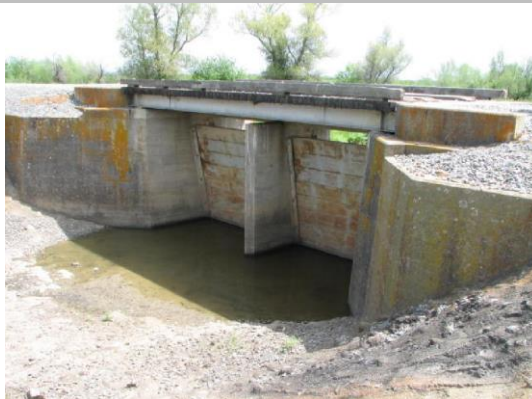
Photo 3 of 3 : UCIP_SP_2020_56094_74501.jpg

LS view of structure

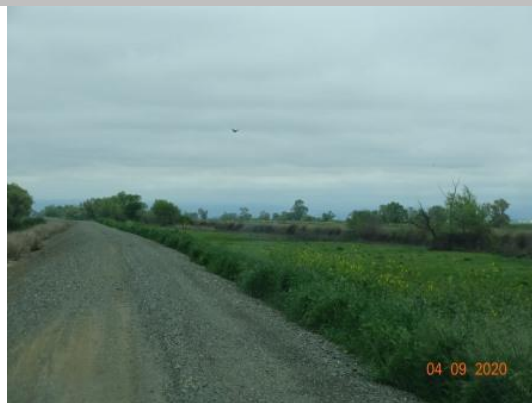
Photo 1 of 1 : SP_2020_MA0013_300_81_20200415_00182.jpg

LM Start	16.96	Rating **	M	Issue No.	81
LM End	18.50	Issue Type +	Ma	Location *	WS
Category	Earthen Levee			GPS Latitude/Longitude	
				Start	End
Item	Vegetation			39.387644 °	39.373427 °
				-121.828223 °	-121.850438 °
DWR ID	DWR_MA0013_01_s_2020_81				
Comment Code					
V1 : Control annual grass and weeds on the levee slopes and easements.					
Inspector Comment

View of the vegetation along the waterside slope. Spring 2020.

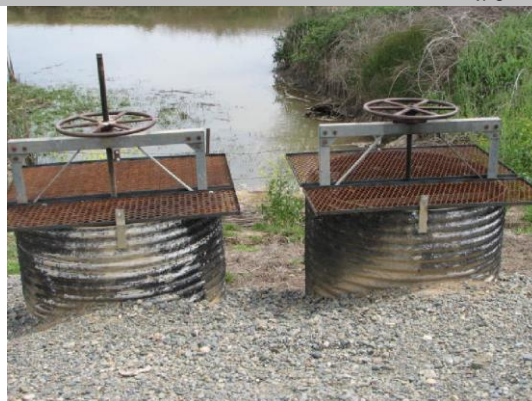
Photo 1 of 3 : UCIP_SP_2020_55968_67011.jpg

DS_ID:16370
FS_ID:55968
EP_NO: N/A
Repair Type: Non-Urgent
Crossing Status: Found
UCIP Comments: 08/27/2019 Record has been updated from No Action Needed to Non-Urgent due to maintenance issue. Minor scour is present at the concrete wingwalls located on LS. Need to contact owner to address maintenance issue (minor scour). No permit has been identified authorizing pipe. Structure is referenced in permit number 11805. Need to pull permit to review details and update structure description to reference correct permit. (O. Magana - DWR UCIP, A. Freitag - DWR Sutter Yard)06/15/2017 Crossing appears to be in good condition. (DWR Sutter Yard- A.Freitag)11/17/2016 Crossing appears to be in good condition. (DWR Sutter Yard- A.Freitag)05/03/2016 Crossing appears to be in good condition.07/13/2015 Crossing appears in good condition. No noticeable issues to report.05/22/2014 Same as last inspection.12/03/2013 Same as last inspection.07/15/2013 Same as last inspection.04/18/2012 42 inch pipes transport water to LS sump. Quantity (4) irrigation pumps push water to adjacent irrigation ditches. WS crossing underwater.

WS View of slope, risers, and channel.
