**Flood Control Project Maintenance
Levee Inspections**
LMA District Cover Sheet
Spring 2020 Levee Inspection Results

Sutter Maintenance Yard Maintenance Area 0013

Spring 2020 Levee Inspection Results

Waterway			Bank	Unit Miles
Unit No. 01 Cherokee Canal			Right	18.19
	Spring (March - May)	Summer (June - August)	(September - November) Fall	Winter (December - February)
Unit Maintenance Rating (Fall Only)				
Date of Inspection	4/9/2020 - 4/9/2020			
DWR Inspector	Makar Sokol			
Accompanied By	Bob Duffey Sutter Maintenance Yard

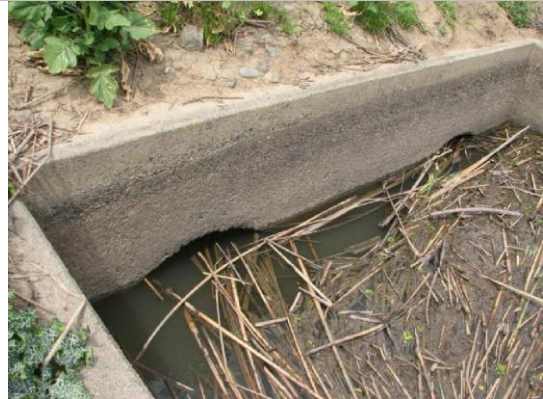
Photo 3 of 3 : UCIP_SP_2020_55968_67009.jpg

WS view of inlets during normal flow in April.

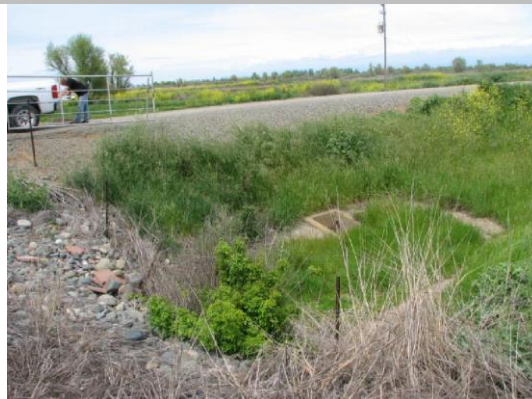
Photo 1 of 3 : UCIP_SP_2020_55006_67017.jpg

DS_ID:16369
FS_ID:55006
EP_NO: N/A
Repair Type: Non-Urgent
Crossing Status: Found
UCIP Comments: 08/27/2019 Record remains Non-Urgent, no permit has been identified authorizing pipe. Pipe has been lined. (O. Magana - DWR UCIP, A. Freitag - DWR Sutter Yard)06/15/2017 Flap gate bolted shut. Hinges seem very stiff to operate as gate will not fully close and has about a 1/2" gap near the top. Land owner claims the gate leaks during high water times. Pipe has been selected to be internally cleaned and inspected as part of the DMP project. (DWR Sutter Yard- A.Freitag)11/17/2016 Crossing appears to be in good condition. (DWR Sutter Yard- A.Freitag)05/03/2016 Crossing appears to be in good condition.07/13/2015 WS flap gate is blocked from opening by sediment. Needs to be dug out.05/22/2014 Same as last inspection.12/03/2013 Sediment was dug out from WS flap gate allowing it to open.07/15/2013 Slopes have been sprayed and cleared of vegetation and are in good condition. WS flap gate is blocked from opening by sediment buildup.04/18/2012 Limited inspection on WS and LS slope due to dense vegetation and steep slopes. Need photos of cleared WS & LS slopes.

View of WS slope and toe.

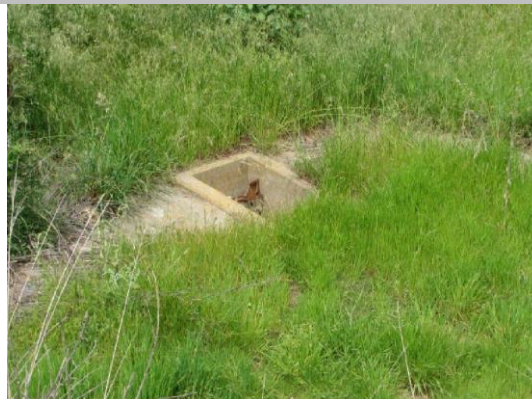
Photo 2 of 3 : UCIP_SP_2020_55006_67019.jpg

View of WS headwall and flap gate.

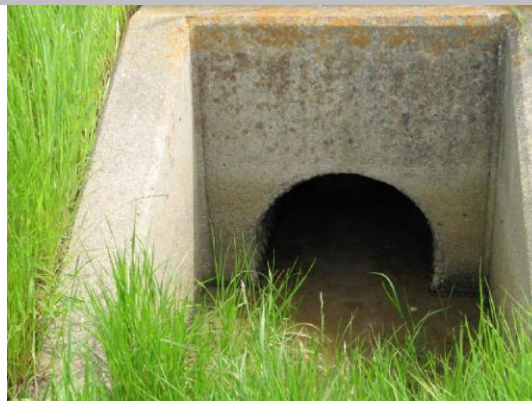
Photo 3 of 3 : UCIP_SP_2020_55006_67018.jpg

View of LS headwall.

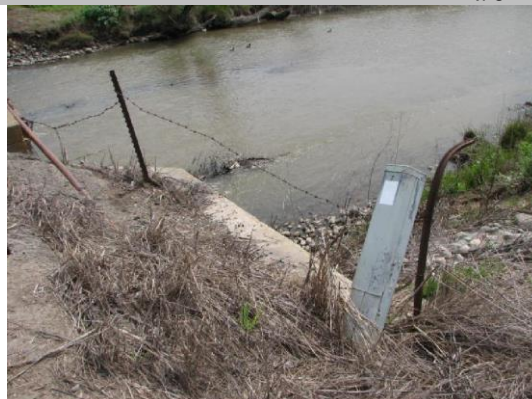
Photo 2 of 3 : UCIP_SP_2020_55007_67025.jpg

Underground telephone cable splice box.

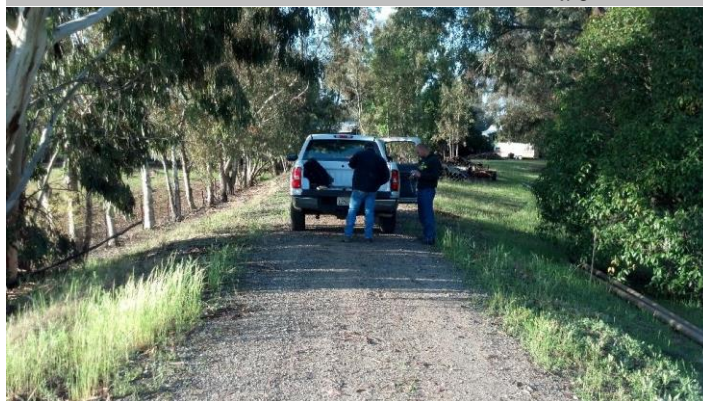
Photo 1 of 3 : UCIP_SP_2020_55415_45640.jpg

Comment Code					
Inspector Comment					
DS_ID:16397 FS_ID:55415 EP_NO: N/A Repair Type: Non-Urgent Crossing Status: Found UCIP Comments: 08/28/2019 Record remains Non-Urgent, no permit has been identified authorizing pipe. Pipe has been lined. (O. Magana - DWR UCIP, A. Freitag - DWR Sutter Yard)06/05/2017 Crossing appears to be in good condition. (DWR Sutter Yard- A Freitag)11/18/2016 Crossing appears to be in good condition. 4inch pipe still present on LS but it does not affect the function of the crossing. (DWR Sutter Yard- A Freitag)09/27/2016 Crossing has been downgraded from Urgent to Non-Urgent--sleeved pipe does not prevent flap gate from closing on WS. Still need to coordinate with owner to remove sleeved pipe through existing crossing per Title 23. (DWR UCIP - omagana)04/27/2016 Crossing appears to be in good condition. 4 inch pipe is still present in LS opening but does not go all the way through to the WS. (DWR Sutter Yard - a Freitag)07/01/2015 Crossing appears in good condition. No noticeable issues to report. (DWR Sutter Yard - a Freitag)05/29/2014 Same as last inspection. (DWR Sutter Yard - a Freitag)12/09/2013 4in. Pipe was removed and flap gate is closed and ready for high water. (DWR Sutter Yard - a Freitag)07/10/2013 Same as last inspection. Urgency rating carry over from last entry. (DWR Sutter Yard - a Freitag)04/19/2012 4-6 inch pipe is not part of original crossing--remove pipe. WS-pipe stockpile on WS slope. LS-Overgrown branches limit inspection. This crossing was listed in the USACE Periodic Inspection report listed as Corp's Inspect ID# USACE_CESPK_M13G_2011_p_0009 for WS flap gate not functioning properly as irrigation pipe passes inside crossing. (DWR UCIP - omagana) FIELD_STRUCT_DESC: 24-inch CIPP-lined corrugated metal drainage pipe through the levee, 6 feet below the crown. Concrete "U" headwalls on both WS and landside (LS). Flap gate on the waterside (WS) end. [Additional Reference(s): DWR Levee Log, 1993 (HLM 0.04). USACE Sacramento O&M Manual 519, June 1962 (HLM 0.04), listed as 24-inch pipe]. FS Date: 8/28/2019 12:55:00 PM

Overview looking south on left levee

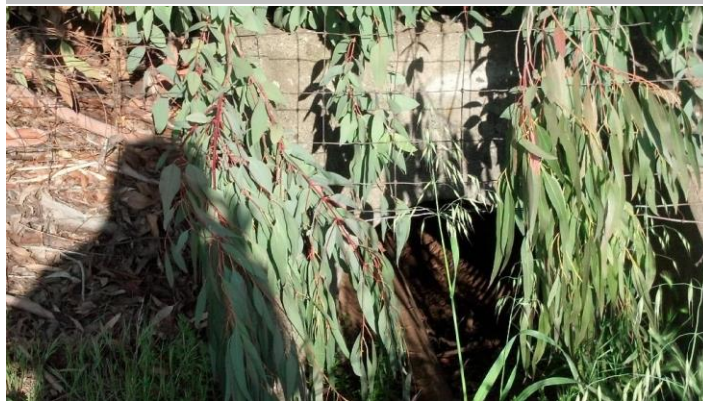
Photo 3 of 3 : UCIP_SP_2020_55415_45643.jpg

LS headwall blocked by overgrown branches.

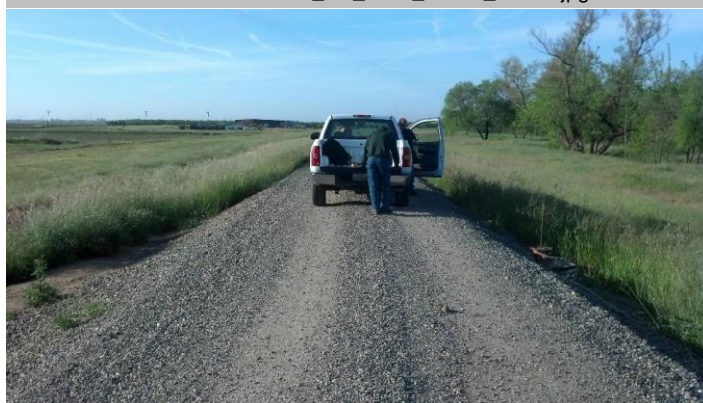
Photo 1 of 3 : UCIP_SP_2020_55970_67047.jpg

DS_ID:16398
FS_ID:55970
EP_NO: N/A
Repair Type: Non-Urgent
Crossing Status: Found
UCIP Comments: 08/28/2019 Record remains Non-Urgent, no permit has been identified authorizing pipe and modifications. Structure type has been changed from drainage to irrigation. Mr. Sohnrey property owner mentioned that this pipe is being used as irrigation line. DMP phase 1 internal inspection did not show any major defects through the section inspected (about 30 feet). (O. Magana - DWR UCIP, A. Freitag - DWR Sutter Yard)06/05/2017 LS ditch at outlet is getting over grown with vegetation. WS near concrete standpipe is overgrown with vegetation. Pipe has been selected to be internally cleaned and inspected as part of the DMP project. (DWR Sutter Yard-AFreitag)11/18/2016 Between the screw gate on the WS shoulder and the LS pipe end the pipe is about 50% full of soil. Crossing is still actively used by landowner for irrigation purposes. (DWR Sutter Yard-AFreitag)04/27/2016 Pipe gets used by the landowner to irrigate his rice fields. It appeared to be in good condition.07/01/2015 LS pipe end is still about 50% full of sediment.05/29/2014 Same as last inspection.12/09/2013 Same as last inspection.07/10/2013 LS and WS slopes have been cleared of vegetation and are in good condition. LS pipe end is half full of sediment. Sediment inside of WS standpipe may hinder slide gate from fully closing. Standpipe cover is still broken.04/19/2012 Need to fix the top of slide gate cover. The wooden cap on standpipe is broken. Limited evaluation of crossing due to dense vegetation on LS slope. Need photos of cleared slopes during fall inspection.

Overview looking south

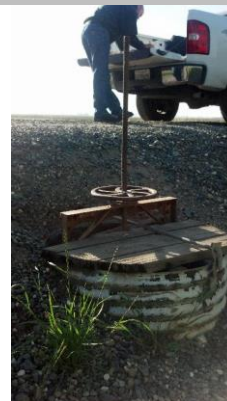
Photo 3 of 3 : UCIP_SP_2020_55970_67045.jpg

Screw gate located on WS of levee. Screw gate covers needs to be repaired.

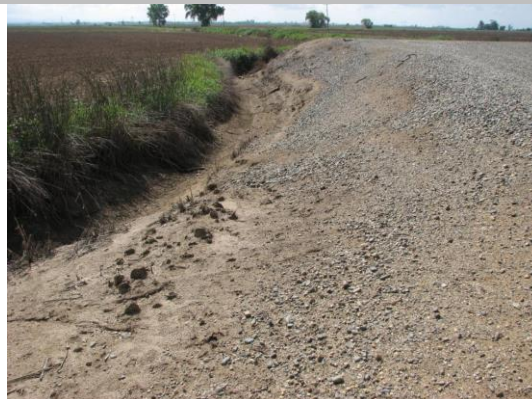
Photo 1 of 1 : SP_2020_MA0013_301_56_20200226_00007.jpg

LM Start	1.60	Rating **	U	Issue No.	56
LM End	1.63	Issue Type +	En	Location *	LS
Category	Earthen Levee			GPS Latitude/Longitude	
				Start	End
Item	Encroachments			39.552195 °	39.551731 °
				-121.704786 °	-121.704721 °
DWR ID	DWR_MA0013_02_s_2016_56				
Comment Code					
DT : Ditch					
Inspector Comment

View of the agricultural ditch along the landside toe.

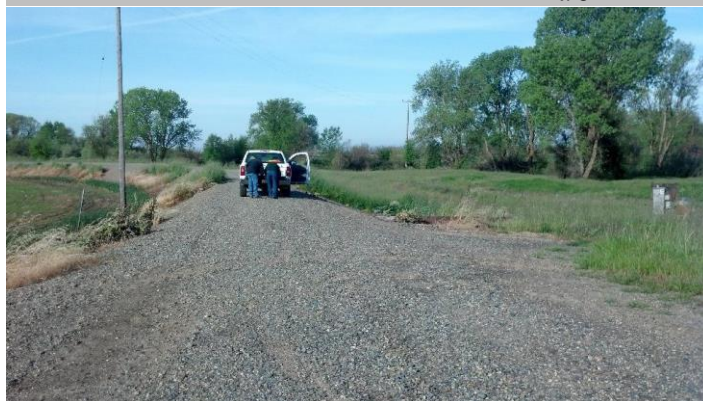
Photo 1 of 3 : UCIP_SP_2020_55091_67055.jpg

DS_ID:16833
FS_ID:55091
EP_NO: N/A
Repair Type: Non-Urgent
Crossing Status: Found
UCIP Comments: 08/28/2019 Record has been updated from No Action Needed to Non-Urgent, no permit has been identified for this crossing. No other issues were recorded during inspection. (O. Magana - DWR UCIP, A. Freitag - DWR Sutter Yard)6/5/2017 Crossing appears to be in good condition. Pump was running during site visit. (DWR Sutter Yard- A.Freitag)11/18/2016 Crossing appears to be in good condition. (DWR Sutter Yard- A.Freitag)04/27/2016 Crossing appears to be in good condition.07/01/2015 Same as last inspection.05/29/2014 Same as last inspection.12/09/2013 Same as last inspection.07/10/2013 Same as last inspection.04/19/2012 This crossing was listed in the USACE Periodic Inspection report as Corp's Inspect ID# USACE_CESPK_M13G_2011_p_0106 for pump station. Permit 3953 is not associated to this crossing. This 16 inch crossing is listed under the USACE O&M Manual with pump on WS. Permit information was incorrect in USACE's report.

Overview looking south

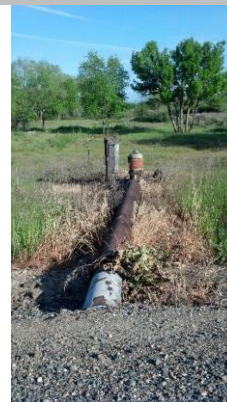
Photo 2 of 3 : UCIP_SP_2020_55091_67054.jpg

Pump located on water side of levee

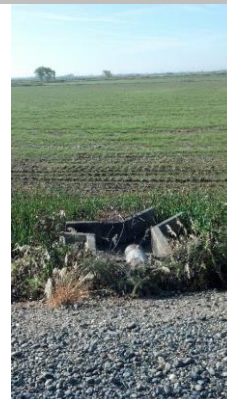
Photo 3 of 3 : UCIP_SP_2020_55091_67053.jpg

Discharge pipe and distribution box located on land side of levee

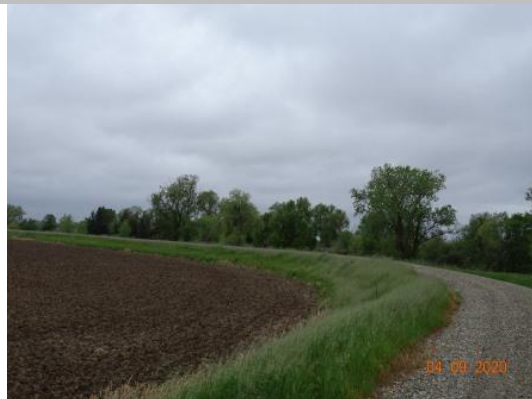
Photo 1 of 1 : SP_2020_MA0013_301_85_20200415_00178.jpg

LM Start	1.67	Rating **	M	Issue No.	85
LM End	1.91	Issue Type +	Ma	Location *	LS
Category	Earthen Levee			GPS Latitude/Longitude	
				Start	End
Item	Vegetation			39.551368 °	39.548161 °
				-121.705344 °	-121.706047 °
DWR ID	DWR_MA0013_02_s_2020_85				
Comment Code					
V1 : Control annual grass and weeds on the levee slopes and easements.					
Inspector Comment

View of the vegetation along the landside slope. Spring 2020.

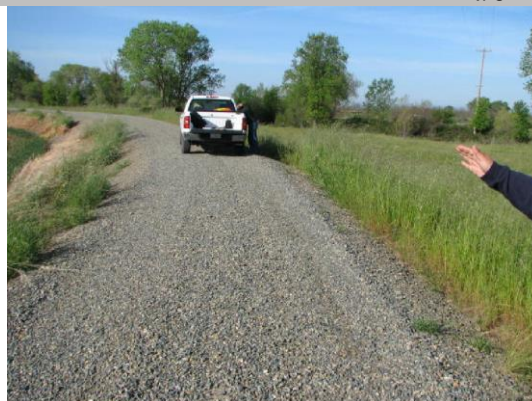
Photo 1 of 3 : UCIP_SP_2020_55416_67059.jpg

DS_ID:16399
FS_ID:55416
EP_NO: N/A
Repair Type: Non-Urgent
Crossing Status: Found
UCIP Comments: 08/28/2019 Record remains Non-Urgent, no permit has been identified authorizing pipe. Pipe has been lined. (O. Magana - DWR UCIP, A. Freitag - DWR Sutter Yard)06/05/2017 LS slide gate stem is bent and the gate appears as if it will not open. LS inlet is becoming heavily vegetated next to rice field. WS flap gate is blocked shut by sediment. Pipe has been selected to be internally cleaned and inspected as part of the DMP project. (DWR Sutter Yard- A.Freitag)11/18/2016 LS screw gate still bent and in-operable. (DWR Sutter Yard- A.Freitag)04/27/2016 LS screw gate is still bent. Rest of crossing appeared in good condition.07/01/2015 LS screw gate frame is still twisted and hindering the gate from opening.05/29/2014 Same as last inspection.12/09/2013 Same as last inspection.07/10/2013 WS slope is cleared of vegetation and is in good condition. LS screw gate frame is twisted and is preventing the gate from opening.04/19/2012 Limited inspection dense vegetation on WS. Need photos of clear WS slope & toe. Ditch present in channel? This crossing was listed in the USACE Periodic Inspection report as Corp's Inspect ID# USACE_CESPK_M13G_2011_p_0108 for WS flap gate filled with soil and LS gate not functioning because of overgrown vegetation.

Overview of crossing

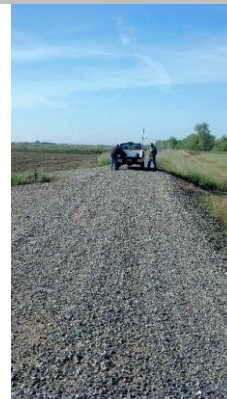
Photo 1 of 3 : UCIP_SP_2020_56150_67063.jpg

DS_ID:16400
FS_ID:56150
EP_NO: N/A
Repair Type: Non-Urgent
Crossing Status: Found
UCIP Comments: 08/28/2019 Record has been updated from No Action Needed to Non-Urgent, no permit has been identified authorizing pipe. Pipe is scheduled to be lined. (O. Magana - DWR UCIP, A. Freitag - DWR Sutter Yard)6/5/2017 LS inlet was underwater. WS flap gate blocked shut by sediment. Pipe has been selected to be internally cleaned and inspected as part of the DMP project. (DWR Sutter Yard- AFreitag)11/18/2016 Sediment dug out from in front of flap gate. Gate can now function properly. (DWR Sutter Yard- AFreitag)4/27/2016 WS flap gate still blocked from opening by sediment buildup.7/01/2015 New screw gate installed on the LS. WS flap gate is still blocked from opening by sediment.5/29/2014 Same as last inspection.12/9/2013 Same as last inspection.7/10/2013 Sediment is built up against WS flap gate not allowing it to open. Handle for LS slide gate is still missing.4/19/2012 Handle missing on slide gate.

Overview of levee crown looking south

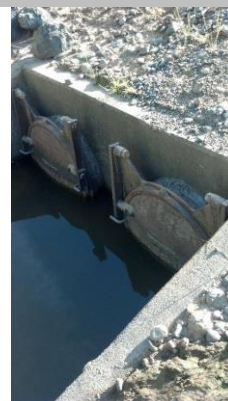
Photo 3 of 3 : UCIP_SP_2020_56150_67064.jpg

Headwall and flap gates (2) located on WS

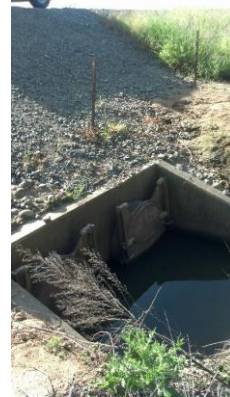
Photo 3 of 3 : UCIP_SP_2020_56095_67071.jpg

Headwall and flap gates (2) located on the WS.

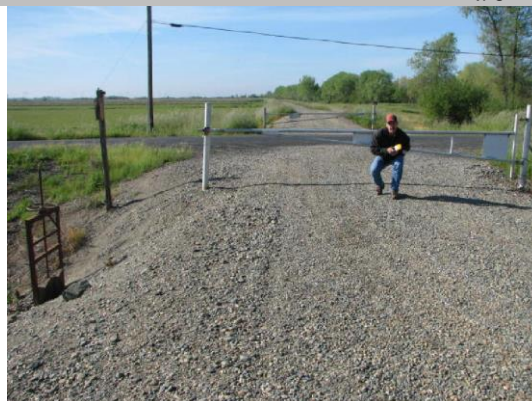
Photo 1 of 3 : UCIP_SP_2020_56096_67077.jpg

DS_ID:16402
FS_ID:56096
EP_NO: N/A
Repair Type: Non-Urgent
Crossing Status: Found
UCIP Comments: 08/28/2019 Record remains Non-Urgent, no permit has been identified authorizing pipe. Pipe is scheduled to be lined (O. Magana - DWR UCIP, A. Freitag - DWR Sutter Yard)06/05/2017 Sediment blocking LS slide gate from closing fully. Pipe has been selected to be internally cleaned and inspected as part of the DMP project. (DWR Sutter Yard- A.Freitag)11/18/2016 Sediment still blocking screw gate from fully closing. (DWR Sutter Yard- A.Freitag)04/27/2016 LS slide gate is full of sediment and needs to be dug out so gate can close fully.07/01/2015 LS screw gate is still silted in and unable to be screwed down all the way. Needs to be cleaned out.05/29/2014 Same as last inspection.12/09/2013 WS flap gate was closed but LS slide gate is heavily vegetated and blocked from closing by sediment.07/10/2013 Same as last inspection.04/19/2012 Minor sediment built up on LS, remove sediment. Need photo of LS slide gate without sediment build up. This crossing was listed in the USACE Periodic Inspection report as Corp's inspect ID# USACE_CESPK_M13G_2011_p_0148 for LS gate obstructed by vegetation and WS flap gate is not functioning (propped open).

Overview looking south from left levee

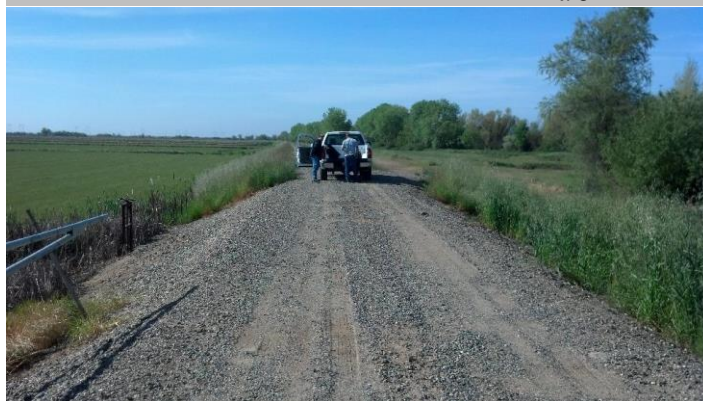
Photo 1 of 3 : UCIP_SP_2020_55094_67090.jpg

DS_ID:16415
FS_ID:55094
EP_NO: N/A
Repair Type: Non-Urgent
Crossing Status: Found
UCIP Comments: 08/28/2019 Record remains Non-Urgent, no permit has been identified authorizing pipe. Both inlet/outlet were underwater during inspection. Pipe is scheduled to be lined. (O. Magana - DWR UCIP, A. Freitag - DWR Sutter Yard)6/5/2017 Both gates partially submerged during site visit. Appears to be in good condition. Pipe has been selected to be internally cleaned and inspected as part of the DMP project. (DWR Sutter Yard- A.Freitag)11/18/2016 LS screw gate closed but partially buried. WS flap gate was half submerged for inspection. (DWR Sutter Yard- A.Freitag)04/27/2016 Both gates were underwater for inspection.07/01/2015 WS flap gate is partially held open by sediment and needs to be dug out to allow it to fully close.05/29/2014 Same as last inspection.12/09/2013 Both gates were out of water and in good condition.07/10/2013 LS and WS slopes are in good condition. Both LS and WS gates were fully submerged in water and unable to be inspected.

Overview looking south from left levee

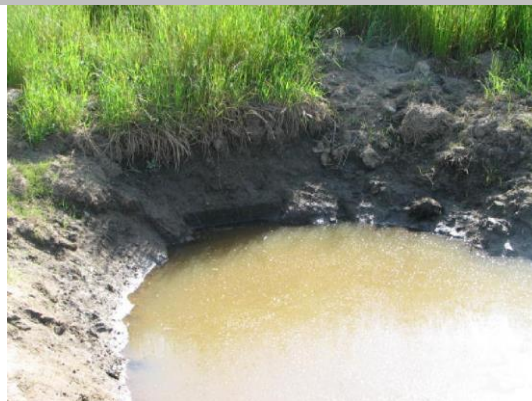
Photo 3 of 3 : UCIP_SP_2020_55095_67096.jpg

View of flap gate submerged on WS toe.

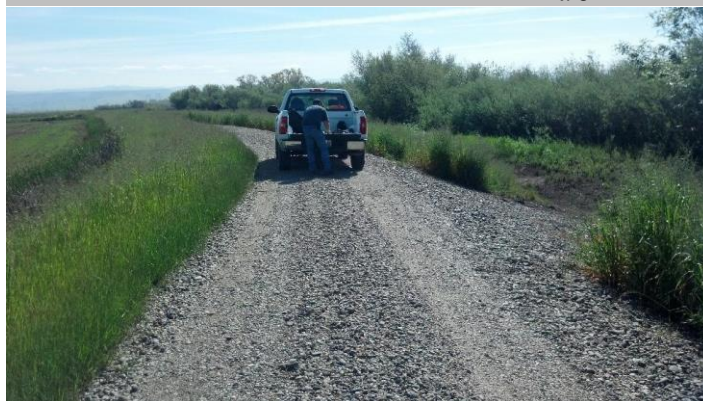
Photo 1 of 3 : UCIP_SP_2020_55096_67102.jpg

DS_ID:16848
FS_ID:55096
EP_NO: N/A
Repair Type: Non-Urgent
Crossing Status: Found
UCIP Comments: 08/28/2019 Record has been updated from No Action Needed to Non-Urgent, no permit has been identified authorizing pipe. Pending internal inspection under DMP Phase 1 both inlet and outlet underwater. (O. Magana - DWR UCIP, A. Freitag - DWR Sutter Yard)06/05/2017 Both ends submerged but appear to be in good condition. Pipe has been selected to be internally cleaned and inspected as part of the DMP project. (DWR Sutter Yard- A.Freitag)11/18/2016 Crossing appears to be in good condition. (DWR Sutter Yard- A.Freitag)04/27/2016 Crossing appears to be in good condition. New slide gate installed on LS.07/01/2015 Both gates were still submerged in water. Levee slopes were in good condition.05/29/2014 Same as last inspection.12/09/2013 Same as last inspection.07/10/2013 LS slope has been cleared of vegetation and is in good condition. Both gates are still underwater and not able to be inspected.04/19/2012 Dense vegetation makes it difficult to evaluate the condition of the LS slope. Both gates underwater. Recommend taking photos of clear slopes and gates during fall inspection.

Overview looking south on left levee

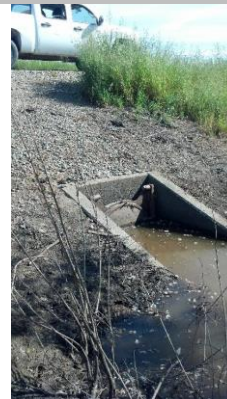
Photo 2 of 3 : UCIP_SP_2020_55096_67103.jpg

Headwall and flap gate located on WS.

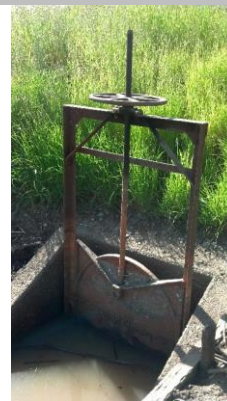
Photo 3 of 3 : UCIP_SP_2020_55096_67101.jpg

Headwall and screw gate located on LS.

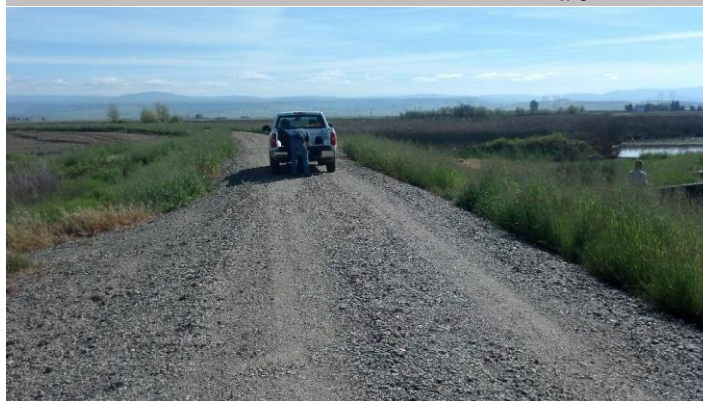
Photo 1 of 3 : UCIP_SP_2020_55097_67107.jpg

DS_ID:16847
FS_ID:55097
EP_NO: N/A
Repair Type: Non-Urgent
Crossing Status: Found
UCIP Comments: 08/28/2019 Record remains Non-Urgent, no permit has been identified authorizing pipe. Pending internal inspection under DMP Phase 1 both inlet and outlet underwater. (O. Magana - DWR UCIP, A. Freitag - DWR Sutter Yard)06/05/2017 Both ends submerged but crossing appears to be in good condition. (DWR Sutter Yard- A.Freitag)11/18/2016 Crossing appears to be in good condition. It appears that this crossing does not require a slide gate. (DWR Sutter Yard- A.Freitag)04/27/2016 LS slide gate was still missing. Rest of crossing appears to be in good condition.07/01/2015 There appears to be a LS gate now but both pipe ends were submerged so it was hard to tell for certain.05/29/2014 Same as last inspection.12/09/2013 Pulled sticks from WS flap gate to allow it to close. Ls gate is still missing.07/10/2013 WS and LS slopes have been cleared of vegetation and are in good condition. LS gate is still missing and WS flap gate is still wedged open with sticks.04/19/2012 LS gate missing & limited inspection. Need photos of WS & LS cleared slopes. Description calls for slide gate on LS-slide gate missing. Debris scattered near LS headwall. This crossing was listed in the USACE Periodic Inspection report as Corp's Inspect ID# USACE_CESPK_M13J_2011_p_0010 for WS gate wedged open & missing LS slide gate.

Overview looking south on left levee

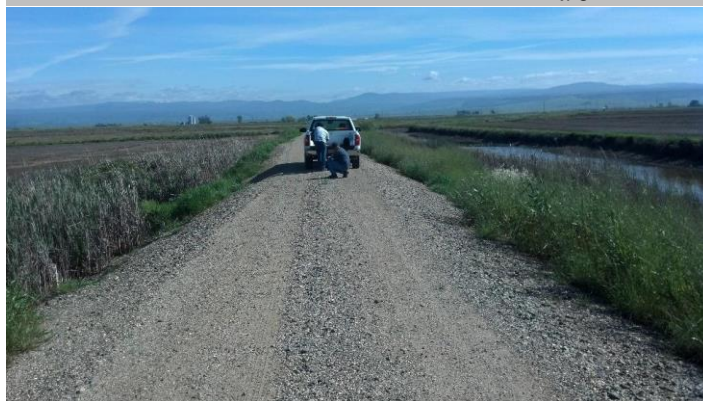
Photo 1 of 3 : UCIP_SP_2020_55098_67115.jpg

DS_ID:16846
FS_ID:55098
EP_NO: N/A
Repair Type: Non-Urgent
Crossing Status: Found
UCIP Comments: 08/28/2019 Record remains Non-Urgent due to potential levee threat. Minor scour was visible on both WS and LS toe. No permit has been identified authorizing pipe. Pending internal inspection under DMP Phase 1 both inlet and outlet underwater. (O. Magana - DWR UCIP, A. Freitag - DWR Sutter Yard)6/5/2017 Both ends submerged during site visit. Pipe has been selected to be internally cleaned and inspected as part of the DMP project. (DWR Sutter Yard- A Freitag)11/18/2016 Both pipe ends underwater for this inspection. (DWR Sutter Yard- A Freitag)04/27/2016 Both pipe ends were underwater for inspection.07/01/2015 Both pipe ends and gates were fully submerged.05/29/2014 Same as last inspection.12/09/2013 Same as last inspection.07/10/2013 WS slope is cleared of vegetation and is in good condition. Both gates were fully submerged under water and unable to be inspected.04/19/2012 Rodent activity caused partial collapse on LS of levee in the vicinity of pipe. Limited inspection on WS slope due to dense vegetation. Limited inspection on gates due to both gates submerged under water.

Overview looking east on right bank of Cottonwood

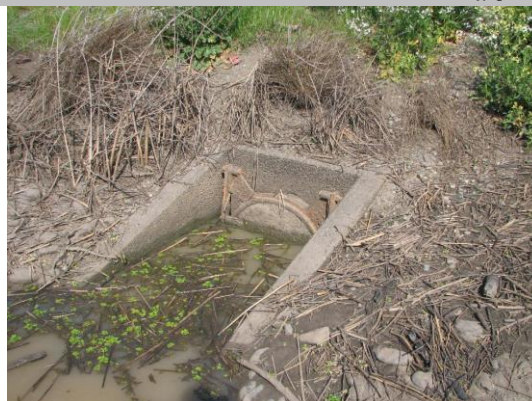
Photo 2 of 3 : UCIP_SP_2020_55098_67116.jpg

Unable to determine condition of flap gate on WS due to high water.

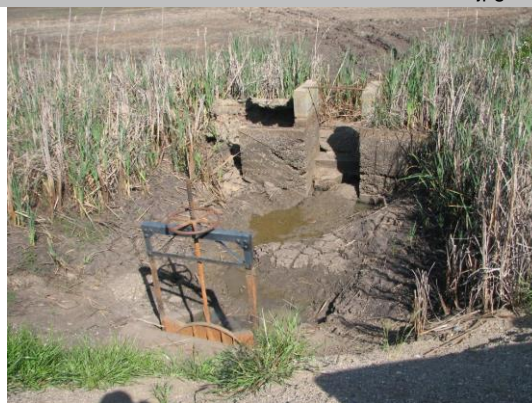
Photo 3 of 3 : UCIP_SP_2020_55098_67113.jpg

Overview of LS screw gate and concrete sump structure.

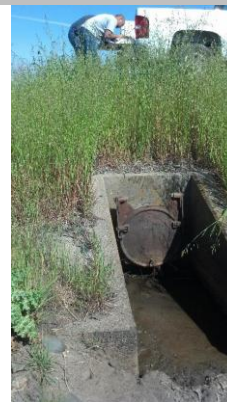
Photo 2 of 3 : UCIP_SP_2020_55099_67122.jpg

Headwall and flap gate located on WS.

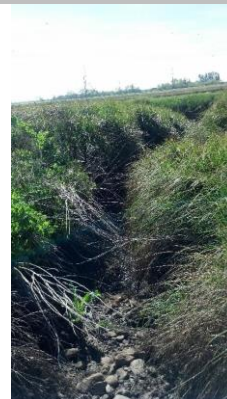
Photo 3 of 3 : UCIP_SP_2020_55099_67123.jpg

View of channel at crossing.

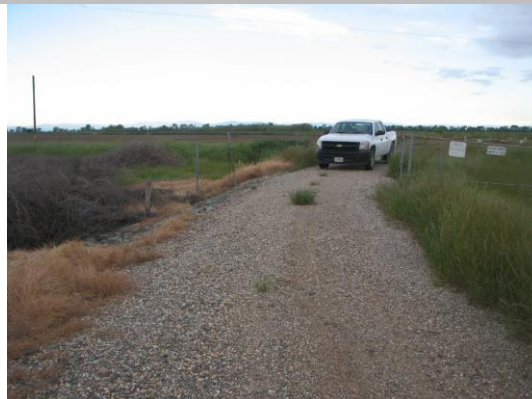
Photo 1 of 3 : UCIP_SP_2020_56098_67131.jpg

DS_ID:16395
FS_ID:56098
EP_NO: N/A
Repair Type: Non-Urgent
Crossing Status: Found
UCIP Comments: 08/28/2019 Record has been updated from No Action Needed to Non-Urgent, no permit has been identified authorizing pipe. Pipe is scheduled to be lined. (O. Magana - DWR UCIP, A. Freitag - DWR Sutter Yard)06/05/2017 WS mostly submerged but crossing appears to be in good condition.(DWR Sutter Yard-AFreitag)11/18/2016 Crossing appears to be in good condition. Pipe is a 30" cmp. (DWR Sutter Yard- AFreitag)04/27/2016 Crossing appears to be in good condition.06/30/2015 Erosion on LS does not appear to be getting any worse with the rip-rap there. WS pipe end and gate appeared in good condition.05/29/2014 Same as last inspection.12/09/2013 Same as last inspection.07/09/2013 Same as last inspection.04/19/2012 Rusted pipe debris located on WS. Remove pipe debris on WS and monitor the LS erosion near headwall. Rip-rap used to protect LS headwall from erosion. Was pipe exposed prior to dumping rock? Erosion on the LS could have exposed pipe. Dense shrub on the LS could restrict flow.

Overview looking west on the left levee of Cottonwood

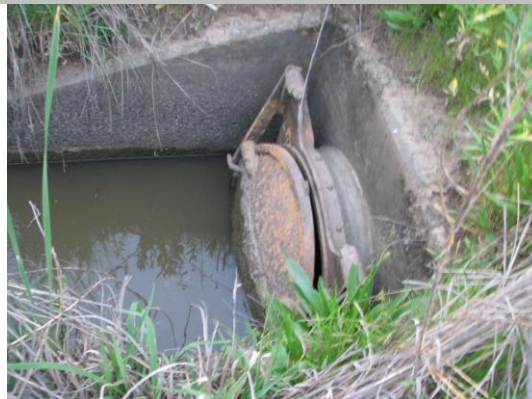
Photo 2 of 3 : UCIP_SP_2020_56098_67129.jpg

Headwall and flap gate located on WS.

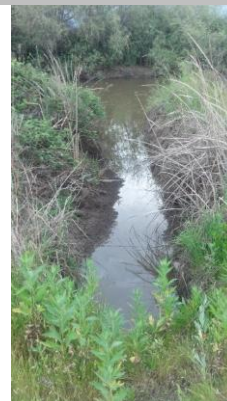
Photo 3 of 3 : UCIP_SP_2020_56098_67126.jpg

View of channel at crossing.

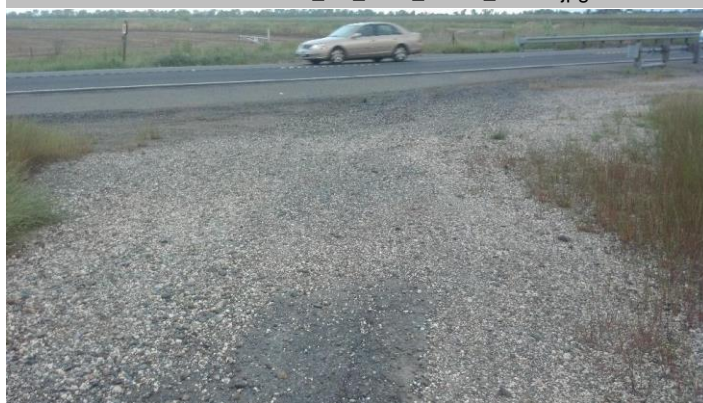
Photo 1 of 3 : UCIP_SP_2020_56105_67132.jpg

DS_ID:16837
FS_ID:56105
EP_NO: N/A
Repair Type: Non-Urgent
Crossing Status: Indicator Found
UCIP Comments: 08/28/2019 Record has been updated from No Action Needed to Non-Urgent, no records were obtained to determine line status. Need to contact owner to obtain maintenance records. (O. Magana - DWR UCIP, A. Freitag - DWR Sutter Yard)06/05/2017 Crossing appears to be in good condition. (DWR Sutter Yard-AFreitag)11/18/2016 Crossing appears to be in good condition. (DWR Sutter Yard- AFreitag)04/27/2016 Crossing appears to be in good condition.06/30/2015 Markers are present. Crossing is in good condition.05/29/2014 Same as last inspection.12/09/2013 Same as last inspection.07/09/2013 New carsonite marker installed with concrete access box on LS about 10 feet east of highway 99. Depth is still unknown.04/24/2012 Markers not present or visible for hazard line (Health & Safety Issue) unknown depth. Owner is not compliant with Title 23. USA flag located on LS however not visible. No permanent markers available only underground service alert (USA) flags. Active line? Will need to contact PG&E and find out the status of line through levee.

Overview looking west from the left levee of Cottonwood

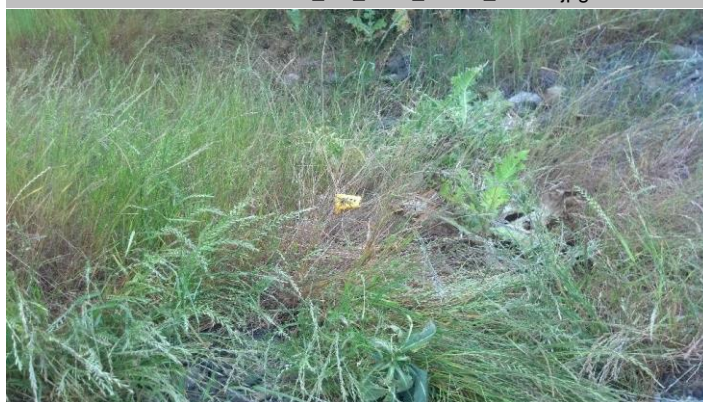
Photo 2 of 3 : UCIP_SP_2020_56105_67133.jpg

USA indicator located at land side of levee

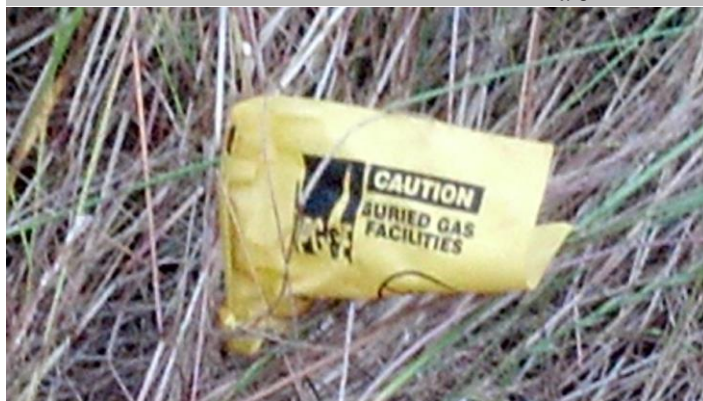
Photo 3 of 3 : UCIP_SP_2020_56105_67134.jpg

USA indicator located at land side of levee

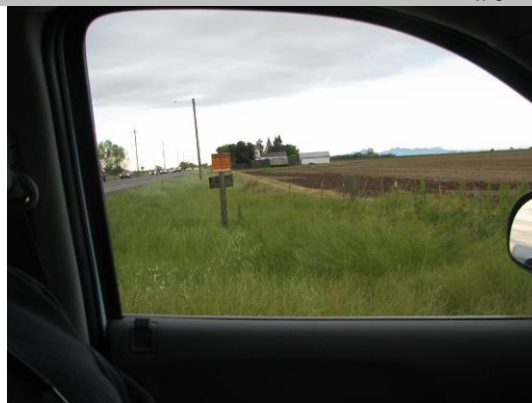
Photo 1 of 3 : UCIP_SP_2020_56100_67136.jpg

DS_ID:16407
FS_ID:56100
EP_NO: 6084
Repair Type: Non-Urgent
Crossing Status: Indicator Found
UCIP Comments: 08/28/2019 Record has been updated from No Action Needed to Non-Urgent due to maintenance issues. Sign knocked over. Unable to determine if line has been abandoned. Need to contact owner to make them aware of the sign knocked over and to determine whether line is still in use. (O. Magana - DWR UCIP, A. Freitag - DWR Sutter Yard)06/05/2017 Crossing appears to be in good condition. (DWR Sutter Yard- AFreitag)11/18/2016 Crossing appears to be in good condition. (DWR Sutter Yard- AFreitag)04/27/2016 Crossing appears to be in good condition.06/30/2015 Crossing is in good condition.05/29/2014 Same as last inspection.12/09/2013 Same as last inspection.07/09/2013 Same as last inspection.
FIELD_STRUCT_DESC: Underground telephone cable, 1.5-inch through the levee at approximately 2 feet below the crown. (buried cable across the levees and channels of Cottonwood Creek and Cherokee Canal authorized under Permit No. 6084, 1968 - Pacific Telephone and Telegraph Company [PT&T]) . Contact number for this crossing is 1-800-642-2444. [Additional Reference(s): DWR Levee Log, 1993 (HLM 5.10)]

Underground telephone line indicator on LS of Cottonwood left levee looking South on highway.

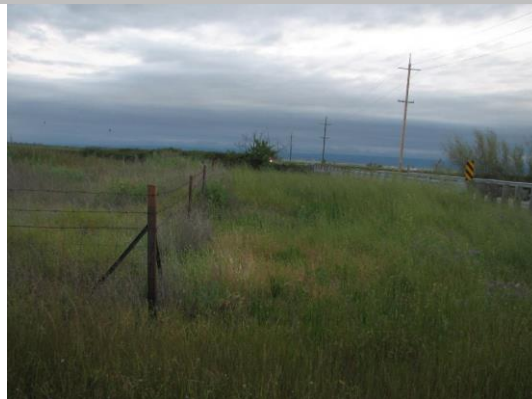
Photo 2 of 3 : UCIP_SP_2020_56100_67137.jpg

Underground telephone line looking North towards highway.

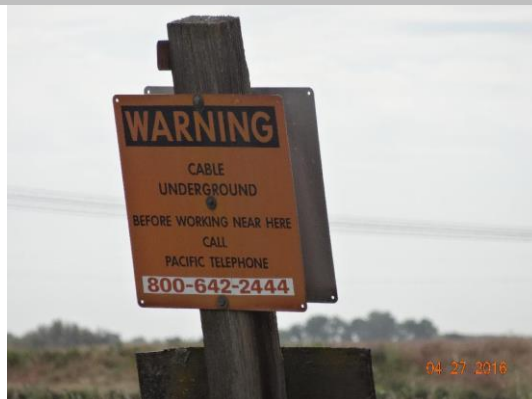
Photo 3 of 3 : UCIP_SP_2020_56100_74975.jpg

close up of marker sign LS.

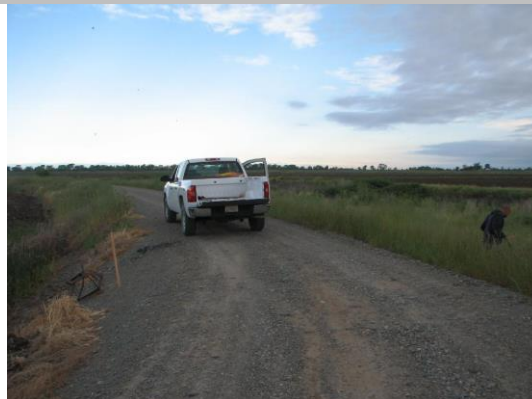
Photo 1 of 3 : UCIP_SP_2020_56101_67138.jpg

Comment Code						
Inspector Comment						
DS_ID:16408 FS_ID:56101 EP_NO: N/A Repair Type: Non-Urgent Crossing Status: Found UCIP Comments: 08/28/2019 Record has been updated from No Action Needed to Non-Urgent, no permit has been identified authorizing pipe. Pipe has been lined. (O. Magana - DWR UCIP, A. Freitag - DWR Sutter Yard)06/05/2017 Crossing appears to be in good condition. Pipe has been selected to be internally cleaned and inspected as part of the DMP project. (DWR Sutter Yard- A.Freitag)11/18/2016 Crossing appears to be in good condition. (DWR Sutter Yard- A.Freitag)04/27/2016 Crossing appears to be in good condition.06/30/2015 Crossing appears to be in good condition. No apparent issues to report.05/29/2014 Same as last inspection.12/9/2013 Same as last inspection.07/09/2013 WS and LS slopes have been cleared of vegetation and are in good condition. Slide gate on LS has been replaced.04/24/2012 Slide gate is damaged, needs to be replaced. Limited inspection on WS slope and toe due to dense vegetation. Need photos of clear WS slope and toe. This crossing was listed in the USACE Periodic Inspection report as Corp's inspection ID# USACE_CESPK_M13H_2011_p_0026 for broken gate on LS. FIELD_STRUCT_DESC: 24-inch CIPP-lined corrugated metal drainage pipe through the levee, 5.7 feet below the crown. Flap gate on the waterside (WS). Slide gate on the landside (LS). Concrete "U" headwalls located on both WS and LS ends. [Additional Reference(s): DWR Levee Log, 1993 (HLM 5.13). USACE Sacramento O&M Manual 519, June 1962 (HLM 5.13), listed as 24-inch pipe] FS Date: 8/28/2019 3:11:00 PM

Overview of levee crown at crossing looking west.

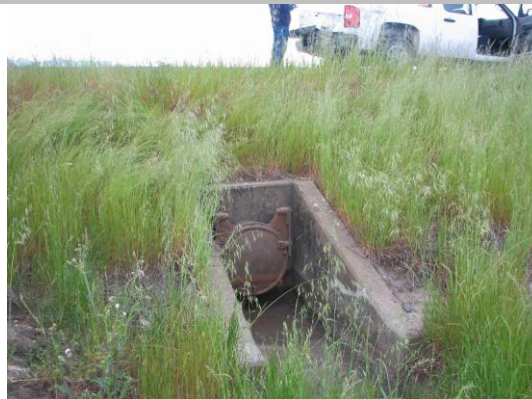
Photo 2 of 3 : UCIP_SP_2020_56101_67140.jpg

Headwall and flap gate located on WS.

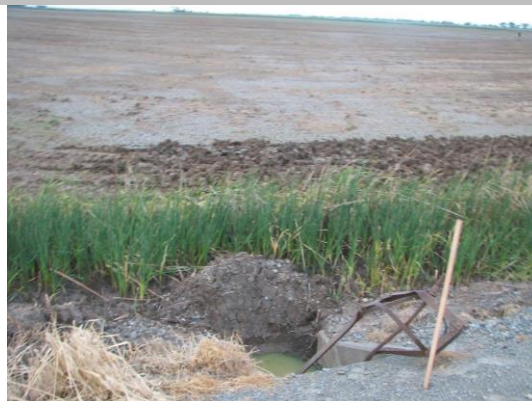
Photo 3 of 3 : UCIP_SP_2020_56101_67141.jpg

Overview of LS floor is higher in elevation than pipe invert causing build up sediment.

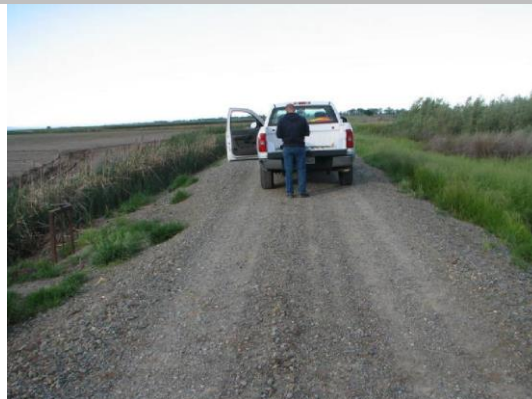
Photo 1 of 3 : UCIP_SP_2020_56102_67146.jpg

Comment Code						
Inspector Comment						
DS_ID:16409 FS_ID:56102 EP_NO: N/A Repair Type: Non-Urgent Crossing Status: Found UCIP Comments: 08/28/2019 Record remains Non-Urgent, no permit has been identified authorizing pipe. Internal inspection under DMP Phase 1 is still pending, both inlet and outlet are underwater. (O. Magana - DWR UCIP, A. Freitag - DWR Sutter Yard)06/05/2017 WS fully submerged and LS slide gate mostly buried by sediment. Pipe has been selected to be internally cleaned and inspected as part of the DMP project. (DWR Sutter Yard- AFreitag)11/18/2016 There is a flap gate on the WS and a slide gate on the LS. The LS slide gate appears to be partially buried and blocked by vegetation. (DWR Sutter Yard- AFreitag)04/27/2016 LS slide gate is blocked by vegetation. Pipe appears to not be used.06/30/2015 WS flap gate was still overgrown with vegetation. Needs to be cleared away.05/29/2014 Same as last inspection.12/09/2013 Same as last inspection.07/09/2013 Same as last inspection.04/24/2012 Limited inspection on WS slope due to dense vegetation. Need photo of clear WS slope during next inspection. This crossing was listed in the USACE Periodic Inspection report as Corp's inspect ID# USACE_CESPK_M13H_2011_p_0035 non-functional crossing due to overgrown vegetation on WS flap gate. FIELD_STRUCT_DESC: 30-inch corrugated metal drainage pipe through the levee, 5.8 feet below the crown. Flap gate on the waterside (WS). Slide gate on the landside (LS). Concrete "U" headwalls located on both ends. [Additional Reference(s): DWR Levee Log, 1993 (HLM 5.34). USACE Sacramento O&M Manual 519, June 1962 (HLM 5.34), listed as 30-inch pipe] FS Date: 8/28/2019 3:22:00 PM

Overview of crossing looking downstream.

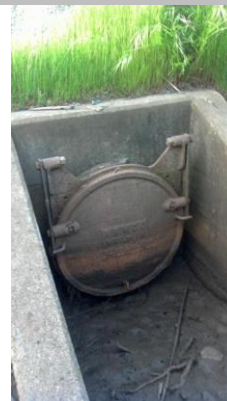
Photo 3 of 3 : UCIP_SP_2020_56102_67148.jpg

Headwall and flap gate located on WS.

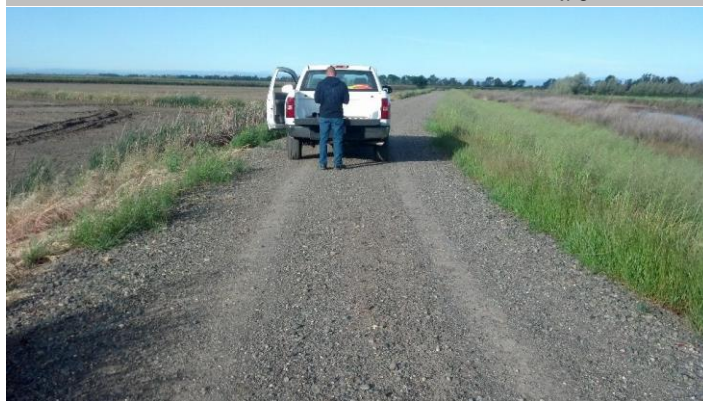
Photo 1 of 3 : UCIP_SP_2020_56103_67152.jpg

DS_ID:16410
FS_ID:56103
EP_NO: N/A
Repair Type: Non-Urgent
Crossing Status: Found
UCIP Comments: 08/28/2019 Record remains Non-Urgent, no permit has been identified authorizing pipe. Pipe remains abandoned through the mid section of the levee. (O. Magana - DWR UCIP, A. Freitag - DWR Sutter Yard)06/05/2017 Abandoned- needs to be done properly. (DWR Sutter Yard- A.Freitag)11/18/2016 Abandoned pipe. It is still present on both sides of the levee and capped on the WS. (DWR Sutter Yard- A.Freitag)04/27/2016 Pipe appears abandoned. Should be removed.06/30/2015 Pipe still present with the cap on the waterside.05/29/2014 Same as last inspection.12/09/2013 Same as last inspection.07/09/2013 Same as last inspection.04/24/2012 Limited inspection on WS and LS slope due to dense vegetation. Need photos of clear slopes during next inspection. Metal plate bolted on pipe for closure on WS, open on LS.
FIELD_STRUCT_DESC: *ABANDONED* 6-inch steel pipe through the levee, 1.6 feet below the crown. Plate bolted on the waterside (WS) end. Open on the landside (LS) end. [Additional Reference(s): DWR Levee Log, 1993 (HLM 5.41). USACE Sacramento O&M Manual 519, June 1962 (HLM 5.41), listed as 6-inch pipe]

Overview of site

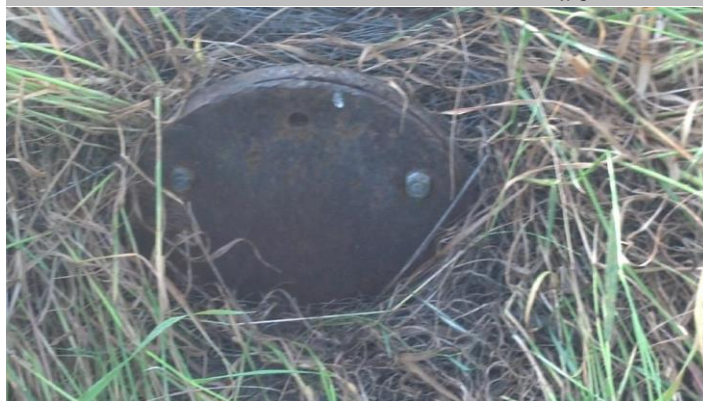
Photo 2 of 3 : UCIP_SP_2020_56103_67150.jpg

Capped irrigation pipe located on water side of levee

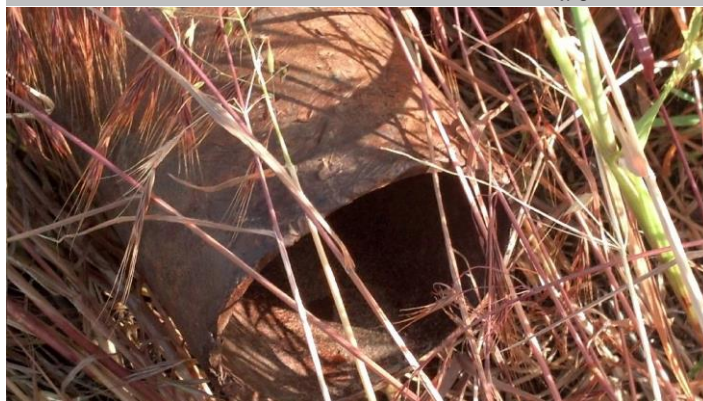
Photo 3 of 3 : UCIP_SP_2020_56103_67151.jpg

Irrigation crossing located on land side of levee

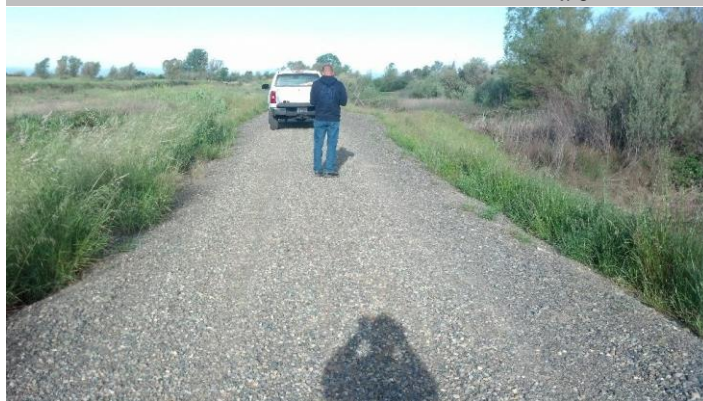
Photo 1 of 3 : UCIP_SP_2020_55106_67155.jpg

FIELD_STRUCT_DESC: 36-inch corrugated metal drainage pipe through the levee, 9.2 feet below the crown. Flap gate on the waterside (WS) end. Slide gate on the landside (LS) end. Concrete "U" headwalls located on both WS and LS toes. (secondary permit reference: 48-inch irrigation pipe authorized under Permit No. 13170, 1981 - S. S. Hinaman, Jr., USACE letter covers installation of a 36-inch pipe dated 14 July 1981, Board summary report references 36-inch pipe and not 48-inch pipe)[Additional Reference(s): DWR Levee Log, 1993 (HLM 5.85). USACE Sacramento O&M Manual 519, June 1962 (HLM 5.85), As-built DWG No. 50-4-3608, Sheet No. 3608/22.3, STA 19+30 LT. BK. (Cottonwood), page 23 of 28 electronic file, listed as 36-inch pipe; As-built DWG No. 50-4-3037 referenced not available]
FS Date: 8/28/2019 3:17:00 PM

Overview looking south

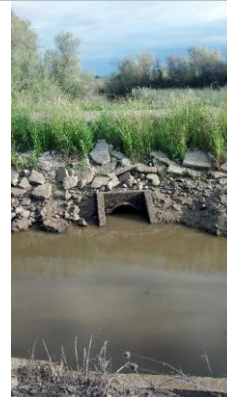
Photo 3 of 3 : UCIP_SP_2020_55106_67156.jpg

Headwall and damaged/missing screw gate on LS.

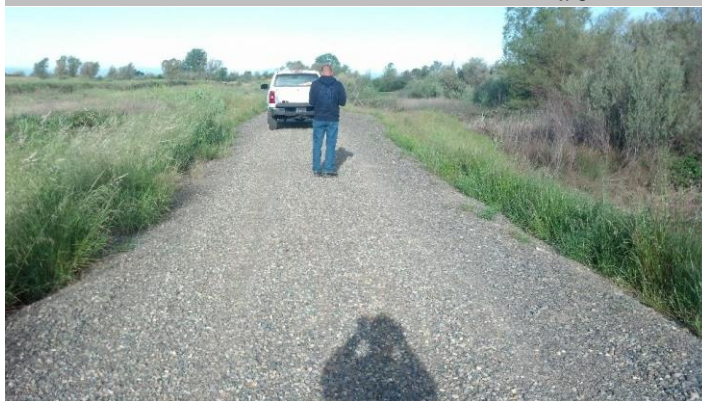
Photo 1 of 3 : UCIP_SP_2020_55971_67158.jpg

FIELD_STRUCT_DESC: 36-inch corrugated metal irrigation pipe through the levee approximately 7 feet below the crown. Flap gate is located on the waterside (WS). (48-inch irrigation pipe authorized under Permit No. 13170, 1981 - S. S. Hinaman, Jr., USACE letter covers installation of a 36-inch pipe dated 14 July 1981, Board summary report references 36-inch pipe and not 48-inch pipe)
FS Date: 8/28/2019 3:19:00 PM

Overview photo of crossing looking downstream.

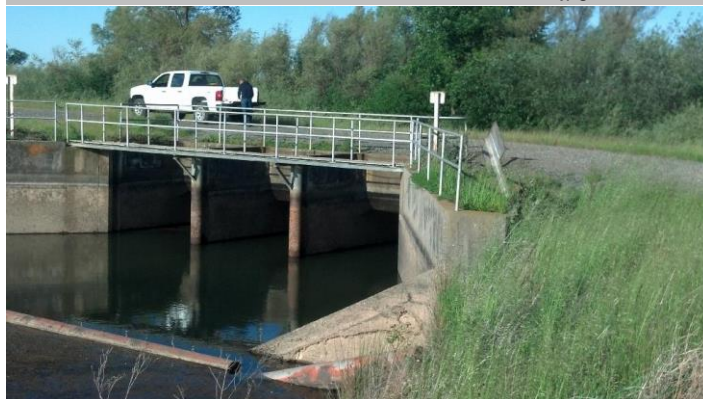
Photo 2 of 3 : UCIP_SP_2020_54787_67165.jpg

View of Western Canal Siphon (Richvale Siphon) on LS.

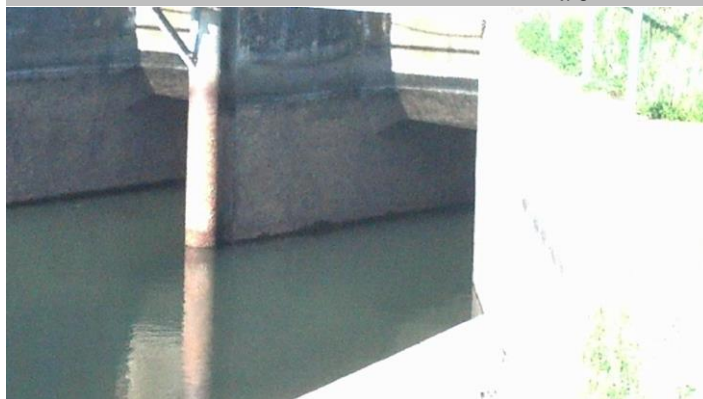
Photo 3 of 3 : UCIP_SP_2020_54787_67162.jpg

1 of 3 Eight (8) foot by Ten (10) foot concrete conduit (upstream conduit).

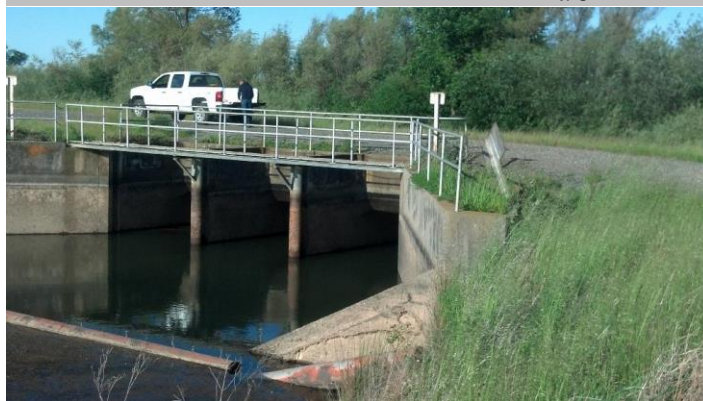
Photo 1 of 3 : UCIP_SP_2020_55108_67169.jpg

DS_ID:17373
 FS_ID:55108
 EP_NO: N/A
 Repair Type: Non-Urgent
 Crossing Status: Found
 UCIP Comments: 08/28/2019 Record has been updated from No Action Needed to Non-Urgent, no permit has been identified authorizing structure. (O. Magana - DWR UCIP, A. Freitag - DWR Sutter Yard)06/05/2017 Crossing appears to be in good condition.(DWR Sutter Yard- A.Freitag)11/18/2016 Crossing appears to be in good condition. (DWR Sutter Yard- A.Freitag)04/27/2016 Crossing appears to be in good condition.06/30/2015 Crossing appears in good condition. No noticeable issues to report.05/29/2014 Same as last inspection.12/09/2013 Same as last inspection.07/09/2013 Same as last inspection.04/24/2012 Limited inspection on WS slope due to dense vegetation. Need photo of WS slope when cleared. Unable to find WS outlet.
 FIELD_STRUCT_DESC: [Western Canal Siphon] 2 of 3: 8-foot by 10-foot concrete irrigation conduit through the levee and channel. Top of concrete conduit 4 feet below the crown. Catwalk and guardrails around headwall. Debris catchment line located at the wings of the headwall. All conduits are open. [Additional Reference(s): DWR Levee Log, 1993 (HLM 6.13). USACE Sacramento O&M Manual 519, June 1962 (HLM 6.13), listed as three 8-foot by 10-foot concrete conduit]

View of Western Canal Siphon (Richvale Siphon) located LS.

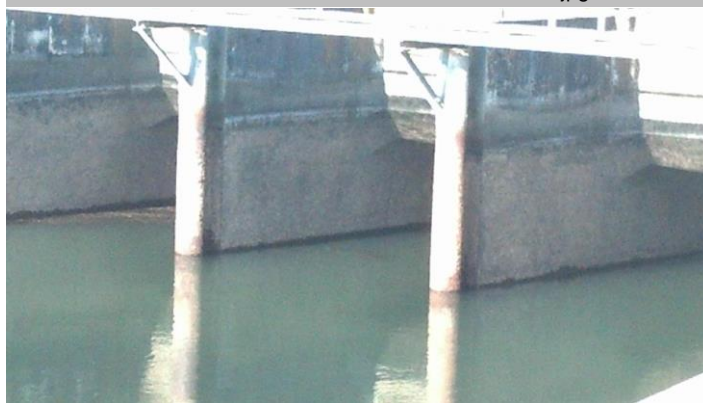
Photo 3 of 3 : UCIP_SP_2020_55108_67166.jpg

2 of 3 Eight (8) foot by Ten (10) foot conduit (middle conduit).

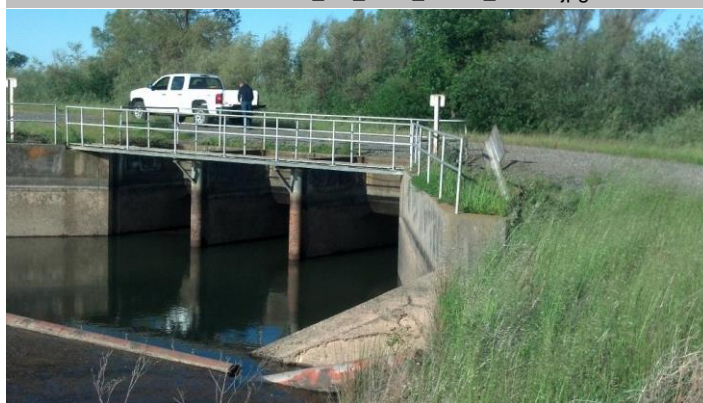
Photo 1 of 3 : UCIP_SP_2020_56104_67172.jpg

DS_ID:17374
FS_ID:56104
EP_NO: N/A
Repair Type: Non-Urgent
Crossing Status: Found
UCIP Comments: 08/28/2019 Record has been updated from No Action Needed to Non-Urgent, no permit has been identified authorizing structure. (O. Magana - DWR UCIP, A. Freitag - DWR Sutter Yard)06/05/2017 Crossing appears to be in good condition. (DWR Sutter Yard- AFreitag)11/18/2016 Crossing appears to be in good condition. (DWR Sutter Yard- AFreitag)04/27/2016 Crossing appears to be in good condition.06/30/2015 Crossing appears to be in good condition. No noticeable issues to report.05/29/2014 Same as last inspection.12/09/2013 Same as last inspection.07/09/2013 Same as last inspection.04/24/2012 Limited inspection on WS slope due to dense vegetation. Need photo of WS slope when cleared. Unable to find WS outlet.
FIELD_STRUCT_DESC: [Western Canal Siphon] 3 of 3: 8-foot by 10-foot concrete irrigation conduit through the levee and channel. Top of concrete conduit 4 feet below the crown. Catwalk and guardrails around headwall. Debris catchment line located at the wings of the headwall. All conduits are open. [Additional Reference(s): DWR Levee Log, 1993 (HLM 6.13). USACE Sacramento O&M Manual 519, June 1962 (HLM 6.13), listed as three 8-foot by 10-foot concrete conduit]

View of Western Canal Siphon (Richvale Siphon) looking south.

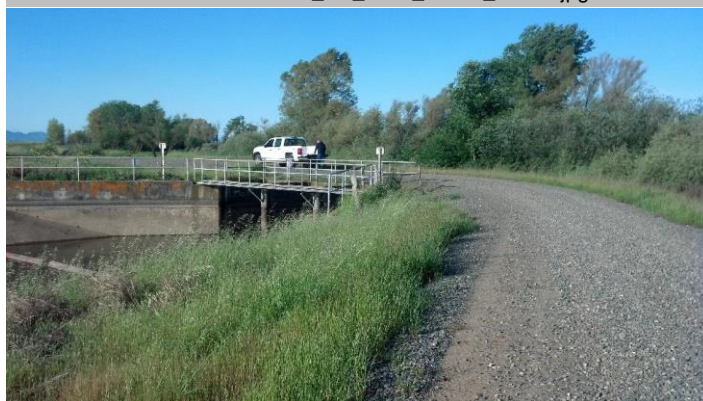
Photo 2 of 3 : UCIP_SP_2020_56104_67171.jpg

Overview looking south from levee

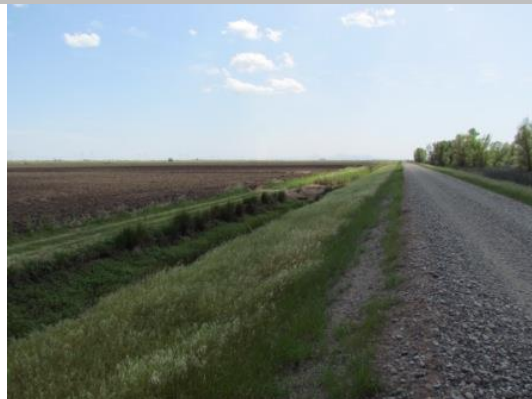
Photo 1 of 1 : SP_2020_MA0013_301_12_20200226_00001.jpg

LM Start	6.18	Rating **	M	Issue No.	12
LM End	7.54	Issue Type +	En	Location *	LS
Category	Earthen Levee			GPS Latitude/Longitude	
				Start	End
Item	Encroachments			39.520843 °	39.502958 °
				-121.706345 °	-121.716953 °
DWR ID	DWR_MA0013_02_s_2012_12				
Comment Code					
DT : Ditch					
Inspector Comment

View of the agricultural ditch along the toe.

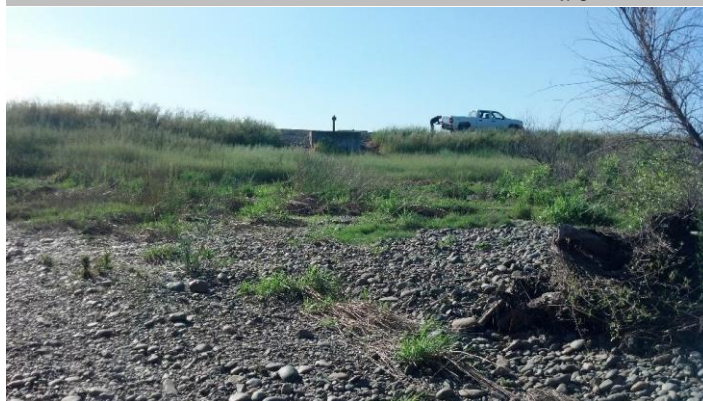
Photo 2 of 3 : UCIP_SP_2020_55114_67214.jpg

View of crossing looking from the channel towards WS levee. Access well is covered by vegetation right corner.
