**Flood Control Project Maintenance
Levee Inspections**
LMA District Cover Sheet
Spring 2020 Levee Inspection Results

Sutter Maintenance Yard Maintenance Area 0013

Spring 2020 Levee Inspection Results

Waterway			Bank	Unit Miles
Unit No. 01 Cherokee Canal			Right	18.19
	Spring (March - May)	Summer (June - August)	(September - November) Fall	Winter (December - February)
Unit Maintenance Rating (Fall Only)				
Date of Inspection	4/9/2020 - 4/9/2020			
DWR Inspector	Makar Sokol			
Accompanied By	Bob Duffey Sutter Maintenance Yard

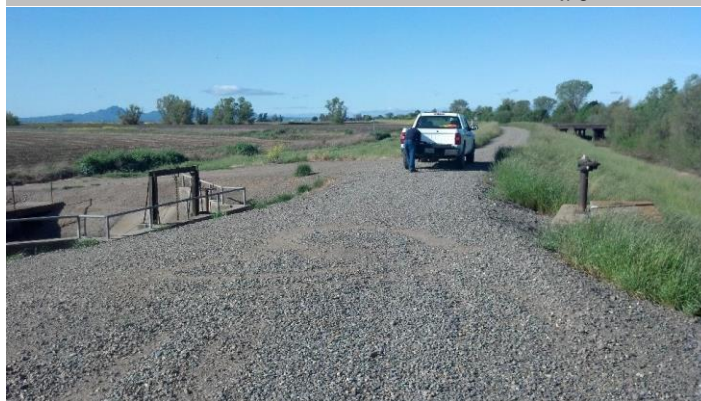
Photo 1 of 3 : UCIP_SP_2020_55119_67265.jpg

DS_ID:17523
FS_ID:55119
EP_NO: N/A
Repair Type: Non-Urgent
Crossing Status: Found
UCIP Comments: 08/28/2019 Record has been updated from No Action Needed to Non-Urgent, no permit has been identified authorizing structure. (O. Magana - DWR UCIP, A. Freitag - DWR Sutter Yard)06/05/2017 Crossing appears to be in good condition. (DWR Sutter Yard- A.Freitag)11/18/2016 Crossing appears to be in good condition. (DWR Sutter Yard- A.Freitag)04/27/2016 Crossing appears to be in good condition.06/30/2015 Crossing appears in good condition. No noticeable issues to report.05/28/2014 Same as last inspection.12/04/2013 Same as last inspection.07/09/2013 Same as last inspection.
FIELD_STRUCT_DESC: [Richvale Irrigation District Siphon] 3 of 3: 6-foot by 6.5-foot concrete irrigation culvert through the levee, 17.5 feet below the crown. Concrete "U" headwalls with slots for flashboards on the landside (LS). Slide gate in gate well on downstream culvert on the waterside (WS) slope. Access well on downstream culvert 60 feet from the WS toe, manhole flush with the top of the ground. 36-inch corrugated metal pipe through the levee, 11.2 feet below the crown. Flap gate on the WS end. Concrete "U" headwalls on both ends. This pipe drains excess water from the District's canal into Cherokee Canal. The pipe runs through the levee on an angle and discharges opposite historic levee mile (HLM) 9.58. Richvale Irrigation District siphon crosses the channel and levee. [Additional Reference(s): DWR Levee Log, 1993 (HLM 9.66). USACE Sacramento O&M Manual 519, June 1962 (HLM 9.66), listed as three 6-foot by 6.5-foot concrete conduit, As-built DWG No. 50-4-3608, Sheet No. 3608/20, ~ STA 650+00E, page 21 of 28 electronic file, listed as conduit]

Overview of crossing looking downstream at the left bank of Cherokee Canal.

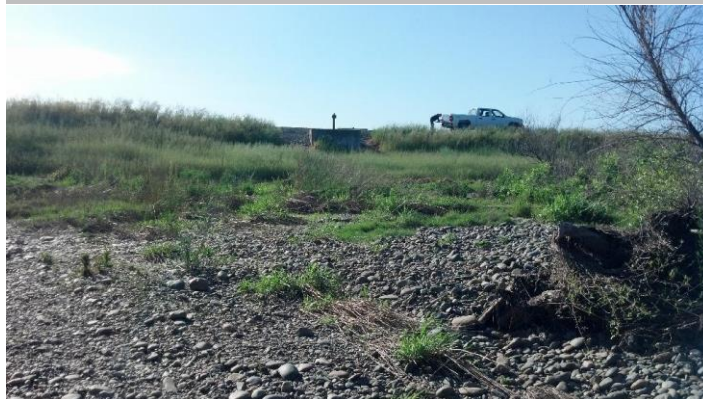
Photo 2 of 3 : UCIP_SP_2020_55120_67285.jpg

Comment Code						
Inspector Comment						
DS_ID:16838 FS_ID:55120 EP_NO: N/A Repair Type: Non-Urgent Crossing Status: Found UCIP Comments: 08/28/2019 Record has been updated from No Action Needed to Non-Urgent, no permit has been identified authorizing structure. (O. Magana - DWR UCIP, A. Freitag - DWR Sutter Yard)06/05/2017 Crossing appears to be in good condition. (DWR Sutter Yard- A.Freitag)11/18/2016 Crossing appears to be in good condition. (DWR Sutter Yard- A.Freitag)04/27/2016 Crossing appears to be in good condition.06/30/2015 Path to access the WS flap gate was getting overgrown with vegetation but other than that everything with the crossing looked in good condition.05/28/2014 Same as last inspection.12/04/2013 Same as last inspection.04/24/2012 This crossing was listed in the USACE Periodic Inspection report as Corp's inspect ID# USACE_CESPK_M13F_2011_p_0080 for limited visibility of LS slide gate and WS flap gate.07/09/2013 Same as last inspection. FIELD_STRUCT_DESC: 36-inch corrugated metal drainage pipe through the levee, 11.2 feet below the crown. Crossing drains into Cherokee Canal and is part of the Richvale Irrigation District siphon structure. Slide gate is located on the landside (LS). Flap gate is located on the waterside (WS). Crossing angles to the southwest to a flap gate and headwall located about 60 feet from WS toe. [Additional Reference(s): USACE Sacramento O&M Manual 519, June 1962 (HLM 9.66), listed as 36-inch pipe drain into Cherokee Canal, As-built DWG No. 50-4-3608, Sheet No. 3608/20, ~ STA 649+85E, page 21 of 28 electronic file] FS Date: 8/28/2019 4:05:00 PM

View of crossing looking from channel towards WS levee.

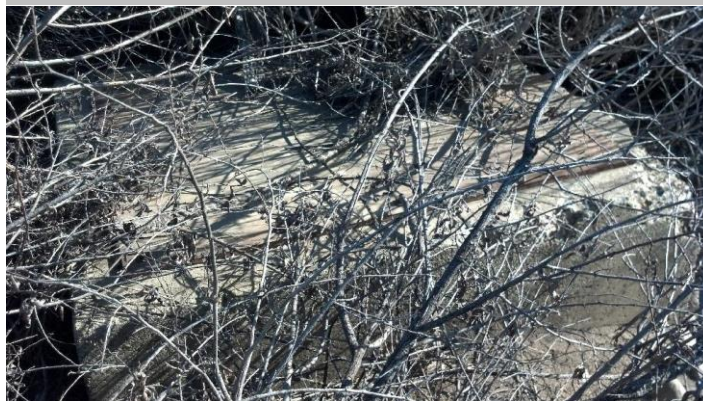
Photo 3 of 3 : UCIP_SP_2020_55120_67283.jpg

WS view-access well located 60 feet from WS toe.

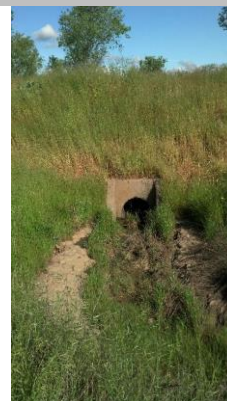
Photo 3 of 3 : UCIP_SP_2020_55118_67286.jpg

View of crossing from LS. Dense vegetation along LS slope limited visual inspection. (LS Photo 1 of 2)

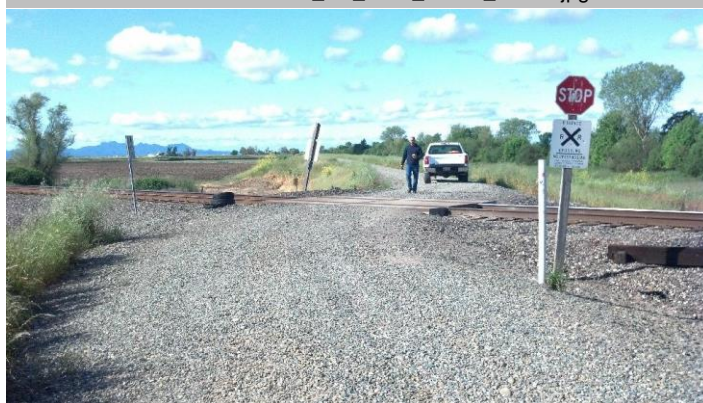
Photo 1 of 3 : UCIP_SP_2020_55122_67292.jpg

DS_ID:18912
FS_ID:55122
EP_NO: N/A
Repair Type: Non-Urgent
Crossing Status: Indicator Found
UCIP Comments: 08/28/2019 Record remains Non-Urgent, no permit has been found authorizing this encroachment. Marker down on WS shoulder. (O. Magana - DWR UCIP, A. Freitag - DWR Sutter Yard)06/05/2017 Crossing appears to be in good condition. (DWR Sutter Yard- A.Freitag)11/18/2016 Crossing appears to be in good condition. Another marker was found/photographed near the LS toe. Crossing also appears to cross through the Unit1 levee around CLM8.860. (DWR Sutter Yard- A.Freitag)04/27/2016 Crossing appears to be in good condition.06/30/2015 Crossing is in good condition.05/28/2014 Same as last inspection.12/04/2013 Same as last inspection.07/09/2013 Same as last inspection.04/24/2012 Unable to determine if crossing is an authorized or unauthorized encroachment. Unable to find permit number for this encroachment. Will need to coordinate with LMA Superintendent and DWR-Inspector, photo includes utility contact information.

Overview of levee crown at crossing.

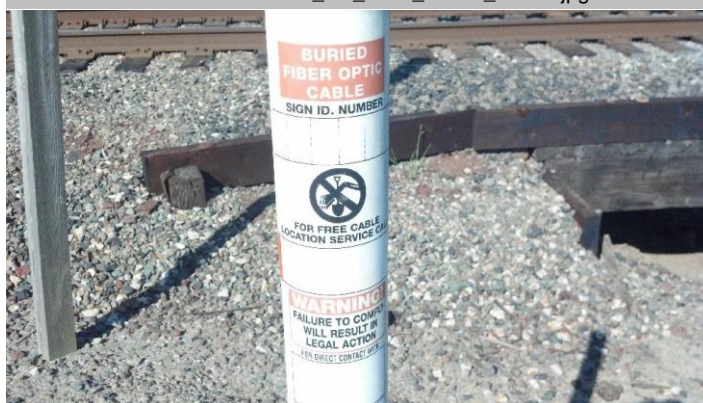
Photo 2 of 3 : UCIP_SP_2020_55122_67291.jpg

Marker for buried fiber optic cable on WS.

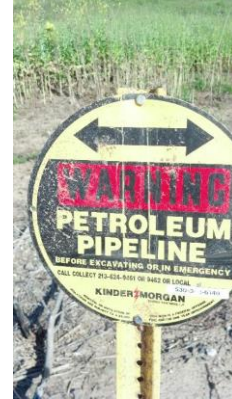
Photo 2 of 3 : UCIP_SP_2020_55123_67294.jpg

DS_ID:18913
FS_ID:55123
EP_NO: N/A
Repair Type: Non-Urgent
Crossing Status: Indicator Found
UCIP Comments: 08/28/2019 Record remains Non-Urgent, no permit has been found authorizing this crossing. Also need maintenance records to determine condition of line. (O. Magana - DWR UCIP, A. Freitag - DWR Sutter Yard)06/05/2017 Crossing appears to be in good condition. (DWR Sutter Yard- AFreitag)11/18/2016 Crossing appears to be in good condition. (DWR Sutter Yard- AFreitag)04/27/2016 Crossing appears to be in good condition.06/30/2015 Crossing appears to be in good condition. But still unknown if this crossing was authorized or unauthorized.05/28/2014 Same as last inspection.12/04/2013 Same as last inspection.07/09/2013 Same as last inspection.04/24/2012 Authorized/unauthorized encroachment? Contact Chico Local Area Manager, Frank Villalovos 530.342.6140 (o) or 530.624.4048 (c) or email villalovosf@kindermorgan.com for additional info. Inquiries pertaining to inspection submit to pipelineinquiries@kindermorgan.com and reference as Engr Station 3173+48 plus include coordinates.

WS marker with utility contact information.

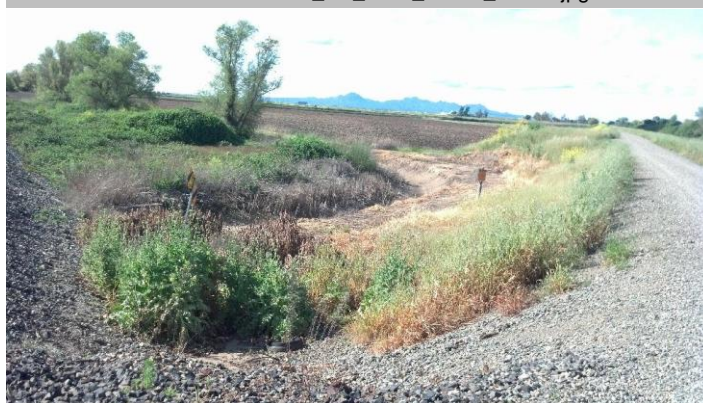
Photo 2 of 3 : UCIP_SP_2020_55972_67300.jpg

Marker located on LS.

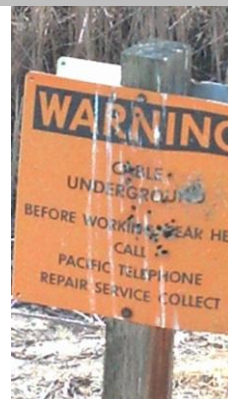
Photo 3 of 3 : UCIP_SP_2020_55972_67298.jpg

Underground cable marker with contact information.

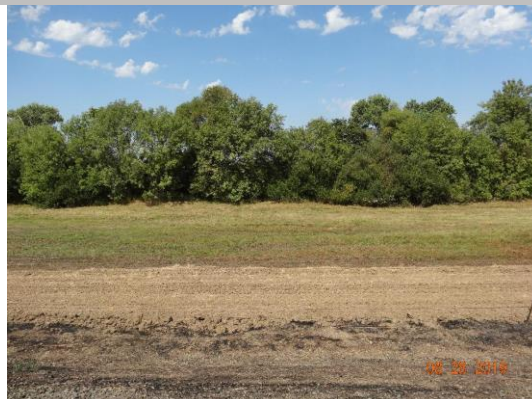
Photo 3 of 3 : UCIP_SP_2020_55125_80926.jpg

WS view: overview of WS.

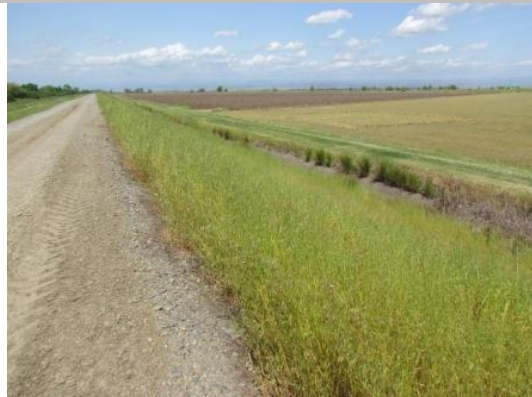
Photo 1 of 1 : SP_2020_MA0013_301_13_20200226_00002.jpg

LM Start	10.03	Rating **	M	Issue No.	13
LM End	10.52	Issue Type +	En	Location *	LS
Category	Earthen Levee			GPS Latitude/Longitude	
				Start	End
Item	Encroachments			39.471517 °	39.465113 °
				-121.739433 °	-121.743592 °
DWR ID	DWR_MA0013_02_s_2012_13				
Comment Code					
DT : Ditch					
Inspector Comment

View of the agricultural ditch along the toe.

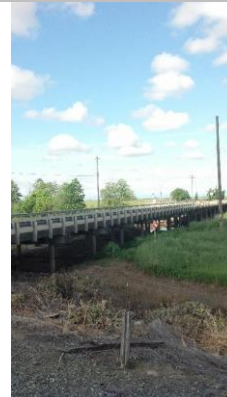
Photo 1 of 3 : UCIP_SP_2020_55126_67332.jpg

Comment Code					
Inspector Comment					
DS_ID:16406 FS_ID:55126 EP_NO: 1238 Repair Type: Non-Urgent Crossing Status: Indicator Found UCIP Comments: 08/29/2019 Record has been updated from No Action Needed to Non-Urgent, no maintenance records were made available to determine condition of line through the levee. Need to obtain maintenance records to determine status of crossing. (O. Magana - DWR UCIP, A. Freitag - DWR Sutter Yard)06/05/2017 Crossing appears to be in good condition. (DWR Sutter Yard-AFreitag)11/17/2016 Crossing appears to be in good condition. (DWR Sutter Yard- AFreitag)04/26/2016 Crossing appears to be in good condition.06/30/2015 Crossing appears in good condition. 05/28/2014 Same as last inspection.12/04/2013 Same as last inspection.07/08/2013 Same as last inspection.04/24/2012 Permit was approved for 6-5/8 inch diameter not 8 inch. The permit granted permission to construct pipe to cross Cherokee Canal, Butte Creek, Clear Creek, & Ash Creek. The O&M manual list an 8 inch steel gas line at HLM 10.67, unable to determine if the gas line is the same crossing. Will need to contact applicant to obtain records. FIELD_STRUCT_DESC: 8-inch steel gas pipe through the levee at an unknown depth below the crown. Utility marker visible at the upstream and downstream face of highway bridge and along highway. Buried utility crosses bridge and crosses left bank of Cherokee Canal downstream of highway bridge. USA marking on highway indicate 6" STL LN 151. (Permit No. 1238, 1947 - Pacific Gas and Electric Company [PG&E]) [Additional Reference(s): DWR Levee Log, 1993 (HLM 10.67). USACE Sacramento O&M Manual 519, June 1962 (HLM 10.67), listed as 8-inch pipe, As-built DWG No. 50-4-3511, Sheet No. 3511/25.1, STA 597+05E, page 25 of 31 electronic file, listed as gas line through both levees] FS Date: 8/29/2019 7:30:00 AM

Utility marker is located near the upstream face of the highway bridge.

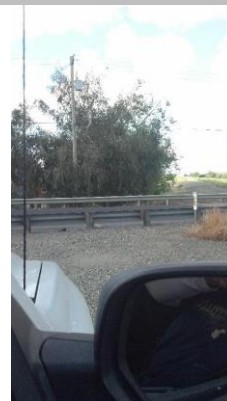
Photo 3 of 3 : UCIP_SP_2020_55126_67331.jpg

Downstream utility marker is located across highway.

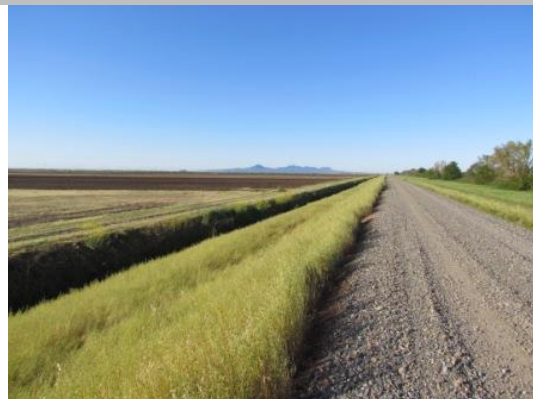
Photo 1 of 1 : SP_2020_MA0013_301_18_20200226_00003.jpg

LM Start	10.59	Rating **	M	Issue No.	18
LM End	11.66	Issue Type +	En	Location *	LS
Category	Earthen Levee			GPS Latitude/Longitude	
				Start	End
Item	Encroachments			39.464305 °	39.450333 °
				-121.744172 °	-121.753157 °
DWR ID	DWR_MA0013_02_s_2012_18				
Comment Code					
DT : Ditch					
Inspector Comment

View of the agricultural ditch along the toe.

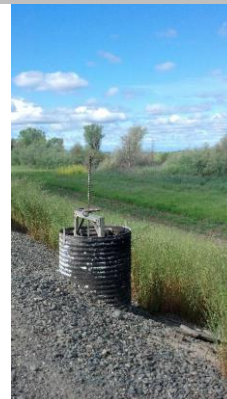
Photo 2 of 3 : UCIP_SP_2020_56106_67337.jpg

Stand pipe with screw gate WS

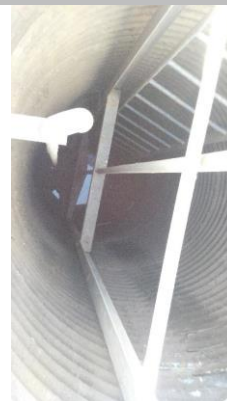
Photo 3 of 3 : UCIP_SP_2020_56106_67335.jpg

View of the inside of the WS stand pipe. No obstructions blocking slide gate.

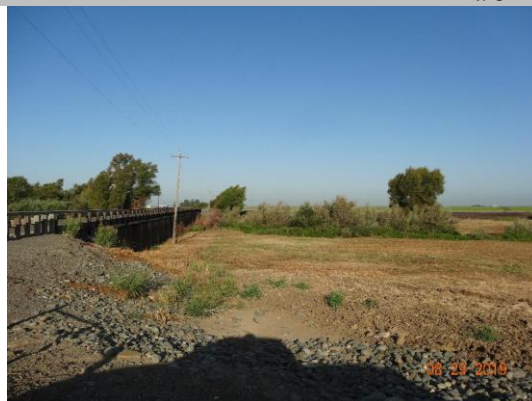
Photo 1 of 3 : UCIP_SP_2020_55128_80938.jpg

DS_ID:16474
FS_ID:55128
EP_NO: 17030
Repair Type: Non-Urgent
Crossing Status: Not Found
UCIP Comments: 08/29/2019 Record has been updated from No Action Needed to Non-Urgent, crossing is not found. Need to contact owner to determine status of crossing. Need to determine status of pipe through the levee. (O. Magana - DWR UCIP, A. Freitag - DWR Sutter Yard)05/30/2017 Unable to locate. (DWR Sutter Yard-AFreitag)11/17/2016 Unable to locate. (DWR Sutter Yard-AFreitag)04/26/2016 Unable to locate.06/30/2015 Unable to locate.05/28/2014 Same as last inspection.12/04/2013 Unable to locate.07/08/2013 Same as last inspection. Unable to locate.
FIELD_STRUCT_DESC: 8-inch high density polyethylene (HDPE), contains three 2-inch and three 1.5-inch fiber optic cables, backfilled with bentonite on the ends of the bore casing through the levee at an unknown depth below the crown. Conduit is bored across and under Cherokee Canal and its levees. Permit records indicates the conduit is buried 5 feet below the bottom of the low flow of the channel. Permit indicates work was completed as shown in submitted plans. Owner is listed in the permit as Pacific Fiber Link LLC but permit Inspection sheets list Worldwide Fiber. (Permit No. 17030, 2000 - Worldwide Fiber)

WS view: overview of WS. No signs of crossing.

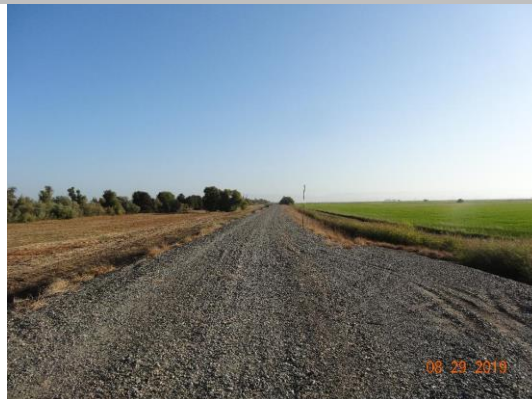
Photo 3 of 3 : UCIP_SP_2020_55128_80940.jpg

Overview of levee crown looking u/s towards where pipe should cross.

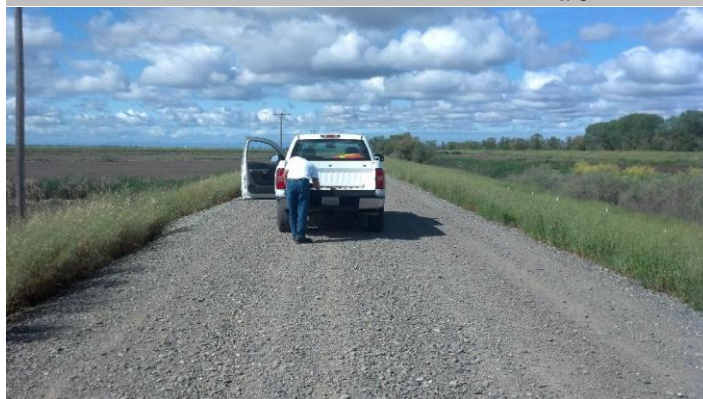
Photo 1 of 3 : UCIP_SP_2020_55129_67341.jpg

DS_ID:16376
FS_ID:55129
EP_NO: N/A
Repair Type: Non-Urgent
Crossing Status: Found
UCIP Comments: 08/29/2019 Record remains Non-Urgent, no permit has been identified authorizing pipe. Crossing appears abandoned. LMA will need to coordinate with landowner to determine is drainage structure is still needed. DMP internal inspection shows that 90% of the pipe is filled with soil at a length of about 42 feet from WS flap gate. If crossing is not in use anymore, crossing will need to be abandoned properly or removed. (O. Magana - DWR UCIP, A. Freitag - DWR Sutter Yard)5/30/2017 LS pipe end is buried and location unknown. WS flap gate is bolted shut. Pipe has been selected to be internally cleaned and inspected as part of the DMP project. (DWR Sutter Yard-AFreitag)11/17/2016 Unable to locate LS pipe end. WS flap gate bolted shut. (DWR Sutter Yard-AFreitag)4/26/2016 LS inlet appears to be buried as could not locate it. WS flap gate was bolted shut. This appears to be an abandoned crossing.6/30/2015 Still unable to locate the LS pipe end. 5/28/2014 Same as last inspection.12/4/2013 Same as last inspection. WS flap gate was bolted shut to keep LS rice field flooded.7/08/2013 WS slope has been cleared of vegetation and is in good condition. LS slope also cleared of vegetation but still very dense on LS toe and unable to locate LS headwall.4/24/2012 Could not find LS end of pipe. Limited inspection on WS and LS slopes and toe due to dense vegetation. Need photos of cleared WS and LS slopes, and LS headwall during next inspection. This crossing was listed in the USACE Periodic Inspection report as Corp's inspect ID# USACE_CESPK_M13E_2011_p_0011 for WS gate blocked by vegetation.

Overview of crossing looking downstream at the left bank of Cherokee Canal.

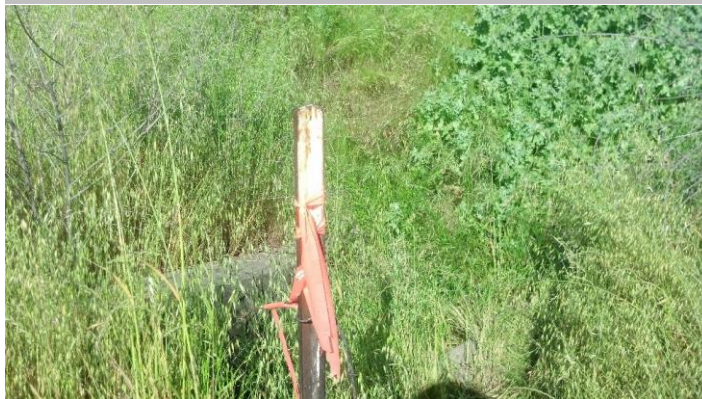
Photo 2 of 3 : UCIP_SP_2020_55129_67343.jpg

Dense vegetation covering the majority of the WS. WS headwall difficult to see through dense vegetation.

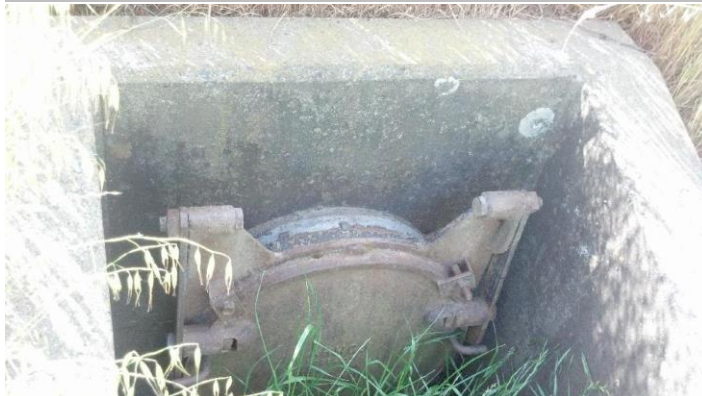
Photo 3 of 3 : UCIP_SP_2020_55129_67342.jpg

View of WS headwall and flap gate.

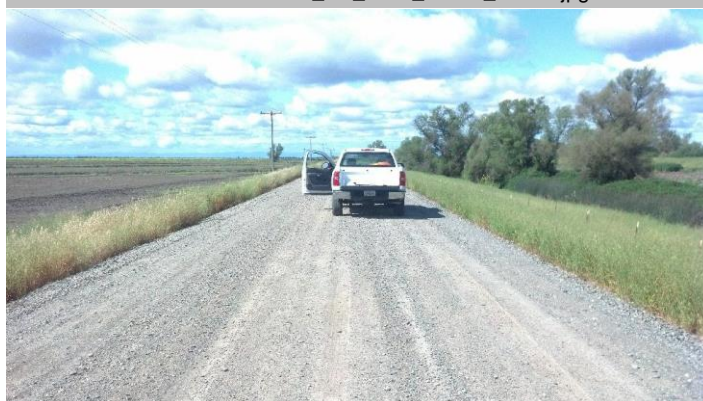
Photo 1 of 3 : UCIP_SP_2020_55974_67352.jpg

DS_ID:16382
FS_ID:55974
EP_NO: N/A
Repair Type: Non-Urgent
Crossing Status: Found
UCIP Comments: 08/29/2019 Record remains Non-Urgent, structure is non-functional and abandoned. Structure is abandoned. LMA will need to coordinate with landowner to determine if pipe is still needed as drainage structure. Dense vegetation covers the WS outlet and only LS headwall is visible at LS toe. If structure is no longer needed then structure will need to be abandoned properly or removed according to Title 23. DWR DMP internal inspection shows pipe has been filled with grout starting at about 47 feet from WS flap gate. No permit has been identified authorizing pipe. (O. Magana - DWR UCIP, A. Freitag - DWR Sutter Yard)05/30/2017 LS pipe end is buried and location unknown. WS flap gate bolted shut. Pipe has been selected to be internally cleaned and inspected as part of the DMP project. (DWR Sutter Yard-AFreitag)11/17/2016 Unable to locate LS pipe end. WS flap gate bolted shut. (DWR Sutter Yard-AFreitag)04/26/2016 Appears to be an abandoned crossing. LS pipe end was still buried and WS flap gate was bolted shut.06/30/2015 LS headwall still buried somewhere. WS looked to be in good condition.05/28/2014 Same as last inspection.12/04/2013 Same as last inspection.07/08/2013 Same as last inspection.04/24/2012 LS headwall buried. Limited inspection on WS and LS slopes due to dense vegetation. Need photos of cleared WS and LS slopes during next inspection. Need to determine the status of LS headwall. This crossing was listed in the USACE Periodic Inspection report as Corp's inspect ID# USACE_CESPK_M13E_2011_p_0022 -- unknown issue. FIELD_STRUCT_DESC: *ABANDONED* 24-inch corrugated metal drainage pipe through the levee, 9 feet below the crown. Flap gate located on the waterside (WS) end. Concrete "U" headwalls on both WS and landside (LS). WS gate bolted shut and LS crossing is non-operable (inlet not found). Additional Reference(s): DWR Levee Log, 1993 (HLM 15.87). USACE Sacramento O&M Manual 519, June 1962 (HLM 15.87), As-built DWG No. 50-4-3511, Sheet No. 3511/8.3, STA 392+42E, page 8 of 31 electronic file, listed as 24-inch CMP; As-built DWG No 50-4-3037 referenced not available]

Overview of crossing looking downstream of the left bank of Cherokee

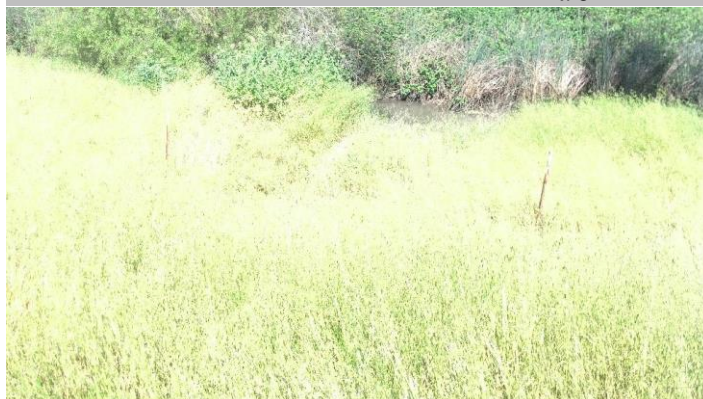
Photo 2 of 3 : UCIP_SP_2020_55974_67351.jpg

View of WS slope. Limited inspection due to the dense vegetation.

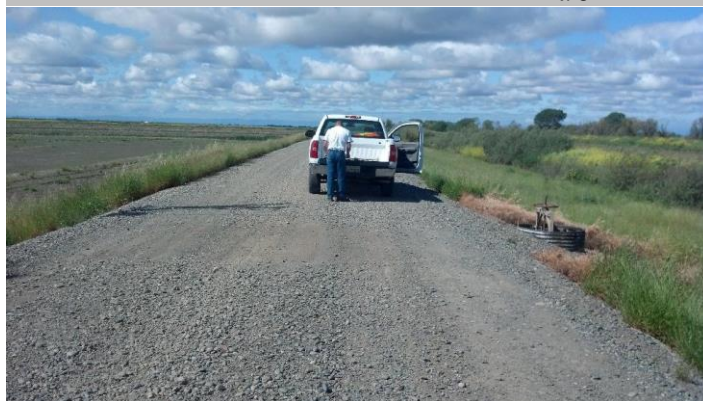
Photo 1 of 3 : UCIP_SP_2020_55131_67353.jpg

DS_ID:16377
FS_ID:55131
EP_NO: N/A
Repair Type: Non-Urgent
Crossing Status: Found
UCIP Comments: 08/29/2019 Record remains Non-Urgent due to maintenance issues. Unable to determine status of crossing. Steel pipe is deteriorated on the WS between concrete boxes. 36-inch pipe not visible inside concrete boxes. Recommend internal inspection to determine pipe condition through the levee. Riser lid missing on WS (considered a safety issue). LS inlet shows about 75% blockage. No permit has been identified authorizing pipe. (O. Magana - DWR UCIP, A. Freitag - DWR Sutter Yard)05/30/2017 LS headwall was mostly buried and pipe end over 50% full of sediment. WS distribution box appears to have not been repaired yet but it does not seem to affect the integrity of the levee. (DWR Sutter Yard- A.Freitag)11/17/2016 LS pipe end was about 50% plugged with soil. WS riser box is still cracked and appears to still be leaking. (DWR Sutter Yard- A.Freitag)04/26/2016 LS headwall was dry and photographed. LS pipe end was about 50% plugged with soil. WS riser box is still cracked and appears to still be leaking.06/30/2015 Bee boxes stacked near the riser box on WS so could not get close enough to see if the leak issue had been fixed. 05/28/2014 Water appears to be leaking out of the WS concrete riser box. Causing minor erosion under pipe near pump structure.12/04/2013 Same as last inspection.07/08/2013 LS slope has been cleared of vegetation and is in good condition. LS headwall was underwater and unable to be inspected. All WS appurtenances in good condition.04/24/2012 Limited inspection on LS slope due to dense vegetation. Need photos of cleared LS slope and LS headwall. Cracks in riser box. New pump installed recently this work might be covered under separate permit.

Overview of levee crown.

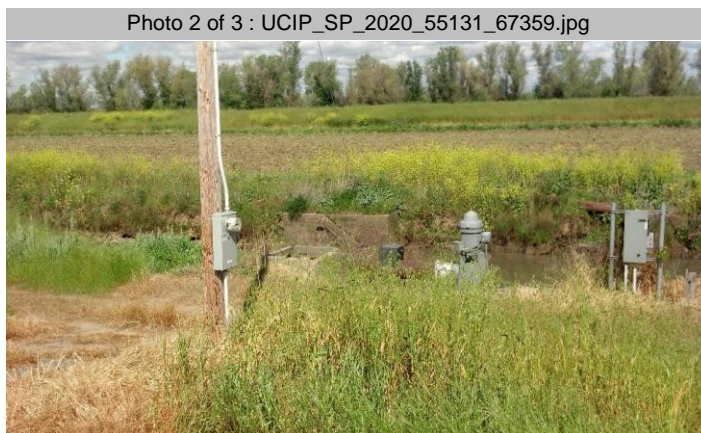
Appurtenances on WS.

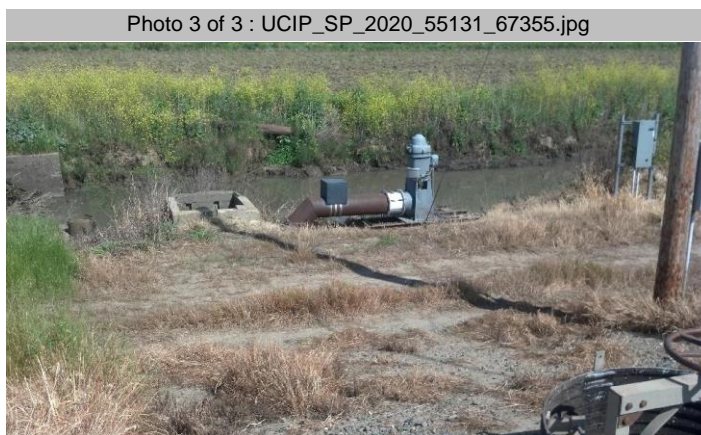
WS view of crossing.

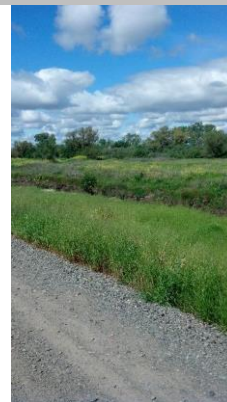
Photo 2 of 3 : UCIP_SP_2020_55132_67383.jpg

View of WS slope.

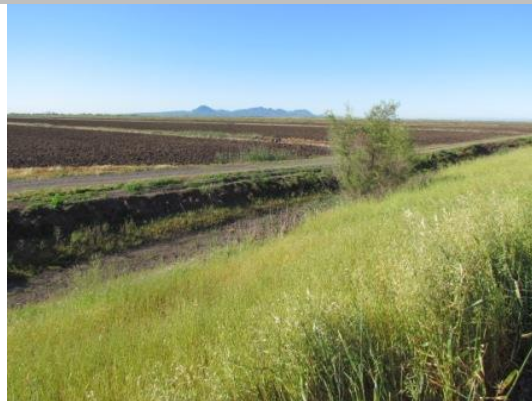
Photo 1 of 1 : SP_2020_MA0013_301_20_20200226_00005.jpg

LM Start	16.89	Rating **	M	Issue No.	20
LM End	18.72	Issue Type +	En	Location *	LS
Category	Earthen Levee			GPS Latitude/Longitude	
				Start	End
Item	Encroachments			39.406217 °	39.389187 °
				-121.794945 °	-121.821233 °
DWR ID	DWR_MA0013_02_s_2012_20				
Comment Code					
DT : Ditch					
Inspector Comment

View of the agricultural ditch along the toe.

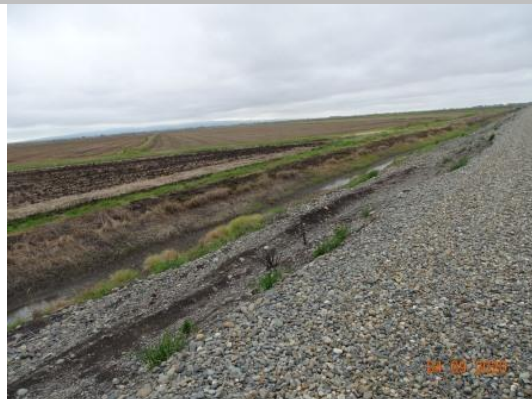
Photo 1 of 1 : SP_2020_MA0013_301_69_20200415_00179.jpg

LM Start	17.63	Rating **	U	Issue No.	69
LM End	17.65	Issue Type +	Ma	Location *	LS
Category	Earthen Levee			GPS Latitude/Longitude	
				Start	End
Item	Slope Stability			39.399319 °	39.399147 °
				-121.805524 °	-121.805783 °
DWR ID	DWR_MA0013_02_f_2016_69				
Comment Code					
S1 : Repair slope instability.					
Inspector Comment

View of slope instability along the landside slope. Spring 2020.

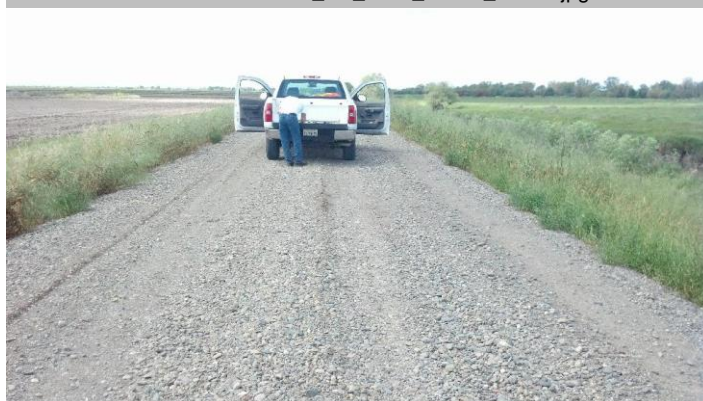
Photo 1 of 3 : UCIP_SP_2020_55133_67387.jpg

DS_ID:16379
FS_ID:55133
EP_NO: N/A
Repair Type: Non-Urgent
Crossing Status: Found
UCIP Comments: 08/29/2019 Record has been updated from No Action Needed to Non-Urgent, no permit has been identified authorizing pipe. Pipe is under water. Pipe is scheduled to be lined. (O. Magana - DWR UCIP, A. Freitag - DWR Sutter Yard)05/30/2017 Crossing appears to be in good condition. Pipe has been selected to be internally cleaned and inspected as part of the DMP project. (DWR Sutter Yard- A.Freitag)11/17/2016 Crossing appears to be in good condition. (DWR Sutter Yard- A.Freitag)04/26/2016 Crossing appears to be in good condition.06/30/2015 Vegetation still present on WS. LS side was underwater during inspection.05/28/2014 Same as last inspection.12/04/2013 Same as last inspection.07/08/2013 LS slope cleared of vegetation and is in good condition. WS is still vegetated. LS pipe end under water and blocked off by plywood so unable to measure culvert size.04/24/2012 Limited inspection on WS and LS slopes due to dense vegetation. Need photos of cleared WS and LS slopes. This crossing was listed in the USACE Periodic Inspection report as Corp's inspect ID# USACE_CESPK_M13E_2011_p_0134 for unknown culvert size on LS and no outlet visible on WS.

Overview of crossing looking D/S at left bank of Cherokee Canal.

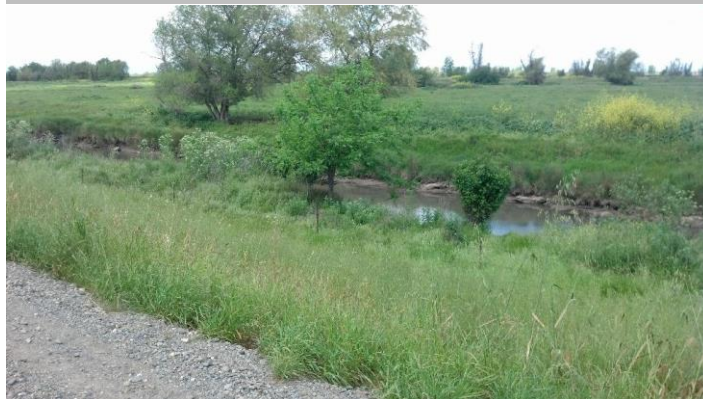
Photo 2 of 3 : UCIP_SP_2020_55133_67386.jpg

View of WS slope and berm.

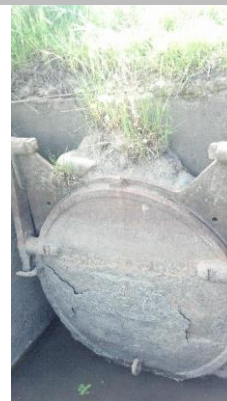
Photo 3 of 3 : UCIP_SP_2020_55133_67390.jpg

View of flap gate located on WS.

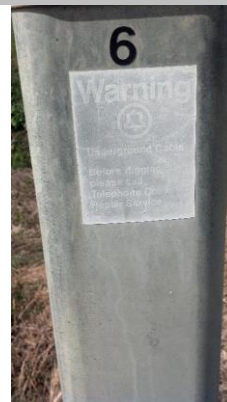
Photo 2 of 3 : UCIP_SP_2020_55134_67394.jpg

Splice box information located on LS approximately 60 feet from levee crown.

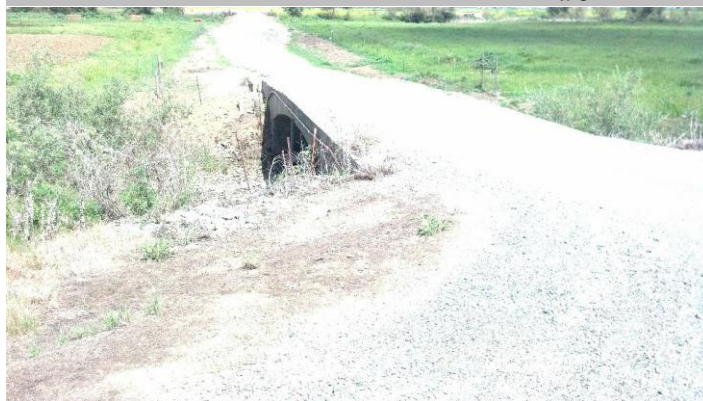
Photo 3 of 3 : UCIP_SP_2020_55134_67395.jpg

View of WS where cable line is attached to culvert crossing.

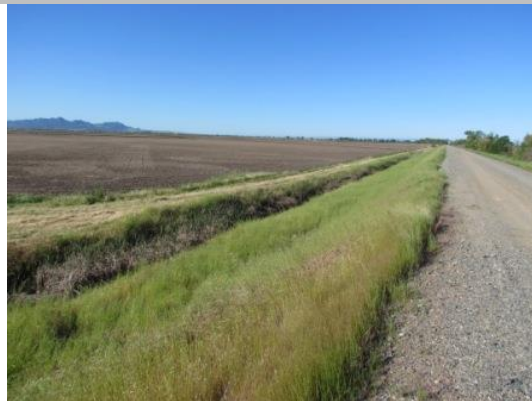
Photo 1 of 1 : SP_2020_MA0013_301_21_20200226_00006.jpg

LM Start	19.37	Rating **	M	Issue No.	21
LM End	19.92	Issue Type +	En	Location *	LS
Category	Earthen Levee			GPS Latitude/Longitude	
				Start	End
Item	Encroachments			39.383252 °	39.378192 °
				-121.830565 °	-121.838543 °
DWR ID	DWR_MA0013_02_s_2012_21				
Comment Code					
DT : Ditch					
Inspector Comment

View of the agricultural ditch along the toe.

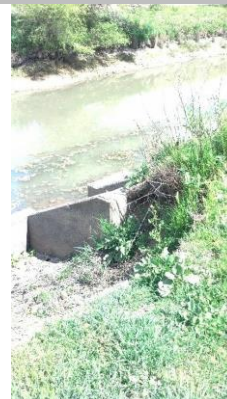
Photo 1 of 3 : UCIP_SP_2020_55135_67401.jpg

DS_ID:16375
FS_ID:55135
EP_NO: N/A
Repair Type: Non-Urgent
Crossing Status: Found
UCIP Comments: 08/29/2019 Record remains Non-Urgent, no permit has been identified authorizing pipe. Pipe is scheduled to be lined. (O. Magana - DWR UCIP, A. Freitag - DWR Sutter Yard)05/30/2017 Erosion still present at WS headwall. Pipe has been selected to be internally cleaned and inspected as part of the DMP project. (DWR Sutter Yard- A.Freitag)11/17/2016 Erosion still present at WS headwall. (DWR Sutter Yard- A.Freitag)04/26/2016 Erosion still present behind the WS headwall. The rest of the crossing appears in good condition.06/30/2015 Erosion still present behind the WS headwall. Everything thing else with the crossing appeared to be in good condition.12/04/2013 Same as last inspection.05/28/2014 Same as last inspection.07/08/2013 Erosion problem same as last inspection. WS and LS slopes have been cleared of vegetation and are in good shape.04/24/2012 Erosion present behind WS headwall. Limited inspection on WS and LS slopes due to dense vegetation. Need photos of cleared WS and LS slopes during next inspection. FIELD_STRUCT_DESC: 30-inch corrugated metal drainage pipe through the levee, 13.1 feet below the crown. Flap gate on the waterside (WS) end. Concrete "U" headwalls on both WS and landside (LS). [Additional Reference(s): DWR Levee Log, 1993 (HLM 20.15). USACE Sacramento O&M Manual 519, June 1962 (HLM 20.15), As-built DWG No. 50-4-3511, Sheet No. 3511/4.3, STA 168+68E, page 4 of 31 electronic file, listed as 30-inch CMP through the levee]

Erosion behind WS headwall looking at the downstream edge of headwall.

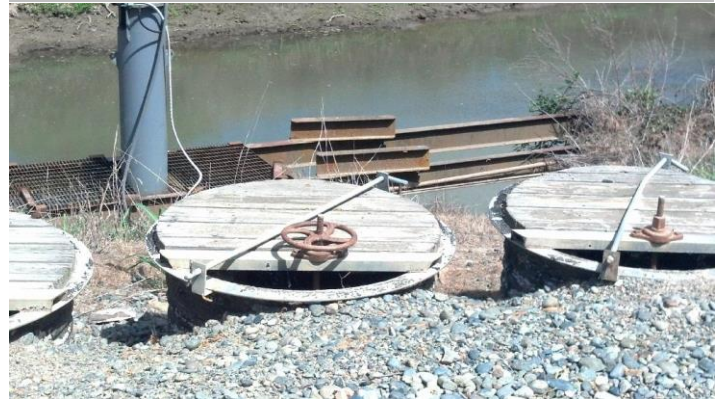
Photo 2 of 3 : UCIP_SP_2020_56079_67418.jpg

DS_ID:17014
FS_ID:56079
EP_NO: N/A
Repair Type: Urgent
Crossing Status: Found
UCIP Comments: 08/29/2019 Record remains Urgent due to pipe and levee integrity concerns. Also no permit has been identified authorizing pump station. Pump station is still active. Crossing shows sloughing on the WS with visible holes in pipe on the LS. This crossing is under investigation under CVFPB enforcement case (ENF ID) 723. (O. Magana - DWR UCIP, A. Freitag - DWR Sutter Yard)08/23/2018 The CVFPB has filed an enforcement for this crossing, Enforcement Case: 2018-723. There is still massive erosion around the WS headwall and corrosion and degradation of the LS outlet pipes, so the crossing remains Urgent (D. Sanoski - DWR UCIP).05/30/2017 No repairs have been made here yet. WS still has depressions above the pipe alignment. LS pipe end still showing heavy signs of rusting and deterioration. Sediment build up inside of concrete distribution box on the LS. (DWR Sutter Yard - A.Freitag)11/17/2016 Crossing has not been repaired yet. pipe ends still showing heavy signs of rust and corrosion. (DWR Sutter Yard - A.Freitag)04/26/2016 No repairs have been made at this crossing yet. (DWR Sutter Yard - a.freitag)06/30/2015 Crossing has not been repaired yet. pipe ends still showing heavy signs of rust and corrosion. (DWR Sutter Yard - a.freitag)05/28/2014 Same as last inspection. (DWR Sutter Yard - a.freitag)12/04/2013 Same as last inspection. (DWR Sutter Yard - a.freitag)07/08/2013 Same as last inspection. (DWR Sutter Yard - a.freitag)04/24/2012 LS pipe collars severely damaged--section missing at flap gate. Crossing needs repair. Will need to coordinate with owner. (DWR UCIP - omagana)

Riser for pipe 2 of 3.

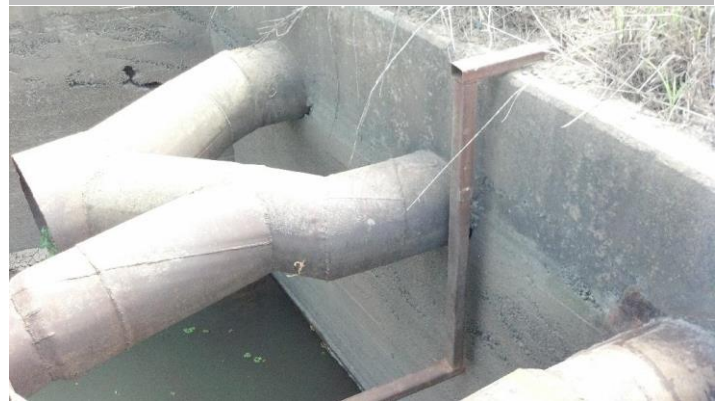
Photo 3 of 3 : UCIP_SP_2020_56079_67415.jpg

View of pipe 2. Pipe 2 diverts flow to pipe 1.

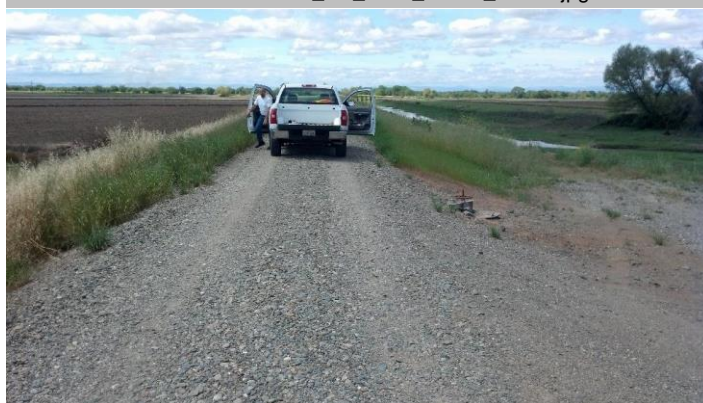
Photo 1 of 3 : UCIP_SP_2020_55413_67447.jpg

DS_ID:16384
FS_ID:55413
EP_NO: N/A
Repair Type: Non-Urgent
Crossing Status: Found
UCIP Comments: 08/29/2019 Record remains Non-Urgent due to unauthorized encroachment with recent modifications. Structure type needs to be corrected from Drainage to Irrigation. During inspection water was flowing from WS to LS to irrigate the rice fields. Structure has been modified since 2012, unable to determine extent of repair through levee. Need to contact owner to determine section replaced through levee. Structure is not maintained or operated by LMA-DWR Sutter Yard. (O. Magana - DWR UCIP, A. Freitag - DWR Sutter Yard)05/30/2017 Crossing appears to be in good condition. Pipe has been selected to be internally cleaned and inspected as part of the DMP project. (DWR Sutter Yard - A.Freitag)11/17/2016 Pipe section that crosses through the levee appears to be in good condition. (DWR Sutter Yard - A.Freitag)04/26/2016 Pipe appears to have been repaired. Not sure on the extent of the repairs or if they were approved by the Central Valley Flood Control Board.06/30/2015 Pipe is currently undergoing repairs. Not sure what all is planned to be fixed but will update the photos and inspection report with new details when its completed.05/28/2014 Same as last inspection.12/04/2013 Same as last inspection.07/08/2013 Pipe appears to have been repaired. Need to talk to inspections and supervisor to find out more details on repair.04/24/2012 Needs repair. Internal piping, severe corrosion. Debris present--rusted pipe stockpiled on LS slope. Limited inspection on WS and LS slopes due to dense vegetation. Need photos of cleared WS & LS slopes. This crossing was listed in the USACE Periodic Inspection report as Corp's inspect ID# USACE_CESPK_M13E_2011_p_0234 for no WS gate but sluice gate present.

FIELD_STRUCT_DESC: 24-inch corrugated metal irrigation pipe through the levee, 8.2 feet below the crown. Crossing penetrates levee at angle. Slide gate in corrugated metal pipe (CMP) riser on the waterside (WS) slope. Pipe crosses the channel. Corroded section of existing pipe, 9-foot and 8-inch of an 18-inch corrugated metal pipe section, was replaced under Permit 7231 prior to 1974. (24-inch CMP authorized to match existing 24-inch CMP through left bank under Permit No. 7231, 1960 - Estate of Walter L. King) [Additional Reference(s): DWR Levee Log, 1993 (HLM 21.60). USACE Sacramento O&M Manual 519, June 1962 (HLM 21.60), As-built DWG No. 50-4-3511, Sheet No. 3511/22, STA 93+21E, page 22 of 31 electronic file, listed as 24-inch CMP section through the levee (irrigation structure); As-built DWG No. 50-4-3037 referenced not available]
FS Date: 8/29/2019 7:39:00 AM

Overview of crossing looking downstream.

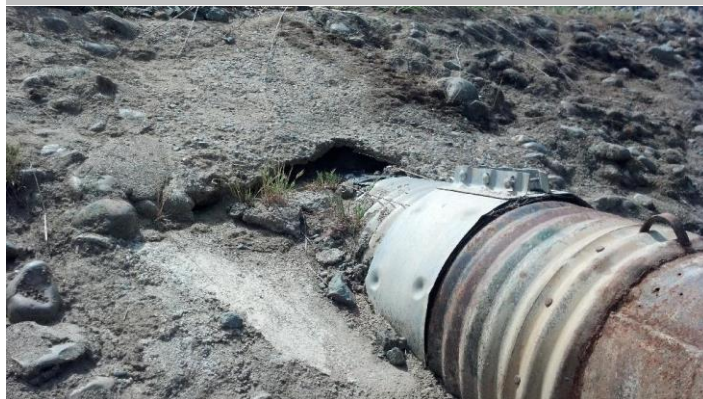
Photo 2 of 3 : UCIP_SP_2020_55413_67451.jpg

View of WS daylight. Hole present at pipe daylight.

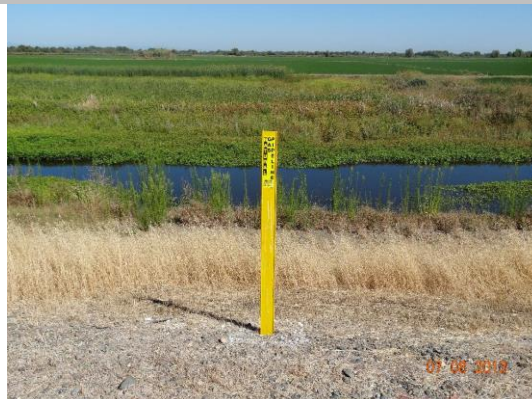
Photo 1 of 3 : UCIP_SP_2020_55141_67457.jpg

DS_ID:17732
FS_ID:55141
EP_NO: 17504
Repair Type: Non-Urgent
Crossing Status: Indicator Found
UCIP Comments: 08/29/2019 Record has been updated from No Action Needed to Non-Urgent, no maintenance records were made available to determine condition of pipe through levee. (O. Magana - DWR UCIP, A. Freitag - DWR Sutter Yard)05/30/2017 Crossing appears to be in good condition. (DWR Sutter Yard - A Freitag)11/17/2016 Crossing appears to be in good condition. (DWR Sutter Yard - A Freitag)04/26/2016 Crossing appears to be in good condition.06/30/2015 Crossing and markers are in good condition.05/28/2014 Same as last inspection.12/04/2013 Same as last inspection.07/08/2013 Carsonite marker installed on WS shoulder identifying gas line location.04/24/2012 Unable to find crossing during spring inspection. Will need to verify during Fall inspection when vegetation is removed from slopes.
FIELD_STRUCT_DESC: 30-inch gas pipeline across and under (bored) Cherokee Canal and its levees with minimum of 50 feet of cover below the levee toes. (30-inch line authorized under Permit No. 17504, 2004 - David D. Davis-Matrix Environmental Planning) Emergency contact number is 1-800-352-8781.

Carsonite marker on WS shoulder

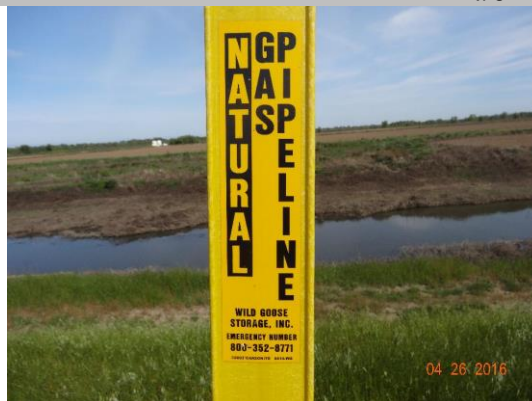
Photo 2 of 3 : UCIP_SP_2020_55141_74994.jpg

Close up of marker with contact info

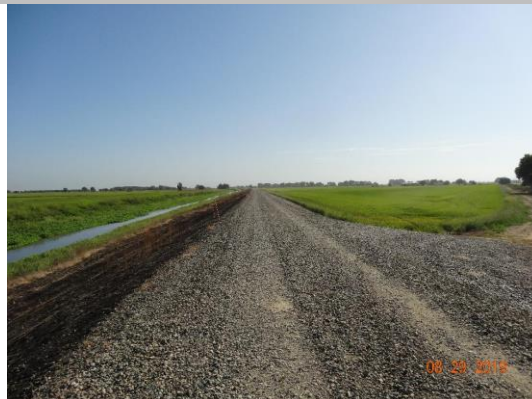
Photo 3 of 3 : UCIP_SP_2020_55141_81020.jpg

Overview of levee crown looking u/s towards pipe crossing.

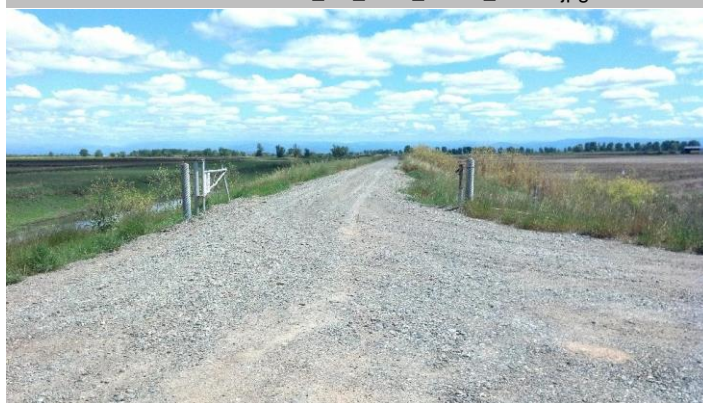
Photo 1 of 3 : UCIP_SP_2020_55414_67462.jpg

Comment Code						
Inspector Comment						
DS_ID:16394 FS_ID:55414 EP_NO: N/A Repair Type: Non-Urgent Crossing Status: Found UCIP Comments: 08/29/2019 Record remains Non-Urgent, no permit has been identified authorizing pipe. Pipe has been lined and a new flap gate has been installed on the WS. (O. Magana - DWR UCIP, A. Freitag - DWR Sutter Yard)05/30/2017 WS flap gate showing signs of rusting and deterioration but still appears to be able to function properly. Pipe has been selected to be internally cleaned and inspected as part of the DMP project. (DWR Sutter Yard - AFreitag)11/17/2016 WS flap gate is really rusted and deteriorated but it appears to still function properly. (DWR Sutter Yard - AFreitag)04/26/2016 WS flap gate is really rusted and deteriorated. May need to be replaced. The rest of the crossing appeared in good condition.06/30/2015 Crossing is in good condition. No noticeable issues to be reported.05/28/2014 Same as last inspection.12/04/2013 WS and LS slopes are in good condition.07/08/2013 Same as last inspection.04/24/2012 Limited inspection on WS and LS slopes due to dense vegetation. Need photos of cleared WS and LS slopes. This crossing was listed in the USACE Periodic Inspection report as Corp's inspect ID# USACE_CESPK_M13E_2011_p_0251 for no outlet visible on WS. FIELD_STRUCT_DESC: 24-inch CIPP-lined corrugated metal drainage pipe through the levee, 11.6 feet below the crown. Flap gate on the waterside (WS) end. Concrete "U" headwalls on both WS and landside (LS). Rusted gate located on the WS (gate stuck). [Additional Reference(s): DWR Levee Log, 1993 (HLM 22.08). USACE Sacramento O&M Manual 519, June 1962 (HLM 22.08), As-built DWG No. 50-4-3511, Sheet No. 3511/2.2 and 31.2, STA 67+70E, page 2, 31 of 31 electronic file, listed as 24-inch CMP section through the levee] FS Date: 8/29/2019 7:40:00 AM

Overview of crossing looking upstream at the left bank of Cherokee Canal.

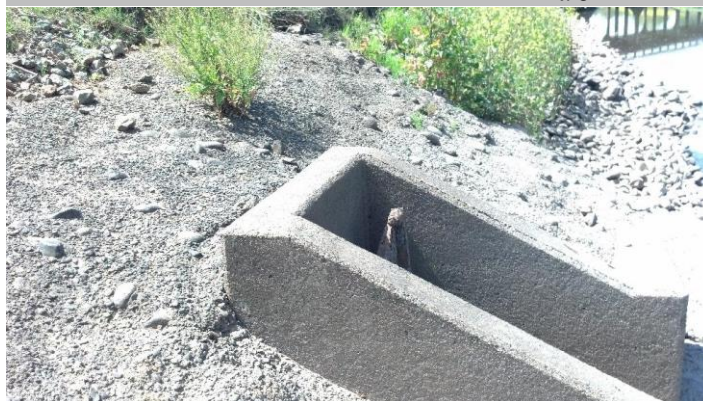
Photo 2 of 3 : UCIP_SP_2020_55414_67460.jpg

View of WS headwall.

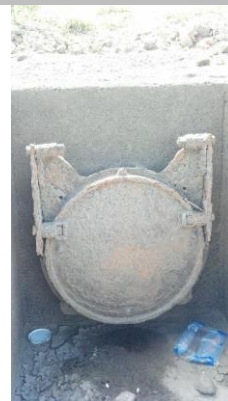
Photo 3 of 3 : UCIP_SP_2020_55414_67461.jpg

Flap gate located on WS.

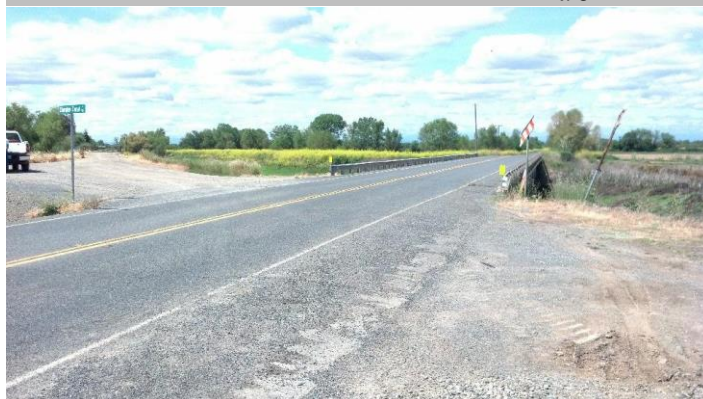
Photo 1 of 3 : UCIP_SP_2020_55143_67463.jpg

DS_ID:16386
FS_ID:55143
EP_NO: N/A
Repair Type: Non-Urgent
Crossing Status: Indicator Found
UCIP Comments: 08/29/2019 Record has been updated from No Action Needed to Non-Urgent, no permit has been identified authorizing this pipe. No maintenance records are available for this crossing. Need to contact owner to determine status of crossing. (O. Magana - DWR UCIP, A. Freitag - DWR Sutter Yard)05/30/2017 Crossing appears to be in good condition. (DWR Sutter Yard - A.Freitag)11/17/2016 Crossing appears to be in good condition. (DWR Sutter Yard - A.Freitag)04/26/2016 Crossing appears to be in good condition.06/30/2015 Crossing and markers are in good condition.05/28/2014 Same as last inspection.12/04/2013 Same as last inspection.07/08/2013 Same as last inspection.04/24/2012 Markers visible for crossing.
FIELD_STRUCT_DESC: High pressure gas line through the levee. Depth unknown. [Additional Reference(s): DWR Levee Log, 1993 (HLM 22.11). USACE Sacramento O&M Manual 519, June 1962, listed in As-built DWG No. 50-4-3511 only and not manual, Sheet No. 3511/31.2, STA 66+00E, page 31 of 31 electronic file, listed as 12-inch underground gas main section through the levee]

Overview of gas line marker located at the upstream face of the highway bridge.

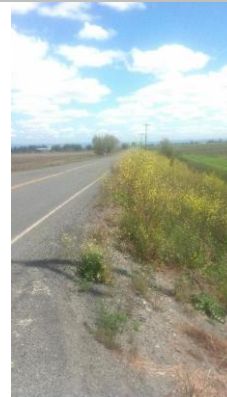
Photo 3 of 3 : UCIP_SP_2020_55143_67464.jpg

View of second gas line marker looking East at highway (LS view).

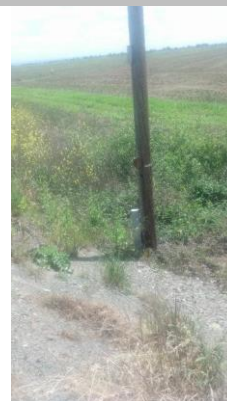
Photo 1 of 1 : UCIP_SP_2020_54857_67480.jpg

Comment Code					
Inspector Comment					
DS_ID:16374 FS_ID:54857 EP_NO: N/A Repair Type: Non-Urgent Crossing Status: Indicator Found UCIP Comments: 08/29/2019 Record remains Non-Urgent, no permit has been identified authorizing pipe. Also modification have been made without prior notification to the CVFPB. Multiple splice boxes can be found along the LS toe. Need to review CVFPB enforcement case to determine if issue has been resolved. Need updated photos for this crossing. (O. Magana - DWR UCIP, A. Freitag - DWR Sutter Yard)05/30/2017 Splice box still present at LS toe. (DWR Sutter Yard - A.Freitag)11/17/2016 Splice box still present at LS toe. (DWR Sutter Yard - A.Freitag)04/26/2016 Communication Splice box was still present. Not sure what was done to ever resolve the encroachment issue.06/30/2015 Same as last inspection.05/28/2014 Same as last inspection.12/04/2013 Same as last inspection.07/08/2013 Same as last inspection.04/24/2012 Unauthorized Encroachment. This crossing is listed multiple times in the USACE Periodic Inspection report as USACE_CESPK_M13E_2011_p_0307, 0315, 0317, 0318 for slope failure on LS hinge. DWR-Flood Maintenance Office records shows that CVFPB has requested AT&T to remove conduit in June 2, 2009 letter. LMA working with CVFPB to resolve. FIELD_STRUCT_DESC: Underground telephone cable through the levee. Depth unknown. (AT&T) START latitude 39.36210336, longitude -121.8678207 END latitude 39.35458541, longitude -121.8823409. Line extends from Gridley Colusa Highway to the south end of project levee along landside (LS) shoulder and levee crown hinge point. Levee sloughs along cable trench after heavy rains. [Additional Reference(s): DWR Levee Log, 1993. USACE Sacramento O&M Manual 519, June 1962, listed in As-built DWG No. 50-4-3511 only and not manual, Sheet No. 3511/31.2, STA 66+00E, page 31 of 31 electronic file, listed as underground telephone and electric line through the levee] FS Date: 8/29/2019 7:42:00 AM

View of utility line located on LS toe.

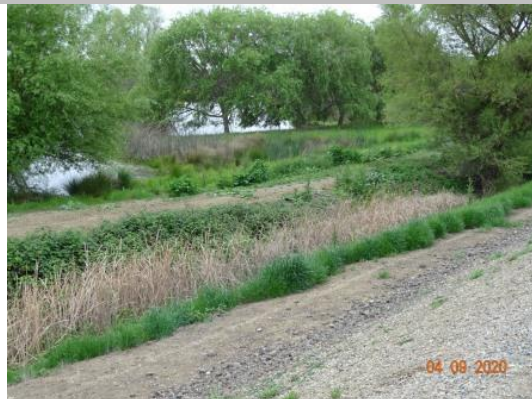
Photo 1 of 1 : SP_2020_MA0013_301_59_20200415_00180.jpg

LM Start	21.87	Rating **	U	Issue No.	59
LM End	22.09	Issue Type +	En	Location *	LS
Category	Earthen Levee			GPS Latitude/Longitude	
				Start	End
Item	Encroachments			39.362022 °	39.360294 °
				-121.867949 °	-121.871339 °
DWR ID	DWR_MA0013_02_s_2016_59				
Comment Code					
DT : Ditch					
Inspector Comment

View of the ditch along the landside toe. Spring 2020.

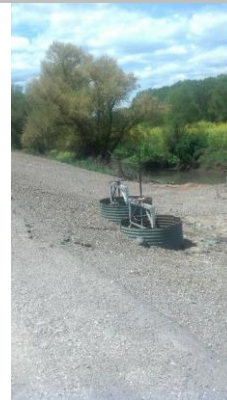
Photo 2 of 3 : UCIP_SP_2020_55144_67482.jpg

View of corrugated metal risers located on WS slope.

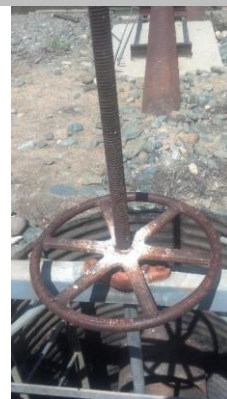
Photo 3 of 3 : UCIP_SP_2020_55144_67485.jpg

WS view of 18 inch line through corrugated metal riser.

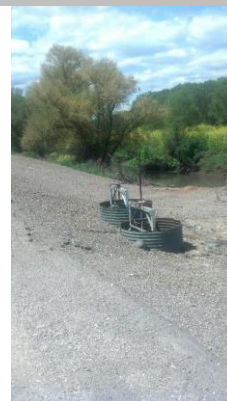
Photo 2 of 3 : UCIP_SP_2020_55145_67491.jpg

Comment Code					
Inspector Comment					
DS_ID:16389 FS_ID:55145 EP_NO: N/A Repair Type: Non-Urgent Crossing Status: Found UCIP Comments: 08/29/2019 Record has been updated from No Action Needed to Non-Urgent, no permit has been identified authorizing pipe. Recommend CMP riser covers for this crossing for safety purposes. (O. Magana - DWR UCIP, A. Freitag - DWR Sutter Yard)05/30/2017 Crossing appears to be in good condition. (DWR Sutter Yard - A.Freitag)11/17/2016 Crossing appears to be in good condition. (DWR Sutter Yard - A.Freitag)04/26/2016 Crossing appears to be in good condition.06/30/2015 Crossing is in good condition. No noticeable issues to report.05/28/2014 Same as last inspection.12/04/2013 Top of screw gate has been replaced and gate is now fully functional.07/08/2013 Top of slide gate frame and wheel missing making gate inoperable. Needs to be replaced before flood season. FIELD_STRUCT_DESC: 42-inch corrugated metal irrigation pipe through the levee, 11.7 feet below the crown. Slide gate in corrugated metal pipe riser on the waterside (WS) slope. Concrete "U" headwall on the WS end. A concrete headwall trash gate is located on the WS inlet. [Additional Reference(s): DWR Levee Log, 1993 (HLM 22.40), listed as 42-inch pipe. USACE Sacramento O&M Manual 519, June 1962 (HLM 22.40), listed as 36-inch pipe, As-built DWG No. 50-4-3511, Sheet No. 3511/21.2, STA 51+32E, page 21 of 31 electronic file, listed as combination of existing 36-inch CMP and new 42-inch CMP section through the levee (irrigation and drainage structures); As-built DWG No. 50-4-3037 referenced not available] FS Date: 8/29/2019 7:43:00 AM

LM Start	22.14	Rating **	M	Issue No.	969 (cont)
LM End	22.14	Issue Type +	En	Location *	
Category	Supplemental		GPS Latitude/Longitude		
			Start	End	
Item	DWR UCIP Field Study		39.359870 °	39.359870 °	
			-121.872140 °	-121.872140 °	
DWR ID	16389

View of corrugated metal risers located on WS.

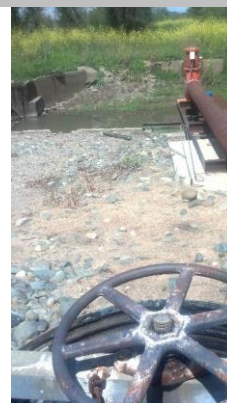
Photo 3 of 3 : UCIP_SP_2020_55145_67492.jpg

LM Start	22.14	Rating **	M	Issue No.	969 (cont)
LM End	22.14	Issue Type +	En	Location *

WS view of buried line through levee berm looking at berm edge from levee crown.

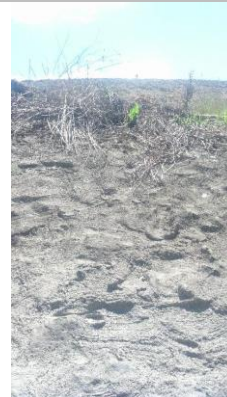
Photo 1 of 3 : UCIP_SP_2020_56064_67498.jpg

DS_ID:16391
FS_ID:56064
EP_NO: N/A
Repair Type: Non-Urgent
Crossing Status: Found
UCIP Comments: 08/29/2019 Record remains Non-Urgent, no permit has been identified authorizing pipe. WS outlet is blocked by dense vegetation. LS inlet is still unknown. DWR Geophysical Survey was unable to confirm alignment. Need to contact property owner to determine if crossing is still being used and confirm pipe alignment. (O. Magana - DWR UCIP, A. Freitag - DWR Sutter Yard)05/30/2017 Location of LS inlet still unknown. Need to trace with utility locator/GPR to find. Pipe has been selected to be internally cleaned and inspected as part of the DMP project. (DWR Sutter Yard - A.Freitag)11/17/2016 Unable to locate LS pipe end. WS appears to be in good condition. (DWR Sutter Yard - A.Freitag)04/26/2016 Still unable to locate the LS headwall and end of pipe. Pipe is still being used. Pipe was draining to WS.06/30/2015 Still unable to locate the LS headwall and pipe end.05/28/2014 Same as last inspection.12/04/2013 Same as last inspection.07/08/2013 Same as last inspection. Unable to locate LS headwall.04/24/2012 Unable to locate LS headwall. Need photo of LS headwall during next inspection.

FIELD_STRUCT_DESC: 30-inch corrugated metal drainage pipe through the levee, 15.3 feet below the crown. Concrete "U" headwalls on both waterside (WS) and landside (LS) ends. Flap gate on the WS end. This pipe runs on an angle through the levee, then underground along the LS slope to historic levee mile (HLM) 22.39 where it enters a ditch on the LS. [Additional Reference(s): DWR Levee Log, 1993 (HLM 22.41), listed as 30-inch pipe. USACE Sacramento O&M Manual 519, June 1962 (HLM 22.41), listed as 24-inch pipe, As-built DWG No. 50-4-3511, Sheet No. 3511/21.2, STA 50+87E, page 21 of 31 electronic file, listed as 30-inch CMP section through the levee (irrigation and drainage structures); As-built DWG No. 50-4-3037 referenced not available]
FS Date: 8/29/2019 7:44:00 AM

View of WS slope looking from WS headwall to levee crown.
