**Flood Control Project Maintenance
Levee Inspections**
LMA District Cover Sheet
Spring 2020 Levee Inspection Results

Sutter Maintenance Yard Maintenance Area 0013

Spring 2020 Levee Inspection Results

Waterway			Bank	Unit Miles
Unit No. 01 Cherokee Canal			Right	18.19
	Spring (March - May)	Summer (June - August)	(September - November) Fall	Winter (December - February)
Unit Maintenance Rating (Fall Only)				
Date of Inspection	4/9/2020 - 4/9/2020			
DWR Inspector	Makar Sokol			
Accompanied By	Bob Duffey Sutter Maintenance Yard

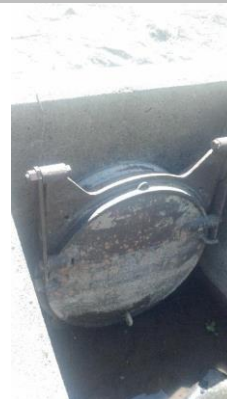
Photo 3 of 3 : UCIP_SP_2020_56064_67497.jpg

LM Start	22.15	Rating **	M	Issue No.	970 (cont)
LM End	22.15	Issue Type +	Ma	Location *

View of flap gate on WS.

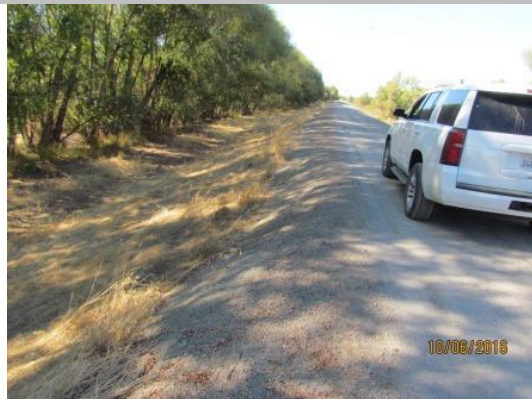
Photo 1 of 1 : SP_2020_MA0013_301_62_20200226_00011.jpg

LM Start	22.33	Rating **	A/W	Issue No.	62
LM End	22.33	Issue Type +	Ma	Location *	LS
Category	Earthen Levee			GPS Latitude/Longitude	
				Start	End
Item	Slope Stability			39.358419 °	39.358419 °
				-121.875088 °	-121.875088 °
DWR ID	DWR_MA0013_02_s_2016_62				
Comment Code					
S1 : Repair slope instability.					
Inspector Comment

View of slope instability issue along the landside slope.

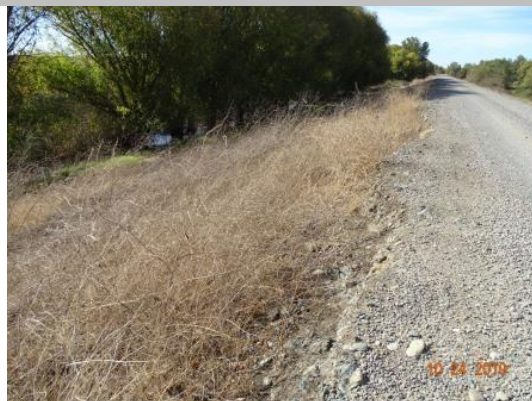
Photo 1 of 1 : SP_2020_MA0013_301_58_20200226_00008.jpg

LM Start	22.50	Rating **	U	Issue No.	58
LM End	22.51	Issue Type +	Ma	Location *	LS
Category	Earthen Levee			GPS Latitude/Longitude	
				Start	End
Item	Erosion / Bank Caving			39.357085 °	39.357033 °
				-121.877812 °	-121.877901 °
DWR ID	DWR_MA0013_02_f _ 2019_58				
Comment Code					
E2 : Schedule repair of erosion site prior to the next inspection.					
Inspector Comment

View of erosion on the landside slope. Fall 2019.

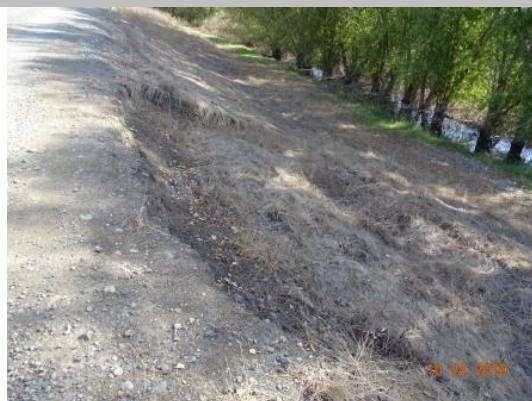
Photo 1 of 1 : SP_2020_MA0013_301_60_20200226_00009.jpg

LM Start	22.54	Rating **	M	Issue No.	60
LM End	22.54	Issue Type +	Ma	Location *	LS
Category	Earthen Levee			GPS Latitude/Longitude	
				Start	End
Item	Slope Stability			39.356780 °	39.356780 °
				-121.878422 °	-121.878422 °
DWR ID	DWR_MA0013_02_f_2019_60				
Comment Code					
S1 : Repair slope instability.					
Inspector Comment

View of sloughing on the landside slope. Fall 2019.

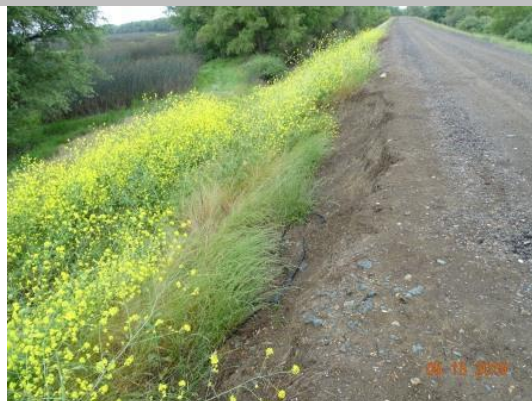
Photo 1 of 1 : SP_2020_MA0013_301_61_20200226_00010.jpg

LM Start	22.58	Rating **	U	Issue No.	61
LM End	22.58	Issue Type +	Ma	Location *	LS
Category	Earthen Levee			GPS Latitude/Longitude	
				Start	End
Item	Erosion / Bank Caving			39.356476 °	39.356476 °
				-121.879089 °	-121.879089 °
DWR ID	DWR_MA0013_02_s_2019_61				
Comment Code					
E2 : Schedule repair of erosion site prior to the next inspection.					
Inspector Comment

View of the erosion at the landside shoulder and slope. Spring 2019.
