**Flood Control Project Maintenance
Levee Inspections
LMA District Cover Sheet**

**Flood Control Project Maintenance
Levee Inspections
Unit Cover Sheet**

Waterway			Bank	Unit Miles
Unit No. 01 Cherokee Canal			Right	18.19
	Spring (March - May)	Summer (June - August)	(September - November) Fall	Winter (December - February)
Unit Maintenance Rating (Fall Only)				
Date of Inspection	3/23/2022 - 3/23/2022			
DWR Inspector	Makar Sokol			
Accompanied By

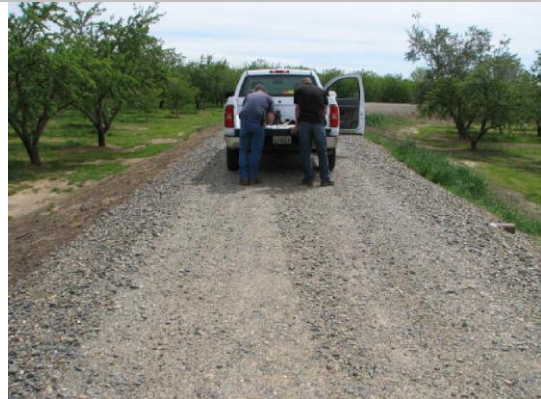
Photo 1 of 3 : UCIP_SP_2022_57515_66686.jpg

FS_ID:57515
DS_ID:16342
EP_NO: 12129
Repair Type: Non-Urgent
Crossing Status: Found
UCIP Comments: 08/06/2019 Need to contact owner to address proper abandonment per Title 23. Owner will need to coordinate with CVFPB. (O. Magana - DWR UCIP, A. Freitag - DWR Sutter Yard)06/14/2017 Abandoned- needs to be done properly. (A. Freitag - DWR Sutter Yard)11/16/2016 Abandoned. WS end still has plate bolted on. (A. Freitag - DWR Sutter Yard)04/28/2016 Crossing still has plate bolted on it at the WS end and LS end was mostly buried. (A. Freitag - DWR Sutter Yard)07/14/2015 WS pipe end still had plate bolted on it. (A. Freitag - DWR Sutter Yard)05/21/2014 Same as last inspection. (A. Freitag - DWR Sutter Yard)12/02/2013 Same as last inspection. (A. Freitag - DWR Sutter Yard)07/10/2013 Same as last inspection. (A. Freitag - DWR Sutter Yard)04/12/2012 WS pipe daylight has bolted plate. (O. Magana - DWR UCIP)

View of levee crown at crossing looking downstream at right bank of Cherokee Canal.

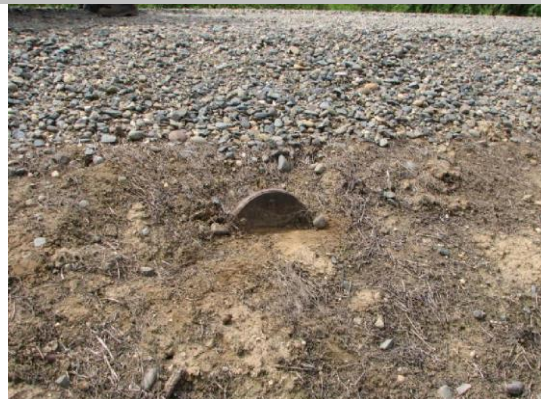
Photo 2 of 3 : UCIP_SP_2022_57515_66684.jpg

WS-Bolted plate

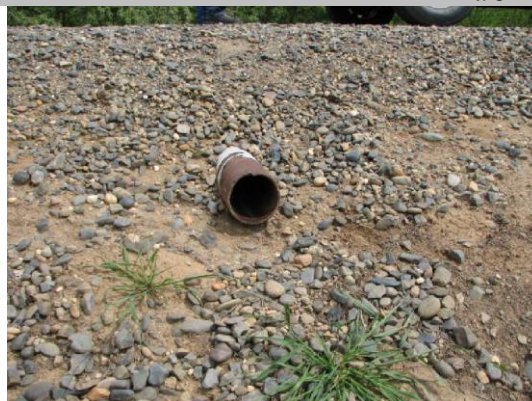
Photo 3 of 3 : UCIP_SP_2022_57515_66685.jpg

LS-Outlet

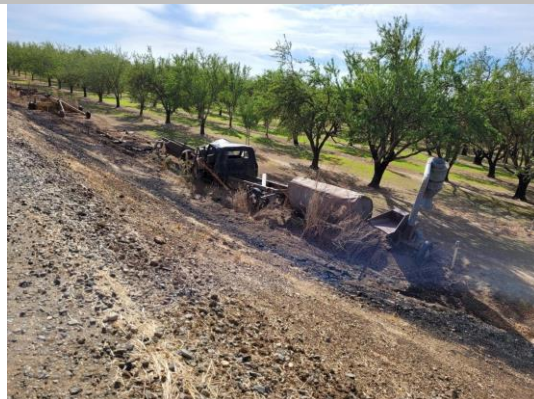
Photo 1 of 1 : SP_2022_MA0013_300_12_20220307_00004.jpg

LM Start	0.73	Rating **	M	Issue No.	12
LM End	0.76	Issue Type +	En	Location *	LS
Category	Earthen Levee			GPS Latitude/Longitude	
				Start	End
Item	Encroachments			39.587905 °	39.587505 °
				-121.700822 °	-121.700880 °
DWR ID	DWR_MA0013_01_s_2012_12				
Comment Code					
EQ : Equipment					
Inspector Comment					
Remove the equipment from the landside toe.

View of the equipment along the landside toe. Fall 2021.

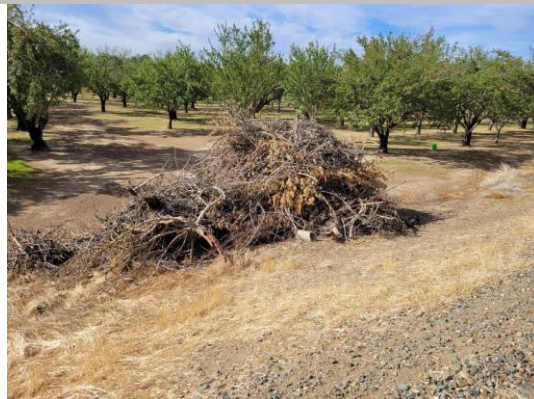
Photo 1 of 1 : SP_2022_MA0013_300_61_20220307_00007.jpg

LM Start	0.83	Rating **	M	Issue No.	61
LM End	0.83	Issue Type +	En	Location *	LS
Category	Earthen Levee			GPS Latitude/Longitude	
				Start	End
Item	Encroachments			39.586417 °	39.586417 °
				-121.700585 °	-121.700585 °
DWR ID	DWR_MA0013_01_f_2018_61				
Comment Code					
PR : Prunings					
Inspector Comment

View of the prunings along the landside slope. Fall 2021.

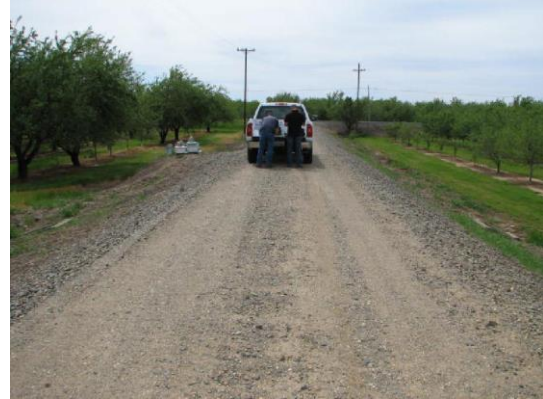
Photo 1 of 3 : UCIP_SP_2022_58576_66689.jpg

Comment Code						
Inspector Comment						
FS_ID:58576 DS_ID:16343 EP_NO: N/A Repair Type: Non-Urgent Crossing Status: Found UCIP Comments: 08/06/2019 Record has been updated from No Action Needed to Non-Urgent, due to unauthorized encroachment. Pipe has been lined. (O. Magana - DWR UCIP, A. Freitag - DWR Sutter Yard)06/14/2017 Crossing appears to be in good condition. Pipe has been selected to be internally cleaned and inspected as part of the DMP project. (A. Freitag - DWR Sutter Yard)11/16/2016 Crossing appears to be in good condition. (A. Freitag - DWR Sutter Yard)04/28/2016 Crossing appears to be in good condition. (A. Freitag - DWR Sutter Yard)07/14/2015 Crossing appears in good condition. No noticeable issues to report. (A. Freitag - DWR Sutter Yard)05/21/2014 Same as last inspection. (A. Freitag - DWR Sutter Yard)12/02/2013 Same as last inspection. (A. Freitag - DWR Sutter Yard)07/10/2013 Same as last inspection. (A. Freitag - DWR Sutter Yard)04/17/2012 Drain is still in use. 4 inch pipe in channel near WS headwall (see photo). The pipe does not appear to impact the crossing. (O. Magana - DWR UCIP) FIELD_STRUCT_DESC: 24-inch CIPP-lined corrugated metal drainage pipe through the levee, 8.6 feet below the crown. Concrete "U" headwalls on both the waterside (WS) and landside (LS). Flap gate on the WS end. [Additional Reference(s): DWR Levee Log, 1993 (HLM 1.15). USACE Sacramento O&M Manual, Unit 519, June 1962, Revised 3 Feb 2011, (HLM 1.15), As-built DWG No. 50-4-3608, Sheet No. 3608/19.1, STA 1072+20E, page 20 of 28 electronic file, listed as 24-inch CMP; As-built DWG No 50-4-3037 referenced not available] FS Date: 8/6/2019 8:46:00 AM

Overview of levee crown at crossing looking D/S .

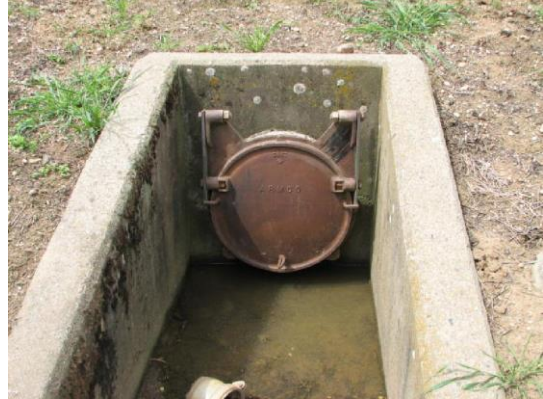
Photo 2 of 3 : UCIP_SP_2022_58576_66688.jpg

View of WS headwall and flap gate.

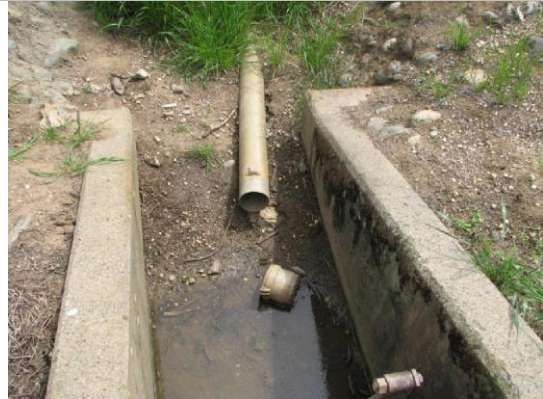
Photo 3 of 3 : UCIP_SP_2022_58576_66687.jpg

View of WS with pipe in channel.

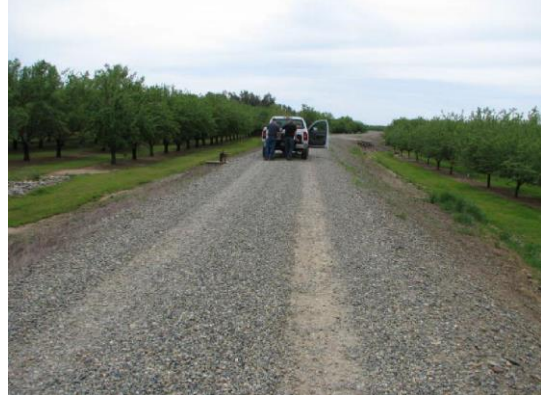
Photo 1 of 3 : UCIP_SP_2022_58462_66695.jpg

FS_ID:58462
DS_ID:16831
EP_NO: N/A
Repair Type: Non-Urgent
Crossing Status: Found
UCIP Comments: 08/06/2019 Record remains Non-Urgent, need to clarify owner for this crossing. This pipe has been identified as an LMA responsible drainage pipe. However, adjacent property owner has modified the WS outlet by burying the concrete headwall. No permit has been found authorizing the modification to the WS. LMA and adjacent property owner will need to coordinate with the CVFPB to comply with Title 23. DMP internal video inspection has not found pipe integrity issues. LOF of crossing is less or equal to 4. Recommend next video inspection in 5 years. (O. Magana - DWR UCIP, A. Freitag - DWR Sutter Yard)08/23/2018 Same as last inspection; still no sign of WS pipe end. Unclear if this SD crossing is still in use. The WS toe has standing, mucky, water around where the pipe end should be. Downgrading to Non-Urgent from Urgent because there appears no immediate threat to levee. Recommend follow up with owner to determine pipe use, and an internal pipe inspection to determine pipe integrity and threat to levee. (D. Sanoski - DWR UCIP)06/14/2017 Still no sign of WS pipe end. Pipe may need to be traced with GPR and excavated to determine if the WS end was properly capped after the Headwall and pipe sections were removed. Pipe has been selected to be internally cleaned and inspected as part of the DMP project. (A. Freitag - DWR Sutter Yard)11/16/2016 WS structures still removed. (A. Freitag - DWR Sutter Yard)10/17/2016 Landowner removed WS concrete headwall and pipe section through floodway to make room for orchard. The area disturbed appears to be from WS toe to where the mature trees are located within floodway, approximately 45 feet from WS toe. Crossing is classified as Urgent with potential levee integrity issues due to the disturbance of the WS without prior approval from the CVFPB. (O. Magana - DWR UCIP)

Overview of levee crown at crossing looking downstream.

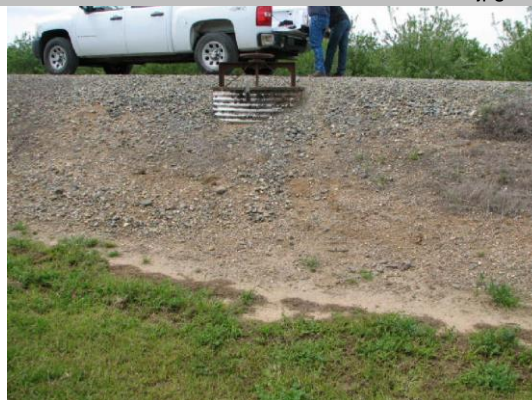
Photo 2 of 3 : UCIP_SP_2022_58462_66699.jpg

Corrugated metal riser with slide gate located on WS slope.

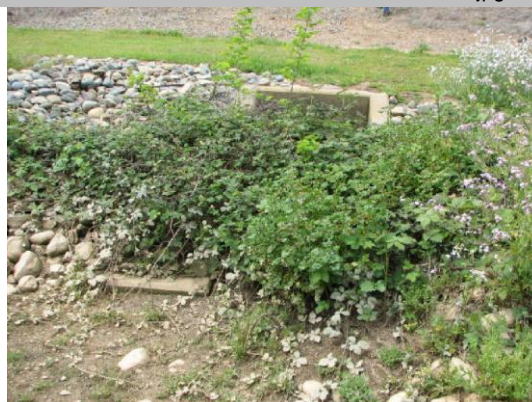
Photo 3 of 3 : UCIP_SP_2022_58462_66698.jpg

WS headwall, rock protection, and outlet blocked by shrub.

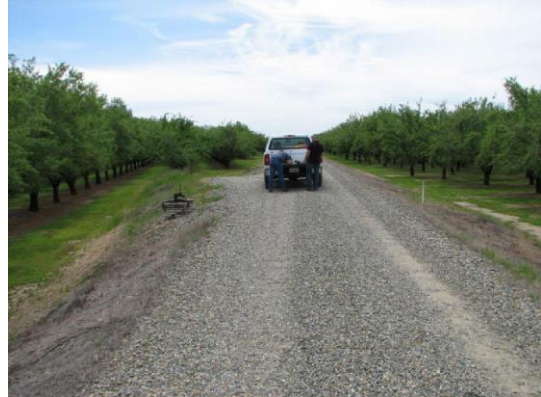
Photo 1 of 3 : UCIP_SP_2022_58463_66700.jpg

Comment Code						
Inspector Comment						
FS_ID:58463 DS_ID:16345 EP_NO: N/A Repair Type: Non-Urgent Crossing Status: Found UCIP Comments: 08/06/2019 Record remains Non-Urgent, pipe has been abandoned. Crossing needs to be abandoned properly per Title 23. No owner has been identified for this crossing. Recommend adding cover to riser as a safety measure. (O. Magana - DWR UCIP, A. Freitag - DWR Sutter Yard)06/14/2017 PVC pipe still present blocking screw gate. LS inlet of the 24" cmp pipe is about 75% blocked by sediment. (A. Freitag - DWR Sutter Yard)11/16/2016 PVC pipe still present blocking the screw gate. (A. Freitag - DWR Sutter Yard)04/28/2016 Pvc pipe is still present through the crossing. Slide gate cannot shut fully. (A. Freitag - DWR Sutter Yard)07/14/2015 4-inch pipe still present and blocking the screw gate. (A. Freitag - DWR Sutter Yard)05/21/2014 Same as last inspection. (A. Freitag - DWR Sutter Yard)12/02/2013 Same as last inspection. (A. Freitag - DWR Sutter Yard)07/15/2013 Same as last inspection. (A. Freitag - DWR Sutter Yard)04/17/2012 Crossing has 4-inch pipe inside blocking positive closure/notify landowner to remove prior to flood season. LS crossing is blocked about 50% by sediment build up. Burrow activity present on LS near crossing. (O. Magana - DWR UCIP) FIELD_STRUCT_DESC: 24-inch corrugated metal irrigation pipe through the levee, 7.6 feet below the crown. Slide gate in corrugated metal pipe (CMP) riser on the waterside (WS) slope. Concrete headwall on the landside (LS). 36-inch concrete standpipe in the channel with 2 piles to deflect debris (39.576614, -121.7009). [Additional Reference(s): DWR Levee Log, 1993 (HLM 1.68). USACE Sacramento O&M Manual, Unit 519, June 1962, Revised 3 Feb 2011, (HLM 1.69), listed as 24-inch pipe, no as-built referenced found] FS Date: 8/6/2019 9:20:00 AM

Overview of levee at crossing looking downstream.

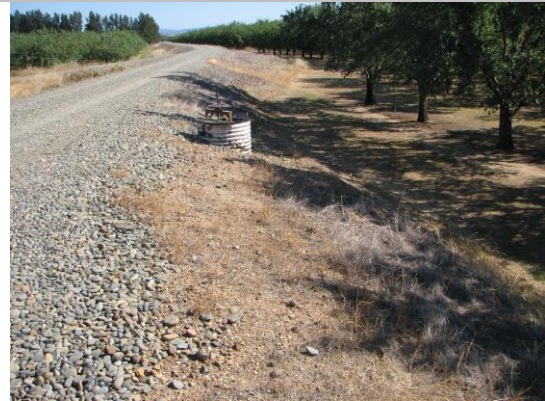
Photo 2 of 3 : UCIP_SP_2022_58463_66704.jpg

WS view looking upstream.

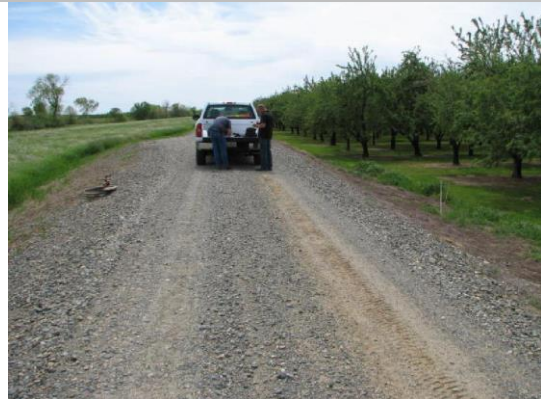
Photo 1 of 3 : UCIP_SP_2022_58464_66708.jpg

FS_ID:58464
DS_ID:16346
EP_NO: N/A
Repair Type: Non-Urgent
Crossing Status: Found
UCIP Comments: 08/06/2019 Record remains Non-Urgent, pipe has been abandoned. Crossing needs to be abandoned properly per Title 23. No owner has been identified for this irrigation pipe. Recommend adding cover to riser as a safety measure. DMP internal video inspection has not found pipe integrity issues. LOF of crossing is less or equal to 4. Recommend next video inspection in 5 years. (O. Magana - DWR UCIP, A. Freitag - DWR Sutter Yard)06/14/2017 Still no LS inlet visible- trace with locator/GPR to try and locate. Wooden debris down inside of WS standpipe. Pipe has been selected to be internally cleaned and inspected as part of the DMP project. (A. Freitag - DWR Sutter Yard)11/16/2016 Appears abandoned. Unable to find anything on LS. (A. Freitag - DWR Sutter Yard)04/28/2016 Appears to be an abandoned crossing. LS headwall and pipe inlet are still completely buried. (A. Freitag - DWR Sutter Yard)07/14/2015 Still cannot find an inlet or outlet. (A. Freitag - DWR Sutter Yard)05/21/2014 Same as last inspection. (A. Freitag - DWR Sutter Yard)12/02/2013 Same as last inspection. (A. Freitag - DWR Sutter Yard)07/15/2013 Same as last inspection. (A. Freitag - DWR Sutter Yard)04/17/2012 Non functional crossing due to LS headwall buried. This crossing was listed in the USACE Periodic Inspection report as Corp's inspect ID#USACE_CESPK_M13D_2011_p_0119 for no inlet or outlet visible. (O. Magana - DWR UCIP)

Overview of crossing looking DS.

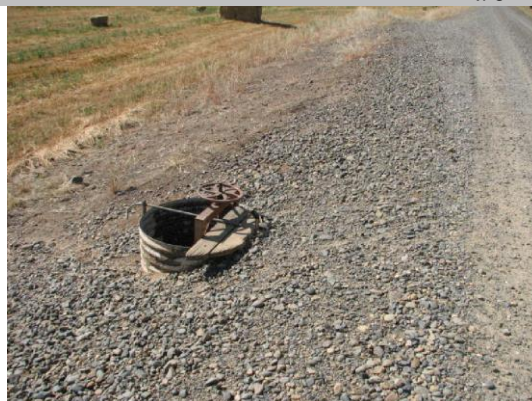
Photo 2 of 3 : UCIP_SP_2022_58464_66709.jpg

Corrugated riser located on WS slope.

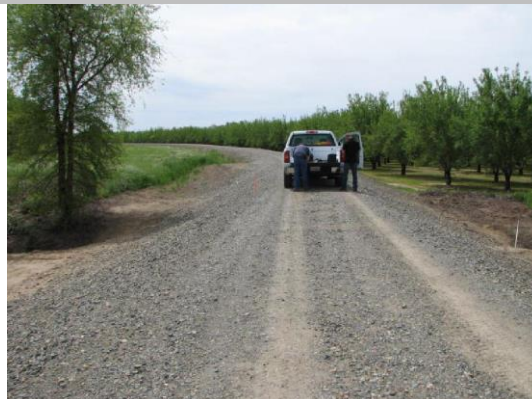
Photo 1 of 3 : UCIP_SP_2022_58465_66715.jpg

FS_ID:58465
DS_ID:16347
EP_NO: N/A
Repair Type: Non-Urgent
Crossing Status: Found
UCIP Comments: 08/06/2019 Record has been updated from No Action Needed to Non-Urgent, no permit identified. Crossing is scheduled to be lined. (O. Magana - DWR UCIP, A. Freitag - DWR Sutter Yard)06/14/2017 Crossing appears to be in good condition. (A. Freitag - DWR Sutter Yard)11/16/2016 Crossing appears to be in good condition. (A. Freitag - DWR Sutter Yard)04/28/2016 Crossing appears to be in good condition. (A. Freitag - DWR Sutter Yard)07/14/2015 Crossing appears in good condition. No noticeable issues to report. (A. Freitag - DWR Sutter Yard)05/21/2014 Same as last inspection. (A. Freitag - DWR Sutter Yard)12/02/2013 Same as last inspection. (A. Freitag - DWR Sutter Yard)07/15/2013 Same as last inspection. (A. Freitag - DWR Sutter Yard)04/17/2012 Vegetation/sedimentation from WS has been removed. This crossing was listed in the USACE Periodic Inspection report as Corp's inspect ID#USACE_CESPK_M13D_2011_p_0130 for WS flap gate closed and blocked by sediment. (O. Magana - DWR UCIP)

Overview of levee crown looking downstream at crossing.

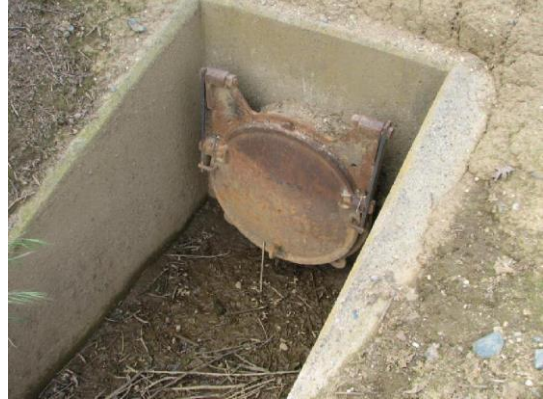
Photo 2 of 3 : UCIP_SP_2022_58465_66714.jpg

Flap gate at WS.

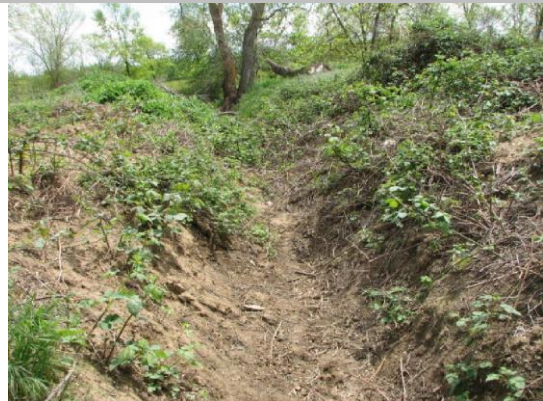
Photo 3 of 3 : UCIP_SP_2022_58465_66711.jpg

View of channel.

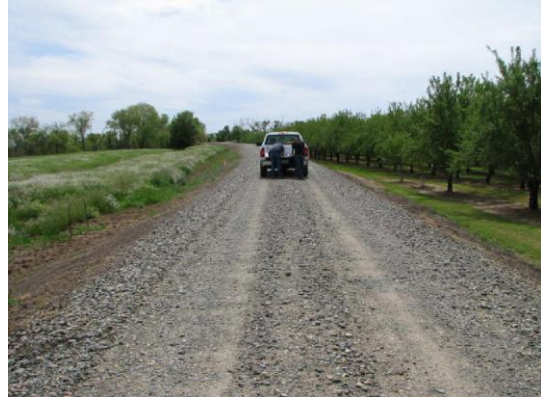
Photo 1 of 3 : UCIP_SP_2022_58466_66718.jpg

Comment Code						
Inspector Comment						
FS_ID:58466 DS_ID:17372 EP_NO: N/A Repair Type: Non-Urgent Crossing Status: Found UCIP Comments: 08/06/2019 Record remains Non-Urgent, no permit identified authorizing pipe. Pipe has been internally cleaned and cleared of any obstructions on the WS and LS. DMP internal inspection pending. (O. Magana - DWR UCIP, A. Freitag - DWR Sutter Yard)06/14/2017 WS flap gate is completely buried by sediment-needs to be dug out. Pipe is about 50% full of sediment inside. Pipe has been selected to be internally cleaned and inspected as part of the DMP project. (A. Freitag - DWR Sutter Yard)11/16/2016 Pipe about 50% full of sediment. (A. Freitag - DWR Sutter Yard)04/28/2016 Pipe on LS is about 50% full of sediment. There is now a concrete pipe that discharges into the LS inlet of this crossing. Not sure where the concrete pipe comes from. (A. Freitag - DWR Sutter Yard)07/14/2015 Crossing appears in good condition. No noticeable issues to report. (A. Freitag - DWR Sutter Yard)05/21/2014 Same as last inspection. (A. Freitag - DWR Sutter Yard)12/02/2013 Pipe section was dug up and repaired. Crossing is now in good condition. (A. Freitag - DWR Sutter Yard)07/15/2013 Pipe appears to have a possible hole in top of pipe about 10ft. in from LS headwall. (A. Freitag - DWR Sutter Yard)04/17/2012 LS headwall blocked by sediment (50 % of opening is covered). LS floor is higher than LS pipe invert. WS headwall has been recently cleared of vegetation and sediment. This crossing was listed in the USACE Periodic Inspection report as Corp's inspect ID#USACE_CESPK_M13D_2011_p_0157 for WS and LS inlet/outlet blocked by sediment. (O. Magana - DWR UCIP) FIELD_STRUCT_DESC: 36-inch corrugated metal drainage pipe through the levee, 11.8 feet below the crown. Flap gate is located on the waterside (WS). Concrete headwall located on the landside (LS). [Additional Reference(s): DWR Levee Log, 1993 (HLM 3.07), listed as 24-inch pipe. USACE Sacramento O&M Manual, Unit 519, June 1962, Revised 3 Feb 2011, (HLM 3.10), listed as 36-inch pipe, no as-built referenced found] FS Date: 8/6/2019 9:47:00 AM

Overview of levee crown looking downstream at crossing.

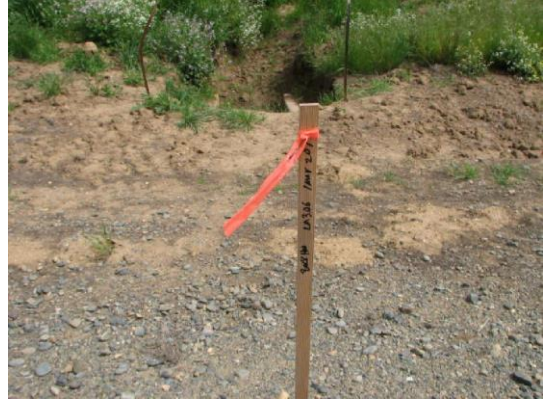
Photo 2 of 3 : UCIP_SP_2022_58466_66716.jpg

WS levee slope.

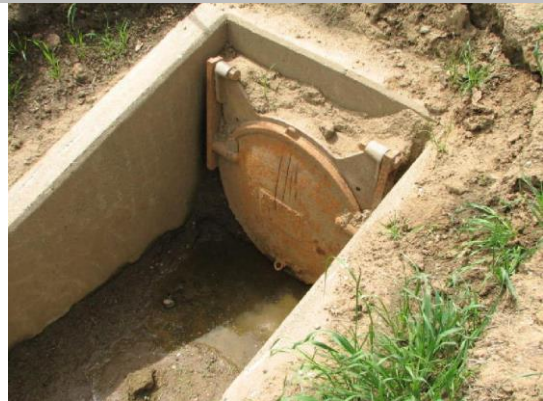
Photo 3 of 3 : UCIP_SP_2022_58466_66720.jpg

Flap gate on waterside.

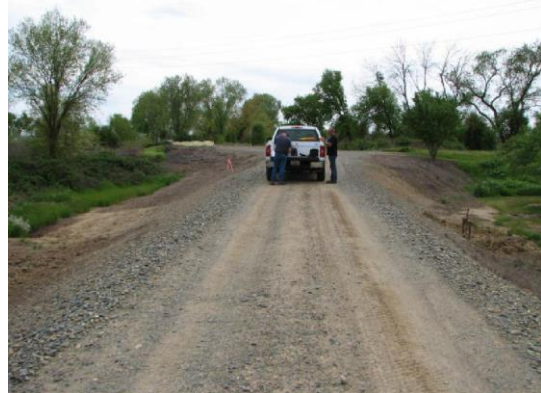
Photo 1 of 3 : UCIP_SP_2022_58577_66725.jpg

FS_ID:58577
DS_ID:16349
EP_NO: N/A
Repair Type: Non-Urgent
Crossing Status: Found
UCIP Comments: 08/06/2019 Record remains Non-Urgent, no permit found authorizing pipe. Pipe has been lined. (O. Magana - DWR UCIP, A. Freitag - DWR Sutter Yard)06/14/2017 Both pipe ends and gates are mostly buried- need to be dug out. Pipe has been selected to be internally cleaned and inspected as part of the DMP project. (A. Freitag - DWR Sutter Yard)11/16/2016 Both gates closed but partially buried and unable to open. (A. Freitag - DWR Sutter Yard)04/28/2016 Sediment build up on both gates blocking them from operating properly. (A. Freitag - DWR Sutter Yard)07/14/2015 Crossing appears in good condition. No noticeable issues to report. (A. Freitag - DWR Sutter Yard)05/21/2014 Same as last inspection. (A. Freitag - DWR Sutter Yard)12/02/2013 Same as last inspection. (A. Freitag - DWR Sutter Yard)07/15/2013 Stem on LS screw gate has been replaced and is now full functional. (A. Freitag - DWR Sutter Yard)04/17/2012 LS slide gate stem is bent and prevents gate from fully closing. Both WS and LS have been cleared of debris and sediment. This crossing was listed in the USACE Periodic Inspection report as Corp's inspect ID#USACE_CESPK_M13D_2011_p_0162 for inoperable gates on WS & LS due to sediment and grass blocking inlet and outlet. (O. Magana - DWR UCIP)

Overview of levee crown looking DS at crossing.

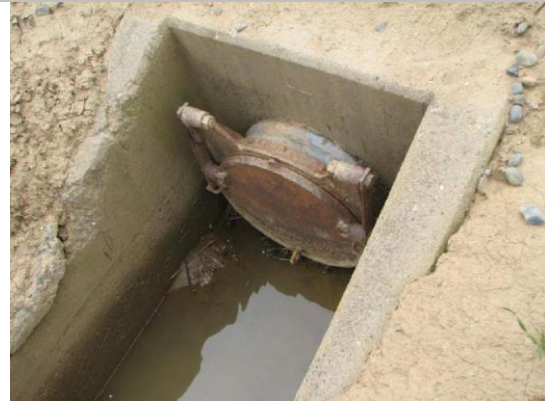
Photo 2 of 3 : UCIP_SP_2022_58577_66724.jpg

Flap gate on WS.

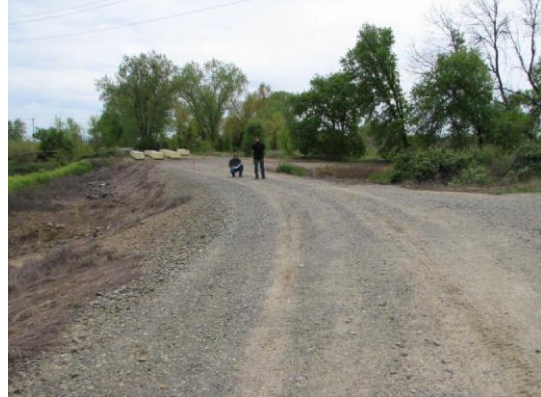
Photo 1 of 3 : UCIP_SP_2022_58578_66731.jpg

Comment Code						
Inspector Comment						
FS_ID:58578 DS_ID:16350 EP_NO: N/A Repair Type: Non-Urgent Crossing Status: Found UCIP Comments: 08/06/2019 Record has been updated from No Action Needed to Non-Urgent, no permit has been found authorizing pipe. Pipe has been lined. (O. Magana - DWR UCIP, A. Freitag - DWR Sutter Yard)06/14/2017 WS flap gate is buried by sediment- needs to be dug out. Pipe has been selected to be internally cleaned and inspected as part of the DMP project. (A. Freitag - DWR Sutter Yard)11/16/2016 Crossing appears to be in good condition. (A. Freitag - DWR Sutter Yard)04/28/2016 Crossing appears to be in good condition. (A. Freitag - DWR Sutter Yard)07/14/2015 Crossing appears in good condition. No noticeable issues to report. (A. Freitag - DWR Sutter Yard)05/21/2014 Same as last inspection. (A. Freitag - DWR Sutter Yard)12/02/2013 Same as last inspection. (A. Freitag - DWR Sutter Yard)07/15/2013 Same as last inspection. (A. Freitag - DWR Sutter Yard)04/17/2012 WS headwall has been cleared of debris and sedimentation. (O. Magana - DWR UCIP) FIELD_STRUCT_DESC: 24-inch CIPP-lined corrugated metal drainage pipe through the levee, 8.4 feet below the crown. Concrete "U" headwalls on both the waterside (WS) and landside (LS) ends. Flap gate on the WS end. [Additional Reference(s): DWR Levee Log, 1993 (HLM 3.31). USACE Sacramento O&M Manual, Unit 519, June 1962, Revised 3 Feb 2011, (HLM 3.31), listed as 24-inch pipe, no as-built referenced found] FS Date: 8/6/2019 10:03:00 AM

Overview of levee crown at crossing.

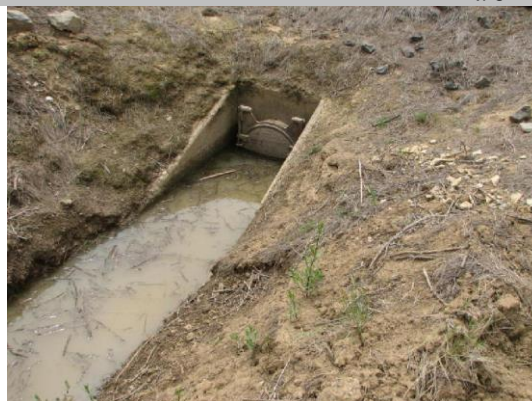
Photo 2 of 3 : UCIP_SP_2022_58578_66730.jpg

View of WS flap gate.

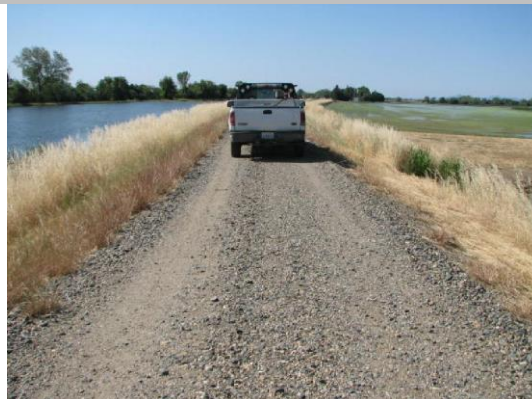
Photo 1 of 3 : UCIP_SP_2022_58469_66736.jpg

Comment Code						
Inspector Comment						
FS_ID:58469 DS_ID:16351 EP_NO: N/A Repair Type: Non-Urgent Crossing Status: Found UCIP Comments: 08/26/2019 Record has been updated from No Action Needed to Non-Urgent, no permit has been identified for this crossing. Crossing is scheduled to be lined. (O. Magana - DWR UCIP, A. Freitag - DWR Sutter Yard)06/14/2017 Both pipe ends were underwater during site visit. Pipe has been selected to be internally cleaned and inspected as part of the DMP project. (A. Freitag - DWR Sutter Yard)11/16/2016 Crossing appears to be in good condition. (A. Freitag - DWR Sutter Yard)04/28/2016 Both sides of the crossing were underwater during time of inspection. (A. Freitag - DWR Sutter Yard)07/14/2015 Crossing appears in good condition. No noticeable issues to report. (A. Freitag - DWR Sutter Yard)05/21/2014 Same as last inspection. (A. Freitag - DWR Sutter Yard)12/02/2013 Same as last inspection. (A. Freitag - DWR Sutter Yard)07/15/2013 Slopes have been cleared of vegetation and are in good condition. (A. Freitag - DWR Sutter Yard)04/18/2012 Limited inspection on WS and LS slope due to dense vegetation. Need photos of cleared slopes. (O. Magana - DWR UCIP) FIELD_STRUCT_DESC: 24-inch CIPP-lined corrugate metal drainage pipe through the levee, 8.1 feet below the crown. Flap gate on the waterside (WS) end. Slide gate located on the landside (LS) end. Concrete "U" headwalls on both ends. [Additional Reference(s): DWR Levee Log, 1993 (HLM 3.80). USACE Sacramento O&M Manual, Unit 519, June 1962, Revised 3 Feb 2011, (HLM 3.80), listed as 24-inch pipe, no as-built referenced found] FS Date: 8/26/2019 12:22:00 PM

Overview of levee crown at crossing looking downstream.

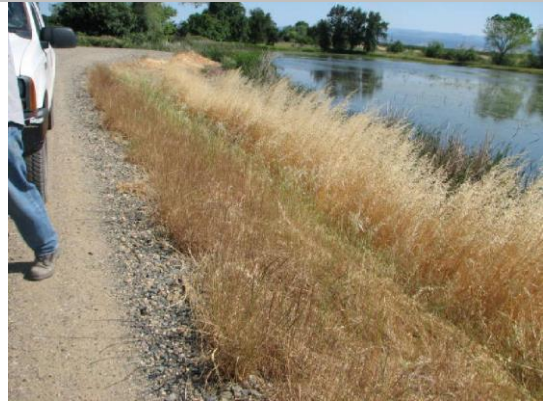
Photo 2 of 3 : UCIP_SP_2022_58469_66738.jpg

WS slope covered by dense vegetation.

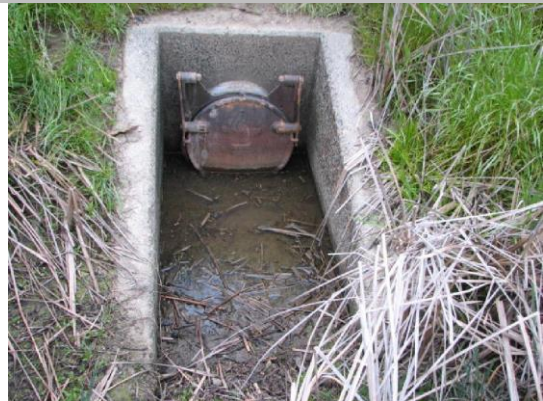
Photo 3 of 3 : UCIP_SP_2022_58469_66735.jpg

WS flap gate

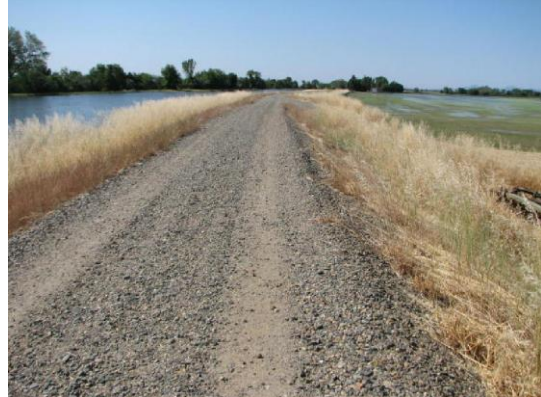
Photo 1 of 3 : UCIP_SP_2022_58470_66743.jpg

Comment Code						
Inspector Comment						
FS_ID:58470 DS_ID:16365 EP_NO: N/A Repair Type: Non-Urgent Crossing Status: Found UCIP Comments: 08/26/2019 Record remains Non-Urgent, pipe has been abandoned. No permit has been identified for this crossing. DMP internal inspection has not been completed. (O. Magana - DWR UCIP, A. Freitag - DWR Sutter Yard)06/14/2017 Appears abandoned-needs to be done properly. WS gate was buried/submerged and the LS slide gate is still damaged and buried. Pipe has been selected to be internally cleaned and inspected as part of the DMP project. (A. Freitag - DWR Sutter Yard)11/16/2016 Both LS and WS gates buried. (A. Freitag - DWR Sutter Yard)04/28/2016 Abandoned crossing. Ls screw is still bent and mostly buried. (A. Freitag - DWR Sutter Yard)07/14/2015 LS screw gate is still damaged and buried. Crossing is non-functional. (A. Freitag - DWR Sutter Yard)05/21/2014 Same as last inspection. (A. Freitag - DWR Sutter Yard)12/02/2013 Same as last inspection. (A. Freitag - DWR Sutter Yard)07/15/2013 Slopes have been cleared of vegetation and are in good condition. LS screw gate is still bent and silted over. (A. Freitag - DWR Sutter Yard)04/18/2012 LS slide gate covered with silt. Slide gate is bent. Crossing appears not be in use. Limited inspection on WS and LS slope due to dense vegetation. Need photos of cleared slopes. (O. Magana - DWR UCIP) FIELD_STRUCT_DESC: 24-inch corrugated metal drainage pipe through the levee, 7.9 feet below the crown. Flap gate on the waterside (WS) end. Screw gate on the landside (LS) end. Concrete "U" headwalls on both ends. [Additional Reference(s): DWR Levee Log, 1993 (HLM 3.80). USACE Sacramento O&M Manual, Unit 519, June 1962, Revised 3 Feb 2011, (HLM 3.82), listed as 24-inch pipe, no as-built referenced found] FS Date: 8/26/2019 12:24:00 PM

Overview of levee crown at crossing looking downstream.

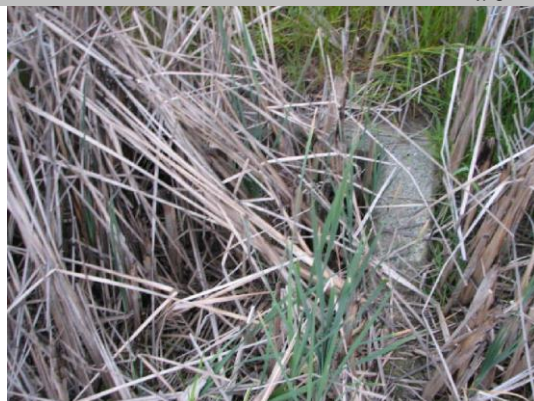
Photo 2 of 3 : UCIP_SP_2022_58470_66741.jpg

WS flap gate blocked by debris.

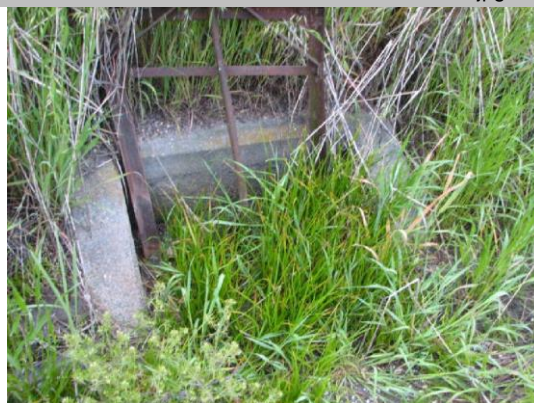
Photo 3 of 3 : UCIP_SP_2022_58470_66742.jpg

LS slide gate covered with silt. Slide gate is bent.

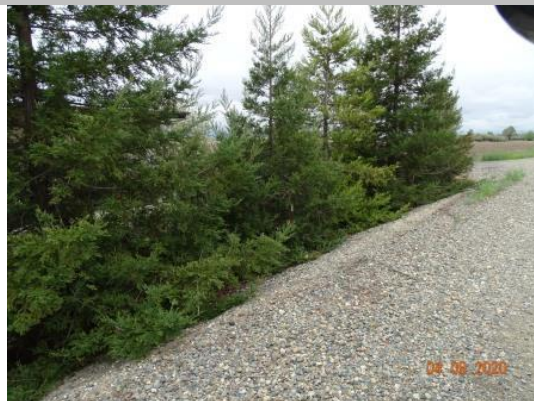
Photo 1 of 1 : SP_2022_MA0013_300_18_20220307_00005.jpg

LM Start	4.06	Rating **	M	Issue No.	18
LM End	4.13	Issue Type +	En	Location *	LS
Category	Earthen Levee			GPS Latitude/Longitude	
				Start	End
Item	Vegetation			39.541660 °	39.540651 °
				-121.707408 °	-121.707404 °
DWR ID	DWR_MA0013_01_s_2022_18				
Comment Code					
V6 : Landscaping					
Inspector Comment

View of the trees along the landside slope. Spring 2020.

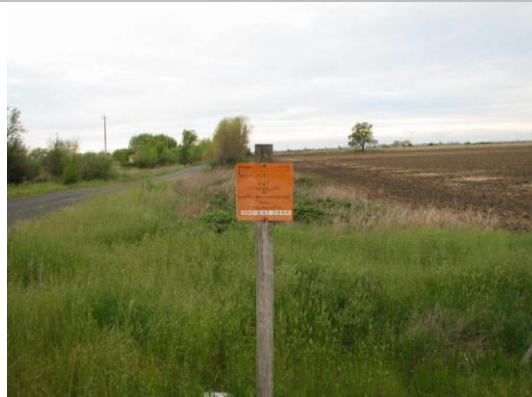
Photo 1 of 3 : UCIP_SP_2022_57531_66747.jpg

Comment Code						
Inspector Comment						
FS_ID:57531 DS_ID:16353 EP_NO: 6084 Repair Type: Non-Urgent Crossing Status: Indicator Found UCIP Comments: 08/26/2019 Record has been updated from No Action Needed to Non-Urgent, maintenance required. Sign is down on LS. (O. Magana - DWR UCIP, A. Freitag - DWR Sutter Yard)06/14/2017 Crossing appears to be in good condition. (A. Freitag - DWR Sutter Yard)11/16/2016 Crossing appears to be in good condition. (A. Freitag - DWR Sutter Yard)04/28/2016 Crossing appears to be in good condition. (A. Freitag - DWR Sutter Yard)07/14/2015 Crossing appears in good condition. (A. Freitag - DWR Sutter Yard)05/21/2014 Same as last inspection. (A. Freitag - DWR Sutter Yard)12/02/2013 Same as last inspection. (A. Freitag - DWR Sutter Yard)07/15/2013 Same as last inspection. (A. Freitag - DWR Sutter Yard)04/18/2012 Visible marker on LS. (O. Magana - DWR UCIP) FIELD_STRUCT_DESC: Underground telephone cable, 1.5-inch through the levee at approximately 2 feet below the crown. (buried cable authorized to go through Cherokee Canal and across Cottonwood Creek under Permit No. 6084, 1968 - Pacific Telephone and Telegraph Company [PT&T]) Contact No. listed in case of emergencies is 1-800-642-2444. [Additional Reference(s): DWR Levee Log, 1993 (HLM 4.41)] FS Date: 8/26/2019 12:25:00 PM

Visible marker for underground cable on LS.

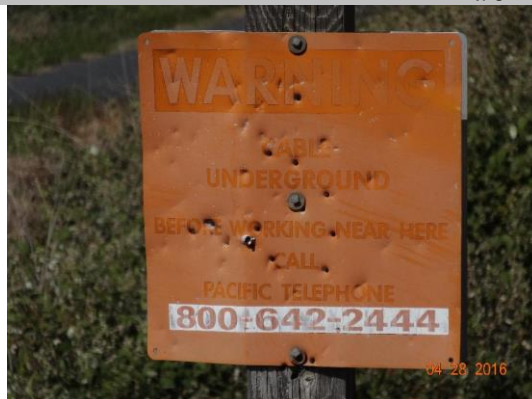
Photo 2 of 3 : UCIP_SP_2022_57531_75003.jpg

Marker sign with contact info

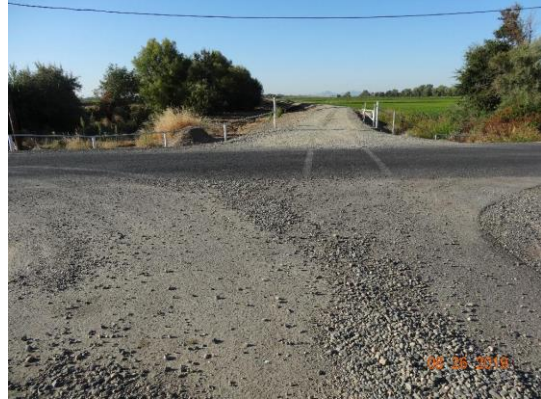
Photo 3 of 3 : UCIP_SP_2022_57531_80281.jpg

Overview of levee crown looking d/s towards crossing.

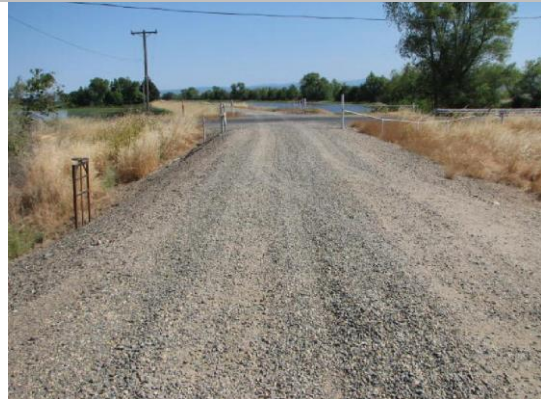
Photo 1 of 3 : UCIP_SP_2022_58471_66752.jpg

Comment Code						
Inspector Comment						
FS_ID:58471 DS_ID:16341 EP_NO: N/A Repair Type: Non-Urgent Crossing Status: Found UCIP Comments: 08/26/2019 Record has been updated from No Action Needed to Non-Urgent, no permit has been found authorizing pipe. Pipe is scheduled to be lined. (O. Magana - DWR UCIP, A. Freitag - DWR Sutter Yard)06/14/2017 WS flap gate is shut but blocked by sediment- needs to be dug out. LS slide gate has some minor sediment built up against it. Pipe has been selected to be internally cleaned and inspected as part of the DMP project. (A. Freitag - DWR Sutter Yard)11/16/2016 Crossing appears to be in good condition. (A. Freitag - DWR Sutter Yard)04/28/2016 Crossing appears to be in good condition. (A. Freitag - DWR Sutter Yard)07/13/2015 Crossing appears in good condition. No noticeable issues to report. (A. Freitag - DWR Sutter Yard)05/21/2014 Same as last inspection. (A. Freitag - DWR Sutter Yard)12/02/2013 Same as last inspection. (A. Freitag - DWR Sutter Yard)07/15/2013 Same as last inspection. (A. Freitag - DWR Sutter Yard)04/18/2012 Minor debris on landside inlet. This crossing was listed in the USACE Periodic Inspection report as Corp's inspect ID#USACE_CESPK_M13D_2011_p_0189 for sediment and grass blocking WS and LS. (O. Magana - DWR UCIP) FIELD_STRUCT_DESC: 36-inch CIPP-lined corrugated metal drainage pipe through the levee, 9.1 feet below the crown. Flap gate on the waterside (WS) end. Slide gate located on the landside (LS) end. Concrete "U" headwalls on both ends. [Additional Reference(s): DWR Levee Log, 1993 (HLM 4.43). USACE Sacramento O&M Manual, Unit 519, June 1962, Revised 3 Feb 2011, (HLM 4.43), As-built DWG No. 50-4-3608, Sheet No. 3608/19.1, STA 891+52E, page 20 of 28 electronic file, listed as 36-inch CMP; As-built DWG No 50-4-3037 referenced not available] FS Date: 8/26/2019 12:26:00 PM

Overview of levee crown at crossing looking upstream.

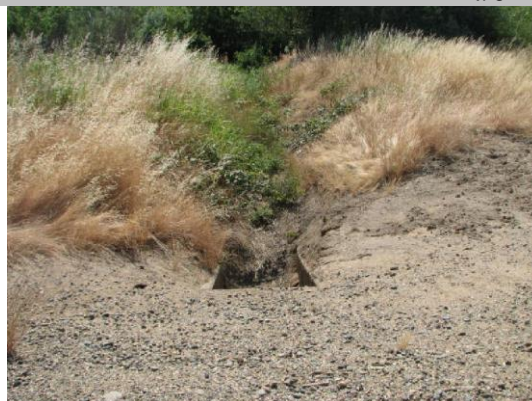
Photo 2 of 3 : UCIP_SP_2022_58471_66753.jpg

View of WS slope and toe.

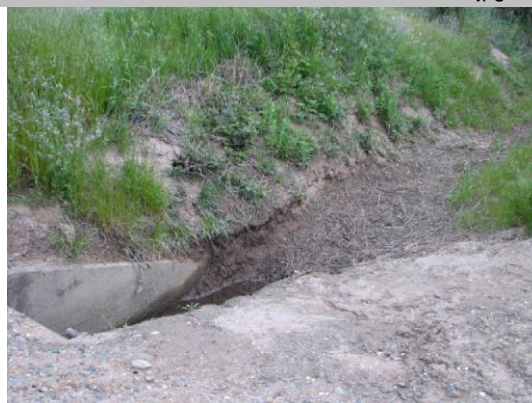
Photo 3 of 3 : UCIP_SP_2022_58471_66750.jpg

View of WS.

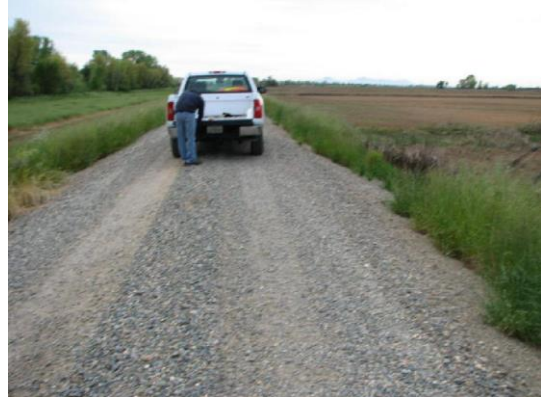
Photo 1 of 3 : UCIP_SP_2022_58472_66756.jpg

FS_ID:58472
DS_ID:16355
EP_NO: N/A
Repair Type: Non-Urgent
Crossing Status: Found
UCIP Comments: 08/26/2019 Record has been updated from No Action Needed to Non-Urgent, no permit has been identified for this pipe. Pipe is scheduled to be lined. (O. Magana - DWR UCIP, A. Freitag - DWR Sutter Yard)06/14/2017 WS flap gate is submerged and appears to be half buried by sediment. LS slide gate is fully submerged on the edge of the rice field. Pipe has been selected to be internally cleaned and inspected as part of the DMP project. (A. Freitag - DWR Sutter Yard) 11/16/2016 Crossing appears to be in good condition. (A. Freitag - DWR Sutter Yard)04/28/2016 Crossing appears to be in good condition. (A. Freitag - DWR Sutter Yard)07/13/2015 LS screw gate was completely submerged but crossing appears to be in good condition. (A. Freitag - DWR Sutter Yard)05/21/2014 Same as last inspection. (A. Freitag - DWR Sutter Yard)12/02/2013 Same as last inspection. (A. Freitag - DWR Sutter Yard)07/15/2013 No signs of burrowing activity on this inspection. (A. Freitag - DWR Sutter Yard)04/18/2012 Burrow activity near crossing, burrow holes present on WS slope. (O. Magana - DWR UCIP)

Overview of levee crown at crossing looking downstream at right bank of Cherokee Canal.

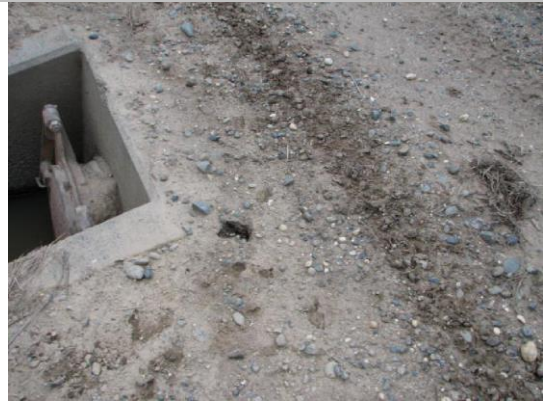
Photo 2 of 3 : UCIP_SP_2022_58472_66758.jpg

Burrow activity on WS slope.

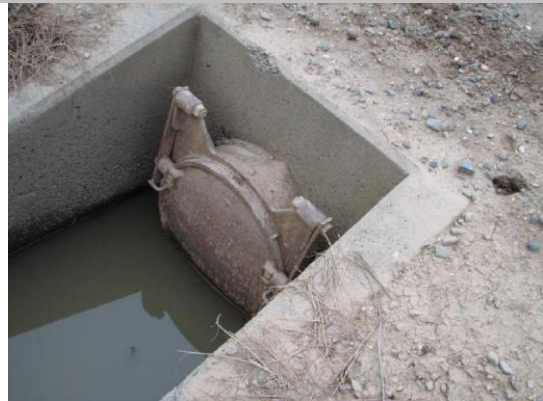
Photo 3 of 3 : UCIP_SP_2022_58472_66755.jpg

View of WS flap gate.

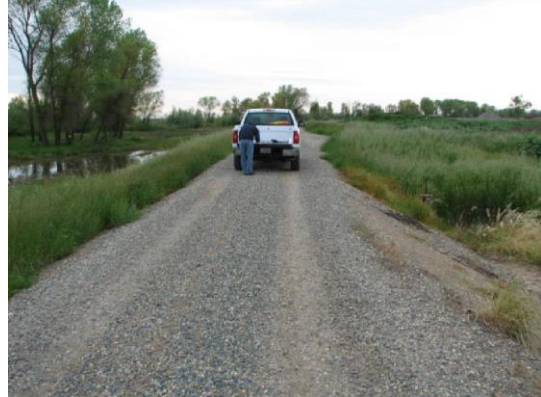
Photo 1 of 3 : UCIP_SP_2022_58473_66762.jpg

Comment Code						
Inspector Comment						
FS_ID:58473 DS_ID:16356 EP_NO: N/A Repair Type: Non-Urgent Crossing Status: Found UCIP Comments: 08/26/2019 Record has been updated from No Action Needed to Non-Urgent, no permit has been identified authorizing this pipe. Pipe is scheduled to be lined. Minor sloughing observed on LS just immediately d/s of concrete headwall (see photo). (O. Magana - DWR UCIP, A. Freitag - DWR Sutter Yard)06/14/2017 Crossing appears to be in good condition. Pipe has been selected to be internally cleaned and inspected as part of the DMP project. (A. Freitag - DWR Sutter Yard)11/16/2016 Crossing appears to be in good condition. (A. Freitag - DWR Sutter Yard)04/28/2016 Crossing appears to be in good condition. (A. Freitag - DWR Sutter Yard)07/13/2015 LS screw gate was completely submerged and WS flap gate was propped open by a wood block but crossing appears to be in good condition. (A. Freitag - DWR Sutter Yard)05/21/2014 Same as last inspection. (A. Freitag - DWR Sutter Yard)12/02/2013 Same as last inspection. (A. Freitag - DWR Sutter Yard)07/15/2013 Same as last inspection. (A. Freitag - DWR Sutter Yard)04/18/2012 Minor vegetation on LS slope. This crossing was listed in the USACE Periodic Inspection report as Corp's inspect ID#USACE_CESPK_M13D_2011_p_0204 for restriction view of gates. (O. Magana - DWR UCIP) FIELD_STRUCT_DESC: 24-inch CIPP-lined corrugated metal drainage pipe through the levee, 8.4 feet below the crown. Flap gate on the waterside (WS) end. Slide gate on the landside (LS) end. Concrete "U" headwalls on both ends. [Additional Reference(s): DWR Levee Log, 1993 (HLM 5.43). USACE Sacramento O&M Manual, Unit 519, June 1962, Revised 3 Feb 2011, (HLM 5.43), As-built DWG No. 50-4-3608, Sheet No. 3608/18, STA 839+50E, page 19 of 28 electronic file, listed as 24-inch CMP; As-built DWG No 50-4-3037 referenced not available] FS Date: 8/26/2019 12:29:00 PM

Overview of levee crown at crossing looking D/S on right bank of Cherokee Canal.

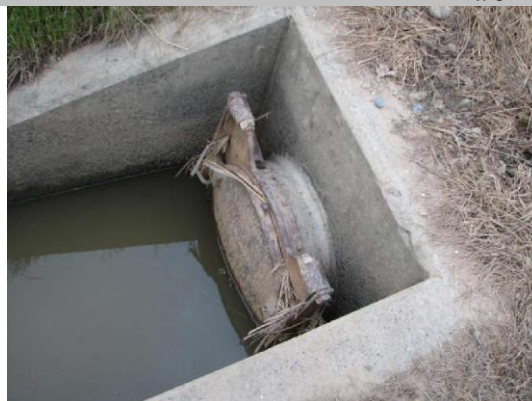
Photo 2 of 3 : UCIP_SP_2022_58473_66760.jpg

WS Flap Gate

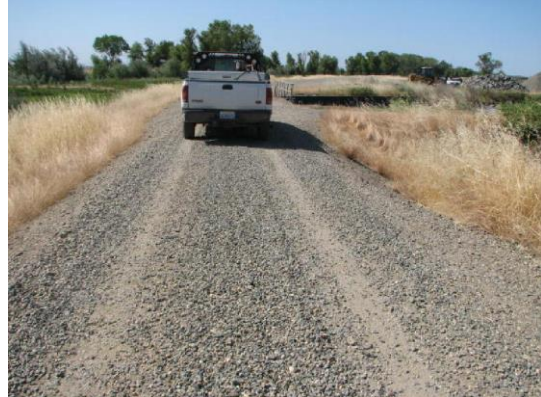
Photo 1 of 3 : UCIP_SP_2022_58579_66764.jpg

Comment Code						
Inspector Comment						
FS_ID:58579 DS_ID:16357 EP_NO: N/A Repair Type: Non-Urgent Crossing Status: Found UCIP Comments: 08/26/2019 Record remains Non-Urgent, no permit has been identified authorizing this pipe. Pipe has been lined. (O. Magana - DWR UCIP, A. Freitag - DWR Sutter Yard)06/14/2017 WS flap gate is partially buried by sediment- needs to be dug out. LS appears to be in good condition. Pipe has been selected to be internally cleaned and inspected as part of the DMP project. (A. Freitag - DWR Sutter Yard)11/16/2016 WS flap gate closed but blocked from opening by sediment. (A. Freitag - DWR Sutter Yard)04/28/2016 WS flap gate blocked from opening by sediment. (A. Freitag - DWR Sutter Yard)07/13/2015 WS flap gate is blocked from opening by sediment. Needs to be dug out. (A. Freitag - DWR Sutter Yard)05/21/2014 Same as last inspection. (A. Freitag - DWR Sutter Yard)12/02/2013 Same as last inspection. (A. Freitag - DWR Sutter Yard)07/15/2013 Slopes have been cleared of vegetation and are in good condition. (A. Freitag - DWR Sutter Yard)04/18/2012 Limited inspection on WS and LS slopes due to dense vegetation. Need photos of cleared slopes. (O. Magana - DWR UCIP) FIELD_STRUCT_DESC: 24-inch CIPP-lined corrugated metal drainage pipe through the levee, 8.6 feet below the crown. Flap gate on the waterside (WS) end. Concrete "U" headwalls an both ends. [Additional Reference(s): DWR Levee Log, 1993 (HLM 5.48). USACE Sacramento O&M Manual, Unit 519, June 1962, Revised 3 Feb 2011, (HLM 5.48), listed as 24-inch pipe, no as-built referenced found] FS Date: 8/26/2019 12:30:00 PM

Overview of levee crown at crossing looking downstream.

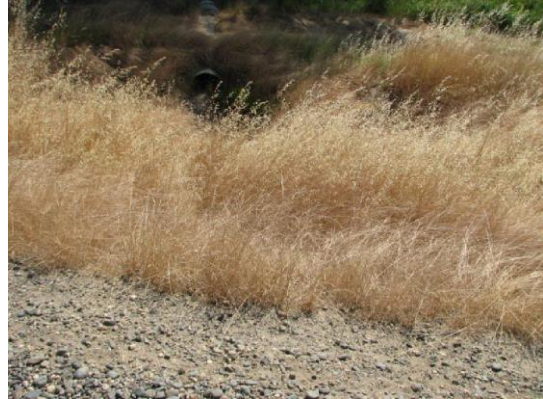
Photo 2 of 3 : UCIP_SP_2022_58579_66765.jpg

View of WS slope and channel.

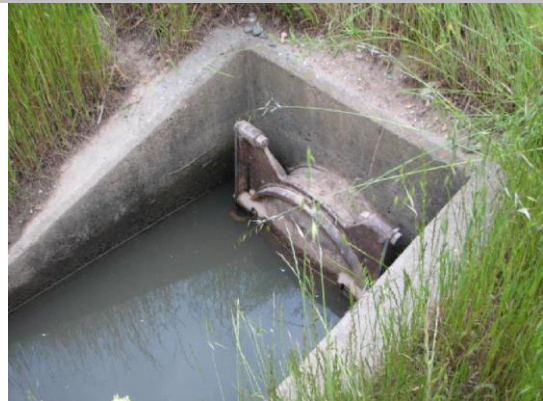
Photo 3 of 3 : UCIP_SP_2022_58579_66768.jpg

View of WS flap gate.

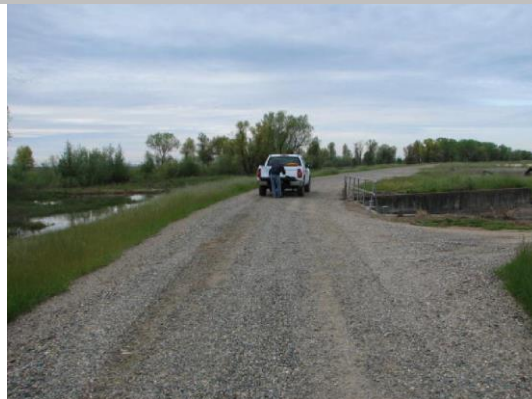
Photo 1 of 3 : UCIP_SP_2022_58475_66778.jpg

Comment Code						
Inspector Comment						
FS_ID:58475 DS_ID:16358 EP_NO: N/A Repair Type: Non-Urgent Crossing Status: Found UCIP Comments: 08/26/2019 Record has been updated from No Action Needed to Non-Urgent, no permit has been identified for this crossing. Western Canal Siphon was running during inspection. WS was dry and no signs of leaks were observed during inspection. No other issues were noted during inspection. (O. Magana - DWR UCIP, A. Freitag - DWR Sutter Yard)06/14/2017 Crossing appears to be in good condition. (A. Freitag - DWR Sutter Yard)11/16/2016 Crossing appears to be in good condition. (A. Freitag - DWR Sutter Yard)04/28/2016 Crossing appears to be in good condition. (A. Freitag - DWR Sutter Yard)07/13/2015 Crossing appears in good condition. No noticeable issues to report. (A. Freitag - DWR Sutter Yard)05/21/2014 Same as last inspection. (A. Freitag - DWR Sutter Yard)12/02/2013 Same as last inspection. (A. Freitag - DWR Sutter Yard)07/15/2013 Same as last inspection. (A. Freitag - DWR Sutter Yard) FIELD_STRUCT_DESC: [Western Canal Siphon] 1 of 3: Three 8-foot by 10-foot irrigation concrete conduits through the levee and channel. Top of concrete conduit, 4 feet below the crown. Conduit on the downstream end is closed off with a removable concrete flashboard. Concrete "U" headwall on the landside (LS) with slots for flashboards for other two openings. Guardrails around headwall. [Additional Reference(s): DWR Levee Log, 1993 (HLM 5.50). USACE Sacramento O&M Manual, Unit 519, June 1962, Revised 3 Feb 2011, (HLM 5.49), listed as three 8-foot by 10-foot concrete conduit, no as-built referenced found] FS Date: 8/26/2019 12:31:00 PM

Levee view over Siphon

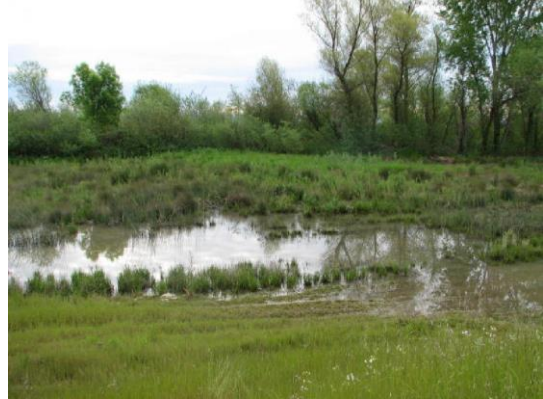
Photo 2 of 3 : UCIP_SP_2022_58475_66777.jpg

Flood Channel over Siphon

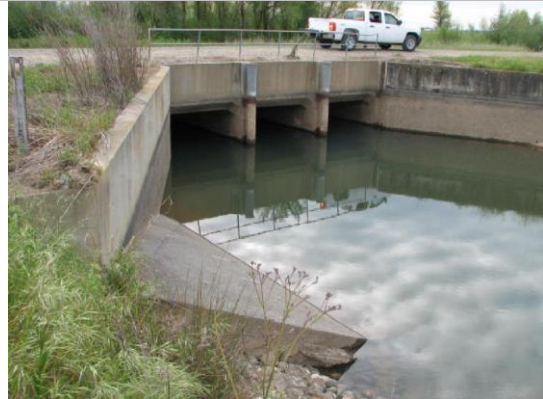
Photo 3 of 3 : UCIP_SP_2022_58475_66776.jpg

Siphon - LS. View of U/S wingwall.

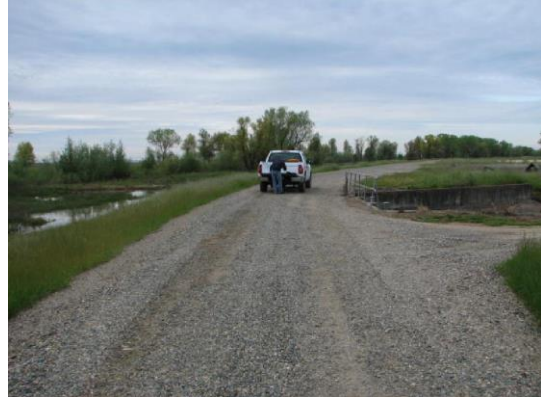
Photo 1 of 3 : UCIP_SP_2022_58476_66772.jpg

Comment Code					
Inspector Comment					
FS_ID:58476 DS_ID:17375 EP_NO: N/A Repair Type: Non-Urgent Crossing Status: Found UCIP Comments: 08/26/2019 Record has been updated from No Action Needed to Non-Urgent, no permit has been identified for this crossing. Western Canal Siphon was running during inspection. WS was dry and no signs of leaks were observed during inspection. No other issues were noted during inspection. (O. Magana - DWR UCIP, A. Freitag - DWR Sutter Yard)06/14/2017 Crossing appears to be in good condition. (A. Freitag - DWR Sutter Yard)11/16/2016 Crossing appears to be in good condition. (A. Freitag - DWR Sutter Yard)04/28/2016 Crossing appears to be in good condition. (A. Freitag - DWR Sutter Yard)07/13/2015 Crossing appears in good condition. No noticeable issues to report. (A. Freitag - DWR Sutter Yard)05/21/2014 Same as last inspection. (A. Freitag - DWR Sutter Yard)12/02/2013 Same as last inspection. (A. Freitag - DWR Sutter Yard)07/15/2013 Same as last inspection. (A. Freitag - DWR Sutter Yard) FIELD_STRUCT_DESC: [Western Canal Siphon] 2 of 3: 8-foot by 10-foot concrete irrigation conduit through the levee and channel. Top of concrete conduit, 4 feet below the crown. Conduit on the downstream end is closed off with a removable concrete flashboard. Concrete "U" headwall on the landside (LS) with slots for flashboards for other two openings. Guardrails around headwall. [Additional Reference(s): DWR Levee Log, 1993 (HLM 5.50). USACE Sacramento O&M Manual, Unit 519, June 1962, Revised 3 Feb 2011, (HLM 5.49), listed as three 8-foot by 10-foot concrete conduit, no as-built referenced found] FS Date: 8/26/2019 12:31:00 PM

Overview of levee crown at crossing looking downstream.

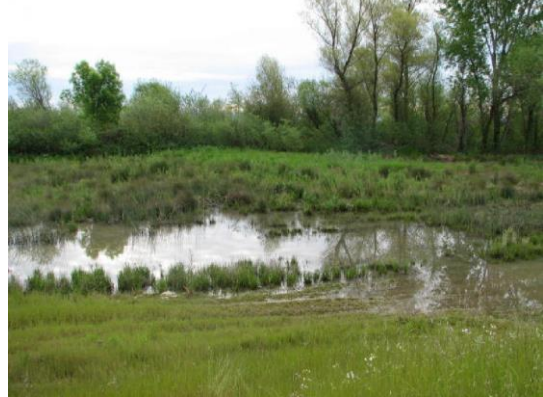
Photo 2 of 3 : UCIP_SP_2022_58476_66773.jpg

View of flood channel over siphon.

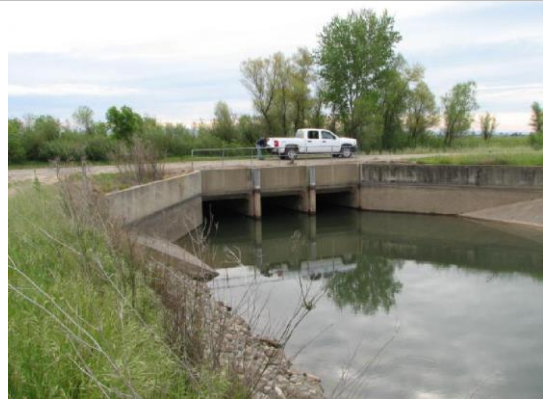
Photo 3 of 3 : UCIP_SP_2022_58476_66774.jpg

View of LS structure.

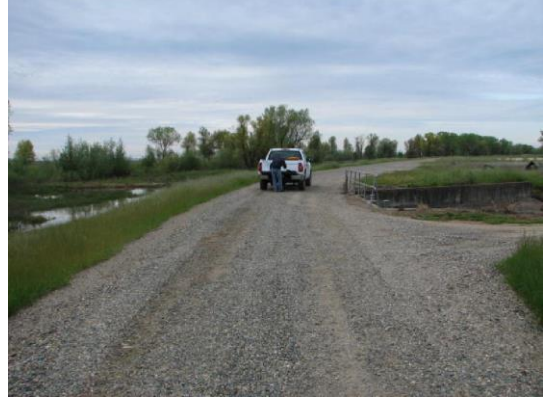
Photo 1 of 3 : UCIP_SP_2022_58477_66781.jpg

Comment Code					
Inspector Comment					
FS_ID:58477 DS_ID:17376 EP_NO: N/A Repair Type: Non-Urgent Crossing Status: Found UCIP Comments: 08/26/2019 Record has been updated from No Action Needed to Non-Urgent, no permit has been identified for this crossing. Western Canal Siphon was running during inspection. WS was dry and no signs of leaks were observed during inspection. No other issues were noted during inspection. (O. Magana - DWR UCIP, A. Freitag - DWR Sutter Yard)06/14/2017 Crossing appears to be in good condition. (A. Freitag - DWR Sutter Yard)11/16/2016 Crossing appears to be in good condition. (A. Freitag - DWR Sutter Yard)04/28/2016 Crossing appears to be in good condition. (A. Freitag - DWR Sutter Yard)07/13/2015 Crossing appears in good condition. No noticeable issues to report. (A. Freitag - DWR Sutter Yard)05/21/2014 Same as last inspection. (A. Freitag - DWR Sutter Yard)07/15/2013 Same as last inspection. (A. Freitag - DWR Sutter Yard)12/02/2013 Same as last inspection. (A. Freitag - DWR Sutter Yard) FIELD_STRUCT_DESC: [Western Canal Siphon] 3 of 3: 8-foot by 10-foot concrete irrigation conduit through the levee and channel. Top of concrete conduit, 4 feet below the crown elevation. Conduit on the downstream end is closed off with a removable concrete flashboard. Concrete "U" headwall on the landside (LS) with slots for flashboards for other two openings. Guardrails around headwall. [Additional Reference(s): DWR Levee Log, 1993 (HLM 5.50). USACE Sacramento O&M Manual, Unit 519, June 1962, Revised 3 Feb 2011, (HLM 5.49), listed as three 8-foot by 10-foot concrete conduit, no as-built referenced found] FS Date: 8/26/2019 12:33:00 PM

Overview of levee crown at crossing looking D/S at right bank of Cherokee Canal.

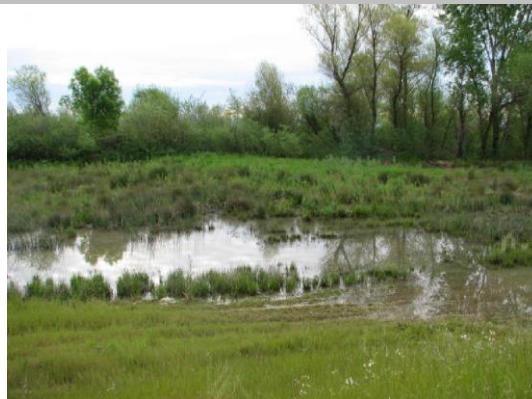
Photo 2 of 3 : UCIP_SP_2022_58477_66782.jpg

View of flood channel over siphon.

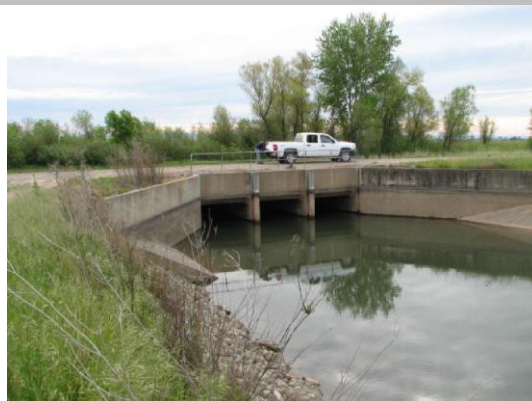
Photo 3 of 3 : UCIP_SP_2022_58477_66780.jpg

View of LS structure.
