**Flood Control Project Maintenance
Levee Inspections
LMA District Cover Sheet**

**Flood Control Project Maintenance
Levee Inspections
Unit Cover Sheet**

Waterway			Bank	Unit Miles
Unit No. 01 Cherokee Canal			Right	18.19
	Spring (March - May)	Summer (June - August)	(September - November) Fall	Winter (December - February)
Unit Maintenance Rating (Fall Only)				
Date of Inspection	3/23/2022 - 3/23/2022			
DWR Inspector	Makar Sokol			
Accompanied By

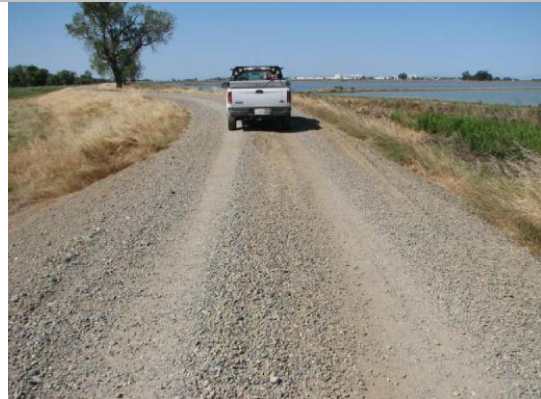
Photo 1 of 3 : UCIP_SP_2022_58478_66793.jpg

FS_ID:58478
DS_ID:16359
EP_NO: N/A
Repair Type: Non-Urgent
Crossing Status: Found
UCIP Comments: 08/26/2019 Record remains Non-Urgent, no permit has been identified authorizing pipe. Pipe is scheduled to be lined. (O. Magana - DWR UCIP, A. Freitag - DWR Sutter Yard)06/14/2017 WS Flap gate is completely buried- needs to be dug out. LS is blocked off by flashboards that are partially buried. Pipe has been selected to be internally cleaned and inspected as part of the DMP project. (A. Freitag - DWR Sutter Yard)11/16/2016 WS still completely buried. (A. Freitag - DWR Sutter Yard)04/28/2016 WS gate and headwall are buried. Only the top of the headwall was visible. LS appeared ok. (A. Freitag - DWR Sutter Yard)07/13/2015 Both the LS screw gate and WS flap gate are completely buried. (A. Freitag - DWR Sutter Yard)05/21/2014 Same as last inspection. (A. Freitag - DWR Sutter Yard)12/02/2013 Same as last inspection. (A. Freitag - DWR Sutter Yard)07/15/2013 Slopes have been cleared of vegetation and are in good condition. WS headwall and flap gate are fully covered in debris and not visible. Need to clear. (A. Freitag - DWR Sutter Yard)04/18/2012 High sedimentation build up at WS and LS headwall. Limited inspection due to dense vegetation on WS and LS slope. Need photo of cleared WS and LS slopes. This crossing was listed in the USACE Periodic Inspection report as Corp's inspect ID# USACE_CESPK_M13D_2011_p_0210 for WS gate submerged. (O. Magana - DWR UCIP)

Overview of levee crown at crossing looking downstream.

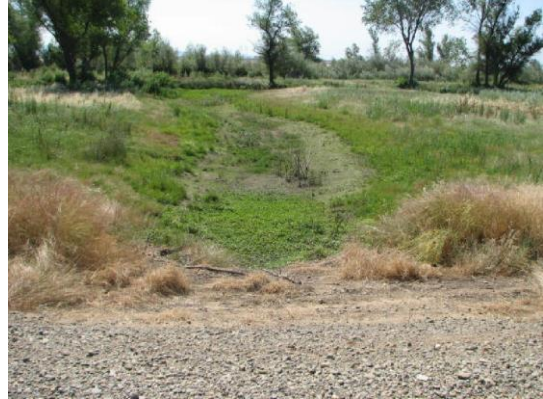
Photo 2 of 3 : UCIP_SP_2022_58478_66794.jpg

View of WS slope and toe.

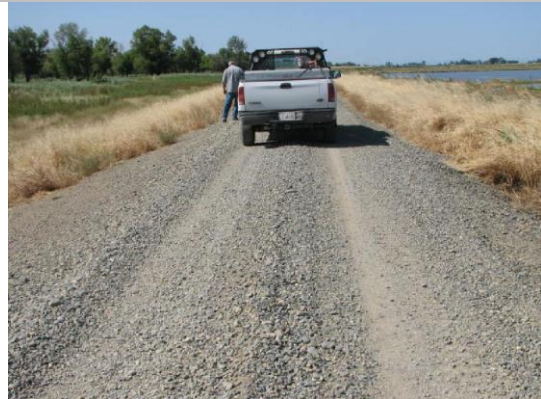
Photo 1 of 3 : UCIP_SP_2022_58479_66800.jpg

Comment Code						
Inspector Comment						
FS_ID:58479 DS_ID:16360 EP_NO: N/A Repair Type: Non-Urgent Crossing Status: Found UCIP Comments: 08/26/2019 Record has been updated from No Action Needed to Non-Urgent, no permit has been identified authorizing pipe. Pipe is scheduled to be lined. (O. Magana - DWR UCIP, A. Freitag - DWR Sutter Yard)06/14/2017 Crossing appears to be in good condition. LS is completely submerged in an irrigation ditch. Pipe has been selected to be internally cleaned and inspected as part of the DMP project. (A. Freitag - DWR Sutter Yard)11/16/2016 Crossing appears to be in good condition. (A. Freitag - DWR Sutter Yard)04/28/2016 Crossing appears to be in good condition. (A. Freitag - DWR Sutter Yard)07/13/2015 LS screw gate was completely submerged but crossing appears to be in good condition. (A. Freitag - DWR Sutter Yard)05/21/2014 Same as last inspection. (A. Freitag - DWR Sutter Yard)12/02/2013 Same as last inspection. (A. Freitag - DWR Sutter Yard)07/15/2013 Same as last inspection. (A. Freitag - DWR Sutter Yard)04/18/2012 Burrow activity near crossing; burrow holes present on LS. (O. Magana - DWR UCIP) FIELD_STRUCT_DESC: 24-inch CIPP-lined corrugated metal drainage pipe through the levee, 6.2 feet below the crown. Flap gate on the waterside (WS) end. Slide gate on the landside (LS) end. Concrete "U" headwalls on both ends. [Additional Reference(s): DWR Levee Log, 1993 (HLM 5.97). USACE Sacramento O&M Manual, Unit 519, June 1962, Revised 3 Feb 2011, (HLM 5.97), As-built DWG No. 50-4-3608, Sheet No. 3608/18, STA 808+00E, page 19 of 28 electronic file, listed as 24-inch CMP; As-built DWG No 50-4-3037 referenced not available] FS Date: 8/26/2019 12:40:00 PM

Overview of levee crown at crossing looking downstream.

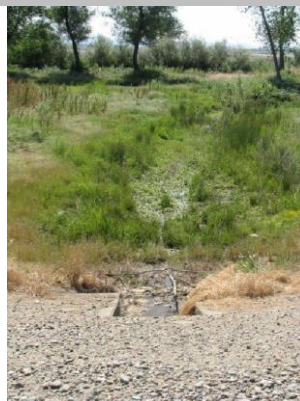
Photo 2 of 3 : UCIP_SP_2022_58479_66801.jpg

View of WS slope and toe.

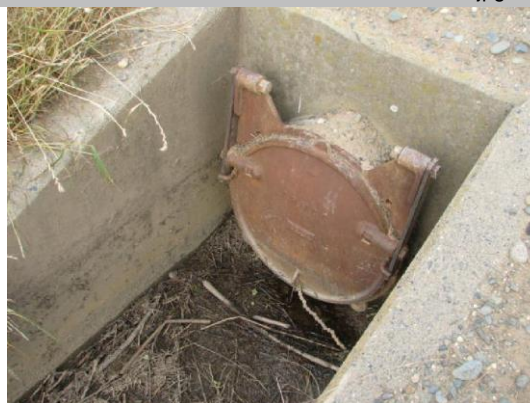
Photo 3 of 3 : UCIP_SP_2022_58479_66799.jpg

Flap gate WS

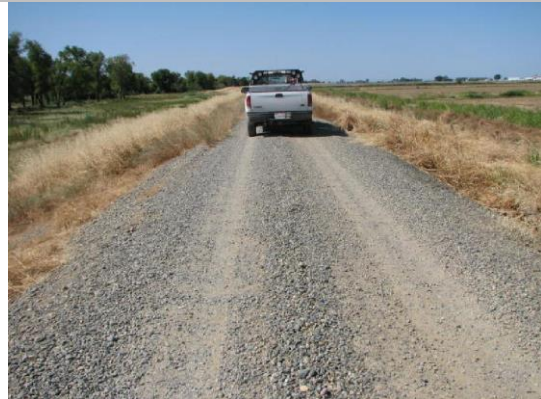
Photo 1 of 3 : UCIP_SP_2022_58480_66808.jpg

Comment Code						
Inspector Comment						
FS_ID:58480 DS_ID:16361 EP_NO: N/A Repair Type: Non-Urgent Crossing Status: Found UCIP Comments: 08/26/2019 Record remains Non-Urgent, no permit has been identified authorizing pipe. Pipe is scheduled to be lined. (O. Magana - DWR UCIP, A. Freitag - DWR Sutter Yard)06/14/2017 WS appears to be in good condition. LS slide gate is buried and submerged. Pipe has been selected to be internally cleaned and inspected as part of the DMP project. (A. Freitag - DWR Sutter Yard)11/16/2016 LS screw gate is buried and non-operational. (A. Freitag - DWR Sutter Yard)04/28/2016 LS screw gate is still completely buried. (A. Freitag - DWR Sutter Yard) 07/13/2015 LS screw gate is completely buried. (A. Freitag - DWR Sutter Yard)05/21/2014 Same as last inspection. (A. Freitag - DWR Sutter Yard)07/15/2013 WS slope has been cleared of vegetation and is in good condition. LS screw gate is still buried. (A. Freitag - DWR Sutter Yard)12/02/2013 Same as last inspection. (A. Freitag - DWR Sutter Yard)04/18/2012 LS slide gate is buried. Pipe is not visible on LS toe. Limited inspection on WS slope due to dense vegetation. (O. Magana - DWR UCIP) FIELD_STRUCT_DESC: 24-inch CIPP-lined corrugated metal drainage pipe through the levee, 7.4 feet below the crown. Flap gate on the waterside (WS) end. Slide gate on the landside (LS) end. Concrete "U" headwalls on both ends. [Additional Reference(s): DWR Levee Log, 1993 (HLM 6.32). USACE Sacramento O&M Manual, Unit 519, June 1962, Revised 3 Feb 2011, (HLM 6.34), As-built DWG No. 50-4-3608, Sheet No. 3608/18, STA 789+00E, page 19 of 28 electronic file, listed as 24-inch CMP; As-built DWG No 50-4-3037 referenced not available] FS Date: 8/26/2019 12:41:00 PM

Overview of levee crown at crossing looking downstream.

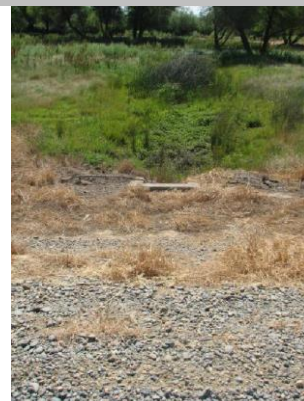
Photo 2 of 3 : UCIP_SP_2022_58480_66806.jpg

View of WS slope and toe.

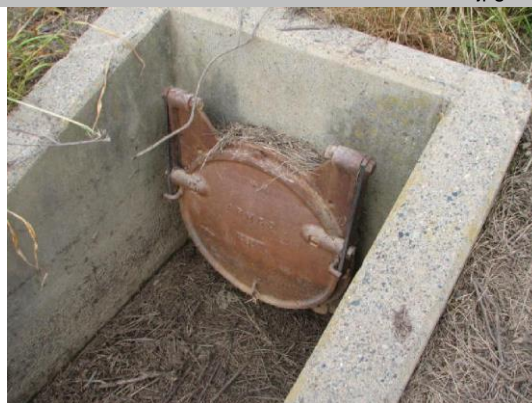
Photo 3 of 3 : UCIP_SP_2022_58480_66804.jpg

View of WS flap gate.

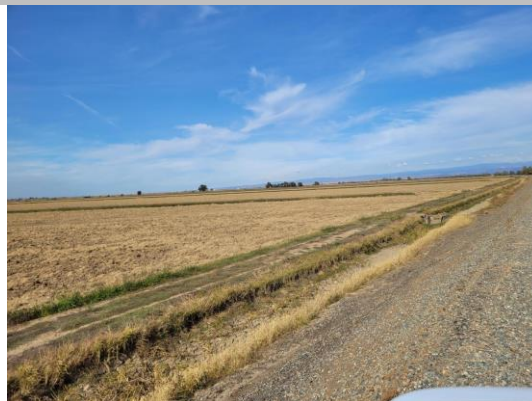
Photo 1 of 1 : SP_2022_MA0013_300_3_20220307_00001.jpg

LM Start	6.41	Rating **	M	Issue No.	3
LM End	6.99	Issue Type +	En	Location *	LS
Category	Earthen Levee			GPS Latitude/Longitude	
				Start	End
Item	Encroachments			39.508928 °	39.501438 °
				-121.714842 °	-121.719715 °
DWR ID	DWR_MA0013_01_s_2012_3				
Comment Code					
DT : Ditch					
Inspector Comment

View of the agricultural ditch along the toe. Fall 2021.

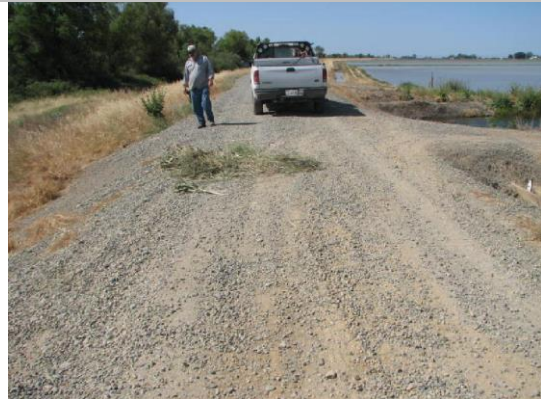
Photo 1 of 3 : UCIP_SP_2022_58481_66814.jpg

FS_ID:58481
DS_ID:16362
EP_NO: 5200B
Repair Type: Non-Urgent
Crossing Status: Found
UCIP Comments: 08/26/2019 Record has been updated from No Action Needed to Non-Urgent, potential levee integrity issues. This crossing is part of DMP's Phase 1 eligibility. No internal inspection has been completed for this crossing. Minor holes visible on LS that could be associated with burrow activity or signs of sink hole. Need internal inspection of pipe to determine condition of pipe through the levee. (O. Magana - DWR UCIP, A. Freitag - DWR Sutter Yard)06/14/2017 Hole/erosion behind the flashboards was repaired. New flash boards were installed and the erosion hole filled back in. Pipe has been selected to be internally cleaned and inspected as part of the DMP project. (A. Freitag - DWR Sutter Yard)11/16/2016 Hole/erosion still present behind the LS flashboards. (DWR Sutter Yard-AFreitag)04/28/2016 Hole still present behind the LS flashboards. Rest of the crossing appeared in good condition. (A. Freitag - DWR Sutter Yard)07/13/2015 Hole still present behind the LS flashboards. (A. Freitag - DWR Sutter Yard)05/21/2014 Same as last inspection. (A. Freitag - DWR Sutter Yard)12/02/2013 Same as last inspection. (A. Freitag - DWR Sutter Yard)07/15/2013 WS slope has been cleared of vegetation and is in good condition. Hole is still present behind flash boards on LS. (A. Freitag - DWR Sutter Yard)04/18/2012 Hole behind flashboards against slide gate on LS slope (Health and Safety Issue). Limited inspection on WS slope due to dense vegetation. Need photo of cleared slope on WS. (O. Magana - DWR UCIP)

Overview of levee crown at crossing looking downstream.

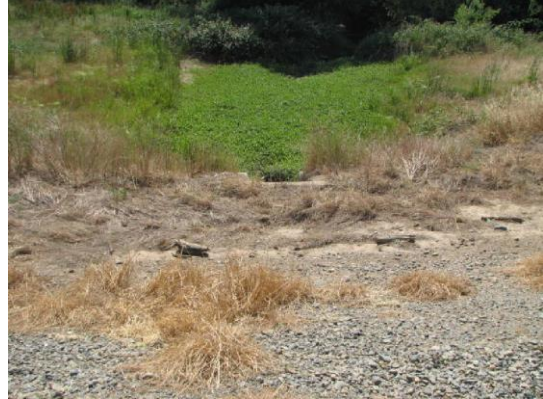
Photo 2 of 3 : UCIP_SP_2022_58481_66813.jpg

View of WS slope and toe.

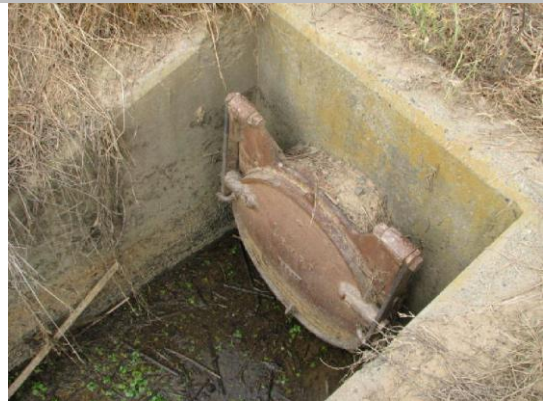
Photo 3 of 3 : UCIP_SP_2022_58481_66811.jpg

WS flap gate.

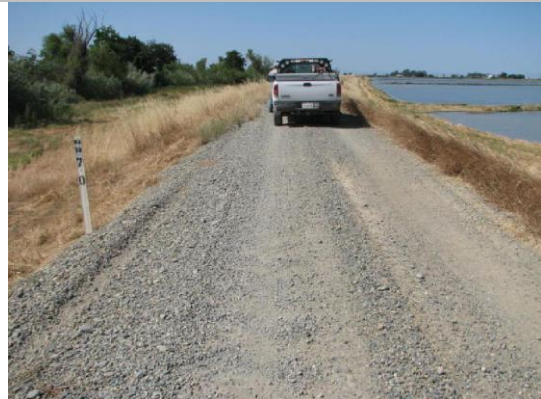
Photo 1 of 3 : UCIP_SP_2022_58483_66833.jpg

FS_ID:58483
DS_ID:16329
EP_NO: N/A
Repair Type: Non-Urgent
Crossing Status: Found
UCIP Comments: 08/26/2019 Record remains Non-Urgent, due to no permit found authorizing pipe and maintenance issue. Pipe is scheduled to be lined. Slide gate detached and sitting on the side of concrete wingwall. Slide gate will need to be re-attached. (O. Magana - DWR UCIP, A. Freitag - DWR Sutter Yard)06/14/2017 LS slide gate is still damaged and needing to be replaced. WS appeared to be in good condition. Pipe has been selected to be internally cleaned and inspected as part of the DMP project. (A. Freitag - DWR Sutter Yard)11/16/2016 Needs a new screw gate installed on the LS. (A. Freitag - DWR Sutter Yard)04/28/2016 LS slide gate is still bent. Everything else with the crossing appeared ok. (A. Freitag - DWR Sutter Yard)07/13/2015 LS screw gate needs to be replaced. Everything else with crossing seems to be in good condition. (A. Freitag - DWR Sutter Yard)05/21/2014 Same as last inspection. (A. Freitag - DWR Sutter Yard)12/02/2013 Same as last inspection. (A. Freitag - DWR Sutter Yard)07/15/2013 Slopes have been cleared of vegetation and are in good condition. There were no apparent signs of settling. LS screw gate is still damaged. (A. Freitag - DWR Sutter Yard)04/18/2012 LMA's inspection sheet of 2011 indicates settlement and visible corrosion. Damage/severe corrosion on screw gate where it bolts to headwall. No visible signs of settlement due to high vegetation cover. Limited inspection on WS and LS slopes due to dense vegetation. Need photos of cleared slopes for this crossing. (O. Magana - DWR UCIP)

Overview of levee crown at crossing looking D/S.

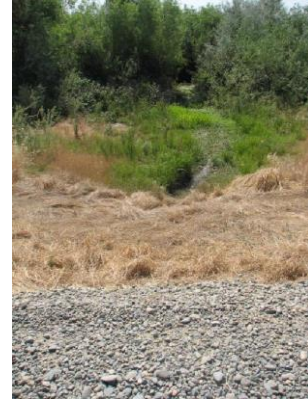
Photo 2 of 3 : UCIP_SP_2022_58483_66832.jpg

View of WS slope and toe.

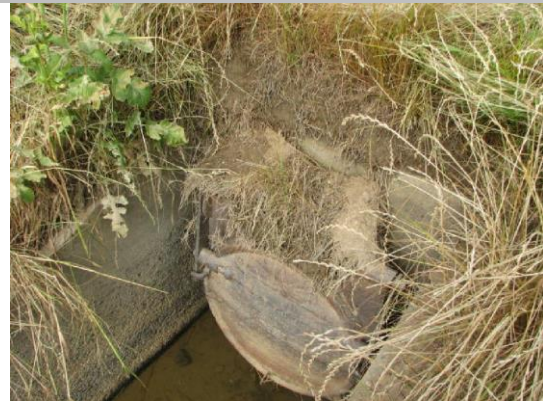
Photo 3 of 3 : UCIP_SP_2022_58483_66837.jpg

WS Flap Gate

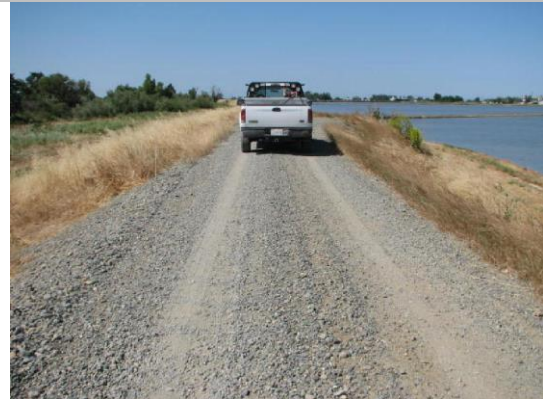
Photo 1 of 3 : UCIP_SP_2022_58484_66844.jpg

Comment Code					
Inspector Comment					
FS_ID:58484 DS_ID:16354 EP_NO: N/A Repair Type: Non-Urgent Crossing Status: Found UCIP Comments: 08/26/2019 Record remains Non-Urgent, no permit has been identified authorizing pipe. Pipe is scheduled to be lined. (O. Magana - DWR UCIP, A. Freitag - DWR Sutter Yard)06/14/2017 LS slide gate stem still bent. WS appeared to be in good condition. Pipe has been selected to be internally cleaned and inspected as part of the DMP project. (A. Freitag - DWR Sutter Yard)11/16/2016 Screw gate stem bent but gate is still operational. (A. Freitag - DWR Sutter Yard)04/28/2016 Tested positive closure device the bent stem on the slide gate did not seem to affect its functions. Gate operable. (A. Freitag - DWR Sutter Yard)07/13/2015 LS screw gate stem is still bent. Gate should still be able to close fully. The rest of the crossing seems to be in good condition. (A. Freitag - DWR Sutter Yard)05/21/2014 Same as last inspection. (A. Freitag - DWR Sutter Yard)12/02/2013 Same as last inspection. (A. Freitag - DWR Sutter Yard)07/15/2013 Slopes have been cleared of vegetation and are in good condition. LS screw gate stem is still bent. (A. Freitag - DWR Sutter Yard)04/18/2012 LS slide gate stem is bent and needs to be replaced. Limited inspection on WS and LS slope due to dense vegetation. Need photos of cleared slopes during next inspection. Confirmed flap gate on WS. This crossing was listed in the USACE Periodic Inspection report as Corp's inspect ID#USACE_CESPK_M13D_2011_p_0244 for submerged WS gate. (O. Magana - DWR UCIP) FIELD_STRUCT_DESC: 24-inch CIPP-lined corrugated metal drainage pipe through the levee, 11.2 feet below the crown. Flap gate on the waterside (WS) end. Slide gate on the landside (LS) end. Concrete "U" headwall on both ends. [Additional Reference(s): DWR Levee Log, 1993 (HLM 7.34). USACE Sacramento O&M Manual, Unit 519, June 1962, Revised 3 Feb 2011, (HLM 7.34), As-built DWG No. 50-4-3608, Sheet No. 3608/18, STA 736+00E, page 19 of 28 electronic file, listed as 24-inch CMP; As-built DWG No 50-4-3037 referenced not available] FS Date: 8/26/2019 1:02:00 PM

Overview of levee crown at crossing looking D/S.

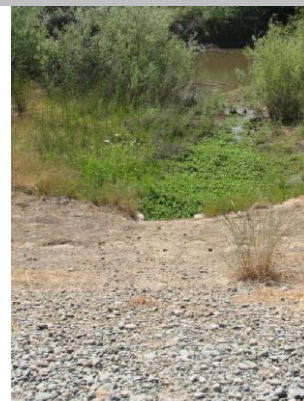
Photo 2 of 3 : UCIP_SP_2022_58484_66845.jpg

View of WS slope and toe.

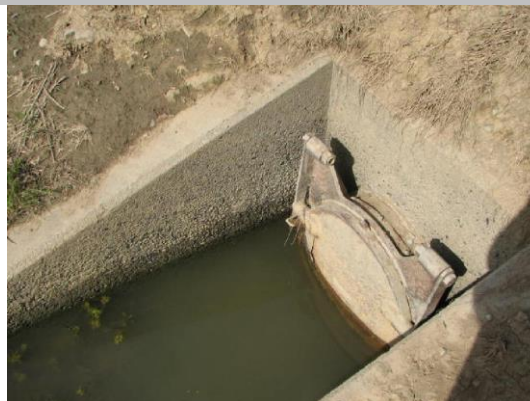
Photo 3 of 3 : UCIP_SP_2022_58484_66842.jpg

WS Flap Gate

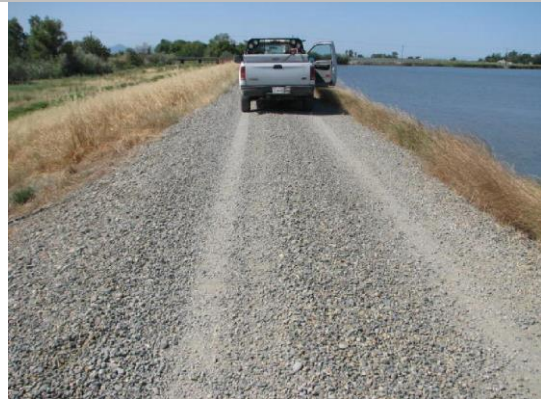
Photo 1 of 3 : UCIP_SP_2022_58485_66853.jpg

Comment Code						
Inspector Comment						
FS_ID:58485 DS_ID:16352 EP_NO: N/A Repair Type: Non-Urgent Crossing Status: Found UCIP Comments: 08/26/2019 Record has been updated from No Action Needed to Non-Urgent, no permit has been identified authorizing pipe. Pipe is scheduled to be lined. (O. Magana - DWR UCIP, A. Freitag - DWR Sutter Yard)06/14/2017 Crossing appears to be in good condition. Pipe has been selected to be internally cleaned and inspected as part of the DMP project. (A. Freitag - DWR Sutter Yard)11/16/2016 Crossing appears to be in good condition. (A. Freitag - DWR Sutter Yard)04/28/2016 Crossing appears to be in good condition. (A. Freitag - DWR Sutter Yard)07/13/2015 WS ditch is getting to be heavily vegetated but it is not yet affecting flap gate operation. Vegetation needs to be cleared back some. (A. Freitag - DWR Sutter Yard)05/21/2014 Same as last inspection. (A. Freitag - DWR Sutter Yard)12/02/2013 Same as last inspection. (A. Freitag - DWR Sutter Yard)07/15/2013 Slopes have been cleared of vegetation and are in good condition. (A. Freitag - DWR Sutter Yard)04/18/2012 Limited inspection on WS and LS slopes due to dense vegetation. Need photos of cleared WS and LS slopes during next inspection. (O. Magana - DWR UCIP) FIELD_STRUCT_DESC: 24-inch CIPP-lined corrugated metal drainage pipe through the levee, 10.2 feet below the crown. Flap gate on the waterside (WS) end. Screw gate on the landside (LS) end. Concrete headwall on both ends. [Additional Reference(s): DWR Levee Log, 1993 (HLM 7.58). USACE Sacramento O&M Manual, Unit 519, June 1962, Revised 3 Feb 2011, (HLM 7.58), As-built DWG No. 50-4-3608, Sheet No. 3608/18, STA 724+32E, page 19 of 28 electronic file, listed as 24-inch CMP; As-built DWG No 50-4-3037 referenced not available] FS Date: 8/26/2019 1:03:00 PM

View of levee crown at crossing looking D/S.

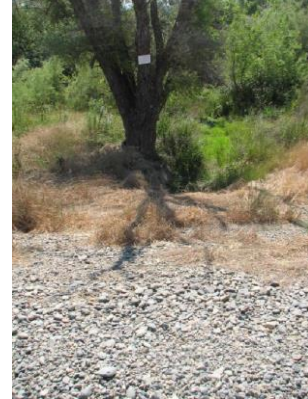
Photo 2 of 3 : UCIP_SP_2022_58485_66851.jpg

WS view of slope and channel.

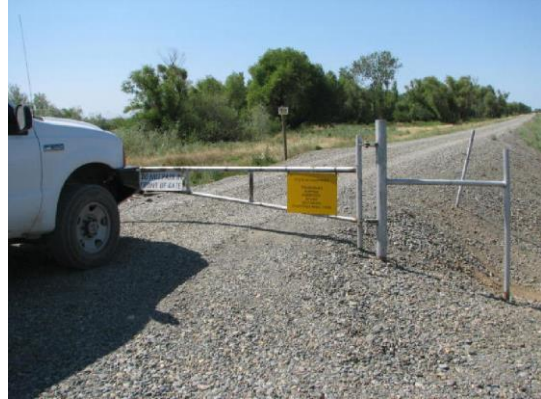
Photo 1 of 3 : UCIP_SP_2022_58487_66867.jpg

Comment Code						
Inspector Comment						
FS_ID:58487 DS_ID:16320 EP_NO: N/A Repair Type: Non-Urgent Crossing Status: Found UCIP Comments: 08/26/2019 Record has been updated from No Action Needed to Non-Urgent, no permit has been identified authorizing pipe. Pipe is scheduled to be lined. DMP internal video inspection has not found pipe integrity issues. LOF of crossing is less or equal to 4. Recommend next video inspection in 5 years. The following maintenance issues should be addressed: clear vegetation from LS inlet and repair CMP riser lid (safety measure). (O. Magana - DWR UCIP, A. Freitag - DWR Sutter Yard)06/14/2017 Debris down inside of WS riser. The rest of the crossing appears to be in good condition. Pipe has been selected to be internally cleaned and inspected as part of the DMP project. (A. Freitag - DWR Sutter Yard)11/16/2016 Crossing appears to be in good condition. (A. Freitag - DWR Sutter Yard)04/28/2016 Crossing appears to be in good condition. (A. Freitag - DWR Sutter Yard)07/13/2015 The bottom of the entire pipe has about 8inch of sediment in it. Sediment is preventing the screw gate from fully closing. WS flap gate seems to be in good condition. (A. Freitag - DWR Sutter Yard)05/21/2014 Same as last inspection. (A. Freitag - DWR Sutter Yard)12/03/2013 Same as last inspection. (A. Freitag - DWR Sutter Yard)07/15/2013 Same as last inspection. (A. Freitag - DWR Sutter Yard) FIELD_STRUCT_DESC: 48-inch corrugated metal drainage pipe through the levee, 9.9 feet below the crown. Flap gate on the waterside (WS) end. Slide gate in corrugated metal pipe riser on the WS slope. Concrete "U" headwalls on both ends. Spillway grouted for 35 feet. [Additional Reference(s): DWR Levee Log, 1993 (HLM 7.76). USACE Sacramento O&M Manual, Unit 519, June 1962, Revised 3 Feb 2011, (HLM 7.76), As-built DWG No. 50-4-3608, Sheet No. 3608/18, STA 714+28E, page 19 of 28 electronic file, listed as 48-inch CMP; As-built DWG No 50-4-3037 referenced not available] FS Date: 8/26/2019 1:06:00 PM

Overview of levee crown at crossing (past gate) looking D/S.

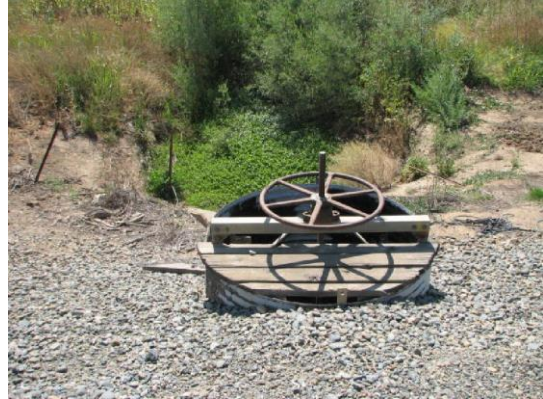
Photo 2 of 3 : UCIP_SP_2022_58487_66865.jpg

View of WS slope, corrugated metal riser with slide gate.

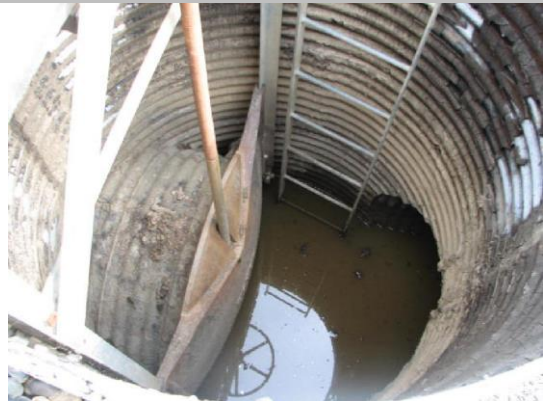
Photo 3 of 3 : UCIP_SP_2022_58487_66863.jpg

WS Slide gate

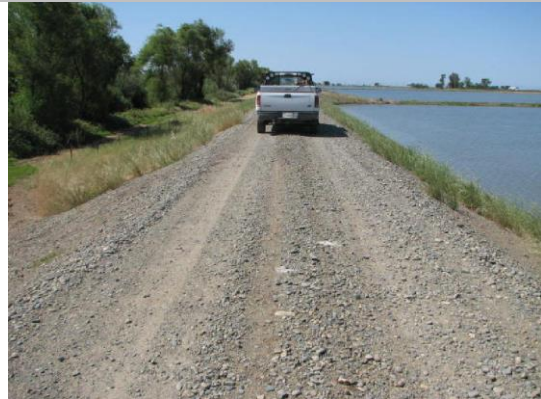
Photo 1 of 3 : UCIP_SP_2022_58488_66872.jpg

Comment Code						
Inspector Comment						
FS_ID:58488 DS_ID:16321 EP_NO: N/A Repair Type: Non-Urgent Crossing Status: Found UCIP Comments: 08/27/2019 Record has been updated from No Action Needed to Non-Urgent, no permit has been identified authorizing pipe. Pipe is scheduled to be lined. (O. Magana - DWR UCIP, A. Freitag - DWR Sutter Yard)06/14/2017 Crossing appears to be in good condition. Pipe has been selected to be internally cleaned and inspected as part of the DMP project. (A. Freitag - DWR Sutter Yard)11/16/2016 Crossing appears to be in good condition. (A. Freitag - DWR Sutter Yard)04/28/2016 Crossing appears to be in good condition. (A. Freitag - DWR Sutter Yard)07/13/2015 Crossing appears to be in good condition. (A. Freitag - DWR Sutter Yard)05/21/2014 Same as last inspection. (A. Freitag - DWR Sutter Yard)12/03/2013 Same as last inspection. (A. Freitag - DWR Sutter Yard)07/15/2013 Same as last inspection. (A. Freitag - DWR Sutter Yard)04/18/2012 Sediment build up against flashboards. Flashboards are in use on landside of levee. (O. Magana - DWR UCIP) FIELD_STRUCT_DESC: 24-inch CIPP-lined corrugated metal drainage pipe through the levee, 8.2 feet below the crown. Flap gate on the waterside (WS) end. Concrete "U" headwalls on both ends. Flashboards should be present on the landside (LS). [Additional Reference(s): DWR Levee Log, 1993 (HLM 8.11). USACE Sacramento O&M Manual, Unit 519, June 1962, Revised 3 Feb 2011, (HLM 8.12), As-built DWG No. 50-4-3608, Sheet No. 3608/18, STA 696+00E, page 19 of 28 electronic file, listed as 24-inch CMP; As-built DWG No 50-4-3037 referenced not available] FS Date: 8/27/2019 2:07:00 PM

Overview of levee crown at crossing looking D/S.

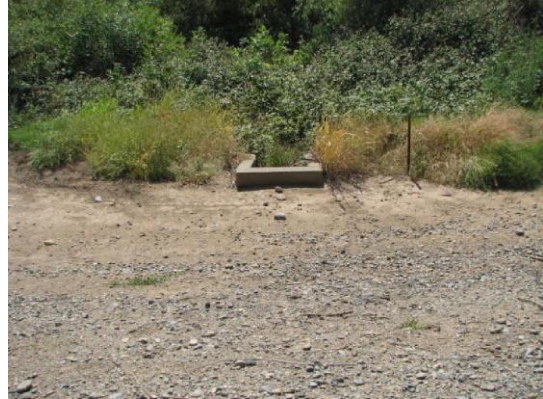
Photo 2 of 3 : UCIP_SP_2022_58488_66873.jpg

View of WS slope and toe.

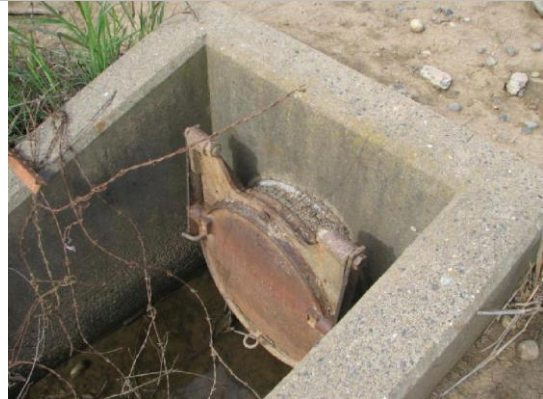
Photo 3 of 3 : UCIP_SP_2022_58488_66869.jpg

WS Flap gate

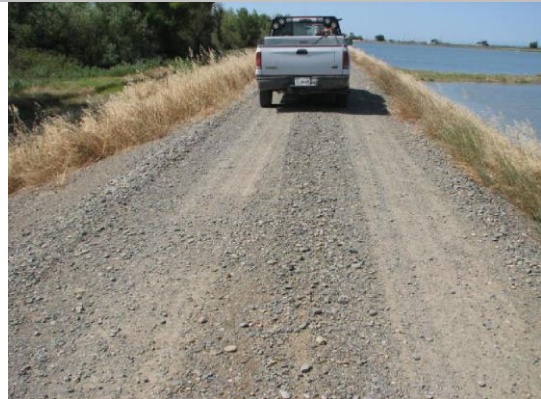
Photo 1 of 3 : UCIP_SP_2022_58489_66876.jpg

Comment Code						
Inspector Comment						
FS_ID:58489 DS_ID:16322 EP_NO: N/A Repair Type: Non-Urgent Crossing Status: Found UCIP Comments: 08/27/2019 Record remains Non-Urgent, no permit has been identified authorizing pipe. Vegetation needs to be cleared from inlet/outlet. Pipe is scheduled to be lined. (O. Magana - DWR UCIP, A. Freitag - DWR Sutter Yard)06/14/2017 Both sides of the crossing were buried with sediment- needs to be cleared away. Pipe has been selected to be internally cleaned and inspected as part of the DMP project. (A. Freitag - DWR Sutter Yard)11/16/2016 WS flap gate is closed but is blocked from opening by sediment. (A. Freitag - DWR Sutter Yard)04/28/2016 Crossing appears to be in good condition. (A. Freitag - DWR Sutter Yard)07/13/2015 Minor sediment build up blocking flap gate from opening on WS. Needs to be dug out. (A. Freitag - DWR Sutter Yard)05/21/2014 Same as last inspection. (A. Freitag - DWR Sutter Yard)12/03/2013 Same as last inspection. (A. Freitag - DWR Sutter Yard)07/15/2013 Slopes are cleared of vegetation and are in good condition. WS flap gate is blocked from opening fully by sediment. (A. Freitag - DWR Sutter Yard)04/18/2012 Sediment build up on LS. Debris (broken panels) scattered near LS headwall. Limited inspection on WS and LS slope due to dense vegetation. Need photos of cleared WS and LS slopes. (O. Magana - DWR UCIP) FIELD_STRUCT_DESC: 24-inch CIPP-lined corrugated metal drainage pipe through the levee, 9.3 feet below the crown. Flap gate on the waterside (WS) end. Concrete "U" headwalls on both ends. Flashboards should be present on the landside (LS). [Additional Reference(s): DWR Levee Log, 1993 (HLM 8.40). USACE Sacramento O&M Manual, Unit 519, June 1962, Revised 3 Feb 2011, (HLM 8.40), As-built DWG No. 50-4-3608, Sheet No. 3608/18, STA 681+30E, page 19 of 28 electronic file, listed as 24-inch CMP; As-built DWG No 50-4-3037 referenced not available] FS Date: 8/27/2019 2:08:00 PM

Overview of levee crown at crossing looking D/S.

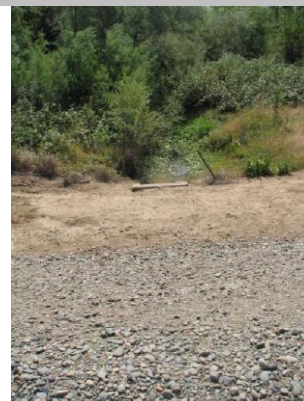
Photo 2 of 3 : UCIP_SP_2022_58489_66874.jpg

View of WS slope and toe.

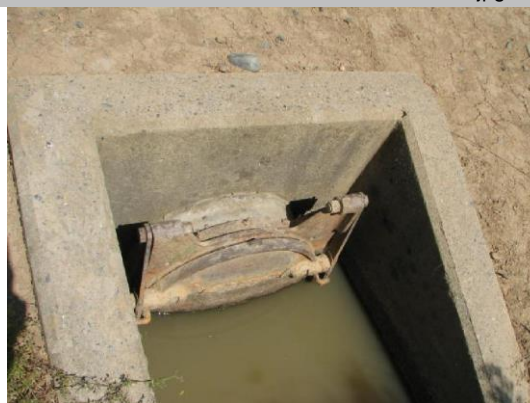
Photo 3 of 3 : UCIP_SP_2022_58489_66877.jpg

View of WS flap gate and headwall.

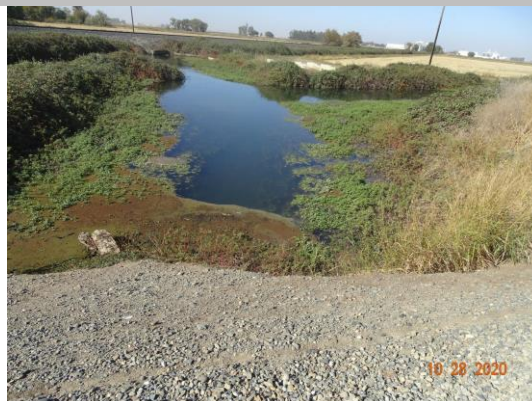
Photo 1 of 1 : SP_2022_MA0013_300_49_20220307_00006.jpg

LM Start	8.81	Rating **	M	Issue No.	49
LM End	8.81	Issue Type +	Ma	Location *	LS
Category	Earthen Levee			GPS Latitude/Longitude	
				Start	End
Item	Erosion / Bank Caving			39.478648 °	39.478648 °
				-121.736477 °	-121.736477 °
DWR ID	DWR_MA0013_01_f _ 2016_49				
Comment Code					
E2 : Schedule repair of erosion site prior to the next inspection.					
Inspector Comment

View of the erosion site along the landside toe. Fall 2020.

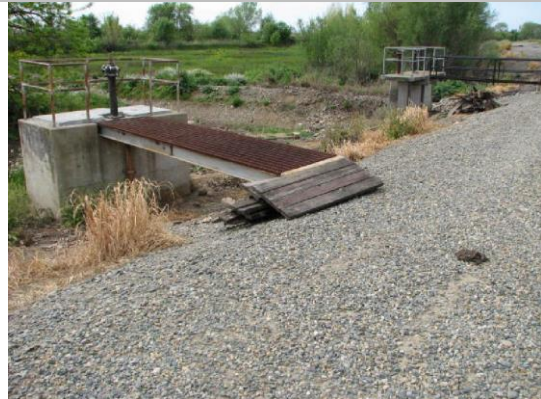
Photo 1 of 3 : UCIP_SP_2022_58490_66881.jpg

Comment Code						
Inspector Comment						
FS_ID:58490 DS_ID:16323 EP_NO: N/A Repair Type: Urgent Crossing Status: Found UCIP Comments: 08/27/2019 Same as last inspection; crossing remains Urgent due to LS toe erosion. No permit has been identified authorizing irrigation structure. (O. Magana - DWR UCIP, A. Freitag - DWR Sutter Yard)08/23/2018 Same as last inspection; crossing remains Urgent because LS erosion is still present and poses a levee integrity risk (D. Sanoski - DWR UCIP).06/14/2017 LS underwater but levee erosion is still present- needs to be repaired. Pipe has been selected to be internally cleaned and inspected as part of the DMP project. (A. Freitag - DWR Sutter Yard)11/16/2016 LS erosion is still a major problem here. (A. Freitag - DWR Sutter Yard)04/28/2016 Erosion still present at the LS headwall. (A. Freitag - DWR Sutter Yard)07/13/2015 Erosion still present behind the LS headwall. It looks to be getting worse and is starting to affect the levee slope. (A. Freitag - DWR Sutter Yard)05/21/2014 Same as last inspection. (A. Freitag - DWR Sutter Yard)12/03/2013 Same as last inspection. (A. Freitag - DWR Sutter Yard)07/15/2013 Same as last inspection. (A. Freitag - DWR Sutter Yard)04/18/2012 Concrete headwall is cracked, erosion behind headwall is also present. LS headwall needs to be repaired/replaced. Remove wooden debris from levee shoulder. (O. Magana - DWR UCIP) FIELD_STRUCT_DESC: [Richvale Irrigation Canal Siphon] 60-inch by 84-inch (5-foot by 7 foot) concrete irrigation conduit through the levee, 18.4 feet below the crown. Distribution box and walkway are located on the waterside (WS). Concrete headwall on the landside (LS). 28-foot reinforced concrete protective slab on top of the conduit in the center of the levee. [Additional Reference(s): DWR Levee Log, 1993 (HLM 8.95). USACE Sacramento O&M Manual, Unit 519, June 1962, Revised 3 Feb 2011, (HLM 8.95), listed as 5-foot by 7-foot concrete conduit, As-built DWG No. 50-4-3608, Sheet No. 3608/20, STA 651+66E, page 21 of 28 electronic file, listed as 6-foot diameter concrete pipe (siphon)] FS Date: 8/27/2019 2:09:00 PM

Catwalk and screw gate located on WS.

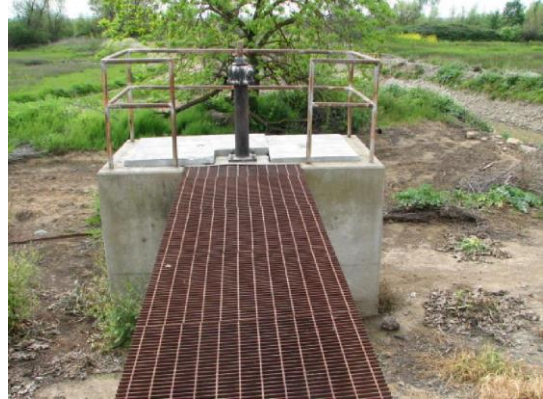
Photo 2 of 3 : UCIP_SP_2022_58490_66884.jpg

LM Start	8.82	Rating **	U	Issue No.	40 (cont)
LM End	8.82	Issue Type +	En	Location *	
Category	Supplemental		GPS Latitude/Longitude		
			Start	End	
Item	DWR UCIP Field Study		39.478573 °	39.478573 °	
			-121.736550 °	-121.736550 °	
DWR ID	16323

Catwalk & gate located on WS. No daylight point on WS.

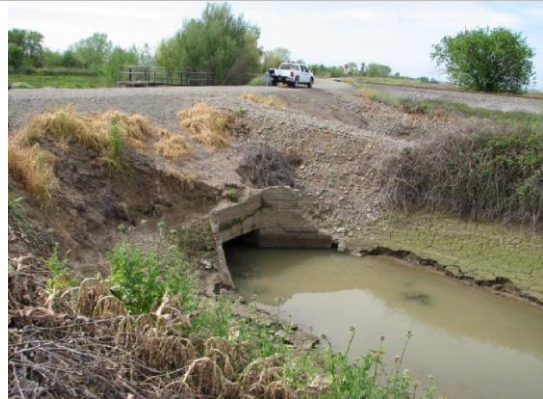
Photo 3 of 3 : UCIP_SP_2022_58490_66882.jpg

View of LS structure. Erosion present behind headwall.

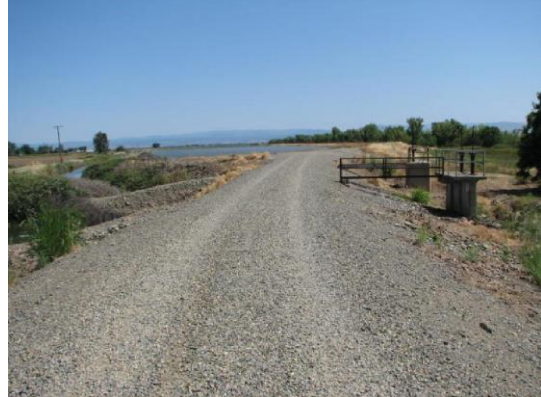
Photo 1 of 3 : UCIP_SP_2022_58491_66894.jpg

Comment Code					
Inspector Comment					
FS_ID:58491 DS_ID:16324 EP_NO: N/A Repair Type: Non-Urgent Crossing Status: Found UCIP Comments: 08/27/2019 Record has been updated from No Action Needed to Non-Urgent, no permit has been found authorizing structure. No other issues were noted during inspection. (O. Magana - DWR UCIP, A. Freitag - DWR Sutter Yard)06/14/2017 Crossing appears to be in good condition. Pipe has been selected to be internally cleaned and inspected as part of the DMP project. (A. Freitag - DWR Sutter Yard)11/16/2016 Crossing appears to be in good condition. (A. Freitag - DWR Sutter Yard)04/28/2016 Crossing appears to be in good condition. (A. Freitag - DWR Sutter Yard)07/13/2015 Crossing appears in good condition. No noticeable issues to report. (A. Freitag - DWR Sutter Yard)05/21/2014 Same as last inspection. (A. Freitag - DWR Sutter Yard)12/03/2013 Same as last inspection. (A. Freitag - DWR Sutter Yard)07/15/2013 Same as last inspection. (A. Freitag - DWR Sutter Yard) FIELD_STRUCT_DESC: 1 of 2: 48-inch by 48-inch (4-foot by 4-foot) concrete irrigation conduit through the levee 13.9 feet below the crown. This crossing record is for the upstream conduit. Sluice gates on the concrete headwall on the waterside (WS) side. Wooden walkway to the sluice gates. Concrete "U" headwall on the landside (LS) end. WS slope cobble revetted. [Additional Reference(s): DWR Levee Log, 1993 (HLM 8.96). USACE Sacramento O&M Manual, Unit 519, June 1962, Revised 3 Feb 2011, (HLM 8.96), listed as two 4.5-foot by 4.5-foot concrete conduits, As-built DWG No. 50-4-3608, Sheet No. 3608/20, 28, STA 651+11E, page 21, 27, 28 (dup) of 28 electronic file, listed as dual 4'-6" concrete conduit (irrigation structure)] FS Date: 8/27/2019 2:10:00 PM

Overview of levee crown at crossing looking U/S.

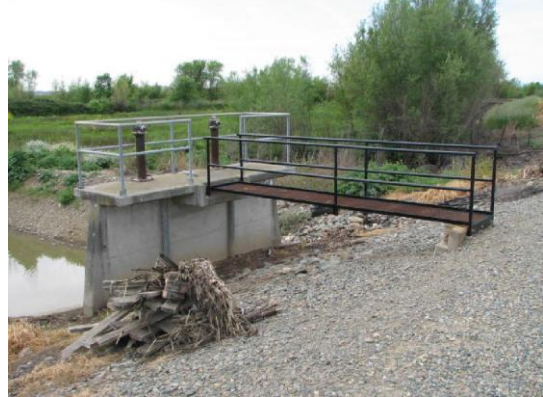
Photo 2 of 3 : UCIP_SP_2022_58491_66892.jpg

Catwalk, sluice gates, & headwall on WS.

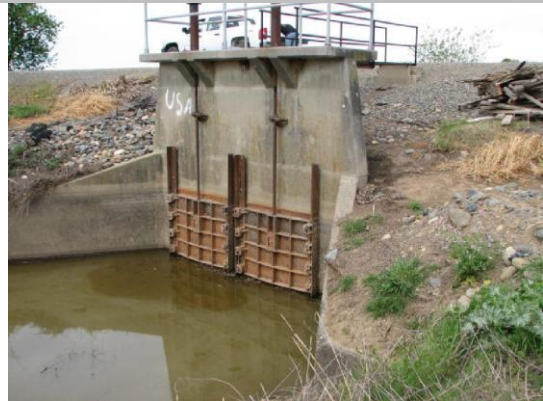
Photo 3 of 3 : UCIP_SP_2022_58491_66891.jpg

Headwall and sluice gates located on WS.

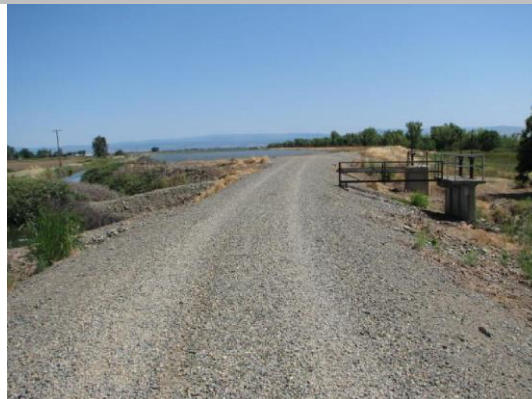
Photo 1 of 3 : UCIP_SP_2022_58492_66889.jpg

FS_ID:58492
DS_ID:17521
EP_NO: N/A
Repair Type: Non-Urgent
Crossing Status: Found
UCIP Comments: 08/27/2019 Record has been updated from No Action Needed to Non-Urgent, no permit has been found authorizing structure. No other issues were noted during inspection. (O. Magana - DWR UCIP, A. Freitag - DWR Sutter Yard)06/14/2017 Crossing appears to be in good condition. Pipe has been selected to be internally cleaned and inspected as part of the DMP project. (A. Freitag - DWR Sutter Yard)11/16/2016 Crossing appears to be in good condition. (A. Freitag - DWR Sutter Yard)04/28/2016 Crossing appears to be in good condition. (A. Freitag - DWR Sutter Yard)07/13/2015 Crossing appears to be in good condition. No noticeable issues to report. (A. Freitag - DWR Sutter Yard)05/21/2014 Same as last inspection. (A. Freitag - DWR Sutter Yard)12/03/2013 Same as last inspection. (A. Freitag - DWR Sutter Yard)07/15/2013 Same as last inspection. (A. Freitag - DWR Sutter Yard)

Overview of levee crown at crossing looking U/S.

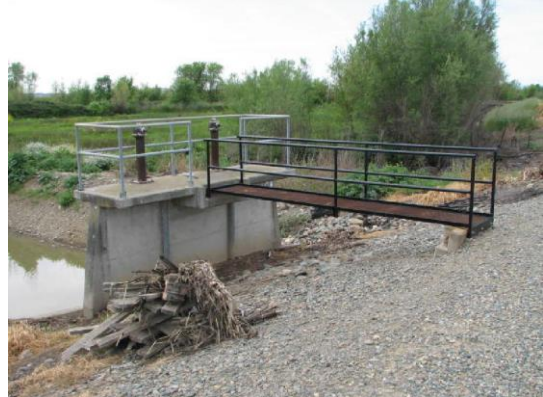
Photo 2 of 3 : UCIP_SP_2022_58492_66887.jpg

Catwalk and screw gates on WS, view looking south from crown road

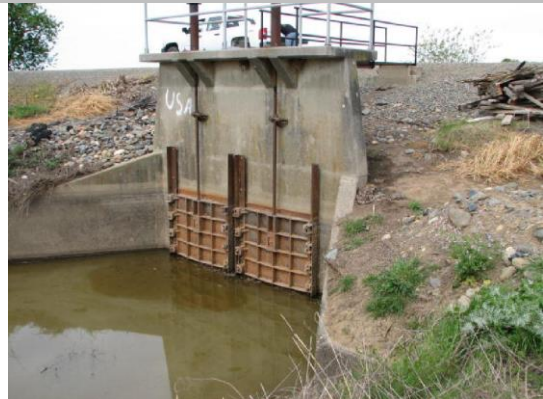
Photo 3 of 3 : UCIP_SP_2022_58492_66888.jpg

Sluice gates located on WS

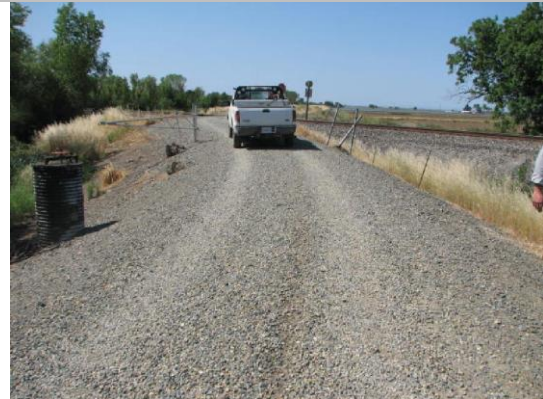
Photo 1 of 3 : UCIP_SP_2022_58493_66895.jpg

FS_ID:58493
DS_ID:16325
EP_NO: N/A
Repair Type: Non-Urgent
Crossing Status: Found
UCIP Comments: 08/28/2019 Record remains Non-Urgent, no permit has been identified authorizing pipe. Spoke to Richville Irrigation District manager and he mentioned that this structure is not theirs. He recommended that LMA-Sutter Yard break lock to access crossing. Crossing appears to fit general configuration for drainage structure. DMP internal video inspection has not found pipe integrity issues. LOF of crossing is less or equal to 4. Recommend next video inspection in 5 years. (O. Magana - DWR UCIP, A. Freitag - DWR Sutter Yard)08/27/2019 No permit has been found authorizing this structure. Need to find owner. Originally assigned to LMA-Sutter Yard however, unknown locks on WS slide gates. This crossing is not maintained or operated by LMA-Sutter Yard. (O. Magana - DWR UCIP, A. Freitag - DWR Sutter Yard)06/14/2017 Debris drifts built up around the WS slide gates- needs to be cleared away. LS appears to be in good condition. Pipe has been selected to be internally cleaned and inspected as part of the DMP project. (A. Freitag - DWR Sutter Yard)11/16/2016 Crossing appears to be in good condition. (A. Freitag - DWR Sutter Yard)04/28/2016 Crossing appears to be in good condition. (A. Freitag - DWR Sutter Yard)07/13/2015 Crossing appears in good condition. No noticeable issues to report. (A. Freitag - DWR Sutter Yard)05/21/2014 Same as last inspection. (A. Freitag - DWR Sutter Yard)12/03/2013 Same as last inspection. (A. Freitag - DWR Sutter Yard)07/15/2013 LS slope has been sprayed and cleared of vegetation and is in good condition. (A. Freitag - DWR Sutter Yard)04/18/2012 Limited inspection on LS slope due to dense vegetation. Need photo of cleared vegetation from slopes and WS headwall. Minor debris scattered on WS slope. (O. Magana - DWR UCIP)

Overview of levee crown at crossing looking D/S.

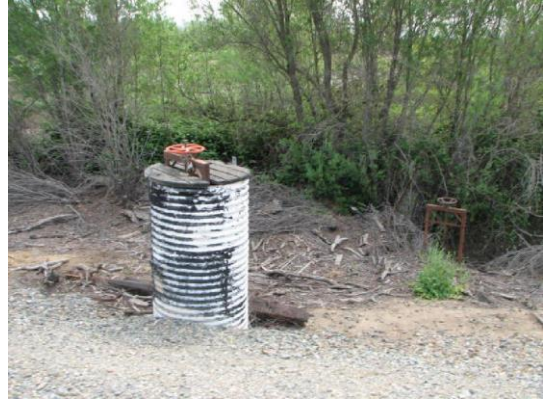
Photo 2 of 3 : UCIP_SP_2022_58493_66897.jpg

LM Start	8.84	Rating **	M	Issue No.	43 (cont)
LM End	8.84	Issue Type +	Ma	Location *	
Category	Supplemental		GPS Latitude/Longitude		
			Start	End	
Item	DWR UCIP LMA Responsibility		39.478281 °	39.478281 °	
			-121.736780 °	-121.736780 °	
DWR ID	16325

View of WS slope with 2 slide gates.

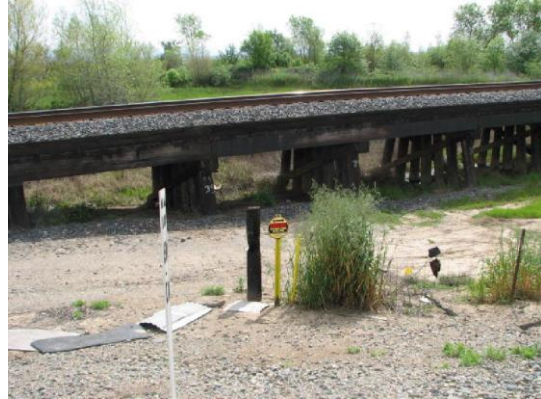
Photo 1 of 3 : UCIP_SP_2022_57571_66904.jpg

Comment Code					
Inspector Comment					
FS_ID:57571 DS_ID:16326 EP_NO: 3836 Repair Type: Non-Urgent Crossing Status: Indicator Found UCIP Comments: 08/27/2019 Record has been updated from No Action Needed to Non-Urgent, need to reach out to owner to obtain maintenance records. (O. Magana - DWR UCIP, A. Freitag - DWR Sutter Yard)06/14/2017 Crossing appears to be in good condition. (A. Freitag - DWR Sutter Yard)11/16/2016 Crossing appears to be in good condition. (A. Freitag - DWR Sutter Yard)04/28/2016 Crossing appears to be in good condition. (A. Freitag - DWR Sutter Yard)07/13/2015 Crossing appears in good condition. No noticeable issues to report. (A. Freitag - DWR Sutter Yard)05/21/2014 Same as last inspection. (A. Freitag - DWR Sutter Yard)12/03/2013 Same as last inspection. (A. Freitag - DWR Sutter Yard)07/15/2013 Same as last inspection. (A. Freitag - DWR Sutter Yard)04/18/2012 Line is still in use. Visible markers on WS and LS. (O. Magana - DWR UCIP) FIELD_STRUCT_DESC: 8.625-inch high pressure steel fuel line through the levee, 3.2 feet below the crown. Marker located on the waterside (WS). Kinder Morgan is the owner of line--contact information is 213.624.9461 or Chico Local Area Manager, Frank Villalovos 530.342.6140 (o) or 530.624.4048 ? Or email villalovosf@kindermorgan.com. Additional contact is Ken Yeo, Sacramento Local Area Manager, at 916.416.7938 or by email yeok@kindermorgan.com. Frank Villalovos is the primary contact for this crossing. (8.625-inch pipe authorized under Permit No. 3836, 1962 - Southern Pacific Pipelines Inc.) [Additional Reference(s): DWR Levee Log, 1993 (HLM 9.01)] FS Date: 8/27/2019 2:11:00 PM

Underground petroleum pipeline marker visible on WS.

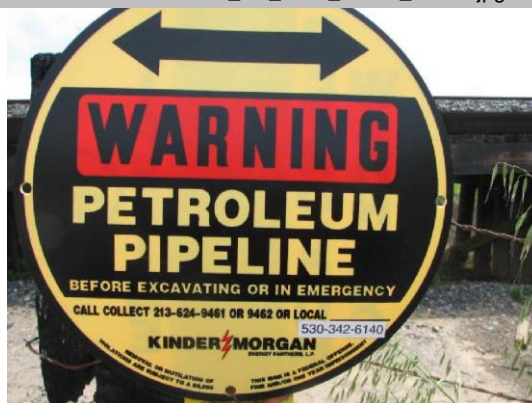
Photo 2 of 3 : UCIP_SP_2022_57571_66903.jpg

Petroleum information marker.

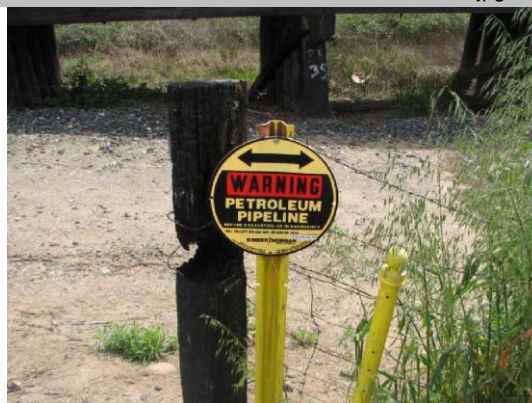
Photo 3 of 3 : UCIP_SP_2022_57571_66902.jpg

Sign visible on WS.

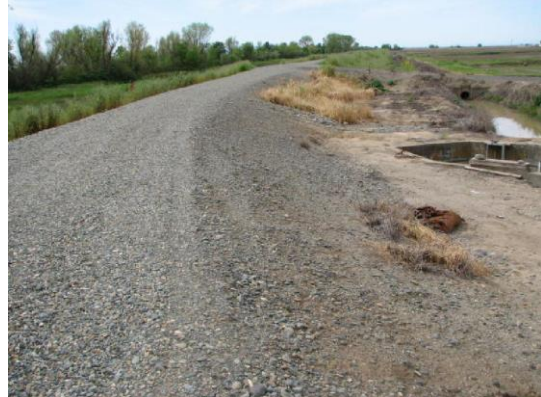
Photo 1 of 3 : UCIP_SP_2022_58494_66908.jpg

FS_ID:58494
DS_ID:16828
EP_NO: N/A
Repair Type: Non-Urgent
Crossing Status: Found
UCIP Comments: 08/27/2019 Record remains Non-Urgent due to potential threat to levee and no permit identified authorizing this pipe. Small leak found on LS by concrete distribution box about 10 feet from levee toe. (O. Magana - DWR UCIP, A. Freitag - DWR Sutter Yard)06/14/2017 Erosion still present on the side of the LS structure-still not affecting levee yet. (A. Freitag - DWR Sutter Yard)11/16/2016 Some erosion still present near the LS structure. Does not affect the levee yet. (A. Freitag - DWR Sutter Yard)04/28/2016 Erosion happening around the concrete structure on LS. Its not yet affecting the levee but will keep monitoring. (A. Freitag - DWR Sutter Yard)07/13/2015 Crossing appears in good condition. No noticeable issues to report. (A. Freitag - DWR Sutter Yard)05/21/2014 Same as last inspection. (A. Freitag - DWR Sutter Yard)12/03/2013 Same as last inspection. (A. Freitag - DWR Sutter Yard)07/15/2013 Same as last inspection. (A. Freitag - DWR Sutter Yard)04/18/2012 Crossing is not visible on WS. (O. Magana - DWR UCIP)

Overview picture looking south

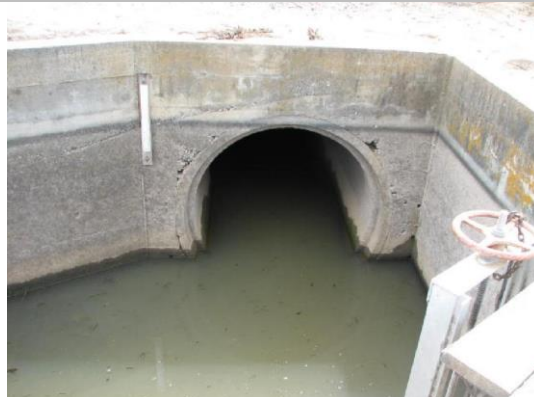
Photo 2 of 3 : UCIP_SP_2022_58494_66907.jpg

Headwall at LS distribution box

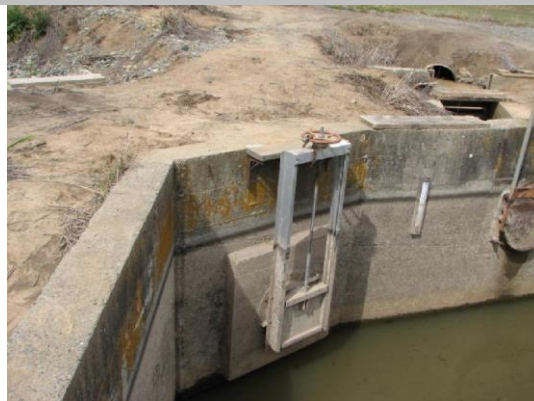
Photo 3 of 3 : UCIP_SP_2022_58494_66905.jpg

LS Screw gate in distribution box (downstream view)

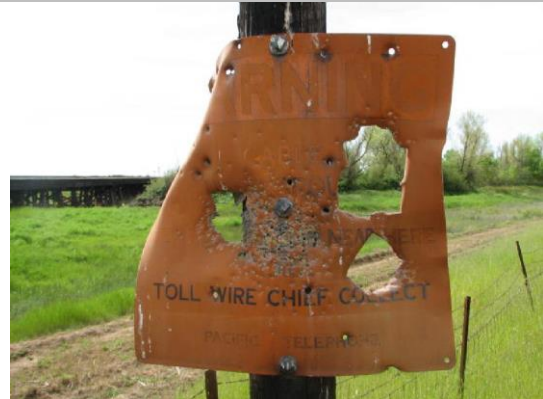
Photo 1 of 3 : UCIP_SP_2022_58516_66909.jpg

Comment Code					
Inspector Comment					
FS_ID:58516 DS_ID:16328 EP_NO: 1234A Repair Type: Non-Urgent Crossing Status: Indicator Found UCIP Comments: 08/27/2019 Record remains Non-Urgent, due to maintenance issue and/or potential abandonment of pipe through levee. Marker is still missing unable to determine if crossing has been abandoned. Need to contact owner to determine status of crossing. (O. Magana - DWR UCIP, A. Freitag - DWR Sutter Yard)06/14/2017 WS marker missing. (A. Freitag - DWR Sutter Yard)11/16/2016 WS marker is knocked over and laying on the ground. (A. Freitag - DWR Sutter Yard)04/28/2016 Marker missing on WS. (A. Freitag - DWR Sutter Yard)07/13/2015 Crossing appears in good condition. No noticeable issues to report. (A. Freitag - DWR Sutter Yard)05/21/2014 Same as last inspection. (A. Freitag - DWR Sutter Yard)12/03/2013 Same as last inspection. (A. Freitag - DWR Sutter Yard)07/15/2013 Same as last inspection. (A. Freitag - DWR Sutter Yard)04/18/2012 Need to contact owner to replace marker. (O. Magana - DWR UCIP) FIELD_STRUCT_DESC: Underground telephone cable through the levee at an unknown depth below the crown. (buried and submarine cables authorized under Permit No. 1234, 1234A, 1947 - Pacific Telephone and Telegraph Company [PT&T]) [Additional Reference(s): DWR Levee Log, 1993 (HLM 9.03)] FS Date: 8/27/2019 2:13:00 PM

Underground telephone cable marker located on WS.

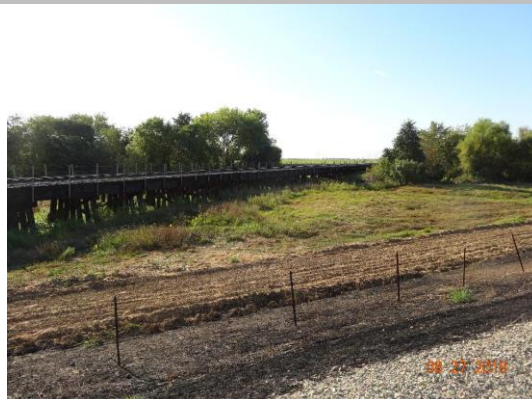
Photo 3 of 3 : UCIP_SP_2022_58516_80468.jpg

WS view: overview of WS, no marker found.

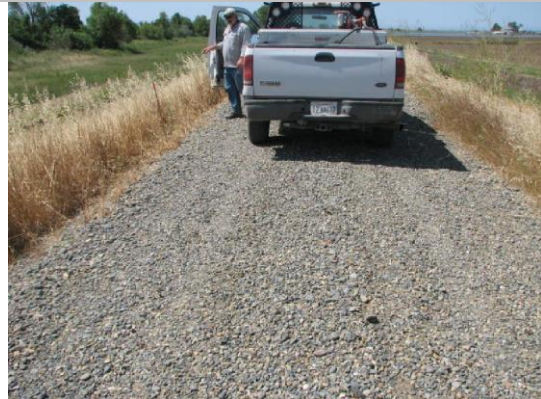
Photo 1 of 3 : UCIP_SP_2022_58495_66910.jpg

Comment Code						
Inspector Comment						
FS_ID:58495						
DS_ID:16317						
EP_NO: N/A						
Repair Type: Non-Urgent						
Crossing Status: Found						
UCIP Comments: 08/27/2019 Record has been updated from No						
Action Needed to Non-Urgent, no permit has been identified authorizing						
pipe. Pipe is scheduled to be lined. (O. Magana - DWR UCIP, A.						
Freitag - DWR Sutter Yard)06/14/2017 Crossing appears to be in						
good condition. Pipe has been selected to be internally cleaned and						
inspected as part of the DMP project. (A. Freitag - DWR Sutter						
Yard)11/16/2016 Crossing appears to be in good condition. (A.						
Freitag - DWR Sutter Yard)04/28/2016 Crossing appears to be in						
good condition. (A. Freitag - DWR Sutter Yard)07/13/2015 LS inlet						
has minor vegetation still. WS appears in good condition. (A. Freitag -						
DWR Sutter Yard)05/21/2014 Same as last inspection. (A. Freitag -

Overview of levee crown at crossing looking downstream.

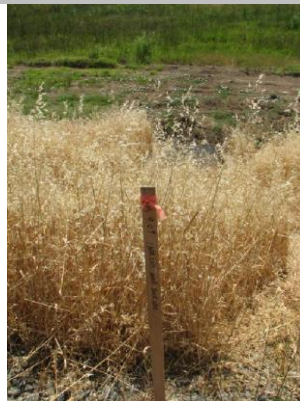
Photo 2 of 3 : UCIP_SP_2022_58495_66911.jpg

View of WS slope and toe.

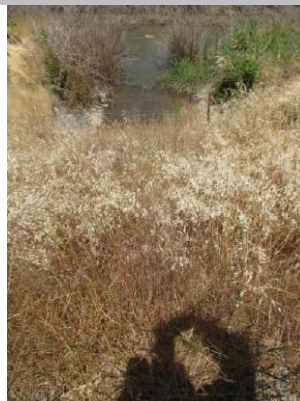
Photo 3 of 3 : UCIP_SP_2022_58495_66912.jpg

View of LS slope and toe.

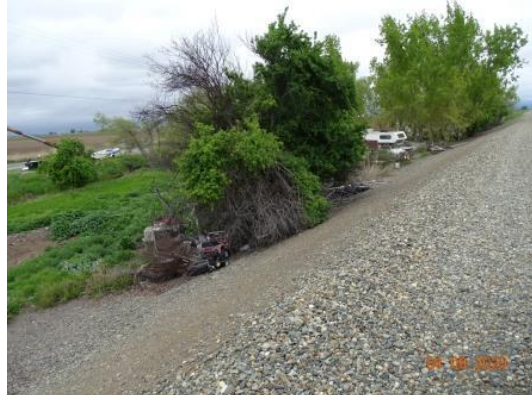
Photo 1 of 1 : SP_2022_MA0013_300_10_20220307_00003.jpg

View of trailer and material along the landside toe. Spring 2020.

LM Start	9.73	Rating **	M	Issue No.	10
LM End	9.75	Issue Type +	En	Location *	LS
Category	Earthen Levee			GPS Latitude/Longitude	
				Start	End
Item	Encroachments			39.466732 °	39.466478 °
				-121.744180 °	-121.744338 °
DWR ID	DWR_MA0013_01_f_2013_10				
Comment Code					
MA : Material					
Inspector Comment					
Move the trailer and materials outside the 10 foot easement.

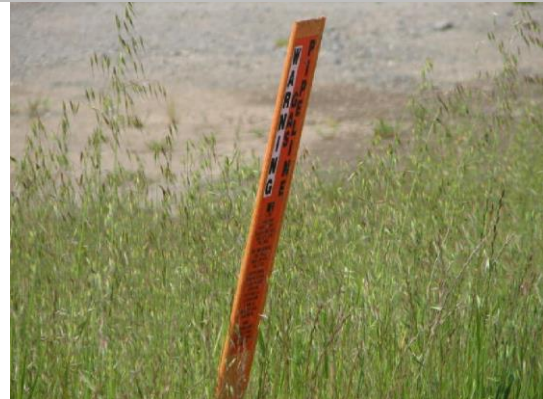
Photo 1 of 3 : UCIP_SP_2022_57608_66917.jpg

FS_ID:57608
DS_ID:16331
EP_NO: 1238
Repair Type: Non-Urgent
Crossing Status: Indicator Found
UCIP Comments: 08/27/2019 Record has been updated from No Action Needed to Non-Urgent, no maintenance records were made available to determine condition of line through levee. Need to contact owner to request maintenance records to confirm integrity of line. (O. Magana - DWR UCIP, A. Freitag - DWR Sutter Yard)06/14/2017 Crossing appears to be in good condition. (A. Freitag - DWR Sutter Yard)11/16/2016 Crossing appears to be in good condition. (A. Freitag - DWR Sutter Yard) 04/28/2016 Crossing appears to be in good condition. (A. Freitag - DWR Sutter Yard)07/13/2015 Crossing appears in good condition. No noticeable issues to report. (A. Freitag - DWR Sutter Yard)05/21/2014 Same as last inspection. (A. Freitag - DWR Sutter Yard)12/03/2013 Same as last inspection. (A. Freitag - DWR Sutter Yard)07/15/2013 New structure with shutoff valve installed about 5ft. from LS toe. (A. Freitag - DWR Sutter Yard) FIELD_STRUCT_DESC: 8-inch high pressure gas line through the levee, 13.3 feet below the crown. Substation with wire enclosure at the landside (LS) toe. (6.625-inch gas line authorized under Permit No. 1238, 1947 - Pacific Gas and Electric Company [PG&E]) [Additional Reference(s): DWR Levee Log, 1993 (HLM 10.03). USACE Sacramento O&M Manual 519, June 1962 (HLM 10.03), listed as 8-inch gas line]

Underground gas line marker on LS.

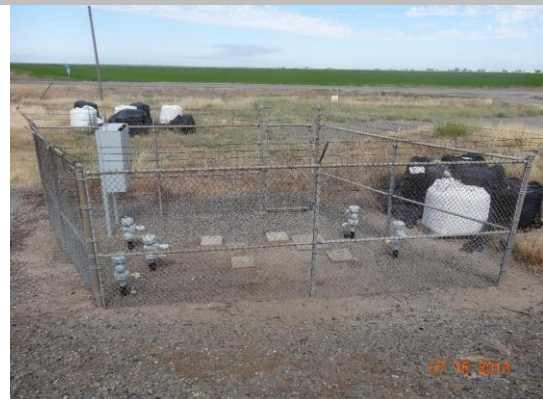
Photo 2 of 3 : UCIP_SP_2022_57608_66919.jpg

Substation near LS toe

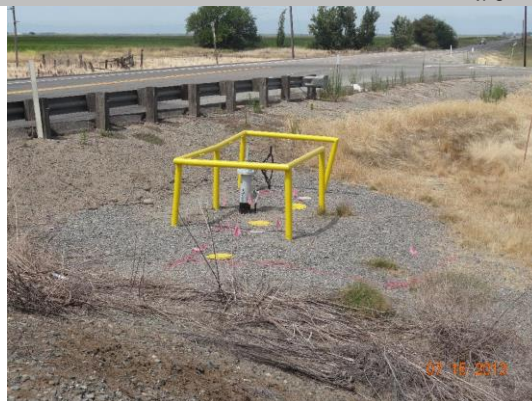
Photo 3 of 3 : UCIP_SP_2022_57608_66918.jpg

New shutoff valve structure near LS toe
