**Flood Control Project Maintenance
Levee Inspections
LMA District Cover Sheet**

**Flood Control Project Maintenance
Levee Inspections
Unit Cover Sheet**

Waterway			Bank	Unit Miles
Unit No. 01 Cherokee Canal			Right	18.19
	Spring (March - May)	Summer (June - August)	(September - November) Fall	Winter (December - February)
Unit Maintenance Rating (Fall Only)				
Date of Inspection	3/23/2022 - 3/23/2022			
DWR Inspector	Makar Sokol			
Accompanied By

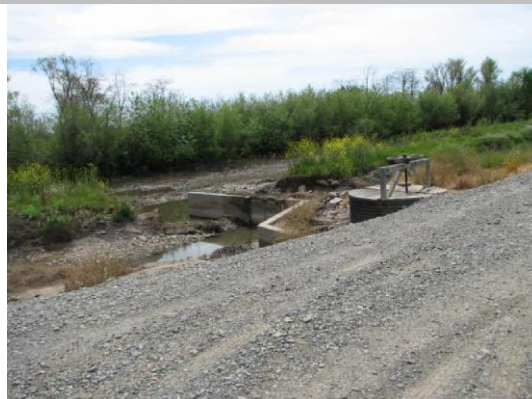
Photo 1 of 3 : UCIP_SP_2022_58496_66926.jpg

FS_ID:58496
DS_ID:16332
EP_NO: N/A
Repair Type: Non-Urgent
Crossing Status: Found
UCIP Comments: 08/27/2019 Record has been updated from No Action Needed to Non-Urgent, no permit has been identified authorizing the dual purpose of this crossing. Crossing is used as an irrigation turnout. Flow from Cherokee canal is diverted about 900 feet upstream by weir and feed into an irrigation canal that runs parallel along WS levee toe for about 2.5 miles. The irrigation turnout is used to divert water from WS irrigation canal to LS. Need to update crossing type from Drainage to Other. This crossing is not maintained or operated by LMA-Sutter Yard. (O. Magana - DWR UCIP, A. Freitag - DWR Sutter Yard)06/15/2017 Crossing appears to be in good condition. Pipe has been selected to be internally cleaned and inspected as part of the DMP project. (A. Freitag - DWR Sutter Yard)11/16/2016 Crossing appears to be in good condition. (A. Freitag - DWR Sutter Yard)04/28/2016 Crossing appears to be in good condition. (A. Freitag - DWR Sutter Yard)07/13/2015 Crossing appears in good condition. No noticeable issues to report. (A. Freitag - DWR Sutter Yard)05/21/2014 Same as last inspection. (A. Freitag - DWR Sutter Yard)12/03/2013 Same as last inspection. (A. Freitag - DWR Sutter Yard)07/15/2013 Same as last inspection. (A. Freitag - DWR Sutter Yard)

View of WS corrugated metal riser and concrete wall.

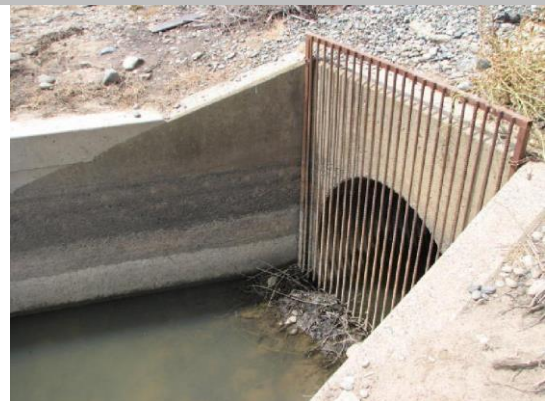
Photo 3 of 3 : UCIP_SP_2022_58496_66928.jpg

Trash rack on WS headwall.

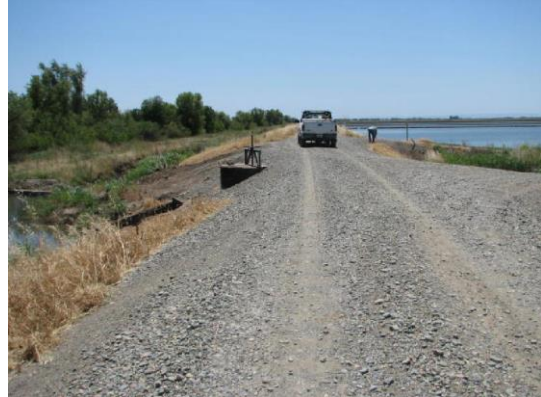
Photo 1 of 3 : UCIP_SP_2022_58498_66934.jpg

Comment Code						
Inspector Comment						
FS_ID:58498 DS_ID:16333 EP_NO: N/A Repair Type: Non-Urgent Crossing Status: Found UCIP Comments: 08/27/2019 Record has been updated from No Action Needed to Non-Urgent, no permit has been identified authorizing the dual purpose of this crossing. Crossing is used as an irrigation turnout. Flow from Cherokee canal is diverted upstream by weir and feed into an irrigation canal that runs parallel along WS levee toe for about 2.5 miles. The irrigation turnout is used to divert water from WS irrigation canal to LS. Need to update crossing type from Drainage to Other. This crossing is not maintained or operated by LMA-Sutter Yard. (O. Magana - DWR UCIP, A. Freitag - DWR Sutter Yard)06/15/2017 Crossing appears to be in good condition. Pipe has been selected to be internally cleaned and inspected as part of the DMP project. (A. Freitag - DWR Sutter Yard)11/17/2016 Crossing appears to be in good condition. (A. Freitag - DWR Sutter Yard)04/28/2016 Crossing appears to be in good condition. (A. Freitag - DWR Sutter Yard)07/13/2015 Crossing appears in good condition. No noticeable issues to report. (A. Freitag - DWR Sutter Yard)05/21/2014 Same as last inspection. (A. Freitag - DWR Sutter Yard)12/03/2013 Same as last inspection. (A. Freitag - DWR Sutter Yard)07/15/2013 Same as last inspection. (A. Freitag - DWR Sutter Yard) FIELD_STRUCT_DESC: 60-inch corrugated metal drainage pipe angled through the levee, 11.3 feet below the crown. Slide gate in corrugated metal pipe riser on the waterside (WS) slope. Concrete "U" headwall on both ends. Crossing is used as an irrigation turnout bar code plate located on the WS slide gate (identified as 145). [Additional Reference(s): DWR Levee Log, 1993 (HLM 11.78). USACE Sacramento O&M Manual, Unit 519, June 1962, Revised 3 Feb 2011, (HLM 11.78), listed as 60-inch pipe, As-built DWG No. 50-4-3511, Sheet No. 3511/9.3, 28.2, STA 504+71E, page 9, 28 of 31 electronic file, As-built DWG No. 50-4-3037 referenced not available] FS Date: 8/27/2019 2:16:00 PM

Overview of levee crown at crossing looking downstream.

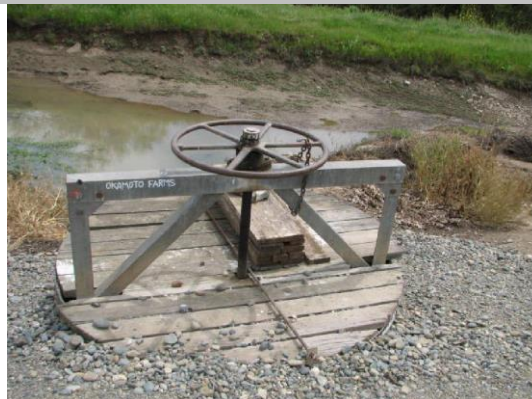
Photo 2 of 3 : UCIP_SP_2022_58498_66932.jpg

WS slide gate with owner information.

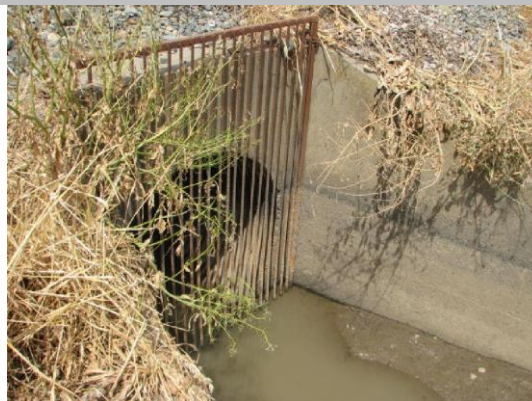
Photo 3 of 3 : UCIP_SP_2022_58498_66930.jpg

Trash rack on WS headwall.

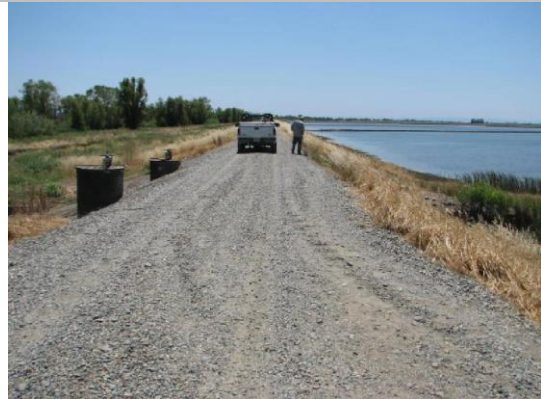
Photo 1 of 3 : UCIP_SP_2022_58499_66940.jpg

FS_ID:58499
DS_ID:16334
EP_NO: N/A
Repair Type: Non-Urgent
Crossing Status: Found
UCIP Comments: 08/27/2019 Record has been updated from No Action Needed to Non-Urgent, no permit has been identified authorizing this crossing. Irrigation siphon crosses under Cherokee Canal and Unit 2 levee at DSID 16385. DMP internal video inspection has not found pipe integrity issues. LOF of crossing is less or equal to 4. Recommend next video inspection in 5 years. (O. Magana - DWR UCIP, A. Freitag - DWR Sutter Yard)06/15/2017 WS pipe end still unknown- try to locate using GPR/ utility locator. Pipe has been selected to be internally cleaned and inspected as part of the DMP project. (A. Freitag - DWR Sutter Yard)11/17/2016 Cannot locate the WS pipe end. (A. Freitag - DWR Sutter Yard)04/28/2016 Crossing appears to be in good condition but could not locate the WS pipe end. (A. Freitag - DWR Sutter Yard)07/13/2015 New screw gate installed inside the WS standpipe. (A. Freitag - DWR Sutter Yard) 05/21/2014 Same as last inspection. (A. Freitag - DWR Sutter Yard)12/03/2013 Same as last inspection. (A. Freitag - DWR Sutter Yard)07/15/2013 Slopes have been cleared of vegetation and are in good condition. Still no sign of WS end of pipe. (A. Freitag - DWR Sutter Yard)04/18/2012 Limited inspection on WS and LS slope due to dense vegetation. WS outlet of pipe not found. Need photos of cleared WS and LS slopes. Determine if WS outlet daylight after WS slope is cleared. (O. Magana - DWR UCIP)

Overview of levee crown at crossing looking downstream.

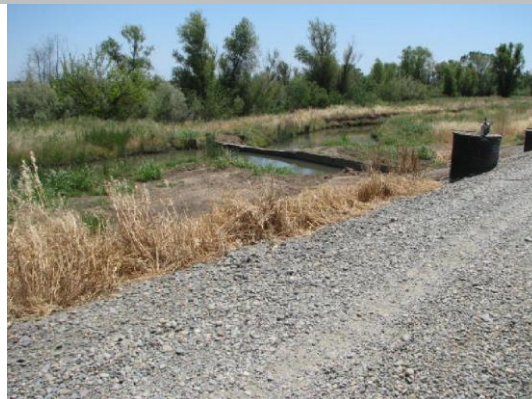
Photo 2 of 3 : UCIP_SP_2022_58499_66936.jpg

View of Ws slope and channel.

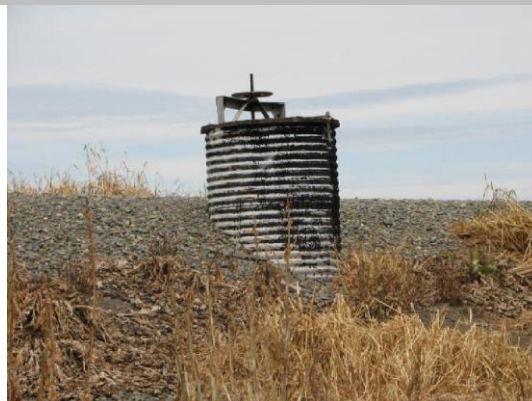
Photo 3 of 3 : UCIP_SP_2022_58499_66939.jpg

Slide gate located on WS slope.

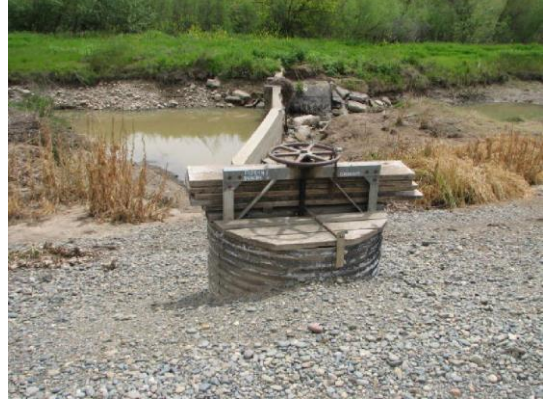
Photo 2 of 3 : UCIP_SP_2022_58500_66947.jpg

FS_ID:58500
DS_ID:16335
EP_NO: N/A
Repair Type: Non-Urgent
Crossing Status: Found
UCIP Comments: 08/27/2019 Record has been updated from No Action Needed to Non-Urgent, no permit has been identified authorizing the dual purpose of this crossing. Crossing is used as an irrigation turnout. Flow from Cherokee Canal is diverted upstream by weir and feed into an irrigation canal that runs parallel along WS levee toe for about 2.5 miles. The irrigation turnout is used to divert water from WS irrigation canal to LS. Need to update crossing type from Drainage to Other. This crossing is not maintained or operated by LMA-Sutter Yard. DMP internal video inspection has not found pipe integrity issues. LOF of crossing is less or equal to 4. Recommend next video inspection in 5 years. (O. Magana - DWR UCIP, A. Freitag - DWR Sutter Yard)06/15/2017 Crossing appears to be in good condition. Pipe has been selected to be internally cleaned and inspected as part of the DMP project. (A. Freitag - DWR Sutter Yard)11/17/2016 Crossing appears to be in good condition. (A. Freitag - DWR Sutter Yard)04/28/2016 Crossing appears to be in good condition. (A. Freitag - DWR Sutter Yard)07/13/2015 Crossing appears in good condition. No noticeable issues to report. (A. Freitag - DWR Sutter Yard)05/21/2014 Same as last inspection. (A. Freitag - DWR Sutter Yard)12/03/2013 Same as last inspection. (A. Freitag - DWR Sutter Yard)07/15/2013 LS slope has been cleared of vegetation and is in good condition. (A. Freitag - DWR Sutter Yard)04/18/2012 Limited inspection on LS slope due to dry vegetation. Need photos of cleared LS slope. (O. Magana - DWR UCIP)

View from levee crown of WS slope and channel.

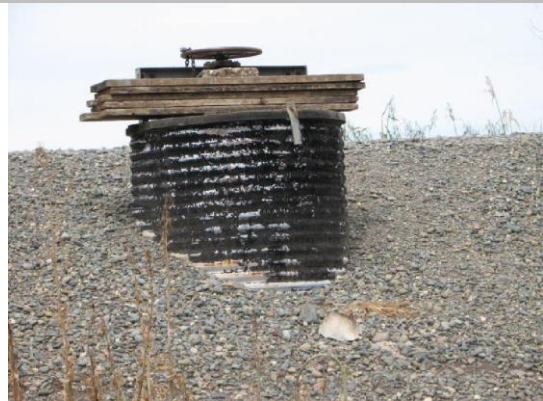
Photo 3 of 3 : UCIP_SP_2022_58500_66948.jpg

Water side screw gate located near crown hinge

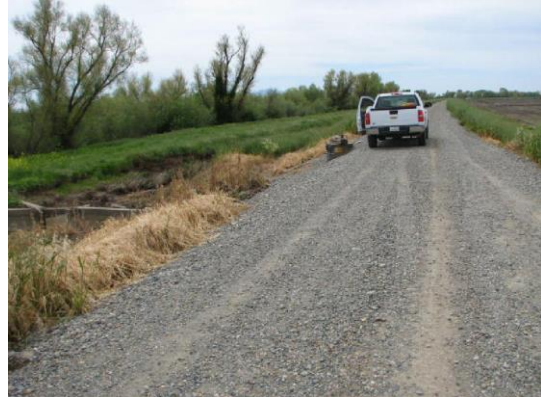
Photo 1 of 3 : UCIP_SP_2022_58501_66952.jpg

FS_ID:58501
DS_ID:16336
EP_NO: N/A
Repair Type: Urgent
Crossing Status: Found
UCIP Comments: 08/27/2019 Record updated from Non-Urgent to Urgent. DMP internal video inspection has found pipe integrity issues. LOF of crossing is between 5 and 6. Crossing will be monitored until funding becomes available to address the issues. No permit has been identified authorizing the dual purpose of this crossing and slide gate is still missing from the WS CMP riser. Crossing is used as an irrigation turnout. Flow from Cherokee Canal is diverted upstream by weir and feed into an irrigation canal that runs parallel along WS levee toe for about 2.5 miles. The irrigation turnout is used to divert water from WS irrigation canal to LS. Need to update crossing type from Drainage to Other. This crossing is not maintained or operated by LMA-Sutter Yard. (O. Magana - DWR UCIP, A. Freitag - DWR Sutter Yard)06/15/2017 Slide gate still missing from inside of WS standpipe. Pipe has been selected to be internally cleaned and inspected as part of the DMP project. (A. Freitag - DWR Sutter Yard)11/17/2016 Slide gate still missing from inside the WS standpipe. (A. Freitag - DWR Sutter Yard)04/28/2016 Slide gate was removed from inside the WS standpipe. (A. Freitag - DWR Sutter Yard)07/13/2015 New screw gate installed on the WS pipe end in the irrigation ditch. (A. Freitag - DWR Sutter Yard)05/21/2014 Same as last inspection. (A. Freitag - DWR Sutter Yard)12/03/2013 Same as last inspection. (A. Freitag - DWR Sutter Yard)07/15/2013 Same as last inspection. (A. Freitag - DWR Sutter Yard)04/18/2012 Irrigation turnout. Not in use during April 2012 Inspection. During the follow up May 2012 Inspection structure was being used as irrigation turnout, reason for barcode tags. (O. Magana - DWR UCIP)

FIELD_STRUCT_DESC: 30-inch corrugated metal drainage pipe through the levee, 10.7 feet below the crown. Slide gate in corrugated metal pipe (CMP) riser on the waterside (WS) slope. Concrete "U" headwalls on both ends. This crossing is used as an irrigation turnout bar code plate located on the WS slide gate (identified as 141 and 142). [Additional Reference(s): DWR Levee Log, 1993 (HLM 12.94). USACE Sacramento O&M Manual, Unit 519, June 1962, Revised 3 Feb 2011, (HLM 12.94), As-built DWG No. 50-4-3511, Sheet No. 3511/8.3, STA 444+29E, page 8 of 31 electronic file, listed as 30-inch CMP; As-built DWG No 50-4-3037 referenced not available]
FS Date: 8/27/2019 2:18:00 PM

Overview picture looking south on right bank of Cherokee Canal.

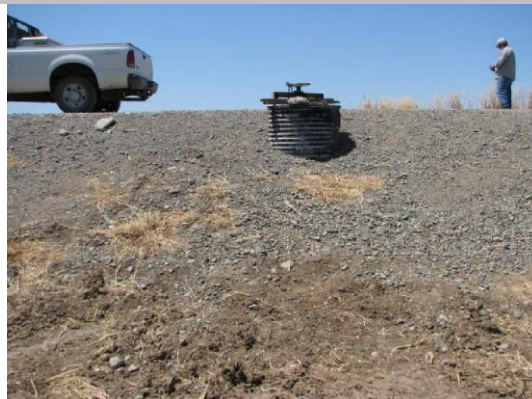
Photo 2 of 3 : UCIP_SP_2022_58501_66959.jpg

View of WS slope.

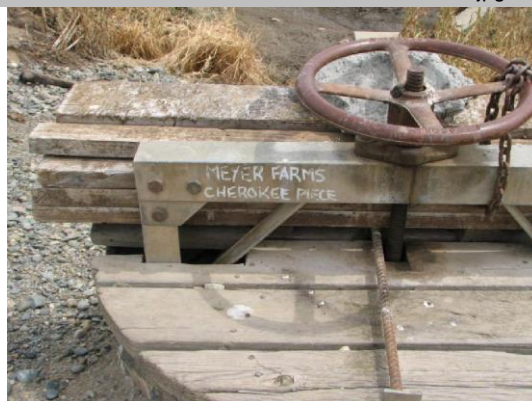
Photo 3 of 3 : UCIP_SP_2022_58501_66951.jpg

Slide gate located on WS slope. Owner information marked on gate.

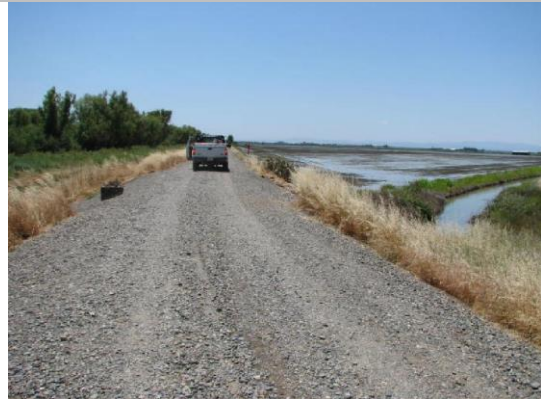
Photo 1 of 3 : UCIP_SP_2022_58502_66966.jpg

Comment Code						
Inspector Comment						
FS_ID:58502 DS_ID:16337 EP_NO: N/A Repair Type: Non-Urgent Crossing Status: Found UCIP Comments: 08/27/2019 Record has been updated from No Action Needed to Non-Urgent, no permit has been identified authorizing the dual purpose of this crossing. Crossing is used as an irrigation turnout. Flow from Cherokee Canal is diverted upstream by weir and feed into an irrigation canal that runs parallel along WS levee toe for about 2.5 miles. The irrigation turnout is used to divert water from WS irrigation canal to LS. Need to update crossing type from Drainage to Other. This crossing is not maintained or operated by LMA-Sutter Yard. (O. Magana - DWR UCIP, A. Freitag - DWR Sutter Yard)06/15/2017 Crossing appears to be in good condition. Pipe has been selected to be internally cleaned and inspected as part of the DMP project. (A. Freitag - DWR Sutter Yard)11/17/2016 Ws pipe end was submerged but crossing appears to be in good condition. (A. Freitag - DWR Sutter Yard)05/03/2016 Crossing appears to be in good condition. (A. Freitag - DWR Sutter Yard)07/13/2015 New screw gate installed inside of WS standpipe. (A. Freitag - DWR Sutter Yard)05/21/2014 Same as last inspection. (A. Freitag - DWR Sutter Yard)12/03/2013 Same as last inspection. (A. Freitag - DWR Sutter Yard)07/15/2013 Same as last inspection. (A. Freitag - DWR Sutter Yard) FIELD_STRUCT_DESC: 24-inch corrugated metal drainage pipe through the levee, 11.1 feet below the crown. Slide gate in corrugated metal pipe (CMP) riser on the waterside (WS) slope. Concrete "U" headwalls on both ends. [Additional Reference(s): DWR Levee Log, 1993 (HLM 13.53). USACE Sacramento O&M Manual, Unit 519, June 1962, Revised 3 Feb 2011, (HLM 13.53), As-built DWG No. 50-4-3511, Sheet No. 3511/8.3, 31.2, STA 359+08W, page 8, 31 of 31 electronic file, listed as 24-inch CMP pipe through the levee; As-built DWG No. 50-4-3037 referenced not available] FS Date: 8/27/2019 2:19:00 PM

Overview of levee crown at crossing looking downstream.

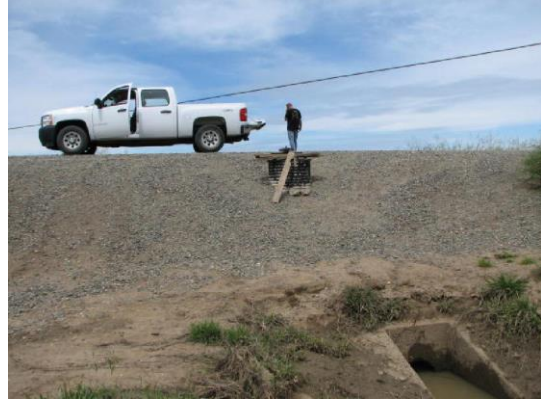
Photo 2 of 3 : UCIP_SP_2022_58502_66963.jpg

View of WS slope.

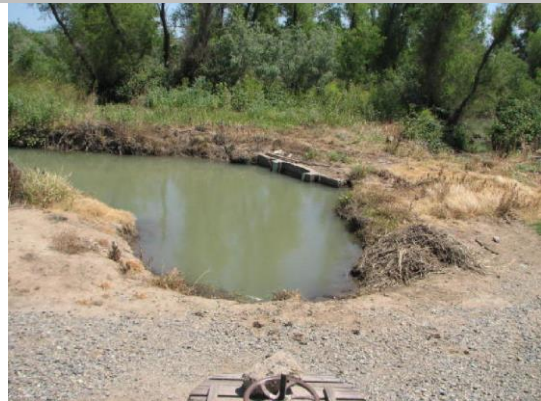
Photo 3 of 3 : UCIP_SP_2022_58502_66967.jpg

View of WS slope and channel.

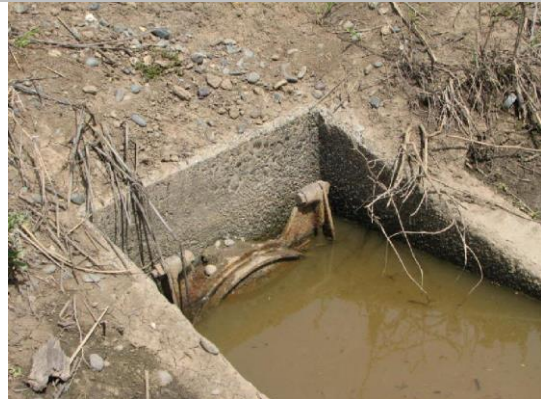
Photo 1 of 3 : UCIP_SP_2022_58515_66970.jpg

FS_ID:58515
DS_ID:16338
EP_NO: N/A
Repair Type: Non-Urgent
Crossing Status: Found
UCIP Comments: 08/27/2019 Record remains Non-Urgent, no permit has been identified authorizing pipe. Pipe is scheduled to be lined. (O. Magana - DWR UCIP, A. Freitag - DWR Sutter Yard)08/23/2018 WS flap gate has been replaced. LS outlet still has a lot of vegetation, but overall levee integrity looks good at time of this inspection. Downgrading to Non-Urgent from Urgent due to fixed flap gate and current levee condition. (D. Sanoski - DWR UCIP)06/15/2017 Not abandoned- WS flap gate was dug out and opened draining water from the LS ditch. WS flap gate is heavily corroded and has a broken hinge-needs to be replaced. LS is still very overgrown and needs to be cleared. Pipe has been selected to be internally cleaned and inspected as part of the DMP project. (A. Freitag - DWR Sutter Yard)11/17/2016 Appears abandoned. WS flap gate completely silted over and LS screw gate is completely overgrown by a tree and is not accessible for inspection. (A. Freitag - DWR Sutter Yard)05/03/2016 Crossing appears to be abandoned. WS flap gate was completely silted over and LS slide gate is very overgrown by a tree. (A. Freitag - DWR Sutter Yard)07/13/2015 WS flap gate is blocked from opening by sediment and vegetation. Needs to be cleared away. LS opening is being over grown by a tree and needs to be cutback. (A. Freitag - DWR Sutter Yard)05/22/2014 Same as last inspection. (A. Freitag - DWR Sutter Yard)12/03/2013 Same as last inspection. (A. Freitag - DWR Sutter Yard)07/15/2013 Same as last inspection. (A. Freitag - DWR Sutter Yard)04/18/2012 Tree has fallen at LS inlet and damaged slide gate. The tree needs to be removed and screw gate repaired. Limited inspection on LS due to fallen tree. (O. Magana - DWR UCIP)

FIELD_STRUCT_DESC: 24-inch CIPP-lined corrugated metal drainage pipe angled through the levee, 12.7 feet below the crown. Flap gate on the waterside (WS). Concrete "U" headwall on both ends. [Additional Reference(s): DWR Levee Log, 1993 (HLM 13.96). USACE Sacramento O&M Manual, Unit 519, June 1962, Revised 3 Feb 2011, (HLM 13.96), As-built DWG No. 50-4-3511, Sheet No. 3511/7. unable to read exact page, STA 336+56W, page 7 of 31 electronic file, listed as 24-inch CMP]
FS Date: 8/27/2019 2:19:00 PM

WS headwall and flap gate.

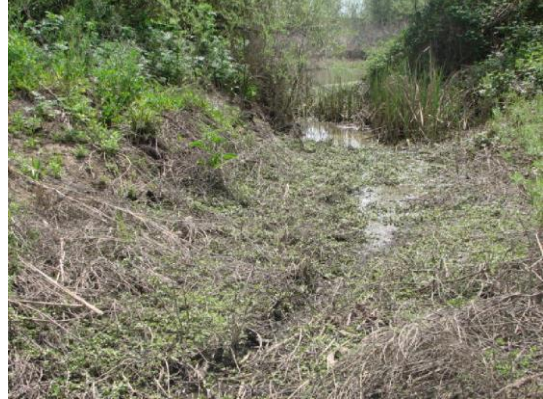
Photo 2 of 3 : UCIP_SP_2022_58515_66971.jpg

View of channel at crossing.

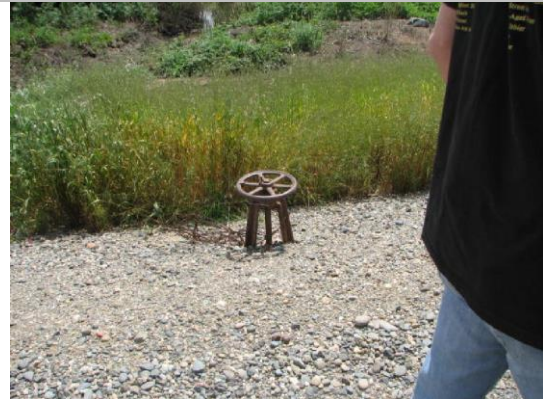
Photo 1 of 3 : UCIP_SP_2022_58504_66972.jpg

FS_ID:58504
DS_ID:16339
EP_NO: N/A
Repair Type: Non-Urgent
Crossing Status: Found
UCIP Comments: 08/27/2019 Record remains Non-Urgent, crossing has been abandoned. Need to update crossing type from Drainage to Irrigation. Crossing was used as a irrigation line and not drainage. This crossing is not maintained or operated by LMA-Sutter Yard. (O. Magana - DWR UCIP, A. Freitag - DWR Sutter Yard)06/15/2017 Abandoned- still only the structure on the WS shoulder found. (A. Freitag - DWR Sutter Yard)11/17/2016 Abandoned. (A. Freitag - DWR Sutter Yard)05/03/2016 ABANDONED CROSSING. (A. Freitag - DWR Sutter Yard)07/13/2015 Abandoned crossing. Slide gate is buried on the WS. (A. Freitag - DWR Sutter Yard)05/22/2014 Same as last inspection. (A. Freitag - DWR Sutter Yard)12/03/2013 Same as last inspection. (A. Freitag - DWR Sutter Yard)07/15/2013 Same as last inspection. (A. Freitag - DWR Sutter Yard)04/18/2012 Non-functional crossing-buried slide gate on WS. Limited inspection on WS and LS slope/toe due to dense vegetation. Need photo of cleared WS & LS slopes or toe. This crossing is listed in the USACE periodic inspection report as Corp's Inspection ID# USACE_CESPK_M13D_2011_p_0352 for abandoned gate on WS slope. (O. Magana - DWR UCIP)

FIELD_STRUCT_DESC: 12-inch steel irrigation pipe through the levee, 3 feet below the crown. Gate valve on the waterside (WS) slope. 0.25-inch steel plate welded on both ends. [Additional Reference(s): DWR Levee Log, 1993 (HLM 13.97). USACE Sacramento O&M Manual, Unit 519, June 1962, Revised 3 Feb 2011, (HLM 13.97), As-built DWG No. 50-4-3511, Sheet No. 3511/7. unable to read exact page and 24.1, STA 334+60W, page 7, 24 of 31 electronic file, listed as 12-inch steel pipe with welded 1/4-inch steel plate on both ends of the pipe (WS and LS)]
FS Date: 8/27/2019 2:20:00 PM

Buried slide gate on the WS slope.

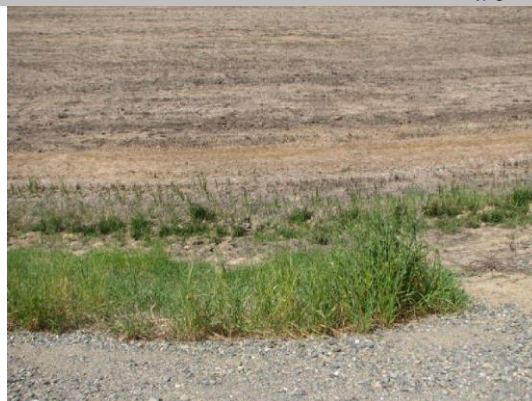
Photo 2 of 3 : UCIP_SP_2022_58504_66973.jpg

View of LS slope and toe. Unable to find welded plate on LS.

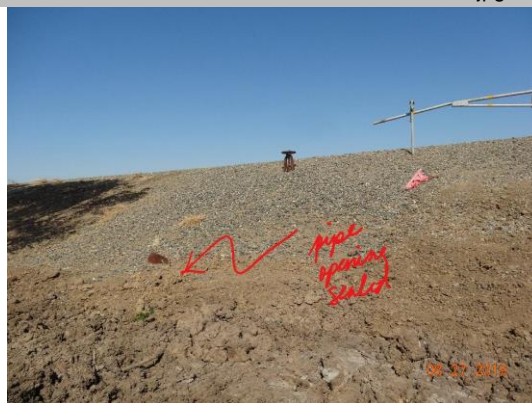
Photo 3 of 3 : UCIP_SP_2022_58504_80558.jpg

WS view: pipe section capped off on WS.

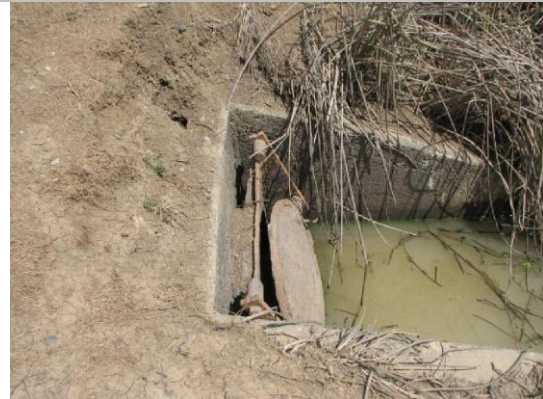
Photo 1 of 3 : UCIP_SP_2022_58505_66976.jpg

FS_ID:58505
DS_ID:16368
EP_NO: N/A
Repair Type: Non-Urgent
Crossing Status: Found
UCIP Comments: 02/11/2020 Record updated from Urgent to Non-Urgent. Pipe has been CIPP-lined. Levee integrity issue recorded previously needs to be confirmed during next field inspection and upated if not present. (O.Yakimov - DWR UCIP)
08/27/2019 Record remains Urgent due to pipe integrity and levee integrity issues. Previously noted holes on the pipe collar located at WS have been sealed using splash zone epoxy. Two holes (possible sink holes) were observed behind WS concrete headwall. Recommend internal inspection of pipe through levee to determine if sink holes are attributed to holes in pipe. (O. Magana - DWR UCIP, A. Freitag - DWR Sutter Yard)08/23/2018 WS pipe unable to be inspected due to heavy vegetation at inlet, so assume same as last inspection. Noticed a long crack a couple feet above WS headwall that could be of concern; possible future slough if soil gets saturated during next high water event and could be a sign of internal pipe degradation. LS outlet and slope looked good. Urgent due to long crack, obstructed inspection view of WS inlet, and 2016 photos of holes in pipe. (D. Sanoski - DWR UCIP)06/15/2017 WS pipe end still showing heavy signs of corrosion and deterioration with visible holes between the concrete headwall and flap gate flange. Pipe was almost 100% full of water so could not visually inspect inside of the pipe to see if theres any damage inside of the levee segment. Pipe has been selected to be internally cleaned and inspected as part of the DMP project. (A. Freitag - DWR Sutter Yard)11/17/2016 Top of pipe on WS still showing heavy signs of corrosion with visible holes between the flap gate flange and the concrete headwall. The pipe was mostly underwater so could not internally inspect it for more damage or corrosion. (A. Freitag - DWR Sutter Yard)05/03/2016 Top of the pipe on the WS has holes in it between the flap gate flange and headwall. Crossing is showing signs of rust and deterioration but it was mostly underwater so could not inspect the inside of the pipe. (A. Freitag - DWR Sutter Yard)07/13/2015 Both sides of crossing were underwater at the time of inspection. (A. Freitag - DWR Sutter Yard)05/22/2014 Same as last inspection. (A. Freitag - DWR Sutter Yard)12/03/2013 Same as last inspection. (A. Freitag - DWR Sutter Yard)07/15/2013 Slopes have been cleared of vegetation and are in good condition. WS flap gate is still lodged open. (A. Freitag - DWR Sutter Yard)04/18/2012 Limited inspection on LS slope due to dense vegetation. Need photos of cleared WS & LS slopes. The flap gate is lodged open. (O. Magana - DWR UCIP)

FIELD_STRUCT_DESC: 36-inch CIPP-lined corrugated metal drainage pipe through the levee, 12.9 feet below the crown. Concrete "U"

Headwall and flapgate located on water side of levee

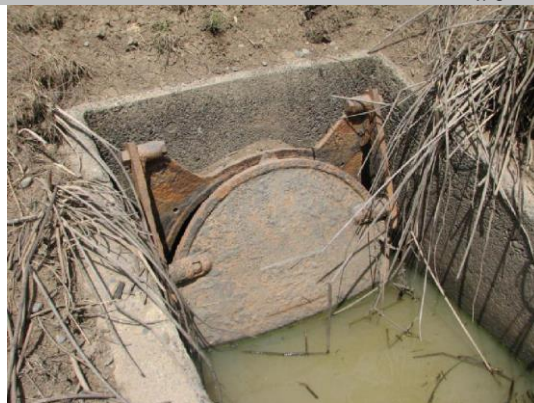
Photo 2 of 3 : UCIP_SP_2022_58505_66974.jpg

Headwall and flapgate located on water side of levee

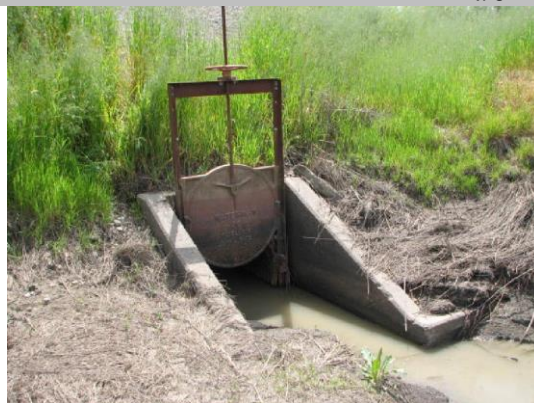
Photo 3 of 3 : UCIP_SP_2022_58505_66975.jpg

Head wall and screw gate located on land side of levee

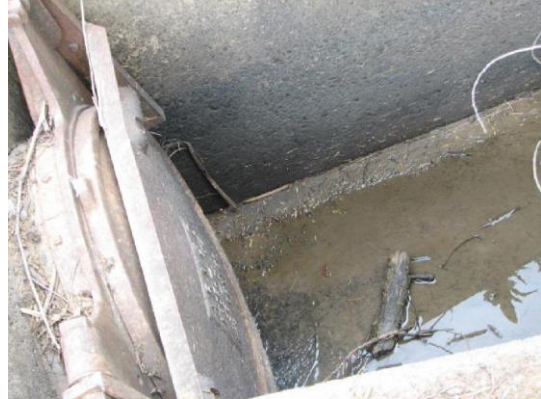
Photo 1 of 3 : UCIP_SP_2022_58506_66981.jpg

Comment Code					
Inspector Comment					
FS_ID:58506 DS_ID:16367 EP_NO: N/A Repair Type: Non-Urgent Crossing Status: Found UCIP Comments: 08/27/2019 Record has been updated from No Action Needed to Non-Urgent, no permit has been identified authorizing pipe. Pipe is scheduled to be lined. (O. Magana - DWR UCIP, A. Freitag - DWR Sutter Yard)06/15/2017 Crossing appears to be in good condition. Pipe has been selected to be internally cleaned and inspected as part of the DMP project. (A. Freitag - DWR Sutter Yard)11/17/2016 Crossing appears to be in good condition. (A. Freitag - DWR Sutter Yard)05/03/2016 Crossing appears to be in good condition. (A. Freitag - DWR Sutter Yard)07/13/2015 Crossing appears in good condition. No noticeable issues to report. (A. Freitag - DWR Sutter Yard)05/22/2014 Same as last inspection. (A. Freitag - DWR Sutter Yard)12/03/2013 Same as last inspection. (A. Freitag - DWR Sutter Yard)07/15/2013 Slopes have been cleared of vegetation and are in good condition. (A. Freitag - DWR Sutter Yard)04/18/2012 Limited inspection on WS and LS slope due to dense vegetation. Need overall photo of crossing and photos of cleared WS & LS slopes. (O. Magana - DWR UCIP) FIELD_STRUCT_DESC: 36-inch CIPP-lined corrugated metal drainage pipe through the levee, 12.4 feet below the crown. Concrete "U" headwalls on both waterside (WS) and landside (LS). Flap gate on the waterside (WS) end. [Additional Reference(s): DWR Levee Log, 1993 (HLM 15.12). USACE Sacramento O&M Manual, Unit 519, June 1962, Revised 3 Feb 2011, (HLM 15.12), As-built DWG No. 50-4-3511, Sheet No. 3511/6. unable to read exact page, STA 276+00W, page 6 of 31 electronic file, listed as 36-inch CMP; As-built DWG No. 50-4-3037 referenced not available] FS Date: 8/27/2019 2:21:00 PM

WS headwall and flapgate

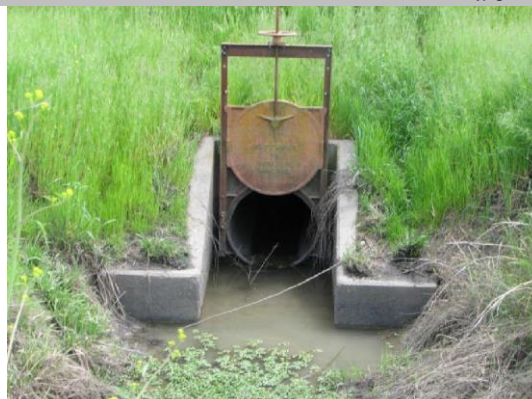
Photo 2 of 3 : UCIP_SP_2022_58506_66980.jpg

Slide gate located on LS toe. Dense vegetation present on LS slope.

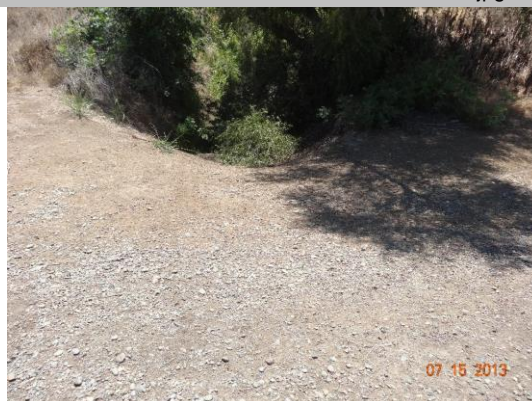
Photo 3 of 3 : UCIP_SP_2022_58506_66982.jpg

WS slope cleared of vegetation

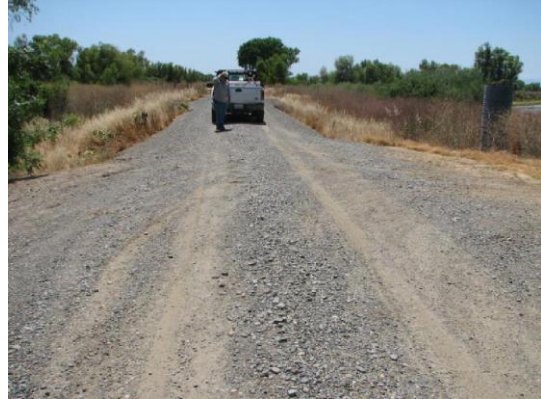
Photo 1 of 3 : UCIP_SP_2022_58507_66989.jpg

Comment Code					
Inspector Comment					
FS_ID:58507 DS_ID:16364 EP_NO: 7521 Repair Type: Non-Urgent Crossing Status: Found UCIP Comments: 08/27/2019 Record remains Non-Urgent due to limited inspection, both pipe ends completely submerged. DMP internal inspection has not been completed. (O. Magana - DWR UCIP, A. Freitag - DWR Sutter Yard)06/15/2017 Both pipe ends completely submerged during site visit. Pipe has been selected to be internally cleaned and inspected as part of the DMP project. (A. Freitag - DWR Sutter Yard)11/17/2016 Both pipe ends underwater at time of inspection. (A. Freitag - DWR Sutter Yard)05/03/2016 Tree near the WS pipe end has been cut down. Stump is still in place. Water was too high to be able to see if the pipe inside was damaged. Minor erosion starting behind the WS headwall. (A. Freitag - DWR Sutter Yard)07/13/2015 WS pipe end is heavily vegetated with trees and is making it almost impossible to inspect. Needs to be cleared out. LS appears in good condition. (A. Freitag - DWR Sutter Yard)05/22/2014 Same as last inspection. (A. Freitag - DWR Sutter Yard)12/03/2013 Same as last inspection. (A. Freitag - DWR Sutter Yard)07/15/2013 Slopes have been cleared of vegetation and are in good condition. (A. Freitag - DWR Sutter Yard)04/18/2012 Limited inspection on WS and LS slopes/toe due to dense vegetation. Erosion behind headwall on WS toe. Need photos of cleared WS & LS slopes. (O. Magana - DWR UCIP) FIELD_STRUCT_DESC: 30-inch corrugated metal drainage pipe through the levee, 13.6 feet below the crown. Flap gate on the waterside (WS) end. Concrete "U" headwalls on both ends. A 48-inch corrugated metal standpipe located approximately 12 feet from landside (LS) levee toe. (30-inch pipe authorized under Permit No. 7521, 1972 - Askew Ranch, replace intake structure with standpipe for drainage pump on LS) [Additional Reference(s): DWR Levee Log, 1993 (HLM 15.95). USACE Sacramento O&M Manual, Unit 519, June 1962, Revised 3 Feb 2011, (HLM 15.95), As-built DWG No. 50-4-3511, Sheet No. 3511/6. unable to read exact page, STA 232+93W, page 6 of 31 electronic file, listed as 30-inch CMP; As-built DWG No. 50-4-3037 referenced not available] FS Date: 8/27/2019 2:22:00 PM

Overview of levee crown at crossing looking downstream.

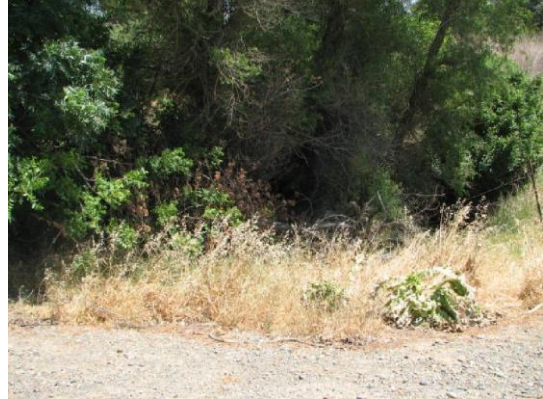
Photo 2 of 3 : UCIP_SP_2022_58507_66987.jpg

View of WS.

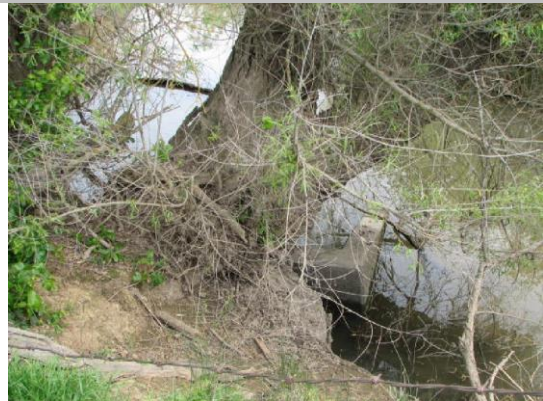
Photo 3 of 3 : UCIP_SP_2022_58507_66986.jpg

View of headwall within channel.

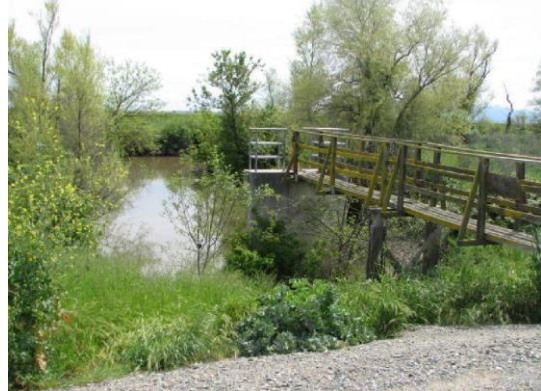
Photo 1 of 3 : UCIP_SP_2022_57621_66993.jpg

Comment Code						
Inspector Comment						
FS_ID:57621 DS_ID:16373 EP_NO: 11805B Repair Type: Non-Urgent Crossing Status: Found UCIP Comments: 08/27/2019 Record remains Non-Urgent, sloughing/erosion observed on the LS toe during inspection. Recommend monitoring to determine progression of sloughing/erosion. (O. Magana - DWR UCIP, A. Freitag - DWR Sutter Yard)06/15/2017 Both pipe ends submerged during site visit. LS ditch near pipe end is heavily vegetated and covering the pipe end. There is some erosion happening at the LS levee toe but this is more of a ditch problem and not a problem with the pipe. (A. Freitag - DWR Sutter Yard)11/17/2016 Both pipe ends underwater at time of inspection. (A. Freitag - DWR Sutter Yard)05/03/2016 Crossing was underwater on both sides of levee during this inspection. Looks as if the wooden walkway was the same and no repairs have been made. (A. Freitag - DWR Sutter Yard)07/13/2015 LS inlet still underwater. WS screw gate appears in good condition. Wooden walkway to the screw gate needs repairs. (A. Freitag - DWR Sutter Yard)05/22/2014 Same as last inspection. (A. Freitag - DWR Sutter Yard)12/03/2013 Same as last inspection. (A. Freitag - DWR Sutter Yard)07/15/2013 Same as last inspection. (A. Freitag - DWR Sutter Yard)04/18/2012 LS inlet is not visible-underwater. Limited inspection on WS and LS slope/toe due to dense vegetation. Need photos of cleared WS & LS slopes. (O. Magana - DWR UCIP) FIELD_STRUCT_DESC: 48-inch reinforced concrete irrigation pipe with six concrete collars through the levee, 14.4 feet below the crown to center of conduit. Slide gate, head-wall and wood walkway on two concrete piers on the waterside (WS) of levee. Revetment on the WS slope. Irrigation ditch on the landside (LS). (two 30-inch pipes and one 48-inch pipe authorized under Permit No. 11805, -A, -B, and -C 1979 - Elna Schohr, Inc.) [Additional Reference(s): DWR Levee Log, 1993 (HLM 16.00)] FS Date: 8/27/2019 2:22:00 PM

WS view of appurtenances (catwalk, slide gate, and headwall)

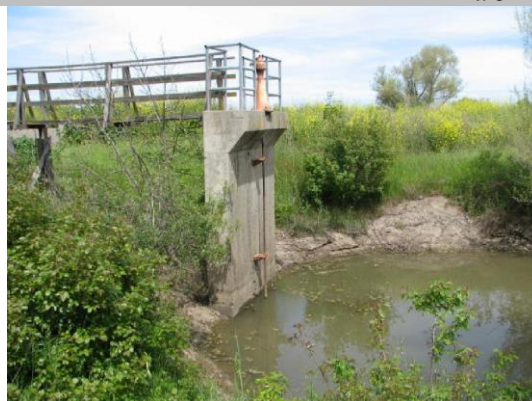
Photo 2 of 3 : UCIP_SP_2022_57621_66995.jpg

WS view of catwalk, slide/screw gate, and headwall

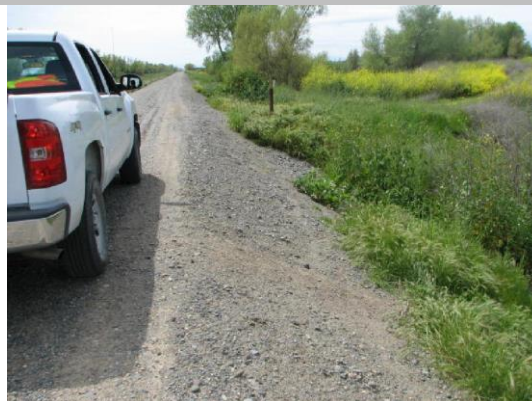
Photo 3 of 3 : UCIP_SP_2022_57621_66996.jpg

LS view of shoulder and slope.

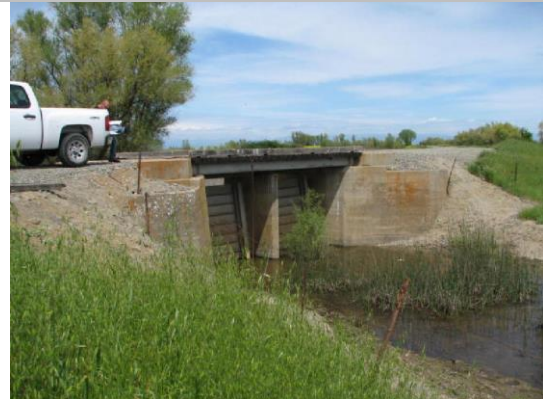
Photo 1 of 3 : UCIP_SP_2022_58508_74500.jpg

Comment Code						
Inspector Comment						
FS_ID:58508 DS_ID:16372 EP_NO: N/A Repair Type: Non-Urgent Crossing Status: Found UCIP Comments: 08/27/2019 Structure is referenced in Permit Number 11805. Need to pull permit to review details. Need to update structure description to reference correct permit. (O. Magana - DWR UCIP, A. Freitag - DWR Sutter Yard)06/15/2017 Crossing appears to be in good condition. Pipe has been selected to be internally cleaned and inspected as part of the DMP project. (A. Freitag - DWR Sutter Yard)11/17/2016 Crossing appears to be in good condition. (A. Freitag - DWR Sutter Yard)05/03/2016 Crossing appears to be in good condition. (A. Freitag - DWR Sutter Yard)07/13/2015 Crossing appears in good condition. No noticeable issues to report. (A. Freitag - DWR Sutter Yard)05/22/2014 Same as last inspection. (A. Freitag - DWR Sutter Yard)12/03/2013 Same as last inspection. (A. Freitag - DWR Sutter Yard)07/15/2013 Same as last inspection. (A. Freitag - DWR Sutter Yard)04/18/2012 The structures are closed with metal stop logs (weir type structure). The stop logs appear to be removable, however; there is a wooden bridge over the structure that would have to be removed in order to raise the stop logs. There is 1-foot of clearance between the bottom of the bridge and the top of the stop logs. (O. Magana - DWR UCIP) FIELD_STRUCT_DESC: Two 10-foot by 10-foot concrete drain openings through the levee at an unknown depth below the crown. Wooden bridge, 10 ton load limit. [Additional Reference(s): DWR Levee Log, 1993 (HLM 16.43). USACE Sacramento O&M Manual, Unit 519, June 1962, Revised 3 Feb 2011, (HLM 16.43), listed as two 9.9-foot by 9.7-foot concrete conduits, As-built DWG No. 50-4-3511, Sheet No. 3511/27.1, STA 208+02W, page 27 of 31 electronic file, listed as drainage structure] FS Date: 8/27/2019 2:23:00 PM

WS view of structure.

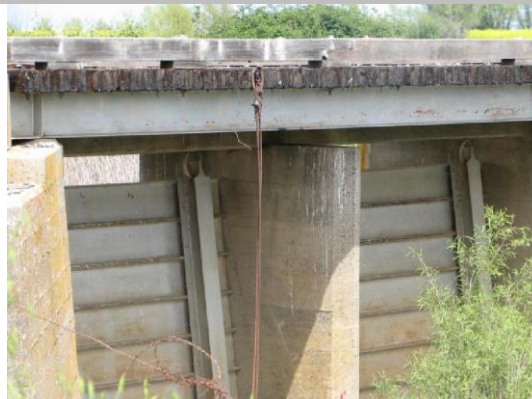
Photo 2 of 3 : UCIP_SP_2022_58508_74503.jpg

View of crossing and panels attached to concrete walls.

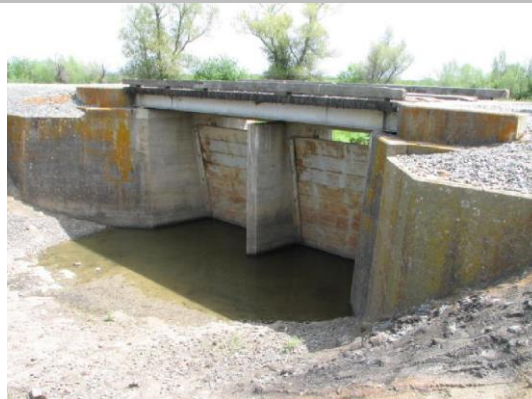
Photo 3 of 3 : UCIP_SP_2022_58508_74501.jpg

LS view of structure

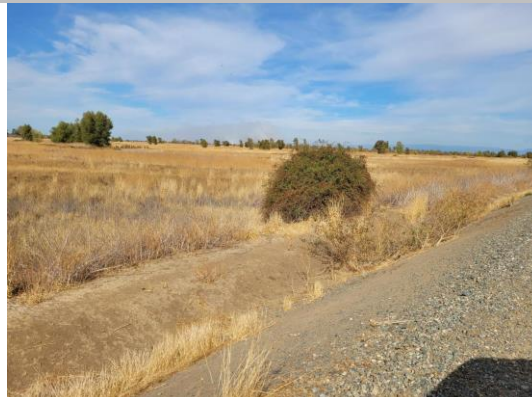
Photo 1 of 1 : SP_2022_MA0013_300_7_20220307_00002.jpg

LM Start	16.22	Rating **	M	Issue No.	7
LM End	17.17	Issue Type +	En	Location *	LS
Category	Earthen Levee			GPS Latitude/Longitude	
				Start	End
Item	Encroachments			39.394523 °	39.385580 °
				-121.817630 °	-121.831282 °
DWR ID	DWR_MA0013_01_s_2012_7				
Comment Code					
DT : Ditch					
Inspector Comment

View of the ditch along the landside toe. Fall 2021.

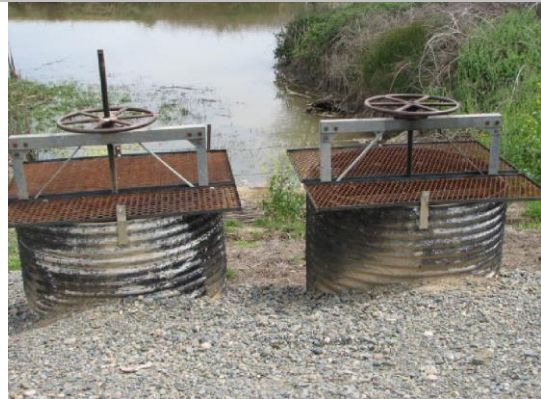
Photo 1 of 3 : UCIP_SP_2022_58510_67011.jpg

Comment Code						
Inspector Comment						
FS_ID:58510 DS_ID:16370 EP_NO: N/A Repair Type: Non-Urgent Crossing Status: Found UCIP Comments: 08/27/2019 Record has been updated from No Action Needed to Non-Urgent due to maintenance issue. Minor scour is present at the concrete wingwalls located on LS. Need to contact owner to address maintenance issue (minor scour). No permit has been identified authorizing pipe. Structure is referenced in permit number 11805. Need to pull permit to review details and update structure description to reference correct permit. (O. Magana - DWR UCIP, A. Freitag - DWR Sutter Yard)06/15/2017 Crossing appears to be in good condition. (A. Freitag - DWR Sutter Yard)11/17/2016 Crossing appears to be in good condition. (A. Freitag - DWR Sutter Yard)05/03/2016 Crossing appears to be in good condition. (A. Freitag - DWR Sutter Yard)07/13/2015 Crossing appears in good condition. No noticeable issues to report. (A. Freitag - DWR Sutter Yard)05/22/2014 Same as last inspection. (A. Freitag - DWR Sutter Yard)12/03/2013 Same as last inspection. (A. Freitag - DWR Sutter Yard)07/15/2013 Same as last inspection. (A. Freitag - DWR Sutter Yard)04/18/2012 42 inch pipes transport water to LS sump. Quantity (4) irrigation pumps push water to adjacent irrigation ditches. WS crossing underwater. (O. Magana - DWR UCIP) FIELD_STRUCT_DESC: 1 of 2: 42-inch corrugated metal irrigation pipe through the levee, 13.5 feet below the crown. Slide gates in corrugated metal pipe risers on the waterside (WS) slope. Concrete headwall on the WS end. Distribution box on the landside (LS) with three pumps mounted on I-beam. [Additional Reference(s): DWR Levee Log, 1993 (HLM 17.43). USACE Sacramento O&M Manual, Unit 519, June 1962, Revised 3 Feb 2011, (HLM 17.43), As-built DWG No. 50-4-3511, Sheet No. 3511/26.2, STA 155+66W, page 26 of 31 electronic file, listed as two 42-inch CMPs through the levee (irrigation structure); As-built DWG No. 50-4-3037 referenced not available] FS Date: 8/27/2019 2:24:00 PM

WS View of slope, risers, and channel.

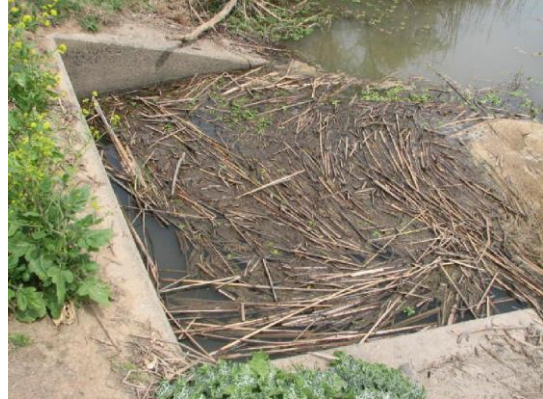
Photo 2 of 3 : UCIP_SP_2022_58510_67010.jpg

View of WS headwall.

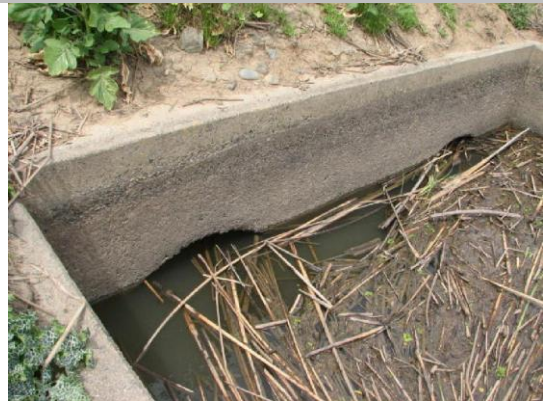
Photo 3 of 3 : UCIP_SP_2022_58510_67009.jpg

WS view of inlets during normal flow in April.

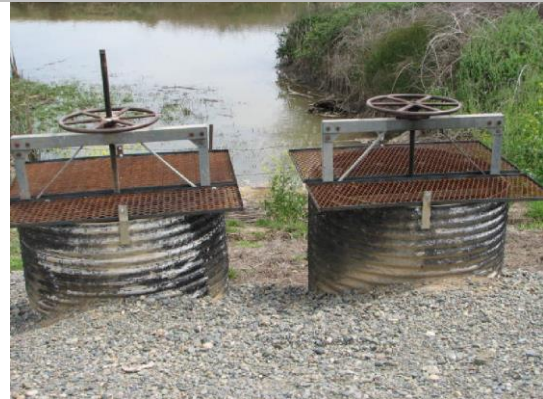
Photo 1 of 3 : UCIP_SP_2022_58511_67003.jpg

Comment Code						
Inspector Comment						
FS_ID:58511 DS_ID:17133 EP_NO: N/A Repair Type: Non-Urgent Crossing Status: Found UCIP Comments: 08/27/2019 Record has been updated from No Action Needed to Non-Urgent due to maintenance issue. Minor scour is present at the concrete wingwalls located on LS. Need to contact owner to address maintenance issue (minor scour). No permit has been identified authorizing pipe. Structure is referenced in permit number 11805. Need to pull permit to review details and update structure description to reference correct permit. (O. Magana - DWR UCIP, A. Freitag - DWR Sutter Yard)06/15/2017 Crossing appears to be in good condition. (A. Freitag - DWR Sutter Yard)11/17/2016 Crossing appears to be in good condition. (A. Freitag - DWR Sutter Yard)05/03/2016 Crossing appears to be in good condition. (A. Freitag - DWR Sutter Yard)07/13/2015 Crossing appears in good condition. No noticeable issues to report. (A. Freitag - DWR Sutter Yard)05/22/2014 Same as last inspection. (A. Freitag - DWR Sutter Yard)12/03/2013 Same as last inspection. (A. Freitag - DWR Sutter Yard)07/15/2013 Same as last inspection. (A. Freitag - DWR Sutter Yard)04/18/2012 42 inch pipes transport water to LS sump. Quantity (4) irrigation pumps push water to adjacent irrigation ditches. WS crossing underwater. (O. Magana - DWR UCIP) FIELD_STRUCT_DESC: 2 of 2: 42-inch corrugated metal irrigation pipe through the levee, 13.5 feet below the crown. Slide gate in corrugated metal pipe riser on the waterside (WS) slope. Concrete headwall on the WS end. Distribution box on the landside (LS) with three pumps mounted on I-beam. [Additional Reference(s): DWR Levee Log, 1993 (HLM 17.43). USACE Sacramento O&M Manual, Unit 519, June 1962, Revised 3 Feb 2011, (HLM 17.43), As-built DWG No. 50-4-3511, Sheet No. 3511/26.2, STA 155+66W, page 26 of 31 electronic file, listed as two 42-inch CMPs through the levee (irrigation structure); As-built DWG No. 50-4-3037 referenced not available] FS Date: 8/27/2019 2:25:00 PM

View of WS slope, channel, and risers.

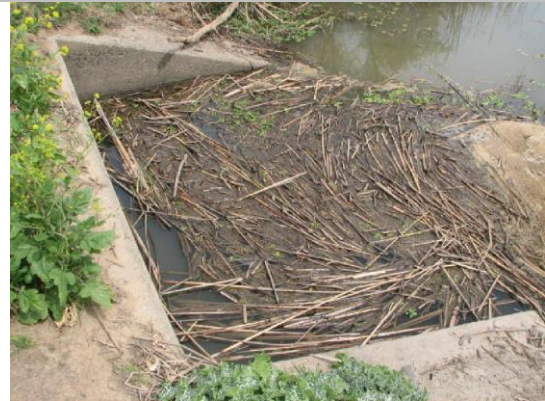
Photo 2 of 3 : UCIP_SP_2022_58511_67002.jpg

View of WS headwall.

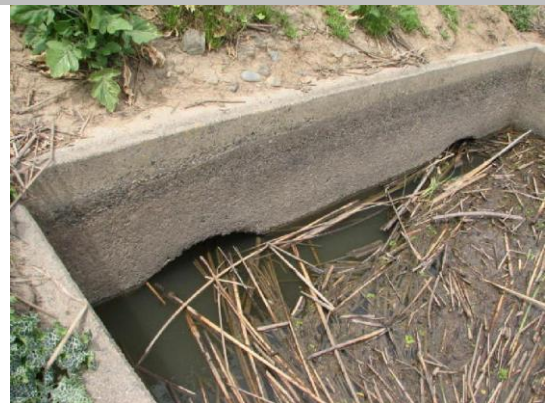
Photo 3 of 3 : UCIP_SP_2022_58511_67001.jpg

View of WS headwall during normal water flow in April.

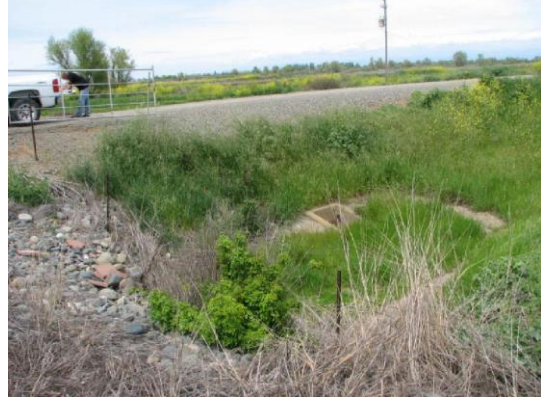
Photo 1 of 3 : UCIP_SP_2022_58512_67017.jpg

FS_ID:58512
DS_ID:16369
EP_NO: N/A
Repair Type: Non-Urgent
Crossing Status: Found
UCIP Comments: 08/27/2019 Record remains Non-Urgent, no permit has been identified authorizing pipe. Pipe has been lined. (O. Magana - DWR UCIP, A. Freitag - DWR Sutter Yard)06/15/2017 Flap gate bolted shut. Hinges seem very stiff to operate as gate will not fully close and has about a 1/2" gap near the top. Land owner claims the gate leaks during high water times. Pipe has been selected to be internally cleaned and inspected as part of the DMP project. (A. Freitag - DWR Sutter Yard)11/17/2016 Crossing appears to be in good condition. (A. Freitag - DWR Sutter Yard)05/03/2016 Crossing appears to be in good condition. (A. Freitag - DWR Sutter Yard)07/13/2015 WS flap gate is blocked from opening by sediment. Needs to be dug out. (A. Freitag - DWR Sutter Yard)05/22/2014 Same as last inspection. (A. Freitag - DWR Sutter Yard)12/03/2013 Sediment was dug out from WS flap gate allowing it to open. (A. Freitag - DWR Sutter Yard)07/15/2013 Slopes have been sprayed and cleared of vegetation and are in good condition. WS flap gate is blocked from opening by sediment buildup. (A. Freitag - DWR Sutter Yard)04/18/2012 Limited inspection on WS and LS slope due to dense vegetation and steep slopes. Need photos of cleared WS & LS slopes. (O. Magana - DWR UCIP)

View of WS slope and toe.

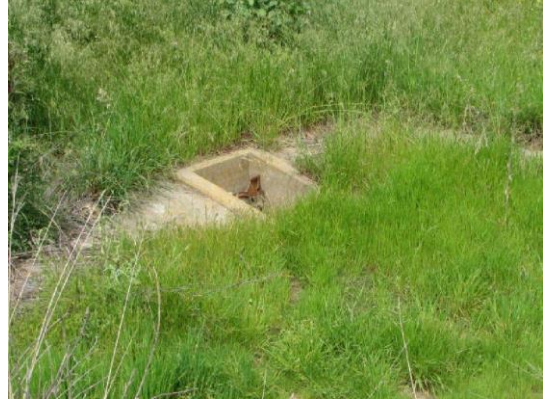
Photo 2 of 3 : UCIP_SP_2022_58512_67019.jpg

View of WS headwall and flap gate.

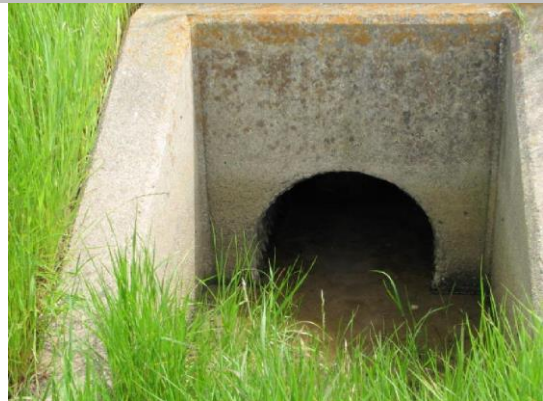
Photo 3 of 3 : UCIP_SP_2022_58512_67018.jpg

View of LS headwall.

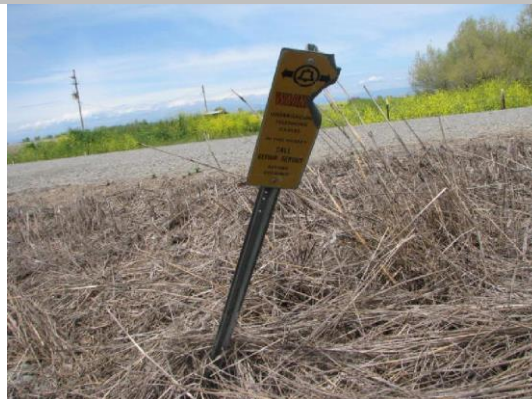
Photo 1 of 3 : UCIP_SP_2022_57627_67024.jpg

FS_ID:57627
DS_ID:16366
EP_NO: 10918
Repair Type: Non-Urgent
Crossing Status: Indicator Found
UCIP Comments: 08/27/2019 Record has been updated from No Action Needed to Non-Urgent due to maintenance issue. Marker is no longer available on WS side. Recommend contacting owner to determine if line is still in use. (O. Magana - DWR UCIP, A. Freitag - DWR Sutter Yard)06/15/2017 Crossing appears to be in good condition. (A. Freitag - DWR Sutter Yard)11/17/2016 Crossing appears to be in good condition. (A. Freitag - DWR Sutter Yard)05/03/2016 Crossing appears to be in good condition. (A. Freitag - DWR Sutter Yard)07/13/2015 Crossing is in good condition. (A. Freitag - DWR Sutter Yard)05/22/2014 Same as last inspection. (A. Freitag - DWR Sutter Yard)12/03/2013 Same as last inspection. (A. Freitag - DWR Sutter Yard)07/15/2013 Same as last inspection. (A. Freitag - DWR Sutter Yard)
FIELD_STRUCT_DESC: 0.6-inch telephone cable through the levee, 2 feet below the crown. Cable goes through MA13 at Unit 1 historic levee mile (HLM) 17.48 and Unit 2 HLM 19.56. (buried cable across channel (attached to bridge) and levees of Cherokee Canal authorized under Permit No. 10918, 1975 - Pacific Telephone and Telegraph Company [PT&T]) [Additional Reference(s): DWR Levee Log, 1993 (HLM 17.48)]

Underground telephone line marker.

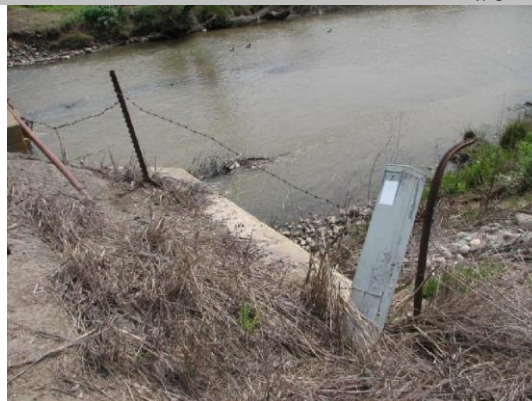
Photo 2 of 3 : UCIP_SP_2022_57627_67025.jpg

Underground telephone cable splice box.

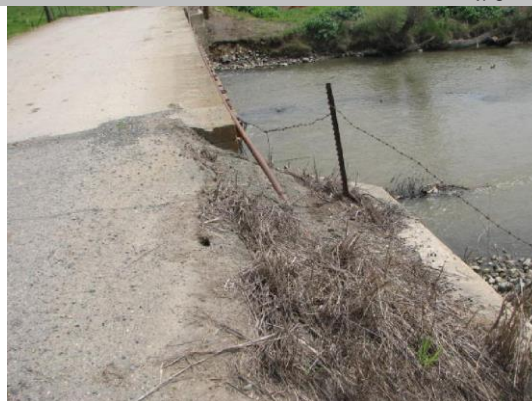
Photo 3 of 3 : UCIP_SP_2022_57627_67023.jpg

Underground telephone line crossing at bridge

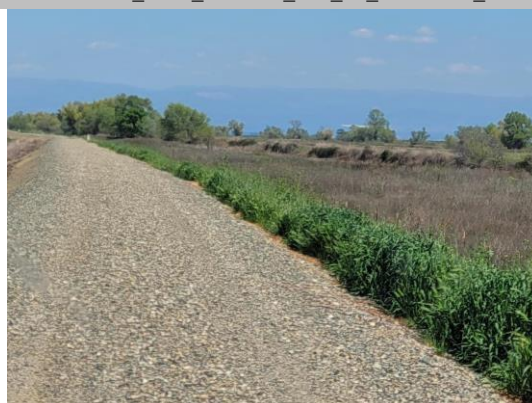
Photo 1 of 1 : SP_2022_MA0013_300_74_20220328_00173.jpg

LM Start	17.90	Rating **	M	Issue No.	74
LM End	18.50	Issue Type +	Ma	Location *	WS
Category	Earthen Levee			GPS Latitude/Longitude	
				Start	End
Item	Vegetation			39.378841 °	39.373462 °
				-121.841810 °	-121.850400 °
DWR ID	DWR_MA0013_01_s_2022_74				
Comment Code					
V1 : Control annual grass and weeds on the levee slopes and easements.					
Inspector Comment

View of the vegetation along the waterside slope. Spring 2022.

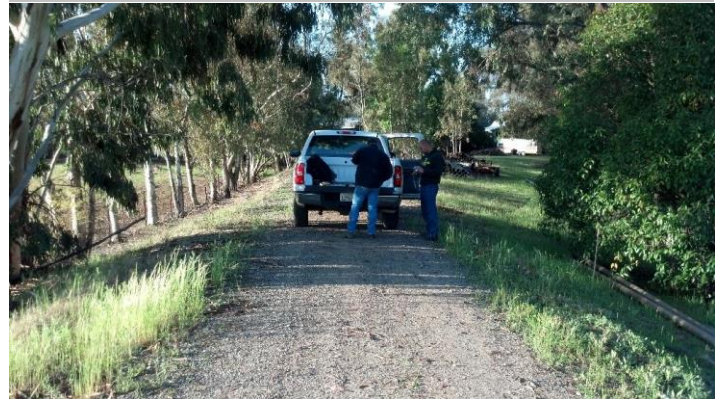
Photo 1 of 3 : UCIP_SP_2022_58518_45640.jpg

FS_ID:58518
DS_ID:16397
EP_NO: N/A
Repair Type: Non-Urgent
Crossing Status: Found
UCIP Comments: 08/28/2019 Record remains Non-Urgent, no permit has been identified authorizing pipe. Pipe has been lined. (O. Magana - DWR UCIP, A. Freitag - DWR Sutter Yard)06/05/2017 Crossing appears to be in good condition. (A. Freitag - DWR Sutter Yard)11/18/2016 Crossing appears to be in good condition. 4inch pipe still present on LS but it does not affect the function of the crossing. (A. Freitag - DWR Sutter Yard)09/27/2016 Crossing has been downgraded from Urgent to Non-Urgent--sleeved pipe does not prevent flap gate from closing on WS. Still need to coordinate with owner to remove sleeved pipe through existing crossing per Title 23. (O. Magana - DWR UCIP)04/27/2016 Crossing appears to be in good condition. 4 inch pipe is still present in LS opening but does not go all the way through to the WS. (A. Freitag - DWR Sutter Yard)07/01/2015 Crossing appears in good condition. No noticeable issues to report. (A. Freitag - DWR Sutter Yard)05/29/2014 Same as last inspection. (A. Freitag - DWR Sutter Yard)12/09/2013 4in. Pipe was removed and flap gate is closed and ready for high water. (A. Freitag - DWR Sutter Yard)07/10/2013 Same as last inspection. Urgency rating carry over from last entry. (A. Freitag - DWR Sutter Yard)04/19/2012 4-6 inch pipe is not part of original crossing--remove pipe. WS-pipe stockpile on WS slope. LS-Overgrown branches limit inspection. This crossing was listed in the USACE Periodic Inspection report listed as Corp's Inspect ID# USACE_CESPK_M13G_2011_p_0009 for WS flap gate not functioning properly as irrigation pipe passes inside crossing. (O. Magana - DWR UCIP)

Overview looking south on left levee
