**Flood Control Project Maintenance
Levee Inspections
LMA District Cover Sheet**

**Flood Control Project Maintenance
Levee Inspections
Unit Cover Sheet**

Waterway			Bank	Unit Miles
Unit No. 01 Cherokee Canal			Right	18.19
	Spring (March - May)	Summer (June - August)	(September - November) Fall	Winter (December - February)
Unit Maintenance Rating (Fall Only)				
Date of Inspection	3/23/2022 - 3/23/2022			
DWR Inspector	Makar Sokol			
Accompanied By

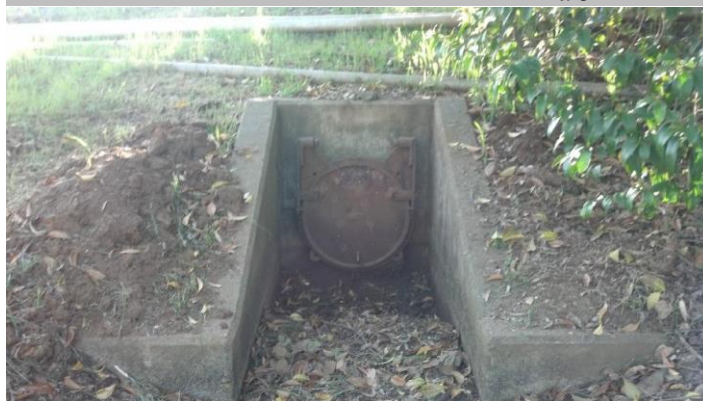
Photo 2 of 3 : UCIP_SP_2022_58518_45642.jpg

Headwall and flap gate on WS. Soil and pipes stockpiled next to headwall.

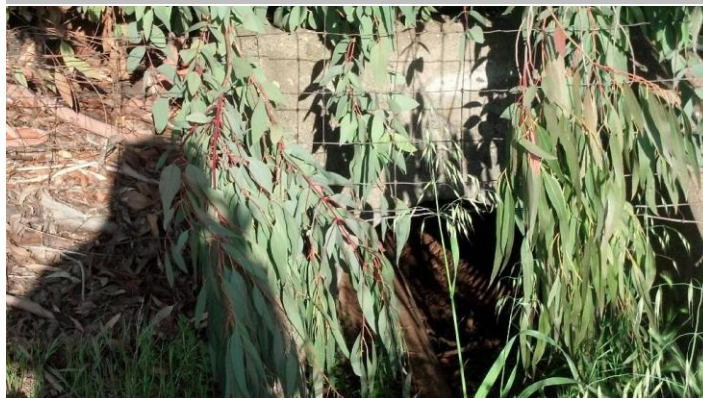
Photo 3 of 3 : UCIP_SP_2022_58518_45643.jpg

LS headwall blocked by overgrown branches.

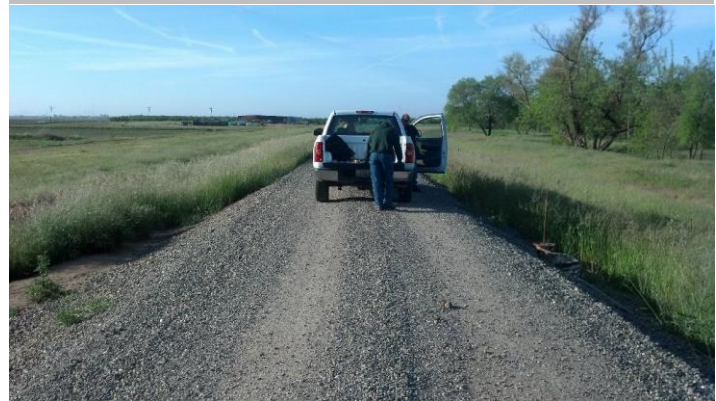
Photo 1 of 3 : UCIP_SP_2022_58519_67047.jpg

FS_ID:58519
DS_ID:16398
EP_NO: N/A
Repair Type: Non-Urgent
Crossing Status: Found
UCIP Comments: 08/28/2019 Record remains Non-Urgent, no permit has been identified authorizing pipe and modifications. Structure type has been changed from drainage to irrigation. Mr. Sohnrey property owner mentioned that this pipe is being used as irrigation line. DMP internal video inspection has not found pipe integrity issues. LOF of crossing is less or equal to 4. Recommend next video inspection in 5 years. (O. Magana - DWR UCIP, A. Freitag - DWR Sutter Yard)06/05/2017 LS ditch at outlet is getting over grown with vegetation. WS near concrete standpipe is overgrown with vegetation. Pipe has been selected to be internally cleaned and inspected as part of the DMP project. (A. Freitag - DWR Sutter Yard)11/18/2016 Between the screw gate on the WS shoulder and the LS pipe end the pipe is about 50% full of soil. Crossing is still actively used by landowner for irrigation purposes. (A. Freitag - DWR Sutter Yard)04/27/2016 Pipe gets used by the landowner to irrigate his rice fields. It appeared to be in good condition. (A. Freitag - DWR Sutter Yard)07/01/2015 LS pipe end is still about 50% full of sediment. (A. Freitag - DWR Sutter Yard)05/29/2014 Same as last inspection. (A. Freitag - DWR Sutter Yard)12/09/2013 Same as last inspection. (A. Freitag - DWR Sutter Yard)07/10/2013 LS and WS slopes have been cleared of vegetation and are in good condition. LS pipe end is half full of sediment. Sediment inside of WS standpipe may hinder slide gate from fully closing. Standpipe cover is still broken. (A. Freitag - DWR Sutter Yard)04/19/2012 Need to fix the top of slide gate cover. The wooden cap on standpipe is broken. Limited evaluation of crossing due to dense vegetation on LS slope. Need photos of cleared slopes during fall inspection. (O. Magana - DWR UCIP)

Overview looking south

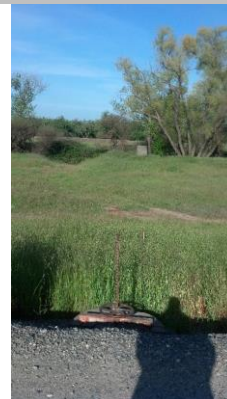
Photo 2 of 3 : UCIP_SP_2022_58519_67048.jpg

View of WS slope and toe.

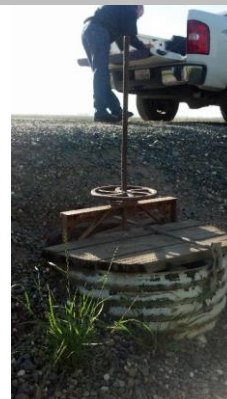
Photo 3 of 3 : UCIP_SP_2022_58519_67045.jpg

Screw gate located on WS of levee. Screw gate covers needs to be repaired.

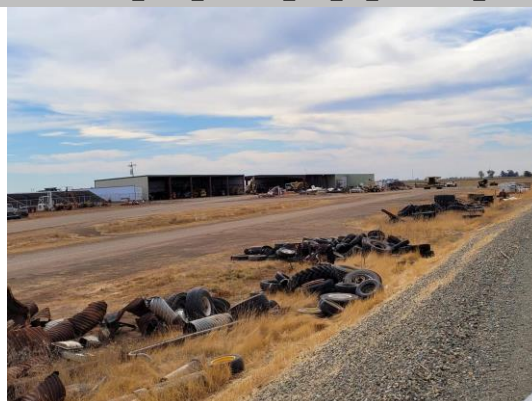
Photo 1 of 1 : SP_2022_MA0013_301_91_20220307_00015.jpg

LM Start	0.77	Rating **	M	Issue No.	91
LM End	0.85	Issue Type +	En	Location *	LS
Category	Earthen Levee			GPS Latitude/Longitude	
				Start	End
Item	Encroachments			39.563684 °	39.562508 °
				-121.702413 °	-121.702535 °
DWR ID	DWR_MA0013_02_f_2021_91				
Comment Code					
EQ : Equipment					
Inspector Comment

View of the equipment along the landside toe. Fall 2021.

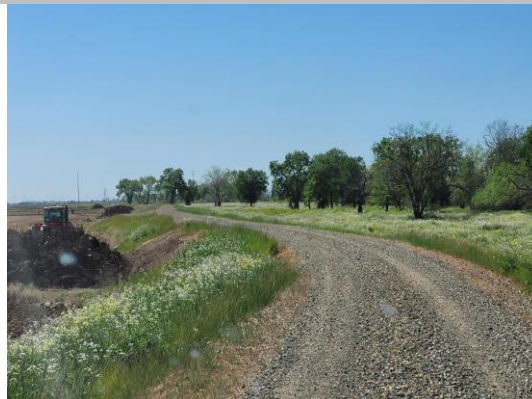
Photo 1 of 1 : SP_2022_MA0013_301_84_20220328_00182.jpg

LM Start	0.96	Rating **	M	Issue No.	84
LM End	1.57	Issue Type +	Ma	Location *	WS
Category	Earthen Levee			GPS Latitude/Longitude	
				Start	End
Item	Vegetation			39.561099 °	39.552542 °
				-121.703467 °	-121.704857 °
DWR ID	DWR_MA0013_02_s_2022_84				
Comment Code					
V1 : Control annual grass and weeds on the levee slopes and easements.					
Inspector Comment

View of the vegetation along the waterside slope. Spring 2022.

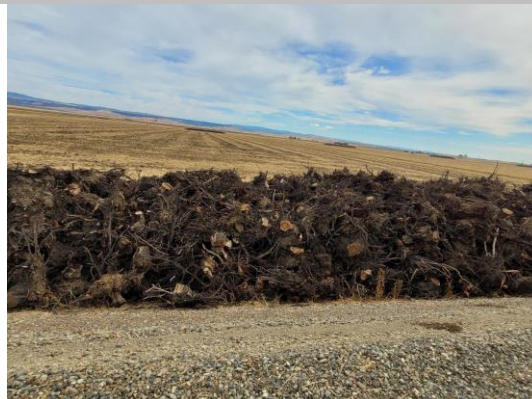
Photo 1 of 1 : SP_2022_MA0013_301_92_20220307_00016.jpg

LM Start	1.15	Rating **	U	Issue No.	92
LM End	1.15	Issue Type +	En	Location *	LS
Category	Earthen Levee			GPS Latitude/Longitude	
				Start	End
Item	Encroachments			39.558741 °	39.558741 °
				-121.704800 °	-121.704800 °
DWR ID	DWR_MA0013_02_f _ 2021_92				
Comment Code					
TR : Tree or limb					
Inspector Comment

View of the pile of tree limbs along the landside toe. Fall 2021.

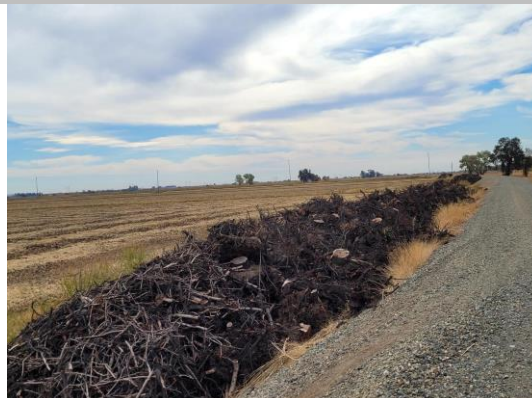
Photo 1 of 1 : SP_2022_MA0013_301_93_20220307_00017.jpg

LM Start	1.26	Rating **	U	Issue No.	93
LM End	1.29	Issue Type +	En	Location *	LS
Category	Earthen Levee			GPS Latitude/Longitude	
				Start	End
Item	Encroachments			39.557153 °	39.556600 °
				-121.704880 °	-121.704936 °
DWR ID	DWR_MA0013_02_f _ 2021_93				
Comment Code					
TR : Tree or limb					
Inspector Comment

View of the pile of tree limbs along landside toe. Fall 2021.

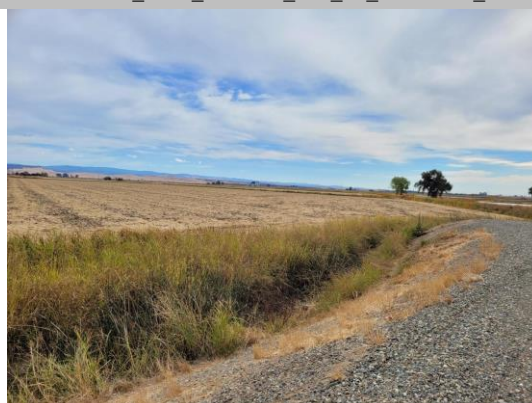
Photo 1 of 1 : SP_2022_MA0013_301_56_20220307_00007.jpg

LM Start	1.60	Rating **	U	Issue No.	56
LM End	1.63	Issue Type +	En	Location *	LS
Category	Earthen Levee			GPS Latitude/Longitude	
				Start	End
Item	Encroachments			39.552195 °	39.551731 °
				-121.704786 °	-121.704721 °
DWR ID	DWR_MA0013_02_s_2016_56				
Comment Code					
DT : Ditch					
Inspector Comment

View of the agricultural ditch along the landside toe. Fall 2021.

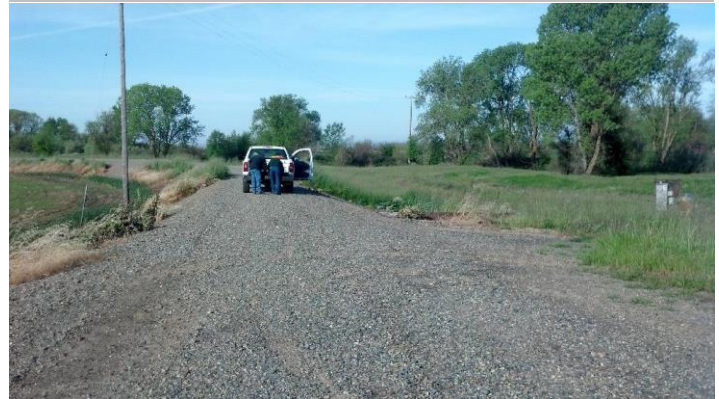
Photo 1 of 3 : UCIP_SP_2022_58520_67055.jpg

Comment Code					
Inspector Comment					
FS_ID:58520 DS_ID:16833 EP_NO: N/A Repair Type: Non-Urgent Crossing Status: Found UCIP Comments: 08/28/2019 Record has been updated from No Action Needed to Non-Urgent, no permit has been identified for this crossing. No other issues were recorded during inspection. (O. Magana - DWR UCIP, A. Freitag - DWR Sutter Yard)6/5/2017 Crossing appears to be in good condition. Pump was running during site visit. (A. Freitag - DWR Sutter Yard)11/18/2016 Crossing appears to be in good condition. (A. Freitag - DWR Sutter Yard)04/27/2016 Crossing appears to be in good condition. (A. Freitag - DWR Sutter Yard)07/01/2015 Same as last inspection. (A. Freitag - DWR Sutter Yard)05/29/2014 Same as last inspection. (A. Freitag - DWR Sutter Yard)12/09/2013 Same as last inspection. (A. Freitag - DWR Sutter Yard)07/10/2013 Same as last inspection. (A. Freitag - DWR Sutter Yard)04/19/2012 This crossing was listed in the USACE Periodic Inspection report as Corp's Inspect ID# USACE_CESPK_M13G_2011_p_0106 for pump station. Permit 3953 is not associated to this crossing. This 16 inch crossing is listed under the USACE O&M Manual with pump on WS. Permit information was incorrect in USACE's report. (O. Magana - DWR UCIP) FIELD_STRUCT_DESC: 16-inch steel irrigation pipe through the levee at an unknown depth below the crown. Groundwater pump is located on the waterside (WS). Power pole located on the landside (LS) of levee. Power runs through the levee to pump meter located on the WS. [Additional Reference(s): USACE Sacramento O&M Manual, Unit 519, June 1962, Revised 3 Feb 2011, (HLM 1.67), listed as 16-inch pipe, no As-built reference found] FS Date: 8/28/2019 1:25:00 PM

Overview looking south

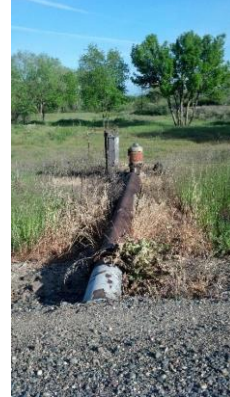
Photo 2 of 3 : UCIP_SP_2022_58520_67054.jpg

LM Start	1.67	Rating **	M	Issue No.	4 (cont)
LM End	1.67	Issue Type +	En	Location *	
Category	Supplemental			GPS Latitude/Longitude	
				Start	End
Item	DWR UCIP Field Study			39.551439 °	39.551439 °
				-121.705230 °	-121.705230 °
DWR ID	16833

Pump located on water side of levee

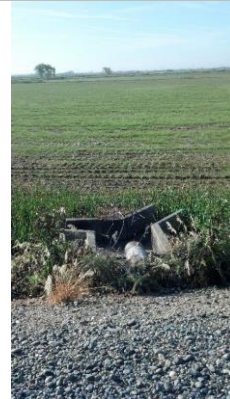
Photo 3 of 3 : UCIP_SP_2022_58520_67053.jpg

Discharge pipe and distribution box located on land side of levee

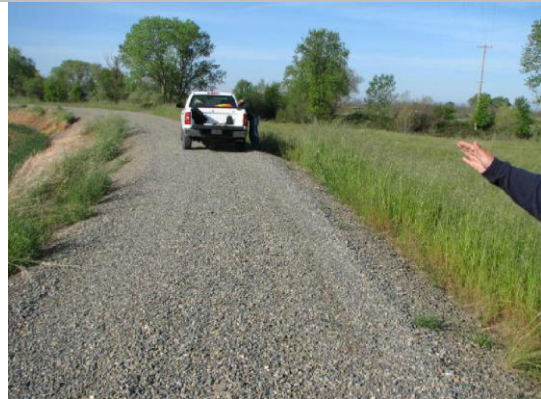
Photo 1 of 3 : UCIP_SP_2022_58573_67059.jpg

FS_ID:58573
DS_ID:16399
EP_NO: N/A
Repair Type: Non-Urgent
Crossing Status: Found
UCIP Comments: 08/28/2019 Record remains Non-Urgent, no permit has been identified authorizing pipe. Pipe has been lined. (O. Magana - DWR UCIP, A. Freitag - DWR Sutter Yard)06/05/2017 LS slide gate stem is bent and the gate appears as if it will not open. LS inlet is becoming heavily vegetated next to rice field. WS flap gate is blocked shut by sediment. Pipe has been selected to be internally cleaned and inspected as part of the DMP project. (A. Freitag - DWR Sutter Yard)11/18/2016 LS screw gate still bent and in-operable. (A. Freitag - DWR Sutter Yard)04/27/2016 LS screw gate is still bent. Rest of crossing appeared in good condition. (A. Freitag - DWR Sutter Yard)07/01/2015 LS screw gate frame is still twisted and hindering the gate from opening. (A. Freitag - DWR Sutter Yard)05/29/2014 Same as last inspection. (A. Freitag - DWR Sutter Yard)12/09/2013 Same as last inspection. (A. Freitag - DWR Sutter Yard)07/10/2013 WS slope is cleared of vegetation and is in good condition. LS screw gate frame is twisted and is preventing the gate from opening. (A. Freitag - DWR Sutter Yard)04/19/2012 Limited inspection dense vegetation on WS. Need photos of clear WS slope & toe. Ditch present in channel? This crossing was listed in the USACE Periodic Inspection report as Corp's Inspect ID# USACE_CESPK_M13G_2011_p_0108 for WS flap gate filled with soil and LS gate not functioning because of overgrown vegetation. (O. Magana - DWR UCIP)

Overview of crossing

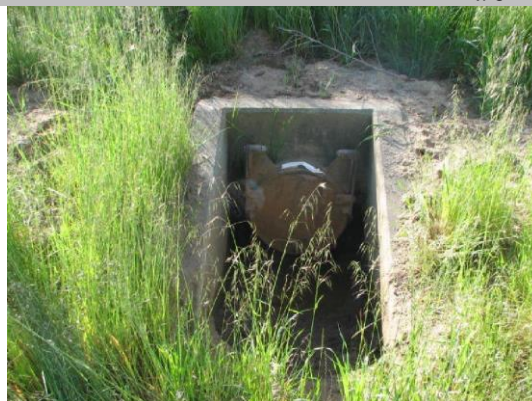
Photo 2 of 3 : UCIP_SP_2022_58573_67058.jpg

LM Start	1.70	Rating **	M	Issue No.	5 (cont)
LM End	1.70	Issue Type +	Ma	Location *	
Category	Supplemental			GPS Latitude/Longitude	
				Start	End
Item	DWR UCIP LMA Responsibility			39.551178 °	39.551178 °
				-121.705660 °	-121.705660 °
DWR ID	16399

View of flap gate on WS.

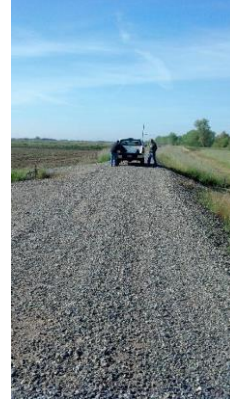
Photo 1 of 3 : UCIP_SP_2022_58522_67063.jpg

Comment Code						
Inspector Comment						
FS_ID:58522 DS_ID:16400 EP_NO: N/A Repair Type: Non-Urgent Crossing Status: Found UCIP Comments: 08/28/2019 Record has been updated from No Action Needed to Non-Urgent, no permit has been identified authorizing pipe. Pipe is scheduled to be lined. (O. Magana - DWR UCIP, A. Freitag - DWR Sutter Yard)06/05/2017 LS inlet was underwater. WS flap gate blocked shut by sediment. Pipe has been selected to be internally cleaned and inspected as part of the DMP project. (A. Freitag - DWR Sutter Yard) 11/18/2016 Sediment dug out from in front of flap gate. Gate can now function properly. (A. Freitag - DWR Sutter Yard)04/27/2016 WS flap gate still blocked from opening by sediment buildup. (A. Freitag - DWR Sutter Yard)07/01/2015 New screw gate installed on the LS. WS flap gate is still blocked from opening by sediment. (A. Freitag - DWR Sutter Yard)05/29/2014 Same as last inspection. (A. Freitag - DWR Sutter Yard)12/09/2013 Same as last inspection. (A. Freitag - DWR Sutter Yard)07/10/2013 Sediment is built up against WS flap gate not allowing it to open. Handle for LS slide gate is still missing. (A. Freitag - DWR Sutter Yard)04/19/2012 Handle missing on slide gate. (O. Magana - DWR UCIP) FIELD_STRUCT_DESC: 1 of 2: 36-inch CIPP-lined corrugated metal drainage pipe through the levee, 9.7 feet below the crown. Concrete "U" headwalls located on the waterside (WS) and landside (LS) ends. Flap gate on the WS end. Slide gate on the LS end. [Additional Reference(s): DWR Levee Log, 1993 (HLM 2.53). USACE Sacramento O&M Manual, Unit 519, June 1962, Revised 3 Feb 2011, (HLM 2.54), As-built DWG No. 50-4-3608, Sheet No. 3608/19.1, STA 899+10E LT BK, page 20 of 28 electronic file, listed as two 36-inch CMP; As-built DWG No 50-4-3037 referenced not available] FS Date: 8/28/2019 1:09:00 PM

Overview of levee crown looking south

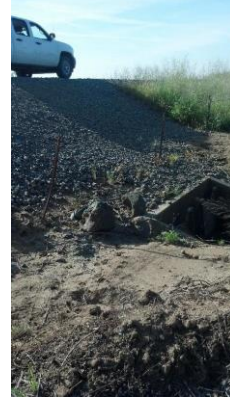
Photo 2 of 3 : UCIP_SP_2022_58522_67068.jpg

LM Start	2.53	Rating **	M	Issue No.	6 (cont)	
LM End	2.53	Issue Type +	Ma	Location *		
Category	Supplemental			GPS Latitude/Longitude		
				Start		End
Item	DWR UCIP LMA Responsibility			39.539195 °	39.539195 °	
				-121.706070 °	-121.706070 °	
DWR ID	16400

View of WS slope.

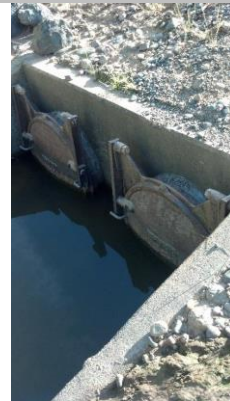
Photo 3 of 3 : UCIP_SP_2022_58522_67064.jpg

Headwall and flap gates (2) located on WS

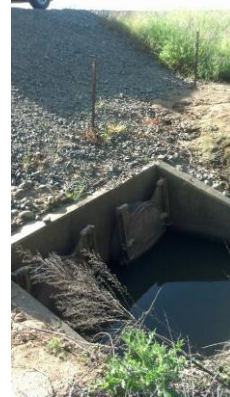
Photo 3 of 3 : UCIP_SP_2022_58523_67071.jpg

Headwall and flap gates (2) located on the WS.

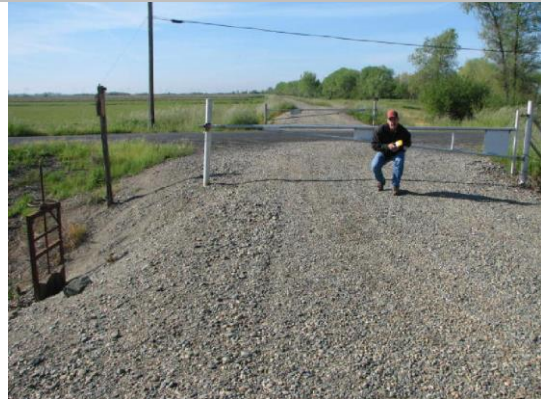
Photo 1 of 3 : UCIP_SP_2022_58524_67077.jpg

Comment Code						
Inspector Comment						
FS_ID:58524 DS_ID:16402 EP_NO: N/A Repair Type: Non-Urgent Crossing Status: Found UCIP Comments: 08/28/2019 Record remains Non-Urgent, no permit has been identified authorizing pipe. Pipe is scheduled to be lined (O. Magana - DWR UCIP, A. Freitag - DWR Sutter Yard)06/05/2017 Sediment blocking LS slide gate from closing fully. Pipe has been selected to be internally cleaned and inspected as part of the DMP project. (A. Freitag - DWR Sutter Yard)11/18/2016 Sediment still blocking screw gate from fully closing. (A. Freitag - DWR Sutter Yard)04/27/2016 LS slide gate is full of sediment and needs to be dug out so gate can close fully. (A. Freitag - DWR Sutter Yard)07/01/2015 LS screw gate is still silted in and unable to be screwed down all the way. Needs to be cleaned out. (A. Freitag - DWR Sutter Yard)05/29/2014 Same as last inspection. (A. Freitag - DWR Sutter Yard)12/09/2013 WS flap gate was closed but LS slide gate is heavily vegetated and blocked from closing by sediment. (A. Freitag - DWR Sutter Yard)07/10/2013 Same as last inspection. (A. Freitag - DWR Sutter Yard)04/19/2012 Minor sediment built up on LS, remove sediment. Need photo of LS slide gate without sediment build up. This crossing was listed in the USACE Periodic Inspection report as Corp's inspect ID# USACE_CESPK_M13G_2011_p_0148 for LS gate obstructed by vegetation and WS flap gate is not functioning (propped open). (O. Magana - DWR UCIP) FIELD_STRUCT_DESC: 36-inch CIPP-lined corrugated metal drainage pipe through the levee, 8.8 feet below the crown. Concrete "U" headwalls located on both the waterside (WS) and landside (LS) ends. Flap gate on the WS end. Slide gate on the LS end. Structure used to drain water from Nelson Shippe Road. [Additional Reference(s): DWR Levee Log, 1993 (HLM 2.63). USACE Sacramento O&M Manual, Unit 519, June 1962 , Revised 3 Feb 2011, (HLM 2.63), As-built DWG No. 50-4-3608, Sheet No. 3608/19.1, STA 895+65E LT BK, page 20 of 28 electronic file, listed as 36-inch CMP; As-built DWG No 50-4-3037 referenced not available] FS Date: 8/28/2019 1:13:00 PM

Overview looking south from left levee

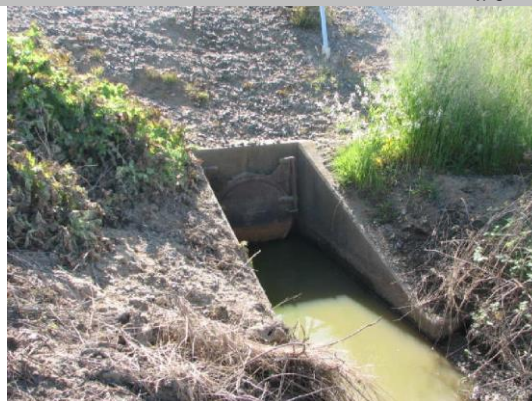
Photo 2 of 3 : UCIP_SP_2022_58524_67076.jpg

LM Start	2.62	Rating **	M	Issue No.	8 (cont)
LM End	2.62	Issue Type +	Ma	Location *	
Category	Supplemental			GPS Latitude/Longitude	
				Start	End
Item	DWR UCIP LMA Responsibility			39.537864 °	39.537864 °
				-121.706190 °	-121.706190 °
DWR ID	16402

Headwall and flap gate located on WS.

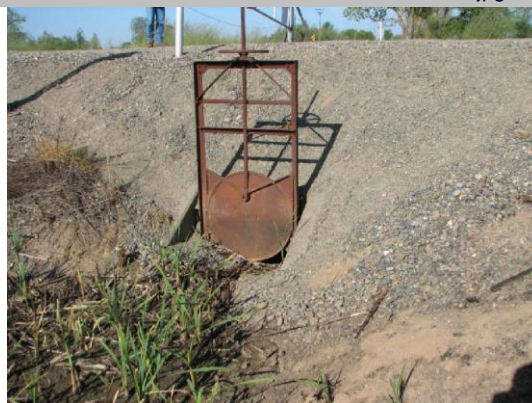
Photo 3 of 3 : UCIP_SP_2022_58524_67078.jpg

Headwall and screw gate located on LS.

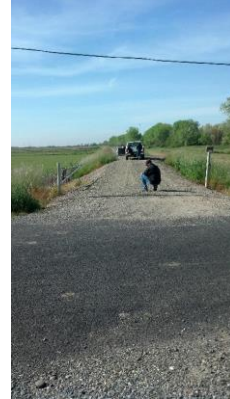
Photo 1 of 3 : UCIP_SP_2022_58525_67087.jpg

Comment Code						
Inspector Comment						
FS_ID:58525 DS_ID:16403 EP_NO: N/A Repair Type: Non-Urgent Crossing Status: Found UCIP Comments: 08/28/2019 Record remains Non-Urgent, no permit has been identified authorizing pipe. Pipe is scheduled to be lined. (O. Magana - DWR UCIP, A. Freitag - DWR Sutter Yard)06/05/2017 Crossing appears to be in good condition. Pipe has been selected to be internally cleaned and inspected as part of the DMP project. (A. Freitag - DWR Sutter Yard)11/18/2016 Crossing appears to be in good condition. (A. Freitag - DWR Sutter Yard)04/27/2016 Crossing appears to be in good condition. (A. Freitag - DWR Sutter Yard)07/01/2015 WS flap gate is partially blocked by sediment and needs to be cleaned. (A. Freitag - DWR Sutter Yard)05/29/2014 Same as last inspection. (A. Freitag - DWR Sutter Yard)12/09/2013 Same as last inspection. (A. Freitag - DWR Sutter Yard)07/10/2013 LS and WS slopes have been cleared of vegetation and are in good condition. (A. Freitag - DWR Sutter Yard)04/19/2012 Burrowing holes located above WS headwall. Limited inspection on WS and LS slopes due to dense vegetation. Need photos of cleared WS & LS slopes. (O. Magana - DWR UCIP) FIELD_STRUCT_DESC: 36-inch CIPP-lined corrugated metal drainage pipe through the levee, 8.7 feet below the crown. Concrete "U" headwalls located on the waterside (WS) and landside (LS) ends. Flap gate on the WS end. Slide gate on the LS end. [Additional Reference(s): DWR Levee Log, 1993 (HLM 2.64). USACE Sacramento O&M Manual, Unit 519, June 1962, Revised 3 Feb 2011, (HLM 2.65), As-built DWG No. 50-4-3608, Sheet No. 3608/19.1, STA 892+57E LT BK, page 20 of 28 electronic file, listed as 36-inch CMP; As-built DWG No 50-4-3037 referenced not available] FS Date: 8/28/2019 1:15:00 PM

Overview at levee crown looking south

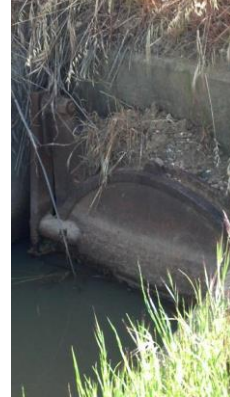
Photo 2 of 3 : UCIP_SP_2022_58525_67084.jpg

LM Start	2.63	Rating **	M	Issue No.	9 (cont)	
LM End	2.63	Issue Type +	Ma	Location *		
Category	Supplemental			GPS Latitude/Longitude		
				Start		End
Item	DWR UCIP LMA Responsibility			39.537671 °	39.537671 °	
				-121.706210 °	-121.706210 °	
DWR ID	16403

Headwall and flap gate located on WS

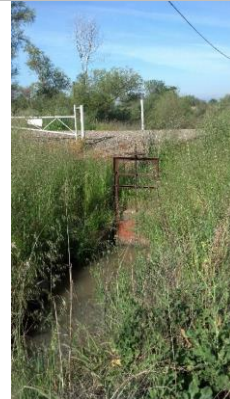
Photo 3 of 3 : UCIP_SP_2022_58525_67086.jpg

Headwall and screw gate located on the LS

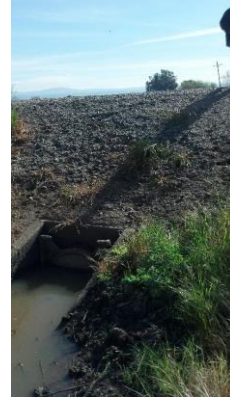
Photo 2 of 3 : UCIP_SP_2022_58526_67091.jpg

LM Start	2.65	Rating **	M	Issue No.	10 (cont)
LM End	2.65	Issue Type +	Ma	Location *	
Category	Supplemental			GPS Latitude/Longitude	
				Start	End
Item	DWR UCIP LMA Responsibility			39.537466 °	39.537466 °
				-121.706240 °	-121.706240 °
DWR ID	16415

Headwall and flap gate located on WS.

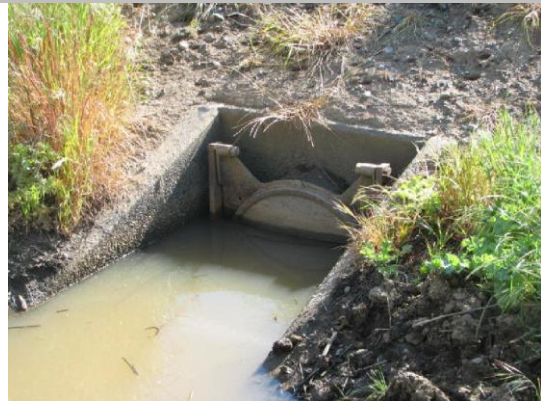
Photo 3 of 3 : UCIP_SP_2022_58526_67092.jpg

WS headwall and flap gate.

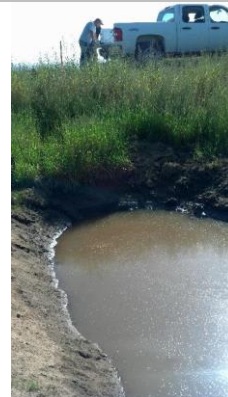
Photo 2 of 3 : UCIP_SP_2022_58527_67095.jpg

LM Start	3.59	Rating **	M	Issue No.	11 (cont)
LM End	3.59	Issue Type +	Ma	Location *	
Category	Supplemental			GPS Latitude/Longitude	
				Start	End
Item	DWR UCIP LMA Responsibility			39.523829 °	39.523829 °
				-121.706290 °	-121.706290 °
DWR ID	16405

Flap gate submerged in water on WS of levee

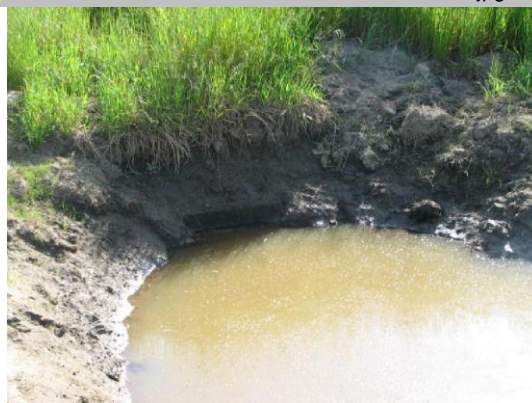
Photo 3 of 3 : UCIP_SP_2022_58527_67096.jpg

View of flap gate submerged on WS toe.

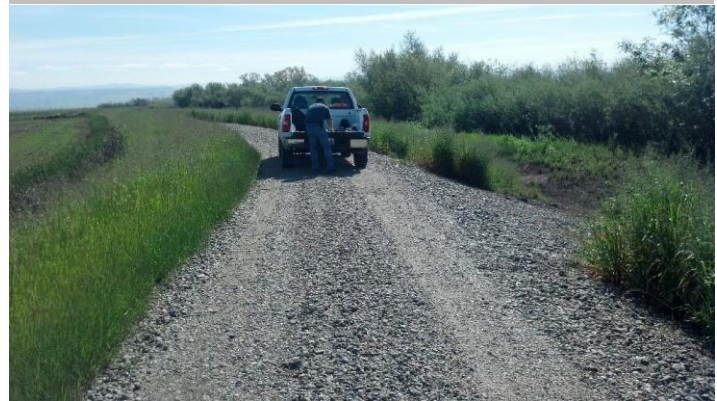
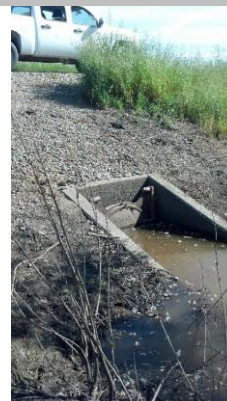
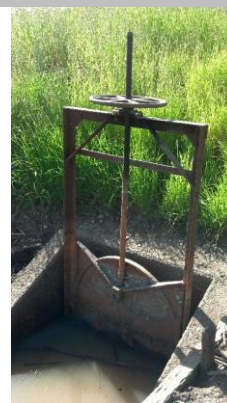
Photo 1 of 3 : UCIP_SP_2022_58528_67102.jpg

Comment Code					
Inspector Comment					
FS_ID:58528 DS_ID:16848 EP_NO: N/A Repair Type: Non-Urgent Crossing Status: Found UCIP Comments: 08/28/2019 Record has been updated from No Action Needed to Non-Urgent, no permit has been identified authorizing pipe. Pending internal inspection under DMP Phase 1 both inlet and outlet underwater. (O. Magana - DWR UCIP, A. Freitag - DWR Sutter Yard)06/05/2017 Both ends submerged but appear to be in good condition. Pipe has been selected to be internally cleaned and inspected as part of the DMP project. (A. Freitag - DWR Sutter Yard)11/18/2016 Crossing appears to be in good condition. (A. Freitag - DWR Sutter Yard)04/27/2016 Crossing appears to be in good condition. New slide gate installed on LS. (A. Freitag - DWR Sutter Yard)07/01/2015 Both gates were still submerged in water. Levee slopes were in good condition. (A. Freitag - DWR Sutter Yard)05/29/2014 Same as last inspection. (A. Freitag - DWR Sutter Yard)12/09/2013 Same as last inspection. (A. Freitag - DWR Sutter Yard)07/10/2013 LS slope has been cleared of vegetation and is in good condition. Both gates are still underwater and not able to be inspected. (A. Freitag - DWR Sutter Yard)04/19/2012 Dense vegetation makes it difficult to evaluate the condition of the LS slope. Both gates underwater. Recommend taking photos of clear slopes and gates during fall inspection. (O. Magana - DWR UCIP) FIELD_STRUCT_DESC: 36-inch CIPP-lined corrugated metal drainage pipe through the levee, 9.2 feet below the crown. Concrete "U" headwalls on both the waterside (WS) and landside (LS) ends. Flap gate on the WS end. Slide gate on the LS end. [Additional Reference(s): DWR Levee Log, 1993 (HLM 3.67). USACE Sacramento O&M Manual, Unit 519, June 1962, Revised 3 Feb 2011, (HLM 3.67), As-built DWG No. 50-4-3608, Sheet No. 3608/5.2, 19.1, STA 7+70C RT. BK. (Cottonwood), page 5, 20 of 28 electronic file, listed as 36-inch pipe] FS Date: 8/28/2019 1:19:00 PM

Overview looking south on left levee

Headwall and flap gate located on WS.

Headwall and screw gate located on LS.

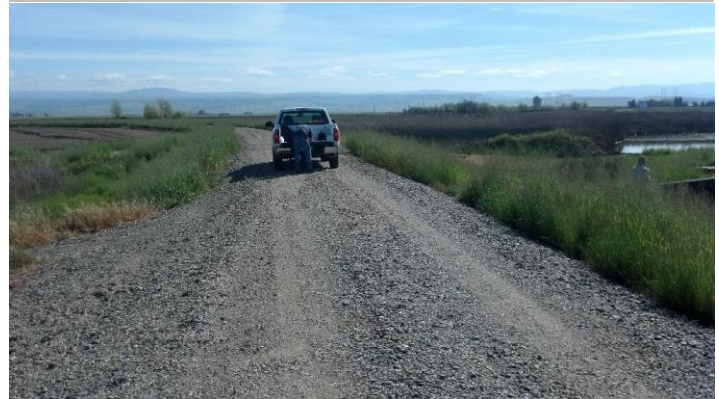
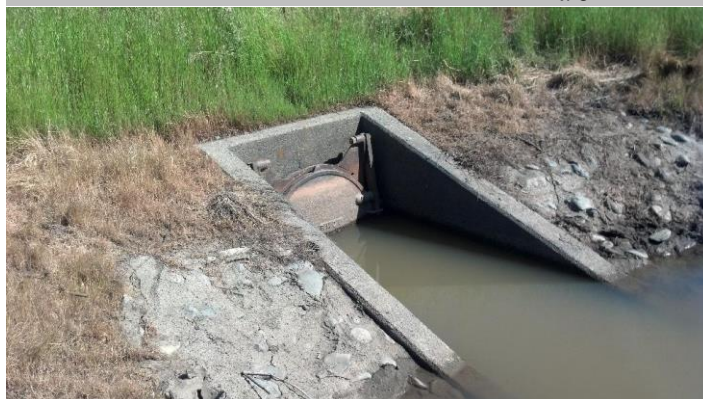
Photo 1 of 3 : UCIP_SP_2022_58529_67107.jpg

Comment Code						
Inspector Comment						
FS_ID:58529 DS_ID:16847 EP_NO: N/A Repair Type: Non-Urgent Crossing Status: Found UCIP Comments: 08/28/2019 Record remains Non-Urgent, no permit has been identified authorizing pipe. Pending internal inspection under DMP Phase 1 both inlet and outlet underwater. (O. Magana - DWR UCIP, A. Freitag - DWR Sutter Yard)06/05/2017 Both ends submerged but crossing appears to be in good condition. (A. Freitag - DWR Sutter Yard)11/18/2016 Crossing appears to be in good condition. It appears that this crossing does not require a slide gate. (A. Freitag - DWR Sutter Yard)04/27/2016 LS slide gate was still missing. Rest of crossing appears to be in good condition. (A. Freitag - DWR Sutter Yard)07/01/2015 There appears to be a LS gate now but both pipe ends were submerged so it was hard to tell for certain. (A. Freitag - DWR Sutter Yard)05/29/2014 Same as last inspection. (A. Freitag - DWR Sutter Yard)12/09/2013 Pulled sticks from WS flap gate to allow it to close. Ls gate is still missing. (A. Freitag - DWR Sutter Yard)07/10/2013 WS and LS slopes have been cleared of vegetation and are in good condition. LS gate is still missing and WS flap gate is still wedged open with sticks. (A. Freitag - DWR Sutter Yard)04/19/2012 LS gate missing & limited inspection. Need photos of WS & LS cleared slopes. Description calls for slide gate on LS-slide gate missing. Debris scattered near LS headwall. This crossing was listed in the USACE Periodic Inspection report as Corp's Inspect ID# USACE_CESPK_M13J_2011_p_0010 for WS gate wedged open & missing LS slide gate. (O. Magana - DWR UCIP) FIELD_STRUCT_DESC: 36-inch CIPP-lined corrugated metal drainage pipe through the levee, 8.8 feet below the crown. Flap gate on the waterside (WS) end. Slide gate on the landside (LS) end. Concrete "U" headwalls on both ends. [Additional Reference(s): DWR Levee Log, 1993 (HLM 3.85). USACE Sacramento O&M Manual, Unit 519, June 1962, Revised 3 Feb 2011, (HLM 3.85), As-built DWG No. 50-4-3608, Sheet No. 3608/5.2, 19.1, STA 16+85C RT. BK. (Cottonwood), page 5, 20 of 28 electronic file, listed as 36-inch pipe] FS Date: 8/28/2019 1:21:00 PM

Overview looking south on left levee

Headwall and flap gate located on WS toe.

View of channel at crossing looking D/S.

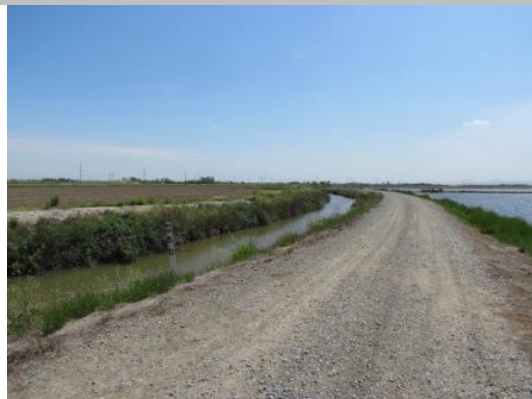
Photo 1 of 1 : SP_2022_MA0013_301_911_20220307_00018.jpg

LM Start	4.04	Rating **	M	Issue No.	911
LM End	4.78	Issue Type +	En	Location *	WS
Category	Earthen Levee			GPS Latitude/Longitude	
				Start	End
Item	Encroachments			39.526653 °	39.534091 °
				-121.699675 °	-121.690404 °
DWR ID	DWR_MA0013_02_s_2012_911				
Comment Code					
DT : Ditch					
Inspector Comment

View of agricultural ditch along the toe.

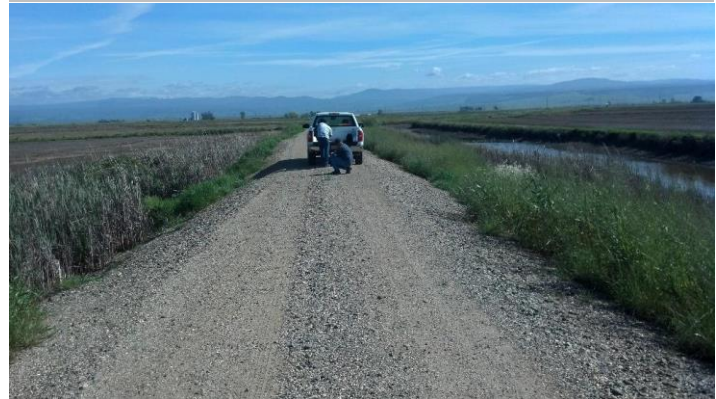
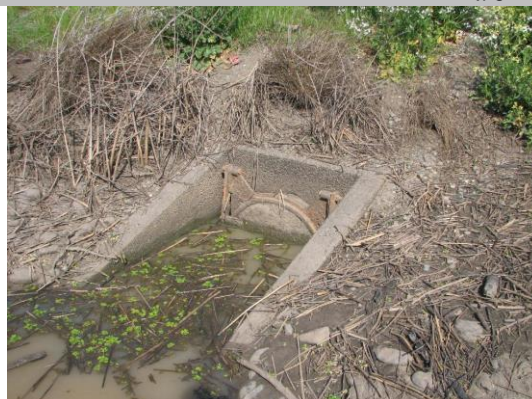
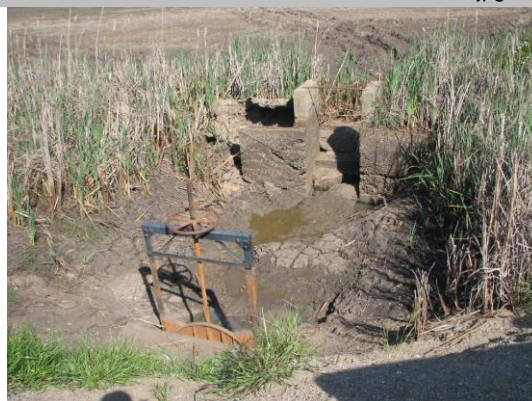
Photo 1 of 3 : UCIP_SP_2022_58530_67115.jpg

Comment Code						
Inspector Comment						
FS_ID:58530 DS_ID:16846 EP_NO: N/A Repair Type: Non-Urgent Crossing Status: Found UCIP Comments: 08/28/2019 Record remains Non-Urgent due to potential levee threat. Minor scour was visible on both WS and LS toe. No permit has been identified authorizing pipe. Pending internal inspection under DMP Phase 1 both inlet and outlet underwater. (O. Magana - DWR UCIP, A. Freitag - DWR Sutter Yard)6/5/2017 Both ends submerged during site visit. Pipe has been selected to be internally cleaned and inspected as part of the DMP project. (A. Freitag - DWR Sutter Yard)11/18/2016 Both pipe ends underwater for this inspection. (A. Freitag - DWR Sutter Yard)04/27/2016 Both pipe ends were underwater for inspection. (A. Freitag - DWR Sutter Yard)07/01/2015 Both pipe ends and gates were fully submerged. (A. Freitag - DWR Sutter Yard)05/29/2014 Same as last inspection. (A. Freitag - DWR Sutter Yard)12/09/2013 Same as last inspection. (A. Freitag - DWR Sutter Yard)07/10/2013 WS slope is cleared of vegetation and is in good condition. Both gates were fully submerged under water and unable to be inspected. (A. Freitag - DWR Sutter Yard)04/19/2012 Rodent activity caused partial collapse on LS of levee in the vicinity of pipe. Limited inspection on WS slope due to dense vegetation. Limited inspection on gates due to both gates submerged under water. (O. Magana - DWR UCIP) FIELD_STRUCT_DESC: 36-inch CIPP-lined corrugated metal drainage pipe through the levee, 9.3 feet below the crown. Flap gate on the waterside (WS) end. Slide gate on the landside (LS) end. Concrete "U" headwalls on both ends. Concrete sump area with flash boards to drain farmers field is located on farmer's property near drain inlet. [Additional Reference(s): DWR Levee Log, 1993 (HLM 4.18). USACE Sacramento O&M Manual, Unit 519, June 1962, Revised 3 Feb 2011, (HLM 4.20), As-built DWG No. 50-4-3608, Sheet No. 3608/19, STA 15+85G RT. BK. (Gold Run), page 20 of 28 electronic file, listed as 36-inch pipe] FS Date: 8/28/2019 1:31:00 PM

Overview looking east on right bank of Cottonwood

Unable to determine condition of flap gate on WS due to high water.

Overview of LS screw gate and concrete sump structure.

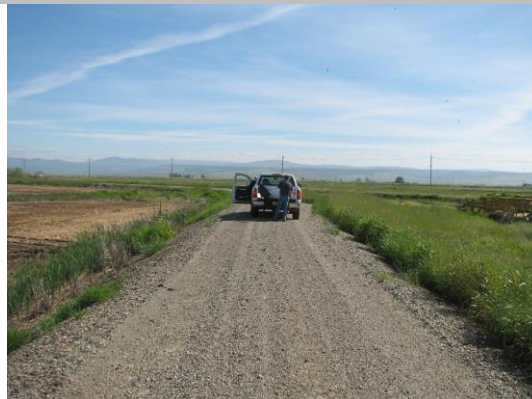
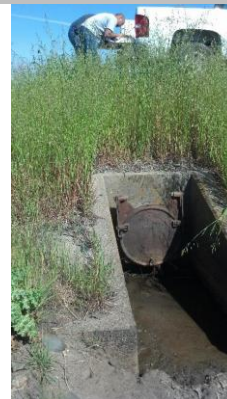
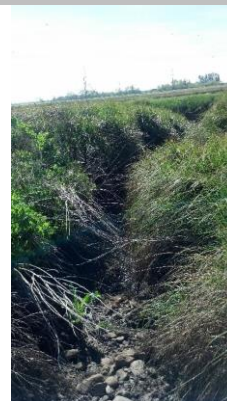
Photo 1 of 3 : UCIP_SP_2022_58532_67119.jpg

Comment Code						
Inspector Comment						
FS_ID:58532 DS_ID:16845 EP_NO: N/A Repair Type: Non-Urgent Crossing Status: Found UCIP Comments: 08/28/2019 Record has been updated from No Action Needed to Non-Urgent, no permit has been identified authorizing pipe. Pipe is scheduled to be lined. (O. Magana - DWR UCIP, A. Freitag - DWR Sutter Yard)06/05/2017 LS Slide gate mostly underwater due to rice field being flooded but crossing appears to be in good condition. Pipe has been selected to be internally cleaned and inspected as part of the DMP project. (A. Freitag - DWR Sutter Yard)11/18/2016 Crossing appears to be in good condition. (A. Freitag - DWR Sutter Yard)04/27/2016 Crossing appears to be in good condition. (A. Freitag - DWR Sutter Yard)07/01/2015 Crossing appears to be in good condition. No noticeable issues to report. (A. Freitag - DWR Sutter Yard)05/29/2014 Same as last inspection. (A. Freitag - DWR Sutter Yard)12/09/2013 Same as last inspection. (A. Freitag - DWR Sutter Yard)07/10/2013 WS slope has been cleared of vegetation and is in good condition. (A. Freitag - DWR Sutter Yard)04/19/2012 Limited inspection due to dense vegetation on WS slope. Need photos of clear WS slope. (O. Magana - DWR UCIP) FIELD_STRUCT_DESC: 24-inch CIPP-lined corrugated metal drainage pipe through the levee, 5.6 feet below the crown. Flap gate on the waterside (WS) end. Slide gate on the landside (LS) end. Concrete "U" headwalls on both ends. [Additional Reference(s): DWR Levee Log, 1993 (HLM 4.69). USACE Sacramento O&M Manual, Unit 519, June 1962, Revised 3 Feb 2011, (HLM 4.69), listed as 24-inch pipe, no As-built reference found] FS Date: 8/28/2019 3:31:00 PM

Overview looking east on right levee of Gold Run Creek (referred to Unit 2 of Cherokee Canal).

Headwall and flap gate located on WS.

View of channel at crossing.

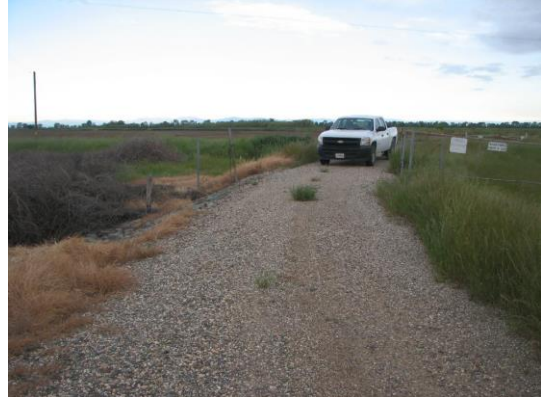
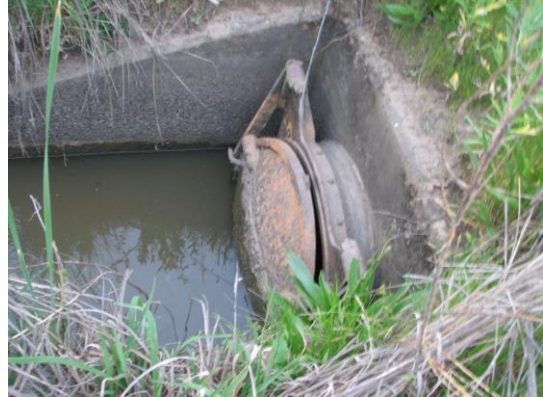
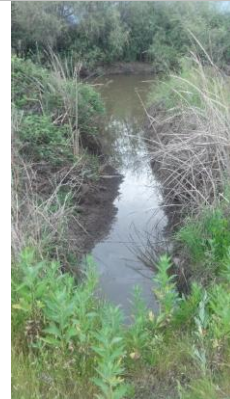
Photo 1 of 3 : UCIP_SP_2022_58533_67131.jpg

Comment Code					
Inspector Comment					
FS_ID:58533 DS_ID:16395 EP_NO: N/A Repair Type: Non-Urgent Crossing Status: Found UCIP Comments: 08/28/2019 Record has been updated from No Action Needed to Non-Urgent, no permit has been identified authorizing pipe. Pipe is scheduled to be lined. (O. Magana - DWR UCIP, A. Freitag - DWR Sutter Yard)06/05/2017 WS mostly submerged but crossing appears to be in good condition. (A. Freitag - DWR Sutter Yard)11/18/2016 Crossing appears to be in good condition. Pipe is a 30" cmp. (A. Freitag - DWR Sutter Yard)04/27/2016 Crossing appears to be in good condition. (A. Freitag - DWR Sutter Yard)06/30/2015 Erosion on LS does not appear to be getting any worse with the rip-rap there. WS pipe end and gate appeared in good condition. (A. Freitag - DWR Sutter Yard)05/29/2014 Same as last inspection. (A. Freitag - DWR Sutter Yard)12/09/2013 Same as last inspection. (A. Freitag - DWR Sutter Yard)07/09/2013 Same as last inspection. (A. Freitag - DWR Sutter Yard)04/19/2012 Rusted pipe debris located on WS. Remove pipe debris on WS and monitor the LS erosion near headwall. Rip-rap used to protect LS headwall from erosion. Was pipe exposed prior to dumping rock? Erosion on the LS could have exposed pipe. Dense shrub on the LS could restrict flow. (O. Magana - DWR UCIP) FIELD_STRUCT_DESC: 30-inch CIPP-lined corrugated metal drainage pipe through the levee, 8.6 feet below the crown. Flap gate on the waterside (WS) end. Concrete "U" headwalls on both ends. [Additional Reference(s): DWR Levee Log, 1993 (HLM 5.06), listed as 3-inch pipe. USACE Sacramento O&M Manual, Unit 519, June 1962, Revised 3 Feb 2011, (HLM 5.06), listed as 30-inch pipe, no As-built reference found] FS Date: 8/28/2019 3:04:00 PM

Overview looking west on the left levee of Cottonwood

Headwall and flap gate located on WS.

View of channel at crossing.

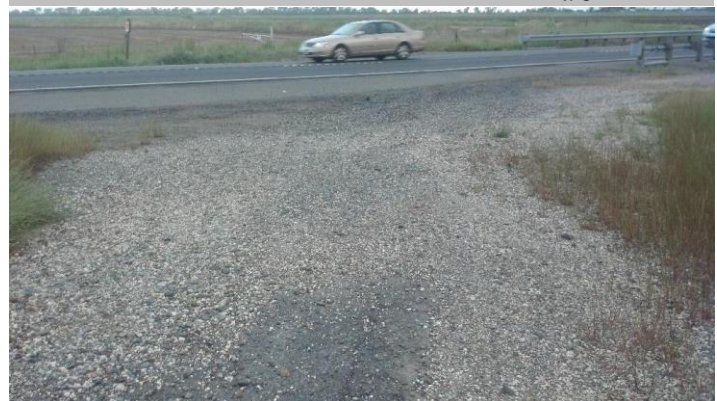
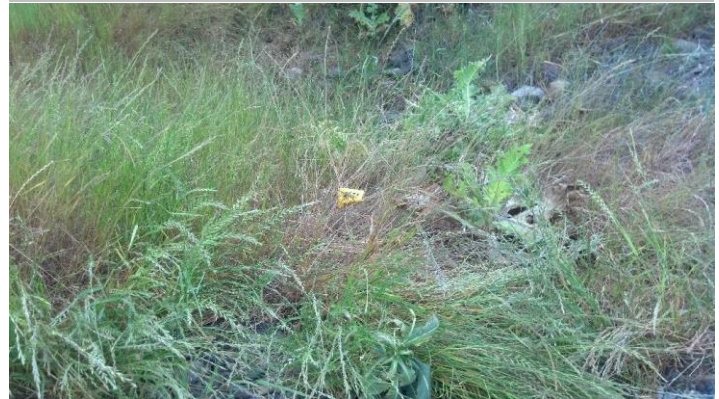
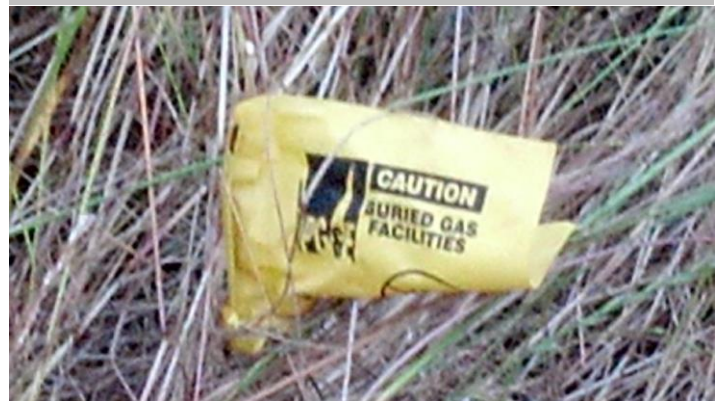
Photo 1 of 3 : UCIP_SP_2022_58534_67132.jpg

FS_ID:58534
DS_ID:16837
EP_NO: N/A
Repair Type: Non-Urgent
Crossing Status: Indicator Found
UCIP Comments: 08/28/2019 Record has been updated from No Action Needed to Non-Urgent, no records were obtained to determine line status. Need to contact owner to obtain maintenance records. (O. Magana - DWR UCIP, A. Freitag - DWR Sutter Yard)06/05/2017 Crossing appears to be in good condition. (A. Freitag - DWR Sutter Yard)11/18/2016 Crossing appears to be in good condition. (A. Freitag - DWR Sutter Yard)04/27/2016 Crossing appears to be in good condition. (A. Freitag - DWR Sutter Yard)06/30/2015 Markers are present. Crossing is in good condition. (A. Freitag - DWR Sutter Yard)05/29/2014 Same as last inspection. (A. Freitag - DWR Sutter Yard)12/09/2013 Same as last inspection. (A. Freitag - DWR Sutter Yard)07/09/2013 New carsonite marker installed with concrete access box on LS about 10 feet east of highway 99. Depth is still unknown. (A. Freitag - DWR Sutter Yard)04/24/2012 Markers not present or visible for hazard line (Health & Safety Issue) unknown depth. Owner is not compliant with Title 23. USA flag located on LS however not visible. No permanent markers available only underground service alert (USA) flags. Active line? Will need to contact PG&E and find out the status of line through levee. (O. Magana - DWR UCIP)

FIELD_STRUCT_DESC: 6-inch steel gas line through the levee unknown depth below the crown. [Additional Reference(s): USACE Sacramento O&M Manual, Unit 519, June 1962, Revised 3 Feb 2011, (HLM 5.08), listed as 6-inch pipe, no As-built reference found]
FS Date: 8/28/2019 3:05:00 PM

Overview looking west from the left levee of Cottonwood

USA indicator located at land side of levee

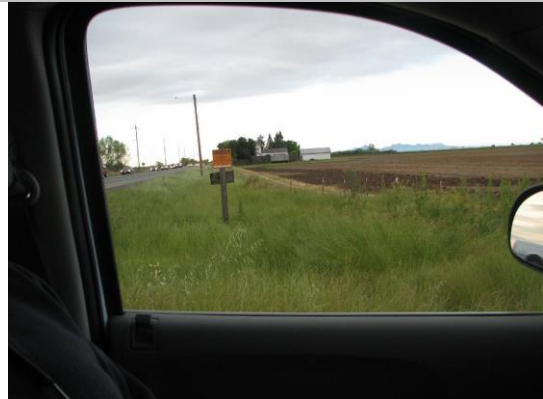
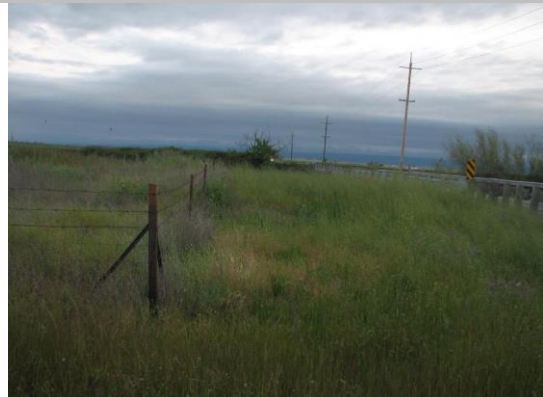
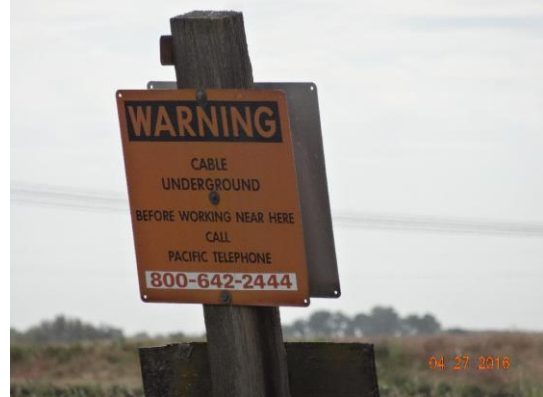
Photo 1 of 3 : UCIP_SP_2022_57645_67136.jpg

Comment Code						
Inspector Comment						
FS_ID:57645 DS_ID:16407 EP_NO: 6084 Repair Type: Non-Urgent Crossing Status: Indicator Found UCIP Comments: 08/28/2019 Record has been updated from No Action Needed to Non-Urgent due to maintenance issues. Sign knocked over. Unable to determine if line has been abandoned. Need to contact owner to make them aware of the sign knocked over and to determine whether line is still in use. (O. Magana - DWR UCIP, A. Freitag - DWR Sutter Yard)06/05/2017 Crossing appears to be in good condition. (A. Freitag - DWR Sutter Yard)11/18/2016 Crossing appears to be in good condition. (A. Freitag - DWR Sutter Yard)04/27/2016 Crossing appears to be in good condition. (A. Freitag - DWR Sutter Yard)06/30/2015 Crossing is in good condition. (A. Freitag - DWR Sutter Yard)05/29/2014 Same as last inspection. (A. Freitag - DWR Sutter Yard)12/09/2013 Same as last inspection. (A. Freitag - DWR Sutter Yard)07/09/2013 Same as last inspection. (A. Freitag - DWR Sutter Yard) FIELD_STRUCT_DESC: Underground telephone cable, 1.5-inch through the levee at approximately 2 feet below the crown. (buried cable across the levees and channels of Cottonwood Creek and Cherokee Canal authorized under Permit No. 6084, 1968 - Pacific Telephone and Telegraph Company [PT&T]) . Contact number for this crossing is 1-800-642-2444. [Additional Reference(s): DWR Levee Log, 1993 (HLM 5.10)] FS Date: 8/28/2019 3:09:00 PM

Underground telephone line indicator on LS of Cottonwood left levee looking South on highway.

Underground telephone line looking North towards highway.

close up of marker sign LS.

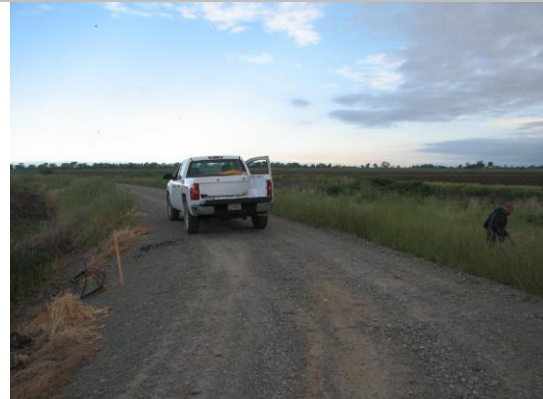
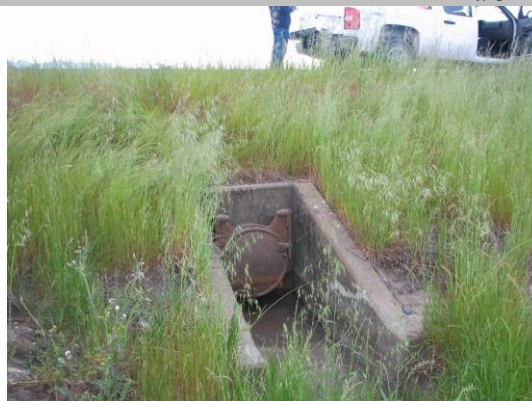
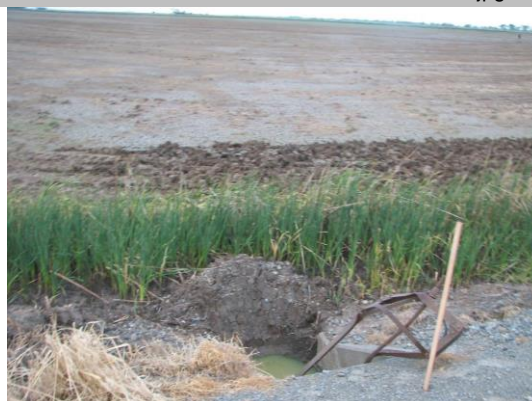
Photo 1 of 3 : UCIP_SP_2022_58574_67138.jpg

Comment Code						
Inspector Comment						
FS_ID:58574 DS_ID:16408 EP_NO: N/A Repair Type: Non-Urgent Crossing Status: Found UCIP Comments: 08/28/2019 Record has been updated from No Action Needed to Non-Urgent, no permit has been identified authorizing pipe. Pipe has been lined. (O. Magana - DWR UCIP, A. Freitag - DWR Sutter Yard)06/05/2017 Crossing appears to be in good condition. Pipe has been selected to be internally cleaned and inspected as part of the DMP project. (A. Freitag - DWR Sutter Yard)11/18/2016 Crossing appears to be in good condition. (A. Freitag - DWR Sutter Yard)04/27/2016 Crossing appears to be in good condition. (A. Freitag - DWR Sutter Yard)06/30/2015 Crossing appears to be in good condition. No apparent issues to report. (A. Freitag - DWR Sutter Yard)05/29/2014 Same as last inspection. (A. Freitag - DWR Sutter Yard)12/09/2013 Same as last inspection. (A. Freitag - DWR Sutter Yard)07/09/2013 WS and LS slopes have been cleared of vegetation and are in good condition. Slide gate on LS has been replaced. (A. Freitag - DWR Sutter Yard)04/24/2012 Slide gate is damaged, needs to be replaced. Limited inspection on WS slope and toe due to dense vegetation. Need photos of clear WS slope and toe. This crossing was listed in the USACE Periodic Inspection report as Corp's inspection ID# USACE_CESPK_M13H_2011_p_0026 for broken gate on LS. (O. Magana - DWR UCIP) FIELD_STRUCT_DESC: 24-inch CIPP-lined corrugated metal drainage pipe through the levee, 5.7 feet below the crown. Flap gate on the waterside (WS). Slide gate on the landside (LS). Concrete "U" headwalls located on both WS and LS ends. [Additional Reference(s): DWR Levee Log, 1993 (HLM 5.13). USACE Sacramento O&M Manual, Unit 519, June 1962, Revised 3 Feb 2011, (HLM 5.13), listed as 24-inch pipe, no As-built reference found] FS Date: 8/28/2019 3:11:00 PM

Overview of levee crown at crossing looking west.

Headwall and flap gate located on WS.

Overview of LS floor is higher in elevation than pipe invert causing build up sediment.

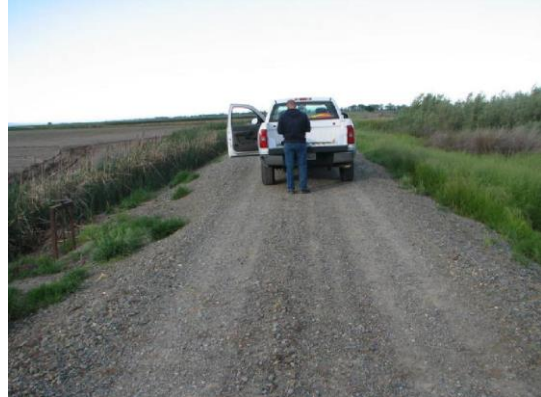
Photo 1 of 3 : UCIP_SP_2022_58536_67146.jpg

Comment Code						
Inspector Comment						
FS_ID:58536 DS_ID:16409 EP_NO: N/A Repair Type: Non-Urgent Crossing Status: Found UCIP Comments: 08/28/2019 Record remains Non-Urgent, no permit has been identified authorizing pipe. Internal inspection under DMP Phase 1 is still pending, both inlet and outlet are underwater. (O. Magana - DWR UCIP, A. Freitag - DWR Sutter Yard)06/05/2017 WS fully submerged and LS slide gate mostly buried by sediment. Pipe has been selected to be internally cleaned and inspected as part of the DMP project. (A. Freitag - DWR Sutter Yard)11/18/2016 There is a flap gate on the WS and a slide gate on the LS. The LS slide gate appears to be partially buried and blocked by vegetation. (A. Freitag - DWR Sutter Yard)04/27/2016 LS slide gate is blocked by vegetation. Pipe appears to not be used. (A. Freitag - DWR Sutter Yard)06/30/2015 WS flap gate was still overgrown with vegetation. Needs to be cleared away. (A. Freitag - DWR Sutter Yard)05/29/2014 Same as last inspection. (A. Freitag - DWR Sutter Yard)12/09/2013 Same as last inspection. (A. Freitag - DWR Sutter Yard)07/09/2013 Same as last inspection. (A. Freitag - DWR Sutter Yard)04/24/2012 Limited inspection on WS slope due to dense vegetation. Need photo of clear WS slope during next inspection. This crossing was listed in the USACE Periodic Inspection report as Corp's inspect ID# USACE_CESPK_M13H_2011_p_0035 non-functional crossing due to overgrown vegetation on WS flap gate. (O. Magana - DWR UCIP) FIELD_STRUCT_DESC: 30-inch CIPP-lined corrugated metal drainage pipe through the levee, 5.8 feet below the crown. Flap gate on the waterside (WS). Slide gate on the landside (LS). Concrete "U" headwalls located on both ends. [Additional Reference(s): DWR Levee Log, 1993 (HLM 5.34). USACE Sacramento O&M Manual, Unit 519, June 1962, Revised 3 Feb 2011, (HLM 5.34), listed as 30-inch pipe, no As-built reference found] FS Date: 8/28/2019 3:22:00 PM

Overview of crossing looking downstream.

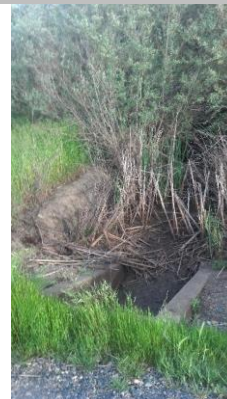
Photo 2 of 3 : UCIP_SP_2022_58536_67149.jpg

View of WS headwall with dense vegetation in channel.

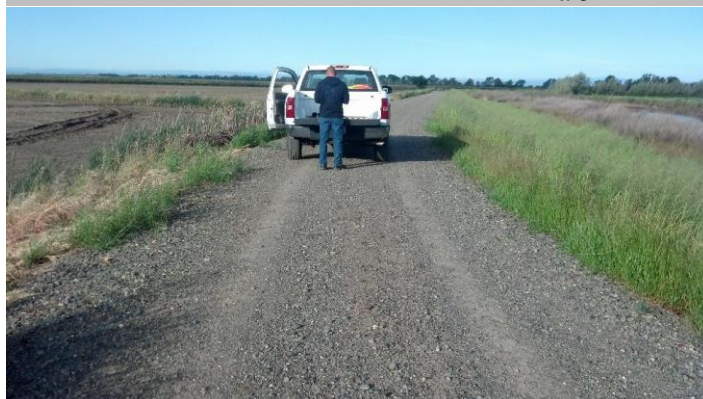
Photo 1 of 3 : UCIP_SP_2022_58537_67152.jpg

FS_ID:58537
DS_ID:16410
EP_NO: N/A
Repair Type: Non-Urgent
Crossing Status: Found
UCIP Comments: 08/28/2019 Record remains Non-Urgent, no permit has been identified authorizing pipe. Pipe remains abandoned through the mid section of the levee. (O. Magana - DWR UCIP, A. Freitag - DWR Sutter Yard)06/05/2017 Abandoned- needs to be done properly. (A. Freitag - DWR Sutter Yard)11/18/2016 Abandoned pipe. It is still present on both sides of the levee and capped on the WS. (A. Freitag - DWR Sutter Yard)04/27/2016 Pipe appears abandoned. Should be removed. (A. Freitag - DWR Sutter Yard)06/30/2015 Pipe still present with the cap on the waterside. (A. Freitag - DWR Sutter Yard)05/29/2014 Same as last inspection. (A. Freitag - DWR Sutter Yard)12/09/2013 Same as last inspection. (A. Freitag - DWR Sutter Yard)07/09/2013 Same as last inspection. (A. Freitag - DWR Sutter Yard)04/24/2012 Limited inspection on WS and LS slope due to dense vegetation. Need photos of clear slopes during next inspection. Metal plate bolted on pipe for closure on WS, open on LS. (O. Magana - DWR UCIP)

FIELD_STRUCT_DESC: 6-inch steel pipe through the levee, 1.6 feet below the crown. Plate bolted on the waterside (WS) end. Open on the landside (LS) end. [Additional Reference(s): DWR Levee Log, 1993 (HLM 5.41). USACE Sacramento O&M Manual, Unit 519, June 1962, Revised 3 Feb 2011, (HLM 5.41), listed as 6-inch pipe, no As-built reference found]
FS Date: 8/28/2019 3:15:00 PM

Overview of site

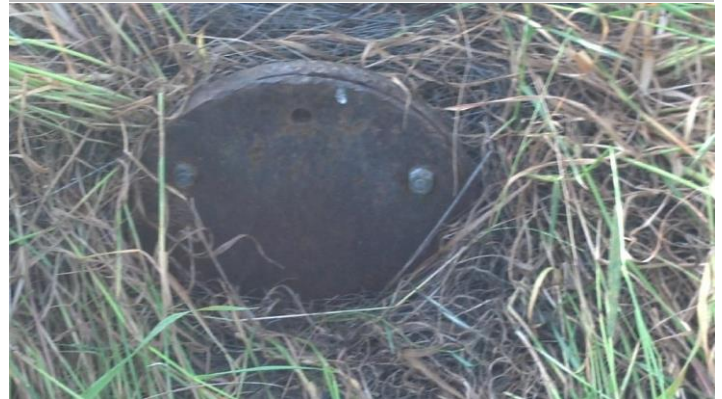
Photo 2 of 3 : UCIP_SP_2022_58537_67150.jpg

Capped irrigation pipe located on water side of levee

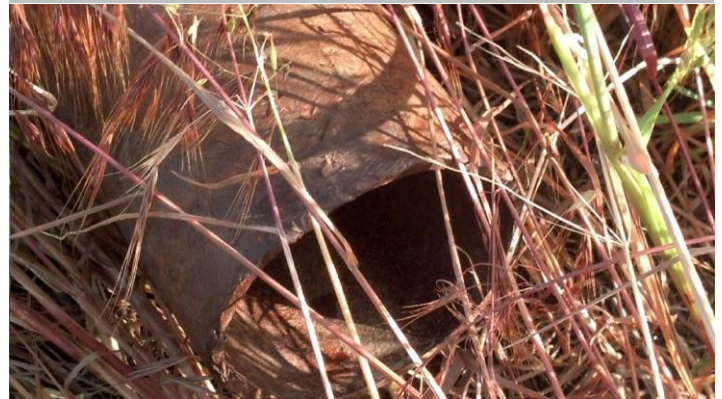
Photo 3 of 3 : UCIP_SP_2022_58537_67151.jpg

Irrigation crossing located on land side of levee
