**Flood Control Project Maintenance
Levee Inspections
LMA District Cover Sheet**

**Flood Control Project Maintenance
Levee Inspections
Unit Cover Sheet**

Waterway			Bank	Unit Miles
Unit No. 01 Cherokee Canal			Right	18.19
	Spring (March - May)	Summer (June - August)	(September - November) Fall	Winter (December - February)
Unit Maintenance Rating (Fall Only)				
Date of Inspection	3/23/2022 - 3/23/2022			
DWR Inspector	Makar Sokol			
Accompanied By

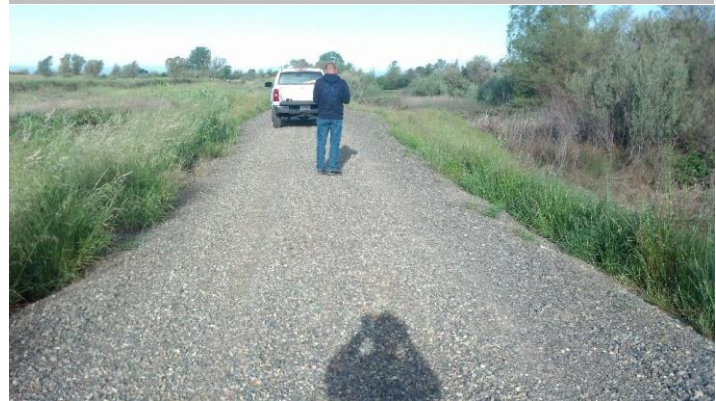
Photo 1 of 3 : UCIP_SP_2022_58538_67155.jpg

FS_ID:58538
DS_ID:16411
EP_NO: N/A
Repair Type: Non-Urgent
Crossing Status: Found
UCIP Comments: 08/28/2019 Record remains Non-Urgent, unable to determine if crossing is in use. Need to audit record to determine if Permit No. 13170 is associated with 36-inch. Slide gate that is supposed to be located on the WS is still missing. Need to check permit 13170 to see if this pipe crossing is also part of permit. (O. Magana - DWR UCIP, A. Freitag - DWR Sutter Yard)06/05/2017 Both ends were underwater but it appears that the LS slide gate is still missing. (A. Freitag - DWR Sutter Yard)11/18/2016 LS slide gate still missing. Both pipe ends were submerged during inspection. (A. Freitag - DWR Sutter Yard)09/27/2016 Crossing has been downgraded from Urgent to Non-Urgent-flap gate on WS is present only LS gate missing. (O. Magana - DWR UCIP)04/27/2016 Both sides of pipe were underwater. Appears that LS gate is still missing. (A. Freitag - DWR Sutter Yard)06/30/2015 Slide gate still missing on the LS. WS appears to be in good condition. (A. Freitag - DWR Sutter Yard)05/29/2014 Same as last inspection. (A. Freitag - DWR Sutter Yard)12/09/2013 Same as last inspection. (A. Freitag - DWR Sutter Yard)07/09/2013 Same as last inspection. (A. Freitag - DWR Sutter Yard)04/24/2012 Slide gate missing on LS. Limited inspection on WS and LS slopes due to dense vegetation. Need photos of cleared WS & LS slopes. This crossing was listed in the USACE Periodic Inspection report as Corp's inspect ID# USACE_CESPK_M13H_2011_p_0017 for missing slide gate. (O. Magana - DWR UCIP)

FIELD_STRUCT_DESC: 36-inch corrugated metal drainage pipe through the levee, 9.2 feet below the crown. Flap gate on the waterside (WS) end. Slide gate on the landside (LS) end. Concrete "U" headwalls located on both WS and LS toes. (secondary permit reference: 48-inch irrigation pipe authorized under Permit No. 13170, 1981 - S. S. Hinaman, Jr., USACE letter covers installation of a 36-inch pipe dated 14 July 1981, Board summary report references 36-inch pipe and not 48-inch pipe)[Additional Reference(s): DWR Levee Log, 1993 (HLM 5.85). USACE Sacramento O&M Manual, Unit 519, June 1962, Revised 3 Feb 2011, (HLM 5.85), As-built DWG No. 50-4-3608, Sheet No. 3608/22.3, STA 19+30 LT. BK. (Cottonwood), page 23 of 28 electronic file, listed as 36-inch pipe; As-built DWG No. 50-4-3037 referenced not available]
FS Date: 8/28/2019 3:17:00 PM

Overview looking south

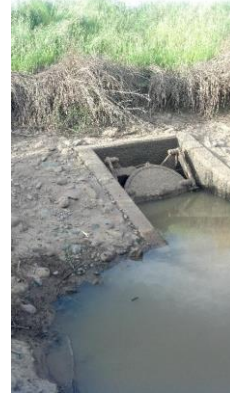
Photo 2 of 3 : UCIP_SP_2022_58538_67157.jpg

Headwall and flap gate on WS.

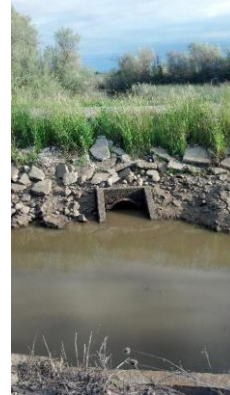
Photo 3 of 3 : UCIP_SP_2022_58538_67156.jpg

Headwall and damaged/missing screw gate on LS.

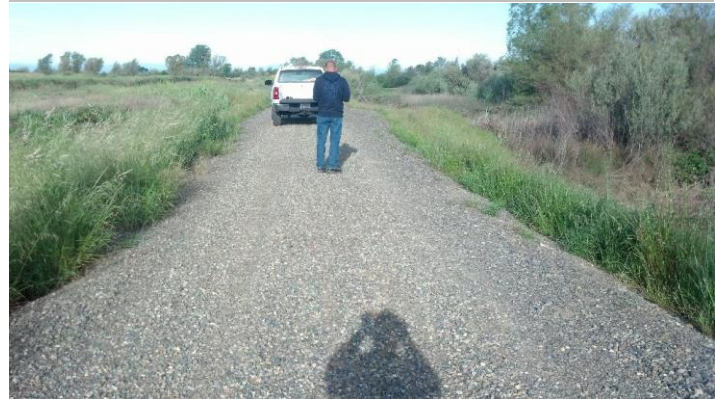
Photo 1 of 3 : UCIP_SP_2022_57650_67158.jpg

FS_ID:57650
DS_ID:16466
EP_NO: 13170
Repair Type: Non-Urgent
Crossing Status: Found
UCIP Comments: 08/28/2019 Record has been updated from No Action Needed to Non-Urgent, pipe appears to be part of a larger system and could have been modified. Flow meter labelled 30-58 located on the canal berm lines up with pipe crossing. Both inlet and outlet were underwater during inspection. Need to contact owner to determine purpose of pipe crossing. No other issues were recorded. (O. Magana - DWR UCIP, A. Freitag - DWR Sutter Yard)06/05/2017 Both pipe ends fully submerged during site visit but crossing appears to be in good condition. Pipe has been selected to be internally cleaned and inspected as part of the DMP project. (A. Freitag - DWR Sutter Yard)11/18/2016 Crossing appears to be in good condition. Both pipe ends were submerged during inspection. (A. Freitag - DWR Sutter Yard)04/27/2016 Both sides of crossing were underwater but appeared in good condition. (A. Freitag - DWR Sutter Yard)06/30/2015 High water on both side of crossing still. Slopes appear in good condition. Both pipe ends and gates were submerged. (A. Freitag - DWR Sutter Yard)05/29/2014 Same as last inspection. (A. Freitag - DWR Sutter Yard)12/09/2013 Same as last inspection. (A. Freitag - DWR Sutter Yard)07/09/2013 Same as last inspection. (A. Freitag - DWR Sutter Yard)04/24/2012 Limited inspection on WS and LS slopes due to dense vegetation. Need photos of cleared WS & LS slopes. This crossing was listed in the USACE Periodic Inspection report as Corp's inspect ID# USACE_CESPK_M13H_2011_p_0058 for high water unable to see crossing. (O. Magana - DWR UCIP)

FIELD_STRUCT_DESC: 36-inch corrugated metal irrigation pipe through the levee approximately 7 feet below the crown. Flap gate is located on the waterside (WS). (48-inch irrigation pipe authorized under Permit No. 13170, 1981 - S. S. Hinaman, Jr., USACE letter covers installation of a 36-inch pipe dated 14 July 1981, Board summary report references 36-inch pipe and not 48-inch pipe)
FS Date: 8/28/2019 3:19:00 PM

Overview photo of crossing looking downstream.

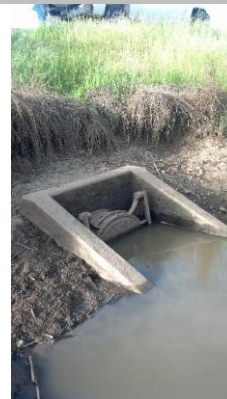
Photo 2 of 3 : UCIP_SP_2022_57650_67159.jpg

Flap gate on WS unable to determine slope condition on WS due to overgrown vegetation.

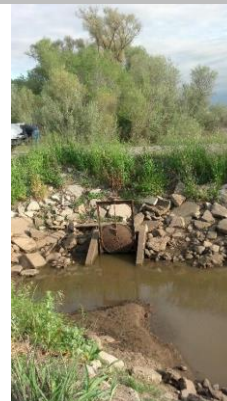
Photo 3 of 3 : UCIP_SP_2022_57650_67160.jpg

Headwall and screw gate on land side of levee

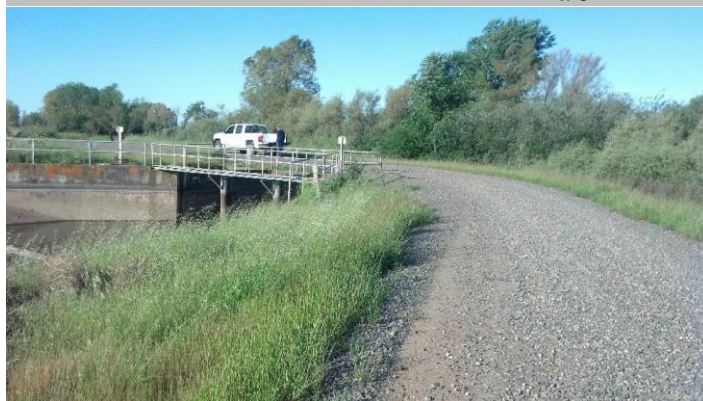
Photo 1 of 3 : UCIP_SP_2022_58539_67164.jpg

Comment Code						
Inspector Comment						
FS_ID:58539 DS_ID:16412 EP_NO: N/A Repair Type: Non-Urgent Crossing Status: Found UCIP Comments: 08/28/2019 Record has been updated from No Action Needed to Non-Urgent, no permit has been identified authorizing structure. (O. Magana - DWR UCIP, A. Freitag - DWR Sutter Yard)06/05/2017 Crossing appears to be in good condition. (A. Freitag - DWR Sutter Yard)11/18/2016 Crossing appears to be in good condition. (A. Freitag - DWR Sutter Yard)04/27/2016 Crossing appears to be in good condition. (A. Freitag - DWR Sutter Yard)06/30/2015 Crossing appears in good condition. No noticeable issues to report. (A. Freitag - DWR Sutter Yard)05/29/2014 Same as last inspection. (A. Freitag - DWR Sutter Yard)12/09/2013 Same as last inspection. (A. Freitag - DWR Sutter Yard)07/09/2013 Same as last inspection. (A. Freitag - DWR Sutter Yard)04/24/2012 Limited inspection on WS slope due to dense vegetation. Need photos of WS slope when cleared. Unable to find WS daylight point. (O. Magana - DWR UCIP) FIELD_STRUCT_DESC: [Western Canal Siphon] 1 of 3: 8-foot by 10-foot concrete irrigation conduit through the levee and channel. Top of concrete conduit 4 feet below the crown. Catwalk and guardrails around headwall. Debris catchment line located at the wings of the headwall. [Additional Reference(s): DWR Levee Log, 1993 (HLM 6.13). USACE Sacramento O&M Manual, Unit 519, June 1962, Revised 3 Feb 2011, (HLM 6.13), listed as three 8-foot by 10-foot concrete conduit, no As-built reference found] FS Date: 8/28/2019 3:26:00 PM

Overview looking south from left levee

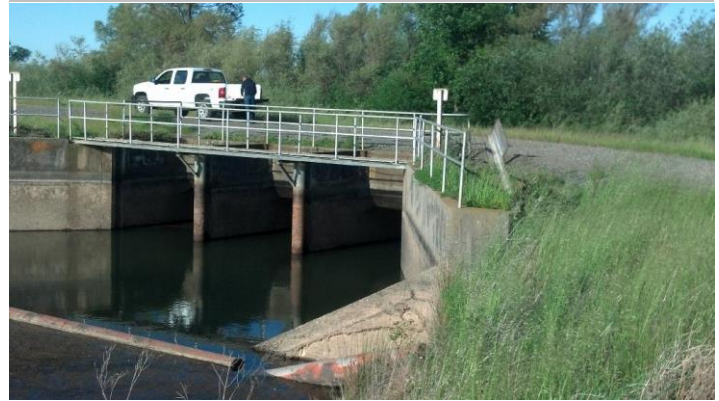
Photo 2 of 3 : UCIP_SP_2022_58539_67165.jpg

View of Western Canal Siphon (Richvale Siphon) on LS.

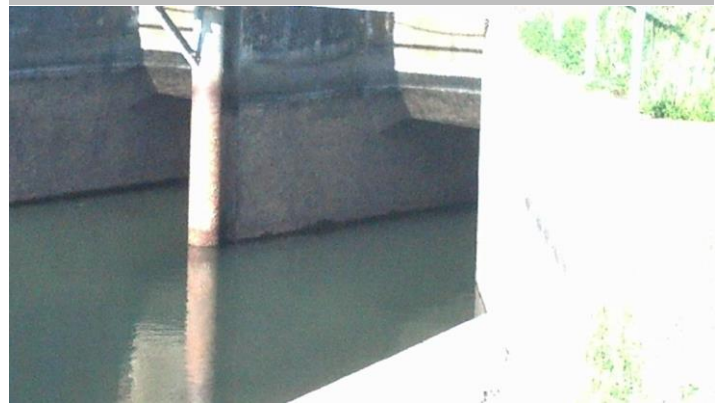
Photo 3 of 3 : UCIP_SP_2022_58539_67162.jpg

1 of 3 Eight (8) foot by Ten (10) foot concrete conduit (upstream conduit).

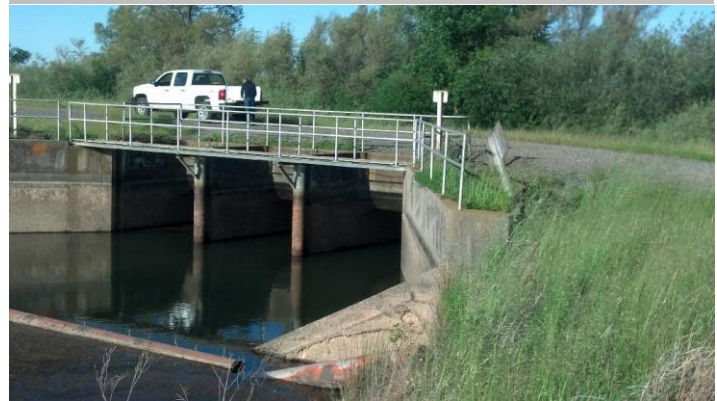
Photo 1 of 3 : UCIP_SP_2022_58540_67169.jpg

Comment Code						
Inspector Comment						
FS_ID:58540 DS_ID:17373 EP_NO: N/A Repair Type: Non-Urgent Crossing Status: Found UCIP Comments: 08/28/2019 Record has been updated from No Action Needed to Non-Urgent, no permit has been identified authorizing structure. (O. Magana - DWR UCIP, A. Freitag - DWR Sutter Yard)06/05/2017 Crossing appears to be in good condition. (A. Freitag - DWR Sutter Yard)11/18/2016 Crossing appears to be in good condition. (A. Freitag - DWR Sutter Yard)04/27/2016 Crossing appears to be in good condition. (A. Freitag - DWR Sutter Yard)06/30/2015 Crossing appears in good condition. No noticeable issues to report. (A. Freitag - DWR Sutter Yard)05/29/2014 Same as last inspection. (A. Freitag - DWR Sutter Yard)12/09/2013 Same as last inspection. (A. Freitag - DWR Sutter Yard)07/09/2013 Same as last inspection. (A. Freitag - DWR Sutter Yard)04/24/2012 Limited inspection on WS slope due to dense vegetation. Need photo of WS slope when cleared. Unable to find WS outlet. (O. Magana - DWR UCIP) FIELD_STRUCT_DESC: [Western Canal Siphon] 2 of 3: 8-foot by 10-foot concrete irrigation conduit through the levee and channel. Top of concrete conduit 4 feet below the crown. Catwalk and guardrails around headwall. Debris catchment line located at the wings of the headwall. All conduits are open. [Additional Reference(s): DWR Levee Log, 1993 (HLM 6.13). USACE Sacramento O&M Manual, Unit 519, June 1962, Revised 3 Feb 2011, (HLM 6.13), listed as three 8-foot by 10-foot concrete conduit, no As-built reference found] FS Date: 8/28/2019 3:55:00 PM

View of Western Canal Siphon (Richvale Siphon) located LS.

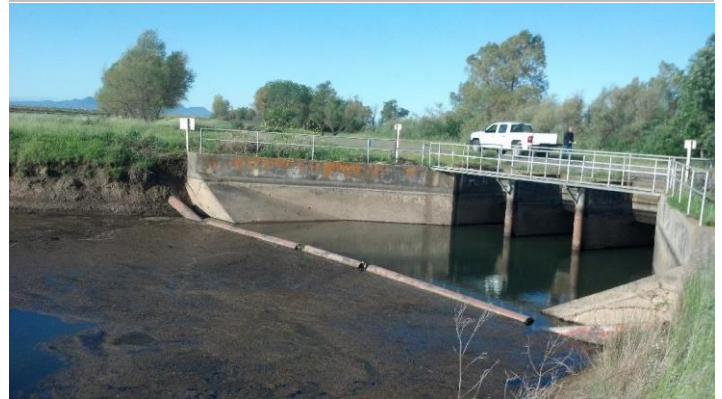
Photo 2 of 3 : UCIP_SP_2022_58540_67168.jpg

Debris catchment line across structure.

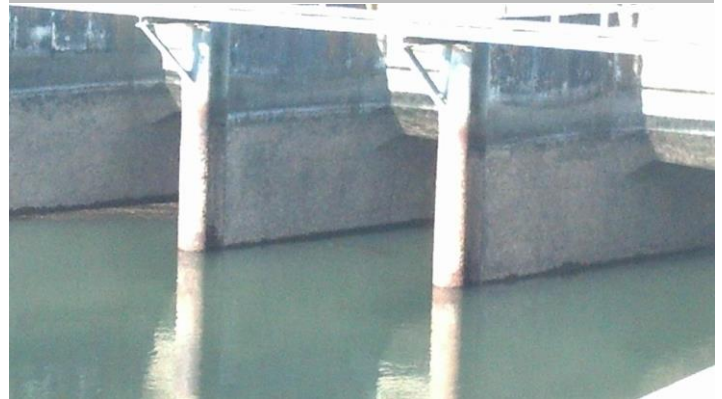
Photo 3 of 3 : UCIP_SP_2022_58540_67166.jpg

2 of 3 Eight (8) foot by Ten (10) foot conduit (middle conduit).

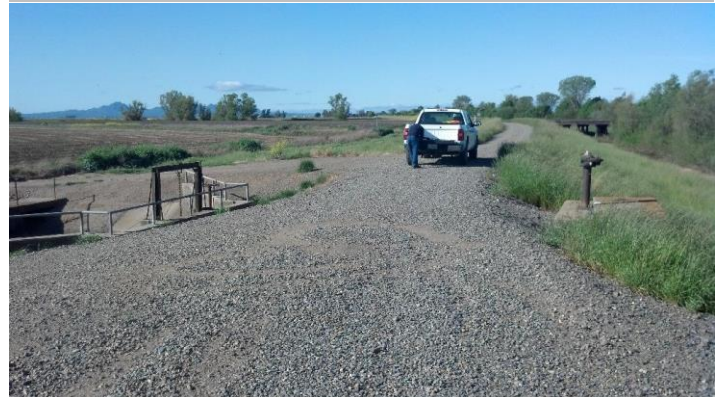
Photo 1 of 3 : UCIP_SP_2022_58545_67212.jpg

Comment Code					
Inspector Comment					
FS_ID:58545 DS_ID:16414 EP_NO: N/A Repair Type: Non-Urgent Crossing Status: Found UCIP Comments: 08/28/2019 Record has been updated from No Action Needed to Non-Urgent, no permit has been identified authorizing structure. (O. Magana - DWR UCIP, A. Freitag - DWR Sutter Yard)06/05/2017 Crossing appears to be in good condition. (A. Freitag - DWR Sutter Yard)11/18/2016 Crossing appears to be in good condition. (A. Freitag - DWR Sutter Yard)04/27/2016 Crossing appears to be in good condition. (A. Freitag - DWR Sutter Yard)06/30/2015 Crossing appears in good condition. No noticeable issues to report. (A. Freitag - DWR Sutter Yard)05/28/2014 Same as last inspection. (A. Freitag - DWR Sutter Yard)12/04/2013 Same as last inspection. (A. Freitag - DWR Sutter Yard)07/09/2013 Same as last inspection. (A. Freitag - DWR Sutter Yard) FIELD_STRUCT_DESC: [Richvale Irrigation District Siphon] 1 of 3: 6-foot by 6.5-foot reinforced concrete irrigation culverts through the levee, 17.5 feet below the crown. Concrete "U" headwall with slots for flashboards on the landside (LS). Slide gate in gate well on downstream culvert on the waterside (WS) slope. Access well on downstream culvert 60 feet from the WS toe, manhole flush with the top of the ground. 36-inch corrugated metal pipe through the levee, 11.2 feet below the crown. Flap gate on the WS end. Concrete "U" headwalls on both ends. This pipe drains excess water from the District's canal into Cherokee Canal. The pipe runs through the levee on an angle and discharges opposite historic levee mile (HLM) 9.58. Richvale Irrigation District siphon crosses the channel and levee. [Additional Reference(s): DWR Levee Log, 1993 (HLM 9.66). USACE Sacramento O&M Manual, Unit 519, June 1962, Revised 3 Feb 2011, (HLM 9.66), listed as three 6-foot by 6.5-foot concrete conduit, As-built DWG No. 50-4-3608, Sheet No. 3608/20, ~ STA 650+00E, page 21 of 28 electronic file, listed as conduit] FS Date: 8/28/2019 4:04:00 PM

Overview of crossing looking downstream at the left bank of Cherokee Canal.

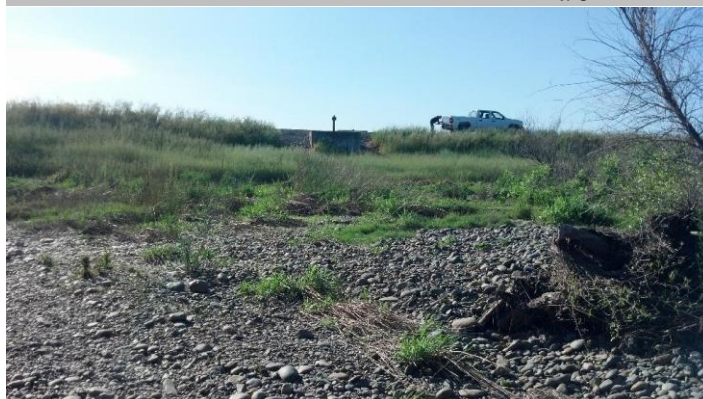
Photo 2 of 3 : UCIP_SP_2022_58545_67214.jpg

View of crossing looking from the channel towards WS levee. Access well is covered by vegetation right corner.

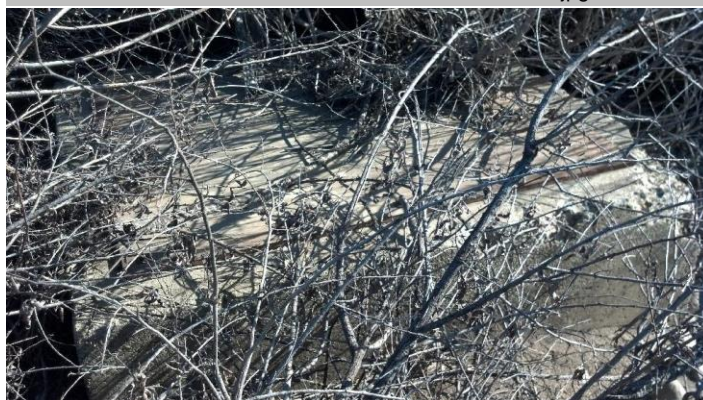
Photo 3 of 3 : UCIP_SP_2022_58545_67213.jpg

WS view, close up of access well located approximately 60 feet from WS toe.

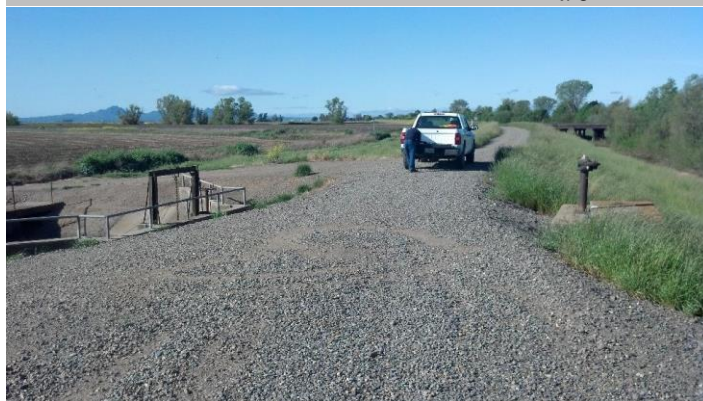
Photo 1 of 3 : UCIP_SP_2022_58546_67231.jpg

Comment Code						
Inspector Comment						
FS_ID:58546 DS_ID:17522 EP_NO: N/A Repair Type: Non-Urgent Crossing Status: Found UCIP Comments: 08/28/2019 Record has been updated from No Action Needed to Non-Urgent, no permit has been identified authorizing structure. (O. Magana - DWR UCIP, A. Freitag - DWR Sutter Yard)06/05/2017 Crossing appears to be in good condition. (A. Freitag - DWR Sutter Yard)11/18/2016 Crossing appears to be in good condition. (A. Freitag - DWR Sutter Yard)04/27/2016 Crossing appears to be in good condition. (A. Freitag - DWR Sutter Yard)06/30/2015 Crossing appears in good condition. No noticeable issues to report. (A. Freitag - DWR Sutter Yard)05/28/2014 Same as last inspection. (A. Freitag - DWR Sutter Yard)12/04/2013 Same as last inspection. (A. Freitag - DWR Sutter Yard)07/09/2013 Same as last inspection. (A. Freitag - DWR Sutter Yard) FIELD_STRUCT_DESC: [Richvale Irrigation District Siphon] 2 of 3: 6-foot by 6.5-foot concrete culvert through the levee, 17.5 feet below the crown. Concrete "U" headwalls with slots for flashboards on the landside (LS). Slide gate in gate well on downstream culvert on the waterside (WS) slope. Access well on downstream culvert 60 feet from the WS toe, manhole flush with the top of the ground. 36-inch corrugated metal pipe through the levee, 11.2 feet below the crown. Flap gate on the WS end. Concrete "U" headwalls on both ends. This pipe drains excess water from the District's canal into Cherokee Canal. The pipe runs through the levee on an angle and discharges opposite historic levee mile (HLM) 9.58. Richvale Irrigation District siphon crosses the channel and levee. [Additional Reference(s): DWR Levee Log, 1993 (HLM 9.66). USACE Sacramento O&M Manual, Unit 519, June 1962, Revised 3 Feb 2011, (HLM 9.66), listed as three 6-foot by 6.5-foot concrete conduit, As-built DWG No. 50-4-3608, Sheet No. 3608/20, ~ STA 650+00E, page 21 of 28 electronic file, listed as conduit] FS Date: 8/28/2019 4:02:00 PM

Overview of crossing looking downstream at Cherokee Canal.

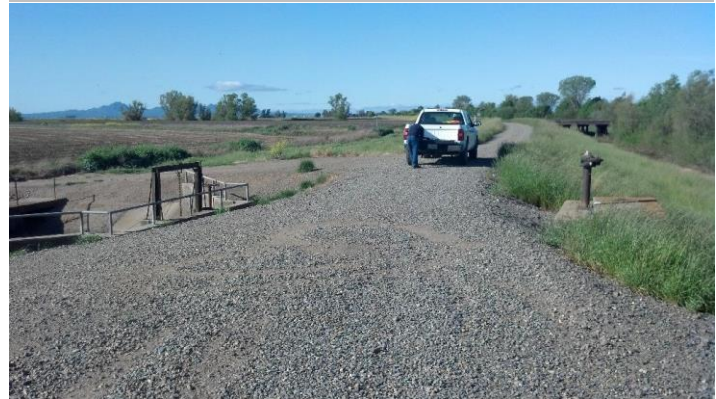
Photo 1 of 3 : UCIP_SP_2022_58547_67265.jpg

Comment Code					
Inspector Comment					
FS_ID:58547 DS_ID:17523 EP_NO: N/A Repair Type: Non-Urgent Crossing Status: Found UCIP Comments: 08/28/2019 Record has been updated from No Action Needed to Non-Urgent, no permit has been identified authorizing structure. (O. Magana - DWR UCIP, A. Freitag - DWR Sutter Yard)06/05/2017 Crossing appears to be in good condition. (A. Freitag - DWR Sutter Yard)11/18/2016 Crossing appears to be in good condition. (A. Freitag - DWR Sutter Yard)04/27/2016 Crossing appears to be in good condition. (A. Freitag - DWR Sutter Yard)06/30/2015 Crossing appears in good condition. No noticeable issues to report. (A. Freitag - DWR Sutter Yard)05/28/2014 Same as last inspection. (A. Freitag - DWR Sutter Yard)12/04/2013 Same as last inspection. (A. Freitag - DWR Sutter Yard)07/09/2013 Same as last inspection. (A. Freitag - DWR Sutter Yard) FIELD_STRUCT_DESC: [Richvale Irrigation District Siphon] 3 of 3: 6-foot by 6.5-foot concrete irrigation culvert through the levee, 17.5 feet below the crown. Concrete "U" headwalls with slots for flashboards on the landside (LS). Slide gate in gate well on downstream culvert on the waterside (WS) slope. Access well on downstream culvert 60 feet from the WS toe, manhole flush with the top of the ground. 36-inch corrugated metal pipe through the levee, 11.2 feet below the crown. Flap gate on the WS end. Concrete "U" headwalls on both ends. This pipe drains excess water from the District's canal into Cherokee Canal. The pipe runs through the levee on an angle and discharges opposite historic levee mile (HLM) 9.58. Richvale Irrigation District siphon crosses the channel and levee. [Additional Reference(s): DWR Levee Log, 1993 (HLM 9.66). USACE Sacramento O&M Manual, Unit 519, June 1962, Revised 3 Feb 2011, (HLM 9.66), listed as three 6-foot by 6.5-foot concrete conduit, As-built DWG No. 50-4-3608, Sheet No. 3608/20, ~ STA 650+00E, page 21 of 28 electronic file, listed as conduit] FS Date: 8/28/2019 4:03:00 PM

Overview of crossing looking downstream at the left bank of Cherokee Canal.

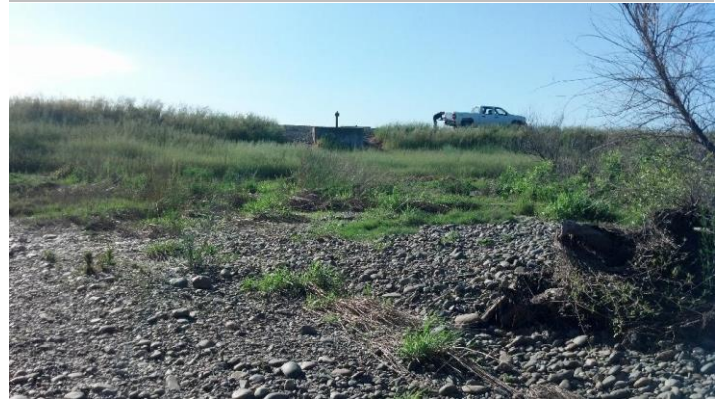
Photo 2 of 3 : UCIP_SP_2022_58547_67263.jpg

View of crossing looking from the channel towards WS levee. Access well is covered by vegetation right corner.

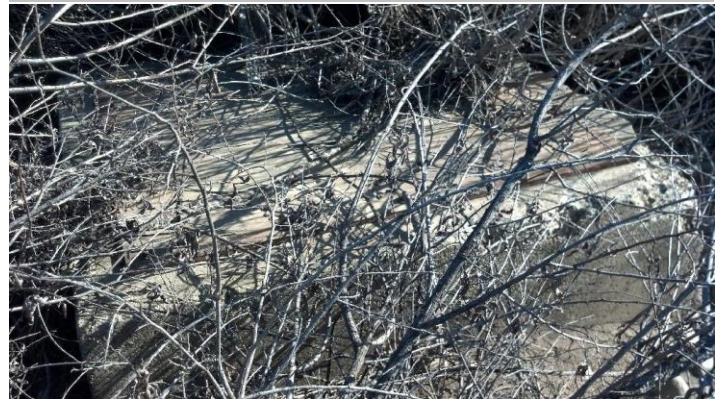
Photo 3 of 3 : UCIP_SP_2022_58547_67267.jpg

WS view, close up of access well located approximately 60 feet from WS toe.

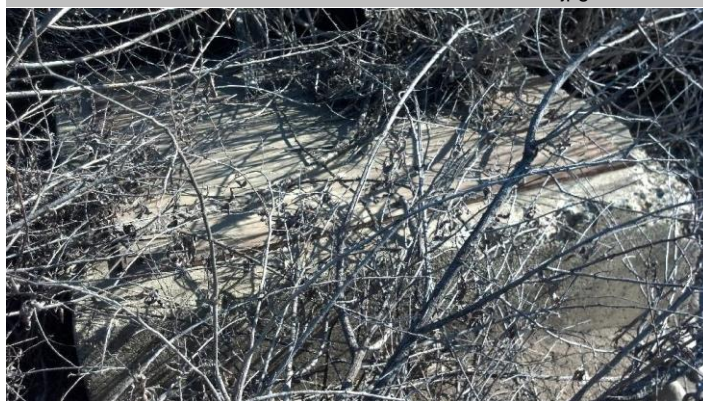
Photo 3 of 3 : UCIP_SP_2022_58548_67283.jpg

WS view-access well located 60 feet from WS toe.

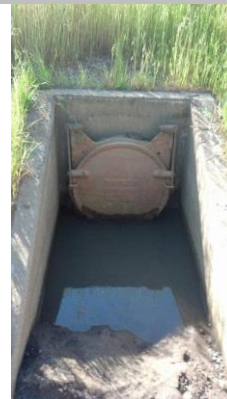
Photo 1 of 3 : UCIP_SP_2022_58549_67289.jpg

Comment Code						
Inspector Comment						
FS_ID:58549 DS_ID:16839 EP_NO: N/A Repair Type: Non-Urgent Crossing Status: Found UCIP Comments: 08/28/2019 Record has been updated from No Action Needed to Non-Urgent, no permit has been identified authorizing structure. (O. Magana - DWR UCIP, A. Freitag - DWR Sutter Yard)06/05/2017 Crossing appears to be in good condition. (A. Freitag - DWR Sutter Yard)11/18/2016 Crossing appears to be in good condition. (A. Freitag - DWR Sutter Yard)04/27/2016 Crossing appears to be in good condition. (A. Freitag - DWR Sutter Yard)06/30/2015 WS flap gate is silted over and unable to open. Needs to be dug out. (A. Freitag - DWR Sutter Yard)05/28/2014 Same as last inspection. (A. Freitag - DWR Sutter Yard)12/04/2013 Slopes were cleared of vegetation and are in good condition. (A. Freitag - DWR Sutter Yard)07/09/2013 Same as last inspection. (A. Freitag - DWR Sutter Yard)04/24/2012 Limited inspection on WS and LS slopes due to dense vegetation. Need photos of WS and LS slopes during next inspection with cleared slopes. (O. Magana - DWR UCIP) FIELD_STRUCT_DESC: 30-inch CIPP-lined corrugated metal drainage pipe through the levee, 11.5 feet below the crown. Flap gate on the waterside (WS). [Additional Reference(s): USACE Sacramento O&M Manual, Unit 519, June 1962, Revised 3 Feb 2011, (HLM 9.68), As-built DWG No. 50-4-3608, Sheet No. 3608/20, ~ STA 648+82E, page 21 of 28 electronic file, listed as 30-inch; As-built DWG No. 50-4-3037 referenced not available] FS Date: 8/28/2019 4:05:00 PM

WS view of crossing. Dense vegetation along WS slope limited visual inspection. (WS Photo 1 of 2)

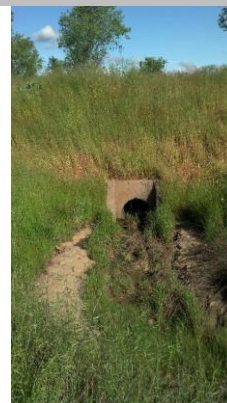
Photo 3 of 3 : UCIP_SP_2022_58549_67286.jpg

View of crossing from LS. Dense vegetation along LS slope limited visual inspection. (LS Photo 1 of 2)

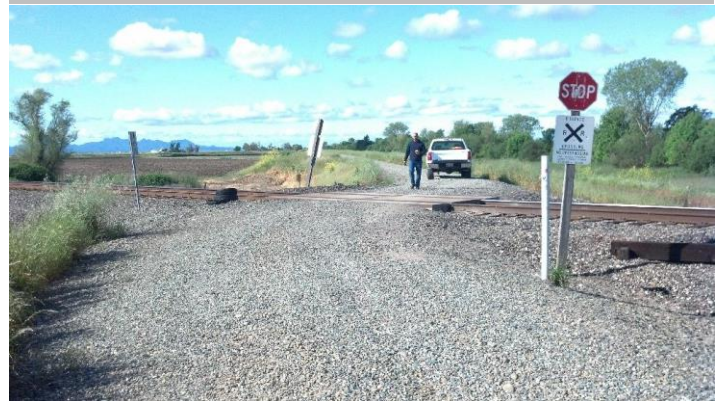
Photo 1 of 3 : UCIP_SP_2022_57670_67292.jpg

FS_ID:57670
DS_ID:18912
EP_NO: N/A
Repair Type: Non-Urgent
Crossing Status: Indicator Found
UCIP Comments: 08/28/2019 Record remains Non-Urgent, no permit has been found authorizing this encroachment. Marker down on WS shoulder. (O. Magana - DWR UCIP, A. Freitag - DWR Sutter Yard)06/05/2017 Crossing appears to be in good condition. (A. Freitag - DWR Sutter Yard)11/18/2016 Crossing appears to be in good condition. Another marker was found/photographed near the LS toe. Crossing also appears to cross through the Unit1 levee around CLM8.860. (A. Freitag - DWR Sutter Yard)04/27/2016 Crossing appears to be in good condition. (A. Freitag - DWR Sutter Yard)06/30/2015 Crossing is in good condition. (A. Freitag - DWR Sutter Yard)05/28/2014 Same as last inspection. (A. Freitag - DWR Sutter Yard)12/04/2013 Same as last inspection. (A. Freitag - DWR Sutter Yard)07/09/2013 Same as last inspection. (A. Freitag - DWR Sutter Yard)04/24/2012 Unable to determine if crossing is an authorized or unauthorized encroachment. Unable to find permit number for this encroachment. Will need to coordinate with LMA Superintendent and DWR-Inspector, photo includes utility contact information. (O. Magana - DWR UCIP)

FIELD_STRUCT_DESC: Buried communication line of unknown material through the levee at an unknown depth below the crown. Owner of line is Qwest Communications 1-800 At Fiber Sign ID Number 16601 as indicated by marker. (Qwest Communication) No permit has been identified since crossing was field discovered in 2012.
FS Date: 8/28/2019 4:08:00 PM

Overview of levee crown at crossing.

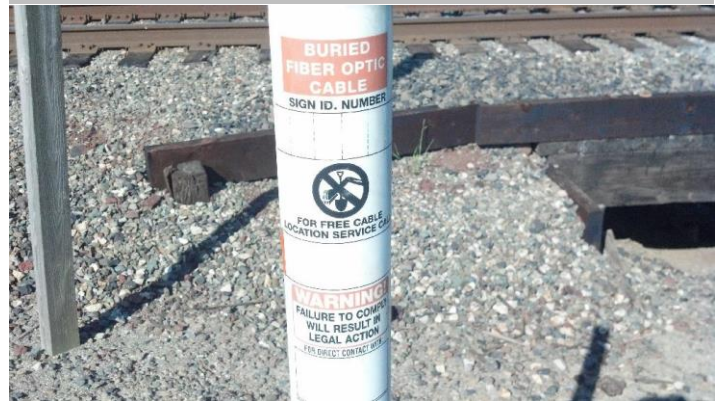
Photo 2 of 3 : UCIP_SP_2022_57670_67291.jpg

Marker for buried fiber optic cable on WS.

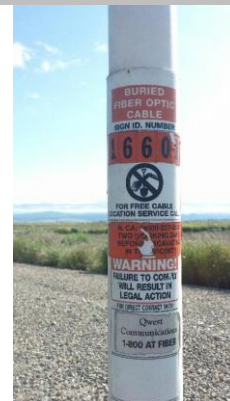
Photo 3 of 3 : UCIP_SP_2022_57670_67290.jpg

Marker for buried fiber optic cable on LS with contact information.

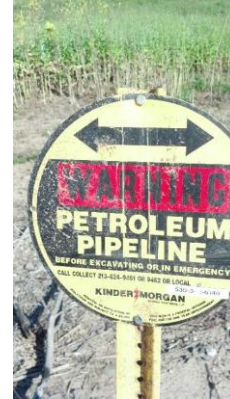
Photo 2 of 3 : UCIP_SP_2022_57671_67294.jpg

WS marker with utility contact information.

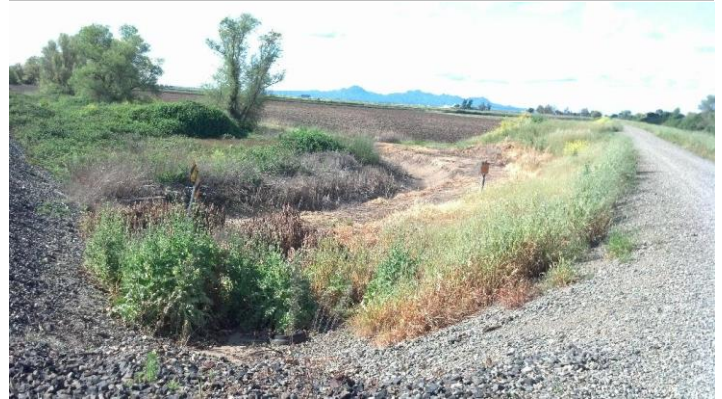
Photo 3 of 3 : UCIP_SP_2022_57671_67293.jpg

View of LS slope and marker.

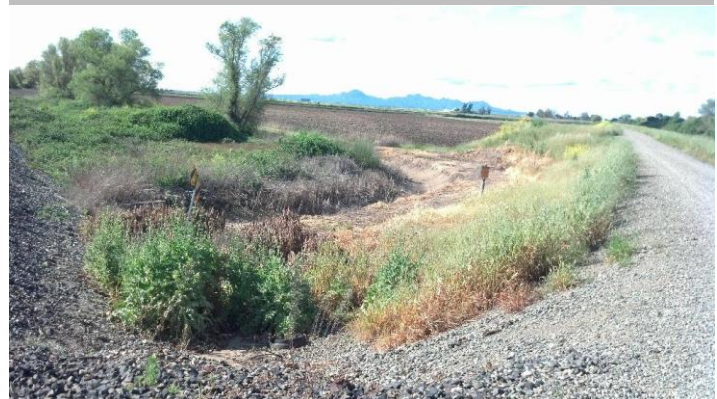
Photo 2 of 3 : UCIP_SP_2022_57672_67300.jpg

Marker located on LS.

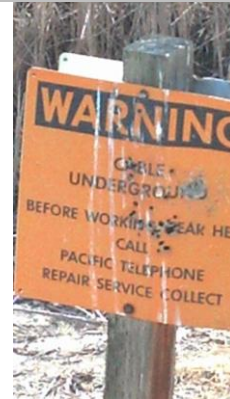
Photo 3 of 3 : UCIP_SP_2022_57672_67298.jpg

Underground cable marker with contact information.

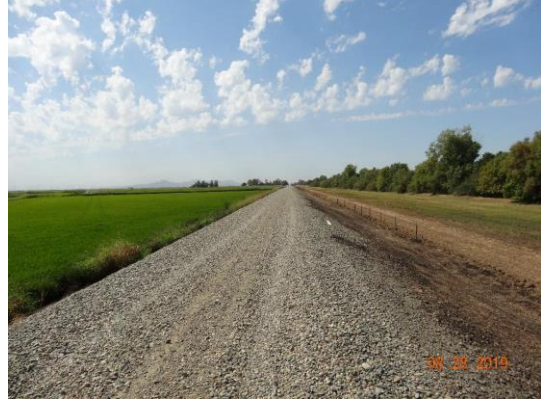
Photo 1 of 3 : UCIP_SP_2022_57673_80923.jpg

Comment Code					
Inspector Comment					
FS_ID:57673 DS_ID:17731 EP_NO: 16994 Repair Type: Non-Urgent Crossing Status: Not Found UCIP Comments: 08/28/2019 Record remains Non-Urgent, no crossing found. Will need to review permit in detail to determine status of crossing. (O. Magana - DWR UCIP, A. Freitag - DWR Sutter Yard)06/05/2017 Unable to locate. (A. Freitag - DWR Sutter Yard)11/18/2016 Unable to locate. (A. Freitag - DWR Sutter Yard)04/27/2016 Unable to locate. (A. Freitag - DWR Sutter Yard)06/30/2015 Unable to locate. (A. Freitag - DWR Sutter Yard)05/28/2014 Same as last inspection. (A. Freitag - DWR Sutter Yard)12/04/2013 Unable to locate. (A. Freitag - DWR Sutter Yard)07/09/2013 Same as last inspection. Unable to locate any signs of this crossing. (A. Freitag - DWR Sutter Yard)04/24/2012 Unable to find any indicators for this crossing. It appears that this encroachment was not built. Check again during next inspection. (O. Magana - DWR UCIP) FIELD_STRUCT_DESC: 10-inch high-density polyethylene (HDPE) communication conduit through the levee, unknown depth below the crown. Conduit contains fiber-optic cables that goes across and under (bored) Cherokee Canal and its levees. Twelve inner ducts through casing with hand holes placed at each end for initial and future installation of fiber optic telecommunications cable. (10-inch HDPE conduit across and under (bored) Cherokee Canal and its levees authorized under Permit No. 16994, 2000 - Level 3 Comm) FS Date: 8/28/2019 4:10:00 PM

Overview of levee crown looking d/s towards where crossing should be.

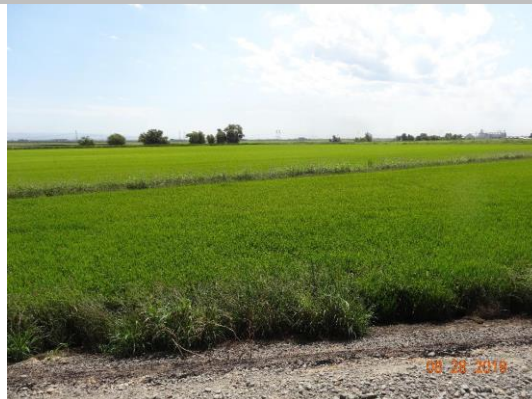
Photo 2 of 3 : UCIP_SP_2022_57673_80925.jpg

LS view: overview of LS.

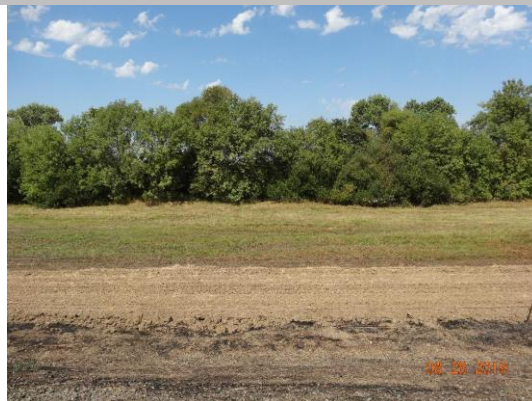
Photo 3 of 3 : UCIP_SP_2022_57673_80926.jpg

WS view: overview of WS.

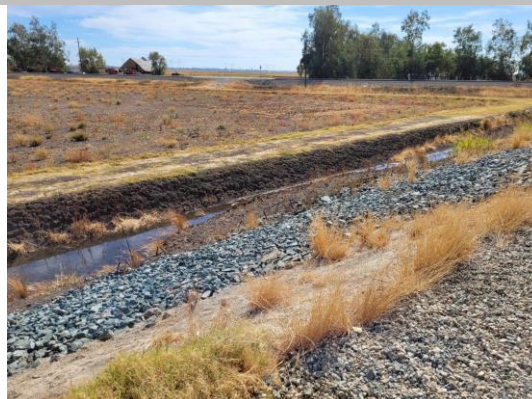
Photo 1 of 1 : SP_2022_MA0013_301_13_20220307_00002.jpg

LM Start	10.03	Rating **	M	Issue No.	13
LM End	10.52	Issue Type +	En	Location *	LS
Category	Earthen Levee			GPS Latitude/Longitude	
				Start	End
Item	Encroachments			39.471517 °	39.465113 °
				-121.739433 °	-121.743592 °
DWR ID	DWR_MA0013_02_s_2012_13				
Comment Code					
DT : Ditch					
Inspector Comment

View of the agricultural ditch along the toe. Fall 2021.

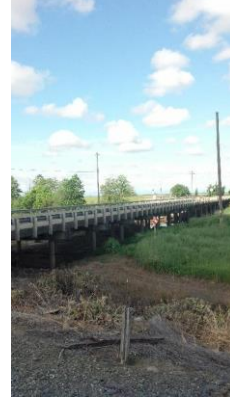
Photo 1 of 3 : UCIP_SP_2022_58550_67332.jpg

Item	DWR UCIP Field Study		39.464710 °	39.464710 °								
			-121.743810 °	-121.743810 °								
DWR ID	16406											
Comment Code												
Inspector Comment												
<p>FS_ID:58550 DS_ID:16406 EP_NO: 1238 Repair Type: Non-Urgent Crossing Status: Indicator Found UCIP Comments: 08/29/2019 Record has been updated from No Action Needed to Non-Urgent, no maintenance records were made available to determine condition of line through the levee. Need to obtain maintenance records to determine status of crossing. (O. Magana - DWR UCIP, A. Freitag - DWR Sutter Yard)06/05/2017 Crossing appears to be in good condition. (A. Freitag - DWR Sutter Yard)11/17/2016 Crossing appears to be in good condition. (A. Freitag - DWR Sutter Yard)04/26/2016 Crossing appears to be in good condition. (A. Freitag - DWR Sutter Yard)06/30/2015 Crossing appears in good condition. (A. Freitag - DWR Sutter Yard)05/28/2014 Same as last inspection. (A. Freitag - DWR Sutter Yard)12/04/2013 Same as last inspection. (A. Freitag - DWR Sutter Yard)07/08/2013 Same as last inspection. (A. Freitag - DWR Sutter Yard)04/24/2012 Permit was approved for 6-5/8 inch diameter not 8 inch. The permit granted permission to construct pipe to cross Cherokee Canal, Butte Creek, Clear Creek, & Ash Creek. The O&M manual list an 8 inch steel gas line at HLM 10.67, unable to determine if the gas line is the same crossing. Will need to contact applicant to obtain records. (O. Magana - DWR UCIP) FIELD_STRUCT_DESC: 8-inch steel gas pipe through the levee at an unknown depth below the crown. Utility marker visible at the upstream and downstream face of highway bridge and along highway. Buried utility crosses bridge and crosses left bank of Cherokee Canal downstream of highway bridge. USA marking on highway indicate 6" STL LN 151. (Permit No. 1238, 1947 - Pacific Gas and Electric Company [PG&E]) [Additional Reference(s): DWR Levee Log, 1993 (HLM 10.67). USACE Sacramento O&M Manual, Unit 519, June 1962, Revised 3 Feb 2011, (HLM 10.67), listed as 8-inch pipe, As-built DWG No. 50-4-3511, Sheet No. 3511/25.1, STA 597+05E, page 25 of 31 electronic file, listed as gas line through both levees] FS Date: 8/29/2019 7:30:00 AM</p>

Utility marker is located near the upstream face of the highway bridge.

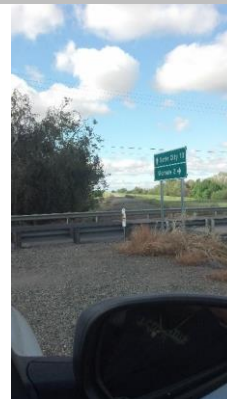
Photo 2 of 3 : UCIP_SP_2022_58550_67333.jpg

Utility is angled. Alignment crosses highway.

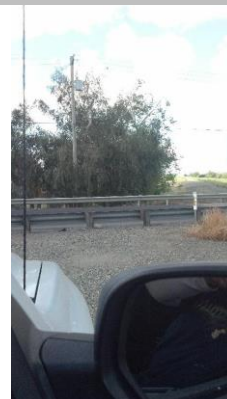
Photo 3 of 3 : UCIP_SP_2022_58550_67331.jpg

Downstream utility marker is located across highway.

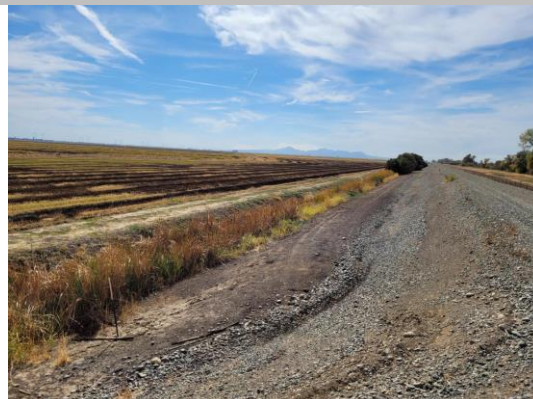
Photo 1 of 1 : SP_2022_MA0013_301_18_20220307_00003.jpg

LM Start	10.59	Rating **	M	Issue No.	18
LM End	11.66	Issue Type +	En	Location *	LS
Category	Earthen Levee			GPS Latitude/Longitude	
				Start	End
Item	Encroachments			39.464305 °	39.450333 °
				-121.744172 °	-121.753157 °
DWR ID	DWR_MA0013_02_s_2012_18				
Comment Code					
DT : Ditch					
Inspector Comment

View of the agricultural ditch along the landside toe. Fall 2021.

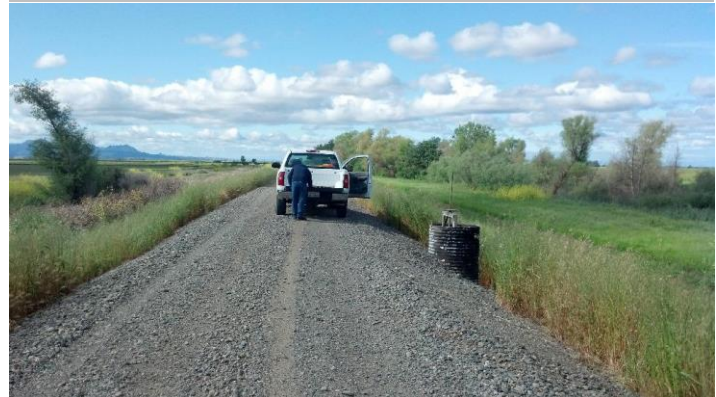
Photo 1 of 3 : UCIP_SP_2022_58551_67336.jpg

FS_ID:58551
DS_ID:16385
EP_NO: N/A
Repair Type: Non-Urgent
Crossing Status: Found
UCIP Comments: 08/29/2019 Record remains Non-Urgent, no permit has been identified authorizing pipe. Need to change structure type from drainage to irrigation siphon. This crossing is associated with DSID 16334 in Unit 1. LS slide gate was under water during inspection. This structure is not maintained or operated by LMA-DWR Sutter Yard. (O. Magana - DWR UCIP, A. Freitag - DWR Sutter Yard)05/30/2017 WS end cannot be located due to heavy vegetation. LS screw gate was mostly submerged during site visit. Pipe has been selected to be internally cleaned and inspected as part of the DMP project. (A. Freitag - DWR Sutter Yard)11/17/2016 WS still heavily vegetated and cannot access the WS pipe end for inspection. Vegetation needs to be cleared back. (A. Freitag - DWR Sutter Yard)04/26/2016 LS headwall was visible but gate was underwater. WS still heavily vegetated and unable to be inspected. Vegetation needs to be cleared back. (A. Freitag - DWR Sutter Yard)06/30/2015 WS heavily vegetated passed the toe-road and could not make it to the WS pipe end for inspection. Vegetation needs to be cleared back. LS pipe end was fully submerged under water. (A. Freitag - DWR Sutter Yard)05/28/2014 Same as last inspection. (A. Freitag - DWR Sutter Yard)12/04/2013 Same as last inspection. (A. Freitag - DWR Sutter Yard)07/08/2013 LS slope has been cleared of vegetation and is in good condition. LS headwall is now visible but mostly underwater so unable to do full inspection. WS is still vegetated. (A. Freitag - DWR Sutter Yard)04/24/2012 LS pipe & slide gate sedimented in. Limited inspection WS and LS slopes due to dense vegetation. Need photos of cleared WS and LS slopes during next inspection. This crossing was listed in the USACE Periodic Inspection report as Corp's inspect ID# USACE_CESPK_M13F_2011_p_0147 for limited visibility of LS and WS. (O. Magana - DWR UCIP)

FIELD_STRUCT_DESC: 30-inch corrugated metal drainage pipe through the levee, 13 feet below the crown. Slide gate in corrugated metal pipe riser on the waterside (WS) slope. Slide gate in ditch on the landside (LS). Pipe under channel is a 24-inch siphon. [Additional Reference(s): DWR Levee Log, 1993 (HLM 13.02). USACE Sacramento O&M Manual, Unit 519, June 1962, Revised 3 Feb 2011, (HLM 13.03), listed as 30-inch pipe, As-built DWG No. 50-4-3511, Sheet No. 3511/9.3, 24.1, STA 474+13E, page 9, 24 of 31 electronic file, listed as combination of new 30-inch section pipe through the levee and existing 24-inch concrete siphon pipe through the channel (Keller Siphon structure, irrigation facilities); As-built DWG No. 50-4-3037 referenced not available]
FS Date: 8/29/2019 7:31:00 AM

Overview of crossing looking downstream at the left bank of Cherokee Canal.

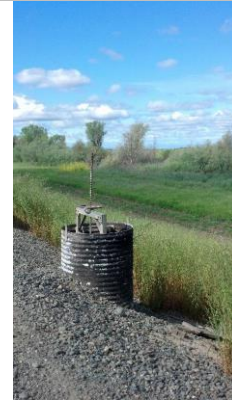
Photo 2 of 3 : UCIP_SP_2022_58551_67337.jpg

Stand pipe with screw gate WS

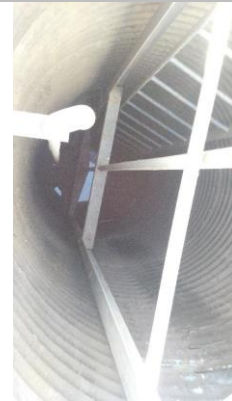
Photo 3 of 3 : UCIP_SP_2022_58551_67335.jpg

View of the inside of the WS stand pipe. No obstructions blocking slide gate.

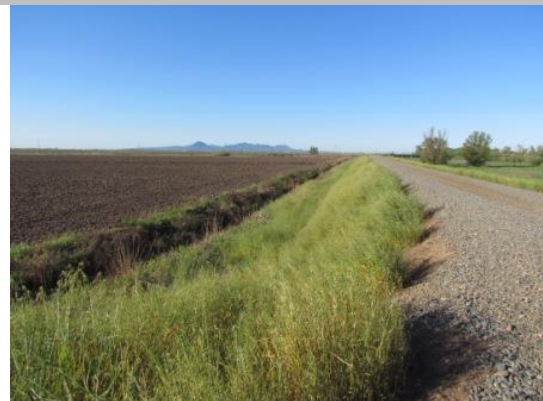
Photo 1 of 1 : SP_2022_MA0013_301_19_20220307_00004.jpg

LM Start	13.40	Rating **	M	Issue No.	19
LM End	16.00	Issue Type +	En	Location *	LS
Category	Earthen Levee			GPS Latitude/Longitude	
				Start	End
Item	Encroachments			39.428192 °	39.414202 °
				-121.768443 °	-121.781863 °
DWR ID	DWR_MA0013_02_s_2012_19				
Comment Code					
DT : Ditch					
Inspector Comment

View of the agricultural ditch along the toe.

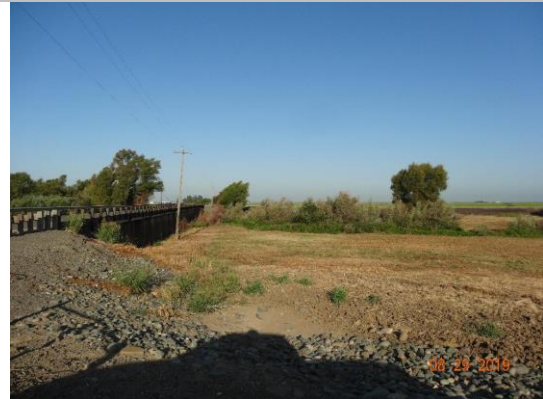
Photo 1 of 3 : UCIP_SP_2022_57654_80938.jpg

Comment Code						
Inspector Comment						
FS_ID:57654 DS_ID:16474 EP_NO: 17030 Repair Type: Non-Urgent Crossing Status: Not Found UCIP Comments: 08/29/2019 Record has been updated from No Action Needed to Non-Urgent, crossing is not found. Need to contact owner to determine status of crossing. Need to determine status of pipe through the levee. (O. Magana - DWR UCIP, A. Freitag - DWR Sutter Yard)05/30/2017 Unable to locate. (A. Freitag - DWR Sutter Yard)11/17/2016 Unable to locate. (A. Freitag - DWR Sutter Yard)04/26/2016 Unable to locate. (A. Freitag - DWR Sutter Yard)06/30/2015 Unable to locate. (A. Freitag - DWR Sutter Yard)05/28/2014 Same as last inspection. (A. Freitag - DWR Sutter Yard)12/04/2013 Unable to locate. (A. Freitag - DWR Sutter Yard)07/08/2013 Same as last inspection. Unable to locate. (A. Freitag - DWR Sutter Yard) FIELD_STRUCT_DESC: 8-inch high density polyethylene (HDPE), contains three 2-inch and three 1.5-inch fiber optic cables, backfilled with bentonite on the ends of the bore casing through the levee at an unknown depth below the crown. Conduit is bored across and under Cherokee Canal and its levees. Permit records indicates the conduit is buried 5 feet below the bottom of the low flow of the channel. Permit indicates work was completed as shown in submitted plans. Owner is listed in the permit as Pacific Fiber Link LLC but permit Inspection sheets list Worldwide Fiber. (three 2-inch and three 1.5-inch pipes containing fiber optic cables across and under (bored) Cherokee Canal and its levees authorized under Permit No. 17030, 2000 - Worldwide Fiber) FS Date: 8/29/2019 7:32:00 AM

WS view: overview of WS. No signs of crossing.

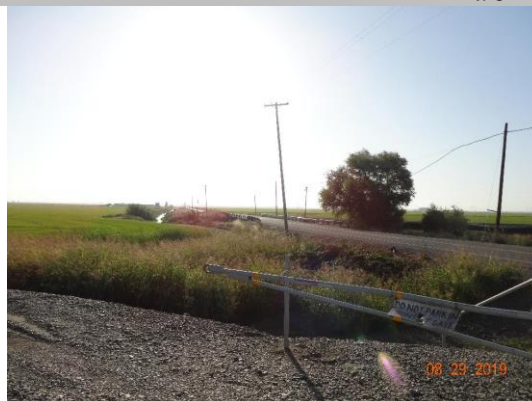
Photo 2 of 3 : UCIP_SP_2022_57654_80939.jpg

LS view: overview of LS. No signs of crossing.

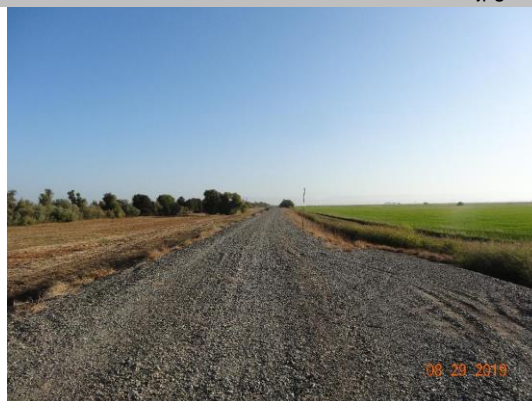
Photo 3 of 3 : UCIP_SP_2022_57654_80940.jpg

Overview of levee crown looking u/s towards where pipe should cross.

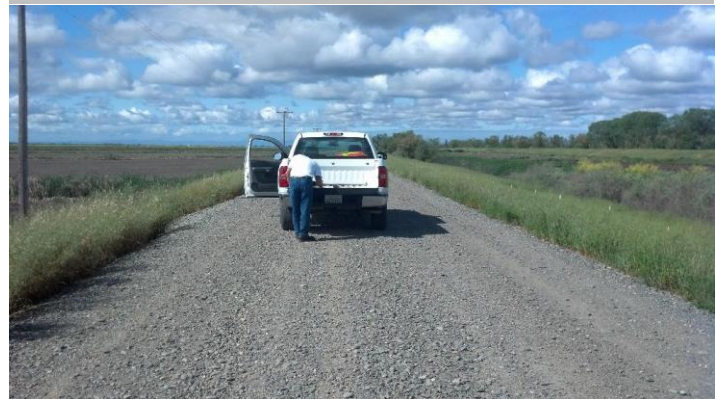
Photo 1 of 3 : UCIP_SP_2022_58552_67341.jpg

FS_ID:58552
DS_ID:16376
EP_NO: N/A
Repair Type: Non-Urgent
Crossing Status: Found
UCIP Comments: 08/29/2019 Record remains Non-Urgent, no permit has been identified authorizing pipe. Crossing appears abandoned. LMA will need to coordinate with landowner to determine is drainage structure is still needed. DMP internal inspection shows that 90% of the pipe is filled with soil at a length of about 42 feet from WS flap gate. If crossing is not in use anymore, crossing will need to be abandoned properly or removed. DMP internal video inspection has not found pipe integrity issues. LOF of crossing is less or equal to 4. Recommend next video inspection in 5 years. (O. Magana - DWR UCIP, A. Freitag - DWR Sutter Yard)05/30/2017 LS pipe end is buried and location unknown. WS flap gate is bolted shut. Pipe has been selected to be internally cleaned and inspected as part of the DMP project. (A. Freitag - DWR Sutter Yard)11/17/2016 Unable to locate LS pipe end. WS flap gate bolted shut. (A. Freitag - DWR Sutter Yard)04/26/2016 LS inlet appears to be buried as could not locate it. WS flap gate was bolted shut. This appears to be an abandoned crossing. (A. Freitag - DWR Sutter Yard)06/30/2015 Still unable to locate the LS pipe end. (A. Freitag - DWR Sutter Yard) 05/28/2014 Same as last inspection. (A. Freitag - DWR Sutter Yard)12/04/2013 Same as last inspection. WS flap gate was bolted shut to keep LS rice field flooded. (A. Freitag - DWR Sutter Yard)07/08/2013 WS slope has been cleared of vegetation and is in good condition. LS slope also cleared of vegetation but still very dense on LS toe and unable to locate LS headwall. (A. Freitag - DWR Sutter Yard)04/24/2012 Could not find LS end of pipe. Limited inspection on WS and LS slopes and toe due to dense vegetation. Need photos of cleared WS and LS slopes, and LS headwall during next inspection. This crossing was listed in the USACE Periodic Inspection report as Corp's inspect ID# USACE_CESPK_M13E_2011_p_0011 for WS gate blocked by vegetation. (O. Magana - DWR UCIP)

Overview of crossing looking downstream at the left bank of Cherokee Canal.

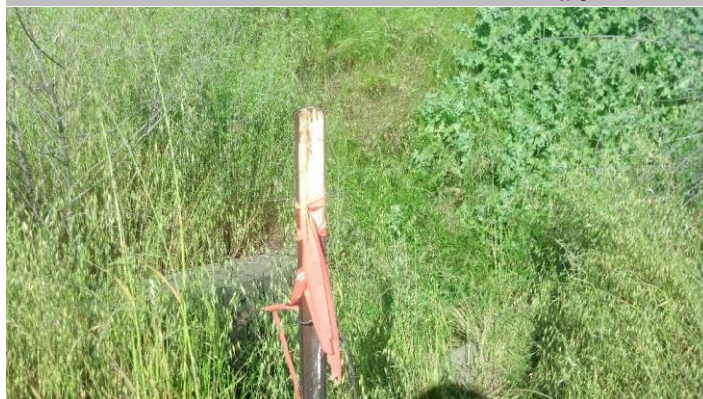
Photo 2 of 3 : UCIP_SP_2022_58552_67343.jpg

Dense vegetation covering the majority of the WS. WS headwall difficult to see through dense vegetation.

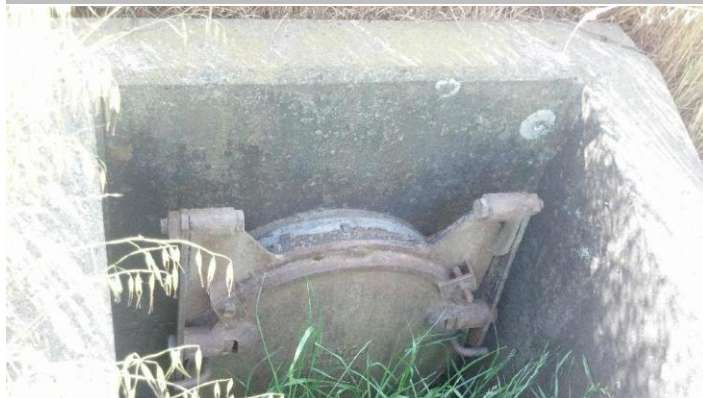
Photo 3 of 3 : UCIP_SP_2022_58552_67342.jpg

View of WS headwall and flap gate.

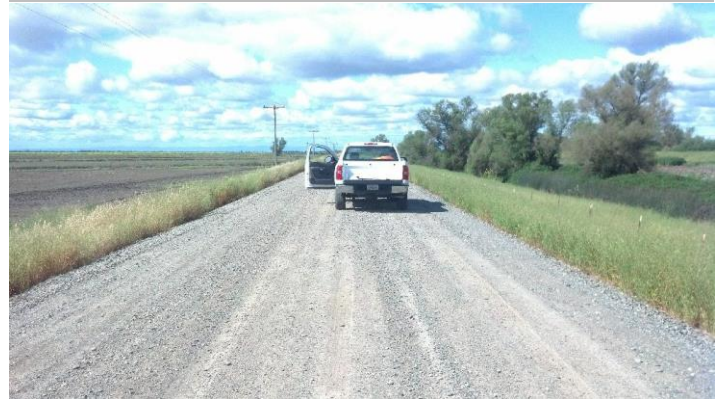
Photo 1 of 3 : UCIP_SP_2022_58553_67352.jpg

FS_ID:58553
DS_ID:16382
EP_NO: N/A
Repair Type: Non-Urgent
Crossing Status: Found
UCIP Comments: 08/29/2019 Record remains Non-Urgent, structure is non-functional and abandoned. Structure is abandoned. LMA will need to coordinate with landowner to determine if pipe is still needed as drainage structure. Dense vegetation covers the WS outlet and only LS headwall is visible at LS toe. If structure is no longer needed then structure will need to be abandoned properly or removed according to Title 23. DWR DMP internal inspection shows pipe has been filled with grout starting at about 47 feet from WS flap gate. No permit has been identified authorizing pipe. DMP internal video inspection has not found pipe integrity issues. LOF of crossing is less or equal to 4. Recommend next video inspection in 5 years. (O. Magana - DWR UCIP, A. Freitag - DWR Sutter Yard)05/30/2017 LS pipe end is buried and location unknown. WS flap gate bolted shut. Pipe has been selected to be internally cleaned and inspected as part of the DMP project. (A. Freitag - DWR Sutter Yard)11/17/2016 Unable to locate LS pipe end. WS flap gate bolted shut. (A. Freitag - DWR Sutter Yard)04/26/2016 Appears to be an abandoned crossing. LS pipe end was still buried and WS flap gate was bolted shut. (A. Freitag - DWR Sutter Yard)06/30/2015 LS headwall still buried somewhere. WS looked to be in good condition. (A. Freitag - DWR Sutter Yard)05/28/2014 Same as last inspection. (A. Freitag - DWR Sutter Yard)12/04/2013 Same as last inspection. (A. Freitag - DWR Sutter Yard)07/08/2013 Same as last inspection. (A. Freitag - DWR Sutter Yard)04/24/2012 LS headwall buried. Limited inspection on WS and LS slopes due to dense vegetation. Need photos of cleared WS and LS slopes during next inspection. Need to determine the status of LS headwall. This crossing was listed in the USACE Periodic Inspection report as Corp's inspect ID# USACE_CESPK_M13E_2011_p_0022 -- unknown issue. (O. Magana - DWR UCIP)

FIELD_STRUCT_DESC: 24-inch corrugated metal drainage pipe through the levee, 9 feet below the crown. Flap gate located on the waterside (WS) end. Concrete "U" headwalls on both WS and landside (LS). WS gate bolted shut and LS crossing is non-operable (inlet not found). Additional Reference(s): DWR Levee Log, 1993 (HLM 15.87). USACE Sacramento O&M Manual, Unit 519, June 1962, Revised 3 Feb 2011, (HLM 15.87), As-built DWG No. 50-4-3511, Sheet No. 3511/8.3, STA 392+42E, page 8 of 31 electronic file, listed as 24-inch CMP; As-built DWG No 50-4-3037 referenced not available]
FS Date: 8/29/2019 7:33:00 AM

Overview of crossing looking downstream of the left bank of Cherokee

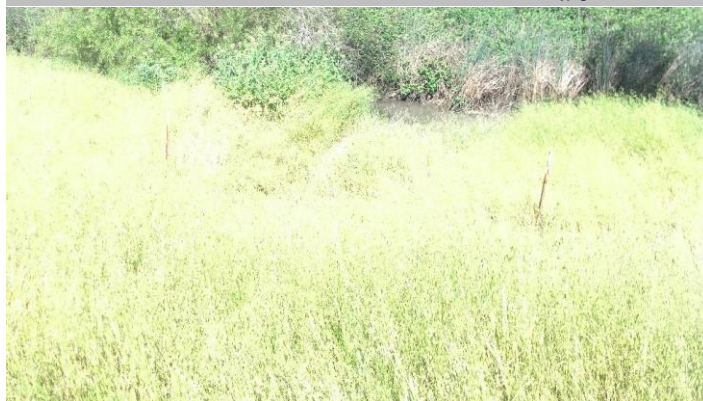
Photo 2 of 3 : UCIP_SP_2022_58553_67351.jpg

View of WS slope. Limited inspection due to the dense vegetation.

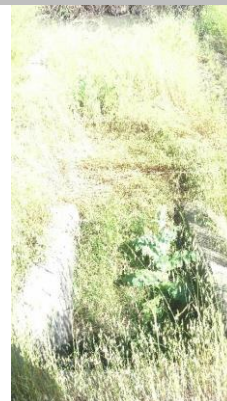
Photo 3 of 3 : UCIP_SP_2022_58553_67350.jpg

View of WS headwall.

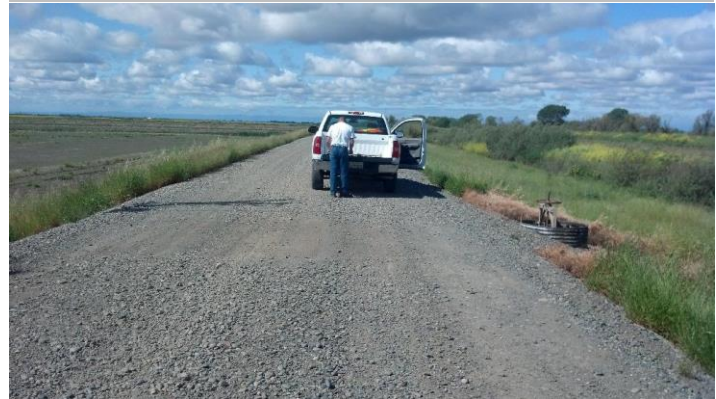
Photo 1 of 3 : UCIP_SP_2022_58554_67353.jpg

FS_ID:58554
DS_ID:16377
EP_NO: N/A
Repair Type: Non-Urgent
Crossing Status: Found
UCIP Comments: 08/29/2019 Record remains Non-Urgent due to maintenance issues. Unable to determine status of crossing. Steel pipe is deteriorated on the WS between concrete boxes. 36-inch pipe not visible inside concrete boxes. Recommend internal inspection to determine pipe condition through the levee. Riser lid missing on WS (considered a safety issue). LS inlet shows about 75% blockage. No permit has been identified authorizing pipe. (O. Magana - DWR UCIP, A. Freitag - DWR Sutter Yard)05/30/2017 LS headwall was mostly buried and pipe end over 50% full of sediment. WS distribution box appears to have not been repaired yet but it does not seem to affect the integrity of the levee. (A. Freitag - DWR Sutter Yard)11/17/2016 LS pipe end was about 50% plugged with soil. WS riser box is still cracked and appears to still be leaking. (A. Freitag - DWR Sutter Yard)04/26/2016 LS headwall was dry and photographed. LS pipe end was about 50% plugged with soil. WS riser box is still cracked and appears to still be leaking. (A. Freitag - DWR Sutter Yard)06/30/2015 Bee boxes stacked near the riser box on WS so could not get close enough to see if the leak issue had been fixed. (A. Freitag - DWR Sutter Yard) 05/28/2014 Water appears to be leaking out of the WS concrete riser box. Causing minor erosion under pipe near pump structure. (A. Freitag - DWR Sutter Yard)12/04/2013 Same as last inspection. (A. Freitag - DWR Sutter Yard)07/08/2013 LS slope has been cleared of vegetation and is in good condition. LS headwall was underwater and unable to be inspected. All WS appurtenances in good condition. (A. Freitag - DWR Sutter Yard)04/24/2012 Limited inspection on LS slope due to dense vegetation. Need photos of cleared LS slope and LS headwall. Cracks in riser box. New pump installed recently this work might be covered under separate permit. (O. Magana - DWR UCIP)

Overview of levee crown.

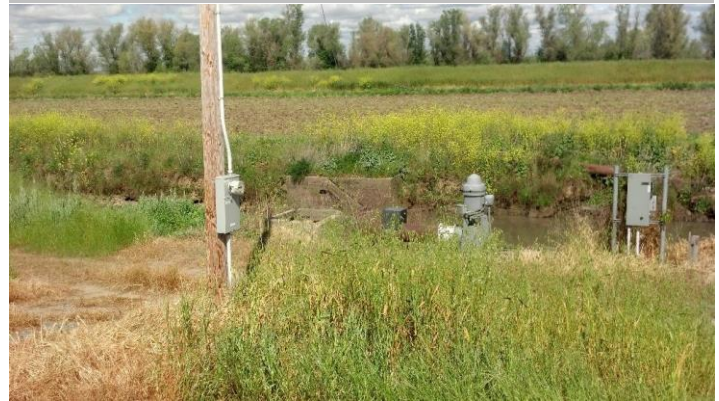
Photo 2 of 3 : UCIP_SP_2022_58554_67359.jpg

Appurtenances on WS.
