**Flood Control Project Maintenance
Levee Inspections
LMA District Cover Sheet**

**Flood Control Project Maintenance
Levee Inspections
Unit Cover Sheet**

Waterway			Bank	Unit Miles
Unit No. 01 Cherokee Canal			Right	18.19
	Spring (March - May)	Summer (June - August)	(September - November) Fall	Winter (December - February)
Unit Maintenance Rating (Fall Only)				
Date of Inspection	3/23/2022 - 3/23/2022			
DWR Inspector	Makar Sokol			
Accompanied By

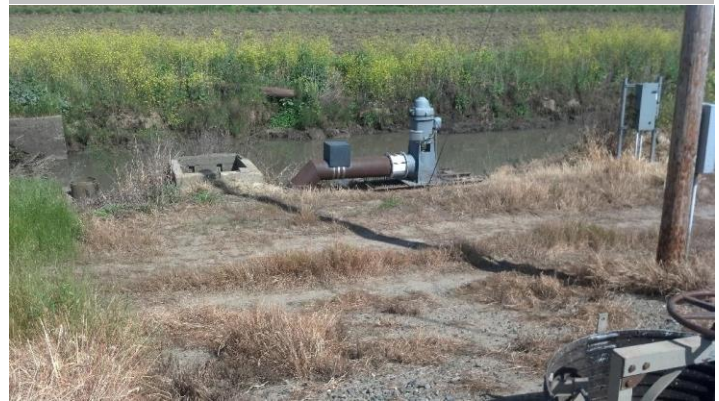
Photo 3 of 3 : UCIP_SP_2022_58554_67355.jpg

WS view of crossing.

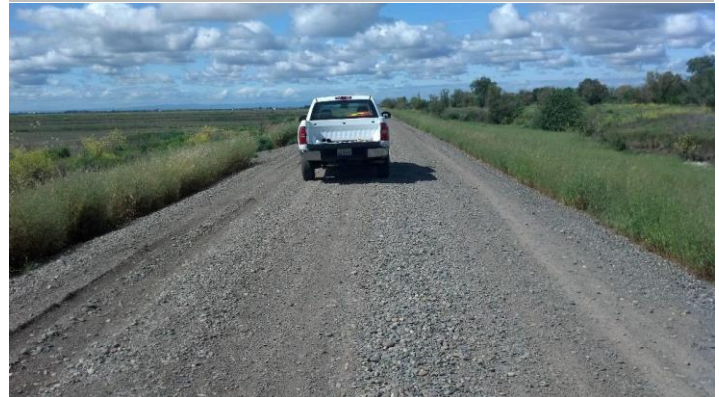
Photo 1 of 3 : UCIP_SP_2022_58556_67382.jpg

Comment Code						
Inspector Comment						
FS_ID:58556 DS_ID:16378 EP_NO: N/A Repair Type: Non-Urgent Crossing Status: Found UCIP Comments: 08/29/2019 Record has been updated from No Action Needed to Non-Urgent, no permit has been identified authorizing pipe. No DWR internal inspection has been completed yet. (O. Magana - DWR UCIP, A. Freitag - DWR Sutter Yard)05/30/2017 Crossing appears to be in good condition. Pipe has been selected to be internally cleaned and inspected as part of the DMP project. (A. Freitag - DWR Sutter Yard)11/17/2016 Crossing appears to be in good condition. (A. Freitag - DWR Sutter Yard)04/26/2016 Crossing appears to be in good condition. (A. Freitag - DWR Sutter Yard)06/30/2015 Crossing appears in good condition. No noticeable issues to report. (A. Freitag - DWR Sutter Yard)05/28/2014 Same as last inspection. (A. Freitag - DWR Sutter Yard)12/04/2013 Same as last inspection. (A. Freitag - DWR Sutter Yard)07/08/2013 Same as last inspection. (A. Freitag - DWR Sutter Yard)04/24/2012 Dense vegetation on the slopes restricted the field inspection at this crossing. Need photos of cleared WS and LS slopes, and appurtances. (O. Magana - DWR UCIP) FIELD_STRUCT_DESC: 30-inch corrugated metal drainage pipe through the levee, 14.7 feet below the crown. Flap gate on the waterside (WS) end. Walkway and slide gate located on the landside (LS) end. Concrete "U" headwalls on both end. Reference noted in Levee Logs as USACE-1960 does not match entry in . [Additional Reference(s): DWR Levee Log, 1993 (HLM 17.06), listed as 30-inch pipe. USACE Sacramento O&M Manual, Unit 519, June 1962, Revised 3 Feb 2011, (HLM 17.06), listed as 36-inch CMP] FS Date: 8/29/2019 7:36:00 AM

Overview of crossing looking downstream of the left bank of Cherokee Canal.

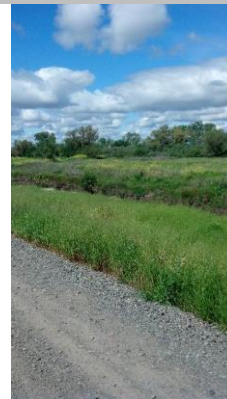
Photo 2 of 3 : UCIP_SP_2022_58556_67383.jpg

View of WS slope.

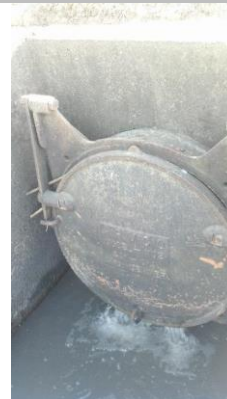
Photo 3 of 3 : UCIP_SP_2022_58556_67380.jpg

View of flap gate slightly propped open by the sticks on the left.

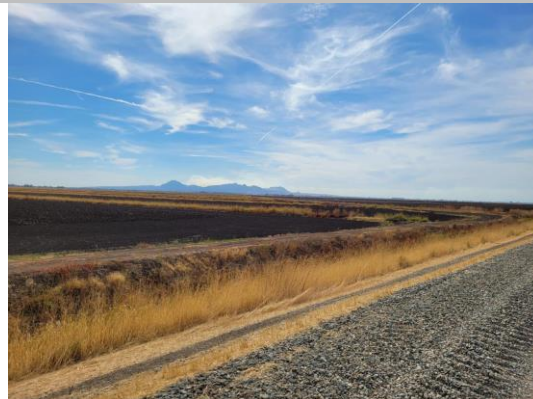
Photo 1 of 1 : SP_2022_MA0013_301_20_20220307_00005.jpg

LM Start	16.89	Rating **	M	Issue No.	20
LM End	18.72	Issue Type +	En	Location *	LS
Category	Earthen Levee			GPS Latitude/Longitude	
				Start	End
Item	Encroachments			39.406217 °	39.389187 °
				-121.794945 °	-121.821233 °
DWR ID	DWR_MA0013_02_s_2012_20				
Comment Code					
DT : Ditch					
Inspector Comment

View of the agricultural ditch along the landside toe. Fall 2021.

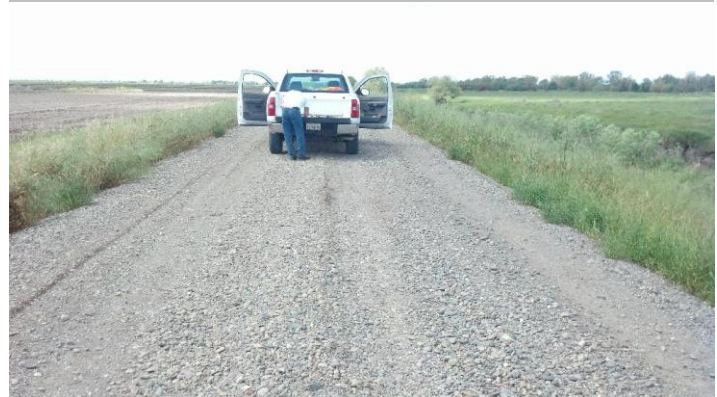
Photo 1 of 3 : UCIP_SP_2022_58557_67387.jpg

Comment Code					
Inspector Comment					
FS_ID:58557 DS_ID:16379 EP_NO: N/A Repair Type: Non-Urgent Crossing Status: Found UCIP Comments: 08/29/2019 Record has been updated from No Action Needed to Non-Urgent, no permit has been identified authorizing pipe. Pipe is under water. Pipe is scheduled to be lined. (O. Magana - DWR UCIP, A. Freitag - DWR Sutter Yard)05/30/2017 Crossing appears to be in good condition. Pipe has been selected to be internally cleaned and inspected as part of the DMP project. (A. Freitag - DWR Sutter Yard)11/17/2016 Crossing appears to be in good condition. (A. Freitag - DWR Sutter Yard)04/26/2016 Crossing appears to be in good condition. (A. Freitag - DWR Sutter Yard)06/30/2015 Vegetation still present on WS. LS side was underwater during inspection. (A. Freitag - DWR Sutter Yard)05/28/2014 Same as last inspection. (A. Freitag - DWR Sutter Yard)12/04/2013 Same as last inspection. (A. Freitag - DWR Sutter Yard)07/08/2013 LS slope cleared of vegetation and is in good condition. WS is still vegetated. LS pipe end under water and blocked off by plywood so unable to measure culvert size. (A. Freitag - DWR Sutter Yard)04/24/2012 Limited inspection on WS and LS slopes due to dense vegetation. Need photos of cleared WS and LS slopes. This crossing was listed in the USACE Periodic Inspection report as Corp's inspect ID# USACE_CESPK_M13E_2011_p_0134 for unknown culvert size on LS and no outlet visible on WS. (O. Magana - DWR UCIP) FIELD_STRUCT_DESC: 36-inch CIPP-lined corrugated metal drainage pipe through the levee, 13.2 feet below the crown. Flap gate on the waterside (WS) end. Concrete "U" headwalls on both ends. [Additional Reference(s): DWR Levee Log, 1993 (HLM 18.37). USACE Sacramento O&M Manual, Unit 519, June 1962, Revised 3 Feb 2011, (HLM 18.37), As-built DWG No. 50-4-3511, Sheet No. 3511/6. unable to read exact page, STA 261+67E, page 6 of 31 electronic file, listed as 36-inch CMP] FS Date: 8/29/2019 7:36:00 AM

Overview of crossing looking D/S at left bank of Cherokee Canal.

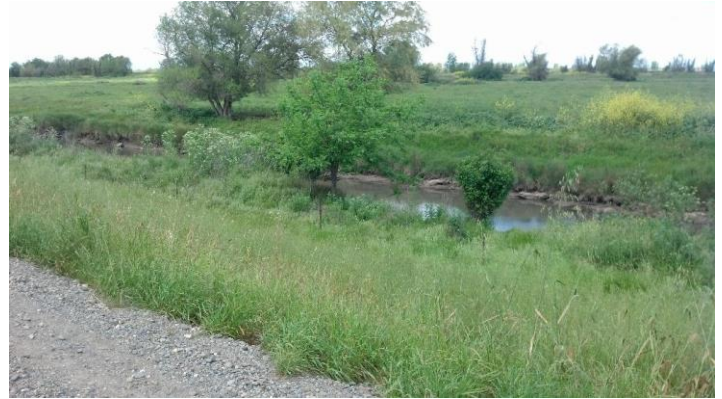
Photo 2 of 3 : UCIP_SP_2022_58557_67386.jpg

View of WS slope and berm.

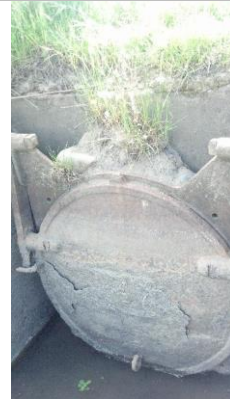
Photo 3 of 3 : UCIP_SP_2022_58557_67390.jpg

View of flap gate located on WS.

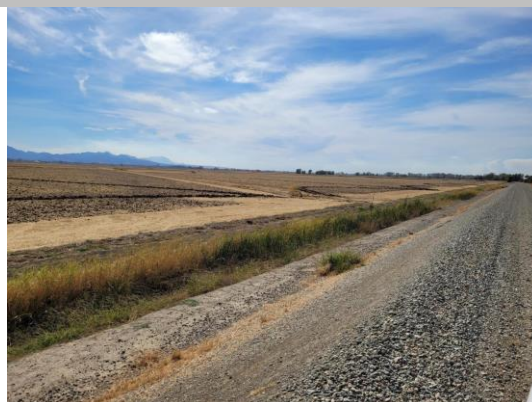
Photo 1 of 1 : SP_2022_MA0013_301_21_20220307_00006.jpg

LM Start	19.37	Rating **	M	Issue No.	21
LM End	19.92	Issue Type +	En	Location *	LS
Category	Earthen Levee			GPS Latitude/Longitude	
				Start	End
Item	Encroachments			39.383252 °	39.378192 °
				-121.830565 °	-121.838543 °
DWR ID	DWR_MA0013_02_s_2012_21				
Comment Code					
DT : Ditch					
Inspector Comment

View of the agricultural ditch along the landside toe. Fall 2021.

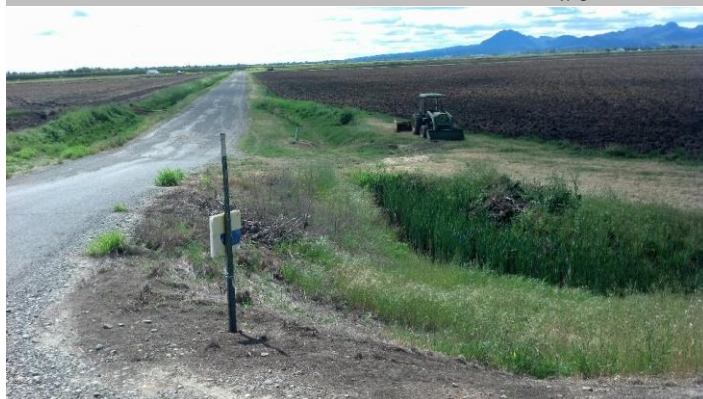
Photo 1 of 3 : UCIP_SP_2022_57681_67393.jpg

Comment Code						
Inspector Comment						
FS_ID:57681 DS_ID:16381 EP_NO: 10918 Repair Type: Non-Urgent Crossing Status: Indicator Found UCIP Comments: 08/29/2019 Record has been updated from No Action Needed to Non-Urgent, due to maintenance issue. Recommend contacting owner to determine if line is still in use. No marker visible. (O. Magana - DWR UCIP, A. Freitag - DWR Sutter Yard)05/30/2017 Crossing appears to be in good condition. (A. Freitag - DWR Sutter Yard)11/17/2016 Crossing appears to be in good condition. (A. Freitag - DWR Sutter Yard)04/26/2016 Crossing appears to be in good condition. (A. Freitag - DWR Sutter Yard)06/30/2015 Crossing is in good condition. (A. Freitag - DWR Sutter Yard)05/28/2014 Same as last inspection. (A. Freitag - DWR Sutter Yard)12/04/2013 Same as last inspection. (A. Freitag - DWR Sutter Yard)07/08/2013 Same as last inspection. (A. Freitag - DWR Sutter Yard) FIELD_STRUCT_DESC: 0.6-inch telephone cable through the levee, 2 feet below the crown. Pipe attached to bridge visible on the waterside (WS). Splice box located on the landside (LS). (buried cable across channel (attached to bridge) and levees of Cherokee Canal authorized under Permit No. 10918, 1975 - Pacific Telephone and Telegraph Company [PT&T]) [Additional Reference(s): DWR Levee Log, 1993 (HLM 19.55)] FS Date: 8/29/2019 7:38:00 AM

Overview of landside where cable splice box (by front loader) is located approximately 60 feet from levee crown.

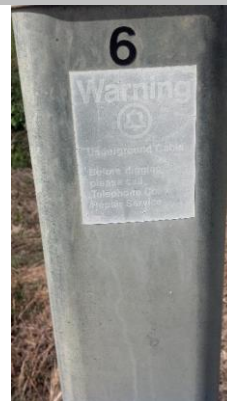
Photo 2 of 3 : UCIP_SP_2022_57681_67394.jpg

Splice box information located on LS approximately 60 feet from levee crown.

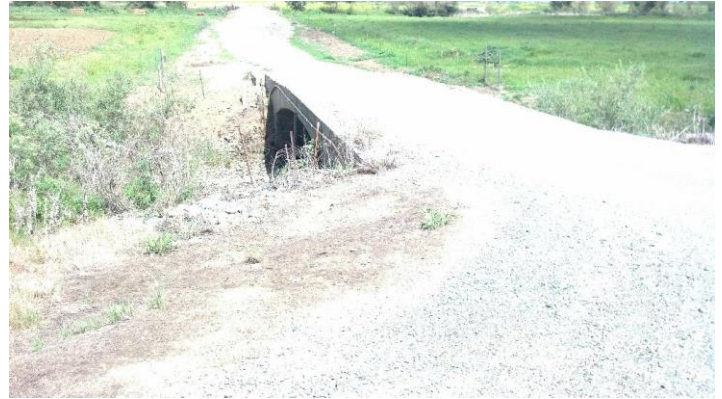
Photo 3 of 3 : UCIP_SP_2022_57681_67395.jpg

View of WS where cable line is attached to culvert crossing.

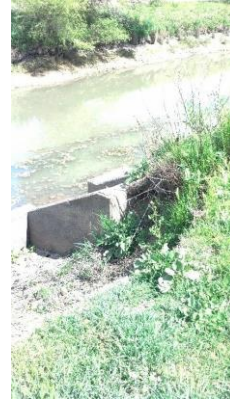
Photo 1 of 3 : UCIP_SP_2022_58558_67401.jpg

FS_ID:58558
DS_ID:16375
EP_NO: N/A
Repair Type: Non-Urgent
Crossing Status: Found
UCIP Comments: 08/29/2019 Record remains Non-Urgent, no permit has been identified authorizing pipe. Pipe is scheduled to be lined. (O. Magana - DWR UCIP, A. Freitag - DWR Sutter Yard)05/30/2017 Erosion still present at WS headwall. Pipe has been selected to be internally cleaned and inspected as part of the DMP project. (A. Freitag - DWR Sutter Yard)11/17/2016 Erosion still present at WS headwall. (A. Freitag - DWR Sutter Yard)04/26/2016 Erosion still present behind the WS headwall. The rest of the crossing appears in good condition. (A. Freitag - DWR Sutter Yard)06/30/2015 Erosion still present behind the WS headwall. Everything thing else with the crossing appeared to be in good condition. (A. Freitag - DWR Sutter Yard)12/04/2013 Same as last inspection. (A. Freitag - DWR Sutter Yard)05/28/2014 Same as last inspection. (A. Freitag - DWR Sutter Yard)07/08/2013 Erosion problem same as last inspection. WS and LS slopes have been cleared of vegetation and are in good shape. (A. Freitag - DWR Sutter Yard)04/24/2012 Erosion present behind WS headwall. Limited inspection on WS and LS slopes due to dense vegetation. Need photos of cleared WS and LS slopes during next inspection. (O. Magana - DWR UCIP)

Erosion behind WS headwall looking at the downstream edge of headwall.

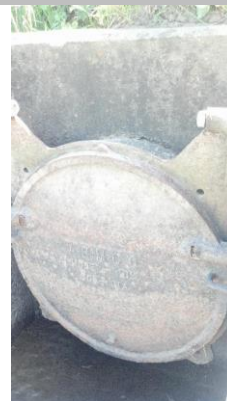
Photo 3 of 3 : UCIP_SP_2022_58558_67402.jpg

Flap gate located on the WS.

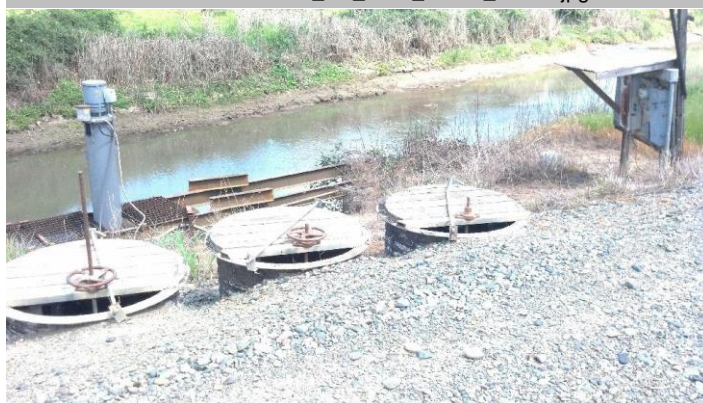
Photo 1 of 3 : UCIP_SP_2022_58559_67406.jpg

FS_ID:58559
DS_ID:16383
EP_NO: N/A
Repair Type: Urgent
Crossing Status: Found
UCIP Comments: 08/29/2019 Record remains Urgent due to pipe and levee integrity concerns. Also no permit has been identified authorizing pump station. Pump station is still active. Crossing shows sloughing on the WS with visible holes in pipe on the LS. This crossing is under investigation under CVFPB enforcement case (ENF ID) 723. (O. Magana - DWR UCIP, A. Freitag - DWR Sutter Yard)08/23/2018 The CVFPB has filed an enforcement for this crossing, Enforcement Case: 2018-723. There is still massive erosion around the WS headwall and corrosion and degradation of the LS outlet pipes, so the crossing remains Urgent. (D. Sanoski - DWR UCIP)05/30/2017 No repairs have been made here yet. WS still has depressions above the pipe alignment. LS pipe end still showing heavy signs of rusting and deterioration. Sediment build up inside of concrete distribution box on the LS. (A. Freitag - DWR Sutter Yard)11/17/2016 Crossing has not been repaired yet. pipe ends still showing heavy signs of rust and corrosion. (A. Freitag - DWR Sutter Yard)04/26/2016 No repairs have been made at this crossing yet. (A. Freitag - DWR Sutter Yard)06/30/2015 Crossing has not been repaired yet. pipe ends still showing heavy signs of rust and corrosion. (A. Freitag - DWR Sutter Yard)05/28/2014 Same as last inspection. (A. Freitag - DWR Sutter Yard)12/04/2013 Same as last inspection. (A. Freitag - DWR Sutter Yard)07/08/2013 Same as last inspection. (A. Freitag - DWR Sutter Yard)04/19/2012 LS pipe collars severely damaged--section missing at flap gate. Buried section of pipe could be in the same condition. Crossing needs to be repaired; will need to coordinate with applicant. WS slide gate handle missing. (O. Magana - DWR UCIP)

Corrugated metal pipe risers with slide gates located on WS slope.

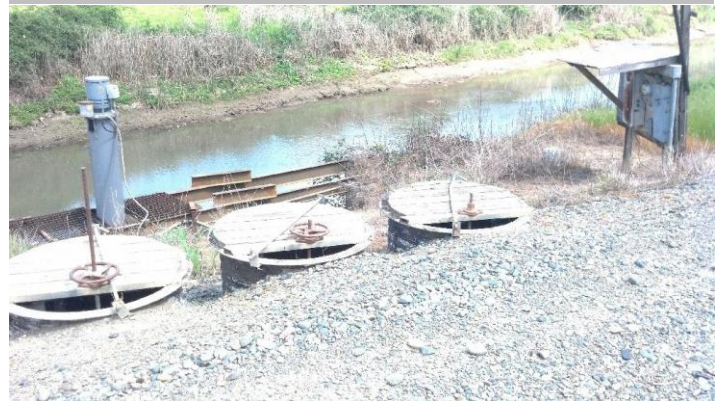
Photo 1 of 3 : UCIP_SP_2022_58560_67416.jpg

FS_ID:58560
DS_ID:17014
EP_NO: N/A
Repair Type: Urgent
Crossing Status: Found
UCIP Comments: 08/29/2019 Record remains Urgent due to pipe and levee integrity concerns. Also no permit has been identified authorizing pump station. Pump station is still active. Crossing shows sloughing on the WS with visible holes in pipe on the LS. This crossing is under investigation under CVFPB enforcement case (ENF ID) 723. (O. Magana - DWR UCIP, A. Freitag - DWR Sutter Yard)08/23/2018 The CVFPB has filed an enforcement for this crossing, Enforcement Case: 2018-723. There is still massive erosion around the WS headwall and corrosion and degradation of the LS outlet pipes, so the crossing remains Urgent. (D. Sanoski - DWR UCIP)05/30/2017 No repairs have been made here yet. WS still has depressions above the pipe alignment. LS pipe end still showing heavy signs of rusting and deterioration. Sediment build up inside of concrete distribution box on the LS. (A. Freitag - DWR Sutter Yard)11/17/2016 Crossing has not been repaired yet. pipe ends still showing heavy signs of rust and corrosion. (A. Freitag - DWR Sutter Yard)04/26/2016 No repairs have been made at this crossing yet. (A. Freitag - DWR Sutter Yard)06/30/2015 Crossing has not been repaired yet. pipe ends still showing heavy signs of rust and corrosion. (A. Freitag - DWR Sutter Yard)05/28/2014 Same as last inspection. (A. Freitag - DWR Sutter Yard)12/04/2013 Same as last inspection. (A. Freitag - DWR Sutter Yard)07/08/2013 Same as last inspection. (A. Freitag - DWR Sutter Yard)04/24/2012 LS pipe collars severely damaged--section missing at flap gate. Crossing needs repair. Will need to coordinate with owner. (O. Magana - DWR UCIP)

WS view of corrugated metal pipe risers .

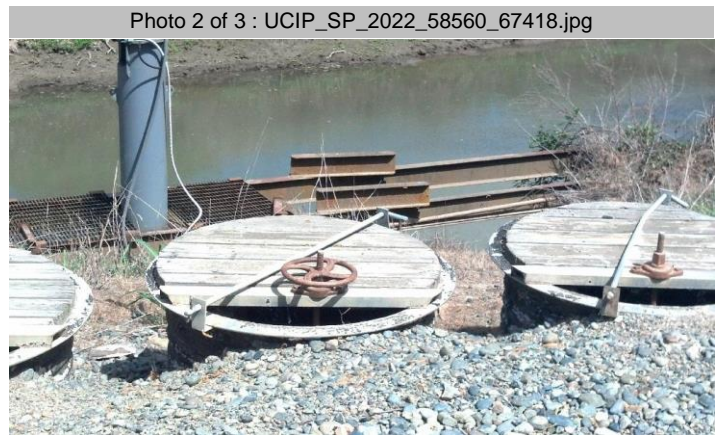
Riser for pipe 2 of 3.

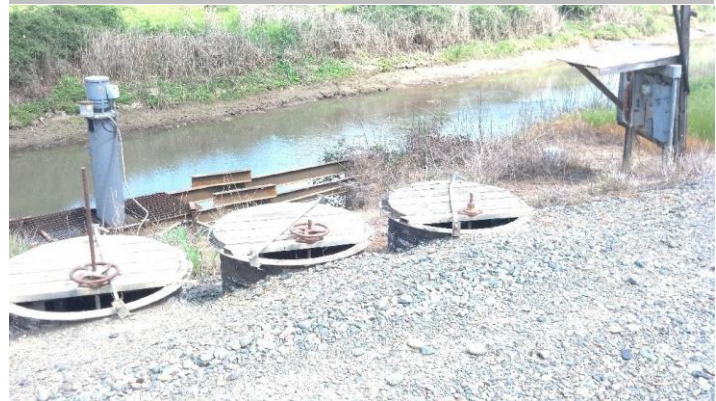
Photo 1 of 3 : UCIP_SP_2022_58561_67441.jpg

FS_ID:58561
DS_ID:17185
EP_NO: N/A
Repair Type: Urgent
Crossing Status: Found
UCIP Comments: 08/29/2019 Record remains Urgent due to pipe and levee integrity concerns. Also no permit has been identified authorizing pump station. Pump station is still active. Crossing shows sloughing on the WS with visible holes in pipe on the LS. This crossing is under investigation under CVFPB enforcement case (ENF ID) 723. (O. Magana - DWR UCIP, A. Freitag - DWR Sutter Yard)08/23/2018 The CVFPB has filed an enforcement for this crossing, Enforcement Case: 2018-723. There is still massive erosion around the WS headwall and corrosion and degradation of the LS outlet pipes, so the crossing remains Urgent. (D. Sanoski - DWR UCIP)05/30/2017 No repairs have been made here yet. WS still has depressions above the pipe alignment. LS pipe end still showing heavy signs of rusting and deterioration. Sediment build up inside of concrete distribution box on the LS. (A. Freitag - DWR Sutter Yard)11/17/2016 Crossing has not been repaired yet. pipe ends still showing heavy signs of rust and corrosion. (A. Freitag - DWR Sutter Yard)04/26/2016 No repairs have been made at this crossing yet. (A. Freitag - DWR Sutter Yard)06/30/2015 Crossing has not been repaired yet. pipe ends still showing heavy signs of rust and corrosion. (A. Freitag - DWR Sutter Yard)05/28/2014 Same as last inspection. (A. Freitag - DWR Sutter Yard)12/04/2013 Same as last inspection. (A. Freitag - DWR Sutter Yard)07/08/2013 Same as last inspection. (A. Freitag - DWR Sutter Yard)04/24/2012 Sink hole present on WS. LS pipe collars severely damaged--section missing at flap gate. Crossing needs repair. Need to coordinate with owner. (O. Magana - DWR UCIP)

View of corrugated metal risers located on WS.

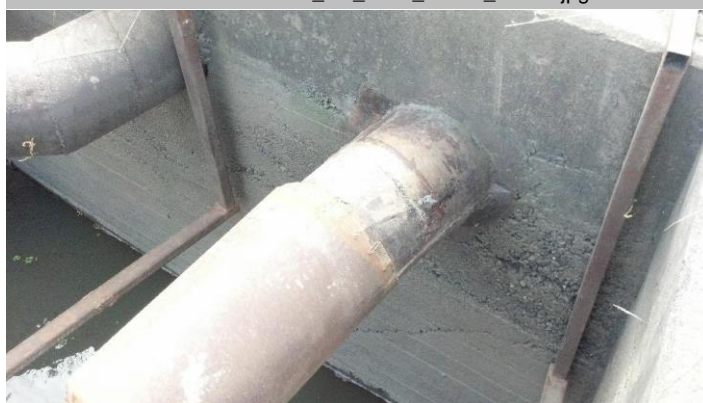
Photo 3 of 3 : UCIP_SP_2022_58561_67442.jpg

View of Pipe 3 of 3 from WS headwall.

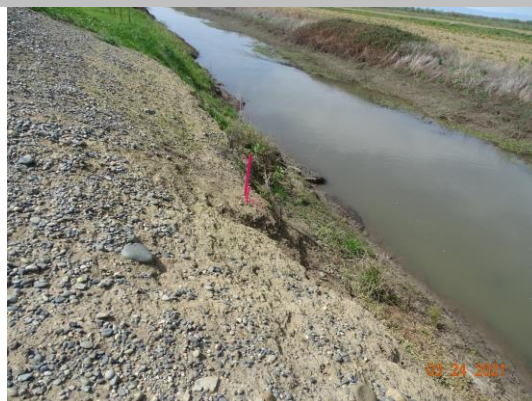
Photo 1 of 1 : SP_2022_MA0013_301_75_20220307_00014.jpg

LM Start	20.77	Rating **	M	Issue No.	75
LM End	20.77	Issue Type +	Ma	Location *	WS
Category	Earthen Levee			GPS Latitude/Longitude	
				Start	End
Item	Erosion / Bank Caving			39.370641 °	39.370641 °
				-121.850572 °	-121.850572 °
DWR ID	DWR_MA0013_02_f_2016_75				
Comment Code					
E2 : Schedule repair of erosion site prior to the next inspection.					
Inspector Comment

View of the erosion along the waterside toe. Spring 2021.

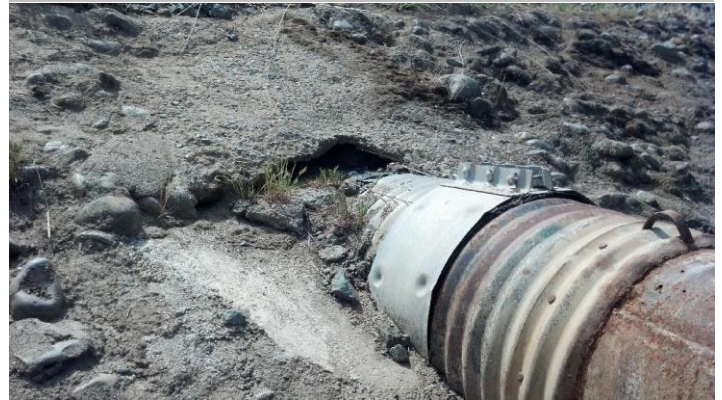
Photo 2 of 3 : UCIP_SP_2022_58562_67451.jpg

View of WS daylight. Hole present at pipe daylight.

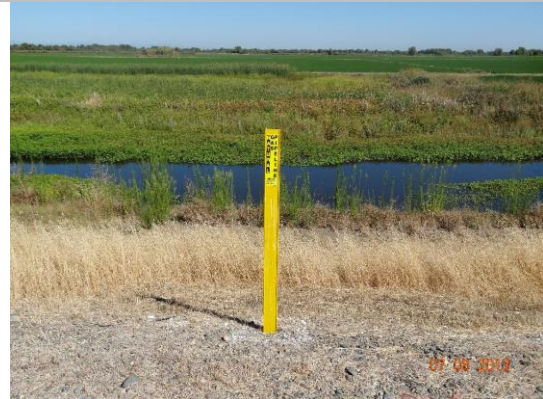
Photo 1 of 3 : UCIP_SP_2022_58707_67457.jpg

Carsonite marker on WS shoulder

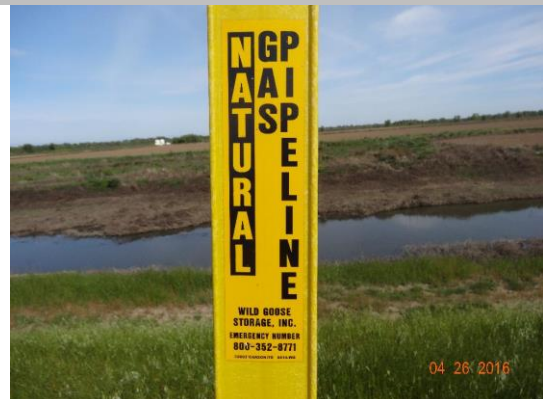
Photo 2 of 3 : UCIP_SP_2022_58707_74994.jpg

Close up of marker with contact info

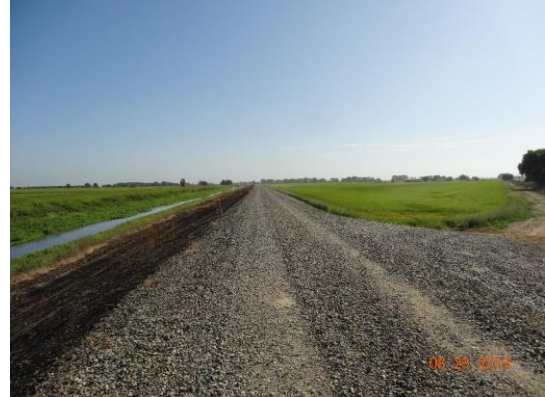
Photo 3 of 3 : UCIP_SP_2022_58707_81020.jpg

Overview of levee crown looking u/s towards pipe crossing.

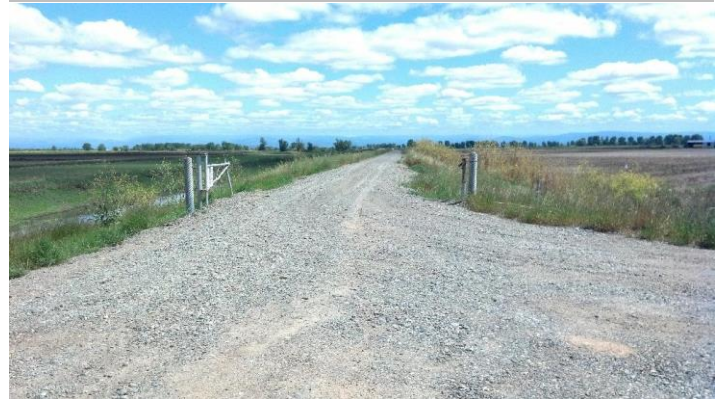
Photo 1 of 3 : UCIP_SP_2022_58575_67462.jpg

Overview of crossing looking upstream at the left bank of Cherokee Canal.

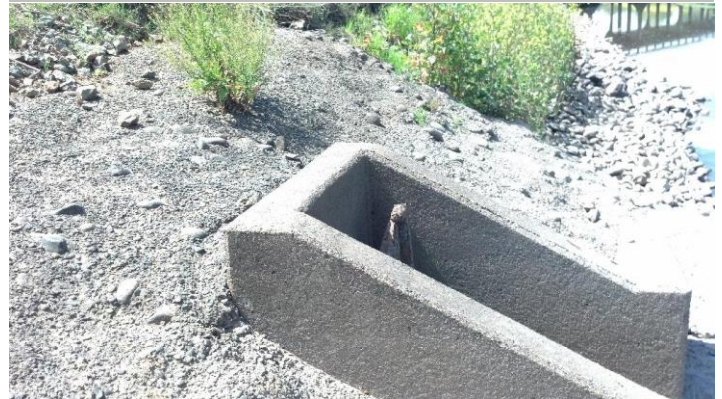
Photo 2 of 3 : UCIP_SP_2022_58575_67460.jpg

View of WS headwall.

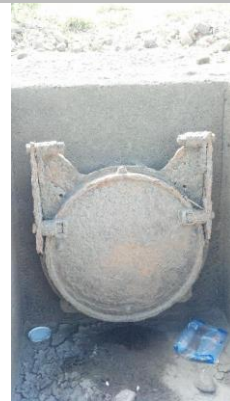
Photo 3 of 3 : UCIP_SP_2022_58575_67461.jpg

Flap gate located on WS.

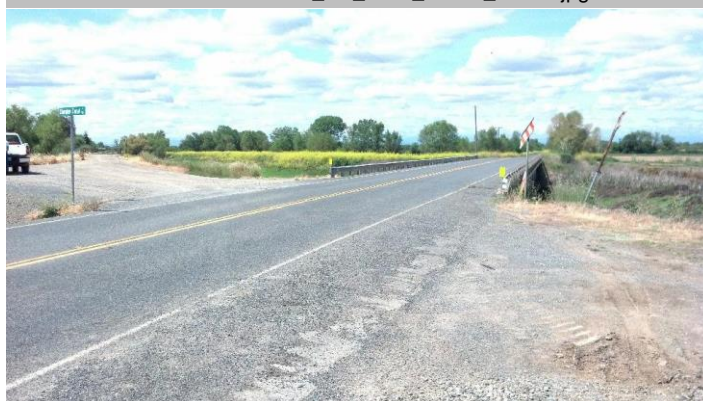
Photo 1 of 3 : UCIP_SP_2022_58568_67463.jpg

Overview of gas line marker located at the upstream face of the highway bridge.

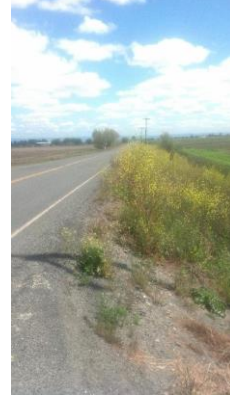
Photo 3 of 3 : UCIP_SP_2022_58568_67464.jpg

View of second gas line marker looking East at highway (LS view).

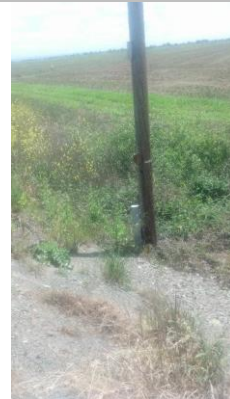
Photo 1 of 1 : UCIP_SP_2022_58569_67480.jpg

Comment Code					
Inspector Comment					
FS_ID:58569 DS_ID:16374 EP_NO: N/A Repair Type: Non-Urgent Crossing Status: Indicator Found UCIP Comments: 08/29/2019 Record remains Non-Urgent, no permit has been identified authorizing pipe. Also modification have been made without prior notification to the CVFPB. Multiple splice boxes can be found along the LS toe. Need to review CVFPB enforcement case to determine if issue has been resolved. Need updated photos for this crossing. (O. Magana - DWR UCIP, A. Freitag - DWR Sutter Yard)05/30/2017 Splice box still present at LS toe. (A. Freitag - DWR Sutter Yard)11/17/2016 Splice box still present at LS toe. (A. Freitag - DWR Sutter Yard)04/26/2016 Communication Splice box was still present. Not sure what was done to ever resolve the encroachment issue. (A. Freitag - DWR Sutter Yard)06/30/2015 Same as last inspection. (A. Freitag - DWR Sutter Yard)05/28/2014 Same as last inspection. (A. Freitag - DWR Sutter Yard)12/04/2013 Same as last inspection. (A. Freitag - DWR Sutter Yard)07/08/2013 Same as last inspection. (A. Freitag - DWR Sutter Yard)04/24/2012 Unauthorized Encroachment. This crossing is listed multiple times in the USACE Periodic Inspection report as USACE_CESPK_M13E_2011_p_0307, 0315, 0317, 0318 for slope failure on LS hinge. DWR-Flood Maintenance Office records shows that CVFPB has requested AT&T to remove conduit in June 2, 2009 letter. LMA working with CVFPB to resolve. (O. Magana - DWR UCIP) FIELD_STRUCT_DESC: Underground telephone cable through the levee. Depth unknown. (AT&T) START latitude 39.36210336, longitude -121.8678207 END latitude 39.35458541, longitude -121.8823409. Line extends from Gridley Colusa Highway to the south end of project levee along landside (LS) shoulder and levee crown hinge point. Levee sloughs along cable trench after heavy rains. [Additional Reference(s): DWR Levee Log, 1993 (HLM 22.11). USACE Sacramento O&M Manual, Unit 519, June 1962, Revised 3 Feb 2011, listed in As-built DWG No. 50-4-3511 only and not manual, Sheet No. 3511/31.2, STA 66+00E, page 31 of 31 electronic file, listed as underground telephone and electric line through the levee] FS Date: 8/29/2019 7:42:00 AM

View of utility line located on LS toe.

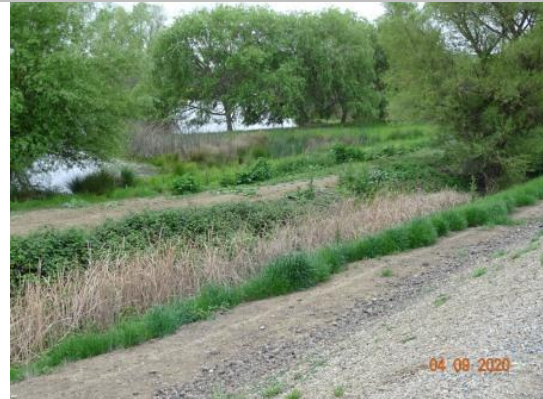
Photo 1 of 1 : SP_2022_MA0013_301_59_20220307_00009.jpg

LM Start	21.87	Rating **	U	Issue No.	59
LM End	22.09	Issue Type +	En	Location *	LS
Category	Earthen Levee			GPS Latitude/Longitude	
				Start	End
Item	Encroachments			39.362022 °	39.360294 °
				-121.867949 °	-121.871339 °
DWR ID	DWR_MA0013_02_s_2016_59				
Comment Code					
DT : Ditch					
Inspector Comment

View of the ditch along the landside toe. Spring 2020.

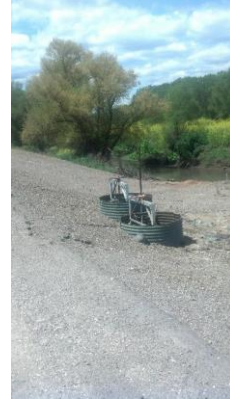
Photo 2 of 3 : UCIP_SP_2022_58570_67482.jpg

View of corrugated metal risers located on WS slope.

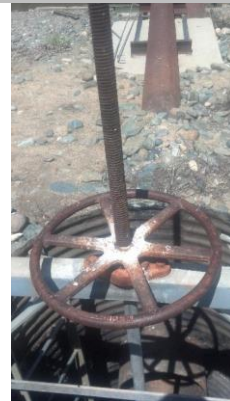
Photo 3 of 3 : UCIP_SP_2022_58570_67485.jpg

WS view of 18 inch line through corrugated metal riser.

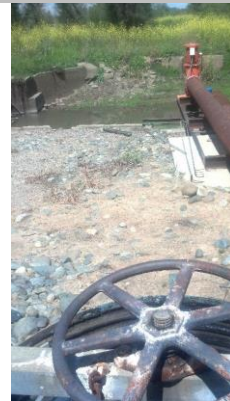
Photo 3 of 3 : UCIP_SP_2022_58571_67492.jpg

WS view of buried line through levee berm looking at berm edge from levee crown.

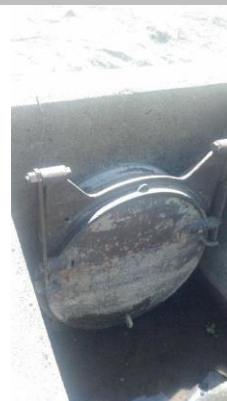
Photo 3 of 3 : UCIP_SP_2022_58572_67497.jpg

LM Start	22.15	Rating **	M	Issue No.	83 (cont)
LM End	22.15	Issue Type +	Ma	Location *

View of flap gate on WS.

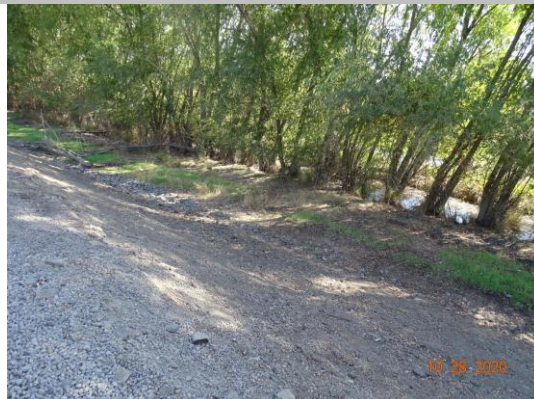
Photo 1 of 1 : SP_2022_MA0013_301_62_20220307_00012.jpg

LM Start	22.33	Rating **	A/W	Issue No.	62
LM End	22.33	Issue Type +	Ma	Location *	LS
Category	Earthen Levee			GPS Latitude/Longitude	
				Start	End
Item	Slope Stability			39.358419 °	39.358419 °
				-121.875088 °	-121.875088 °
DWR ID	DWR_MA0013_02_s_2016_62				
Comment Code					
S1 : Repair slope instability.					
Inspector Comment

View of the slope instability along the landside slope. Fall 2020.

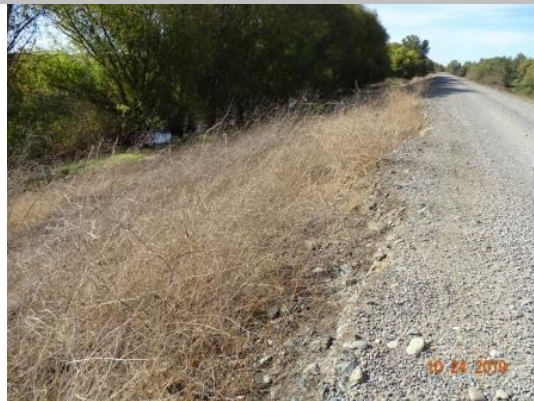
Photo 1 of 1 : SP_2022_MA0013_301_58_20220307_00008.jpg

LM Start	22.50	Rating **	M	Issue No.	58
LM End	22.51	Issue Type +	Ma	Location *	LS
Category	Earthen Levee			GPS Latitude/Longitude	
				Start	End
Item	Erosion / Bank Caving			39.357085 °	39.357033 °
				-121.877812 °	-121.877901 °
DWR ID	DWR_MA0013_02_f _ 2019_58				
Comment Code					
E2 : Schedule repair of erosion site prior to the next inspection.					
Inspector Comment

View of erosion on the landside slope. Fall 2019.
