**Flood Control Project Maintenance
Levee Inspections**

Fall 2011 Levee Maintenance Deficiency Summary Report

Sacramento River Basin

| NA0001 | | Overall LMA Rating | Total LMA Miles | | | | |
|--|---|---|---|---|---|---|--|
| American River Flood Control District | | A | 32.51 | | | | |

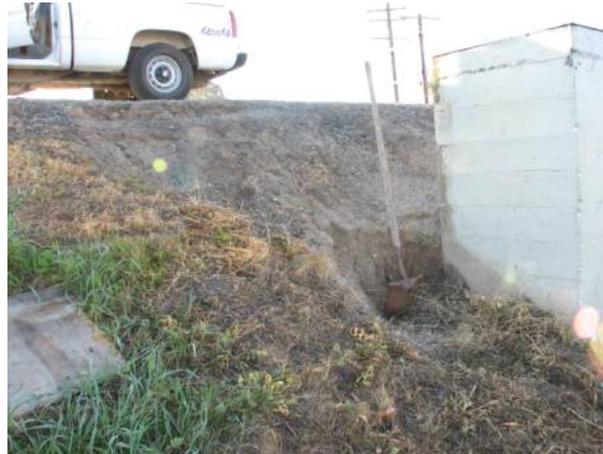
| jeto_f_20111122_666.jpg | |

| 11/17/2011 Erosion adjacent to structure protecting siphon breakers. | |

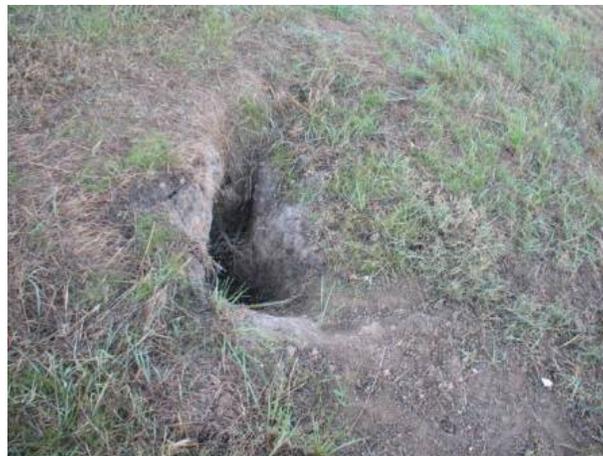
| jeto_f_20111122_669.jpg | |

| Waterway | | | | Bank | Unit Miles | Inspection Start/End | Inspector | | | | |
|---|---|---|---|---|---|---|---|---|---|---|---|
| 2 | 0.16 | 0.16 | Earthen Levee | Animal Control | WS | M | No rodents visible, but rodent burrows visible; need to backfill and compact or grout burrows. Inspector Comments: Hole on waterside, could be caused by dog digging or is an old rodent hole. | 38.620641 ° -121.465173 ° | 38.620641 ° -121.465173 ° | 161 | Y |

| 11/17/2011 Hole on waterside slope. | |

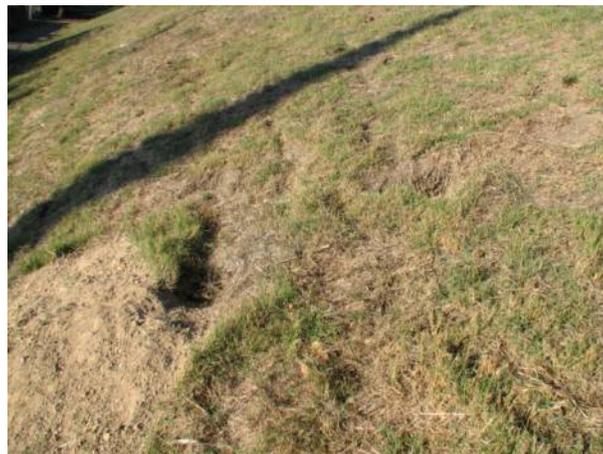
| jeto_f_20111122_668.jpg | |

| 11/17/2011 Landside burrow. | |

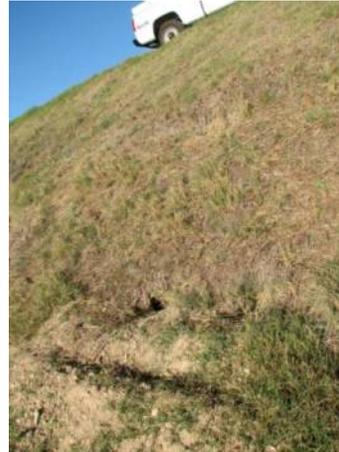
| jeto_f_20111122_670.jpg | |

| 11/17/2011 Rodent burrow. | |

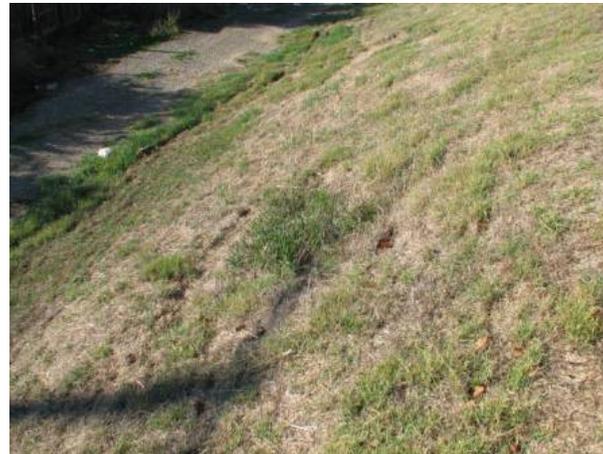
| jeto_f_20111122_671.jpg | |

| 11/17/2011 Hole/depression approximately mid-slope. | |

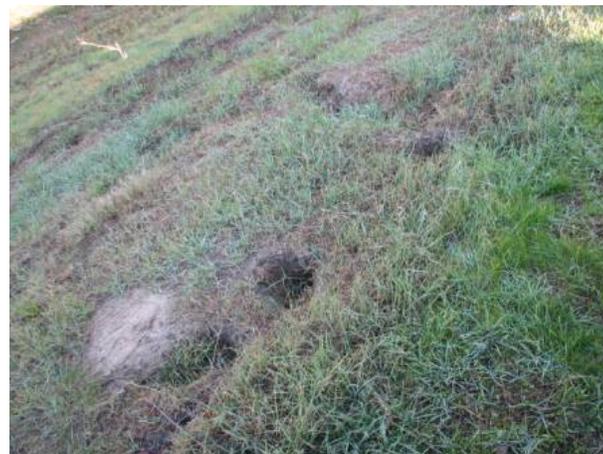
| jeto_f_20111122_672.jpg | |

| 11/17/2011 Old rodent burrows. | |

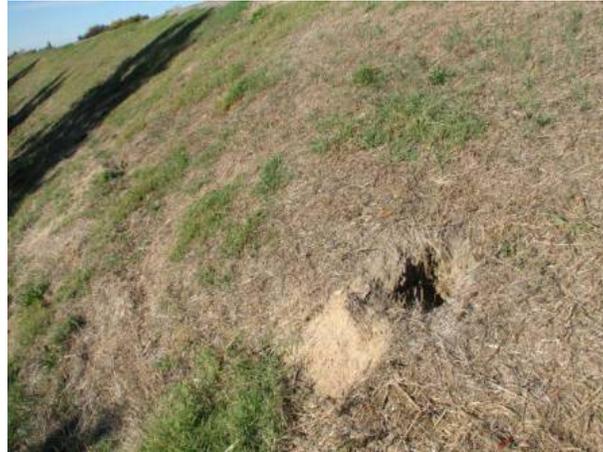
| jeto_f_20111122_673.jpg | |

| 11/17/2011 Rodent burrow located mid-slope. | |

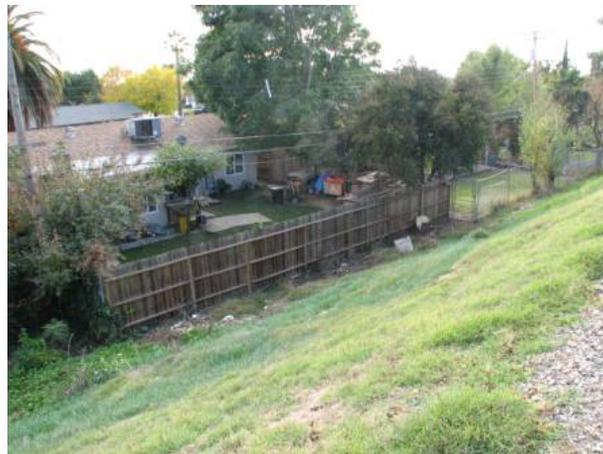
| jeto_f_20111122_674.jpg | |

| 11/17/2011 Wooden privacy fence. | |

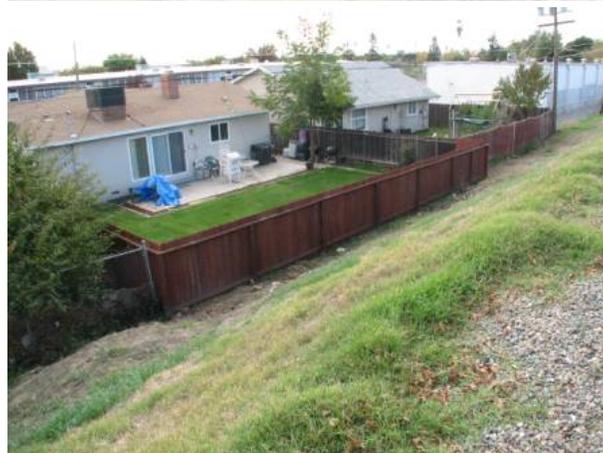
| jeto_f_20111122_675.jpg | |

| 11/17/2011 Wooden privacy fence built at the levee toe. | |

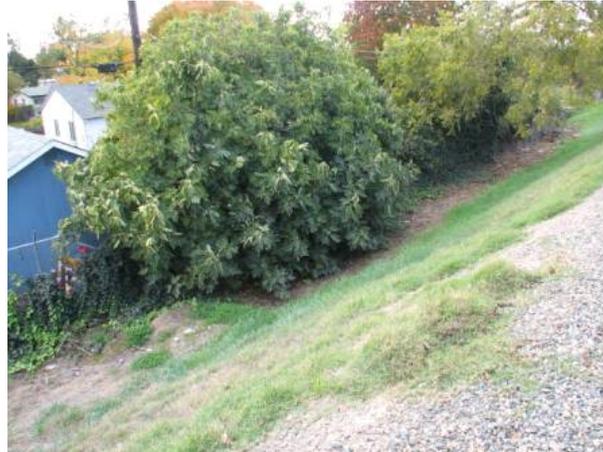
| jeto_f_20111122_676.jpg | |

| 11/17/2011 Low hanging branches from fig tree. | |

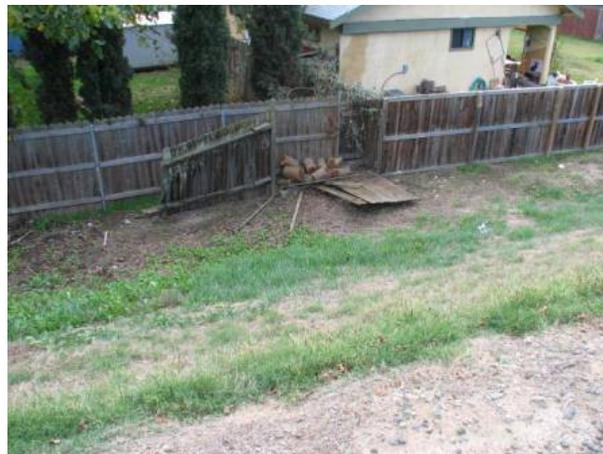
| jeto_f_20111122_677.jpg | |

| 11/17/2011 Old fence is falling down within 15' of the levee toe. | |

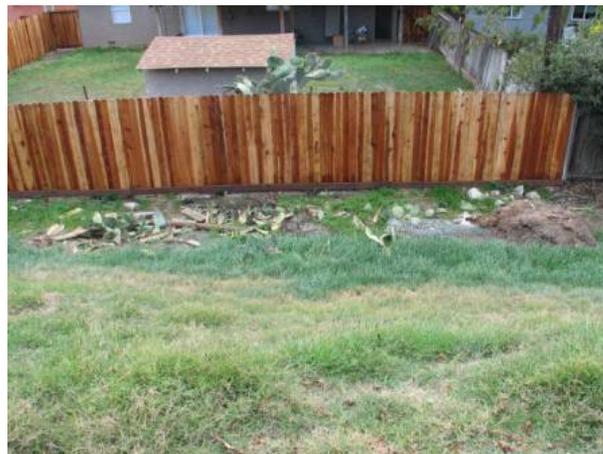
| jeto_f_20111122_678.jpg | |

| LMIR No. | Levee Mile | | Category | Item | Location | Rating | Action/Comment | GPS Latitude/Longitude | | Issue No. Photo |
|---|---|---|---|---|---|---|--|---|---|---|
| 15 | 1.10 | 1.10 | Earthen Levee | Encroachments | LS | M | Debris Inspector Comments: Assorted debris at toe. Noted in USACE PI | 38.624896 ° -121.449465 ° | 38.624896 ° -121.449465 ° | 179 Y |

| 11/17/2011 Assorted debris within 15' of the levee toe. | |

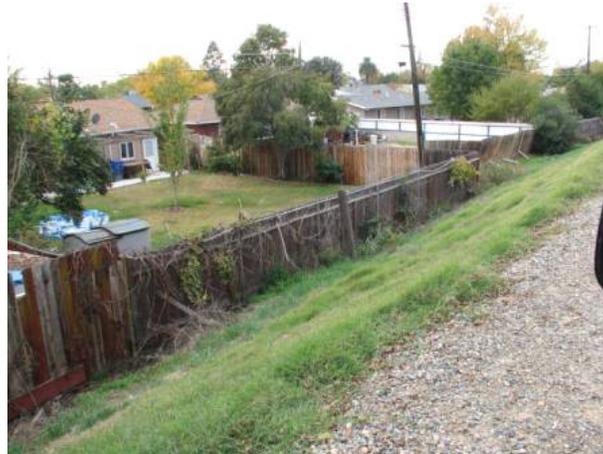
| jeto_f_20111122_679.jpg | |

| 11/17/2011 Fence built on the levee slope. | |

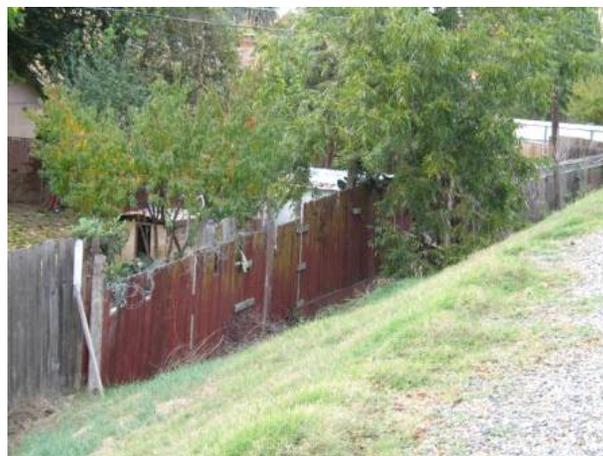
| jeto_f_20111122_680.jpg | |

| 11/17/2011 Wooden privacy fence built at the levee toe. | |

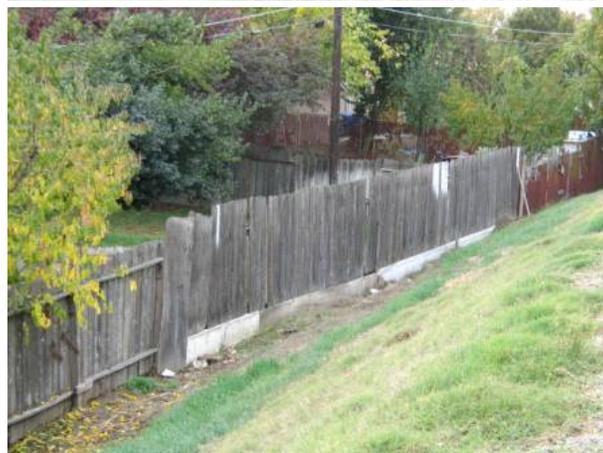
| jeto_f_20111122_681.jpg | |

| 11/17/2011 Wooden privacy fence built at the levee toe. | |

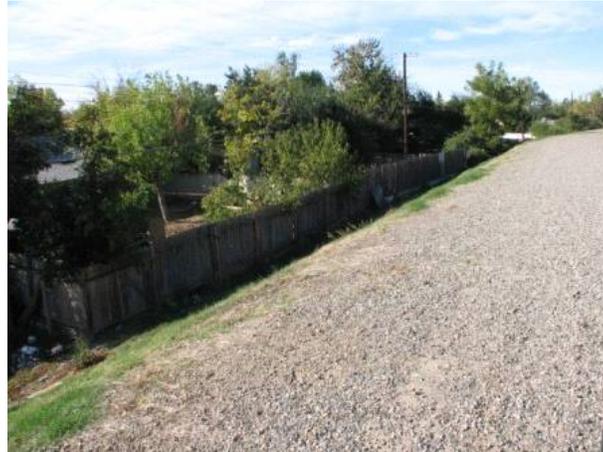
jeto_f_20110923_618.jpg

Photo of solid fences built against the levee slope.

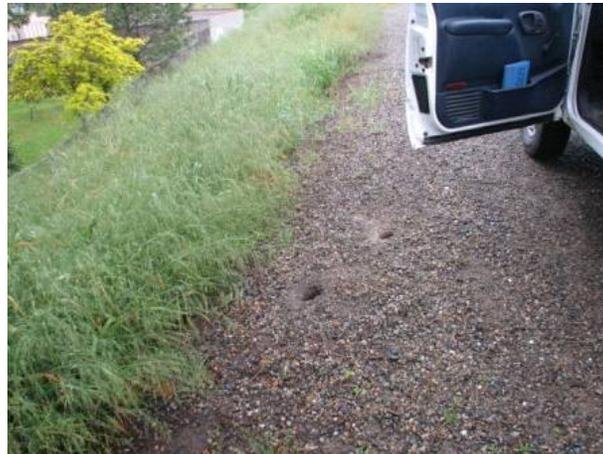
jeto_f_20110923_621.jpg

Rodent burrows on levee crown.

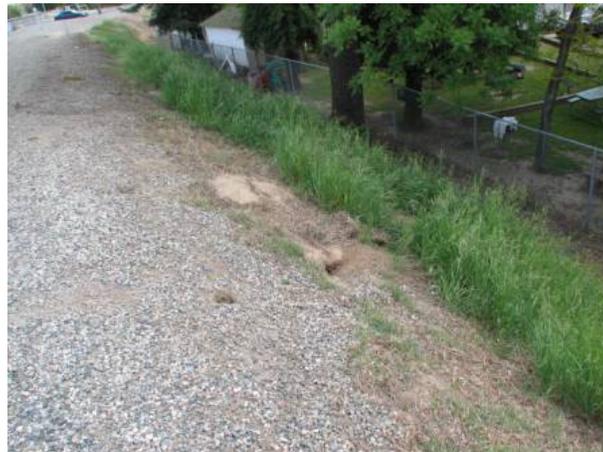
jeto_f_20110923_622.jpg

04/13/2011 Fresh burrows present, rodents are also present.

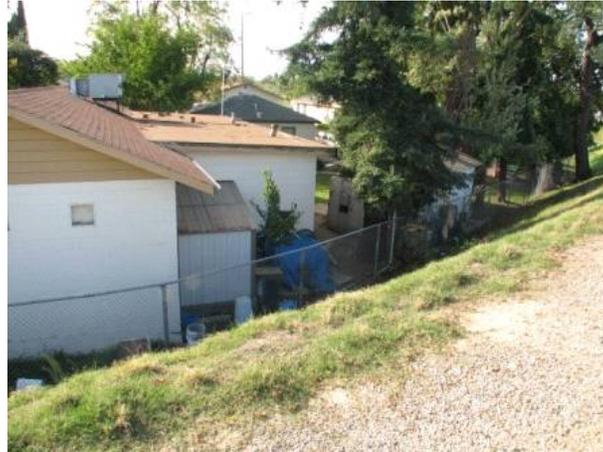
| jeto_f_20110923_616.jpg | |

| Fall 2009 photo: Buildings and fence near levee toe. | |

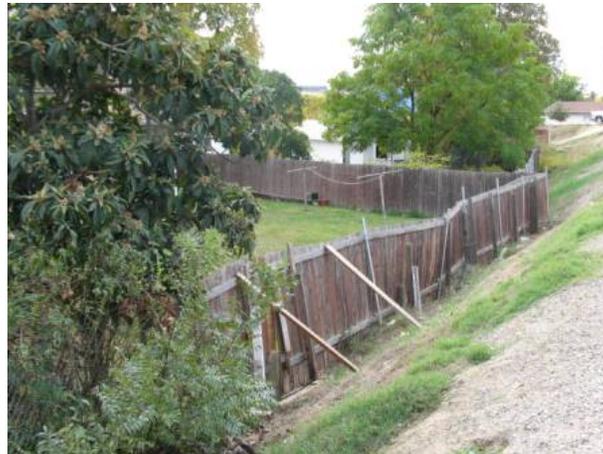
| jeto_f_20111122_682.jpg | |

| 11/17/2011 Wooden privacy fence built at the levee toe. Levee slope is being used to support the fence. | |

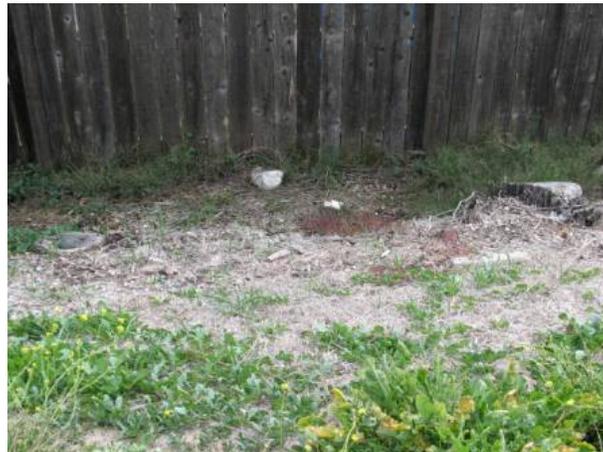
| jeto_f_20111122_683.jpg | |

| 11/17/2011 Two stumps at levee toe. | |

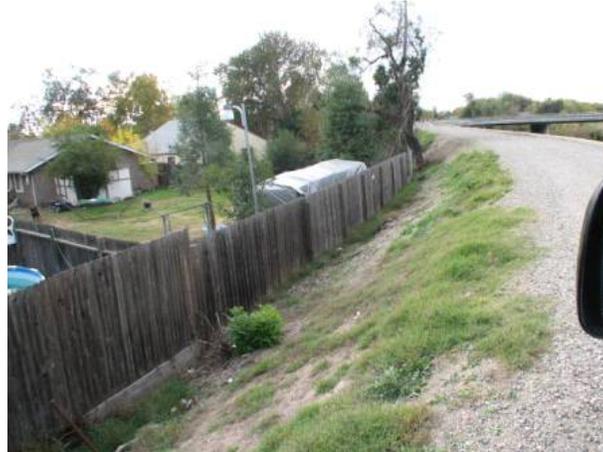
| jeto_f_20111122_684.jpg | |

| 11/17/2011 Wooden privacy fence built at the levee toe. | |

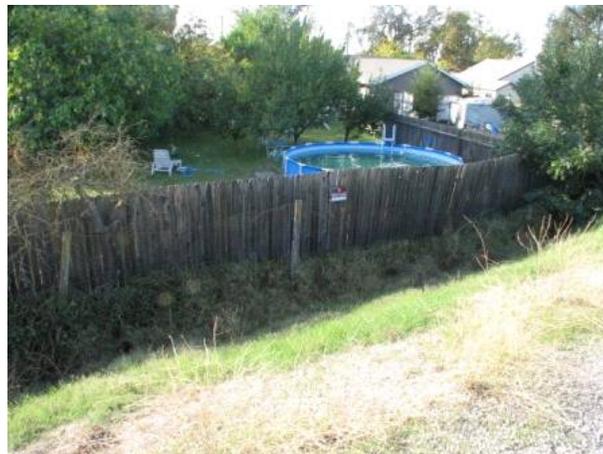
| jeto_f_20110923_615.jpg | |

| Fall 2009 photo: Wooden and wire fence are within 10-ft of levee toe. | |

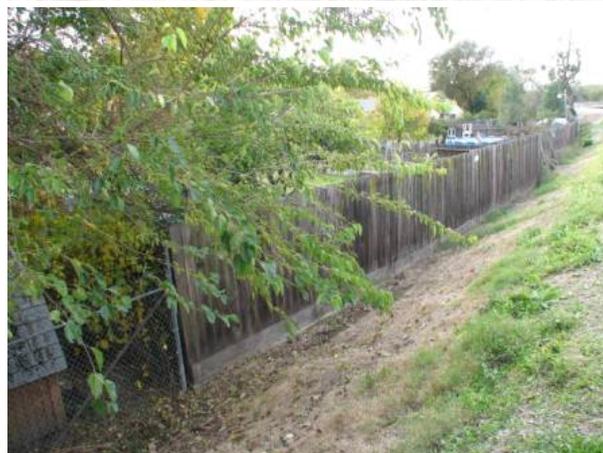
| jeto_f_20111122_685.jpg | |

| 11/17/2011 Wooden privacy fence built at the levee toe. | |

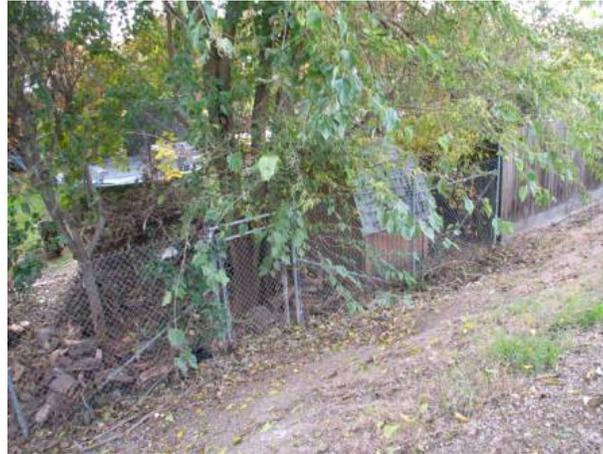
| jeto_f_20111122_686.jpg | |

| 11/17/2011 Shed and firewood can be seen through the chainlink fence. | |

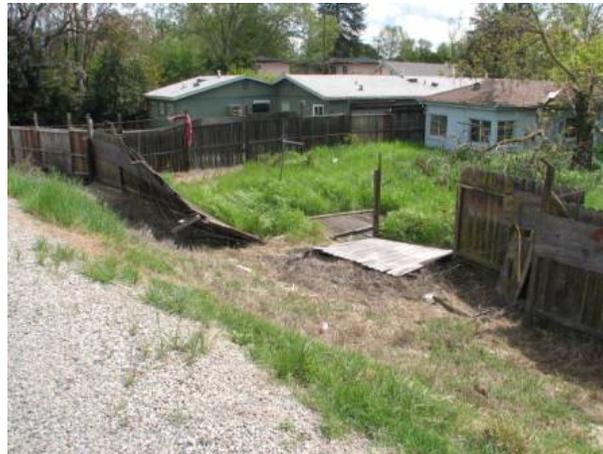
| jeto_f_20110923_614.jpg | |

| 04/13/2011 Fence has fallen down, now encroaches farther onto the levee. | |

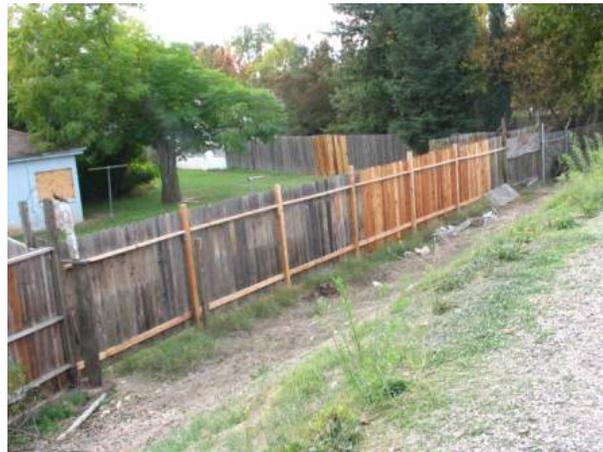
| jeto_f_20111122_687.jpg | |

| 11/17/2011 New wooden privacy fence built within 15' of the levee toe. | |

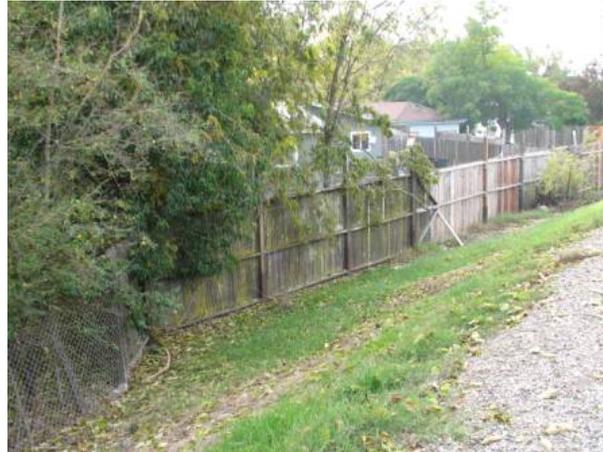
| jeto_f_20111122_688.jpg | |

| 11/17/2011 Wooden privacy fence built within 15' of the levee toe. | |

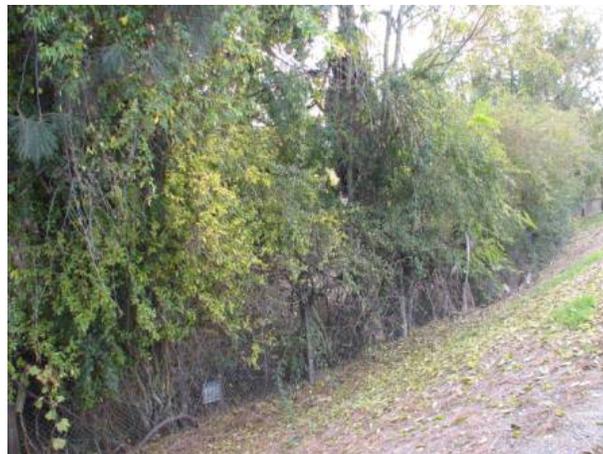
| jeto_f_20111122_689.jpg | |

| 11/17/2011 Thick vegetation at the levee toe. | |

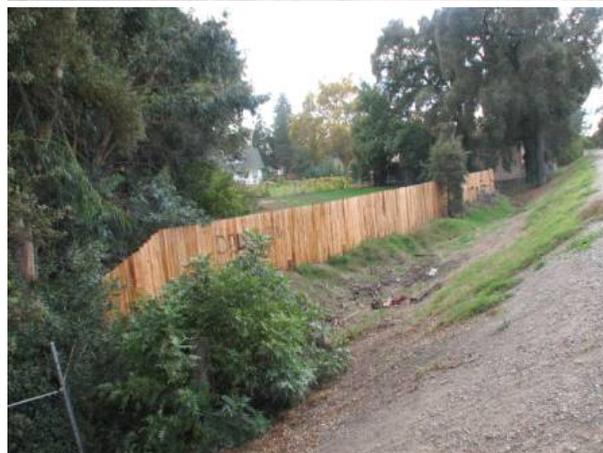
| jeto_f_20111122_690.jpg | |

| 11/17/2011 Wooden privacy fence built within 15' of the levee toe. | |

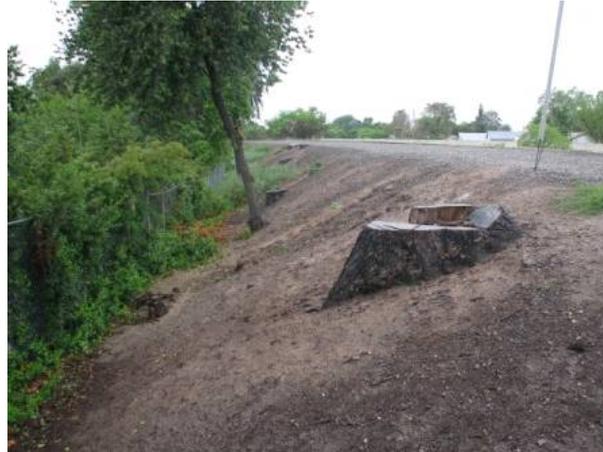
| jeto_f_20110923_626.jpg | |

| Several large stumps on levee slope. | |

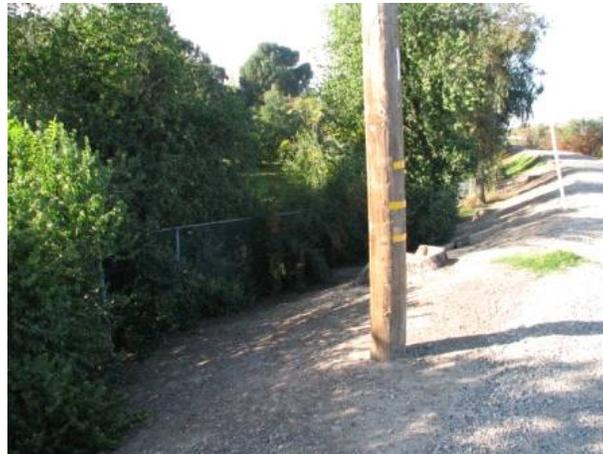
| jeto_f_20110923_619.jpg | |

| Fall 2009 photo:Vegetation obstructing visibility near levee slope. | |

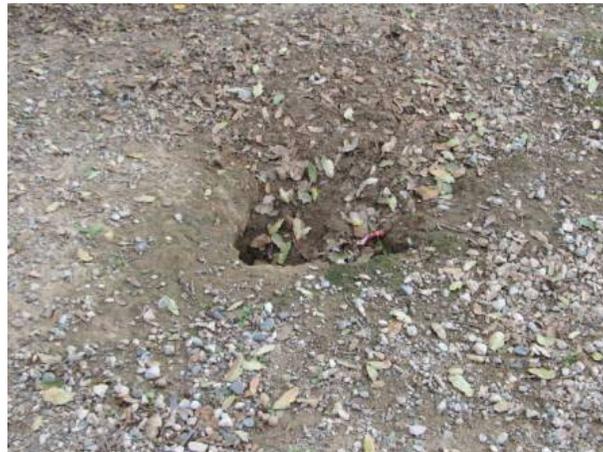
| jeto_f_20111122_691.jpg | |

| 11/17/2011 Rodent burrow at hinge point/ | |

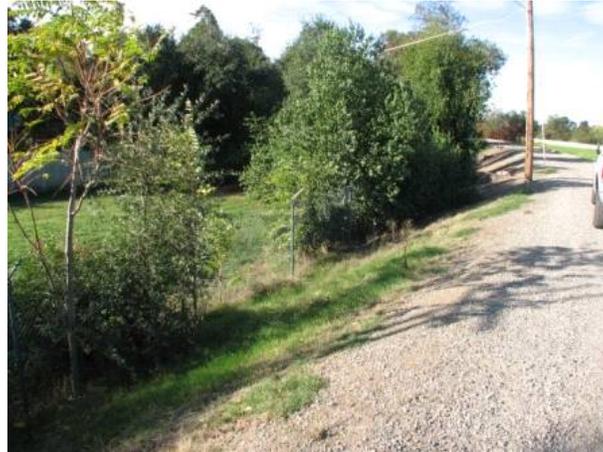
| jeto_f_20110923_613.jpg | |

| Fall 2009 photo: Photinias and other plants planted near levee toe. | |

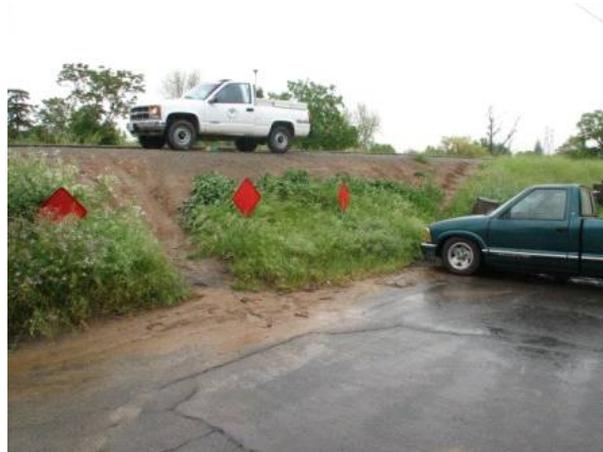
| jeto_f_20110923_625.jpg | |

| Slope stability due to foot traffic needs to be monitored. | |

| LMIR No. | Levee Mile | | Category | Item | Location | Rating | Action/Comment | GPS Latitude/Longitude | | Issue No. Photo |
|---|---|---|---|---|---|---|--|---|---|---|
| 37 | 1.58 | 1.58 | Earthen Levee | Slope Stability | LS | W | Repair the levee slope damaged by foot traffic and prevent access where possible. | 38.627251 ° -121.441460 ° | 38.627251 ° -121.441460 ° | 54 Y |

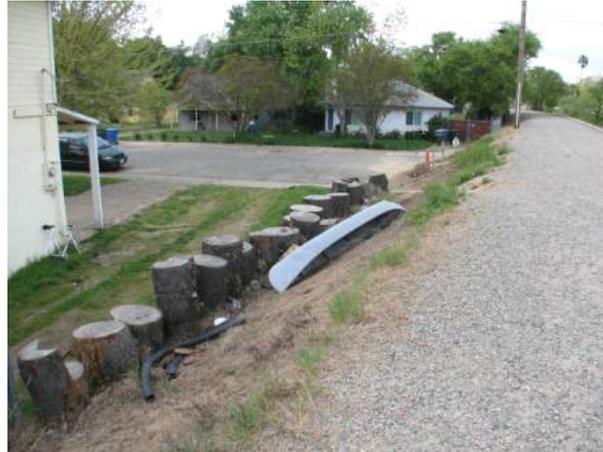
| jeto_f_20110923_620.jpg | |

| 04/13/2011 Items appear to be stored on levee, need to be removed. | |

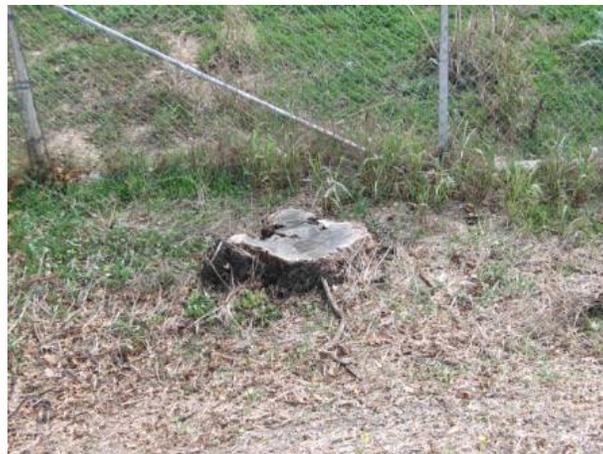
| jeto_f_20111122_693.jpg | |

| 11/17/2011 Stump at levee toe. | |

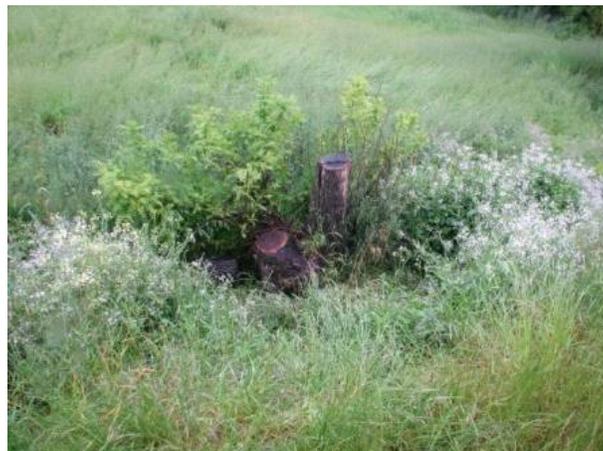
| jeto_f_20110923_624.jpg | |

| Tree stump with some new growth. | |

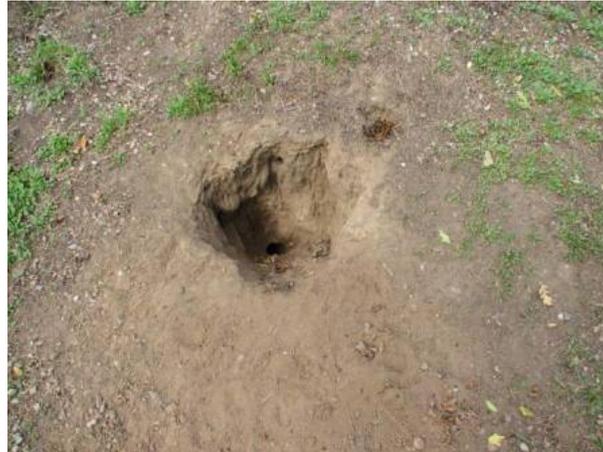
| jeto_f_20111122_694.jpg | |

| 11/17/2011 Active rodent burrow. | |

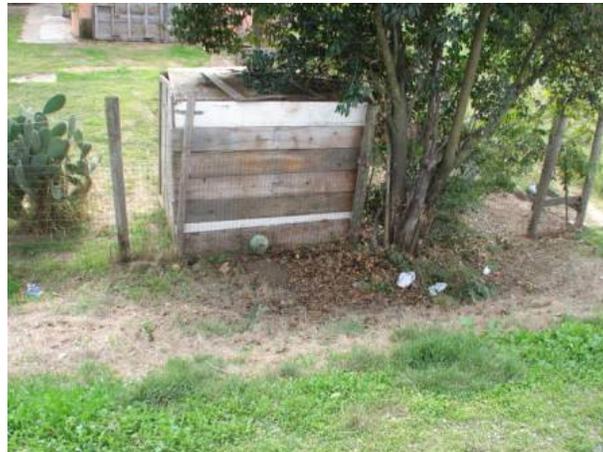
| jeto_f_20111122_695.jpg | |

| 11/17/2011 Wooden structure built within 15' of the toe. | |

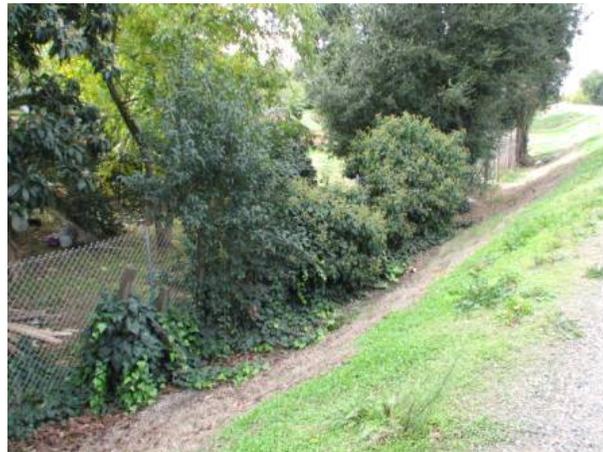
| jeto_f_20111122_696.jpg | |

| 11/17/2011 Growth on existing wooden fence is obstructive. | |

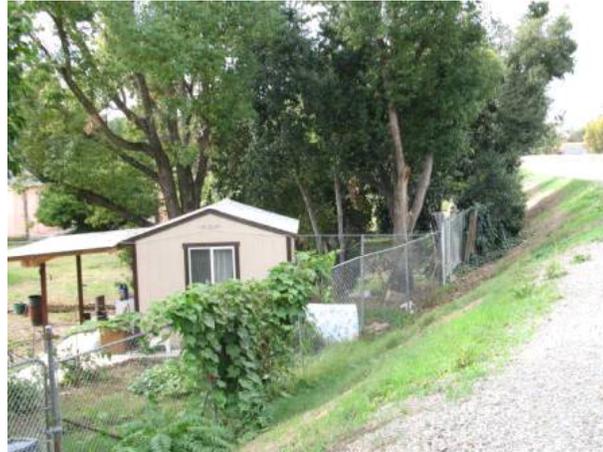
| jeto_f_20111122_698.jpg | |

| 11/17/2011 Wooden shed on concrete pad built within 15' of levee toe. | |

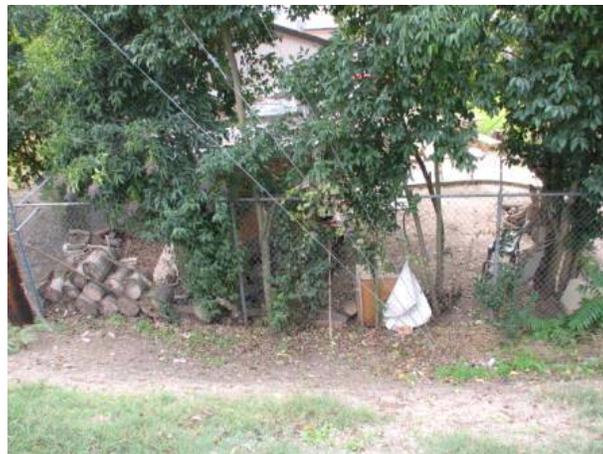
| jeto_f_20111122_697.jpg | |

| 11/17/2011 Wooden structure is built within 15' of the levee toe. | |

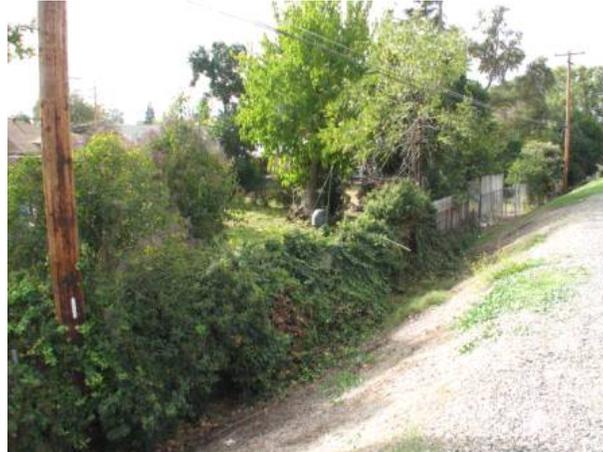
| jeto_f_20111122_699.jpg | |

| 11/17/2011 Landscaping vegetation growth on the fence is obstructive. | |

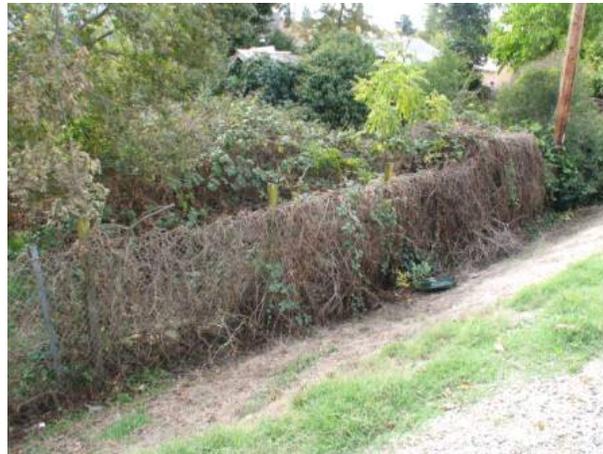
| jeto_f_20111122_700.jpg | |

| 11/17/2011 Blackberries growing on fence are obstructive. | |

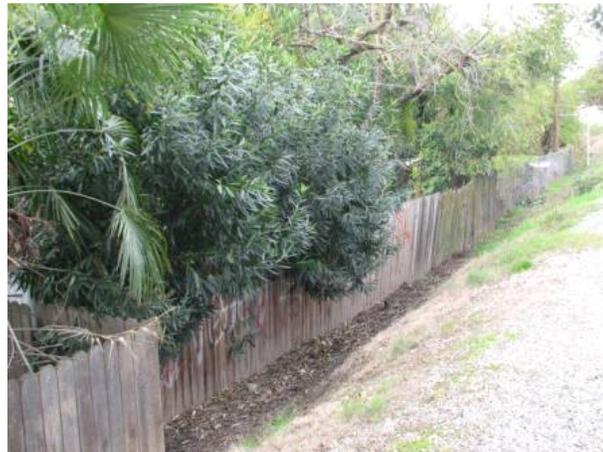
| jeto_f_20111122_701.jpg | |

| 11/17/2011 Wooden privacy fence built at the levee toe. | |

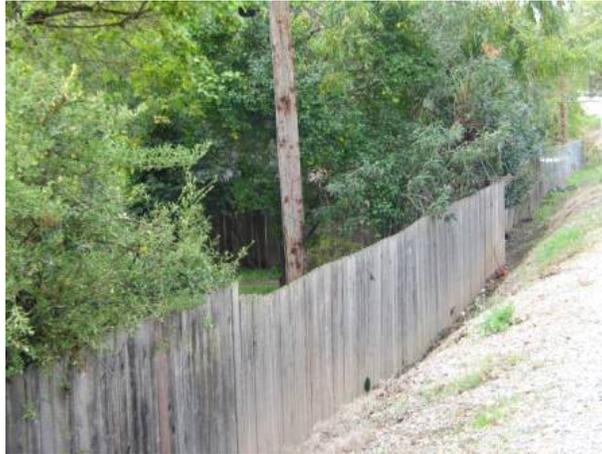
| jeto_f_20111122_702.jpg | |

| 11/17/2011 Wooden privacy fence built at the levee toe. | |

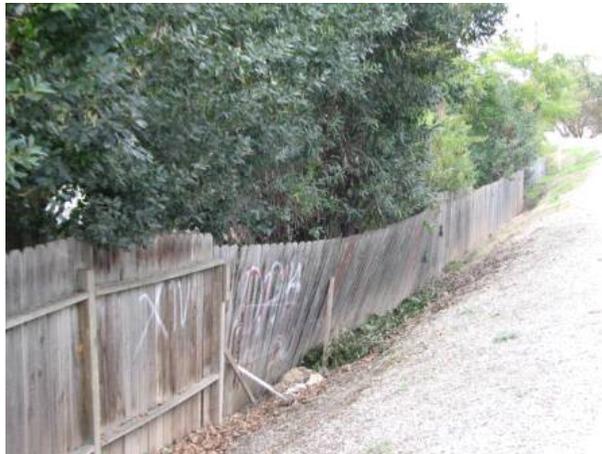
| jeto_f_20111122_703.jpg | |

| 11/17/2011 Wooden privacy fence built at the levee toe. | |

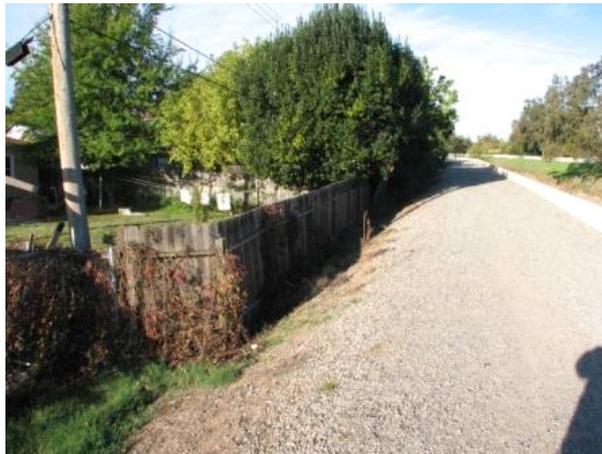
| jeto_f_20110923_611.jpg | |

| Fall 2009 photo: Wooden fence built on levee slope. | |

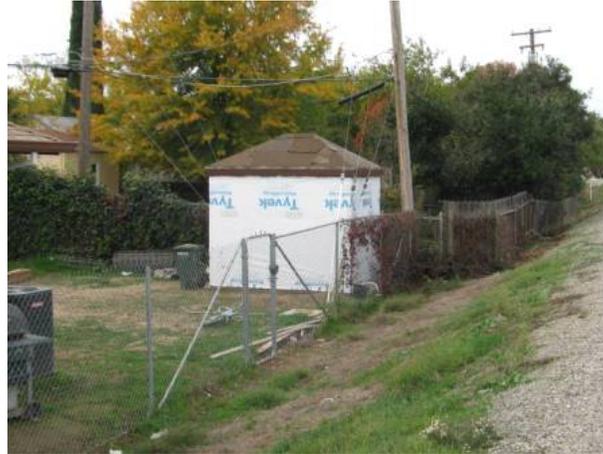
| jeto_f_20111122_704.jpg | |

| 11/17/2011 Building on concrete pad being built within 15' of the levee toe. | |

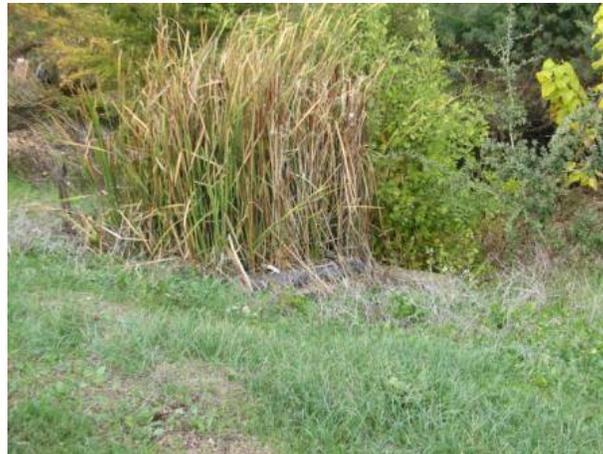
| jeto_f_20111122_705.jpg | |

| 11/17/2011 Tules growing in the outfall structure are keeping the flapgate in the closed position. | |

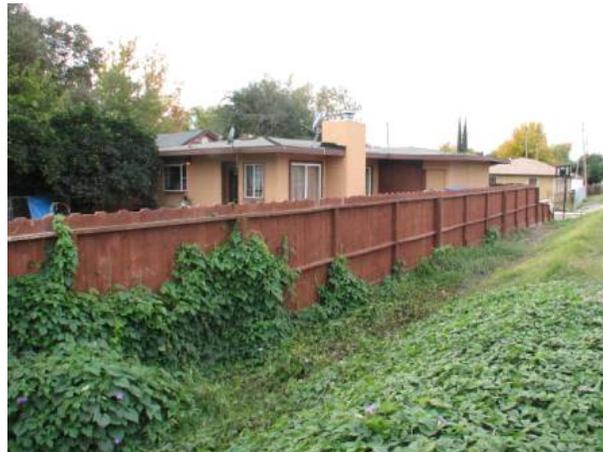
| jeto_f_20111122_706.jpg | |

| 11/17/2011 Wooden privacy fence built at the levee toe. | |

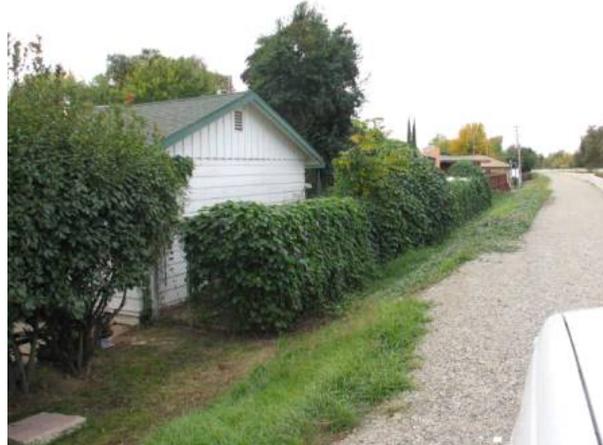
| jeto_f_20111122_707.jpg | |

| 11/17/2011 Landscape vegetation on fence is obstructing. | |

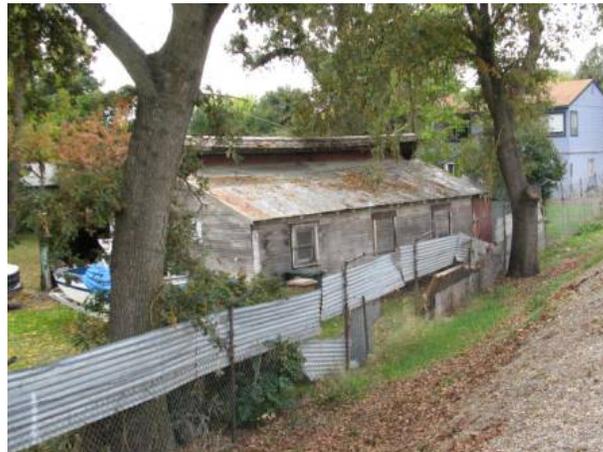
| jeto_f_20111122_709.jpg | |

| 11/17/2011 Wooden structure is within 15' of the levee toe. | |

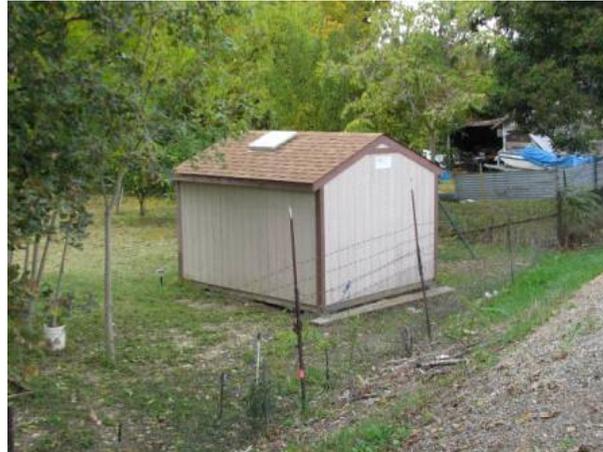
| jeto_f_20111122_710.jpg | |

| 11/17/2011 Wooden structure is within 15' of the levee toe. | |

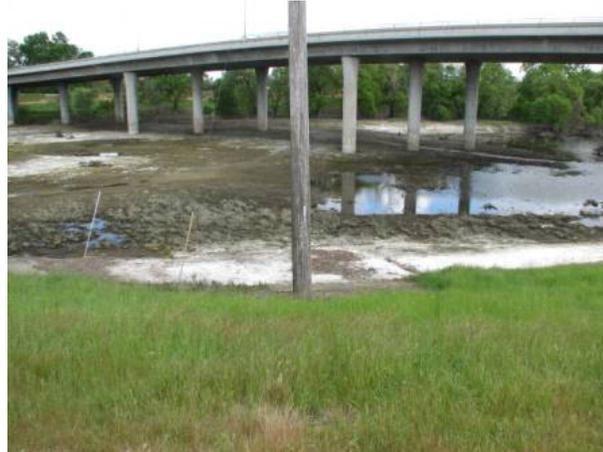
| jeto_f_20110923_759.jpg | |

| 04/13/2011 Power pole is in the levee on the water side. | |

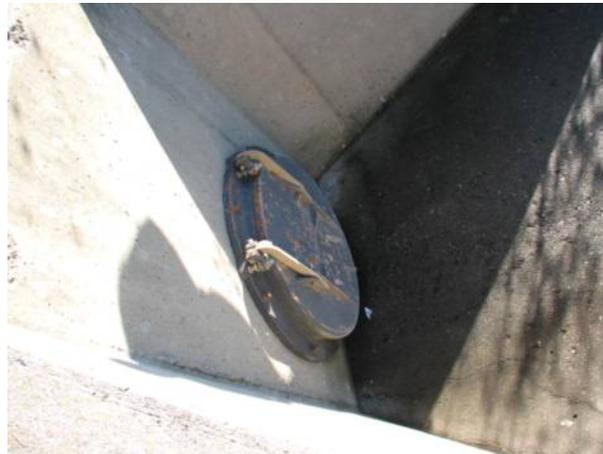
| jeto_f_20111122_657.jpg | |

| 11/16/2011 Clean working flap gate. | |

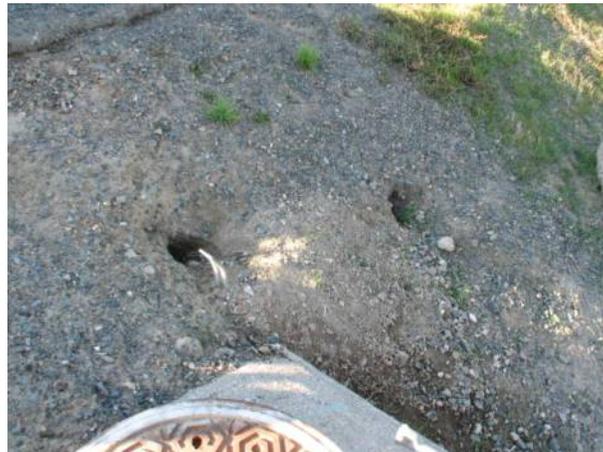
| jeto_f_20111122_658.jpg | |

| 11/16/2011 Burrows located near manhole. | |

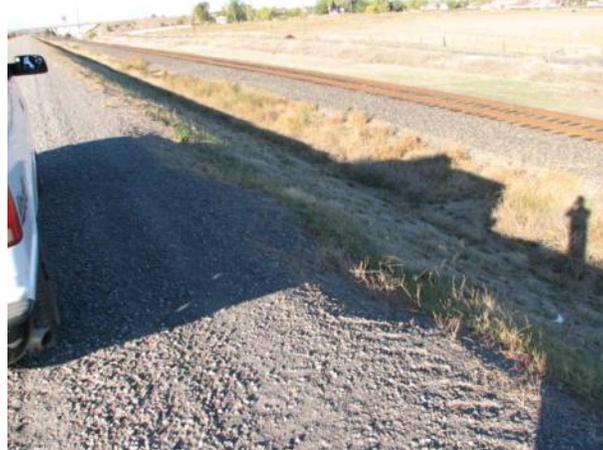
| jeto_f_20111122_659.jpg | |

| 11/16/2011 Depressions present on levee slope. | |

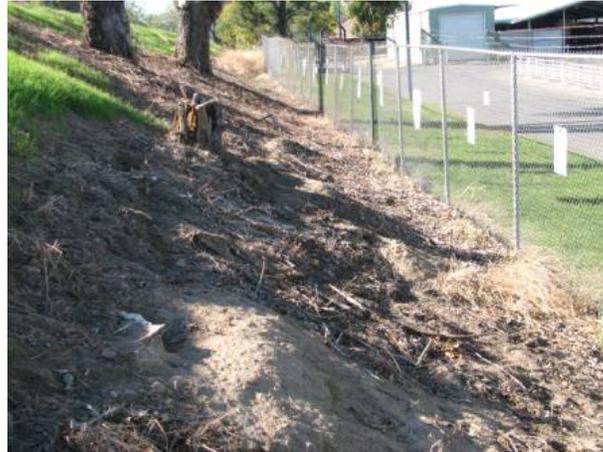
| jeto_f_20111122_650.jpg | |

| 11/16/2011 Numerous burrows in this area. | |

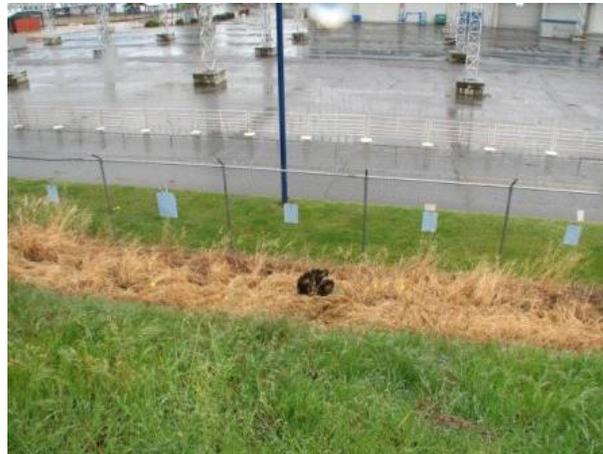
| jeto_f_20110923_915.jpg | |

| Tree stump on levee slope greater than 2" Dia. | |

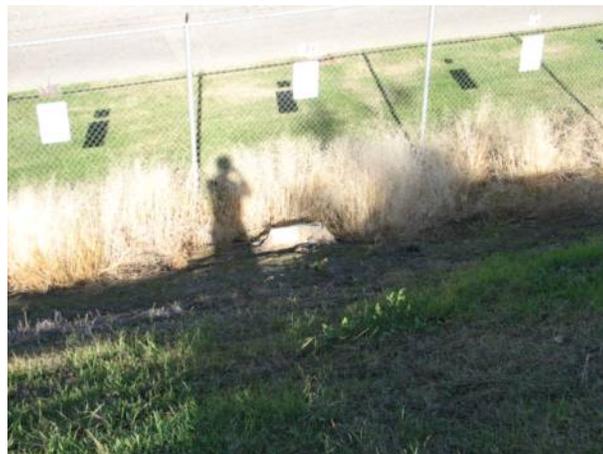
| jeto_f_20111122_651.jpg | |

| 11/16/2011 Stump on slope. | |

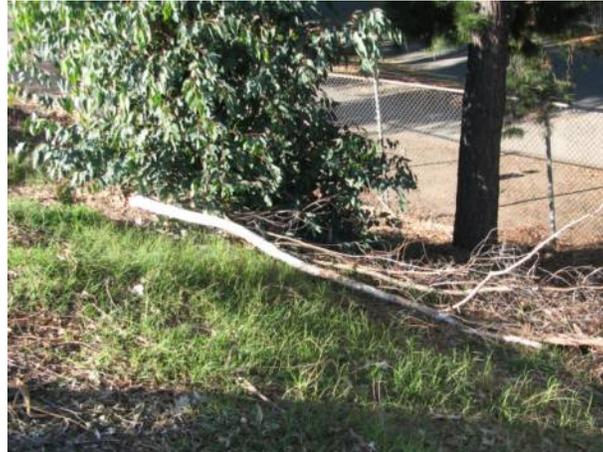
| jeto_f_20111122_652.jpg | |

| 11/16/2011 Limb on slope. | |

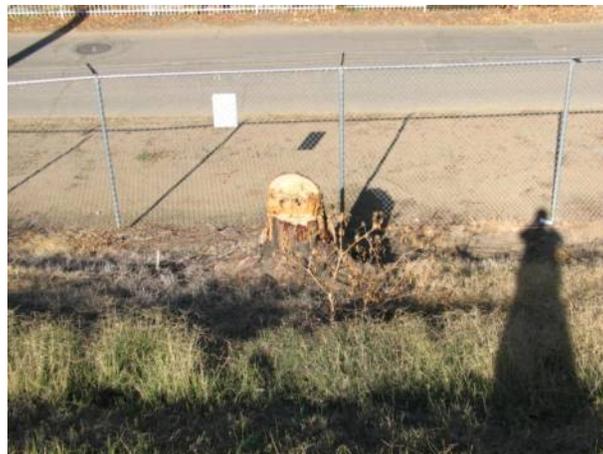
| jeto_f_20111122_653.jpg | |

| 11/16/2011 Stump larger than 2". | |

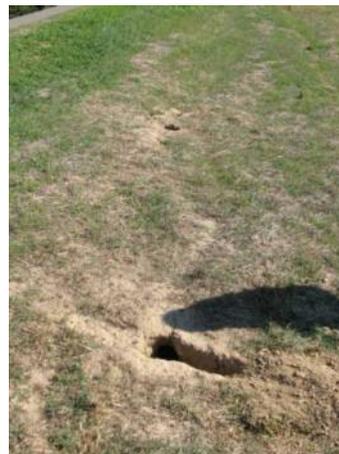
| jeto_f_20111122_654.jpg | |

| 11/16/2011 Single active burrow. | |

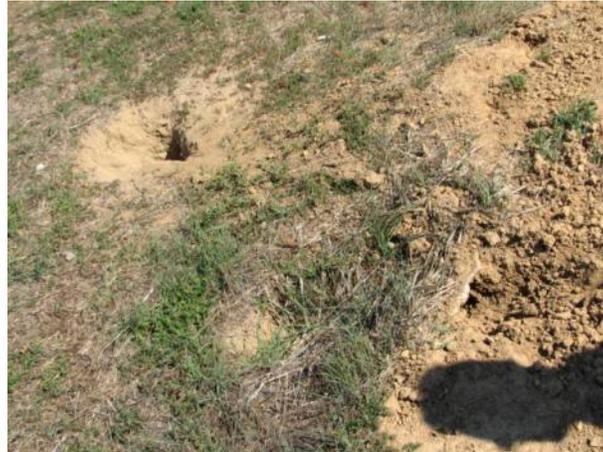
| jeto_f_20111122_655.jpg | |

| 11/16/2011 Several burrows in this area. | |

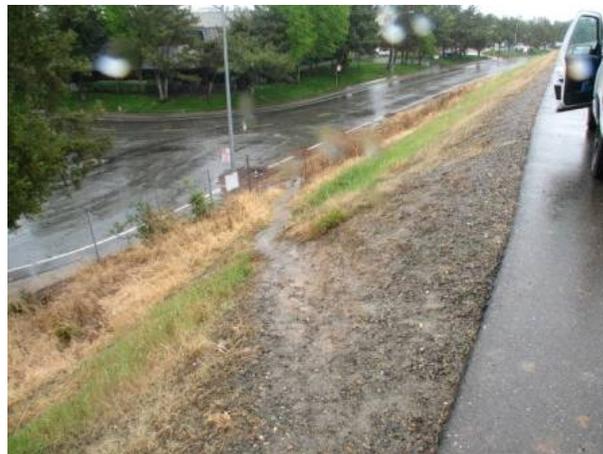
| jeto_f_20110923_914.jpg | |

| Slope needs to be monitored due to heavy foot traffic. | |

| LMIR No. | Levee Mile | | Category | Item | * Location | ** Rating | Action/Comment | GPS Latitude/Longitude | | Issue No. Photo |
|---|---|---|---|---|---|---|--|---|---|---|
| 8 | 1.80 | 1.80 | Earthen Levee | Slope Stability | LS | W | Repair the levee slope damaged by foot traffic and prevent access where possible. | 38.595700 ° -121.448198 ° | 38.595700 ° -121.448198 ° | 9 Y |

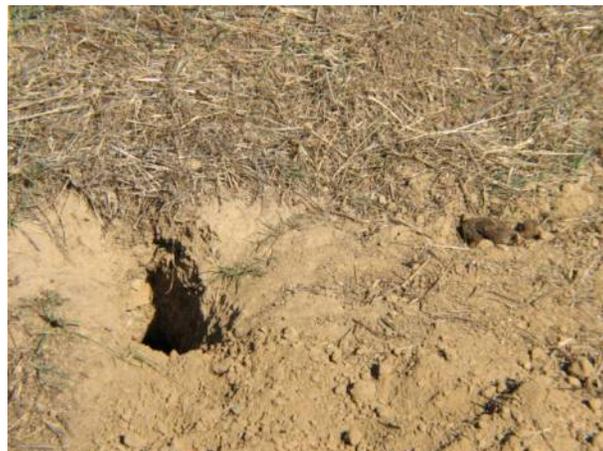
| jeto_f_20111122_656.jpg | |

| 11/16/2011 Large active burrow. | |

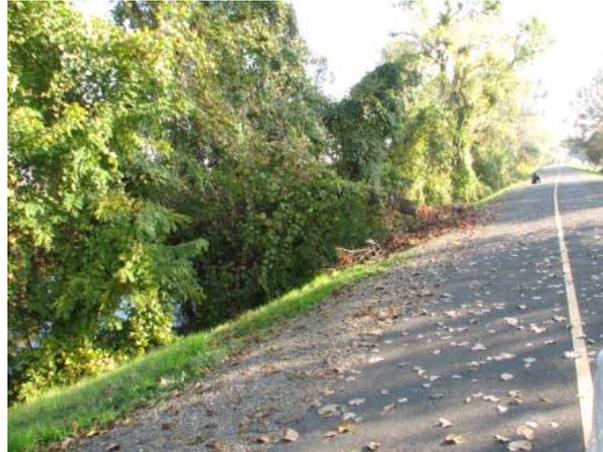
| jeto_f_20111122_625.jpg | |

| 11/15/2011 Fallen limb on waterside slope and crown. | |

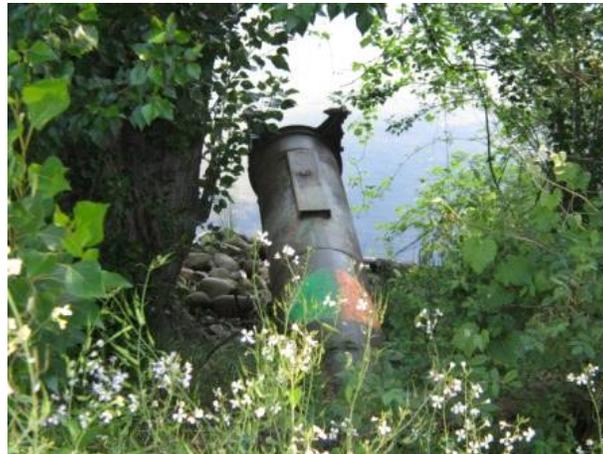
| jeto_f_20110923_998.jpg | |

| Discharge pipe from printing shop into American River. | |

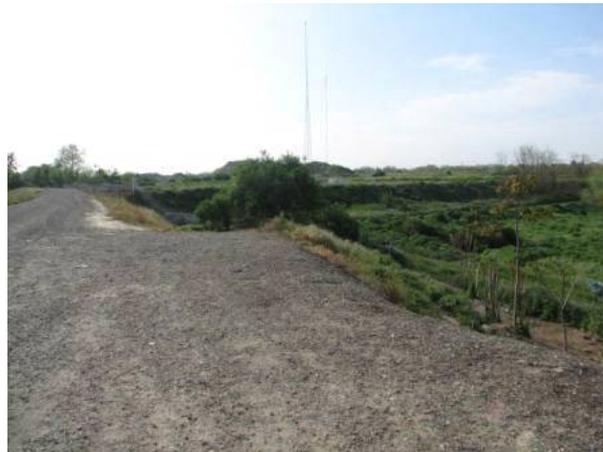
| jeto_f_20110923_993.jpg | |

| 04/14/2011 Elderberry bush prevents visibility of levee toe. | |

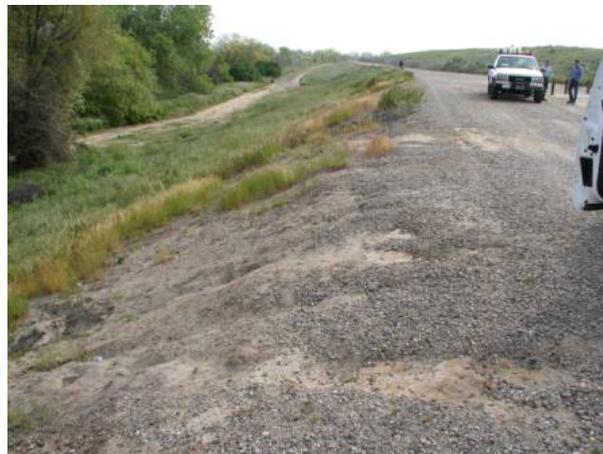
| jeto_f_20110923_989.jpg | |

| 04/14/2011 Erosion caused by runoff from adjacent parking lot. | |

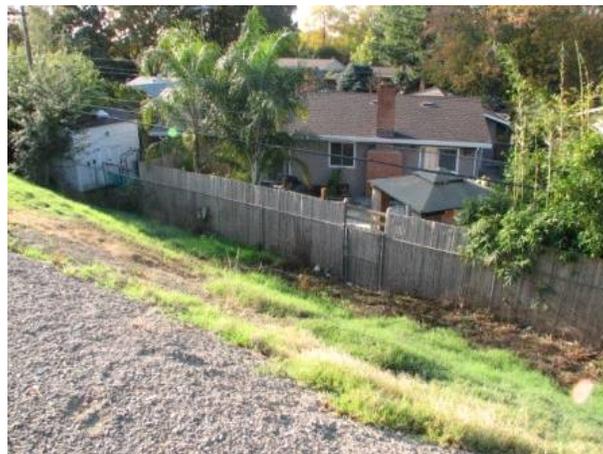
| jeto_f_20110923_983.jpg | |

| Fall 2009 photo: Fence and landscaping within 10-ft of levee toe obstructs access and visibility. | |

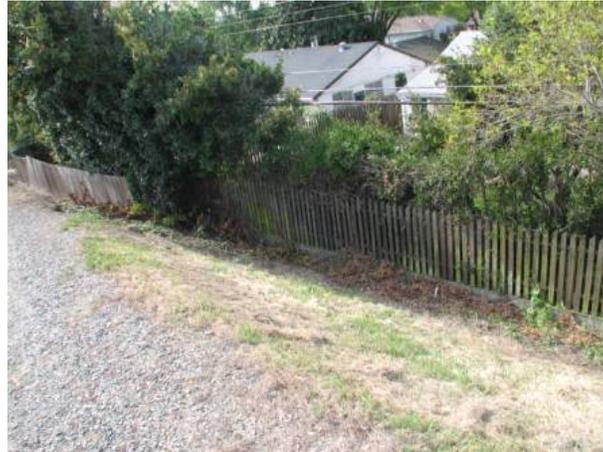
| jeto_f_20110923_982.jpg | |

| 04/14/2011 Landscaping, which was a Fall inspection issue has been removed. | |

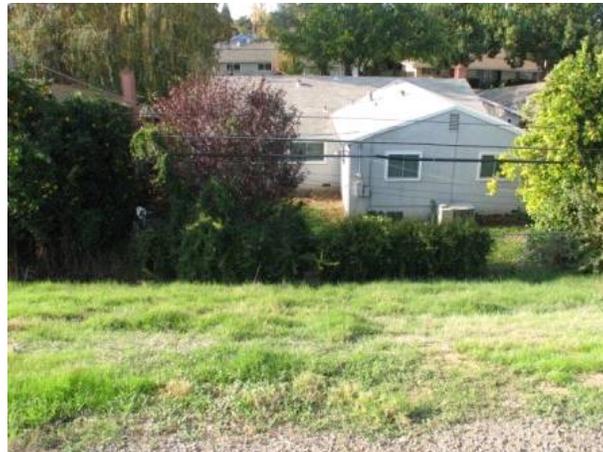
| jeto_f_20110923_994.jpg | |

| Fall 2009 photo: Landscaping within 10-ft of levee toe obstructs access and visibility. | |

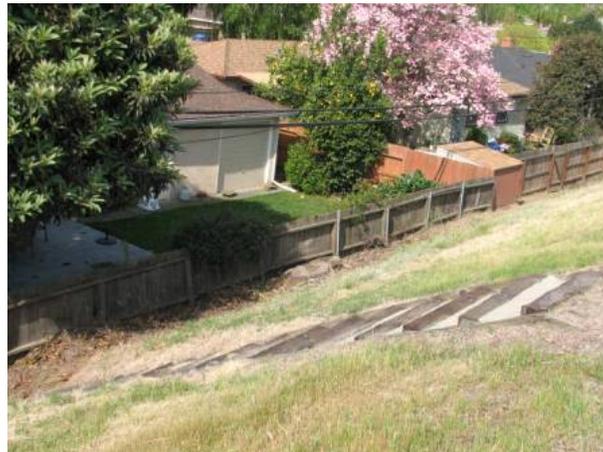
| jeto_f_20110923_984.jpg | |

| 04/14/2011 Palms have been removed. | |
