**Flood Control Project Maintenance
Levee Inspections**

Fall 2011 Levee Maintenance Deficiency Summary Report

Sacramento River Basin

| NA0001 | | Overall LMA Rating | Total LMA Miles | | | | |
|--|---|---|---|---|---|---|--|
| American River Flood Control District | | A | 32.51 | | | | |

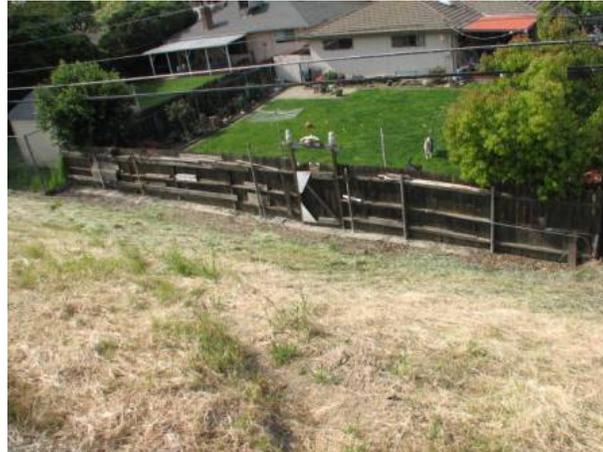
| jeto_f_20110923_985.jpg | |

| 04/14/2011 Retaining wall has been removed. | |

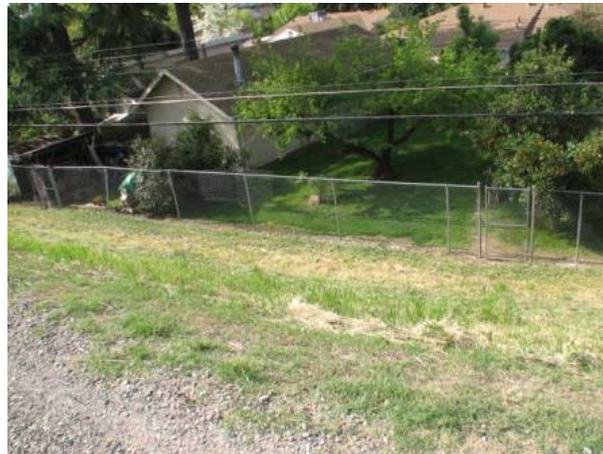
| jeto_f_20110923_995.jpg | |

| 04/14/2011 Planter boxes have been removed. | |

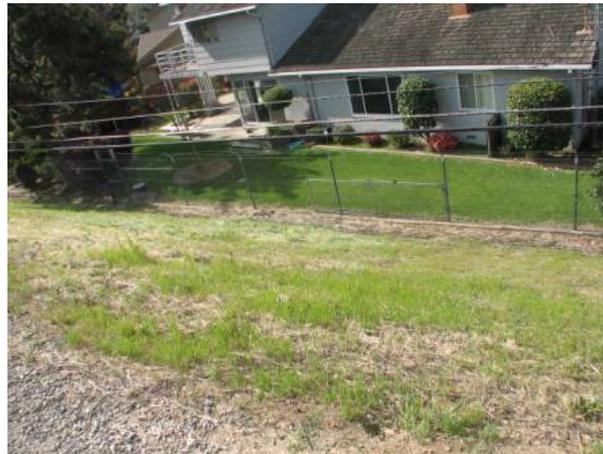
| jeto_f_20110923_996.jpg | |

| 04/14/2011 Landscape removed, changed from CO to PO with chainlink fence. | |

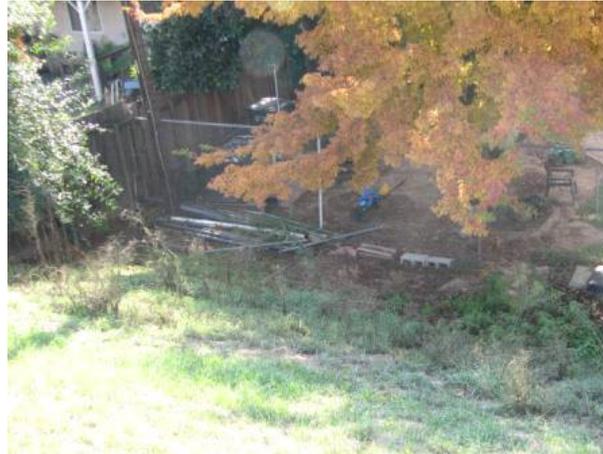
| jeto_f_20111122_627.jpg | |

| 11/15/2011 Debris on levee side of fence. This item was noted in the USACE PI. | |

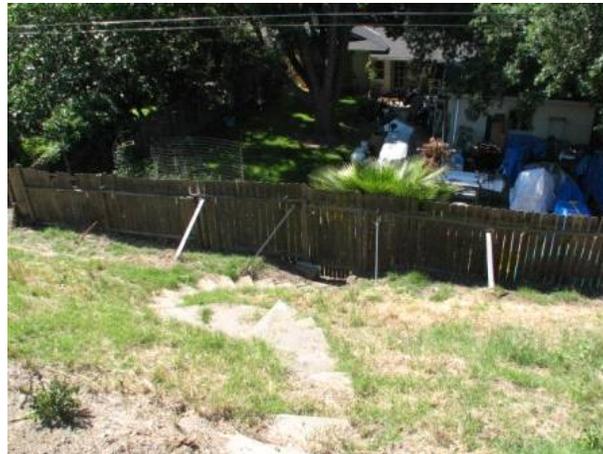
| jeto_f_20110923_986.jpg | |

| Wooden fence and braces obstruct access and visibility. | |

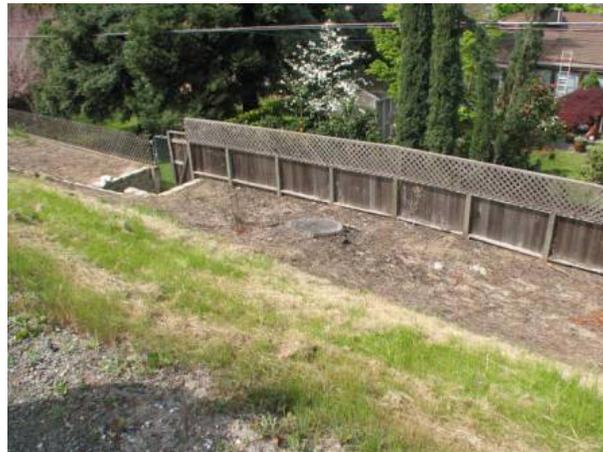
| jeto_f_20110923_991.jpg | |

| 04/14/2011 Large stump at toe of levee. | |

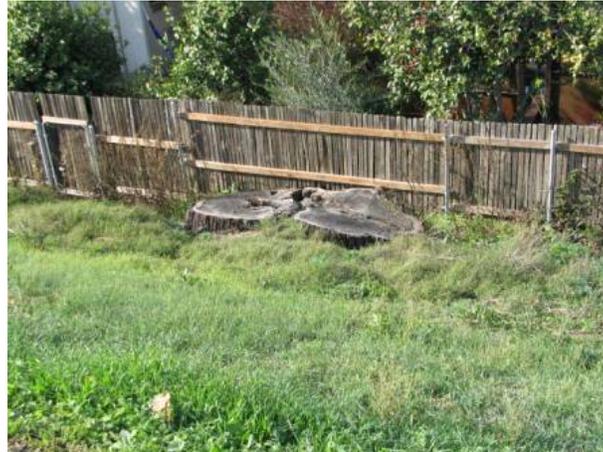
| jeto_f_20111122_628.jpg | |

| 11/15/2011 Large stump at levee toe. | |

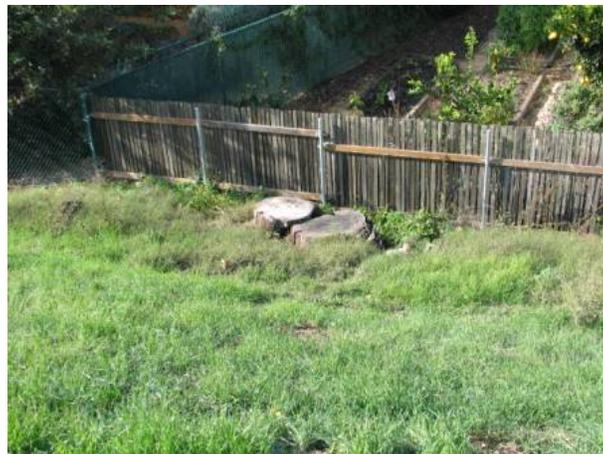
| jeto_f_20111122_629.jpg | |

| 11/15/2011 Stump at levee toe. | |

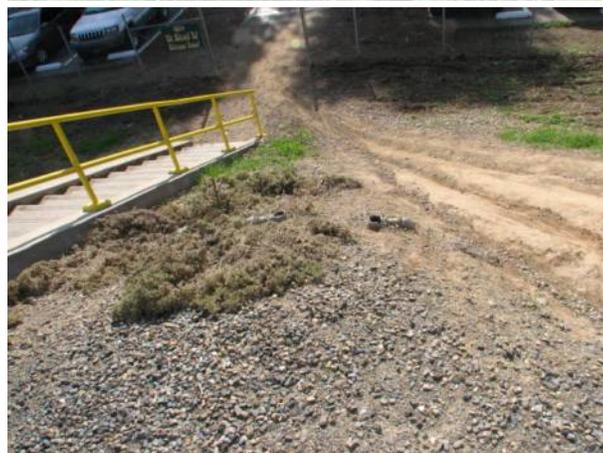
| jeto_f_20111122_630.jpg | |

| 11/15/2011 Cutt off ends of pipe are exposed. Appears as though a check valve was removed. | |

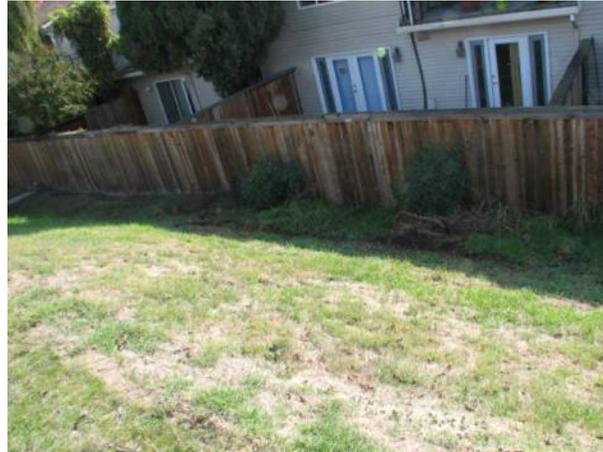
| jeto_f_20111122_631.jpg | |

| 11/15/2011 Landscape debris has been thrown over the fence onto the levee toe. | |

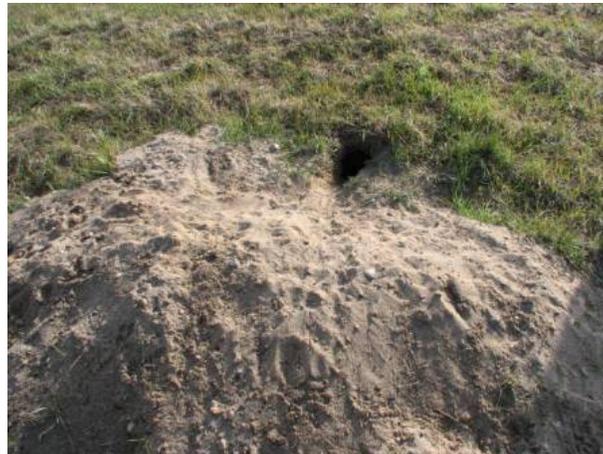
| jeto_f_20111122_632.jpg | |

| 11/15/2011 Large active burrow located approximately mid-slope. | |

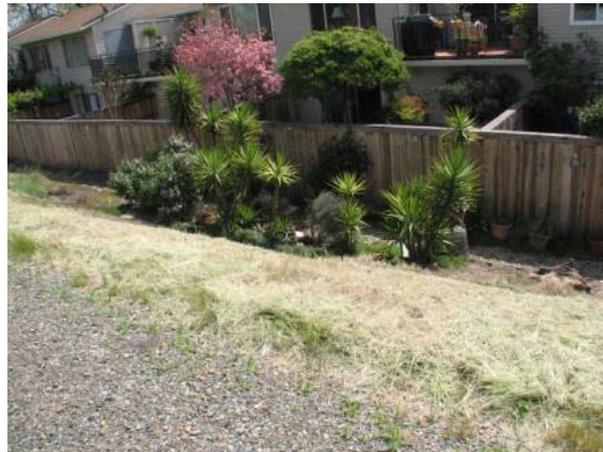
| jeto_f_20110923_992.jpg | |

| 04/14/2011 Landscaping outside of fence on levee and wood fence completely obstruct access and visibility. | |

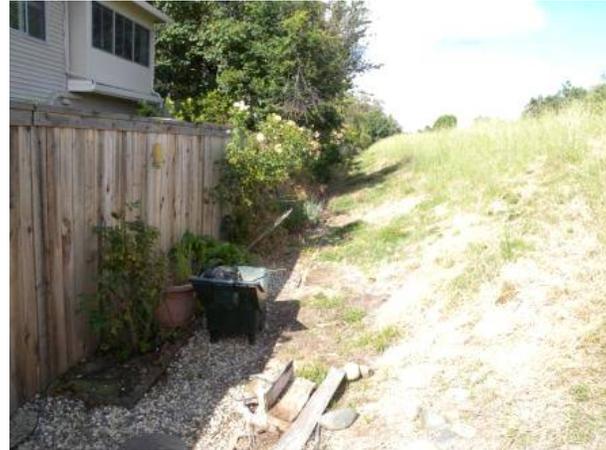
| <p>jeto_f_20111201_634.JPG</p> | |

| <p>11/29/2011 Updated photo provided by ARFCD, shows ihow landscaping has been greatly reduced to allow visibility of the toe. The fence is still a CO issue, until it can be determined if it is outside of the easement.</p> | |

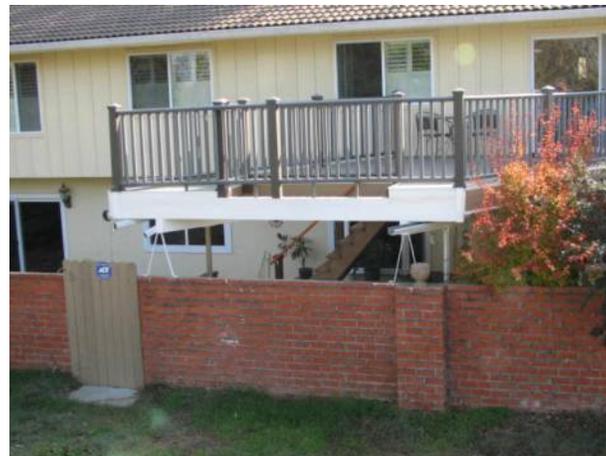
| <p>jeto_f_20111122_633.jpg</p> | |

| <p>11/15/2011 Gutter drains that are suspended from the balcony direct flow onto the levee toe.</p> | |

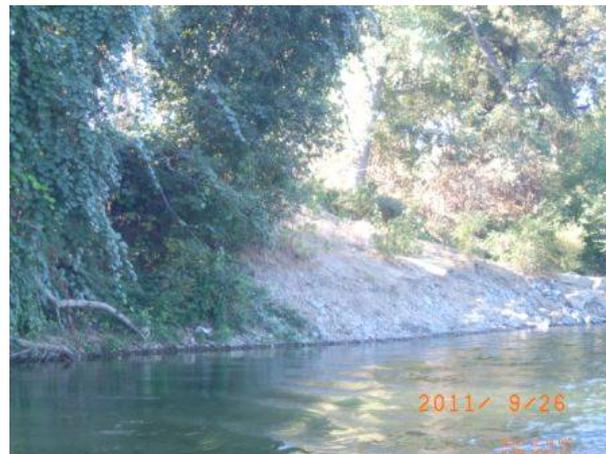
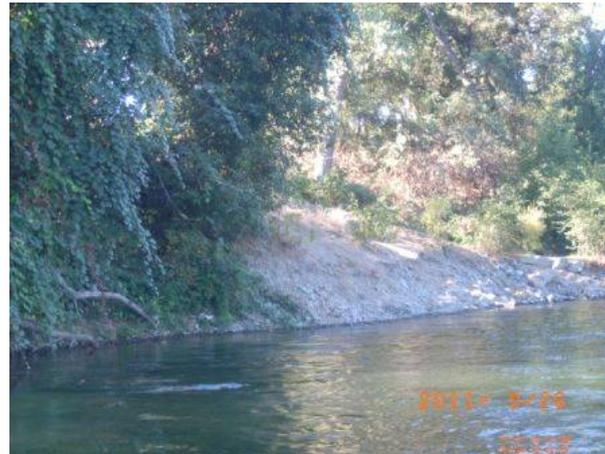
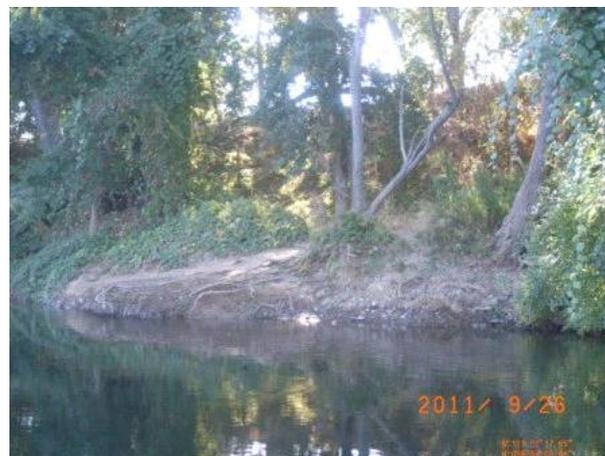
| <p>USACE2011_LAR_10-0_L_1.jpg</p> | |

| LMIR No. | Levee Mile | | Category | Item | Location | Rating | Action/Comment | GPS Latitude/Longitude | | Issue No. Photo |
|---|---|---|---|---|---|---|--|---|---|---|
| 169 | 9.42 | 9.42 | Supplemental | USACE Erosion Survey | WS | M | Inspector Comments: 2003 - Site was identified as critical and repaired, however the repair was vandalized. 2006 - Added back to the inventory. The brush box repair was burned. 2007 - Vegetation is not colonizing or taking root. 2010 - There is a partial fix on downstream end, fresh rock and fenced vegetation. 2011: This site is currently under contract for repair. Repairs should be complete in 2012. [2011 Site ID: LAR_10-0_L] | 38.567270 ° -121.372571 ° | 38.567566 ° -121.370895 ° | 7 Y |

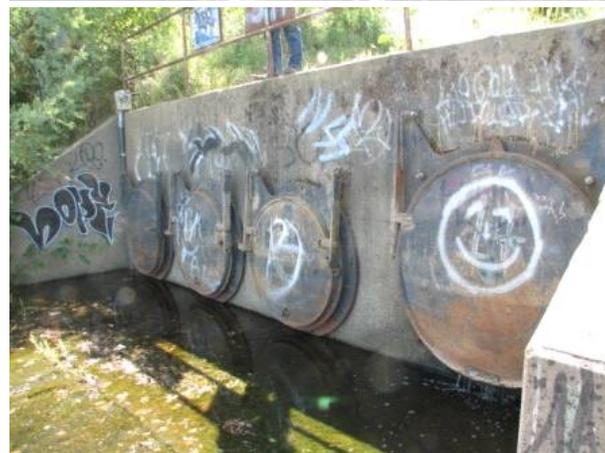
| jeto_f_20110923_990.jpg | |

| LMIR No. | Levee Mile | | Category | Item | Location | Rating | Action/Comment | GPS Latitude/Longitude | | Issue No. Photo |
|---|---|---|---|---|---|---|--|---|---|---|
| 170 | 9.49 | 9.49 | Earthen Levee | Encroachments | WS | W | Pipe Inspector Comments: Flap gates in good condition. | 38.566700 ° -121.372961 ° | 38.566700 ° -121.372961 ° | 175 Y |

| Drainage outfall to American River. | |

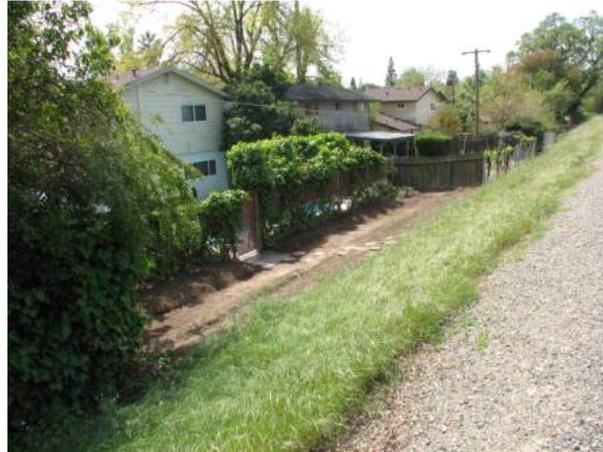
| jeto_f_20110923_997.jpg | |

| 04/14/2011 Owner appears to be preparing ground for landscaping. | |

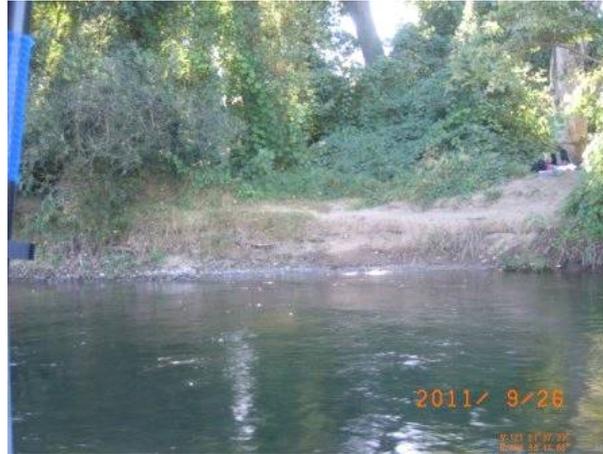
| USACE2011_LAR_10-6_L_1.jpg | |

| LMIR No. | Levee Mile | | Category | Item | Location | Rating | Action/Comment | GPS Latitude/Longitude | | Issue No. Photo |
|---|---|---|---|---|---|---|--|---|---|---|
| 193 | 10.10 | 10.10 | Supplemental | USACE Erosion Survey | WS | M | Inspector Comments: 2006 - Steep, near vertical slope with a recently fallen tree. Bank is very high so failure is into the slope of the levee. There is a cohesive outcrop in the toe and has the potential for "skating." 2010 - Fresh slumping observed, site extended downstream. 2011: This site is currently under contract for repair. Repairs should be complete in 2012. [2011 Site ID: LAR_10-6_L] | 38.569631 ° -121.361396 ° | 38.569833 ° -121.360423 ° | 67 Y |

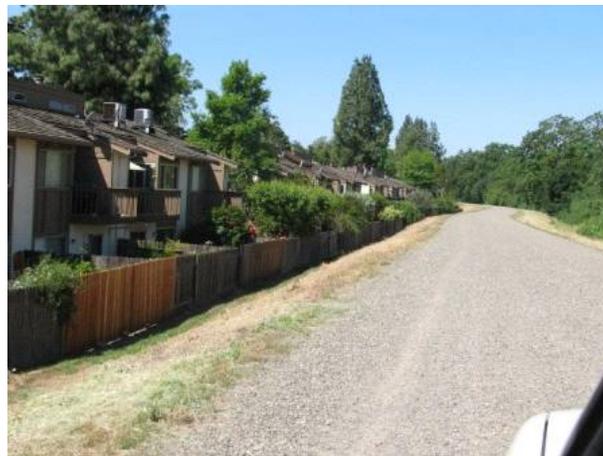
jeto_f_20110923_987.jpg

Wooden fence behind apartments within 10' of levee toe.

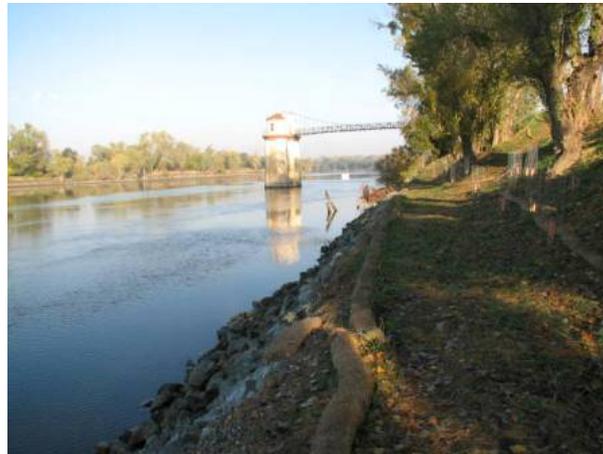
| jeto_f_20111122_624.jpg | |

| 11/15/2011 Bank protection work on Sacramento River. | |

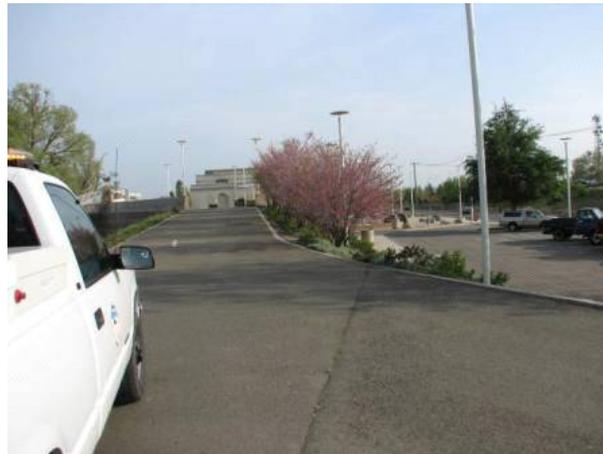
| jeto_f_20110923_593.jpg | |

| 04/14/2011 Landscaping at City intake facility. | |

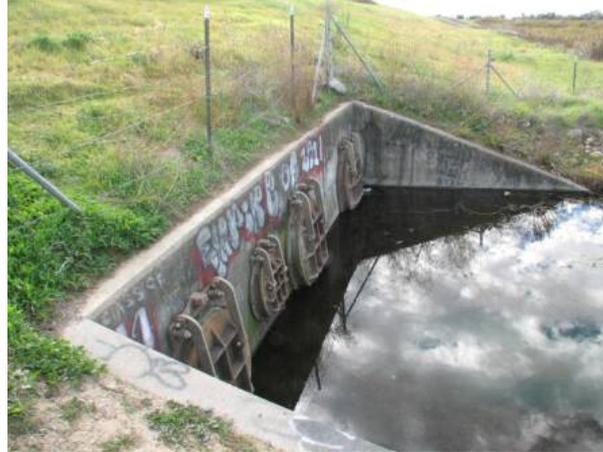
| jeto_f_20111122_660.jpg | |

| LMR No. | Levee Mile | | Category | Item | * Location | ** Rating | Action/Comment | GPS Latitude/Longitude | | Issue No. Photo |
|---|---|---|---|---|---|---|--|---|---|---|
| 1 | 0.60 | 0.60 | Earthen Levee | Encroachments | WS | A | Pipe Inspector Comments: Flap gates are clear and appear to be in good operating condition. | 38.659671 ° -121.464168 ° | 38.659671 ° -121.464168 ° | 31 Y |

| 11/17/2011 Flap gates appear to be in good working condition and free of debris. | |

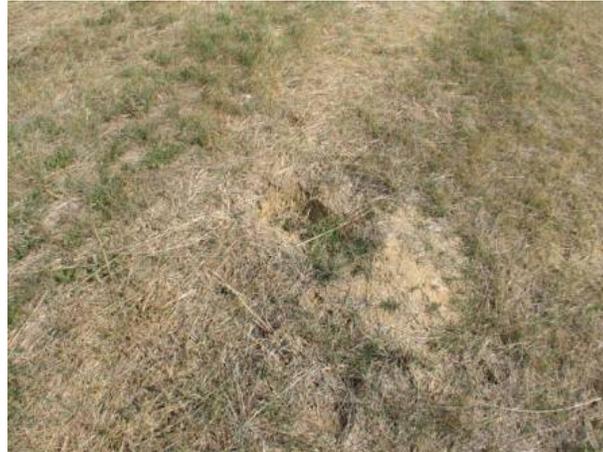
| jeto_f_20111123_711.jpg | |

| 11/17/2011 Large rodent burrow. | |

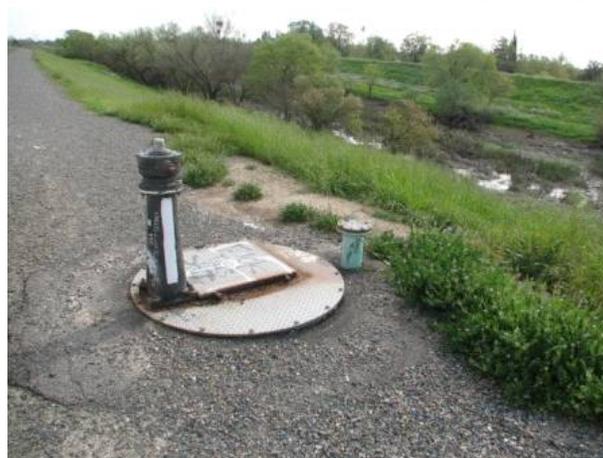
| jeto_f_20110923_651.jpg | |

| Closure device for SS beneath channel. | |

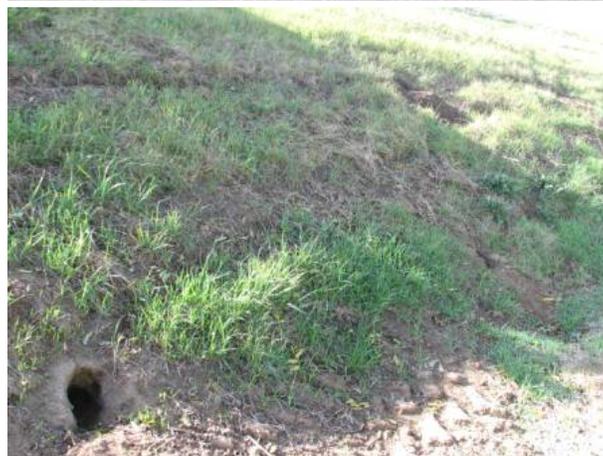
| jeto_f_20111123_712.jpg | |

| 11/17/2011 Multiple rodent burrows. | |

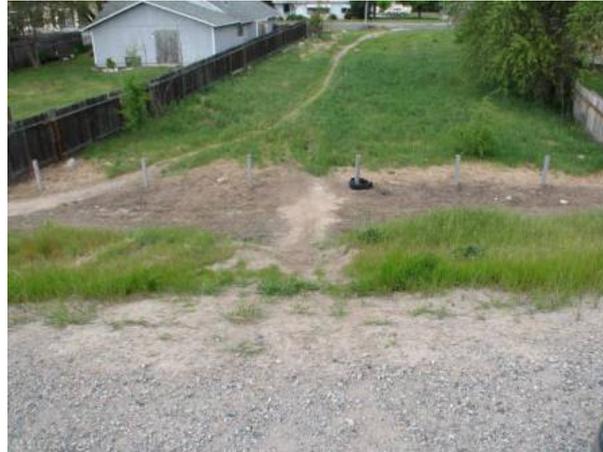
| jeto_f_20110923_654.jpg | |

| 04/13/2011 Damage to levee caused by foot traffic. | |

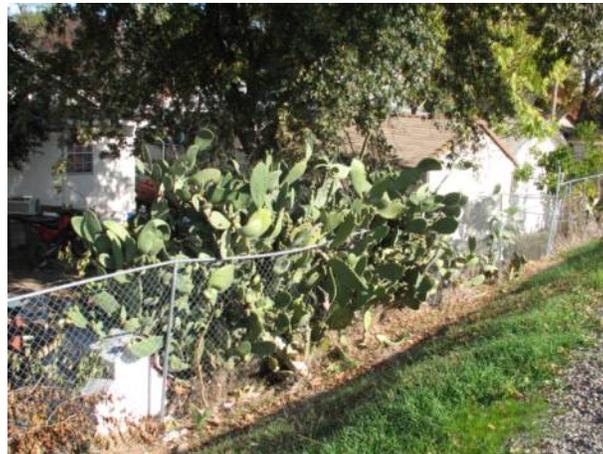
| jeto_f_20111123_713.jpg | |

| 11/17/2011 Large cactus is growing through the fence and obstructing access and visibility at the levee toe. | |

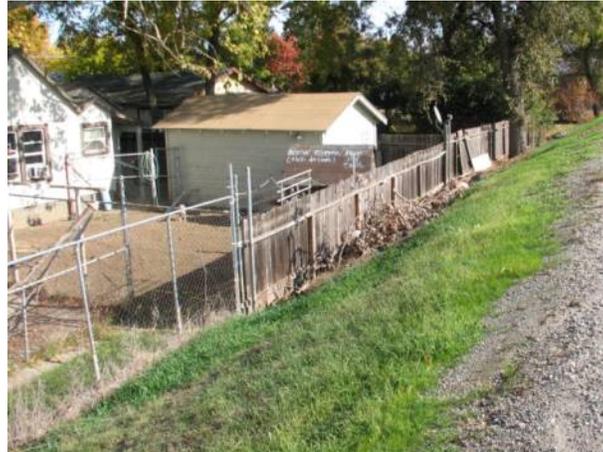
| jeto_f_20111123_715.jpg | |

| 11/17/2011 Wooden privacy fence is constructed at the toe. | |

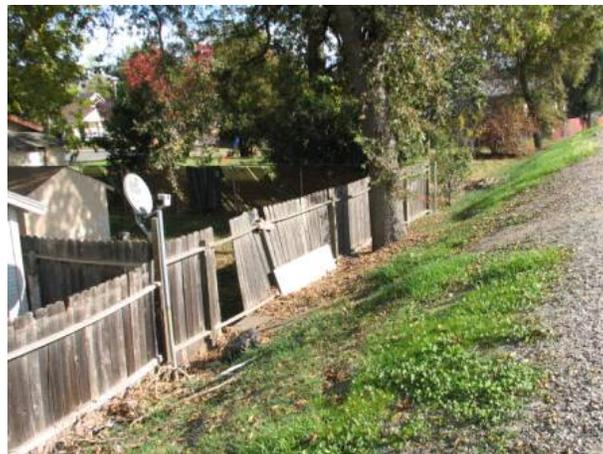
| jeto_f_20111123_716.jpg | |

| 11/17/2011 Wooden privacy fence is constructed at the toe. | |

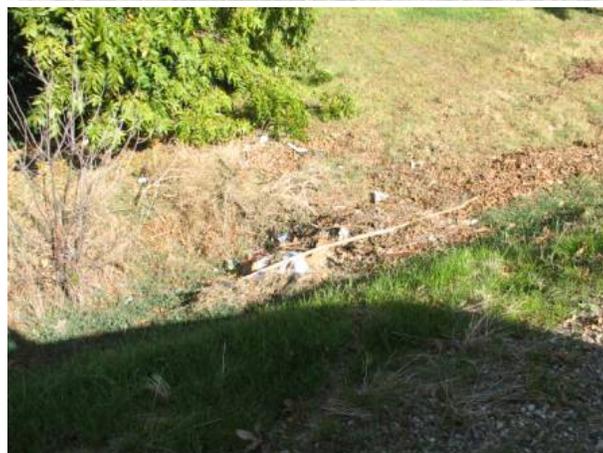
| jeto_f_20111123_717.jpg | |

| 11/17/2011 Yard waste and debris at the toe. | |

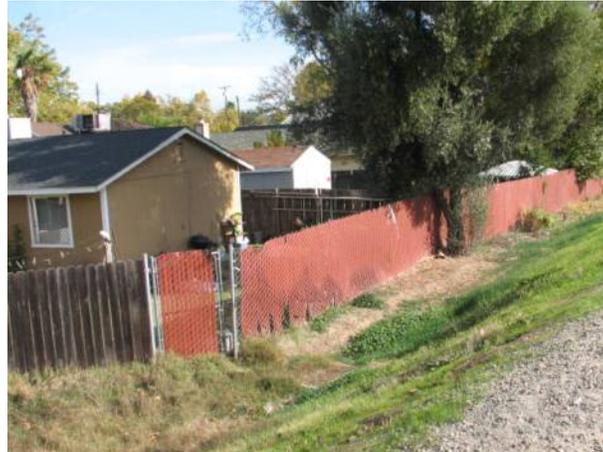
| jeto_f_20111123_718.jpg | |

| 11/17/2011 Privacy fence is constructed at the toe. | |

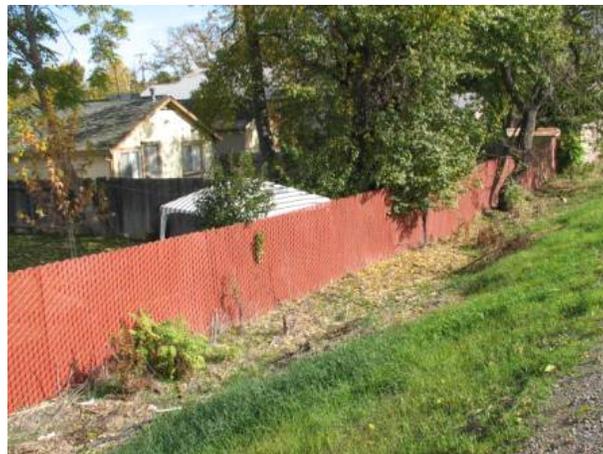
| jeto_f_20111123_719.jpg | |

| 11/17/2011 Privacy fence is constructed at the toe. | |

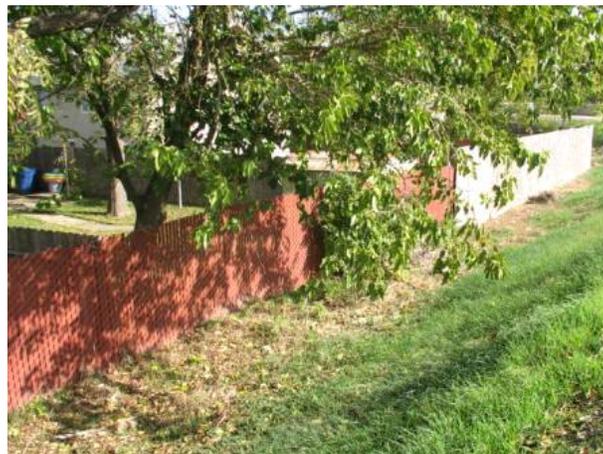
| jeto_f_20111123_720.jpg | |

| 11/17/2011 Privacy fence is constructed at the toe. | |

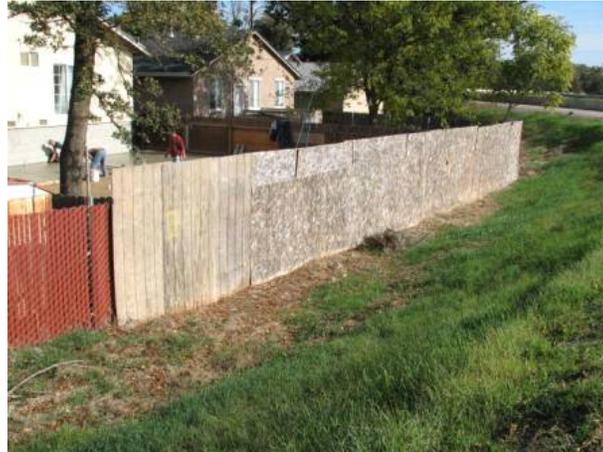
| jeto_f_20111123_721.jpg | |

| 11/17/2011 Wooden privacy fence is constructed at the toe. | |

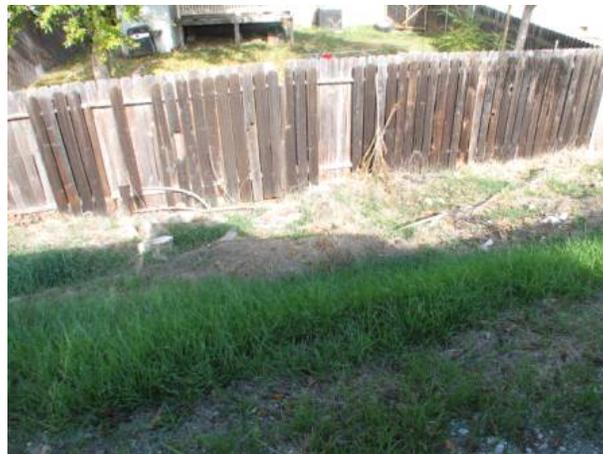
| jeto_f_20111123_722.jpg | |

| 11/17/2011 Debris at levee toe. | |

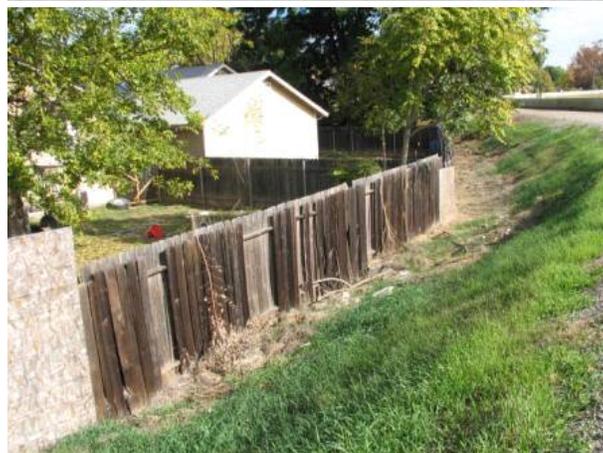
| jeto_f_20111123_737.jpg | |

| 11/17/2011 Wooden privacy fence is constructed at the toe. | |

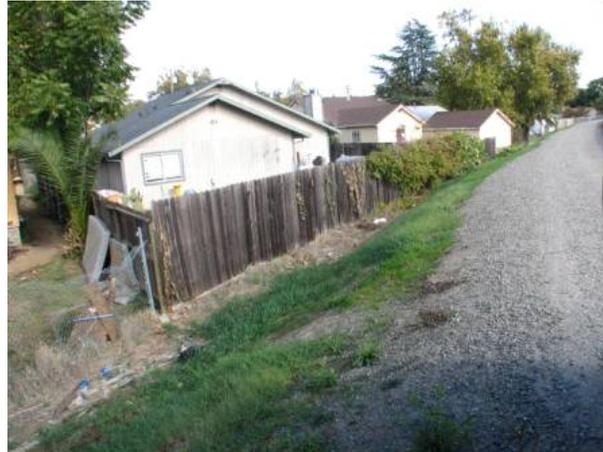
| jeto_f_20111123_725.jpg | |

| 11/17/2011 Wooden privacy fence is constructed at the toe. | |

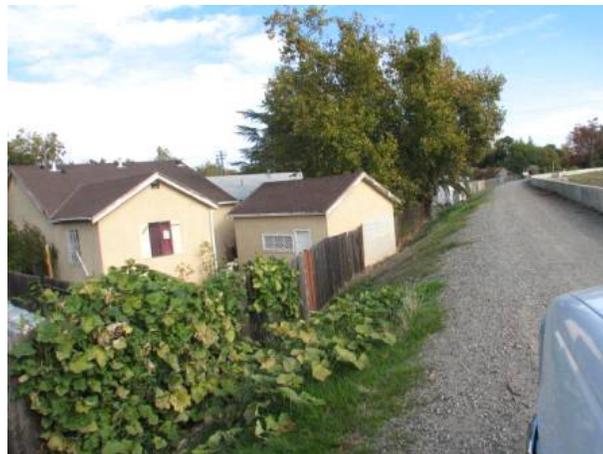
| jeto_f_20111123_726.jpg | |

| 11/17/2011 Building is constructed at the toe. | |

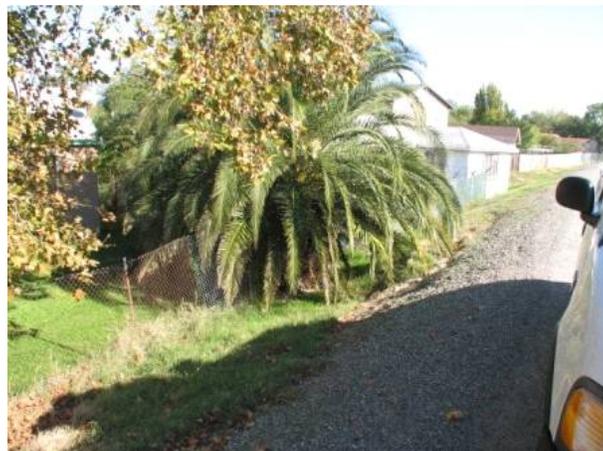
| jeto_f_20110923_652.jpg | |

| Fall 2009 photo of palm tree within 10-ft of the levee toe obstructs visibility and access. | |

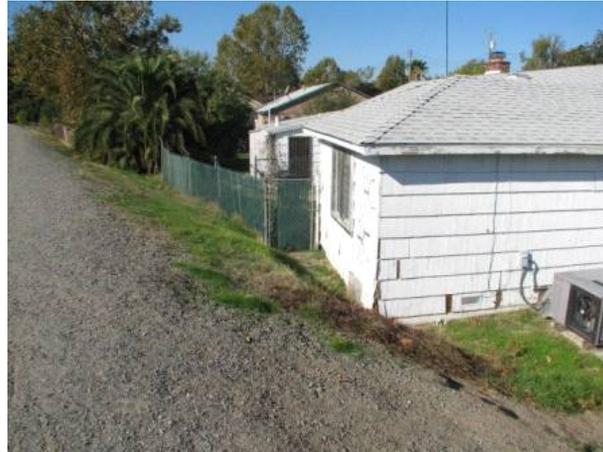
| jeto_f_20110923_647.jpg | |

| Fall 2009 photo of privacy fence and structure within 10-ft of the levee toe obstructs visibility and access. | |

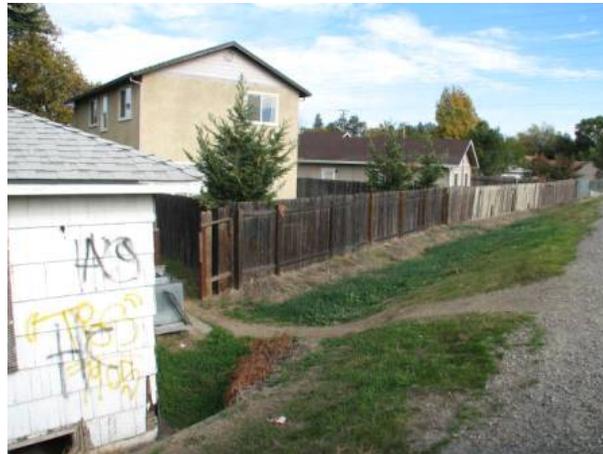
| jeto_f_20111123_727.jpg | |

| 11/17/2011 Wooden privacy fence is constructed at the toe. | |

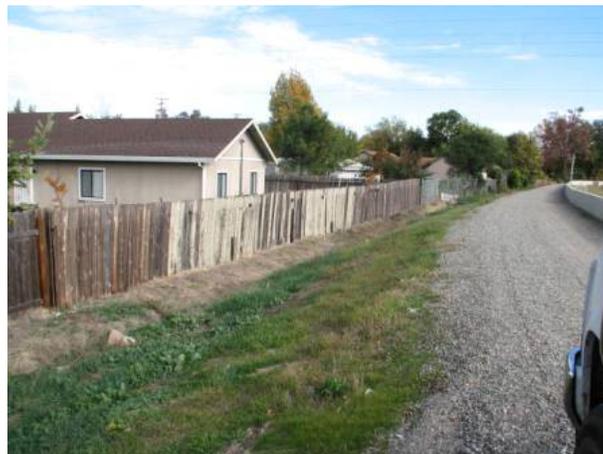
| jeto_f_20111123_728.jpg | |

| 11/17/2011 Wooden privacy fence is constructed at the toe. | |

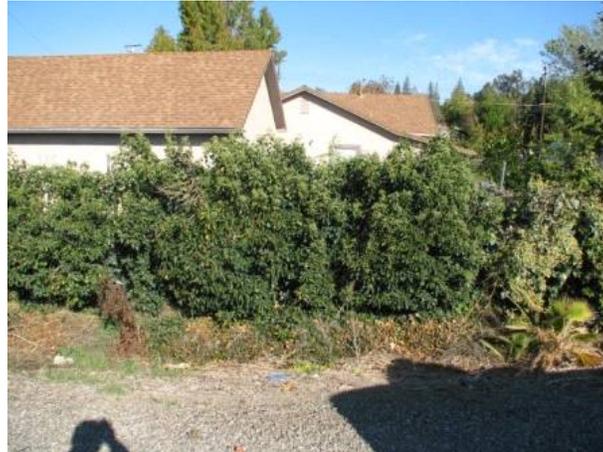
| jeto_f_20110923_648.jpg | |

| Fall 2009 photo of landscaping within 10-ft of the levee toe obstructs visibility and access. | |

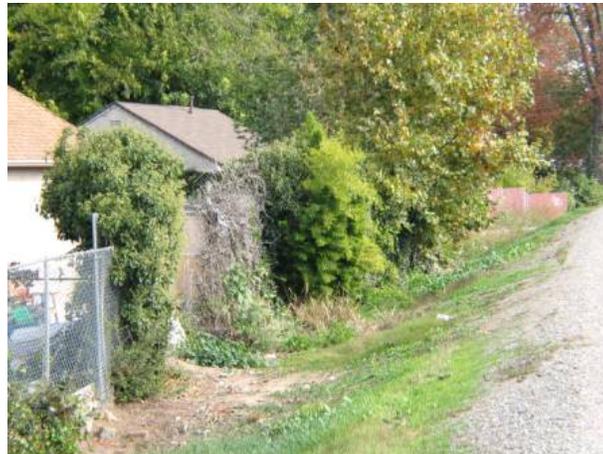
| jeto_f_20111123_729.jpg | |

| 11/17/2011 Landscaping has grown over the fence and obstructs visibility and access. | |

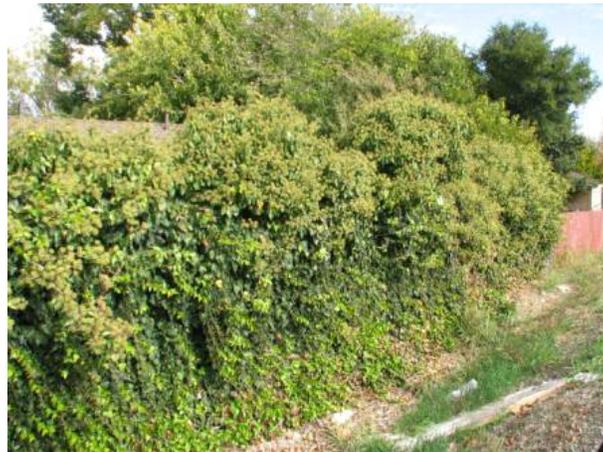
| jeto_f_20111123_730.jpg | |

| 11/17/2011 Overgrown vegetation obstructs visibility and access. | |

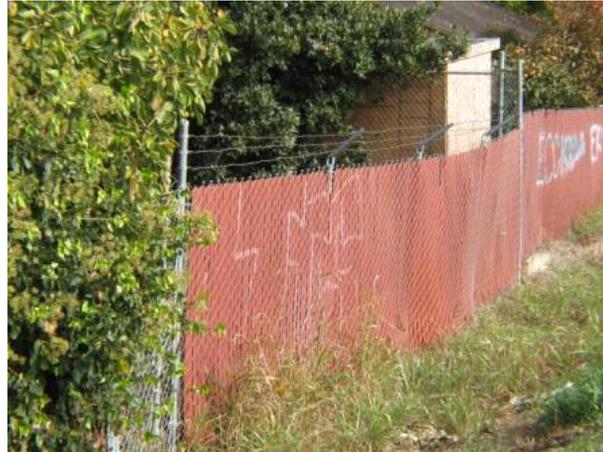
| jeto_f_20111123_731.jpg | |

| 11/17/2011 Barbed wire topped privacy fence is located at the toe. | |

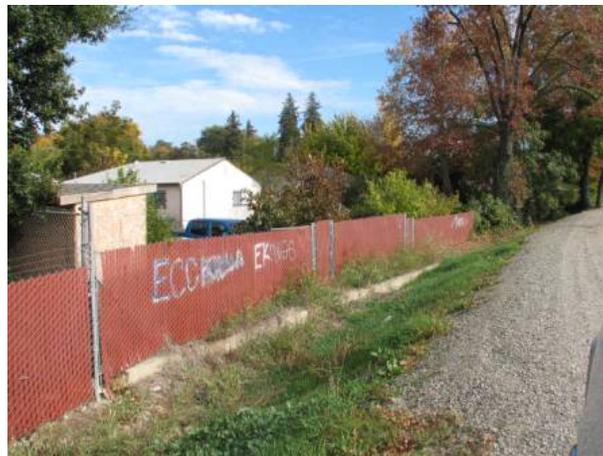
| jeto_f_20111123_732.jpg | |

| 11/17/2011 Privacy fence is located at the toe. | |

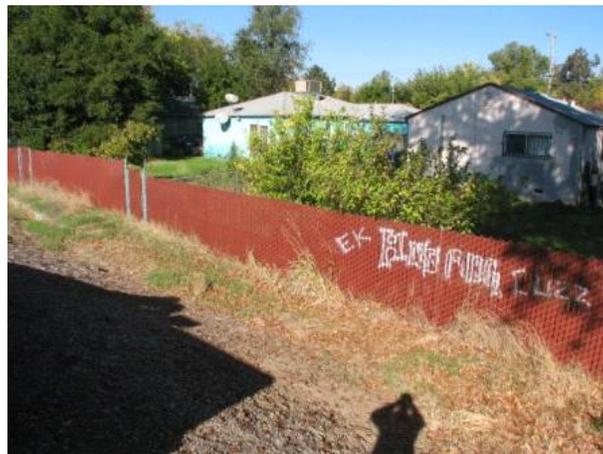
| jeto_f_20110923_649.jpg | |

| Fall 2009 photo of privacy fence within 10-ft of the levee toe obstructs visibility and access. | |

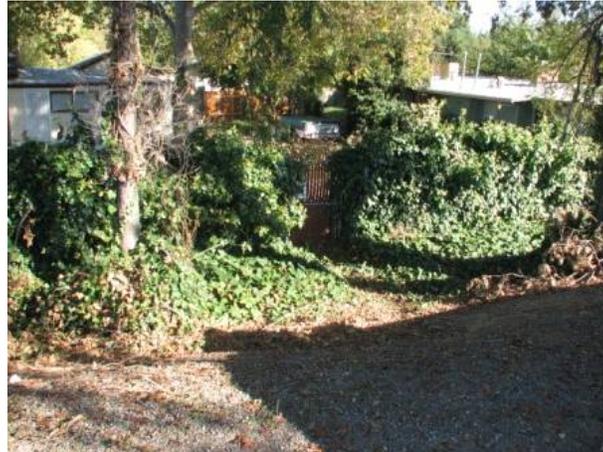
| jeto_f_20110923_650.jpg | |

| Fall 2009 photo of dense ivy and fence obstruct visibility and access. | |

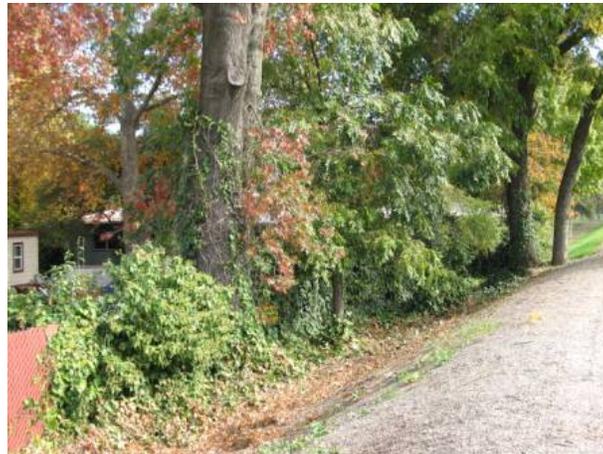
| jeto_f_20111123_733.jpg | |

| 11/17/2011 Dense vegetation at the toe. | |

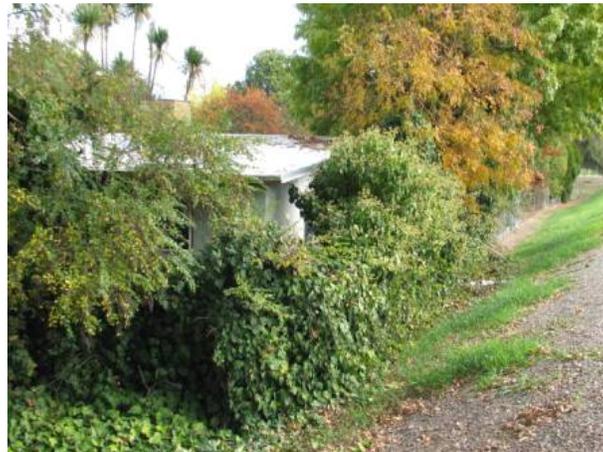
| jeto_f_20111123_734.jpg | |

| 11/17/2011 Vegetation and building obstruct visibility and access to the levee toe. | |

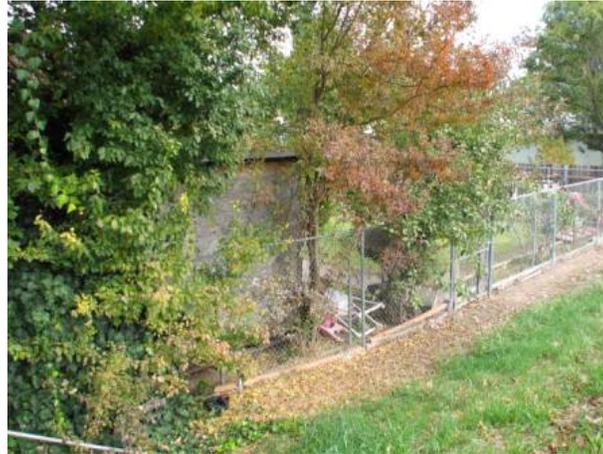
| jeto_f_20111123_735.jpg | |

| 11/17/2011 Building is too close to the levee toe and obstructs visibility and access. | |

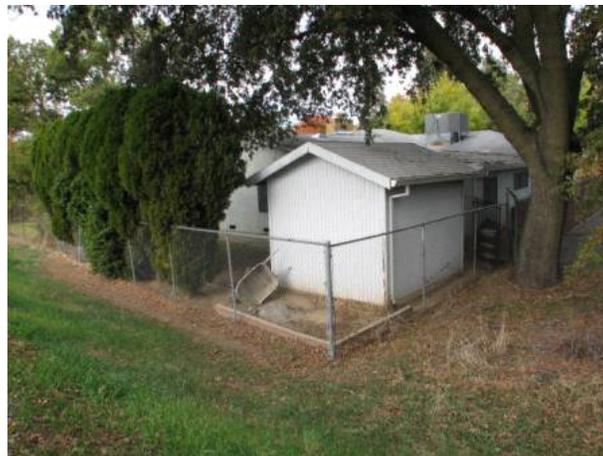
| jeto_f_20111123_736.jpg | |

| 11/17/2011 Building and landscaping are too close to the levee toe. | |

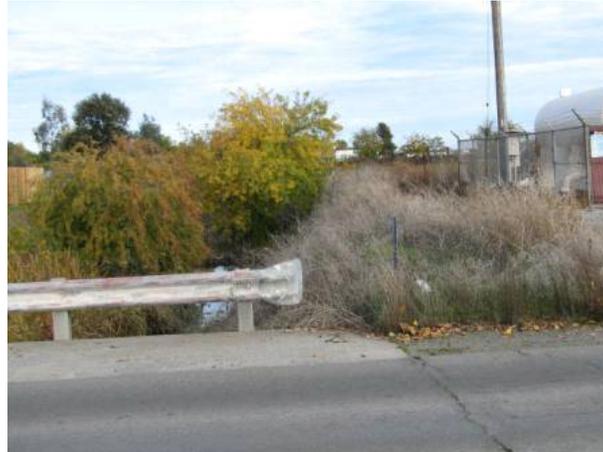
| jeto_f_20111122_661.jpg | |

| 11/17/2011 View from Dry Creek Rd. levee is inaccessible from this point, LM 0.51 to LM 1.02, for inspection. | |

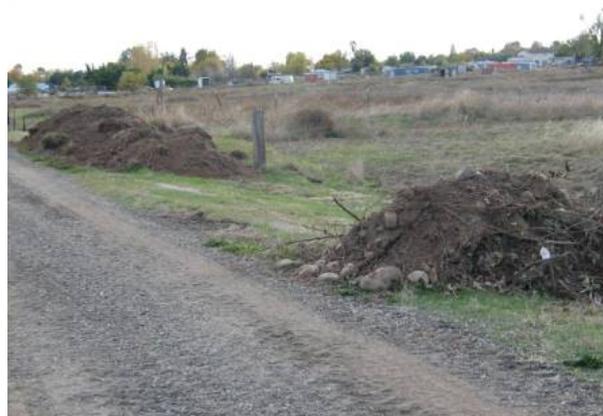
| jeto_f_20111122_662.jpg | |

| 11/17/2011 Temporary storage of fill from levee repair site. | |

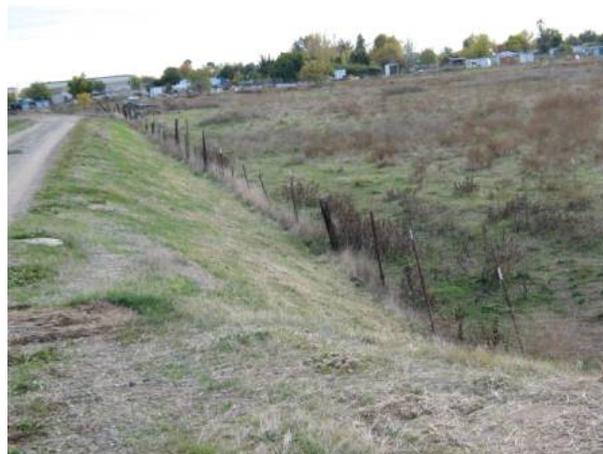
| jeto_f_20111122_663.jpg | |

| 11/17/2011 Barbed wire fence at levee toe. | |

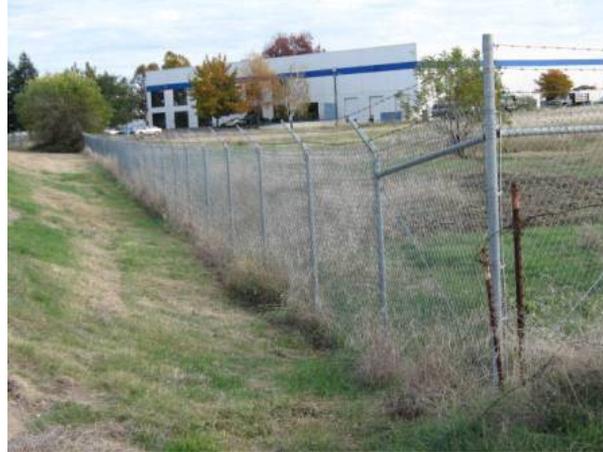
| jeto_f_20111122_664.jpg | |

| 11/17/2011 Chainlink fence at levee toe. | |

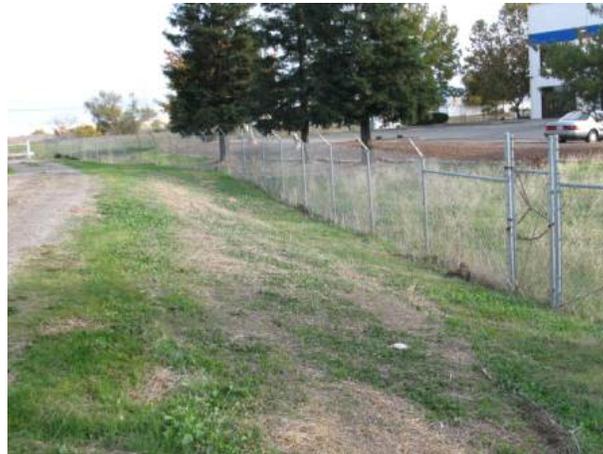
| jeto_f_20111122_665.jpg | |

| 11/17/2011 Chainlink fence alignment returns to the levee toe. | |

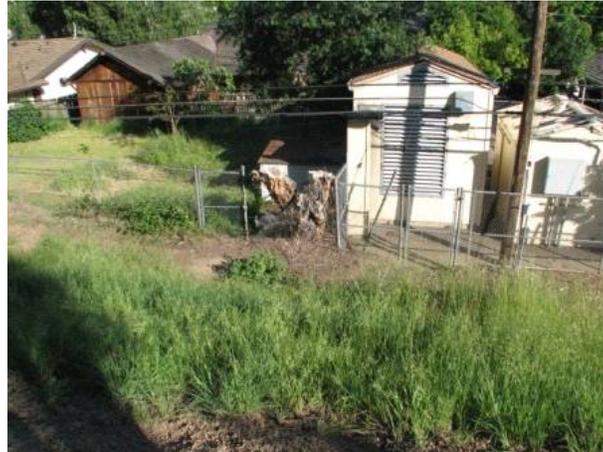
| jeto_f_20110923_830.jpg | |

| Tree trunk at fence line. | |

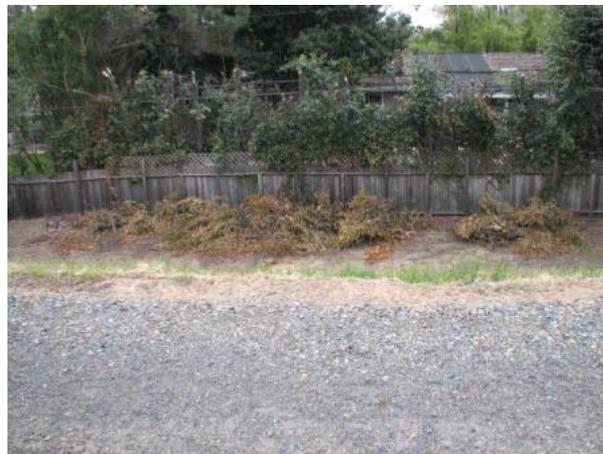
| jeto_f_20110923_828.jpg | |

| 04/13/2011 Letter has already been sent to owner by ARFCD, Superintendent will follow up with second letter. | |

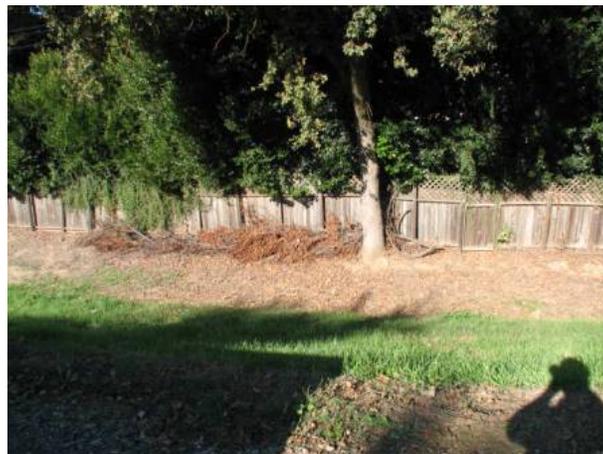
| jeto_f_20111122_641.jpg | |

| 11/16/2011 Updated photo, prunings have not been removed. | |

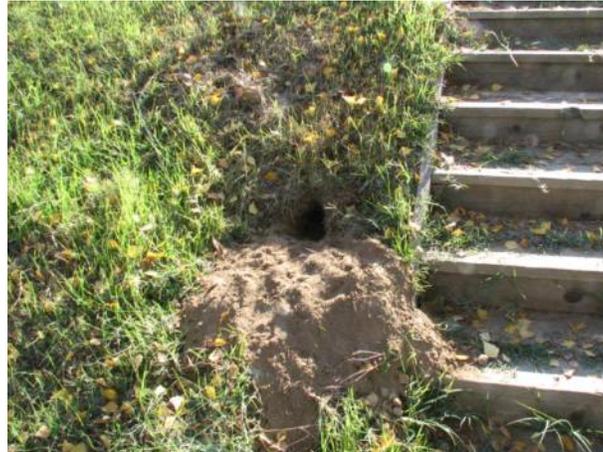
| jeto_f_20111122_642.jpg | |

| 11/16/2011 Active burrow adjacent to steps. | |

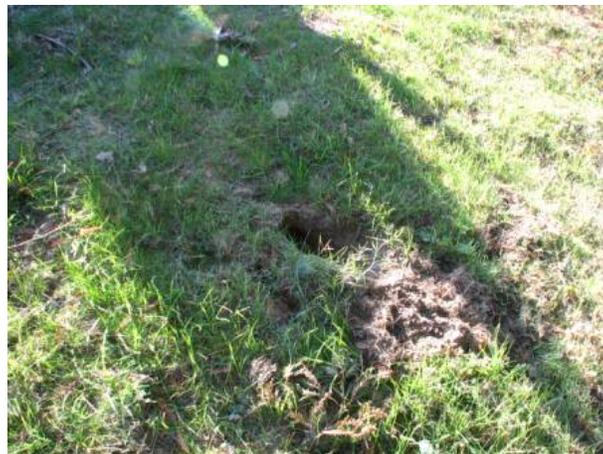
| jeto_f_20111122_643.jpg | |

| 11/16/2011 Active burrows. | |

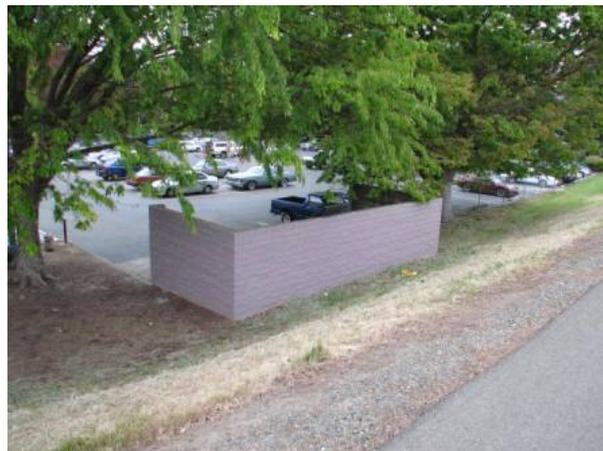
| jeto_f_20110923_829.jpg | |

| 4/13/3011 Cinderblock trash enclosure is encroaching in the toe of the levee. | |

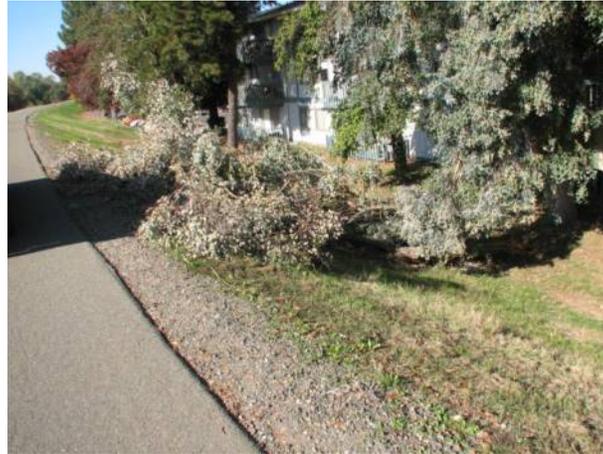
| jeto_f_20111122_644.jpg | |

| 11/16/2011 Large tree limb on landside slope. | |

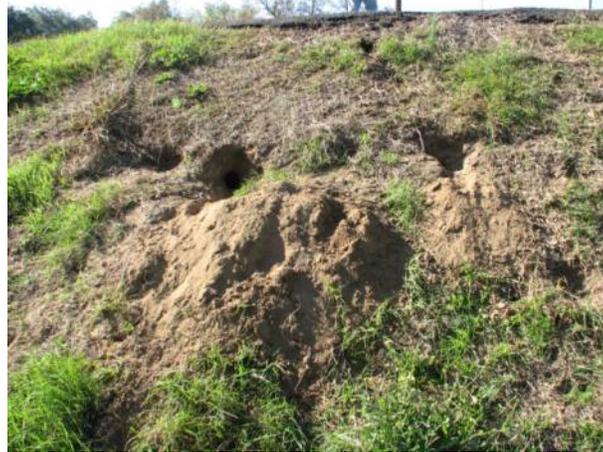
| jeto_f_20111122_646.jpg | |

| 11/16/2011 Numerous large burrows present. | |

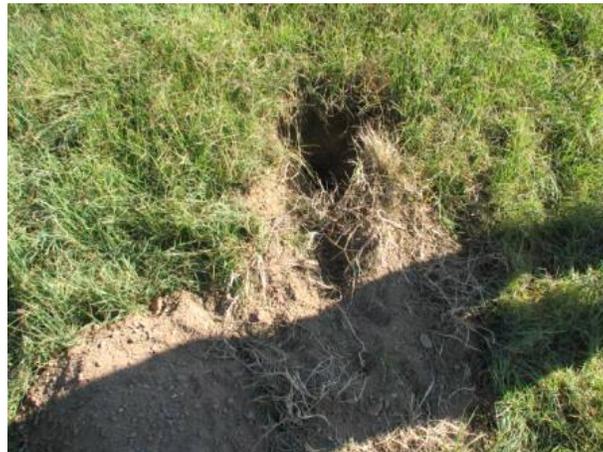
| jeto_f_20111122_648.jpg | |

| 11/16/2011 Single large burrow. | |

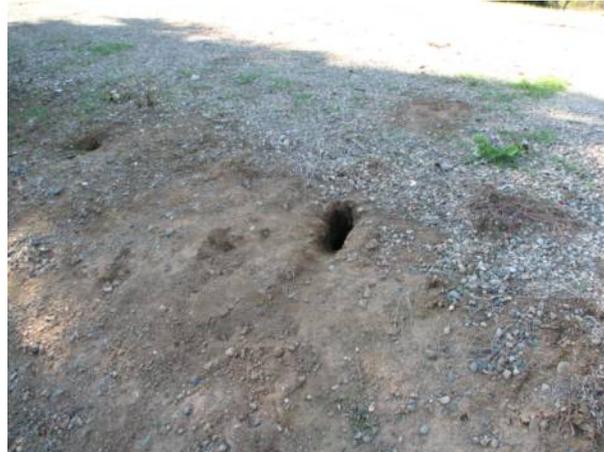
| jeto_f_20111122_649.jpg | |

| 11/16/2011 Several burrows in this area. | |

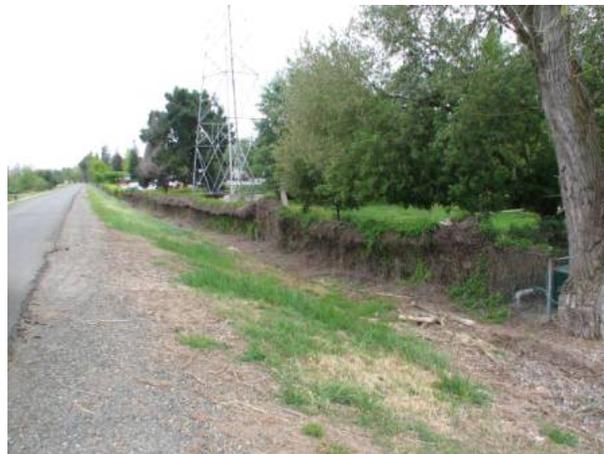
| jeto_f_20110923_827.jpg | |

| 04/13/2011 Plants are being trimmed, but still obstructs visibility. | |

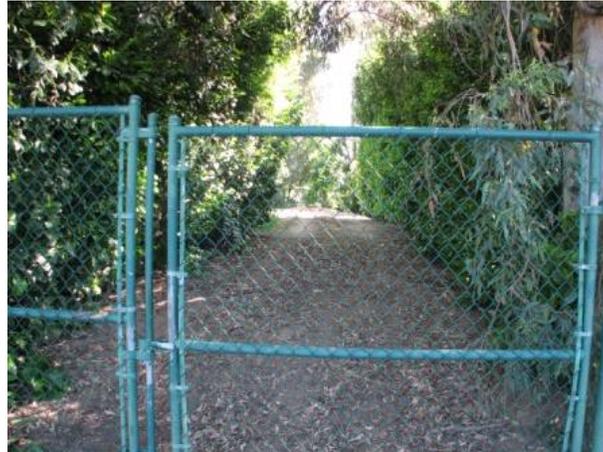
| jeto_f_20110923_950.jpg | |

| Levee encroached on by property owners north of Arden. | |

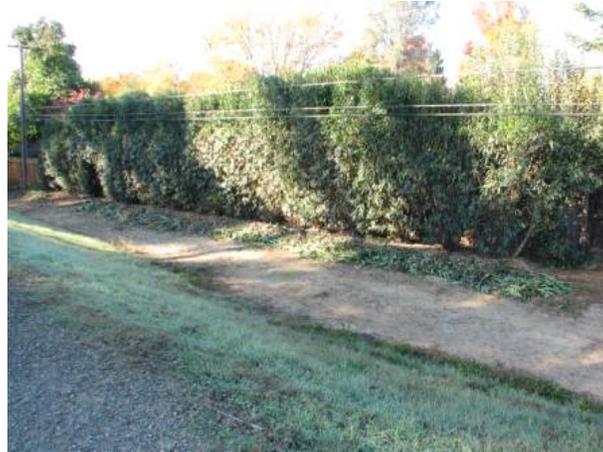
| jeto_f_20111122_634.jpg | |

| 11/16/2011 Prunings need to be removed. | |

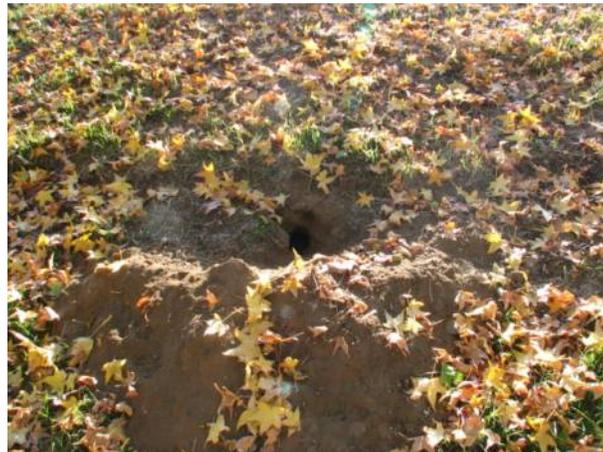
| jeto_f_20111122_635.jpg | |

| 11/16/2011 Active rodent burrow. | |

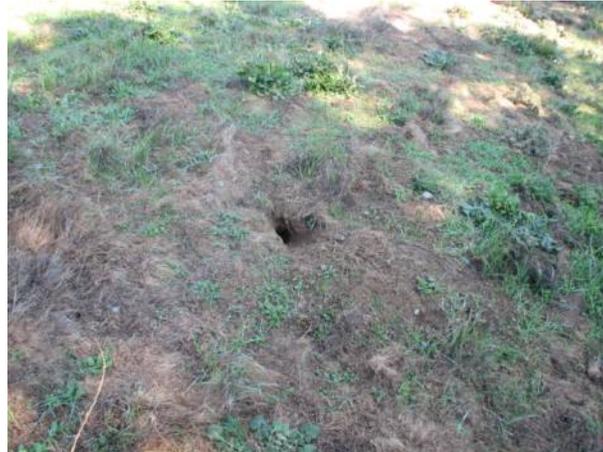
| jeto_f_20111122_636.jpg | |

| 11/16/2011 Active burrow, this area was also noted in the USACE PI. | |
