**Flood Control Project Maintenance
Levee Inspections**

Fall 2011 Levee Maintenance Deficiency Summary Report

Sacramento River Basin

| NA0001 | | Overall LMA Rating | Total LMA Miles | | | | |
|--|---|---|---|---|---|---|--|
| American River Flood Control District | | A | 32.51 | | | | |

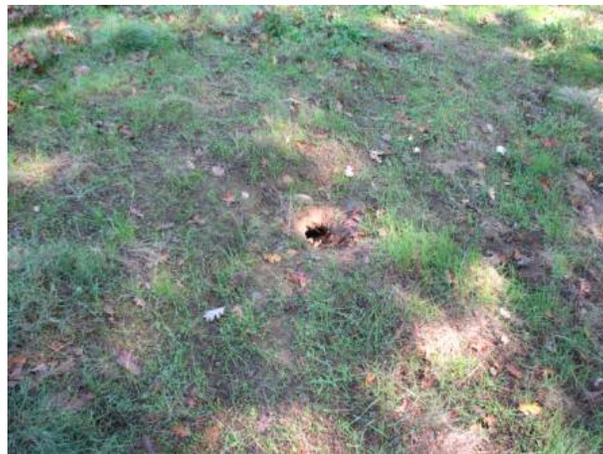
| jeto_f_20111122_637.jpg | |

| 11/16/2011 Active rodent burrow. | |

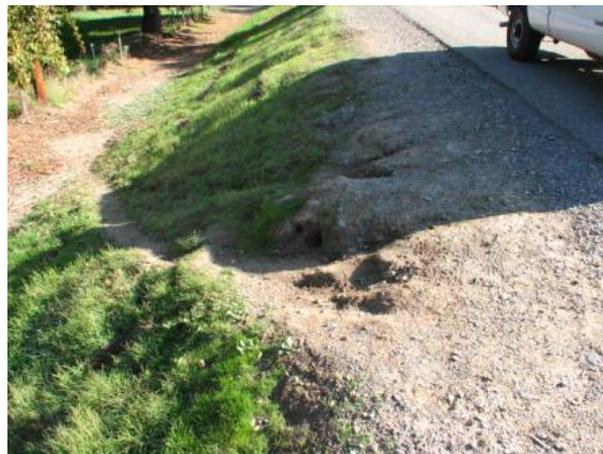
| jeto_f_20111122_638.jpg | |

| 11/16/2011 Erosion from pedestrian traffic, burrow can be seen in the photo in the lower portion of the shadow. | |

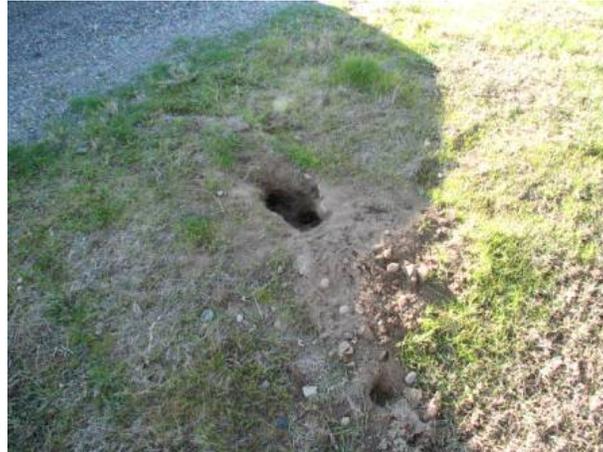
| jeto_f_20111122_639.jpg | |

| 11/16/2011 Active burrows, the location relative to the crown can be seen in the photo. | |

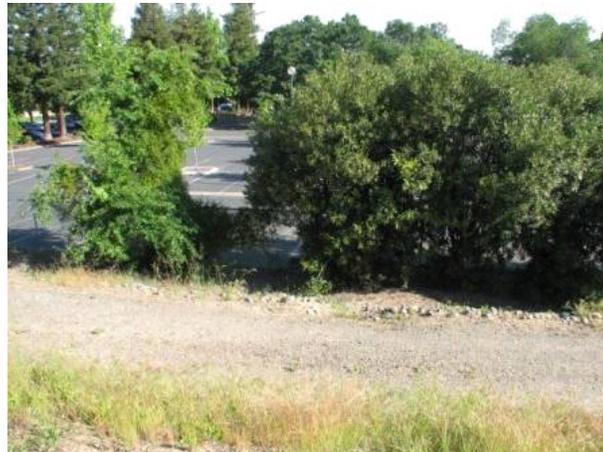
| jeto_f_20110923_949.jpg | |

| Trees at fence line obstruct access and visibility. | |

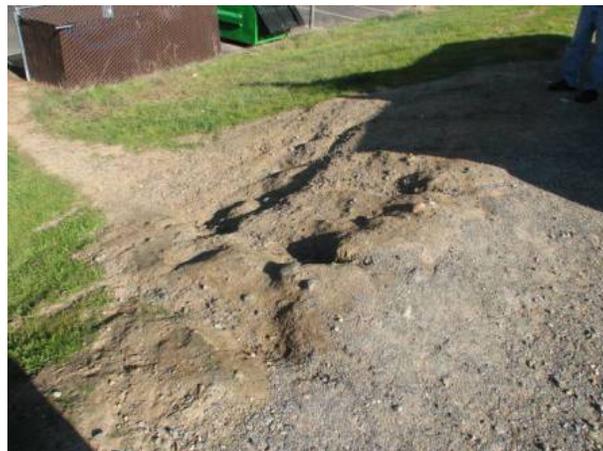
| jeto_f_20111122_640.jpg | |

| 11/16/2011 Erosion caused by pedestrian traffic. | |
