**Flood Control Project Maintenance  
Levee Inspections**

**Maintenance Issue Types Only, Levee Inspection Report By Mile - Fall 2018**

**American River Flood Control District**

Waterway	Bank	Unit Miles	Inspection Start/End	Inspector
Unit No. 01 Arcade Creek	Left	2.08		Luz Dial

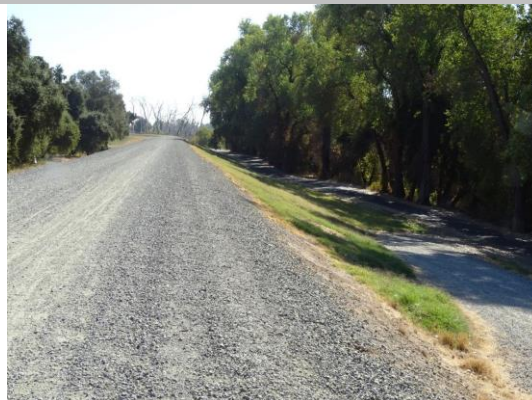
Photo 1 of 1 : FA\_2018\_NA0001\_490\_11\_20181023\_00029.jpg

LM Start	0.60	Rating **	A	Issue No.	11
LM End	3.46	Issue Type +	Ma	Location *	WS
Category	Earthen Levee			GPS Latitude/Longitude	
				Start	End
Item	Vegetation			38.589045 °	38.602875 °
				-121.428313 °	-121.472648 °
DWR ID	DWR_NA0001_03_f_2018_11				
Comment Code					
V1 : Control annual grass and weeds on the levee slopes and easements.					
Inspector Comment					
Annual vegetation is well maintained.

View of waterside vegetation. Fall 2018

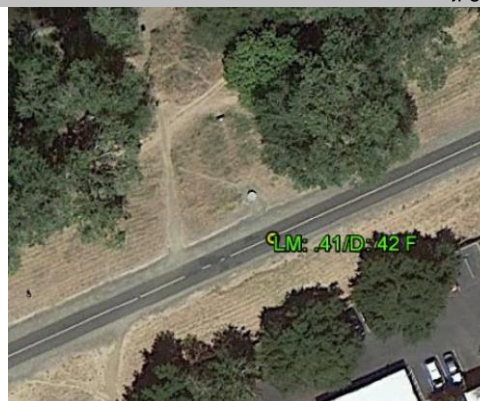
Photo 1 of 3 : UCIP\_FA\_2018\_31249\_57212.jpg

Overview of crossing location.

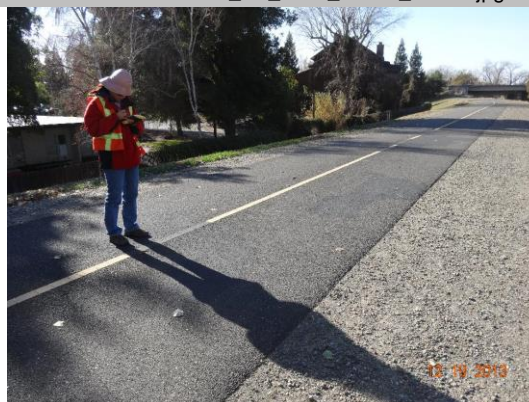
Photo 2 of 3 : UCIP\_FA\_2018\_31249\_57209.jpg

View of levee crown at this location.

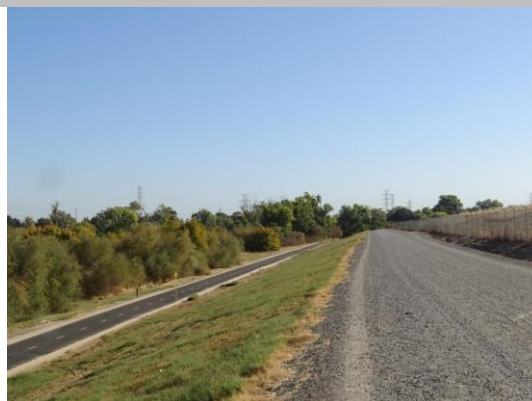
Photo 1 of 1 : FA\_2018\_NA0001\_55\_215\_20181024\_00264.jpg

LM Start	2.96	Rating **	A	Issue No.	215
LM End	3.68	Issue Type +	Ma	Location *	WS
Category	Earthen Levee			GPS Latitude/Longitude	
				Start	End
Item	Vegetation			38.588625 °	38.588295 °
				-121.458491 °	-121.450511 °
DWR ID	DWR_NA0001_04_f_2018_215				
Comment Code					
V1 : Control annual grass and weeds on the levee slopes and easements.					
Inspector Comment					
Vegetation is well maintained.

View of waterside vegetation. Fall 2018

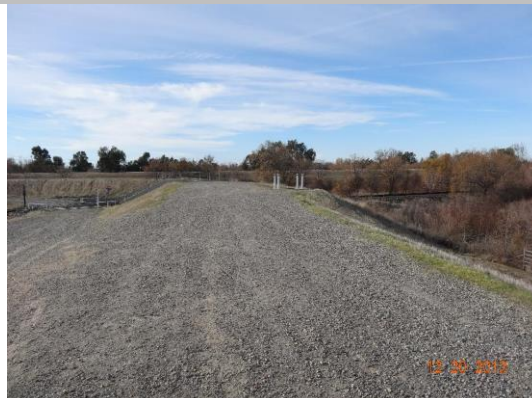
Photo 1 of 3 : UCIP\_FA\_2018\_26884\_49630.jpg

View of levee crown at crossing.

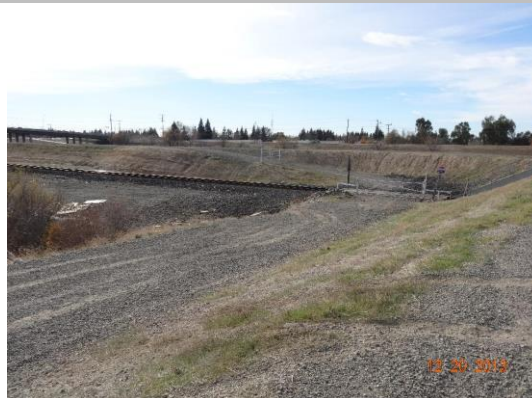
Photo 2 of 3 : UCIP\_FA\_2018\_26884\_49629.jpg

View of landward side.

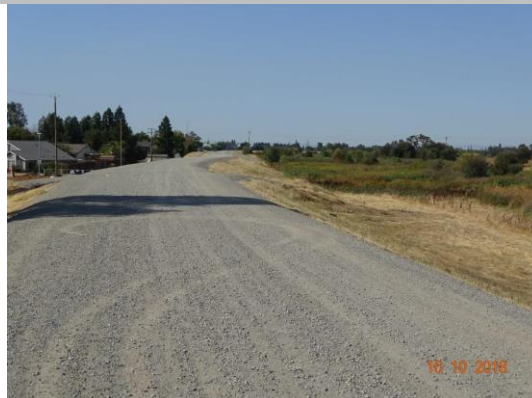
Photo 1 of 1 : FA\_2018\_NA0001\_57\_4\_20181015\_00008.jpg

LM Start	0.79	Rating **	A	Issue No.	4
LM End	0.79	Issue Type +	Ma	Location *	WS
Category	Earthen Levee			GPS Latitude/Longitude	
				Start	End
Item	Vegetation			38.660786 °	38.660786 °
				-121.461205 °	-121.461205 °
DWR ID	DWR_NA0001_06_f _ 2018_4				
Comment Code					
V1 : Control annual grass and weeds on the levee slopes and easements.					
Inspector Comment					
Waterside vegetation is well maintained.

View of waterside vegetation. Fall 2018

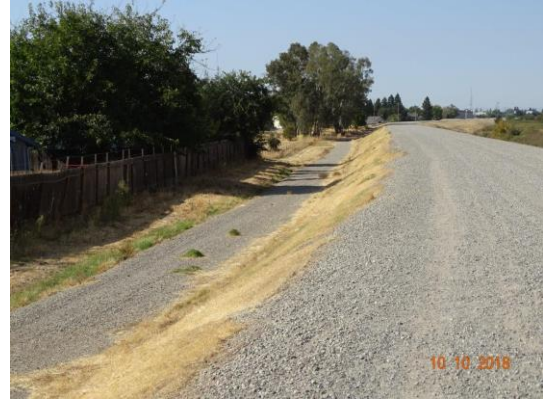
Photo 1 of 1 : FA\_2018\_NA0001\_57\_3\_20181015\_00007.jpg

LM Start	0.96	Rating **	A	Issue No.	3
LM End	0.96	Issue Type +	Ma	Location *	LS
Category	Earthen Levee			GPS Latitude/Longitude	
				Start	End
Item	Vegetation			38.662083 °	38.662083 °
				-121.458561 °	-121.458561 °
DWR ID	DWR_NA0001_06_f _ 2018_3				
Comment Code					
V1 : Control annual grass and weeds on the levee slopes and easements.					
Inspector Comment					
Landside vegetation is well maintained.

View of landside vegetation. Fall 2018

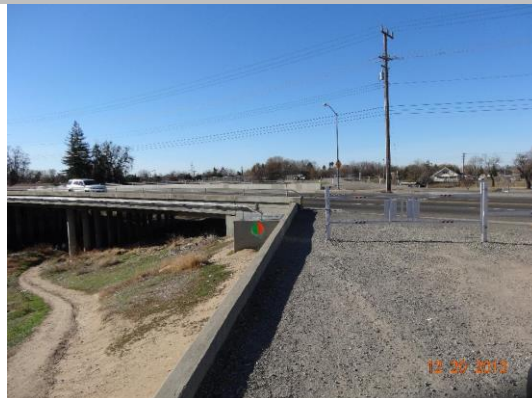
Photo 1 of 3 : UCIP\_FA\_2018\_29301\_54278.jpg

View of flood wall along waterward side.

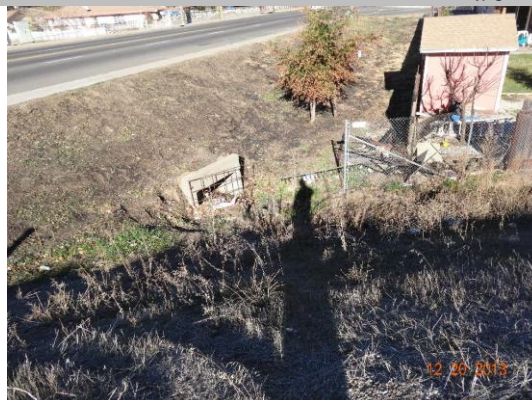
Photo 2 of 3 : UCIP\_FA\_2018\_29301\_54277.jpg

View of landward side.

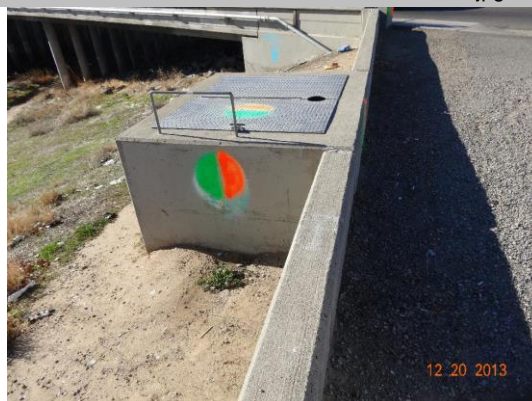
Photo 3 of 3 : UCIP\_FA\_2018\_29301\_54276.jpg

Concrete vault located on waterward shoulder.

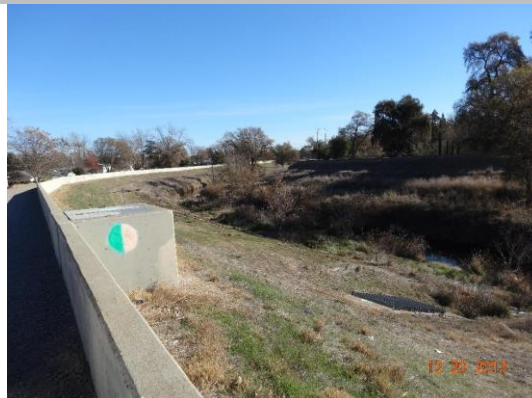
Photo 3 of 3 : UCIP\_FA\_2018\_29302\_54284.jpg

View of waterward side--concrete vault and headwall.

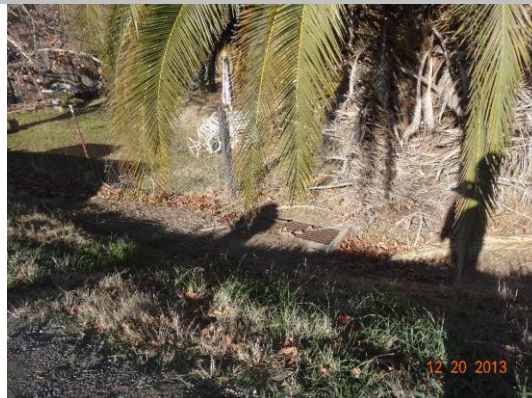
Photo 1 of 3 : UCIP\_FA\_2018\_29324\_54305.jpg

View of landward side.

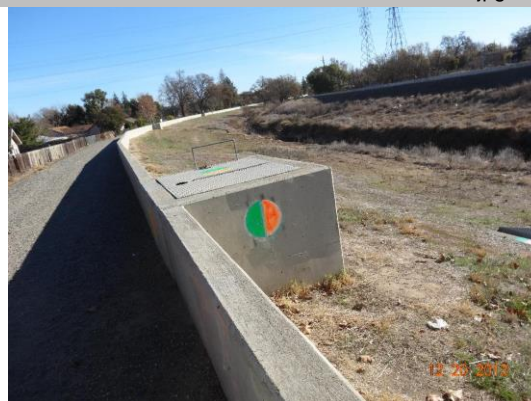
Photo 2 of 3 : UCIP\_FA\_2018\_29324\_54307.jpg

Floodwall along waterward shoulder.

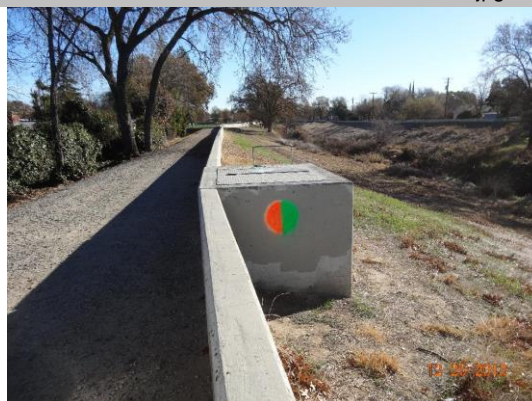
Photo 1 of 3 : UCIP\_FA\_2018\_29326\_54319.jpg

Floodwall along waterward shoulder for almost entire Unit.

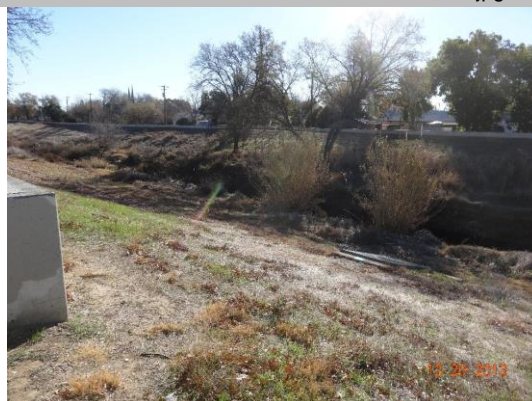
Photo 2 of 3 : UCIP\_FA\_2018\_29326\_54318.jpg

Comment Code						
Inspector Comment						
FS_ID:29326 DS_ID:24375 EP_NO: N/A Repair Type: No Action Needed Crossing Status: Found UCIP Comments: 08/16/2017 DWR Deferred Maintenance Project (DMP), Vince Rodriguez, forwarded email received from Tim Kerr, General Manager of American River Flood Control District (ARFCD) with file "DWR Eligible Pipes Found in ARFCD" from ARFCD that shows the ownership and location of the pipes Tim Kerr investigated. Owner of this crossing is identified as the City of Sacramento, ARFCD Staff Notes indicate Arcade Ck. (DWR UCIP - O. Magana) 06/14/2017 This crossing is scheduled to be cut and replaced as part of Sacramento Area Flood Control (SAFCA) North Area Streams (NAS) Levee Improvement Project: City of Sacramento Utility Permit Modifications Along Arcade Creek Levees. Unable to confirm when pipe will be replaced. Need to coordinate with owner and DWR FPIIB Inspector to determine when project is expected to start. (DWR UCIP - O. Magana). FIELD_STRUCT_DESC: 24-inch corrugated metal (CM) drainage pipe through the levee, 8.6 feet below the crown. Slide gate inside corrugated metal (CM) riser located on the waterside (WS) slope. Flap gate is located on the WS end. Concrete headwalls on both WS and landside (LS) ends. (no permit has been identified authorizing this structure, structure is owned by the City of Sacramento) [Additional Reference(s): DWR Levee Log, 2002. USACE Sacramento O&M Manual Unit 118, Part No. 2, October 1959, Drawing No. 1-4-392 Exhibit B, (Station 84+62)] FS Date: 12/20/2013

View of waterward slope.

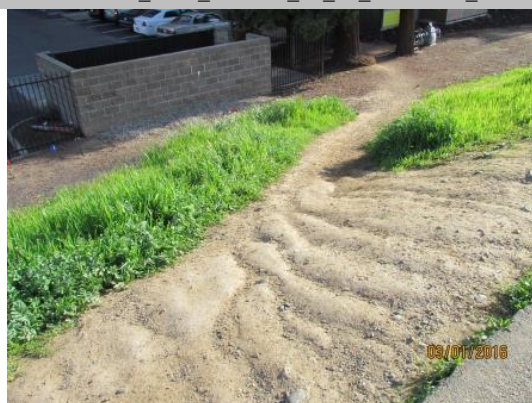
Photo 1 of 1 : FA\_2018\_NA0001\_60\_28\_20180911\_00010.jpg

LM Start	1.88	Rating **	M	Issue No.	28
LM End	1.88	Issue Type +	Ma	Location *	LS
Category	Earthen Levee			GPS Latitude/Longitude	
				Start	End
Item	Slope Stability			38.561171 °	38.561171 °
				-121.415808 °	-121.415808 °
DWR ID	DWR_NA0001_09_s_2016_28				
Comment Code					
S2 : Repair the levee slope damaged by foot traffic and prevent access where possible.					
Inspector Comment

View of the landside levee slope.

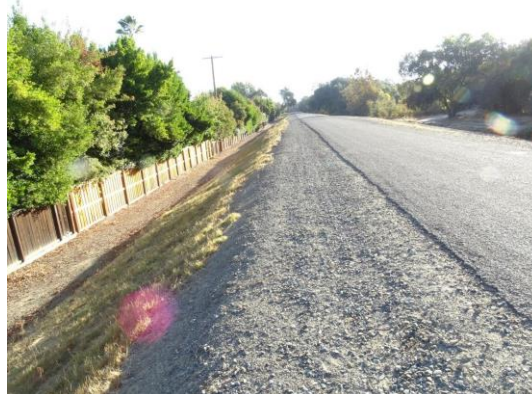
Photo 1 of 1 : FA\_2018\_NA0001\_61\_20\_20181029\_00045.jpg

LM Start	0.00	Rating **	A	Issue No.	20
LM End	3.90	Issue Type +	Ma	Location *	LS
Category	Earthen Levee			GPS Latitude/Longitude	
				Start	End
Item	Vegetation			38.600443 °	38.567911 °
				-121.330793 °	-121.383151 °
DWR ID	DWR_NA0001_10_f_2018_20				
Comment Code					
V1 : Control annual grass and weeds on the levee slopes and easements.					
Inspector Comment					
Annual vegetation is well maintained.

View of landside vegetation. Fall 2018

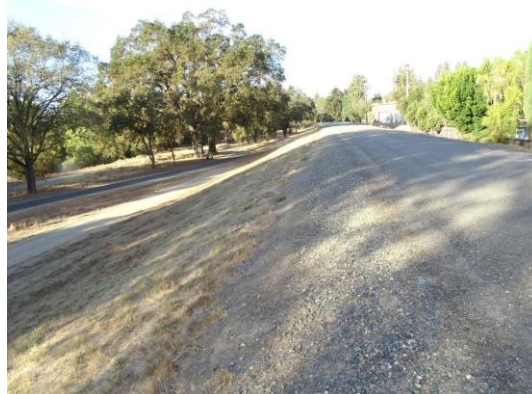
Photo 1 of 1 : FA\_2018\_NA0001\_61\_22\_20181029\_00046.jpg

LM Start	0.00	Rating **	A	Issue No.	22
LM End	3.90	Issue Type +	Ma	Location *	WS
Category	Earthen Levee			GPS Latitude/Longitude	
				Start	End
Item	Vegetation			38.600443 °	38.567911 °
				-121.330793 °	-121.383151 °
DWR ID	DWR_NA0001_10_f_2018_22				
Comment Code					
V1 : Control annual grass and weeds on the levee slopes and easements.					
Inspector Comment					
Annual vegetation is well maintained.

View of waterside vegetation. Fall 2018

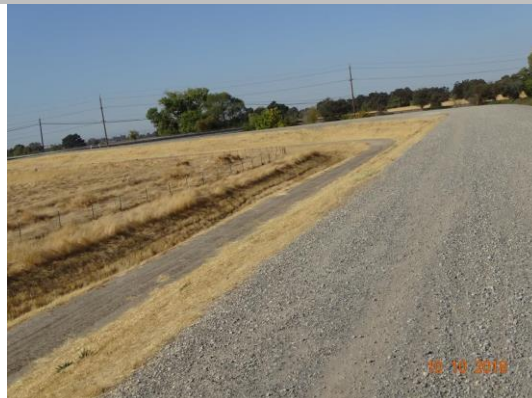
Photo 1 of 1 : FA\_2018\_NA0001\_436\_5\_20181015\_00009.jpg

LM Start	0.63	Rating **	A	Issue No.	5
LM End	0.63	Issue Type +	Ma	Location *	LS
Category	Earthen Levee			GPS Latitude/Longitude	
				Start	End
Item	Vegetation			38.667875 °	38.667875 °
				-121.449338 °	-121.449338 °
DWR ID	DWR_NA0001_11_f_2018_5				
Comment Code					
V1 : Control annual grass and weeds on the levee slopes and easements.					
Inspector Comment					
Landside vegetation is well maintained.

View of landside vegetation. Fall 2018

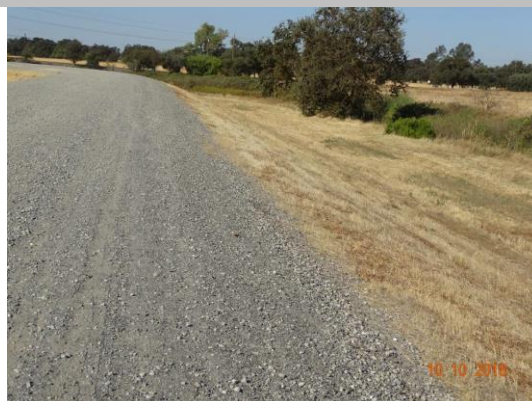
Photo 1 of 1 : FA\_2018\_NA0001\_436\_6\_20181015\_00010.jpg

LM Start	0.63	Rating **	A	Issue No.	6
LM End	0.63	Issue Type +	Ma	Location *	WS
Category	Earthen Levee			GPS Latitude/Longitude	
				Start	End
Item	Vegetation			38.667875 °	38.667875 °
				-121.449338 °	-121.449338 °
DWR ID	DWR_NA0001_11_f_2018_6				
Comment Code					
V1 : Control annual grass and weeds on the levee slopes and easements.					
Inspector Comment					
Waterside vegetation is well maintained.

View of waterside vegetation. Fall 2018
