**Flood Control Project Maintenance  
Levee Inspections**

**Maintenance Issue Types Only, Levee Inspection Report By Mile - Fall 2022**

**American River Flood Control District**

Waterway	Bank	Unit Miles	Inspection Start/End	Inspector
Unit No. 01 Arcade Creek	Left	2.08	11/08/2022 11/08/2022	Marvin Marshall

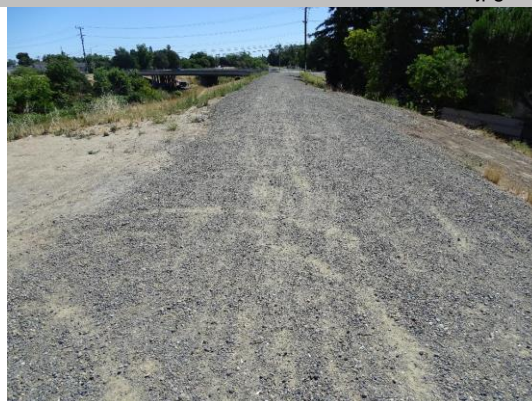
Photo 1 of 3 : UCIP\_FA\_2022\_69020\_85540.jpg

Comment Code						
Inspector Comment						
DS_ID:24250 FS_ID:69020 EP_NO: N/A Repair Type: Non-Urgent EVAL Issue: Crossing Status: Not Found UCIP Comments: 06/16/2020 Crossing evaluated as "Non-Urgent" because pipe was not found during inspection. Geophysical evaluation found a potential pipe at this location. (A. McDonald - DWR UCIP) FIELD_STRUCT_DESC: 15-inch corrugated metal (CM) drainage pipe through the levee, 16 feet below the crown. Flap gate on the waterside (WS) end. [Additional Reference(s): DWR Levee Log, 2002 (HLM 1.23). USACE Sacramento O&M Manual Unit 118, Part No. 2, October 1959, (Station A 64+15)]. FS Date: 6/16/2020

Overview of levee crown looking u/s.

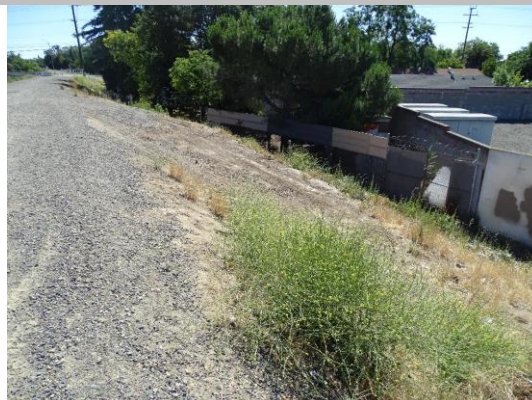
Photo 2 of 3 : UCIP\_FA\_2022\_69020\_85541.jpg

Overview of LS levee slope looking u/s.

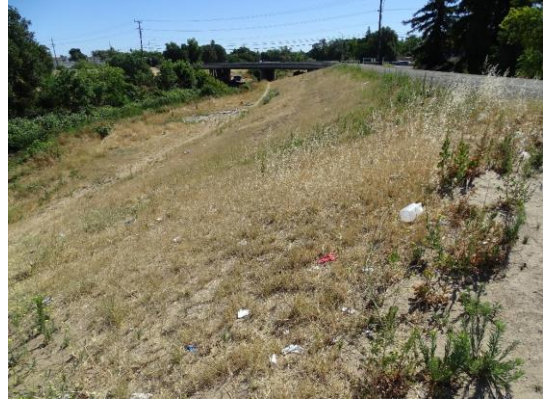
Photo 3 of 3 : UCIP\_FA\_2022\_69020\_85542.jpg

Overview of WS levee slope looking u/s.

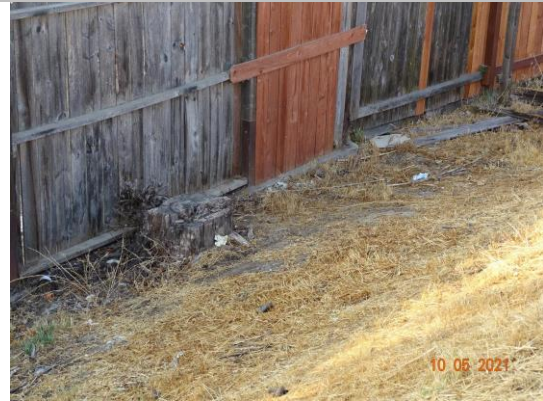
Photo 1 of 1 : FA\_2022\_NA0001\_51\_72\_20220822\_00041.jpg

LM Start	1.41	Rating **	N	Issue No.	72
LM End	1.41	Issue Type +	Ma	Location *	LS
Category	Earthen Levee			GPS Latitude/Longitude	
				Start	End
Item	Trim / Thin Trees			38.626253 °	38.626253 °
				-121.444165 °	-121.444165 °
DWR ID	DWR_NA0001_01_f_2015_72				
Comment Code					
T5 : Tree stumps.					
Inspector Comment

Stumps on the LS toe. Fall 2021

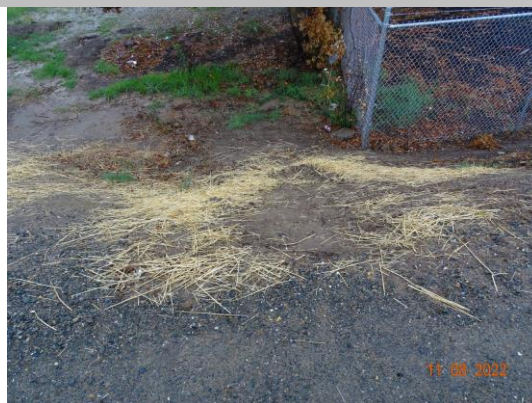
Photo 1 of 1 : FA\_2022\_NA0001\_51\_68\_20221109\_00138.jpg

LM Start	1.81	Rating **	A/W	Issue No.	68
LM End	1.81	Issue Type +	Ma	Location *	LS
Category	Earthen Levee			GPS Latitude/Longitude	
				Start	End
Item	Animal Control			38.627956 °	38.627956 °
				-121.437459 °	-121.437459 °
DWR ID	DWR_NA0001_01_f_2022_68				
Comment Code					
A3 : No rodents visible, but rodent burrows visible; need to backfill and compact or grout burrows.					
Inspector Comment					
Monitor rodent activity.

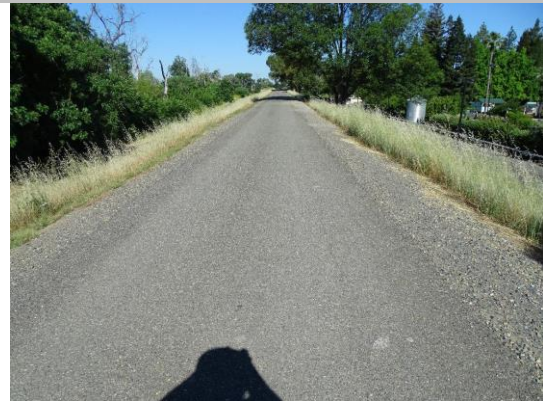
Photo 1 of 3 : UCIP\_FA\_2022\_69078\_84660.jpg

LM Start	0.86	Rating **	M	Issue No.	47	
LM End	0.86	Issue Type +	Ma	Location *		
Category	Supplemental			GPS Latitude/Longitude		
				Start	End	
Item	DWR UCIP LMA Responsibility			38.589607 °	38.589607 °	
				-121.432970 °	-121.432970 °	
DWR ID	24488					
Comment Code						
Inspector Comment						
DS_ID:24488 FS_ID:69078 EP_NO: N/A Repair Type: Non-Urgent EVAL Issue: Crossing Status: Not Found UCIP Comments: 06/03/2020 Crossing evaluated as "Non-Urgent" because pipe was not found during inspection. (A. McDonald - DWR UCIP) FIELD_STRUCT_DESC: 30-inch steel drainage pipe through the levee, at an unknown depth. Pump located on the landside (LS). [Additional Reference(s): USACE Sacramento O&M Manual Unit 118, Part No. 2, October 1959, (Station 87+73). USACE As-Built File No. 1-4-392, Sheet No. 392/3, December 1954]. FS Date: 6/3/2020

Overview of levee crown looking d/s.

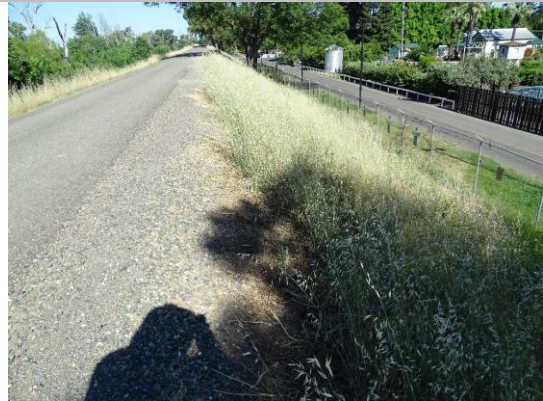
Photo 2 of 3 : UCIP\_FA\_2022\_69078\_84661.jpg

Overview of LS levee slope looking d/s.

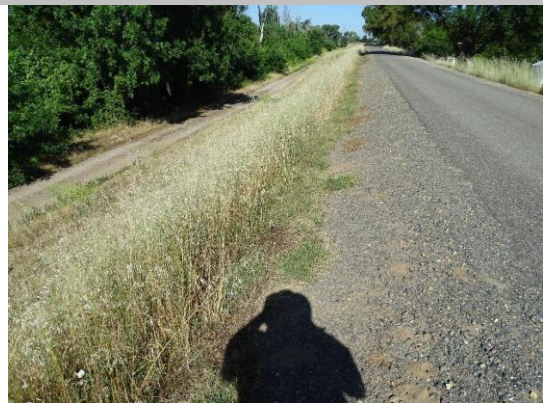
Photo 3 of 3 : UCIP\_FA\_2022\_69078\_84662.jpg

Overview of WS levee slope looking d/s.

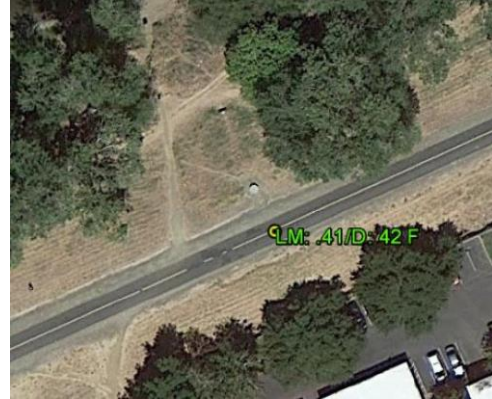
Photo 1 of 3 : UCIP\_FA\_2022\_69301\_57212.jpg

Comment Code					
Inspector Comment					
DS_ID:24303 FS_ID:69301 EP_NO: N/A Repair Type: Non-Urgent EVAL Issue: Crossing Status: Found UCIP Comments: 06/25/2020 Crossing evaluated as "Non-Urgent" because pipe was abandoned and there was no permit found authorizing this pipe. Geophysical evaluation found evidence of a pipe at this location. (A. McDonald - DWR UCIP)08/16/2017 DWR Deferred Maintenance Project (DMP), Vince Rodriguez, forwarded email received from Tim Kerr, General Manager of American River Flood Control District (ARFCD) with file "DWR Eligible Pipes Found in ARFCD" from ARFCD that shows the ownership and location of the pipes Tim Kerr investigated. No owner was identified, ARFCD Staff Notes indicate Abandoned (ARFCD/Bill) - No As-builts. (DWR UCIP - O. Magana) 12/19/2013 Non-functional crossing--need additional information about how crossing was abandoned. (DWR UCIP - O. Magana) FIELD_STRUCT_DESC: *ABANDONED* 42-inch corrugated metal (CM) drainage pipe through the levee, 16.5 feet below the crown. Gravel filled with both ends welded shut. Flap gate on the waterside (WS) end. Slide gate inside a CM riser and splash board drain structure on the landside (LS). (No permit found authorizing this structure. Owner unknown). [Additional Reference(s): DWR Levee Log, 2002 (HLM 0.44). USACE Sacramento O&M Manual Unit 118, Part No. 1, August 1955, (Station 10+00). USACE As-Built Drawing No. 50-10-2792, Sheet 2792/1, (Station 10+00), March 1951]. FS Date: 6/25/2020

Overview of crossing location.

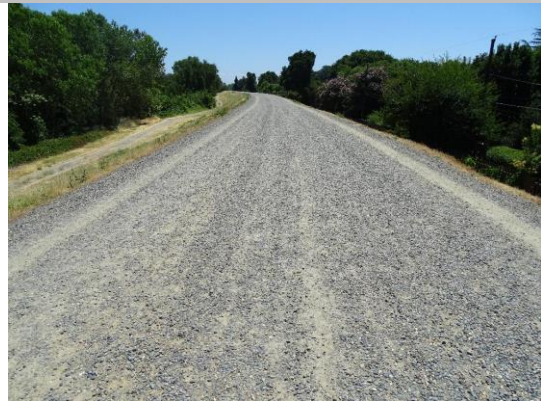
Photo 1 of 3 : UCIP\_FA\_2022\_69220\_86227.jpg

Comment Code					
Inspector Comment					
DS_ID:24496					
FS_ID:69220					
EP_NO: N/A					
Repair Type: Non-Urgent					
EVAL Issue:					
Crossing Status: Not Found					
UCIP Comments: 06/25/2020 Crossing evaluated as "Non-Urgent" because pipe was not found during inspection and there was no permit found authorizing this pipe. (A. McDonald - DWR UCIP)					
FIELD_STRUCT_DESC: 18-inch steel drainage pipe through the levee, at an unknown depth. Flap gate on the waterside (WS) end. (No permit found authorizing this pipe. Owner unknown). [Additional Reference(s): USACE Sacramento O&M Manual Unit 118, Part No. 1, August 1955, (Station 265+07). USACE As-Built Drawing No. 1-4-362, Sheet 362/2, (Station 265+07), December 1947].					
FS Date: 6/25/2020

Overview of levee crown looking u/s.

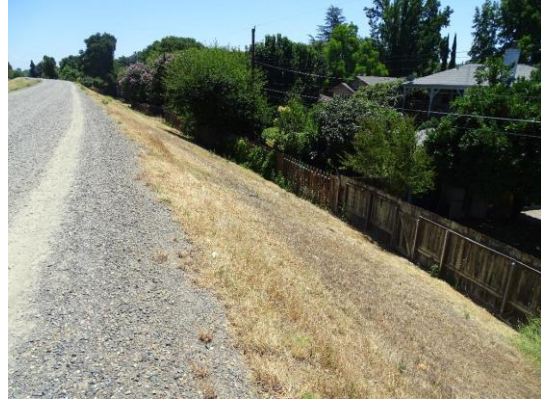
Photo 2 of 3 : UCIP\_FA\_2022\_69220\_86228.jpg

Overview of LS levee slope looking u/s.

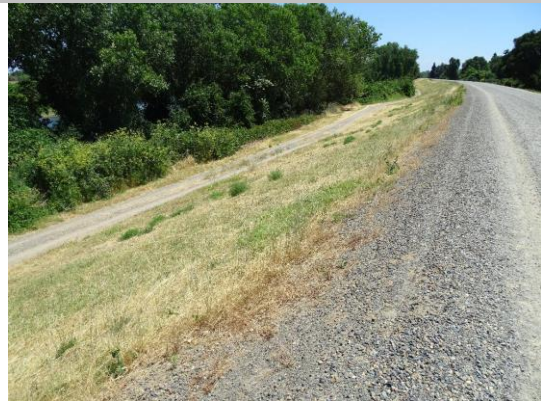
Photo 3 of 3 : UCIP\_FA\_2022\_69220\_86229.jpg

Overview of WS levee slope looking u/s.

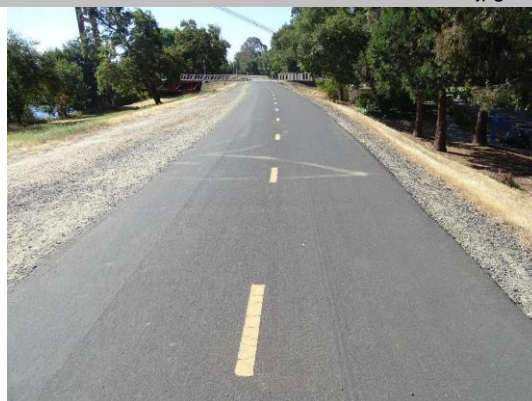
Photo 1 of 3 : UCIP\_FA\_2022\_69231\_86287.jpg

Comment Code					
Inspector Comment					
DS_ID:24497					
FS_ID:69231					
EP_NO: N/A					
Repair Type: Non-Urgent					
EVAL Issue:					
Crossing Status: Not Found					
UCIP Comments: 06/30/2020 Crossing evaluated as "Non-Urgent" because pipe was not found during inspection and there was no permit found authorizing this pipe. (A. McDonald - DWR UCIP)					
FIELD_STRUCT_DESC: 1 of 3: 18-inch corrugated metal (CM) drainage pipe through the levee, at an unknown depth. Flap gate on the waterside (WS) end. (No permit found authorizing this pipe. Owner unknown). [Additional Reference(s): USACE Sacramento O&M Manual Unit 118, Part No. 1, August 1955, (Station 367+40). USACE As-Built Drawing No. 1-4-362, Sheet 362/3, (Station 367+40), December 1947]. FS Date: 6/30/2020

Overview of levee crown looking u/s.

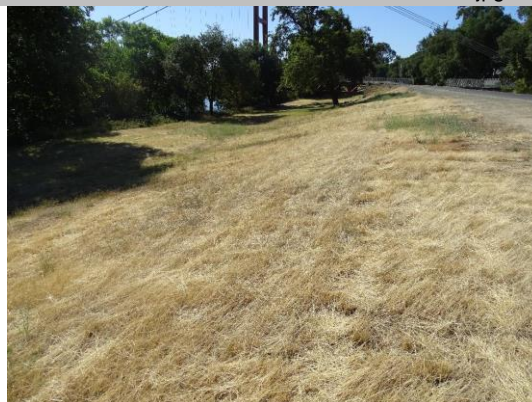
Photo 2 of 3 : UCIP\_FA\_2022\_69231\_86288.jpg

Overview of WS levee slope looking u/s.

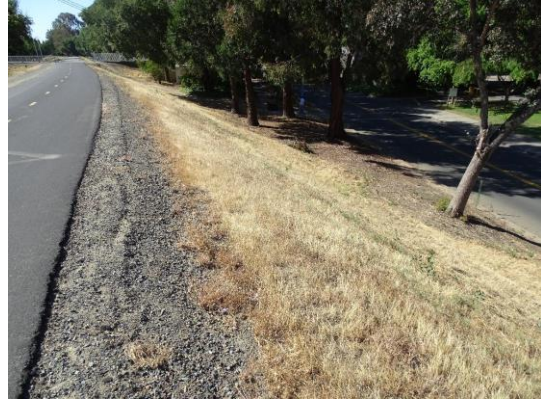
Photo 3 of 3 : UCIP\_FA\_2022\_69231\_86289.jpg

Overview of LS levee slope looking u/s.

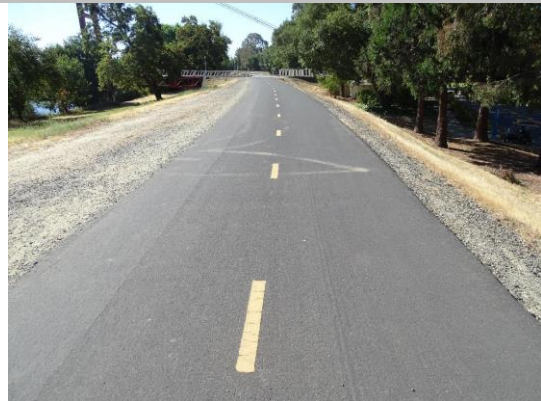
Photo 1 of 3 : UCIP\_FA\_2022\_69232\_86290.jpg

DS\_ID:24585  
 FS\_ID:69232  
 EP\_NO: N/A  
 Repair Type: Non-Urgent  
 EVAL Issue:  
 Crossing Status: Not Found  
 UCIP Comments: 06/30/2020 Crossing evaluated as "Non-Urgent" because pipe was not found during inspection and there was no permit found authorizing this pipe. (A. McDonald - DWR UCIP)  
 FIELD\_STRUCT\_DESC: 2 of 3: 18-inch corrugated metal (CM) drainage pipe through the levee, at an unknown depth. Flap gate on the waterside (WS) end. (No permit found authorizing this pipe. Owner unknown). [Additional Reference(s): USACE Sacramento O&M Manual Unit 118, Part No. 1, August 1955, (Station 367+40). USACE As-Built Drawing No. 1-4-362, Sheet 362/3, (Station 367+40), December 1947].  
 FS Date: 6/30/2020

Overview of levee crown looking u/s.

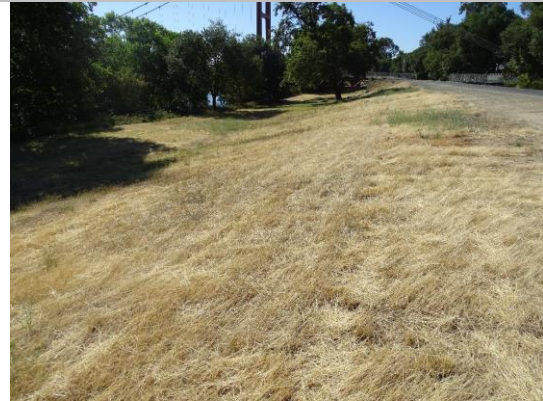
Photo 2 of 3 : UCIP\_FA\_2022\_69232\_86291.jpg

Overview of WS levee slope looking u/s.

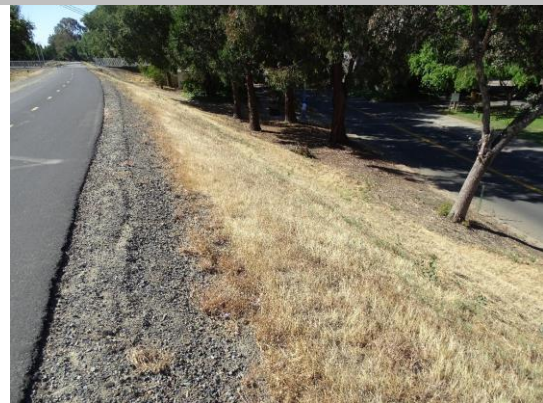
Photo 3 of 3 : UCIP\_FA\_2022\_69232\_86292.jpg

Overview of LS levee slope looking u/s.

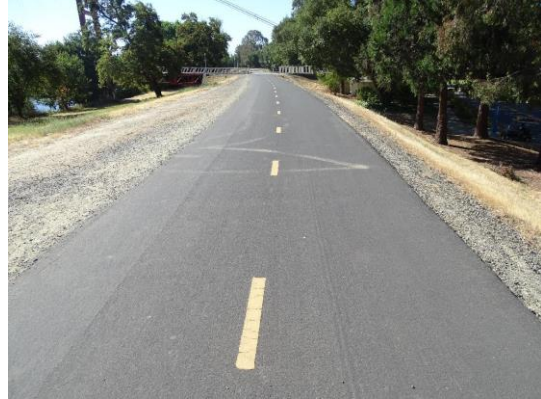
Photo 1 of 3 : UCIP\_FA\_2022\_69233\_86293.jpg

Comment Code					
Inspector Comment					
DS_ID:24586 FS_ID:69233 EP_NO: N/A Repair Type: Non-Urgent EVAL Issue: Crossing Status: Not Found UCIP Comments: 06/30/2020 Crossing evaluated as "Non-Urgent" because pipe was not found during inspection and there was no permit found authorizing this pipe. (A. McDonald - DWR UCIP) FIELD_STRUCT_DESC: 3 of 3: 18-inch corrugated metal (CM) drainage pipe through the levee, at an unknown depth. Flap gate on the waterside (WS) end. (No permit found authorizing this pipe. Owner unknown). [Additional Reference(s): USACE Sacramento O&M Manual Unit 118, Part No. 1, August 1955, (Station 367+40). USACE As-Built Drawing No. 1-4-362, Sheet 362/3, (Station 367+40), December 1947]. FS Date: 6/30/2020

Overview of levee crown looking u/s.

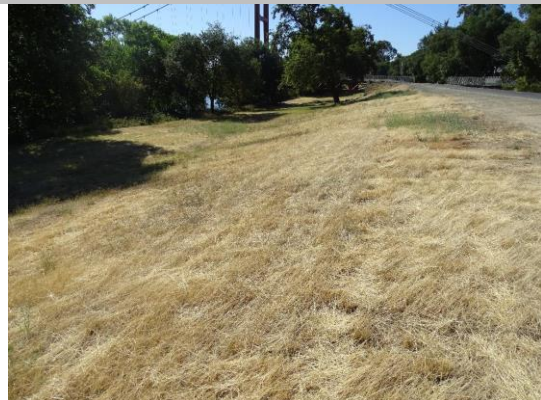
Photo 2 of 3 : UCIP\_FA\_2022\_69233\_86294.jpg

Overview of WS levee slope looking u/s.

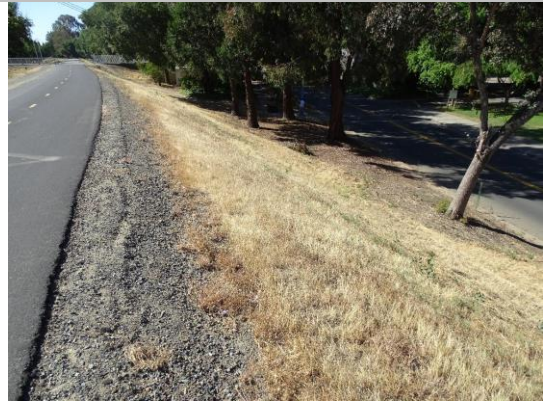
Photo 3 of 3 : UCIP\_FA\_2022\_69233\_86295.jpg

Overview of LS levee slope looking u/s.

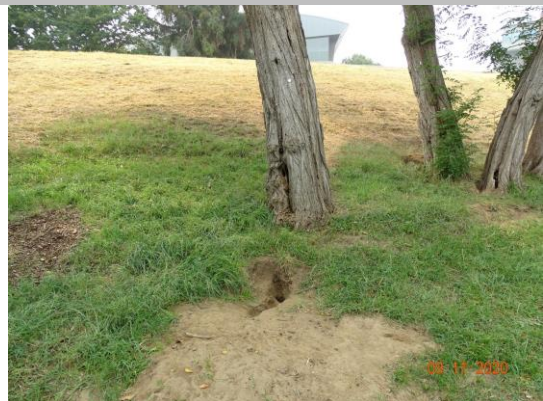
Photo 1 of 1 : FA\_2022\_NA0001\_55\_383\_20220822\_00248.jpg

LM Start	6.71	Rating **	A/W	Issue No.	383
LM End	6.71	Issue Type +	Ma	Location *	WS
Category	Earthen Levee			GPS Latitude/Longitude	
				Start	End
Item	Animal Control			38.560383 °	38.560383 °
				-121.419502 °	-121.419502 °
DWR ID	DWR_NA0001_04_f_2020_383				
Comment Code					
A3 : No rodents visible, but rodent burrows visible; need to backfill and compact or grout burrows.					
Inspector Comment					
Continue to monitor for rehabilitation.

View of animal holes on the waterside slope. Fall 2020

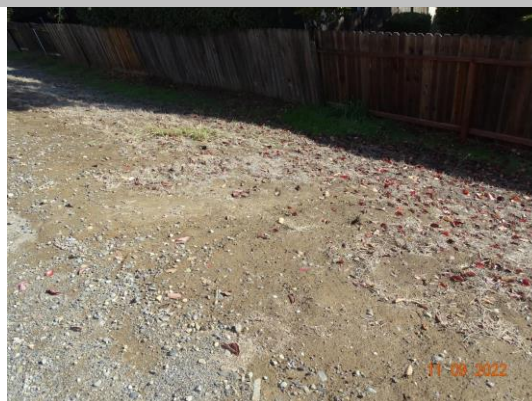
Photo 1 of 1 : FA\_2022\_NA0001\_55\_275\_20221110\_00477.jpg

LM Start	10.38	Rating **	A/W	Issue No.	275
LM End	10.38	Issue Type +	Ma	Location *	LS
Category	Earthen Levee			GPS Latitude/Longitude	
				Start	End
Item	Animal Control			38.570424 °	38.570424 °
				-121.355668 °	-121.355668 °
DWR ID	DWR_NA0001_04_f_2022_275				
Comment Code					
A3 : No rodents visible, but rodent burrows visible; need to backfill and compact or grout burrows.					
Inspector Comment					
Monitor burrows for repopulation.

Filled burrows on the LS slope and easement. Fall 2022

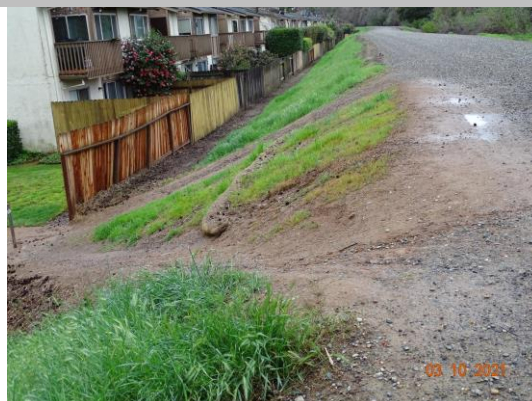
Photo 1 of 1 : FA\_2022\_NA0001\_55\_329\_20220822\_00237.jpg

LM Start	10.42	Rating **	A/W	Issue No.	329
LM End	10.42	Issue Type +	Ma	Location *	LS
Category	Earthen Levee			GPS Latitude/Longitude	
				Start	End
Item	Erosion / Foot Traffic			38.570513 °	38.570513 °
				-121.354934 °	-121.354934 °
DWR ID	DWR_NA0001_04_f_2021_329				
Comment Code					
E3 : Repair the levee slope damaged by foot traffic and prevent access where possible.					
Inspector Comment					
Monitor two foot paths for erosion.

View of the footpaths going the the LS levee slope. Spring 2021.

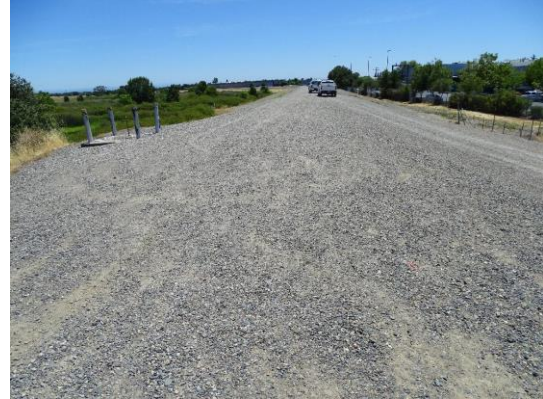
Photo 1 of 3 : UCIP\_FA\_2022\_68568\_85769.jpg

Comment Code					
Inspector Comment					
DS_ID:24092 FS_ID:68568 EP_NO: N/A Repair Type: Non-Urgent EVAL Issue: Crossing Status: Found UCIP Comments: 06/18/2020 Crossing evaluated as "Non-Urgent" because there was no permit found authorizing this pipe. Geophysical evaluation found evidence of a pipe at this location. (A. McDonald - DWR UCIP) FIELD_STRUCT_DESC: 24-inch corrugated metal (CM) drainage pipe through the levee, 22.7 feet below the crown. Two CM cutoff walls around the pipe. Slide gate inside a 30-inch CM riser and flap gate are located on the waterside (WS) end. Concrete headwall on each end, WS and landside (LS). [Additional Reference(s): DWR Levee Log, 2002 (HLM 0.02). USACE Sacramento O&M Manual, Unit 118, Part No. 2, October 1959, (Station 396+65). USACE As-Built Drawing No. 1-4-392, Sheet 392/8, (Station 396+65), December 1954]. FS Date: 6/18/2020

Overview of levee crown looking u/s.

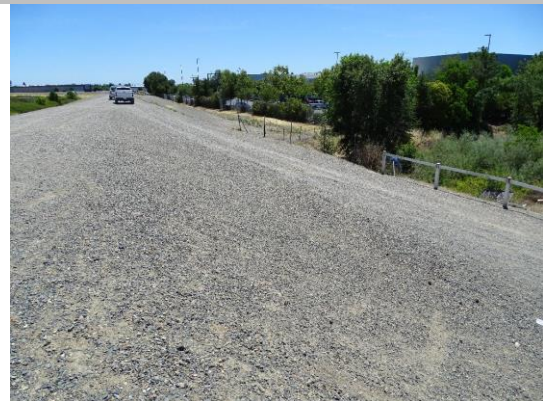
Photo 2 of 3 : UCIP\_FA\_2022\_68568\_85770.jpg

Overview of LS levee slope looking u/s.

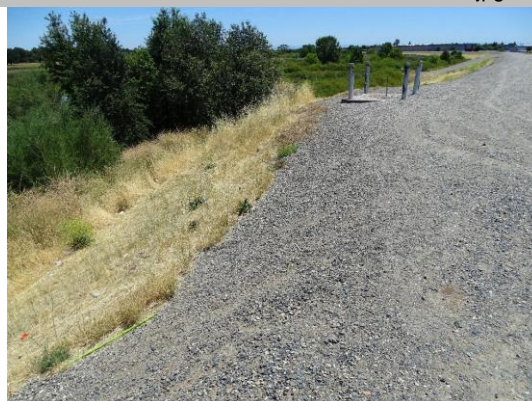
Photo 3 of 3 : UCIP\_FA\_2022\_68568\_85771.jpg

Overview of WS levee slope looking u/s.

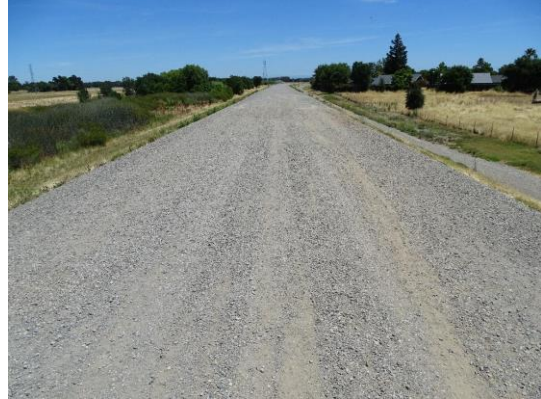
Photo 1 of 3 : UCIP\_FA\_2022\_68578\_85830.jpg

Comment Code					
Inspector Comment					
DS_ID:24354 FS_ID:68578 EP_NO: N/A Repair Type: Non-Urgent EVAL Issue: Crossing Status: Indicator Found UCIP Comments: 06/18/2020 Crossing evaluated as "Non-Urgent" because there was no permit found for this pipe. (A. McDonald - DWR UCIP)08/16/2017 DWR Deferred Maintenance Project (DMP), Vince Rodriguez, forwarded email received from Tim Kerr, General Manager of American River Flood Control District (ARFCD) with file "DWR Eligible Pipes Found in ARFCD" from ARFCD that shows the ownership and location of the pipes Tim Kerr investigated. Owner of this crossing was not identified, ARFCD Staff Notes indicate old pipe between Kelton and Sully (not found). (DWR UCIP - O. Magana) 12/20/2013 Unable to find CM riser and flap gate on waterward end--need to contact owner to determine status of crossing. Manhole found on landward side however unable to determine if manhole is part of this crossing. (DWR UCIP - O. Magana) FIELD_STRUCT_DESC: 24-inch corrugated metal (CM) drainage pipe through the levee, 12.5 feet below the crown. Two CM cutoff walls around the pipe. Slide gate inside a CM riser and flap gate on the waterside (WS) end. Concrete headwall on each end, WS and landside (LS). (No permit found authorizing this structure. Owner unknown). [Additional Reference(s): USACE Sacramento O&M Manual, Unit 118, Part No. 2, October 1959, (Station 440+50). USACE As-Built Drawing No. 1-4-392, Sheet 392/9, (Station 440+50), December 1954]. FS Date: 6/18/2020

Overview of levee crown looking u/s.

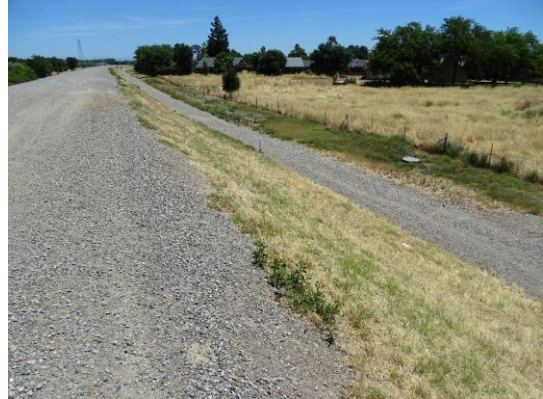
Photo 2 of 3 : UCIP\_FA\_2022\_68578\_85832.jpg

Overview of LS levee slope looking u/s.

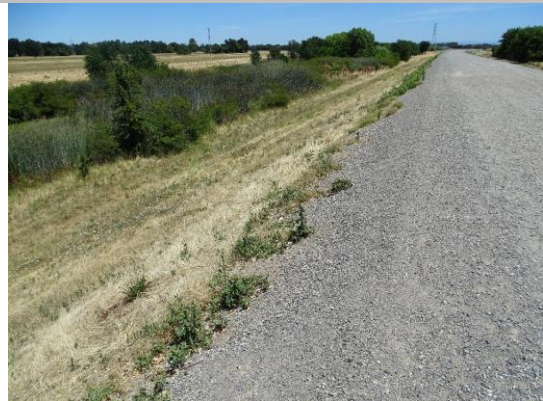
Photo 3 of 3 : UCIP\_FA\_2022\_68578\_85831.jpg

Overview of WS levee slope looking u/s.

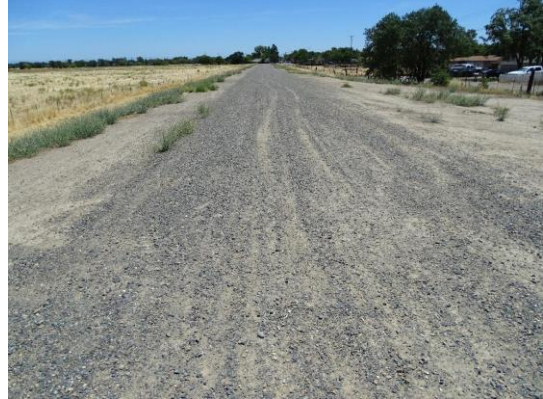
Photo 1 of 3 : UCIP\_FA\_2022\_71915\_85837.jpg

Comment Code					
Inspector Comment					
DS_ID:24350 FS_ID:71915 EP_NO: N/A Repair Type: Non-Urgent EVAL Issue: Crossing Status: Not Found UCIP Comments: 06/18/2020 Crossing evaluated as "Non-Urgent" because pipe was not found during inspection and there was no permit found for this crossing. Geophysical evaluation found a potential pipe at this location. (A. McDonald - DWR UCIP) FIELD_STRUCT_DESC: 24-inch corrugated metal drainage pipe (CMP) through the levee, at an unknown depth. Flap gate and riser on the waterside (WS). Slide gate Vault No. 2 on the WS shoulder. (No permit found authorizing this structure. Owner unknown). [Additional Reference(s): USACE Sacramento O&M Manual, Unit 118, Part No. 2, October 1959, (Station 14+00). USACE As-Built Drawing No. 1-4-392, Sheet 392/9, (Station 14+00), December 1954]. FS Date: 6/18/2020

Overview of levee crown looking u/s.

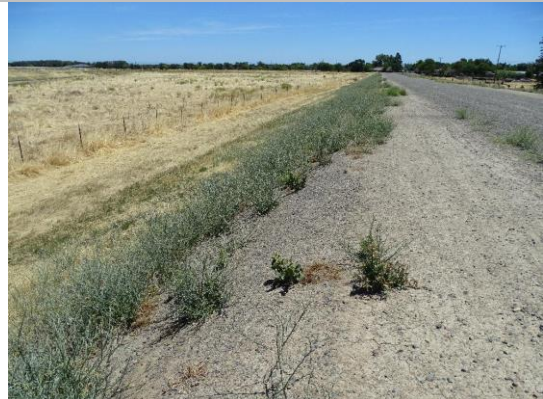
Photo 2 of 3 : UCIP\_FA\_2022\_71915\_85838.jpg

Overview of WS levee slope looking u/s.

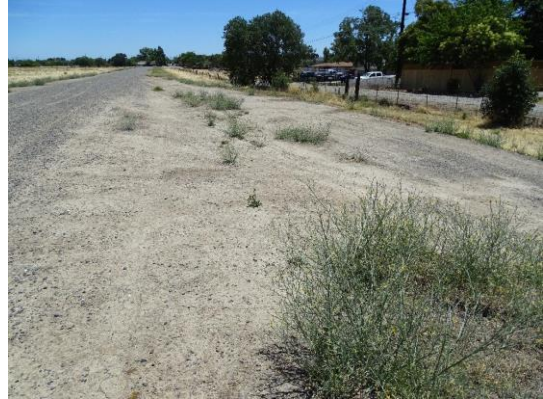
Photo 3 of 3 : UCIP\_FA\_2022\_71915\_85839.jpg

Overview of LS levee slope looking u/s.

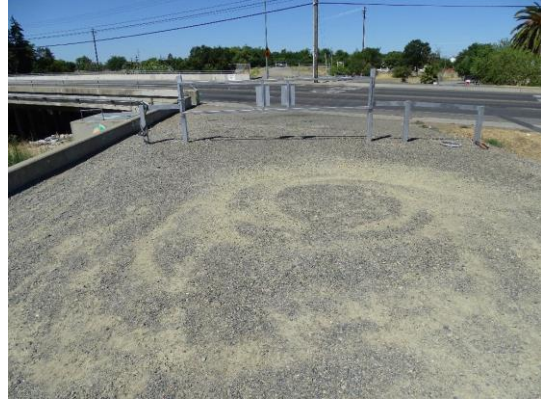
Photo 1 of 3 : UCIP\_FA\_2022\_69448\_85701.jpg

Comment Code						
Inspector Comment						
DS_ID:24370 FS_ID:69448 EP_NO: N/A Repair Type: No Action Needed EVAL Issue: Crossing Status: Found UCIP Comments: 06/18/2020 Crossing evaluated as "No Action Needed." Permit and inspection requirements have been met. (A. McDonald - DWR UCIP)08/16/2017 DWR Deferred Maintenance Project (DMP), Vince Rodriguez, forwarded email received from Tim Kerr, General Manager of American River Flood Control District (ARFCD) with file "DWR Eligible Pipes Found in ARFCD" from ARFCD that shows the ownership and location of the pipes Tim Kerr investigated. Owner of this crossing is identified as the City of Sacramento, ARFCD Staff Notes indicate Arcade CK just upstream of Rio Linda. (DWR UCIP - O. Magana) FIELD_STRUCT_DESC: 24-inch corrugated metal (CM) drainage pipe through the levee, 11.0 feet below the crown. Slide gate inside a CM riser on the waterside (WS) slope. Flap gate on the WS end. Concrete headwall on each end, WS and landside (LS). (No permit found authorizing this structure. Structure is owned by the City of Sacramento). [Additional Reference(s): DWR Levee Log, 2002 (HLM 1.31). USACE Sacramento O&M Manual, Unit 118, Part No. 2, October 1959, (Station A 70+09). USACE As-Built Drawing No. 1-4-392, Sheet 392/6, (Station A 70+09), December 1954]. FS Date: 6/18/2020

Overview of levee crown looking d/s.

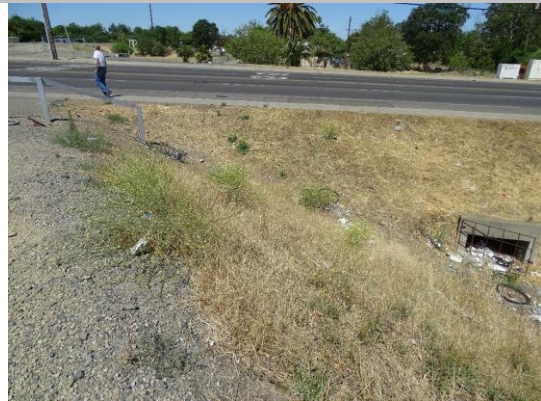
Photo 2 of 3 : UCIP\_FA\_2022\_69448\_85702.jpg

Overview of LS levee slope looking d/s.

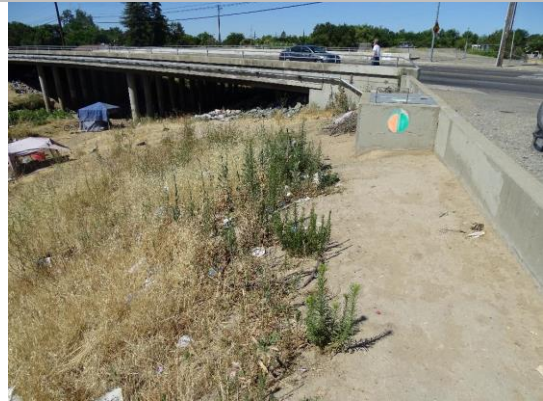
Photo 3 of 3 : UCIP\_FA\_2022\_69448\_85703.jpg

Overview of WS levee slope looking d/s.

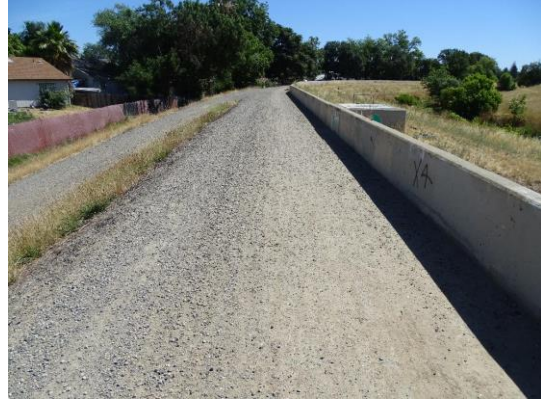
Photo 1 of 3 : UCIP\_FA\_2022\_71925\_85706.jpg

Comment Code					
Inspector Comment					
DS_ID:24371 FS_ID:71925 EP_NO: N/A Repair Type: No Action Needed EVAL Issue: Crossing Status: Found UCIP Comments: 03/08/2022 According to permit records for 12886, "old pipe removed. Concrete pipe in placed and backfilled part of it." Conflicting information makes it difficult to determine the fate of the 24-inch pipe (extent of work completed under permit). (A. McDonald - DWR UCIP)06/18/2020 Crossing evaluated as "No Action Needed." Permit and inspection requirements have been met. (A. McDonald - DWR UCIP)08/16/2017 DWR Deferred Maintenance Project (DMP), Vince Rodriguez, forwarded email received from Tim Kerr, General Manager of American River Flood Control District (ARFCD) with file "DWR Eligible Pipes Found in ARFCD" from ARFCD that shows the ownership and location of the pipes Tim Kerr investigated. Owner of this crossing is identified as the City of Sacramento, ARFCD Staff Notes indicate Arcade Ck near Rivera Dr at Branch St. (DWR UCIP - O. Magana) 06/14/2017 This crossing is scheduled to be cut and replaced as part of Sacramento Area Flood Control (SAFCA) North Area Streams (NAS) Levee Improvement Project: City of Sacramento Utility Permit Modifications Along Arcade Creek Levees. Unable to confirm when pipe will be replaced. Need to coordinate with owner and DWR FPIIB Inspector to determine when project is expected to start. (DWR UCIP - O. Magana). 06/06/2017 Received documentation from the City of Sacramento indicating that this crossing was internally inspected on 11/25/2013, PACP Sewer Report was provided. No additional information was received from the City of Sacramento. PACP report indicates a 24-inch reinforced concrete pipe (RCP) not 24-inch corrugated metal pipe (CMP). (DWR UCIP – O. Magana) FIELD_STRUCT_DESC: 24-inch reinforced concrete (RC) drainage pipe through the levee, 9.3 feet below the crown. Concrete headwall on each end, waterside (WS) and landside (LS). Slide gate inside a corrugated metal pipe (CMP) riser unit on the WS slope. Flap gate on the WS end. (Removal of old pipe and replacement with a 30-inch pipe authorized under Permit No. 12886, 1980 - City of Sacramento. Removal and replacement of an existing 24-inch RC pipe authorized under Permit No. 19129, 2017 - City of Sacramento, Department of Utilities). [Additional Reference(s): DWR Levee Log, 2002 (HLM 1.45). USACE Sacramento O&M Manual, Unit 118, Part No. 2, October 1959, (Station A 77+12). USACE As-Built Drawing No. 1-4-392, Sheet 392/6, (Station A 77+12), December 1954]. FS Date: 6/18/2020

Overview of levee crown looking u/s.

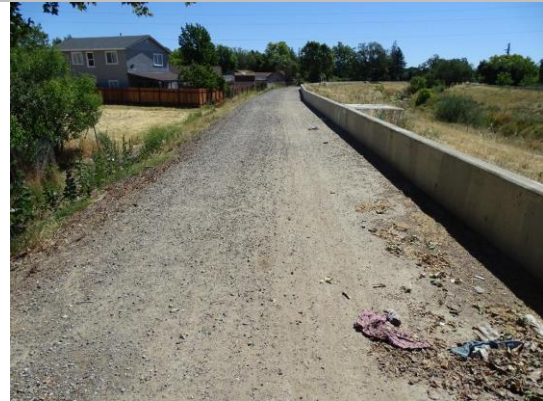
Photo 1 of 3 : UCIP\_FA\_2022\_69453\_85728.jpg

Comment Code					
Inspector Comment					
DS_ID:24373 FS_ID:69453 EP_NO: 19126 Repair Type: No Action Needed EVAL Issue: Crossing Status: Found UCIP Comments: 06/18/2020 Crossing evaluated as "No Action Needed." Permit and inspection requirements have been met. (A. McDonald - DWR UCIP)08/16/2017 DWR Deferred Maintenance Project (DMP), Vince Rodriguez, forwarded email received from Tim Kerr, General Manager of American River Flood Control District (ARFCD) with file "DWR Eligible Pipes Found in ARFCD" from ARFCD that shows the ownership and location of the pipes Tim Kerr investigated. Owner of this crossing is identified as the City of Sacramento, ARFCD Staff Notes indicate Arcade Ck. (DWR UCIP - O. Magana) 06/14/2017 This crossing is scheduled to be cut and replaced as part of Sacramento Area Flood Control (SAFCA) North Area Streams (NAS) Levee Improvement Project: City of Sacramento Utility Permit Modifications Along Arcade Creek Levees. Unable to confirm when pipe will be replaced. Need to coordinate with owner and DWR FPIIB Inspector to determine when project is expected to start. (DWR UCIP - O. Magana). FIELD_STRUCT_DESC: 24-inch reinforced concrete (RC) drainage pipe through the levee, 7.8 feet below the crown. Concrete headwall on each end, waterside (WS) and landside (LS). Slide gate inside a corrugated metal (CM) riser on the WS slope. Flap gate at the outlet on the WS. (No permit found authorizing this structure. Structure is owned by the City of Sacramento. Removal and replacement of an existing 24-inch RC pipe authorized under Permit No. 19126, 2017 - City of Sacramento, Department of Utilities). [Additional Reference(s): DWR Levee Log, 2002 (HLM 1.70). USACE Sacramento O&M Manual, Unit 118, Part No. 2, October 1959, (Station A 90+69). USACE As-Built Drawing No. 1-4-392, Sheet 392/6, (Station A 90+69), December 1954]. FS Date: 6/18/2020

Overview of levee crown looking u/s.

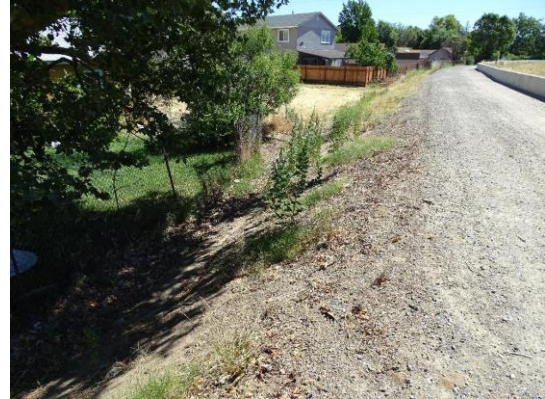
Photo 2 of 3 : UCIP\_FA\_2022\_69453\_85729.jpg

Overview of LS levee slope looking u/s.

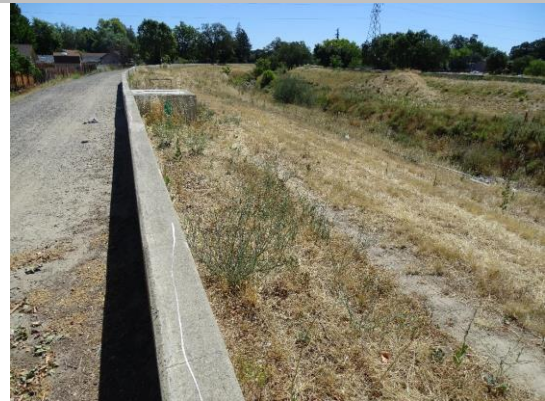
Photo 3 of 3 : UCIP\_FA\_2022\_69453\_85730.jpg

Overview of WS levee slope looking u/s.

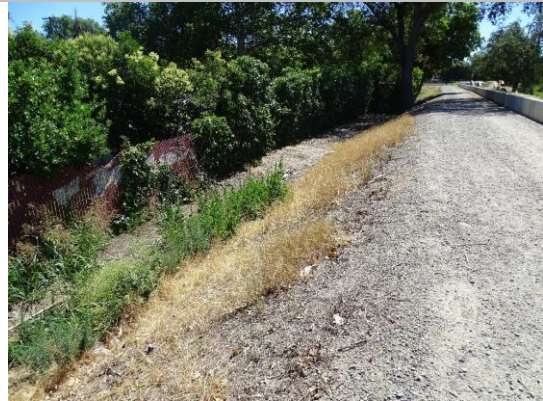
Photo 2 of 3 : UCIP\_FA\_2022\_69456\_85742.jpg

Comment Code					
Inspector Comment					
DS_ID:24375 FS_ID:69456 EP_NO: 19127 Repair Type: No Action Needed EVAL Issue: Crossing Status: Found UCIP Comments: 06/18/2020 Crossing evaluated as "No Action Needed." Permit and inspection requirements have been met. (A. McDonald - DWR UCIP)08/16/2017 DWR Deferred Maintenance Project (DMP), Vince Rodriguez, forwarded email received from Tim Kerr, General Manager of American River Flood Control District (ARFCD) with file "DWR Eligible Pipes Found in ARFCD" from ARFCD that shows the ownership and location of the pipes Tim Kerr investigated. Owner of this crossing is identified as the City of Sacramento, ARFCD Staff Notes indicate Arcade Ck. (DWR UCIP - O. Magana) 06/14/2017 This crossing is scheduled to be cut and replaced as part of Sacramento Area Flood Control (SAFCA) North Area Streams (NAS) Levee Improvement Project: City of Sacramento Utility Permit Modifications Along Arcade Creek Levees. Unable to confirm when pipe will be replaced. Need to coordinate with owner and DWR FPIIB Inspector to determine when project is expected to start. (DWR UCIP - O. Magana). FIELD_STRUCT_DESC: 24-inch reinforced concrete (RC) drainage pipe through the levee, 8.6 feet below the crown. Slide gate inside a corrugated metal (CM) riser on the waterside (WS) slope. Flap gate at the outlet on the WS. Concrete headwall on each end, WS and landside (LS). (No permit found authorizing the original structure. Structure is owned by the City of Sacramento. Removal and replacement of an existing 24-inch RC pipe authorized by Permit No. 19127, 2017 - City of Sacramento, Department of Utilities). [Additional Reference(s): DWR Levee Log, 2002 (HLM 1.82). USACE Sacramento O&M Manual, Unit 118, Part No. 2, October 1959, (Station A 96+00). USACE As-Built Drawing No. 1-4-392, Sheet 392/6, (Station A 96+00), December 1954]. FS Date: 6/18/2020

Overview of LS levee slope looking u/s.

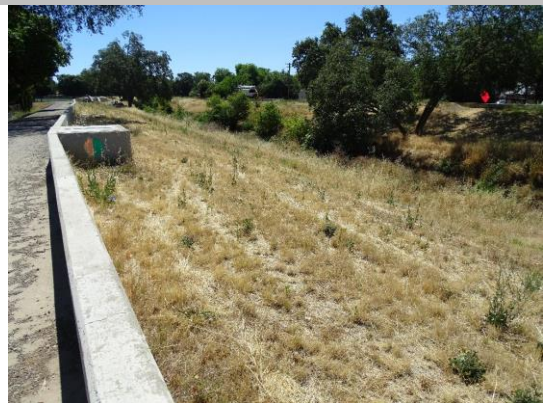
Photo 3 of 3 : UCIP\_FA\_2022\_69456\_85743.jpg

Overview of WS levee slope looking u/s.

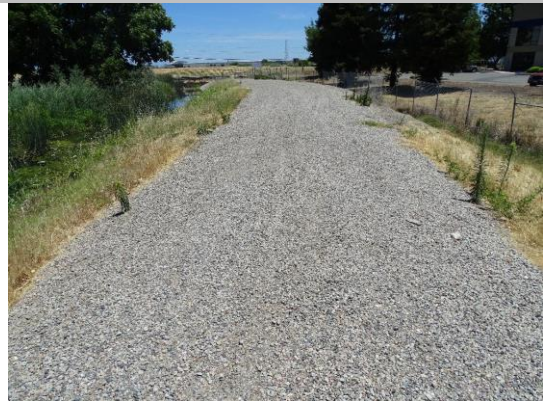
Photo 1 of 3 : UCIP\_FA\_2022\_69467\_85938.jpg

Comment Code						
Inspector Comment						
DS_ID:24384 FS_ID:69467 EP_NO: N/A Repair Type: Non-Urgent EVAL Issue: Crossing Status: Indicator Found UCIP Comments: 06/18/2020 Crossing evaluated as "Non-Urgent" because this is an abandoned encroachment and there is no permit found for this crossing. Geophysical evaluation found evidence of a pipe at this location. (A. McDonald - DWR UCIP)Non-functional crossing--need to coordinate with owner, DWR-Inspector, and CVFPB to determine how to properly abandon crossing. FIELD_STRUCT_DESC: *ABANDONED* 24-inch corrugated metal (CM) drainage pipe through the levee, 8.0 feet below the crown. Two CM cutoff walls around the pipe. Slide gate inside a 30-inch CM riser. Flap gate on the waterside (WS) end. Concrete U-shaped headwall and splash apron on the WS end. Landside (LS) end cut off and plugged. Riser filled with dirt. [Additional Reference(s): DWR Levee Log, 2002 (HLM 1.44). USACE Sacramento O&M Manual, Unit 118, Part No. 2, October 1959, (Station A 72+10). USACE As-Built Drawing No. 1-4-392, Sheet 392/10, (Station A 72+10), December 1954]. FS Date: 6/18/2020

Overview of levee crown looking u/s.

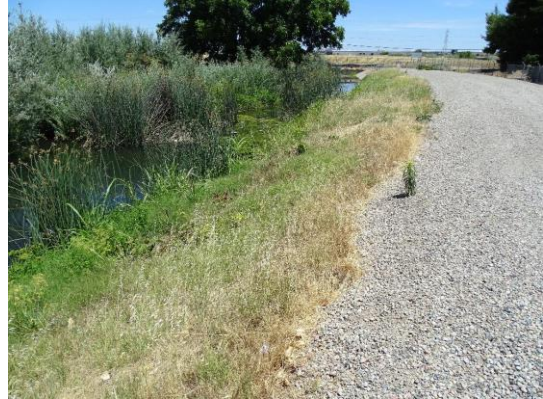
Photo 2 of 3 : UCIP\_FA\_2022\_69467\_85939.jpg

Overview of WS levee slope looking u/s.

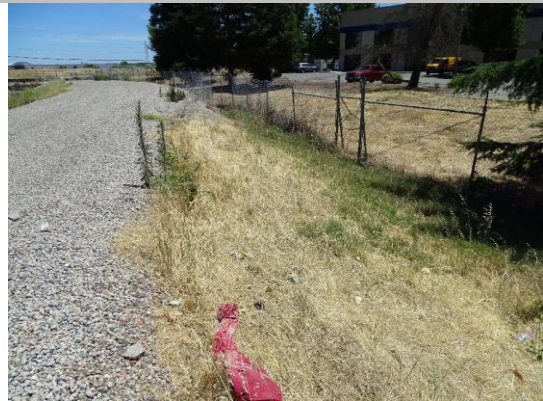
Photo 3 of 3 : UCIP\_FA\_2022\_69467\_85940.jpg

Overview of LS levee slope looking u/s.

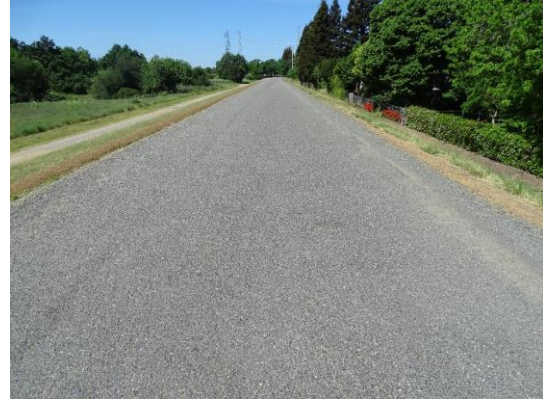
Photo 1 of 3 : UCIP\_FA\_2022\_69473\_84108.jpg

Comment Code					
Inspector Comment					
DS_ID:24394 FS_ID:69473 EP_NO: N/A Repair Type: Non-Urgent EVAL Issue: Crossing Status: Indicator Found UCIP Comments: 04/30/2020 This crossing is rated "Non-Urgent." It has been abandoned without a permit. Geophysical evaluation found no evidence of a pipe at this location. (A. McDonald - DWR UCIP)08/16/2017 DWR Deferred Maintenance Project (DMP), Vince Rodriguez, forwarded email received from Tim Kerr, General Manager of American River Flood Control District (ARFCD) with file "DWR Eligible Pipes Found in ARFCD" from ARFCD that shows the ownership and location of the pipes Tim Kerr investigated. No owner mentioned in email, ARFCD Staff Notes indicate riser in floodway near Beckenwood Way. (DWR UCIP - O. Magana) 12/05/2013 Need to contact owner to determine status of crossing. (DWR UCIP - O. Magana) FIELD_STRUCT_DESC: *ASSUMED ABANDONED* 12-inch steel pipe of an unknown purpose through the levee, 14.0 feet below the crown. Riser on the waterside (WS). (Reference to 12-inch pipe scheduled to be abandoned [no clear direction of action taken available in permit recordation, see page 14 of 27 electronic permit copy] under Permit No. 4622, 1964 - County of Sacramento). [Additional Reference(s): DWR Levee Log, 2002 (HLM 1.31). USACE Sacramento O&M Manual, Unit 517, Part No. 1, November 1959, (Station 296+85). USACE As-Built Drawing No. 1-4-415, Sheet 415/6, (Station 296+85), February 1957]. FS Date: 4/30/2020

Overview of levee crown looking d/s.

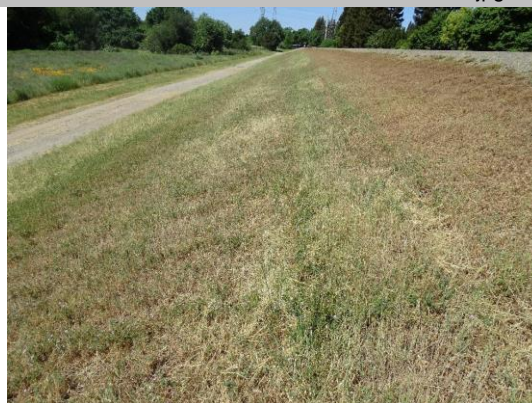
Photo 2 of 3 : UCIP\_FA\_2022\_69473\_84109.jpg

Overview of WS levee slope looking d/s.

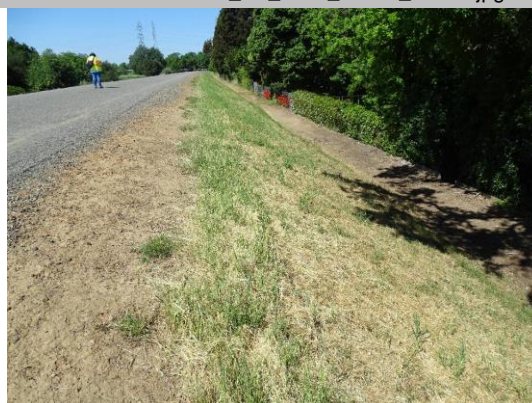
Photo 3 of 3 : UCIP\_FA\_2022\_69473\_84111.jpg

Overview of LS levee slope looking d/s.

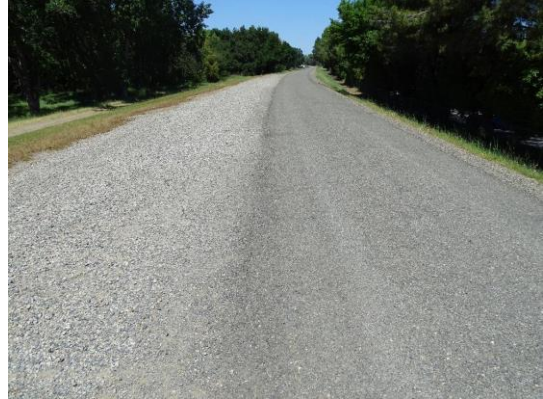
Photo 1 of 3 : UCIP\_FA\_2022\_69476\_84145.jpg

Comment Code					
Inspector Comment					
DS_ID:24397 FS_ID:69476 EP_NO: N/A Repair Type: Non-Urgent EVAL Issue: Crossing Status: Not Found UCIP Comments: 04/30/2020 This crossing is rated "Non-Urgent." Crossing was not found during inspection. Geophysical evaluation found no evidence of a pipe at this location. (A. McDonald - DWR UCIP) FIELD_STRUCT_DESC: *ASSUMED ABANDONED* 12-inch pipe of an unknown material or purpose through the levee, 11.2 feet below the crown. Riser unit on the waterside (WS). (Reference to 12-inch pipe scheduled to be abandoned [no clear direction of action taken available in permit recordation, see page 14 of 27 electronic permit copy] under Permit No. 4622, 1964 - County of Sacramento). [Additional Reference(s): DWR Levee Log, 2002 (HLM 2.26). USACE Sacramento O&M Manual, Unit 517, Part No. 1, November 1959, (Station 346+09). USACE As-Built Drawing No. 1-4-415, Sheet 415/6, (Station 346+09), February 1957]. FS Date: 4/30/2020

Overview of levee crown looking d/s.

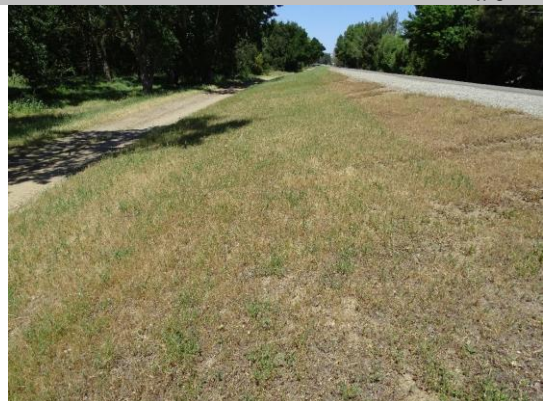
Photo 2 of 3 : UCIP\_FA\_2022\_69476\_84147.jpg

Overview of WS levee slope looking d/s.

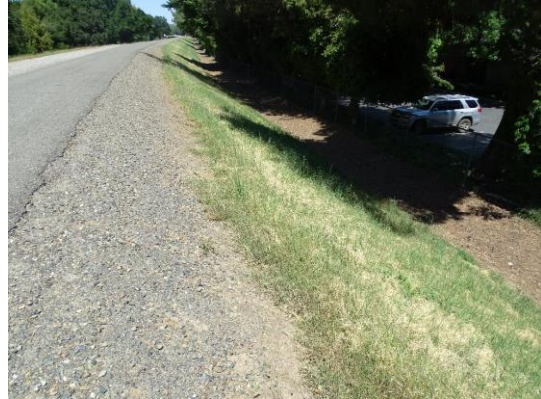
Photo 3 of 3 : UCIP\_FA\_2022\_69476\_84146.jpg

Overview of LS levee slope looking d/s.

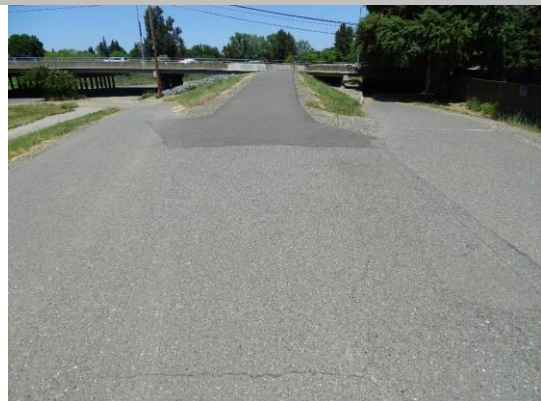
Photo 1 of 3 : UCIP\_FA\_2022\_69477\_84148.jpg

DS\_ID:24515  
 FS\_ID:69477  
 EP\_NO: N/A  
 Repair Type: Non-Urgent  
 EVAL Issue:  
 Crossing Status: Indicator Found  
 UCIP Comments: 04/30/2020 This crossing is rated "Non-Urgent."  
 Crossing was not found during inspection. (A. McDonald - DWR UCIP)12/05/2013 Unable to confirm crossing. will need to contact owner to determine specifics and status of crossing.  
 FIELD\_STRUCT\_DESC: 36-inch corrugated metal (CM) drainage pipe through the levee, at an unknown depth. Riser on the waterside (WS).  
 [Additional Reference(s): USACE Sacramento O&M Manual, Unit 517, Part No. 1, November 1959, (Station 365+14). USACE As-Built Drawing No. 1-4-415, Sheet 415/9, (Station 365+14), February 1957].  
 FS Date: 4/30/2020

Overview of levee crown looking d/s. "H" Street Bridge in the background.

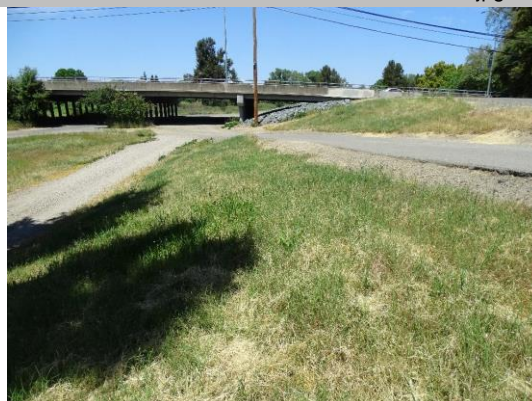
Photo 2 of 3 : UCIP\_FA\_2022\_69477\_84150.jpg

Overview of WS levee slope looking d/s. "H" Street Bridge in the background.

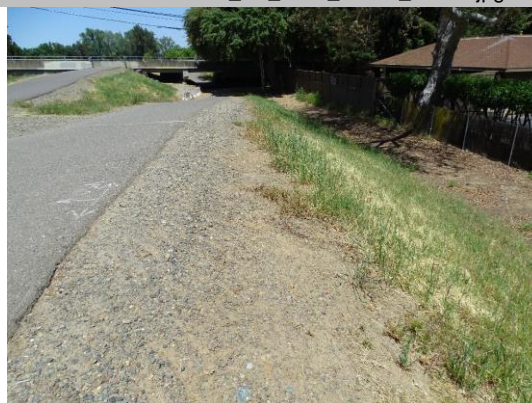
Photo 3 of 3 : UCIP\_FA\_2022\_69477\_84149.jpg

Overview of LS levee slope looking d/s. "H" Street Bridge in the background.

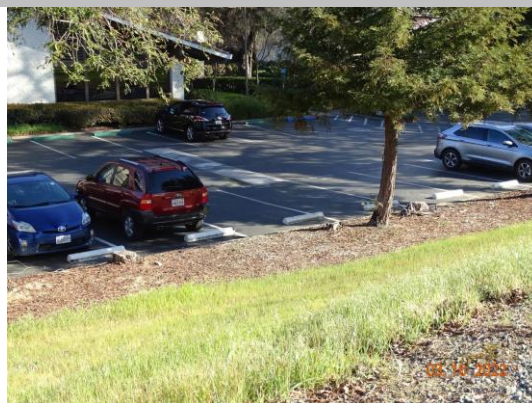
Photo 1 of 1 : FA\_2022\_NA0001\_61\_29\_20220822\_00007.jpg

LM Start	3.56	Rating **	N	Issue No.	29	
LM End	3.56	Issue Type +	Ma	Location *	LS	
Category	Earthen Levee			GPS Latitude/Longitude		
				Start		End
Item	Trim / Thin Trees			38.569242 °		38.569242 °
				-121.377169 °		-121.377169 °
DWR ID	DWR_NA0001_10_s_2017_29					
Comment Code						
T5 : Tree stumps.						
Inspector Comment						
Remove three tree stumps within the levee easement.

Stumps in the easement. Spring 2022
