**Flood Control Project Maintenance
Levee Inspections**

Maintenance Issue Types Only, Levee Inspection Report By Mile - Fall 2023

American River Flood Control District

Waterway	Bank	Unit Miles	Inspection Start/End	Inspector
Unit No. 01 Arcade Creek	Left	2.08	09/19/2023 09/19/2023	Marvin Marshall

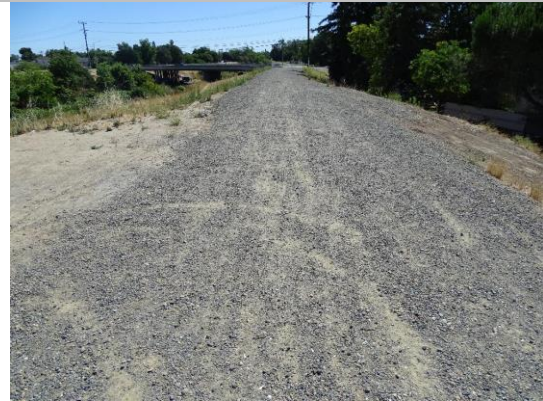
Photo 1 of 3 : UCIP_FA_2023_69020_85540.jpg

LM Start	1.23	Rating **	M	Issue No.	184	
LM End	1.23	Issue Type +	Ma	Location *		
Category	Supplemental			GPS Latitude/Longitude		
				Start	End	
Item	DWR UCIP LMA Responsibility			38.625182°	38.625182°	
				-121.447154°	-121.447154°	
DWR ID	24250					
Comment Code						
Inspector Comment						
DS_ID:24250 FS_ID:69020 EP_NO: N/A Repair Type: Non-Urgent EVAL Issue: Crossing Status: Not Found UCIP Comments: 06/16/2020 Crossing evaluated as "Non-Urgent" because pipe was not found during inspection. Geophysical evaluation found a potential pipe at this location. (A. McDonald - DWR UCIP) FIELD_STRUCT_DESC: 15-inch corrugated metal (CM) drainage pipe through the levee, 16 feet below the crown. Flap gate on the waterside (WS) end. [Additional Reference(s): DWR Levee Log, 2002 (HLM 1.23). USACE Sacramento O&M Manual Unit 118, Part No. 2, October 1959, (Station A 64+15)]. FS Date: 6/16/2020

Overview of levee crown looking u/s.

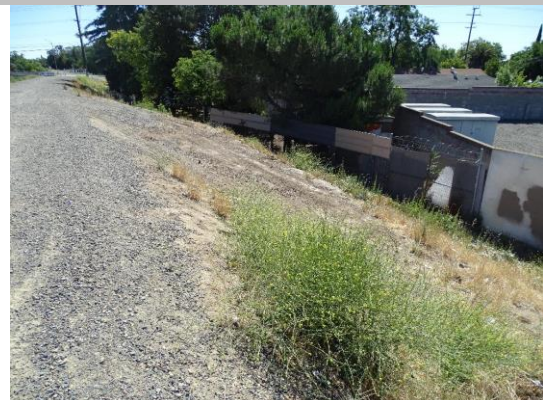
Photo 2 of 3 : UCIP_FA_2023_69020_85541.jpg

Overview of LS levee slope looking u/s.

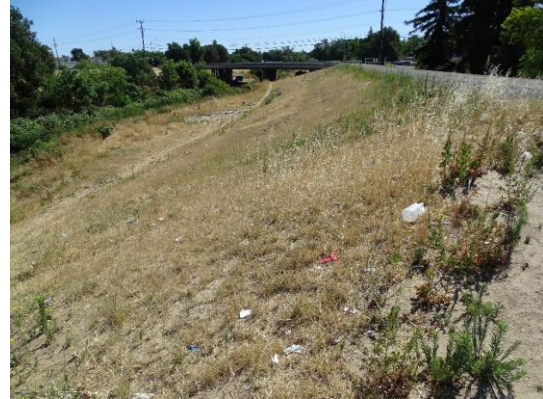
Photo 3 of 3 : UCIP_FA_2023_69020_85542.jpg

Overview of WS levee slope looking u/s.

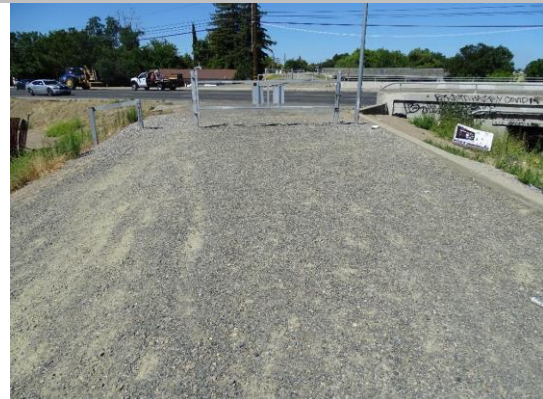
Photo 1 of 3 : UCIP_FA_2023_69395_85368.jpg

DS_ID:24575
 FS_ID:69395
 EP_NO: N/A
 Repair Type: Non-Urgent
 EVAL Issue:
 Crossing Status: Not Found
 UCIP Comments: 06/16/2020 Crossing evaluated as "Non-Urgent" because pipe was not found during inspection and there is no permit for this pipe. (A. McDonald - DWR UCIP)
 FIELD_STRUCT_DESC: 2 of 2: 12-inch corrugated metal (CM) drainage pipe through the levee, 14.0 feet below the crown. Flap gate on the waterside (WS) end. [Additional Reference(s): DWR Levee Log, 2002 (HLM 1.30). USACE Sacramento O&M Manual Unit 118, Part No. 2, October 1959, (Station A 68+40)].
 FS Date: 6/16/2020

Overview of levee crown looking d/s.

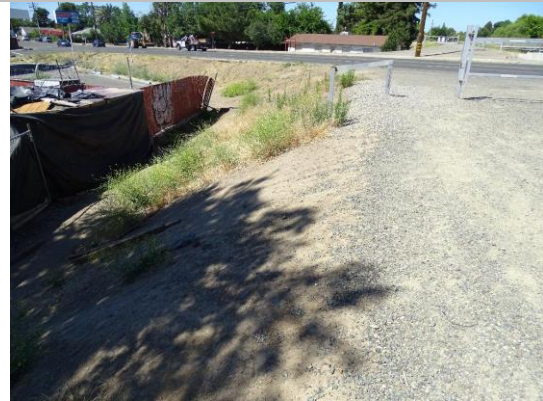
Photo 2 of 3 : UCIP_FA_2023_69395_85369.jpg

Overview of LS levee slope looking d/s.

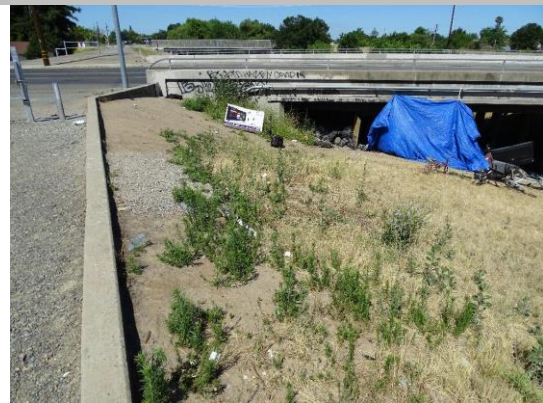
Photo 3 of 3 : UCIP_FA_2023_69395_85370.jpg

Overview of WS levee slope looking d/s.

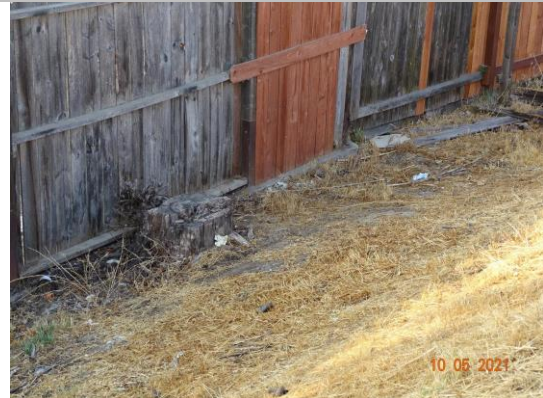
Photo 1 of 1 : FA_2023_NA0001_51_72_20230905_00044.jpg

LM Start	1.41	Rating **	N	Issue No.	72
LM End	1.41	Issue Type +	Ma	Location *	LS
Category	Earthen Levee			GPS Latitude/Longitude	
				Start	End
Item	Trim / Thin Trees			38.626253°	38.626253°
				-121.444165°	-121.444165°
DWR ID	DWR_NA0001_01_f_2015_72				
Comment Code					
T5 : Tree stumps.					
Inspector Comment

Stumps on the LS toe. Fall 2021

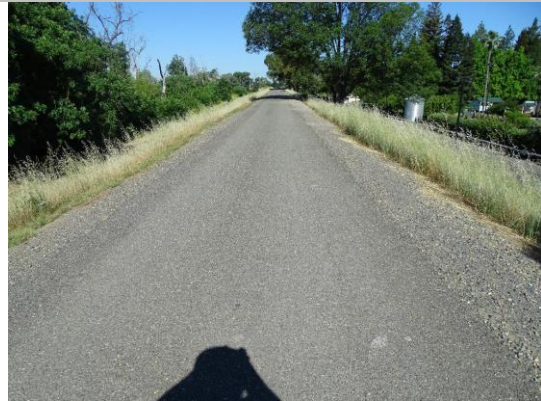
Photo 1 of 3 : UCIP_FA_2023_69078_84660.jpg

LM Start	0.86	Rating **	M	Issue No.	47	
LM End	0.86	Issue Type +	Ma	Location *		
Category	Supplemental			GPS Latitude/Longitude		
				Start	End	
Item	DWR UCIP LMA Responsibility			38.589607°	38.589607°	
				-121.432970°	-121.432970°	
DWR ID	24488					
Comment Code						
Inspector Comment						
DS_ID:24488 FS_ID:69078 EP_NO: N/A Repair Type: Non-Urgent EVAL Issue: Crossing Status: Not Found UCIP Comments: 06/03/2020 Crossing evaluated as "Non-Urgent" because pipe was not found during inspection. (A. McDonald - DWR UCIP) FIELD_STRUCT_DESC: 30-inch steel drainage pipe through the levee, at an unknown depth. Pump located on the landside (LS). [Additional Reference(s): USACE Sacramento O&M Manual Unit 118, Part No. 2, October 1959, (Station 87+73). USACE As-Built File No. 1-4-392, Sheet No. 392/3, December 1954]. FS Date: 6/3/2020

Overview of levee crown looking d/s.

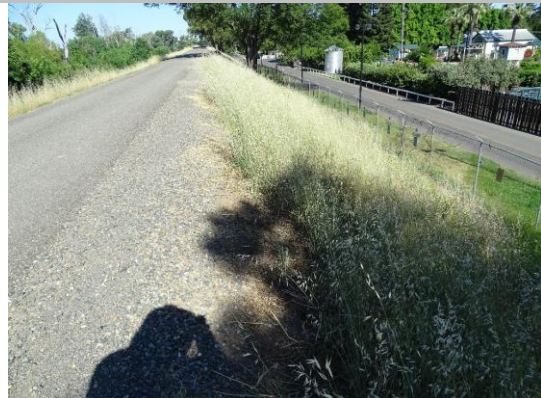
Photo 2 of 3 : UCIP_FA_2023_69078_84661.jpg

Overview of LS levee slope looking d/s.

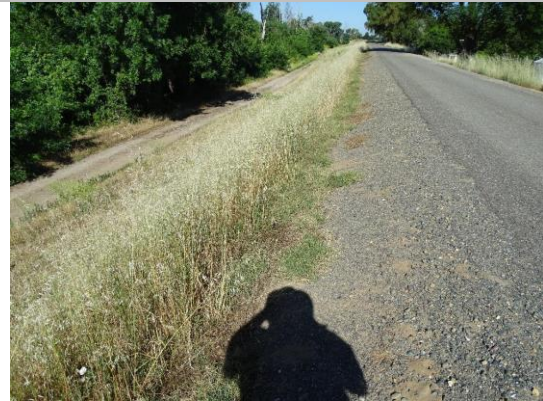
Photo 3 of 3 : UCIP_FA_2023_69078_84662.jpg

Overview of WS levee slope looking d/s.

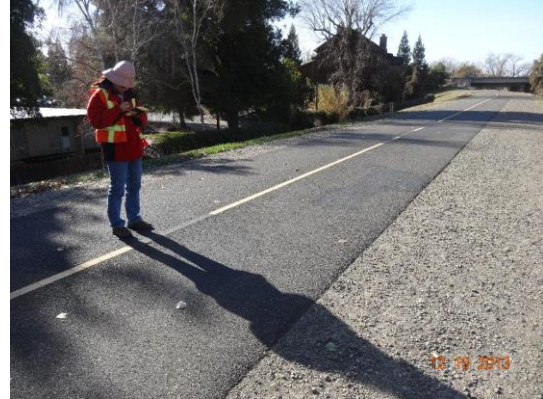
Photo 2 of 3 : UCIP_FA_2023_69301_57209.jpg

View of levee crown at this location.

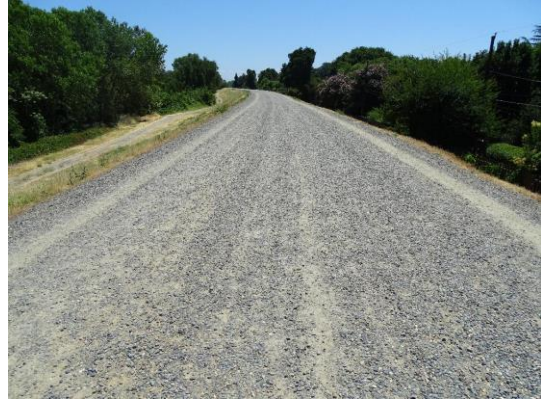
Photo 1 of 3 : UCIP_FA_2023_69220_86227.jpg

Overview of levee crown looking u/s.

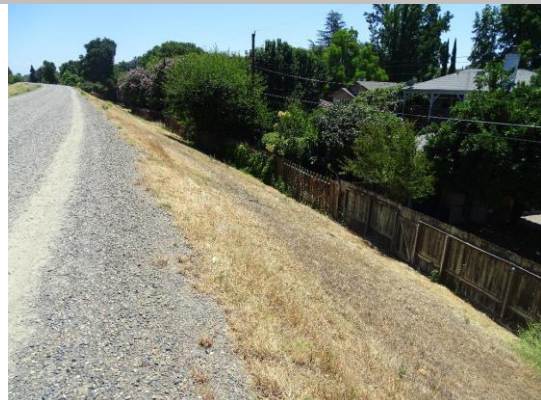
Photo 2 of 3 : UCIP_FA_2023_69220_86228.jpg

Overview of LS levee slope looking u/s.

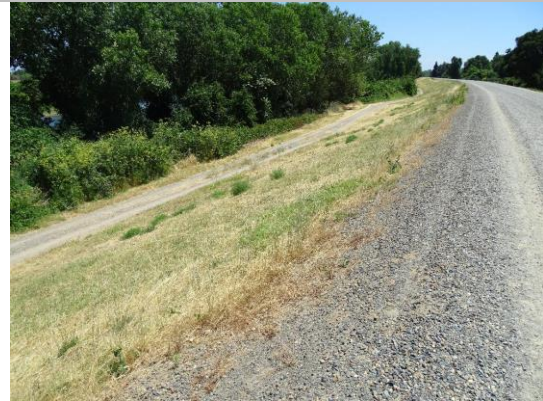
Photo 3 of 3 : UCIP_FA_2023_69220_86229.jpg

Overview of WS levee slope looking u/s.

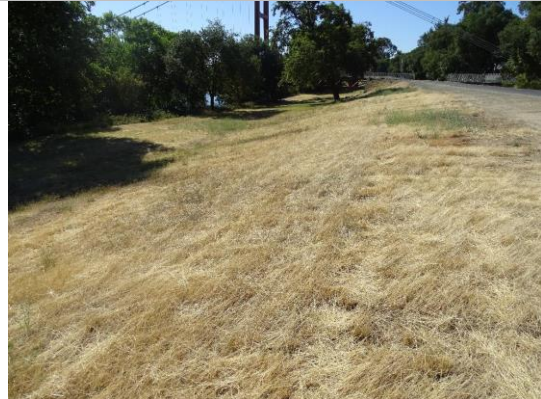
Photo 2 of 3 : UCIP_FA_2023_69231_86288.jpg

Overview of WS levee slope looking u/s.

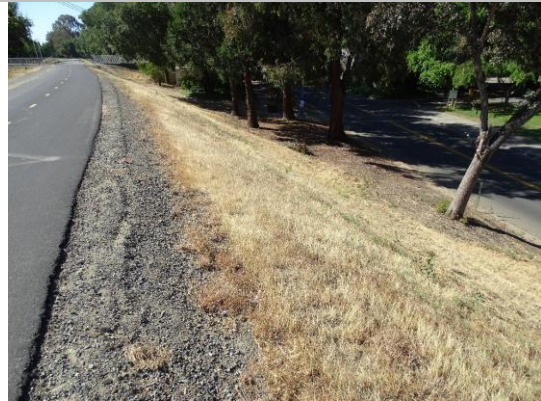
Photo 3 of 3 : UCIP_FA_2023_69231_86289.jpg

Overview of LS levee slope looking u/s.

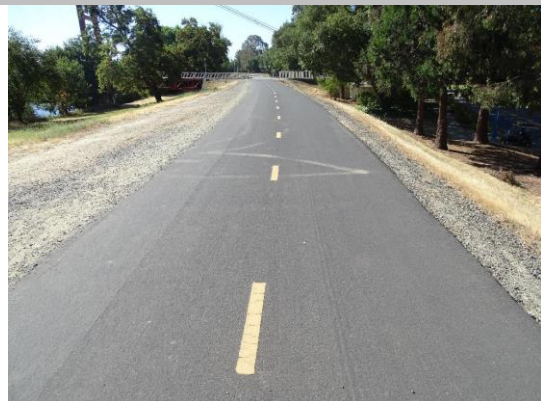
Photo 1 of 3 : UCIP_FA_2023_69232_86290.jpg

DS_ID:24585
 FS_ID:69232
 EP_NO: N/A
 Repair Type: Non-Urgent
 EVAL Issue:
 Crossing Status: Not Found
 UCIP Comments: 06/30/2020 Crossing evaluated as "Non-Urgent" because pipe was not found during inspection and there was no permit found authorizing this pipe. (A. McDonald - DWR UCIP)
 FIELD_STRUCT_DESC: 2 of 3: 18-inch corrugated metal (CM) drainage pipe through the levee, at an unknown depth. Flap gate on the waterside (WS) end. (No permit found authorizing this pipe. Owner unknown). [Additional Reference(s): USACE Sacramento O&M Manual Unit 118, Part No. 1, August 1955, (Station 367+40). USACE As-Built Drawing No. 1-4-362, Sheet 362/3, (Station 367+40), December 1947].
 FS Date: 6/30/2020

Overview of levee crown looking u/s.

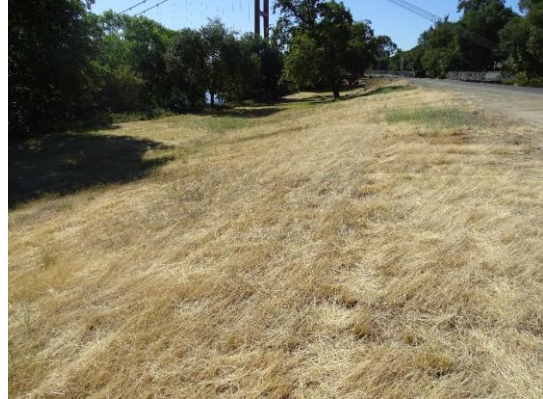
Photo 2 of 3 : UCIP_FA_2023_69232_86291.jpg

Overview of WS levee slope looking u/s.

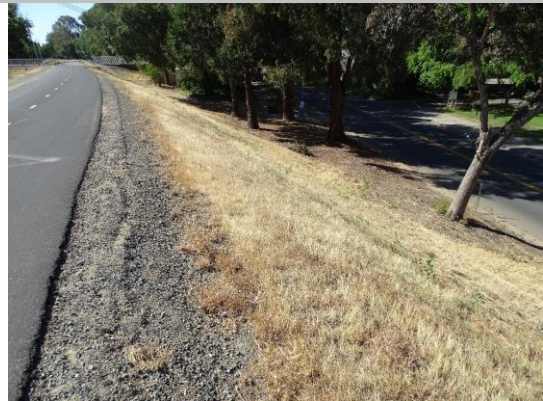
Photo 3 of 3 : UCIP_FA_2023_69232_86292.jpg

Overview of LS levee slope looking u/s.

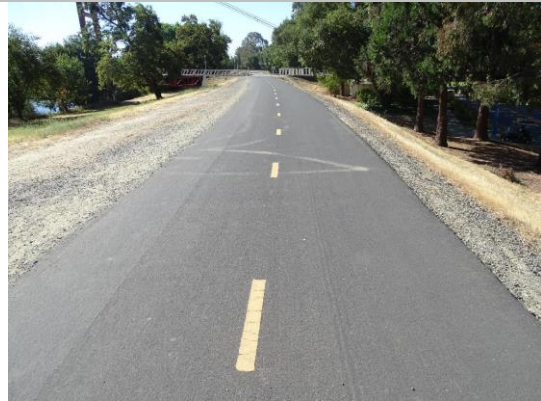
Photo 1 of 3 : UCIP_FA_2023_69233_86293.jpg

Comment Code					
Inspector Comment					
DS_ID:24586 FS_ID:69233 EP_NO: N/A Repair Type: Non-Urgent EVAL Issue: Crossing Status: Not Found UCIP Comments: 06/30/2020 Crossing evaluated as "Non-Urgent" because pipe was not found during inspection and there was no permit found authorizing this pipe. (A. McDonald - DWR UCIP) FIELD_STRUCT_DESC: 3 of 3: 18-inch corrugated metal (CM) drainage pipe through the levee, at an unknown depth. Flap gate on the waterside (WS) end. (No permit found authorizing this pipe. Owner unknown). [Additional Reference(s): USACE Sacramento O&M Manual Unit 118, Part No. 1, August 1955, (Station 367+40). USACE As-Built Drawing No. 1-4-362, Sheet 362/3, (Station 367+40), December 1947]. FS Date: 6/30/2020

Overview of levee crown looking u/s.

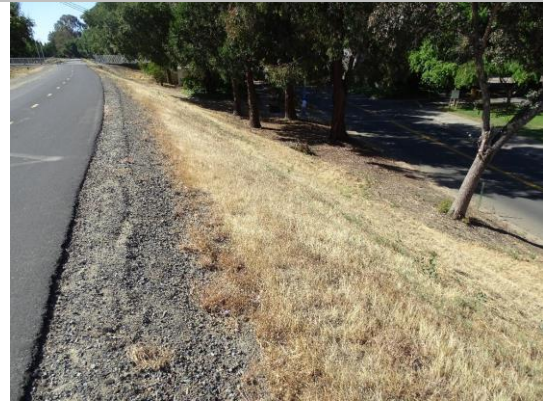
Photo 3 of 3 : UCIP_FA_2023_69233_86295.jpg

Overview of LS levee slope looking u/s.

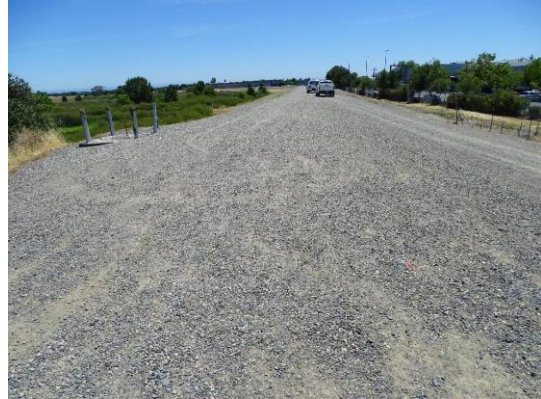
Photo 1 of 3 : UCIP_FA_2023_68568_85769.jpg

Overview of levee crown looking u/s.

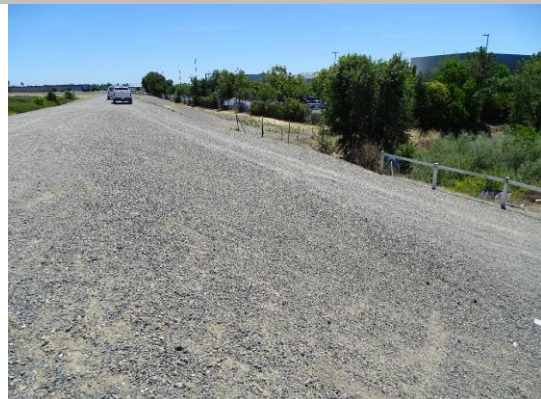
Photo 2 of 3 : UCIP_FA_2023_68568_85770.jpg

Overview of LS levee slope looking u/s.

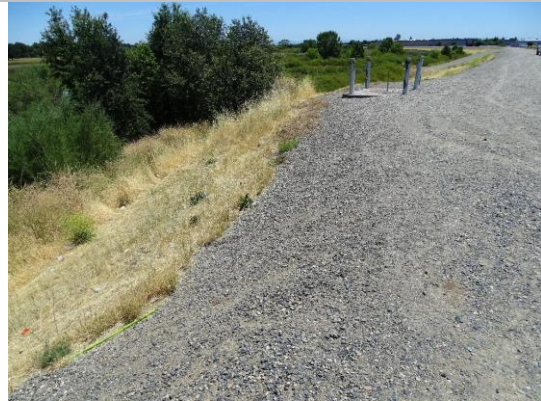
Photo 3 of 3 : UCIP_FA_2023_68568_85771.jpg

Overview of WS levee slope looking u/s.

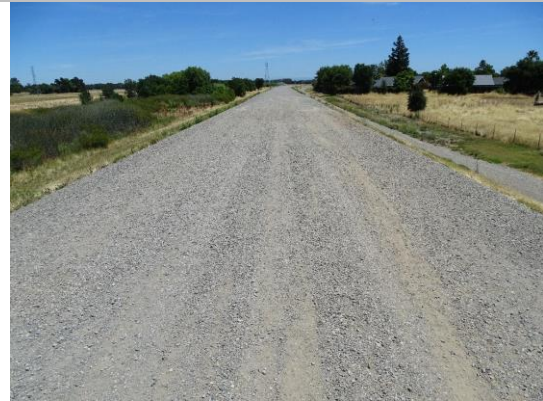
Photo 1 of 3 : UCIP_FA_2023_68578_85830.jpg

Comment Code						
Inspector Comment						
DS_ID:24354 FS_ID:68578 EP_NO: N/A Repair Type: Non-Urgent EVAL Issue: Crossing Status: Indicator Found UCIP Comments: 06/18/2020 Crossing evaluated as "Non-Urgent" because there was no permit found for this pipe. (A. McDonald - DWR UCIP)08/16/2017 DWR Deferred Maintenance Project (DMP), Vince Rodriguez, forwarded email received from Tim Kerr, General Manager of American River Flood Control District (ARFCD) with file "DWR Eligible Pipes Found in ARFCD" from ARFCD that shows the ownership and location of the pipes Tim Kerr investigated. Owner of this crossing was not identified, ARFCD Staff Notes indicate old pipe between Kelton and Sully (not found). (DWR UCIP - O. Magana) 12/20/2013 Unable to find CM riser and flap gate on waterward end-- need to contact owner to determine status of crossing. Manhole found on landward side however unable to determine if manhole is part of this crossing. (DWR UCIP - O. Magana) FIELD_STRUCT_DESC: 24-inch corrugated metal (CM) drainage pipe through the levee, 12.5 feet below the crown. Two CM cutoff walls around the pipe. Slide gate inside a CM riser and flap gate on the waterside (WS) end. Concrete headwall on each end, WS and landside (LS). (No permit found authorizing this structure. Owner unknown). [Additional Reference(s): USACE Sacramento O&M Manual, Unit 118, Part No. 2, October 1959, (Station 440+50). USACE As-Built Drawing No. 1-4-392, Sheet 392/9, (Station 440+50), December 1954]. FS Date: 6/18/2020

Overview of levee crown looking u/s.

Overview of LS levee slope looking u/s.

Overview of WS levee slope looking u/s.

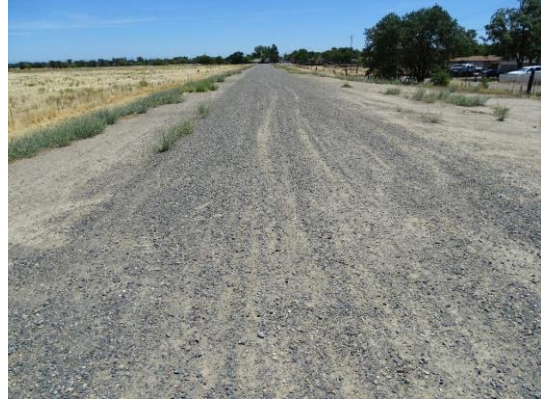
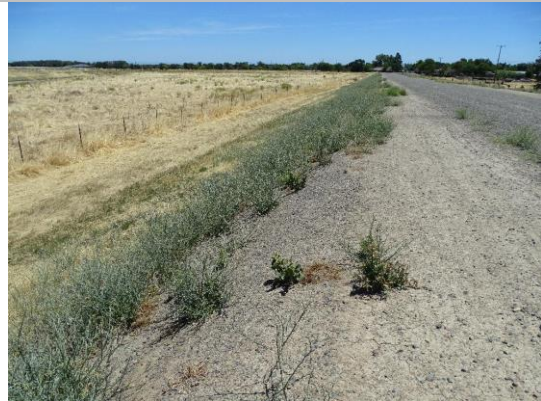
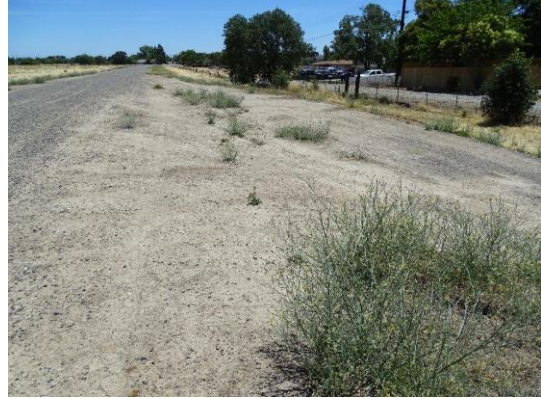
Photo 1 of 3 : UCIP_FA_2023_71915_85837.jpg

Comment Code						
Inspector Comment						
DS_ID:24350 FS_ID:71915 EP_NO: N/A Repair Type: Non-Urgent EVAL Issue: Crossing Status: Not Found UCIP Comments: 06/18/2020 Crossing evaluated as "Non-Urgent" because pipe was not found during inspection and there was no permit found for this crossing. Geophysical evaluation found a potential pipe at this location. (A. McDonald - DWR UCIP) FIELD_STRUCT_DESC: 24-inch corrugated metal drainage pipe (CMP) through the levee, at an unknown depth. Flap gate and riser on the waterside (WS). Slide gate Vault No. 2 on the WS shoulder. (No permit found authorizing this structure. Owner unknown). [Additional Reference(s): USACE Sacramento O&M Manual, Unit 118, Part No. 2, October 1959, (Station 14+00). USACE As-Built Drawing No. 1-4-392, Sheet 392/9, (Station 14+00), December 1954]. FS Date: 6/18/2020

Overview of levee crown looking u/s.

Overview of WS levee slope looking u/s.

Overview of LS levee slope looking u/s.

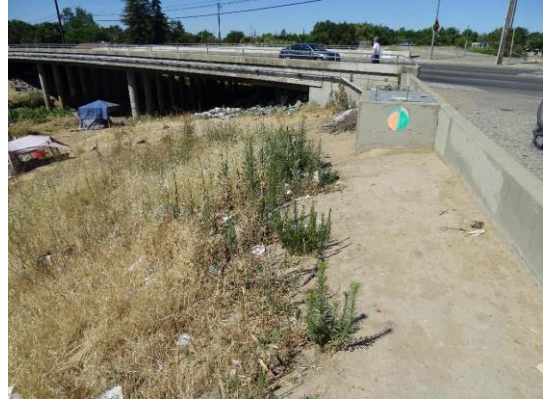
Photo 1 of 3 : UCIP_FA_2023_69448_85701.jpg

Comment Code						
Inspector Comment						
DS_ID:24370 FS_ID:69448 EP_NO: N/A Repair Type: No Action Needed EVAL Issue: Crossing Status: Found UCIP Comments: 06/18/2020 Crossing evaluated as "No Action Needed." Permit and inspection requirements have been met. (A. McDonald - DWR UCIP)08/16/2017 DWR Deferred Maintenance Project (DMP), Vince Rodriguez, forwarded email received from Tim Kerr, General Manager of American River Flood Control District (ARFCD) with file "DWR Eligible Pipes Found in ARFCD" from ARFCD that shows the ownership and location of the pipes Tim Kerr investigated. Owner of this crossing is identified as the City of Sacramento, ARFCD Staff Notes indicate Arcade CK just upstream of Rio Linda. (DWR UCIP - O. Magana) FIELD_STRUCT_DESC: 24-inch corrugated metal (CM) drainage pipe through the levee, 11.0 feet below the crown. Slide gate inside a CM riser on the waterside (WS) slope. Flap gate on the WS end. Concrete headwall on each end, WS and landside (LS). (No permit found authorizing this structure. Structure is owned by the City of Sacramento). [Additional Reference(s): DWR Levee Log, 2002 (HLM 1.31). USACE Sacramento O&M Manual, Unit 118, Part No. 2, October 1959, (Station A 70+09). USACE As-Built Drawing No. 1-4-392, Sheet 392/6, (Station A 70+09), December 1954]. FS Date: 6/18/2020

Overview of levee crown looking d/s.

Overview of LS levee slope looking d/s.

Overview of WS levee slope looking d/s.

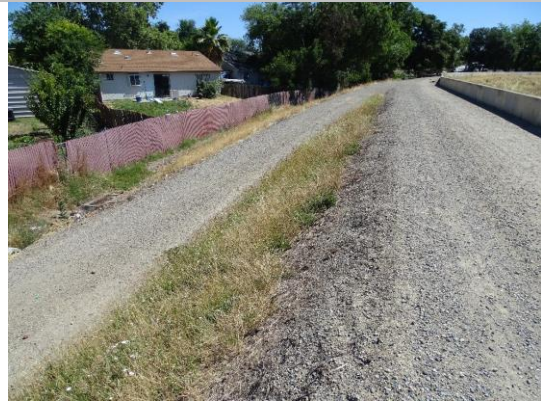
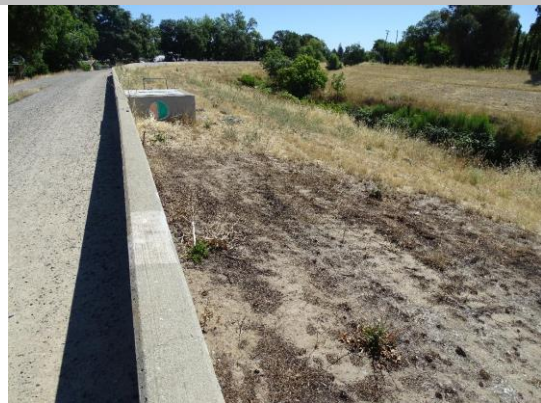
Photo 1 of 3 : UCIP_FA_2023_71925_85706.jpg

DS_ID:24371
FS_ID:71925
EP_NO: N/A
Repair Type: No Action Needed
EVAL Issue:
Crossing Status: Found
UCIP Comments: 03/08/2022 According to permit records for 12886, "old pipe removed. Concrete pipe in placed and backfilled part of it." Conflicting information makes it difficult to determine the fate of the 24-inch pipe (extent of work completed under permit). (A. McDonald - DWR UCIP)06/18/2020 Crossing evaluated as "No Action Needed." Permit and inspection requirements have been met. (A. McDonald - DWR UCIP)08/16/2017 DWR Deferred Maintenance Project (DMP), Vince Rodriguez, forwarded email received from Tim Kerr, General Manager of American River Flood Control District (ARFCD) with file "DWR Eligible Pipes Found in ARFCD" from ARFCD that shows the ownership and location of the pipes Tim Kerr investigated. Owner of this crossing is identified as the City of Sacramento, ARFCD Staff Notes indicate Arcade Ck near Rivera Dr at Branch St. (DWR UCIP - O. Magana) 06/14/2017 This crossing is scheduled to be cut and replaced as part of Sacramento Area Flood Control (SAFCA) North Area Streams (NAS) Levee Improvement Project: City of Sacramento Utility Permit Modifications Along Arcade Creek Levees. Unable to confirm when pipe will be replaced. Need to coordinate with owner and DWR FPIIB Inspector to determine when project is expected to start. (DWR UCIP - O. Magana).

Overview of levee crown looking u/s.

Overview of LS levee slope looking u/s.

Overview of WS levee slope looking u/s.

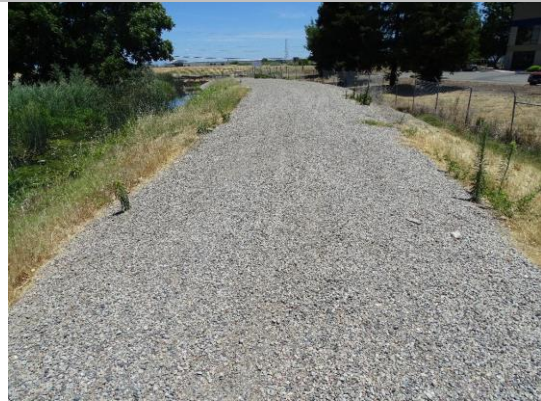
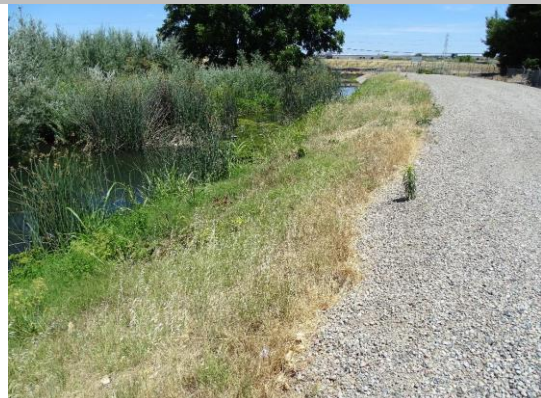
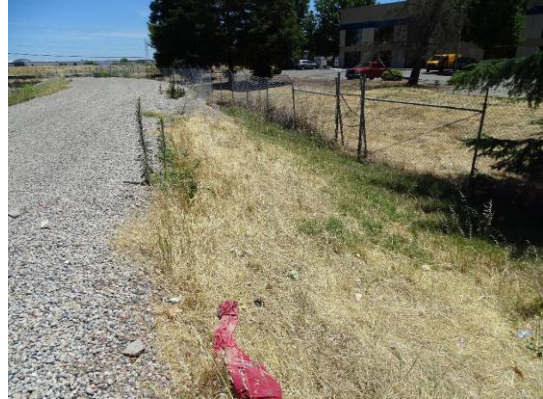
Photo 1 of 3 : UCIP_FA_2023_69467_85938.jpg

Comment Code						
Inspector Comment						
DS_ID:24384 FS_ID:69467 EP_NO: N/A Repair Type: Non-Urgent EVAL Issue: Crossing Status: Indicator Found UCIP Comments: 06/18/2020 Crossing evaluated as "Non-Urgent" because this is an abandoned encroachment and there is no permit found for this crossing. Geophysical evaluation found evidence of a pipe at this location. (A. McDonald - DWR UCIP)Non-functional crossing--need to coordinate with owner, DWR-Inspector, and CVFPB to determine how to properly abandon crossing. FIELD_STRUCT_DESC: 24-inch corrugated metal (CM) drainage pipe through the levee, 8.0 feet below the crown. Two CM cutoff walls around the pipe. Slide gate inside a 30-inch CM riser. Flap gate on the waterside (WS) end. Concrete U-shaped headwall and splash apron on the WS end. Landside (LS) end cut off and plugged. Riser filled with dirt. [Additional Reference(s): DWR Levee Log, 2002 (HLM 1.44). USACE Sacramento O&M Manual, Unit 118, Part No. 2, October 1959, (Station A 72+10). USACE As-Built Drawing No. 1-4-392, Sheet 392/10, (Station A 72+10), December 1954]. FS Date: 6/18/2020

Overview of levee crown looking u/s.

Overview of WS levee slope looking u/s.

Overview of LS levee slope looking u/s.

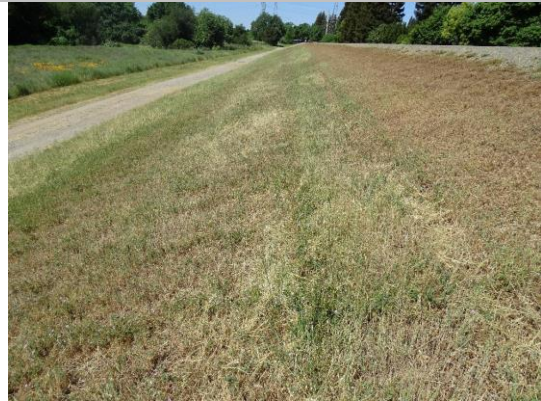
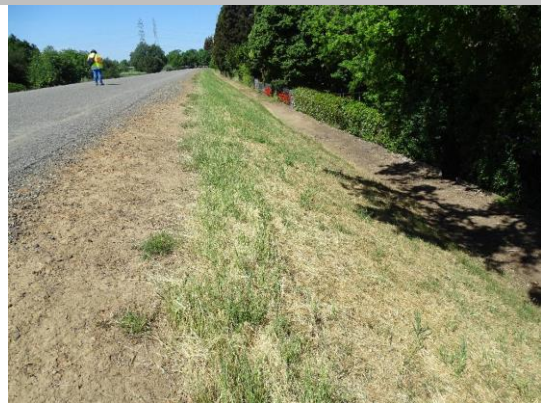
Photo 1 of 3 : UCIP_FA_2023_69473_84108.jpg

Comment Code					
Inspector Comment					
DS_ID:24394 FS_ID:69473 EP_NO: N/A Repair Type: Non-Urgent EVAL Issue: Crossing Status: Indicator Found UCIP Comments: 04/30/2020 This crossing is rated "Non-Urgent." It has been abandoned without a permit. Geophysical evaluation found no evidence of a pipe at this location. (A. McDonald - DWR UCIP)08/16/2017 DWR Deferred Maintenance Project (DMP), Vince Rodriguez, forwarded email received from Tim Kerr, General Manager of American River Flood Control District (ARFCD) with file "DWR Eligible Pipes Found in ARFCD" from ARFCD that shows the ownership and location of the pipes Tim Kerr investigated. No owner mentioned in email, ARFCD Staff Notes indicate riser in floodway near Beckenwood Way. (DWR UCIP - O. Magana) 12/05/2013 Need to contact owner to determine status of crossing. (DWR UCIP - O. Magana) FIELD_STRUCT_DESC: *ASSUMED ABANDONED* 12-inch steel pipe of an unknown purpose through the levee, 14.0 feet below the crown. Riser on the waterside (WS). (Reference to 12-inch pipe scheduled to be abandoned [no clear direction of action taken available in permit recordation, see page 14 of 27 electronic permit copy] under Permit No. 4622, 1964 - County of Sacramento). [Additional Reference(s): DWR Levee Log, 2002 (HLM 1.31). USACE Sacramento O&M Manual, Unit 517, Part No. 1, November 1959, (Station 296+85). USACE As-Built Drawing No. 1-4-415, Sheet 415/6, (Station 296+85), February 1957]. FS Date: 4/30/2020

Overview of levee crown looking d/s.

Overview of WS levee slope looking d/s.

Overview of LS levee slope looking d/s.

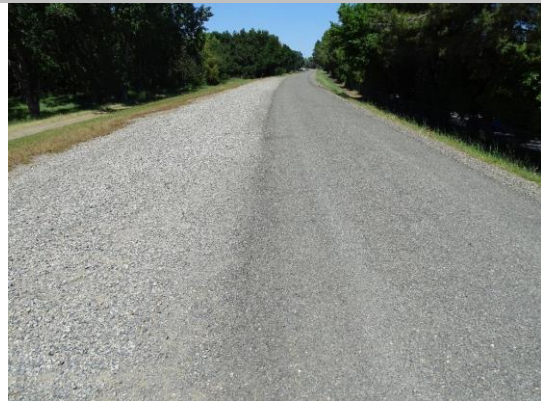
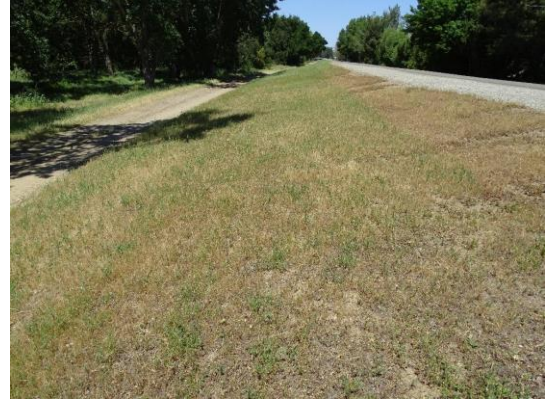
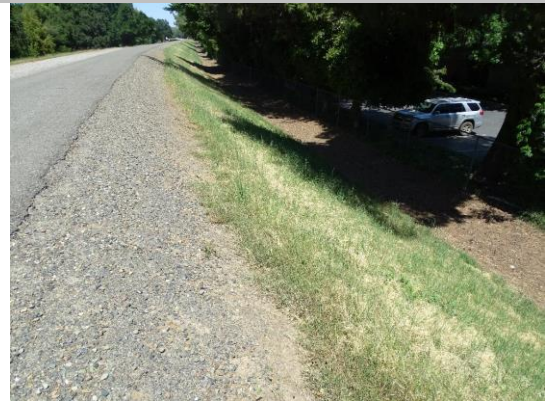
Photo 1 of 3 : UCIP_FA_2023_69476_84145.jpg

Comment Code					
Inspector Comment					
DS_ID:24397 FS_ID:69476 EP_NO: N/A Repair Type: Non-Urgent EVAL Issue: Crossing Status: Not Found UCIP Comments: 04/30/2020 This crossing is rated "Non-Urgent." Crossing was not found during inspection. Geophysical evaluation found no evidence of a pipe at this location. Unable to locate a permit and confirm proper pipe abandonment. (A. McDonald - DWR UCIP) FIELD_STRUCT_DESC: 12-inch pipe of an unknown material or purpose through the levee, 11.2 feet below the crown. Riser unit on the waterside (WS). (Reference to 12-inch pipe scheduled to be abandoned [no clear direction of action taken available in permit recordation, see page 14 of 27 electronic permit copy] under Permit No. 4622, 1964 - County of Sacramento). [Additional Reference(s): DWR Levee Log, 2002 (HLM 2.26). USACE Sacramento O&M Manual, Unit 517, Part No. 1, November 1959, (Station 346+09). USACE As-Built Drawing No. 1-4-415, Sheet 415/6, (Station 346+09), February 1957]. FS Date: 4/30/2020

Overview of levee crown looking d/s.

Overview of WS levee slope looking d/s.

Overview of LS levee slope looking d/s.

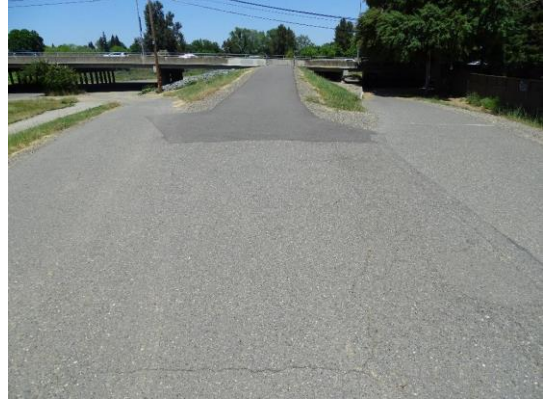
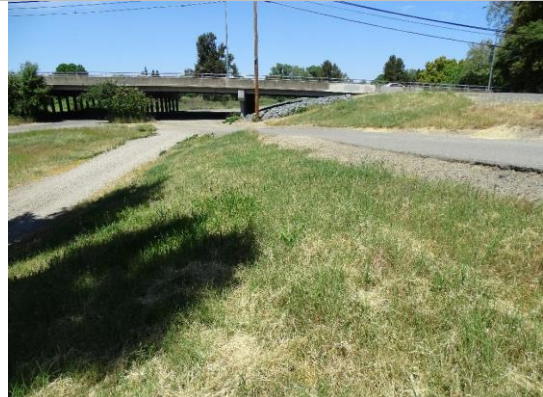
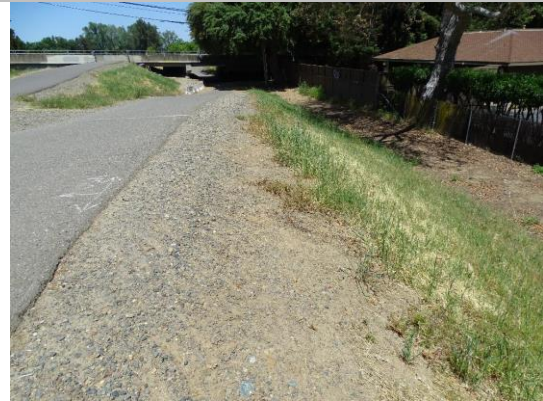
Photo 1 of 3 : UCIP_FA_2023_69477_84148.jpg

Comment Code					
Inspector Comment					
DS_ID:24515 FS_ID:69477 EP_NO: N/A Repair Type: Non-Urgent EVAL Issue: Crossing Status: Indicator Found UCIP Comments: 04/30/2020 This crossing is rated "Non-Urgent." Crossing was not found during inspection. (A. McDonald - DWR UCIP)12/05/2013 Unable to confirm crossing. will need to contact owner to determine specifics and status of crossing. FIELD_STRUCT_DESC: 36-inch corrugated metal (CM) drainage pipe through the levee, at an unknown depth. Riser on the waterside (WS). [Additional Reference(s): USACE Sacramento O&M Manual, Unit 517, Part No. 1, November 1959, (Station 365+14). USACE As-Built Drawing No. 1-4-415, Sheet 415/9, (Station 365+14), February 1957]. FS Date: 4/30/2020

Overview of levee crown looking d/s. "H" Street Bridge in the background.

Overview of WS levee slope looking d/s. "H" Street Bridge in the background.

Overview of LS levee slope looking d/s. "H" Street Bridge in the background.

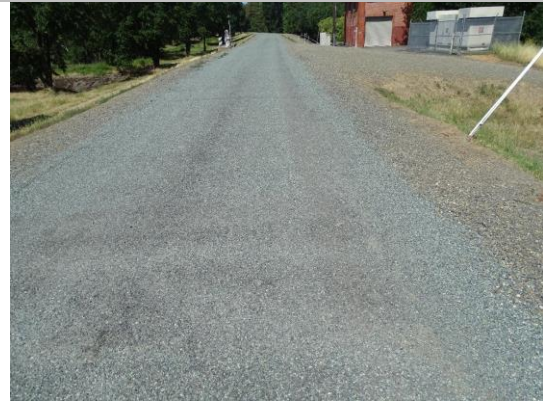
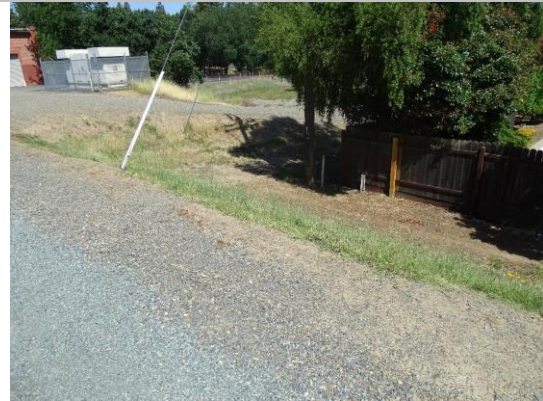
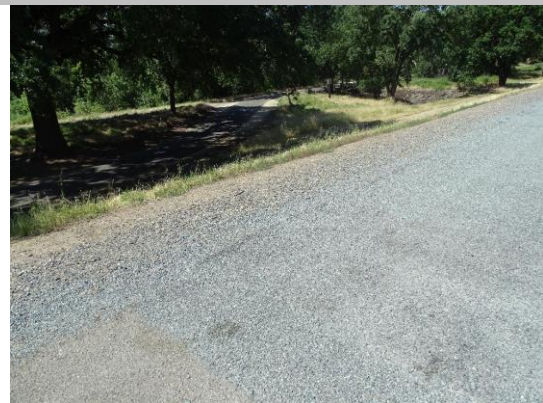
Photo 1 of 3 : UCIP_FA_2023_68960_79514.jpg

Comment Code						
Inspector Comment						
DS_ID:24571 FS_ID:68960 EP_NO: N/A Repair Type: Non-Urgent EVAL Issue: Crossing Status: Found UCIP Comments: 05/29/2019 Drainage structure appears to be in good condition. Crossing evaluated as No Action Needed: Visual and permit documentation requirements have been met. Need to contact owner for maintenance records and internal inspection reports. (A. McDonald - DWR UCIP)10/27/2017 This structure is inspected annually under the Structure and Channel Summer Inspection (part of the Levee Inspection Program) conducted by the DWR Flood Project Integrity and Inspection Branch (FPIIB). (O. Magana - DWR UCIP) FIELD_STRUCT_DESC: [Pumping Plant No. 2: Wilhaggin Storm Drain D-43] 2 of 4: 24-inch concrete drainage pipe through the levee, 17.9 feet below the crown. Pump house on the landside (LS). Flap gate and discharge channel on the waterside (WS). Electric screw gate on the WS shoulder. Large sump basin on the LS. (No permit found with details of 24-inch pipe through the levee. Drainage pipe and sump of Pumping Plant No. 2 authorized under Permit No. 3102, 1959 - County of Sacramento. Electric screw gate authorized under Permit No. 14508, 1987 - County of Sacramento, Water Resources Division). [Additional Reference(s): DWR Levee Log, 2002 (HLM 3.57). USACE Sacramento O&M Manual, Unit 517, Part No. 1, November 1959, (Station 203+45). USACE As-Built Drawing No. 1-4-415, Sheet 415/5, (Station 203+45), February 1957]. FS Date: 5/29/2019

Overview of levee crown looking d/s.

Overview of LS levee slope looking d/s.

Overview of WS levee slope looking d/s.
