**Flood Control Project Maintenance
Levee Inspections**

Maintenance Issue Types Only, Levee Inspection Report By Mile - Fall 2021

Butte County Department of Public Works

Waterway	Bank	Unit Miles	Inspection Start/End	Inspector
Unit No. 01 Mud Creek	Right	6.80	10/18/2021 10/18/2021	Makar Sokol

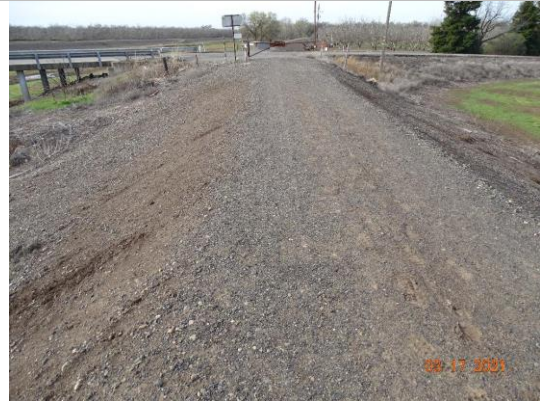
Photo 1 of 3 : UCIP_FA_2021_67236_99222.jpg

DS_ID:19209
FS_ID:67236
EP_NO: N/A
Repair Type: Urgent
EVAL Issue: Pipe Integrity
Crossing Status: Found
UCIP Comments: 03/17/2021 Record updated from No Action Needed to Urgent. DMP internal video inspection has found pipe integrity issues. LOF of crossing is between 5 and 6. Crossing will be monitored until funding becomes available to address the issues. No permit has been identified authorizing pipe. (O.Yakimov - DWR UCIP)
02/20/2014 Looks cleaned recently. (P. Amatya - DWR UCIP)
FIELD_STRUCT_DESC: 24-inch corrugated metal gravity drainage pipe through the levee, 12.5 feet below the crown. Flap gate on the waterside (WS) end. Concrete U-shaped headwall on each end. Grouted riprap apron on the landside (LS) end. Grouted riprap spillway on the WS end. [Additional Reference(s): DWR Levee Log, 1992. USACE Sacramento O&M Manual 504, May 1965, (HLM 0.26)].
FS Date: 3/17/2021 8:31:45 AM

Top of Levee: View of levee crown looking downstream

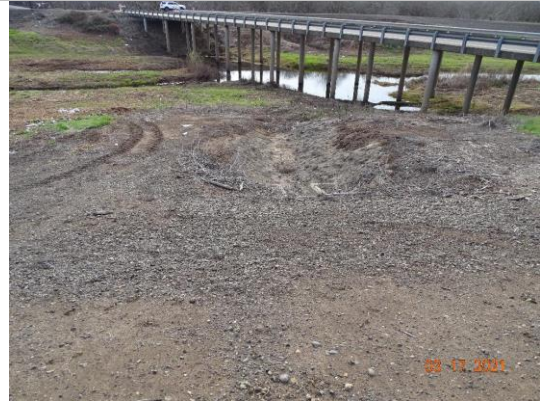
Photo 3 of 3 : UCIP_FA_2021_67236_99224.jpg

Water-Side: View of levee slope looking from crown

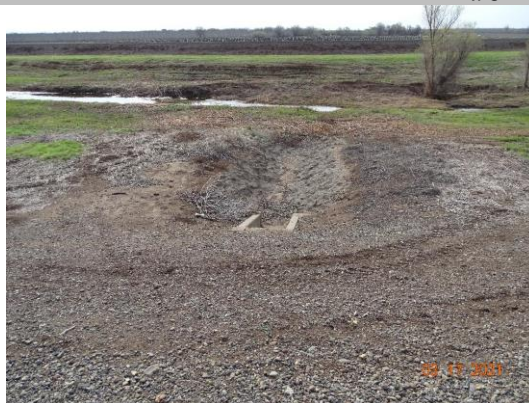
Photo 2 of 3 : UCIP_FA_2021_67238_99232.jpg

DS_ID:19211
 FS_ID:67238
 EP_NO: N/A
 Repair Type: Non-Urgent
 EVAL Issue: Pipe Damage
 Crossing Status: Found
 UCIP Comments: 03/17/2021 Record remains Non-Urgent. Vegetation on waterside has been cleared. No permit has been identified authorizing pipe. DMP internal video inspection has found pipe integrity issues. LOF of crossing is greater than or equal to 4.1 and less than 5. Crossing will be monitored until funding becomes available for rehabilitation. (O.Yakimov - DWR UCIP)
 02/20/2014 Vegetation debris on waterside. Needs clearing and cleaning. (P. Amatya - DWR UCIP)
 FIELD_STRUCT_DESC: 24-inch corrugated metal gravity drainage pipe through the levee, 12 feet below the crown. Flap gate on the waterside (WS) end. Concrete U-shaped headwall on each end. Grouted riprap apron on the landside (LS) end. Grouted riprap spillway on the WS end. [Additional Reference(s): DWR Levee Log, 1992. USACE Sacramento O&M Manual 504, May 1965, (HLM 1.03)].

Water-Side: View of levee slope looking from crown

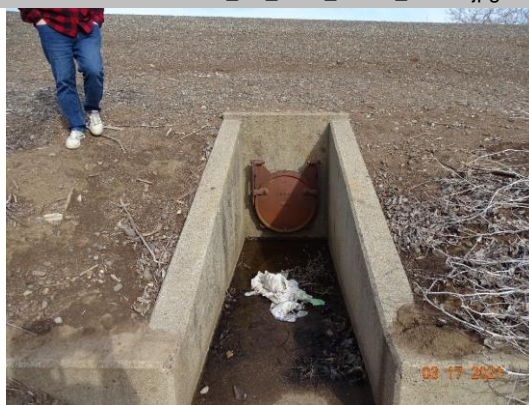
Photo 3 of 3 : UCIP_FA_2021_67238_99236.jpg

Water-Side: Headwall and flap gate at levee toe

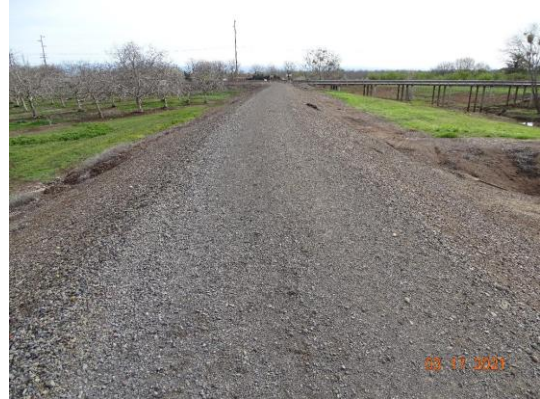
Photo 1 of 3 : UCIP_FA_2021_67239_99237.jpg

Comment Code						
Inspector Comment						
DS_ID:19212 FS_ID:67239 EP_NO: N/A Repair Type: Non-Urgent EVAL Issue: Unauthorized Encroachment, installed decades prior Crossing Status: Found UCIP Comments: 03/17/2021 Record updated from No Action Needed to Non-Urgent. No permit has been identified authorizing pipe. DMP internal video inspection has not found pipe integrity issues. LOF of crossing is less or equal to 4.0. Recommend next video inspection in 5 years. (O.Yakimov - DWR UCIP) 08/29/2016: Shawn Bates of NA0003 has cleared the LS and WS of debris and blockage; WS gate functions properly now. Crossing has been downgraded from Urgent to No Action Needed. (K. Fazel - UCIP) 08/11/2016: Same as last inspection. (K. Fazel - UCIP) 02/20/2014: No riprap spillway on waterside. Needs cleaning and clearing of debris. Flap gate was not fully closed. (P. Amatya - DWR UCIP) FIELD_STRUCT_DESC: 24-inch corrugated metal gravity drainage pipe through the levee, 13 feet below the crown. Flap gate on the waterside (WS) end. Concrete U-shaped headwall on each end. Grouted riprap apron on the landside (LS) end. Grouted riprap spillway on the WS end. [Additional Reference(s): DWR Levee Log, 2005. USACE Sacramento O&M Manual 504, May 1965, (HLM 1.95)]. FS Date: 3/17/2021 9:01:17 AM

Top of Levee: View of levee crown looking upstream

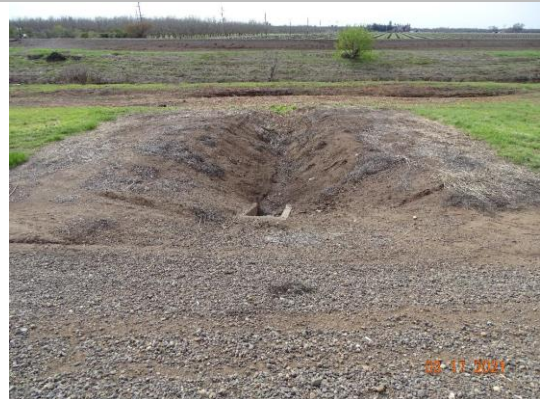
Photo 2 of 3 : UCIP_FA_2021_67239_99238.jpg

Water-Side: View of levee slope looking from crown

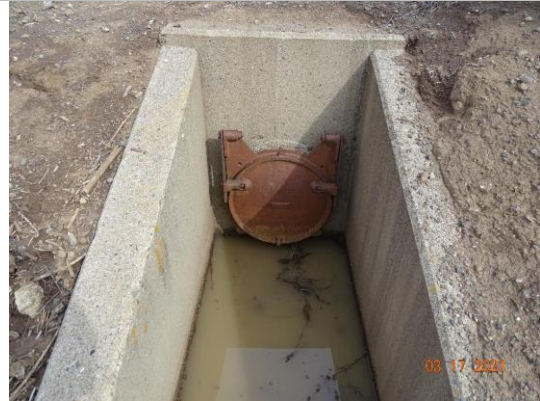
Photo 3 of 3 : UCIP_FA_2021_67239_99242.jpg

Water-Side: Headwall and flap gate at levee toe

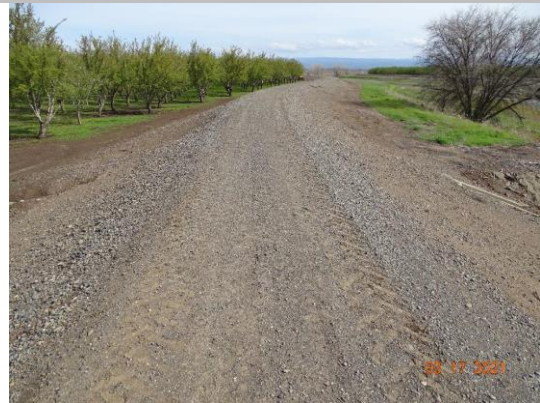
Photo 1 of 3 : UCIP_FA_2021_67246_99270.jpg

DS_ID:19216
 FS_ID:67246
 EP_NO: N/A
 Repair Type: Non-Urgent
 EVAL Issue: Unauthorized Encroachment, installed decades prior
 Crossing Status: Found
 UCIP Comments: 03/17/2021 Record remains Non-Urgent. No permit has been identified authorizing pipe. DMP internal video inspection has not found pipe integrity issues. LOF of crossing is less or equal to 4.0. Recommend next video inspection in 5 years. (O.Yakimov - DWR UCIP)
 02/20/2014 Inlet and outlet needs cleaning and clearing of debris. (P. Amatya - DWR UCIP)
 FIELD_STRUCT_DESC: 24-inch corrugated metal gravity drainage pipe through the levee, 8.5 feet below the crown. Flap gate on the waterside (WS) end. Concrete U-shaped headwall on each end. Grouted riprap apron on the landside (LS) end. Grouted riprap spillway on the WS end. [Additional Reference(s): DWR Levee Log, 1992. USACE Sacramento O&M Manual 504, May 1965, (HLM 3.11)].
 FS Date: 3/17/2021 10:06:03 AM

Top of Levee: View of levee crown looking upstream

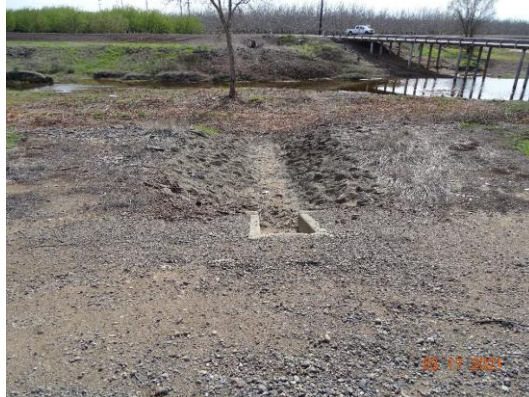
Photo 2 of 3 : UCIP_FA_2021_67246_99272.jpg

Water-Side: View of levee slope looking from crown

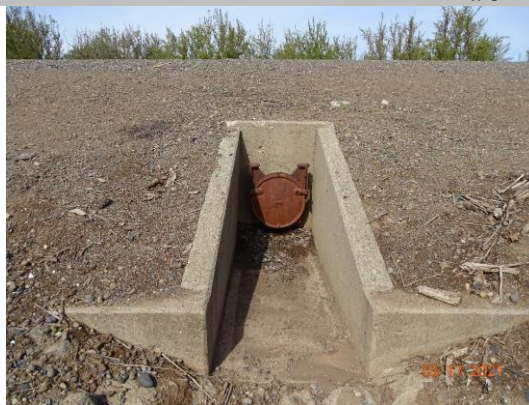
Photo 3 of 3 : UCIP_FA_2021_67246_99273.jpg

Water-Side: Headwall and flap gate at levee toe

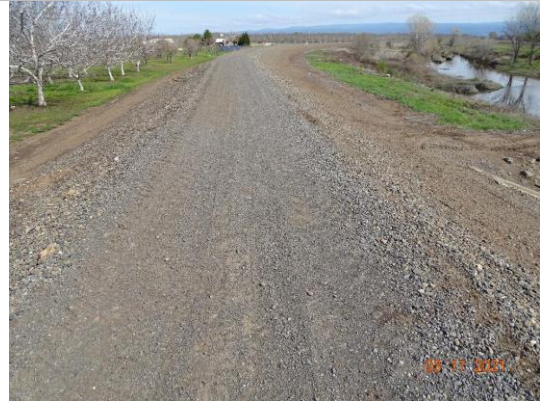
Photo 1 of 3 : UCIP_FA_2021_67247_99276.jpg

Comment Code						
Inspector Comment						
DS_ID:19217 FS_ID:67247 EP_NO: N/A Repair Type: Non-Urgent EVAL Issue: Unauthorized Encroachment, installed decades prior Crossing Status: Found UCIP Comments: 03/17/2021 Record remains Non-Urgent. No permit has been identified authorizing pipe. DMP internal video inspection has not found pipe integrity issues. LOF of crossing is less or equal to 4.0. Recommend next video inspection in 5 years. Debris has been cleared. (O.Yakimov - DWR UCIP) 02/20/2014 It needs cleaning and clearing in inlet and outlet ends. (P. Amatya - DWR UCIP) FIELD_STRUCT_DESC: 24-inch corrugated metal gravity drainage pipe through the levee, 9 feet below the crown. Flap gate on the waterside (WS) end. Concrete U-shaped headwall on each end. Grouted riprap apron on the landside (LS) end. Grouted riprap spillway on the WS end. [Additional Reference(s): DWR Levee Log, 1992. USACE Sacramento O&M Manual 504, May 1965, (HLM 3.27)]. FS Date: 3/17/2021 10:15:12 AM

Top of Levee: View of levee crown looking upstream

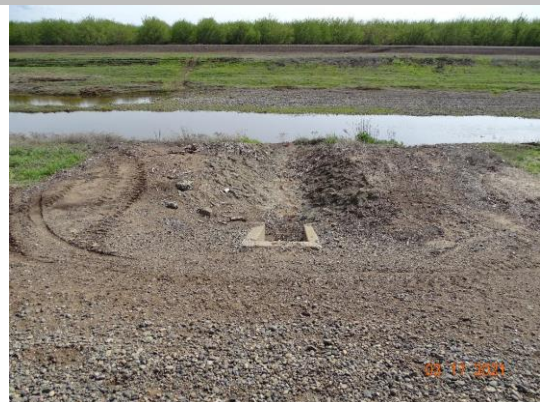
Photo 2 of 3 : UCIP_FA_2021_67247_99277.jpg

Water-Side: View of levee slope looking from crown

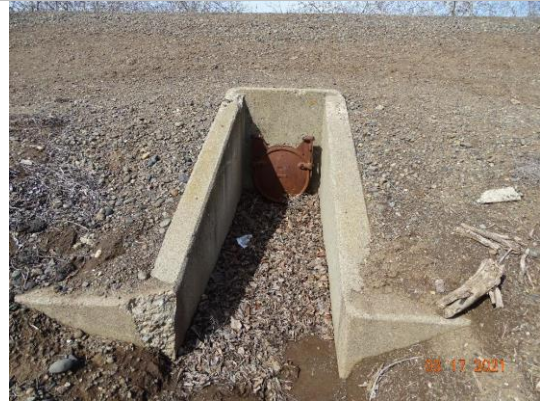
Photo 3 of 3 : UCIP_FA_2021_67247_99281.jpg

Water-Side: Headwall and flap gate at levee toe

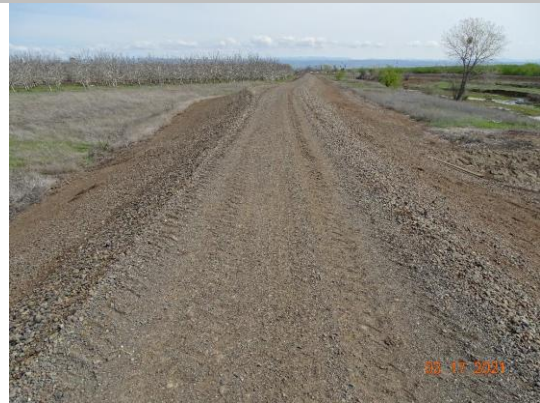
Photo 1 of 3 : UCIP_FA_2021_67248_99282.jpg

DS_ID:19218
FS_ID:67248
EP_NO: N/A
Repair Type: Non-Urgent
EVAL Issue: Unauthorized Encroachment, installed decades prior
Crossing Status: Found
UCIP Comments: 03/17/2021 Record remains Non-Urgent. No permit has been identified authorizing pipe. DMP internal video inspection has not found pipe integrity issues. LOF of crossing is less or equal to 4.0. Recommend next video inspection in 5 years. (O.Yakimov - DWR UCIP)
02/20/2014 Needs cleaning and clearing of debris. (P. Amatya - DWR UCIP)
FIELD_STRUCT_DESC: 24-inch corrugated metal gravity drainage pipe through the levee, 10 feet below the crown. Flap gate on the waterside (WS) end. Concrete U-shaped headwall on each end. Grouted riprap apron on the landside (LS) end. Grouted riprap spillway on the WS end. [Additional Reference(s): DWR Levee Log, 1992. USACE Sacramento O&M Manual 504, May 1965, (HLM 3.48)].
FS Date: 3/17/2021 10:18:14 AM

Top of Levee: View of levee crown looking upstream

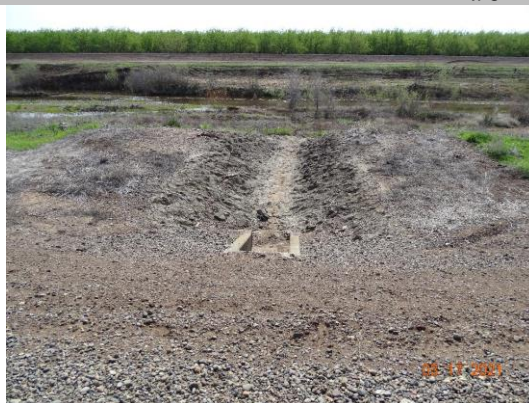
Photo 2 of 3 : UCIP_FA_2021_67248_99283.jpg

Water-Side: View of levee slope looking from crown

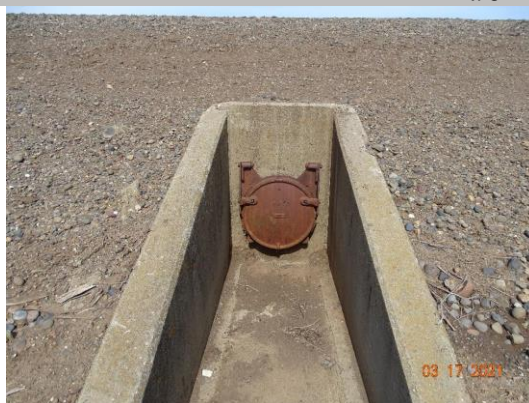
Photo 3 of 3 : UCIP_FA_2021_67248_99287.jpg

Water-Side: Headwall and flap gate at levee toe

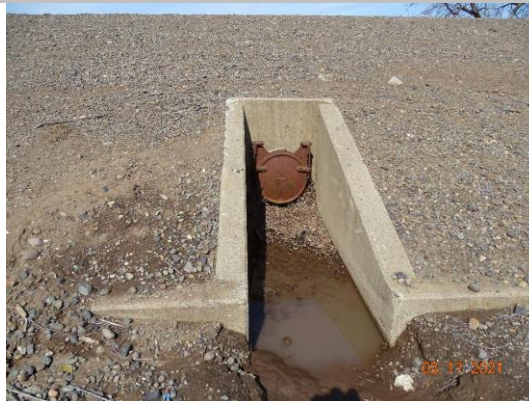
Photo 3 of 3 : UCIP_FA_2021_67249_99293.jpg

Water-Side: Headwall and flap gate at levee toe

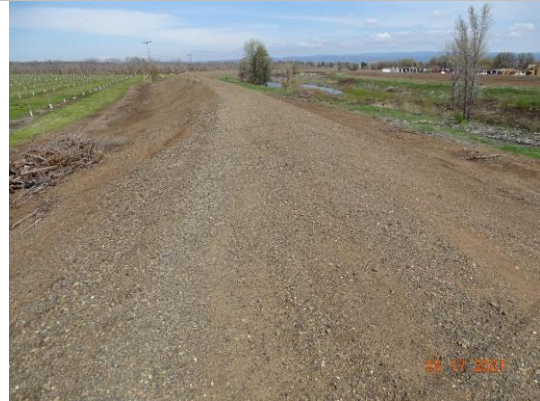
Photo 1 of 3 : UCIP_FA_2021_67250_99294.jpg

Comment Code						
Inspector Comment						
DS_ID:19220 FS_ID:67250 EP_NO: N/A Repair Type: Non-Urgent EVAL Issue: Unauthorized Encroachment, installed decades prior Crossing Status: Found UCIP Comments: 03/17/2021 Record remains Non-Urgent. Debris has been cleared. No permit has been identified authorizing pipe. DMP internal video inspection has not found pipe integrity issues. LOF of crossing is less or equal to 4.0. Recommend next video inspection in 5 years. (O.Yakimov - DWR UCIP) 02/20/2014 Needs cleaning and clearing of debris. (P. Amatya - DWR UCIP) FIELD_STRUCT_DESC: 24-inch corrugated metal gravity drainage pipe through the levee, 13 feet below the crown. Flap gate on the waterside (WS) end. Concrete U-shaped headwall on each end. Grouted riprap apron on the landside (LS) end. Grouted riprap spillway on the WS end. [Additional Reference(s): DWR Levee Log, 1992. USACE Sacramento O&M Manual 504, May 1965, (HLM 4.58)]. FS Date: 3/17/2021 10:24:31 AM

Top of Levee: View of levee crown looking upstream

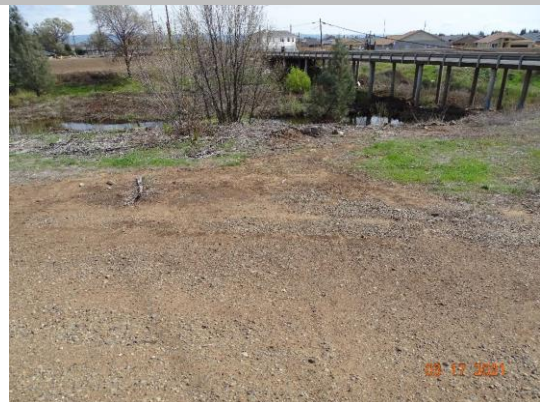
Photo 2 of 3 : UCIP_FA_2021_67250_99296.jpg

Water-Side: View of levee slope looking from crown

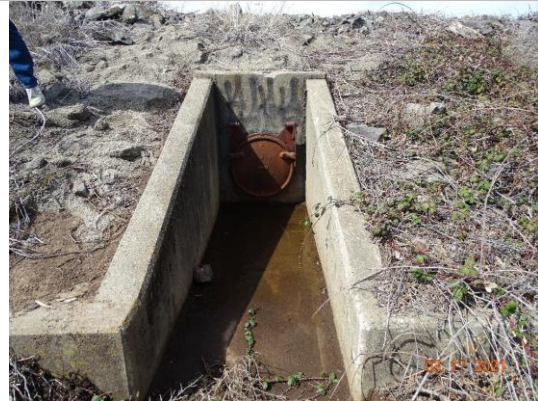
Photo 3 of 3 : UCIP_FA_2021_67250_99299.jpg

Water-Side: Headwall and flap gate on levee slope

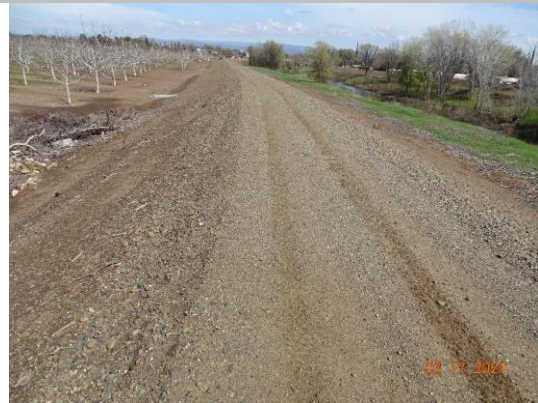
Photo 1 of 3 : UCIP_FA_2021_67251_99304.jpg

DS_ID:19221
FS_ID:67251
EP_NO: N/A
Repair Type: Urgent
EVAL Issue: Pipe Integrity
Crossing Status: Found
UCIP Comments: 03/17/2021 Record updated from Non-Urgent to Urgent. DMP internal video inspection has found pipe integrity issues. LOF of crossing is between 5 and 6. Crossing will be monitored until funding becomes available to address the issues. Flap gate on waterside pipe end is non-operating. Recommend lubricating hinges for easy opening. Drainage inlet at landside toe is buried in soil - unable to locate. Crossing appears abandoned. No permit has been identified authorizing pipe. (O.Yakimov - DWR UCIP)
02/20/2014 CM Standpipe intake. Intake pipe with air vent. Steel rib-bar grit cover on the standpipe on landside levee toe. Needs cleaning and clearing on both ends of the pip. (P. Amatya - DWR UCIP).
FIELD_STRUCT_DESC: 24-inch corrugated metal gravity drainage pipe through the levee, 15 feet below the crown. Flap gate on the waterside (WS) end. Concrete U-shaped headwall on the WS end. Grouted riprap spillway on the WS end. Corrugated metal standpipe intake. Intake pipe with an air vent. Steel rib-bar grit cover on the standpipe on the landside (LS) toe. [Additional Reference(s): DWR Levee Log, 1992. USACE Sacramento O&M Manual 504, May 1965, (HLM 4.94)].

Top of Levee: View of levee crown looking upstream

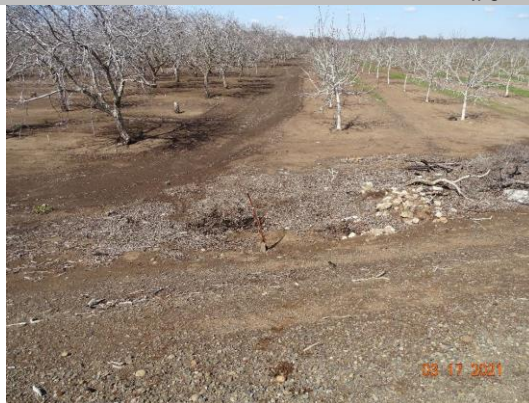
Photo 2 of 3 : UCIP_FA_2021_67251_99303.jpg

Land-Side: View of levee slope looking from crown

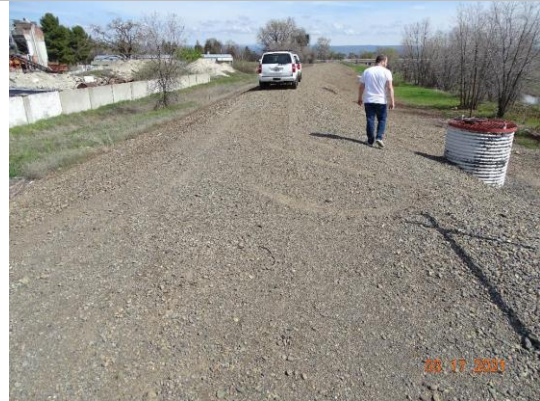
Photo 1 of 3 : UCIP_FA_2021_67286_99399.jpg

Comment Code						
Inspector Comment						
DS_ID:19222 FS_ID:67286 EP_NO: N/A Repair Type: Non-Urgent EVAL Issue: Unauthorized Encroachment, installed decades prior Crossing Status: Found UCIP Comments: 03/17/2021 Record updated from No Action Needed to Non-Urgent. No permit has been identified authorizing pipe. DMP internal video inspection has not found pipe integrity issues. LOF of crossing is less or equal to 4.0. Recommend next video inspection in 5 years. (O.Yakimov - DWR UCIP) 02/20/2014 Slide gate in CM stadpipe on waterside levee slope. (P. Amatya - DWR UCIP) FIELD_STRUCT_DESC: 36-inch corrugated metal gravity drainage pipe through the levee, 17 feet below the crown. Slide gate in a corrugated metal standpipe on the waterside (WS) slope. Flap gate on the WS end. Concrete U-shaped headwall on each end. Grouted riprap apron on the landside (LS) end. Grouted riprap spillway on the WS end. [Additional Reference(s): DWR Levee Log, 1992. USACE Sacramento O&M Manual 504, May 1965, (HLM 5.22)]. FS Date: 3/17/2021 3:46:02 PM

Top of Levee: View of levee crown looking upstream

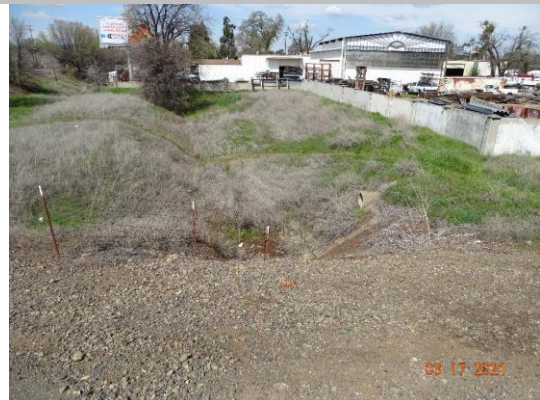
Photo 2 of 3 : UCIP_FA_2021_67286_99400.jpg

Land-Side: View of levee slope looking from crown. Drainage ditch on landside

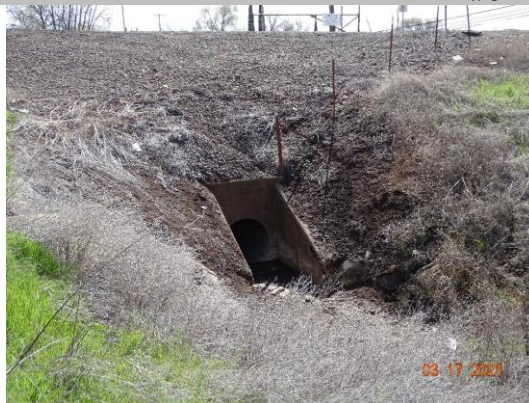
Photo 3 of 3 : UCIP_FA_2021_67286_99404.jpg

Land-Side: Headwall and pipe inlet in drainage ditch at levee toe

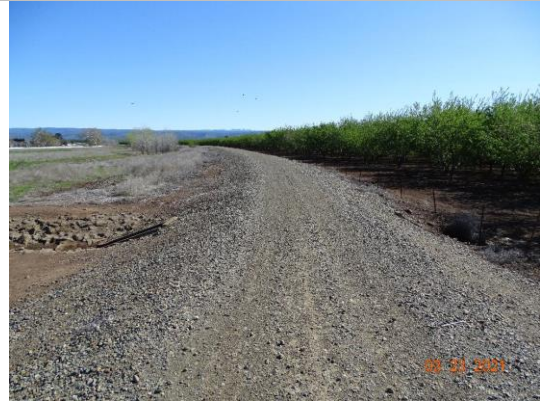
Photo 1 of 3 : UCIP_FA_2021_67304_99515.jpg

Comment Code						
Inspector Comment						
DS_ID:19234 FS_ID:67304 EP_NO: N/A Repair Type: Non-Urgent EVAL Issue: Pipe Damage Crossing Status: Found UCIP Comments: 03/23/2021 Record remains Non-Urgent. No permit has been identified authorizing pipe. Debris noted in previous inspection has been cleared. DMP internal video inspection has found pipe integrity issues. LOF of crossing is greater than or equal to 4.1 and less than 5. Crossing will be monitored until funding becomes available for rehabilitation. (O.Yakimov - DWR UCIP) 03/11/2014 Needs cleaning and clearing the culvert. (P. Amatya - DWR UCIP) FIELD_STRUCT_DESC: 24-inch corrugated metal gravity drainage pipe through the levee, 6.6 feet below the crown. Flap gate on the waterside (WS) end. Concrete U-shaped headwall on each end. Grouted riprap spillway on the WS end. [Additional Reference(s): DWR Levee Log, 1992. USACE Sacramento O&M Manual 504, May 1965, (HLM 0.25)]. FS Date: 3/23/2021 2:26:18 PM

Top of Levee: View of levee crown looking upstream

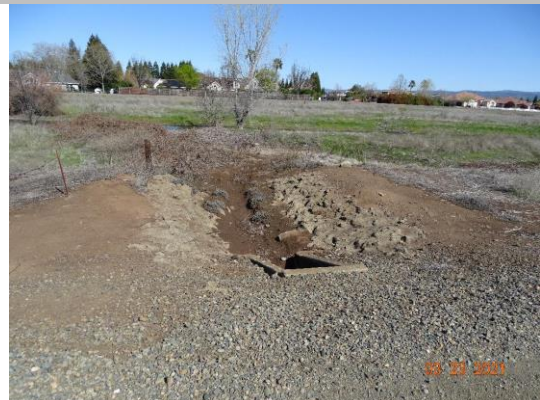
Photo 2 of 3 : UCIP_FA_2021_67304_99516.jpg

Water-Side: View of levee slope looking from crown

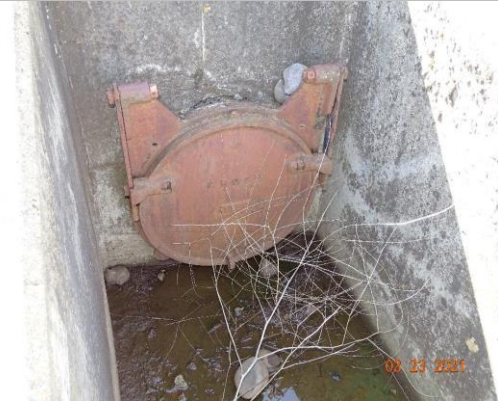
Photo 3 of 3 : UCIP_FA_2021_67304_99520.jpg

Water-Side: Headwall and flap gate at levee toe

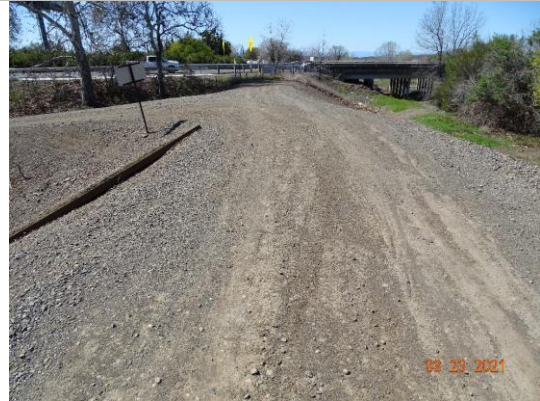
Photo 1 of 3 : UCIP_FA_2021_67305_99521.jpg

Comment Code						
Inspector Comment						
DS_ID:19235 FS_ID:67305 EP_NO: N/A Repair Type: Urgent EVAL Issue: Pipe Integrity Crossing Status: Found UCIP Comments: 03/23/2021 Record updated from Non-Urgent to Urgent. DMP internal video inspection has found pipe integrity issues. LOF of crossing is between 5 and 6. Crossing will be monitored until funding becomes available to address the issues. No permit has been identified authorizing pipe. Recommend clearing debris from landside end of pipe. (O.Yakimov - DWR UCIP) 02/24/2014 Needs cleaning and clearing of debris. (P. Amatya - DWR UCIP) FIELD_STRUCT_DESC: 24-inch corrugated metal gravity drainage pipe through the levee, 12.5 feet below the crown. Flap gate on the waterside (WS) end. Concrete U-shaped headwall on each end. Grouted riprap apron on the landside (LS) end. Grouted riprap spillway on the WS end. [Additional Reference(s): DWR Levee Log, 1992. USACE Sacramento O&M Manual 504, May 1965, (HLM 1.34)]. FS Date: 3/23/2021 2:30:04 PM

Top of Levee: View of levee crown looking downstream

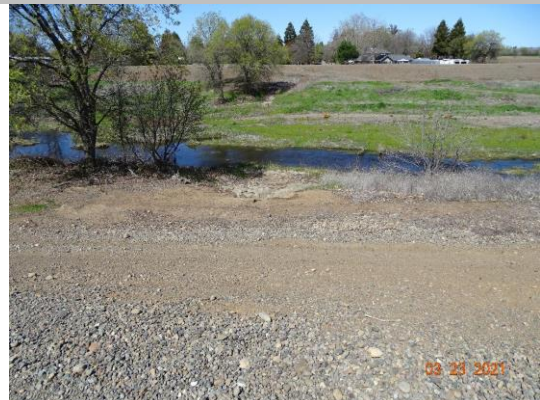
Photo 2 of 3 : UCIP_FA_2021_67305_99522.jpg

Water-Side: View of levee slope looking from crown

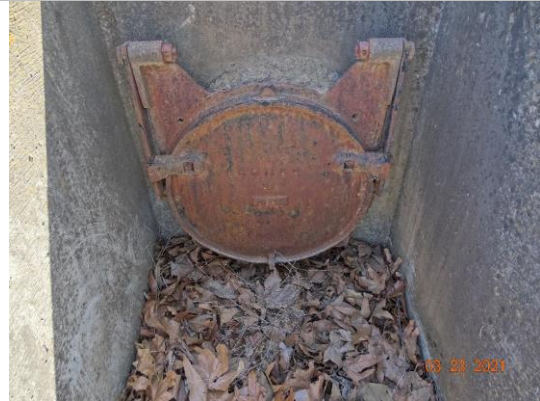
Photo 3 of 3 : UCIP_FA_2021_67305_99526.jpg

Water-Side: Headwall and flap gate at levee toe

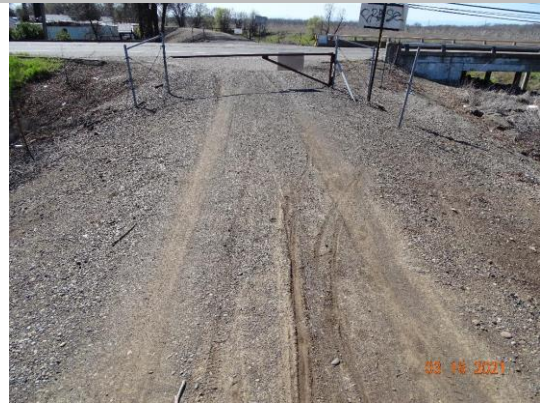
Photo 1 of 3 : UCIP_FA_2021_67308_99539.jpg

DS_ID:19237
FS_ID:67308
EP_NO: N/A
Repair Type: Non-Urgent
EVAL Issue: Unauthorized Encroachment, installed decades prior
Crossing Status: Found
UCIP Comments: 03/16/2021 Record remains Non-Urgent. No permit has been identified authorizing pipe. DMP internal video inspection has not found pipe integrity issues. LOF of crossing is less or equal to 4. Recommend next video inspection in 5 years. (O.Yakimov - DWR UCIP)
02/24/2014 Needs cleaning and clearing of debris. (P. Amatya - DWR UCIP)
FIELD_STRUCT_DESC: 24-inch corrugated metal gravity drainage pipe through the levee, 11 feet below the crown. Flap gate on the waterside (WS) end. Concrete U-shaped headwall on each end. Grouted riprap apron on the landside (LS) end. Grouted riprap spillway on the WS end. [Additional Reference(s): DWR Levee Log, 1992. USACE Sacramento O&M Manual 504, May 1965, (HLM 1.55)].
FS Date: 3/16/2021 3:10:19 PM

Top of Levee: View of levee crown looking downstream

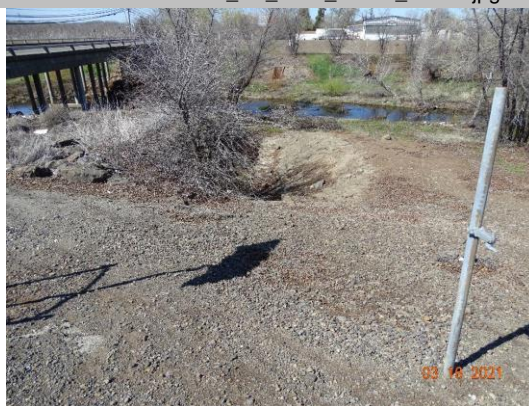
Photo 2 of 3 : UCIP_FA_2021_67308_99540.jpg

Water-Side: View of levee slope looking from crown

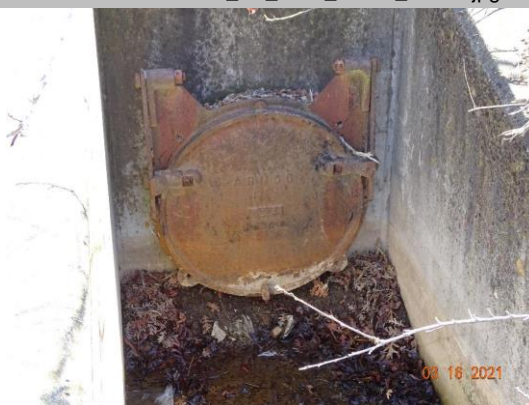
Photo 3 of 3 : UCIP_FA_2021_67308_99544.jpg

Water-Side: Headwall and flap gate at levee toe

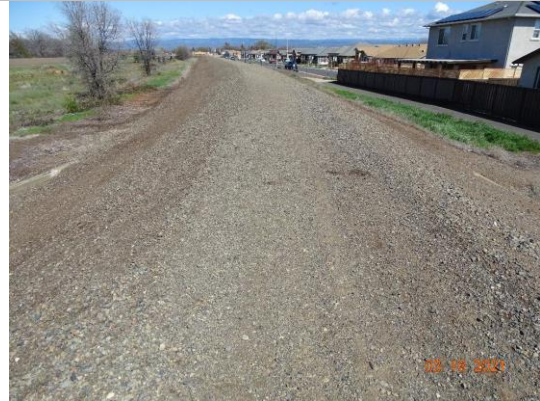
Photo 1 of 3 : UCIP_FA_2021_67340_99744.jpg

Comment Code						
Inspector Comment						
DS_ID:19239 FS_ID:67340 EP_NO: N/A Repair Type: Non-Urgent EVAL Issue: Unauthorized Encroachment, installed decades prior Crossing Status: Found UCIP Comments: 03/16/2021 Record remains Non-Urgent. No permit has been identified authorizing pipe. Debris around landside headwall has been cleared. DMP internal video inspection has not found pipe integrity issues. LOF of crossing is less or equal to 4. Recommend next video inspection in 5 years. (O.Yakimov - DWR UCIP) 02/24/2014 Debris in landside inlet area. Needs cleaning and clearing of debris. (P. Amatya - DWR UCIP) FIELD_STRUCT_DESC: 24-inch corrugated metal gravity drainage pipe through the levee, 10 feet below the crown. Flap gate on the waterside (WS) end. Concrete U-shaped headwall on each end. Grouted riprap apron on the landside (LS) end. Grouted riprap spillway on the WS end. [Additional Reference(s): DWR Levee Log, 1992. USACE Sacramento O&M Manual 504, May 1965, (HLM 2.44)]. FS Date: 3/16/2021 11:39:32 AM

Top of Levee: View of levee crown looking upstream

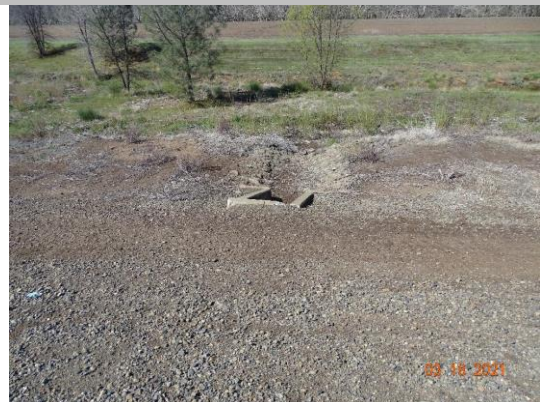
Photo 2 of 3 : UCIP_FA_2021_67340_99746.jpg

Water-Side: View of levee slope looking from crown

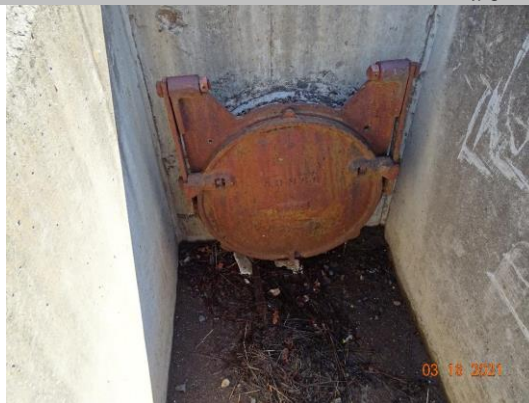
Photo 3 of 3 : UCIP_FA_2021_67340_99747.jpg

Water-Side: Headwall and flap gate at levee toe

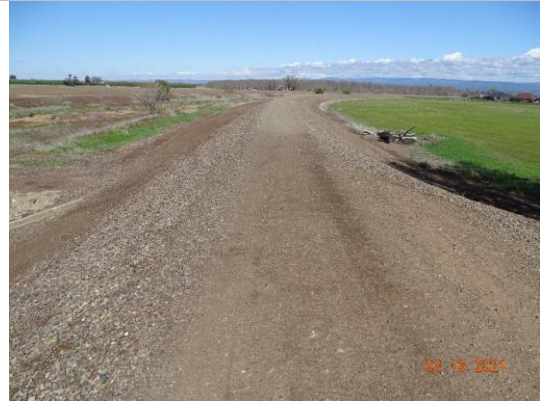
Photo 1 of 3 : UCIP_FA_2021_67341_99750.jpg

Comment Code						
Inspector Comment						
DS_ID:19240 FS_ID:67341 EP_NO: N/A Repair Type: Urgent EVAL Issue: Flood Risk Crossing Status: Found UCIP Comments: 03/16/2021 Record updated from Non-Urgent to Urgent. Flap gate not closing complitley. A gap between flap gate and pipe is visible. Adjustments and lubrication to flap gate hinges need to be done. DMP internal video inspection has not found pipe integrity issues. LOF of crossing is less or equal to 4. Recommend next video inspection in 5 years. (O.Yakimov - DWR UCIP) 02/24/2014 Needs cleaning and clearing of debris. (P. Amatya - DWR UCIP) FIELD_STRUCT_DESC: 24-inch corrugated metal gravity drainage pipe through the levee, 10 feet below the crown. Flap gate on the waterside (WS) end. Concrete U-shaped headwall on each end. Grouted riprap apron on the landside (LS) end. Grouted riprap spillway on the WS end. [Additional Reference(s): DWR Levee Log, 1992. USACE Sacramento O&M Manual 504, May 1965, (HLM 2.86)]. FS Date: 3/16/2021 12:43:55 PM

Top of Levee: View of levee crown looking upstream

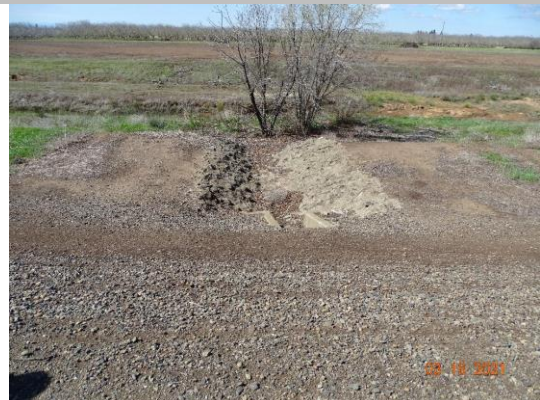
Photo 2 of 3 : UCIP_FA_2021_67341_99751.jpg

Water-Side: View of levee slope looking from crown

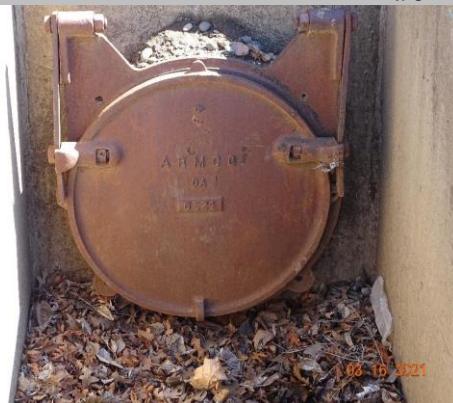
Photo 3 of 3 : UCIP_FA_2021_67341_99756.jpg

Water-Side: Headwall and flap gate at levee toe

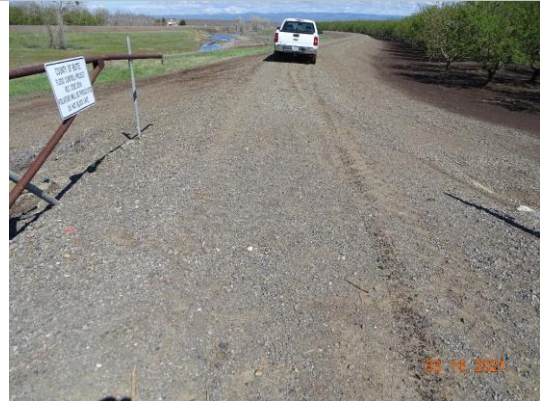
Photo 1 of 3 : UCIP_FA_2021_67342_99757.jpg

Comment Code						
Inspector Comment						
DS_ID:19241 FS_ID:67342 EP_NO: N/A Repair Type: Non-Urgent EVAL Issue: Unauthorized Encroachment, installed decades prior Crossing Status: Found UCIP Comments: 03/16/2021 Record remains Non-Urgent. No permit has been identified authorizing pipe. Debris has been cleared. DMP internal video inspection has not found pipe integrity issues. LOF of crossing is less or equal to 4. Recommend next video inspection in 5 years. (O.Yakimov - DWR UCIP) 02/24/2014 Needs cleaning and clearing of debris. (P. Amatya - DWR UCIP) FIELD_STRUCT_DESC: 24-inch corrugated metal gravity drainage pipe through the levee, 6.5 feet below the crown. Flap gate on the waterside (WS) end. Concrete U-shaped headwall on each end. Grouted riprap apron on the landside (LS) end. Grouted riprap spillway on the WS end. [Additional Reference(s): DWR Levee Log, 1992. USACE Sacramento O&M Manual 504, May 1965, (HLM 3.64)]. FS Date: 3/16/2021 12:48:10 PM

Top of Levee: View of levee crown looking upstream

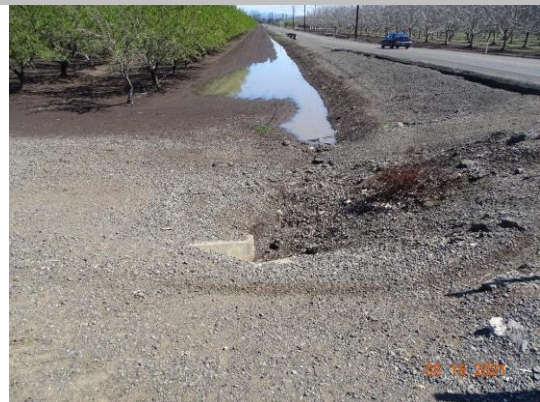
Photo 2 of 3 : UCIP_FA_2021_67342_99758.jpg

Land-Side: View of levee slope looking from crown

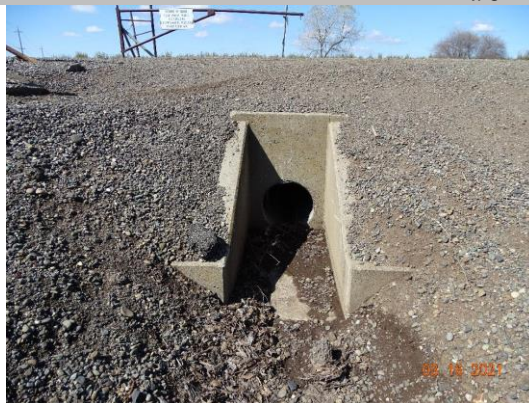
Photo 3 of 3 : UCIP_FA_2021_67342_99761.jpg

Land-Side: U-shaped headwall and pipe at levee toe

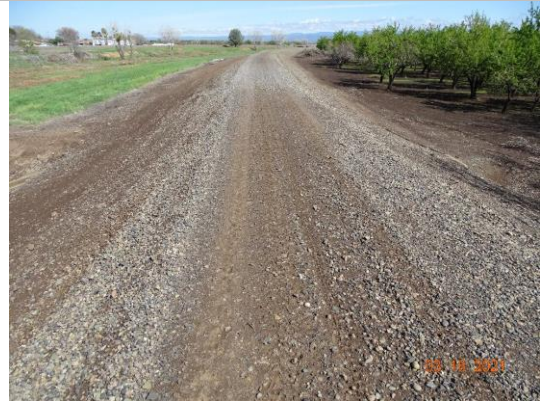
Photo 1 of 3 : UCIP_FA_2021_67347_99780.jpg

Comment Code						
Inspector Comment						
DS_ID:19245 FS_ID:67347 EP_NO: N/A Repair Type: Non-Urgent EVAL Issue: Unauthorized Encroachment, installed decades prior Crossing Status: Found UCIP Comments: 03/16/2021 Record remains Non-Urgent. No permit has been identified authorizing pipe. Debris has been cleared. DMP internal video inspection has not found pipe integrity issues. LOF of crossing is less or equal to 4. Recommend next video inspection in 5 years. (O.Yakimov - DWR UCIP) 02/25/2014 Needs cleaning and clearing of debris. (P. Amatya - DWR UCIP) FIELD_STRUCT_DESC: 24-inch corrugated metal gravity drainage pipe through the levee, 10 feet below the crown. Flap gate on the waterside (WS) end. Concrete U-shaped headwall on each end. Grouted riprap apron on the landside (LS) end. Grouted riprap spillway on the WS end. [Additional Reference(s): DWR Levee Log, 1992. USACE Sacramento O&M Manual 504, May 1965, (HLM 4.77)]. FS Date: 3/16/2021 2:59:36 PM

Top of Levee: View of levee crown looking upstream

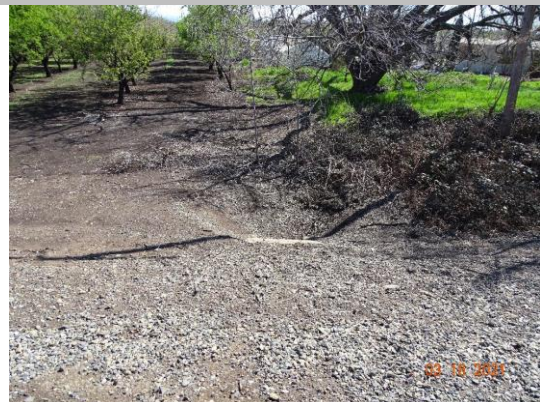
Photo 2 of 3 : UCIP_FA_2021_67347_99781.jpg

Land-Side: View of levee slope looking from crown

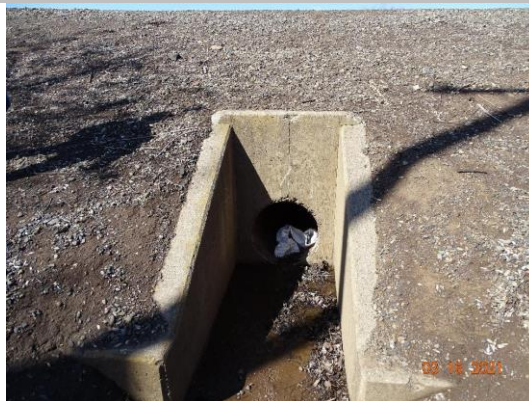
Photo 3 of 3 : UCIP_FA_2021_67347_99784.jpg

Land-Side: U-shaped headwall and pipe at levee toe

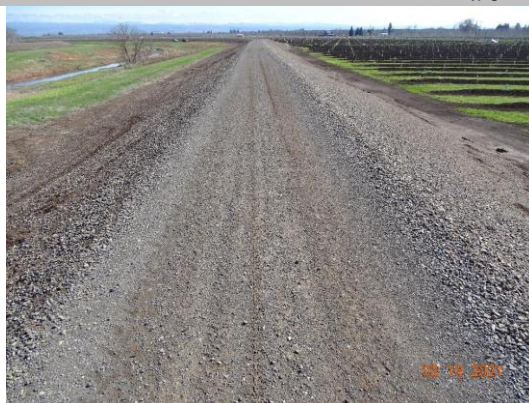
Photo 1 of 3 : UCIP_FA_2021_67350_99792.jpg

DS_ID:19247
FS_ID:67350
EP_NO: N/A
Repair Type: Urgent
EVAL Issue: Pipe Integrity
Crossing Status: Found
UCIP Comments: 03/16/2021 Record updated from Non-Urgent to Urgent. DMP internal video inspection has found pipe integrity issues. LOF of crossing is between 5 and 6. Crossing will be monitored until funding becomes available to address the issues. No permit has been identified authorizing pipe. Sediment at bottom of CMP is still present. (O.Yakimov - DWR UCIP)
02/25/2014 Needs cleaning and clearing of debris. (P. Amatya - DWR UCIP)
FIELD_STRUCT_DESC: 24-inch corrugated metal gravity drainage pipe through the levee, 11.5 feet below the crown. Flap gate on the waterside (WS) end. Concrete U-shaped headwall on each end. Grouted riprap apron on the landside (LS) end. Grouted riprap spillway on the WS end. [Additional Reference(s): DWR Levee Log, 1992. USACE Sacramento O&M Manual 504, May 1965, (HLM 5.83)].

Top of Levee: View of levee crown looking upstream

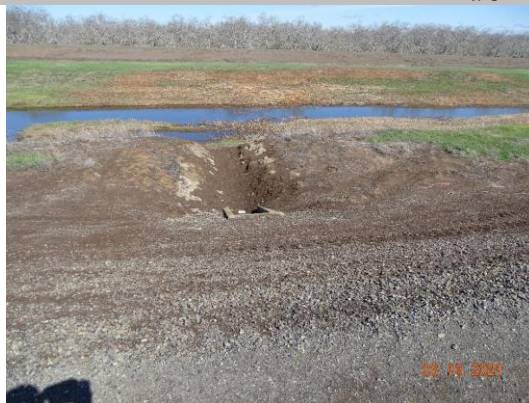
Photo 2 of 3 : UCIP_FA_2021_67350_99793.jpg

Water-Side: View of levee slope looking from crown

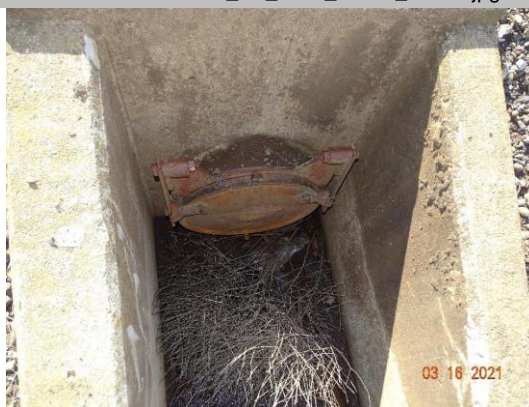
Photo 3 of 3 : UCIP_FA_2021_67350_99795.jpg

Water-Side: Headwall and flap gate at levee toe

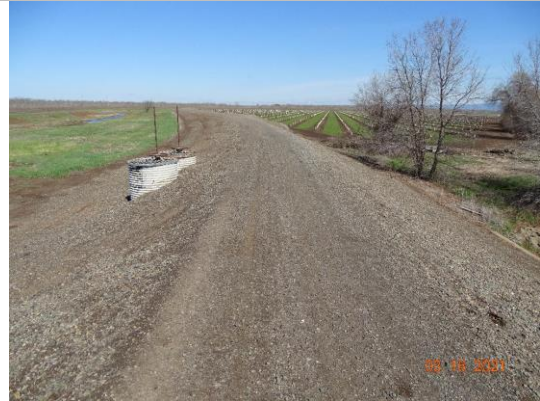
Photo 1 of 3 : UCIP_FA_2021_67351_99802.jpg

Comment Code					
Inspector Comment					
DS_ID:19248 FS_ID:67351 EP_NO: N/A Repair Type: Non-Urgent EVAL Issue: Pipe Damage Crossing Status: Found UCIP Comments: 03/16/2021 Record remains Non-Urgent. DMP internal video inspection has found pipe integrity issues. LOF of crossing is between 4.1 and 5. Crossing will be monitored until funding becomes available for rehabilitation. No permit has been identified authorizing pipe. Debris has been cleared. (O.Yakimov - DWR UCIP) 02/25/2014 Needs cleaning and clearing of debris. (P. Amatya - DWR UCIP) FIELD_STRUCT_DESC: [Channel Slough Drainage Structure] 1 of 2: 42-inch corrugated metal gravity drainage pipe through the levee, 16 feet below the crown. Flap gate on the waterside (WS) end. Slide gate in a corrugated metal pipe (CMP) riser on the WS slope. Concrete U-shaped headwall on each end. Grouted riprap apron and rock revetment on the landside (LS) end. [Additional Reference(s): DWR Levee Log, 1992. USACE Sacramento O&M Manual 504, May 1965, (HLM 6.30)]. FS Date: 3/16/2021 11:45:20 AM

Top of Levee: View of levee crown looking upstream

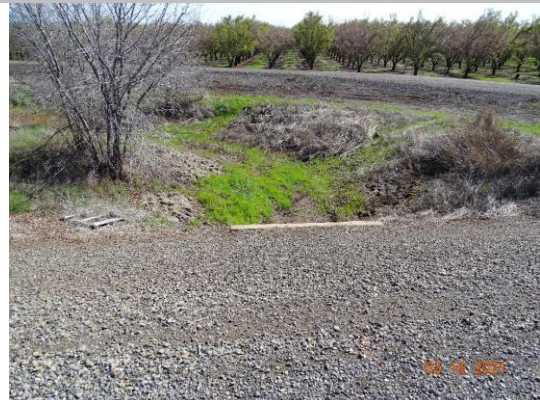
Photo 2 of 3 : UCIP_FA_2021_67351_99800.jpg

Land-Side: View of levee slope looking from crown

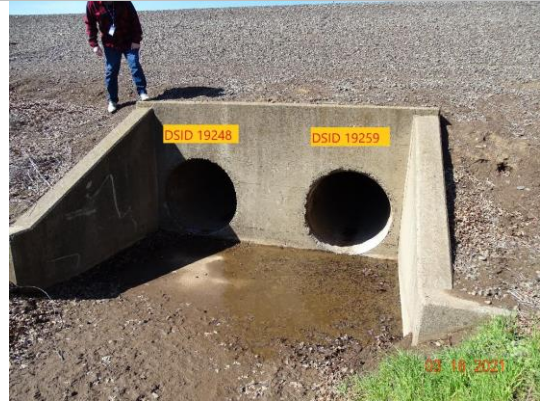
Photo 3 of 3 : UCIP_FA_2021_67351_99801.jpg

Land-Side: U-shaped headwall and pipe at levee toe

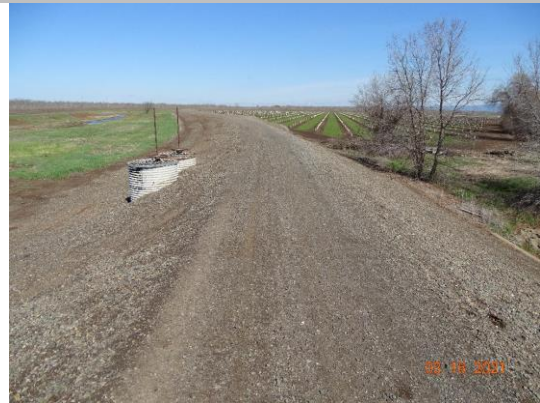
Photo 1 of 3 : UCIP_FA_2021_67352_99808.jpg

DS_ID:19259
 FS_ID:67352
 EP_NO: N/A
 Repair Type: Non-Urgent
 EVAL Issue: Pipe Damage
 Crossing Status: Found
 UCIP Comments: 03/16/2021 Record remains Non-Urgent. No permit has been identified authorizing pipe. Debris has been cleared. DMP internal video inspection has found pipe integrity issues. LOF of crossing is greater than or equal to 4.1 and less than 5. Crossing will be monitored until funding becomes available for rehabilitation.
 (O.Yakimov - DWR UCIP)
 02/25/2014 Needs cleaning and clearing of debris. (P. Amatya - DWR UCIP)
 FIELD_STRUCT_DESC: [Channel Slough Drainage Structure] 2 of 2: 42-inch corrugated metal gravity drainage pipe through the levee, 16 feet below the crown. Flap gate on the waterside (WS) end. Slide gate in a corrugated metal pipe (CMP) riser on the WS slope. Concrete U-shaped headwall on each end. Grouted riprap apron and rock revetment on the landside (LS) end. [Additional Reference(s): DWR Levee Log, 1992. USACE Sacramento O&M Manual 504, May 1965, (HLM 6.30)].

Top of Levee: View of levee crown looking upstream

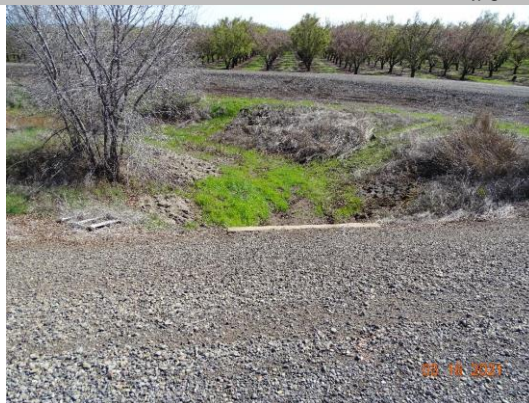
Photo 2 of 3 : UCIP_FA_2021_67352_99806.jpg

Land-Side: View of levee slope looking from crown

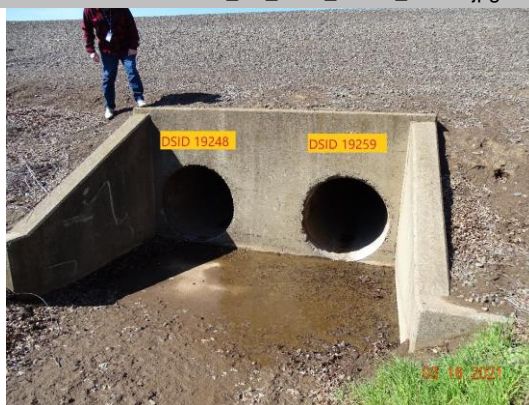
Photo 3 of 3 : UCIP_FA_2021_67352_99807.jpg

Land-Side: U-shaped headwall and pipe at levee toe

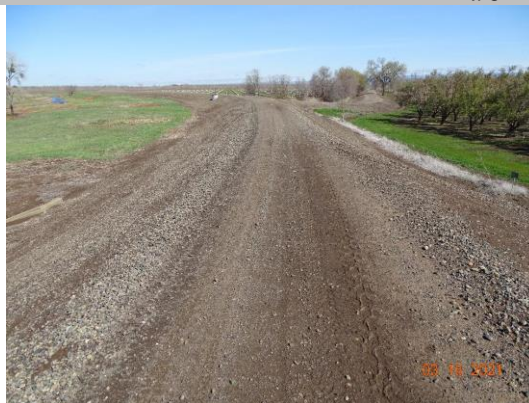
Photo 1 of 3 : UCIP_FA_2021_67353_99809.jpg

Comment Code					
Inspector Comment					
DS_ID:19249 FS_ID:67353 EP_NO: N/A Repair Type: Urgent EVAL Issue: Pipe Integrity Crossing Status: Found UCIP Comments: 03/16/2021 Record updated from Non-Urgent to Urgent. DMP internal video inspection has found pipe integrity issues. LOF of crossing is between 5 and 6. Crossing will be monitored until funding becomes available to address the issues. No permit has been identified authorizing pipe. Debris has been cleared. (O.Yakimov - DWR UCIP) 02/25/2014 Needs cleaning and clearing of debris. (P. Amatya - DWR UCIP) FIELD_STRUCT_DESC: 24-inch corrugated metal gravity drainage pipe through the levee, 12 feet below the crown. Flap gate on the waterside (WS) end. Concrete U-shaped headwall on each end. Grouted riprap apron on the landside (LS) end. Grouted riprap spillway on the WS end. [Additional Reference(s): DWR Levee Log, 1992. USACE Sacramento O&M Manual 504, May 1965, (HLM 6.35)]. FS Date: 3/16/2021 11:50:15 AM

Top of Levee: View of levee crown looking upstream

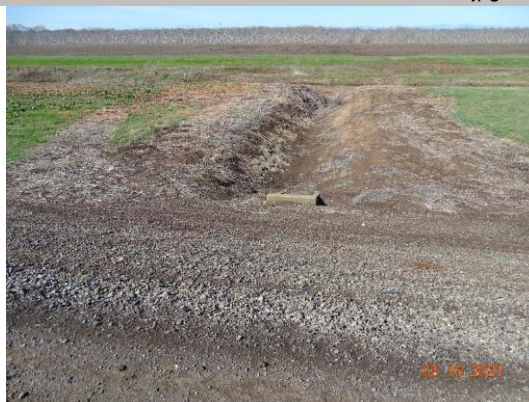
Photo 2 of 3 : UCIP_FA_2021_67353_99810.jpg

Water-Side: View of levee slope looking from crown

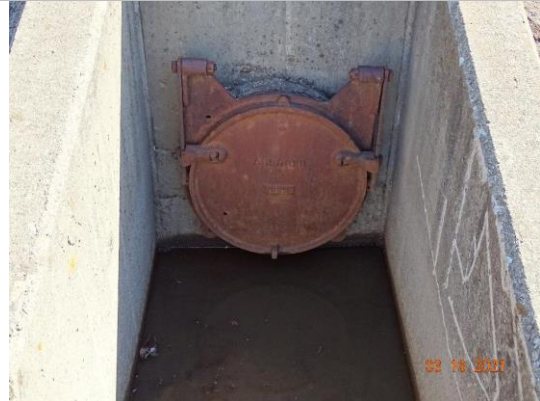
Photo 3 of 3 : UCIP_FA_2021_67353_99814.jpg

Water-Side: Headwall and flap gate at levee toe

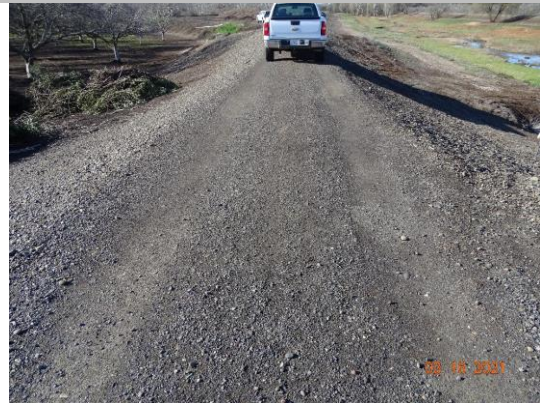
Photo 1 of 3 : UCIP_FA_2021_67357_99827.jpg

DS_ID:19251
FS_ID:67357
EP_NO: N/A
Repair Type: Urgent
EVAL Issue: Pipe Integrity
Crossing Status: Found
UCIP Comments: 03/16/2021 Record updated from Non-Urgent to Urgent. DMP internal video inspection has found pipe integrity issues. LOF of crossing is between 5 and 6. Crossing will be monitored until funding becomes available to address the issues. No permit has been identified authorizing pipe. Debris has been cleared. (O.Yakimov - DWR UCIP)
02/25/2014 Needs cleaning and clearing of debris. (P. Amatya - DWR UCIP)
FIELD_STRUCT_DESC: 24-inch corrugated metal gravity drainage pipe through the levee, 15.5 feet below the crown. Flap gate on the waterside (WS) end. Concrete U-shaped headwall on each end. Grouted riprap apron on the landside (LS) end. Grouted riprap spillway on the WS end. Pipe crossing levee at angle. [Additional Reference(s): DWR Levee Log, 1992. USACE Sacramento O&M Manual 504, May 1965, (HLM 6.65)].

Top of Levee: View of levee crown looking downstream

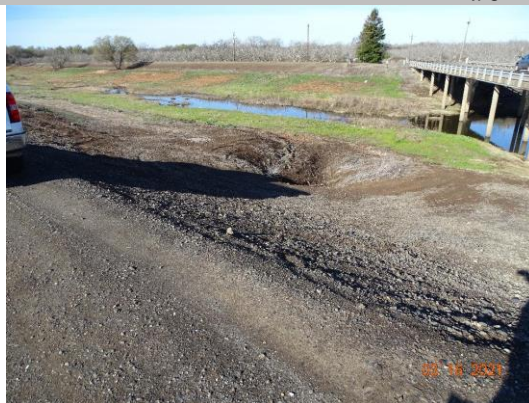
Photo 2 of 3 : UCIP_FA_2021_67357_99828.jpg

Water-Side: View of levee slope looking from crown

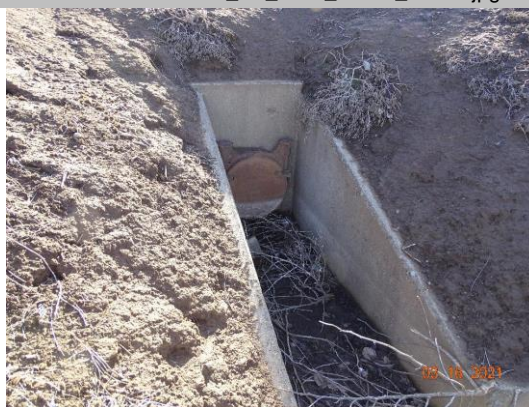
Photo 3 of 3 : UCIP_FA_2021_67357_99832.jpg

Water-Side: Headwall and flap gate at levee toe

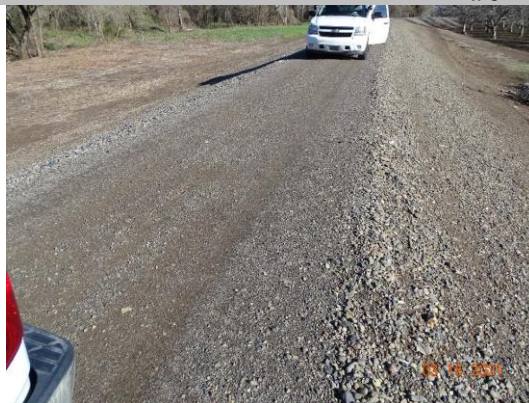
Photo 1 of 3 : UCIP_FA_2021_67358_99833.jpg

Comment Code					
Inspector Comment					
DS_ID:19252 FS_ID:67358 EP_NO: N/A Repair Type: Urgent EVAL Issue: Pipe Integrity Crossing Status: Found UCIP Comments: 03/16/2021 Record updated from Non-Urgent to Urgent. DMP internal video inspection has found pipe integrity issues. LOF of crossing is between 5 and 6. Crossing will be monitored until funding becomes available to address the issues. No permit has been identified authorizing pipe. Sediment at the bottom of CMP needs claeiring. (O.Yakimov - DWR UCIP) 02/25/2014 Needs cleaning and clearing of debris. (P. Amatya - DWR UCIP) FIELD_STRUCT_DESC: 24-inch corrugated metal gravity drainage pipe through the levee, 15 feet below the crown. Flap gate on the waterside (WS) end. Concrete U-shaped headwall on each end. Grouted riprap apron on the landside (LS) end. Grouted riprap spillway on the WS end. [Additional Reference(s): DWR Levee Log, 1992. USACE Sacramento O&M Manual 504, May 1965, (HLM 7.17)]. FS Date: 3/16/2021 2:50:50 PM

Top of Levee: View of levee crown looking upstream

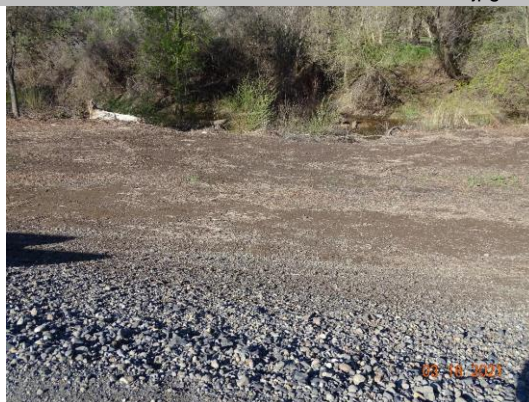
Photo 2 of 3 : UCIP_FA_2021_67358_99835.jpg

Water-Side: View of levee slope looking from crown

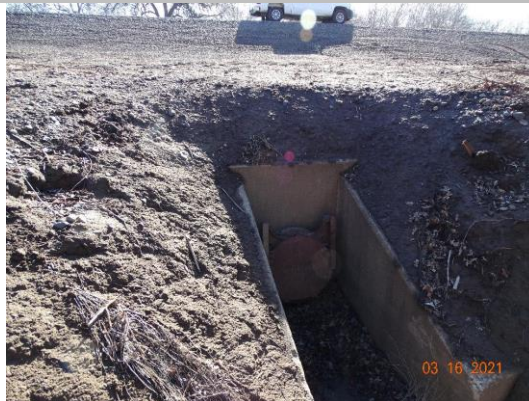
Photo 3 of 3 : UCIP_FA_2021_67358_99836.jpg

Water-Side: Headwall and flap gate on levee berm

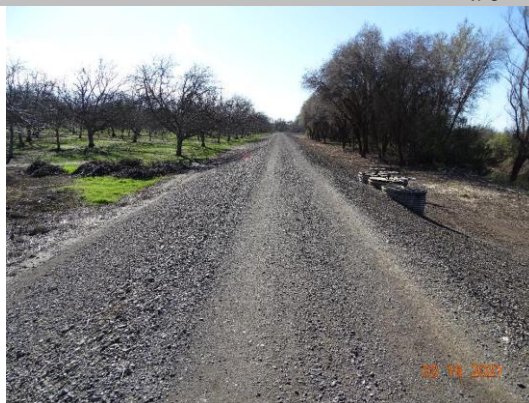
Photo 1 of 3 : UCIP_FA_2021_67359_99839.jpg

DS_ID:19253
FS_ID:67359
EP_NO: N/A
Repair Type: Non-Urgent
EVAL Issue: Unauthorized Encroachment, installed decades prior
Crossing Status: Found
UCIP Comments: 03/16/2021 Record remains Non-Urgent. No permit has been identified authorizing pipe. Debris has been cleared. DMP internal video inspection has not found pipe integrity issues. LOF of crossing is less or equal to 4. Recommend next video inspection in 5 years. (O.Yakimov - DWR UCIP)
02/25/2014 Slide gates in CMP risers on waterside shoulder. Needs cleaning and clearing of debris. (P. Amatya - DWR UCIP)
FIELD_STRUCT_DESC: 1 of 3: 48-inch corrugated metal gravity drainage pipe through the levee, 18 feet below the crown. Flap gate on the waterside (WS) end. Slide gate in a corrugated metal pipe (CMP) riser on the WS shoulder. Concrete U-shaped headwall on each end. Grouted riprap apron on the landside (LS) end. Grouted riprap spillway on the WS end. [Additional Reference(s): DWR Levee Log, 1992. USACE Sacramento O&M Manual 504, May 1965, (HLM 7.46)].

Top of Levee: View of levee crown looking downstream
