**Flood Control Project Maintenance
Levee Inspections**

Maintenance Issue Types Only, Levee Inspection Report By Mile - Fall 2021

Butte County Department of Public Works

Waterway	Bank	Unit Miles	Inspection Start/End	Inspector
Unit No. 01 Mud Creek	Right	6.80	10/18/2021 10/18/2021	Makar Sokol

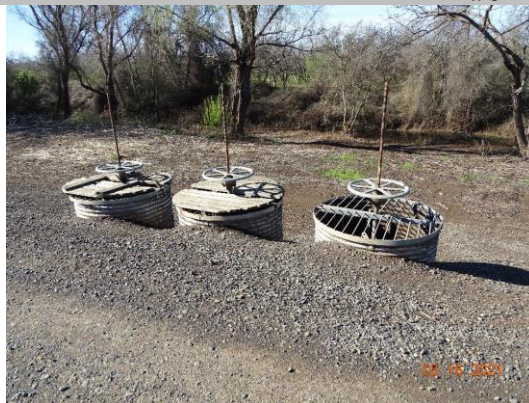
Photo 2 of 3 : UCIP_FA_2021_67359_99840.jpg

DS_ID:19253
FS_ID:67359
EP_NO: N/A
Repair Type: Non-Urgent
EVAL Issue: Unauthorized Encroachment, installed decades prior
Crossing Status: Found
UCIP Comments: 03/16/2021 Record remains Non-Urgent. No permit has been identified authorizing pipe. Debris has been cleared. DMP internal video inspection has not found pipe integrity issues. LOF of crossing is less or equal to 4. Recommend next video inspection in 5 years. (O.Yakimov - DWR UCIP)
02/25/2014 Slide gates in CMP risers on waterside shoulder. Needs cleaning and clearing of debris. (P. Amatya - DWR UCIP)
FIELD_STRUCT_DESC: 1 of 3: 48-inch corrugated metal gravity drainage pipe through the levee, 18 feet below the crown. Flap gate on the waterside (WS) end. Slide gate in a corrugated metal pipe (CMP) riser on the WS shoulder. Concrete U-shaped headwall on each end. Grouted riprap apron on the landside (LS) end. Grouted riprap spillway on the WS end. [Additional Reference(s): DWR Levee Log, 1992. USACE Sacramento O&M Manual 504, May 1965, (HLM 7.46)].

Water-Side: View of levee slope looking from crown. CMP riser with slide gate on levee shoulder

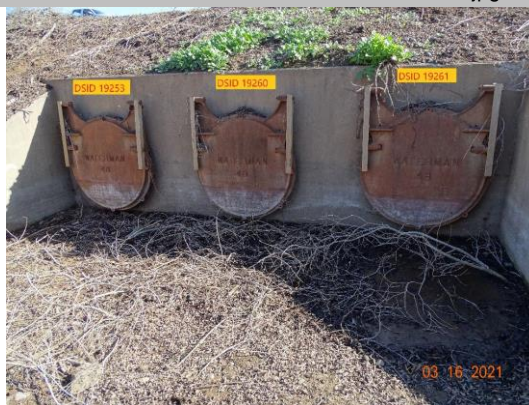
Photo 3 of 3 : UCIP_FA_2021_67359_99842.jpg

Water-Side: Headwall and flap gate at levee toe

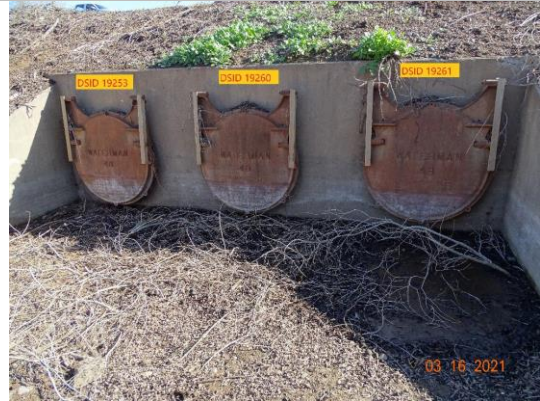
Photo 3 of 3 : UCIP_FA_2021_67360_99847.jpg

Water-Side: Headwall and flap gate at levee toe

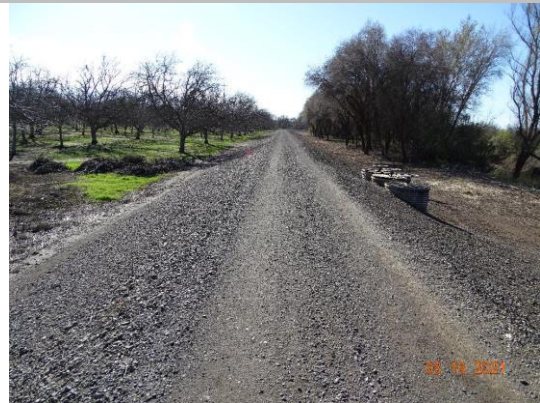
Photo 1 of 3 : UCIP_FA_2021_67361_99849.jpg

DS_ID:19261
FS_ID:67361
EP_NO: N/A
Repair Type: Non-Urgent
EVAL Issue: Unauthorized Encroachment, installed decades prior
Crossing Status: Found
UCIP Comments: 03/16/2021 Record remains Non-Urgent. No permit has been identified authorizing pipe. Debris has been cleared. DMP internal video inspection has not found pipe integrity issues. LOF of crossing is less or equal to 4. Recommend next video inspection in 5 years. (O.Yakimov - DWR UCIP)
02/25/2014 Slide gates in CMP risers on waterside shoulder. Needs cleaning and clearing on both pipe ends. (P. Amatya - DWR UCIP)
FIELD_STRUCT_DESC: 3 of 3: 48-inch corrugated metal gravity drainage pipe through the levee, 18 feet below the crown. Flap gate on the waterside (WS) end. Slide gate in a corrugated metal pipe (CMP) riser on the WS shoulder. Concrete U-shaped headwall on each end. Grouted riprap apron on the landside (LS) end. Grouted riprap spillway on the WS end. [Additional Reference(s): DWR Levee Log, 1992. USACE Sacramento O&M Manual 504, May 1965, (HLM 7.46)].

Top of Levee: View of levee crown looking downstream

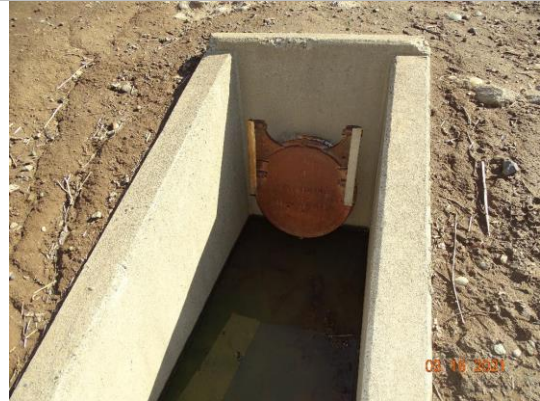
Photo 1 of 3 : UCIP_FA_2021_67362_99859.jpg

Comment Code						
Inspector Comment						
DS_ID:19254 FS_ID:67362 EP_NO: N/A Repair Type: Non-Urgent EVAL Issue: Pipe Damage Crossing Status: Found UCIP Comments: 03/16/2021 Record remains Non-Urgent. DMP internal video inspection has found pipe integrity issues. LOF of crossing is greater than or equal to 4.1 and less than 5. Crossing will be monitored until funding becomes available for rehabilitation. No permit has been identified authorizing pipe. Debris has been cleared. (O.Yakimov - DWR UCIP) 02/25/2014 Debris in inlet pipe, needs cleaning and clearing. (P. Amatya - DWR UCIP) FIELD_STRUCT_DESC: 24-inch corrugated metal gravity drainage pipe through the levee, 18 feet below the crown. Flap gate on the waterside (WS) end. Concrete U-shaped headwall on each end. Grouted riprap apron on the landside (LS) end. Grouted riprap spillway on the WS end. [Additional Reference(s): DWR Levee Log, 1992. USACE Sacramento O&M Manual 504, May 1965, (HLM 8.09)]. FS Date: 3/16/2021 3:19:02 PM

Water-Side: Headwall and flap gate at levee toe

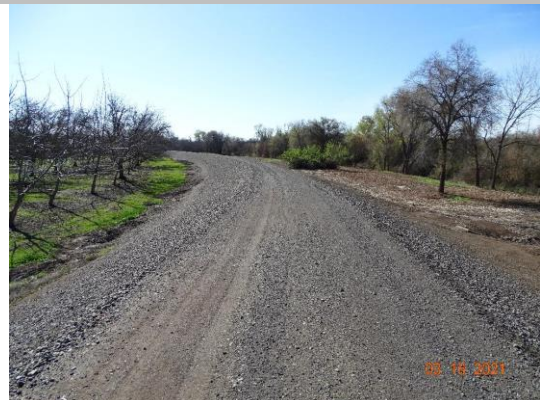
Photo 2 of 3 : UCIP_FA_2021_67362_99854.jpg

Top of Levee: View of levee crown looking downstream

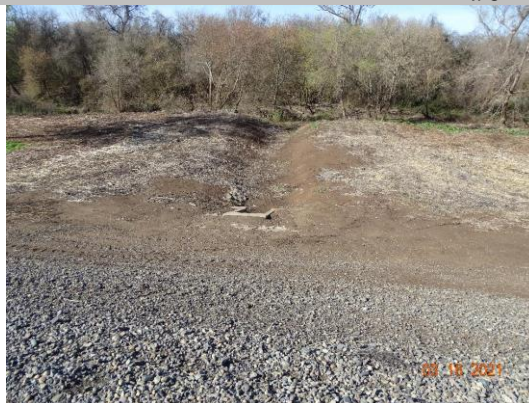
Photo 3 of 3 : UCIP_FA_2021_67362_99855.jpg

Water-Side: View of levee slope looking from crown

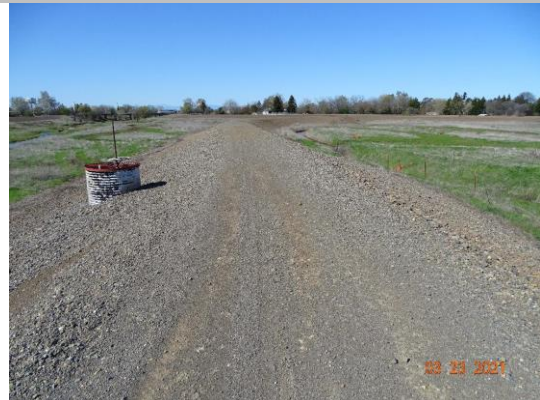
Photo 1 of 3 : UCIP_FA_2021_67668_100475.jpg

Comment Code						
Inspector Comment						
DS_ID:19262 FS_ID:67668 EP_NO: N/A Repair Type: Urgent EVAL Issue: Pipe Integrity Crossing Status: Found UCIP Comments: 03/23/2021 Record updated from No Action Needed to Urgent. DMP internal video inspection has found pipe integrity issues. LOF of crossing is between 5 and 6. Crossing will be monitored until funding becomes available to address the issues. No permit has been identified authorizing pipe. (O.Yakimov - DWR UCIP) 05/16/2017 Crossing has been downgraded from Non-Urgent to No Action Needed. The flap gate appears to be in good working order based on the photos, and the small pile of debris not enough to warrant Non-Urgent rating. (K. Fazel - DWR UCIP) 03/11/2014 Slide gate in CMP riser on watersie. The culvert was working during field inspection. (P. Amatya - DWR) FIELD_STRUCT_DESC: 42-inch corrugated metal gravity drainage pipe through the levee, 14 feet below the crown. Flap gate on the waterside (WS) end. Slide gate in a corrugated metal pipe (CMP) riser on the WS slope. Concrete U-shaped headwall on each end. Grouted riprap apron on the landside (LS) end. Grouted riprap spillway on the WS end. [Additional Reference(s): DWR Levee Log, 1992. USACE Sacramento O&M Manual 504, May 1965, (HLM 0.09)]. FS Date: 3/23/2021 1:52:32 PM

Top of Levee: View of levee crown looking downstream

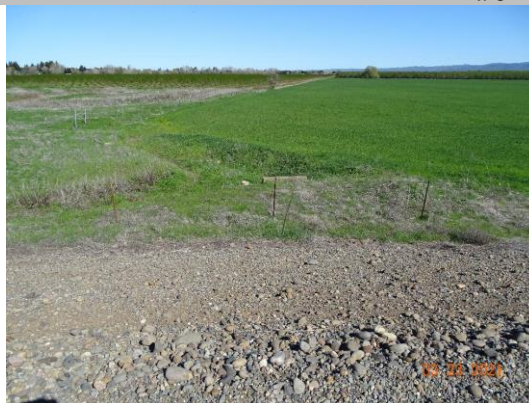
Photo 2 of 3 : UCIP_FA_2021_67668_100476.jpg

Land-Side: View of levee slope looking from crown

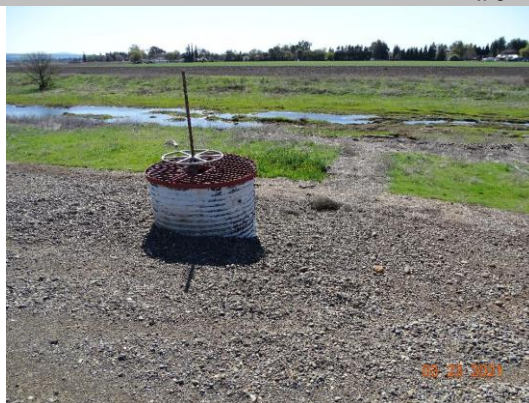
Photo 3 of 3 : UCIP_FA_2021_67668_100477.jpg

Water-Side: View of levee slope looking from crown. CMP riser with slide gate on levee shoulder

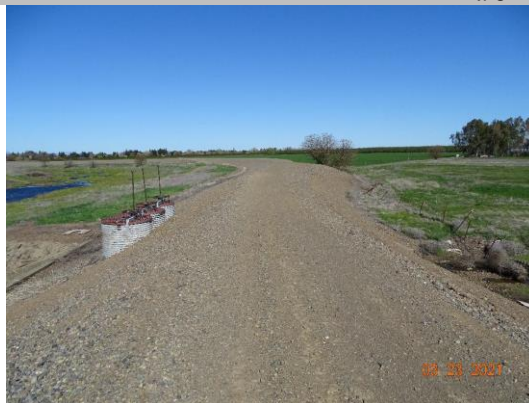
Photo 1 of 3 : UCIP_FA_2021_67669_100480.jpg

Comment Code					
Inspector Comment					
DS_ID:19278 FS_ID:67669 EP_NO: N/A Repair Type: Non-Urgent EVAL Issue: Unauthorized Encroachment, installed decades prior Crossing Status: Found UCIP Comments: 03/23/2021 Record updated from No Action Needed to Non-Urgent. No permit has been identified authorizing pipe. DMP internal video inspection has not found pipe integrity issues. LOF of crossing is less or equal to 4. Recommend next video inspection in 5 years. (O.Yakimov - DWR UCIP) 03/11/2014 Slide gate in CMP riser on waterside. The culvert was working during the field visit. (P. Amatya - DWR UCIP) FIELD_STRUCT_DESC: 1 of 3: 48-inch corrugated metal gravity drainage pipe through the levee, 11.7 feet below the crown. Slide gate in a riser well on the waterside (WS) slope. Concrete U-shaped headwall on each end. Flap gate on the WS end. Grouted riprap outlet channel on the WS. [Additional Reference(s): DWR Levee Log, 1992. USACE Sacramento O&M Manual 504, May 1965, (HLM 0.39)]. FS Date: 3/23/2021 2:00:15 PM

Top of Levee: View of levee crown looking downstream

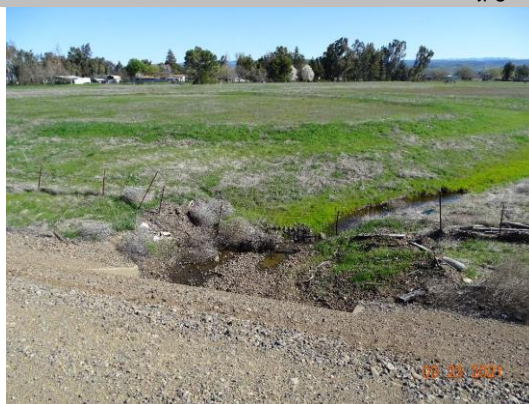
Photo 2 of 3 : UCIP_FA_2021_67669_100481.jpg

Land-Side: View of levee slope looking from crown

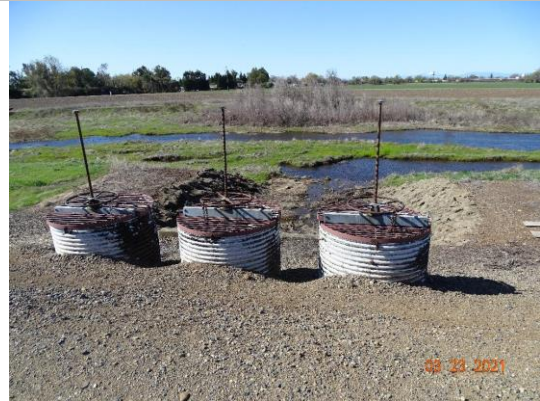
Photo 3 of 3 : UCIP_FA_2021_67669_100482.jpg

Water-Side: View of levee slope looking from crown. CMP riser with slide gate on levee shoulder

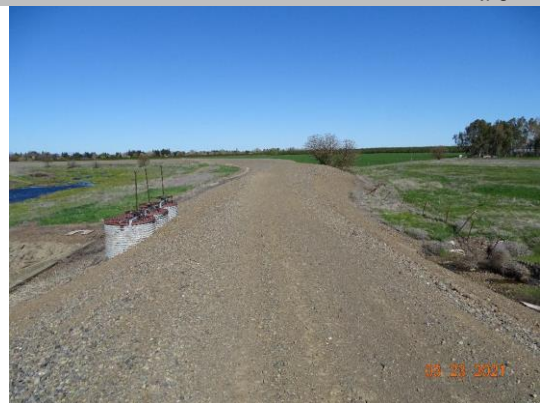
Photo 1 of 3 : UCIP_FA_2021_67670_100486.jpg

DS_ID:19277
FS_ID:67670
EP_NO: N/A
Repair Type: Non-Urgent
EVAL Issue: Unauthorized Encroachment, installed decades prior
Crossing Status: Found
UCIP Comments: 03/23/2021 Record updated from No Action Needed to Non-Urgent. No permit has been identified authorizing pipe. DMP internal video inspection has not found pipe integrity issues. LOF of crossing is less or equal to 4. Recommend next video inspection in 5 years. (O.Yakimov - DWR UCIP)
03/11/2014 Slide gate in CMP riser on waterside. The culvert was working during the field visit. (P. Amatya - DWR UCIP)
FIELD_STRUCT_DESC: 2 of 3: 48-inch corrugated metal gravity drainage pipe through the levee, 11.7 feet below the crown. Slide gate in a riser well on the waterside (WS) slope. Concrete U-shaped headwall on each end. Flap gate on the WS end. Grouted riprap outlet channel on the WS. [Additional Reference(s): DWR Levee Log, 1992. USACE Sacramento O&M Manual 504, May 1965, (HLM 0.39)].

Top of Levee: View of levee crown looking downstream

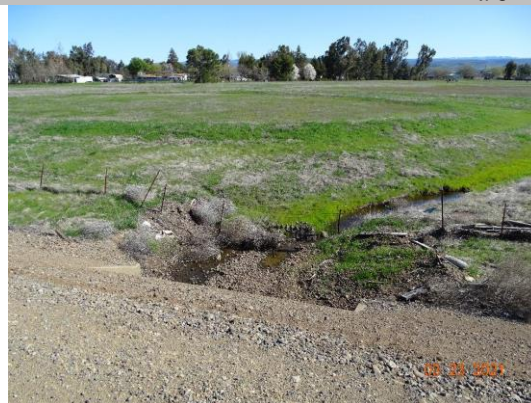
Photo 2 of 3 : UCIP_FA_2021_67670_100487.jpg

Land-Side: View of levee slope looking from crown

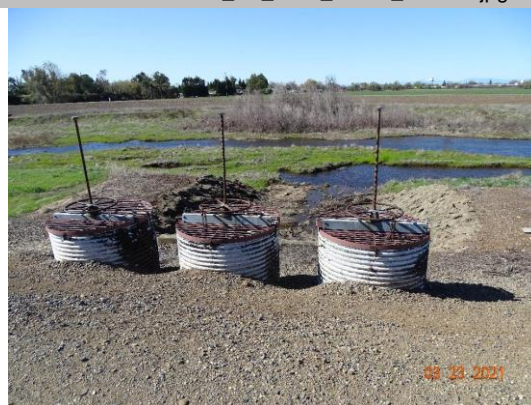
Photo 3 of 3 : UCIP_FA_2021_67670_100488.jpg

Water-Side: View of levee slope looking from crown. CMP riser with slide gate on levee shoulder

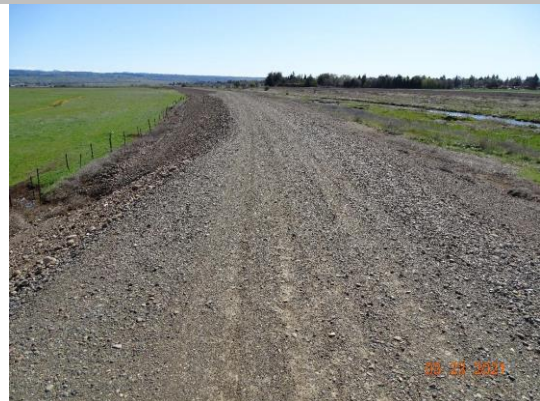
Photo 1 of 3 : UCIP_FA_2021_67676_100511.jpg

DS_ID:19264
 FS_ID:67676
 EP_NO: N/A
 Repair Type: Urgent
 EVAL Issue: Pipe Integrity
 Crossing Status: Found
 UCIP Comments: 03/23/2021 Record updated from No Action Needed to Urgent. DMP internal video inspection has found pipe integrity issues. LOF of crossing is between 5 and 6. Crossing will be monitored until funding becomes available to address the issues. No permit has been identified authorizing pipe. (O.Yakimov - DWR UCIP)
 03/11/2014 The culvert was working during the field visit. (P. Amatya - DWR UCIP)
 FIELD_STRUCT_DESC: 24-inch corrugated metal gravity drainage pipe through the levee, 11.7 feet below the crown. Flap gate on the waterside (WS) end. Concrete U-shaped headwall on each end.
 [Additional Reference(s): DWR Levee Log, 1992. USACE Sacramento O&M Manual 504, May 1965, (HLM 1.28)].
 FS Date: 3/23/2021

Top of Levee: View of levee crown looking upstream

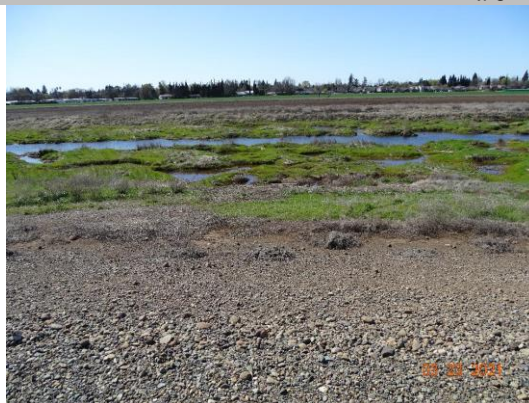
Photo 2 of 3 : UCIP_FA_2021_67676_100513.jpg

Water-Side: View of levee slope looking from crown

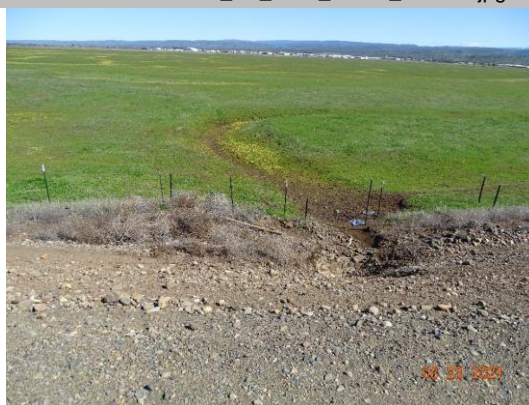
Photo 3 of 3 : UCIP_FA_2021_67676_100512.jpg

Land-Side: View of levee slope looking from crown

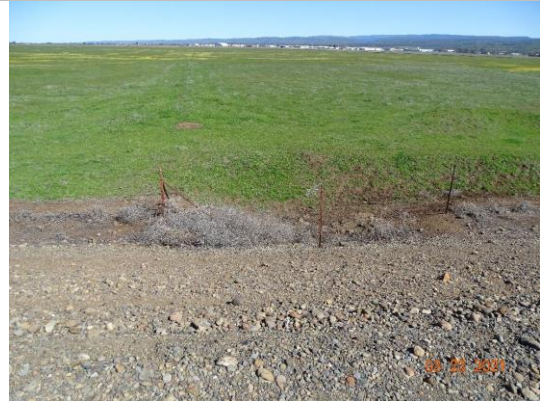
Photo 3 of 3 : UCIP_FA_2021_67677_100519.jpg

Land-Side: View of levee slope looking from crown

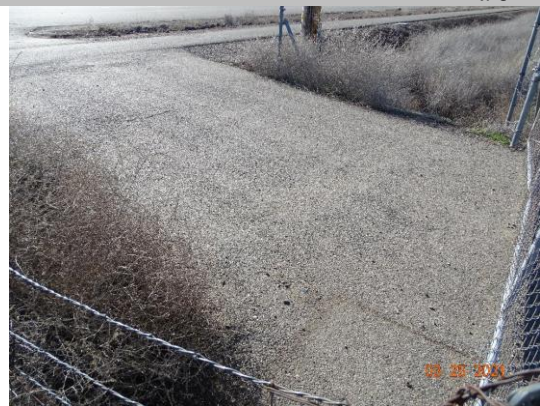
Photo 1 of 3 : UCIP_FA_2021_67679_100529.jpg

DS_ID:19267
FS_ID:67679
EP_NO: N/A
Repair Type: Non-Urgent
EVAL Issue: Unauthorized Encroachment, installed decades prior
Crossing Status: Found
UCIP Comments: 03/25/2021 Record remains Non-Urgent. No permit has been identified authorizing pipe. DMP internal video inspection has not found pipe integrity issues. LOF of crossing is less or equal to 4. Recommend next video inspection in 5 years. (O.Yakimov - DWR UCIP)
03/07/2014 Pipe is about 4 feet below the crown. Needs cleaning and clearing the culvert. (P. Amatya - DWR UCIP)
FIELD_STRUCT_DESC: 24-inch corrugated metal gravity drainage pipe through the levee, 6 feet below the crown. Flap gate on the waterside (WS) end. Concrete U-shaped headwall on each end.
[Additional Reference(s): DWR Levee Log, 1992. USACE Sacramento O&M Manual 504, May 1965, (HLM 2.23)].
FS Date: 3/25/2021 8:45:44 AM

Top of Levee: View of levee crown looking upstream

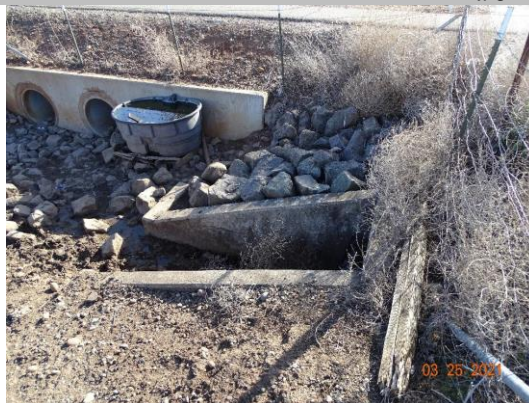
Photo 2 of 3 : UCIP_FA_2021_67679_100528.jpg

Water-Side: U-shaped Headwall and revetment on levee slope

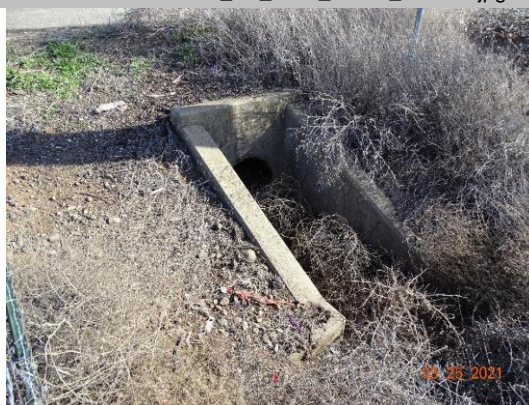
Photo 3 of 3 : UCIP_FA_2021_67679_100530.jpg

Land-Side: U-shaped headwall and pipe at levee toe

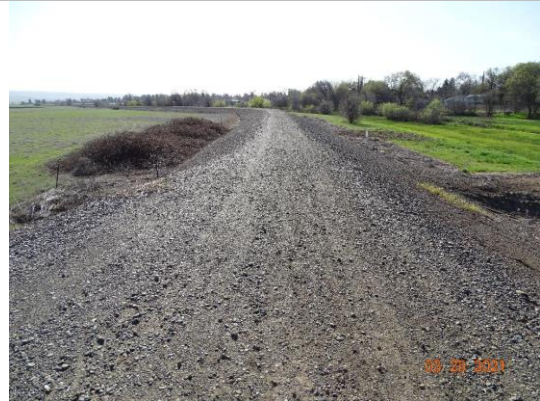
Photo 1 of 3 : UCIP_FA_2021_67681_100537.jpg

Comment Code						
Inspector Comment						
DS_ID:19269 FS_ID:67681 EP_NO: N/A Repair Type: Non-Urgent EVAL Issue: Unauthorized Encroachment, installed decades prior Crossing Status: Found UCIP Comments: 03/25/2021 Record remains Non-Urgent. No permit has been identified authorizing pipe. DMP internal video inspection has not found pipe integrity issues. LOF of crossing is less or equal to 4. Recommend next video inspection in 5 years. (O.Yakimov - DWR UCIP) 03/07/2014 Needs cleaning and clearing the culvert. (P. Amatya - DWR UCIP) FIELD_STRUCT_DESC: 24-inch corrugated metal gravity drainage pipe through the levee, 11 feet below the crown. Flap gate on the waterside (WS) end. Concrete U-shaped headwall on each end. Grouted riprap apron on the landside (LS) end. Grouted riprap spillway on the WS end. [Additional Reference(s): DWR Levee Log, 1992. USACE Sacramento O&M Manual 504, May 1965, (HLM 3.16)]. FS Date: 3/25/2021 10:55:20 AM

Top of Levee: View of levee crown looking upstream

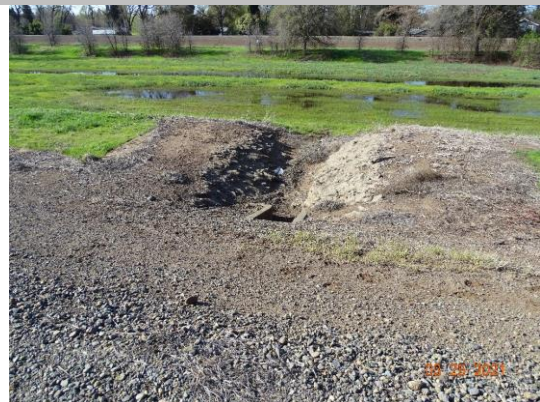
Photo 2 of 3 : UCIP_FA_2021_67681_100538.jpg

Water-Side: View of levee slope looking from crown

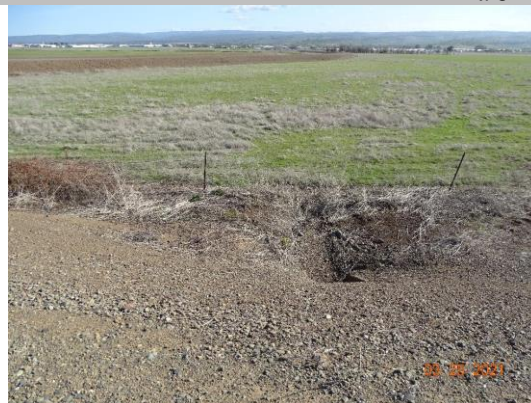
Photo 3 of 3 : UCIP_FA_2021_67681_100539.jpg

Land-Side: View of levee slope looking from crown

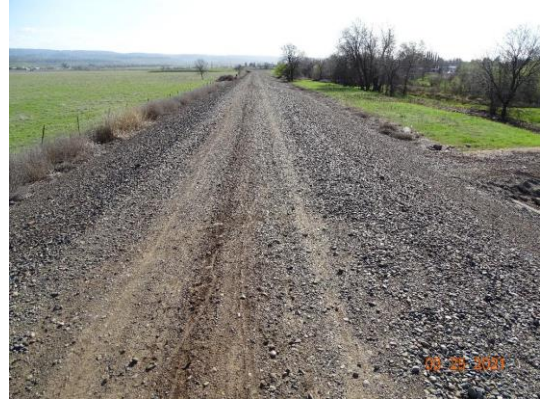
Photo 1 of 3 : UCIP_FA_2021_67682_100543.jpg

DS_ID:19270
FS_ID:67682
EP_NO: N/A
Repair Type: Non-Urgent
EVAL Issue: Unauthorized Encroachment, installed decades prior
Crossing Status: Found
UCIP Comments: 03/25/2021 Record is Non-Urgent. No permit has been identified authorizing pipe. DMP internal video inspection has not found pipe integrity issues. LOF of crossing is less or equal to 4. Recommend next video inspection in 5 years. (O.Yakimov - DWR UCIP)

Top of Levee: View of levee crown looking upstream

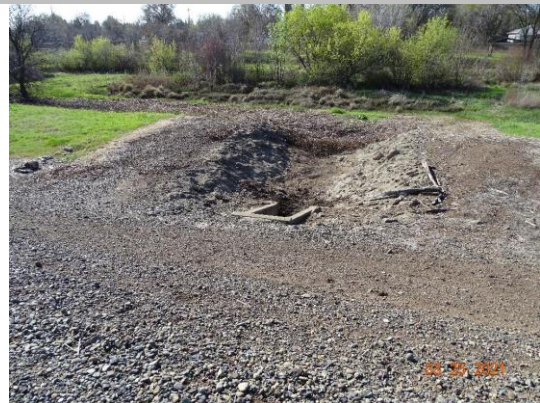
Photo 2 of 3 : UCIP_FA_2021_67682_100544.jpg

Water-Side: View of levee slope looking from crown

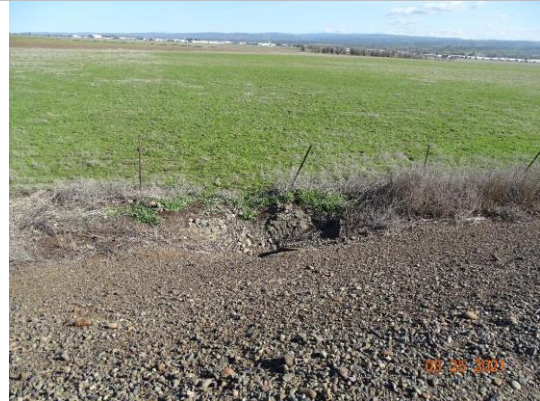
Photo 3 of 3 : UCIP_FA_2021_67682_100545.jpg

Land-Side: View of levee slope looking from crown

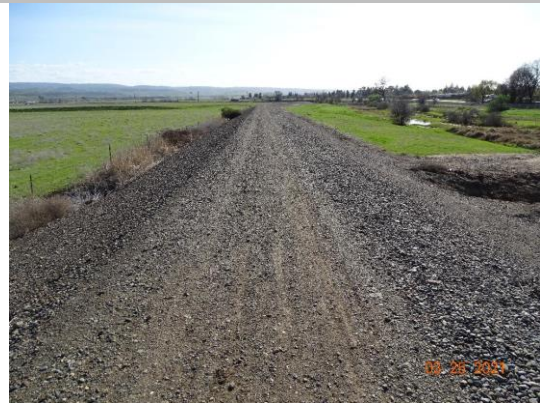
Photo 1 of 3 : UCIP_FA_2021_67683_100549.jpg

DS_ID:19271
FS_ID:67683
EP_NO: N/A
Repair Type: Non-Urgent
EVAL Issue: Unauthorized Encroachment, installed decades prior
Crossing Status: Found
UCIP Comments: 03/25/2021 Record remains Non-Urgent. Debris around culver has been cleared. No permit has been identified authorizing pipe. DMP internal video inspection has not found pipe integrity issues. LOF of crossing is less or equal to 4. Recommend next video inspection in 5 years. (O.Yakimov - DWR UCIP)
03/07/2014 Needs cleaning and clearing the culvert. (P. Amatya - DWR UCIP)
FIELD_STRUCT_DESC: 24-inch corrugated metal gravity drainage pipe through the levee, 10.5 feet below the crown. Flap gate on the waterside (WS) end. Concrete U-shaped headwall on each end. Grouted riprap apron on the landside (LS) end. Grouted riprap spillway on the WS end. [Additional Reference(s): DWR Levee Log, 1992. USACE Sacramento O&M Manual 504, May 1965, (HLM 3.43)].

Top of Levee: View of levee crown looking upstream

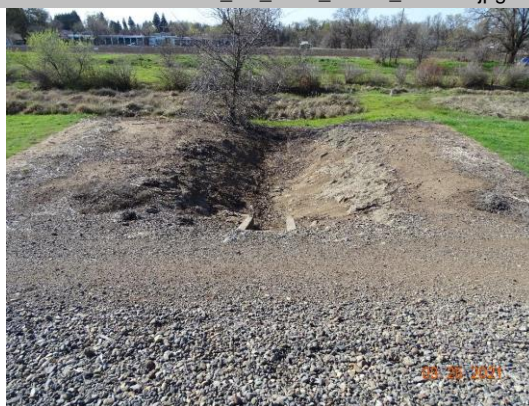
Photo 2 of 3 : UCIP_FA_2021_67683_100550.jpg

Water-Side: View of levee slope looking from crown

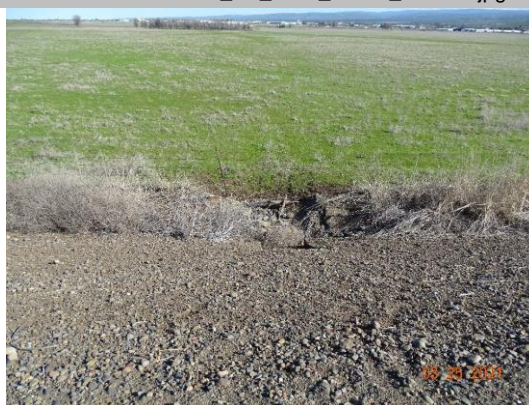
Photo 3 of 3 : UCIP_FA_2021_67683_100551.jpg

Land-Side: View of levee slope looking from crown

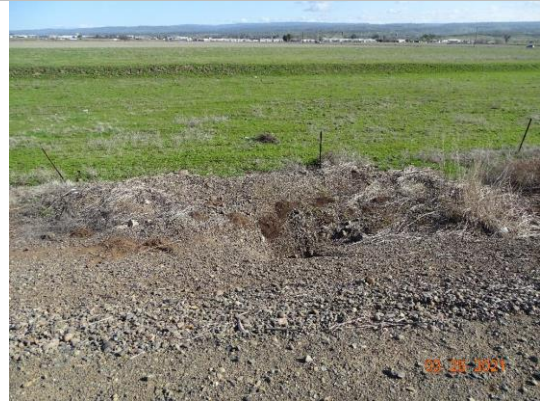
Photo 3 of 3 : UCIP_FA_2021_67684_100557.jpg

Land-Side: View of levee slope looking from crown

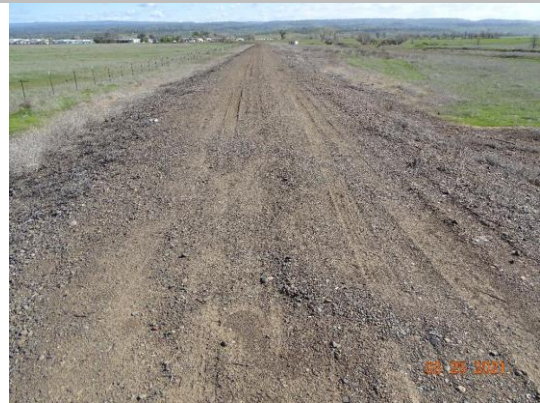
Photo 1 of 3 : UCIP_FA_2021_67687_100570.jpg

DS_ID:19275
FS_ID:67687
EP_NO: N/A
Repair Type: Non-Urgent
EVAL Issue: Unauthorized Encroachment, installed decades prior
Crossing Status: Found
UCIP Comments: 03/25/2021 Record remains Non-Urgent. No permit has been identified authorizing pipe. DMP internal video inspection has not found pipe integrity issues. LOF of crossing is less or equal to 4. Recommend next video inspection in 5 years. (O.Yakimov - DWR UCIP)
03/04/2014 The culvert was working during the field visit. Needs cleaning and clearing on both ends of the pipe. (P. Amatya - DWR UCIP)
FIELD_STRUCT_DESC: 24-inch corrugated metal gravity drainage pipe through the levee, 7.5 feet below the crown. Flap gate on the waterside (WS) end. Concrete U-shaped headwall on each end. Grouted riprap apron on the landside (LS) end. Grouted riprap spillway on the WS end. [Additional Reference(s): DWR Levee Log, 1992. USACE Sacramento O&M Manual 504, May 1965, (HLM 3.76)].

Top of Levee: View of levee crown looking upstream

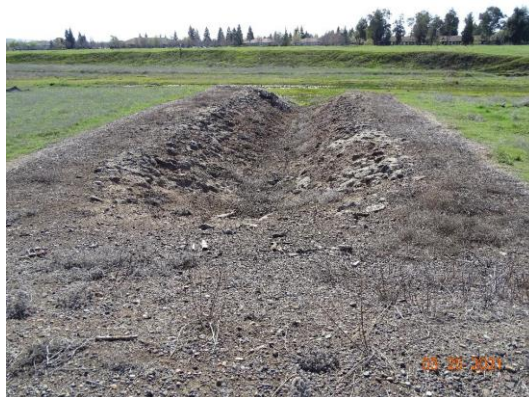
Photo 2 of 3 : UCIP_FA_2021_67687_100571.jpg

Water-Side: View of levee slope looking from crown

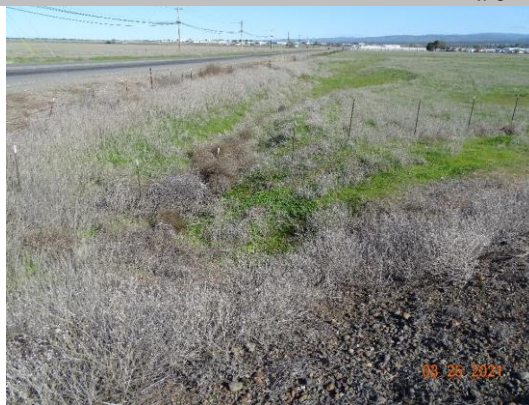
Photo 3 of 3 : UCIP_FA_2021_67687_100572.jpg

Land-Side: View of levee slope looking from crown

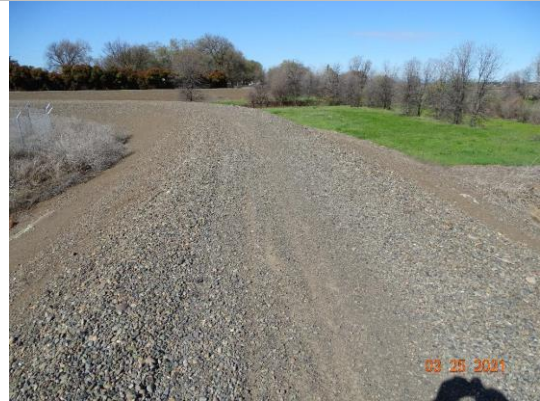
Photo 1 of 3 : UCIP_FA_2021_67692_100580.jpg

Comment Code						
Inspector Comment						
DS_ID:19279 FS_ID:67692 EP_NO: N/A Repair Type: Non-Urgent EVAL Issue: Unauthorized Encroachment, installed decades prior Crossing Status: Found UCIP Comments: 03/25/2021 Record remains Non-Urgent. No permit has been identified authorizing pipe. DMP internal video inspection has not found pipe integrity issues. LOF of crossing is less or equal to 4. Recommend next video inspection in 5 years. (O.Yakimov - DWR UCIP) 03/07/2014 Needs cleaning and clearing the culvert (P. Amatya - DWR UCIP) FIELD_STRUCT_DESC: 24-inch corrugated metal gravity drainage pipe through the levee, 10 feet below the crown. Flap gate on the waterside (WS) end. Concrete U-shaped headwall on each end. Grouted riprap apron on the landside (LS) end. Grouted riprap spillway on the WS end. [Additional Reference(s): DWR Levee Log, 1992. USACE Sacramento O&M Manual 504, May 1965, (HLM 0.28)]. FS Date: 3/25/2021 2:10:39 PM

Top of Levee: View of levee crown looking downstream

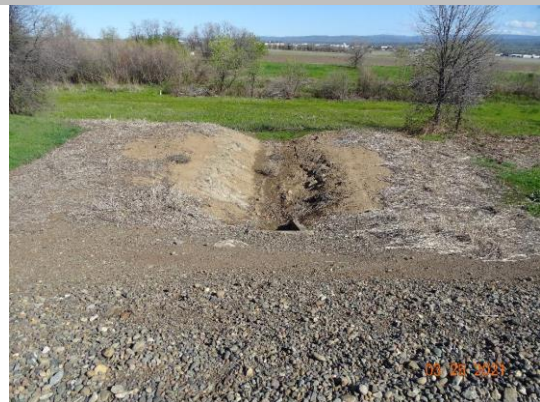
Photo 2 of 3 : UCIP_FA_2021_67692_100581.jpg

Water-Side: View of levee slope looking from crown

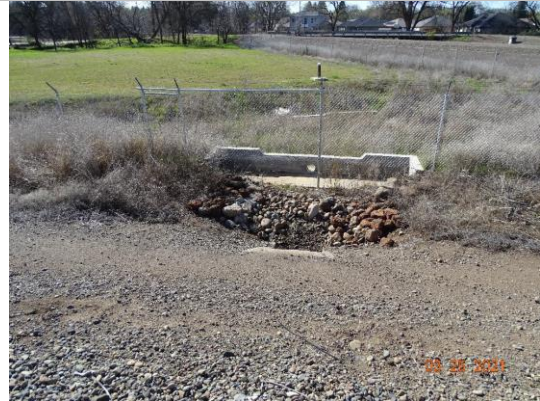
Photo 3 of 3 : UCIP_FA_2021_67692_100582.jpg

Land-Side: View of levee slope looking from crown

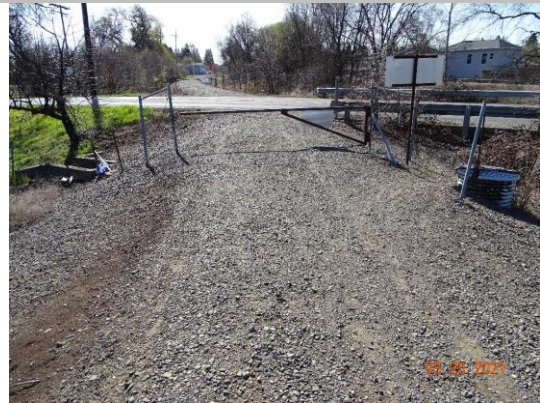
Photo 1 of 3 : UCIP_FA_2021_67693_100586.jpg

DS_ID:19280
FS_ID:67693
EP_NO: N/A
Repair Type: Non-Urgent
EVAL Issue: Unauthorized Encroachment, installed decades prior
Crossing Status: Found
UCIP Comments: 03/25/2021 Record remains Non-Urgent. Debris around on inlet has been cleared. No permit has been identified authorizing pipe. DMP internal video inspection has not found pipe integrity issues. LOF of crossing is less or equal to 4. Recommend next video inspection in 5 years. (O.Yakimov - DWR UCIP)
03/07/2014 Slide gate in a CMP riser. Vegetation debris and mud on inlet box. Needs cleaning and clearing the culvert. (P. Amatya - DWR UCIP)
FIELD_STRUCT_DESC: 24-inch corrugated metal gravity drainage pipe through the levee and under the channel, 9.5 feet below the crown. Slide gate in a corrugated metal pipe (CMP) riser on the waterside (WS) slope. Concrete U-shaped headwall on the landside (LS) end.
[Additional Reference(s): DWR Levee Log, 1992. USACE Sacramento O&M Manual 504, May 1965, (HLM 0.34)].

Top of Levee: View of levee crown looking upstream

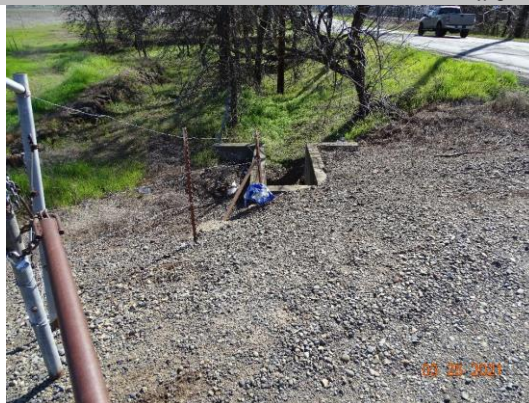
Photo 2 of 3 : UCIP_FA_2021_67693_100588.jpg

Land-Side: View of levee slope looking from crown

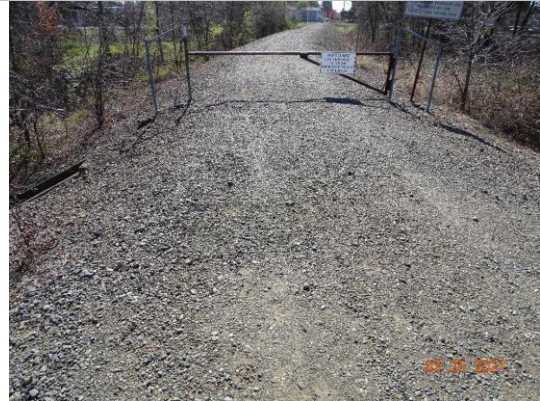
Photo 1 of 3 : UCIP_FA_2021_67694_100592.jpg

Comment Code					
Inspector Comment					
DS_ID:19281 FS_ID:67694 EP_NO: N/A Repair Type: Urgent EVAL Issue: Flood Risk Crossing Status: Found UCIP Comments: 03/25/2021 Record updated from Non-Urgent to Urgent. Debris inside pipe holds flap gate from complete closing. Backflow may cause flood risk to landside. No permit has been identified authorizing pipe. DMP internal video inspection has not found pipe integrity issues. LOF of crossing is less or equal to 4. Recommend next video inspection in 5 years. (O.Yakimov - DWR UCIP) 03/07/2014 Needs cleaning and clearing the culvert. (P. Amatya - DWR UCIP) FIELD_STRUCT_DESC: 24-inch corrugated metal gravity drainage pipe through the levee, 8 feet below the crown. Flap gate on the waterside (WS) end. Concrete U-shaped headwall on each end. Grouted riprap apron on the landside (LS) end. Grouted riprap spillway on the WS end. [Additional Reference(s): DWR Levee Log, 1992. USACE Sacramento O&M Manual 504, May 1965, (HLM 0.36)]. FS Date: 3/25/2021 2:21:16 PM

Top of Levee: View of levee crown looking downstream

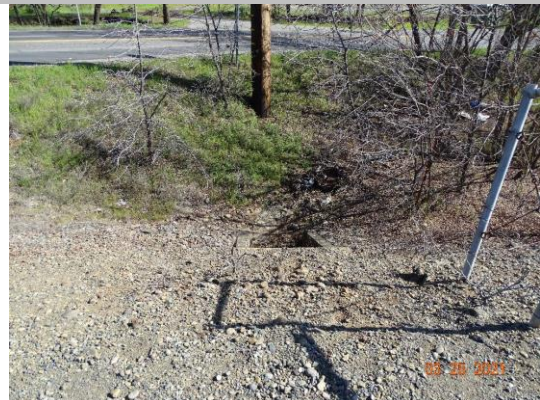
Photo 2 of 3 : UCIP_FA_2021_67694_100593.jpg

Land-Side: View of levee slope looking from crown

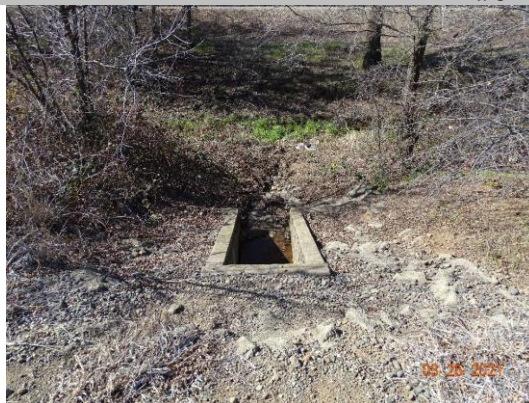
Photo 3 of 3 : UCIP_FA_2021_67694_100594.jpg

Water-Side: View of levee slope looking from crown

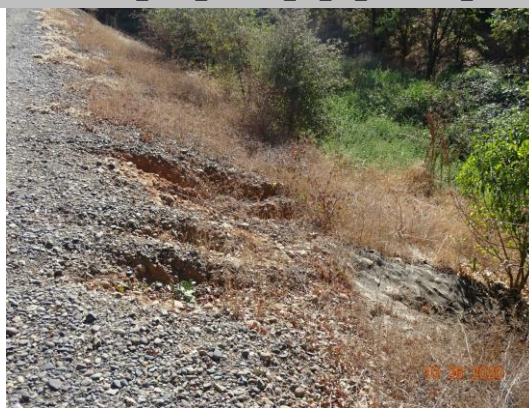
Photo 1 of 1 : FA_2021_NA0003_68_26_20211011_00005.jpg

Erosion rills are located in this area. The storm inlet on the landside may not be functioning properly and may impact ability to access the patrol road.

View of the erosion on the waterside slope. Fall 2020.

E2 : Schedule repair of erosion site prior to the next inspection.

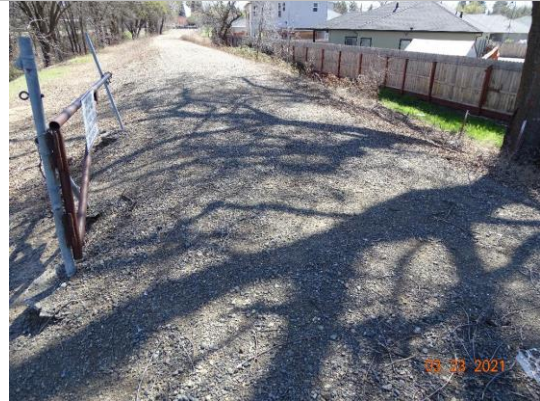
Photo 1 of 3 : UCIP_FA_2021_67765_100840.jpg

Comment Code						
Inspector Comment						
DS_ID:19287 FS_ID:67765 EP_NO: N/A Repair Type: Non-Urgent EVAL Issue: Unauthorized Encroachment, installed decades prior Crossing Status: Found UCIP Comments: 03/23/2021 Record remains Non-Urgent. Debris has been cleared. No permit has been identified authorizing pipe. DMP internal video inspection has not found pipe integrity issues. LOF of crossing is less or equal to 4. Recommend next video inspection in 5 years. (O.Yakimov - DWR UCIP) 03/07/2014 Needs cleaning and clearing the culvert. (P. Amatya - DWR UCIP) FIELD_STRUCT_DESC: 24-inch corrugated metal gravity drainage pipe through the levee, 9 feet below the crown. Flap gate on the waterside (WS) end. Concrete U-shaped headwall on each end. Grouted riprap apron on the landside (LS) end. Grouted riprap spillway on the WS end. [Additional Reference(s): DWR Levee Log, 1992. USACE Sacramento O&M Manual 504, May 1965, (HLM 0.96)]. FS Date: 3/23/2021 2:28:32 PM

Top of Levee: View of levee crown looking upstream

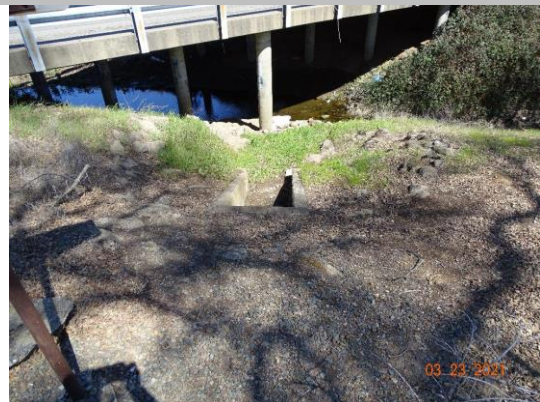
Photo 2 of 3 : UCIP_FA_2021_67765_100841.jpg

Water-Side: View of levee slope looking from crown

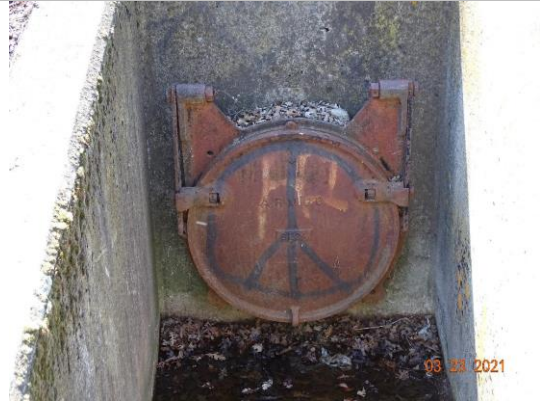
Photo 3 of 3 : UCIP_FA_2021_67765_100845.jpg

Water-Side: Headwall and flap gate at levee toe

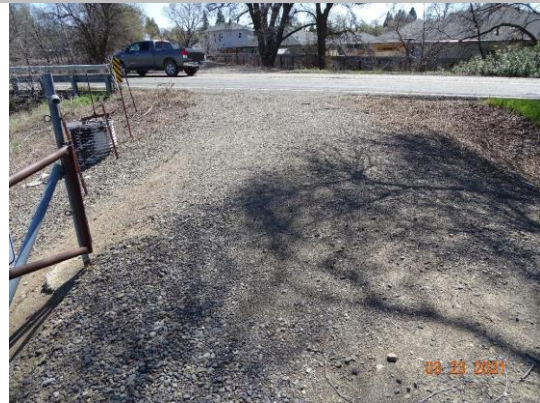
Photo 1 of 3 : UCIP_FA_2021_67774_100884.jpg

DS_ID:19288
FS_ID:67774
EP_NO: N/A
Repair Type: Non-Urgent
EVAL Issue: Pipe Damage
Crossing Status: Found
UCIP Comments: 03/23/2021 Record remains Non-Urgent. DMP internal video inspection has found pipe integrity issues. LOF of crossing is greater than or equal to 4.1 and less than 5. Crossing will be monitored until funding becomes available for rehabilitation. No permit has been identified authorizing pipe. (O.Yakimov - DWR UCIP)
03/07/2014 Slide gate in CMP riser on waterside. No access to CMP riser. Needs cleaning and clearing the culvert. (P. Amaty - DWR UCIP)
FIELD_STRUCT_DESC: 24-inch corrugated metal gravity drainage pipe through the levee and under the channel, 9.5 feet below the crown. Slide gate in a pipe riser on the waterside (WS) slope. Concrete U-shaped headwall on the landside (LS) end. [Additional Reference(s): DWR Levee Log, 1992. USACE Sacramento O&M Manual 504, May 1965, (HLM 0.98)].

Top of Levee: View of levee crown looking upstream

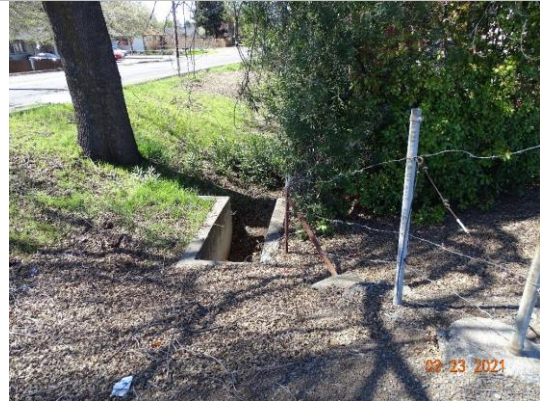
Photo 2 of 3 : UCIP_FA_2021_67774_100885.jpg

Land-Side: View of levee slope looking from crown

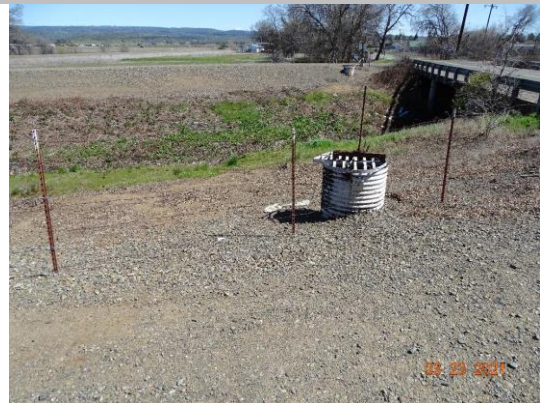
Photo 3 of 3 : UCIP_FA_2021_67774_100886.jpg

Water-Side: View of levee slope looking from crown. CMP riser with slide gate on levee slope

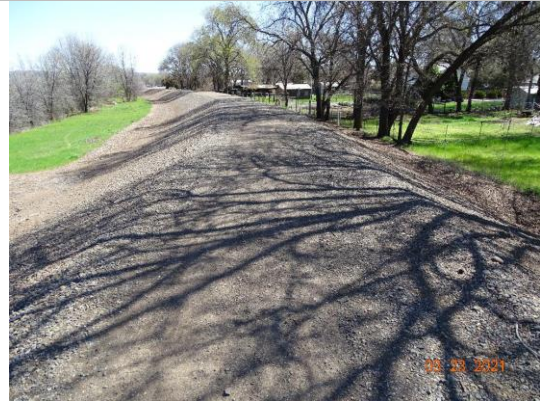
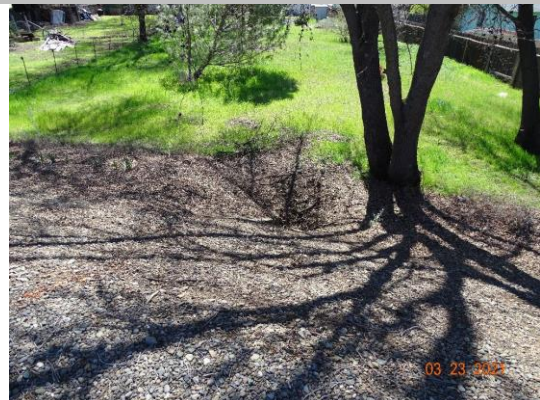
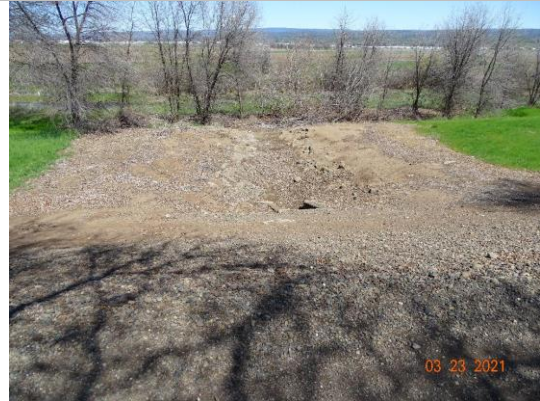
Comment Code						
Inspector Comment						
DS_ID:19289 FS_ID:67776 EP_NO: N/A Repair Type: Non-Urgent EVAL Issue: Maintenance Compliance Issue Crossing Status: Found UCIP Comments: 03/23/2021 Record remains Non-Urgent. Flap gate at waterside headwall is stuck closed. Hinges may need lubrication. No permit has been identified authorizing pipe. DMP internal video inspection has not found pipe integrity issues. LOF of crossing is less or equal to 4. Recommend next video inspection in 5 years. (O.Yakimov - DWR UCIP) 03/07/2014 Needs cleaning and clearing the culvert. (P. Amatya - DWR UCIP) FIELD_STRUCT_DESC: 24-inch corrugated metal gravity drainage pipe through the levee, 11 feet below the crown. Flap gate on the waterside (WS) end. Concrete U-shaped headwall on each end. Grouted riprap apron on the landside (LS) end. Grouted riprap spillway on the WS end. [Additional Reference(s): DWR Levee Log, 1992. USACE Sacramento O&M Manual 504, May 1965, (HLM 1.15)]. FS Date: 3/23/2021 3:10:19 PM

Top of Levee: View of levee crown looking upstream

Land-Side: View of levee slope looking from crown

Water-Side: View of levee slope looking from crown

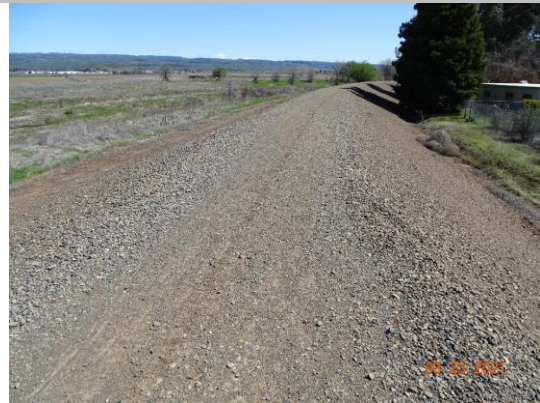
Photo 1 of 3 : UCIP_FA_2021_67777_100900.jpg

DS_ID:19290
FS_ID:67777
EP_NO: N/A
Repair Type: Non-Urgent
EVAL Issue: Unauthorized Encroachment, installed decades prior
Crossing Status: Found
UCIP Comments: 03/23/2021 Record remains Non-Urgent. Debris has been cleared. No permit has been identified authorizing pipe. DMP internal video inspection has not found pipe integrity issues. LOF of crossing is less or equal to 4. Recommend next video inspection in 5 years. (O.Yakimov - DWR UCIP)
03/07/2014 Needs cleaning and clearing the culvert. (P. Amatya - DWR UCIP)
FIELD_STRUCT_DESC: 24-inch corrugated metal gravity drainage pipe through the levee, 13 feet below the crown. Flap gate on the waterside (WS) end. Concrete U-shaped headwall on each end. Grouted riprap apron on the landside (LS) end. Grouted riprap spillway on the WS end. [Additional Reference(s): DWR Levee Log, 1992. USACE Sacramento O&M Manual 504, May 1965, (HLM 1.41)].
FS Date: 3/23/2021 3:14:57 PM

Top of Levee: View of levee crown looking upstream

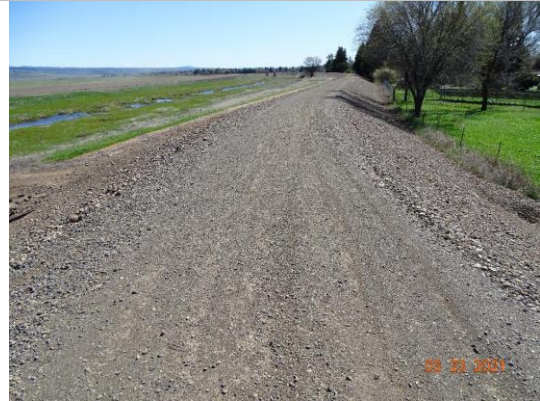
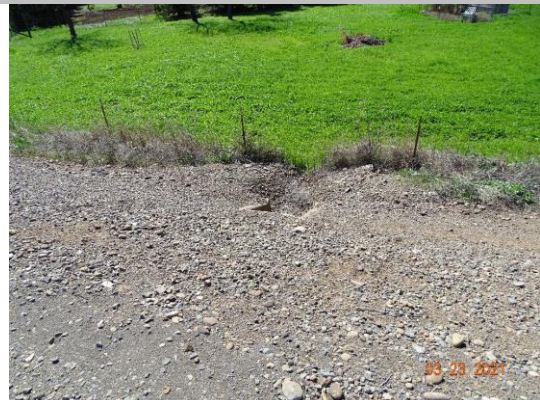
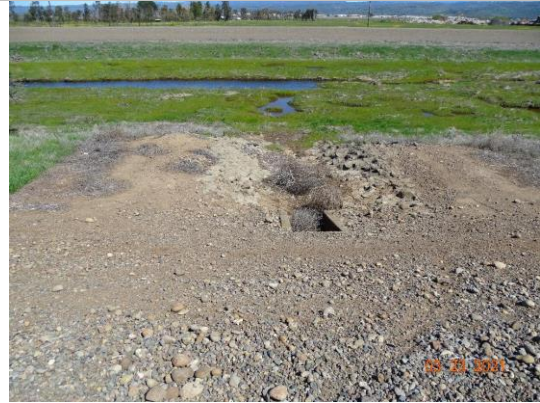
Comment Code					
Inspector Comment					
DS_ID:19291 FS_ID:67779 EP_NO: N/A Repair Type: Non-Urgent EVAL Issue: Pipe Damage Crossing Status: Found UCIP Comments: 03/23/2021 Record remains Non-Urgent. Debris has been cleared. DMP internal video inspection has found pipe integrity issues. LOF of crossing is greater than or equal to 4.1 and less than 5. Crossing will be monitored until funding becomes available for rehabilitation. No permit has been identified authorizing pipe. (O.Yakimov - DWR UCIP) 03/07/2014 Needs cleaning and clearing the culvert. (P. Amatya - DWR UCIP) FIELD_STRUCT_DESC: 24-inch corrugated metal gravity drainage pipe through the levee, 11 feet below the crown. Flap gate on the waterside (WS) end. Concrete U-shaped headwall on each end. Grouted riprap apron on the landside (LS) end. Grouted riprap spillway on the WS end. [Additional Reference(s): DWR Levee Log, 1992. USACE Sacramento O&M Manual 504, May 1965, (HLM 2.22)]. FS Date: 3/23/2021 3:17:08 PM

Top of Levee: View of levee crown looking upstream

Land-Side: View of levee slope looking from crown

Water-Side: View of levee slope looking from crown

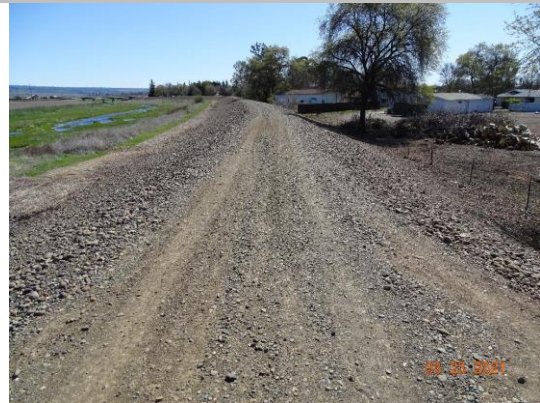
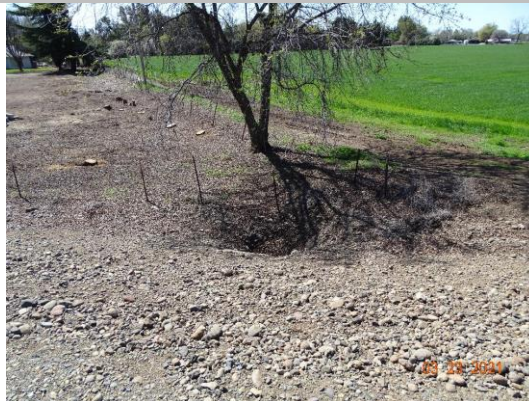
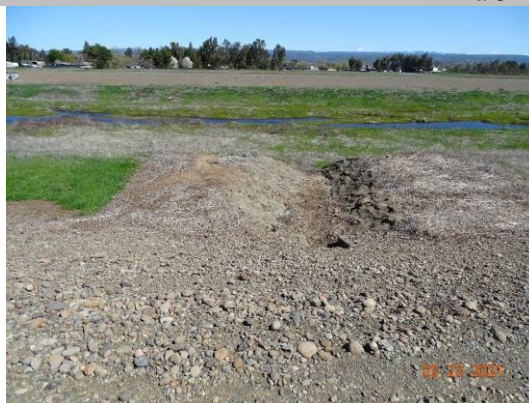
DS_ID:19292
FS_ID:67780
EP_NO: N/A
Repair Type: Non-Urgent
EVAL Issue: Pipe Damage
Crossing Status: Found
UCIP Comments: 03/23/2021 Record remains Non-Urgent. Debris has been cleared. DMP internal video inspection has found pipe integrity issues. LOF of crossing is greater than or equal to 4.1 and less than 5. Crossing will be monitored until funding becomes available for rehabilitation. No permit has been identified authorizing pipe. (O.Yakimov - DWR UCIP)
03/07/2014 Needs cleaning and clearing the culvert. (P. Amatya - DWR UCIP)
FIELD_STRUCT_DESC: 24-inch corrugated metal gravity drainage pipe through the levee, 11 feet below the crown. Flap gate on the waterside (WS) end. Concrete U-shaped headwall on each end. Grouted riprap apron on the landside (LS) end. Grouted riprap spillway on the WS end. [Additional Reference(s): DWR Levee Log, 1992. USACE Sacramento O&M Manual 504, May 1965, (HLM 2.56)].

Top of Levee: View of levee crown looking upstream

Land-Side: View of levee slope looking from crown

Water-Side: View of levee slope looking from crown

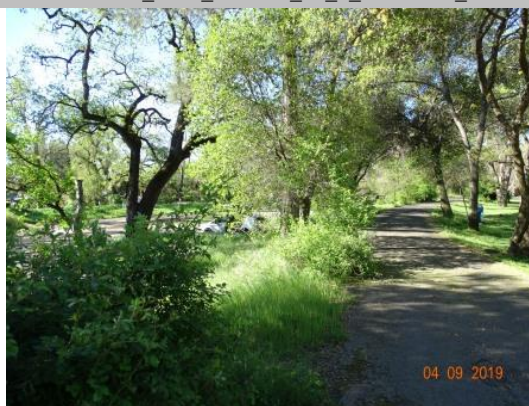
Photo 1 of 1 : FA_2021_NA0003_69_1_20211011_00001.jpg

View of the wild growth on the landside slope. Spring 2019.

LM Start	0.03	Rating **	M	Issue No.	1
LM End	0.20	Issue Type +	Ma	Location *	LS
Category	Earthen Levee			GPS Latitude/Longitude	
				Start	End
Item	Vegetation			39.763164 °	39.761860 °
				-121.790335 °	-121.792635 °
DWR ID	DWR_NA0003_05_s_2012_1				
Comment Code					
V2 : Remove the wild growth other than native grasses from the levee slopes.					
Inspector Comment
