**Flood Control Project Maintenance
Levee Inspections**

Maintenance Issue Types Only, Levee Inspection Report By Mile - Fall 2022

Butte County Department of Public Works

Waterway	Bank	Unit Miles	Inspection Start/End	Inspector
Unit No. 01 Mud Creek	Right	6.80	10/04/2022 10/04/2022	Makar Sokol

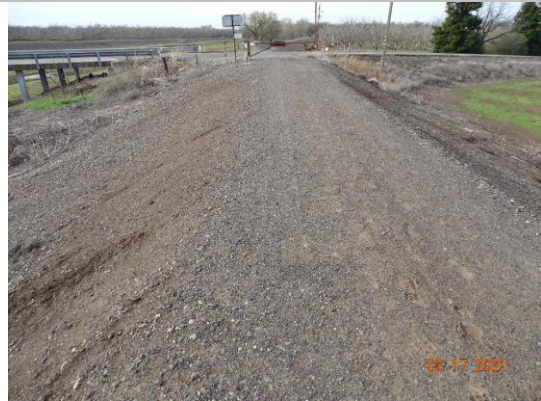
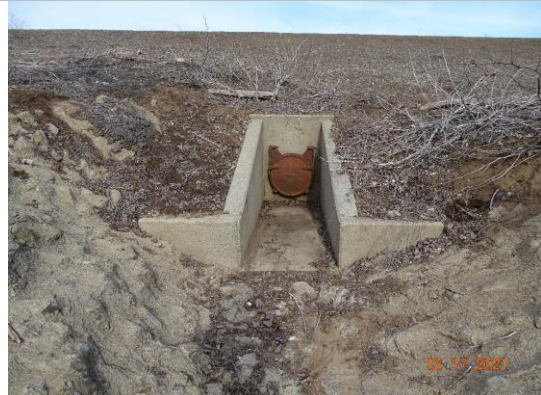
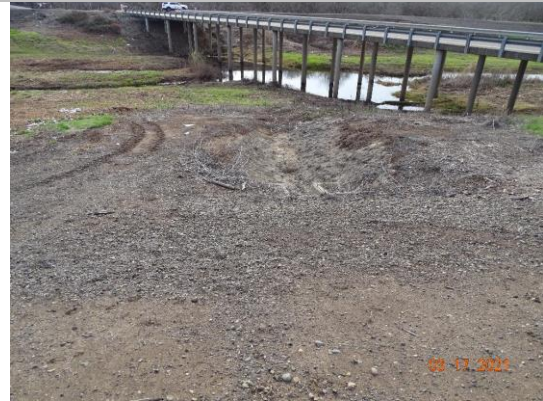
Photo 1 of 3 : UCIP_FA_2022_67236_99222.jpg

Comment Code						
Inspector Comment						
DS_ID:19209 FS_ID:67236 EP_NO: N/A Repair Type: Urgent EVAL Issue: 1, Pipe Integrity Crossing Status: Found UCIP Comments: 03/17/2021 Record updated from No Action Needed to Urgent. DMP internal video inspection has found pipe integrity issues. LOF of crossing is between 5 and 6. Crossing will be monitored until funding becomes available to address the issues. No permit has been identified authorizing pipe. (O.Yakimov - DWR UCIP) 02/20/2014 Looks cleaned recently. (P. Amatya - DWR UCIP) FIELD_STRUCT_DESC: 24-inch corrugated metal gravity drainage pipe through the levee, 12.5 feet below the crown. Flap gate on the waterside (WS) end. Concrete U-shaped headwall on each end. Grouted riprap apron on the landside (LS) end. Grouted riprap spillway on the WS end. [Additional Reference(s): DWR Levee Log, 1992 (HLM 0.26). USACE Sacramento O&M Manual, Unit 504, May 1965, Revised 2 February 2011, (HLM 0.26), listed as 24-inch pipe. USACE As-Built Drawing No. 50-04-3685, Sheet 41 table of drainage structures, STA 92+46, 19 May 1965]. FS Date: 3/17/2021 8:31:45 AM

LM Start	0.25	Rating **	U	Issue No.	64 (cont)
LM End	0.25	Issue Type +	Ma	Location *

Top of Levee: View of levee crown looking downstream

Water-Side: Headwall and flap gate at levee toe

Water-Side: View of levee slope looking from crown

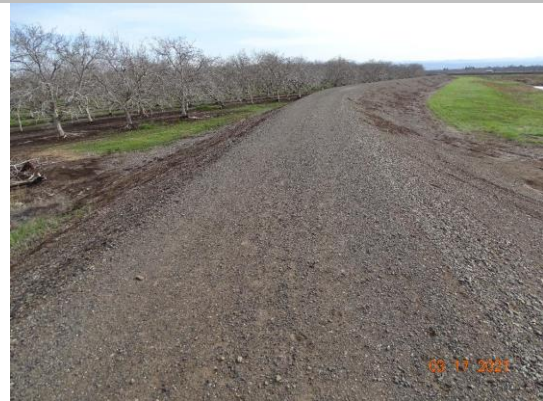
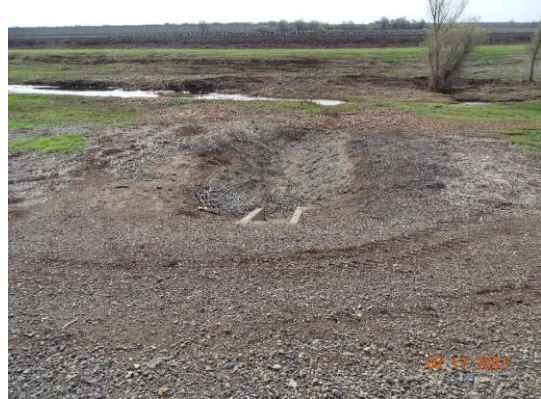
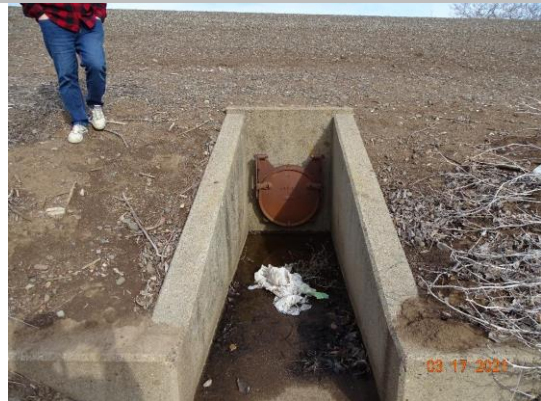
Photo 1 of 3 : UCIP_FA_2022_67238_99231.jpg

DS_ID:19211
FS_ID:67238
EP_NO: N/A
Repair Type: Non-Urgent
EVAL Issue: 5, Pipe Damage
Crossing Status: Found
UCIP Comments: 03/17/2021 Record remains Non-Urgent. Vegetation on waterside has been cleared. No permit has been identified authorizing pipe. DMP internal video inspection has found pipe integrity issues. LOF of crossing is greater than or equal to 4.1 and less than 5. Crossing will be monitored until funding becomes available for rehabilitation. (O.Yakimov - DWR UCIP)
02/20/2014 Vegetation debris on waterside. Needs clearing and cleaning. (P. Amatya - DWR UCIP)
FIELD_STRUCT_DESC: 24-inch corrugated metal gravity drainage pipe through the levee, 12 feet below the crown. Flap gate on the waterside (WS) end. Concrete U-shaped headwall on each end. Grouted riprap apron on the landside (LS) end. Grouted riprap spillway on the WS end. [Additional Reference(s): DWR Levee Log, 1992 (HLM 1.01). USACE Sacramento O&M Manual, Unit 504, May 1965, Revised 2 February 2011, (HLM 1.03), listed as 24-inch pipe. USACE As-Built Drawing No. 50-04-3685, Sheet 3, STA 132+00, 19 May 1965. USACE As-Built Drawing No. 50-04-3685, Sheet 41 table of drainage structures, STA 132+00, 19 May 1965].

Top of Levee: View of levee crown looking upstream

Water-Side: View of levee slope looking from crown

Water-Side: Headwall and flap gate at levee toe

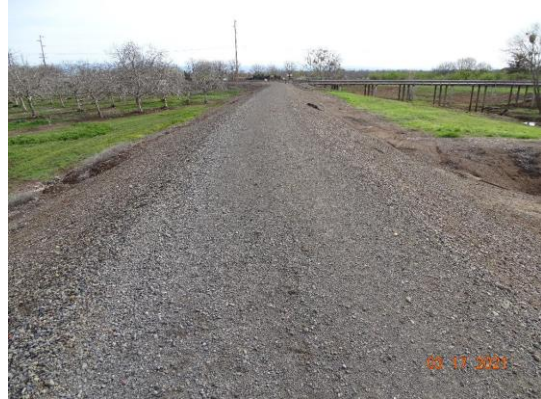
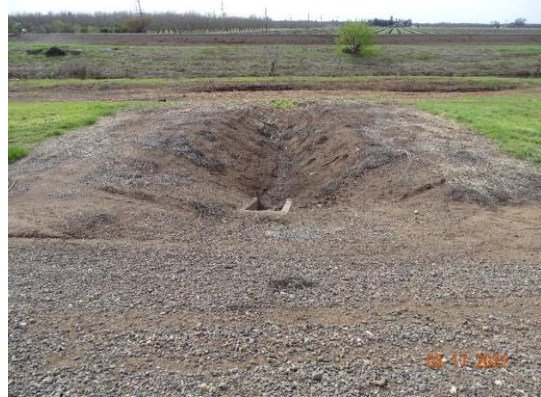
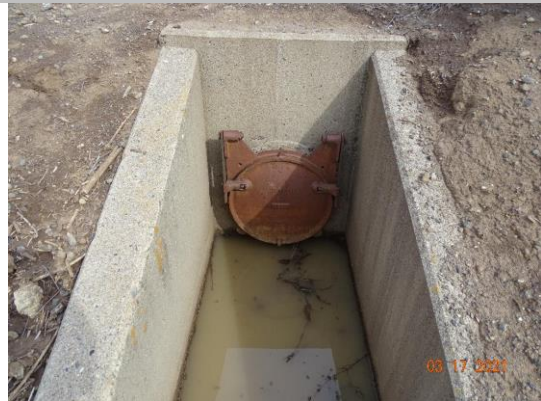
Photo 1 of 3 : UCIP_FA_2022_67239_99237.jpg

Comment Code						
Inspector Comment						
DS_ID:19212 FS_ID:67239 EP_NO: N/A Repair Type: Non-Urgent EVAL Issue: Crossing Status: Found UCIP Comments: 03/17/2021 Record updated from No Action Needed to Non-Urgent. No permit has been identified authorizing pipe. DMP internal video inspection has not found pipe integrity issues. LOF of crossing is less or equal to 4.0. Recommend next video inspection in 5 years. (O.Yakimov - DWR UCIP) 08/29/2016: Shawn Bates of NA0003 has cleared the LS and WS of debris and blockage; WS gate functions properly now. Crossing has been downgraded from Urgent to No Action Needed. (K. Fazel - UCIP) 08/11/2016: Same as last inspection. (K. Fazel - UCIP) 02/20/2014: No riprap spillway on waterside. Needs cleaning and clearing of debris. Flap gate was not fully closed. (P. Amatya - DWR UCIP) FIELD_STRUCT_DESC: 24-inch corrugated metal gravity drainage pipe through the levee, 13 feet below the crown. Flap gate on the waterside (WS) end. Concrete U-shaped headwall on each end. Grouted riprap apron on the landside (LS) end. Grouted riprap spillway on the WS end. [Additional Reference(s): DWR Levee Log, 1992 (HLM 1.90). USACE Sacramento O&M Manual, Unit 504, May 1965, Revised 2 February 2011, (HLM 1.95), listed as 24-inch pipe. USACE As-Built Drawing No. 50-04-3685, Sheet 4, STA 179+60, 19 May 1965. USACE As-Built Drawing No. 50-04-3685, Sheet 41 table of drainage structures, STA 179+60, 19 May 1965]. FS Date: 3/17/2021 9:01:17 AM

Top of Levee: View of levee crown looking upstream

Water-Side: View of levee slope looking from crown

Water-Side: Headwall and flap gate at levee toe

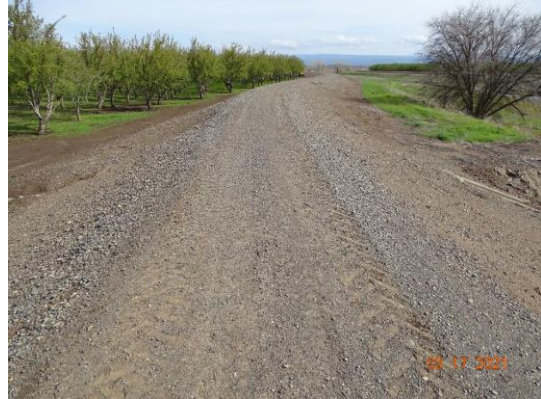
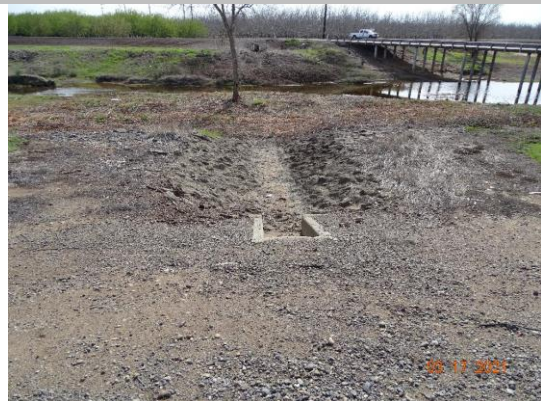
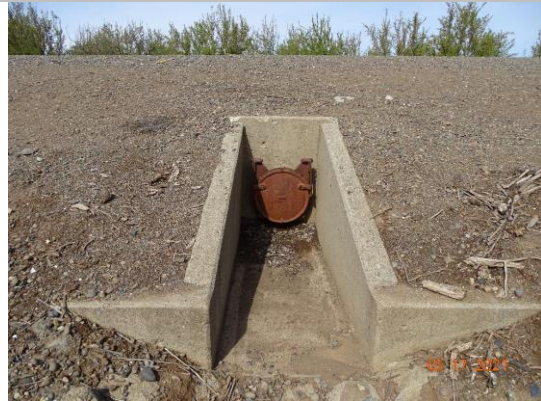
Photo 1 of 3 : UCIP_FA_2022_67246_99270.jpg

Comment Code					
Inspector Comment					
DS_ID:19216 FS_ID:67246 EP_NO: N/A Repair Type: Non-Urgent EVAL Issue: Crossing Status: Found UCIP Comments: 03/17/2021 Record remains Non-Urgent. No permit has been identified authorizing pipe. DMP internal video inspection has not found pipe integrity issues. LOF of crossing is less or equal to 4.0. Recommend next video inspection in 5 years. (O.Yakimov - DWR UCIP) 02/20/2014 Inlet and outlet needs cleaning and clearing of debris. (P. Amatya - DWR UCIP) FIELD_STRUCT_DESC: 24-inch corrugated metal gravity drainage pipe through the levee, 8.5 feet below the crown. Flap gate on the waterside (WS) end. Concrete U-shaped headwall on each end. Grouted riprap apron on the landside (LS) end. Grouted riprap spillway on the WS end. [Additional Reference(s): DWR Levee Log, 1992 (HLM 3.11). USACE Sacramento O&M Manual, Unit 504, May 1965, Revised 2 February 2011, (HLM 3.11), listed as 24-inch pipe. USACE As-Built Drawing No. 50-04-3685, Sheet 5, STA 239+60, 19 May 1965. USACE As-Built Drawing No. 50-04-3685, Sheet 41 table of drainage structures, STA 239+60, 19 May 1965]. FS Date: 3/17/2021 10:06:03 AM

LM Start	3.03	Rating **	M	Issue No.	67 (cont)
LM End	3.03	Issue Type +	Ma	Location *

Top of Levee: View of levee crown looking upstream

Water-Side: View of levee slope looking from crown

Water-Side: Headwall and flap gate at levee toe

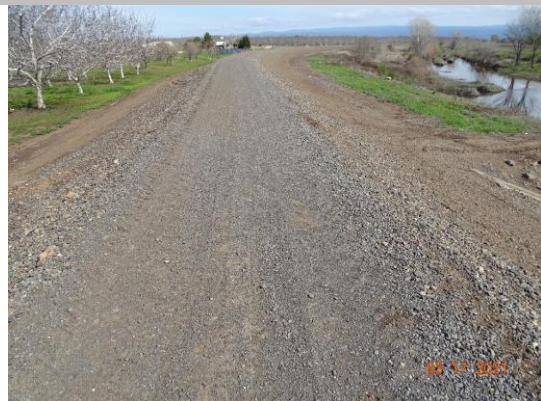
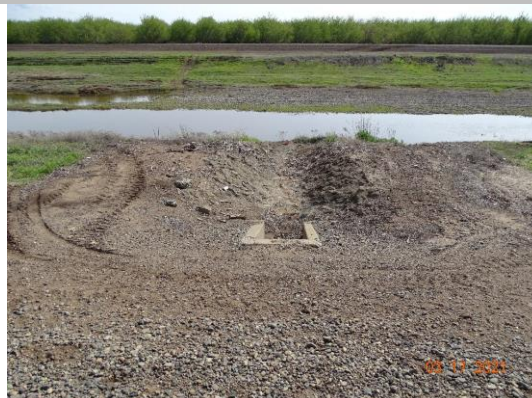
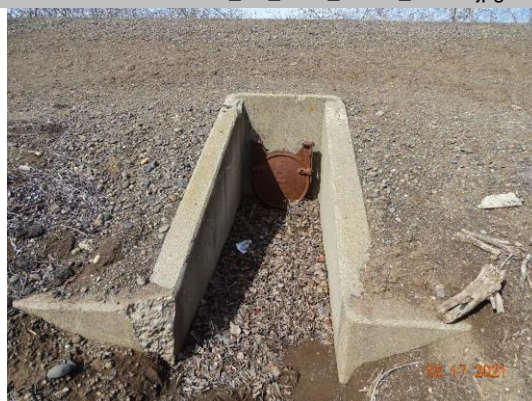
Photo 1 of 3 : UCIP_FA_2022_67247_99276.jpg

DS_ID:19217
 FS_ID:67247
 EP_NO: N/A
 Repair Type: Non-Urgent
 EVAL Issue:
 Crossing Status: Found
 UCIP Comments: 03/17/2021 Record remains Non-Urgent. No permit has been identified authorizing pipe. DMP internal video inspection has not found pipe integrity issues. LOF of crossing is less or equal to 4.0. Recommend next video inspection in 5 years. Debris has been cleared. (O.Yakimov - DWR UCIP)
 02/20/2014 It needs cleaning and clearing in inlet and outlet ends. (P. Amatya - DWR UCIP)
 FIELD_STRUCT_DESC: 24-inch corrugated metal gravity drainage pipe through the levee, 9 feet below the crown. Flap gate on the waterside (WS) end. Concrete U-shaped headwall on each end. Grouted riprap apron on the landside (LS) end. Grouted riprap spillway on the WS end. [Additional Reference(s): DWR Levee Log, 1992 (HLM 3.27). USACE Sacramento O&M Manual, Unit 504, May 1965, Revised 2 February 2011, (HLM 3.27), listed as 24-inch pipe. USACE As-Built Drawing No. 50-04-3685, Sheet 5, STA 247+60, 19 May 1965. USACE As-Built Drawing No. 50-04-3685, Sheet 41 table of drainage structures, STA 247+60, 19 May 1965].

Top of Levee: View of levee crown looking upstream

Water-Side: View of levee slope looking from crown

Water-Side: Headwall and flap gate at levee toe

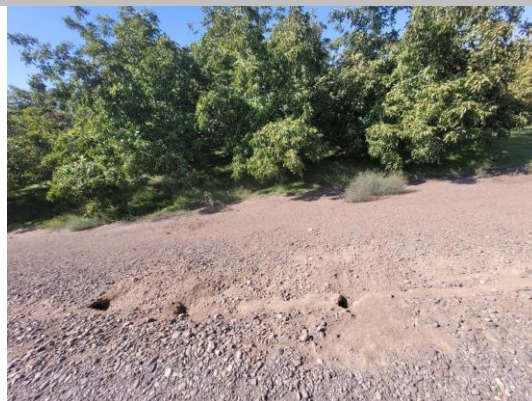
Photo 1 of 1 : FA_2022_NA0003_64_27_20221011_00067.jpg

LM Start	3.19	Rating **	M	Issue No.	27
LM End	3.26	Issue Type +	Ma	Location *	LS
Category	Earthen Levee			GPS Latitude/Longitude	
				Start	End
Item	Animal Control			39.763087 °	39.764081 °
				-121.909616 °	-121.909045 °
DWR ID	DWR_NA0003_01_f_2022_27				
Comment Code					
A3 : No rodents visible, but rodent burrows visible; need to backfill and compact or grout burrows.					
Inspector Comment

View of animal burrows along the landside slope. Fall 2022.

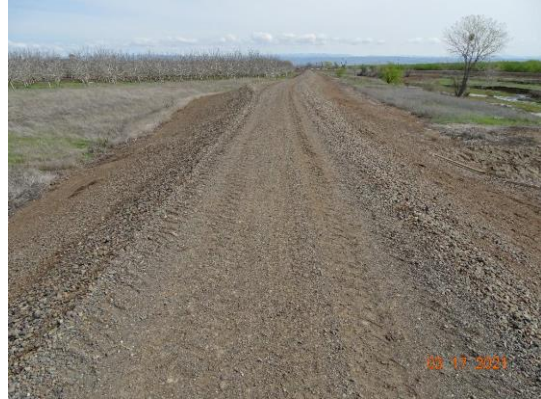
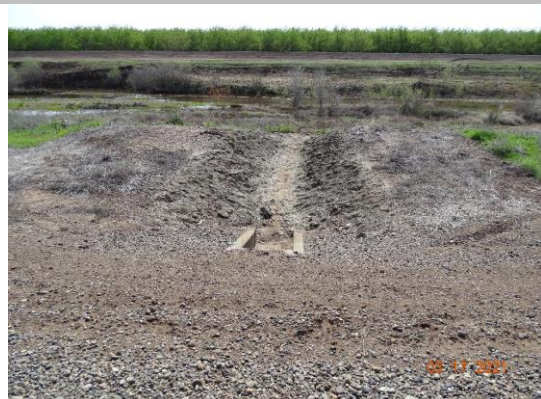
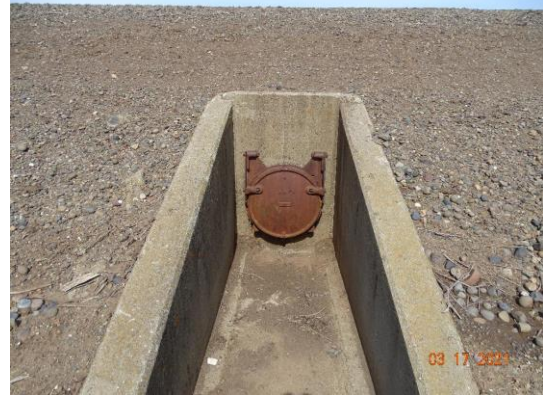
Photo 1 of 3 : UCIP_FA_2022_67248_99282.jpg

Comment Code						
Inspector Comment						
DS_ID:19218 FS_ID:67248 EP_NO: N/A Repair Type: Non-Urgent EVAL Issue: Crossing Status: Found UCIP Comments: 03/17/2021 Record remains Non-Urgent. No permit has been identified authorizing pipe. DMP internal video inspection has not found pipe integrity issues. LOF of crossing is less or equal to 4.0. Recommend next video inspection in 5 years. (O.Yakimov - DWR UCIP) 02/20/2014 Needs cleaning and clearing of debris. (P. Amatya - DWR UCIP) FIELD_STRUCT_DESC: 24-inch corrugated metal gravity drainage pipe through the levee, 10 feet below the crown. Flap gate on the waterside (WS) end. Concrete U-shaped headwall on each end. Grouted riprap apron on the landside (LS) end. Grouted riprap spillway on the WS end. [Additional Reference(s): DWR Levee Log, 1992 (HLM 3.48). USACE Sacramento O&M Manual, Unit 504, May 1965, Revised 2 February 2011, (HLM 3.48), listed as 24-inch pipe. USACE As-Built Drawing No. 50-04-3685, Sheet 5, STA 258+70, 19 May 1965. USACE As-Built Drawing No. 50-04-3685, Sheet 41 table of drainage structures, STA 258+70, 19 May 1965]. FS Date: 3/17/2021 10:18:14 AM

LM Start	3.39	Rating **	M	Issue No.	69 (cont)
LM End	3.39	Issue Type +	Ma	Location *

Top of Levee: View of levee crown looking upstream

Water-Side: View of levee slope looking from crown

Water-Side: Headwall and flap gate at levee toe

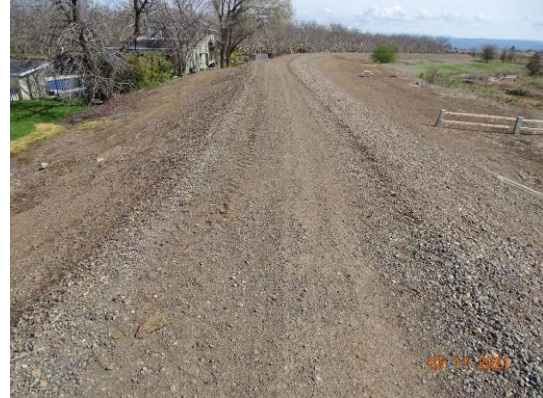
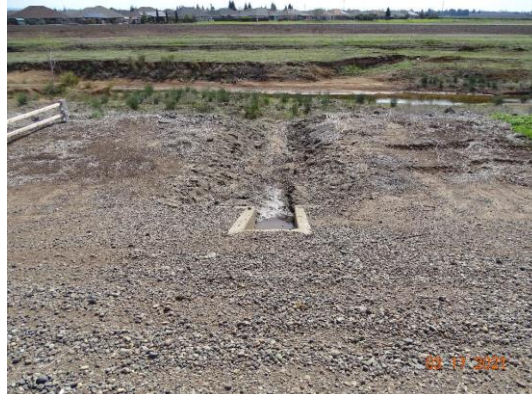
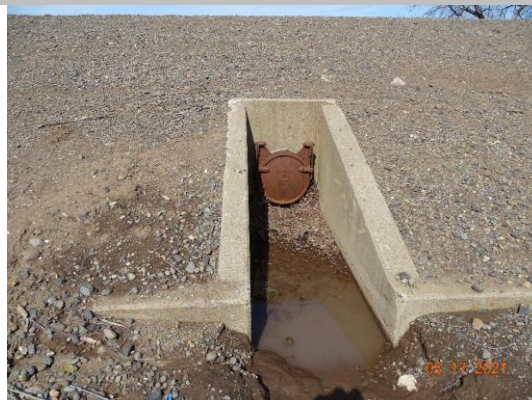
Photo 1 of 3 : UCIP_FA_2022_67249_99288.jpg

DS_ID:19219
FS_ID:67249
EP_NO: N/A
Repair Type: Non-Urgent
EVAL Issue:
Crossing Status: Found
UCIP Comments: 03/17/2021 Record remains Non-Urgent. No permit has been identified authorizing pipe. DMP internal video inspection has not found pipe integrity issues. LOF of crossing is less or equal to 4.0. Recommend next video inspection in 5 years. (O.Yakimov - DWR UCIP)
02/20/2014 Needs cleaning and clearing of debris in both ends of the pipe. (P. Amatya - DWR UCIP)
FIELD_STRUCT_DESC: 24-inch corrugated metal gravity drainage pipe through the levee, 9 feet below the crown. Flap gate on the waterside (WS) end. Concrete U-shaped headwall on each end. Grouted riprap apron on the landside (LS) end. Grouted riprap spillway on the WS end. [Additional Reference(s): DWR Levee Log, 1992 (HLM 4.08). USACE Sacramento O&M Manual, Unit 504, May 1965, Revised 2 February 2011, (HLM 4.08), listed as 24-inch pipe. USACE As-Built Drawing No. 50-04-3685, Sheet 41 table of drainage structures, STA 289+20, 19 May 1965].

Top of Levee: View of levee crown looking upstream

Water-Side: View of levee slope looking from crown

Water-Side: Headwall and flap gate at levee toe

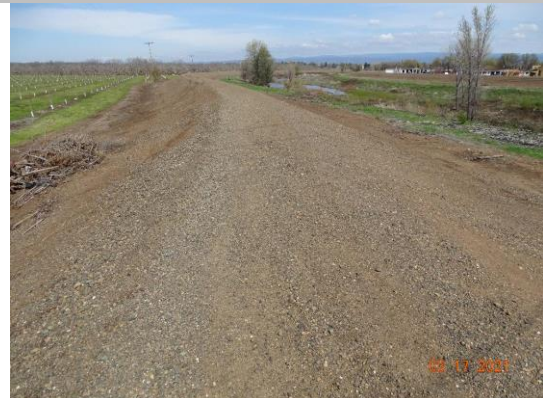
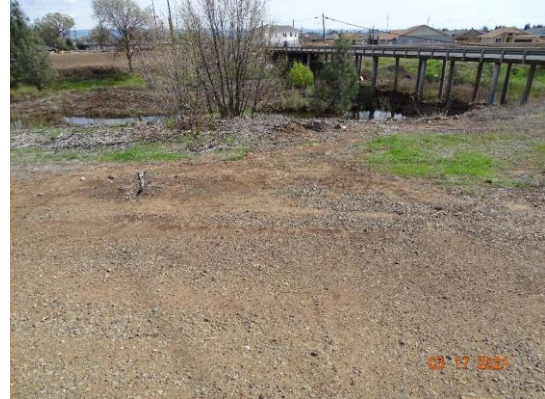
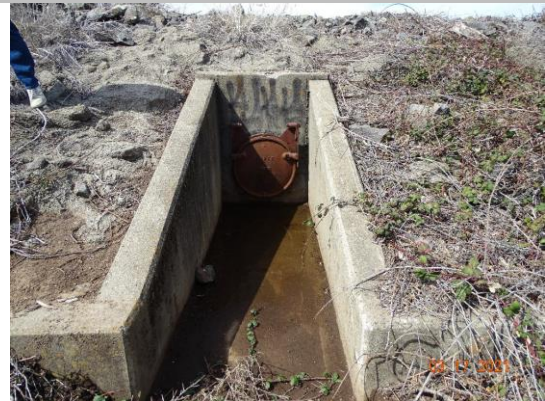
Photo 1 of 3 : UCIP_FA_2022_67250_99294.jpg

Comment Code					
Inspector Comment					
DS_ID:19220 FS_ID:67250 EP_NO: N/A Repair Type: Non-Urgent EVAL Issue: Crossing Status: Found UCIP Comments: 03/17/2021 Record remains Non-Urgent. Debris has been cleared. No permit has been identified authorizing pipe. DMP internal video inspection has not found pipe integrity issues. LOF of crossing is less or equal to 4.0. Recommend next video inspection in 5 years. (O.Yakimov - DWR UCIP) 02/20/2014 Needs cleaning and clearing of debris. (P. Amatya - DWR UCIP) FIELD_STRUCT_DESC: 24-inch corrugated metal gravity drainage pipe through the levee, 13 feet below the crown. Flap gate on the waterside (WS) end. Concrete U-shaped headwall on each end. Grouted riprap apron on the landside (LS) end. Grouted riprap spillway on the WS end. [Additional Reference(s): DWR Levee Log, 1992 (HLM 4.57). USACE Sacramento O&M Manual, Unit 504, May 1965, Revised 2 February 2011, (HLM 4.58), listed as 24-inch pipe. USACE As-Built Drawing No. 50-04-3685, Sheet 6, STA 315+18, 19 May 1965]. FS Date: 3/17/2021 10:24:31 AM

Top of Levee: View of levee crown looking upstream

Water-Side: View of levee slope looking from crown

Water-Side: Headwall and flap gate on levee slope

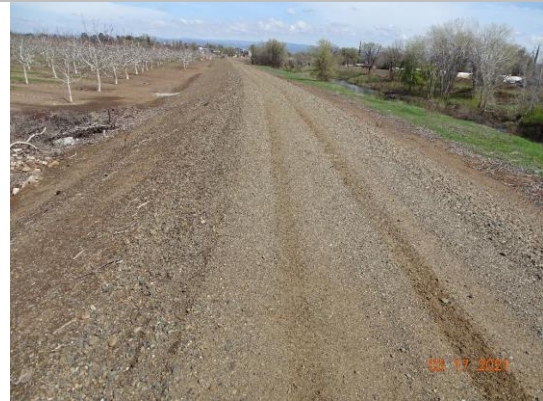
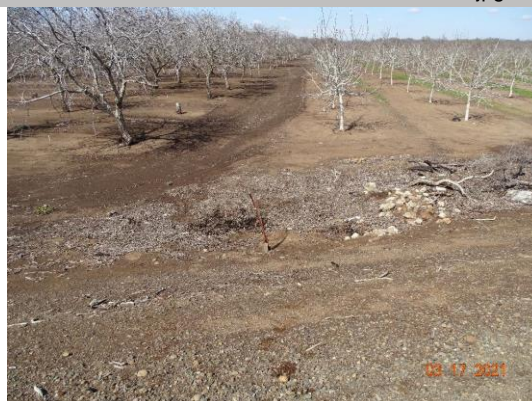
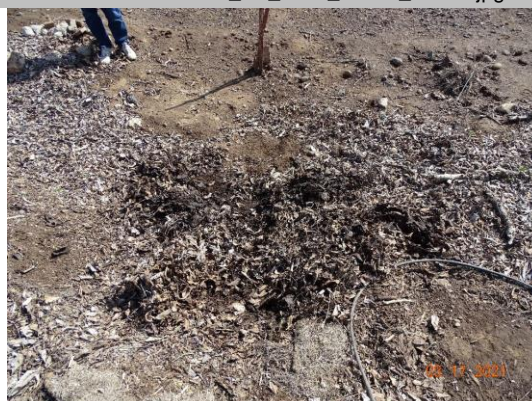
Photo 1 of 3 : UCIP_FA_2022_67251_99304.jpg

Comment Code					
Inspector Comment					
DS_ID:19221 FS_ID:67251 EP_NO: N/A Repair Type: Urgent EVAL Issue: 1, Pipe Integrity Crossing Status: Found UCIP Comments: 03/17/2021 Record updated from Non-Urgent to Urgent. DMP internal video inspection has found pipe integrity issues. LOF of crossing is between 5 and 6. Crossing will be monitored until funding becomes available to address the issues. Flap gate on waterside pipe end is non-operating. Recommend lubricating hinges for easy opening. Drainage inlet at landside toe is burried in soil - unable to locate. Crossing appears abandoned. No permit has been identified authorizing pipe. (O.Yakimov - DWR UCIP) 02/20/2014 CM Standpipe intake. Intake pipe with air vent. Steel rib-bar grit cover on the standpipe on landside levee toe.Needs cleaning and clearing on both ends of the pip. (P. Amatya - DWR UCIP). FIELD_STRUCT_DESC: 24-inch corrugated metal gravity drainage pipe through the levee, 15 feet below the crown. Flap gate on the waterside (WS) end. Concrete U-shaped headwall on the WS end. Grouted riprap spillway on the WS end. Corrugated metal standpipe intake. Intake pipe with an air vent. Steel rib-bar grit cover on the standpipe on the landside (LS) toe. [Additional Reference(s): DWR Levee Log, 1992 (HLM 4.93). USACE Sacramento O&M Manual, Unit 504, May 1965, Revised 2 February 2011, (HLM 4.94), listed as 24-inch pipe. USACE As-Built Drawing No. 50-04-3685, Sheet 6, STA 333+70, 19 May 1965]. FS Date: 3/17/2021 10:28:36 AM

Top of Levee: View of levee crown looking upstream

Land-Side: View of levee slope looking from crown

Land-Side: Approximate location on pipe inlet at levee toe, although inlet was not found

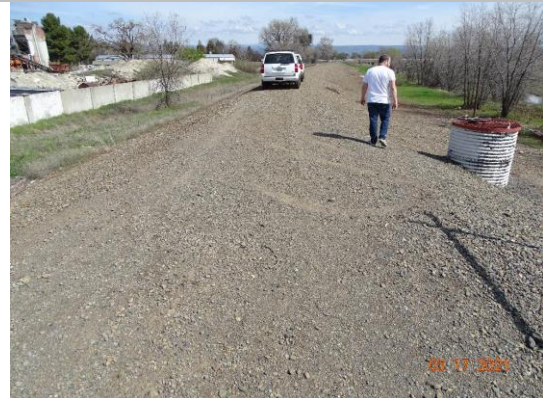
Photo 1 of 3 : UCIP_FA_2022_67286_99399.jpg

Comment Code					
Inspector Comment					
DS_ID:19222 FS_ID:67286 EP_NO: N/A Repair Type: Non-Urgent EVAL Issue: Crossing Status: Found UCIP Comments: 03/17/2021 Record updated from No Action Needed to Non-Urgent. No permit has been identified authorizing pipe. DMP internal video inspection has not found pipe integrity issues. LOF of crossing is less or equal to 4.0. Recommend next video inspection in 5 years. (O.Yakimov - DWR UCIP) 02/20/2014 Slide gate in CM stadpipe on waterside levee slope. (P. Amatya - DWR UCIP) FIELD_STRUCT_DESC: 36-inch corrugated metal gravity drainage pipe through the levee, 17 feet below the crown. Slide gate in a corrugated metal standpipe on the waterside (WS) slope. Flap gate on the WS end. Concrete U-shaped headwall on each end. Grouted riprap apron on the landside (LS) end. Grouted riprap spillway on the WS end. [Additional Reference(s): DWR Levee Log, 1992 (HLM 5.22). USACE Sacramento O&M Manual, Unit 504, May 1965, Revised 2 February 2011, (HLM 5.22), listed as 36-inch pipe. USACE As-Built Drawing No. 50-04-3685, Sheet 7, from STA 348+25 to STA 352+50, 19 May 1965]. FS Date: 3/17/2021 3:46:02 PM

Top of Levee: View of levee crown looking upstream

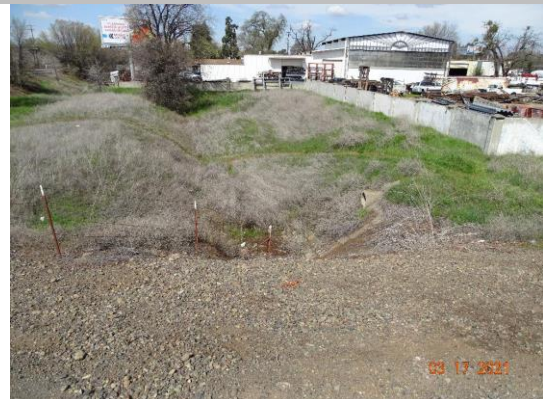
Photo 2 of 3 : UCIP_FA_2022_67286_99400.jpg

Land-Side: View of levee slope looking from crown. Drainage ditch on landside

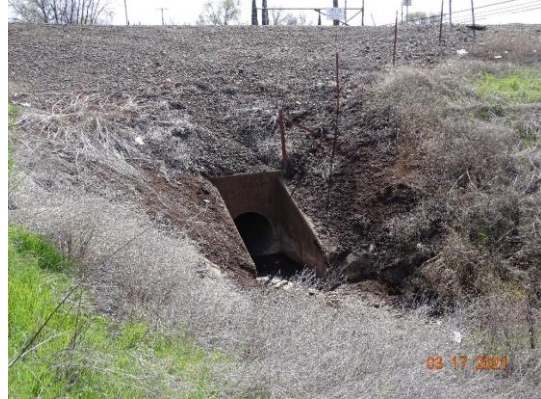
Photo 3 of 3 : UCIP_FA_2022_67286_99404.jpg

Land-Side: Headwall and pipe inlet in drainage ditch at levee toe

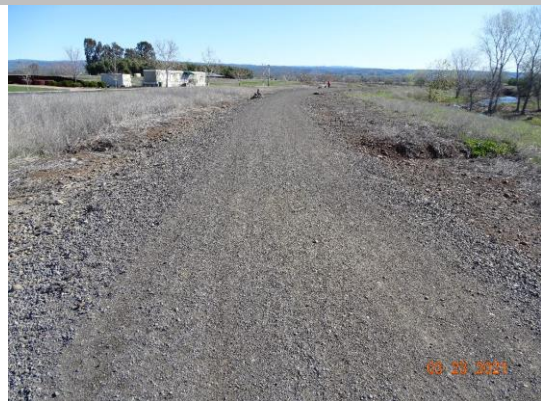
Photo 1 of 3 : UCIP_FA_2022_67292_99434.jpg

DS_ID:19226
 FS_ID:67292
 EP_NO: N/A
 Repair Type: Non-Urgent
 EVAL Issue:
 Crossing Status: Not Found
 UCIP Comments: 03/23/2021 Record is Non-Urgent. Crossing not found. A valley on waterside slope may indicate former pipe location. Need to confirm if pipe was removed. No permit has been identified authorizing pipe installation. (O.Yakimov - DWR UCIP)
 FIELD_STRUCT_DESC: 18-inch corrugated metal gravity drainage pipe through the levee, 2 feet below the crown. Pipe is open on both ends. Both ends appear to be covered with rock. [Additional Reference(s): DWR Levee Log, 1992 (HLM 7.00). USACE Sacramento O&M Manual, Unit 504, May 1965, Revised 2 February 2011, (HLM 7.01), listed as 18-inch pipe. USACE As-Built Drawing No. 50-04-3685, Sheet 8, STA 80+70, 19 May 1965].
 FS Date: 3/23/2021 11:21:39 AM

Top of Levee: View of levee crown looking upstream

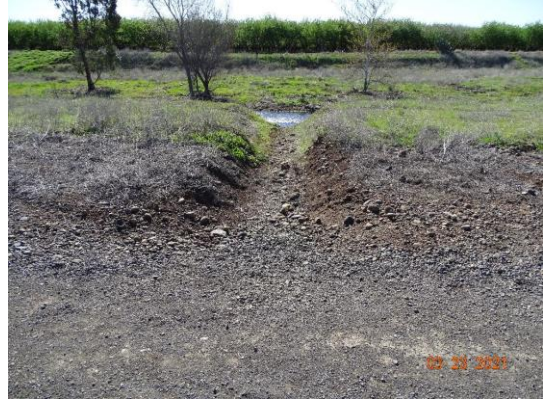
Photo 2 of 3 : UCIP_FA_2022_67292_99435.jpg

Water-Side: View of levee slope looking from crown. Valley on the slope may indicate pipe location

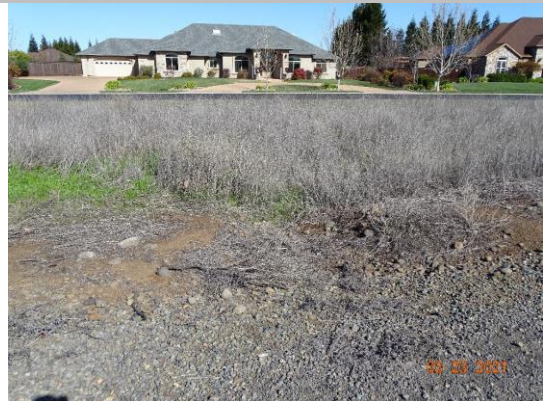
Photo 3 of 3 : UCIP_FA_2022_67292_99436.jpg

Land-Side: View of levee slope looking from crown

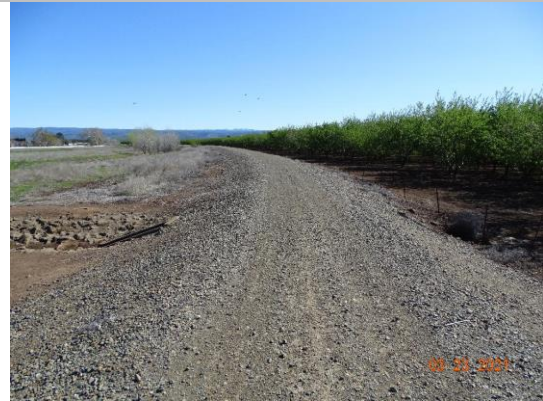
Photo 1 of 3 : UCIP_FA_2022_67304_99515.jpg

Comment Code					
Inspector Comment					
DS_ID:19234 FS_ID:67304 EP_NO: N/A Repair Type: Non-Urgent EVAL Issue: 5, Pipe Damage Crossing Status: Found UCIP Comments: 03/23/2021 Record remains Non-Urgent. No permit has been identified authorizing pipe. Debris noted in previous inspection has been cleared. DMP internal video inspection has found pipe integrity issues. LOF of crossing is greater than or equal to 4.1 and less than 5. Crossing will be monitored until funding becomes available for rehabilitation. (O.Yakimov - DWR UCIP) 03/11/2014 Needs cleaning and clearing the culvert. (P. Amatya - DWR UCIP) FIELD_STRUCT_DESC: 24-inch corrugated metal gravity drainage pipe through the levee, 6.6 feet below the crown. Flap gate on the waterside (WS) end. Concrete U-shaped headwall on each end. Grouted riprap spillway on the WS end. [Additional Reference(s): DWR Levee Log, 1992 (HLM 0.25). USACE Sacramento O&M Manual, Unit 504, May 1965, Revised 2 February 2011, (HLM 0.25), listed as 24-inch pipe. USACE As-Built Drawing No. 50-04-3685, Sheet 8, STA 53+90, 19 May 1965]. FS Date: 3/23/2021 2:26:18 PM

Top of Levee: View of levee crown looking upstream

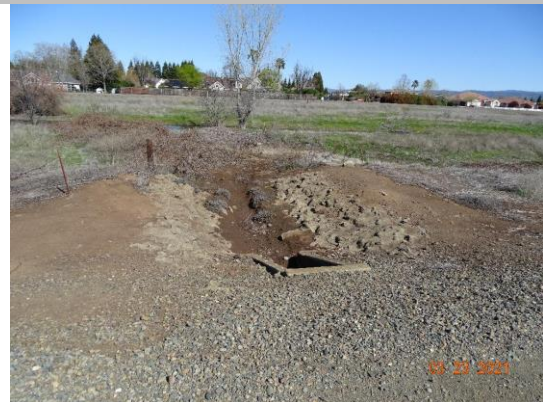
Photo 2 of 3 : UCIP_FA_2022_67304_99516.jpg

Water-Side: View of levee slope looking from crown

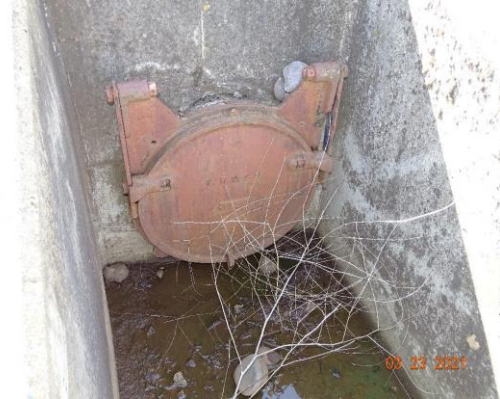
Photo 3 of 3 : UCIP_FA_2022_67304_99520.jpg

Water-Side: Headwall and flap gate at levee toe

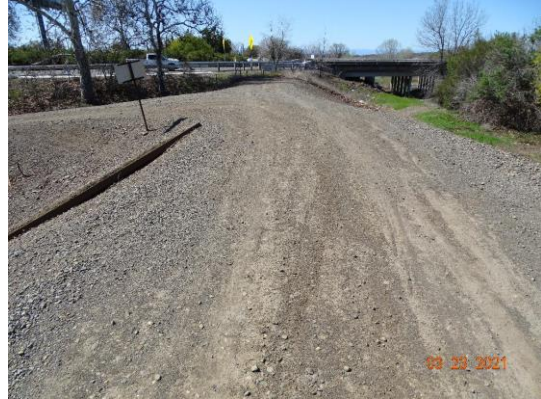
Photo 1 of 3 : UCIP_FA_2022_67305_99521.jpg

Comment Code					
Inspector Comment					
DS_ID:19235 FS_ID:67305 EP_NO: N/A Repair Type: Urgent EVAL Issue: 1, Pipe Integrity Crossing Status: Found UCIP Comments: 03/23/2021 Record updated from Non-Urgent to Urgent. DMP internal video inspection has found pipe integrity issues. LOF of crossing is between 5 and 6. Crossing will be monitored until funding becomes available to address the issues. No permit has been identified authorizing pipe. Recommend clearing debris from landside end of pipe. (O.Yakimov - DWR UCIP) 02/24/2014 Needs cleaning and clearing of debris. (P. Amatya - DWR UCIP) FIELD_STRUCT_DESC: 24-inch corrugated metal gravity drainage pipe through the levee, 12.5 feet below the crown. Flap gate on the waterside (WS) end. Concrete U-shaped headwall on each end. Grouted riprap apron on the landside (LS) end. Grouted riprap spillway on the WS end. [Additional Reference(s): DWR Levee Log, 1992 (HLM 1.34). USACE Sacramento O&M Manual, Unit 504, May 1965, Revised 2 February 2011, (HLM 1.34), listed as 24-inch pipe. USACE As-Built Drawing No. 50-04-3685, Sheets 7 and 41, STA 358+10, 19 May 1965]. FS Date: 3/23/2021 2:30:04 PM

Top of Levee: View of levee crown looking downstream

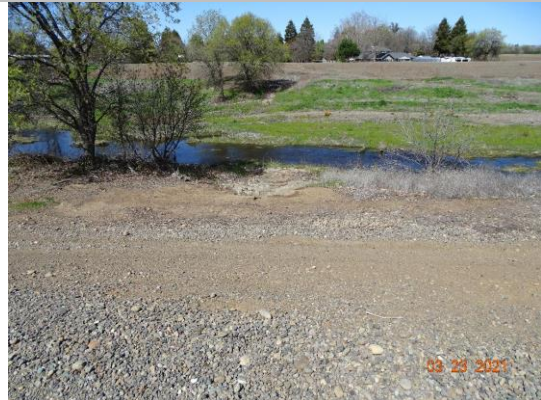
Photo 2 of 3 : UCIP_FA_2022_67305_99522.jpg

Water-Side: View of levee slope looking from crown

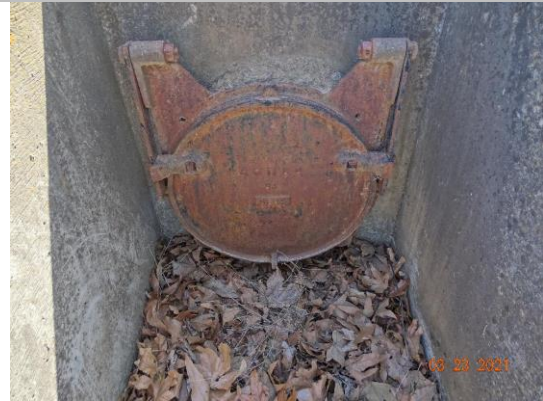
Photo 3 of 3 : UCIP_FA_2022_67305_99526.jpg

Water-Side: Headwall and flap gate at levee toe

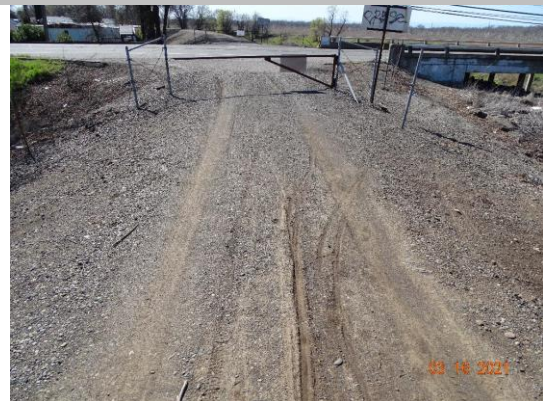
Photo 1 of 3 : UCIP_FA_2022_67308_99539.jpg

DS_ID:19237
 FS_ID:67308
 EP_NO: N/A
 Repair Type: Non-Urgent
 EVAL Issue:
 Crossing Status: Found
 UCIP Comments: 03/16/2021 Record remains Non-Urgent. No permit has been identified authorizing pipe. DMP internal video inspection has not found pipe integrity issues. LOF of crossing is less or equal to 4. Recommend next video inspection in 5 years. (O.Yakimov - DWR UCIP)
 02/24/2014 Needs cleaning and clearing of debris. (P. Amatya - DWR UCIP)
 FIELD_STRUCT_DESC: 24-inch corrugated metal gravity drainage pipe through the levee, 11 feet below the crown. Flap gate on the waterside (WS) end. Concrete U-shaped headwall on each end. Grouted riprap apron on the landside (LS) end. Grouted riprap spillway on the WS end. [Additional Reference(s): DWR Levee Log, 1992 (HLM 1.55). USACE Sacramento O&M Manual, Unit 504, May 1965, Revised 2 February 2011, (HLM 1.55), listed as 24-inch pipe. USACE As-Built Drawing No. 50-04-3685, Sheet 41, STA 347+55, 19 May 1965].

Top of Levee: View of levee crown looking downstream

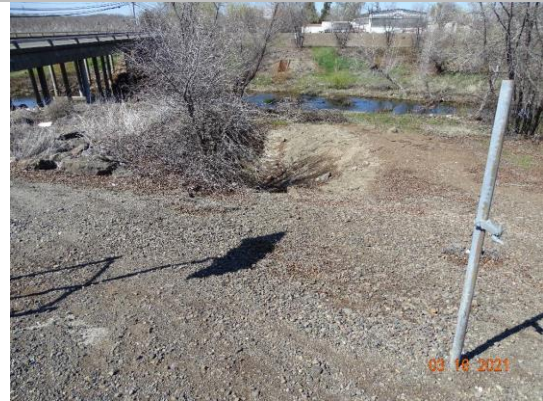
Photo 2 of 3 : UCIP_FA_2022_67308_99540.jpg

Water-Side: View of levee slope looking from crown

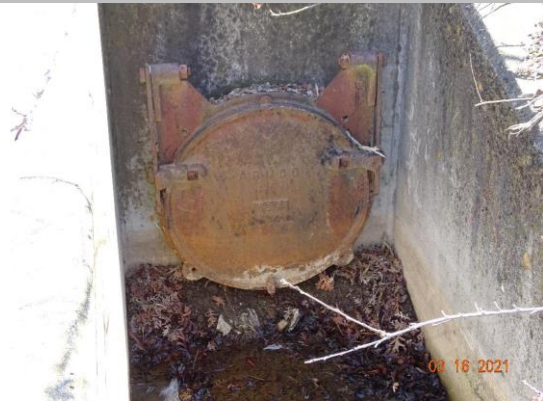
Photo 3 of 3 : UCIP_FA_2022_67308_99544.jpg

Water-Side: Headwall and flap gate at levee toe

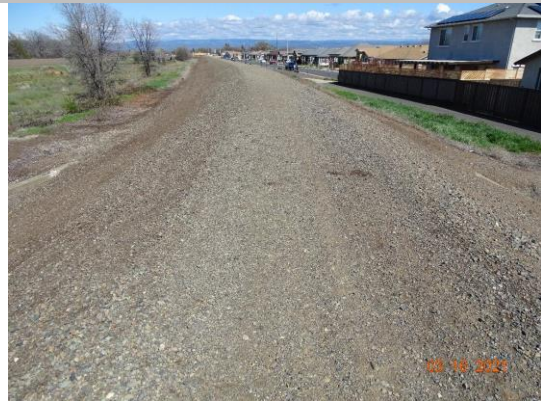
Photo 1 of 3 : UCIP_FA_2022_67340_99744.jpg

Comment Code						
Inspector Comment						
DS_ID:19239 FS_ID:67340 EP_NO: N/A Repair Type: Non-Urgent EVAL Issue: Crossing Status: Found UCIP Comments: 03/16/2021 Record remains Non-Urgent. No permit has been identified authorizing pipe. Debris around landside headwall has been cleared. DMP internal video inspection has not found pipe integrity issues. LOF of crossing is less or equal to 4. Recommend next video inspection in 5 years. (O.Yakimov - DWR UCIP) 02/24/2014 Debris in landside inlet area. Needs cleaning and clearing of debris. (P. Amatya - DWR UCIP) FIELD_STRUCT_DESC: 24-inch corrugated metal gravity drainage pipe through the levee, 10 feet below the crown. Flap gate on the waterside (WS) end. Concrete U-shaped headwall on each end. Grouted riprap apron on the landside (LS) end. Grouted riprap spillway on the WS end. [Additional Reference(s): DWR Levee Log, 1992 (HLM 2.44). USACE Sacramento O&M Manual, Unit 504, May 1965, Revised 2 February 2011, (HLM 2.44), listed as 24-inch pipe. USACE As-Built Drawing No. 50-04-3685, Sheets 6 and 41, STA 302+00, 19 May 1965]. FS Date: 3/16/2021 11:39:32 AM

Top of Levee: View of levee crown looking upstream

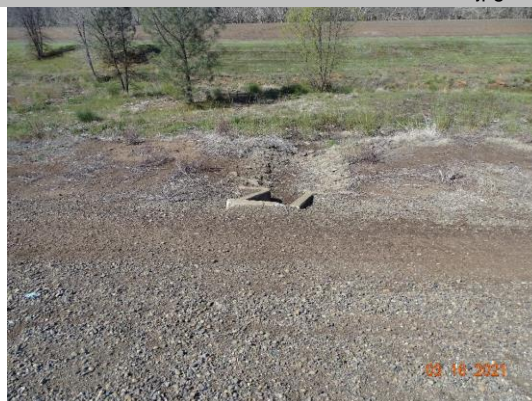
Photo 2 of 3 : UCIP_FA_2022_67340_99746.jpg

Water-Side: View of levee slope looking from crown

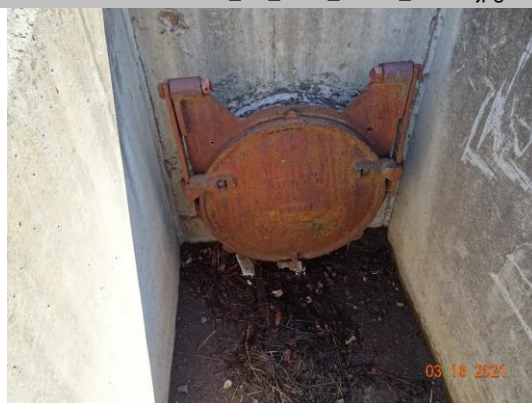
Photo 3 of 3 : UCIP_FA_2022_67340_99747.jpg

Water-Side: Headwall and flap gate at levee toe

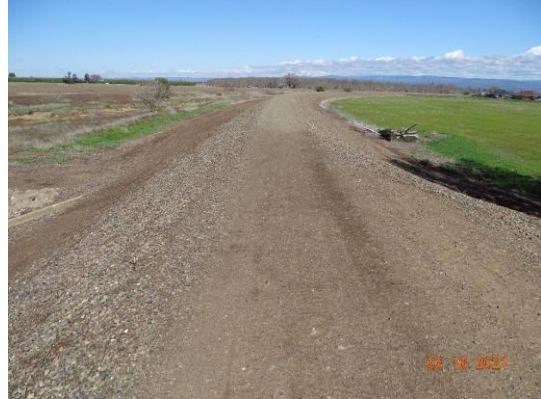
Photo 1 of 3 : UCIP_FA_2022_67341_99750.jpg

Comment Code					
Inspector Comment					
DS_ID:19240 FS_ID:67341 EP_NO: N/A Repair Type: Urgent EVAL Issue: 3a, Flood Risk Crossing Status: Found UCIP Comments: 03/16/2021 Record updated from Non-Urgent to Urgent. Flap gate not closing complitely. A gap between flap gate and pipe is visible. Adjustments and lubrication to flap gate hinges need to be done. DMP internal video inspection has not found pipe integrity issues. LOF of crossing is less or equal to 4. Recommend next video inspection in 5 years. (O.Yakimov - DWR UCIP) 02/24/2014 Needs cleaning and clearing of debris. (P. Amatya - DWR UCIP) FIELD_STRUCT_DESC: 24-inch corrugated metal gravity drainage pipe through the levee, 10 feet below the crown. Flap gate on the waterside (WS) end. Concrete U-shaped headwall on each end. Grouted riprap apron on the landside (LS) end. Grouted riprap spillway on the WS end. [Additional Reference(s): DWR Levee Log, 1992 (HLM 2.84). USACE Sacramento O&M Manual, Unit 504, May 1965, Revised 2 February 2011, (HLM 2.86), listed as 24-inch pipe. USACE As-Built Drawing No. 50-04-3685, Sheets 6 and 41, STA 280+00, 19 May 1965]. FS Date: 3/16/2021 12:43:55 PM

Top of Levee: View of levee crown looking upstream

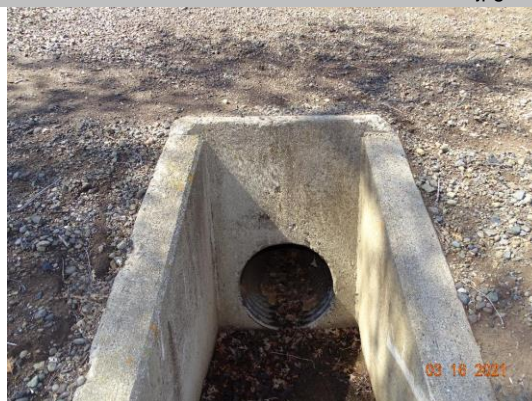
Photo 3 of 3 : UCIP_FA_2022_67341_99753.jpg

Land-Side: U-shaped headwall and pipe at levee toe

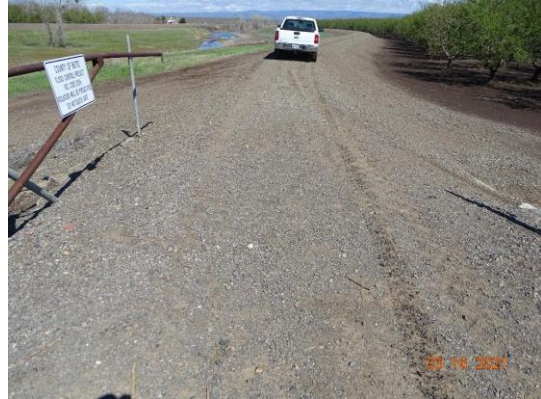
Photo 1 of 3 : UCIP_FA_2022_67342_99757.jpg

Comment Code						
Inspector Comment						
DS_ID:19241 FS_ID:67342 EP_NO: N/A Repair Type: Non-Urgent EVAL Issue: Crossing Status: Found UCIP Comments: 03/16/2021 Record remains Non-Urgent. No permit has been identified authorizing pipe. Debris has been cleared. DMP internal video inspection has not found pipe integrity issues. LOF of crossing is less or equal to 4. Recommend next video inspection in 5 years. (O.Yakimov - DWR UCIP) 02/24/2014 Needs cleaning and clearing of debris. (P. Amatya - DWR UCIP) FIELD_STRUCT_DESC: 24-inch corrugated metal gravity drainage pipe through the levee, 6.5 feet below the crown. Flap gate on the waterside (WS) end. Concrete U-shaped headwall on each end. Grouted riprap apron on the landside (LS) end. Grouted riprap spillway on the WS end. [Additional Reference(s): DWR Levee Log, 1992 (HLM 3.64). USACE Sacramento O&M Manual, Unit 504, May 1965, Revised 2 February 2011, (HLM 3.64), listed as 24-inch pipe. USACE As-Built Drawing No. 50-04-3685, Sheet 41, STA 239+80, 19 May 1965]. FS Date: 3/16/2021 12:48:10 PM

Top of Levee: View of levee crown looking upstream

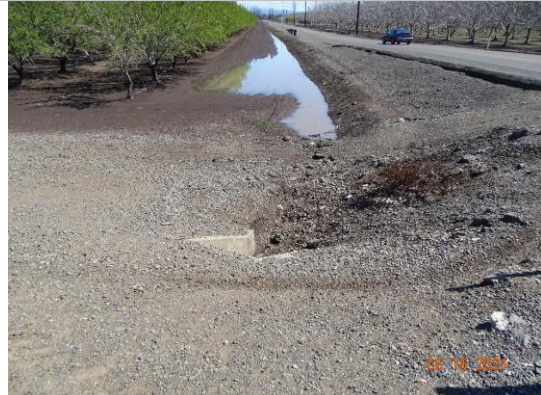
Photo 2 of 3 : UCIP_FA_2022_67342_99758.jpg

Land-Side: View of levee slope looking from crown

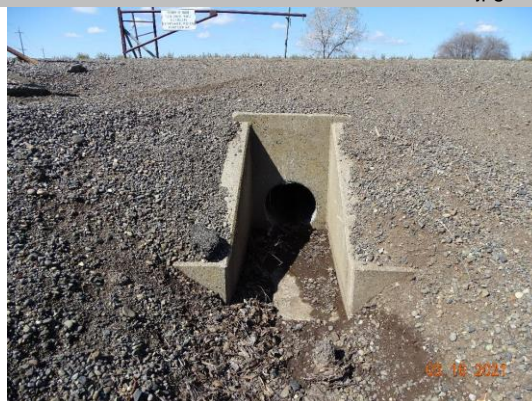
Photo 3 of 3 : UCIP_FA_2022_67342_99761.jpg

Land-Side: U-shaped headwall and pipe at levee toe

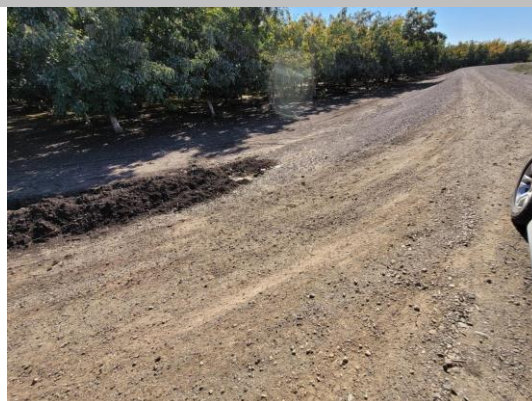
Photo 1 of 1 : FA_2022_NA0003_65_10_20221011_00083.jpg

LM Start	3.52	Rating **	M	Issue No.	10
LM End	3.52	Issue Type +	Ma	Location *	LS
Category	Earthen Levee			GPS Latitude/Longitude	
				Start	End
Item	Erosion / Vehicle Traffic			39.760582 °	39.760582 °
				-121.910303 °	-121.910303 °
DWR ID	DWR_NA0003_02_s_2022_10				
Comment Code					
E6 : Repair the levee slope damaged by vehicle traffic and prevent access where possible.					
Inspector Comment

View of the damaged landside slope due to vehicle traffic. Fall 2022.

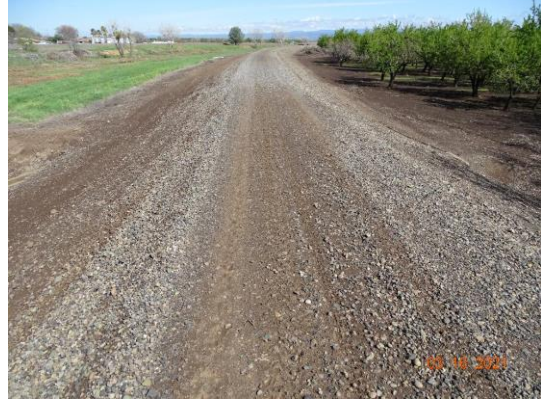
Photo 1 of 3 : UCIP_FA_2022_67347_99780.jpg

Comment Code						
Inspector Comment						
DS_ID:19245 FS_ID:67347 EP_NO: N/A Repair Type: Non-Urgent EVAL Issue: Crossing Status: Found UCIP Comments: 03/16/2021 Record remains Non-Urgent. No permit has been identified authorizing pipe. Debris has been cleared. DMP internal video inspection has not found pipe integrity issues. LOF of crossing is less or equal to 4. Recommend next video inspection in 5 years. (O.Yakimov - DWR UCIP) 02/25/2014 Needs cleaning and clearing of debris. (P. Amatya - DWR UCIP) FIELD_STRUCT_DESC: 24-inch corrugated metal gravity drainage pipe through the levee, 10 feet below the crown. Flap gate on the waterside (WS) end. Concrete U-shaped headwall on each end. Grouted riprap apron on the landside (LS) end. Grouted riprap spillway on the WS end. [Additional Reference(s): DWR Levee Log, 1992 (HLM 4.77). USACE Sacramento O&M Manual, Unit 504, May 1965, Revised 2 February 2011, (HLM 4.77), listed as 24-inch pipe. USACE As-Built Drawing No. 50-04-3685, Sheet 41, STA 188+80, 19 May 1965]. FS Date: 3/16/2021 2:59:36 PM

Top of Levee: View of levee crown looking upstream

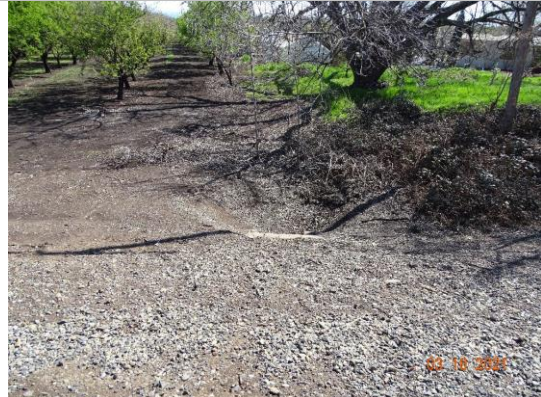
Photo 2 of 3 : UCIP_FA_2022_67347_99781.jpg

Land-Side: View of levee slope looking from crown

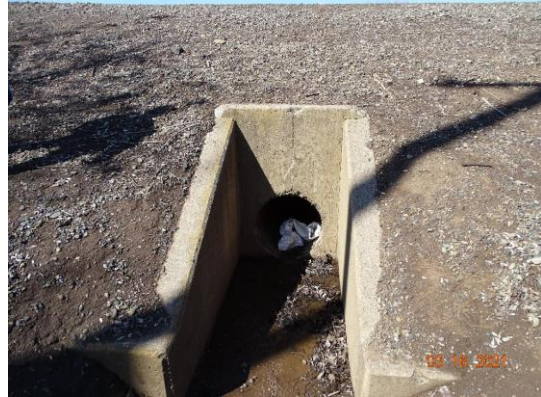
Photo 3 of 3 : UCIP_FA_2022_67347_99784.jpg

Land-Side: U-shaped headwall and pipe at levee toe

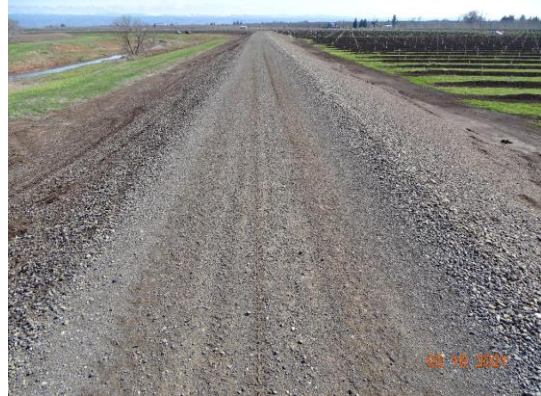
Photo 1 of 3 : UCIP_FA_2022_67350_99792.jpg

DS_ID:19247
FS_ID:67350
EP_NO: N/A
Repair Type: Urgent
EVAL Issue: 1, Pipe Integrity
Crossing Status: Found
UCIP Comments: 03/16/2021 Record updated from Non-Urgent to Urgent. DMP internal video inspection has found pipe integrity issues. LOF of crossing is between 5 and 6. Crossing will be monitored until funding becomes available to address the issues. No permit has been identified authorizing pipe. Sediment at bottom of CMP is still present. (O.Yakimov - DWR UCIP)
02/25/2014 Needs cleaning and clearing of debris. (P. Amatya - DWR UCIP)
FIELD_STRUCT_DESC: 24-inch corrugated metal gravity drainage pipe through the levee, 11.5 feet below the crown. Flap gate on the waterside (WS) end. Concrete U-shaped headwall on each end. Grouted riprap apron on the landside (LS) end. Grouted riprap spillway on the WS end. [Additional Reference(s): DWR Levee Log, 1992 (HLM 5.83). USACE Sacramento O&M Manual, Unit 504, May 1965, Revised 2 February 2011, (HLM 5.83), listed as 24-inch pipe. USACE As-Built Drawing No. 50-04-3685, Sheets 3 and 41, STA 134+60, 19 May 1965]. FS Date: 3/16/2021 11:38:06 AM

Top of Levee: View of levee crown looking upstream

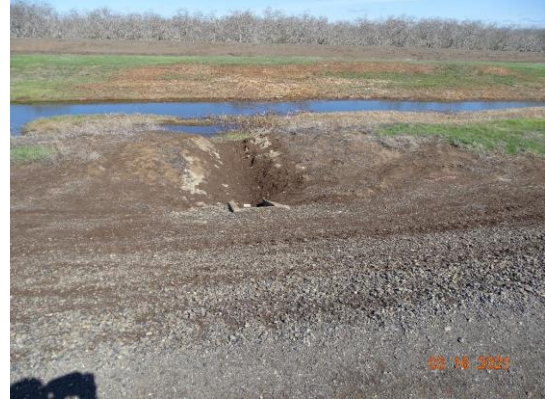
Photo 2 of 3 : UCIP_FA_2022_67350_99793.jpg

Water-Side: View of levee slope looking from crown

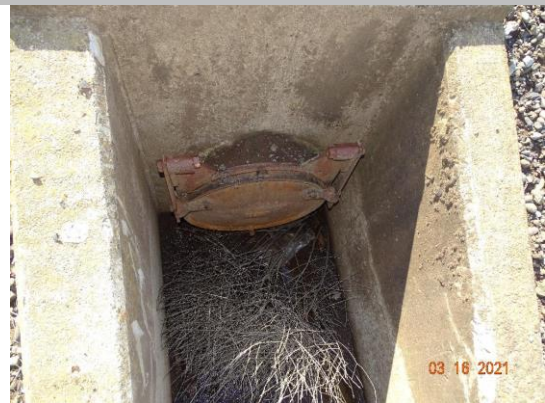
Photo 3 of 3 : UCIP_FA_2022_67350_99795.jpg

Water-Side: Headwall and flap gate at levee toe

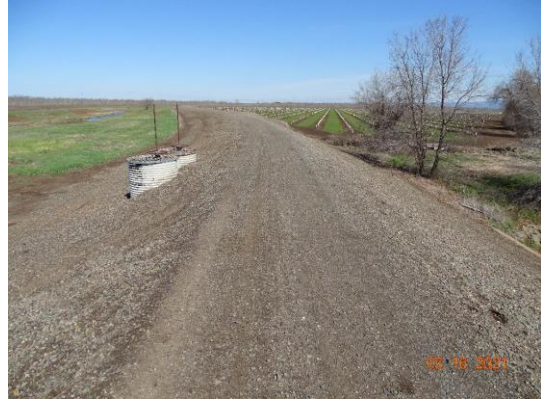
Photo 1 of 3 : UCIP_FA_2022_67351_99802.jpg

Comment Code					
Inspector Comment					
DS_ID:19248 FS_ID:67351 EP_NO: N/A Repair Type: Non-Urgent EVAL Issue: 5, Pipe Damage Crossing Status: Found UCIP Comments: 03/16/2021 Record remains Non-Urgent. DMP internal video inspection has found pipe integrity issues. LOF of crossing is between 4.1 and 5. Crossing will be monitored until funding becomes available for rehabilitation. No permit has been identified authorizing pipe. Debris has been cleared. (O.Yakimov - DWR UCIP) 02/25/2014 Needs cleaning and clearing of debris. (P. Amatya - DWR UCIP) FIELD_STRUCT_DESC: [Channel Slough Drainage Structure] 1 of 2: 42-inch corrugated metal gravity drainage pipe through the levee, 16 feet below the crown. Flap gate on the waterside (WS) end. Slide gate in a corrugated metal pipe (CMP) riser on the WS slope. Concrete U-shaped headwall on each end. Grouted riprap apron and rock revetment on the landside (LS) end. [Additional Reference(s): DWR Levee Log, 1992 (HLM 6.30). USACE Sacramento O&M Manual, Unit 504, May 1965, Revised 2 February 2011, (HLM 6.30), listed as 42-inch pipe]. FS Date: 3/16/2021 11:45:20 AM

Top of Levee: View of levee crown looking upstream

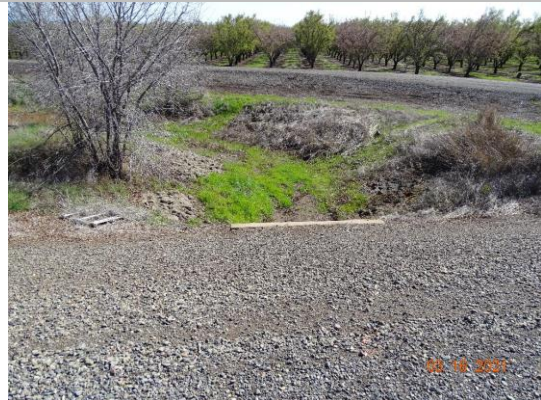
Photo 2 of 3 : UCIP_FA_2022_67351_99800.jpg

Land-Side: View of levee slope looking from crown

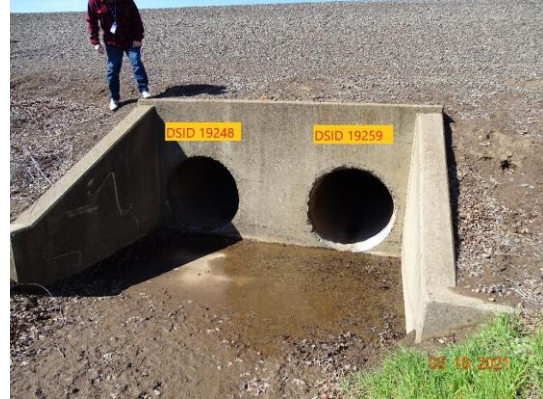
Photo 3 of 3 : UCIP_FA_2022_67351_99801.jpg

Land-Side: U-shaped headwall and pipe at levee toe

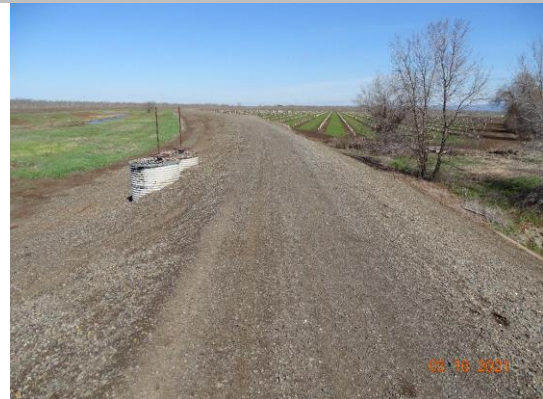
Photo 1 of 3 : UCIP_FA_2022_67352_99808.jpg

DS_ID:19259
 FS_ID:67352
 EP_NO: N/A
 Repair Type: Non-Urgent
 EVAL Issue: 5, Pipe Damage
 Crossing Status: Found
 UCIP Comments: 03/16/2021 Record remains Non-Urgent. No permit has been identified authorizing pipe. Debris has been cleared. DMP internal video inspection has found pipe integrity issues. LOF of crossing is greater than or equal to 4.1 and less than 5. Crossing will be monitored until funding becomes available for rehabilitation.
 (O.Yakimov - DWR UCIP)
 02/25/2014 Needs cleaning and clearing of debris. (P. Amatya - DWR UCIP)
 FIELD_STRUCT_DESC: [Channel Slough Drainage Structure] 2 of 2: 42-inch corrugated metal gravity drainage pipe through the levee, 16 feet below the crown. Flap gate on the waterside (WS) end. Slide gate in a corrugated metal pipe (CMP) riser on the WS slope. Concrete U-shaped headwall on each end. Grouted riprap apron and rock revetment on the landside (LS) end. [Additional Reference(s): DWR Levee Log, 1992 (HLM 6.30). USACE Sacramento O&M Manual, Unit 504, May 1965, Revised 2 February 2011, (HLM 6.30), listed as 42-inch pipe].

Top of Levee: View of levee crown looking upstream

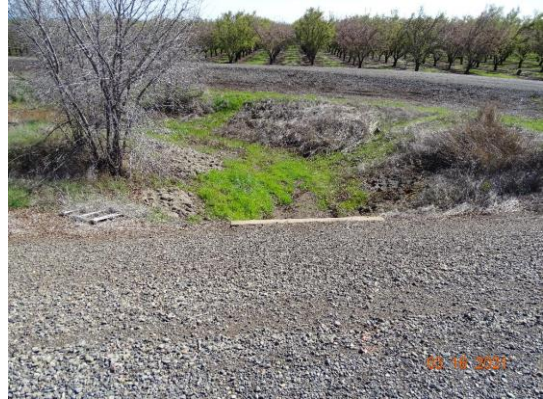
Photo 2 of 3 : UCIP_FA_2022_67352_99806.jpg

Land-Side: View of levee slope looking from crown
