**Flood Control Project Maintenance
Levee Inspections**

Maintenance Issue Types Only, Levee Inspection Report By Mile - Fall 2022

Butte County Department of Public Works

Waterway	Bank	Unit Miles	Inspection Start/End	Inspector
Unit No. 01 Mud Creek	Right	6.80	10/04/2022 10/04/2022	Makar Sokol

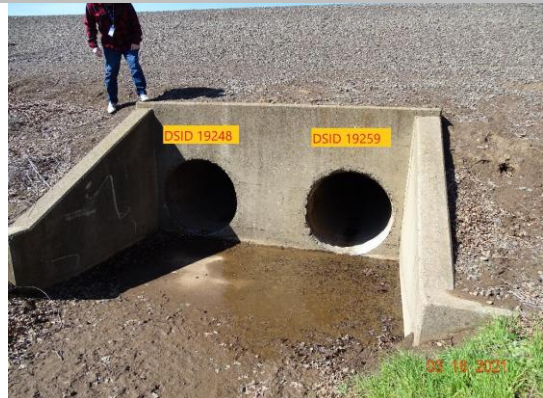
Photo 3 of 3 : UCIP_FA_2022_67352_99807.jpg

DS_ID:19259
 FS_ID:67352
 EP_NO: N/A
 Repair Type: Non-Urgent
 EVAL Issue: 5, Pipe Damage
 Crossing Status: Found
 UCIP Comments: 03/16/2021 Record remains Non-Urgent. No permit has been identified authorizing pipe. Debris has been cleared. DMP internal video inspection has found pipe integrity issues. LOF of crossing is greater than or equal to 4.1 and less than 5. Crossing will be monitored until funding becomes available for rehabilitation.
 (O.Yakimov - DWR UCIP)
 02/25/2014 Needs cleaning and clearing of debris. (P. Amatya - DWR UCIP)
 FIELD_STRUCT_DESC: [Channel Slough Drainage Structure] 2 of 2: 42-inch corrugated metal gravity drainage pipe through the levee, 16 feet below the crown. Flap gate on the waterside (WS) end. Slide gate in a corrugated metal pipe (CMP) riser on the WS slope. Concrete U-shaped headwall on each end. Grouted riprap apron and rock revetment on the landside (LS) end. [Additional Reference(s): DWR Levee Log, 1992 (HLM 6.30). USACE Sacramento O&M Manual, Unit 504, May 1965, Revised 2 February 2011, (HLM 6.30), listed as 42-inch pipe].

Land-Side: U-shaped headwall and pipe at levee toe

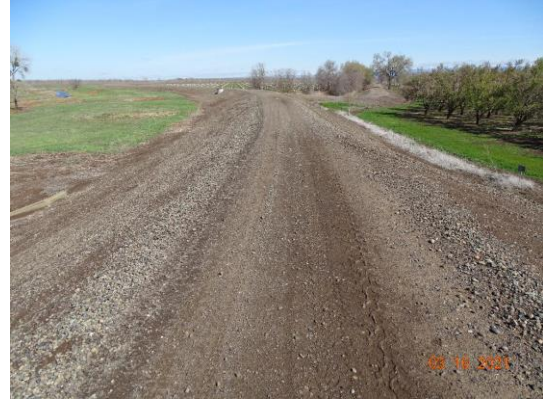
Photo 1 of 3 : UCIP_FA_2022_67353_99809.jpg

Comment Code					
Inspector Comment					
DS_ID:19249 FS_ID:67353 EP_NO: N/A Repair Type: Urgent EVAL Issue: 1, Pipe Integrity Crossing Status: Found UCIP Comments: 03/16/2021 Record updated from Non-Urgent to Urgent. DMP internal video inspection has found pipe integrity issues. LOF of crossing is between 5 and 6. Crossing will be monitored until funding becomes available to address the issues. No permit has been identified authorizing pipe. Debris has been cleared. (O.Yakimov - DWR UCIP) 02/25/2014 Needs cleaning and clearing of debris. (P. Amatya - DWR UCIP) FIELD_STRUCT_DESC: 24-inch corrugated metal gravity drainage pipe through the levee, 12 feet below the crown. Flap gate on the waterside (WS) end. Concrete U-shaped headwall on each end. Grouted riprap apron on the landside (LS) end. Grouted riprap spillway on the WS end. [Additional Reference(s): DWR Levee Log, 1992 (HLM 6.35). USACE Sacramento O&M Manual, Unit 504, May 1965, Revised 2 February 2011, (HLM 6.35), listed as 24-inch pipe. USACE As-Built Drawing No. 50-04-3685, Sheets 3 and 41, STA 107+10, 19 May 1965]. FS Date: 3/16/2021 11:50:15 AM

Top of Levee: View of levee crown looking upstream

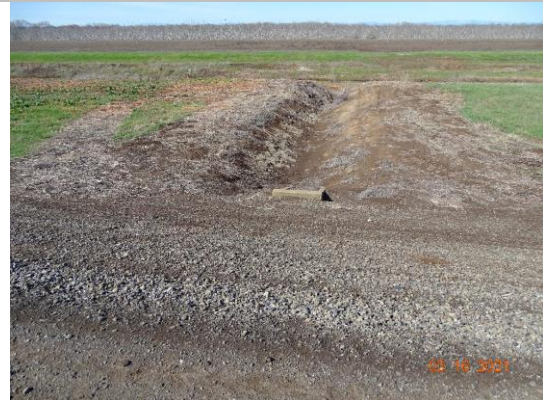
Photo 2 of 3 : UCIP_FA_2022_67353_99810.jpg

Water-Side: View of levee slope looking from crown

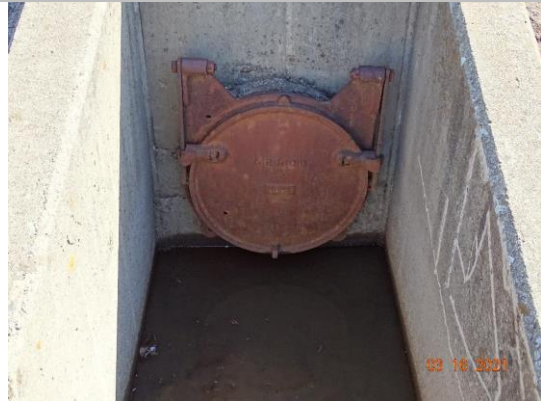
Photo 3 of 3 : UCIP_FA_2022_67353_99814.jpg

Water-Side: Headwall and flap gate at levee toe

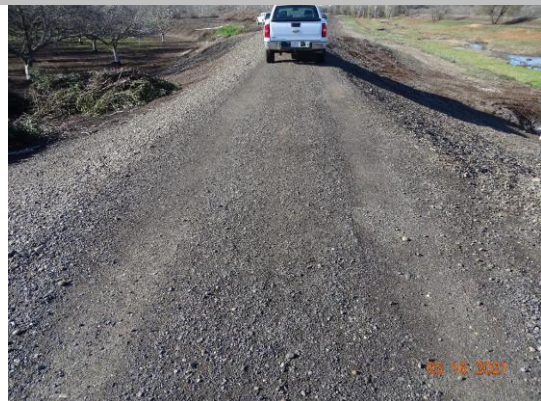
Photo 1 of 3 : UCIP_FA_2022_67357_99827.jpg

DS_ID:19251
 FS_ID:67357
 EP_NO: N/A
 Repair Type: Urgent
 EVAL Issue: 1, Pipe Integrity
 Crossing Status: Found
 UCIP Comments: 03/16/2021 Record updated from Non-Urgent to Urgent. DMP internal video inspection has found pipe integrity issues. LOF of crossing is between 5 and 6. Crossing will be monitored until funding becomes available to address the issues. No permit has been identified authorizing pipe. Debris has been cleared. (O.Yakimov - DWR UCIP)
 02/25/2014 Needs cleaning and clearing of debris. (P. Amatya - DWR UCIP)
 FIELD_STRUCT_DESC: 24-inch corrugated metal gravity drainage pipe through the levee, 15.5 feet below the crown. Flap gate on the waterside (WS) end. Concrete U-shaped headwall on each end. Grouted riprap apron on the landside (LS) end. Grouted riprap spillway on the WS end. Pipe crossing levee at angle. [Additional Reference(s): DWR Levee Log, 1992 (HLM 6.65). USACE Sacramento O&M Manual, Unit 504, May 1965, Revised 2 February 2011, (HLM 6.65), listed as 24-inch pipe. USACE As-Built Drawing No. 50-04-3685, Sheet 41, STA 91+98, 19 May 1965].

Top of Levee: View of levee crown looking downstream

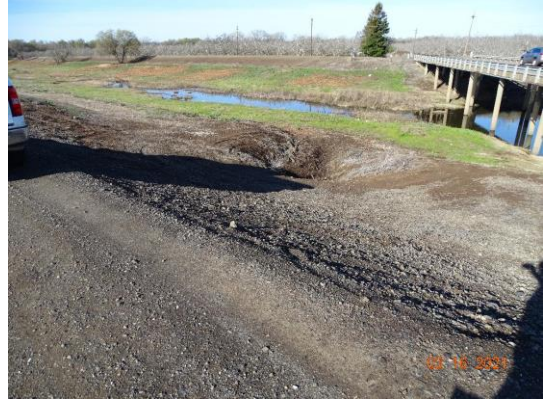
Photo 2 of 3 : UCIP_FA_2022_67357_99828.jpg

Water-Side: View of levee slope looking from crown

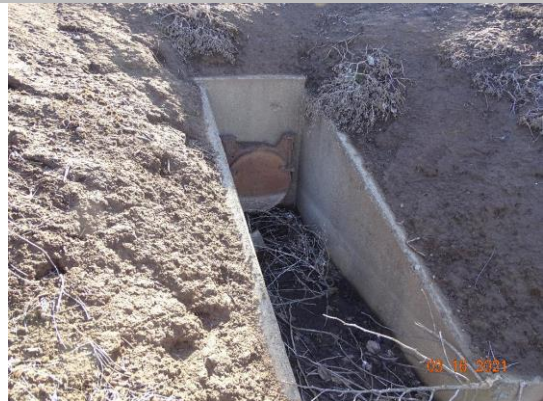
Photo 3 of 3 : UCIP_FA_2022_67357_99832.jpg

Water-Side: Headwall and flap gate at levee toe

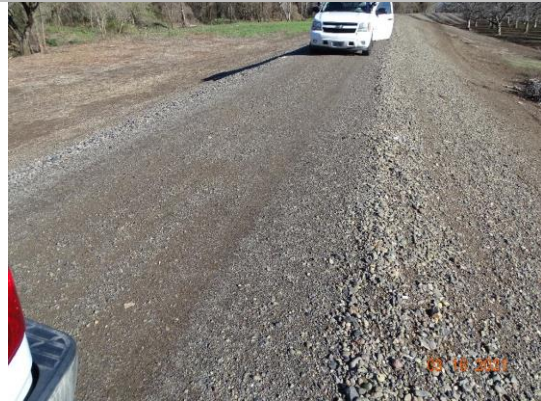
Photo 1 of 3 : UCIP_FA_2022_67358_99833.jpg

Comment Code					
Inspector Comment					
DS_ID:19252 FS_ID:67358 EP_NO: N/A Repair Type: Urgent EVAL Issue: 1, Pipe Integrity Crossing Status: Found UCIP Comments: 03/16/2021 Record updated from Non-Urgent to Urgent. DMP internal video inspection has found pipe integrity issues. LOF of crossing is between 5 and 6. Crossing will be monitored until funding becomes available to address the issues. No permit has been identified authorizing pipe. Sediment at the bottom of CMP needs claeirng. (O.Yakimov - DWR UCIP) 02/25/2014 Needs cleaning and clearing of debris. (P. Amatya - DWR UCIP) FIELD_STRUCT_DESC: 24-inch corrugated metal gravity drainage pipe through the levee, 15 feet below the crown. Flap gate on the waterside (WS) end. Concrete U-shaped headwall on each end. Grouted riprap apron on the landside (LS) end. Grouted riprap spillway on the WS end. [Additional Reference(s): DWR Levee Log, 1992 (HLM 7.17). USACE Sacramento O&M Manual, Unit 504, May 1965, Revised 2 February 2011, (HLM 7.17), listed as 24-inch pipe. USACE As-Built Drawing No. 50-04-3684, Sheets 3 and 6, STA 64+80, 15 April 1963]. FS Date: 3/16/2021 2:50:50 PM

Top of Levee: View of levee crown looking upstream

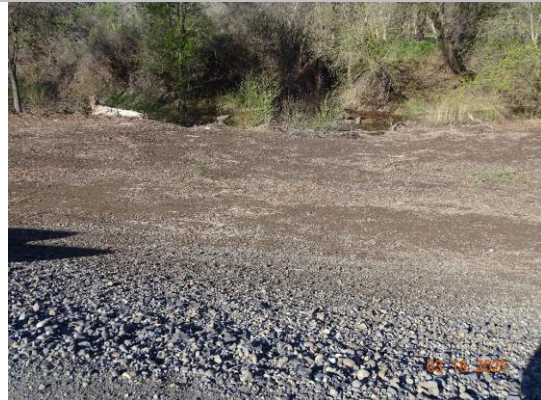
Photo 2 of 3 : UCIP_FA_2022_67358_99835.jpg

Water-Side: View of levee slope looking from crown

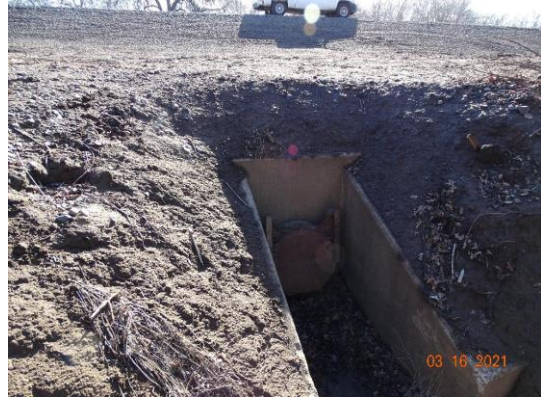
Photo 3 of 3 : UCIP_FA_2022_67358_99836.jpg

Water-Side: Headwall and flap gate on levee berm

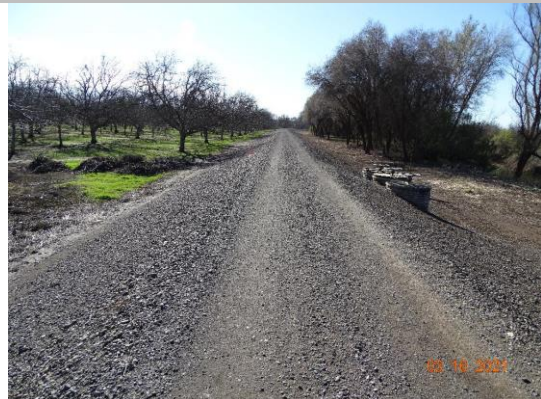
Photo 1 of 3 : UCIP_FA_2022_67359_99839.jpg

DS_ID:19253
 FS_ID:67359
 EP_NO: N/A
 Repair Type: Non-Urgent
 EVAL Issue:
 Crossing Status: Found
 UCIP Comments: 03/16/2021 Record remains Non-Urgent. No permit has been identified authorizing pipe. Debris has been cleared. DMP internal video inspection has not found pipe integrity issues. LOF of crossing is less or equal to 4. Recommend next video inspection in 5 years. (O.Yakimov - DWR UCIP)
 02/25/2014 Slide gates in CMP risers on waterside shoulder. Needs cleaning and clearing of debris. (P. Amatya - DWR UCIP)
 FIELD_STRUCT_DESC: 1 of 3: 48-inch corrugated metal gravity drainage pipe through the levee, 18 feet below the crown. Flap gate on the waterside (WS) end. Slide gate in a corrugated metal pipe (CMP) riser on the WS shoulder. Concrete U-shaped headwall on each end. Grouted riprap apron on the landside (LS) end. Grouted riprap spillway on the WS end. [Additional Reference(s): DWR Levee Log, 1992 (HLM 7.46). USACE Sacramento O&M Manual, Unit 504, May 1965, Revised 2 February 2011, (HLM 7.46), listed as 48-inch pipe. USACE As-Built Drawing No. 50-04-3684, Sheets 3 and 6, STA 50+00, 15 April 1963].

Top of Levee: View of levee crown looking downstream

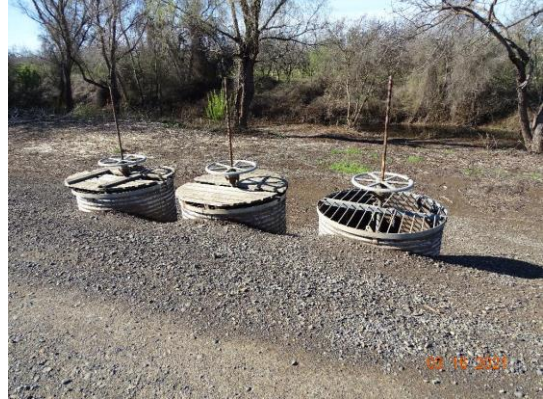
Photo 2 of 3 : UCIP_FA_2022_67359_99840.jpg

Water-Side: View of levee slope looking from crown. CMP riser with slide gate on levee shoulder

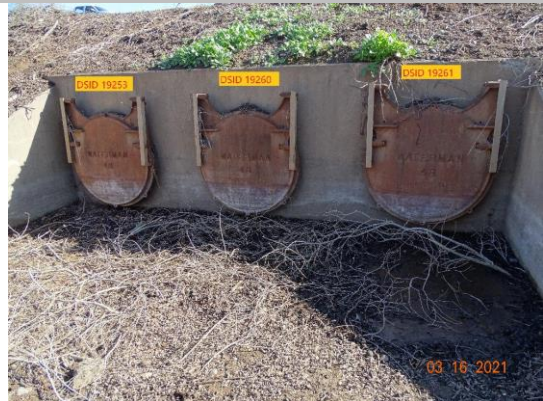
Photo 3 of 3 : UCIP_FA_2022_67359_99842.jpg

Water-Side: Headwall and flap gate at levee toe

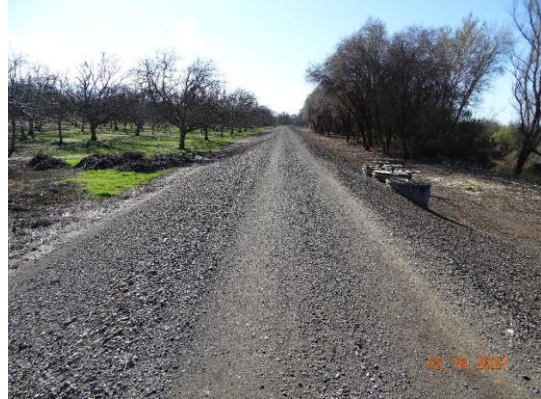
Photo 1 of 3 : UCIP_FA_2022_67361_99849.jpg

Comment Code					
Inspector Comment					
DS_ID:19261 FS_ID:67361 EP_NO: N/A Repair Type: Non-Urgent EVAL Issue: Crossing Status: Found UCIP Comments: 03/16/2021 Record remains Non-Urgent. No permit has been identified authorizing pipe. Debris has been cleared. DMP internal video inspection has not found pipe integrity issues. LOF of crossing is less or equal to 4. Recommend next video inspection in 5 years. (O.Yakimov - DWR UCIP) 02/25/2014 Slide gates in CMP risers on waterside shoulder. Needs cleaning and clearing on both pipe ends. (P. Amatya - DWR UCIP) FIELD_STRUCT_DESC: 3 of 3: 48-inch corrugated metal gravity drainage pipe through the levee, 18 feet below the crown. Flap gate on the waterside (WS) end. Slide gate in a corrugated metal pipe (CMP) riser on the WS shoulder. Concrete U-shaped headwall on each end. Grouted riprap apron on the landside (LS) end. Grouted riprap spillway on the WS end. [Additional Reference(s): DWR Levee Log, 1992 (HLM 7.46). USACE Sacramento O&M Manual, Unit 504, May 1965, Revised 2 February 2011, (HLM 7.46), listed as 48-inch pipe. USACE As-Built Drawing No. 50-04-3684, Sheets 3 and 6, STA 50+00, 15 April 1963]. FS Date: 3/16/2021 3:17:31 PM

Top of Levee: View of levee crown looking downstream

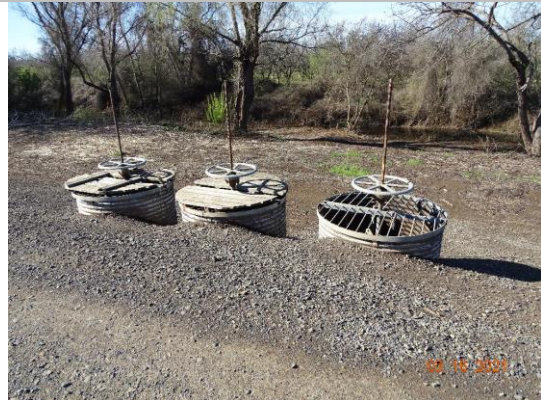
Photo 2 of 3 : UCIP_FA_2022_67361_99850.jpg

Water-Side: View of levee slope looking from crown. CMP riser with slide gate on levee shoulder

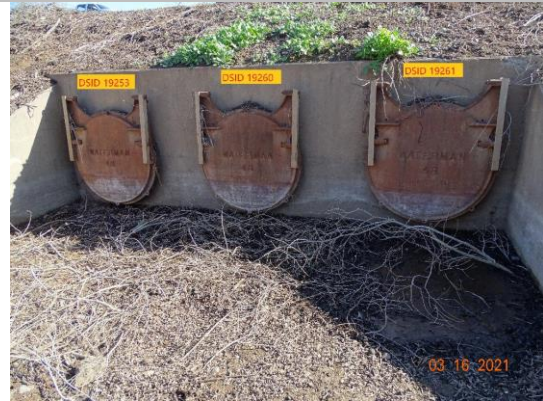
Photo 3 of 3 : UCIP_FA_2022_67361_99852.jpg

Water-Side: Headwall and flap gate at levee toe

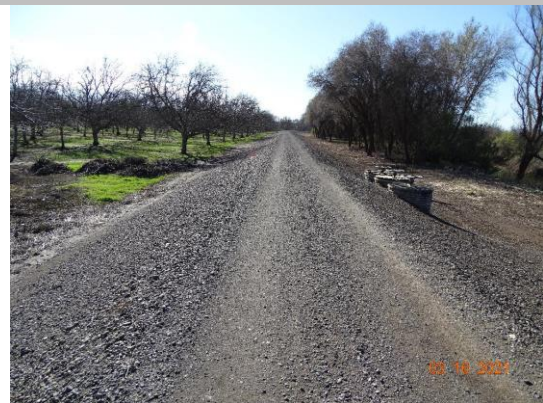
Photo 1 of 3 : UCIP_FA_2022_67360_99844.jpg

DS_ID:19260
FS_ID:67360
EP_NO: N/A
Repair Type: Non-Urgent
EVAL Issue: 5, Pipe Damage
Crossing Status: Found
UCIP Comments: 03/16/2021 Record remains Non-Urgent. DMP internal video inspection has found pipe integrity issues. LOF of crossing is greater than or equal to 4.1 and less than 5. Crossing will be monitored until funding becomes available for rehabilitation. No permit has been identified authorizing pipe. Debris has been cleared.
(O.Yakimov - DWR UCIP)
02/25/2014 Slide gates in CMP risers on waterside shoulder. Needs cleaning and clearing of debris. (P. Amatya - DWR UCIP)
FIELD_STRUCT_DESC: 2 of 3: 48-inch corrugated metal gravity drainage pipe through the levee, 18 feet below the crown. Flap gate on the waterside (WS) end. Slide gate in a corrugated metal pipe (CMP) riser on the WS shoulder. Concrete U-shaped headwall on each end. Grouted riprap apron on the landside (LS) end. Grouted riprap spillway on the WS end. [Additional Reference(s): DWR Levee Log, 1992 (HLM 7.46). USACE Sacramento O&M Manual, Unit 504, May 1965, Revised 2 February 2011, (HLM 7.46), listed as 48-inch pipe. USACE As-Built Drawing No. 50-04-3684, Sheets 3 and 6, STA 50+00, 15 April 1963].

Top of Levee: View of levee crown looking downstream

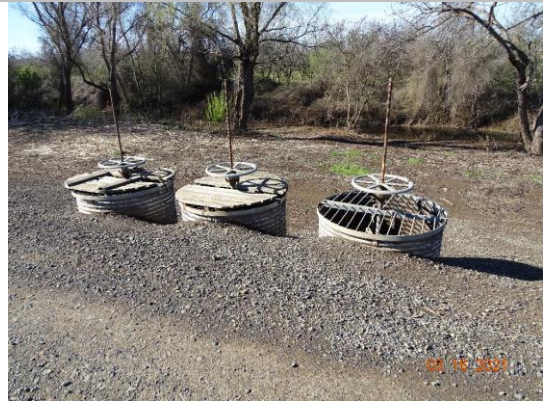
Photo 2 of 3 : UCIP_FA_2022_67360_99845.jpg

Water-Side: View of levee slope looking from crown. CMP riser with slide gate on levee shoulder

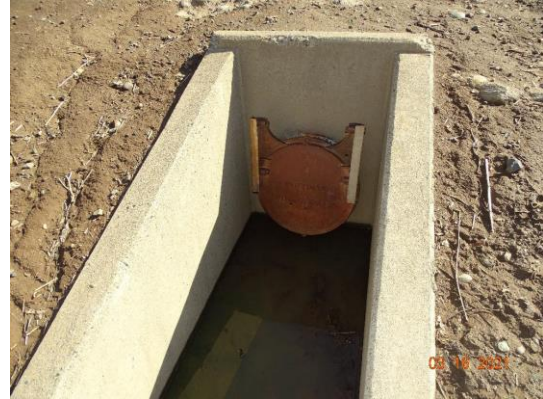
Photo 1 of 3 : UCIP_FA_2022_67362_99859.jpg

Comment Code						
Inspector Comment						
DS_ID:19254 FS_ID:67362 EP_NO: N/A Repair Type: Non-Urgent EVAL Issue: 5, Pipe Damage Crossing Status: Found UCIP Comments: 03/16/2021 Record remains Non-Urgent. DMP internal video inspection has found pipe integrity issues. LOF of crossing is greater than or equal to 4.1 and less than 5. Crossing will be monitored until funding becomes available for rehabilitation. No permit has been identified authorizing pipe. Debris has been cleared. (O.Yakimov - DWR UCIP) 02/25/2014 Debris in inlet pipe, needs cleaning and clearing. (P. Amatya - DWR UCIP) FIELD_STRUCT_DESC: 24-inch corrugated metal gravity drainage pipe through the levee, 18 feet below the crown. Flap gate on the waterside (WS) end. Concrete U-shaped headwall on each end. Grouted riprap apron on the landside (LS) end. Grouted riprap spillway on the WS end. [Additional Reference(s): DWR Levee Log, 1992 (HLM 8.01). USACE Sacramento O&M Manual, Unit 504, May 1965, Revised 2 February 2011, (HLM 8.09), listed as 24-inch pipe. USACE As-Built Drawing No. 50-04-3684, footnote Sheet 2, Sheet 6, STA 21+23, 15 April 1963]. FS Date: 3/16/2021 3:19:02 PM

Water-Side: Headwall and flap gate at levee toe

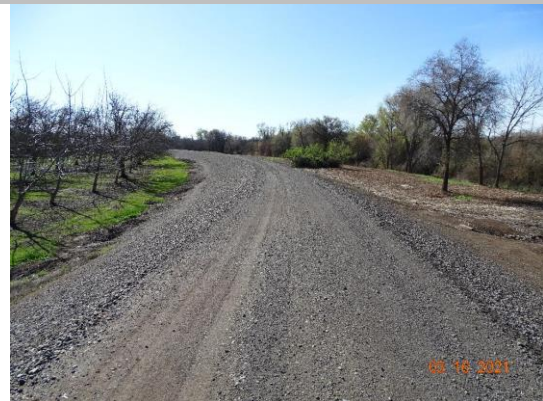
Photo 2 of 3 : UCIP_FA_2022_67362_99854.jpg

Top of Levee: View of levee crown looking downstream

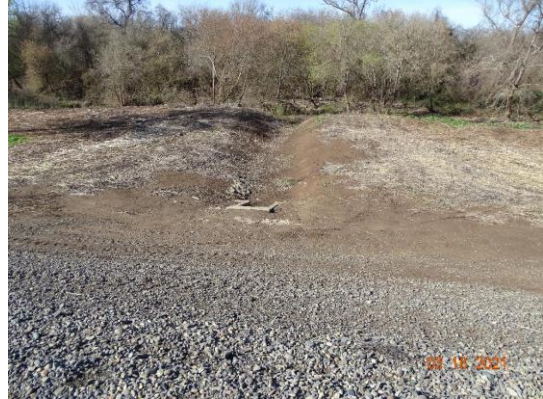
Photo 3 of 3 : UCIP_FA_2022_67362_99855.jpg

Water-Side: View of levee slope looking from crown

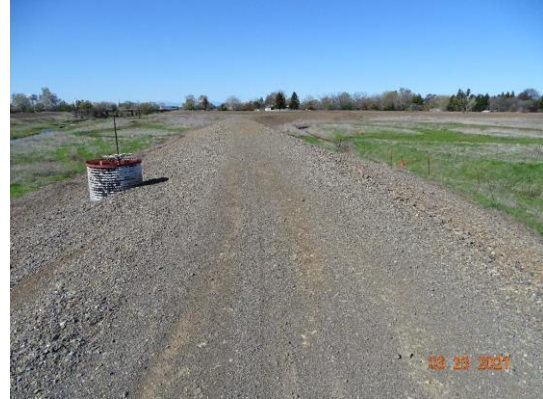
Photo 1 of 3 : UCIP_FA_2022_67668_100475.jpg

Comment Code						
Inspector Comment						
DS_ID:19262 FS_ID:67668 EP_NO: N/A Repair Type: Urgent EVAL Issue: 1, Pipe Integrity Crossing Status: Found UCIP Comments: 03/23/2021 Record updated from No Action Needed to Urgent. DMP internal video inspection has found pipe integrity issues. LOF of crossing is between 5 and 6. Crossing will be monitored until funding becomes available to address the issues. No permit has been identified authorizing pipe. (O.Yakimov - DWR UCIP) 05/16/2017 Crossing has been downgraded from Non-Urgent to No Action Needed. The flap gate appears to be in good working order based on the photos, and the small pile of debris not enough to warrant Non-Urgent rating. (K. Fazel - DWR UCIP) 03/11/2014 Slide gate in CMP riser on watersie. The culvert was working during field inspection. (P. Amatya - DWR) FIELD_STRUCT_DESC: 42-inch corrugated metal gravity drainage pipe through the levee, 14 feet below the crown. Flap gate on the waterside (WS) end. Slide gate in a corrugated metal pipe (CMP) riser on the WS slope. Concrete U-shaped headwall on each end. Grouted riprap apron on the landside (LS) end. Grouted riprap spillway on the WS end. [Additional Reference(s): DWR Levee Log, 1992 (HLM 0.09). USACE Sacramento O&M Manual, Unit 504, May 1965, Revised 2 February 2011, (HLM 0.09), listed as 42-inch pipe. USACE As-Built Drawing No. 50-04-3685, Sheets 7 and 40, STA 370+60, 19 May 1965]. FS Date: 3/23/2021 1:52:32 PM

Top of Levee: View of levee crown looking downstream

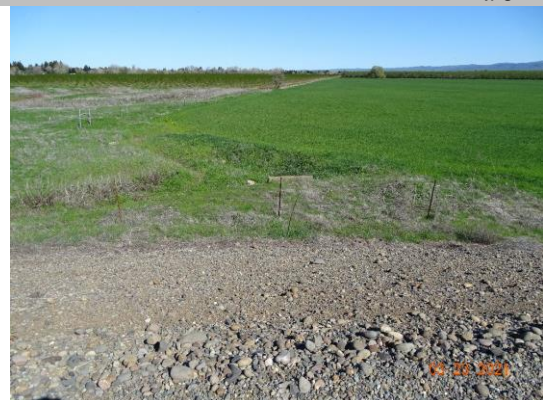
Photo 2 of 3 : UCIP_FA_2022_67668_100476.jpg

Land-Side: View of levee slope looking from crown

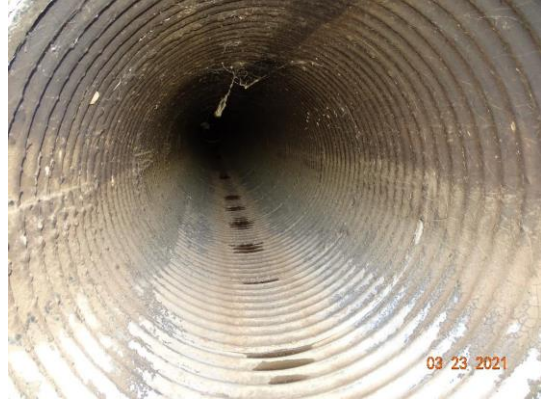
Photo 3 of 3 : UCIP_FA_2022_67668_100474.jpg

Land-Side: View inside of pipe looking from landside end

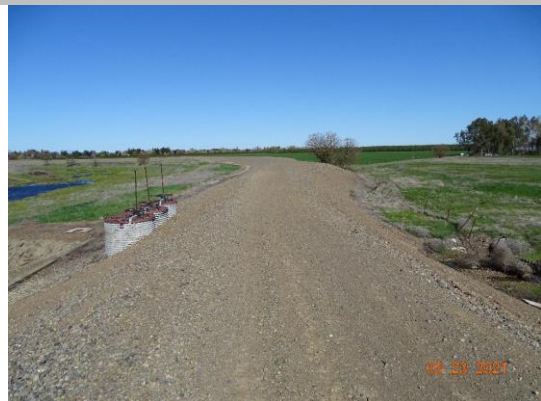
Photo 1 of 3 : UCIP_FA_2022_67669_100480.jpg

DS_ID:19278
FS_ID:67669
EP_NO: N/A
Repair Type: Non-Urgent
EVAL Issue:
Crossing Status: Found
UCIP Comments: 03/23/2021 Record updated from No Action Needed to Non-Urgent. No permit has been identified authorizing pipe. DMP internal video inspection has not found pipe integrity issues. LOF of crossing is less or equal to 4. Recommend next video inspection in 5 years. (O.Yakimov - DWR UCIP)
03/11/2014 Slide gate in CMP riser on waterside. The culvert was working during the field visit. (P. Amatya - DWR UCIP)
FIELD_STRUCT_DESC: 1 of 3: 48-inch corrugated metal gravity drainage pipe through the levee, 11.7 feet below the crown. Slide gate in a riser well on the waterside (WS) slope. Concrete U-shaped headwall on each end. Flap gate on the WS end. Grouted riprap outlet channel on the WS. [Additional Reference(s): DWR Levee Log, 1992 (HLM 0.39). USACE Sacramento O&M Manual, Unit 504, May 1965, Revised 2 February 2011, (HLM 0.39), listed as 48-inch pipe. USACE As-Built Drawing No. 50-04-3685, Sheets 7 and 39, STA 385+90, 19 May 1965].

Top of Levee: View of levee crown looking downstream

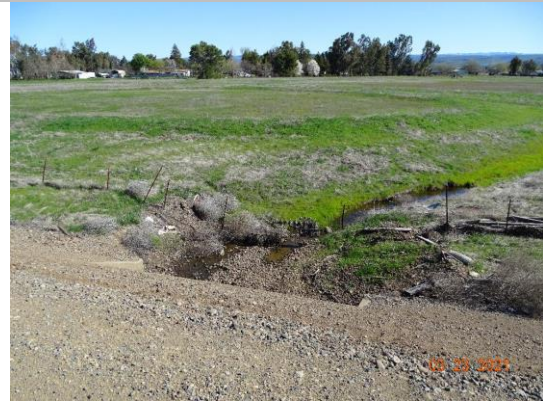
Photo 2 of 3 : UCIP_FA_2022_67669_100481.jpg

Land-Side: View of levee slope looking from crown

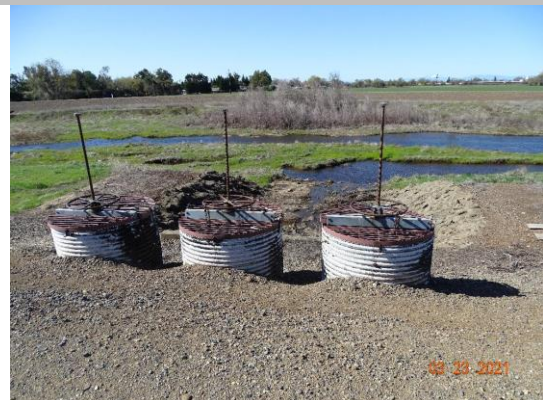
Photo 3 of 3 : UCIP_FA_2022_67669_100482.jpg

Water-Side: View of levee slope looking from crown. CMP riser with slide gate on levee shoulder

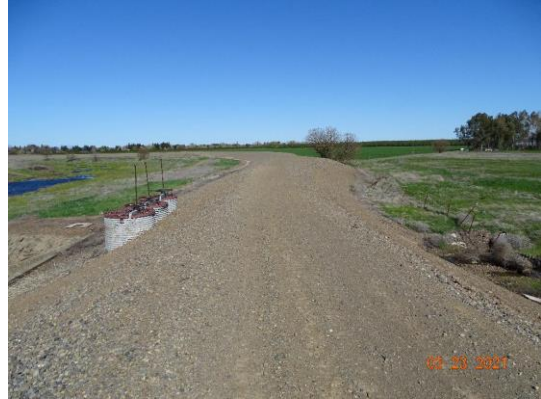
Photo 1 of 3 : UCIP_FA_2022_67670_100486.jpg

Comment Code					
Inspector Comment					
DS_ID:19277 FS_ID:67670 EP_NO: N/A Repair Type: Non-Urgent EVAL Issue: Crossing Status: Found UCIP Comments: 03/23/2021 Record updated from No Action Needed to Non-Urgent. No permit has been identified authorizing pipe. DMP internal video inspection has not found pipe integrity issues. LOF of crossing is less or equal to 4. Recommend next video inspection in 5 years. (O.Yakimov - DWR UCIP) 03/11/2014 Slide gate in CMP riser on waterside. The culvert was working during the field visit. (P. Amatya - DWR UCIP) FIELD_STRUCT_DESC: 2 of 3: 48-inch corrugated metal gravity drainage pipe through the levee, 11.7 feet below the crown. Slide gate in a riser well on the waterside (WS) slope. Concrete U-shaped headwall on each end. Flap gate on the WS end. Grouted riprap outlet channel on the WS. [Additional Reference(s): DWR Levee Log, 1992 (HLM 0.39). USACE Sacramento O&M Manual, Unit 504, May 1965, Revised 2 February 2011, (HLM 0.39), listed as 48-inch pipe. USACE As-Built Drawing No. 50-04-3685, Sheets 7 and 39, STA 385+90, 19 May 1965]. FS Date: 3/23/2021 2:59:04 PM

Top of Levee: View of levee crown looking downstream

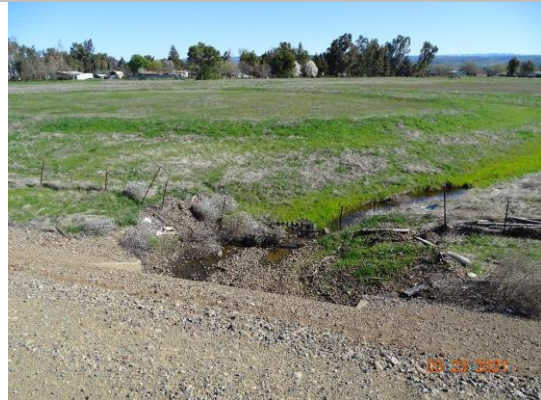
Photo 2 of 3 : UCIP_FA_2022_67670_100487.jpg

Land-Side: View of levee slope looking from crown

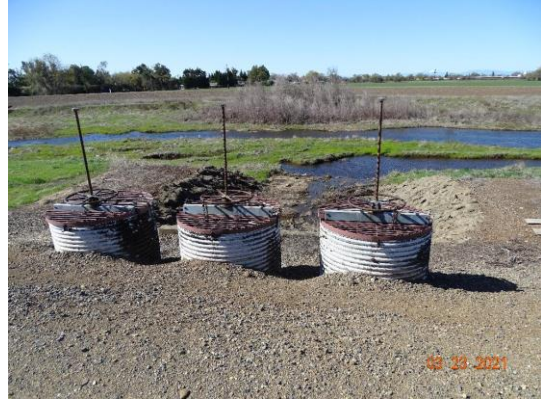
Photo 3 of 3 : UCIP_FA_2022_67670_100488.jpg

Water-Side: View of levee slope looking from crown. CMP riser with slide gate on levee shoulder

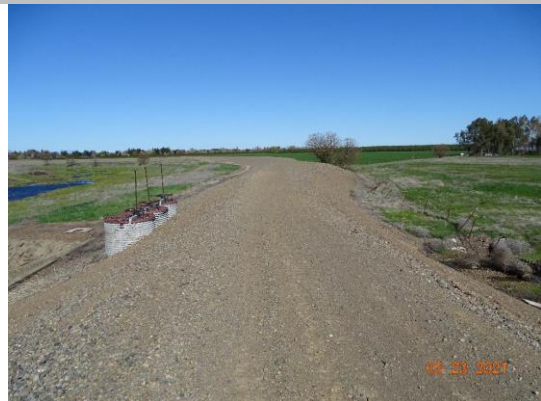
Photo 1 of 3 : UCIP_FA_2022_67671_100492.jpg

DS_ID:19263
 FS_ID:67671
 EP_NO: N/A
 Repair Type: Non-Urgent
 EVAL Issue:
 Crossing Status: Found
 UCIP Comments: 03/23/2021 Record updated from No Action Needed to Non-Urgent. No permit has been identified authorizing pipe. DMP internal video inspection has not found pipe integrity issues. LOF of crossing is less or equal to 4. Recommend next video inspection in 5 years. (O.Yakimov - DWR UCIP)
 03/11/2014 Slide gate in CMP riser on waterside. The culvert was working during the field visit. (P. Amatya - DWR UCIP)
 FIELD_STRUCT_DESC: 3 of 3: 48-inch corrugated metal gravity drainage pipe through the levee, 11.7 feet below the crown. Slide gate in a riser well on the waterside (WS) slope. Concrete U-shaped headwall on each end. Flap gate on the WS end. Grouted riprap outlet channel on the WS. [Additional Reference(s): DWR Levee Log, 1992 (HLM 0.39). USACE Sacramento O&M Manual, Unit 504, May 1965, Revised 2 February 2011, (HLM 0.39), listed as 48-inch pipe. USACE As-Built Drawing No. 50-04-3685, Sheets 7 and 39, STA 385+90, 19 May 1965].

Top of Levee: View of levee crown looking downstream

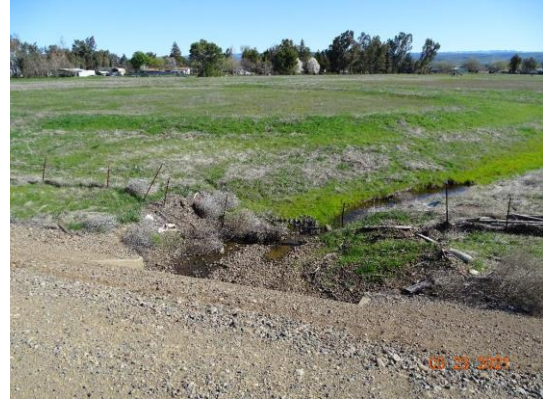
Photo 2 of 3 : UCIP_FA_2022_67671_100493.jpg

Land-Side: View of levee slope looking from crown

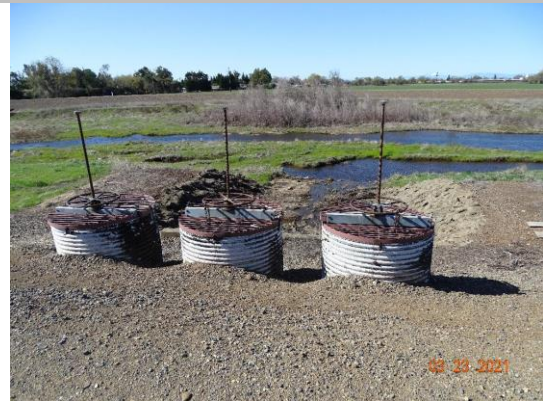
Photo 3 of 3 : UCIP_FA_2022_67671_100494.jpg

Water-Side: View of levee slope looking from crown. CMP riser with slide gate on levee shoulder

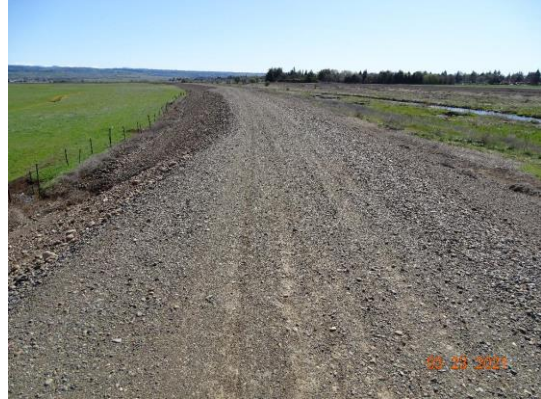
Photo 1 of 3 : UCIP_FA_2022_67676_100511.jpg

Comment Code						
Inspector Comment						
DS_ID:19264 FS_ID:67676 EP_NO: N/A Repair Type: Urgent EVAL Issue: 1, Pipe Integrity Crossing Status: Found UCIP Comments: 03/23/2021 Record updated from No Action Needed to Urgent. DMP internal video inspection has found pipe integrity issues. LOF of crossing is between 5 and 6. Crossing will be monitored until funding becomes available to address the issues. No permit has been identified authorizing pipe. (O.Yakimov - DWR UCIP) 03/11/2014 The culvert was working during the field visit. (P. Amatya - DWR UCIP) FIELD_STRUCT_DESC: 24-inch corrugated metal gravity drainage pipe through the levee, 11.7 feet below the crown. Flap gate on the waterside (WS) end. Concrete U-shaped headwall on each end. [Additional Reference(s): DWR Levee Log, 1992 (HLM 1.26). USACE Sacramento O&M Manual, Unit 504, May 1965, Revised 2 February 2011, (HLM 1.28), listed as 24-inch pipe. USACE As-Built Drawing No. 50-04-3685, Sheet 9, STA 431+50, 19 May 1965]. FS Date: 3/23/2021

Top of Levee: View of levee crown looking upstream

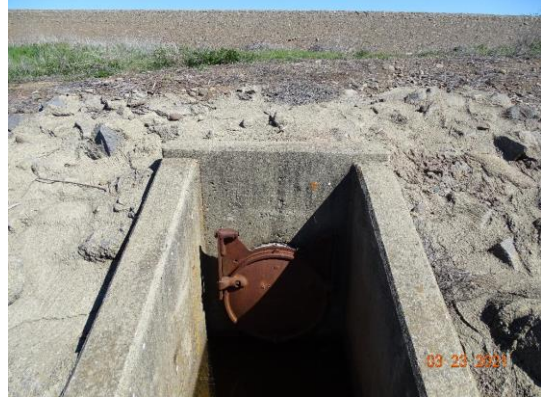
Photo 3 of 3 : UCIP_FA_2022_67676_100516.jpg

Water-Side: Headwall and flap gate at levee toe

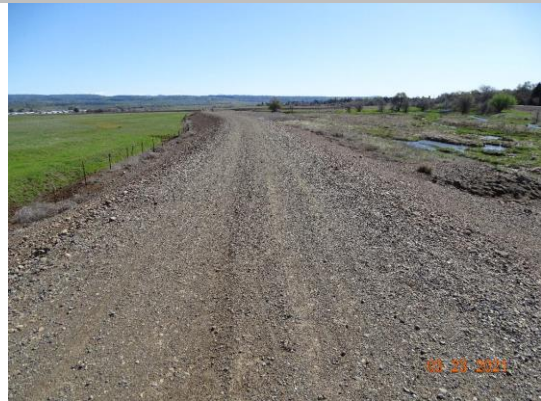
Photo 1 of 3 : UCIP_FA_2022_67677_100517.jpg

DS_ID:19265
 FS_ID:67677
 EP_NO: N/A
 Repair Type: Non-Urgent
 EVAL Issue: 5, Pipe Damage
 Crossing Status: Found
 UCIP Comments: 03/23/2021 Record updated from No Action Needed to Non-Urgent. DMP internal video inspection has found pipe integrity issues. LOF of crossing is greater than or equal to 4.1 and less than 5. Crossing will be monitored until funding becomes available for rehabilitation. No permit has been identified authorizing pipe. (O.Yakimov - DWR UCIP)
 03/11/2014 Working during the field visit. (P. Amatya - DWR UCIP)
 FIELD_STRUCT_DESC: 24-inch corrugated metal gravity drainage pipe through the levee, 11 feet below the crown. Flap gate on the waterside (WS) end. Concrete U-shaped headwall on each end. Grouted riprap apron on each end. [Additional Reference(s): DWR Levee Log, 1992 (HLM 1.52). USACE Sacramento O&M Manual, Unit 504, May 1965, Revised 2 February 2011, (HLM 1.53), listed as 24-inch pipe. USACE As-Built Drawing No. 50-04-3685, Sheet 9, STA 444+80, 19 May 1965].

Top of Levee: View of levee crown looking upstream

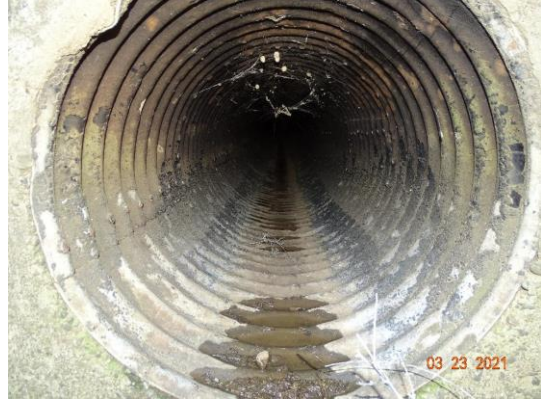
Photo 2 of 3 : UCIP_FA_2022_67677_100520.jpg

Land-Side: View inside of pipe looking from landside end

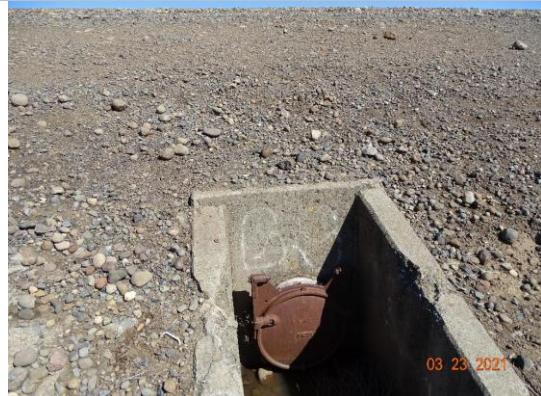
Photo 3 of 3 : UCIP_FA_2022_67677_100521.jpg

Water-Side: Levee slope, headwall and flap gate at levee toe

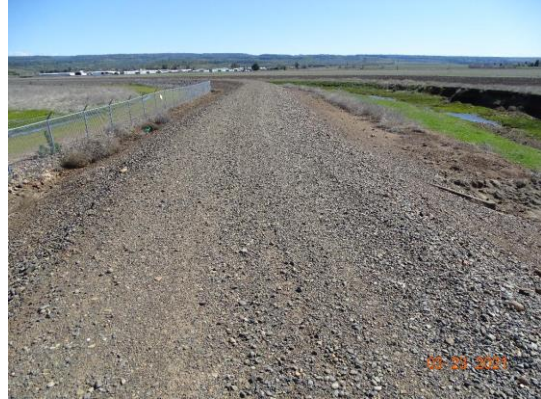
Photo 1 of 3 : UCIP_FA_2022_67678_100522.jpg

Comment Code						
Inspector Comment						
DS_ID:19266 FS_ID:67678 EP_NO: N/A Repair Type: Non-Urgent EVAL Issue: 5, Pipe Damage Crossing Status: Indicator Found UCIP Comments: 03/23/2021 Record remains Non-Urgent. DMP internal video inspection has found pipe integrity issues. LOF of crossing is greater than or equal to 4.1 and less than 5. Crossing will be monitored until funding becomes available for rehabilitation. No permit has been identified authorizing pipe. Coordinates of crossing have been updated. (O.Yakimov - DWR UCIP) 03/11/2014 Needs location confirmation, GPS reading has not taken due to access problem. (P. Amatya - DWR UCIP) FIELD_STRUCT_DESC: 24-inch corrugated metal gravity drainage pipe through the levee, 8 feet below the crown. Flap gate on the waterside (WS) end. Concrete U-shaped headwall on each end. Grouted riprap apron on the landside (LS) end. Grouted riprap spillway on the WS end. (4-inch PVC pipe through existing landside headwall authorized under Permit No. 17680, 2003 - City of Chico, Department of Public Works). [Additional Reference(s): DWR Levee Log, 1992 (HLM 2.00). USACE Sacramento O&M Manual, Unit 504, May 1965, Revised 2 February 2011, (HLM 2.00), listed as 24-inch pipe. USACE As-Built Drawing No. 50-04-3685, Sheet 10, STA 20+30, 19 May 1965]. FS Date: 3/23/2021 8:39:14 AM

Top of Levee: View of levee crown looking upstream

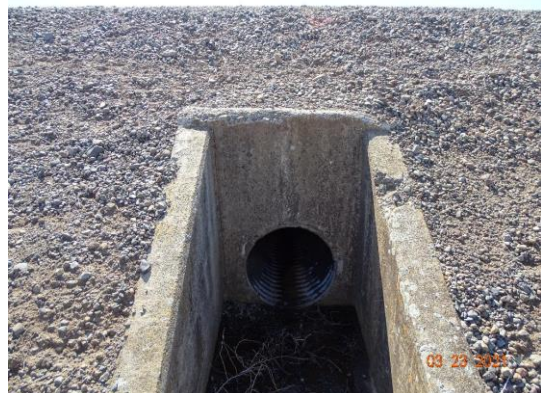
Photo 2 of 3 : UCIP_FA_2022_67678_100525.jpg

Land-Side: Levee slope, U-shaped headwall and pipe at levee toe

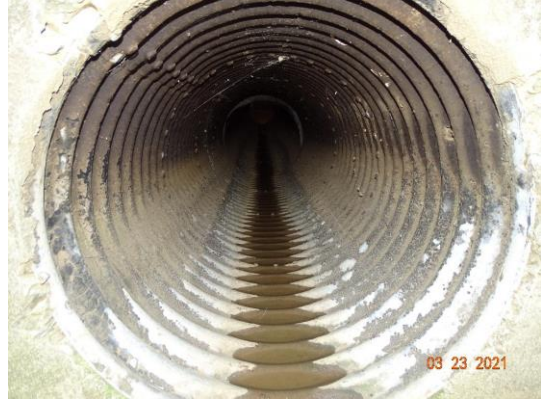
Photo 3 of 3 : UCIP_FA_2022_67678_100526.jpg

Land-Side: View inside of pipe looking from landside end

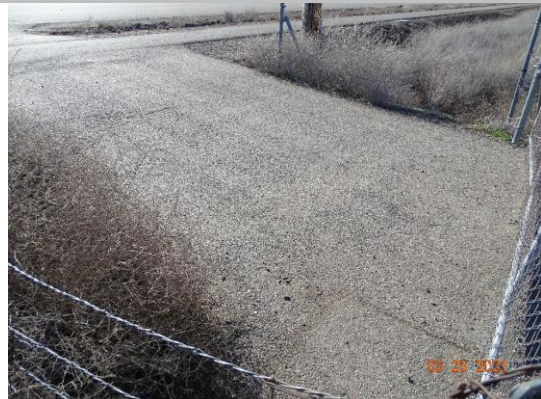
Photo 1 of 3 : UCIP_FA_2022_67679_100529.jpg

DS_ID:19267
FS_ID:67679
EP_NO: N/A
Repair Type: Non-Urgent
EVAL Issue:
Crossing Status: Found
UCIP Comments: 03/25/2021 Record remains Non-Urgent. No permit has been identified authorizing pipe. DMP internal video inspection has not found pipe integrity issues. LOF of crossing is less or equal to 4. Recommend next video inspection in 5 years. (O.Yakimov - DWR UCIP)
03/07/2014 Pipe is about 4 feet below the crown. Needs cleaning and clearing the culvert. (P. Amatya - DWR UCIP)
FIELD_STRUCT_DESC: 24-inch corrugated metal gravity drainage pipe through the levee, 6 feet below the crown. Flap gate on the waterside (WS) end. Concrete U-shaped headwall on each end.
[Additional Reference(s): DWR Levee Log, 1992 (HLM 2.23). USACE Sacramento O&M Manual, Unit 504, May 1965, Revised 2 February 2011, (HLM 2.23), listed as 24-inch pipe. USACE As-Built Drawing No. 50-04-3685, Sheet 10, STA 46+90, 19 May 1965].
FS Date: 3/25/2021 8:45:44 AM

Top of Levee: View of levee crown looking upstream

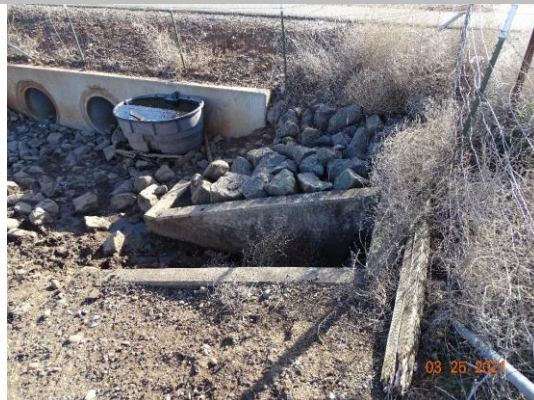
Photo 2 of 3 : UCIP_FA_2022_67679_100528.jpg

Water-Side: U-shaped Headwall and revetment on levee slope

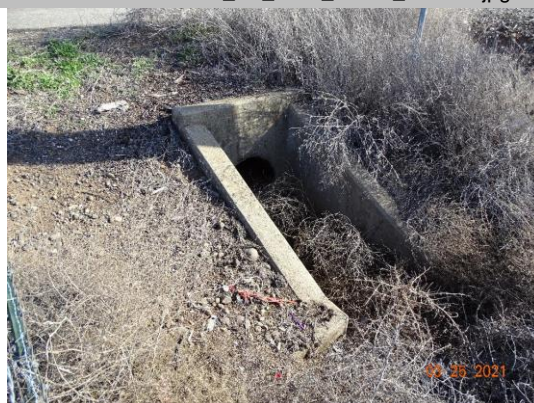
Photo 3 of 3 : UCIP_FA_2022_67679_100530.jpg

Land-Side: U-shaped headwall and pipe at levee toe

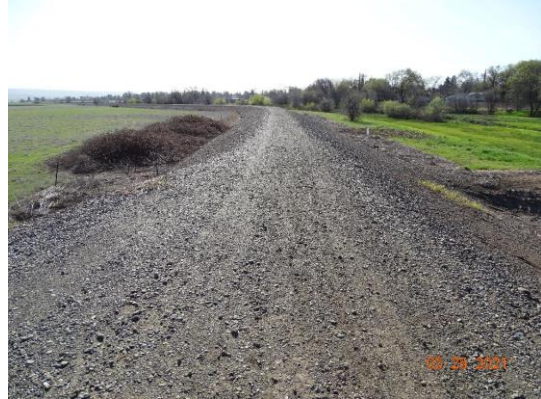
Photo 1 of 3 : UCIP_FA_2022_67681_100537.jpg

Comment Code						
Inspector Comment						
DS_ID:19269 FS_ID:67681 EP_NO: N/A Repair Type: Non-Urgent EVAL Issue: Crossing Status: Found UCIP Comments: 03/25/2021 Record remains Non-Urgent. No permit has been identified authorizing pipe. DMP internal video inspection has not found pipe integrity issues. LOF of crossing is less or equal to 4. Recommend next video inspection in 5 years. (O.Yakimov - DWR UCIP) 03/07/2014 Needs cleaning and clearing the culvert. (P. Amatya - DWR UCIP) FIELD_STRUCT_DESC: 24-inch corrugated metal gravity drainage pipe through the levee, 11 feet below the crown. Flap gate on the waterside (WS) end. Concrete U-shaped headwall on each end. Grouted riprap apron on the landside (LS) end. Grouted riprap spillway on the WS end. [Additional Reference(s): DWR Levee Log, 1992 (HLM 3.16). USACE Sacramento O&M Manual, Unit 504, May 1965, Revised 2 February 2011, (HLM 3.16), listed as 24-inch pipe]. FS Date: 3/25/2021 10:55:20 AM

Top of Levee: View of levee crown looking upstream

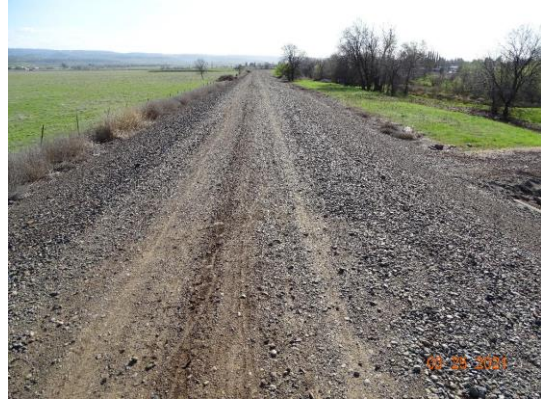
Photo 1 of 3 : UCIP_FA_2022_67682_100543.jpg

Comment Code						
Inspector Comment						
DS_ID:19270 FS_ID:67682 EP_NO: N/A Repair Type: Non-Urgent EVAL Issue: Crossing Status: Found UCIP Comments: 03/25/2021 Record is Non-Urgent. No permit has been identified authorizing pipe. DMP internal video inspection has not found pipe integrity issues. LOF of crossing is less or equal to 4. Recommend next video inspection in 5 years. (O.Yakimov - DWR UCIP)						
FIELD_STRUCT_DESC: 24-inch corrugated metal gravity drainage pipe through the levee, 11 feet below the crown. Flap gate on the waterside (WS) end. Concrete U-shaped headwall on each end. Grouted riprap apron on the landside (LS) end. Grouted riprap spillway on the WS end. [Additional Reference(s): DWR Levee Log, 1992 (HLM 3.28). USACE Sacramento O&M Manual, Unit 504, May 1965, Revised 2 February 2011, (HLM 3.28), listed as 24-inch pipe. USACE As-Built Drawing No. 50-04-3685, Sheet 9, STA 462+10, 19 May 1965]]. FS Date: 3/25/2021 10:58:02 AM

Top of Levee: View of levee crown looking upstream

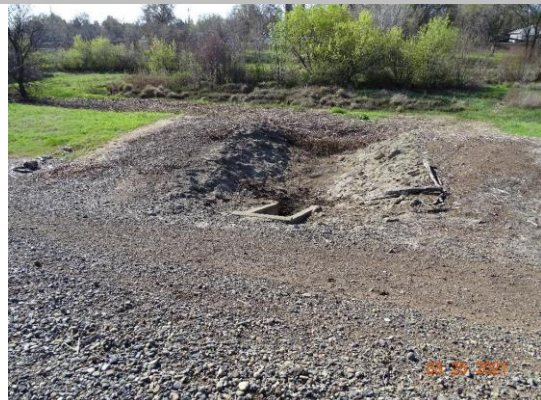
Photo 2 of 3 : UCIP_FA_2022_67682_100544.jpg

Water-Side: View of levee slope looking from crown

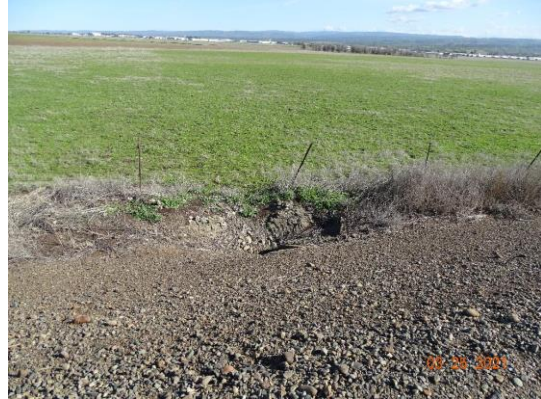
Photo 3 of 3 : UCIP_FA_2022_67682_100545.jpg

Land-Side: View of levee slope looking from crown

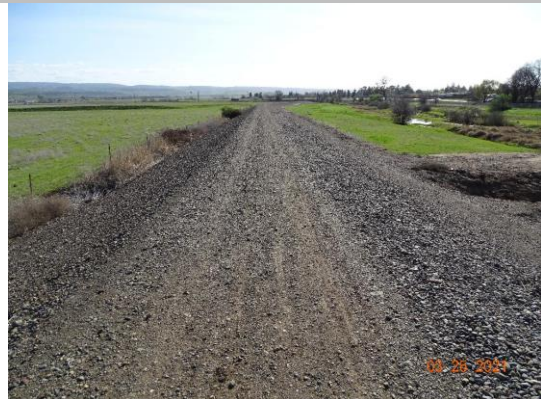
Photo 1 of 3 : UCIP_FA_2022_67683_100549.jpg

DS_ID:19271
 FS_ID:67683
 EP_NO: N/A
 Repair Type: Non-Urgent
 EVAL Issue:
 Crossing Status: Found
 UCIP Comments: 03/25/2021 Record remains Non-Urgent. Debris around culver has been cleared. No permit has been identified authorizing pipe. DMP internal video inspection has not found pipe integrity issues. LOF of crossing is less or equal to 4. Recommend next video inspection in 5 years. (O.Yakimov - DWR UCIP)
 03/07/2014 Needs cleaning and clearing the culvert. (P. Amatya - DWR UCIP)
 FIELD_STRUCT_DESC: 24-inch corrugated metal gravity drainage pipe through the levee, 10.5 feet below the crown. Flap gate on the waterside (WS) end. Concrete U-shaped headwall on each end. Grouted riprap apron on the landside (LS) end. Grouted riprap spillway on the WS end. [Additional Reference(s): DWR Levee Log, 1992 (HLM 3.43). USACE Sacramento O&M Manual, Unit 504, May 1965, Revised 2 February 2011, (HLM 3.43), listed as 24-inch pipe. USACE As-Built Drawing No. 50-04-3685, Sheet 11, STA 470+20, 19 May 1965].

Top of Levee: View of levee crown looking upstream

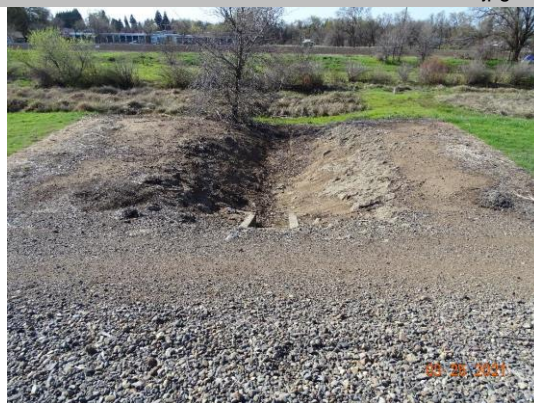
Photo 2 of 3 : UCIP_FA_2022_67683_100550.jpg

Water-Side: View of levee slope looking from crown

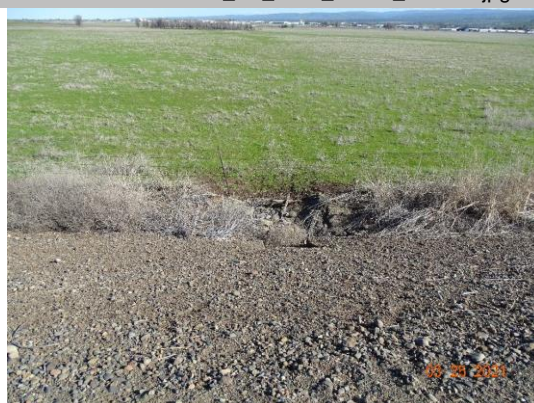
Photo 3 of 3 : UCIP_FA_2022_67683_100551.jpg

Land-Side: View of levee slope looking from crown

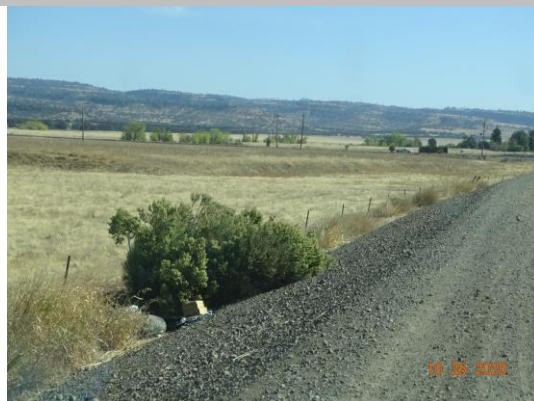
Photo 1 of 1 : FA_2022_NA0003_67_14_20220906_00001.jpg

LM Start	3.38	Rating **	M	Issue No.	14
LM End	3.38	Issue Type +	Ma	Location *	LS
Category	Earthen Levee			GPS Latitude/Longitude	
				Start	End
Item	Vegetation			39.777429 °	39.777429 °
				-121.848937 °	-121.848937 °
DWR ID	DWR_NA0003_03_f_2016_14				
Comment Code					
V2 : Remove the wild growth and woody vegetation other than native grasses from the levee slopes.					
Inspector Comment

View of a bush along the landside slope. Fall 2020.

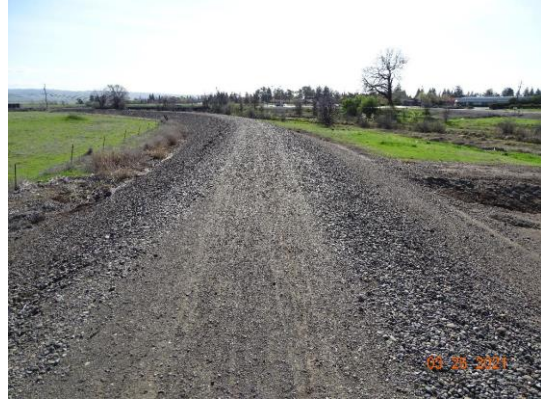
Photo 1 of 3 : UCIP_FA_2022_67684_100555.jpg

Comment Code					
Inspector Comment					
DS_ID:19272 FS_ID:67684 EP_NO: N/A Repair Type: Non-Urgent EVAL Issue: Crossing Status: Found UCIP Comments: 03/25/2021 Record remains Non-Urgent. Debris around culvert has been cleared. No permit has been identified authorizing pipe. DMP internal video inspection has not found pipe integrity issues. LOF of crossing is less or equal to 4. Recommend next video inspection in 5 years. (O.Yakimov - DWR UCIP) 03/07/2014 Needs cleaning and clearing the culvert. (P. Amatya - DWR UCIP) FIELD_STRUCT_DESC: 24-inch corrugated metal gravity drainage pipe through the levee, 9.5 feet below the crown. Flap gate on the waterside (WS) end. Concrete U-shaped headwall on each end. Grouted riprap apron on the landside (LS) end. Grouted riprap spillway on the WS end. [Additional Reference(s): DWR Levee Log, 1992 (HLM 3.59). USACE Sacramento O&M Manual, Unit 504, May 1965, Revised 2 February 2011, (HLM 3.59), listed as 24-inch pipe. USACE As-Built Drawing No. 50-04-3685, Sheet 11, STA 478+40, 19 May 1965]. FS Date: 3/25/2021 11:16:33 AM

Top of Levee: View of levee crown looking upstream

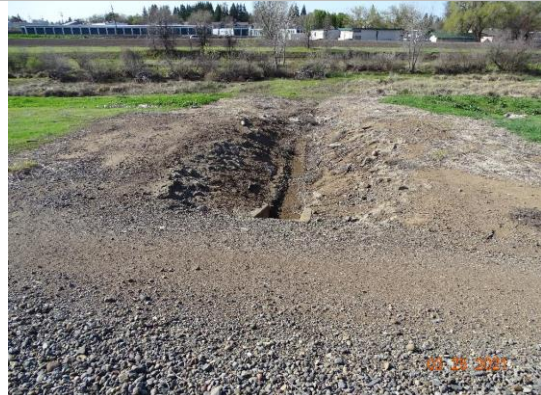
Photo 2 of 3 : UCIP_FA_2022_67684_100556.jpg

Water-Side: View of levee slope looking from crown

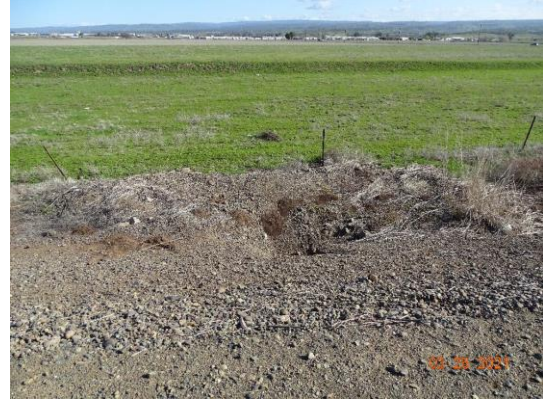
Photo 3 of 3 : UCIP_FA_2022_67684_100557.jpg

Land-Side: View of levee slope looking from crown

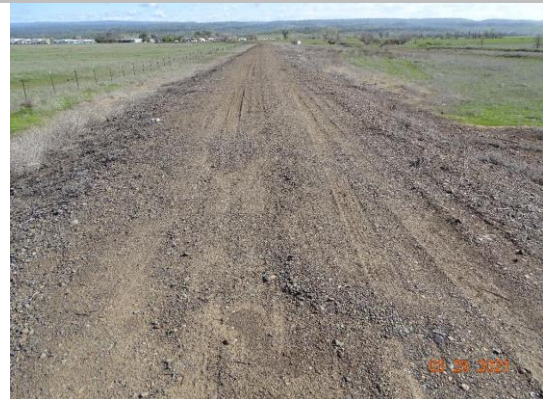
Photo 1 of 3 : UCIP_FA_2022_67687_100570.jpg

DS_ID:19275
 FS_ID:67687
 EP_NO: N/A
 Repair Type: Non-Urgent
 EVAL Issue:
 Crossing Status: Found
 UCIP Comments: 03/25/2021 Record remains Non-Urgent. No permit has been identified authorizing pipe. DMP internal video inspection has not found pipe integrity issues. LOF of crossing is less or equal to 4. Recommend next video inspection in 5 years. (O.Yakimov - DWR UCIP)
 03/04/2014 The culvert was working during the field visit. Needs cleaning and clearing on both ends of the pipe. (P. Amatya - DWR UCIP)
 FIELD_STRUCT_DESC: 24-inch corrugated metal gravity drainage pipe through the levee, 7.5 feet below the crown. Flap gate on the waterside (WS) end. Concrete U-shaped headwall on each end. Grouted riprap apron on the landside (LS) end. Grouted riprap spillway on the WS end. (Installation of flap gate to existing 24-inch-diameter outfall pipe authorized under Permit No. 18106, 2006 - City of Chico). [Additional Reference(s): DWR Levee Log, 1992 (HLM 3.75). USACE Sacramento O&M Manual, Unit 504, May 1965, Revised 2 February 2011, (HLM 3.76), listed as 24-inch pipe. USACE As-Built Drawing No. 50-04-3685, Sheet 11, STA 486+62, 19 May 1965].

Top of Levee: View of levee crown looking upstream

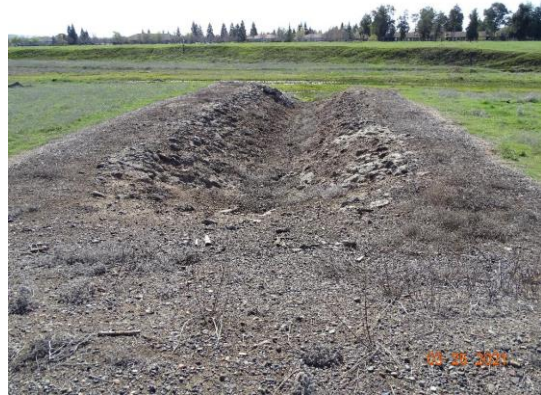
Photo 2 of 3 : UCIP_FA_2022_67687_100571.jpg

Water-Side: View of levee slope looking from crown

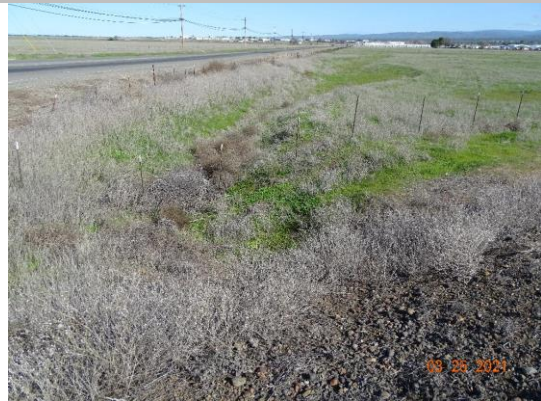
Photo 3 of 3 : UCIP_FA_2022_67687_100572.jpg

Land-Side: View of levee slope looking from crown

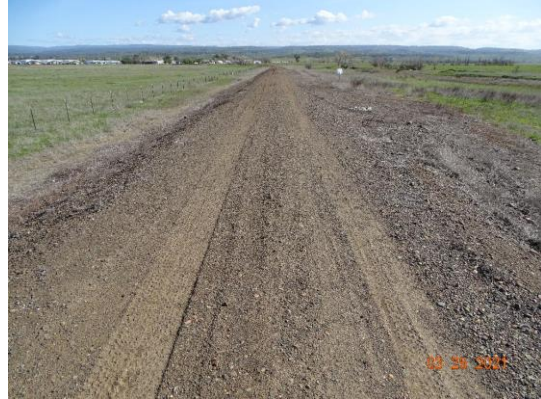
Photo 1 of 3 : UCIP_FA_2022_67688_100576.jpg

Comment Code						
Inspector Comment						
DS_ID:19274 FS_ID:67688 EP_NO: N/A Repair Type: Non-Urgent EVAL Issue: Crossing Status: Not Found UCIP Comments: 03/25/2021 Record is Non-Urgent. Crossing not found. Geophysical results did not confirm presence of pipe through levee. Record will remain in UCIP's inspection records until future Levee Improvement Project can confirm no crossing was found through the levee. No permit has been identified authorizing pipe. (O.Yakimov - DWR UCIP)						
FIELD_STRUCT_DESC: 24-inch corrugated metal gravity drainage pipe through the levee, 10 feet below the crown. Flap gate on the waterside (WS) end. Concrete U-shaped headwall on each end. Grouted riprap apron on the landside (LS) end. Grouted riprap spillway on the WS end. [Additional Reference(s): DWR Levee Log, 1992 (HLM 3.78). USACE Sacramento O&M Manual, Unit 504, May 1965, Revised 2 February 2011, (HLM 3.78), listed as 24-inch pipe. USACE As-Built Drawing No. 50-04-3685, Sheet 11, STA 488+20, 19 May 1965]. FS Date: 3/25/2021 1:25:15 PM

Top of Levee: View of levee crown looking upstream

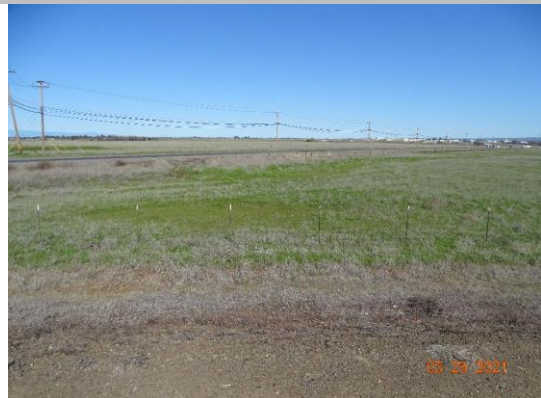
Photo 2 of 3 : UCIP_FA_2022_67688_100577.jpg

Land-Side: View of levee slope looking from crown

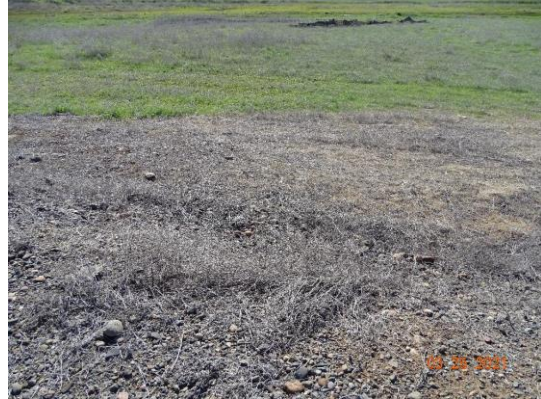
Photo 3 of 3 : UCIP_FA_2022_67688_100578.jpg

Water-Side: View of levee slope looking from crown

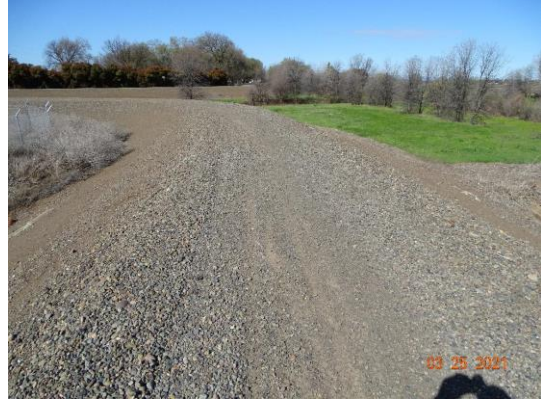
Photo 1 of 3 : UCIP_FA_2022_67692_100580.jpg

Comment Code					
Inspector Comment					
DS_ID:19279 FS_ID:67692 EP_NO: N/A Repair Type: Non-Urgent EVAL Issue: Crossing Status: Found UCIP Comments: 03/25/2021 Record remains Non-Urgent. No permit has been identified authorizing pipe. DMP internal video inspection has not found pipe integrity issues. LOF of crossing is less or equal to 4. Recommend next video inspection in 5 years. (O.Yakimov - DWR UCIP) 03/07/2014 Needs cleaning and clearing the culvert (P. Amatya - DWR UCIP) FIELD_STRUCT_DESC: 24-inch corrugated metal gravity drainage pipe through the levee, 10 feet below the crown. Flap gate on the waterside (WS) end. Concrete U-shaped headwall on each end. Grouted riprap apron on the landside (LS) end. Grouted riprap spillway on the WS end. [Additional Reference(s): DWR Levee Log, 1992 (HLM 0.28). USACE Sacramento O&M Manual, Unit 504, May 1965, Revised 2 February 2011, (HLM 0.28), listed as 24-inch pipe. USACE As-Built Drawing No. 50-04-3685, Sheets 11 and 41, STA 464+00, 19 May 1965]. FS Date: 3/25/2021 2:10:39 PM

Top of Levee: View of levee crown looking downstream
