**Flood Control Project Maintenance
Levee Inspections**

Maintenance Issue Types Only, Levee Inspection Report By Mile - Fall 2022

Butte County Department of Public Works

Waterway	Bank	Unit Miles	Inspection Start/End	Inspector
Unit No. 01 Mud Creek	Right	6.80	10/04/2022 10/04/2022	Makar Sokol

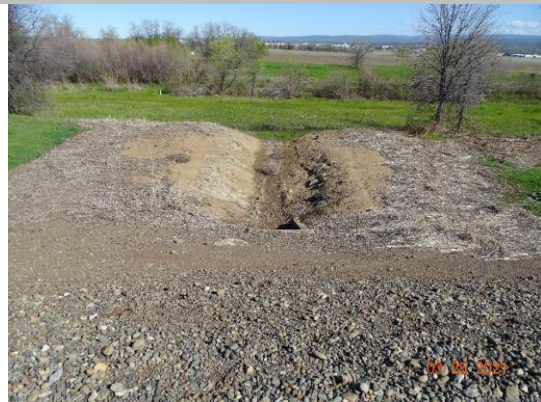
Photo 2 of 3 : UCIP_FA_2022_67692_100581.jpg

Comment Code					
Inspector Comment					
DS_ID:19279 FS_ID:67692 EP_NO: N/A Repair Type: Non-Urgent EVAL Issue: Crossing Status: Found UCIP Comments: 03/25/2021 Record remains Non-Urgent. No permit has been identified authorizing pipe. DMP internal video inspection has not found pipe integrity issues. LOF of crossing is less or equal to 4. Recommend next video inspection in 5 years. (O.Yakimov - DWR UCIP) 03/07/2014 Needs cleaning and clearing the culvert (P. Amatya - DWR UCIP) FIELD_STRUCT_DESC: 24-inch corrugated metal gravity drainage pipe through the levee, 10 feet below the crown. Flap gate on the waterside (WS) end. Concrete U-shaped headwall on each end. Grouted riprap apron on the landside (LS) end. Grouted riprap spillway on the WS end. [Additional Reference(s): DWR Levee Log, 1992 (HLM 0.28). USACE Sacramento O&M Manual, Unit 504, May 1965, Revised 2 February 2011, (HLM 0.28), listed as 24-inch pipe. USACE As-Built Drawing No. 50-04-3685, Sheets 11 and 41, STA 464+00, 19 May 1965]. FS Date: 3/25/2021 2:10:39 PM

Water-Side: View of levee slope looking from crown

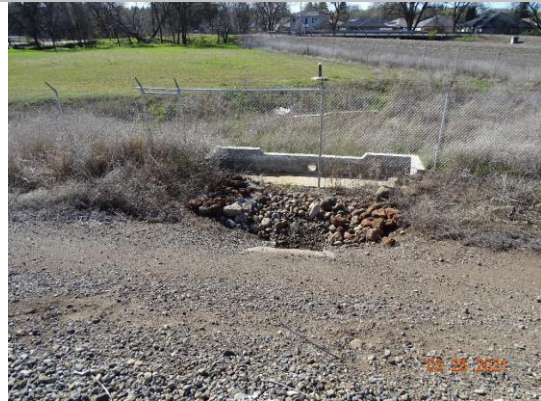
Photo 3 of 3 : UCIP_FA_2022_67692_100582.jpg

Land-Side: View of levee slope looking from crown

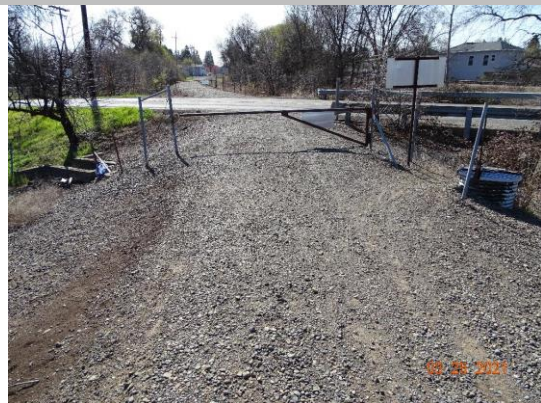
Photo 1 of 3 : UCIP_FA_2022_67693_100586.jpg

DS_ID:19280
FS_ID:67693
EP_NO: N/A
Repair Type: Non-Urgent
EVAL Issue:
Crossing Status: Found
UCIP Comments: 03/25/2021 Record remains Non-Urgent. Debris around on inlet has been cleared. No permit has been identified authorizing pipe. DMP internal video inspection has not found pipe integrity issues. LOF of crossing is less or equal to 4. Recommend next video inspection in 5 years. (O.Yakimov - DWR UCIP)
03/07/2014 Slide gate in a CMP riser. Vegetation debris and mud on inlet box. Needs cleaning and clearing the culvert. (P. Amatya - DWR UCIP)
FIELD_STRUCT_DESC: 24-inch corrugated metal gravity drainage pipe through the levee and under the channel, 9.5 feet below the crown. Slide gate in a corrugated metal pipe (CMP) riser on the waterside (WS) slope. Concrete U-shaped headwall on the landside (LS) end. [Additional Reference(s): DWR Levee Log, 1992 (HLM 0.34). USACE Sacramento O&M Manual, Unit 504, May 1965, Revised 2 February 2011, (HLM 0.34), listed as 24-inch pipe. USACE As-Built Drawing No. 50-04-3685, Sheet 11, between STA 2+20 and STA 3+20, 19 May 1965, shown as existing siphon through both levees and under channel]. FS Date: 3/25/2021 2:16:53 PM

Top of Levee: View of levee crown looking upstream

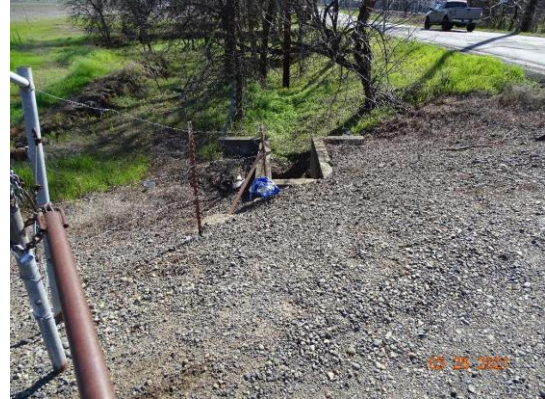
Photo 2 of 3 : UCIP_FA_2022_67693_100588.jpg

Land-Side: View of levee slope looking from crown

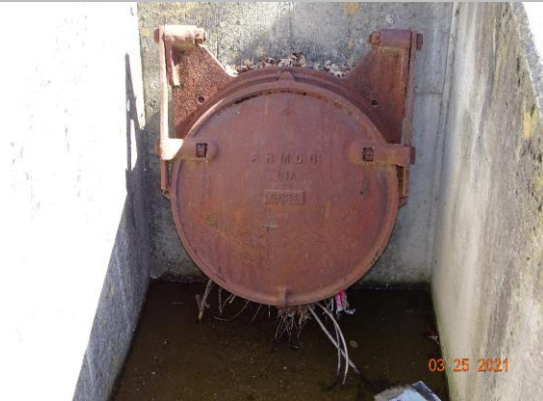
Photo 1 of 3 : UCIP_FA_2022_67694_100595.jpg

Comment Code					
Inspector Comment					
DS_ID:19281 FS_ID:67694 EP_NO: N/A Repair Type: Urgent EVAL Issue: 3a, Flood Risk Crossing Status: Found UCIP Comments: 03/25/2021 Record updated from Non-Urgent to Urgent. Debris inside pipe holds flap gate from complete closing. Backflow may cause flood risk to landside. No permit has been identified authorizing pipe. DMP internal video inspection has not found pipe integrity issues. LOF of crossing is less or equal to 4. Recommend next video inspection in 5 years. (O.Yakimov - DWR UCIP) 03/07/2014 Needs cleaning and clearing the culvert. (P. Amatya - DWR UCIP) FIELD_STRUCT_DESC: 24-inch corrugated metal gravity drainage pipe through the levee, 8 feet below the crown. Flap gate on the waterside (WS) end. Concrete U-shaped headwall on each end. Grouted riprap apron on the landside (LS) end. Grouted riprap spillway on the WS end. [Additional Reference(s): DWR Levee Log, 1992 (HLM 0.36). USACE Sacramento O&M Manual, Unit 504, May 1965, Revised 2 February 2011, (HLM 0.36), listed as 24-inch pipe. USACE As-Built Drawing No. 50-04-3685, Sheets 11 and 41, STA 4+20, 19 May 1965]. FS Date: 3/25/2021 2:21:16 PM

Water-Side: Headwall and flap gate at levee toe

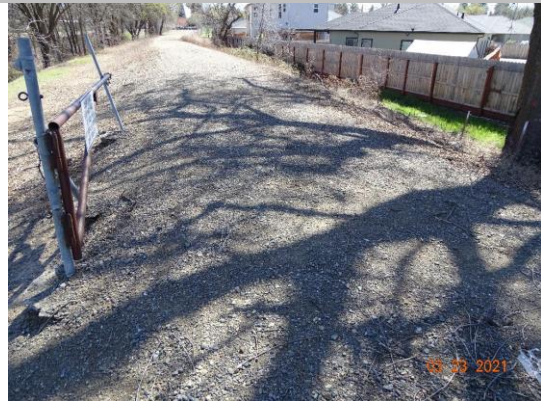
Photo 1 of 3 : UCIP_FA_2022_67765_100840.jpg

Comment Code					
Inspector Comment					
DS_ID:19287 FS_ID:67765 EP_NO: N/A Repair Type: Non-Urgent EVAL Issue: Crossing Status: Found UCIP Comments: 03/23/2021 Record remains Non-Urgent. Debris has been cleared. No permit has been identified authorizing pipe. DMP internal video inspection has not found pipe integrity issues. LOF of crossing is less or equal to 4. Recommend next video inspection in 5 years. (O.Yakimov - DWR UCIP) 03/07/2014 Needs cleaning and clearing the culvert. (P. Amatya - DWR UCIP) FIELD_STRUCT_DESC: 24-inch corrugated metal gravity drainage pipe through the levee, 9 feet below the crown. Flap gate on the waterside (WS) end. Concrete U-shaped headwall on each end. Grouted riprap apron on the landside (LS) end. Grouted riprap spillway on the WS end. [Additional Reference(s): DWR Levee Log, 1992 (HLM 0.96). USACE Sacramento O&M Manual, Unit 504, May 1965, Revised 2 February 2011, (HLM 0.96), listed as 24-inch pipe. USACE As-Built Drawing No. 50-04-3685, Sheets 11 and 41, STA 4+00, 19 May 1965]. FS Date: 3/23/2021 2:28:32 PM

Top of Levee: View of levee crown looking upstream

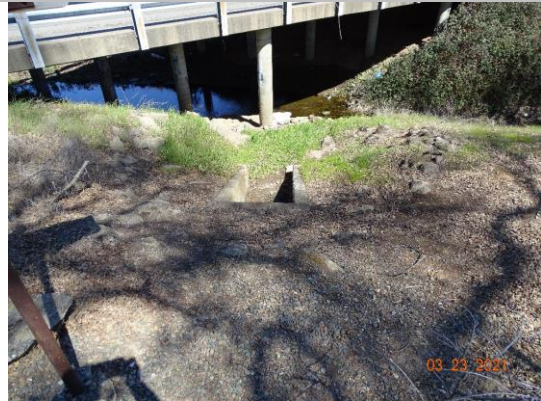
Photo 2 of 3 : UCIP_FA_2022_67765_100841.jpg

Water-Side: View of levee slope looking from crown

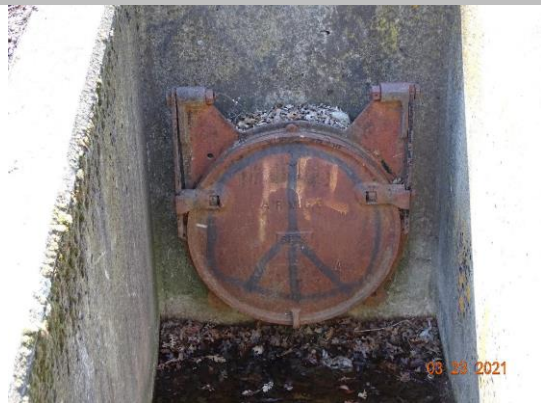
Photo 3 of 3 : UCIP_FA_2022_67765_100845.jpg

Water-Side: Headwall and flap gate at levee toe

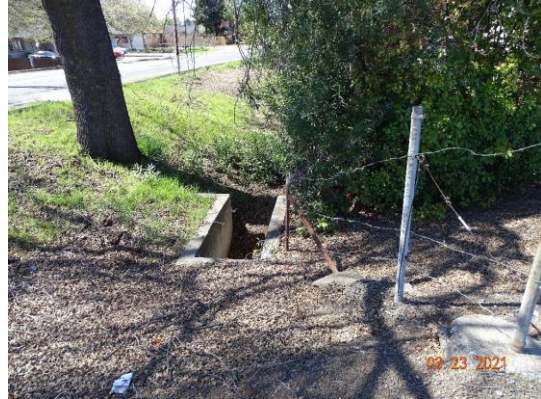
Photo 1 of 3 : UCIP_FA_2022_67774_100885.jpg

Comment Code					
Inspector Comment					
DS_ID:19288 FS_ID:67774 EP_NO: N/A Repair Type: Non-Urgent EVAL Issue: 5, Pipe Damage Crossing Status: Found UCIP Comments: 03/23/2021 Record remains Non-Urgent. DMP internal video inspection has found pipe integrity issues. LOF of crossing is greater than or equal to 4.1 and less than 5. Crossing will be monitored until funding becomes available for rehabilitation. No permit has been identified authorizing pipe. (O.Yakimov - DWR UCIP) 03/07/2014 Slide gate in CMP riser on waterside. No access to CMP riser.Needs cleaning and clearing the culvert. (P. Amatya - DWR UCIP) FIELD_STRUCT_DESC: 24-inch corrugated metal gravity drainage pipe through the levee and under the channel, 9.5 feet below the crown. Slide gate in a pipe riser on the waterside (WS) slope. Concrete U-shaped headwall on the landside (LS) end. [Additional Reference(s): USACE Levee Log, 1992 (HLM 0.98). USACE Sacramento O&M Manual, Unit 504, May 1965, Revised 2 February 2011, (HLM 0.98), listed as 24-inch pipe. USACE As-Built Drawing No. 50-04-3685, Sheet 11, between STA 2+20 and STA 3+20, 19 May 1965, shown as existing siphon through both levees and under channel]. FS Date: 3/23/2021 3:07:34 PM

Land-Side: View of levee slope looking from crown

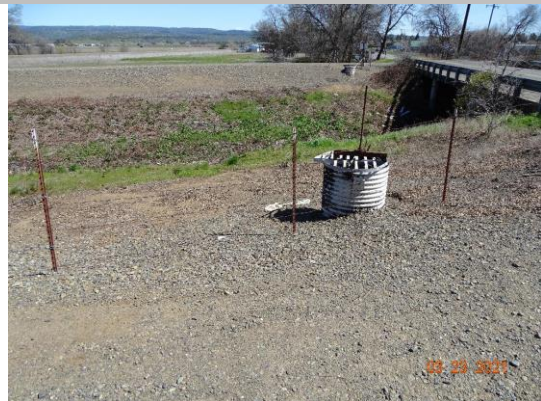
Photo 2 of 3 : UCIP_FA_2022_67774_100886.jpg

Water-Side: View of levee slope looking from crown. CMP riser with slide gate on levee slope

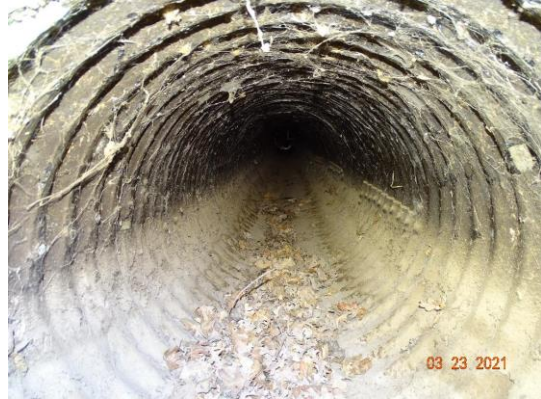
Photo 3 of 3 : UCIP_FA_2022_67774_100888.jpg

Land-Side: View inside of pipe looking from landside end

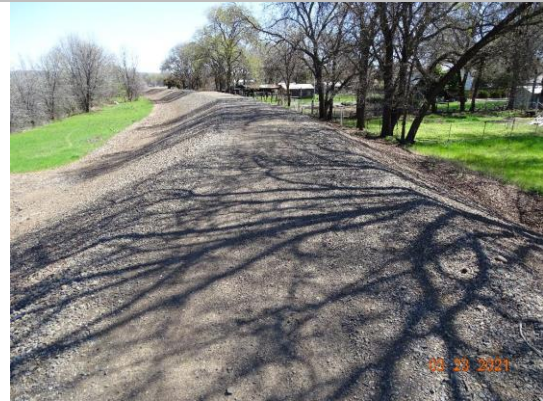
Photo 1 of 3 : UCIP_FA_2022_67776_100894.jpg

Comment Code						
Inspector Comment						
DS_ID:19289 FS_ID:67776 EP_NO: N/A Repair Type: Non-Urgent EVAL Issue: 11, Maintenance Compliance Issue Crossing Status: Found UCIP Comments: 03/23/2021 Record remains Non-Urgent. Flap gate at waterside headwall is stuck closed. Hinges may need lubrication. No permit has been identified authorizing pipe. DMP internal video inspection has not found pipe integrity issues. LOF of crossing is less or equal to 4. Recommend next video inspection in 5 years. (O.Yakimov - DWR UCIP) 03/07/2014 Needs cleaning and clearing the culvert. (P. Amatya - DWR UCIP) FIELD_STRUCT_DESC: 24-inch corrugated metal gravity drainage pipe through the levee, 11 feet below the crown. Flap gate on the waterside (WS) end. Concrete U-shaped headwall on each end. Grouted riprap apron on the landside (LS) end. Grouted riprap spillway on the WS end. [Additional Reference(s): DWR Levee Log, 1992 (HLM 1.15). USACE Sacramento O&M Manual, Unit 504, May 1965, Revised 2 February 2011, (HLM 1.15), listed as 24-inch pipe. USACE As-Built Drawing No. 50-04-3685, Sheet 41, STA 455+00, 19 May 1965]. FS Date: 3/23/2021 3:10:19 PM

Top of Levee: View of levee crown looking upstream

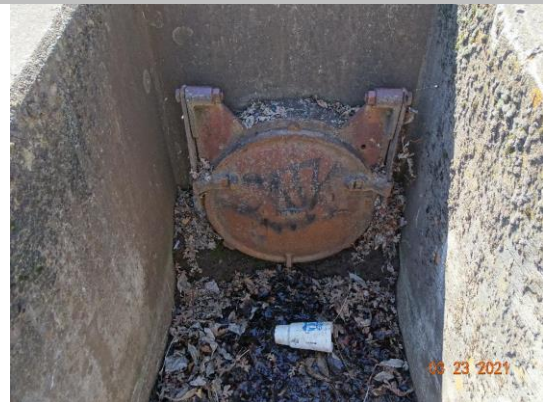
Photo 2 of 3 : UCIP_FA_2022_67776_100899.jpg

Water-Side: U-shaped headwall and flap gate at levee toe

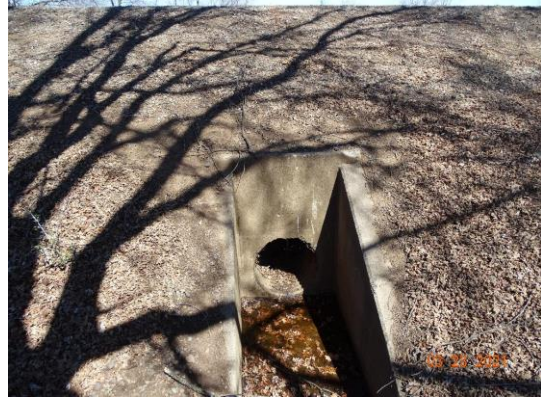
Photo 3 of 3 : UCIP_FA_2022_67776_100897.jpg

Land-Side: Levee slope, headwall, and pipe inlet

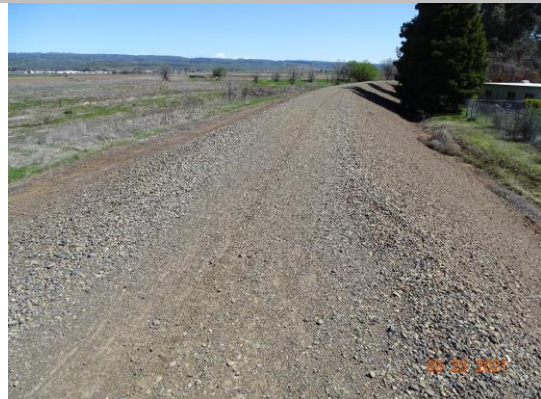
Photo 1 of 3 : UCIP_FA_2022_67777_100900.jpg

DS_ID:19290
 FS_ID:67777
 EP_NO: N/A
 Repair Type: Non-Urgent
 EVAL Issue:
 Crossing Status: Found
 UCIP Comments: 03/23/2021 Record remains Non-Urgent. Debris has been cleared. No permit has been identified authorizing pipe. DMP internal video inspection has not found pipe integrity issues. LOF of crossing is less or equal to 4. Recommend next video inspection in 5 years. (O.Yakimov - DWR UCIP)
 03/07/2014 Needs cleaning and clearing the culvert. (P. Amatya - DWR UCIP)
 FIELD_STRUCT_DESC: 24-inch corrugated metal gravity drainage pipe through the levee, 13 feet below the crown. Flap gate on the waterside (WS) end. Concrete U-shaped headwall on each end. Grouted riprap apron on the landside (LS) end. Grouted riprap spillway on the WS end. [Additional Reference(s): DWR Levee Log, 1992 (HLM 1.39). USACE Sacramento O&M Manual, Unit 504, May 1965, Revised 2 February 2011, (HLM 1.41), listed as 24-inch pipe. USACE As-Built Drawing No. 50-04-3685, Sheets 9 and 40, STA 442+05, 19 May 1965].

Top of Levee: View of levee crown looking upstream

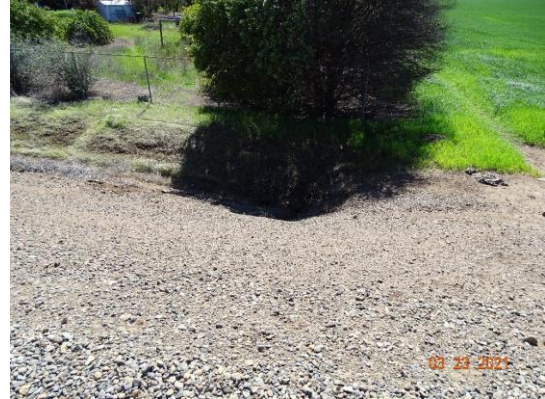
Photo 2 of 3 : UCIP_FA_2022_67777_100901.jpg

Land-Side: View of levee slope looking from crown

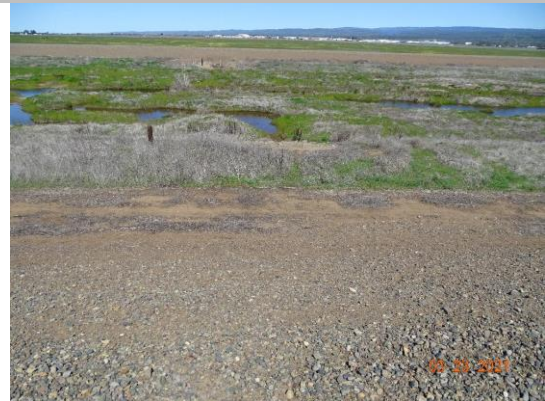
Photo 3 of 3 : UCIP_FA_2022_67777_100902.jpg

Water-Side: View of levee slope looking from crown

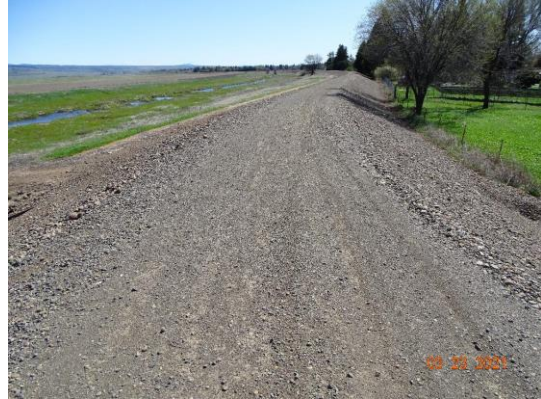
Photo 1 of 3 : UCIP_FA_2022_67779_100908.jpg

Comment Code					
Inspector Comment					
DS_ID:19291 FS_ID:67779 EP_NO: N/A Repair Type: Non-Urgent EVAL Issue: 5, Pipe Damage Crossing Status: Found UCIP Comments: 03/23/2021 Record remains Non-Urgent. Debris has been cleared. DMP internal video inspection has found pipe integrity issues. LOF of crossing is greater than or equal to 4.1 and less than 5. Crossing will be monitored until funding becomes available for rehabilitation. No permit has been identified authorizing pipe. (O.Yakimov - DWR UCIP) 03/07/2014 Needs cleaning and clearing the culvert. (P. Amatya - DWR UCIP) FIELD_STRUCT_DESC: 24-inch corrugated metal gravity drainage pipe through the levee, 11 feet below the crown. Flap gate on the waterside (WS) end. Concrete U-shaped headwall on each end. Grouted riprap apron on the landside (LS) end. Grouted riprap spillway on the WS end. [Additional Reference(s): DWR Levee Log, 1992 (HLM 2.22). USACE Sacramento O&M Manual, Unit 504, May 1965, Revised 2 February 2011, (HLM 2.22), listed as 24-inch pipe. USACE As-Built Drawing No. 50-04-3685, Sheets 9 and 41, STA 400+00, 19 May 1965]. FS Date: 3/23/2021 3:17:08 PM

Top of Levee: View of levee crown looking upstream

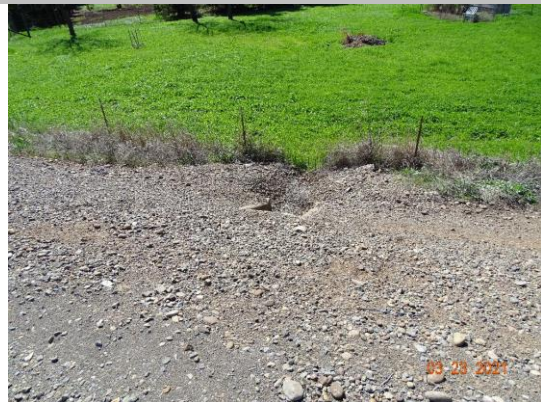
Photo 2 of 3 : UCIP_FA_2022_67779_100909.jpg

Land-Side: View of levee slope looking from crown

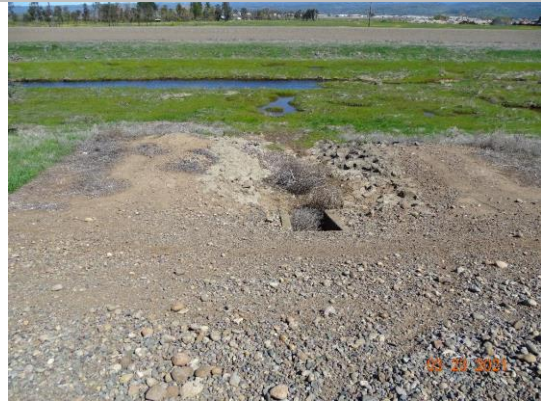
Photo 3 of 3 : UCIP_FA_2022_67779_100910.jpg

Water-Side: View of levee slope looking from crown

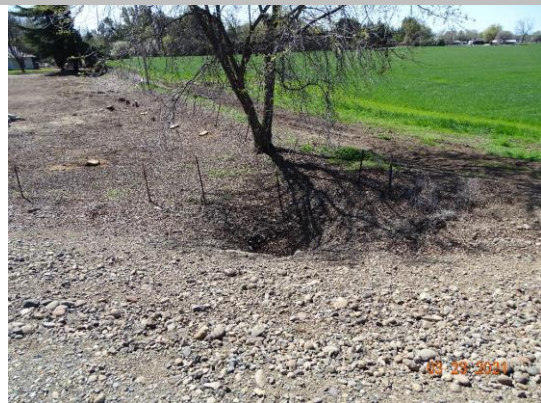
Photo 1 of 3 : UCIP_FA_2022_67780_100915.jpg

DS_ID:19292
FS_ID:67780
EP_NO: N/A
Repair Type: Non-Urgent
EVAL Issue: 5, Pipe Damage
Crossing Status: Found
UCIP Comments: 03/23/2021 Record remains Non-Urgent. Debris has been cleared. DMP internal video inspection has found pipe integrity issues. LOF of crossing is greater than or equal to 4.1 and less than 5. Crossing will be monitored until funding becomes available for rehabilitation. No permit has been identified authorizing pipe. (O.Yakimov - DWR UCIP)
03/07/2014 Needs cleaning and clearing the culvert. (P. Amatya - DWR UCIP)
FIELD_STRUCT_DESC: 24-inch corrugated metal gravity drainage pipe through the levee, 11 feet below the crown. Flap gate on the waterside (WS) end. Concrete U-shaped headwall on each end. Grouted riprap apron on the landside (LS) end. Grouted riprap spillway on the WS end. [Additional Reference(s): DWR Levee Log, 1992 (HLM 2.56). USACE Sacramento O&M Manual, Unit 504, May 1965, Revised 2 February 2011, (HLM 2.56), listed as 24-inch pipe. USACE As-Built Drawing No. 50-04-3685, Sheets 7 and 41, STA 382+90, 19 May 1965]. FS Date: 3/23/2021 3:19:43 PM

Land-Side: View of levee slope looking from crown

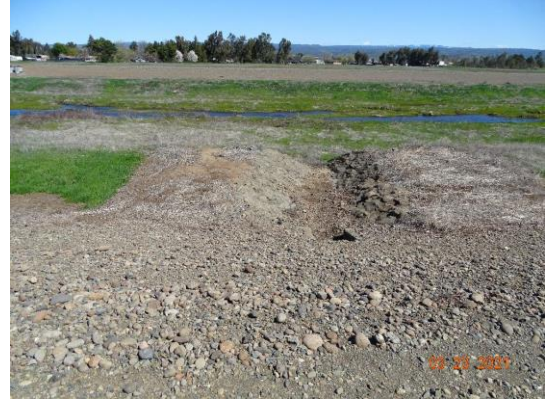
Photo 2 of 3 : UCIP_FA_2022_67780_100916.jpg

Water-Side: View of levee slope looking from crown

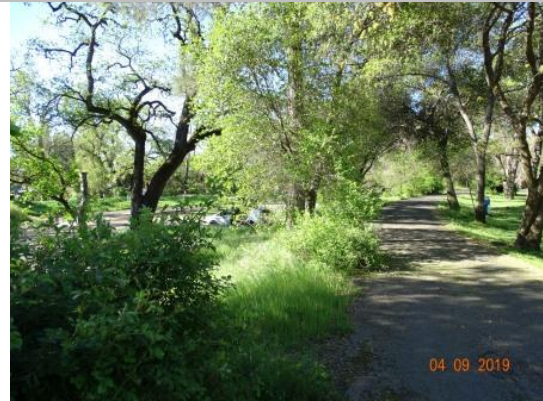
Photo 1 of 1 : FA_2022_NA0003_69_1_20220906_00001.jpg

LM Start	0.03	Rating **	M	Issue No.	1
LM End	0.20	Issue Type +	Ma	Location *	LS
Category	Earthen Levee			GPS Latitude/Longitude	
				Start	End
Item	Vegetation			39.763164 °	39.761860 °
				-121.790335 °	-121.792635 °
DWR ID	DWR_NA0003_05_s_2012_1				
Comment Code					
V2 : Remove the wild growth and woody vegetation other than native grasses from the levee slopes.					
Inspector Comment

View of the wild growth on the landside slope. Spring 2019.
